Data Needs Analysis

Pre-Design Scoping Study

KY 219, Wallins Creek

Harlan County, KY

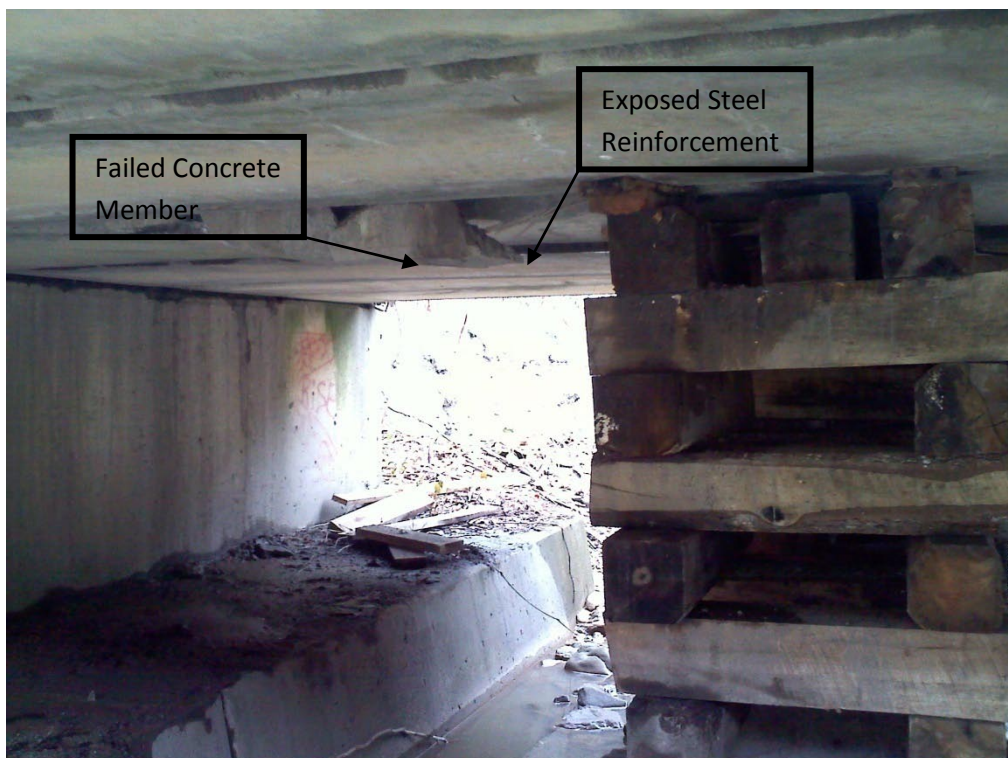
Picture 1: Bridge Substructure

This bridge structure sustained a significant failure on March 18, 2011. Portions of the structure girders collapsed, causing this bridge to be examined for replacement. See Picture 1 below for further illustration.

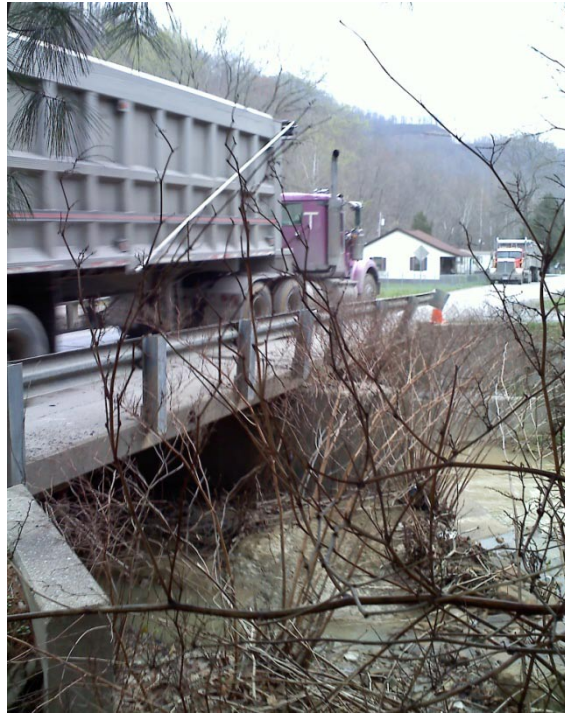
Picture 2: Existing Traffic

Based upon the 2010 traffic forecast map provided by KYTC, below is the traffic summary for KY 219. Also shown in Picture 2 are existing traffic conditions on the narrow bridge.

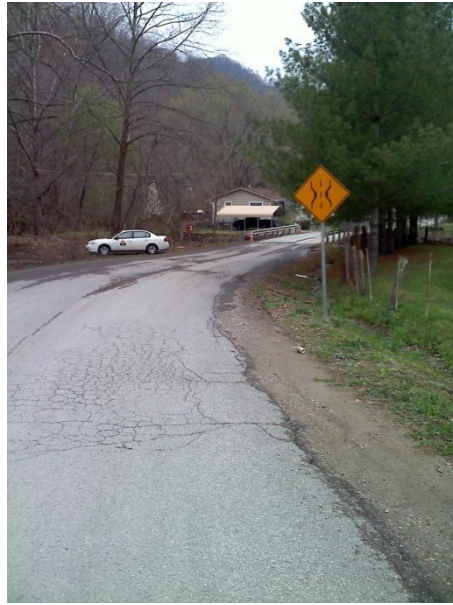
Picture 3: Narrow Bridge Posting

Collision data for KY 219 was obtained using the Kentucky State Police database for the years ranging from 2001 to 2010. No accidents or collisions were reported during this period for the project location. The bridge has a Narrow Bridge warning sign on the south end of the northbound lane. Also shown in Picture 4 is the steel deck panel that was placed over the existing concrete deck due to the failure of the original deck member, and the existing mangled guardrail. Pictures 3 and 4 below show the existing site conditions.

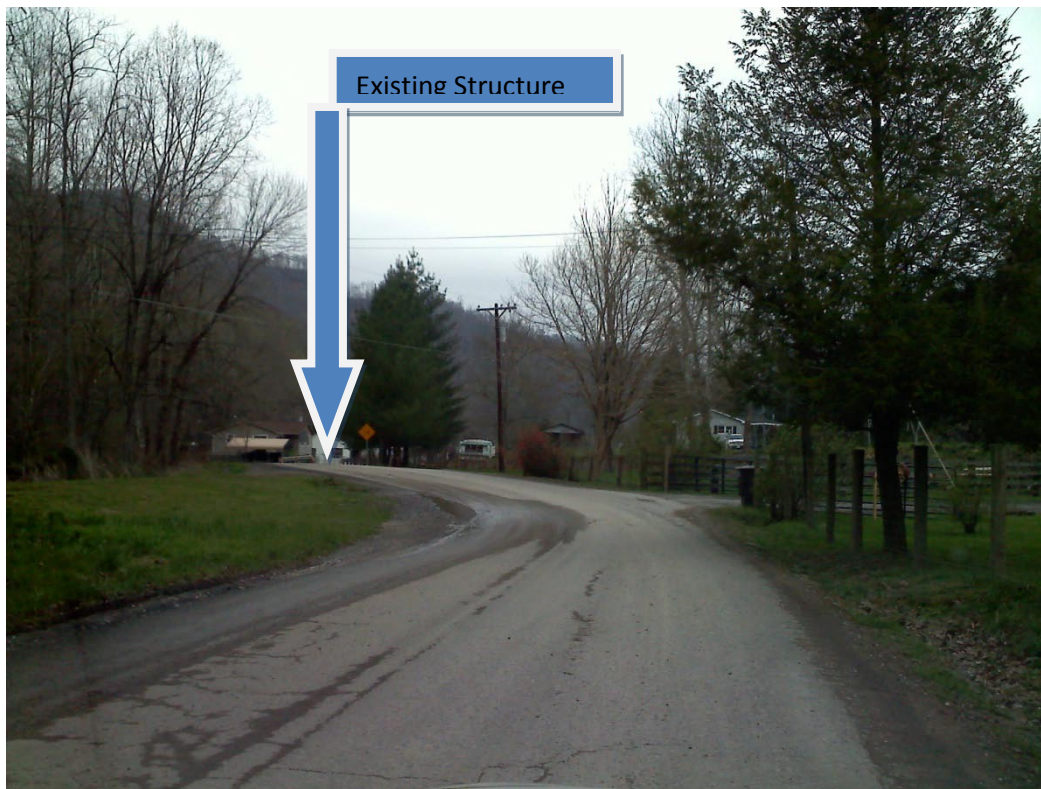
Picture 5: Southern Approach Curve

The current posted speed limit for this project is 55 mph. Currently, immediately upon exiting the bridge northbound on KY 219, Santa Lane intersects KY 219 at approximately 90 degrees from the East. Santa Lane is a rural local access road. The existing curve on the southern approach to the structure is of substandard radius.

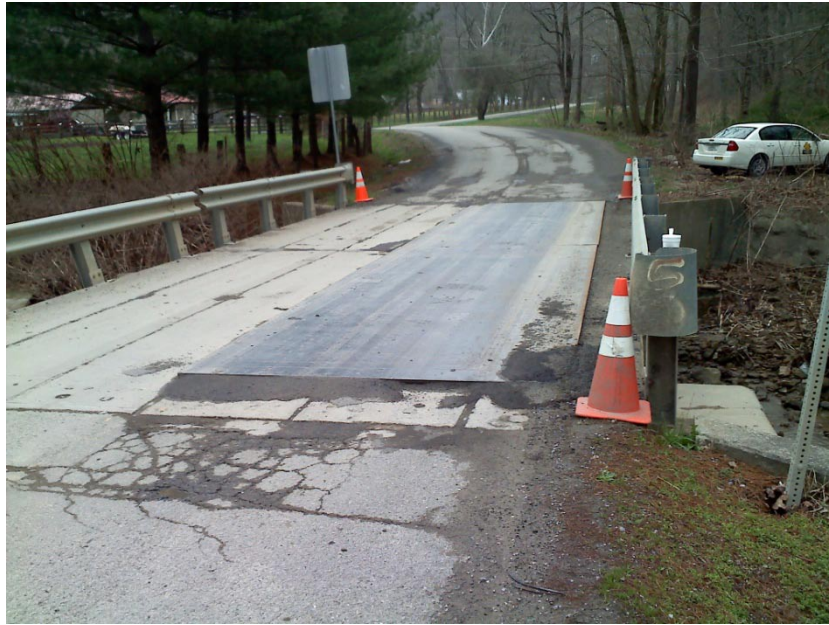
Picture 6: Existing Bridge Conditions

As mentioned earlier, this bridge has a Narrow Bridge warning sign on the southern end. As can be seen from the pictures below, the existing surface has deteriorated to the extent that the concrete beams beneath the deck are visible. Also, portions of the existing substructure have experienced failure. KYTC maintenance crews have placed temporary steel deck plates to allow traffic access to the bridge.

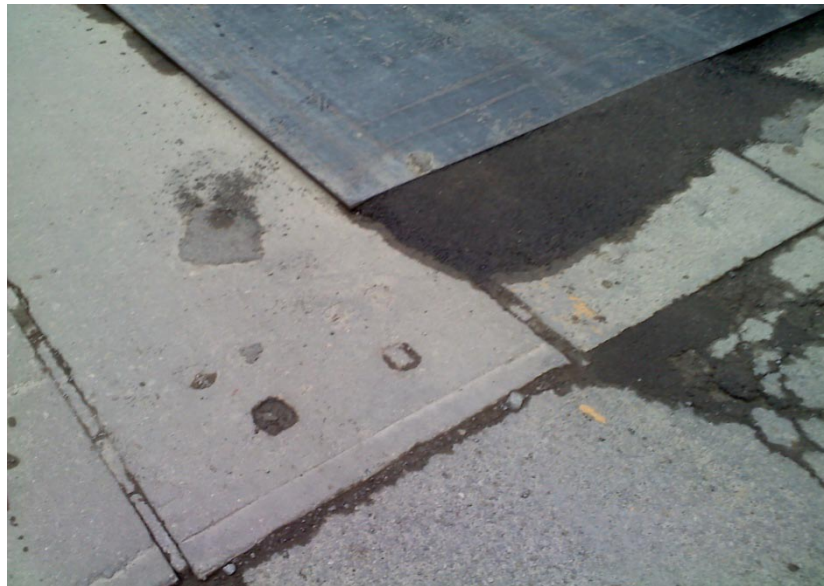
Picture 7: Existing Deck Conditions

Str Unit	Elm/Env	Description	Element Notes
1	12/1	Concrete Deck - Bare	SPALLED @ JOINTS. PATCHED SPOTS, CRKS, WORN
1	104/1	P/S Conc Closed Web/Box Girder	BM #3 IN SOUTH SPAN HAS ALMOST COMPLETELY FAILED DUE TO HEAVY COAL TRUCK TRAFFIC. SPAN HAS BEEN CRIBBED UNDER, AND STEEL PLATE PLACED ON BEAMS. LARGE SPALL (4"X30"X6") IN BOTTOM OF BM 4 OF SPAN 1 BROKEN LOOSE AND HANGING BY PRESTRESSING STRAND. NUMEROUS LARGER THAN HL TRANS STRESS CRKS THRUOUT
1	210/1	Reinforced Conc Pier Wall	DUE TO STREAMWEAR
1	215/1	Reinforced Conc Abutment	NO BAD PROBLEMS. SUPERFICIAL STREAMWEAR N. ABUT.
1	301/1	Pourable Joint Seal	NEED REPLACED @ PIER
1	334/1	Metal Bridge Railing - Coated	RAILS NOT CONNECTED @ PIER. LOOSE, WEAK. IMPACT THRUOUT
1	358/1	Deck Cracking	DECK (PCPS SLAB BEAMS) HAVE CRACKED DUE TO HEAVY COAL TRAFFIC
1	363/1	Section Loss	Prestressing strands rusted. Bm Broken.
1	608/1	Longitudinal Shear Keys	LEAKING IN SPAN #2(NORTH SPAN). BROKEN BETWEEN BMS 2, 3, & 4 IN SPAN #1. ALLOWING BM 3 TO SAG.

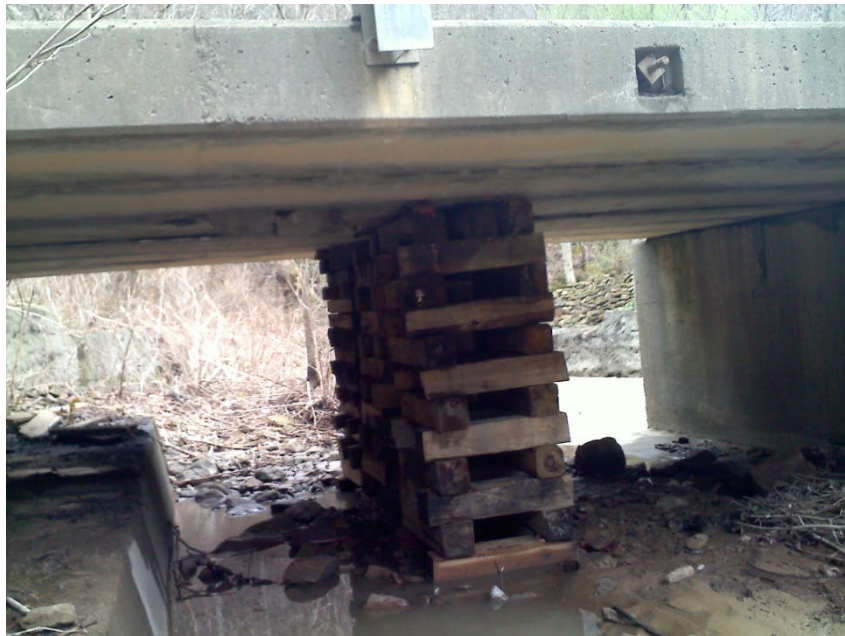
Picture 8: Existing Substructure Conditions

Table 3 lists some general characteristics from the latest bridge inspection performed March 2011. Some comments include: Beam #3 in south span has almost completely failed due to heavy coal truck traffic, guardrail not connected @ pier. See Appendix A for full structure report.
