Inspection Report with SI&A Data

Structure Description: 417.98 Foot - 3 Span Steel continuous Stringer/Multi-beam or Girder

7 Facility Carried: I-64

6A Feature Intersected: TYGARTS CREEK

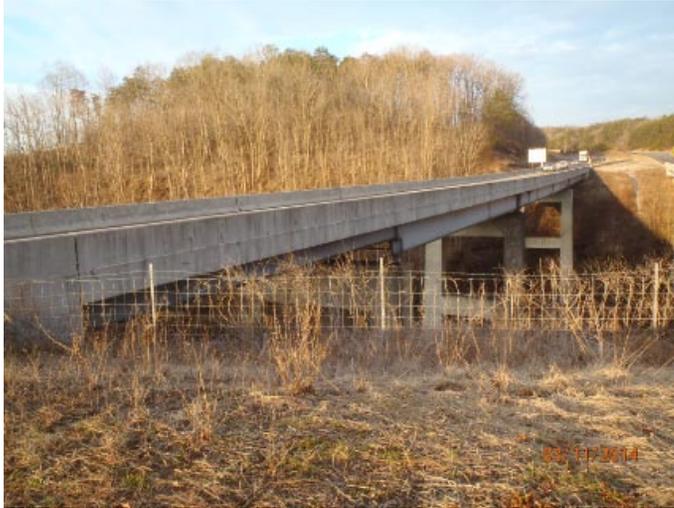
View from the north end of abutment 5.

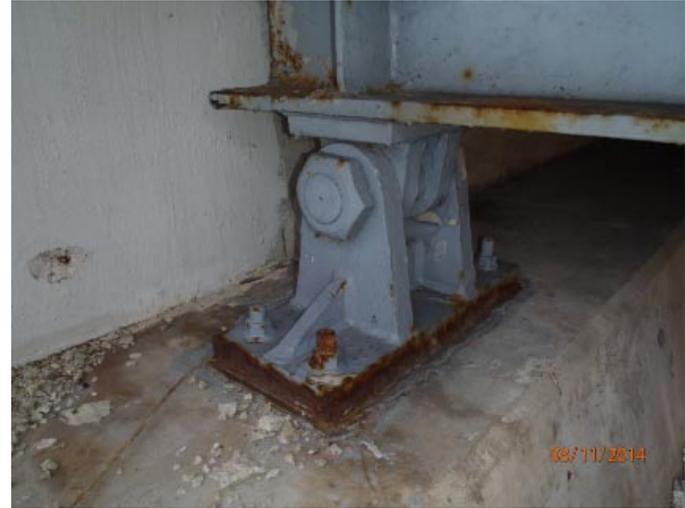
View of the north bearing at abutment 5.

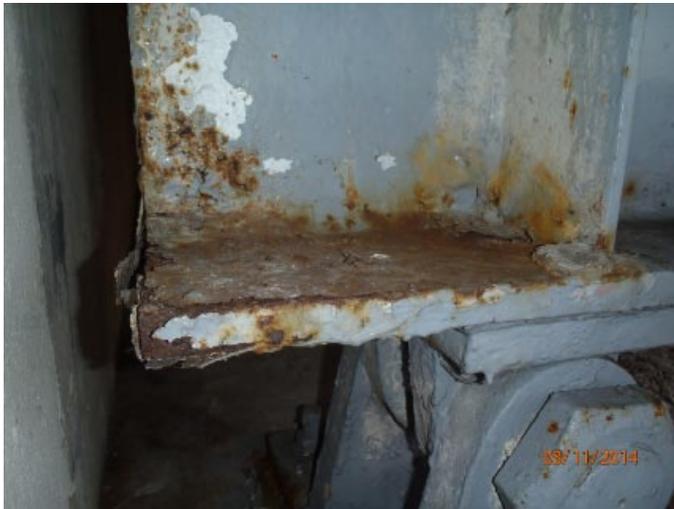
View of minor corrosion at the end of the bottom flange of the north beam at abutment 5.

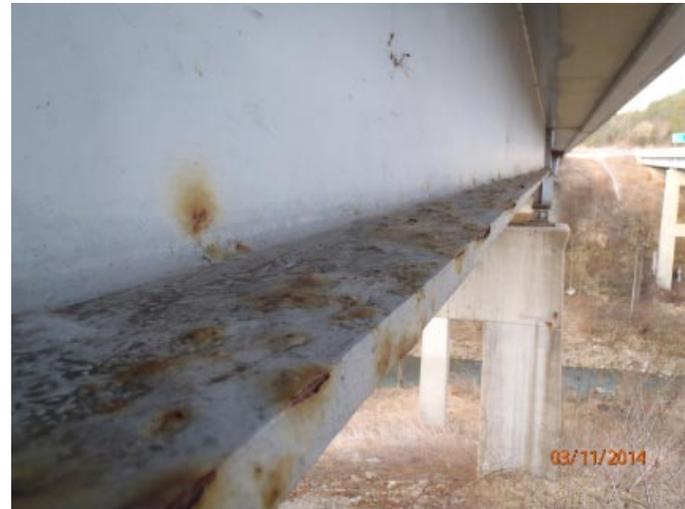
The lower exterior flanges of the exterior beams have bubbling, flaking paint with the exposed steel typically having minor corrosion. The paint is failing and flaking off in large areas between beams 1 & 2 from the south in span 1. Several moderate to large areas of paint failure are present throughout the structure. The interior beam ft.s splice plates on the bottom flanges exhibit minor rusting and corrosion with minor bulging while the exterior beam ft.s have more moderate corrosion and bulging at the bottom flange splice plates. Minor rusting and corrosion are also present in the beam ft.s ends over pier 4. See photos.

View of bubbling and flaking paint with minor rusting corrosion along the bottom flange of the north beam in span 4.

Spot painting or replacing the paint system should be considered. Generated by agreiner on 03/12/2014

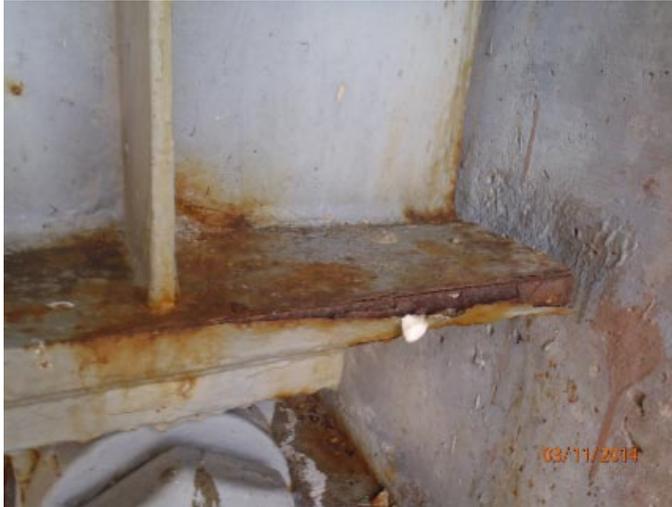
View of flaking paint and minor corrosion in the bottom flange of the south exterior beam at abutment 5.

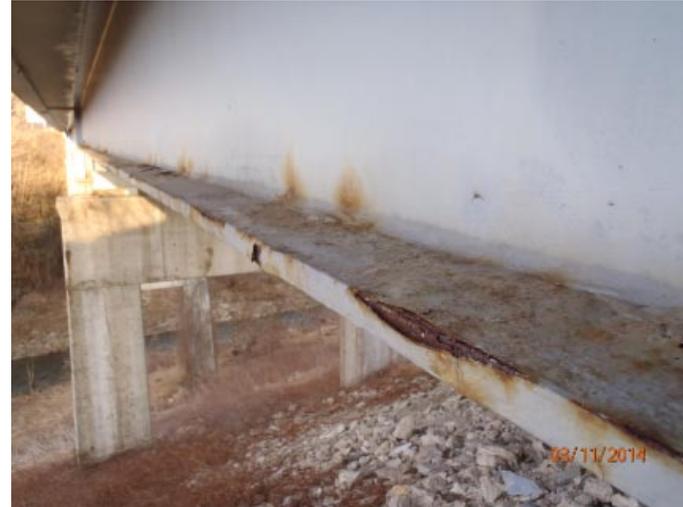
View of bubbling and flaking paint with minor rusting corrosion along the bottom flange of the south beam in span 4.

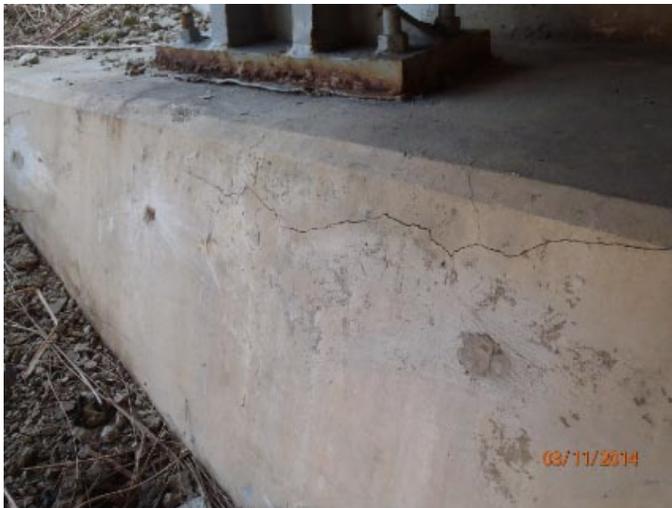
The breast wall of abutment 5 has minor horizontal cracking at the north end for approximately 3 ft.. Water is running down each side of abutment 1 during rain events and this is allowing water to pool up on the breast wall. This is causing accelerated deterioration of the bearings and masonry plates at abutment 1. Some minor cracking is present in the breast wall. See photos.

View of minor horizontal cracking in the north end of abutment 5's breastwall.

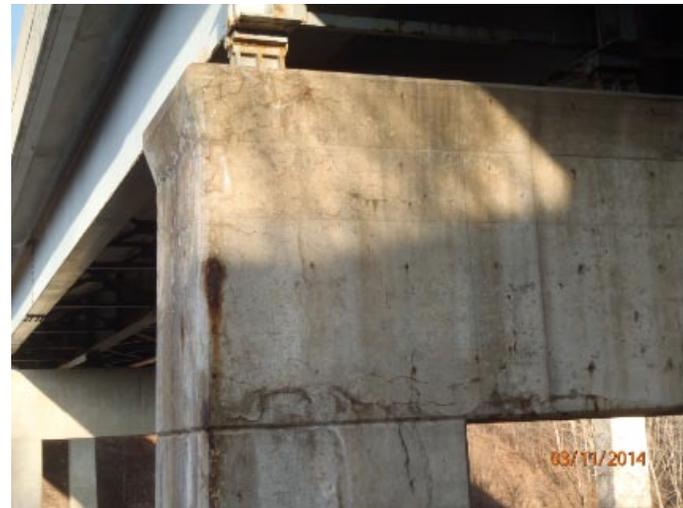
The south end of pier cap 4 has moderate spalling with exposed steel and vertical cracking that extends down into the column. The north end of the pier cap has some shallow spalling with exposed steel. The underside of pier cap 4 has minor to moderate cracking for the visible length of the cap underside. See photos.

View of minor cracking at the south end of pier cap 4 in span 4.

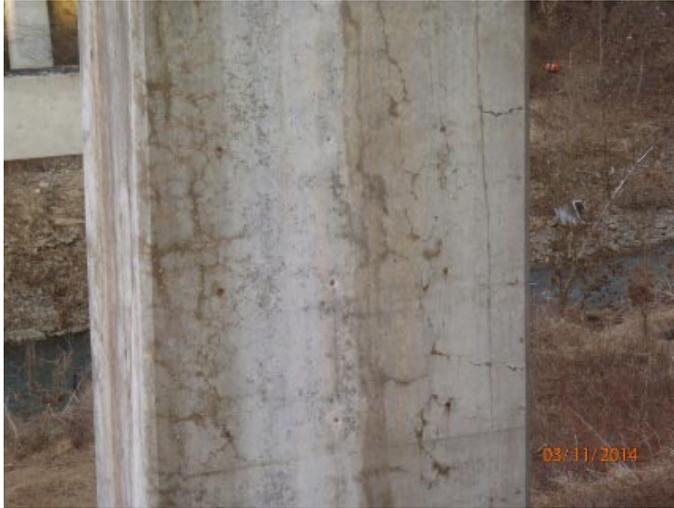
View of minor cracking in the east face of the south column of pier 4.

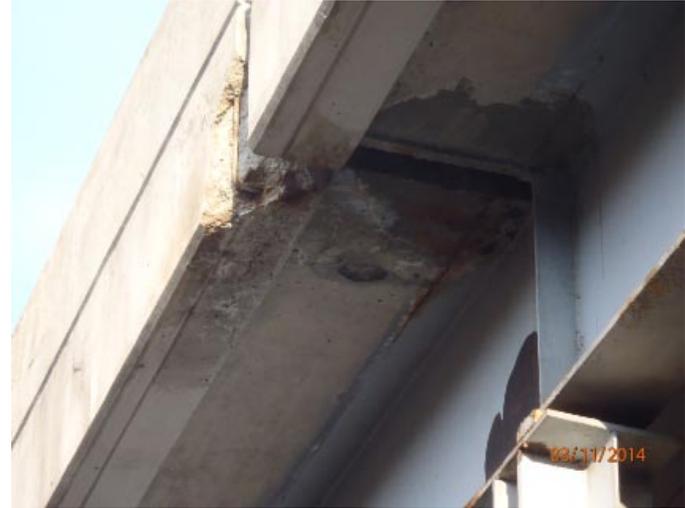
View of a large spall with exposed steel in the south overhang over pier 4.

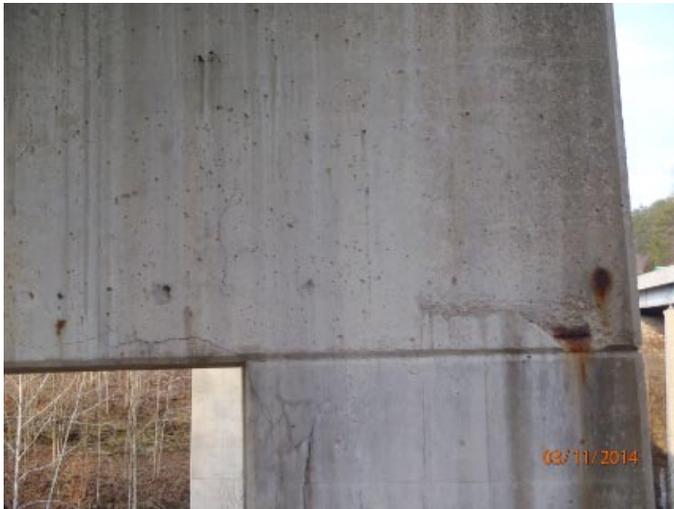
View of minor cracking and spalling with exposed steel at the north end of pier cap 4 in span 4.

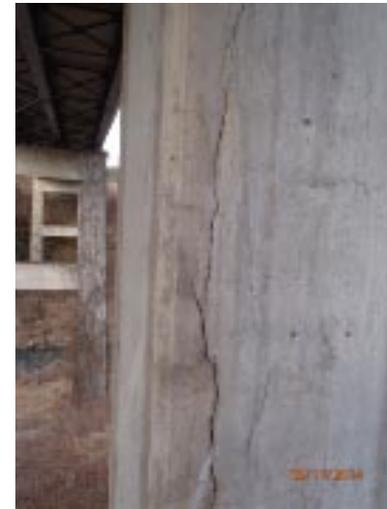
The south column of pier 4 has minor to moderate cracking in all the faces. The west face of the south column has a vertical crack that measured up to 1/4 in. wide, a few feet off the ground. This crack extends from the groundline up to the top of the cap and becomes larger with spalling in the top of the cap. The north column of pier 4 also has minor to moderate cracking in all four faces. The east face has a vertical crack that is up to 1/8 in. wide. See photos.

View of up to a 1/8" wide vertical crack in the east face of the north column of pier 4.

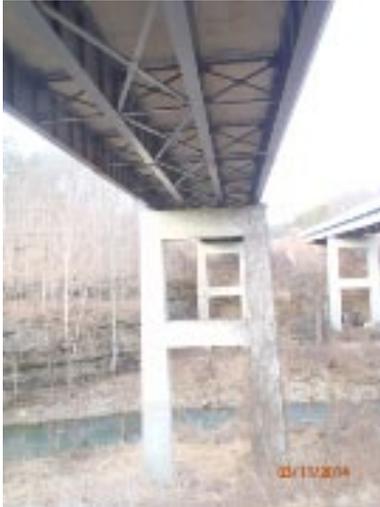
Vegetation in the form of vines are growing up the north side of pier 3. See photos.

View of span 3 and pier 3. Notice the vines on the north column.

Vines should be removed from pier 3. Generated by agreiner on 03/12/2014

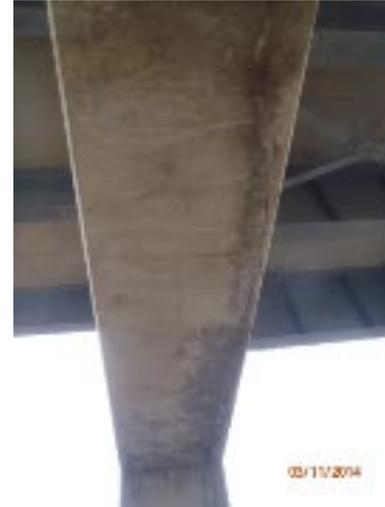
View of minor to moderate cracking along the underside of pier cap 4.

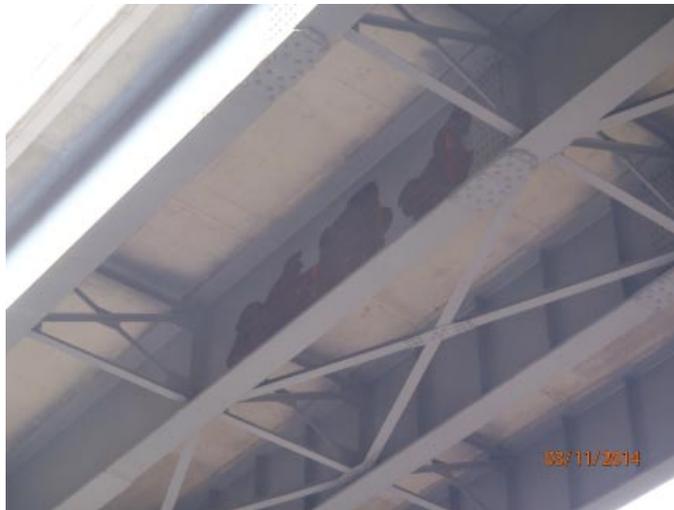
View of a large area of paint failure on beam 2 from the south in span 3 near pier 3.

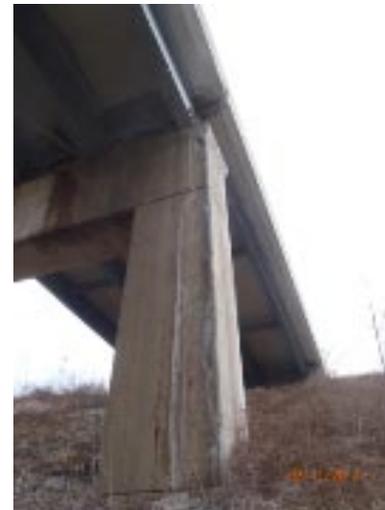
View of moderate cracking and spalling in the west face of the south column and pier cap 4.

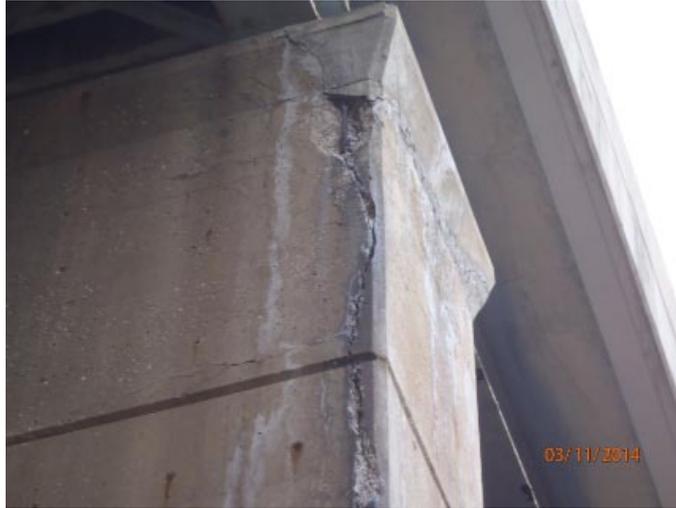
View of moderate spalling with exposed steel in the south end of pier cap 4.

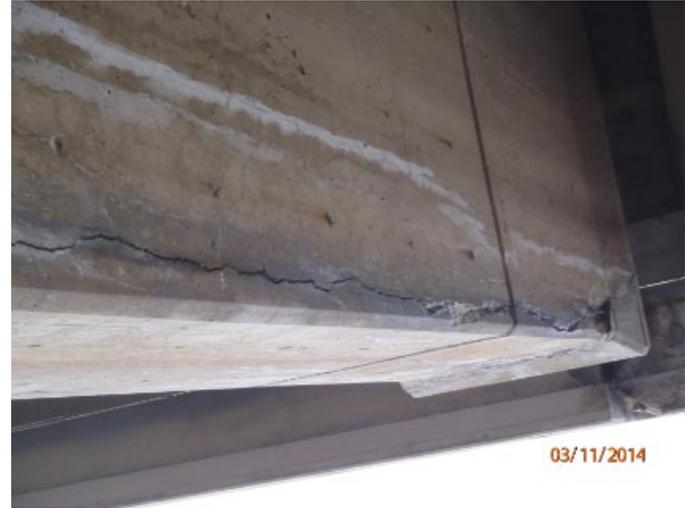
View of moderate vertical cracking (measured up to 1/4") in the west face of the south column of pier 4.

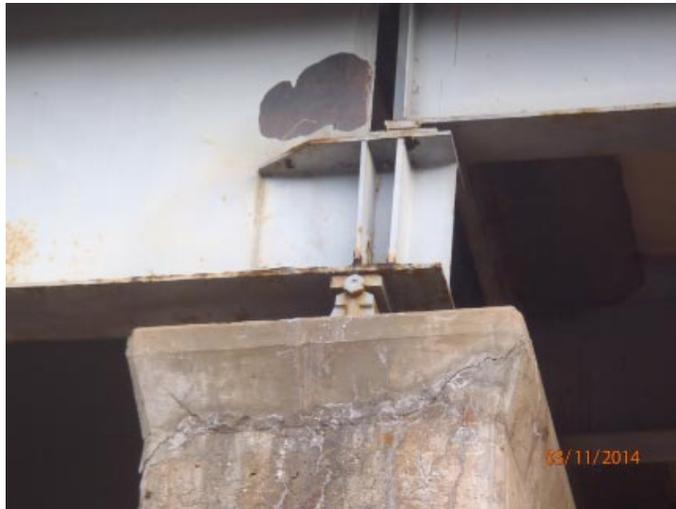
View at the south end of pier 4. Notice the rusting and corrosion along the bottom flange and the area of paint failure.

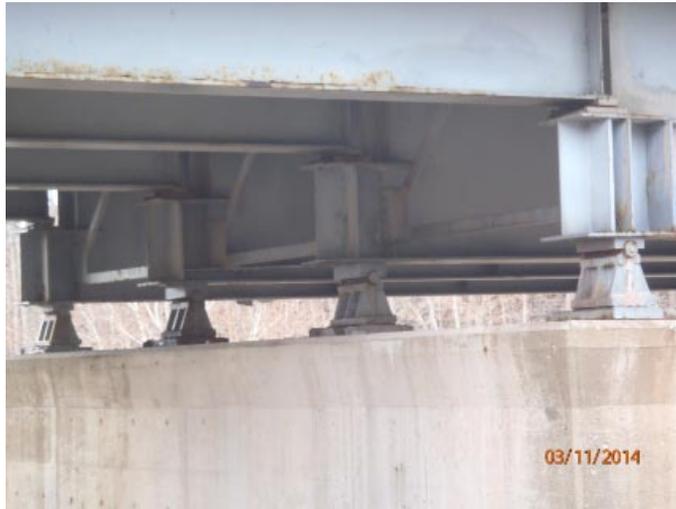
View of the bearings over pier 4.

The bearings at the abutment 1 and pier 4 should be cleaned and coated. Generated by agreiner on 03/12/2014

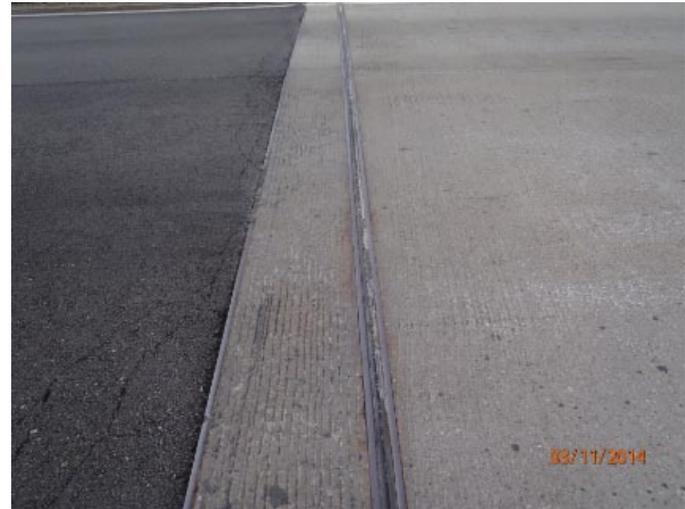
The transverse joints over abutments 1 and 5 have some local adhesion failures. See photos.

View of the transverse joint over abutment 5. It has some local adhesion failures.

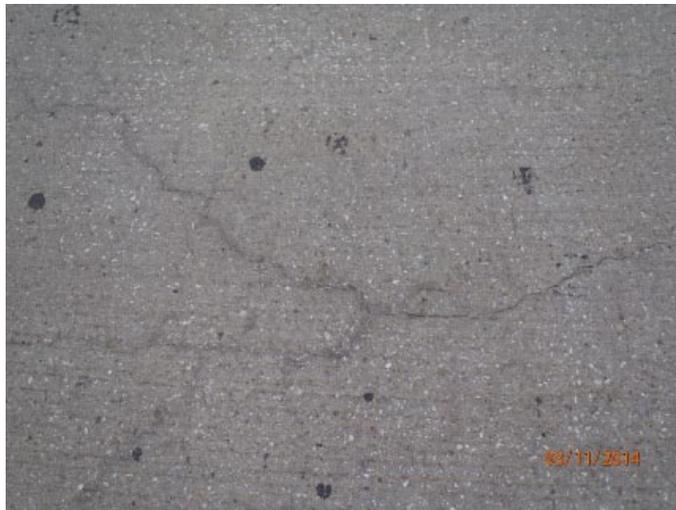
510: Wearing Surfaces									
Units	Total Qty	Qty. St. 1	% in 1	Qty. St. 2	% in 2	Qty. St. 3	% in 3	Qty. St. 4	% in 4
SQ.FT	12,484.41	12,359.57	99%	124.84	1%	0	0%	0	0%
<p>The wearing surface has minor transverse flexure cracking throughout. Overall the wearing surface is in good condition at this time. See photos.</p>

View of some minor cracking in the wearing surface of span 5.

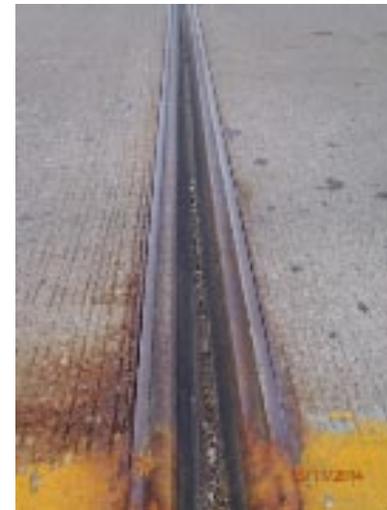
The transverse joint over pier 4 has some minor scattered debris and a 3 ft. section at the south end is partially detached and sagging down. See photos.

View of the transverse joint over pier 4. It has some minor debris.

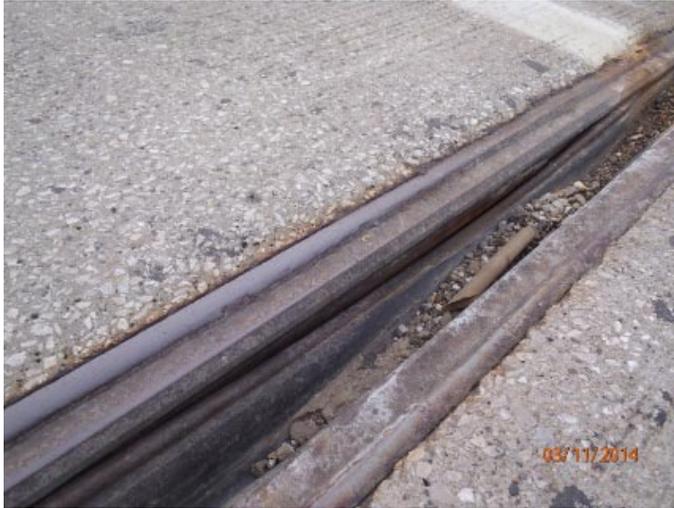
View at the south end of the transverse joint over pier 4. It is partially detached and sagging for ~3'.

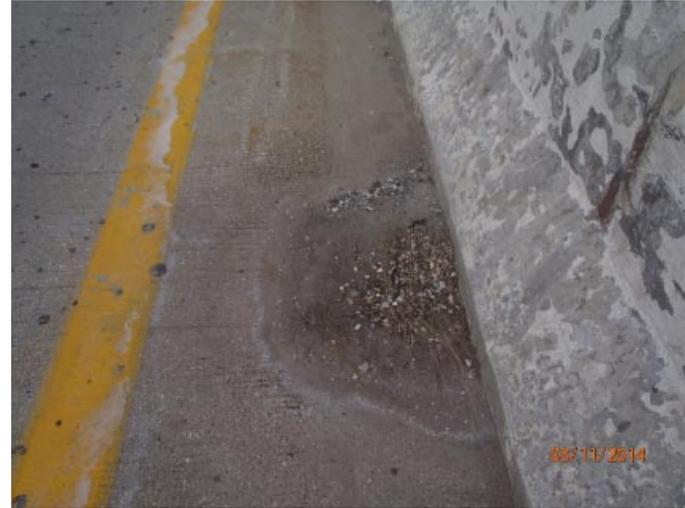
Some of the drains are open and some are blocked. Moderate corrosion is present at the bottom of some downspouts. See photos.

View of a block north drain.

Drains should be cleaned out. Generated by agreiner on 03/12/2014

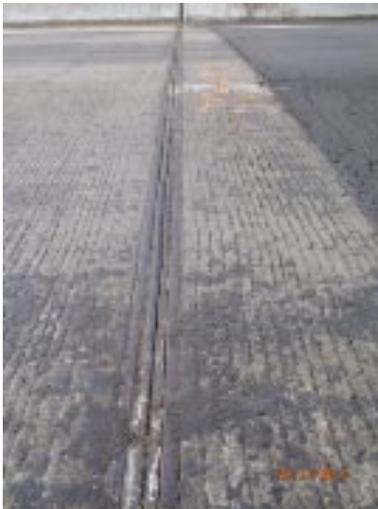
View of the transverse joint over abutment 1. It has some local adhesion failures.

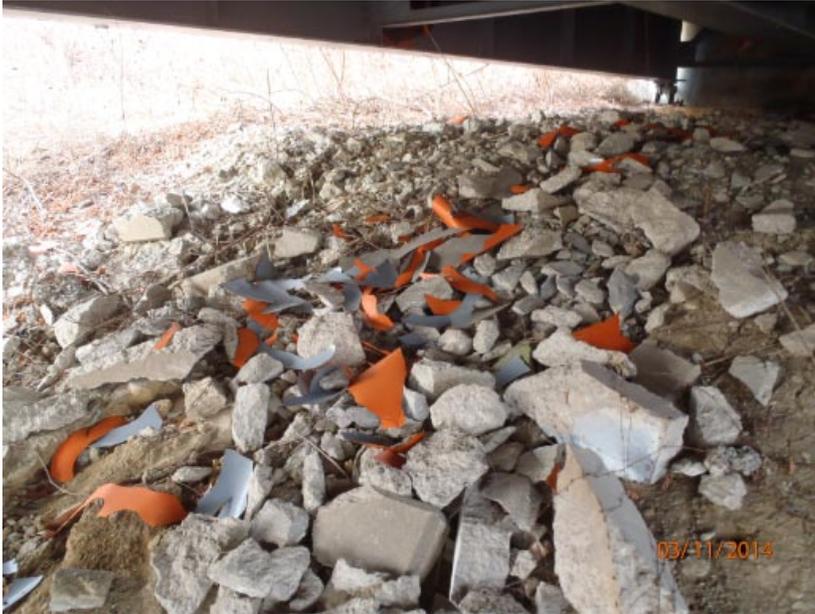
View of paint that has flaked off onto the ground in span 1.

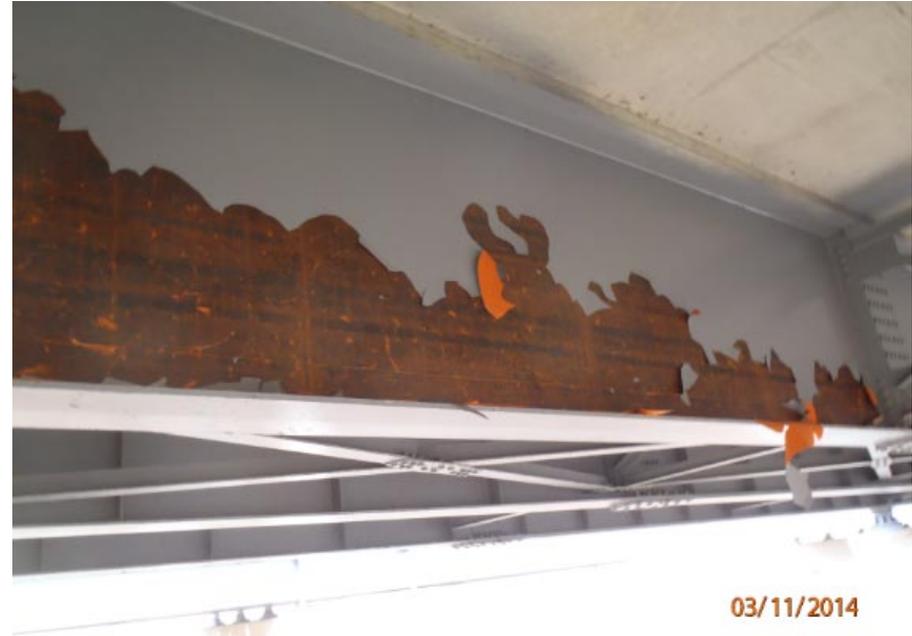
View of a large area of paint failure on beam 2 from the south in span 1.

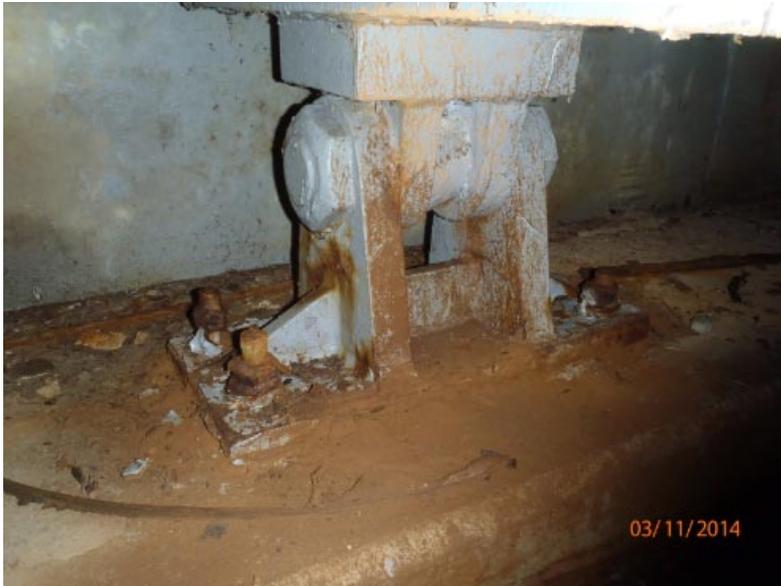
313: Fixed Bearing									
Units	Total Qty	Qty. St. 1	% in 1	Qty. St. 2	% in 2	Qty. St. 3	% in 3	Qty. St. 4	% in 4
EACH	8	4	50%	4	50%	0	0%	0	0%
<p>The bearings at abutment 5 have some flaking paint with minor rusting in the lower bearings. The bearings masonry plates at abutment 5 have minor rusting corrosion. The lower portions of the bearings at abutment 1 have minor rusting and corrosion. The masonry plates and anchor bolts at the abutment 1 bearings have moderate to heavy corrosion. These bearings should be cleaned and protected. See photos.</p>

Typical view of moderate to heavy corrosion of the masonry plate and anchor bolts on the bearings at abutment 1.
