## Inspection Report with SI&A Data

**Structure Description:** 424.87 Foot - 3 Span Steel continuous Stringer/Multi-beam or Girder

**7 Facility Carried:** I-64 NC

**6A Feature Intersected:** BULL FORK CRK & ROAD

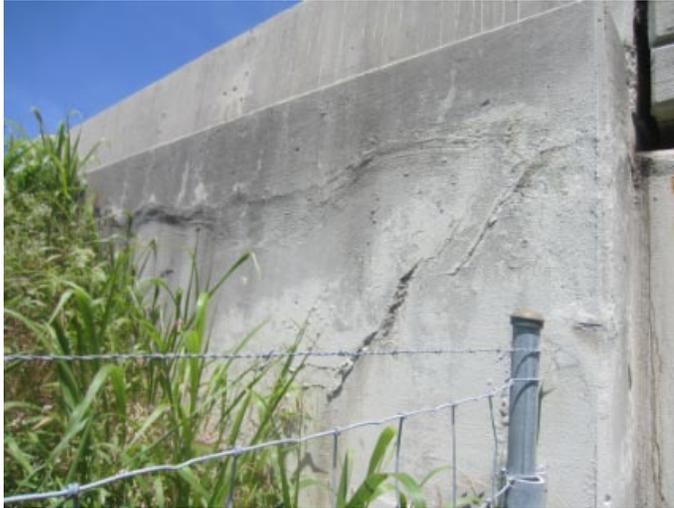
This bridge is built on a lot of fill. It appears abutment #1 may have settled and tilted left slightly. The outside faces of both abutments have some random cracking; these areas have been sealed over. Abutment #1 has a 1? diameter cracked delaminated area in right half of face. Both abutments have some vertical cracking along the vertical construction joint at center; this cracking also extends on up the backwalls some. At this same vertical construction joint in abutment #4 the abutment appears to have separated; the gap is ?? wide at ground line. Both backwalls have a few long vertical cracks. Backwall #1 has been patched up along the top. The right end of #4 backwall is wet up at the top and has some random cracking.

Right face of #1 abutment

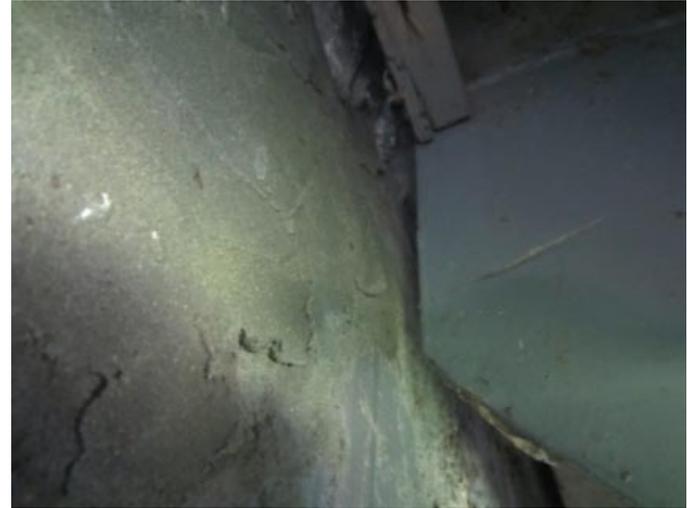
All rockers over abutment #1 are tilted west approximately 30 degrees. Over abutment #4 all rockers are tilted back toward backwall to max. Even with heavy truck traffic there is no movement at any of the rockers. All of these rockers are in place and there is no movement at the base plates. The ends of the beams and deck are not against the backwall. These rockers need re-set. Over pier #3 all rockers are basically straight.

Showing narrow space between  
2nd beam from right and  
backwall over abutment #1

<b>Action:</b>	-1 - Converted Work Candidates
Generated by erichmond on 06/18/2014. Rockers over abutments need re-set.

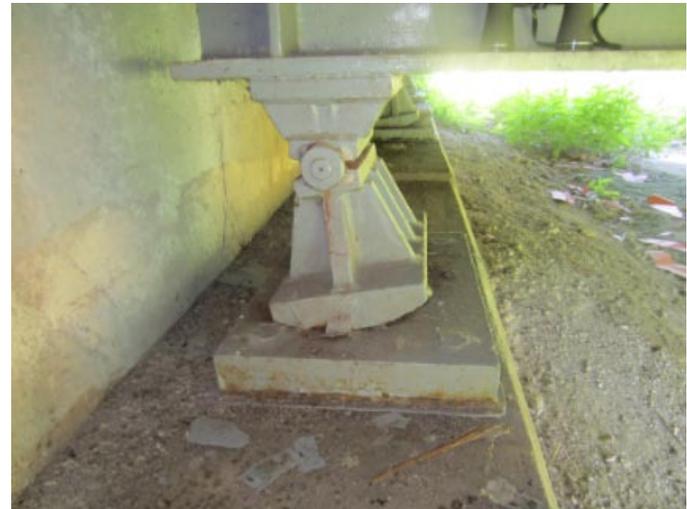
2nd rocker from right over  
abutment #1; typical of all over  
abutment

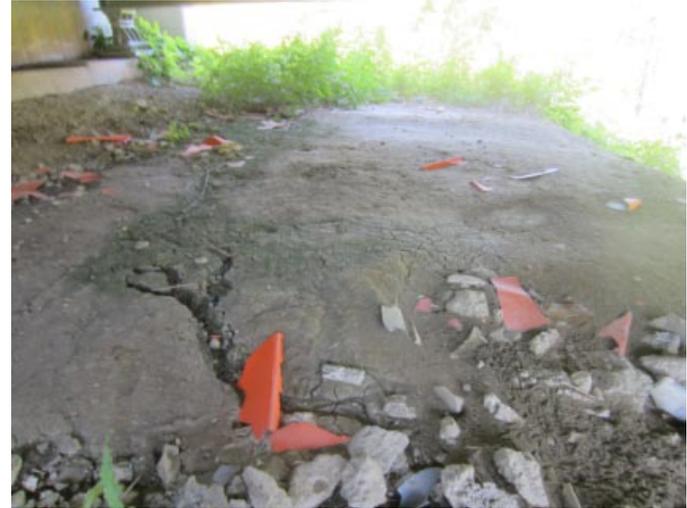
The superstructure is made up of four large steel girders with vertical stiffeners. There are crossframes throughout the bridge between all the beams. Between the two center beams is lower lateral bracing. At the end next to abutment #1 the lower lateral brace has broken loose from the second beam from left in the past and has since been repaired. The right outside face of right outside beam the first vertical stiffener east of pier #3 is bent down next to bottom flange. This most likely was done during construction; no repairs are needed. This is a very high bridge and this inspection is only from the ground looking up. I also used binoculars and did not see any other members bent. Any small cracks or broken welds could not be seen. All throughout the beams large areas of paint is flaking off to bare steel; this is much worse in forward span next to abutment #2. The outside face of right outside beam near abutment #2 has some thin rust along the web down along the bottom flange and is starting to get minor section loss. A few areas along the bottom flanges of outside beams around the downspouts are rusted and may be getting some section loss. A lot of paint is lying on the ground under the bridge where it has flaked off the beams. Paint on the crossframes and lower lateral bracing is still good.

Paint that has flaked off beams  
lying on ground in front of  
abutment #1

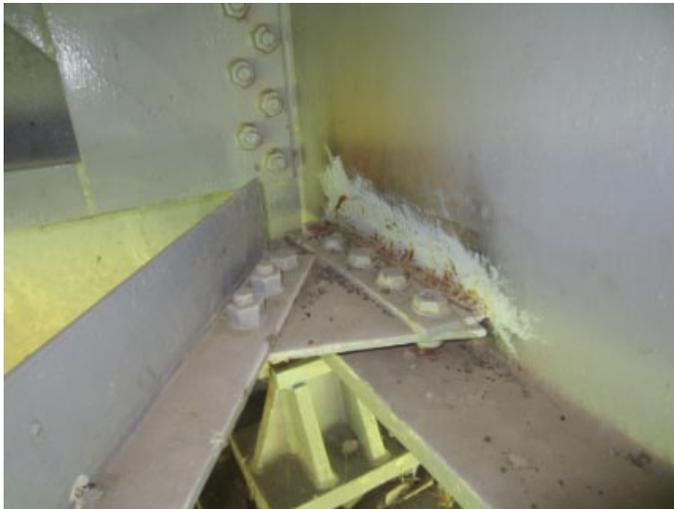
This bridge has crossframes throughout the superstructure and a few diaphragms up next to the deck. Between the two center beams is also lower lateral bracing. At the end next to abutment #1 the lower lateral brace has broken loose from the second beam from left in the past and has since been repaired. From the ground looking up they all appear to be in good condition

Lower lateral bracing repaired  
next to abutment #1

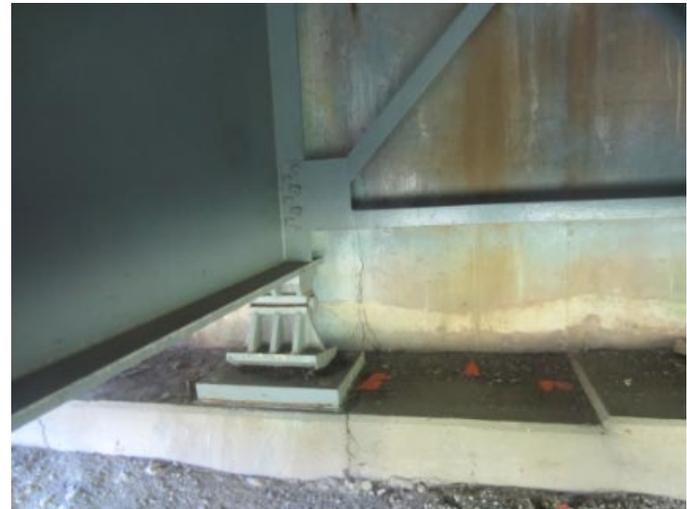
Vertical cracking in backwall #1

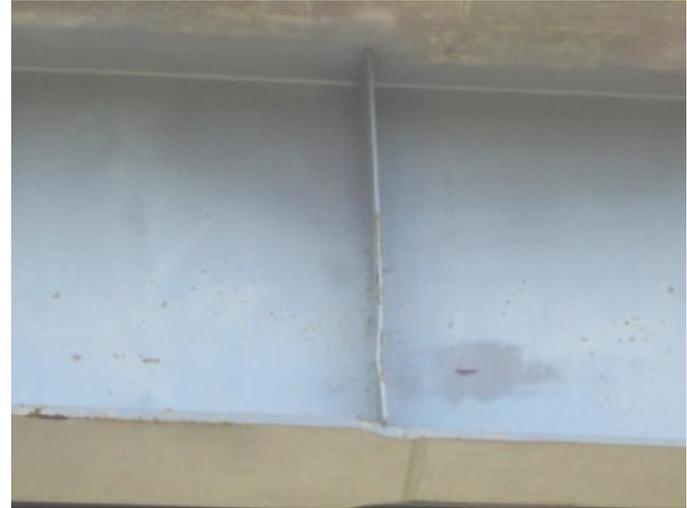
Bent vertical stiffener on outside face of right outside beam

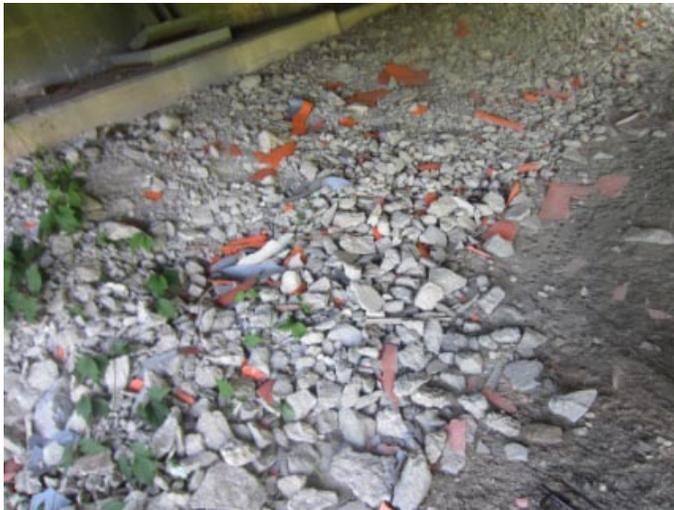
Paint lying on ground around  
abutment #4 that has flaked off  
beams

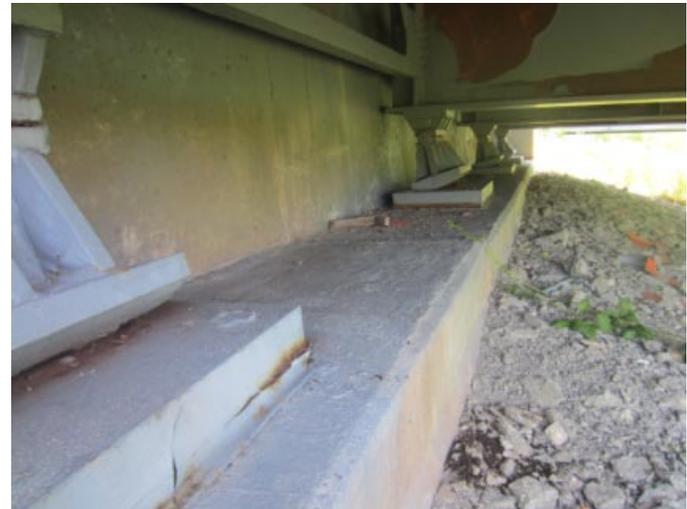
Looking right along rockers over #4 abutment

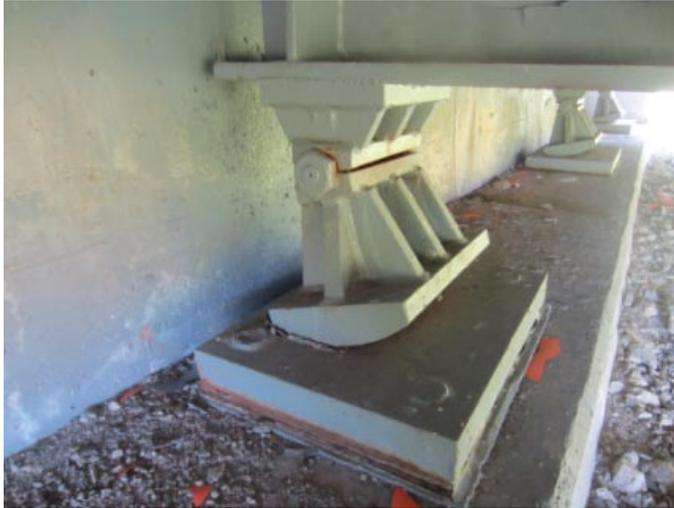
2nd rocker from left over #4 abutment; typical of all over this abutment

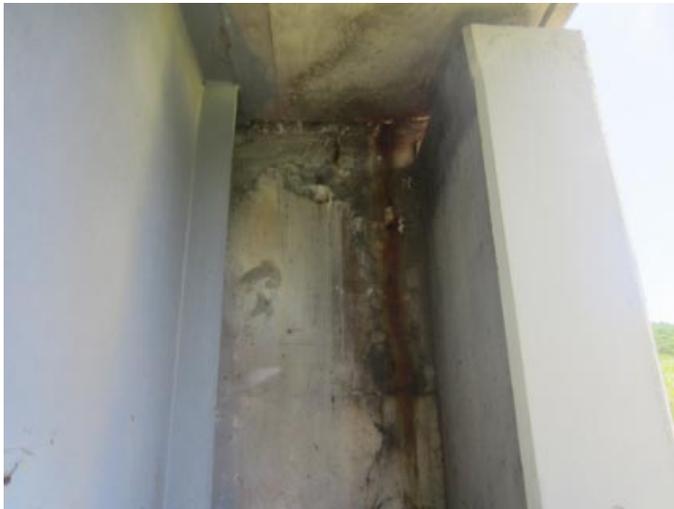
Right end of #4 backwall

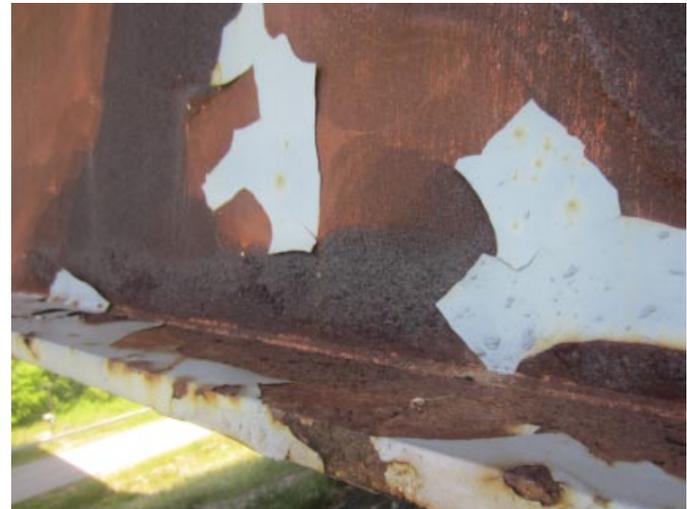
Outside face of right outside beam near east end; slight section loss to web down along

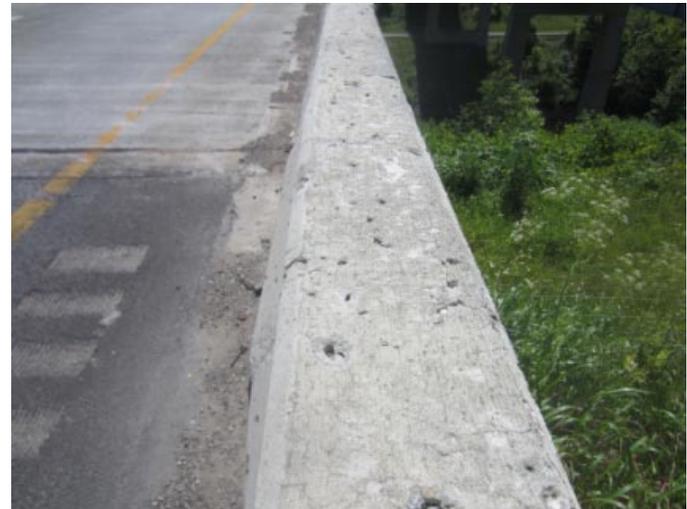
The concrete parapets along both sides have wide spread pop out type spalls along the inside faces and top surfaces. This spalling is worse along the short approach section at west end of deck. The inside face of the short approach section on left side has random cracking down along the bottom. Both sides have the usual vertical cracks scattered here and there along the inside and outside faces found in this type railing. They have been sealed and the sealant is still in fairly good condition.

Fairly deep pop out spalls on top  
surface of right side parapet

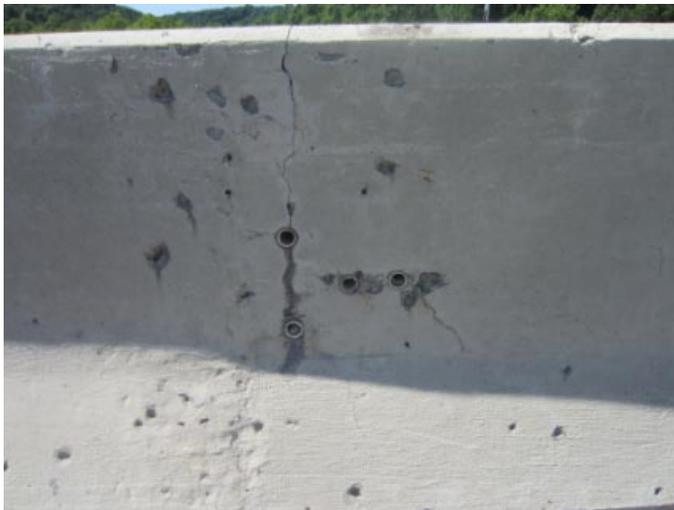
Pop out type spalls along inside face of left parapet; typical

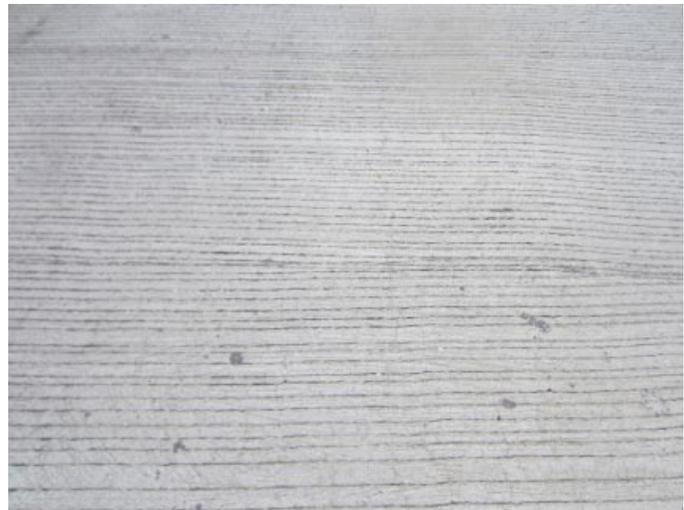
Tight longitudinal crack in w.s.

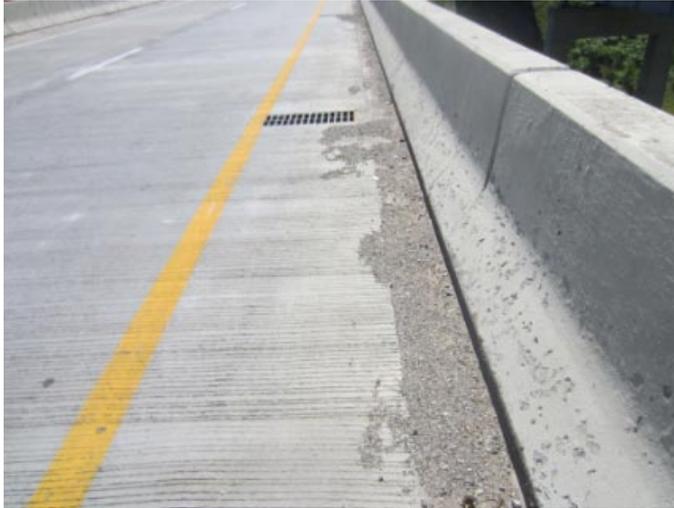
There are scuppers and downspouts along the right side only. All of the scuppers on top are clean and there is only a very small amount of minor debris along the deck edges. Many of the downspouts are rusty with section loss.

Debris lying along right edge of deck

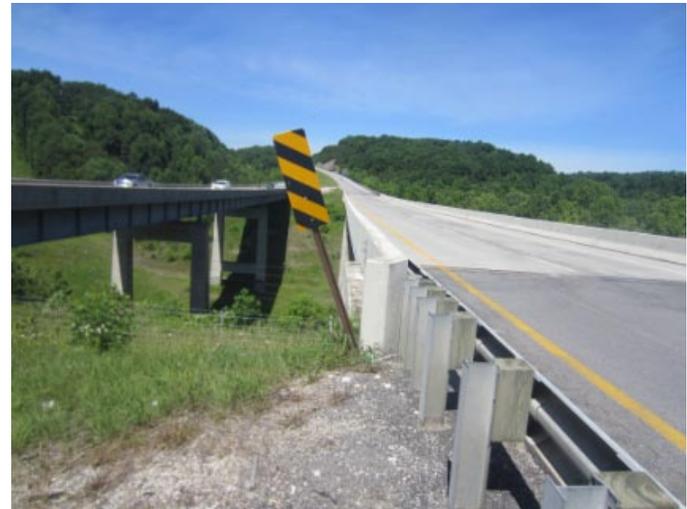
The asphalt approach pavement along the east end of deck has some minor random cracking. Otherwise, the approaches are in good condition. This bridge has galvanized deep beam approach guardrail along the left side at west end of bridge and both sides at east end. There are a few very minor dings but the railing is still in good condition. 12" x 36" obstruction markers have been installed at the east end along both sides; the right marker is leaning over and needs re-set.

Obstruction marker at s-east corner of bridge
