Re: Statewide 2008-2009 Fracture Critical Inspection  
(Contract Package 5)  
**Cairo Bridge (US 60 & US62) over the Ohio River**  
Bridge No. 004B00021N  
Ballard County, Kentucky

# BRIDGE INSPECTION REPORT

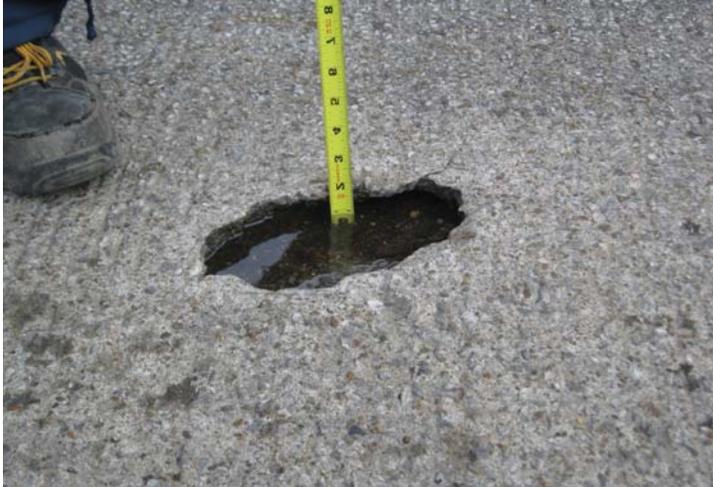
The top of the deck is covered with a concrete overlay wearing surface. The deck is in overall good condition. Heavy surface rust and efflorescence was observed on the stay-in-place deck forms.

Photo 1  
10"x3"x2" deep popout in overlay with ponding water in deck overlay.

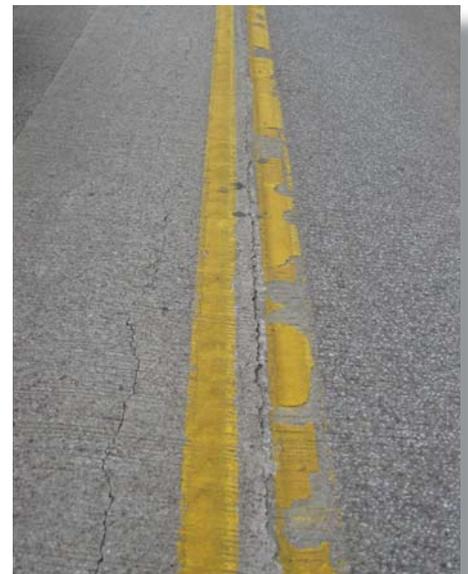
Overall, the wearing surface was in good condition. The transverse tines were visible with only minor polishment in the wheel lines. Transverse and longitudinal cracking was observed in the overlay along the majority of the bridge and approach length. Several spalls were observed typically adjacent to the expansion joints. There is approximately a three (3) foot section near the center of bridge that appears to be a closure pour or deck retrofit extending the length of bridge.

Photo 2  
Typical longitudinal cracking in deck overlay.

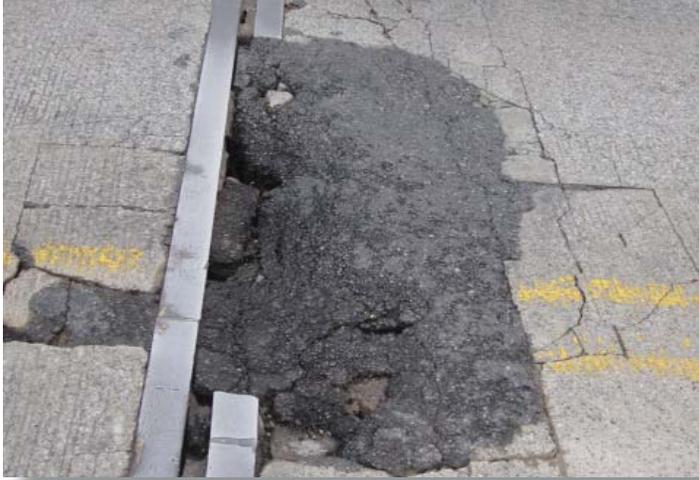
The strip seal and styrofoam backer rod with hot-poured sealant joints were in overall poor condition. The strip seal joints are typically filled with moderate to heavy debris and water ponding across the joint. There were signs of leakage at Piers I1, I2, I4, Pier K7, K8, K12, K16 and K20. The armored edge angles has missing sections and broken splice welds at PP23 several locations.

Photo 3  
Missing armored edge and damage to deck joint at Pier K16. Note: Bituminous asphalt within limits of joint opening.

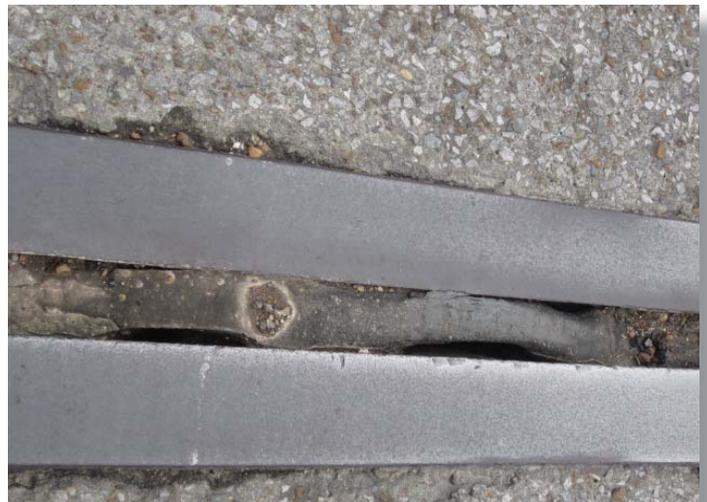
The hot-poured sealant has separation from the angle supports at a few locations possibly due to seasonal changes. This separation allows surface water and debris to drain through the openings to superstructure members below the joint.

Photo 4  
Close up of hot-poured sealant pulling away from armored edge angles at Pier K16.

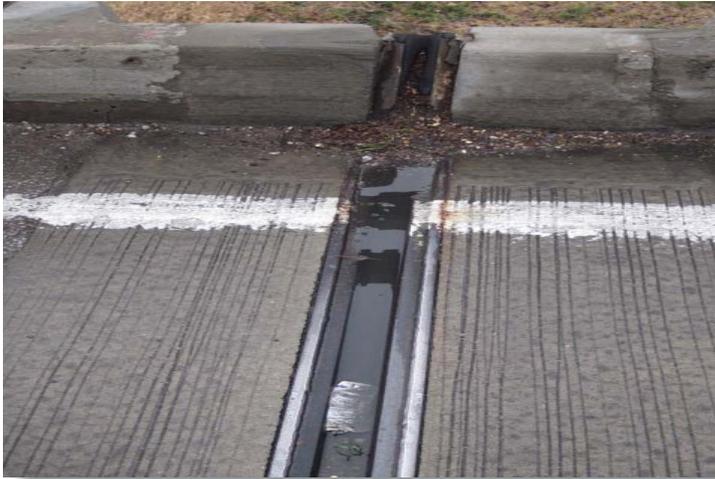
The strip seal neoprene joints are in overall satisfactory condition. The joints are typically filled with debris across the full width of the deck with water pooling along the gutterlines. The joints appear to be functioning properly, however, there are signs of deck joints leaking on both approaches.

Photo 5  
Debris and ponding water in strip seal at Pier I3.

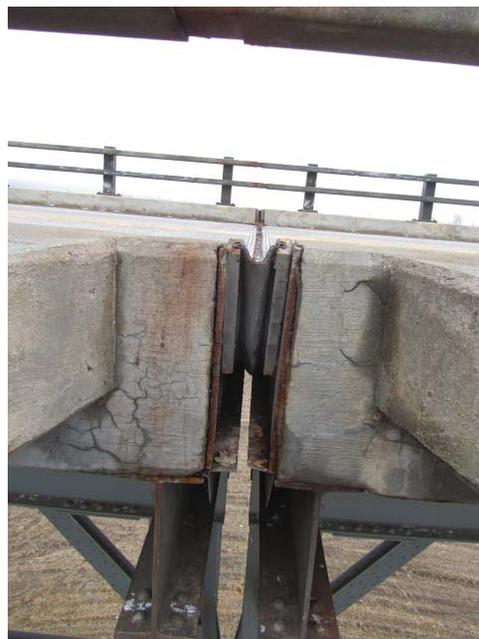
Photo 6  
Strip seal turn-up at Pier K7.

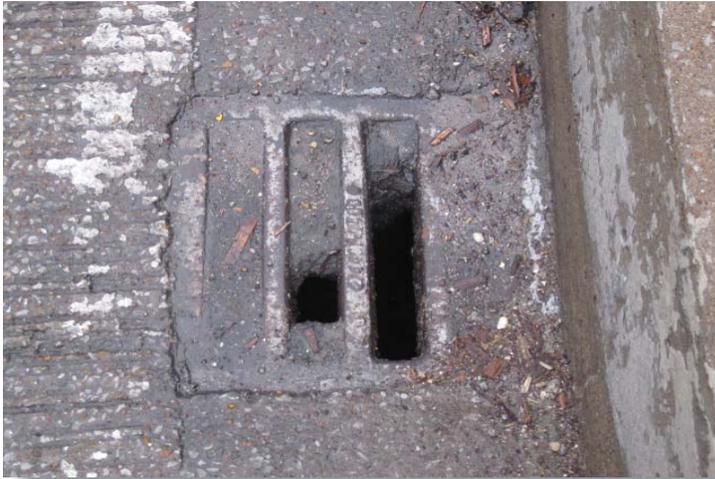
The deck scuppers were observed to be partially or fully clogged with debris minimizing proper drainage from the deck surface.

Photo 7  
Typical condition of deck scuppers on the Illinois and Kentucky approaches.

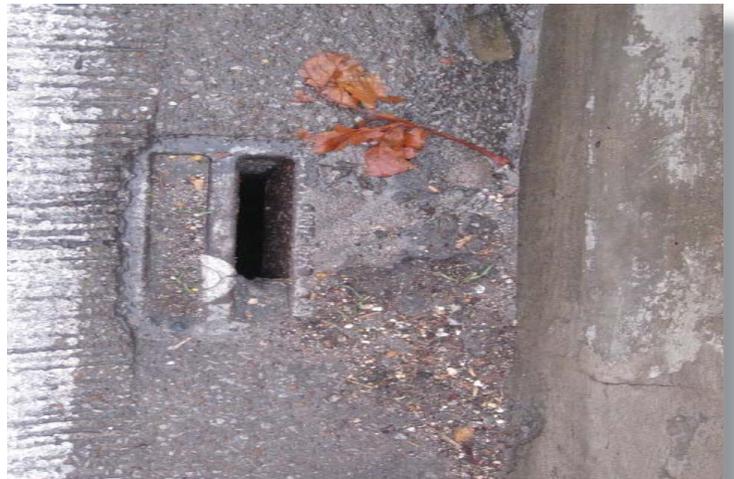
Photo 8  
Typical condition of deck scuppers in the main truss spans.

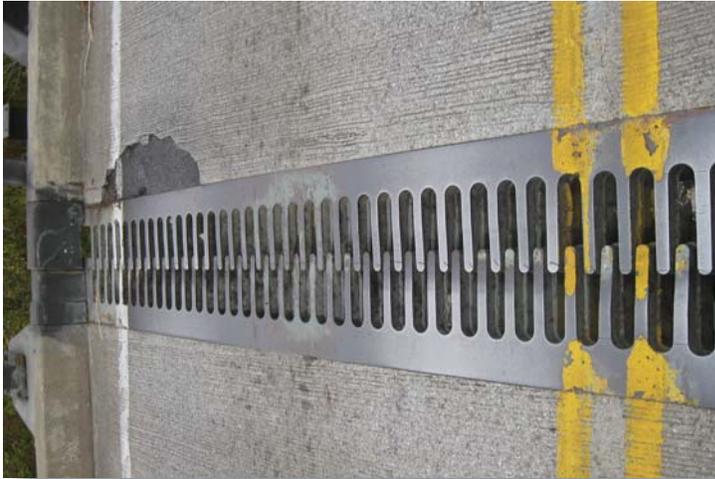
The open finger tooth expansion devices are in satisfactory condition. The expansion dams appear to be functioning properly however, there is no anti-skid studs at any location. There are no troughs located below the finger tooth expansion dam opening. This introduces leaking of salt-laden water runoff and debris collection accelerating the corrosion to the supporting superstructure below the joint opening.

Photo 9  
Typical finger tooth expansion dam for the main through truss.

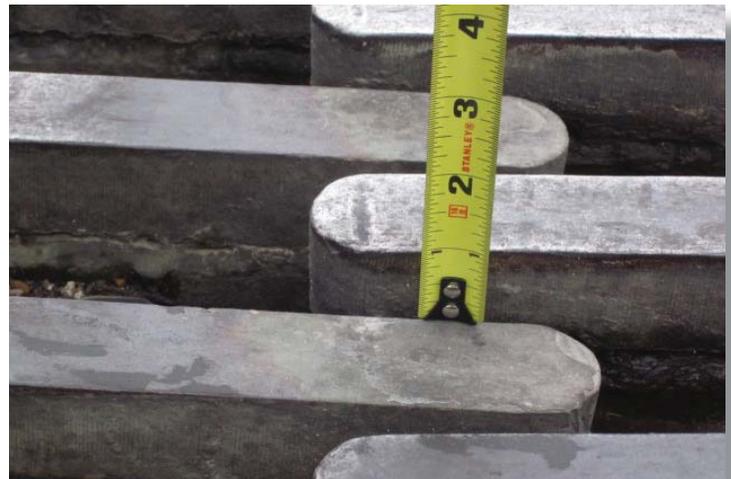
There are slight vertical height differential between adjacent fingers ranging up to 1" at PP15, PP27, PP44 and PP61. This alignment differential could possibly be due to wear to the sole plate from the stringer connection brackets.

Photo 10  
Close up of vertical height differential between expansion dam fingers of at PP0.

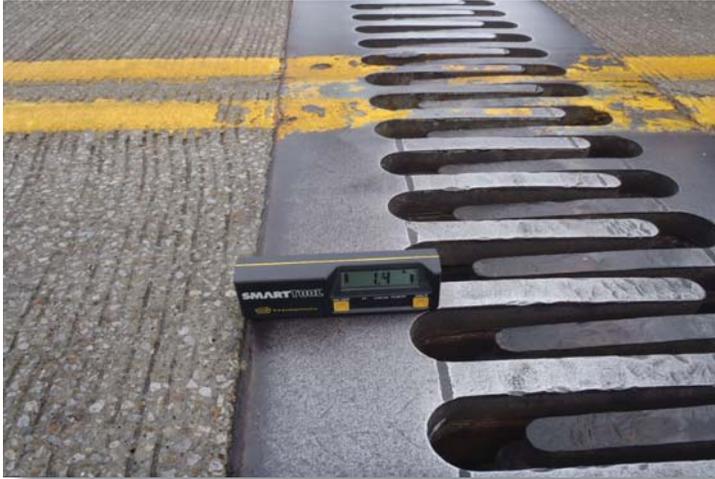
Photo 11  
Close up of vertical height differential between expansion dam fingers at PP15.

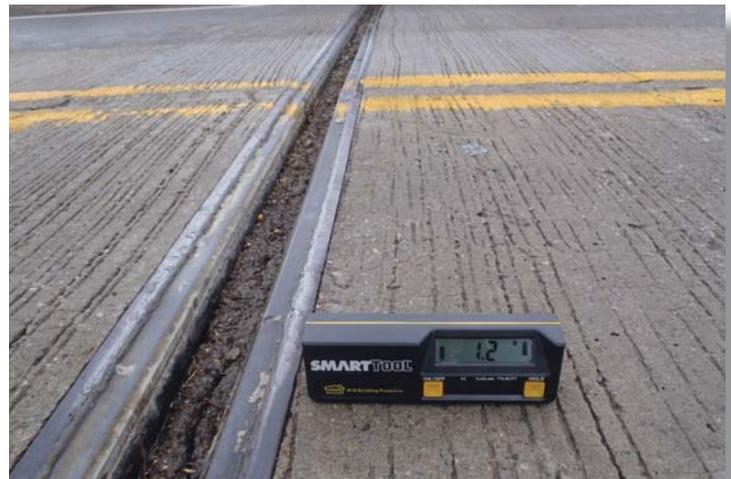
Photo 12  
Typical debris in strip seal joints in main truss spans. Note: PP27 shown.

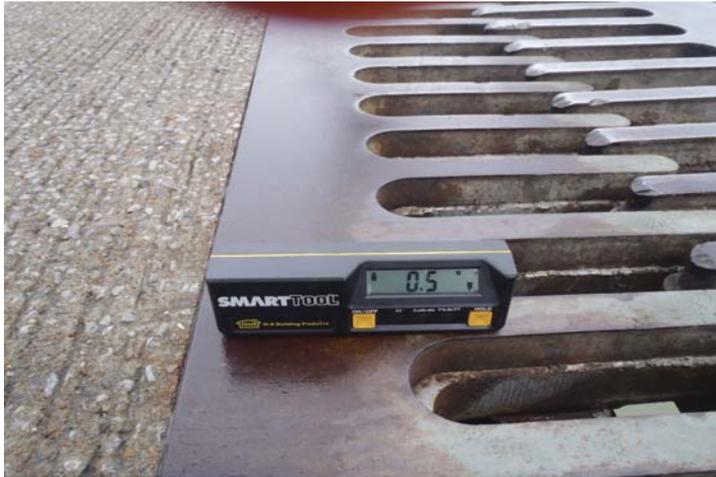
Photo 13  
Close up of vertical height differential between expansion dam fingers at PP44.

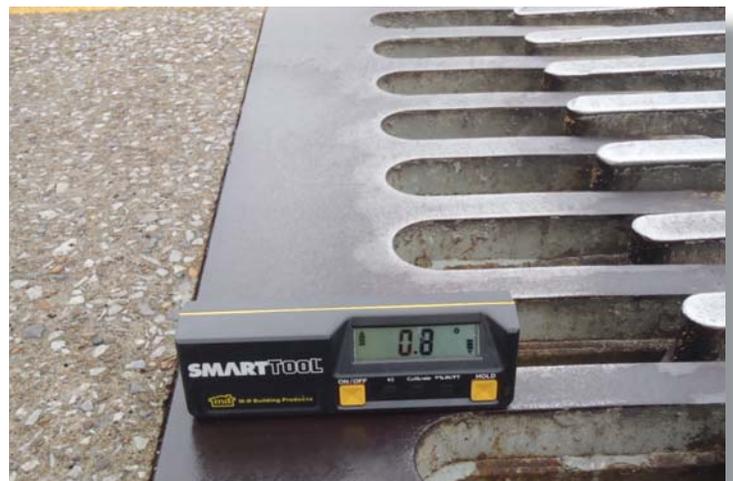
Photo 14  
Close up of vertical height differential between expansion dam fingers at PP61.

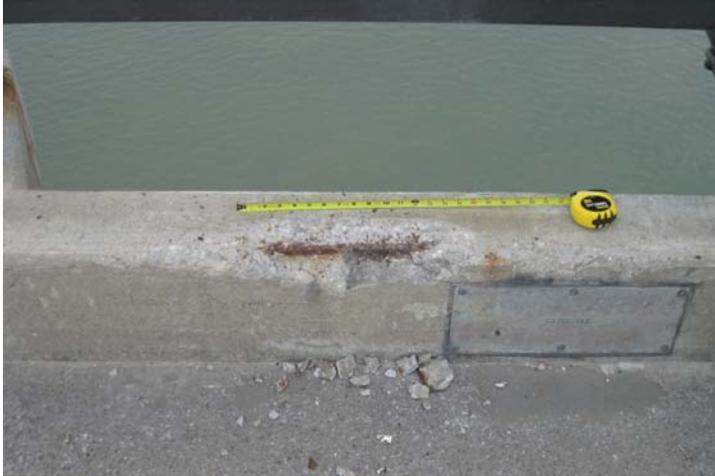
The concrete curbs were in overall fair condition. The curbs exhibit vehicular collision damage, vertical and longitudinal cracks and spalling. Large concrete spalls have exposed rebar, conduit and electrical wiring.

Photo 15  
Typical cracks and spalling with exposed rebar to deck curbing.

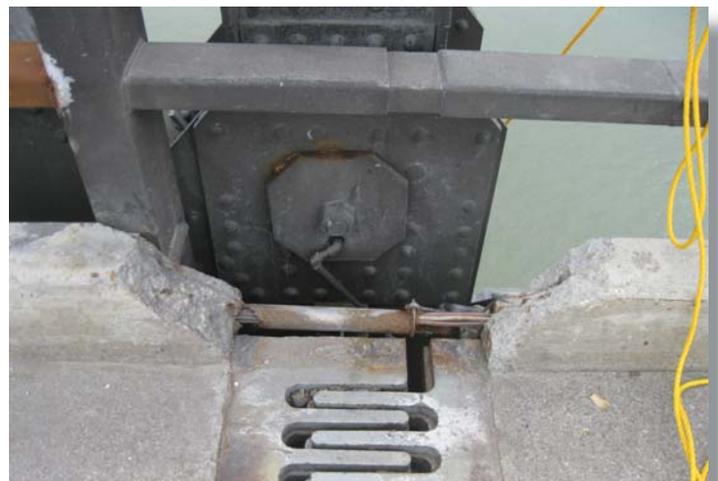
The armored plate cover for protecting the curb is missing at the finger tooth expansion dam at PP15. The missing curb plate and spalls have exposed electrical conduit and wiring.

Photo 16  
Missing expansion plates for concrete curb at PP15, East Truss.

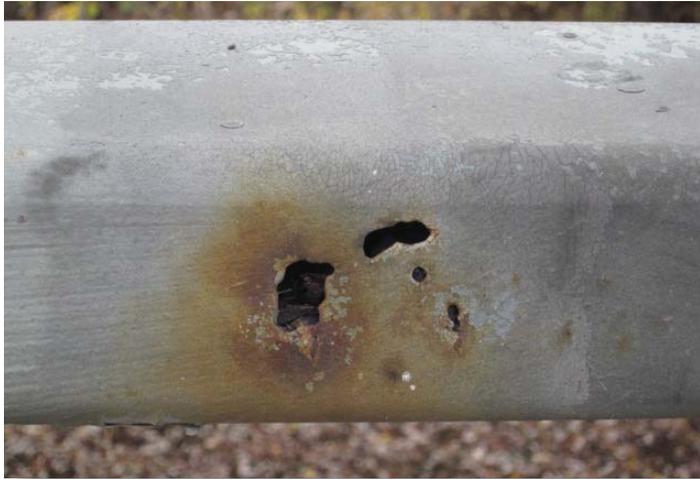
The steel bridge railing is in overall poor condition. Random locations of guardrail post are in poor condition with cracked welds at lower post connections. Numerous guardrail post and railings have moderate size perforations with heavy rust and moisture on the downstream side of the bridge. The concrete barrier wall in the curve on the Kentucky approach exhibited vertical cracks and vehicular impact damage.

Photo 17  
Railing exhibiting 100% deterioration mainly on downstream side.

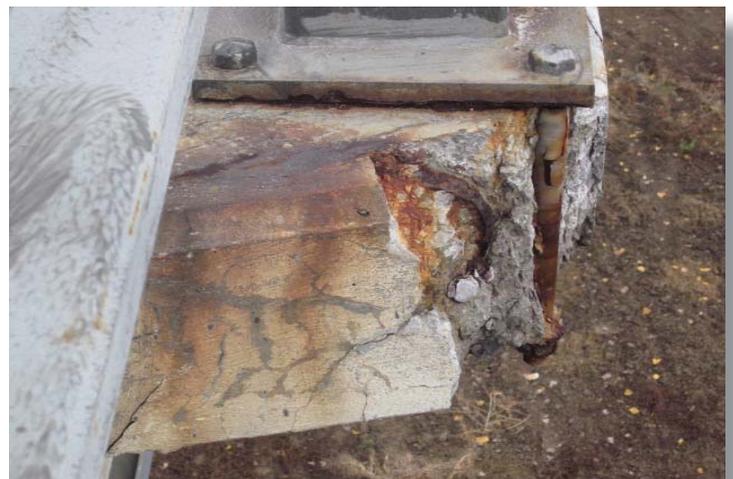
The guardrail post support blisters exhibit sizable vertical cracks and completely spalled sections exposing reinforcement and anchor bolts with heavy rust and corrosion. Inadequate concrete cover is the probable cause to excessive spalling and cracks. These deficiencies were noted at numerous locations within the entire bridge length.

Photo 18  
Typical cracks and spalling with exposed anchor bolts to guardrail support blisters.

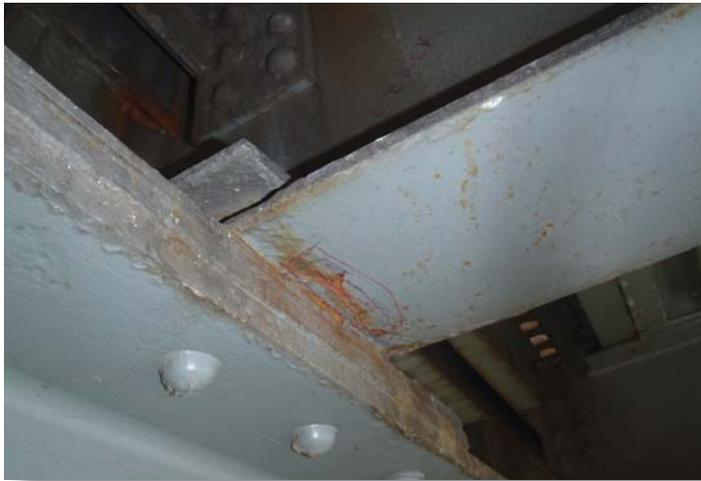
Typically the stringers were in overall fair condition. Active deterioration and 100% section loss along stringer flanges and expansion device connection brackets was observed. Several existing stringer cracks, noted in previous inspection reports, were observed at PP15 (Stringers 2, 3 & 4) and PP61 (Stringer 4). There is no indication of activity, however, there is a good possibility of these cracks turning down into the bottom flange of the stringers. Stringer 4 at PP27 appears to have "non-recordable indication" of an existing crack. This location should be tested further to determine any significant findings.

Photo 21  
Transverse crack in bottom flange of Stringer 3 at PP15.

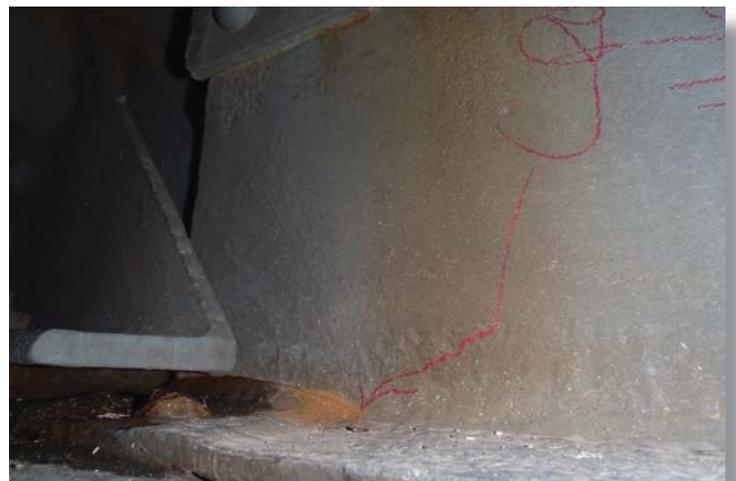
Photo 22  
Longitudinal crack in web near bottom flange  
of Stringer 2 at PP61.

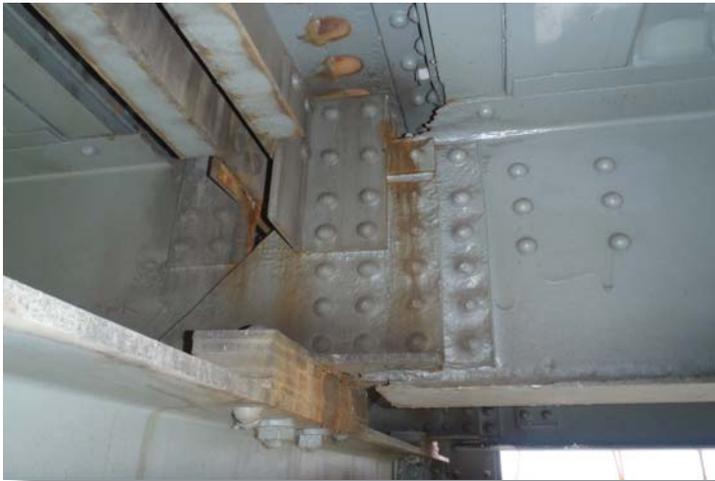
Photo 23

Typical condition of stringers under expansion dam locations with previous perforations and pitting from section loss. Many stringers exhibit localized rust and light corrosion along the top flange and to the expansion brackets connected to the stringer webs.

Typical pitting, perforations and corrosion to superstructure under expansion dam.

Note: No collection trough present under any finger tooth expansion dams.

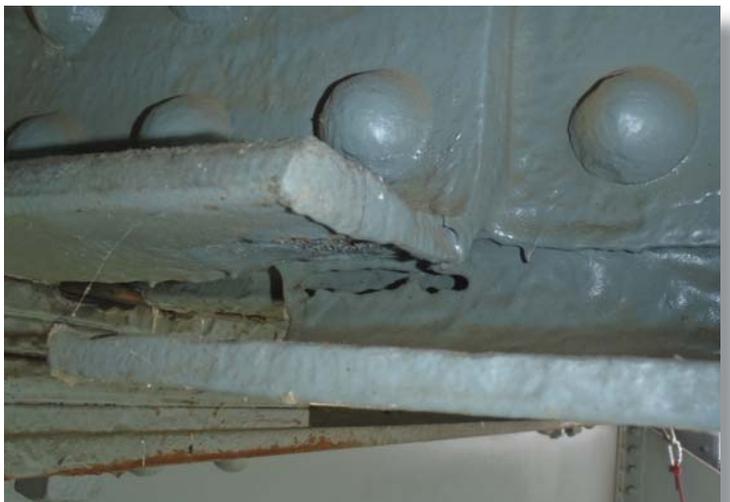
Photo 24

Close up of previous perforation in web of Stringer 3 at PP27.

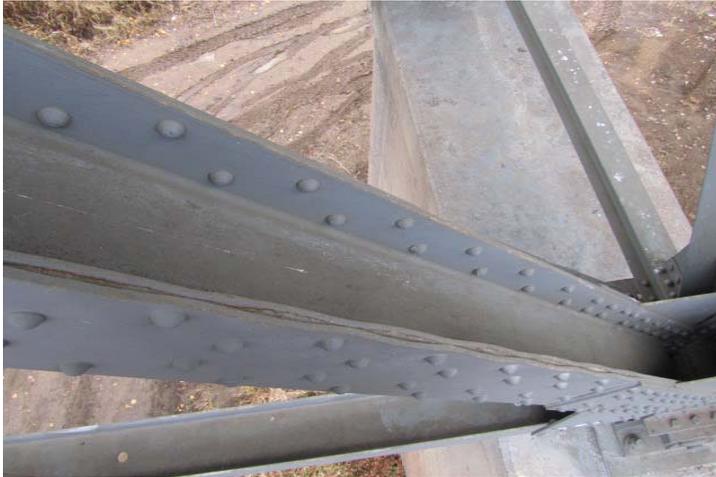
*Kentucky Approach (Spans 12 to 20)* - The main truss members of the deck truss spans were found to be in good condition with minimal localized paint failure, pack rust and minor deterioration. The diagonal from U3 to L2 has a buckle to the top flange. The top flange of the lower transverse strut is bent at L2-U3 West truss and Pier K6.

Photo 25  
Random pack rust to diagonal members of the Kentucky deck truss.

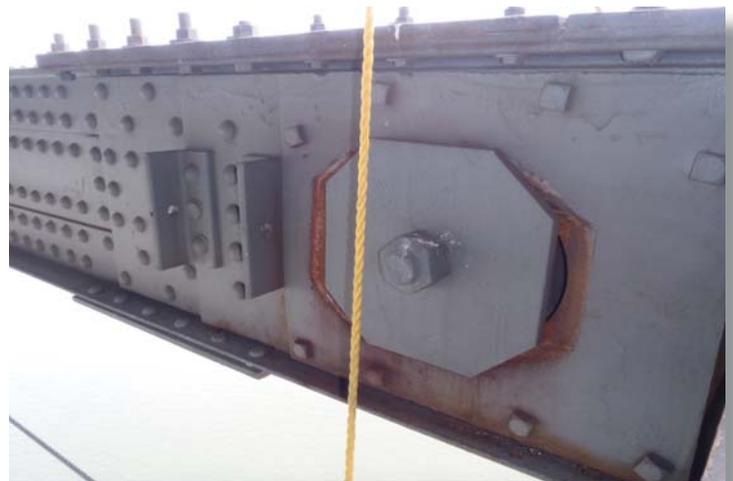
*Main Spans (Spans 7 to 11)* - The main truss members of the through truss spans were found to be in good condition with minimal localized paint failure, pack rust and minor deterioration. The pins for both the upper and lower chord were visually inspected noting wear to side plates from thermal movements. Light fretting and staining was observed to assembly for pins in the upper and lower chords.

Photo 26  
Expansion pin showing expected wear to vertical built-up plates PP27 - East Truss.

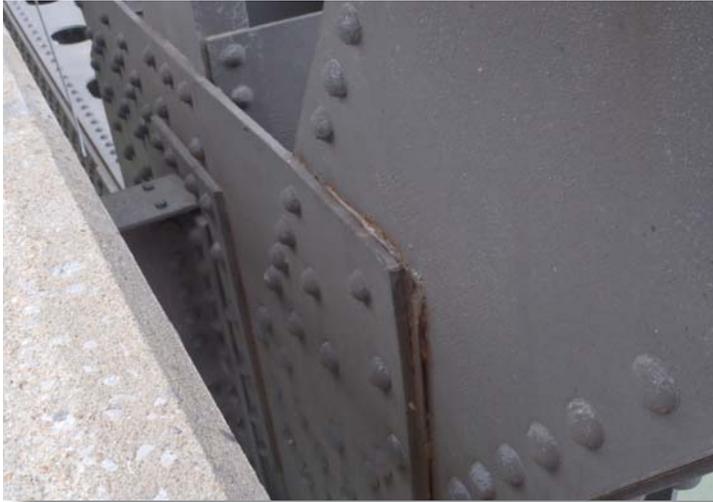
The vertical gusset plate at the lower chord connection exhibits up to 1/2" pack rust while bending the gusset plate in splash zone area.

Photo 27  
Typical pack rust at vertical gusset plate connections in the splash zone.

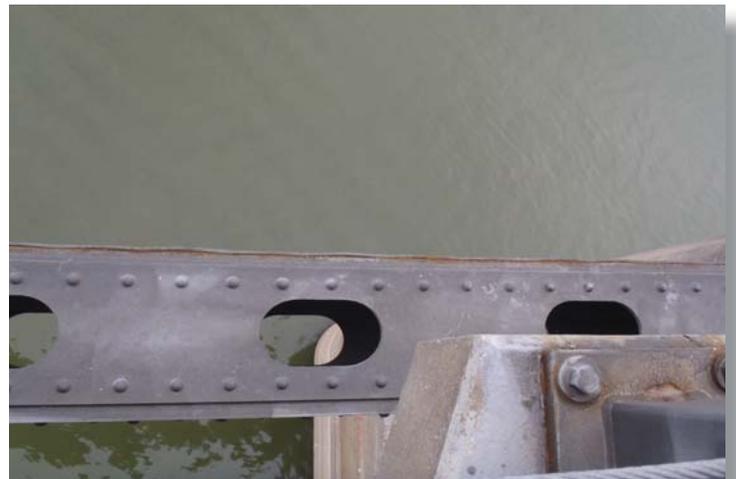
Overall the diagonals for the deck truss in the Kentucky approach were in good condition. However, at some locations the diagonal members exhibit random pack rust up to 1/2" between the main member and cover plate creating a wave pattern.

Photo 28  
Typical rust pack to downstream lower chord.

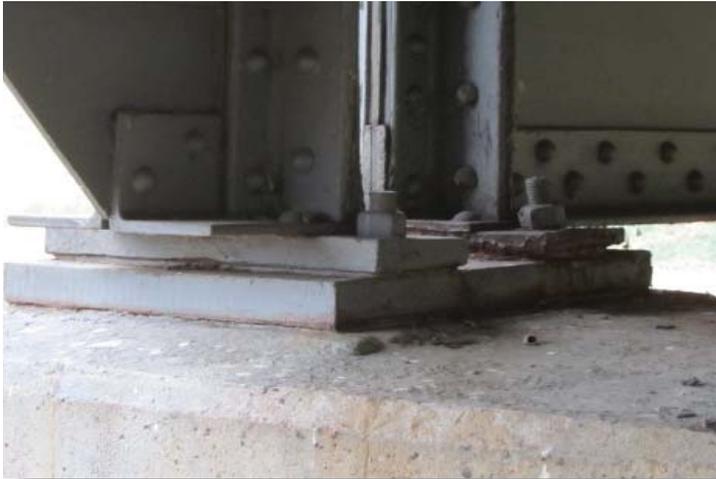
*Illinois Approach (Spans 1 to 6)* - The bearings were found to be in satisfactory good condition. The fixed bearing deficiencies observed 1/8" to 1/2" pack rust between sole and masonry plates and light to moderate surface rust at Piers I2, I4, K15, K17 and K19.

Photo 31  
Typical fixed bearing at Pier I4 with pack rust between sole and masonry plates.

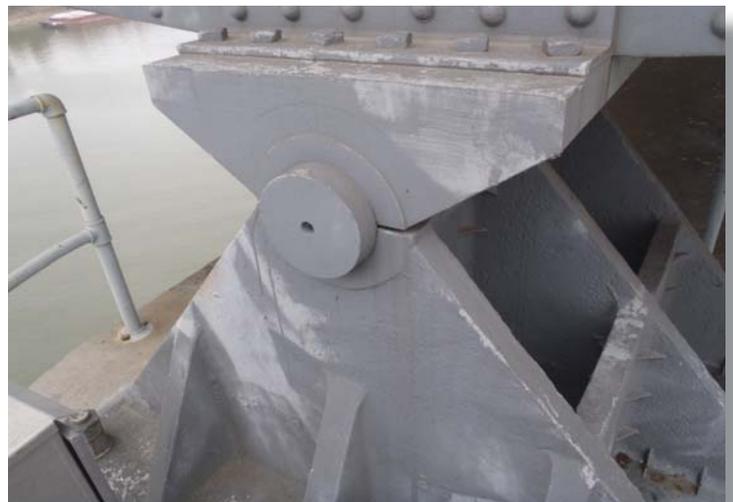
*Main Spans (Spans 1 to 6)* - The main span fixed and expansion bearings are in overall good condition with surface rust. The expansion bearings were observed to be functioning properly.

Photo 32  
Typical expansion main span bearing at Pier C - side view.

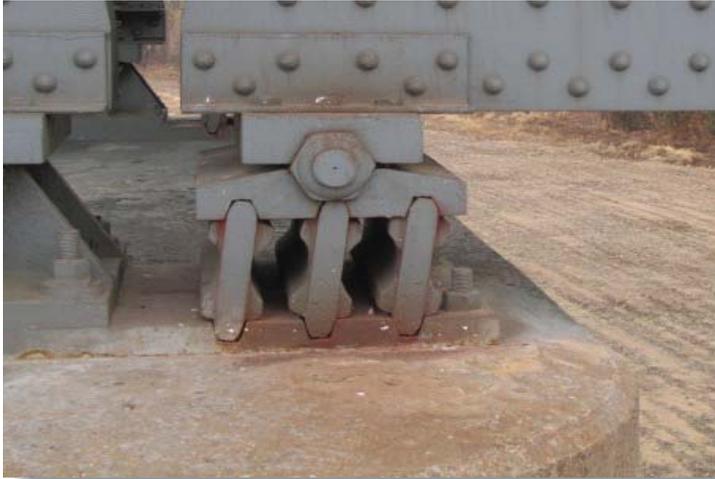
*Kentucky Approach (Spans 12 to 20)* - The bearings were found to be in overall good condition. The fixed expansion bearings deficiencies observed 1/8" to 1/2" pack rust between sole and masonry plates. Elastomeric bearings exhibit wear and cracking near edge of shim plates.

Photo 33  
Typical Kentucky deck truss expansion bearing with surface rust at Pier K8.

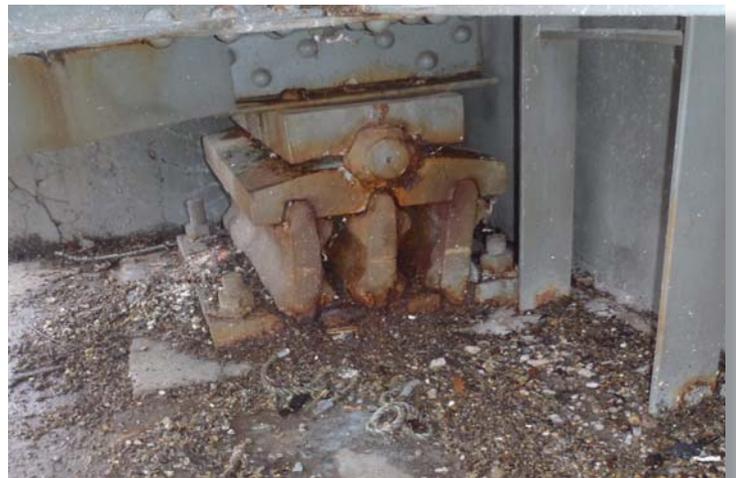
Photo 34  
Typical deck truss rocker at Pier F with corrosion and minor pack rust.

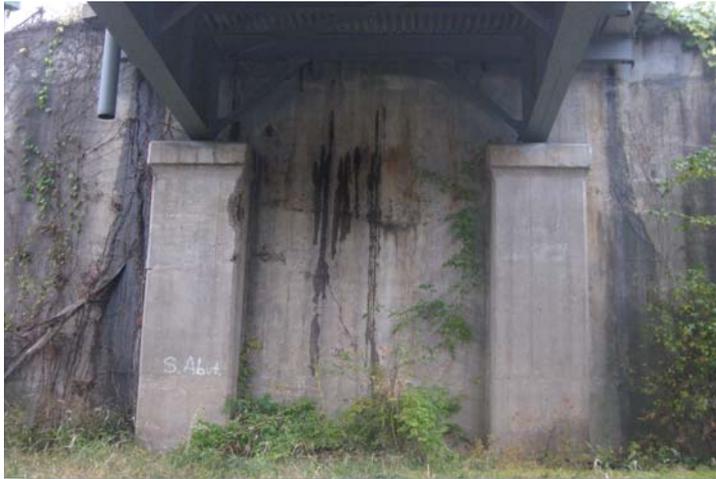
The abutments and wingwalls were observed to be in overall good condition. Noted deficiencies included cracking with heavy efflorescence and spalls with exposed reinforcement. Heavy debris and moisture was observed to the cap of each abutment. Heavy vegetation was observed to the wingwalls for each abutment.

Photo 35  
Illinois Abutment backwall showing vertical cracks with minor spalling to bridge seat support column.

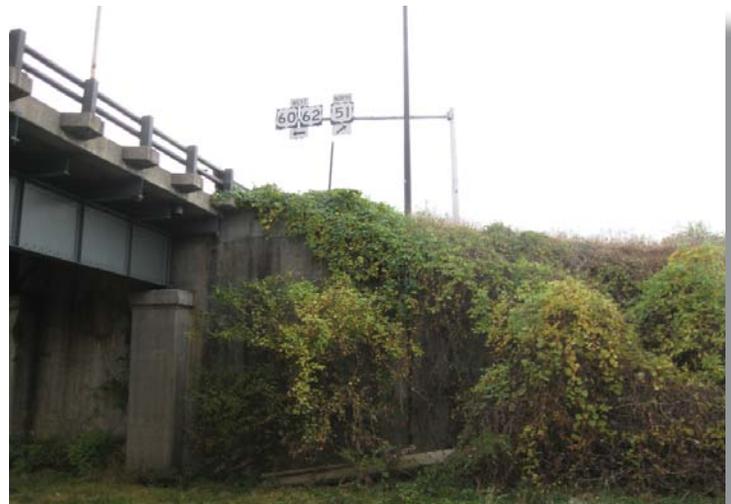
Photo 36  
Illinois Abutment wingwall with heavy vegetation to west wingwall.

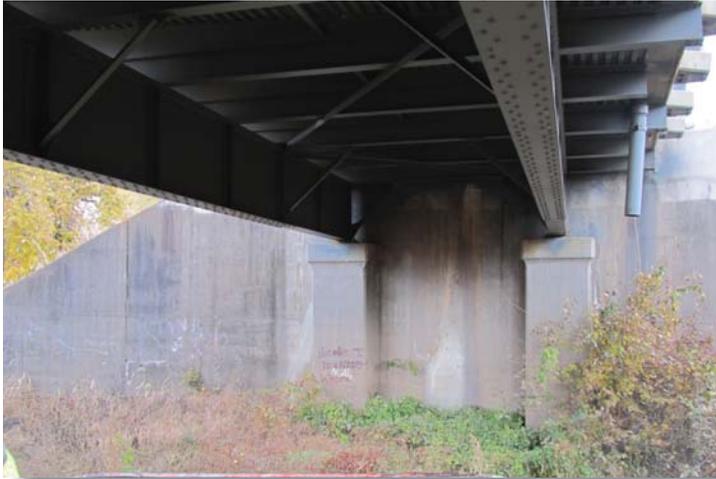
Photo 37  
Kentucky Abutment showing cracking with efflorescence to backwall.

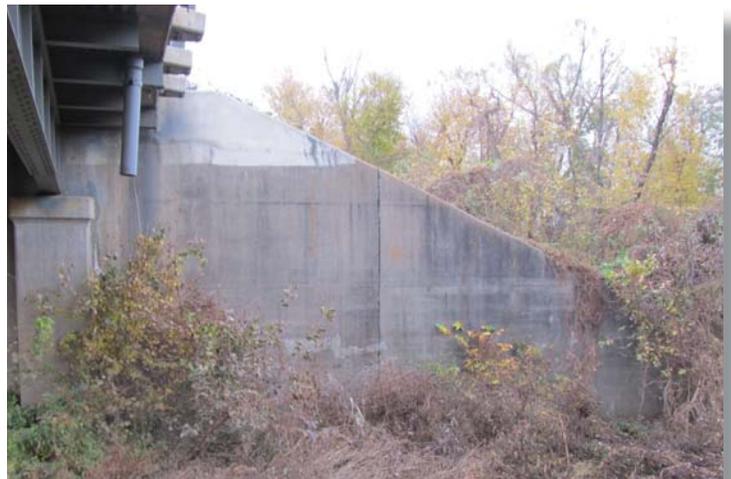
Photo 38  
Kentucky Abutment wingwall showing vertical cracking with efflorescence.

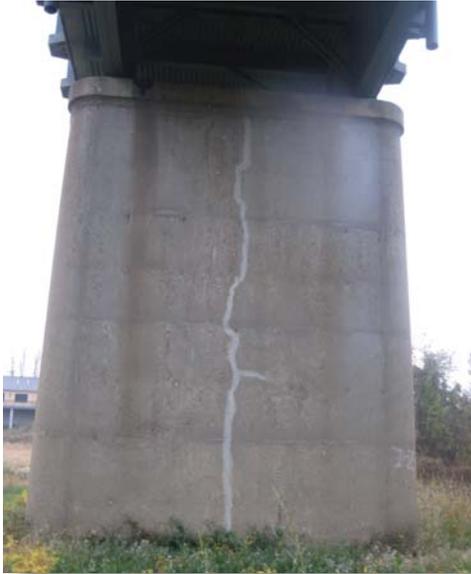
Overall, the piers were observed to be in satisfactory condition. Noted deficiencies include moderate cracking with heavy efflorescence and spalling to the main river pier caps and columns. The cap at Pier D has deteriorated while the top mat has begun to crumble. Several main through truss and Kentucky approach piers caps exhibit patch retrofits which are starting to debond. Several approach piers observed minor to moderate debris moisture runoff under leaking expansion joints.

Photo 39  
Existing patch to vertical crack in Pier I2 (N.F.)  
on the Illinois Approach.

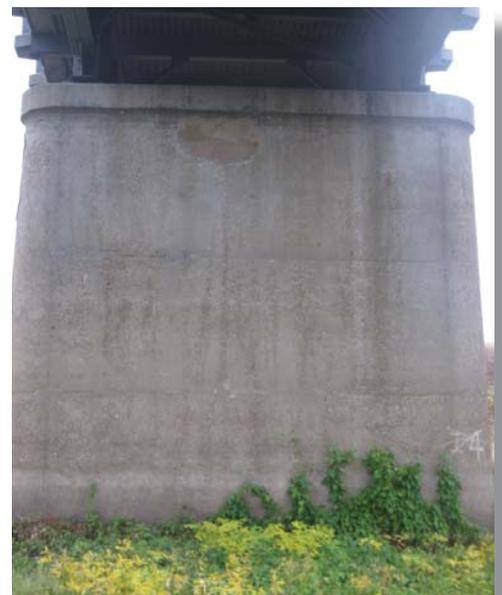
Photo 40  
Existing patch to spall on N.F. of Pier I4 on the  
Illinois Approach.

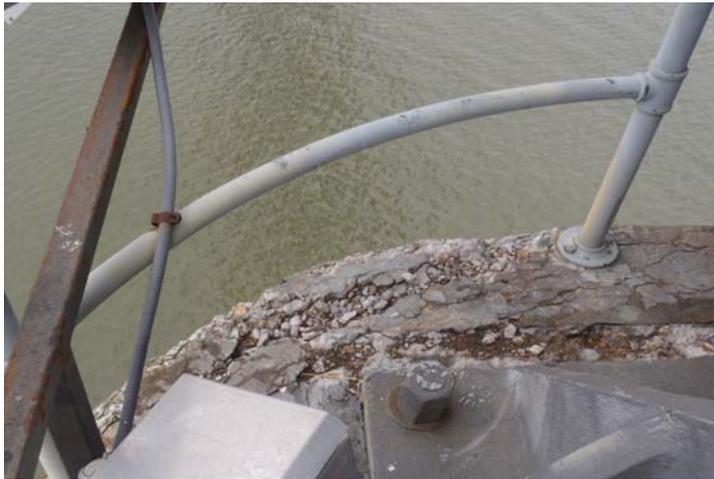
Photo 41  
Concrete deterioration and crumbling to top mat of Pier D near bearing.

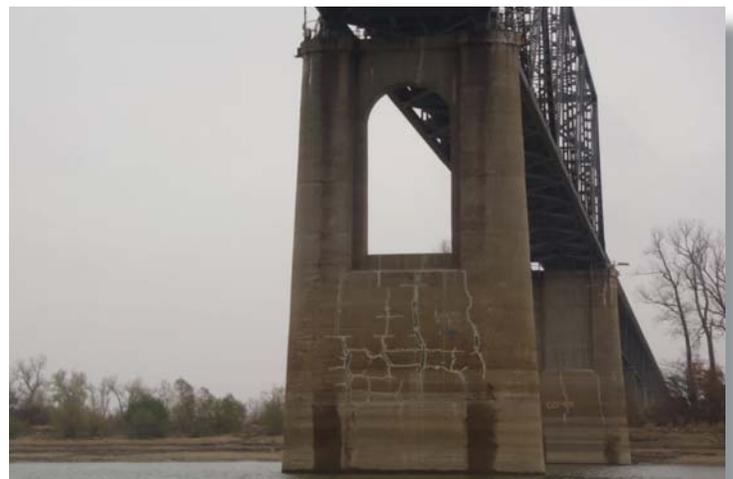
Photo 42  
Previous patching to numerous cracks in S.F. of Pier E. Pier F similar.

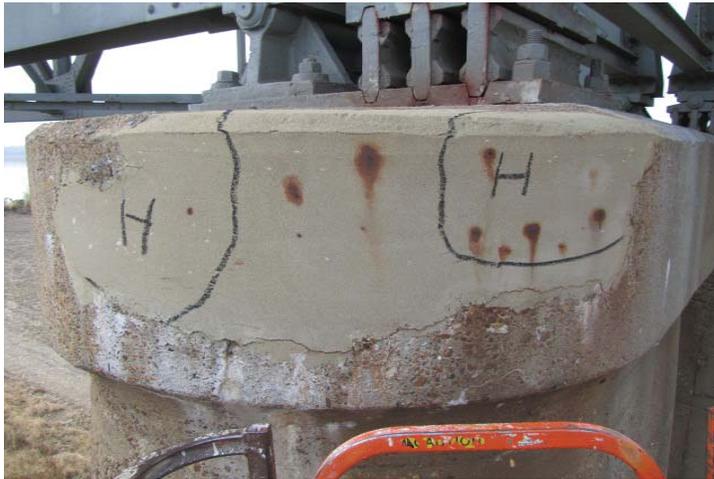
Photo 43  
Existing patch to cap at Pier K3, East Truss  
has begun to debond.

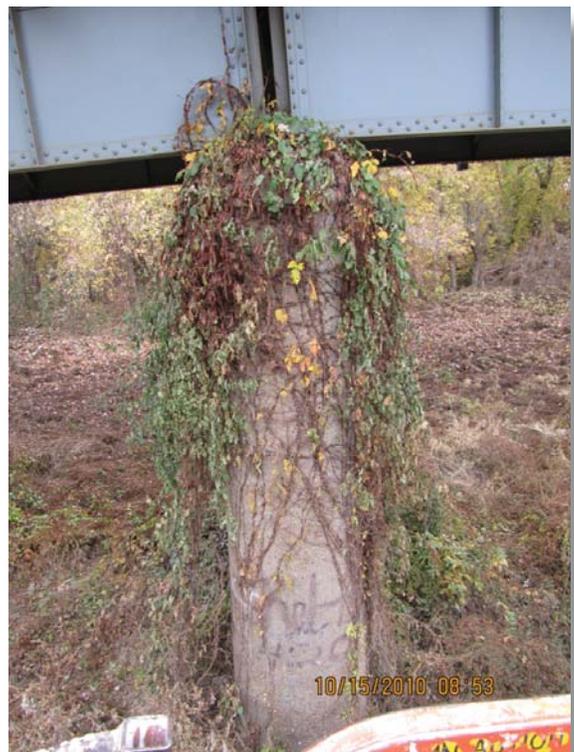
Photo 44  
Moderate vegetation to cap and side of Pier K20.
