# Structure Inventory and Appraisal Sheet (English Units)

Bridge Key: 13224      Agency ID: 112B00029N      SR: 46.2      SD/FO: SD

**112B00029N Inspection 10-11-2013**

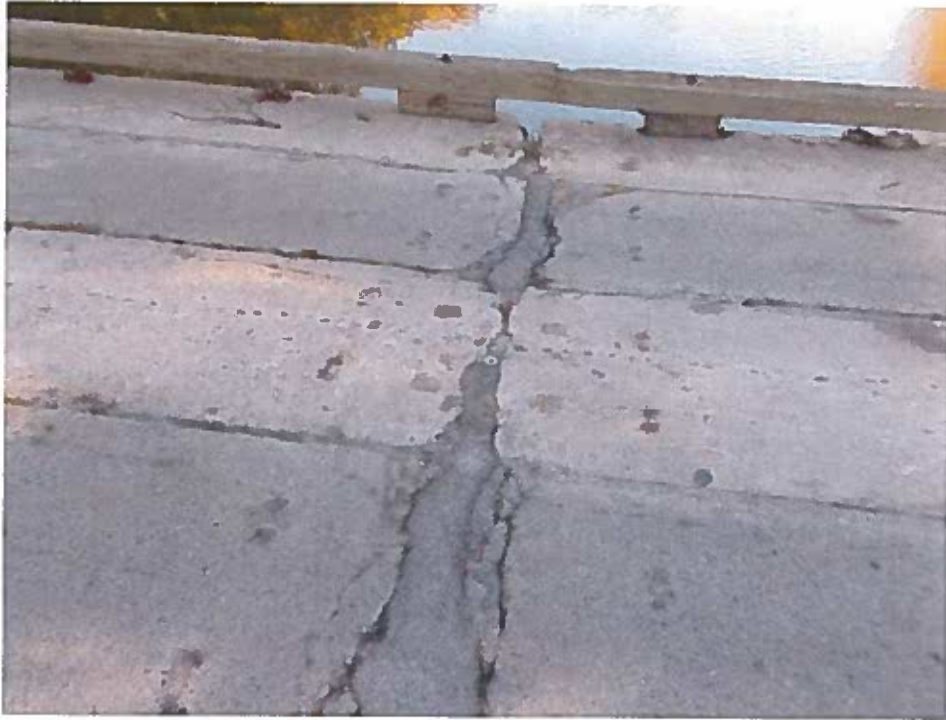
1	508/1	Longitudinal Shear Keys	No repairs or action has been taken since last inspection. Overall poor condition remains. The joints have deteriorated and allow water to leak through the deck. There is cracking in the tops of the beams and spalling at the joints. Spalls have been filled with asphalt in many locations.

**Pier 3 Joint**

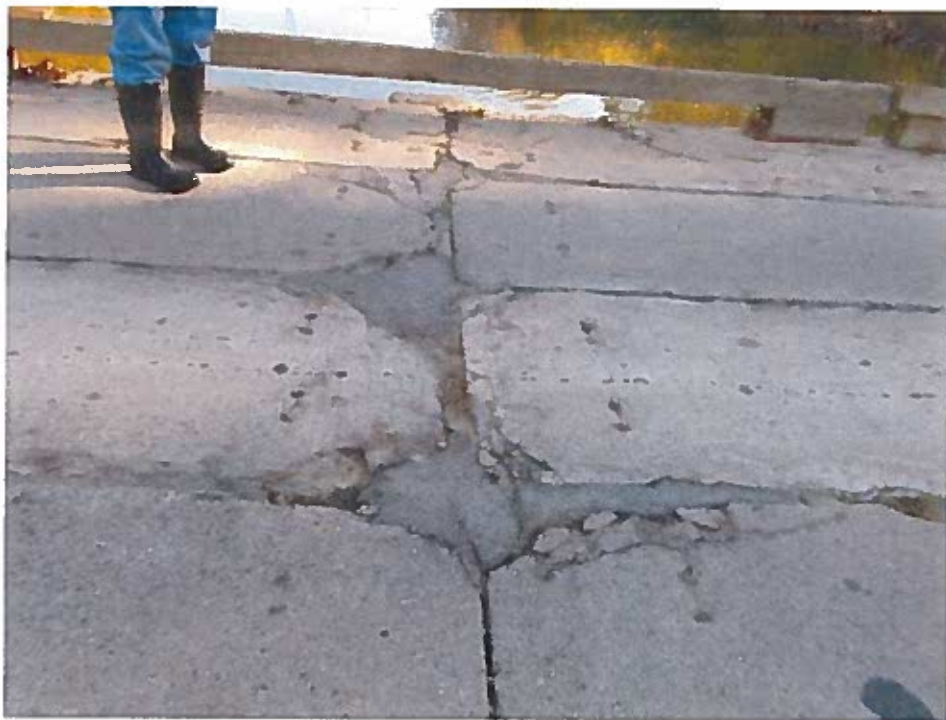
**Pier 2 Joint**

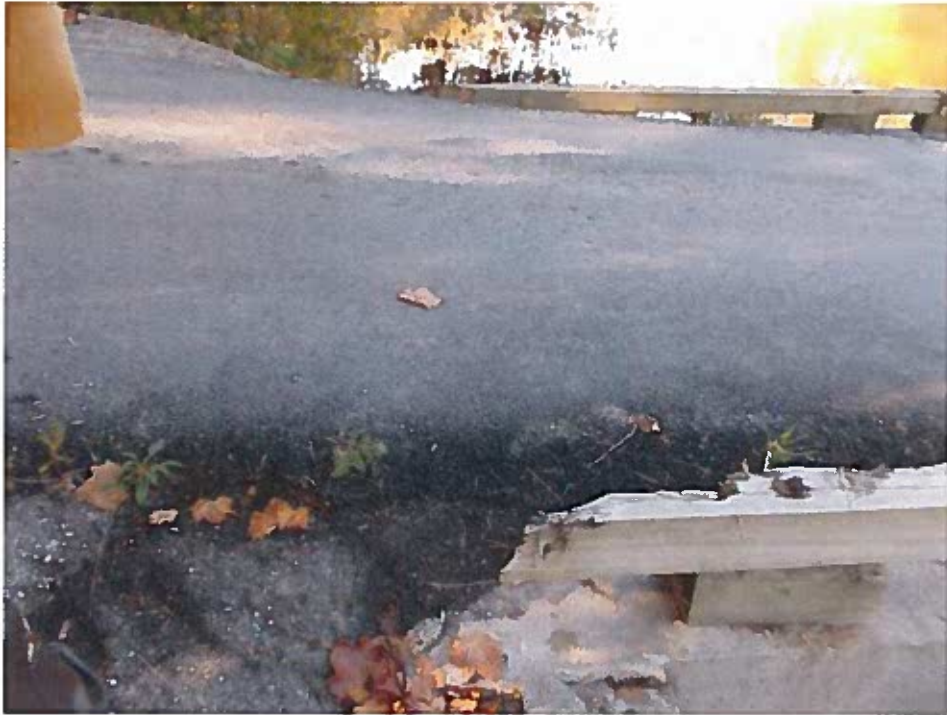
**Abutment 5 Joint**

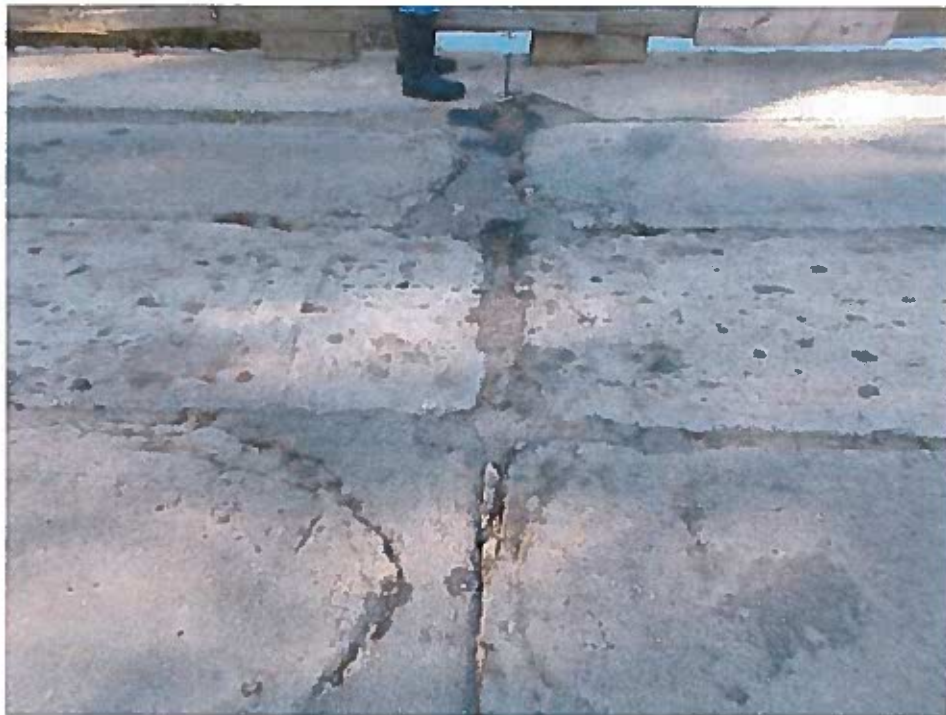
**Pier 4 Joint**

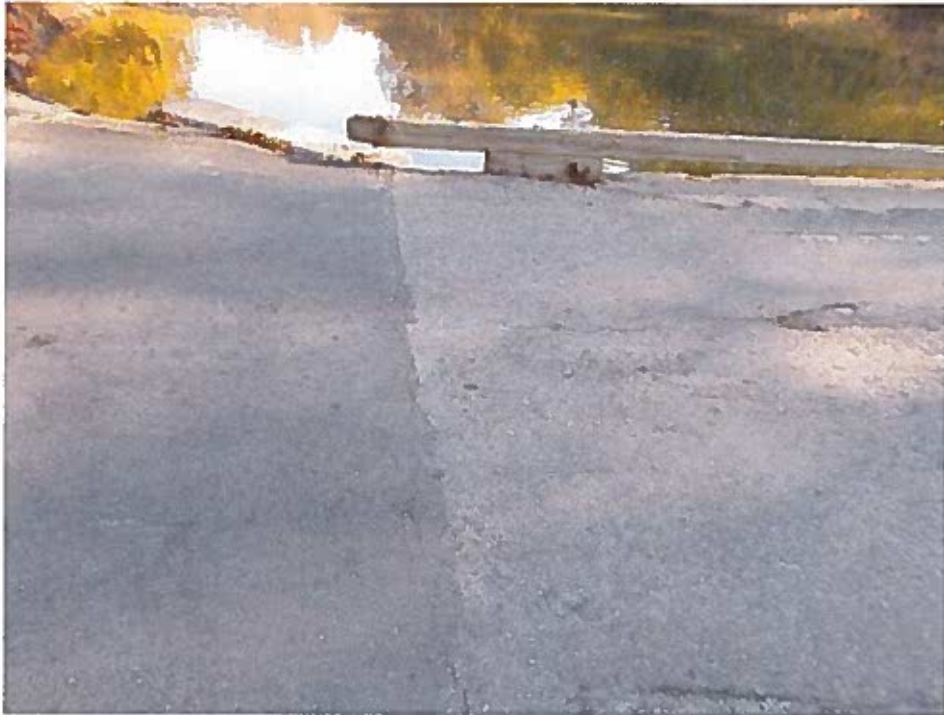
**Abutment 1 Joint**

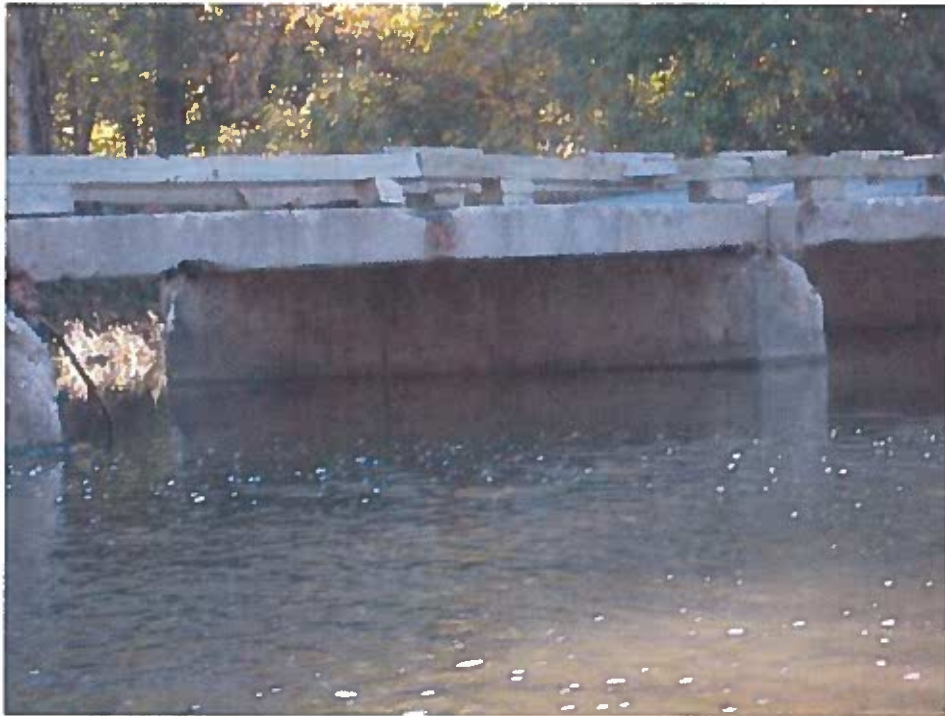
1	210/1	Reinforced Conc Pier Wall	No repairs or action has been taken since last inspection. Overall poor condition remains. Pier 2 has moderate cracks and deterioration. Piers 3 & 4 have spalling/loss of section all across the piers at the bearing area. Beam 1 at Pier 3 has lost bearing due to the spalling. Footing of all piers have some undermining due to constriction scour.
1	215/1	Reinforced Conc Abutment	Abutments have minor cracks and deterioration.
1	301/1	Pourable Joint Seal	No repairs or action has been taken since last inspection. Overall poor condition remains. There is no sealant visible - just debris, and asphalt patches for the numerous spalls at the joints.
1	361/1	Scour	No repairs or action has been taken since last inspection. Overall poor condition remains. Scour is deep at the bridge - too deep to wade. Substructure footings are exposed, with undermining visible.
1	503/1	Reinforced Concrete Curbs and Ties	No repairs or action has been taken since last inspection. Overall poor condition remains. The wooden barriers are bent in several locations and have been dislodged at Beam 1 in Span 2. There is a large spall with exposed reinforcement at this location. Curbs are generally misaligned or completely missing.

**Pier 4 Elevation – Looking Northeast**

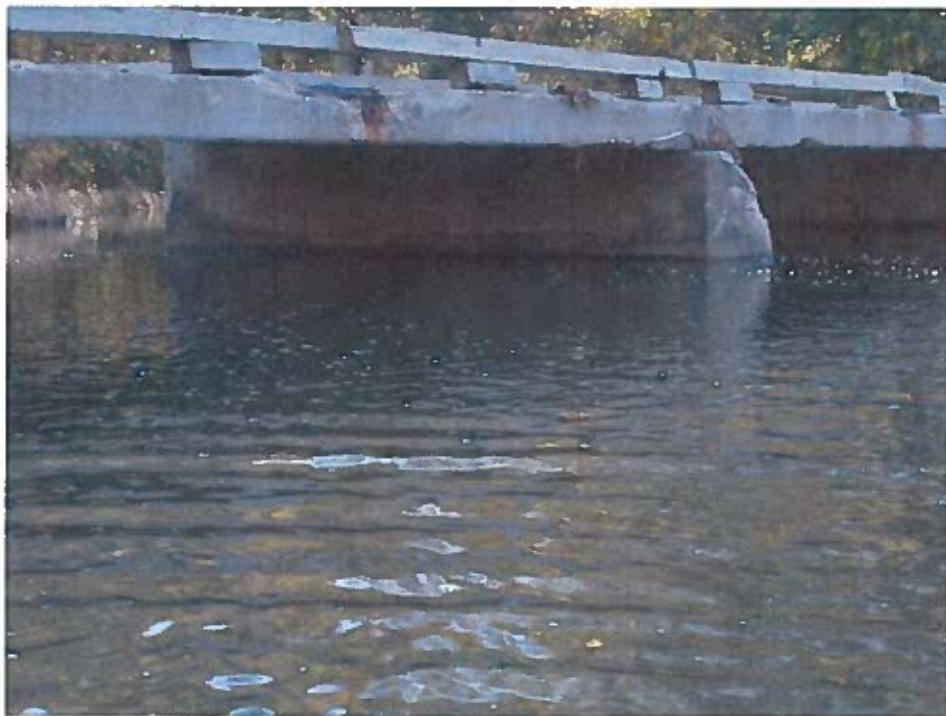
1	104/1	P/S Conc Closed Web/Box Girder	No repairs or action has been taken since last inspection. Overall poor condition remains. The interior beams have spalling and cracking in the surface. The exterior beams are spalled and cracked. The top and south side of the south exterior beams in spans 1, 2, and 3 are heavily spalled in the vicinity of the transverse tie rod location — resteel exposed with some section loss. In Span 1, the transverse tie rod has been cut off at the spall. The top of the north and south exterior beams in span 2 near the middle of the span has around 2 sq. ft. spall — patched with asphalt which has deteriorated, otherwise, the edges of other north exterior beams have light deterioration. Couldn't inspect the underside of the beams due to the deep water/scour. Beams have reduced bearing at Piers 3 & 4 because of the spalling/loss of section of the piers. Lateral tension rods filled with grout on left side. Not evident in spans 1 & 4.

**Pier 3 Elevation – Looking Northeast and Lateral Tensioning Rods Spans 2 & 3**

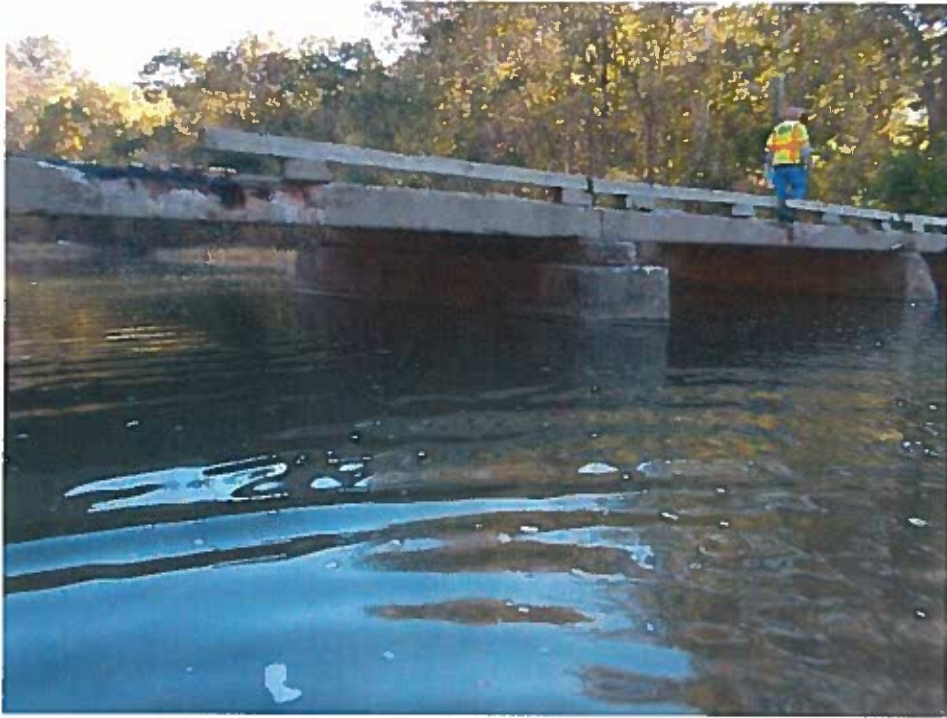
Pier 2 Elevation – Looking Northeast and Beam Spalling with Exposed Reinforcement

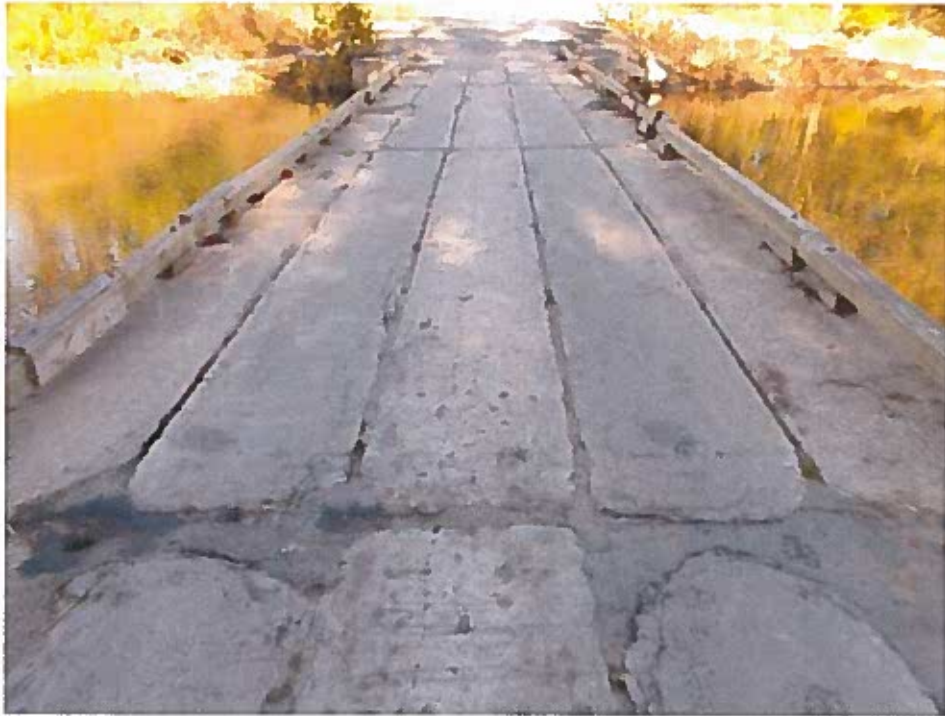
Str Unit	Elm/Env	Description	Element Notes
1	12/1	Concrete Deck - Bare	No repairs or action has been taken since last inspection. Overall poor condition remains. The asphalt pavement extends onto the bridge 10'-12' at each end - with wedges up to 12" thick - in an attempt to mitigate the abrupt change in the vertical alignment. The interior beams have spalling and cracking in the surface. The exterior beams are spalled and cracked. Most of the biggest spalls are patched with asphalt. The top and south side of the south exterior beams in spans 1, 2, and 3 are heavily spalled in the vicinity of the transverse tie rod location — resteel exposed with some section loss. In Span 1, the transverse tie rod has been cut off at the spall. The top of the north and south exterior beams in span 2 near the middle of the span has around 2 sq. ft. spall — patched with asphalt which has deteriorated, otherwise, the edges of other north exterior beams have light deterioration.

Bare Concrete Deck, R/Conc Box Girders, and Longitudinal Shear Keys (Typical)

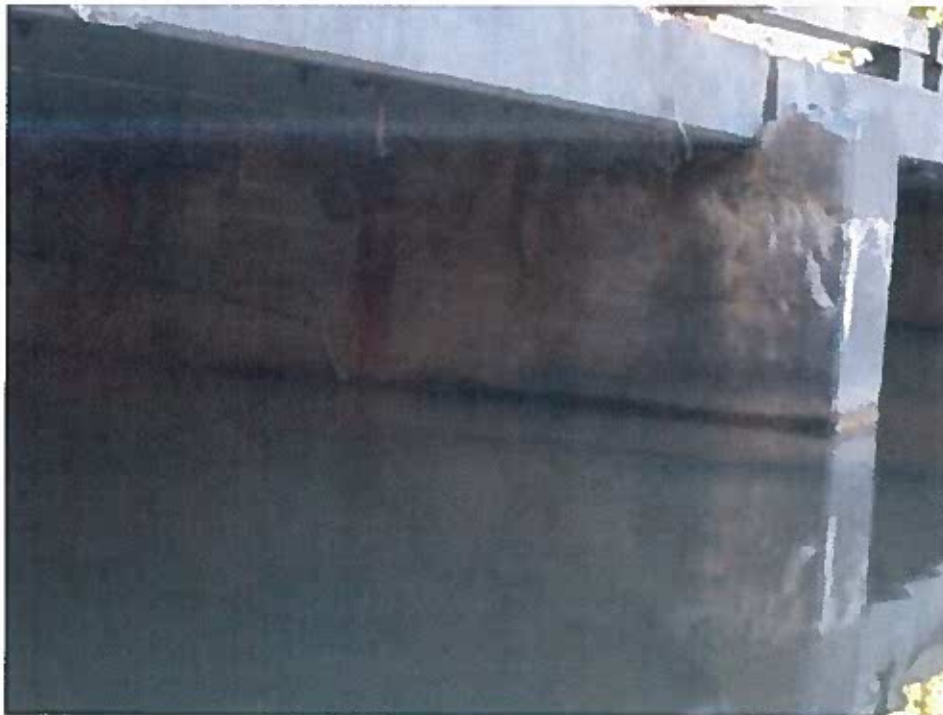
Pier 4 – Spalling with Exposed Reinforcement

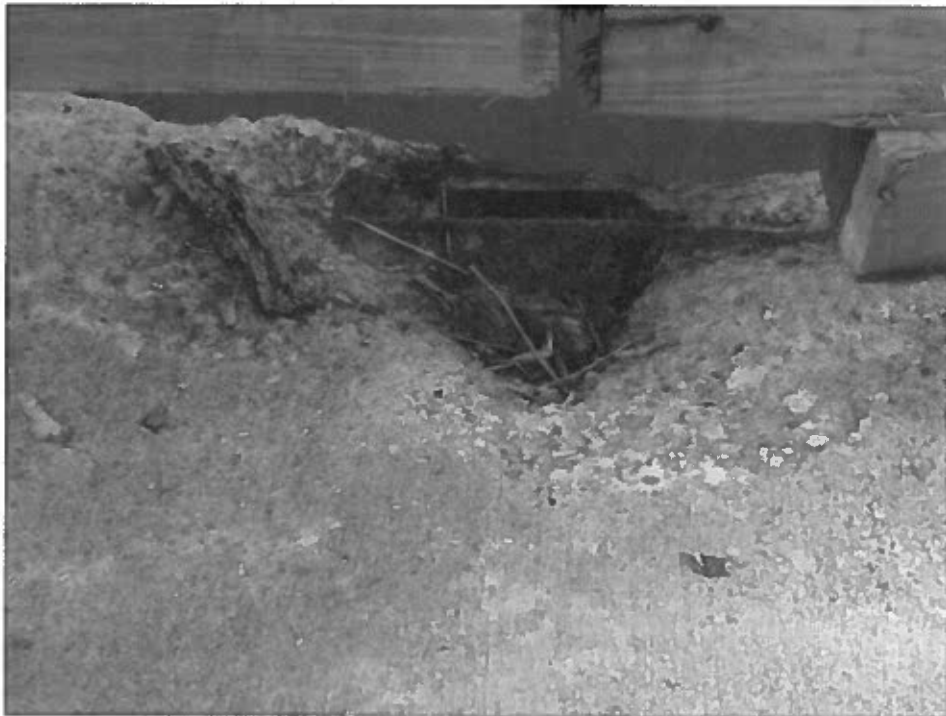
**Beam 5, Span 3 – Spall with Exposed Reinforcement at Lateral Tension Rod Location**

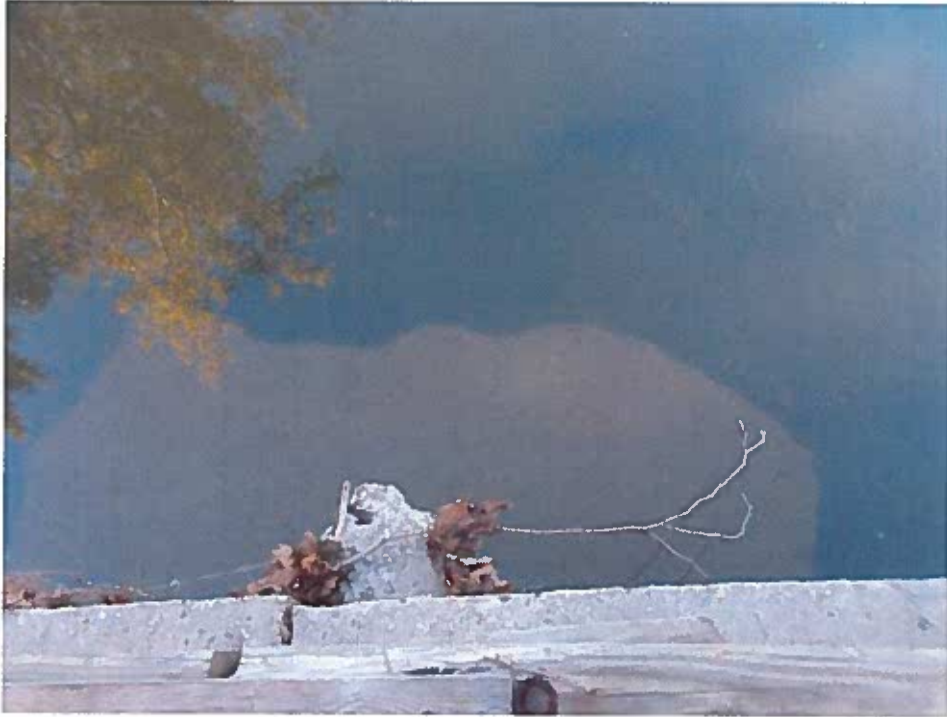
**Pier 4 - Scour**

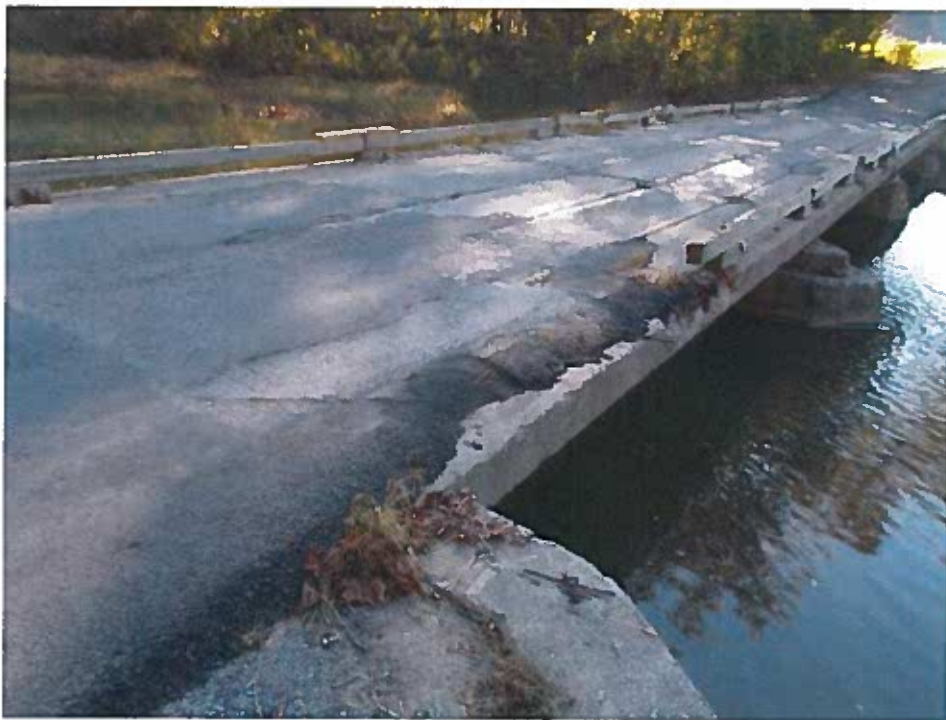
**Missing Curb, Right Side of Span 1**
