# Structure Inventory and Appraisal Sheet (English Units)

Bridge Key: 12939      Agency ID: 108B00041N      SR: 2      SD/FO: SD

State 1: 21 Kentucky      Struc Num 8: 108B00041N  
 Facility Carried 7: KY-2885      Location 9: 4.2 MI SW JCT KY 55

**108B00041N Inspection 02-22-2013**

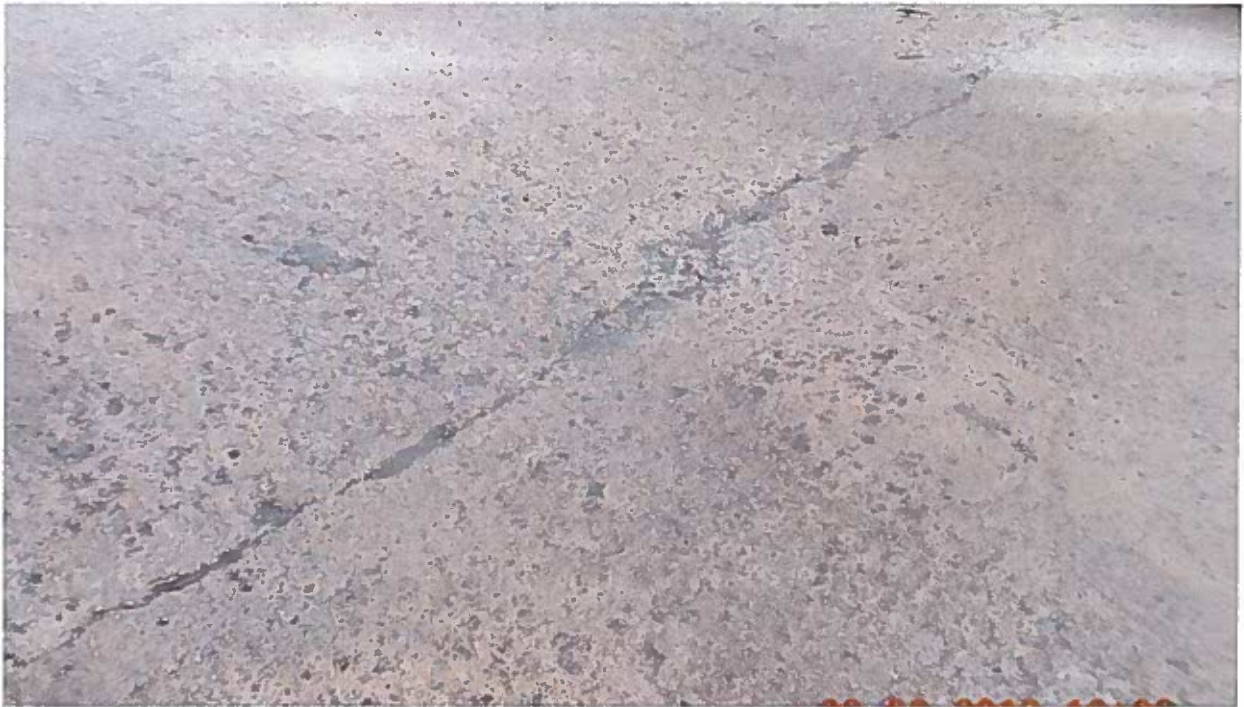
**Transverse Cracking in Approach Slab - Typical**

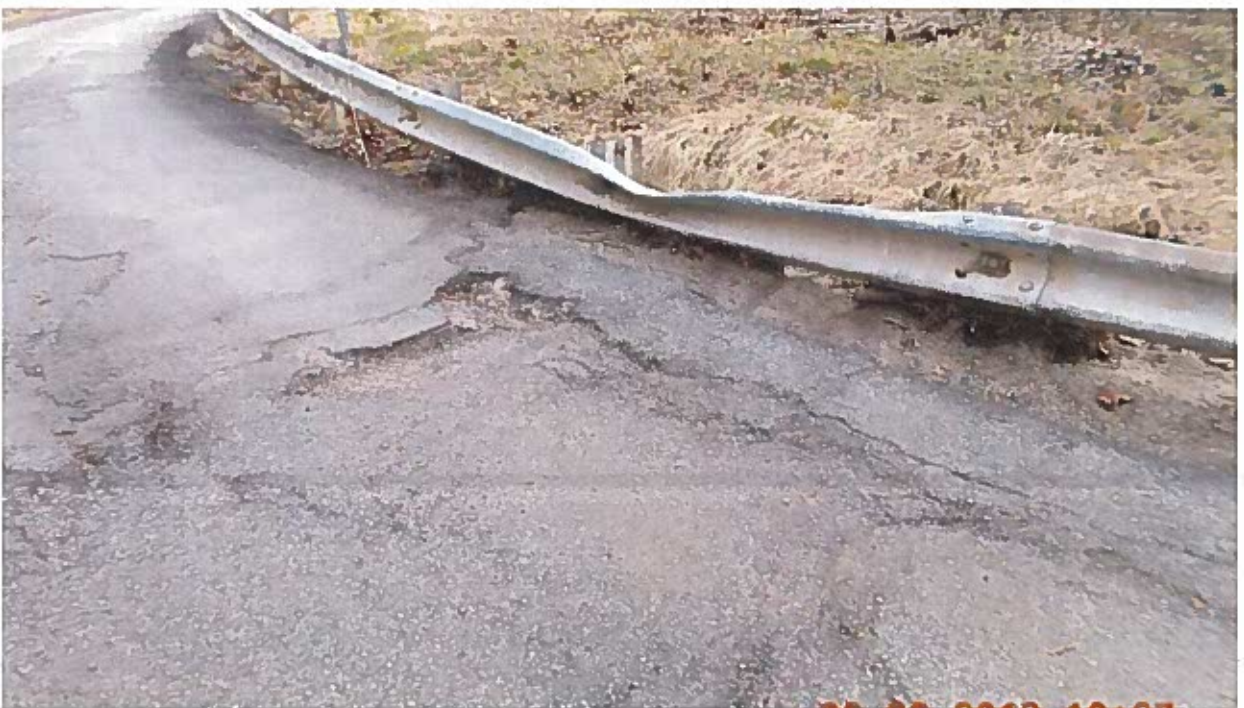
**Guardrail Damage at Northeast Quadrant**

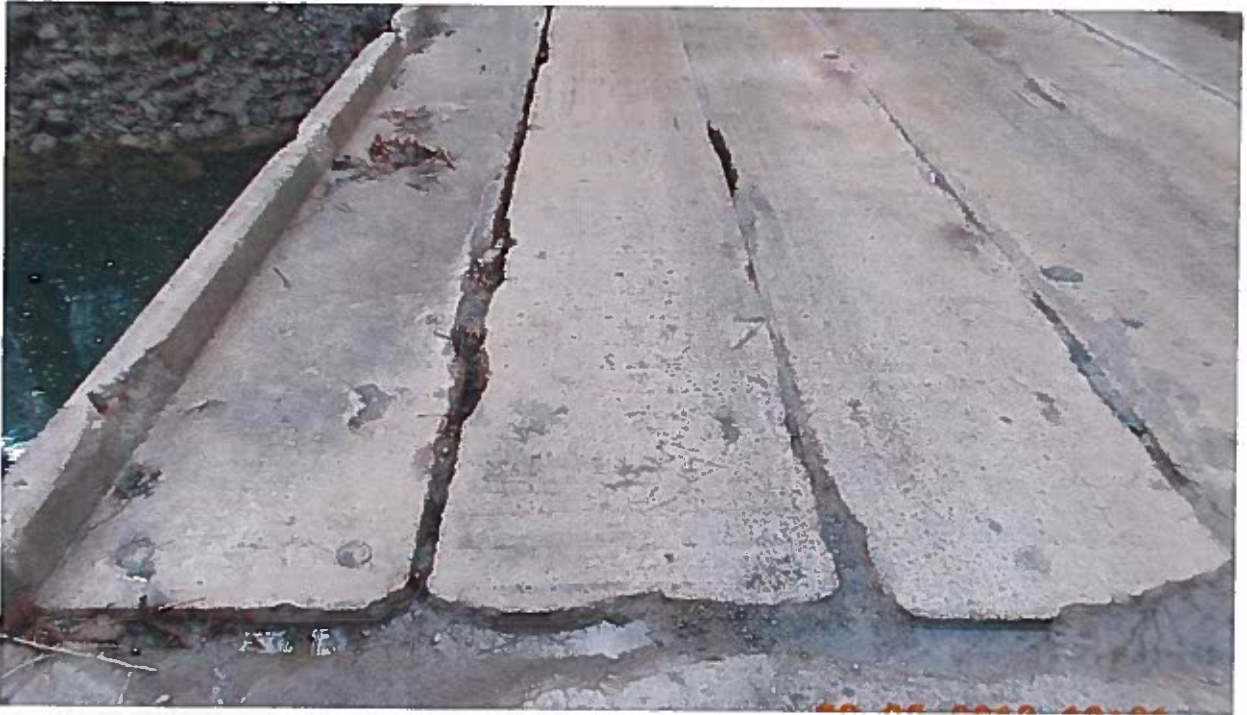
**Deterioration of Joints between Beams - Looking South**

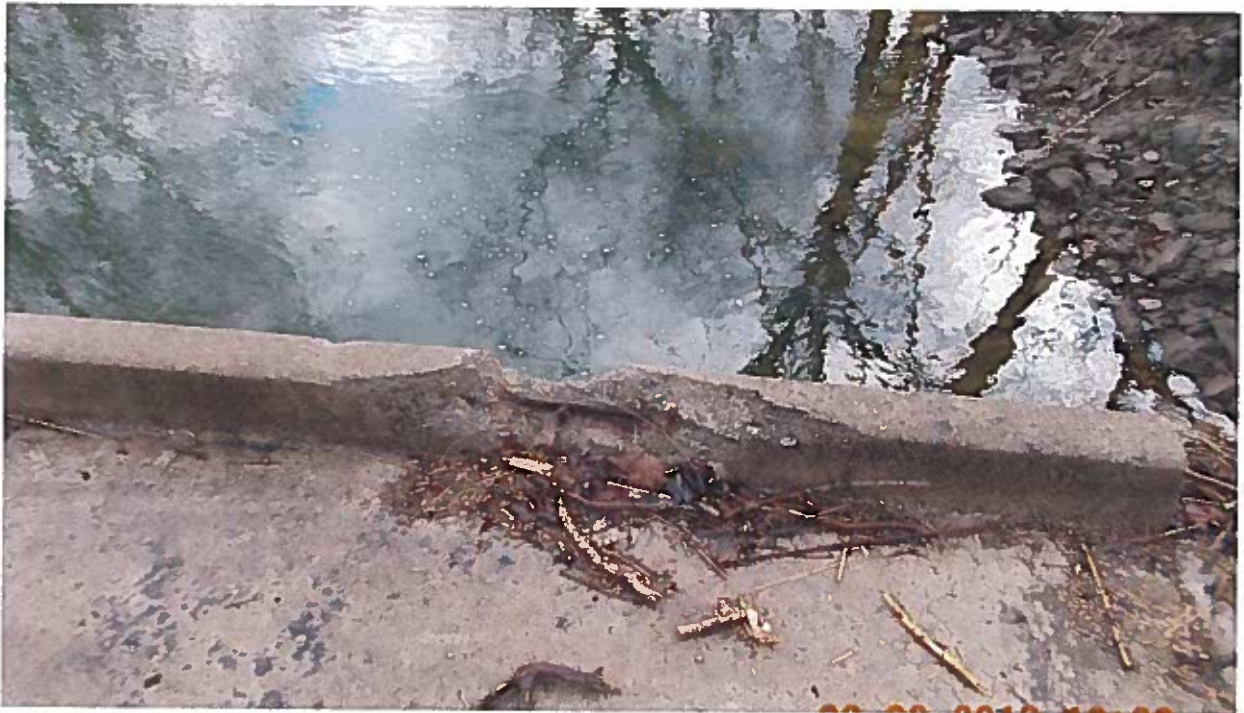
**East Curb Spalled with Exposed Reinforcing Steel**

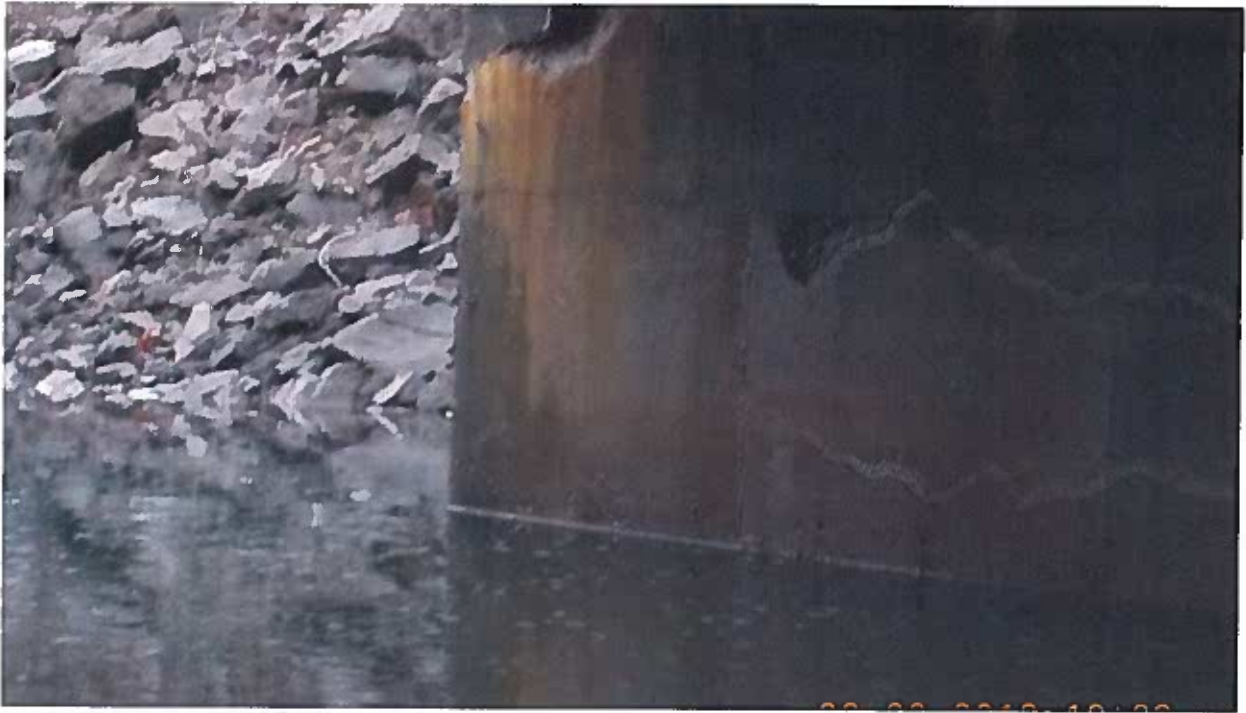
Abutment 1: Concrete surfaces exhibited light scaling from the waterline to the channel bottom. Vertical cracking and spalling was noted in areas of previous repair. See Figure 4 in Appendix A for detailed inspection notes.

**Abutment 1 Spall and Cracking on East Side**

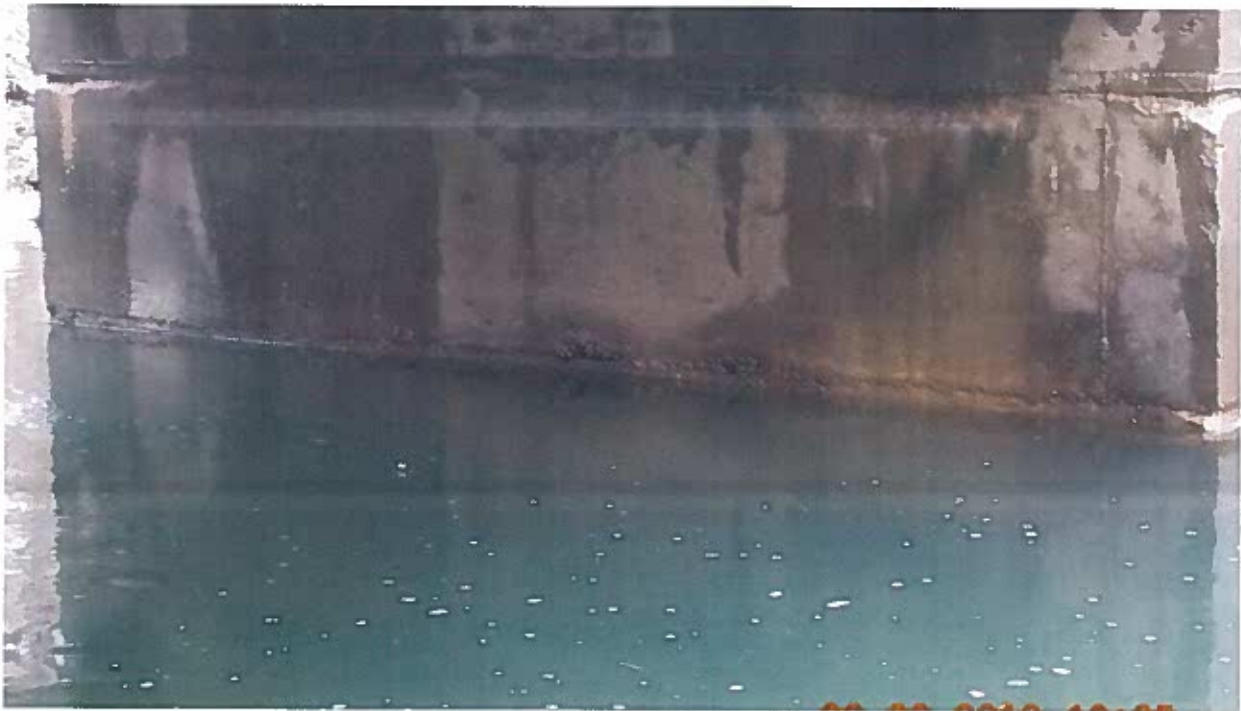
Abutment 2: Concrete surfaces exhibited light scaling from the waterline to the channel bottom. The footing along the south face was undermined and shear cracks were noted on both wingwalls. Construction joints were separated on both wingwalls. Spalling was noted in areas of previous repair. See Figure 5 in Appendix A for detailed inspection notes.

**Abutment 2 Elevation - Minor Vertical Cracking, Spalls along Construction Joint and Staining from Leaking Joints**

Perform structural repair to Abutment 2 with a replacement bridge, see be constructed

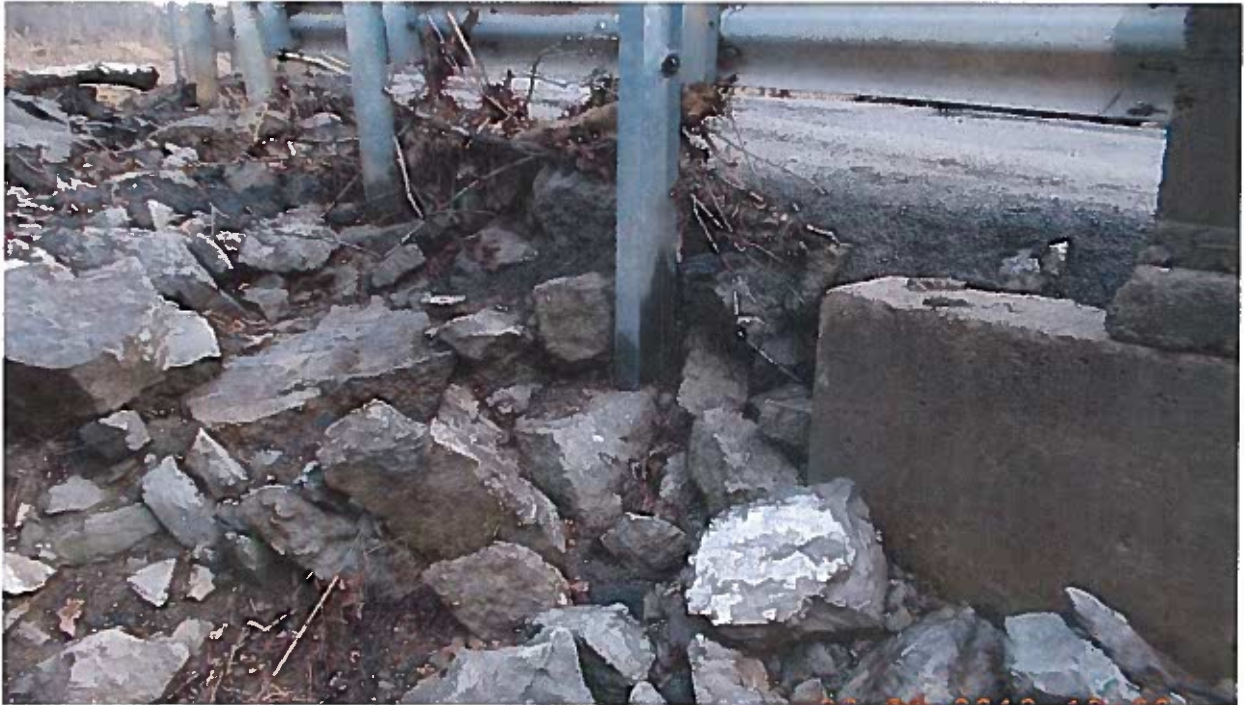
**Guardrail Post not Embedded - Erosion and loss of Fill at Northwest Quadrant**

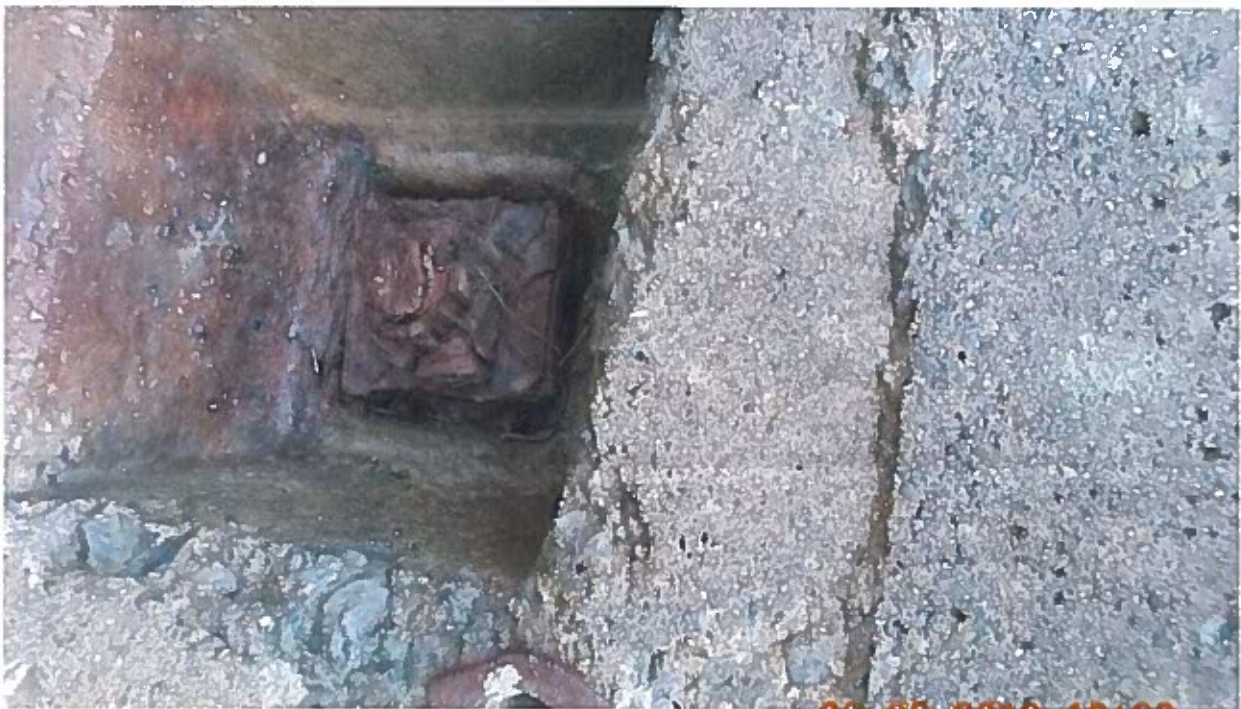
**Lateral Tension Rod - Rust with Section Loss (Typical)**
