Inspection Report with SI&A Data

Structure Description: 417.98 Foot - 3 Span Steel continuous Stringer/Multi-beam or Girder

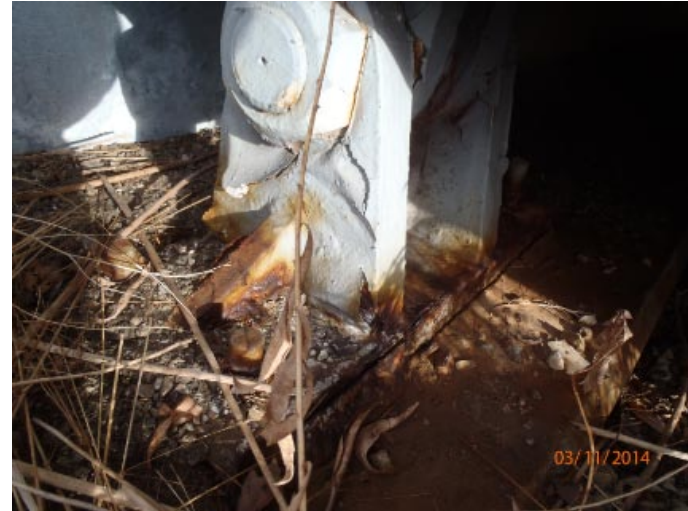
View of the south bearing at abutment 1. Moderate to heavy corrosion is present in the masonry plate and anchor bolts.

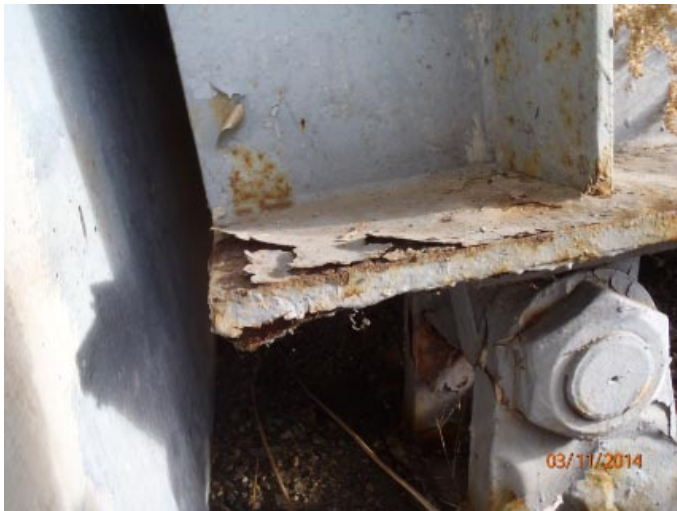
View of flaking paint with minor to moderate corrosion in the bottom flange of the south beam at abutment 1.

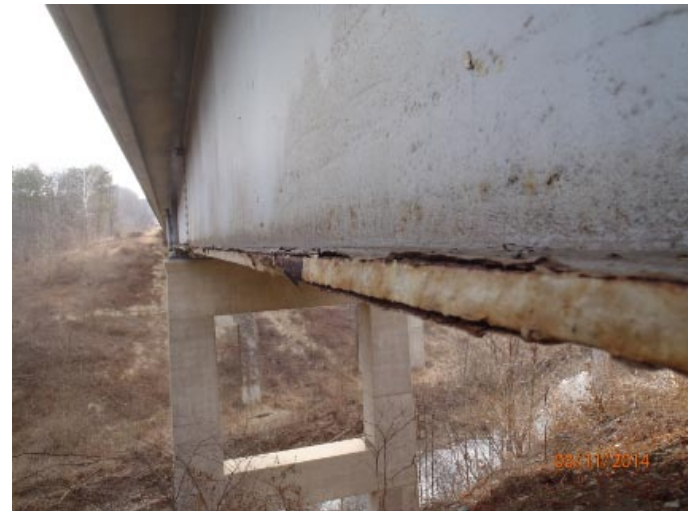
View of flaking paint with moderate corrosion along the bottom flange of the north beam in span 1.

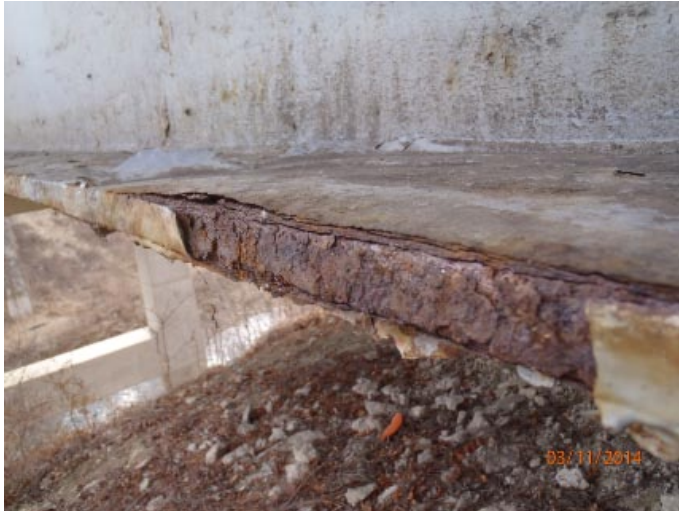
View of flaking paint with moderate corrosion along the bottom flange of the north beam in span 1.

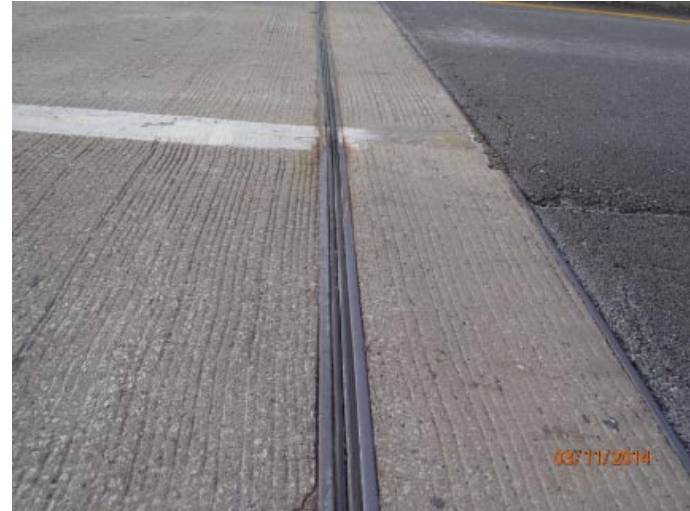
View of the transverse joint at abutment 1. It has some small tears and local adhesion failure.

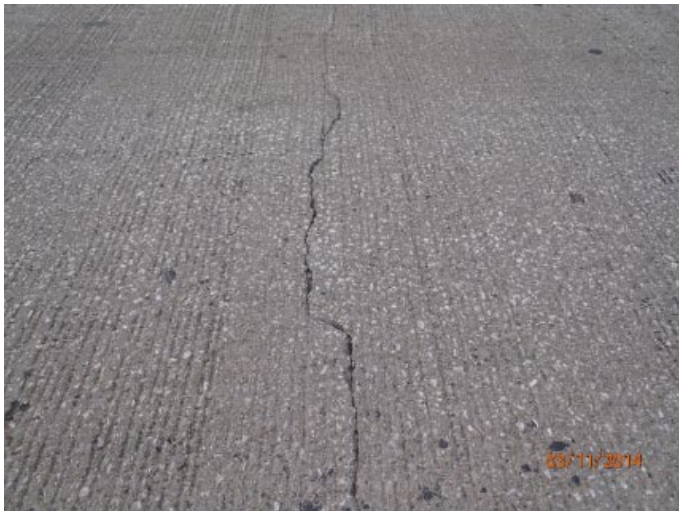
View of some minor transverse cracking in the wearing surface in span 1.

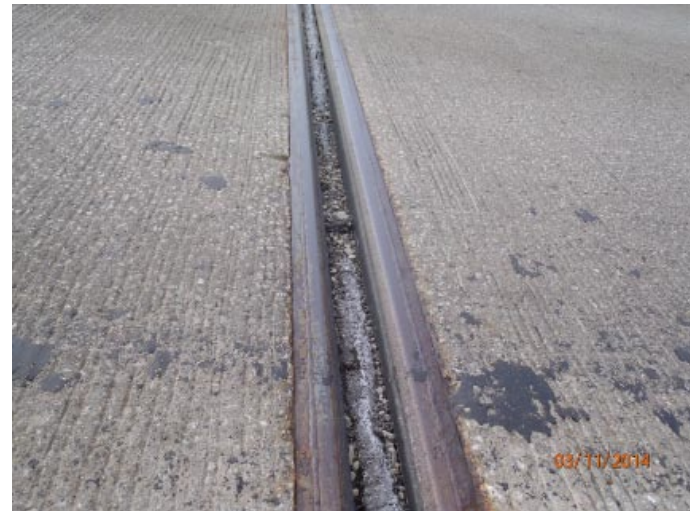
View of the transverse joint over pier 4. It is partially full of debris.

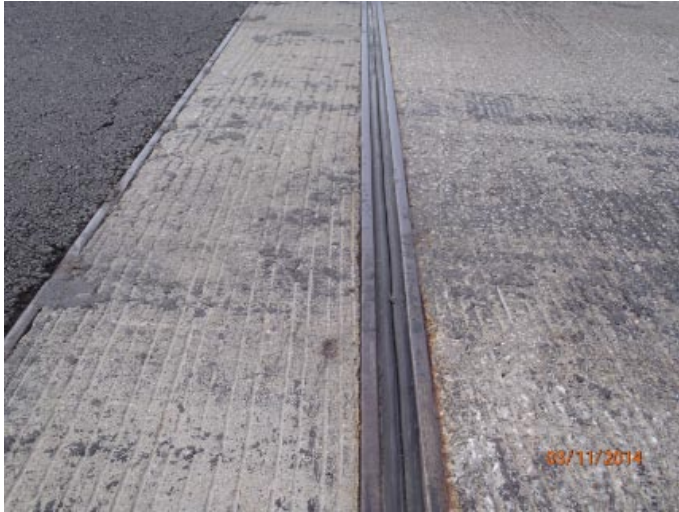
View of the transverse joint over abutment 5. It has some local adhesion failures.

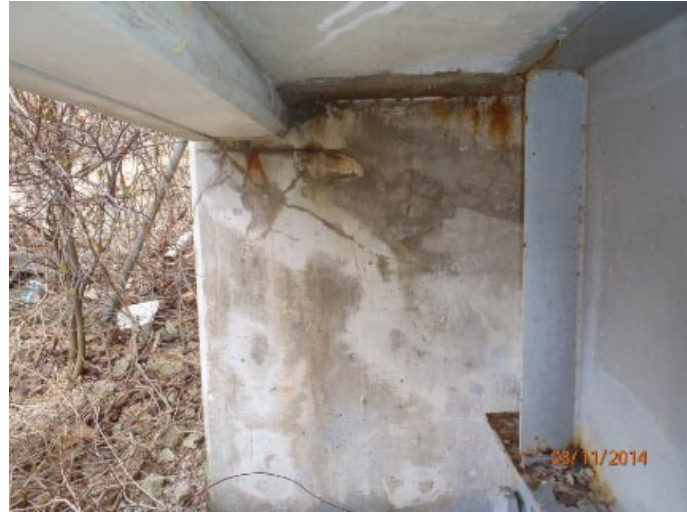
View of minor cracking at the north end of abutment 5's backwall.

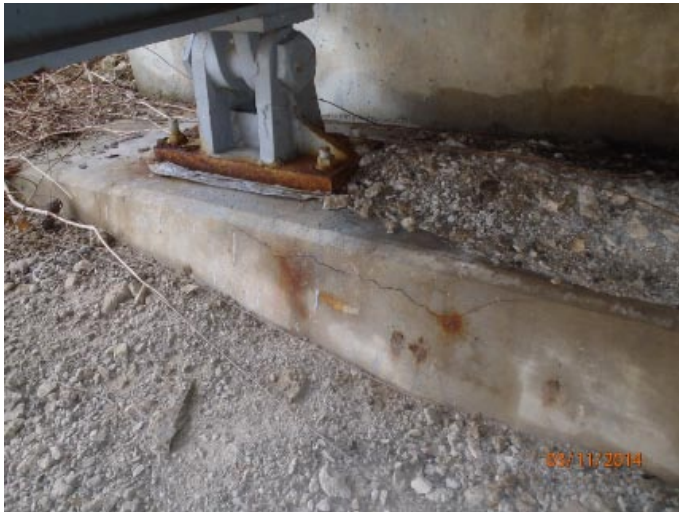
View of minor cracking at the north end of abutment 5's breastwall.

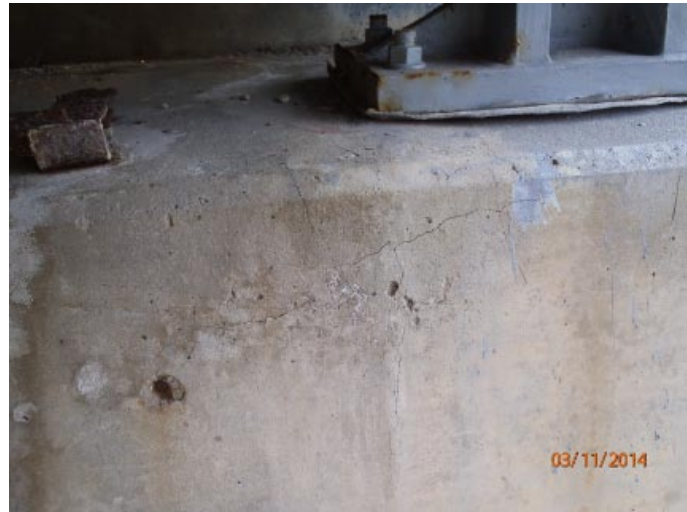
View of minor cracking at the south end of abutment 5's breastwall.

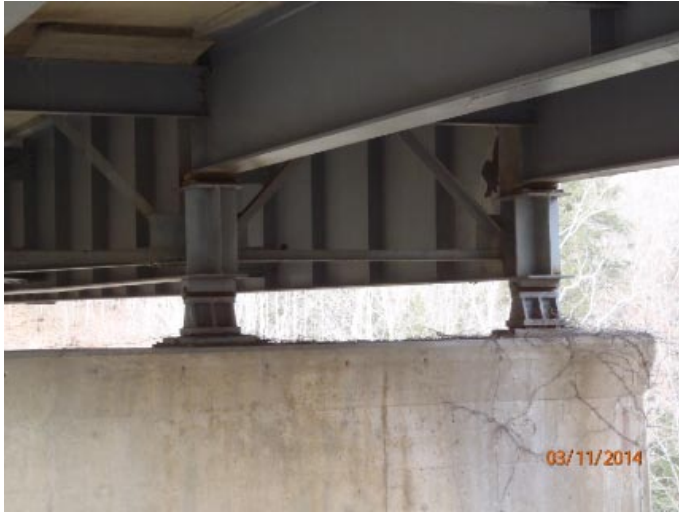
View of the north bearings over pier 4.

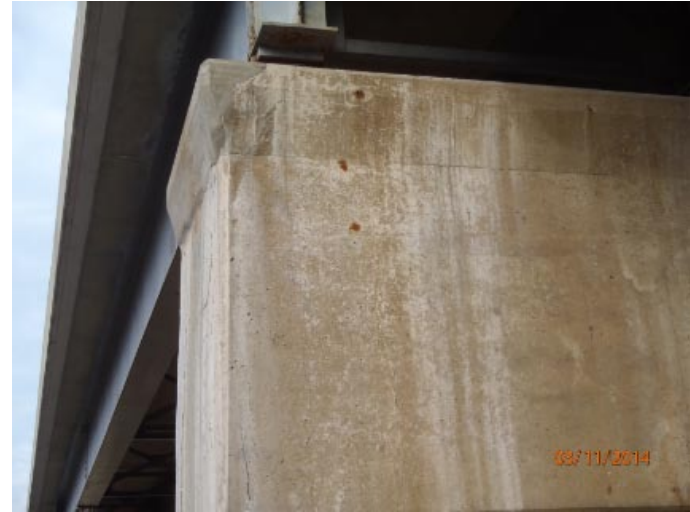
View of minor to moderate cracking at the south end of pier cap 4 in span 4.

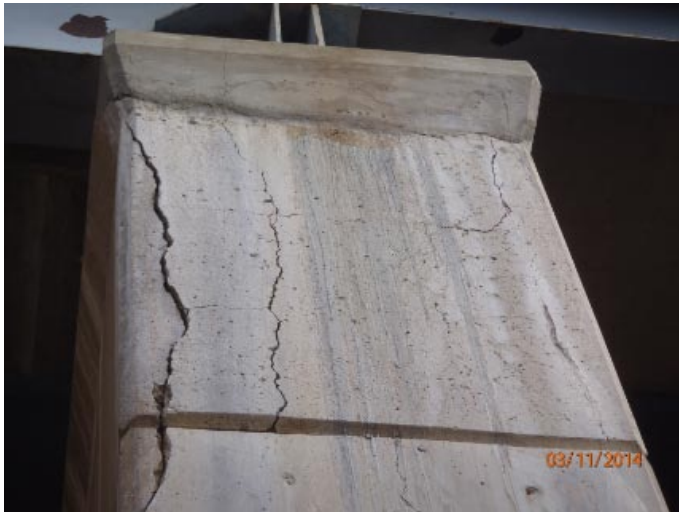
View of moderate to heavy cracking at the south end of pier cap 4.

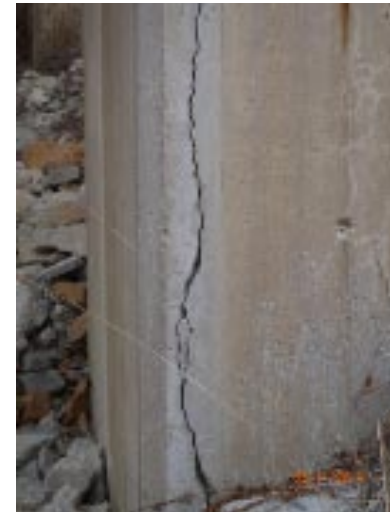
View of moderate vertical cracking (up to 3/16" wide near ground) in the south face of the south column of pier 4.

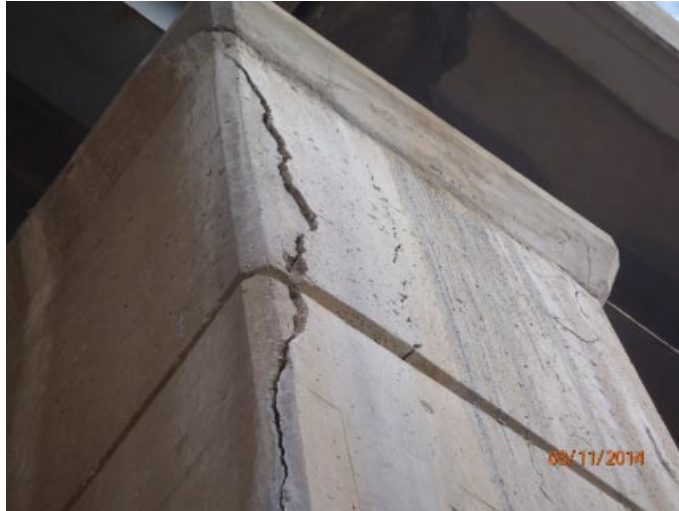
View of moderate to heavy vertical cracking (up to 3/16" wide near ground) in the south face of the south column and cap of pier 4.

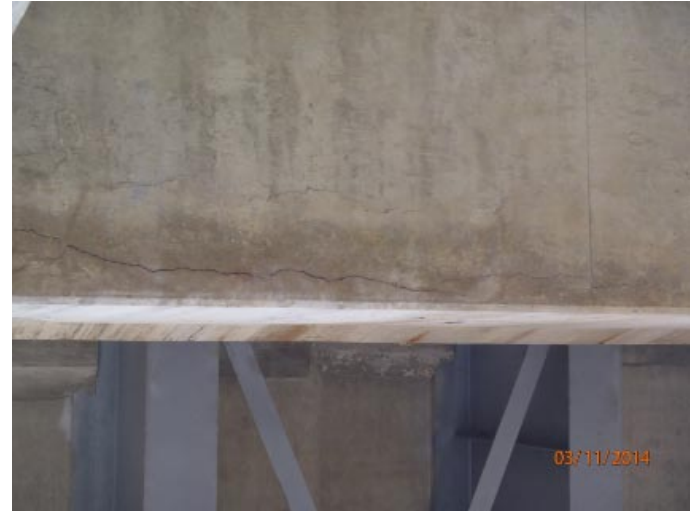
View of minor cracking in the underside of pier cap 4.

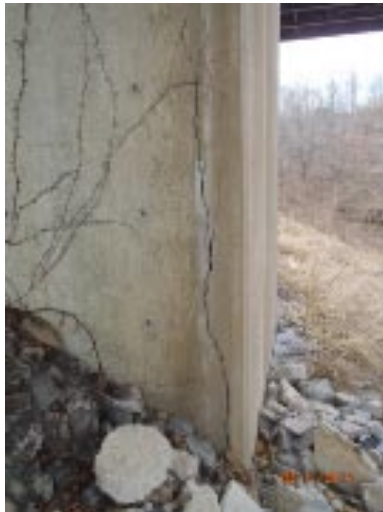
View of moderate vertical cracking (3/8" wide near the ground) in the north face of the south column of pier 4.

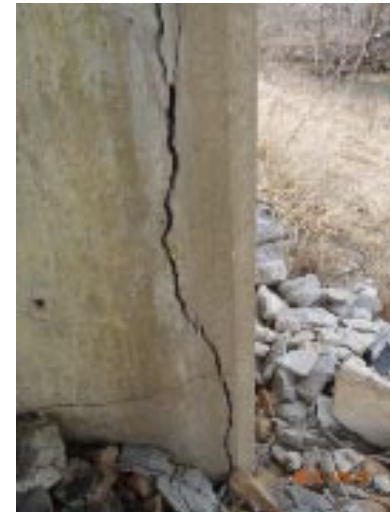
View of moderate vertical cracking (3/8" wide near the ground) in the north face of the south column of pier 4.

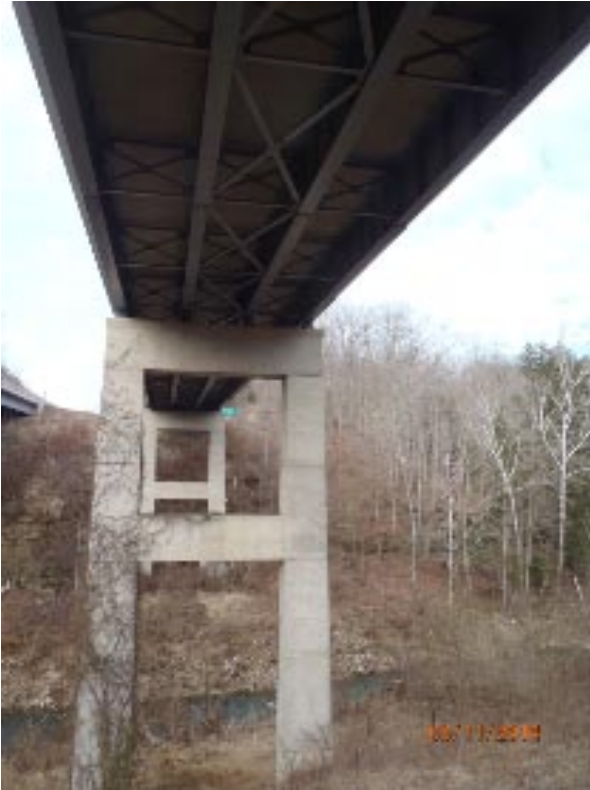
View of span 3 and pier 3. Notice the vines growing on the south column.

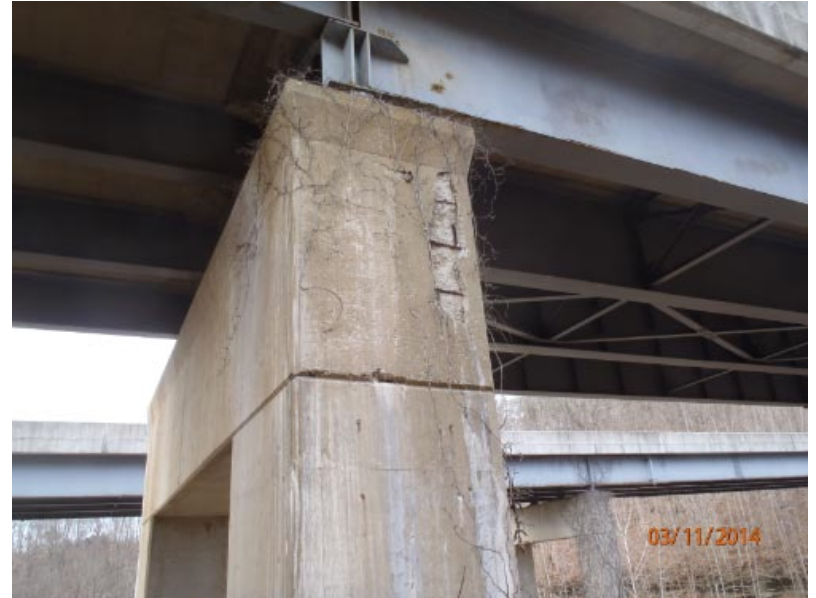
View of a moderately sized and moderately deep spall with exposed steel at the north end of pier cap 4.

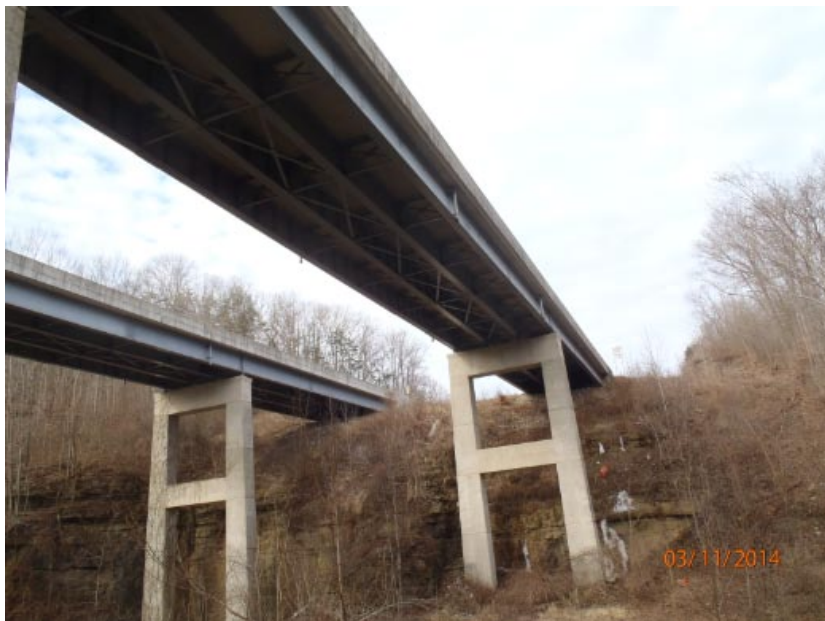
View of span 2 and pier 2.
