Inspection Report with SI&A Data

Structure Description: 61.02 Foot - Single Span Steel Stringer/Multi-beam or Girder

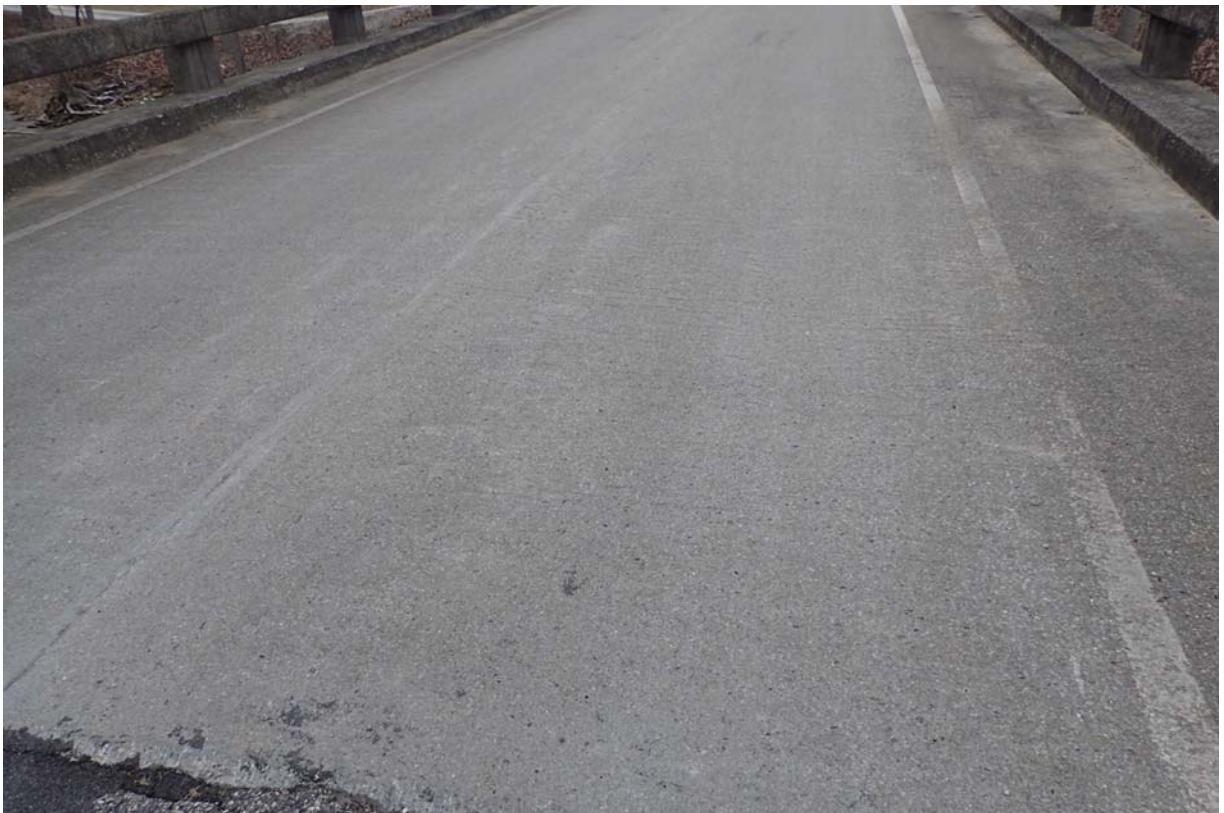
Typical view of the wearing surface.

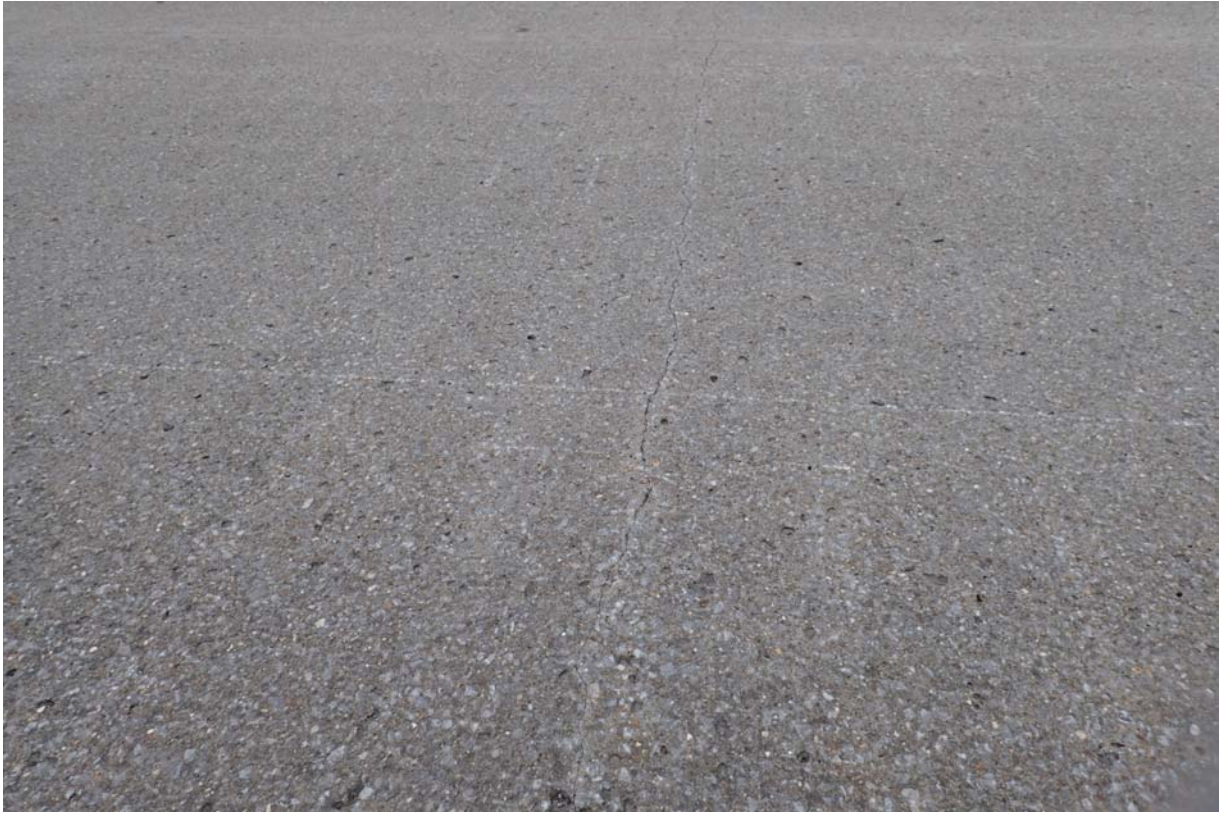
Minor sized transverse cracking in the wearing surface near abutment 1.

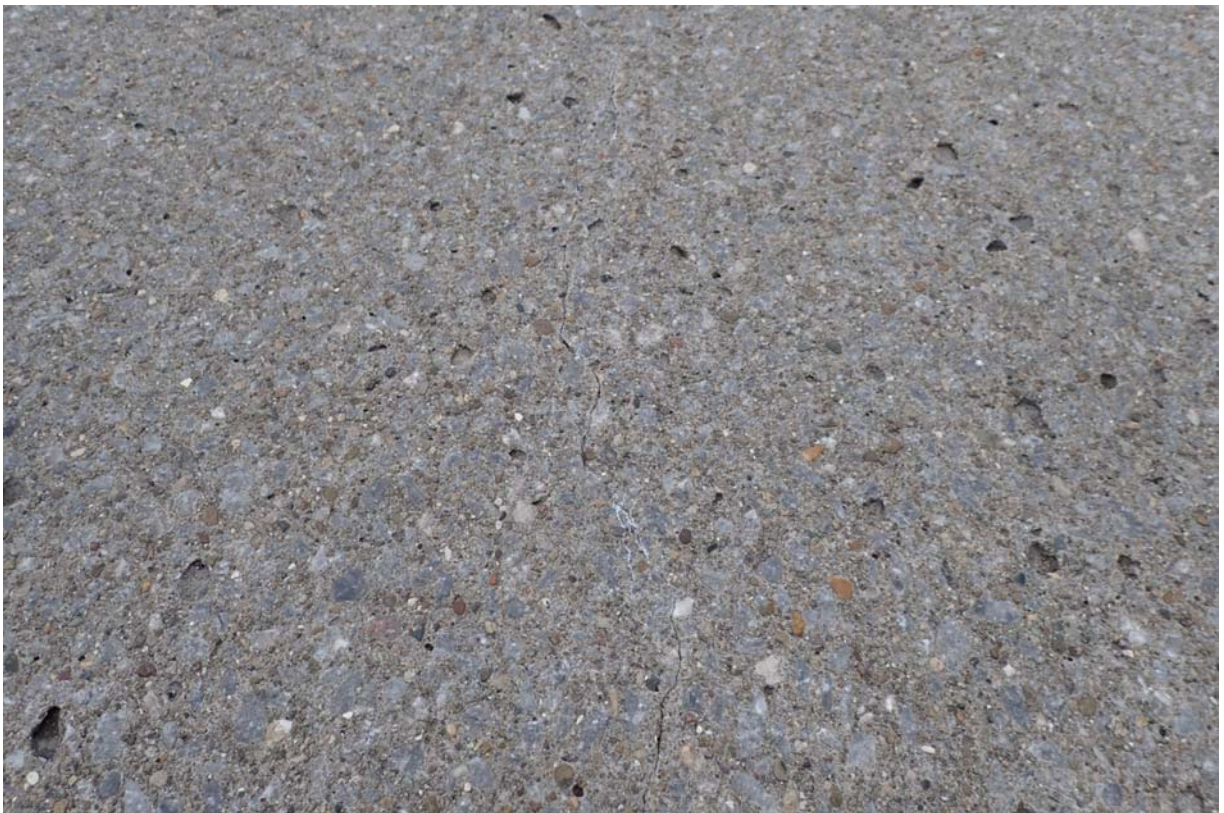
Minor sized transverse cracking in the wearing surface near mid-length.

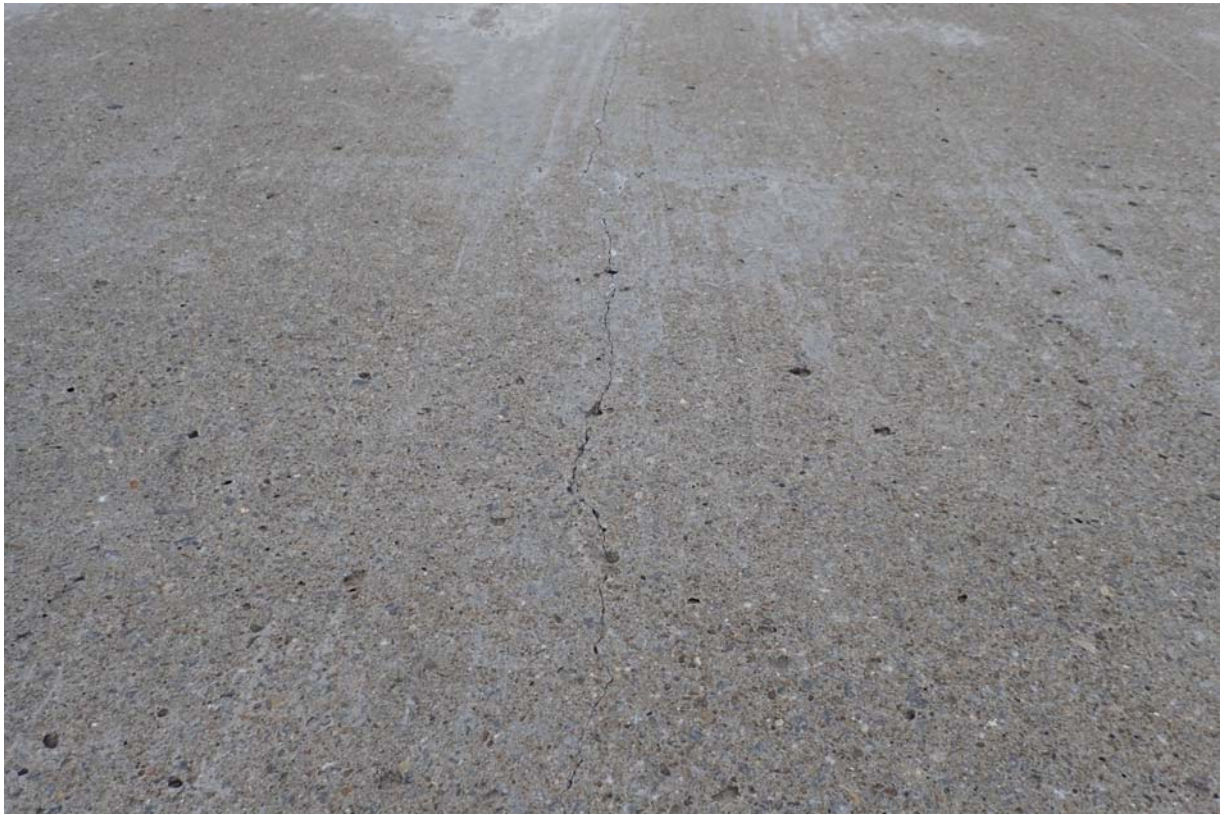
Minor sized transverse cracking in the wearing surface near abutment 2.

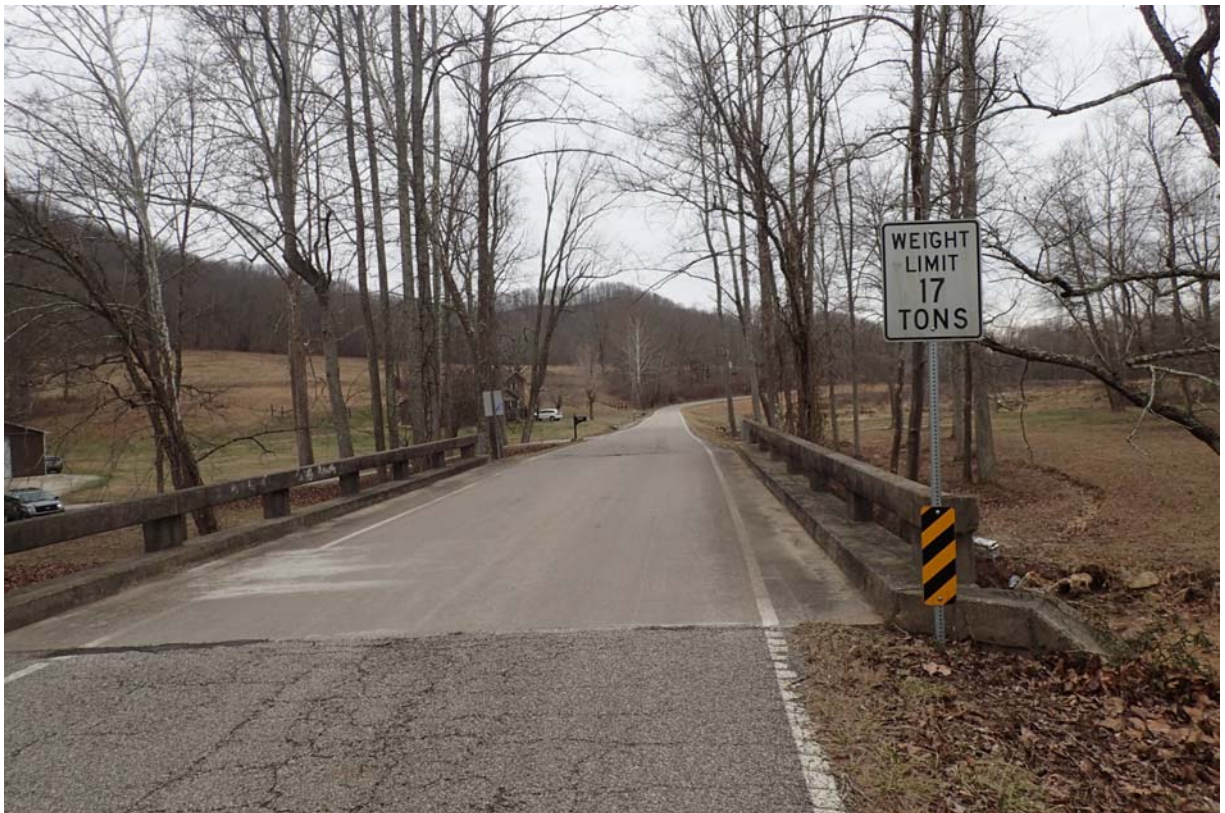
17 tons posting near abutment 2.

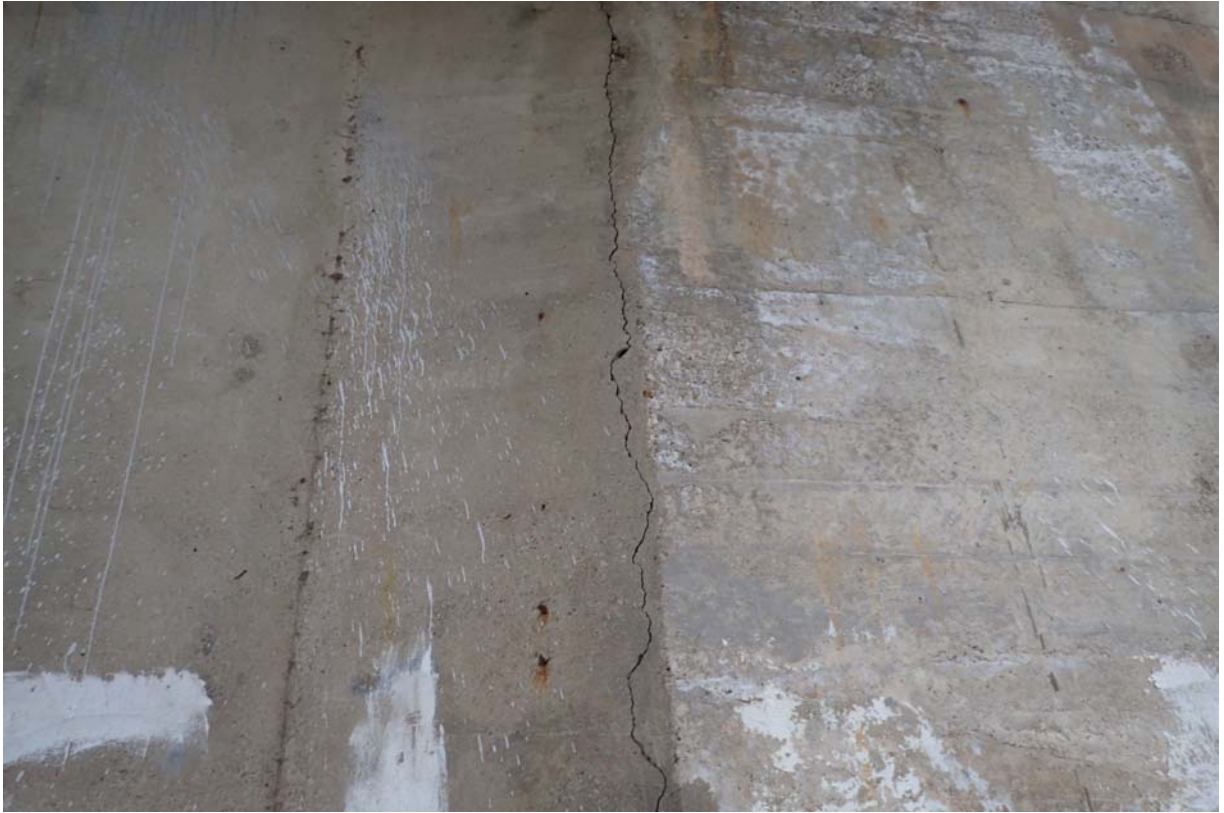
Minor sized vertical crack in abutment 2 near the old/new abutment interface.

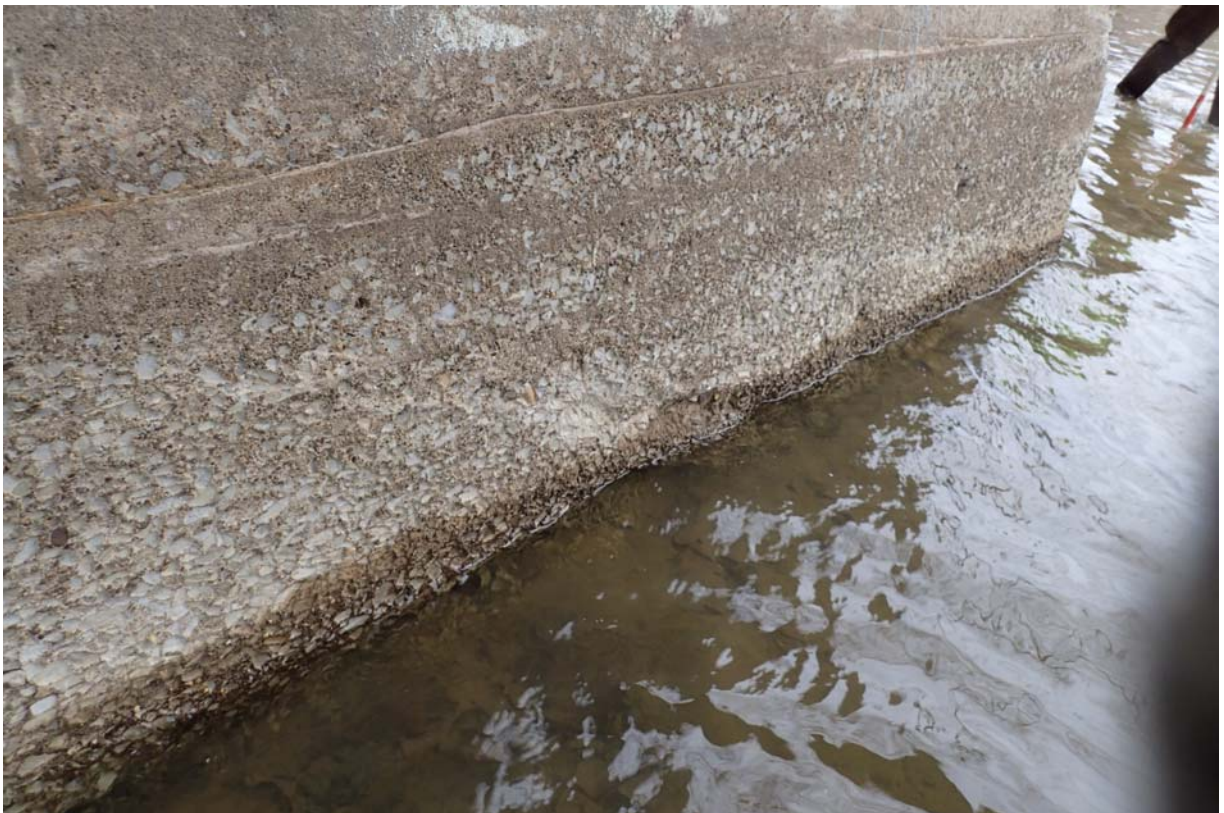
Moderate scaling along the flowline of abutment 2.

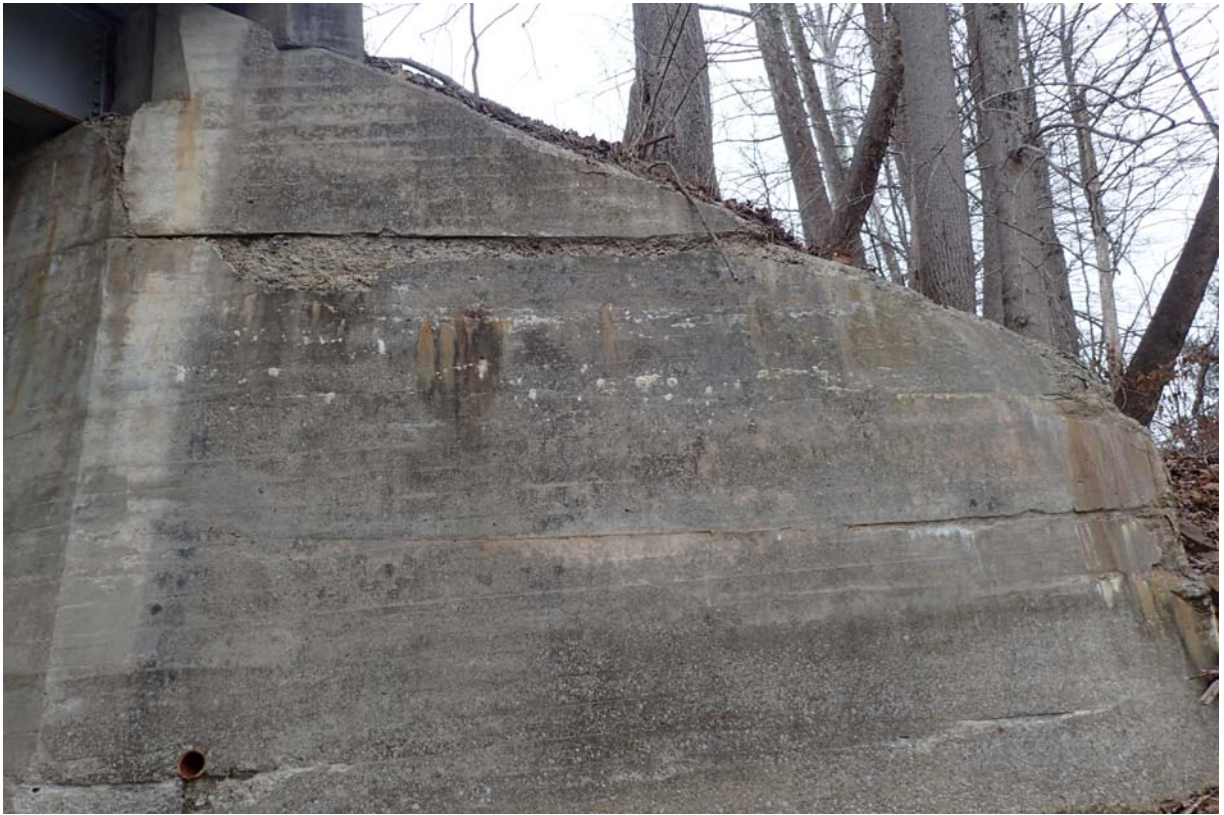
Spalling near and along the top of abutment 2s downstream wingwall.

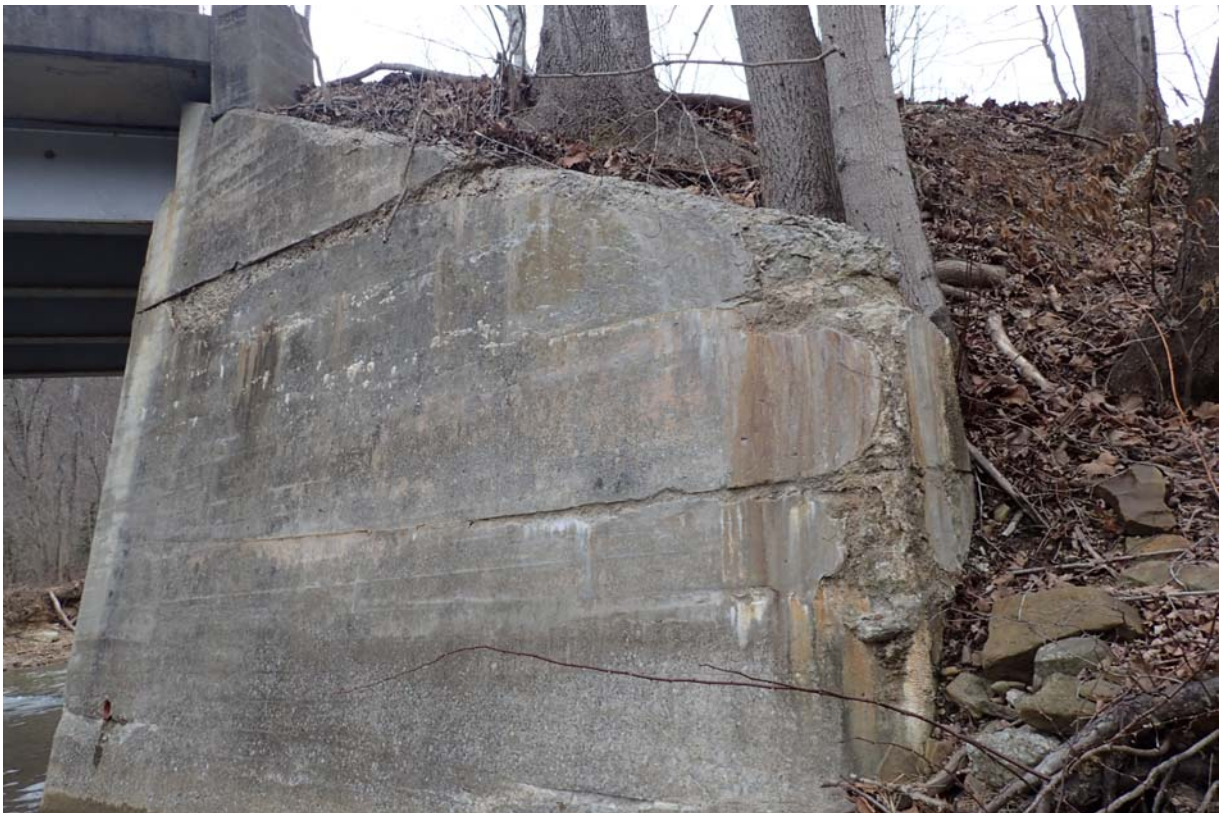
Spalling along the top and at the end of abutment 2s downstream wingwall.

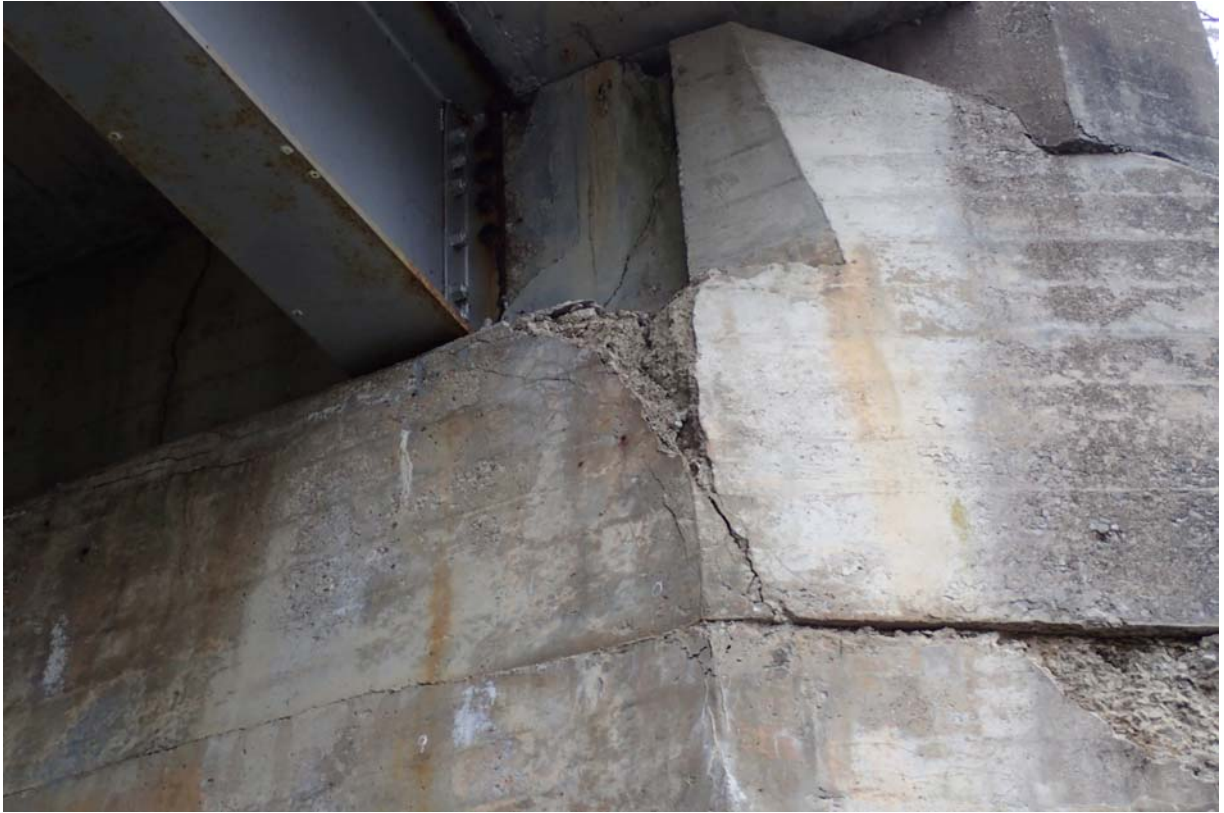
Moderate to heavy cracking/spalling in abutment 2 adjacent to the downstream exterior beam.

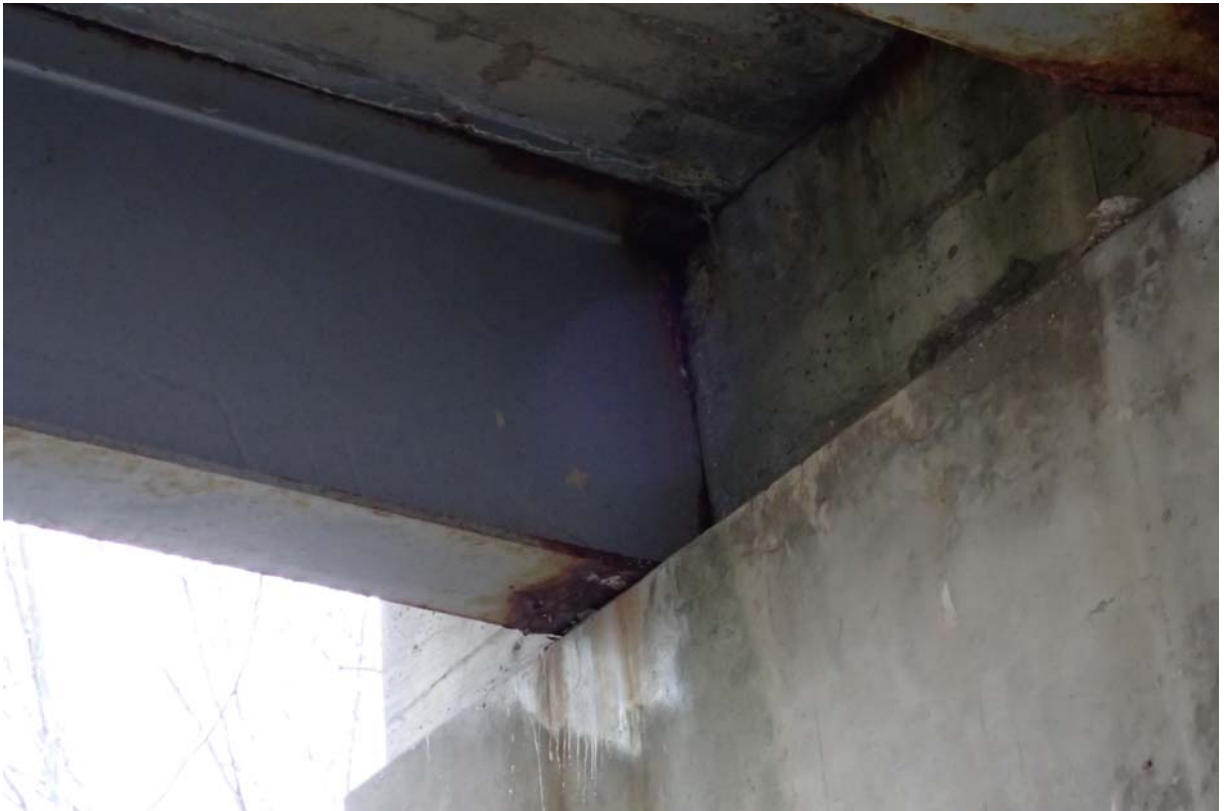
Typical view of the upstream beam at abutment 2. Notice the moderate rust/corrosion of the web and flanges.

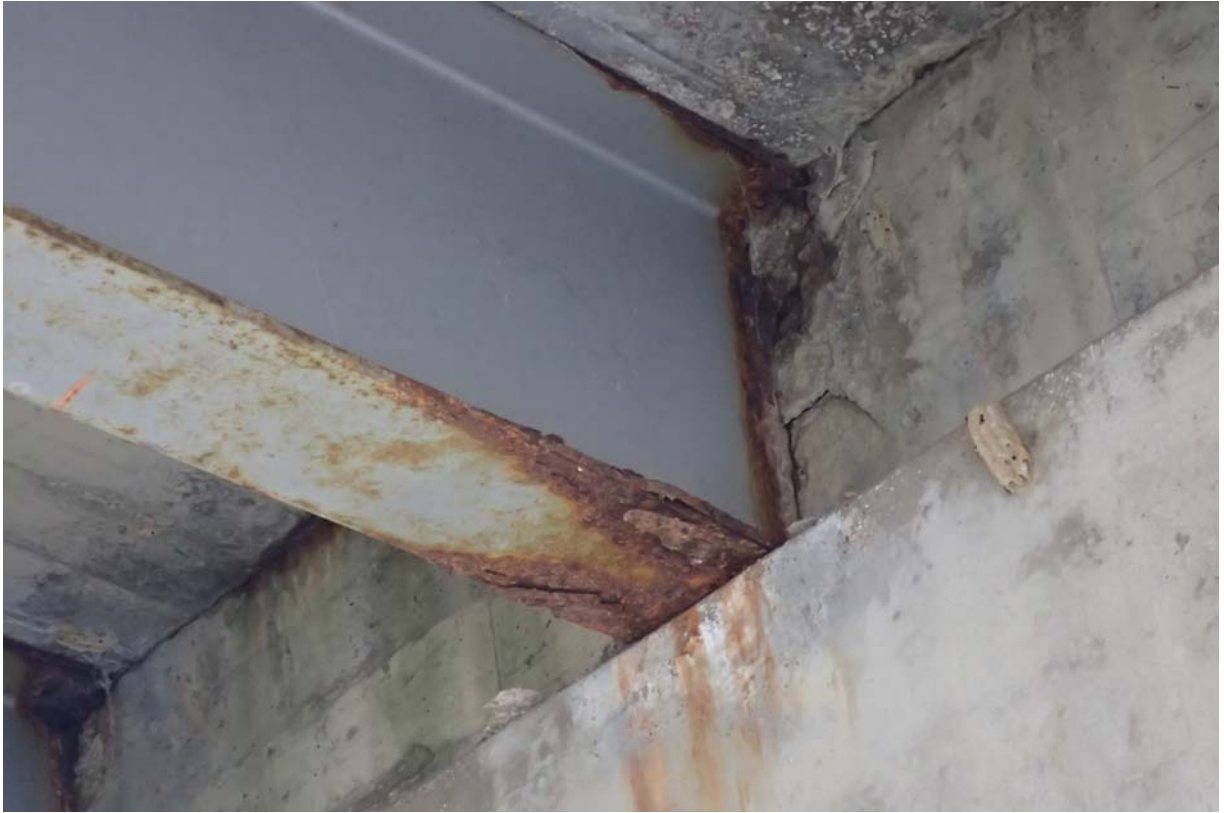
Typical view of beam 2 from upstream at abutment 2. Notice the moderate rust/corrosion of the web and flanges.

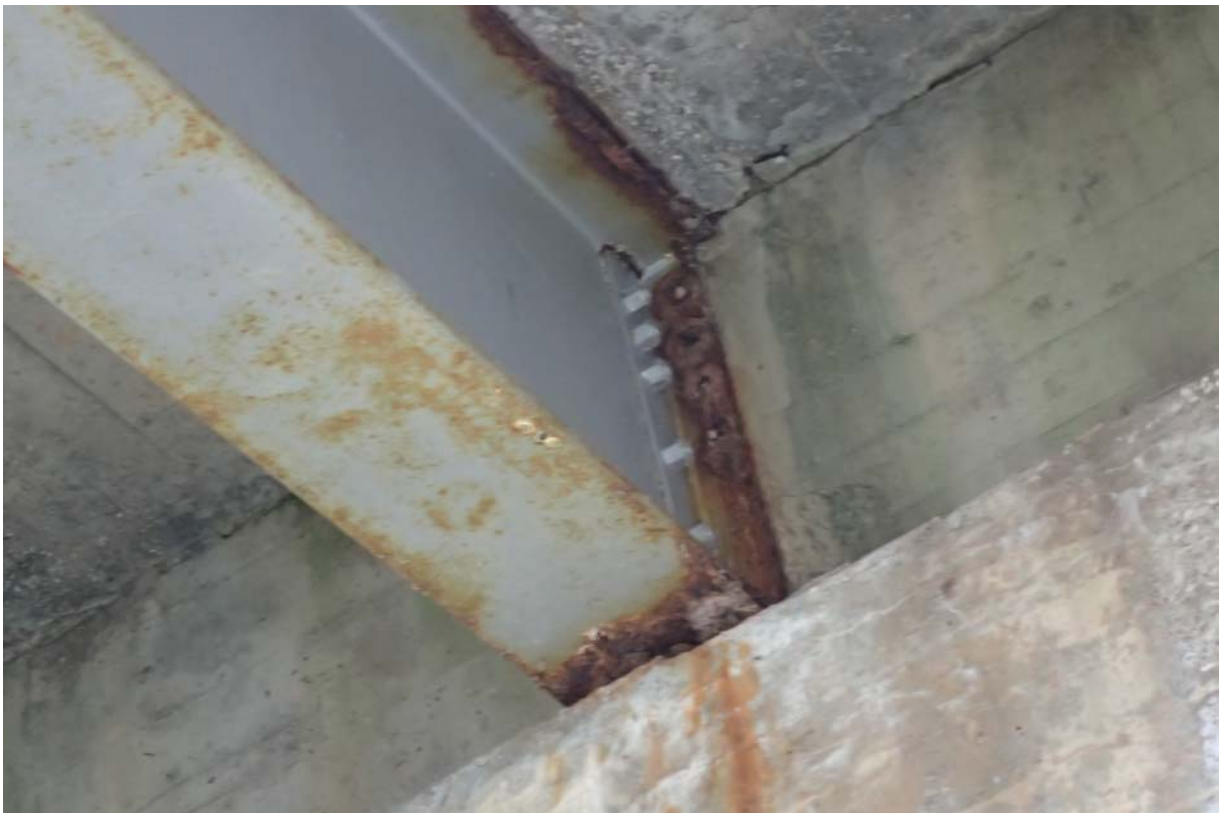
Typical view of beam 3 from upstream at abutment 2. Notice the moderate rust/corrosion of the flanges.

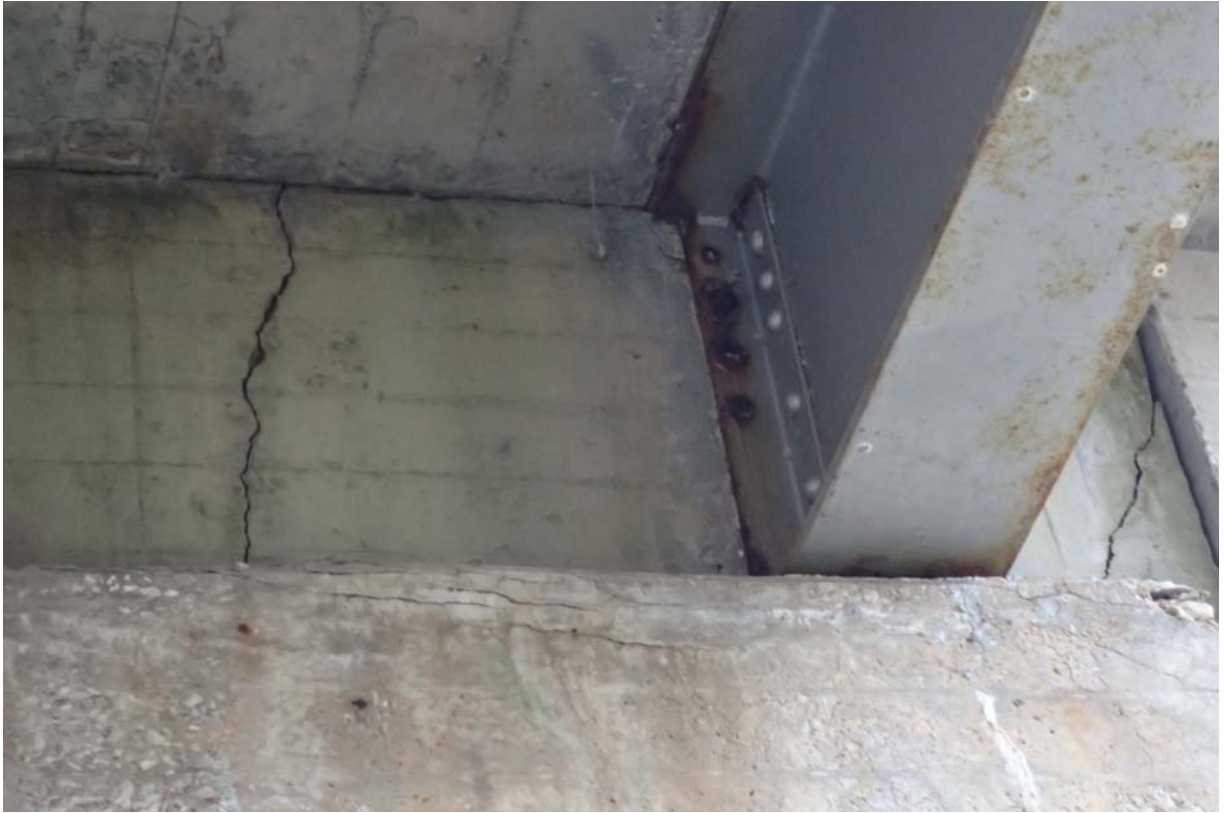
Typical view of beam 4 from upstream at abutment 2. Notice there is only minor rust/corrosion at this time. Notice the moderate sized vertical crack in the adjacent backwall/diaphragm.

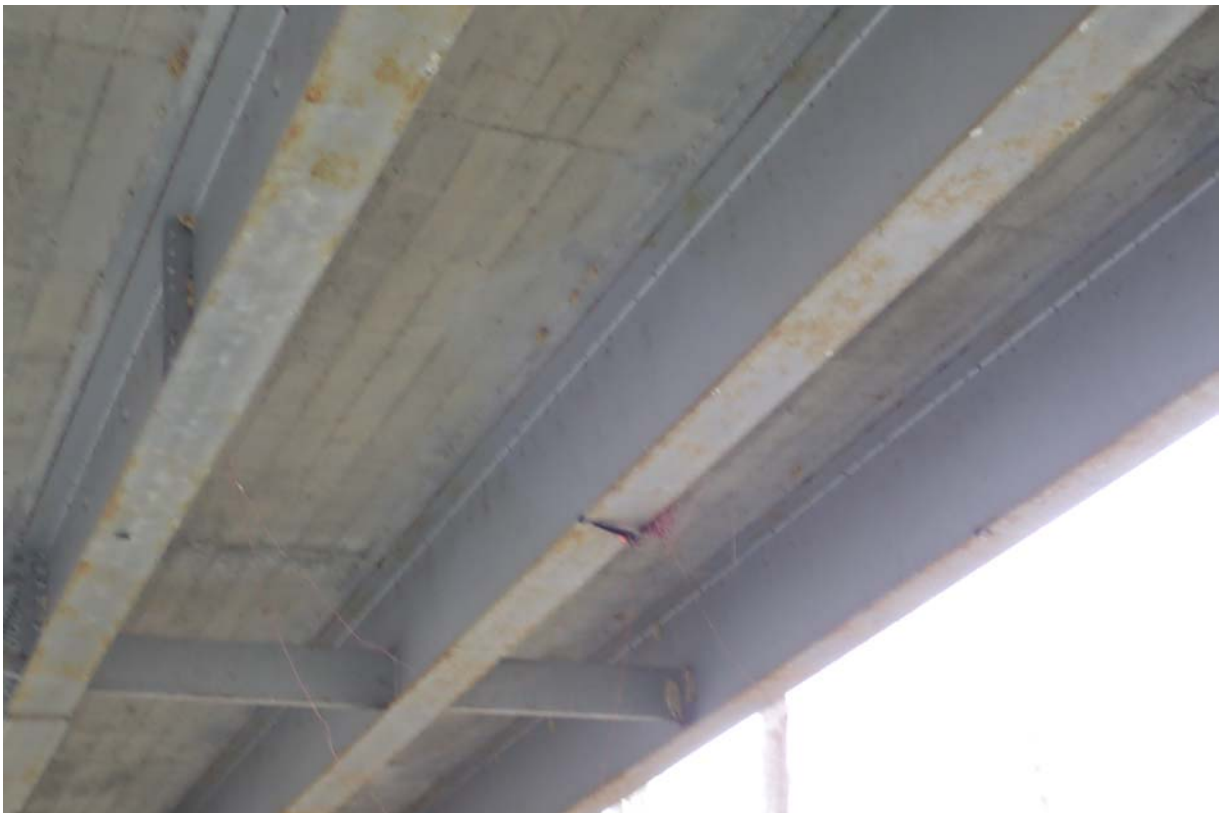
Typical view of the beams near midspan.

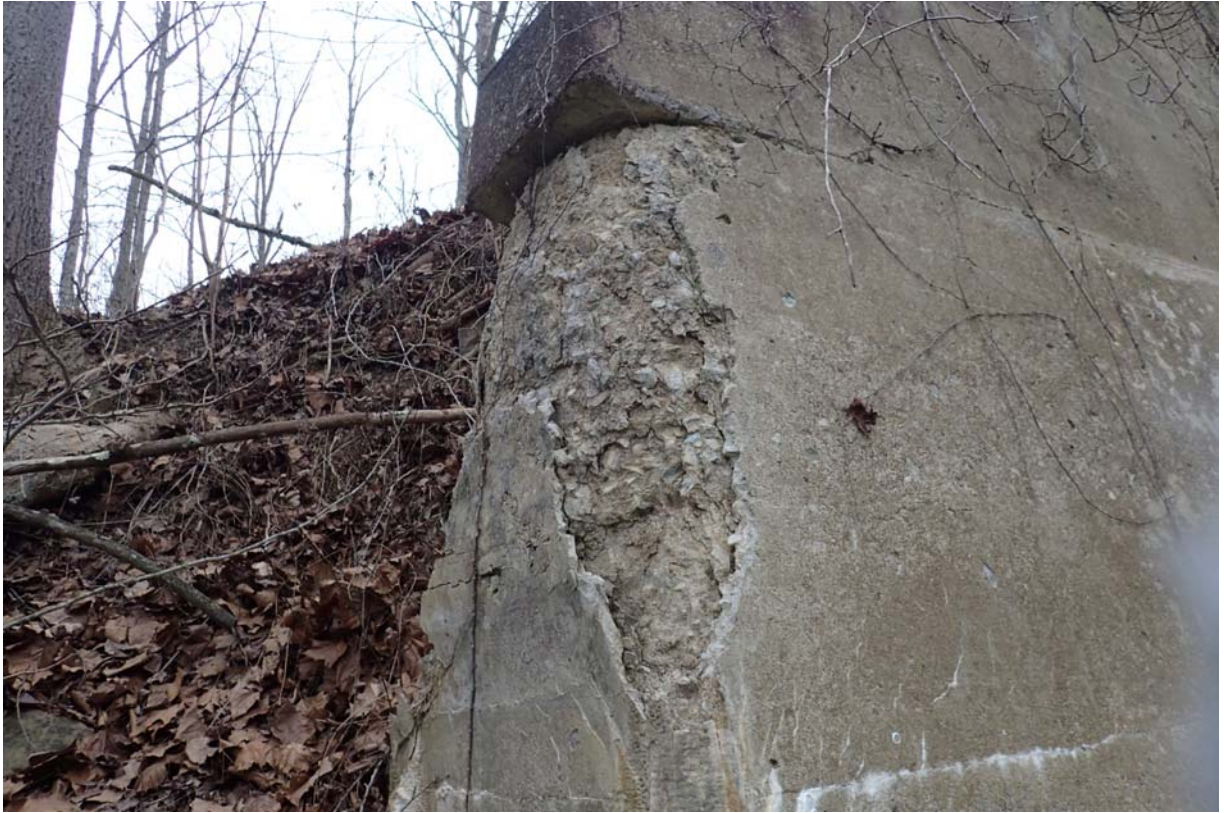
Moderate to heavy spalling at the downstream end of abutment 1s downstream wingwall.

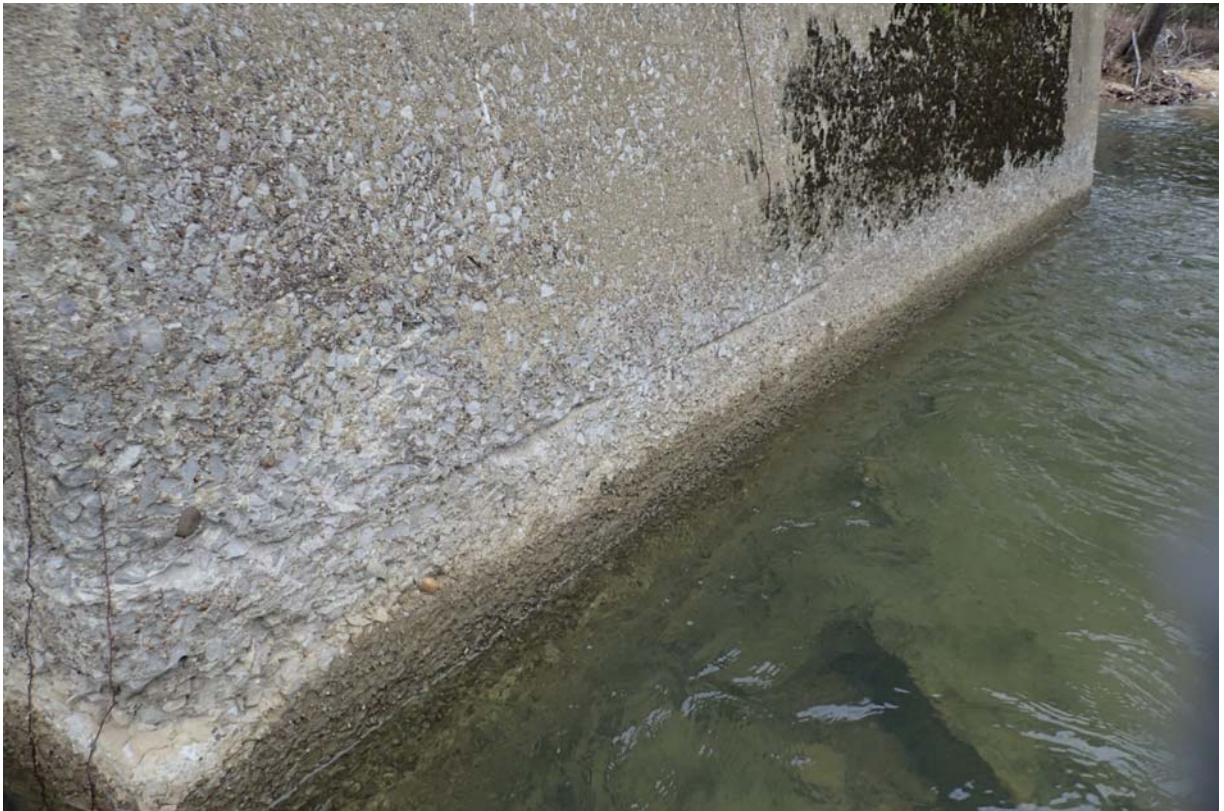
Moderate scaling along the flowline of abutment 1.

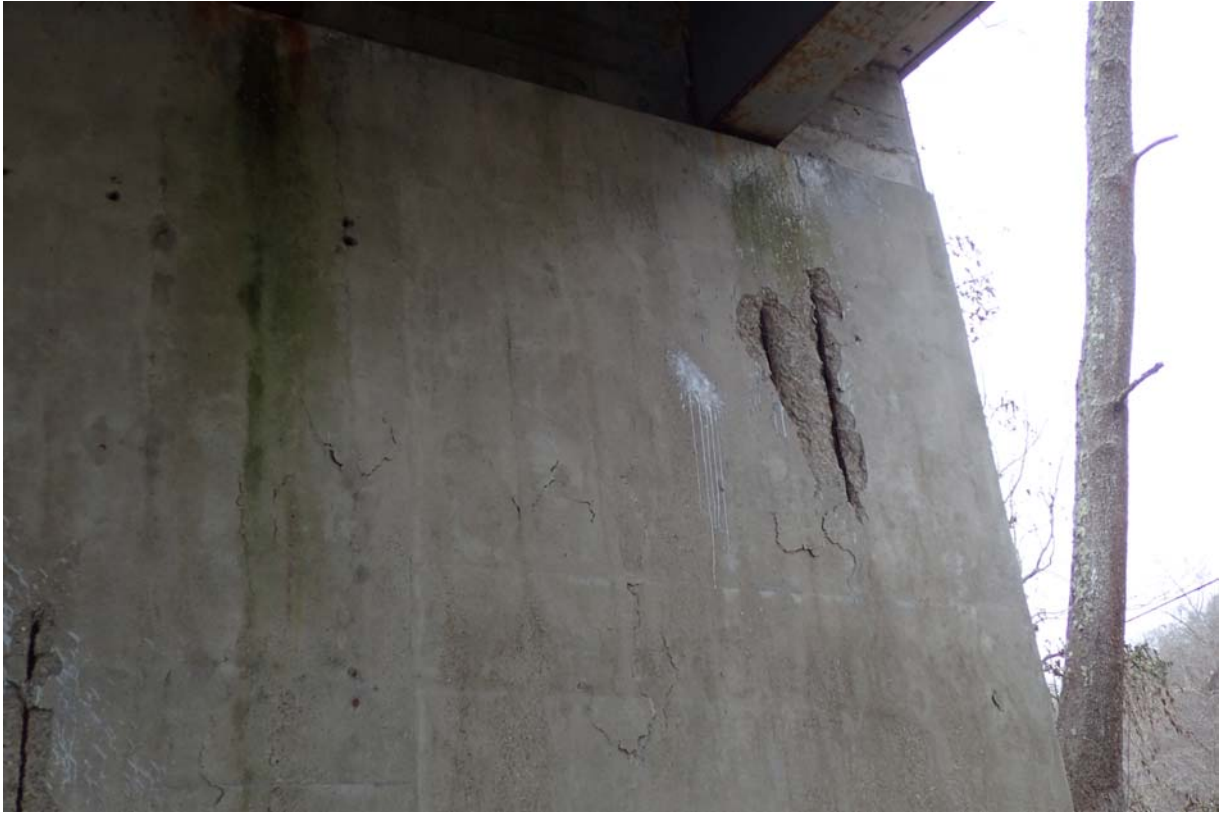
Moderate spalling with exposed steel in abutment 1 below the upstream beam.

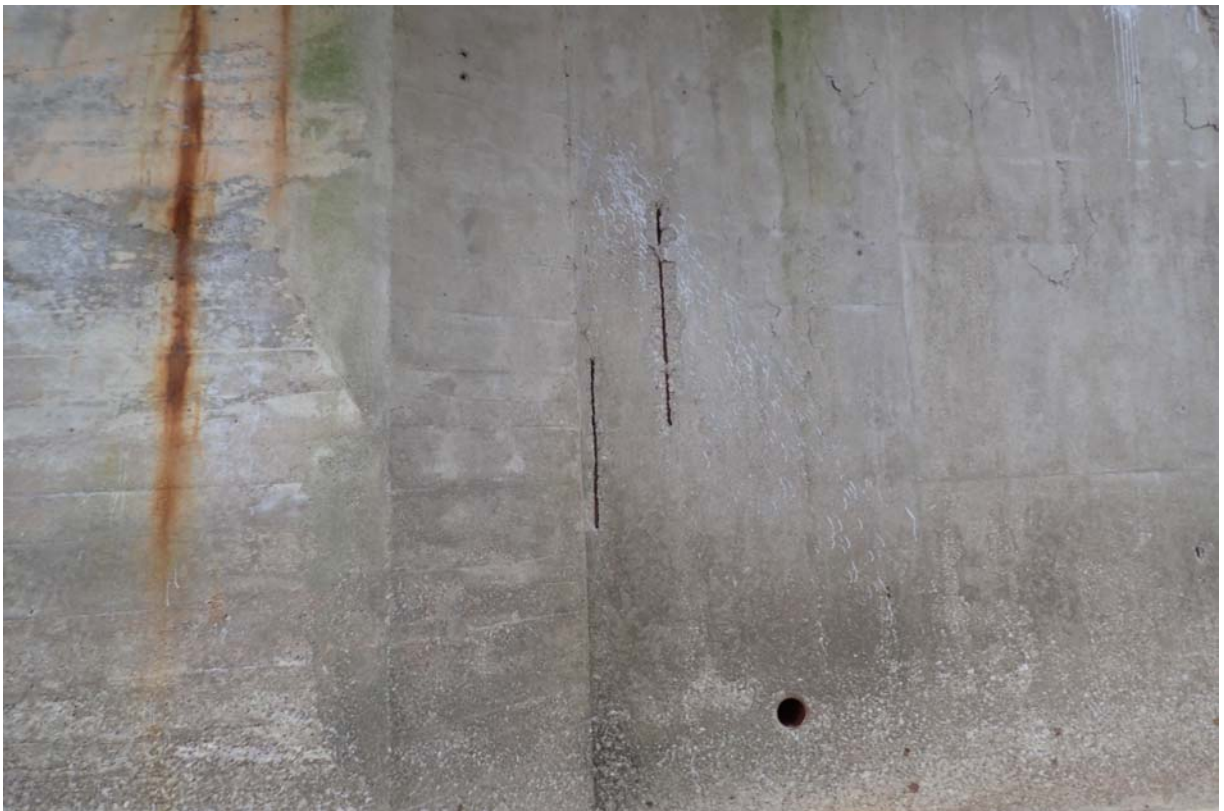
Moderate spalling with exposed steel in abutment 1 near the centerline of the abutment.

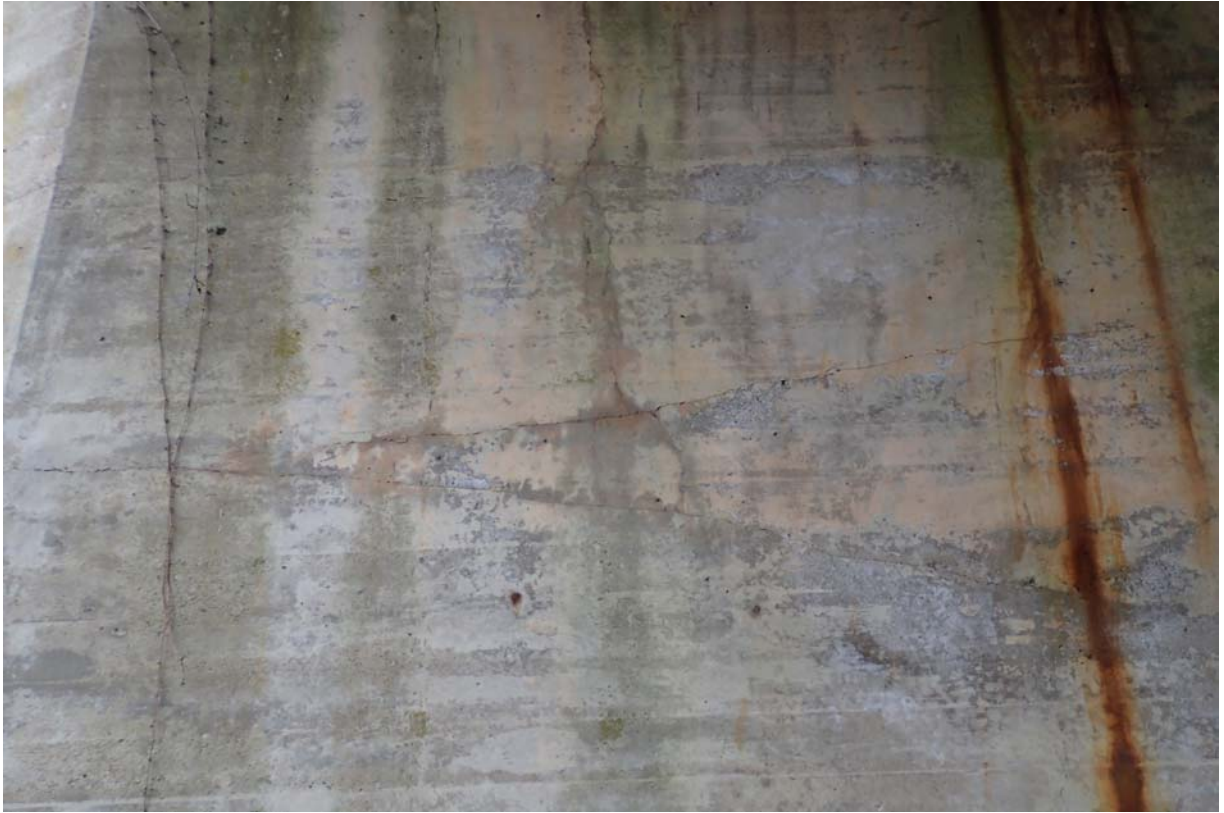
Minor sized horizontal, diagonal, and vertical cracking in abutment 1 between beams 3 and 4 from upstream.

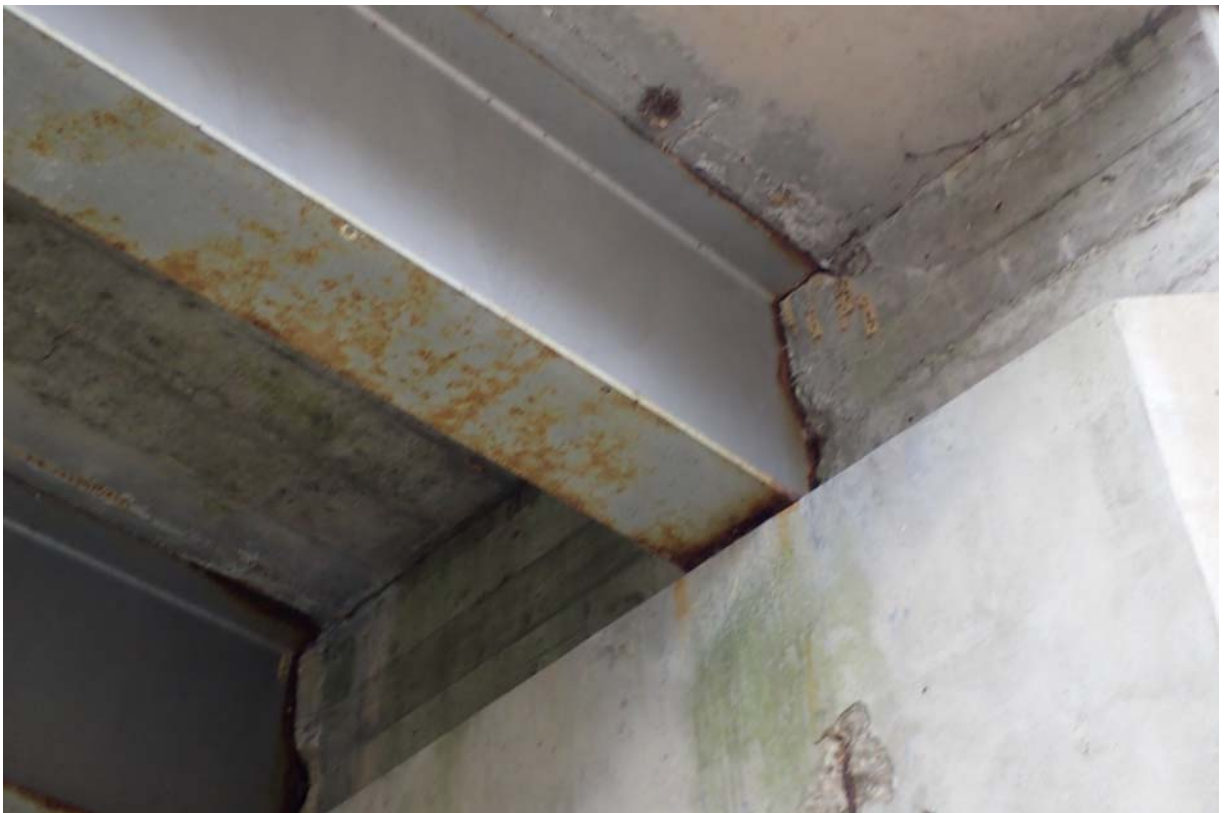
Typical view of the upstream beam at abutment 1. Notice the moderate rust/corrosion of the web and flanges.

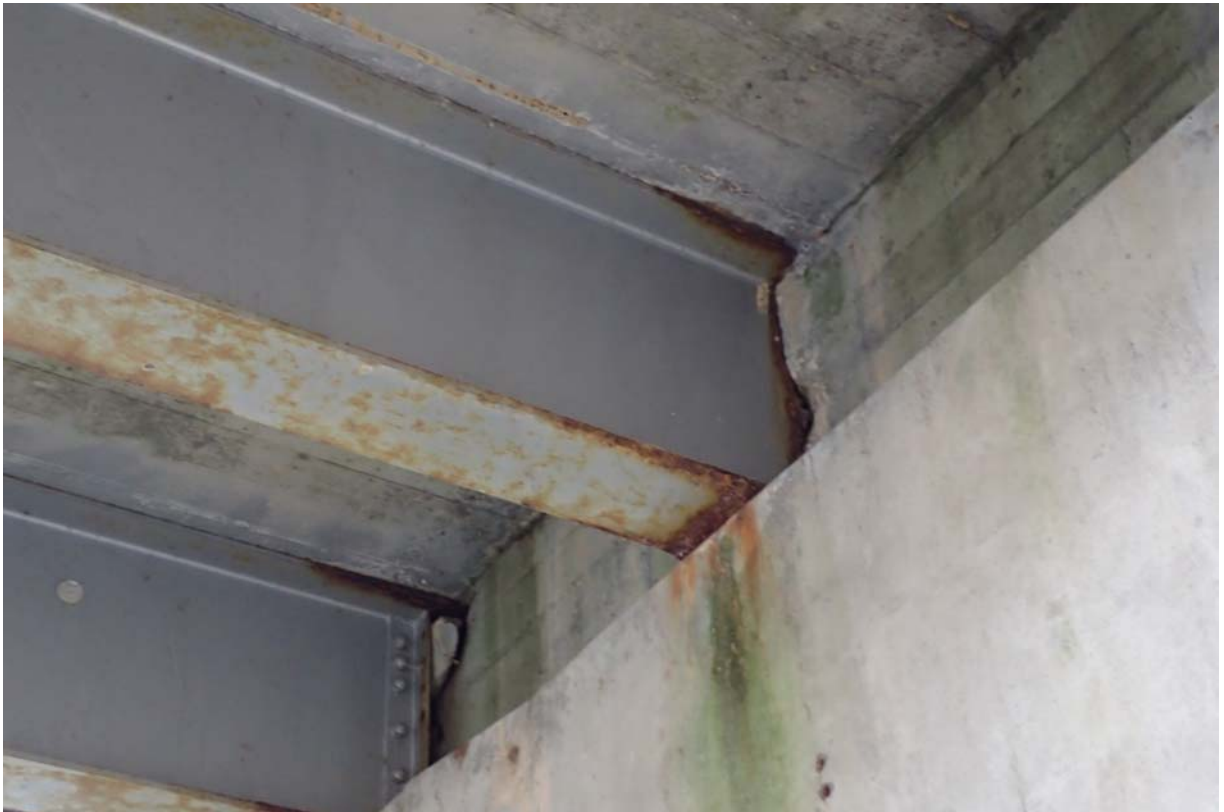
Typical view of beam 2 from upstream at abutment 1. Notice the moderate rust/corrosion of the web and flanges.
