Inspection Report with SI&A Data

Structure Description: 61.02 Foot - Single Span Steel Stringer/Multi-beam or Girder

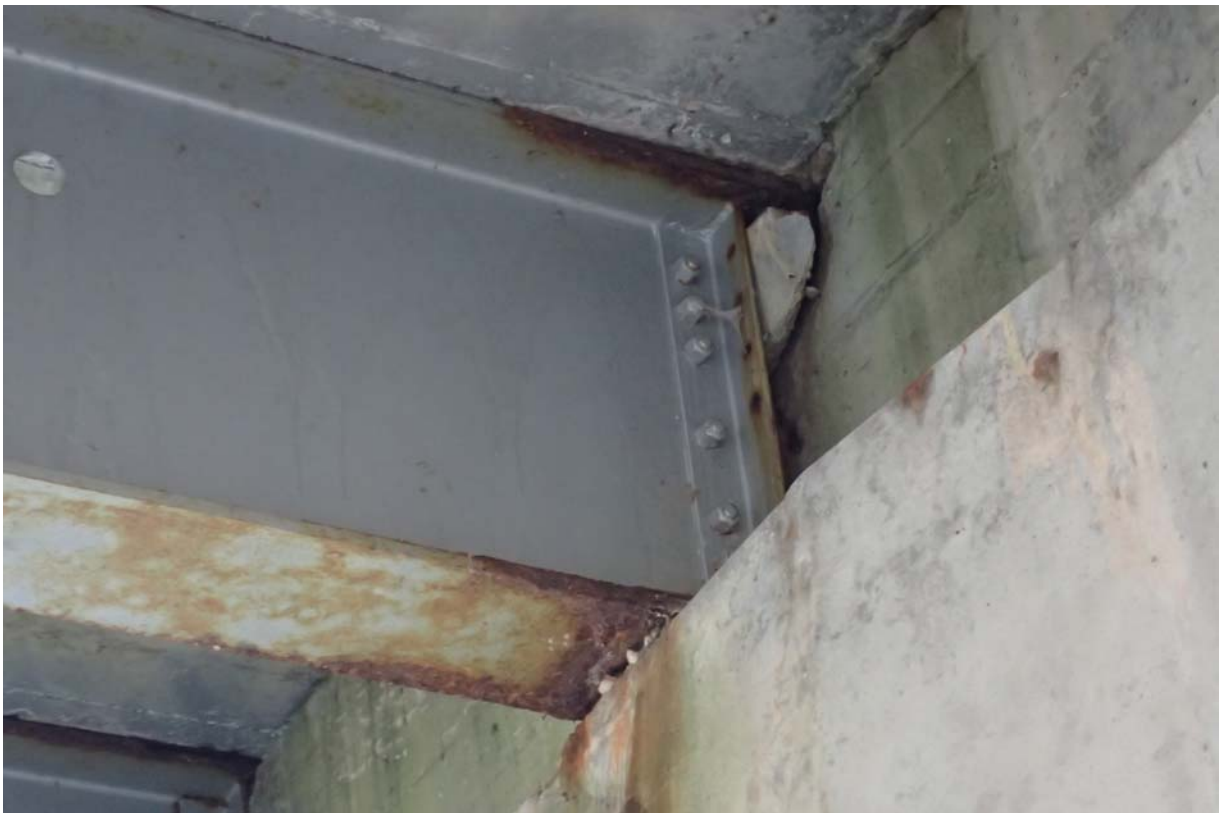
Typical view of beam 3 from upstream at abutment 1. Notice the moderate rust/corrosion of the web and flanges. Also notice the piece of concrete behind the vertical angle at the end of the beam.

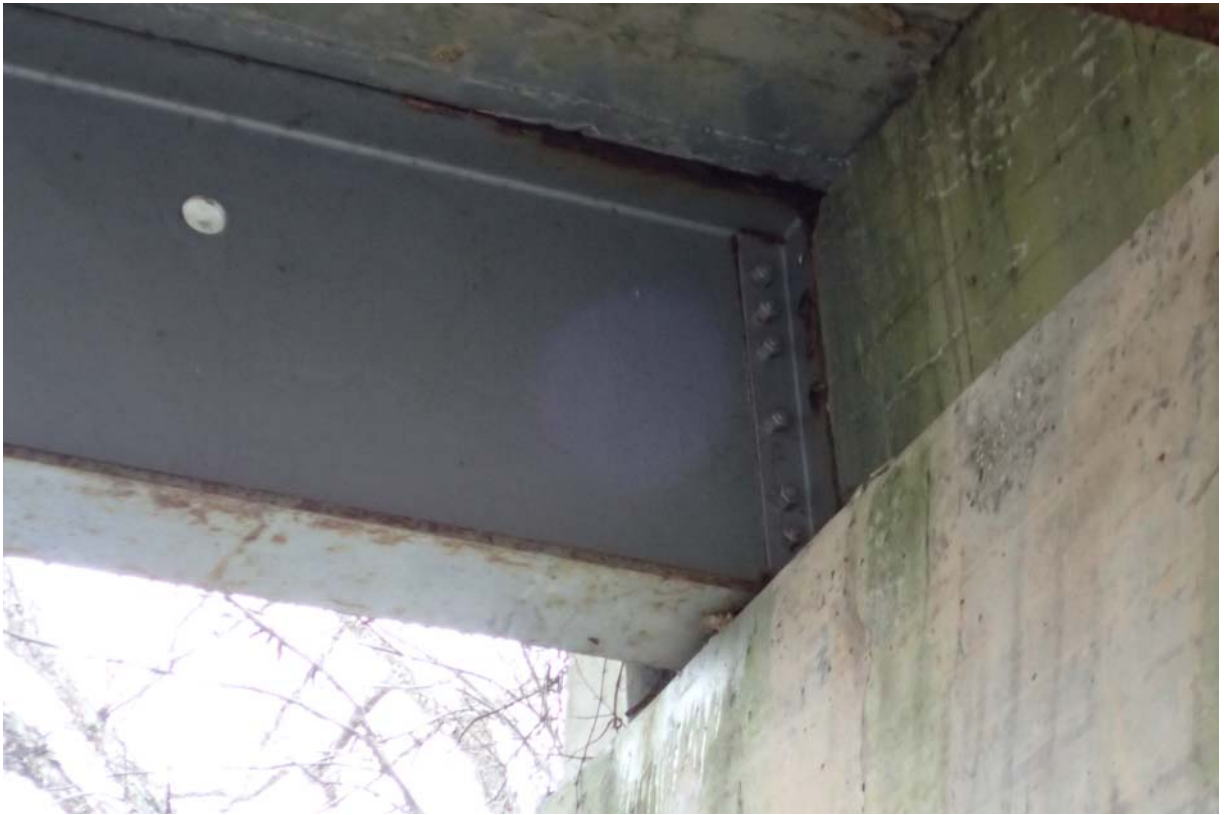
Typical view of beam 4 from upstream at abutment 1. Notice the minor rust/corrosion of the flanges.

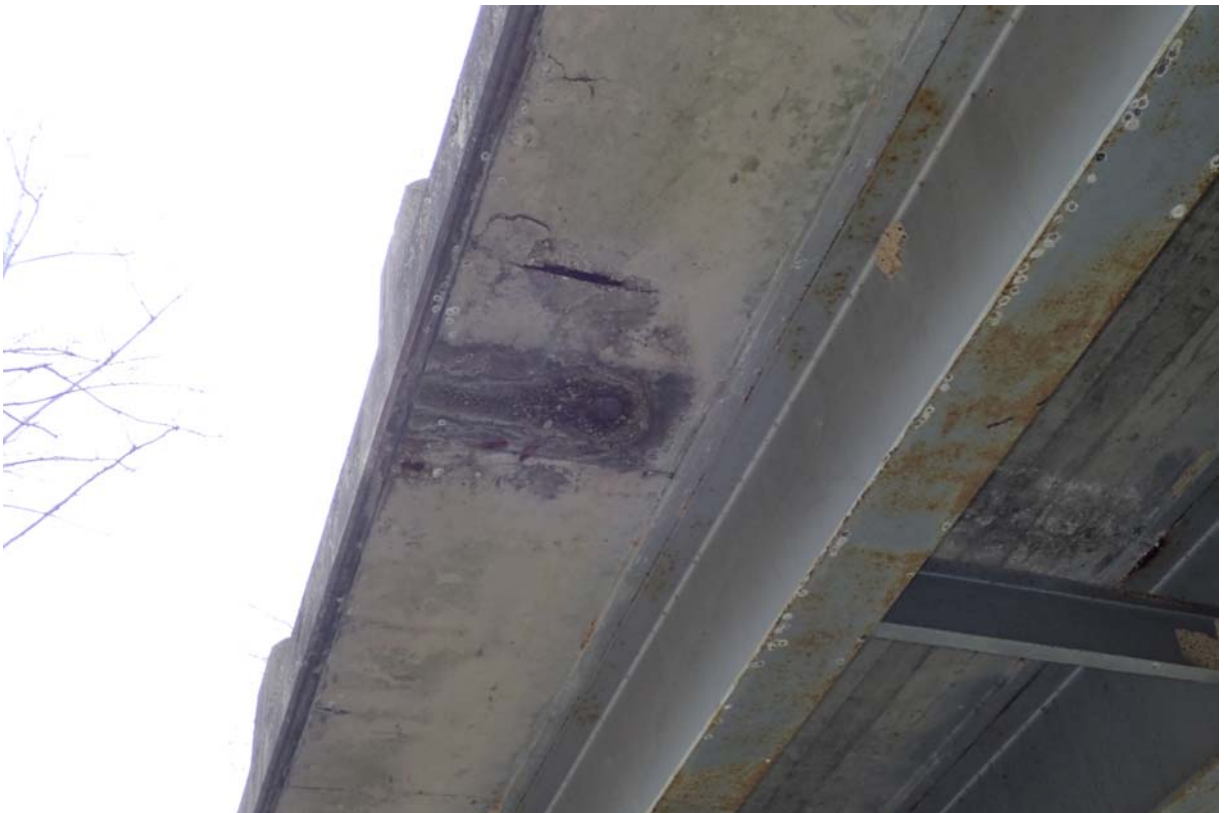
Spalling with exposed steel, delamination cracking, and discoloration in the upstream deck overhang.

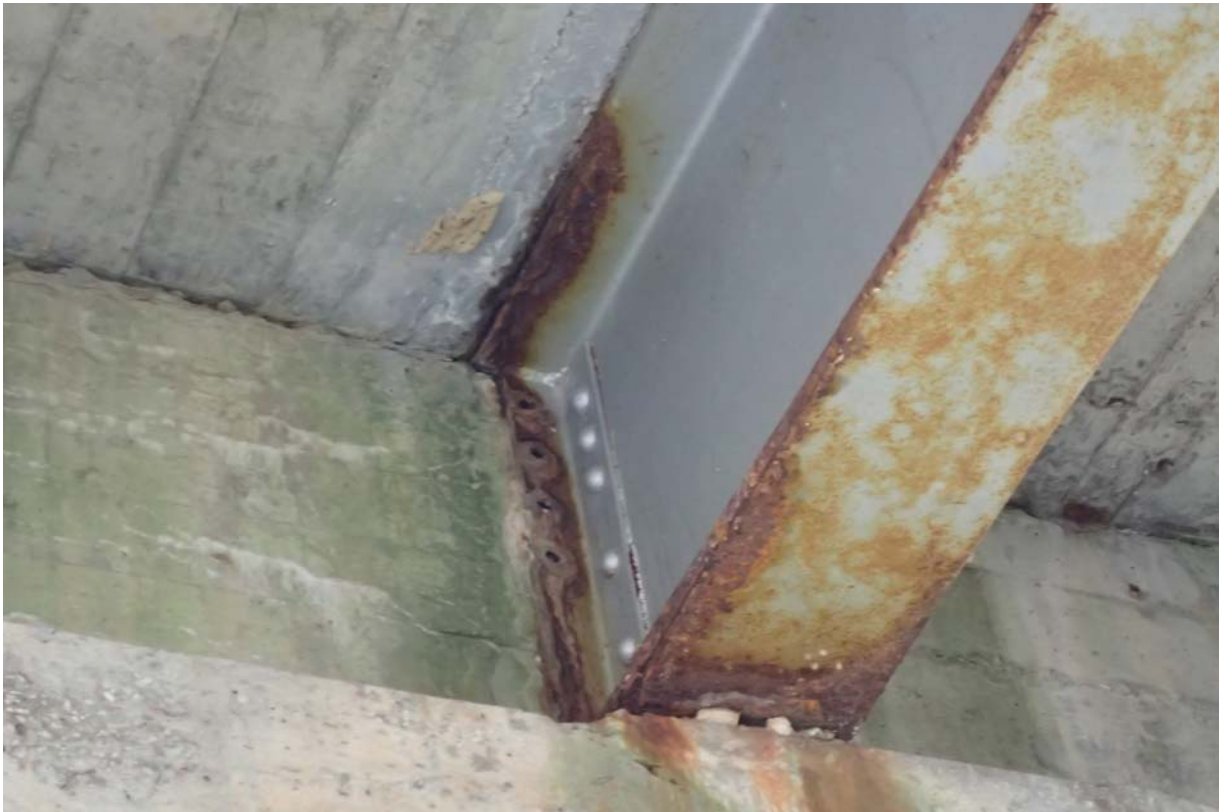
Typical view of beam 3 from upstream at abutment 1 (downstream face). Notice the moderate rust/corrosion of the web and flanges.

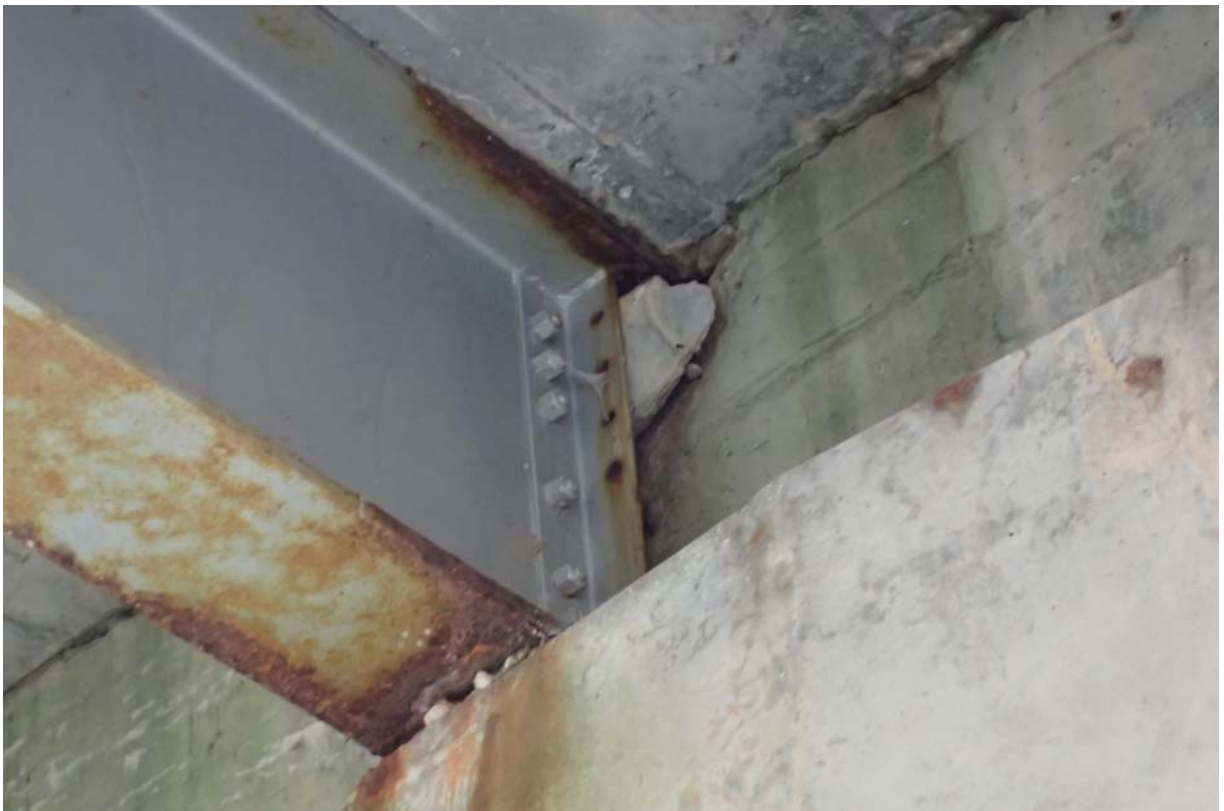
Typical view of beam 3 from upstream at abutment 1 (upstream face). Notice the moderate rust/corrosion of the web and flanges. Also notice the piece of concrete behind the vertical angle at the end of the beam.

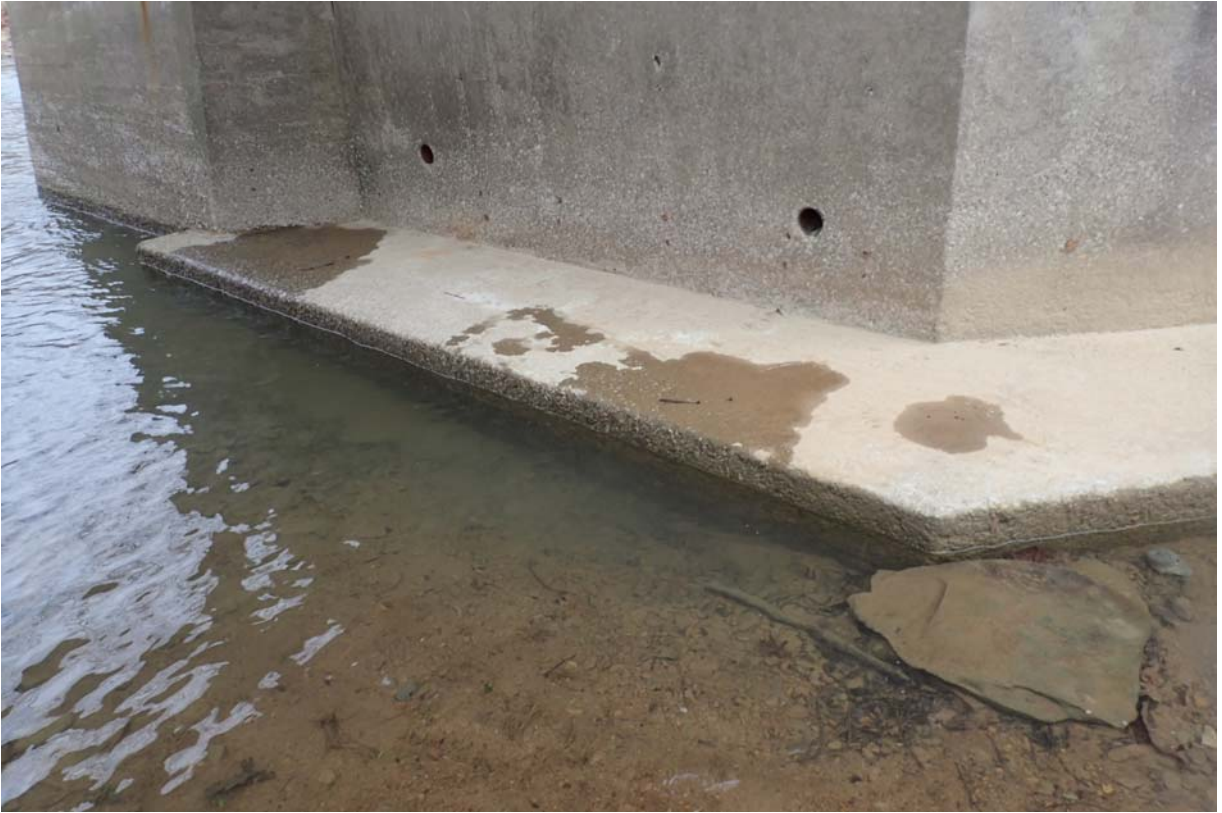
Exposed upstream footing of abutment 1.
