Inspection Report with SI&A Data

Structure Description: 39.04 Foot - Single Span Steel Stringer/Multi-beam or Girder

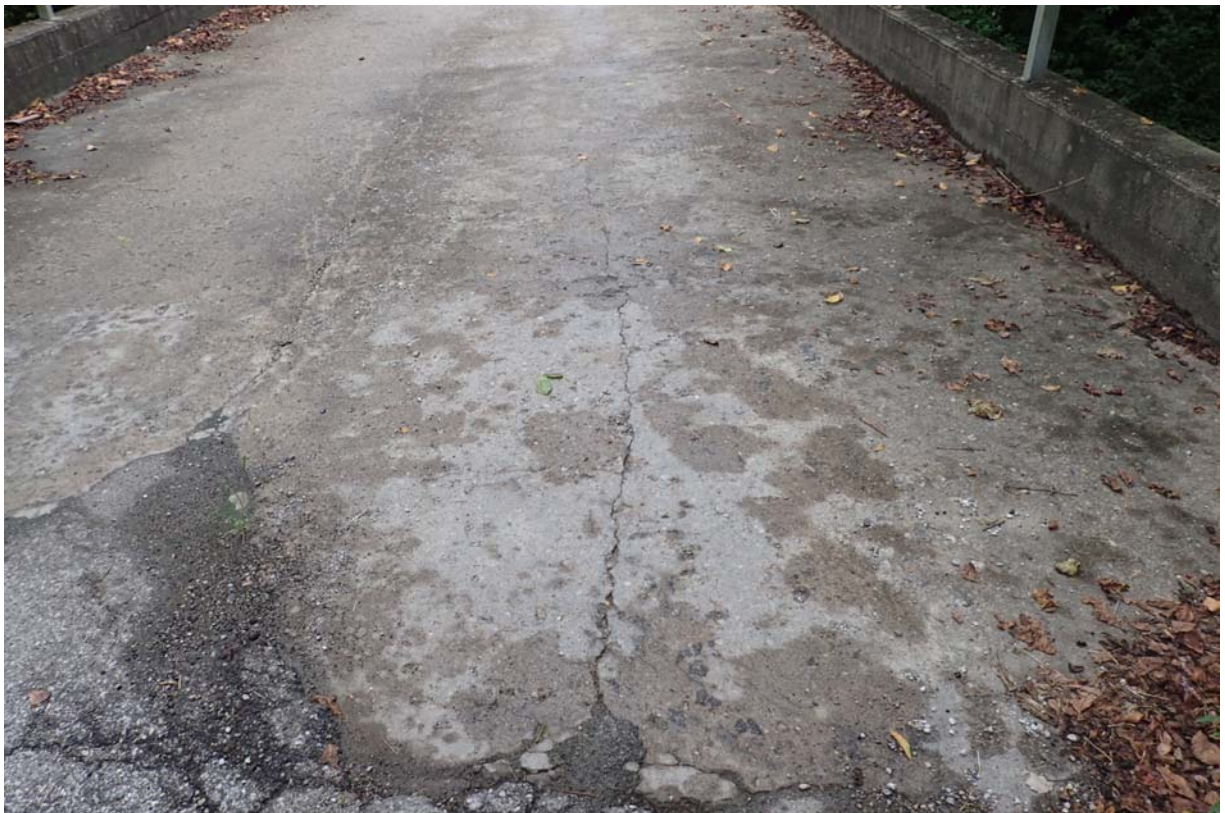
Moderate longitudinal cracking at the east end of the deck.

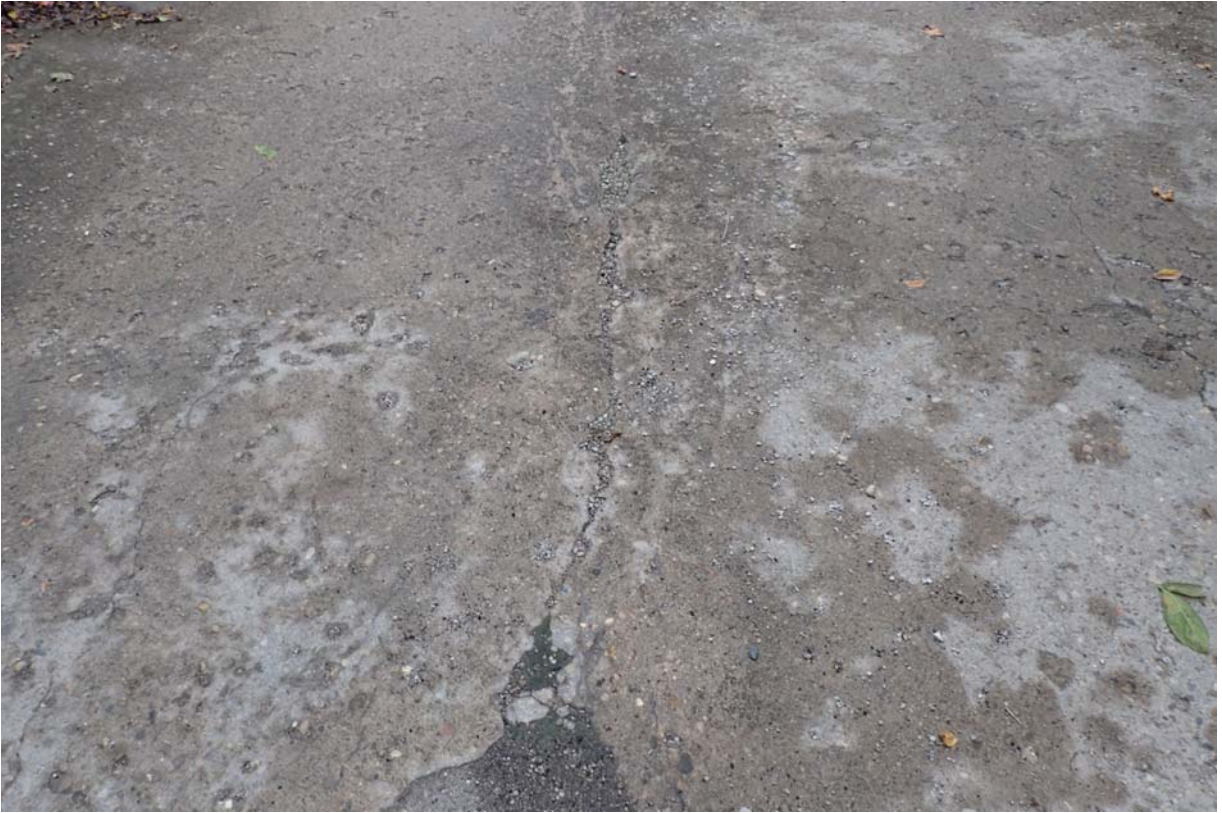
Moderate longitudinal cracking at the east end of the deck along the centerline.

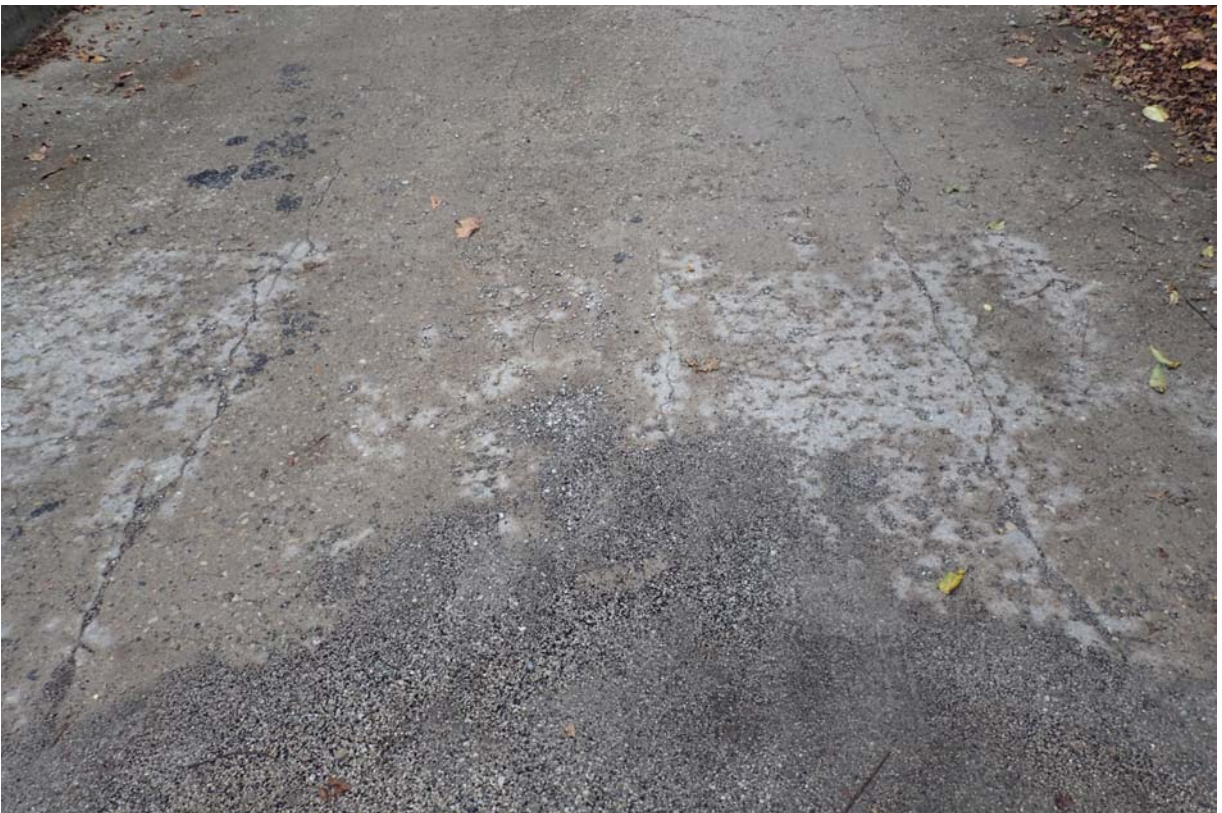
Moderate longitudinal cracking at the west end of the deck.

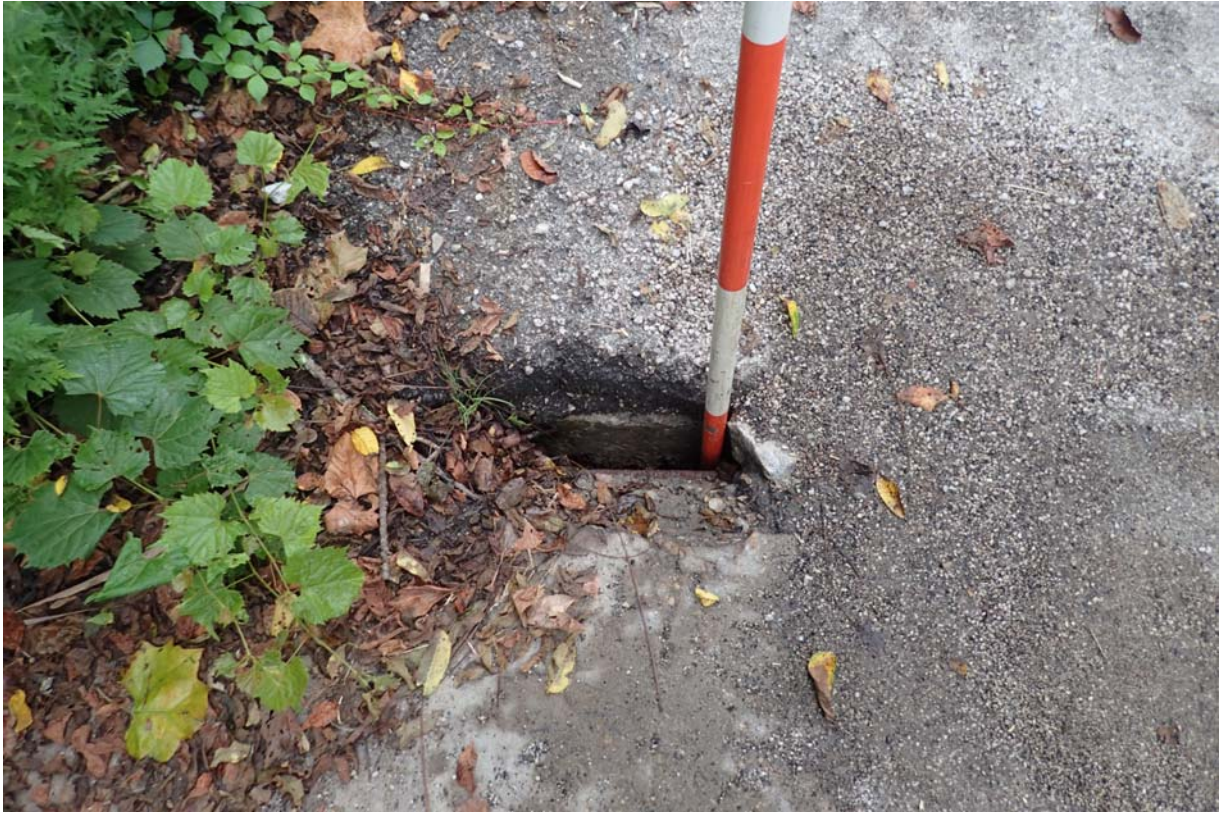
1' x 1' void at the upstream west end of the deck.

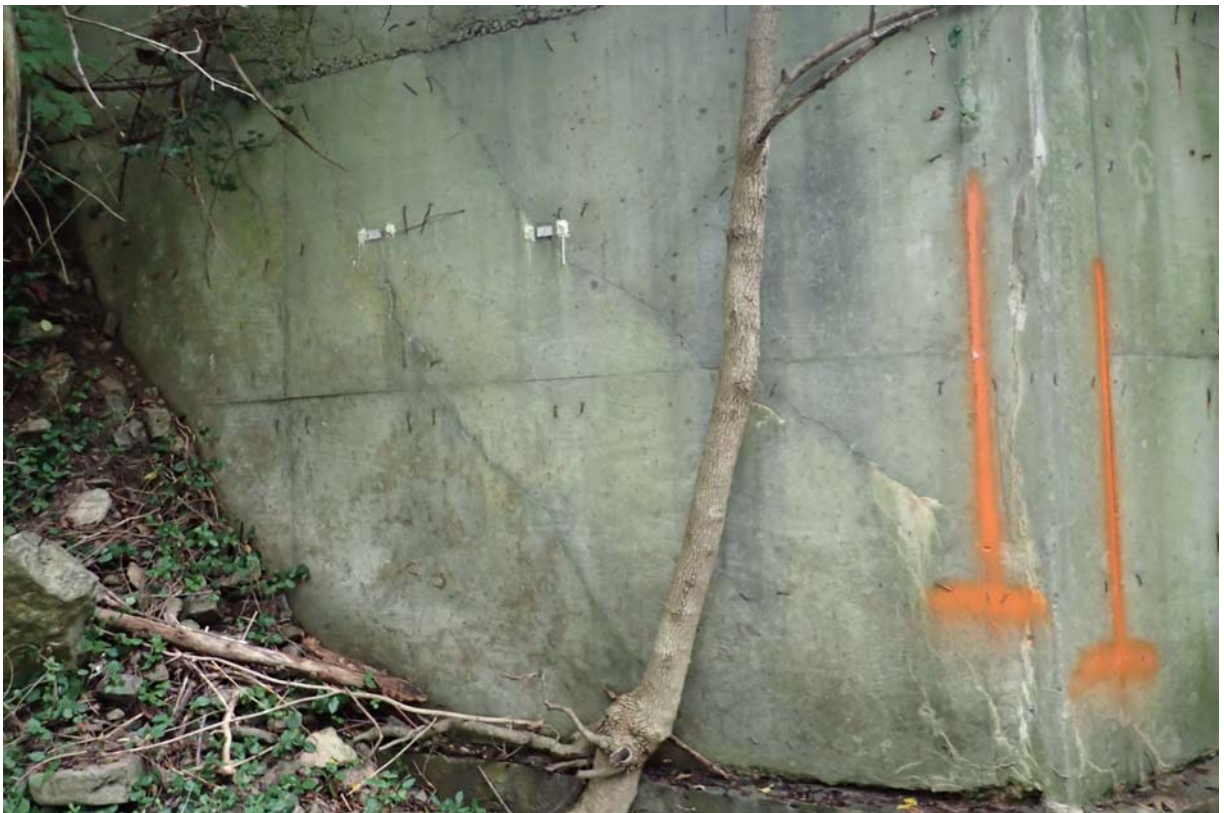
Moderate sized (1/16" typical) diagonal cracking in the upstream west wingwall.

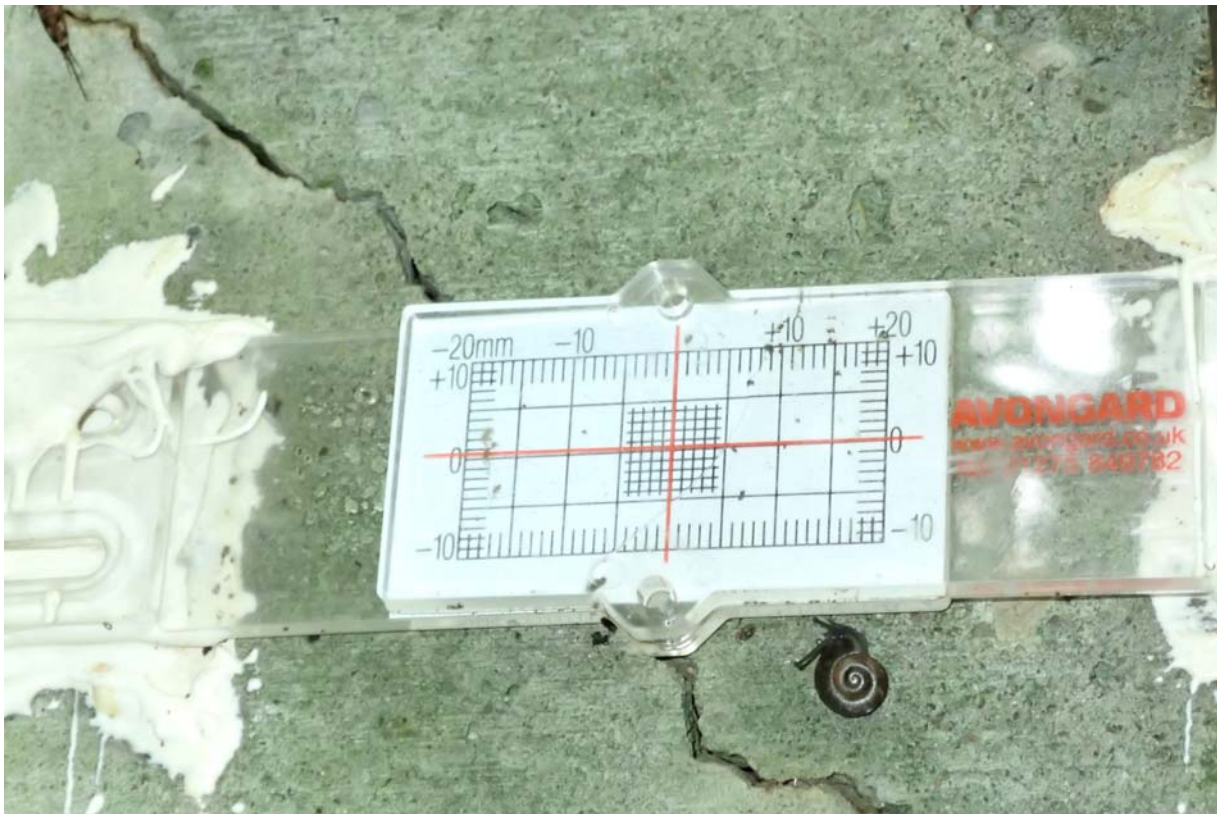
View of the crack gauge on the forward crack (toward stream) in the upstream west wingwall.

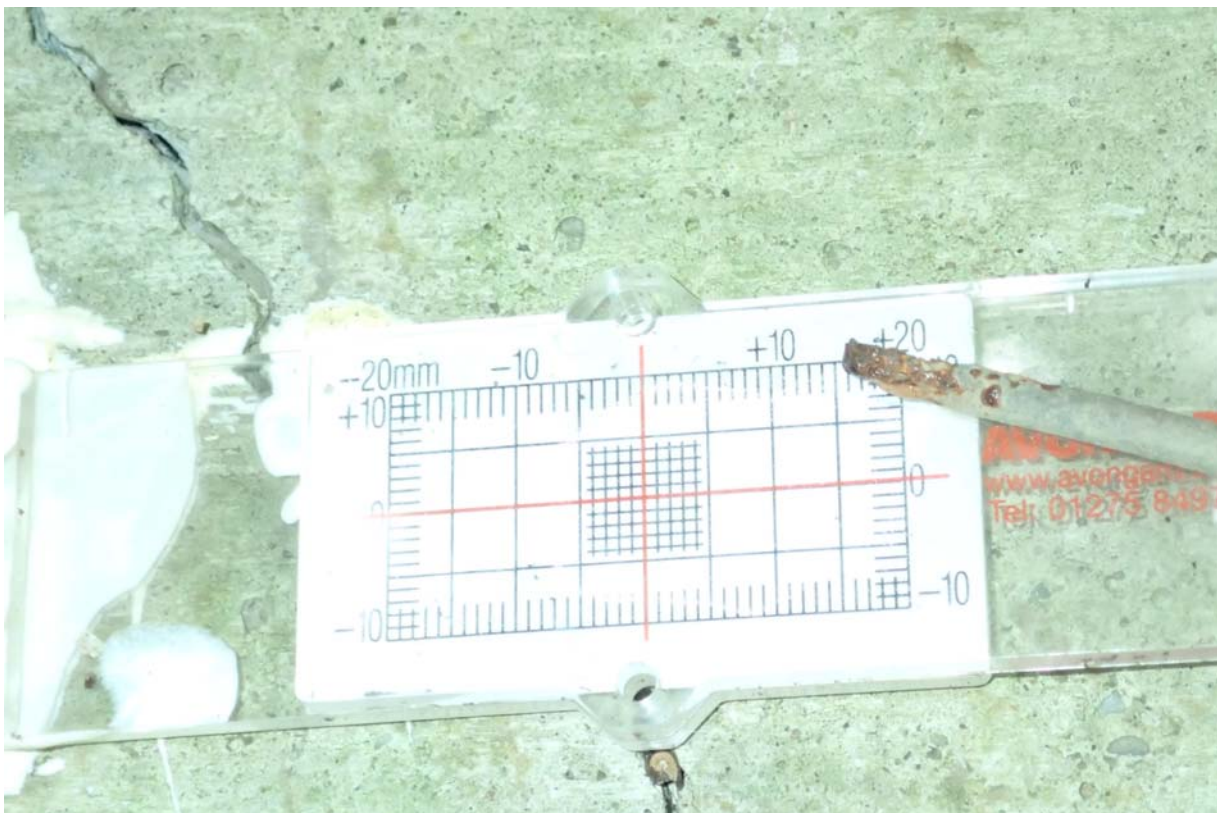
View of the crack gauge on the rear crack in the upstream west wingwall.

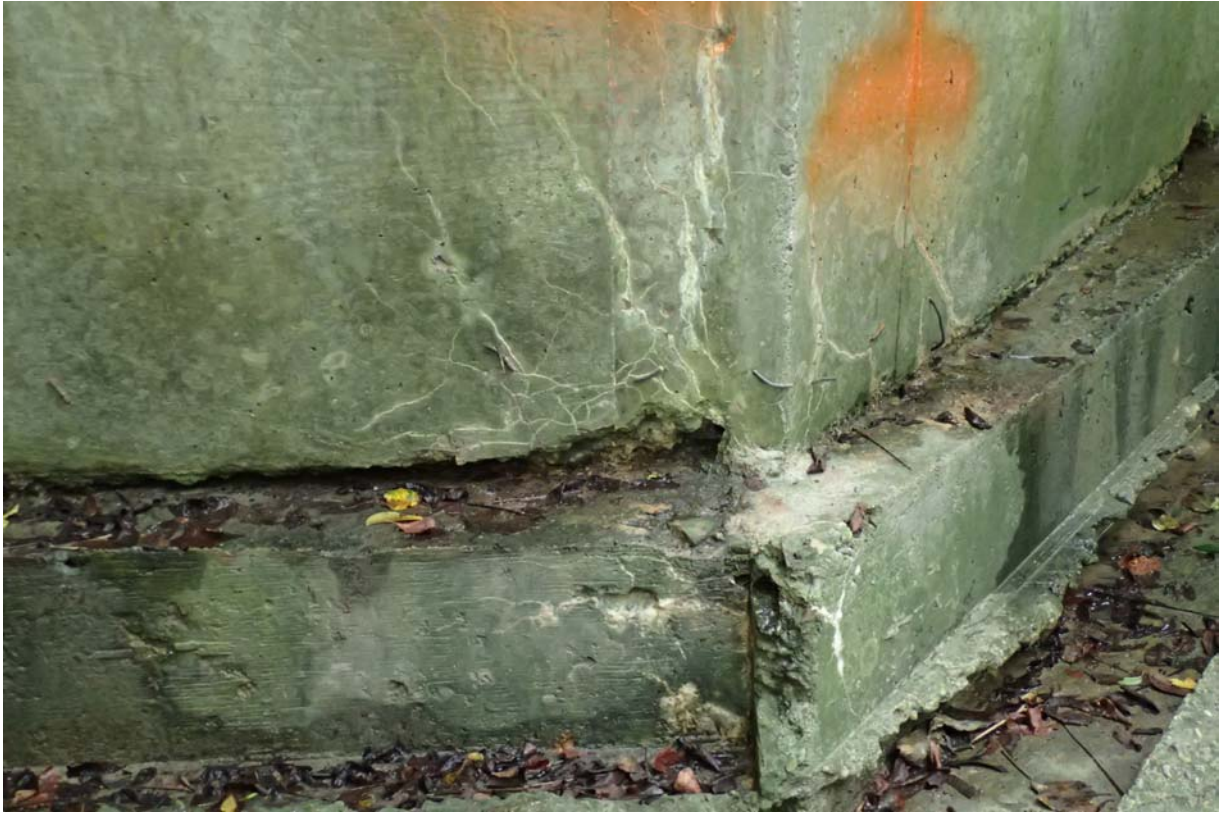
Moderate to heavy intensity of minor sized cracking and moderate spalling at the upstream west abutment/wingwall interface.

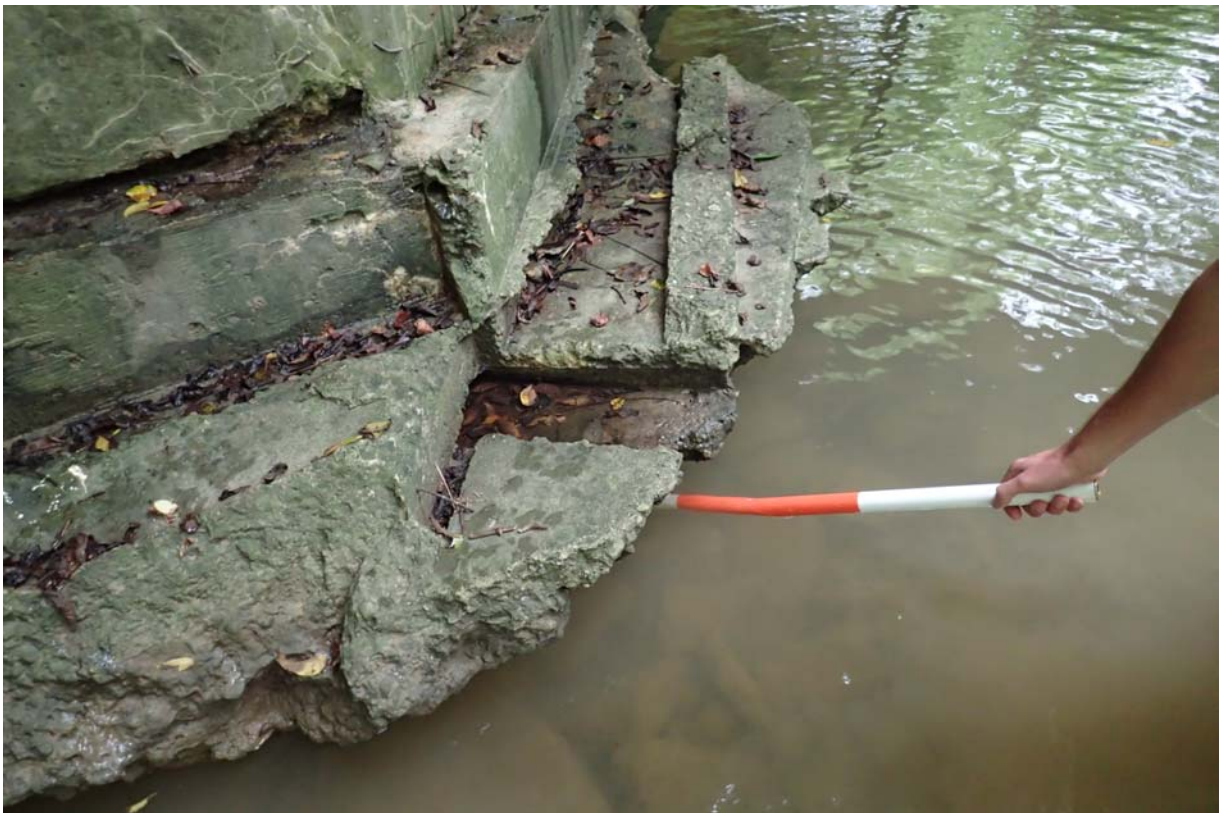
Up to 24" of horizontal undermining at the upstream end of the west abutments footing/apron.

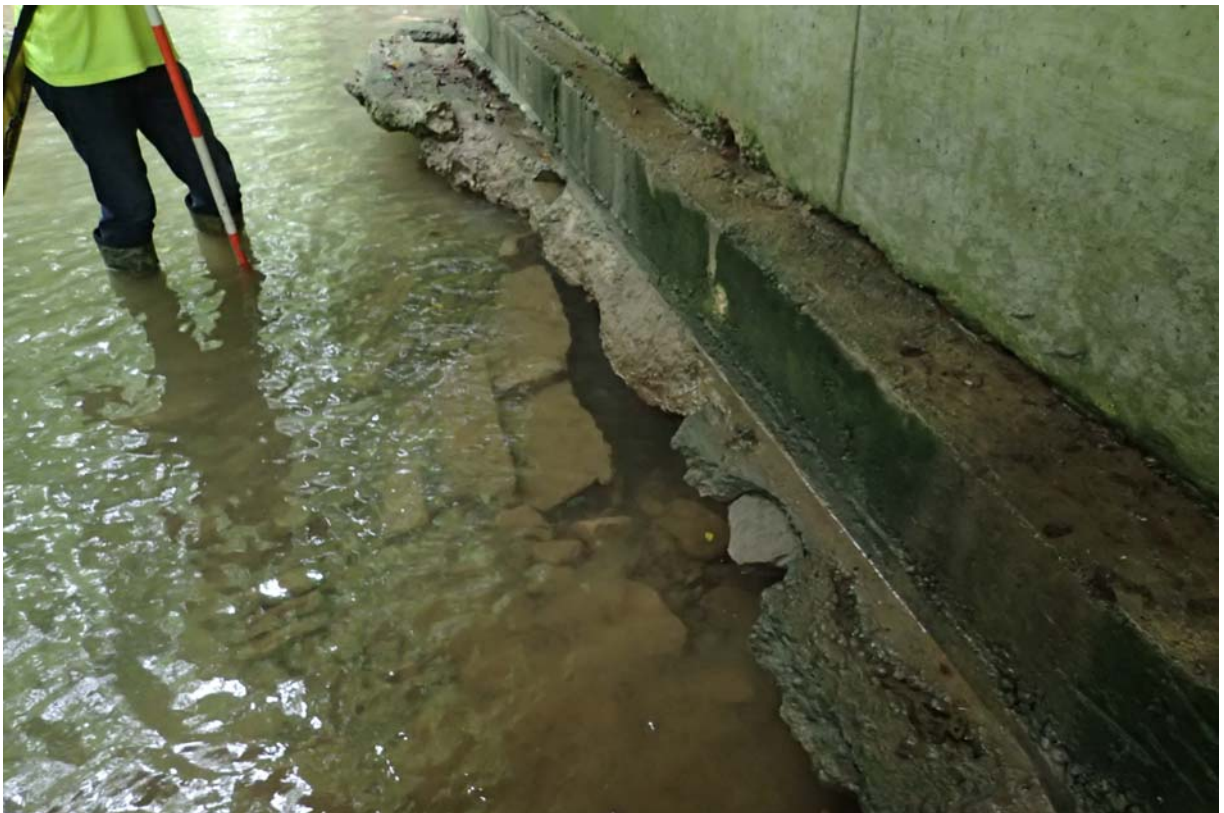
View of spalling and sections broken off of the west abutments concrete protection apron.

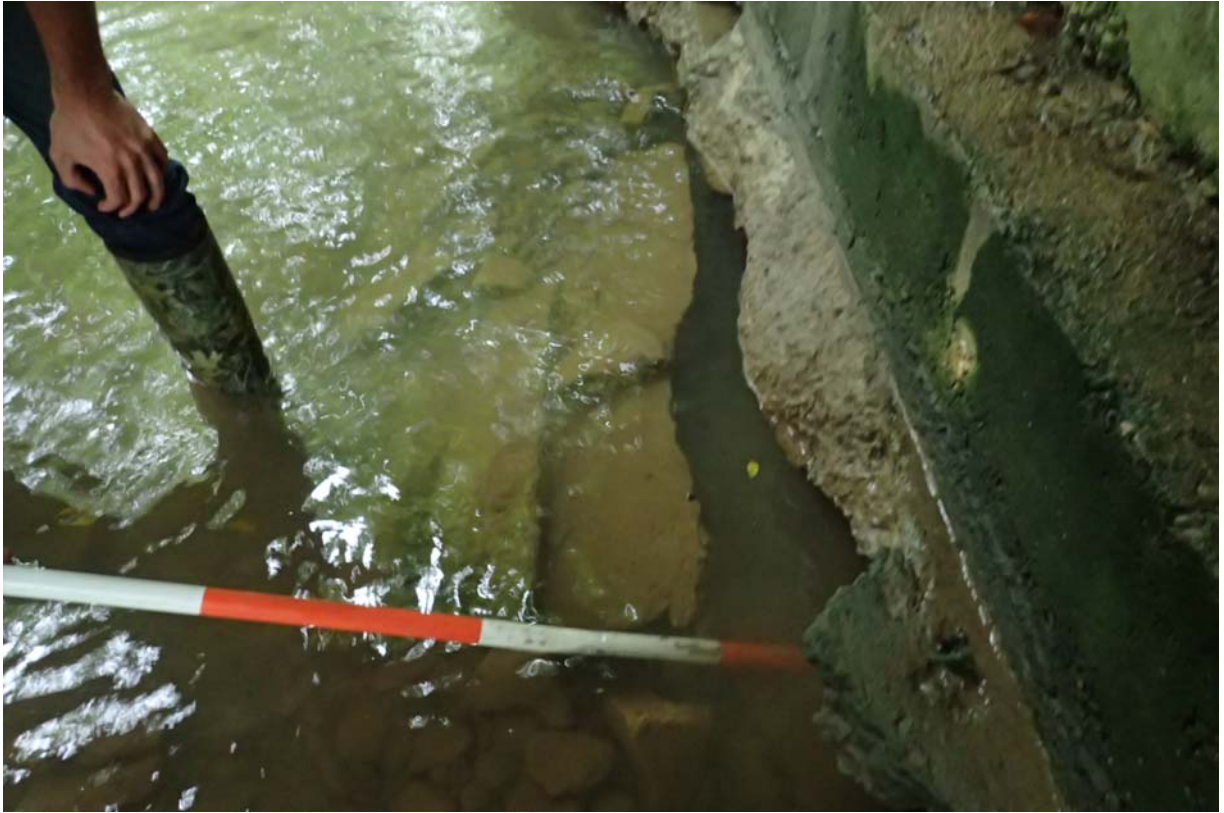
Approximate 1' of horizontal undermining of the west abutments footing near midlength.

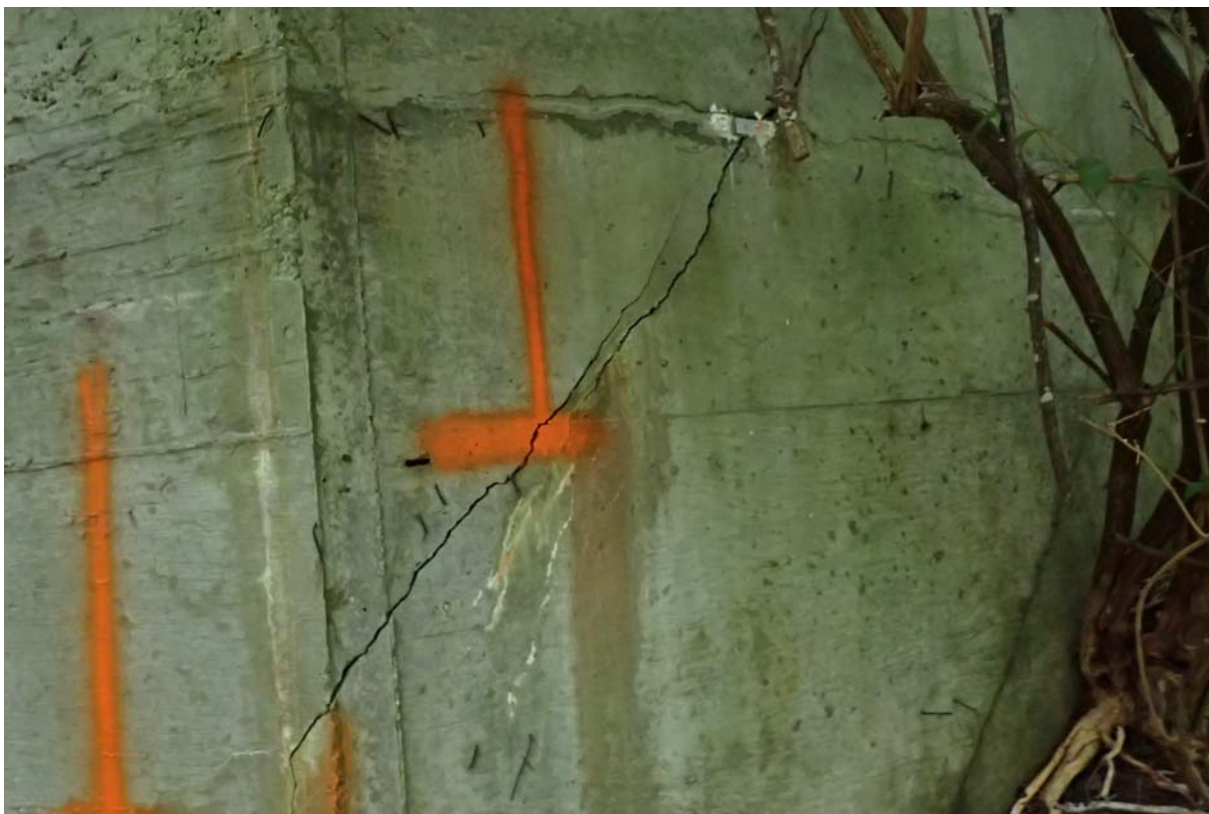
Moderate diagonal cracking ($\sim 3/16'' - 1/4''$) in the downstream west wingwall.

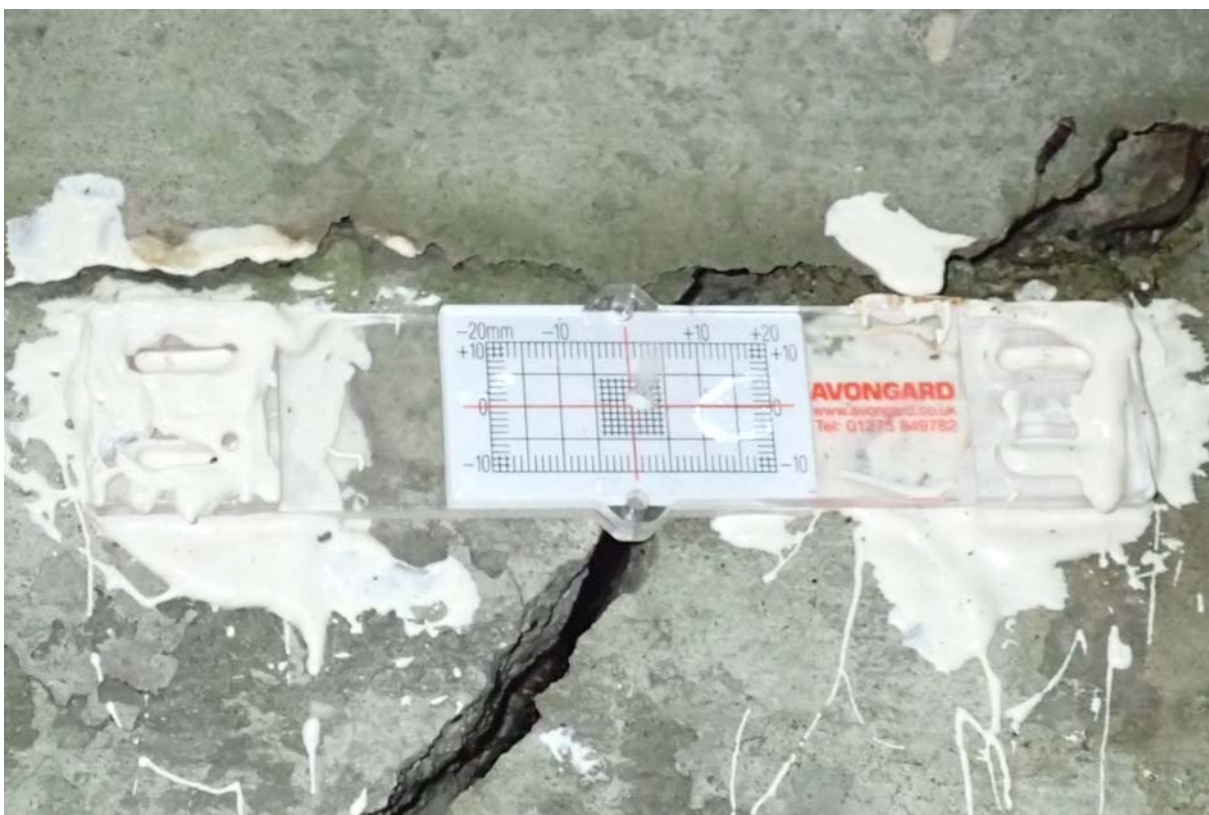
Crack gauge monitoring moderate diagonal cracking ($\sim 3/16'' - 1/4''$) in the downstream west wingwall.

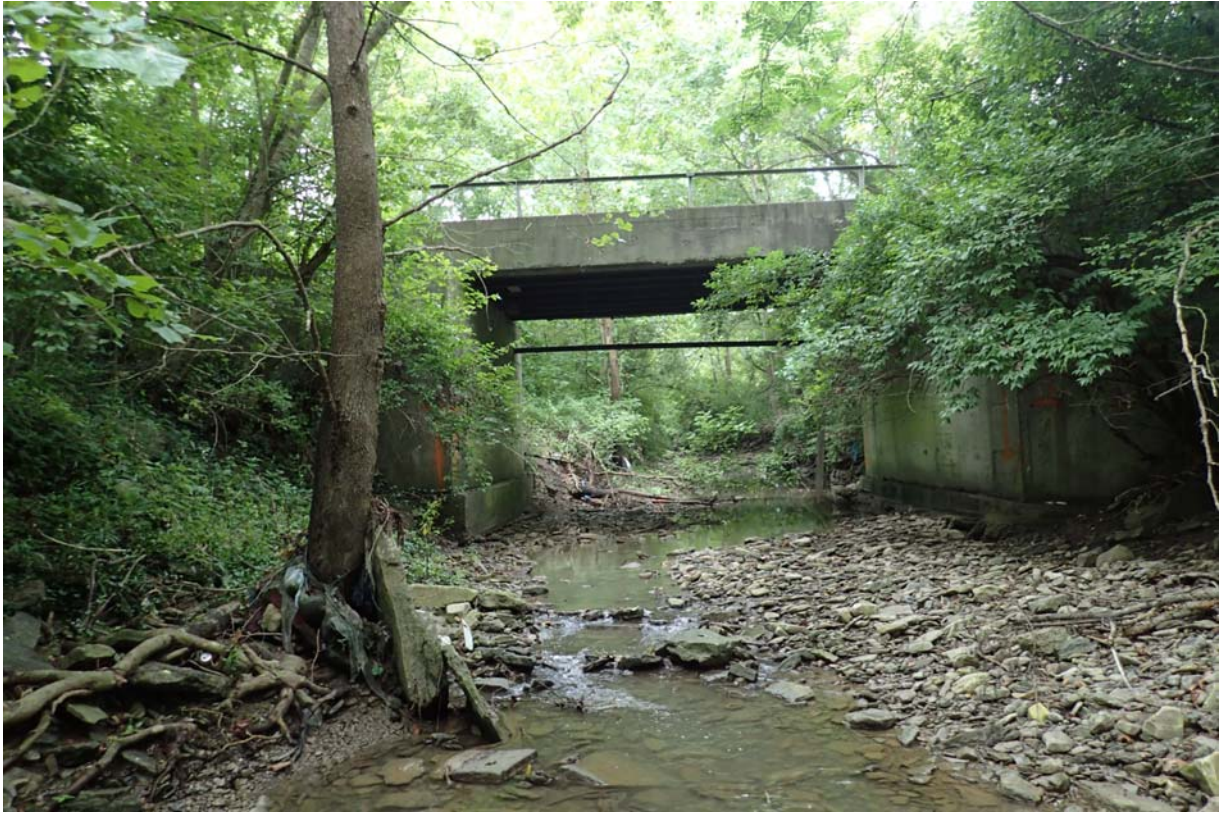
View from downstream.

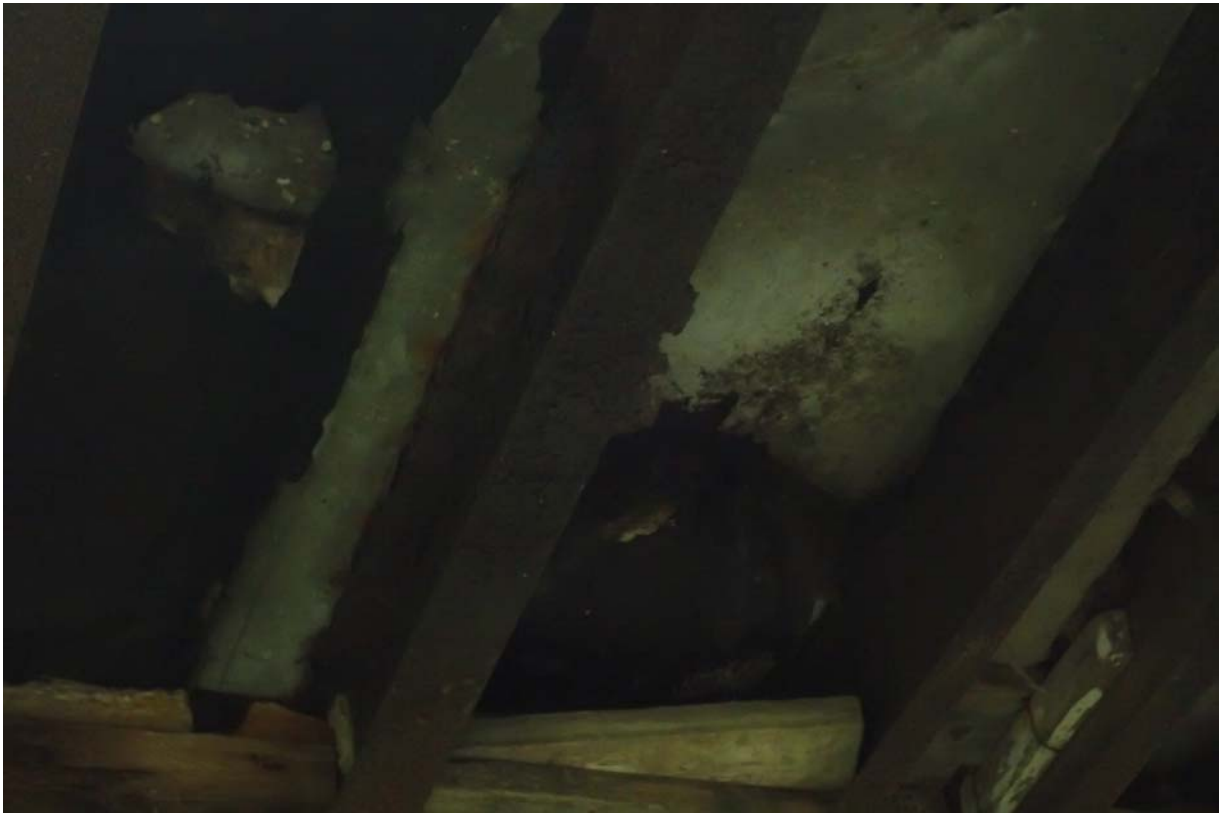
Moderate to heavy corrosion at the west end of beam 3 from upstream.

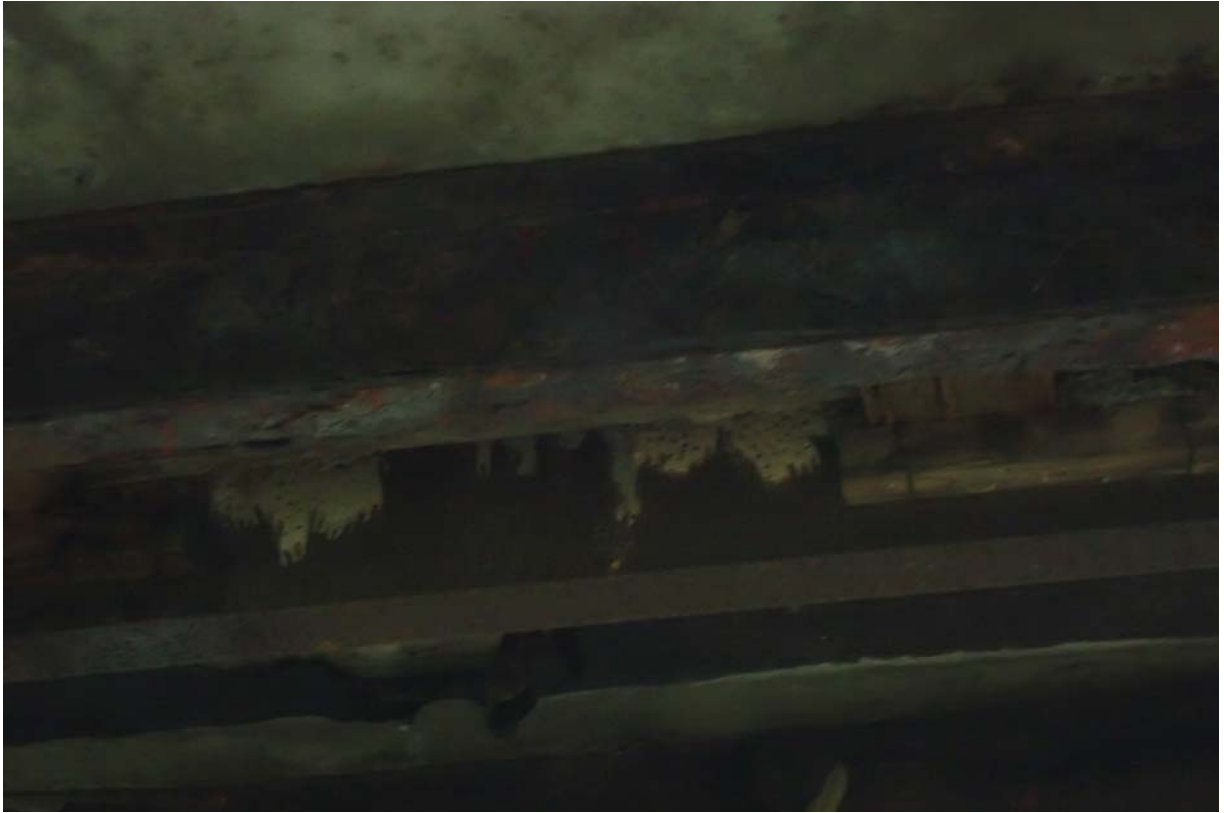
Heavy corrosion along beam 4 from upstream.

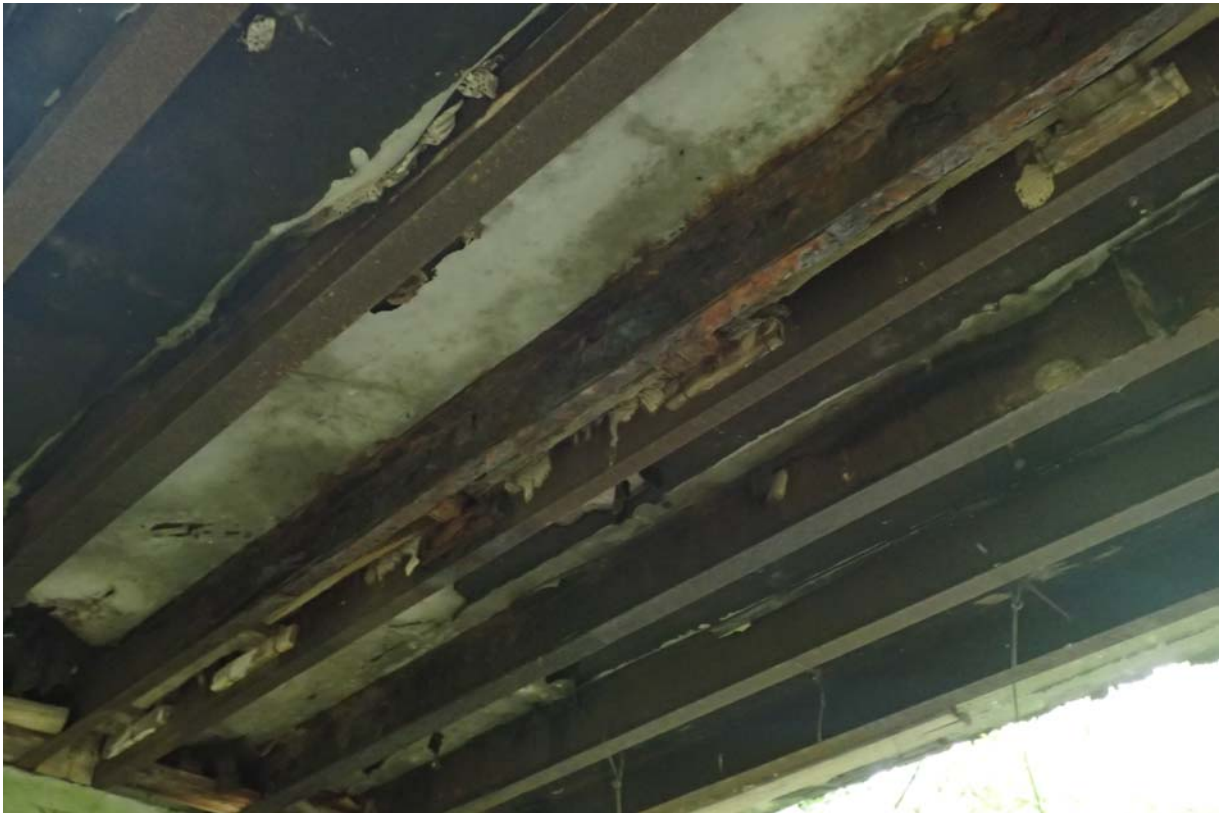
Heavy corrosion along beam 4 from upstream.

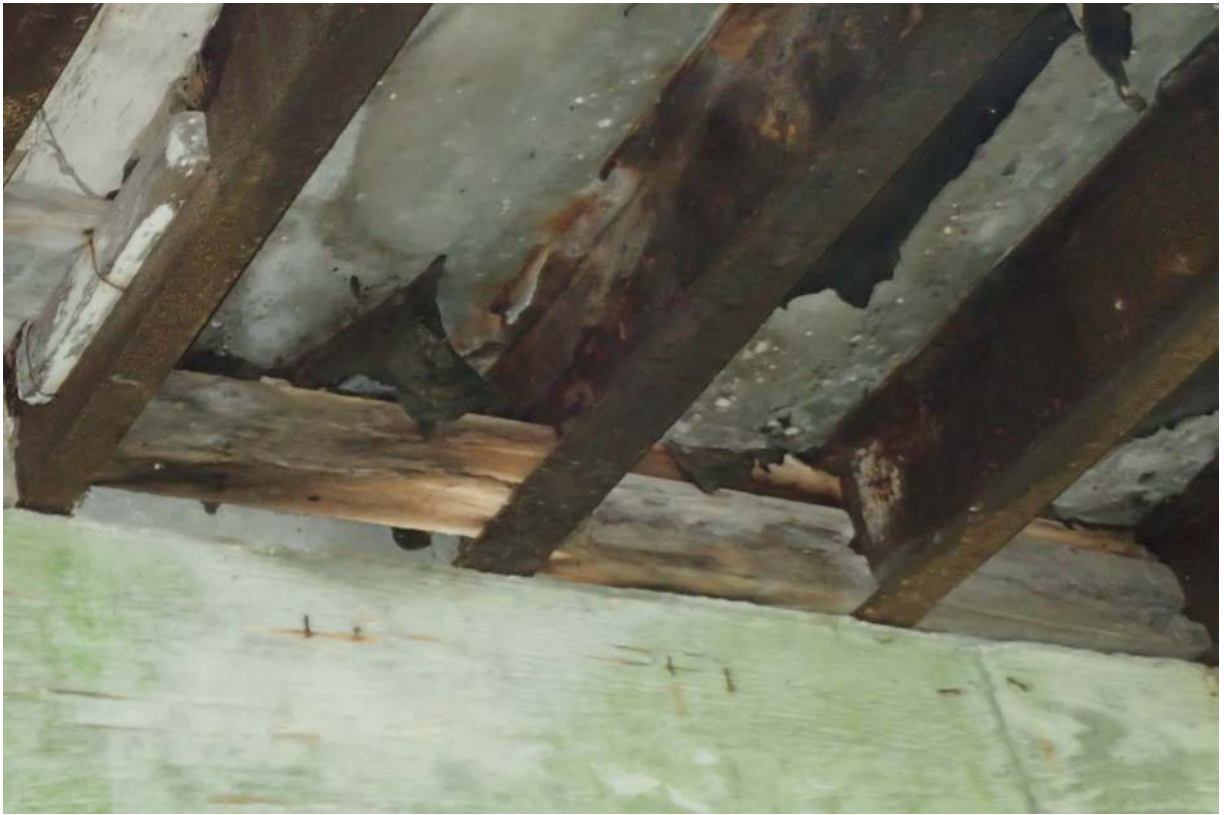
Heavy corrosion at the west end of beam 6 from upstream.

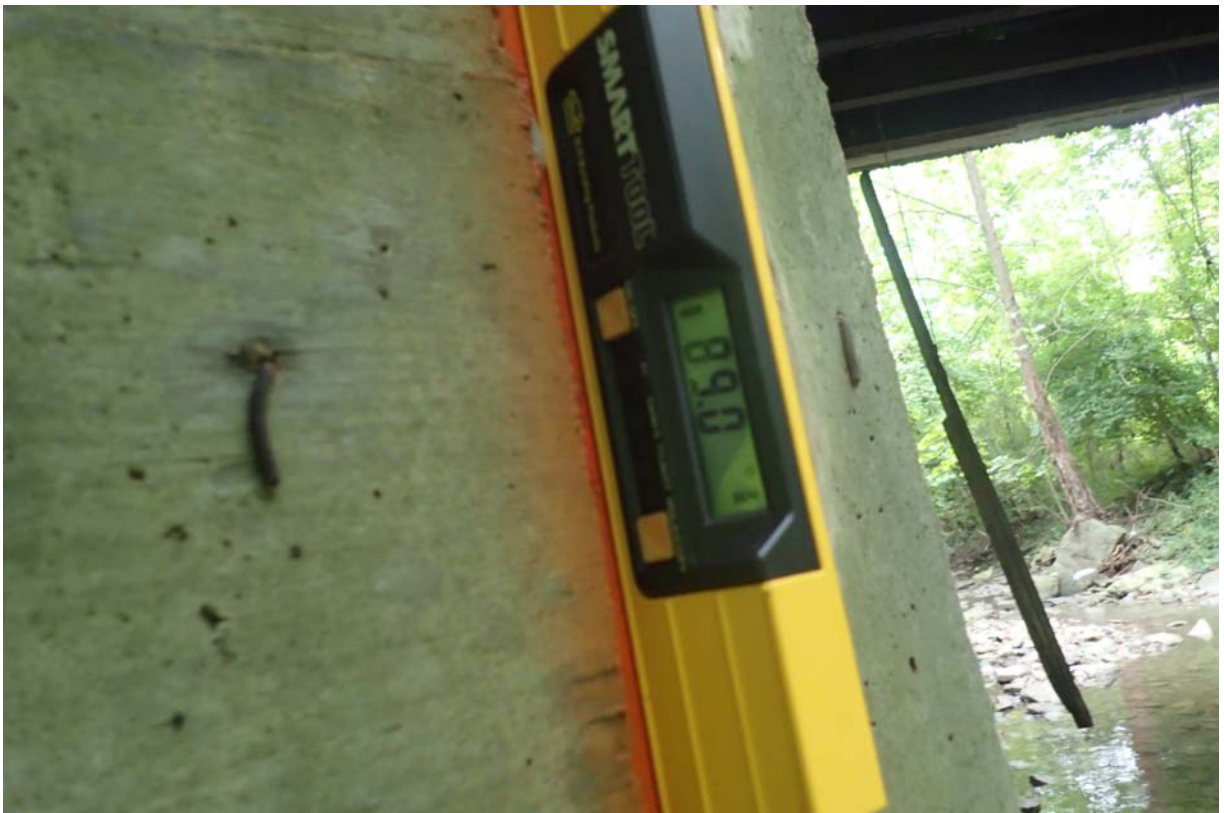
Smart level measurement on the upstream west wingwall.

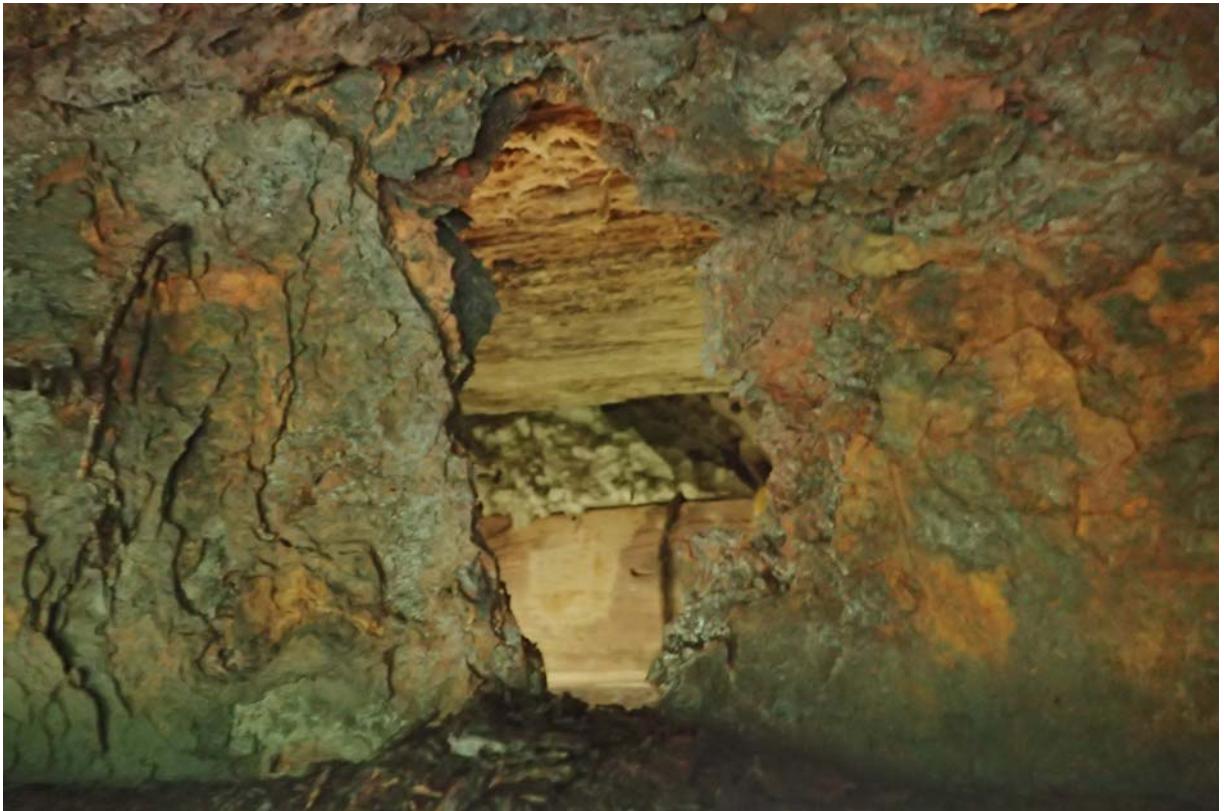
Full height rust through hole in the web of beam 4 from upstream near midspan.

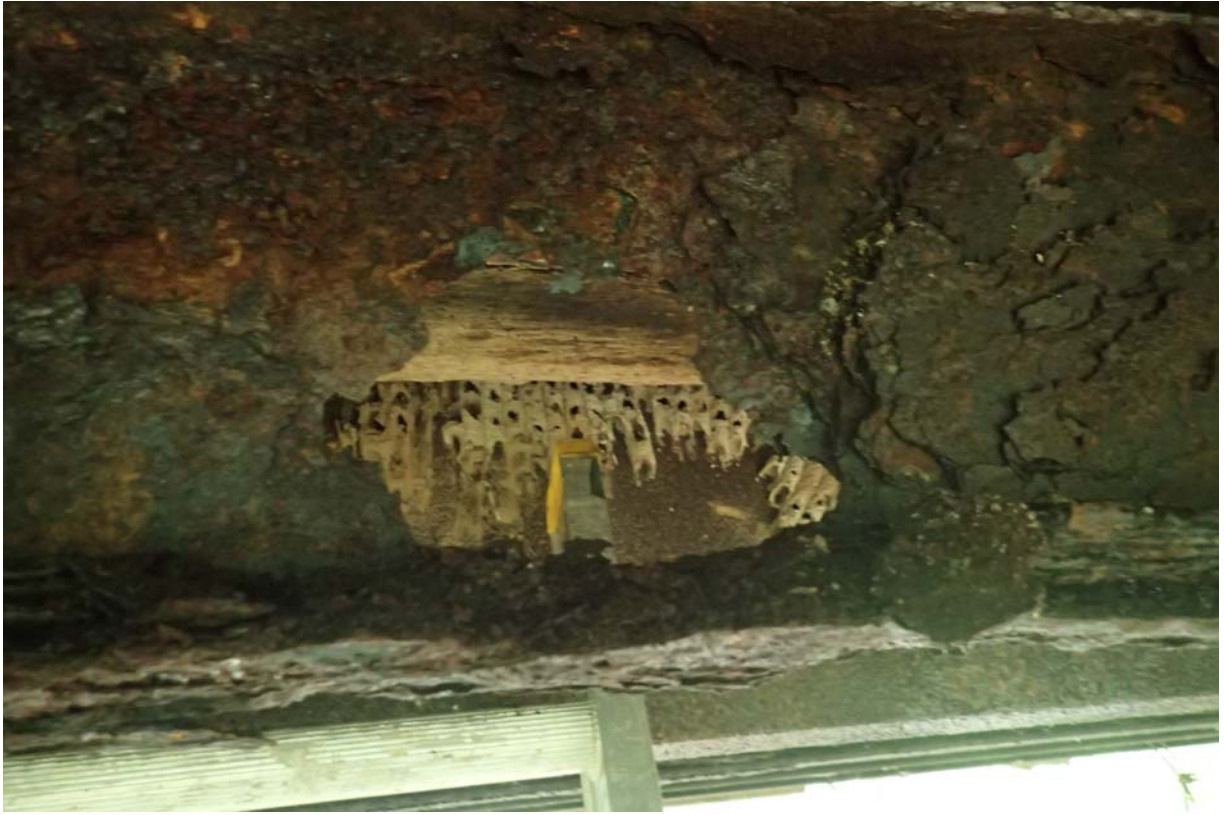
Large rust through hole in the web of beam 4 from upstream ~ 7' from the west abutment.

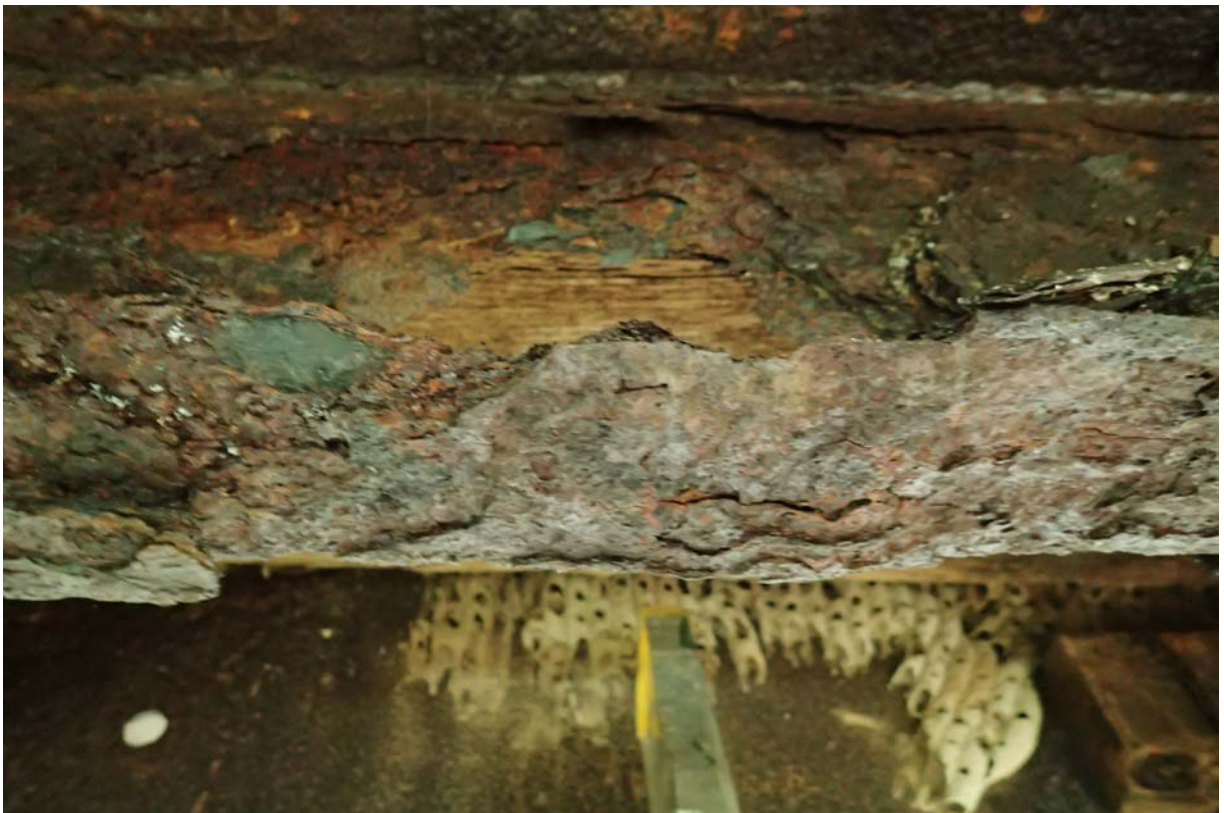
Heavy section loss within the width and thickness of beam 4s bottom flange ~ 7' from the west abutment.

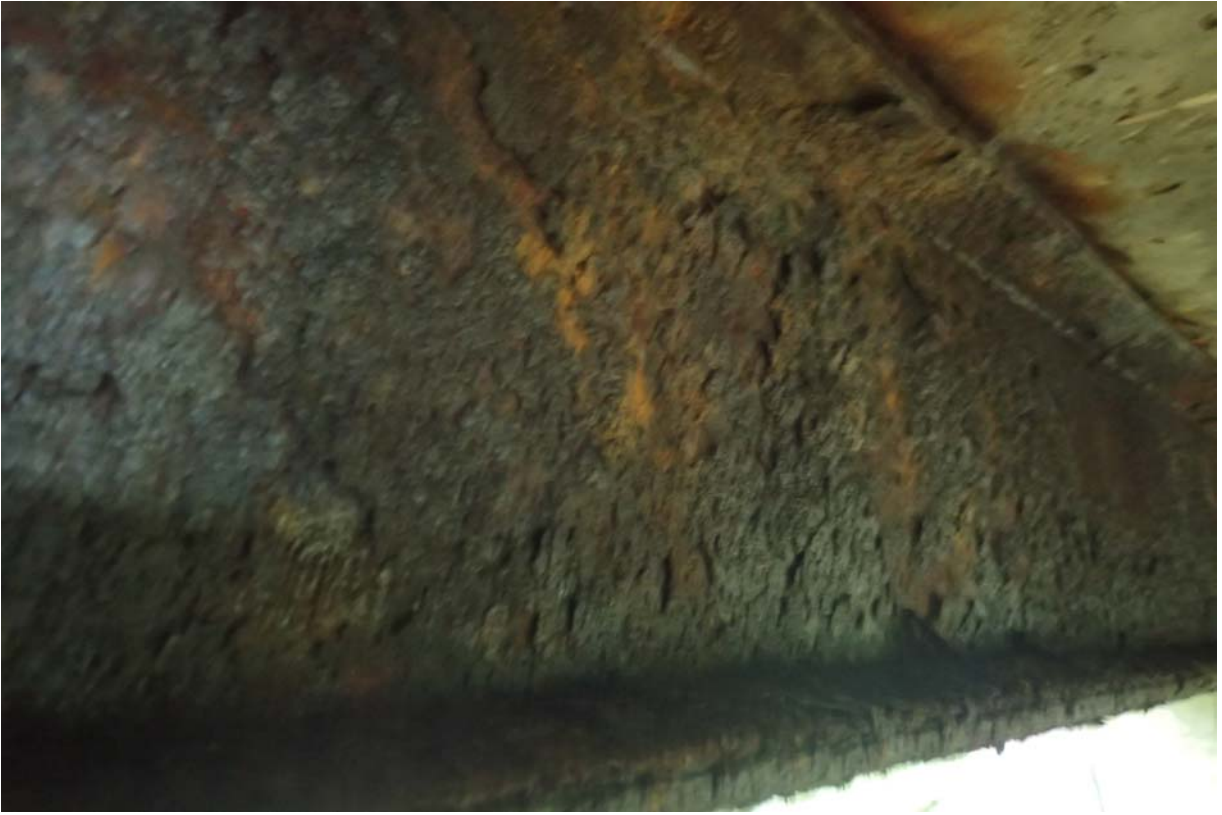
Heavy corrosion of beam 6 from upstream near the west abutment.
