Inspection Report with SI&A Data

Structure Description: 43.96 Foot - 2 Span Concrete Culvert (includes frame culverts)

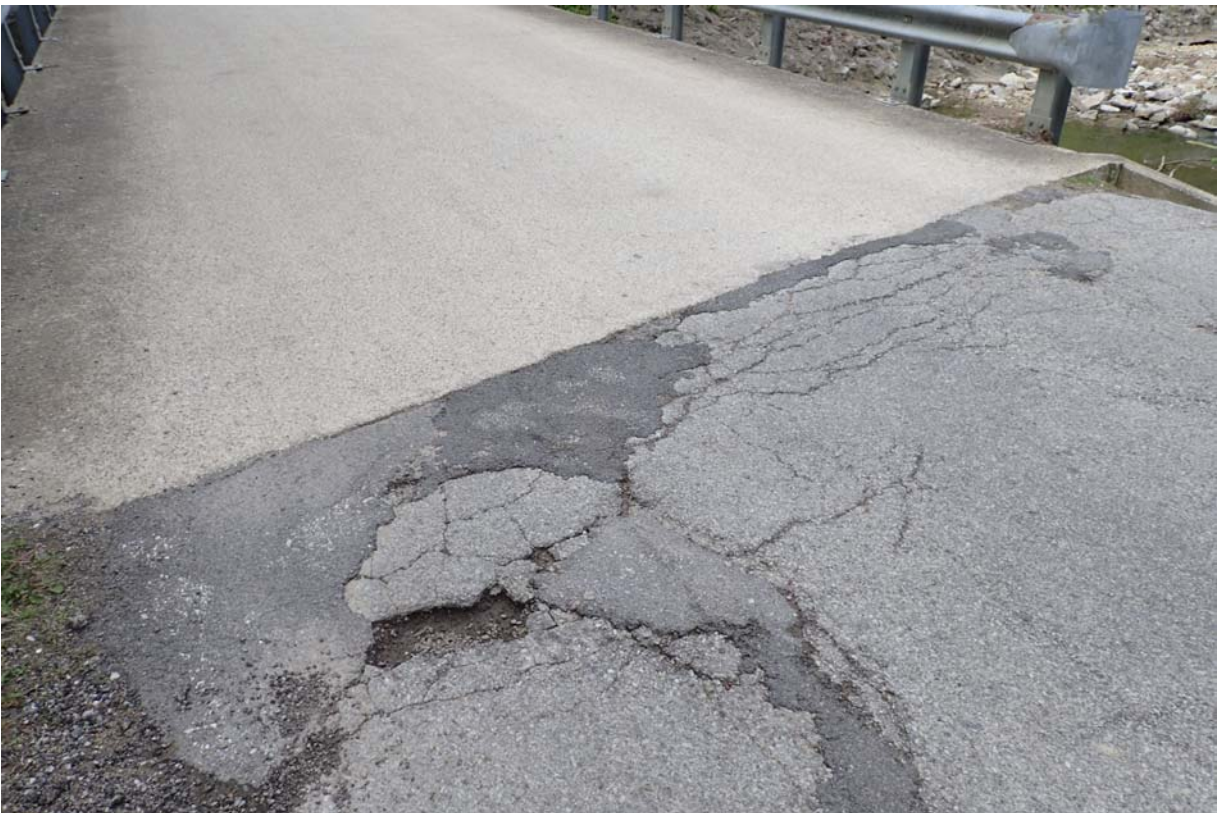
View of moderate cracking, potholes, and patching along the north approach.

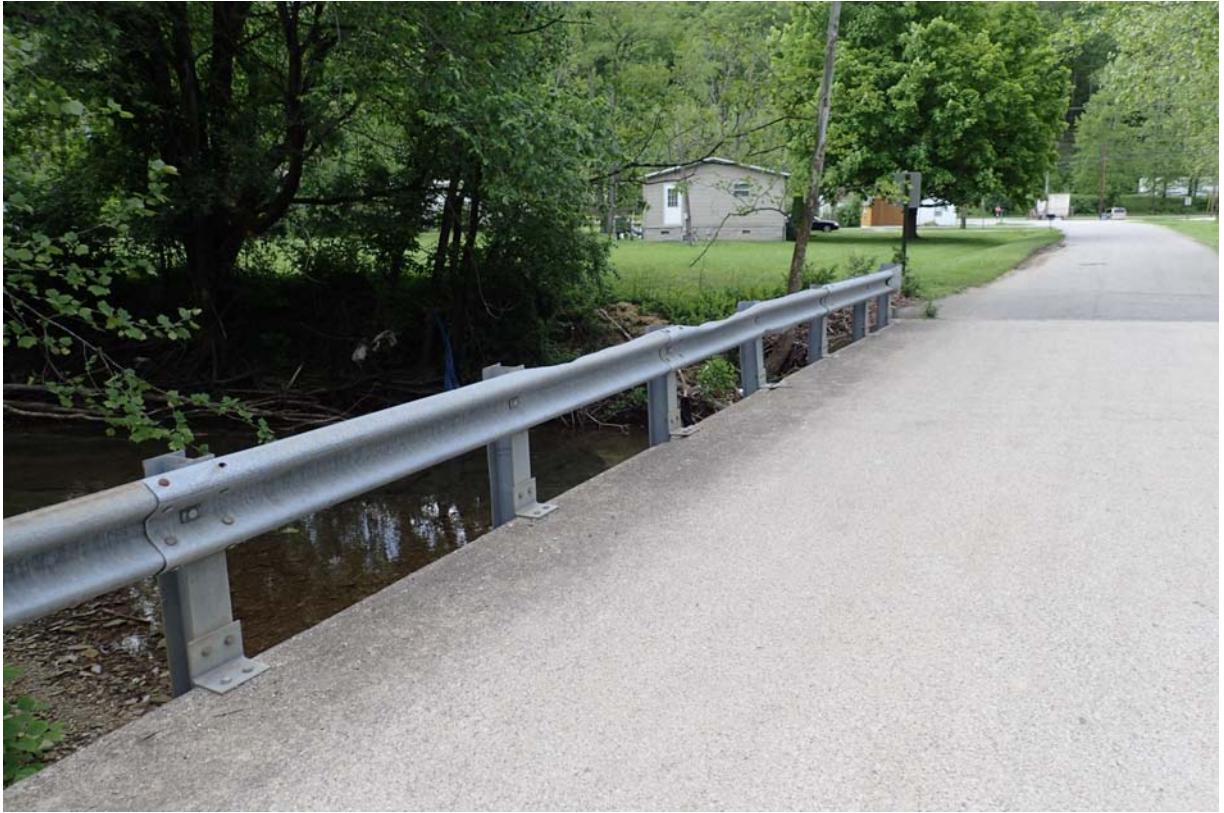
View along the upstream railing. Notice the moderate impact damage near mid-length.

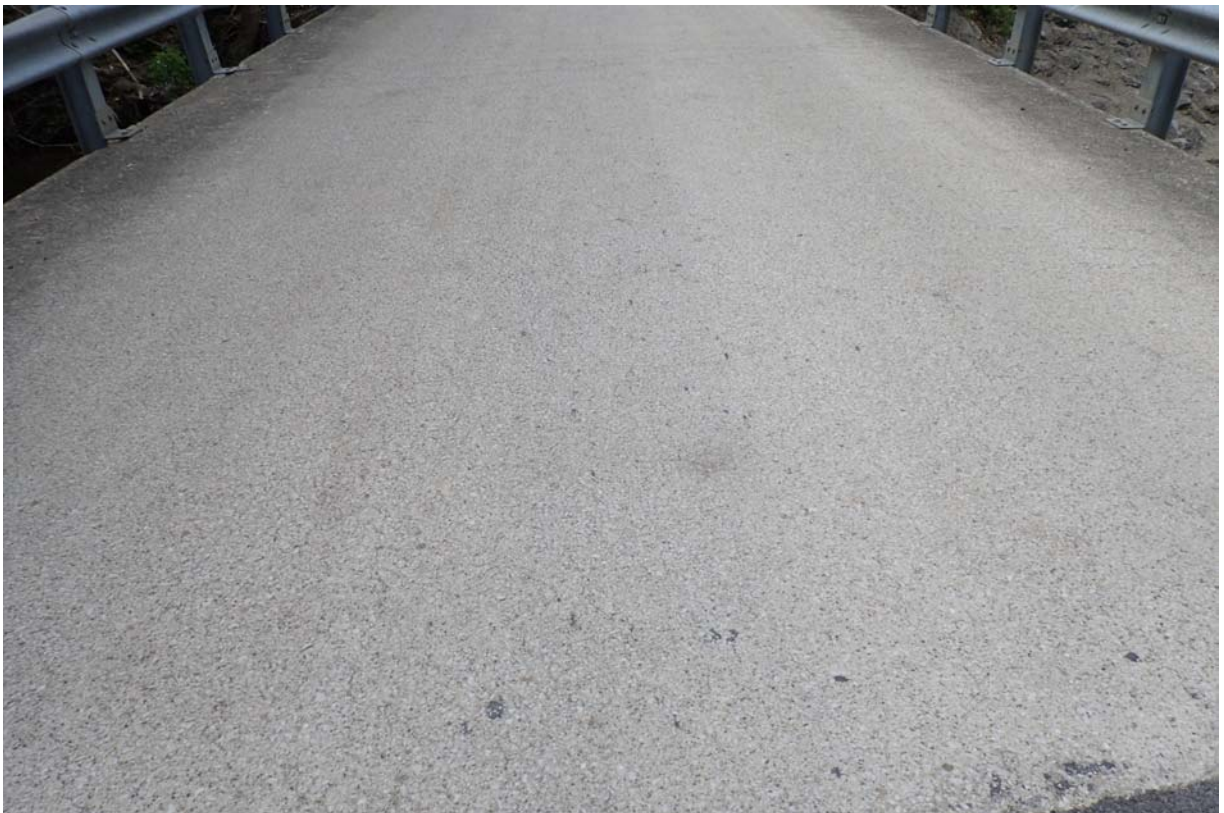
Typical view of the wearing surface.

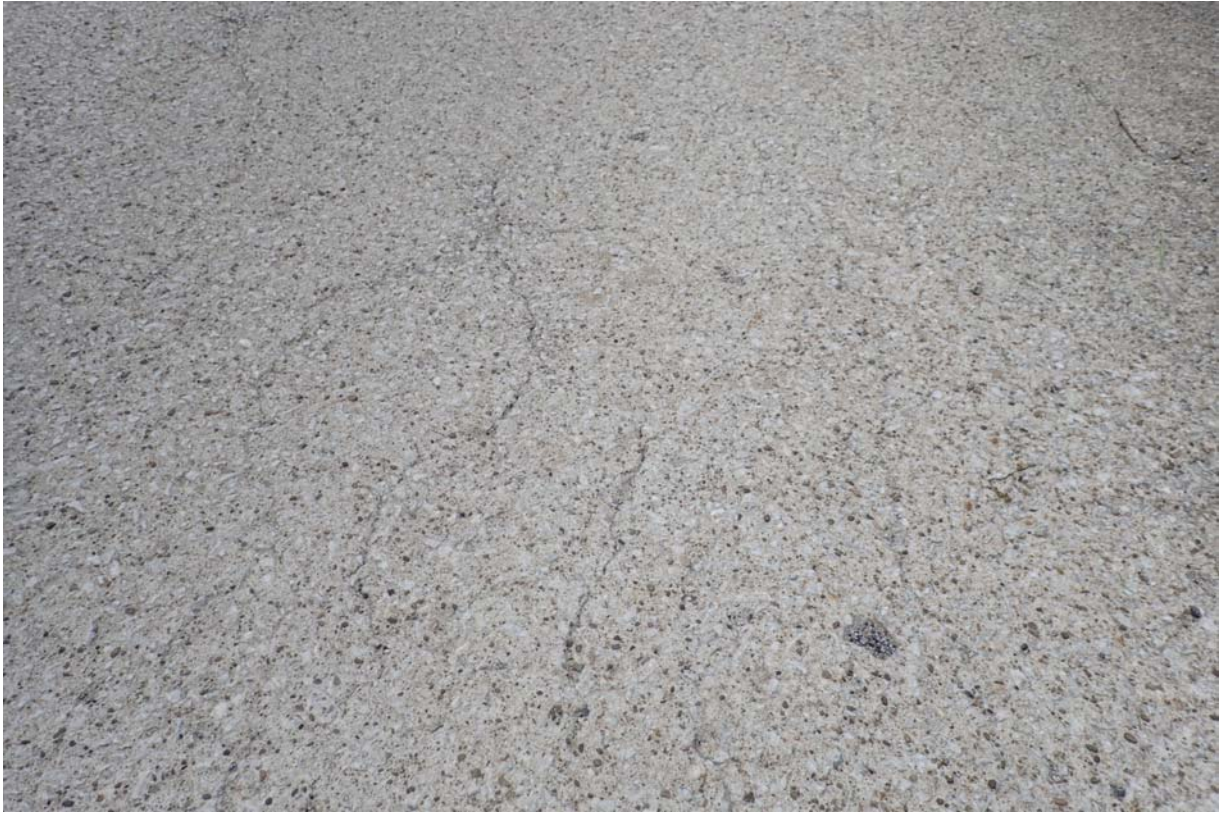
View of several longitudinal cracks at the downstream north end of the wearing surface.

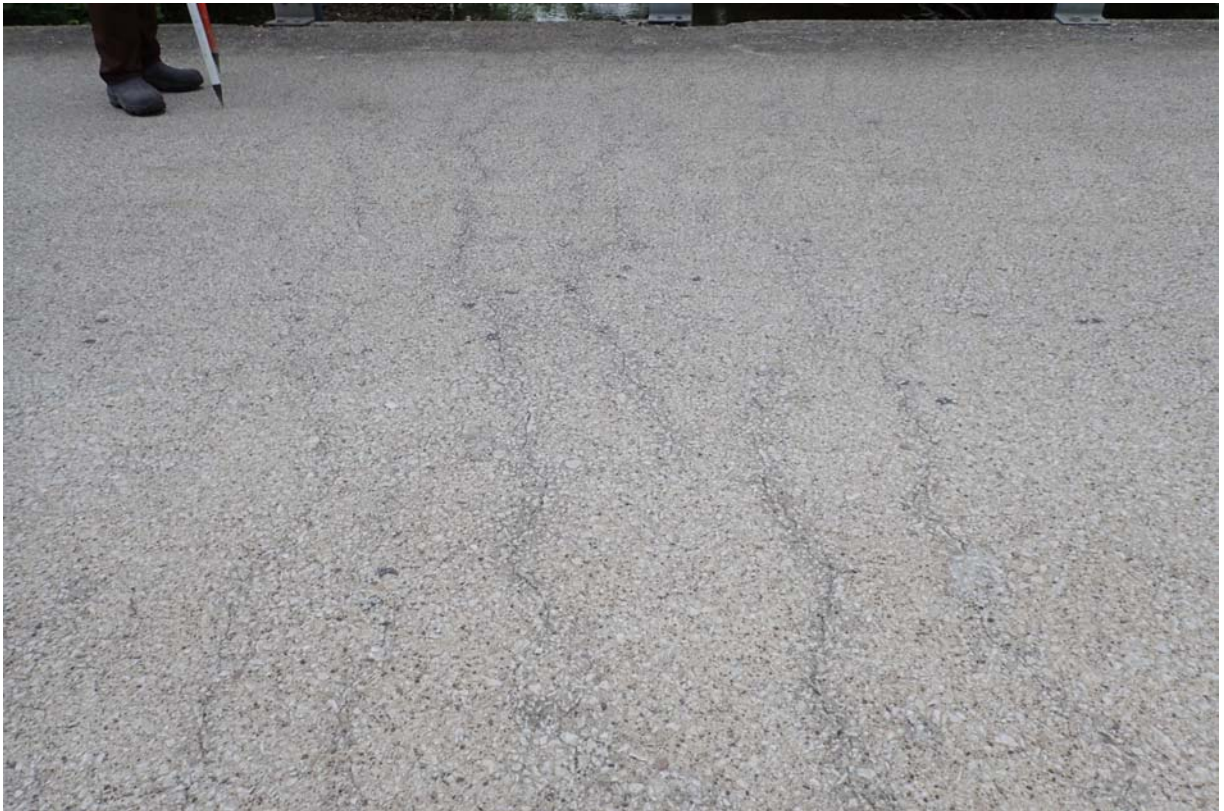
View of several minor sized transverse cracks in the wearing surface over the pier.

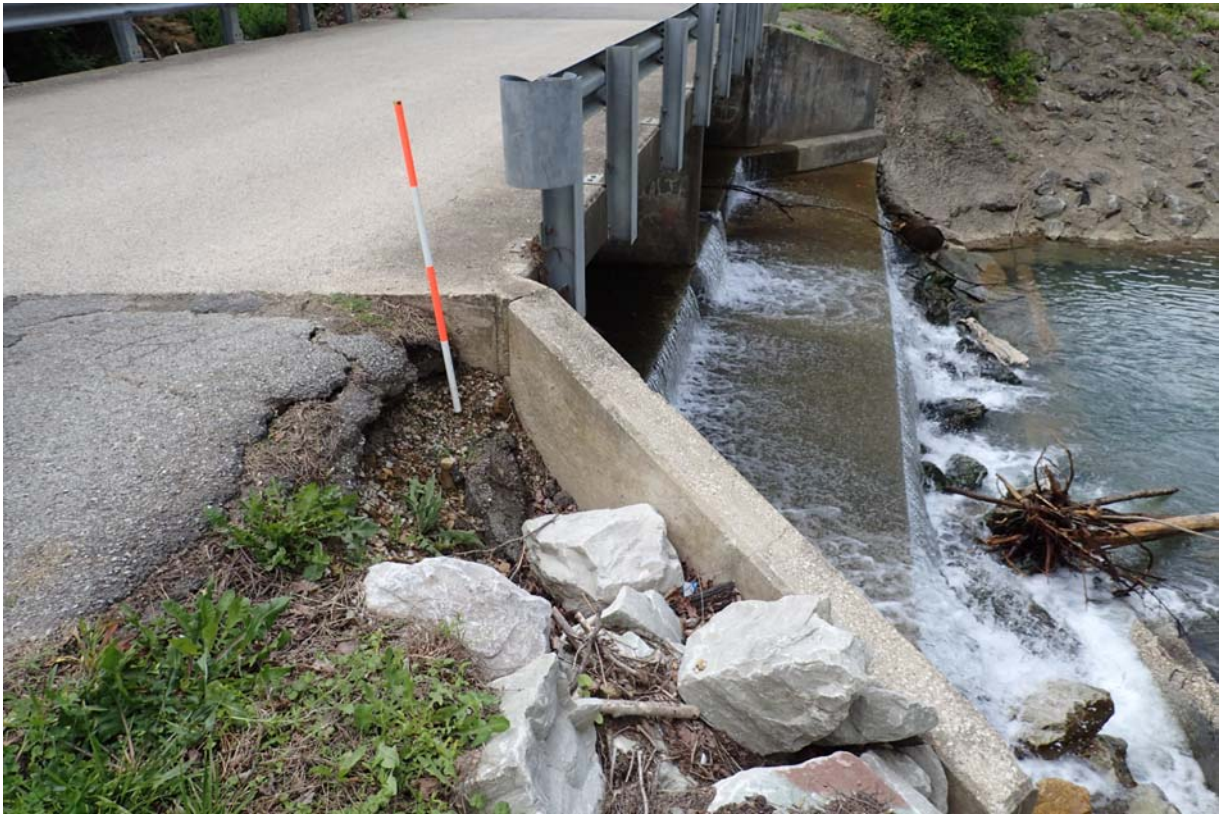
View of moderate erosion at the downstream north wingwall. Notice the roadway shoulder is breaking up.

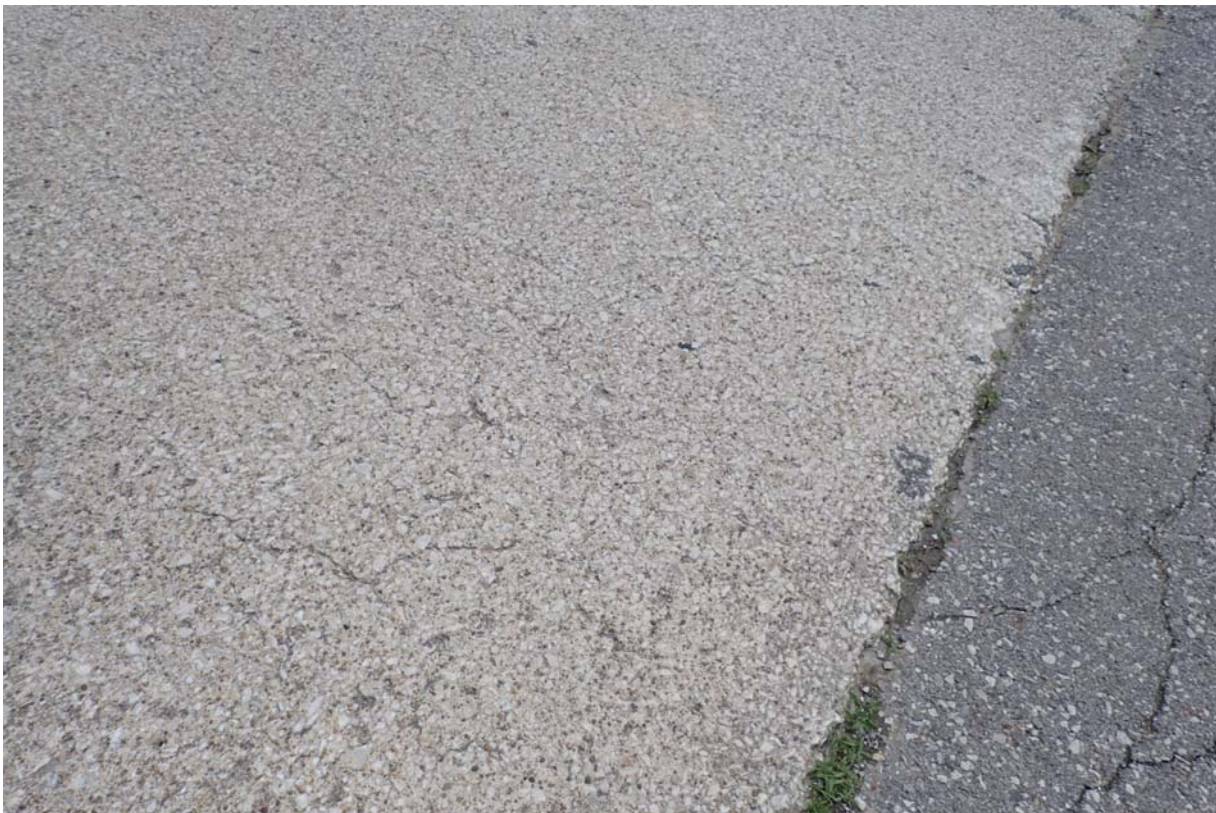
View of several minor sized cracks at the downstream south end of the wearing surface.

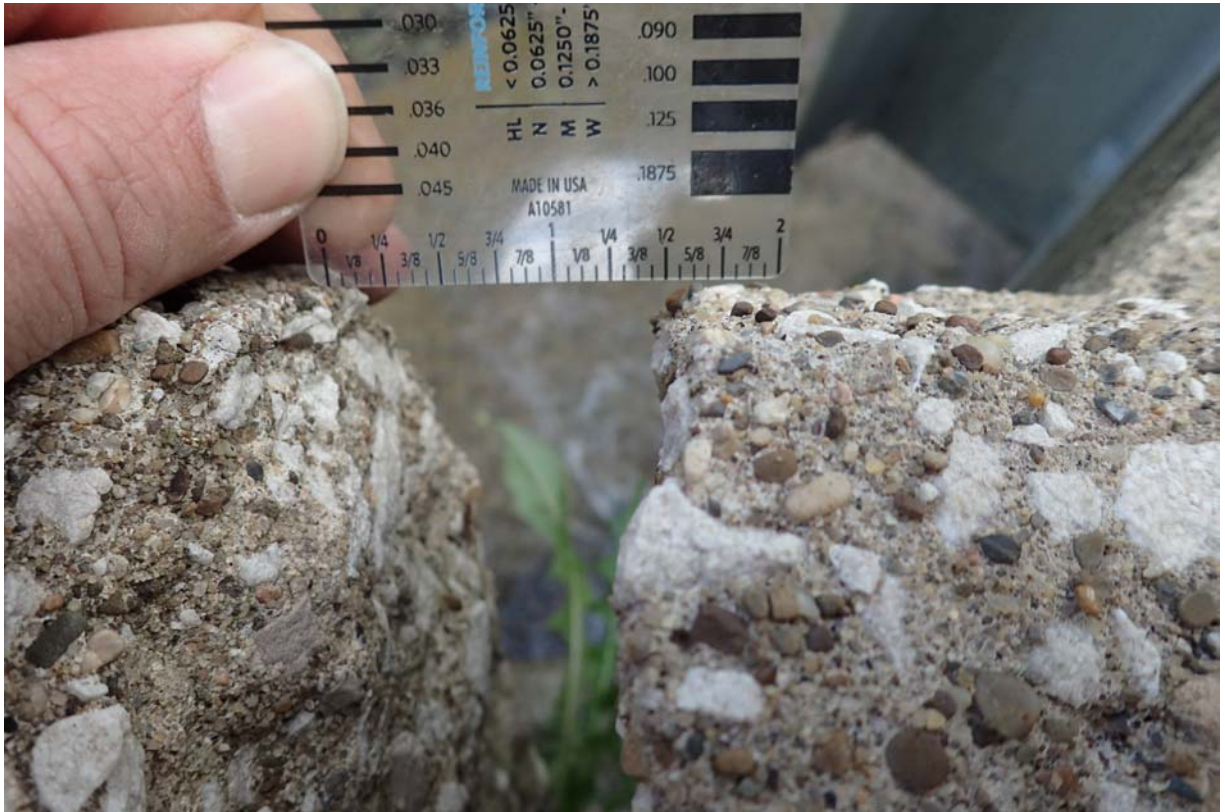
View of ~ 1.5" of separation at the top of the downstream south wingwall.

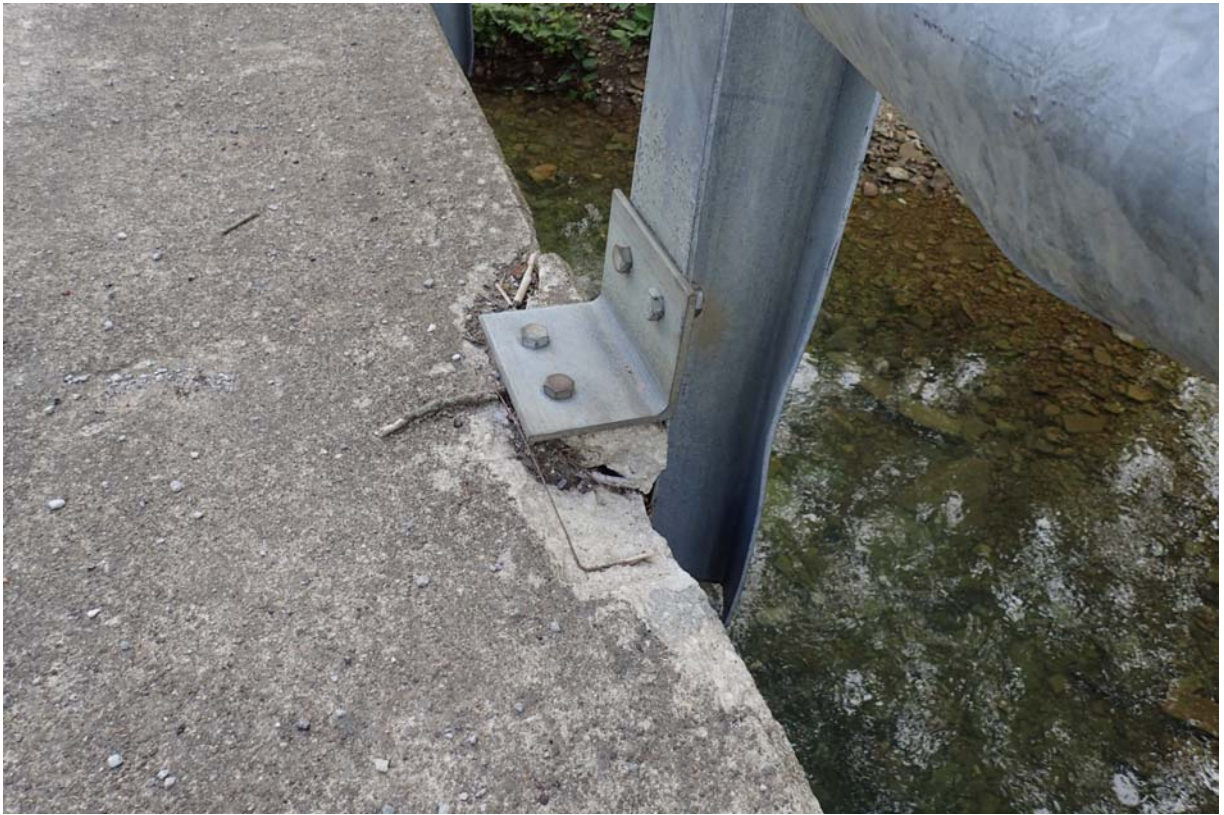
View of moderate cracking and spalling at upstream rail post 4 from the south.

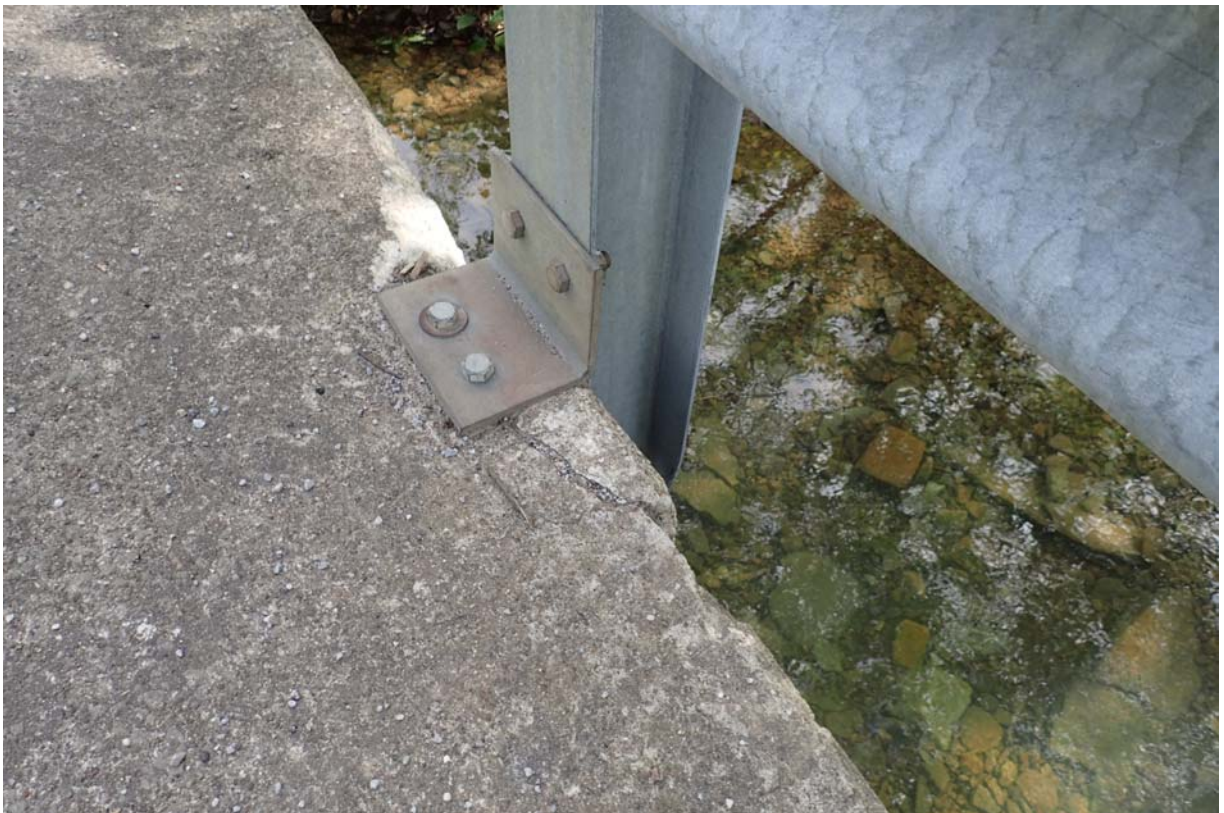
View of moderate cracking and spalling at upstream rail post 5 from the south.

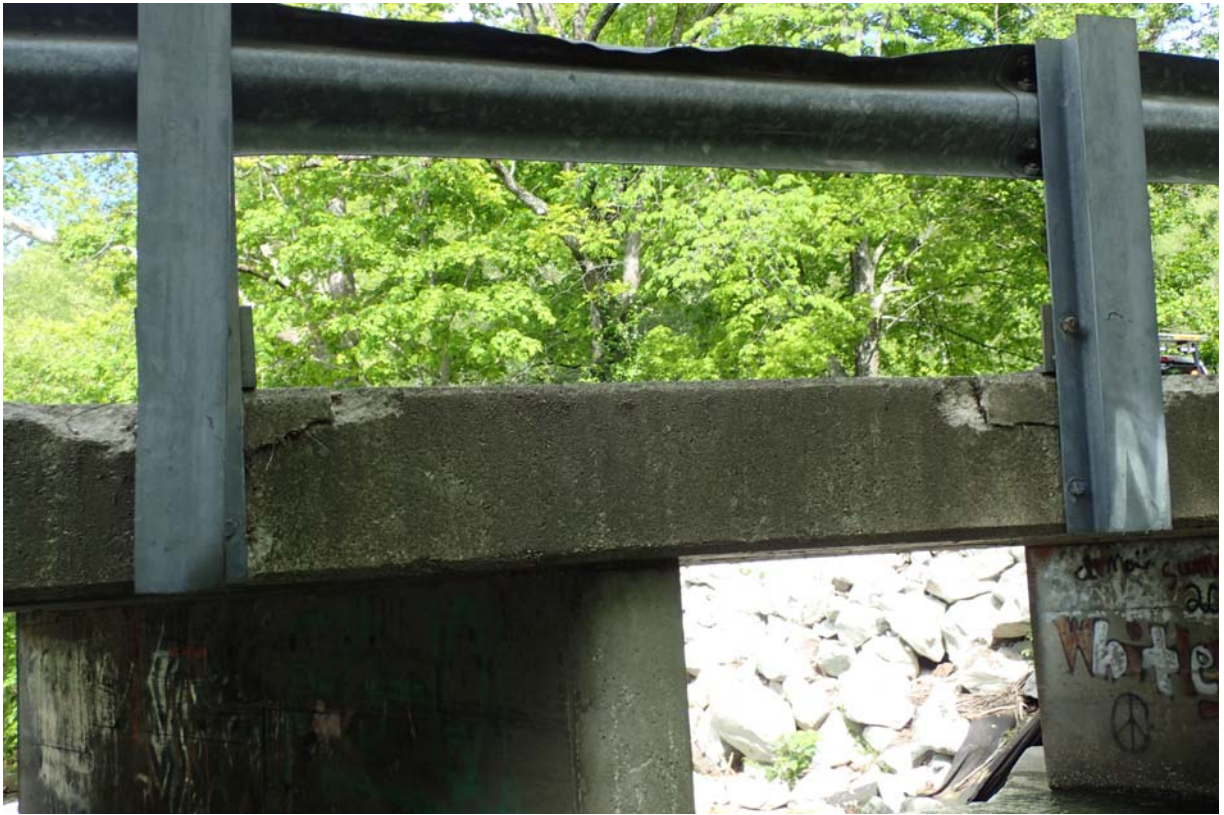
View of moderate spalls in the upstream face of the deck at rail post 4 and 5 from the south.

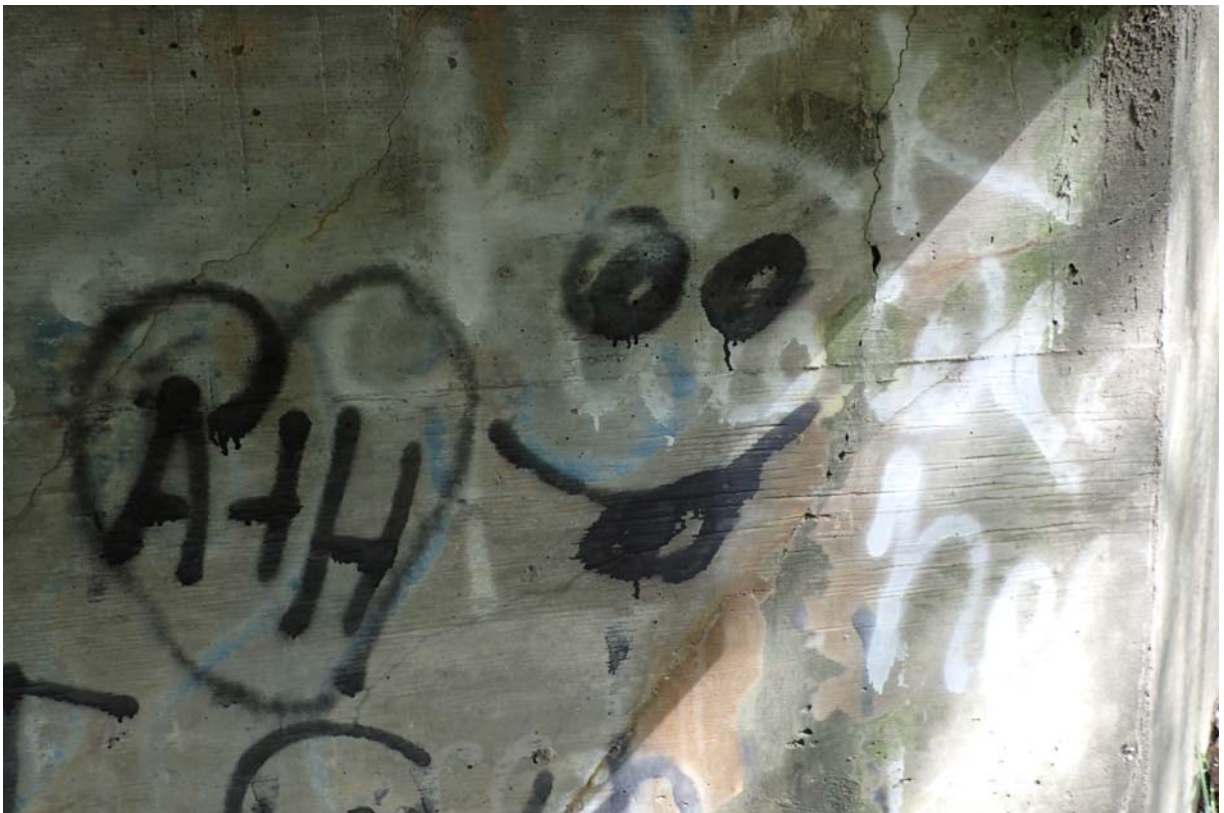
View of some minor cracking at the inlet end of the north abutment.

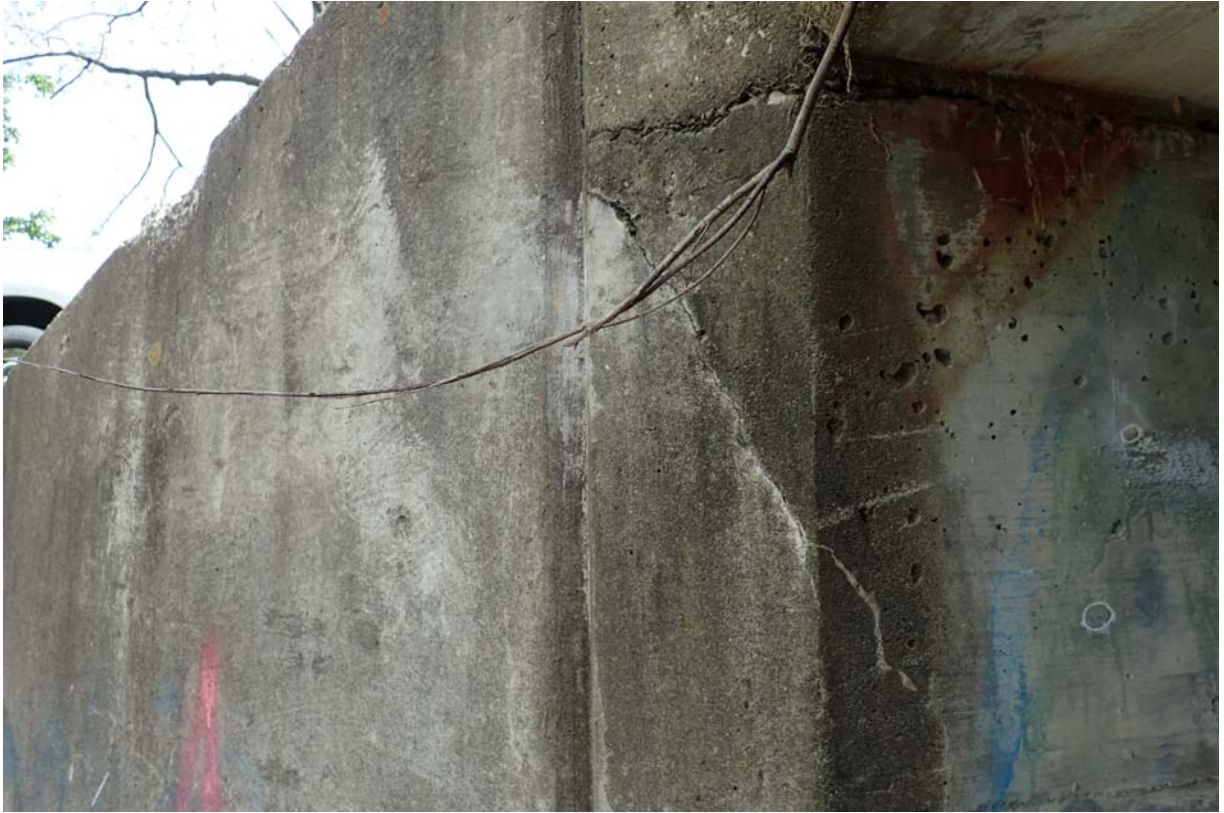
View of some minor cracking at the outlet end of the north abutment.

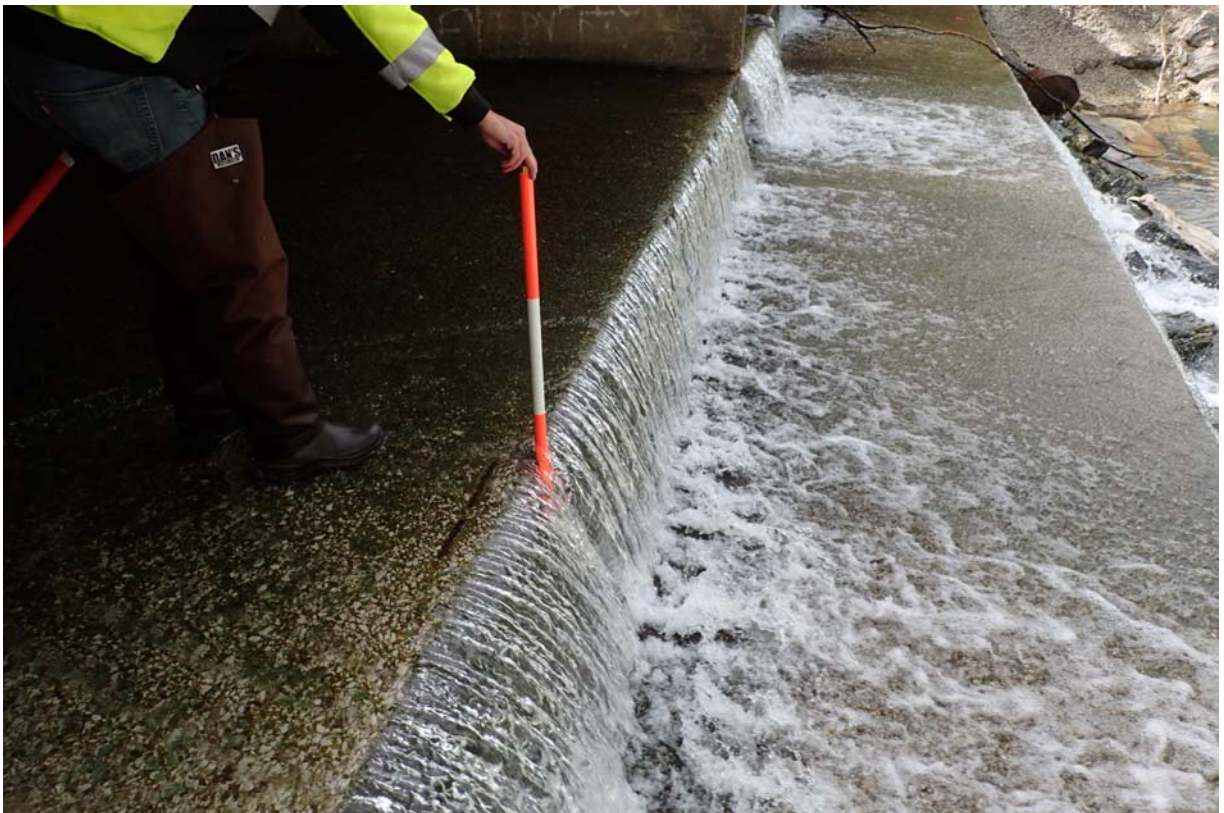
View of an ~ 18" vertical drop of the floor in the north span.

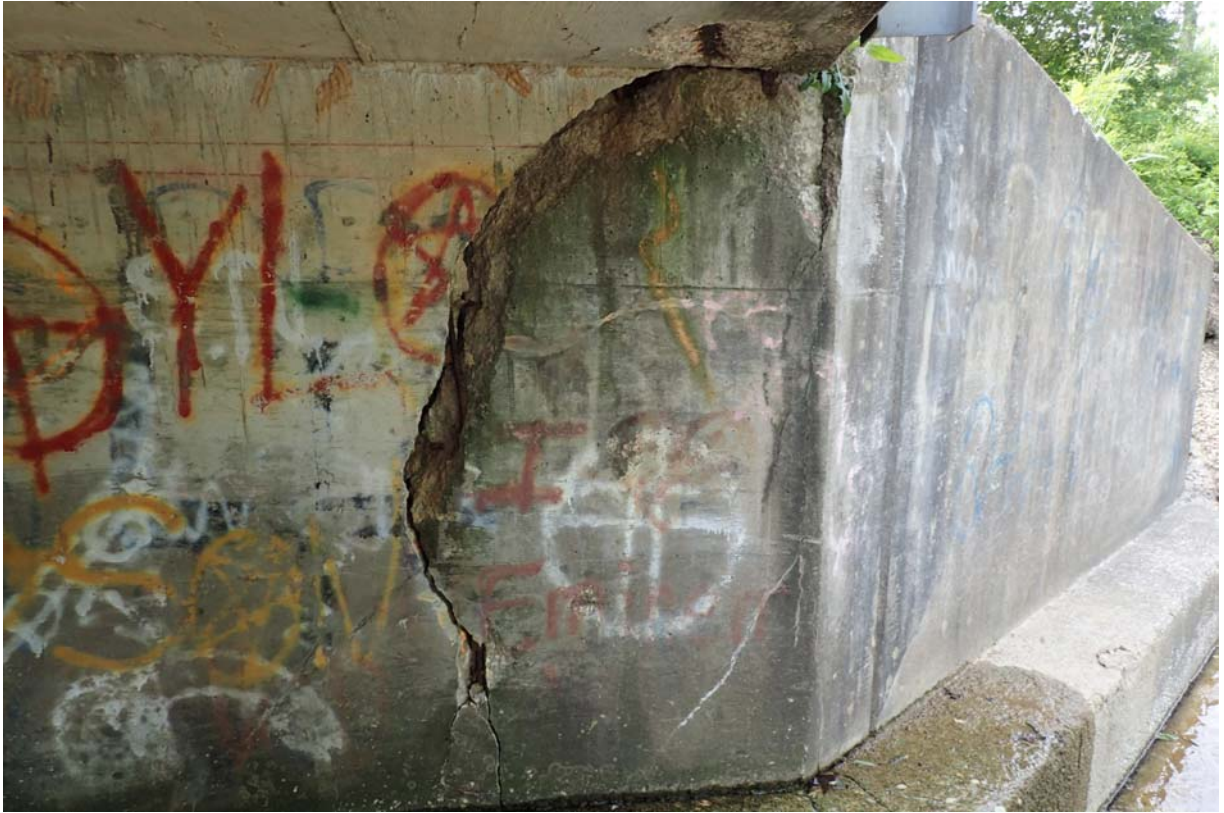
View of large heavy cracking and spalling with exposed steel at the downstream end of the south abutment. This cracking measures ~ 4.5"-5" wide at mid-height.

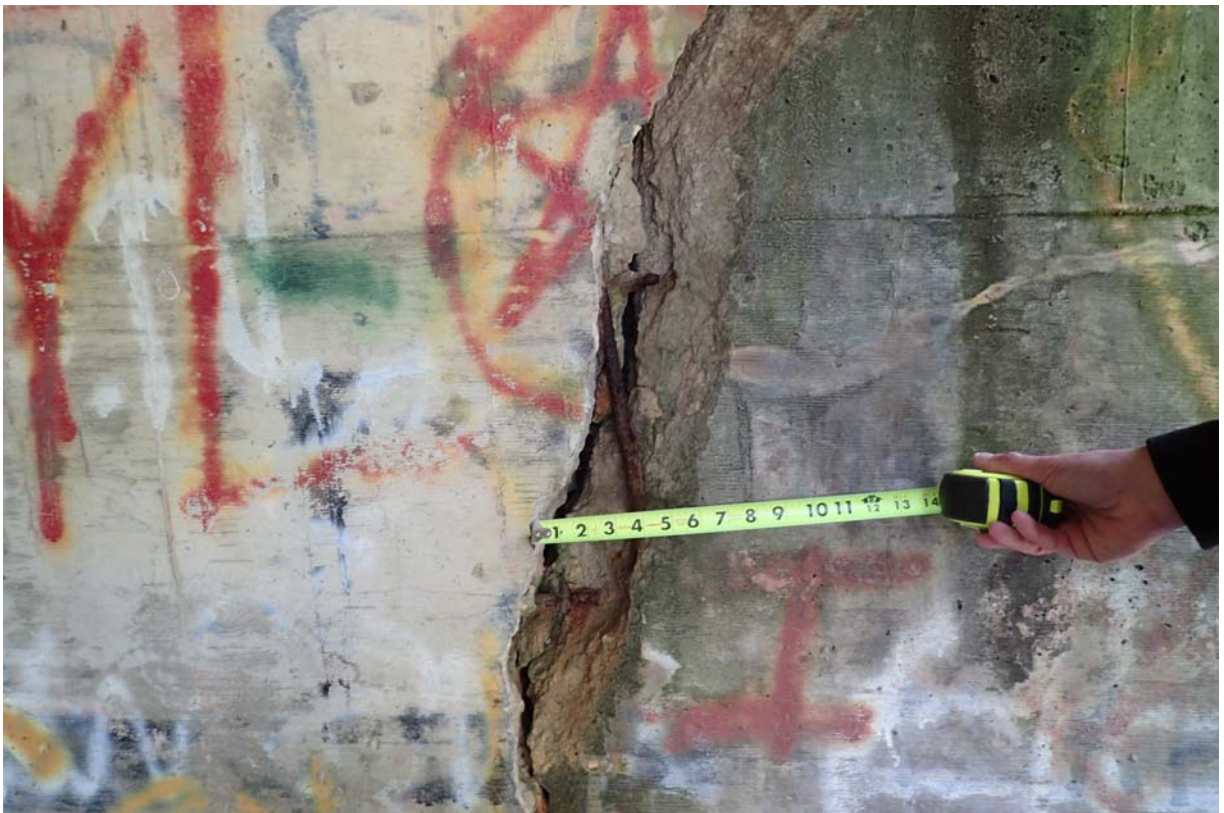
View of large heavy cracking and spalling with exposed steel at the downstream end of the south abutment. This cracking measures ~ 4.5"-5" wide at mid-height.

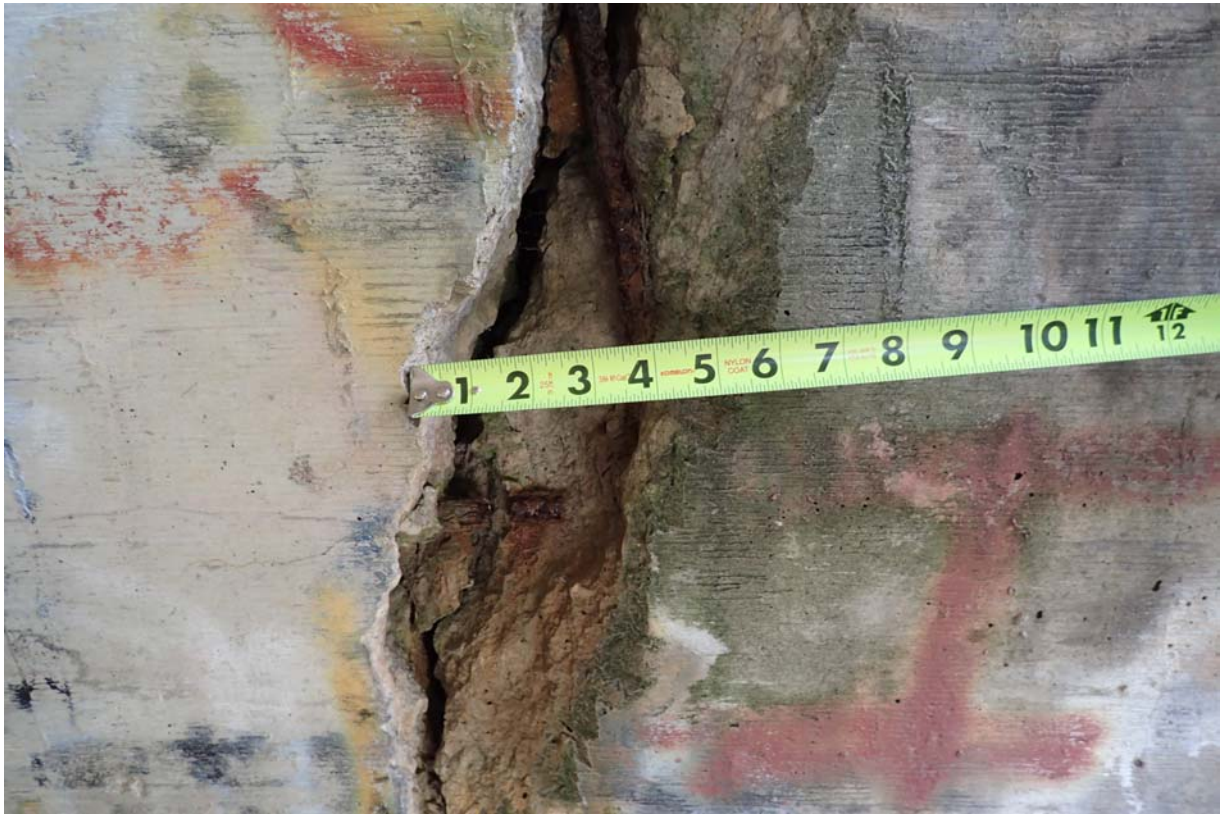
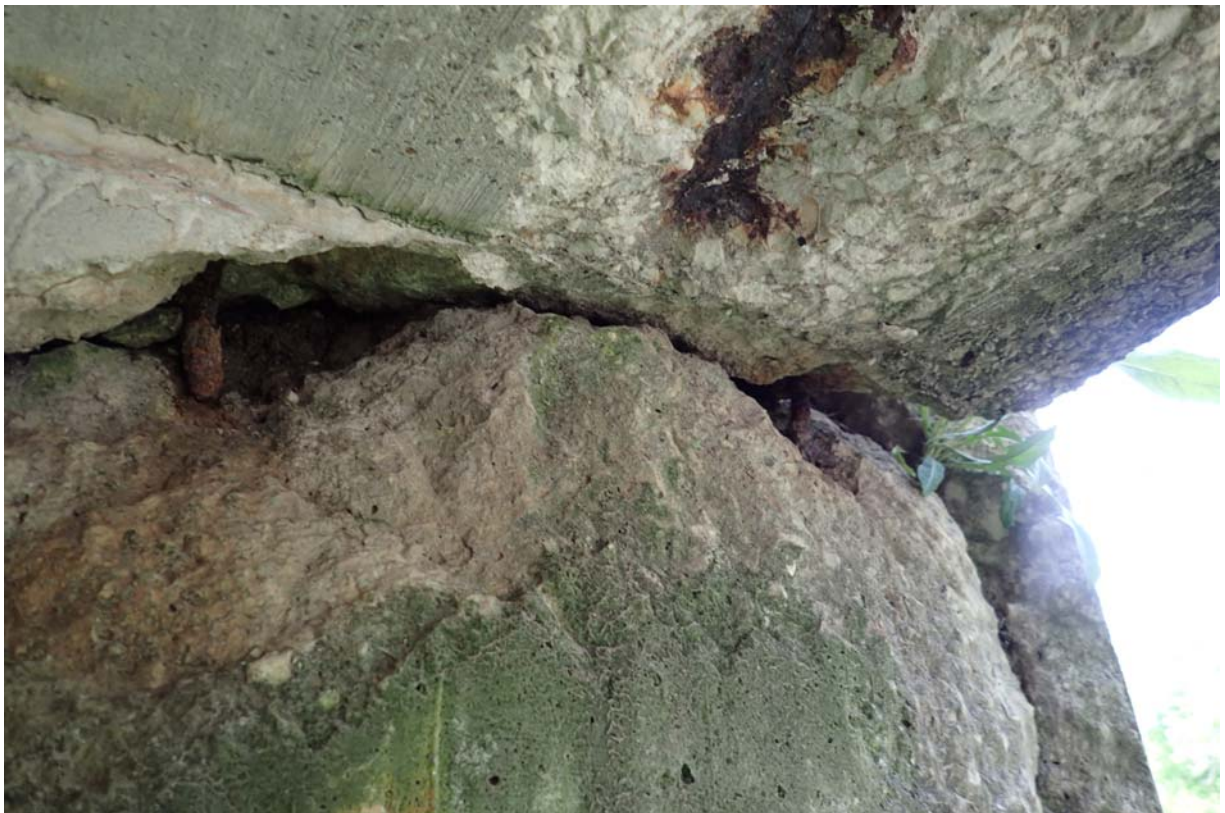
View of large heavy cracking and spalling with exposed steel at the top downstream end of the south abutment/slab interface.

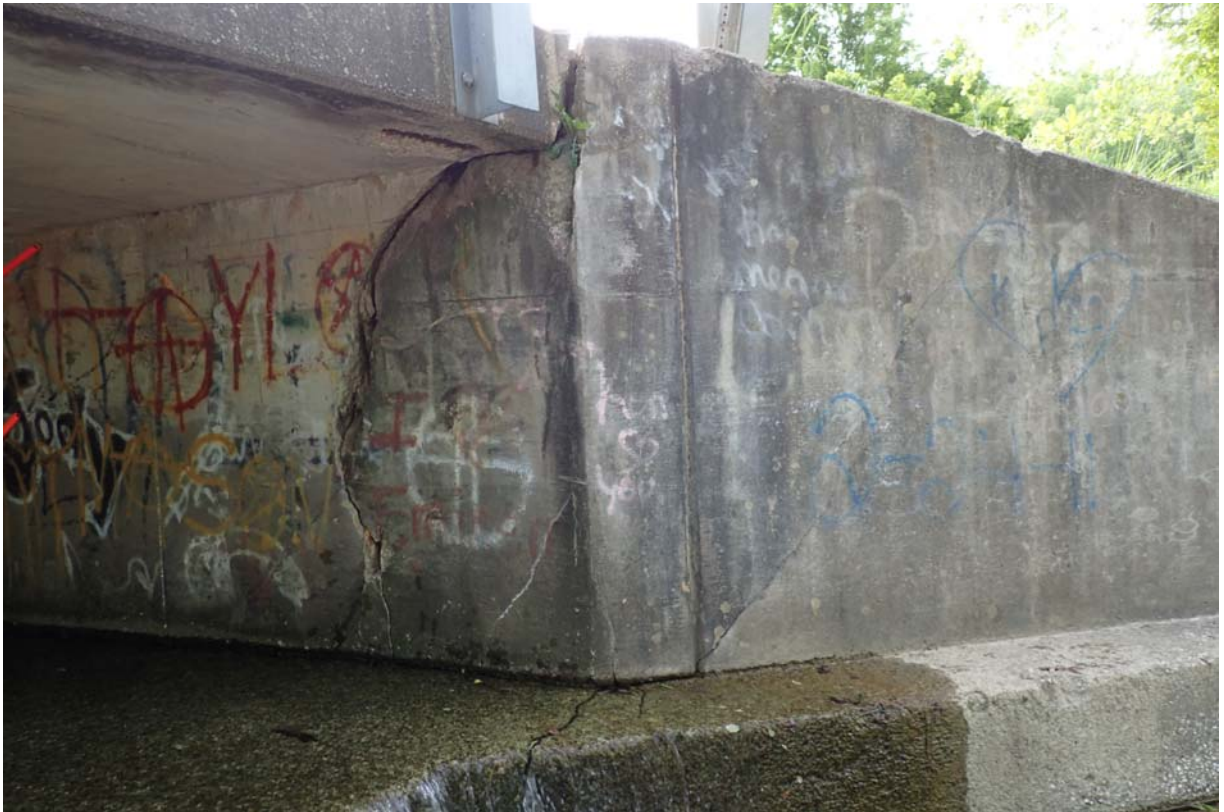
View of large heavy cracking and spalling with exposed steel at the downstream end of the south abutment. This cracking measures ~ 4.5" -5" wide at mid-height. Notice the cracking extends from the bottom of the footing to the top of the wingwall.

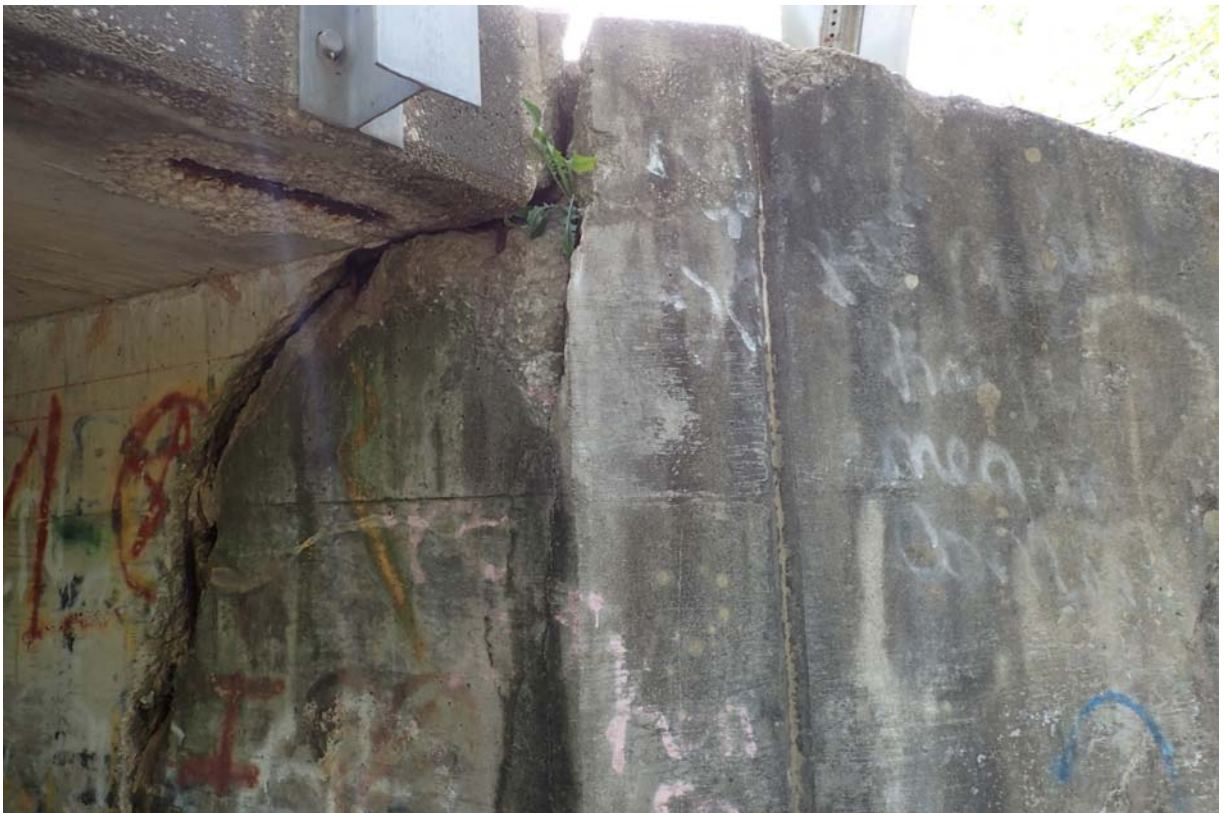
View of large heavy cracking and spalling with exposed steel at the downstream end of the south abutment. This cracking measures ~ 4.5" -5" wide at mid-height. Notice the cracking extends up through the top of the wingwall.

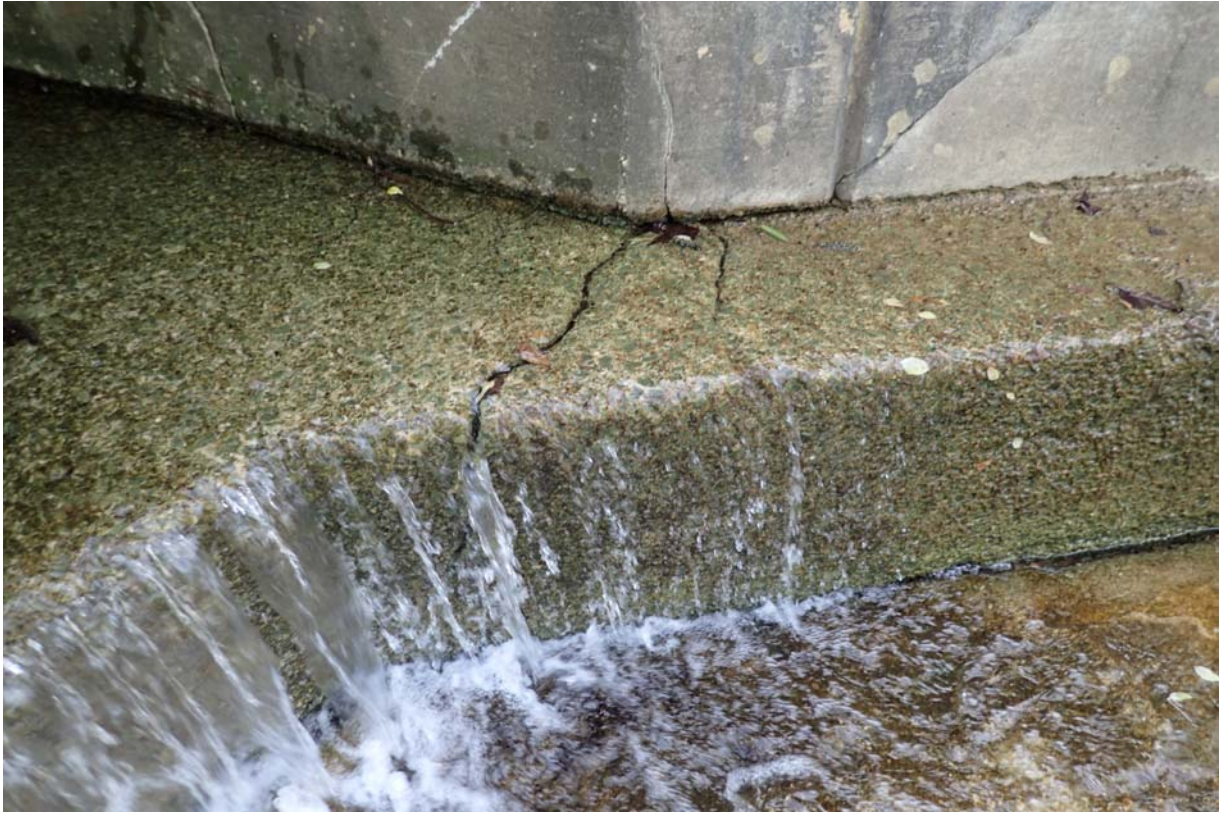
View of full depth cracking in the footing of the downstream south wingwall.

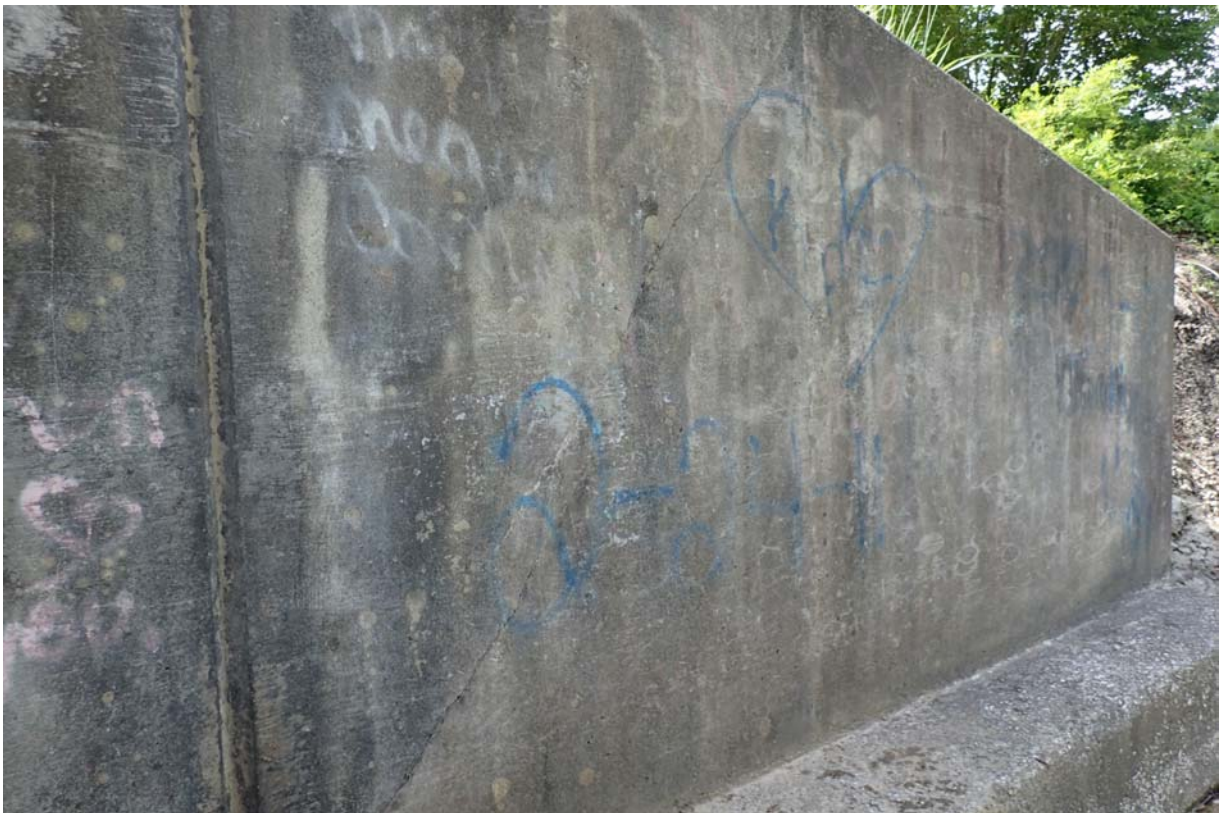
View of a minor sized full height diagonal crack in the downstream south wingwall.
