Inspection Report with SI&A Data

Structure Description: 43.96 Foot - 2 Span Concrete Culvert (includes frame culverts)

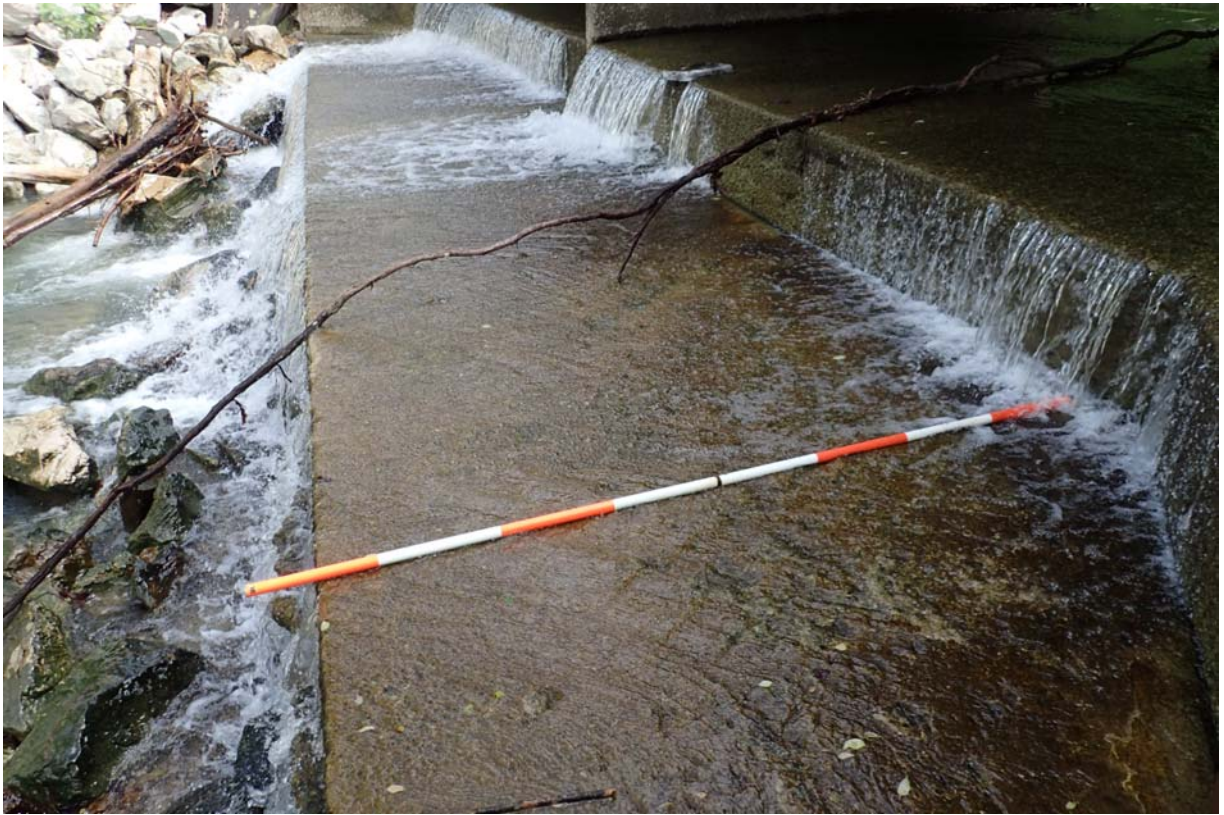
View of the ~ width of the downstream protection apron.
