MEMORANDUM

SUBJECT: Boone County
I-275 Slide #8 Beginning @ MP 8.62
Item # 6-2002.00
Stations 334+00 to 340+00
Geotechnical Engineering Report
for Landslide Correction

PLAN VIEW
I-275 SLIDE 8

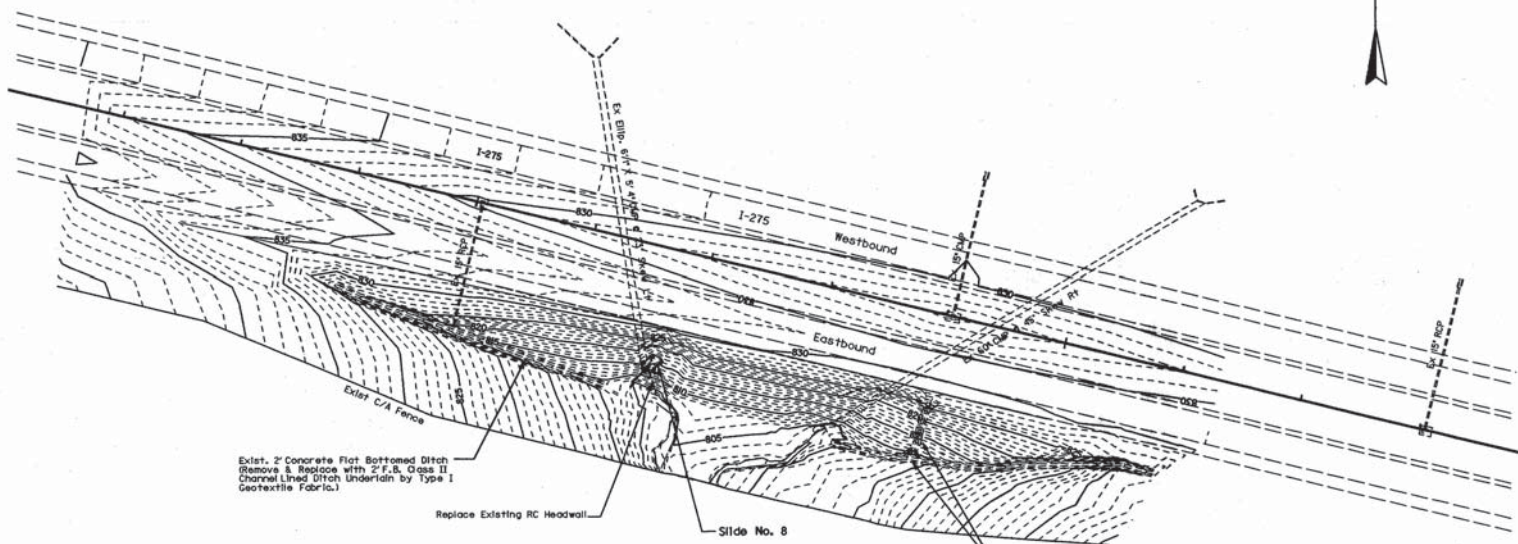
Slide No. 8

Exist. 2' Concrete Flat Bottomed Ditch (Remove & Replace with 2' F.B. Class II Channel Lined Ditch Underlain by Type I Geotextile Fabric.)

Replace Existing RC Headwall

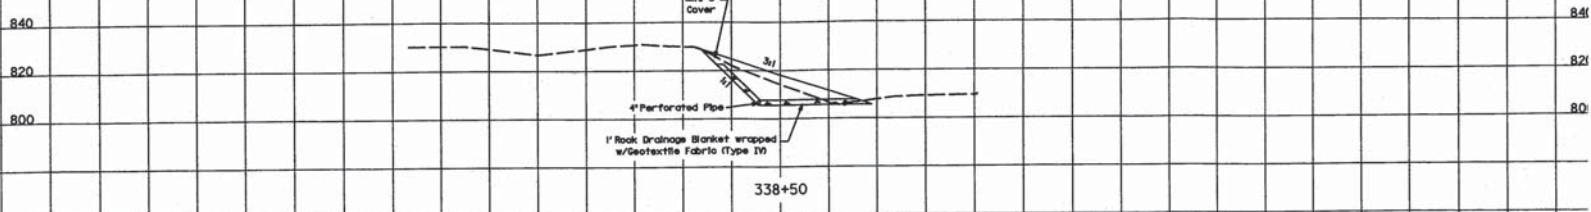
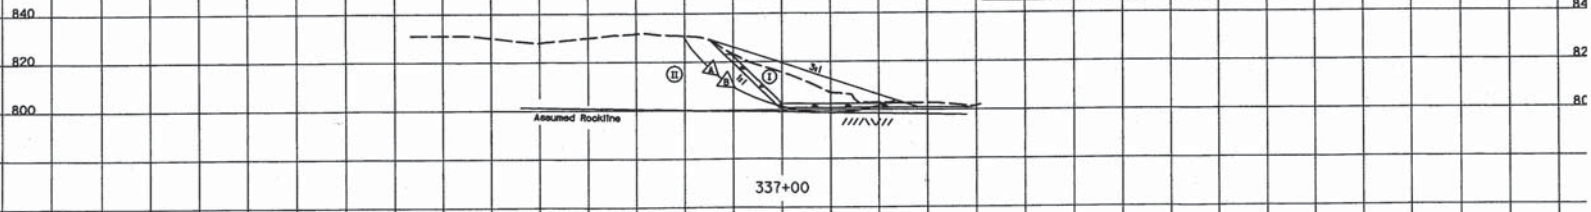
CROSS SECTION STA. 337+00 & 338+50
390

FACTORS OF SAFETY		
SHORT TERM	A	1.6
LONG TERM	B	1.6

ASSUMED SOIL STRENGTH PARAMETERS				
SOIL	I		II	
SHORT TERM	$\phi = 120$ pcf	$\phi = 125$ pcf	$c = 1500$ pcf	$\beta = 0'$
LONG TERM	$\phi = 120$ pcf	$\phi = 125$ pcf	$c = 130$ pcf	$\beta = 18'$
