**VERMONT AMERICAN COMPLEX
500 E. MAIN STREET
LOUISVILLE, KENTUCKY**

**STRUCTURAL ASSESSMENT
JULY 22, 2011**

PARSONS

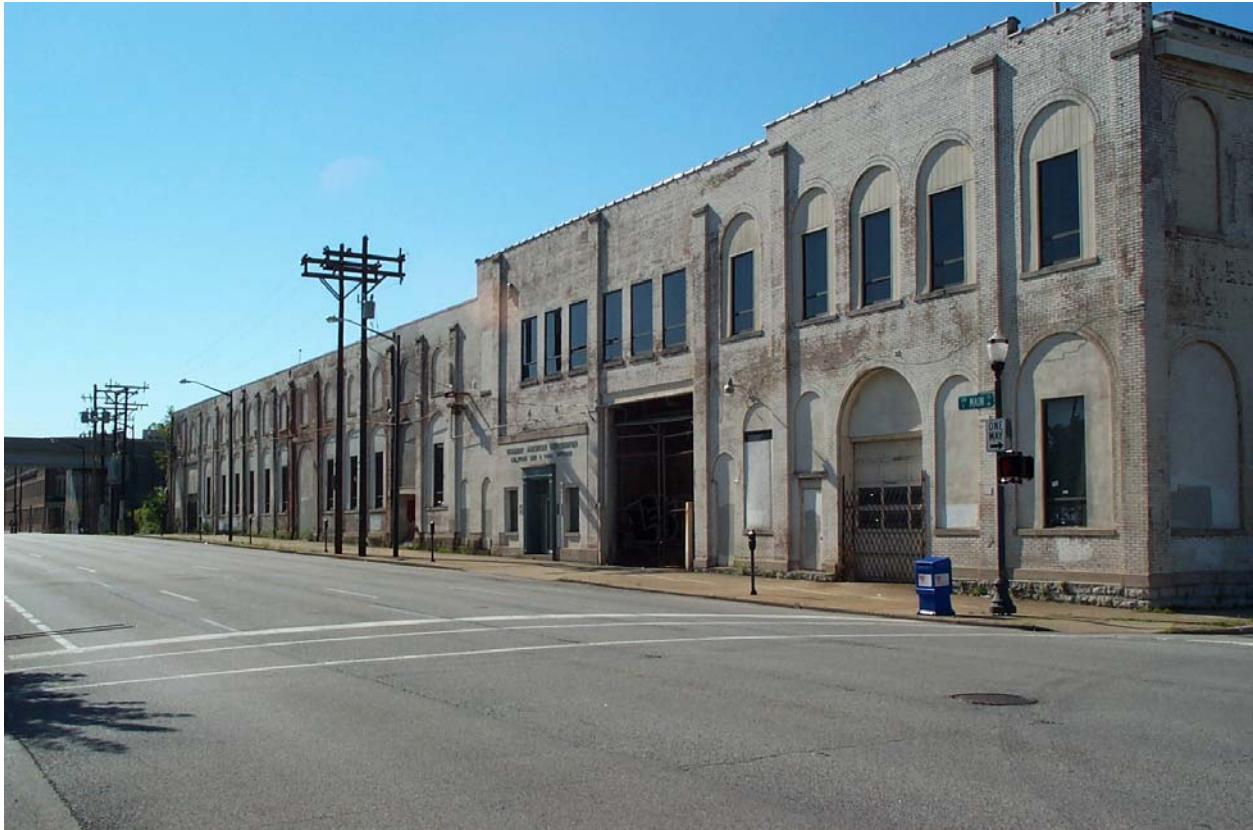
Photograph No. 1 – Left to right view of front of Buildings 6, 5, and 2 from the intersection of Main Street and Jackson Street. The existing highway bridge is shown in the background to the left.

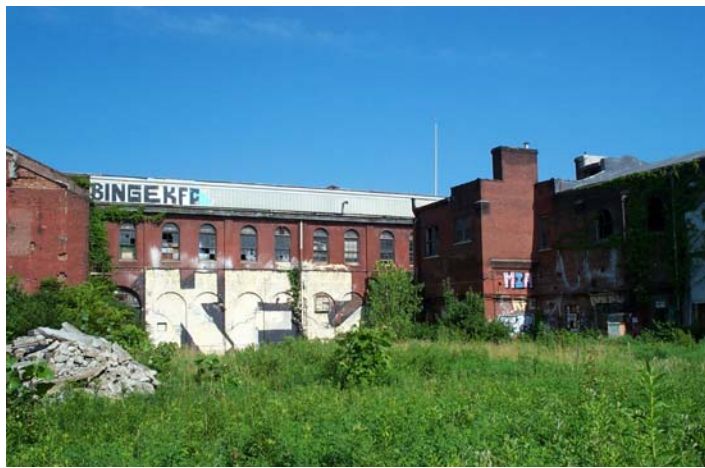
Photograph No. 2 - Left to right view of Buildings 3, 2, and 5 from the courtyard.

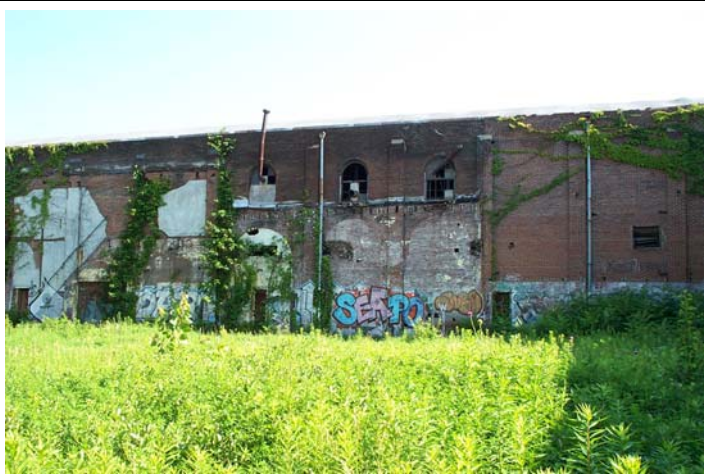
Photograph No. 3 - View of Building 6 from the courtyard.

Building 6 is a long building with an open floor space. It is a single story factory style building. The floor is concrete slab-on-grade. Some areas of the floor have been cut out exposing the subgrade. There are heavy corbelled pilasters on each side supporting two overhead cranes on the same track. The west end on this building contains a mezzanine that is framed with open web steel joists supported by steel girders. The floor of the mezzanine is concrete on metal deck. The mezzanine is heavily designed as is evidenced by a sign on the mezzanine indicating a capacity of 400 pounds per square foot. The roof is framed with steel trusses spanning the entire width of the building. Steel decking is supported on steel roof purlins which span between the trusses. This building appears to be in much better condition than any of the other buildings.

BUILDING 6: As stated earlier, of all of the buildings addressed by this study, Building 6 is in the best condition. It is our opinion that this building is sound enough to last for three more years. Since it is divided by the proposed right of way, at least a portion of it must be demolished in the construction phase of the project. The earlier study “Building Treatment Plan” indicates that the entire building is to be demolished and we suspect that this will be the case. Therefore, we recommend that no money be spent on this building at this time.

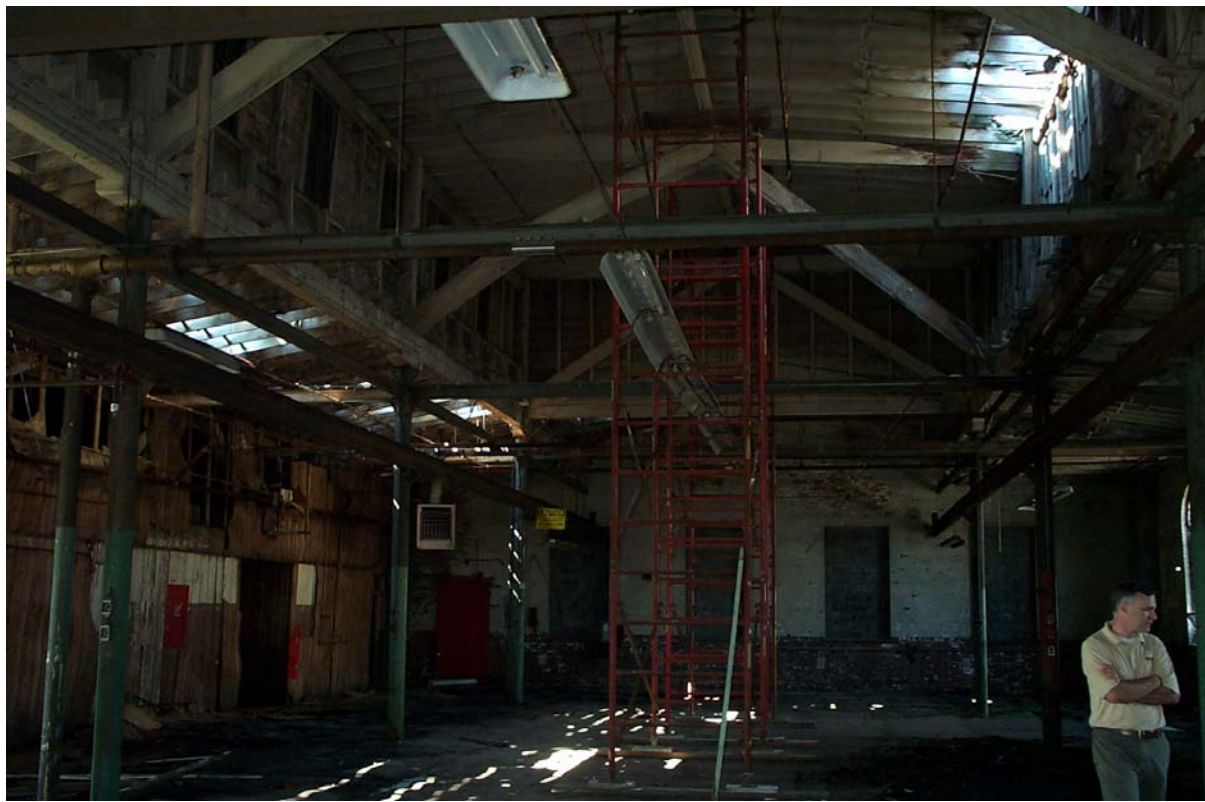
A very large portion of the second floor wood framing in both buildings 2 and 3 has rotted and is in advanced stages of decay. The steel framing at the second floor of Building 2 is rusted but does not appear to have any significant loss of cross section. The upper level of Building 2 is laid out similarly to the lower level with the same columns dividing the building into three transverse bays. There are interior walls in the northernmost bay which divide the space into offices. From there to the south and into Building 3, the space is open with a clerestory extending above the roof down the center of the building. There is a bridge crane running the length of the center bay in Building 2 and another one in Building 3. The roof of Buildings 2 and 3 are framed with wood. There are heavy timber trusses in Building 3 and somewhat lighter wooden trusses framing the clerestory in Building 2. One of the trusses in Building 2 has failed and is currently supported by metal scaffolding on the second floor wooden deck and framing.

Photograph No. 4 – Scaffolding on the second floor of Building 2 which shores up a failed roof truss. The typical framing for the roof of Building 2 can also be seen. Note the numerous holes in the roof of varying sizes and the sun spots on the floor.

BUILDING 2: Significant portions of the roof framing and deck of Building 2 must be removed since there are several members hanging loosely and close to falling. All loose framing members and decking must be removed and properly disposed of. Then temporary supports sufficient to shore up a temporary roof must be erected. This can be accomplished either by installing new wood framing or installing scaffolding either of which must be sized to support code required live loads. If scaffolding is used, it will be similar to that already installed in one area of the second floor to shore up an already failed truss as discussed earlier in this report. An extensive set of scaffolding would be required because nearly the entire roof of this building would have to be shored. In addition, scaffolding would be required on the first floor level to transfer the load from the second floor on down to ground level because it is very doubtful that the second floor framing can support the weight of the scaffolding and the roof loads that it would be supporting. Essentially, this building would be full of scaffolding. For this reason, we believe that the best

way to stabilize the roof is to go ahead and replace the roof framing with like or similar construction. Since this building is outside the proposed right of way and may be salvaged anyway, it makes sense to incorporate the current stabilization effort with the permanent framing of the new roof. This will save both time and money in the future. It is our opinion that once the roof is stabilized and that a temporary roof is placed on the building such that water can no longer penetrate the building envelope, the second floor, while certainly incapable of supporting heavy loads, should last the three years until the construction phase of the project. This idea is based upon the assumption that this space will continue to remain free of any loads. The second floor should be posted with a sign which states that storage of any items is absolutely not allowed. With the roof stabilized, the steel framing at the second floor and the brick masonry walls in this building are currently sufficient to last for the three year period until construction begins.

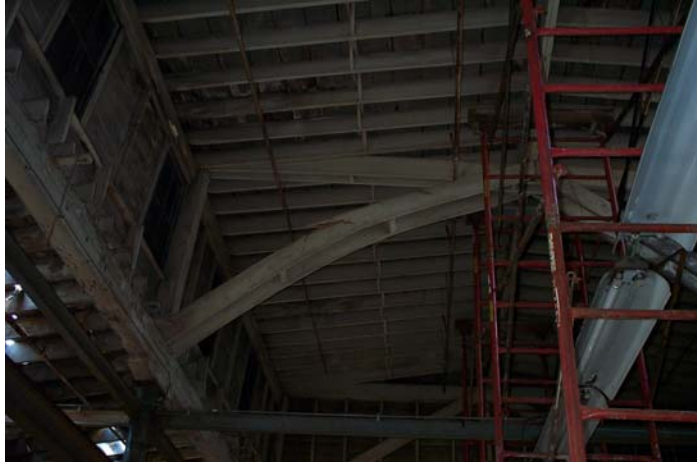
Photograph No. 5 - Failed roof truss in Building No. 2 clerestory.

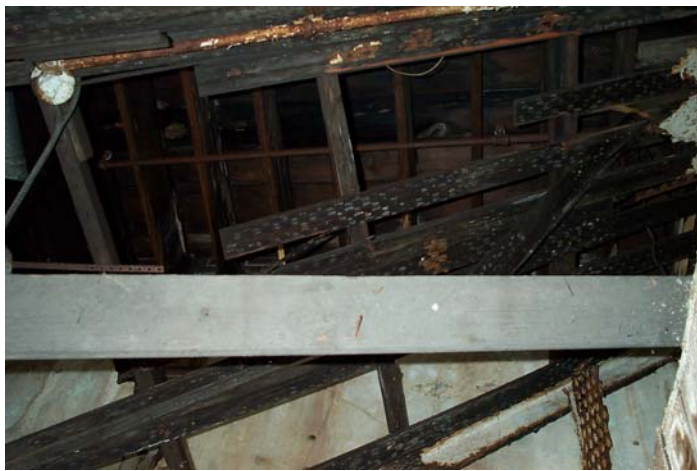
the floor below have deteriorated due to water entering the building through badly compromised roof framing and decking. There are large areas, in fact entire rooms, where the metal lath and plaster ceilings have collapsed. The second floor of Building 5 connects to Building 2 forming a drive through area at the lower level between the two buildings.

Photograph No. 6 - Failed metal lath and plaster ceiling in Building No. 5 exposing the deteriorated roof framing.

BUILDING 5: As is the case with Buildings 2 and 3, the wood framing at the roof level of this building needs to be removed and discarded. This is the case whether or not the building is salvaged for later use. The second floor ceilings have collapsed in a number of areas leaving metal lath and other material hanging from a roof structure that could collapse at any time. It is our opinion that the roof could be framed with wood in a manner similar to the existing with new

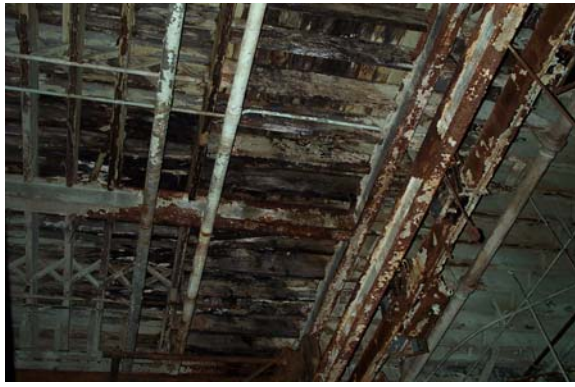
Photograph No. A-1: Decay of second floor wood framing supported by rusted steel in Building No. 2.

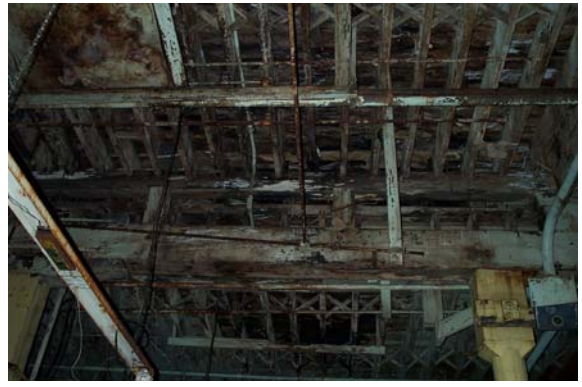
Photograph No. A-2: Decay of second floor wood framing on heavy timber supports in Building 3

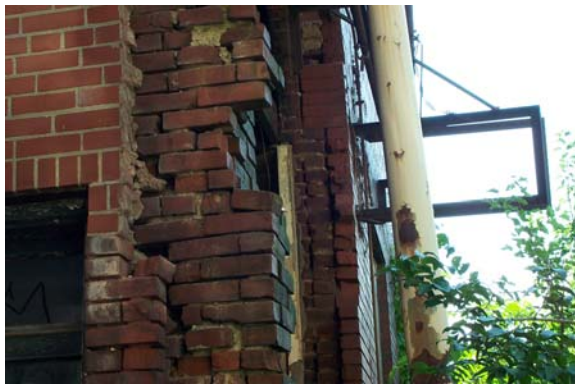
For the most part, the brick masonry walls are in fair condition given their age and lack of maintenance. The mortar has significantly eroded in areas subject to water such as under window sills. Most of the rain leaders are missing so the gutters release water at the pilaster locations and they also show significant erosion of the mortar. In order to salvage the walls and re-use them, the mortar joints will have to be raked to remove loose mortar and then re-pointed to repair them. That will be an expensive operation as well as very time consuming.

Photograph No. A-3: Severe erosion of mortar joints at corner of Building 5.

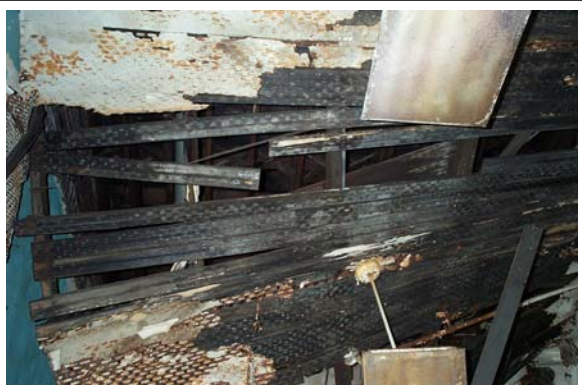
Photograph No. A-4: Ceiling collapse in Building 5

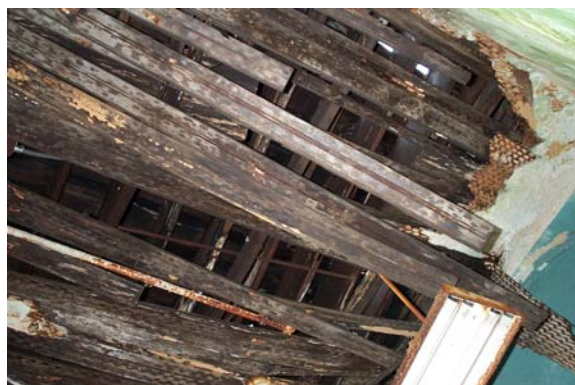
Photograph No. A-5: Ceiling collapse in Building 5.

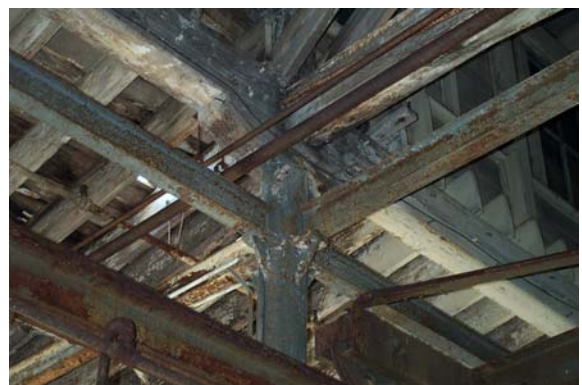
Photograph No. A-6: Deteriorated wood roof at junction of main roof and clerestory in Building 2. Rusted steel support framing.

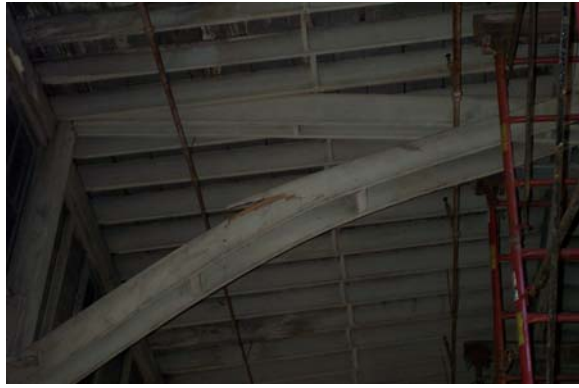
Photograph No. A-7: Failed truss in clerestory of Building No. 2

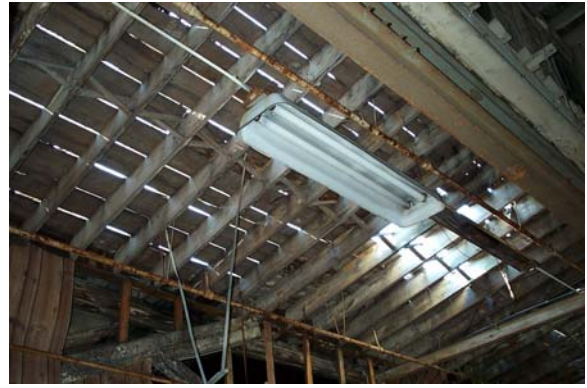
Photograph No. A-8: Daylight through the roof of Building 2.

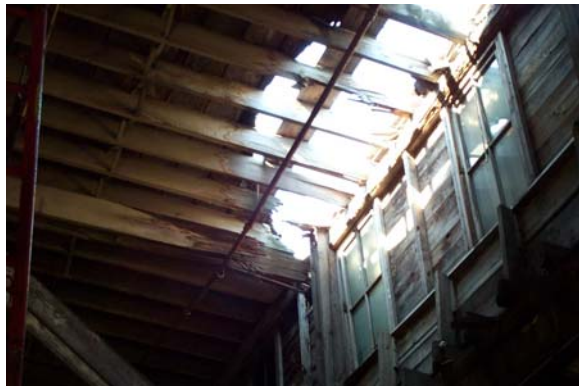
Photograph No. A-9: Daylight through roof of Building 2.

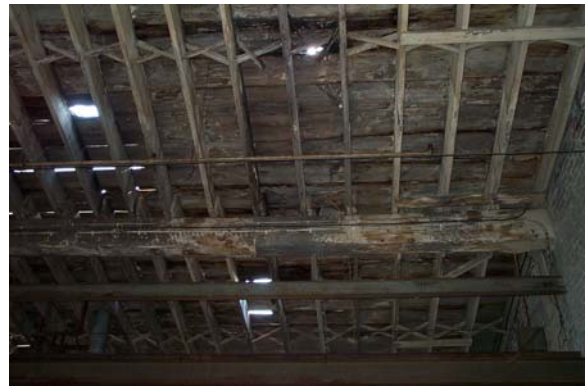
Photograph No. A-10: Deterioration of roof at Building 3.

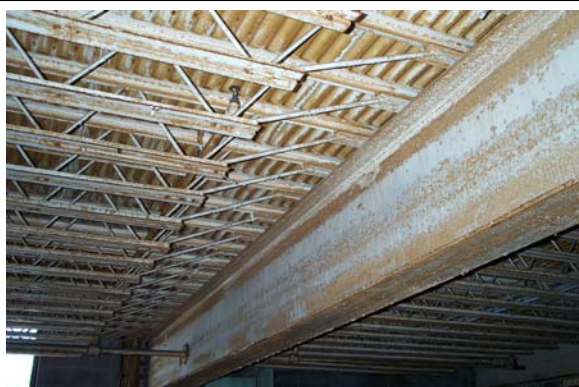
Photograph No. A-11: Mezzanine framing in Building 6 showing that it is relatively good condition.

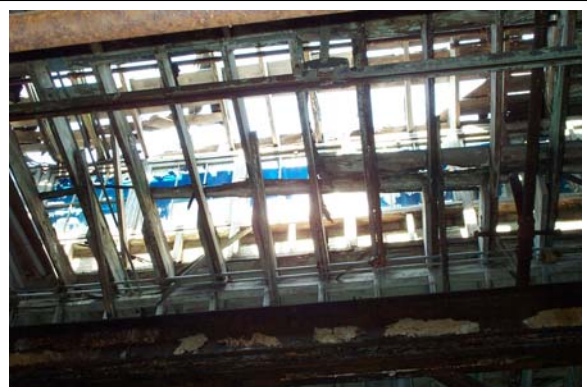
supported on steel girders. The wooden roof deck and the wooden joists framing in the main field of the roof are deteriorated similar to, but not as bad as, Building 2. Even so, the deterioration is in a very advanced state. There is a clerestory running the length of this building which is also framed with wood. The roof of the clerestory is in very bad condition and allows large amounts of rain water to pour through the roof. The clerestory framing is rotten and decayed.

Photograph No. A-12: Deterioration of clerestory in Building 12.

The clerestory on Building 12 should be removed and replaced with temporary framing and temporary roofing at the level of the main roof with the framing being supported by the existing structural steel. There is no need to replace the clerestory since this building will be demolished during the construction phase of this project.
