Site Investigative Report

GEOPHYSICAL SURVEY RESULTS AND FIGURES

Sympson Lake Dam Evaluation

For the Kentucky Transportation Cabinet (KYTC)

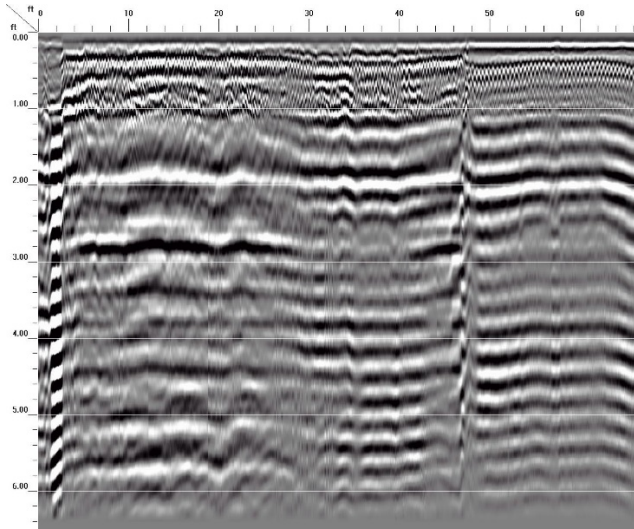
Image 3: Example GPR profile from weir (GPR File 17).

The GPR depth of usable data is defined by the signal to noise, or basically the point where the signal is too noisy to see meaningful reflections of energy. In most areas of the weir and spillway, the GPR's usable signal was limited to 2 to 3 feet below the surface. The joints/seams in the concrete did appear to be very prominent in most cases within the data, suggesting moisture in the joints. Often an increase in the GPR signal amplitude was observed near the concrete joints, most likely indicating wet/moist soils in these areas. This is also evident by water seeping from the joints at several locations along the spillway. The anomalies observed did not seem to be widespread or continuous across the weir or across the spillway, nor very large. The approximate width of the anomalies is represented by the shaded areas on Figure 6. The thickness/depth of the GPR anomalies is difficult to estimate and is not reliable because the signal can reverberate (echo essentially) within the anomalous zone giving a false indication of thickness. The anomalies observed in the GPR data did not appear overly large or widespread to the point that they would be anticipated to impact the structural integrity of the floor of the weir/spillway in the areas surveyed. The GPR signal observed in the spillway did not exhibit characteristics typical of sub-slab voids seen in other similar situations, where large

voids in the magnitude of a foot thick or more were present. However, signal response can vary between sites. Again, as previously noted, very large or extremely high amplitude anomalies were not observed across the weir and along the spillway. Example GPR profiles from the weir and spillway surveys are shown in Images 3 and 4, below. All GPR data files in a graphic format (.jpg) are included with this report as Appendix A. Processed files were displayed and saved prior to interpretation, with each antenna frequency stacked in each image. The 800 MHz on top and 300 MHz data on the bottom split screen. Images below are shown as merged data from the two frequencies into a single depth section plot.

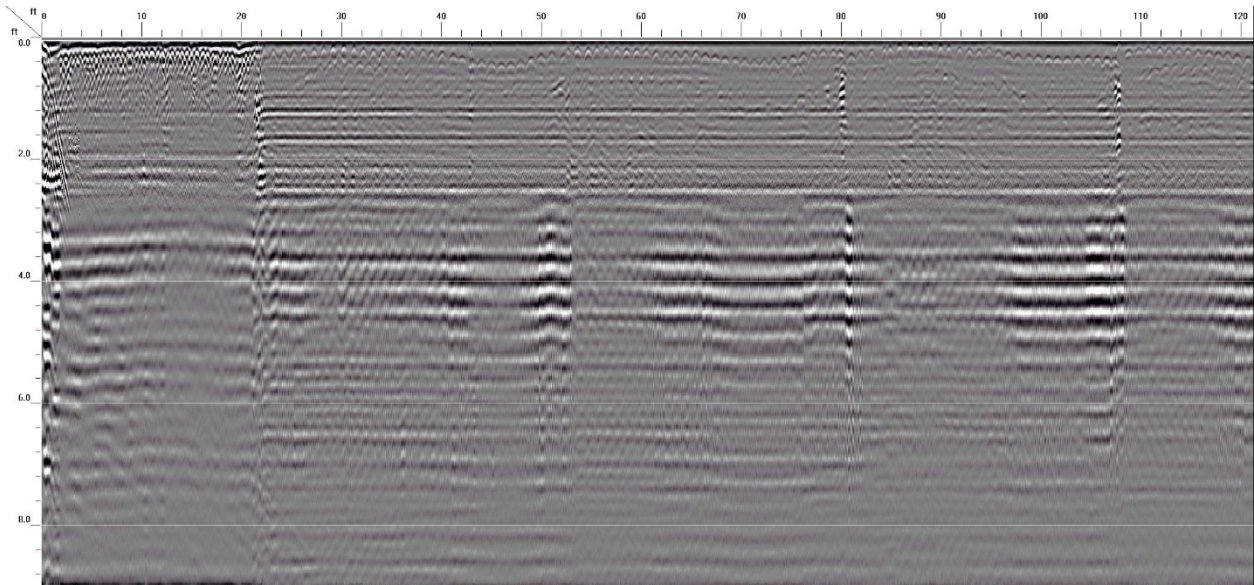
Image 4: Example GPR profile from spillway (GPR File 9).

As for the GPR surveys within the weir and spillway, the joints/seams in the concrete appeared very prominent in most cases within the data, suggesting moisture in the joints. This is also evident by water seeping from the joints in several locations along the spillway. The anomalies observed did not seem to be widespread or continuous across the weir or across the spillway, or to be very large. Obvious conduits or channels were not identified within the GPR data.

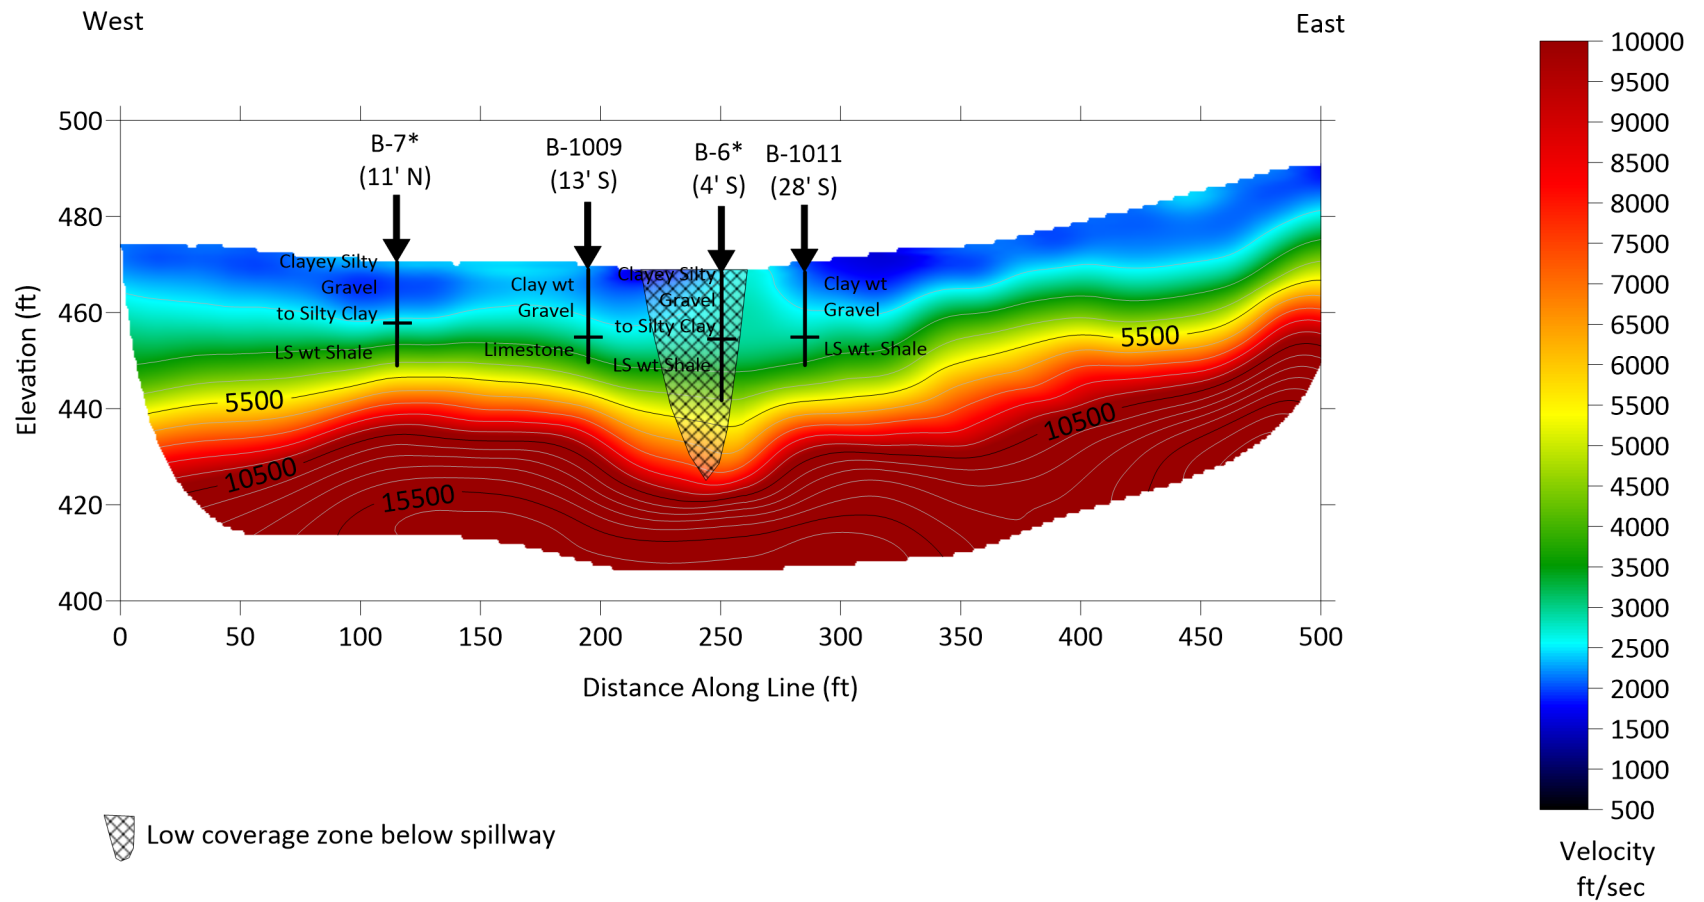
Line 1 was near the toe of the dam and has a length of approximately 520 feet. This line is the shortest of the collected lines due to limited open space with adjacent wooded areas. Line 1 is nearly centered on the concrete spillway apron/bottom pool. Although 520 feet of geophones were deployed for Line 1, the total depth of the line was approximately 60 feet. We feel the shorter than anticipated profile depth is due, in part, to the relatively consistent and higher velocity interpreted rock surface being the shallowest along this line. Velocities of 4,500 feet per second (fps) to 6,500 fps that are consistent with typical top of limestone bedrock were observed at approximately 22–30 feet below the surface near the spillway and 18–24 feet below ground surface near the eastern flank. Borings 1009 and 1011 were located on the west and east sides of the spillway and 13 to 28 feet south of the seismic line (based on provided

coordinates). These borings encountered limestone and started coring at a depth of approximately 14.5 feet. The corresponding velocities near these locations are lower than expected for limestone and could be related to a dipping rock surface (i.e., change in elevation along the rock surface), shallowing of the rock south of the seismic line location, or the amount of fracturing/weathering of the limestone and/or shale layers within the rock as a volume is decreasing the overall velocities of the rock, see Figure 2. Historic borings from a 1976 Dames and Moore investigation report were also added for comparison. These borings were performed prior to the overflow structure being added to the dam. B-6 was located in present day footprint of the overflow structure and approximately 4' south of Line 1, and B-7 was located west of the overflow and approximately 11' north of the line. Both borings show a similar depth to limestone as observed in the recent borings 1009 and 1011, and no anomalous zones or areas of significantly different materials noted above rock.

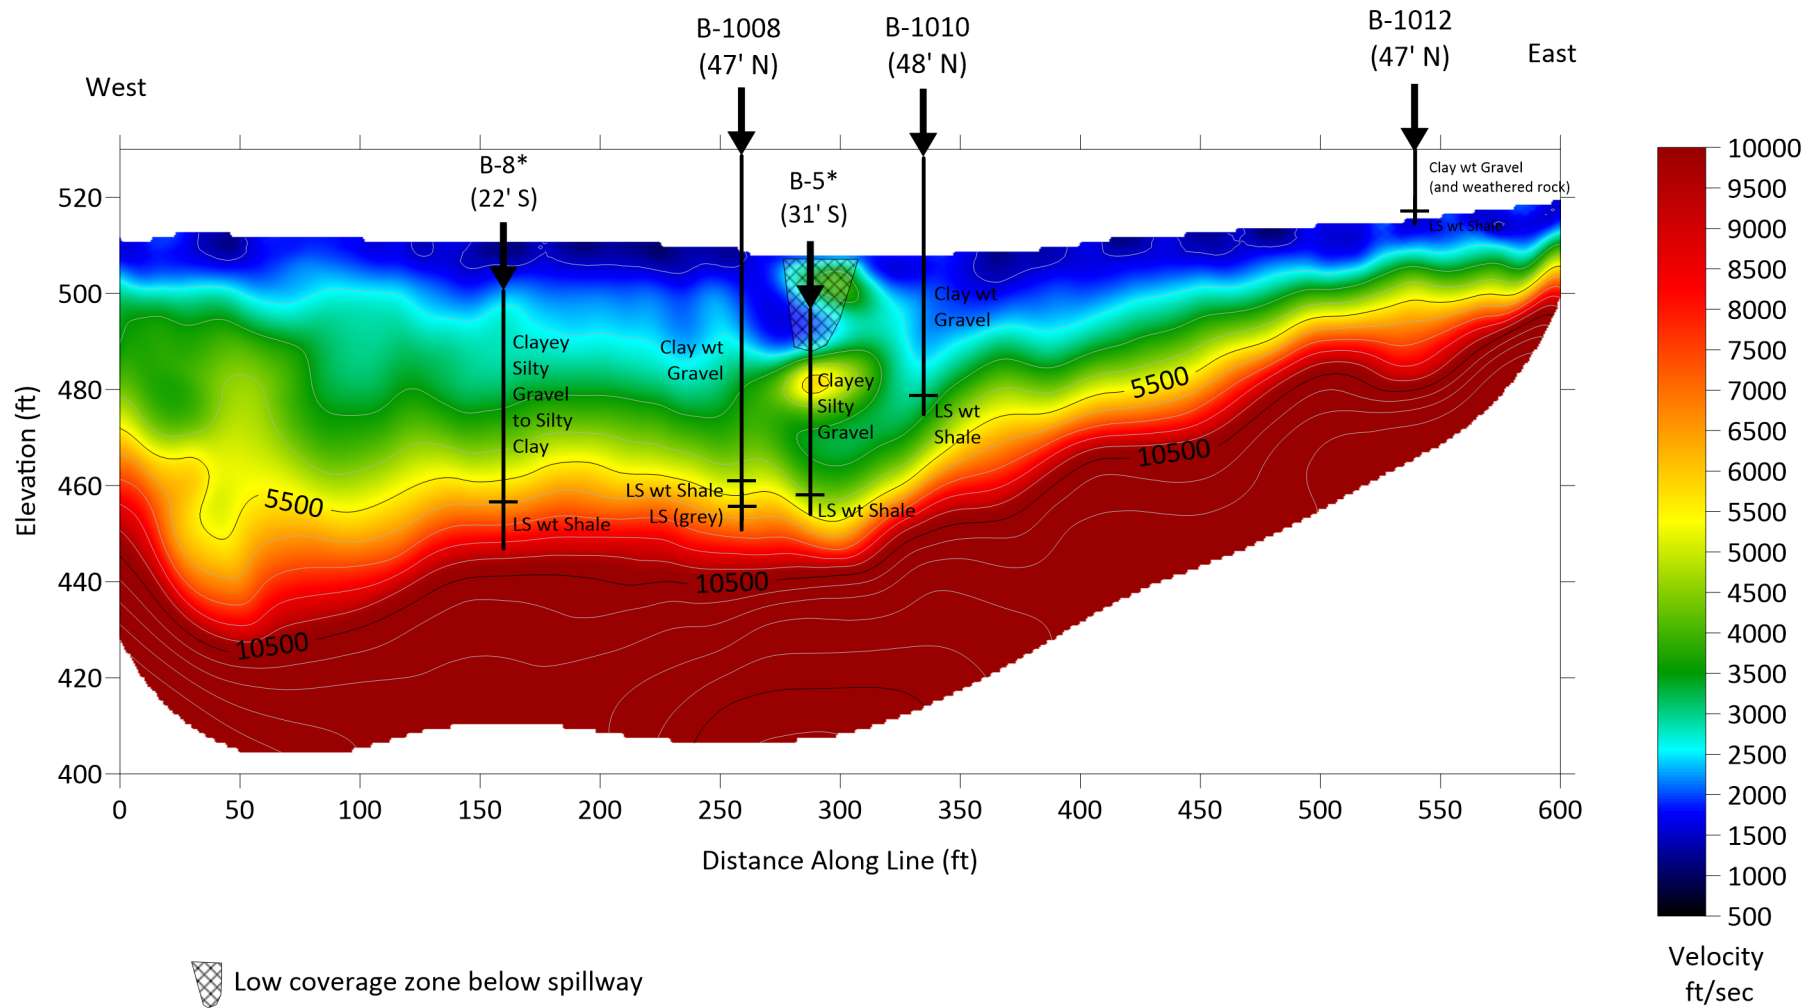
Line 2 was collected upslope from the dam toe and Line 1, see Figures 1 and 3. Line 2 was approximately 600 feet long and centered on the spillway. The depth achieved across this line was approximately 90 feet and it also exhibited a consistent and strong rock-like interface. Using similar velocities as mentioned above, the depth to interpreted rock is approximately 45-55 feet near the spillway and shallowest to the east at about 12–20 feet below the ground surface. Two anomalies were observed within the velocity zone above the rock surface, one under the spillway and a second apparent thicker zone, in the velocity range of 3,500–4,500 fps, a distance along the line of approximately 300-325 feet. This second anomaly was east of the spillway and included a lower than expected velocity that may be an indication of the presences of a wet or saturated zone or possibly the grout from former sinkhole repairs discussed in historic report reviews. The anomaly under the spillway had a higher velocity zone while the second anomaly east of the spillway exhibited a slightly lower velocity zone near the expected top of rock. Although the closest borings to this line were over 45 feet to the north along the roadway, the simplified logs for Boring 1008, 1010, and 1012 are shown on the seismic data plot, Figure 3. Borings 1008 and 1010 are located adjacent, west and east, of the spillway and limestone with shale was found at 68 and 50 feet, respectively. This 18 feet of elevation change in the rock surface occurred over a distance of approximately 100 feet and does generally follow a similar trend in the velocity zone mentioned above. However, when projected onto the data, Boring 1012 shows the limestone to fall above the ground surface at the seismic line location. This is expected to be due to a steeply dipping rock surface near the edges of the dam abutments. The steeply dipping rock surface near this abutment is anticipated to be trending more NW-SE based on the existing topography, and therefore, the near surface rock seen in Boring 1012 would better project to near the end of Line 2 or even just off-end of the line. Again, similar to Line 1, the 1976 Dames and Moore boring data were included in the interpretation. B-5 and B-8 were added to Figure 3 and locations shown on Figure 1. A similar trend in depth to top of the limestone was observed in these historic borings and the current ones. One noteworthy observation is that, based on the 1976 report best fitting of the boring layout figure to the current project's GIS map, B-5 appears to be located within the current day position of the spillway and one of the anomalous areas mentioned above. Nothing on the log for B-5 indicates a change in the dam fill materials. Further, the existing intake structure's pipe/duct system that would be crossing in this area is anticipated to be lower in elevation than the higher velocity

anomalies observed. Note, this boring is also more than a 30+ foot offset (South) of both Line 2 and the anomalies, but falls within the footprint of the spillway.

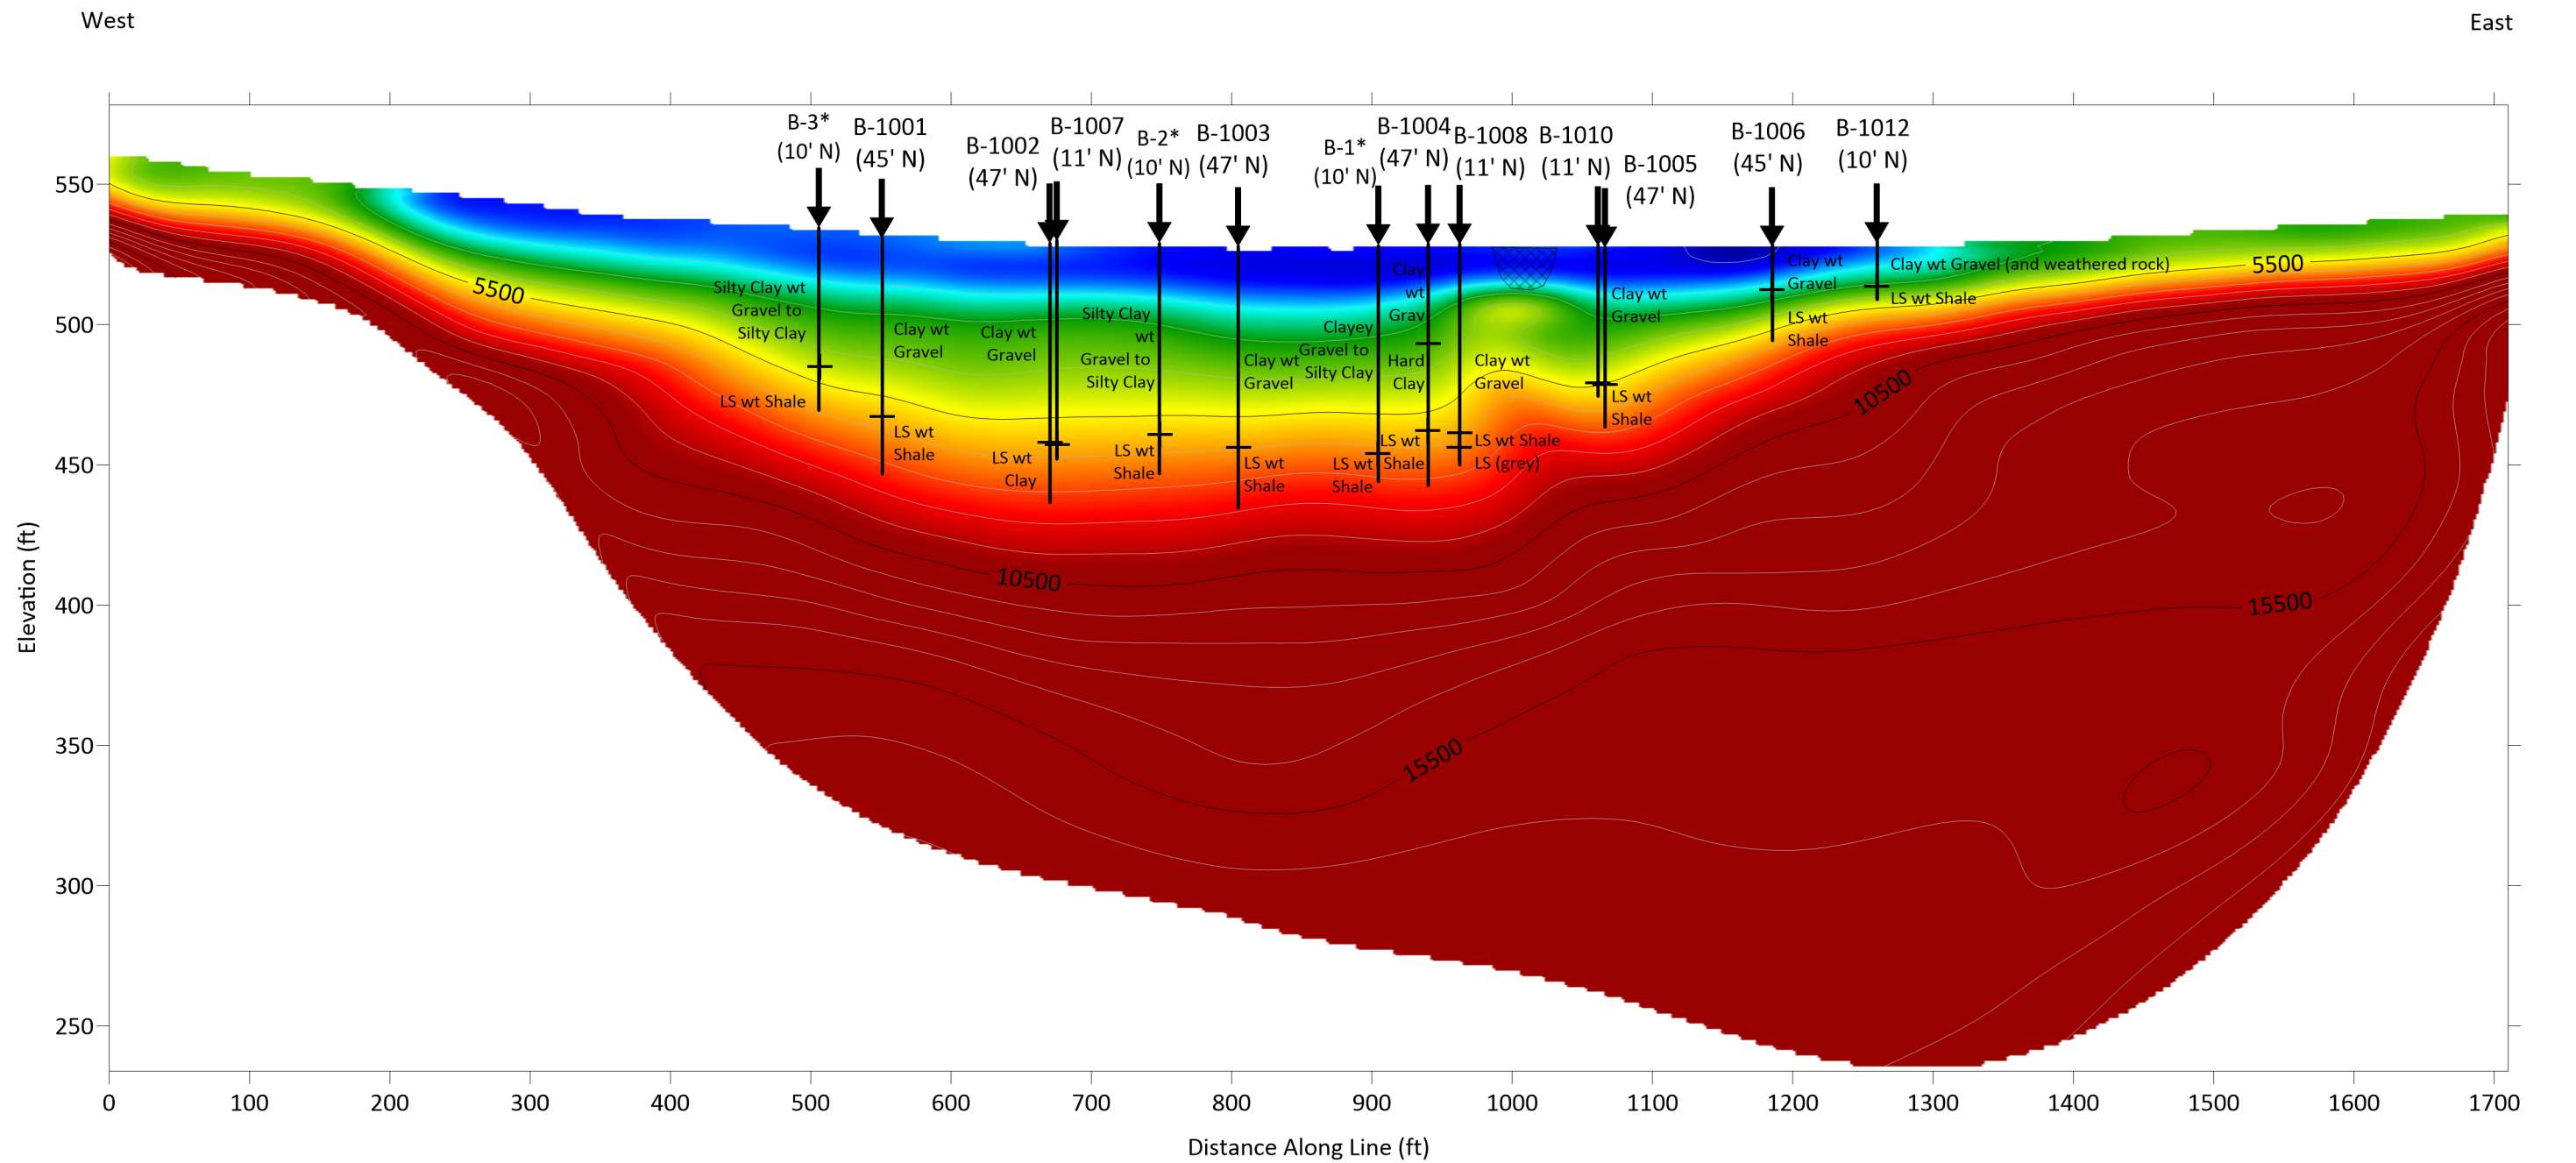
Line 3 was collected over a total distance of approximately 1,710 linear feet (geophone sensor length). Velocities consistent with typical top of rock were observed at approximately 50–70 feet below the surface near the spillway and shallowing to just below the surface on both the east and west flanks. Line 3 was collected just off the road shoulder so the geophone and shots were in soils for better coupling. Figure 4 is the processed refraction tomogram. The entire line was deployed and “live” during recording. As a result, the over 1,700-foot line produced data down to over 200 feet below the road surface. Again, simplified boring logs were overlaid on the seismic data and were used to help refine the interpreted top of rock. The boring logs near the center of the dam and near the spillway show top of rock falling within a smaller velocity range of approximately 5,500–6,000 fps. Two borings (1006 and 1012) that are near the dam’s eastern flank show shallower than expected rock surface based on mapped velocities. However, this could again be related to steeply dipping rock that is trending more NW-SE to the line and would project the shallower depths closer to the eastern end of the line.

Low coverage zone below spillway
