# 056B00214L Special Inspection 2024-10-10

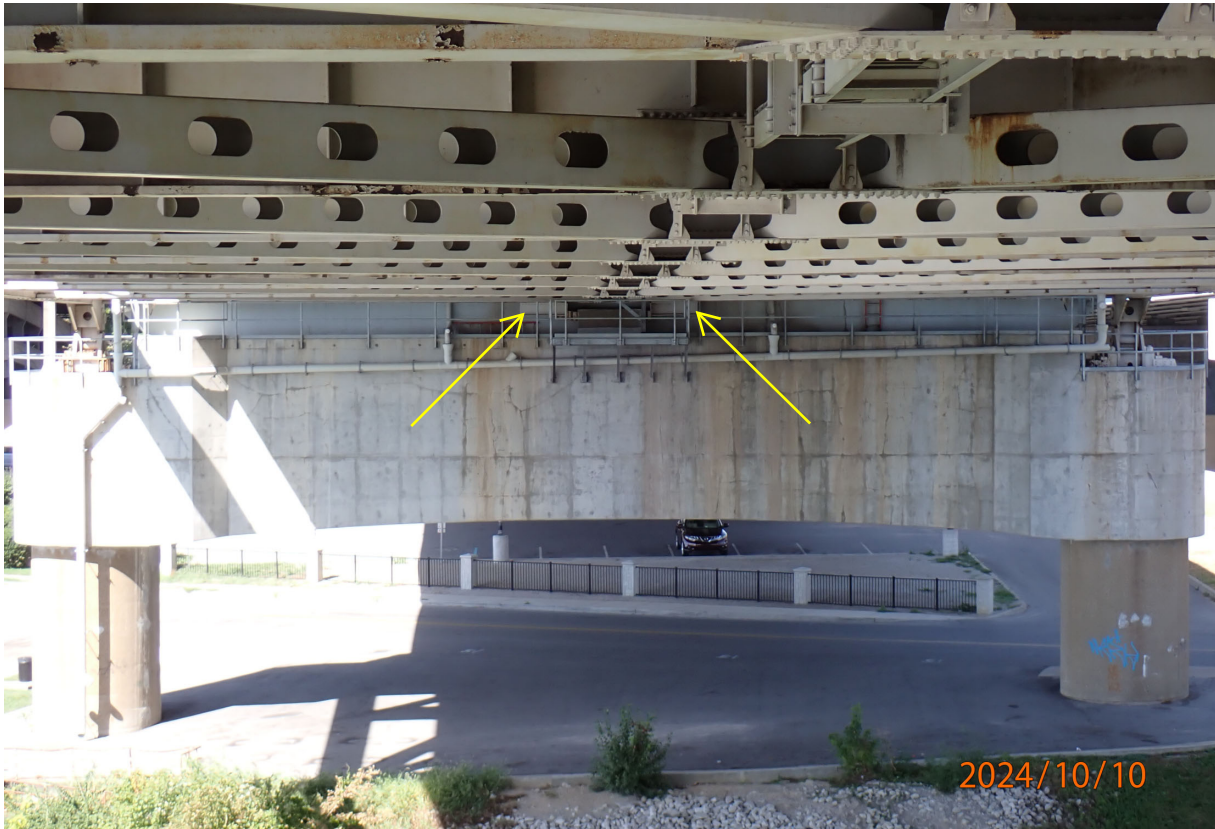
South face of Pier 6 showing location of wind shear beams

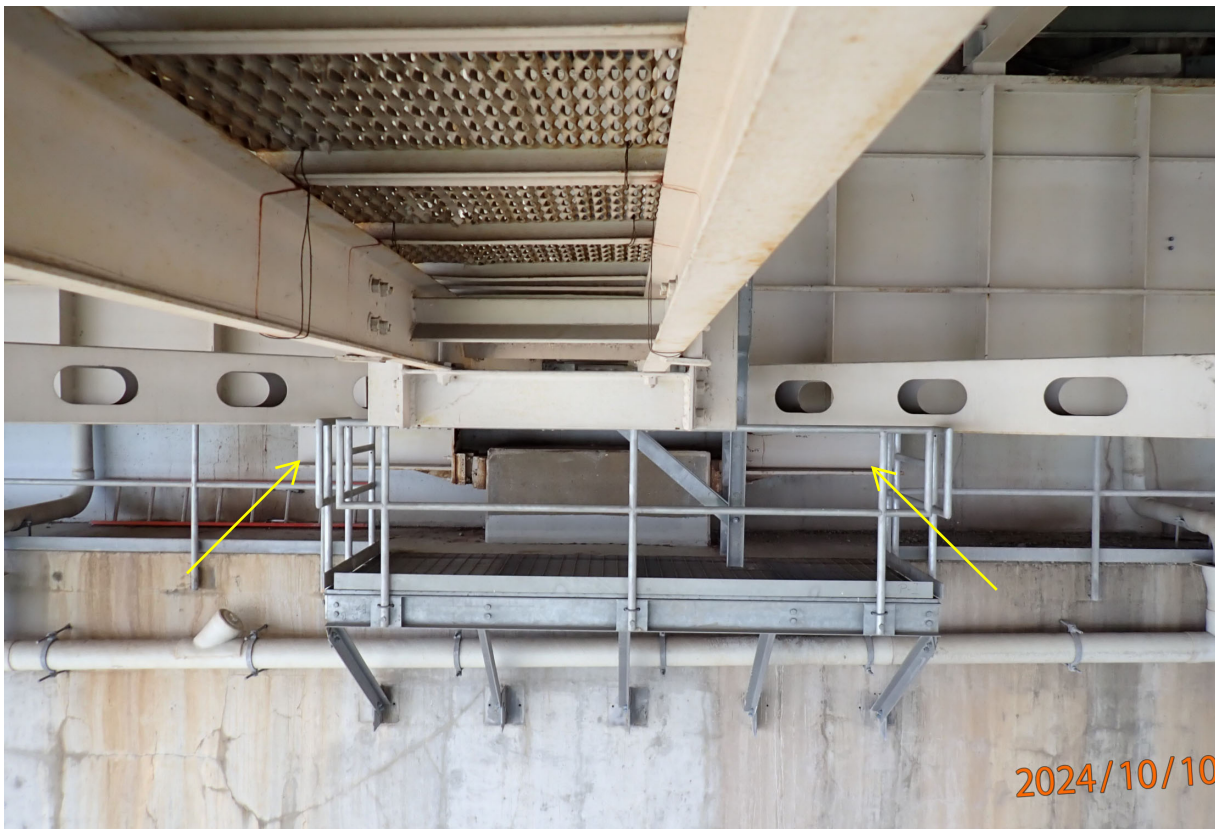
Closer view of previous photo

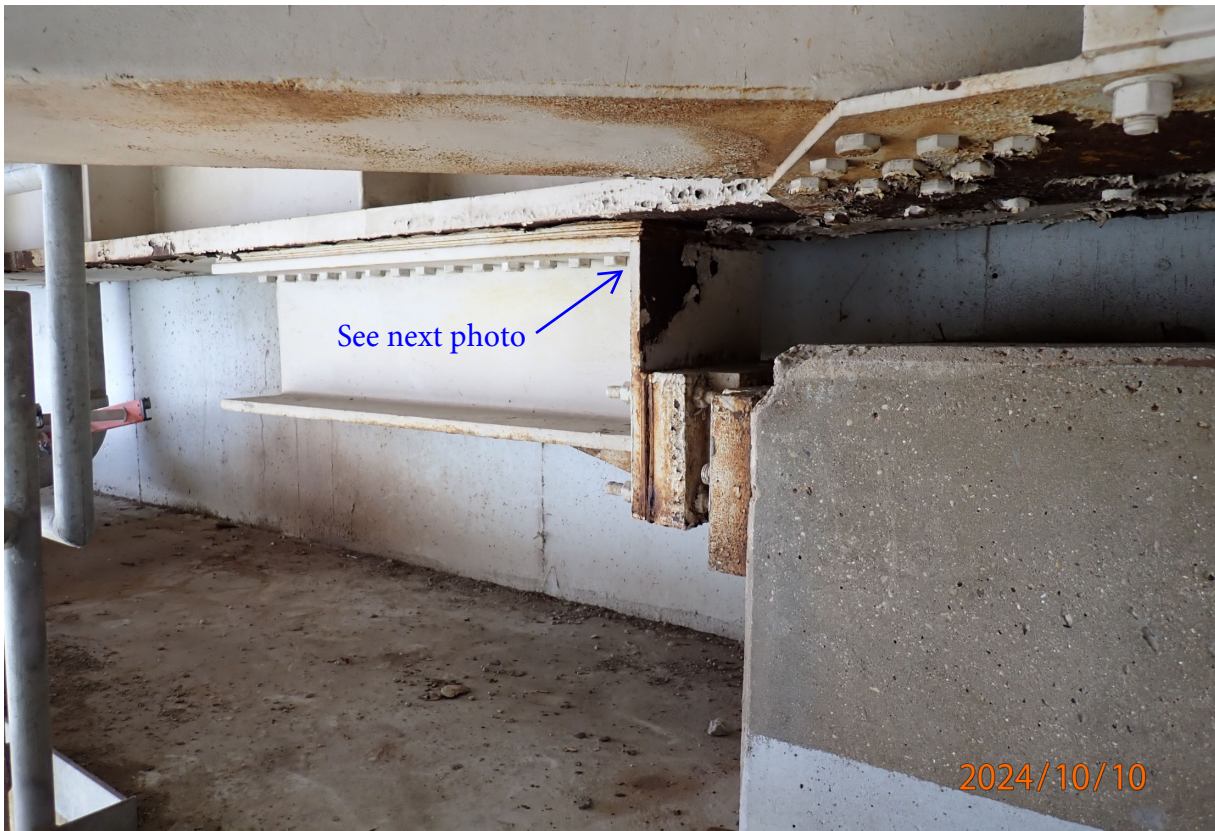
West wind shear beam at Floorbeam 0', Pier 6 (south face)  
Note bolted plate assembly between wind shear beam and wind anchor concrete is relatively plumb.

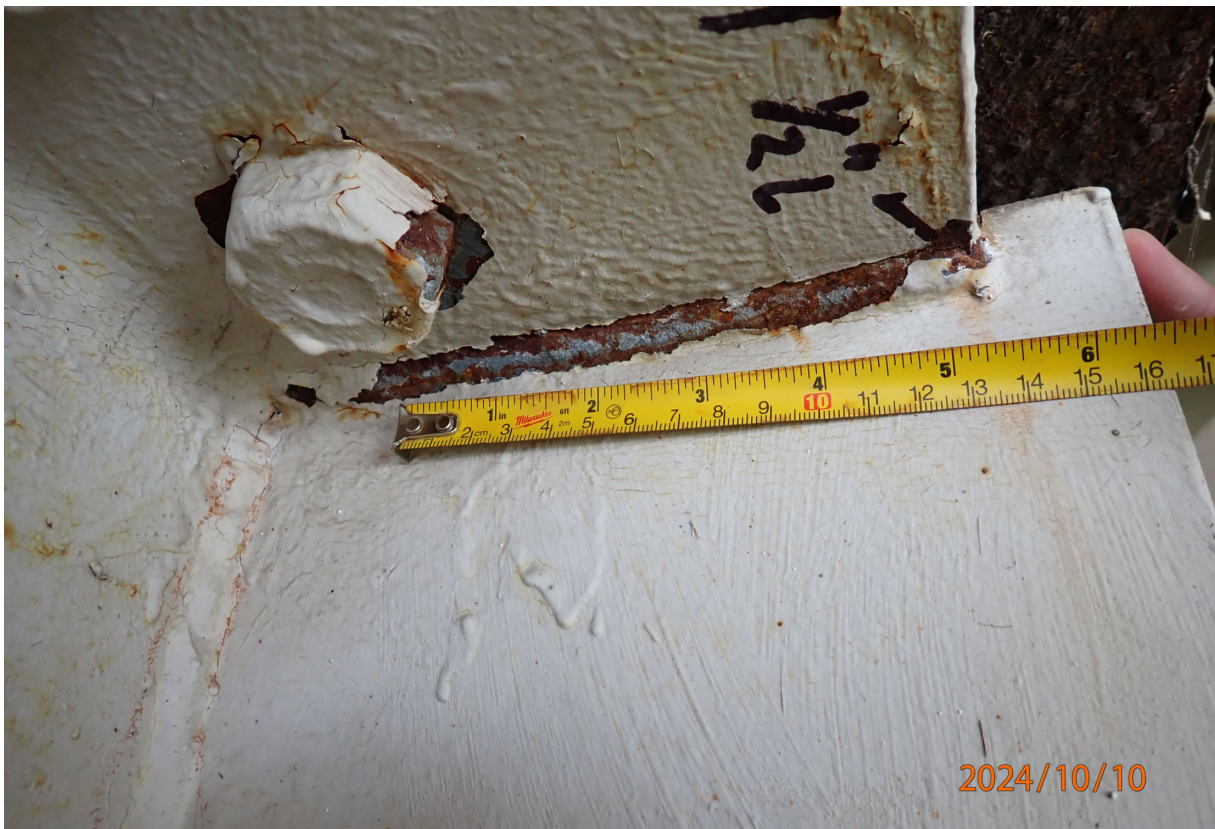
In the west wind shear beam, the top flange to end plate weld has a 1/2" long crack at the south termination (no change).

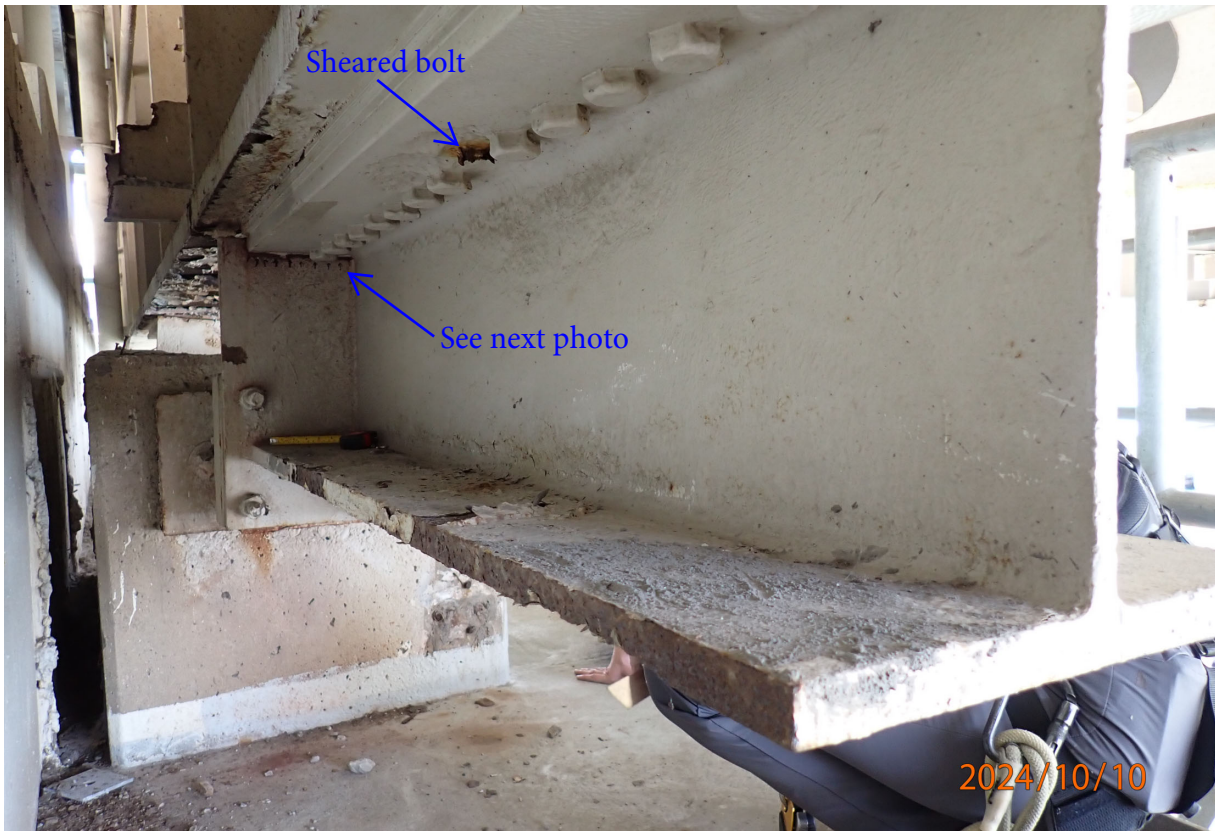
West wind shear beam at Floorbeam 0', Pier 6 (north face)  
Note sheared bolt in floorbeam bottom flange to wind shear beam top flange connection.

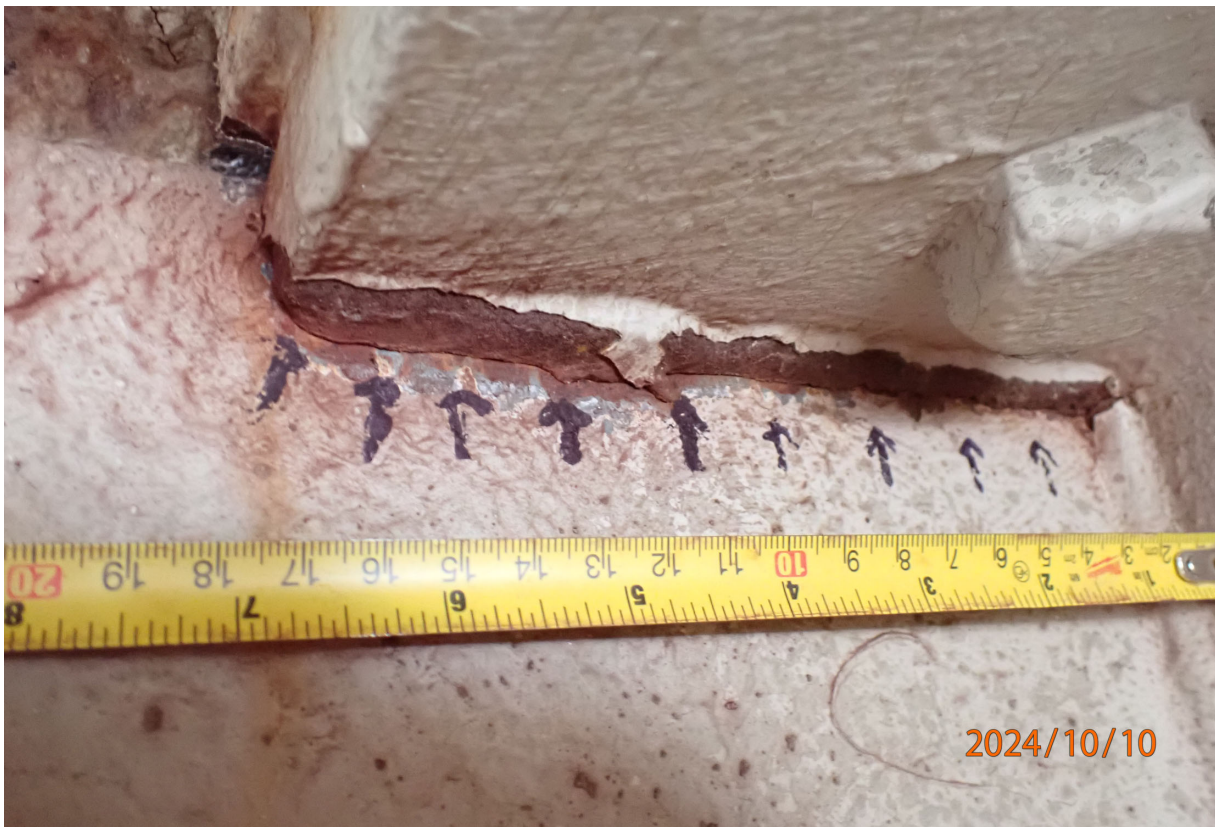
In the west wind shear beam, the north top flange to end plate weld is fully cracked.

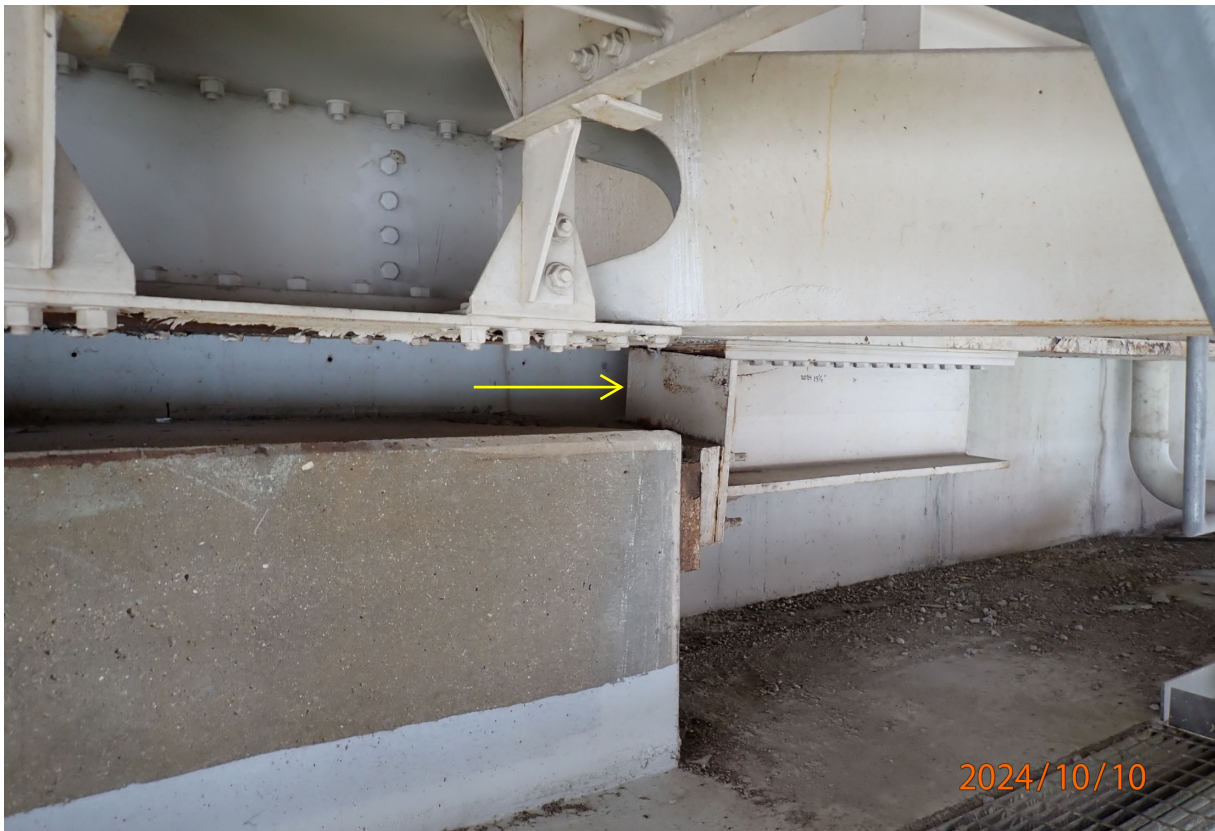
East wind shear beam at Floorbeam 0', Pier 6 (south face)  
Note bolted plate assembly between wind shear beam and wind anchor concrete is rotated relative to the wind shear beam (see following photo).

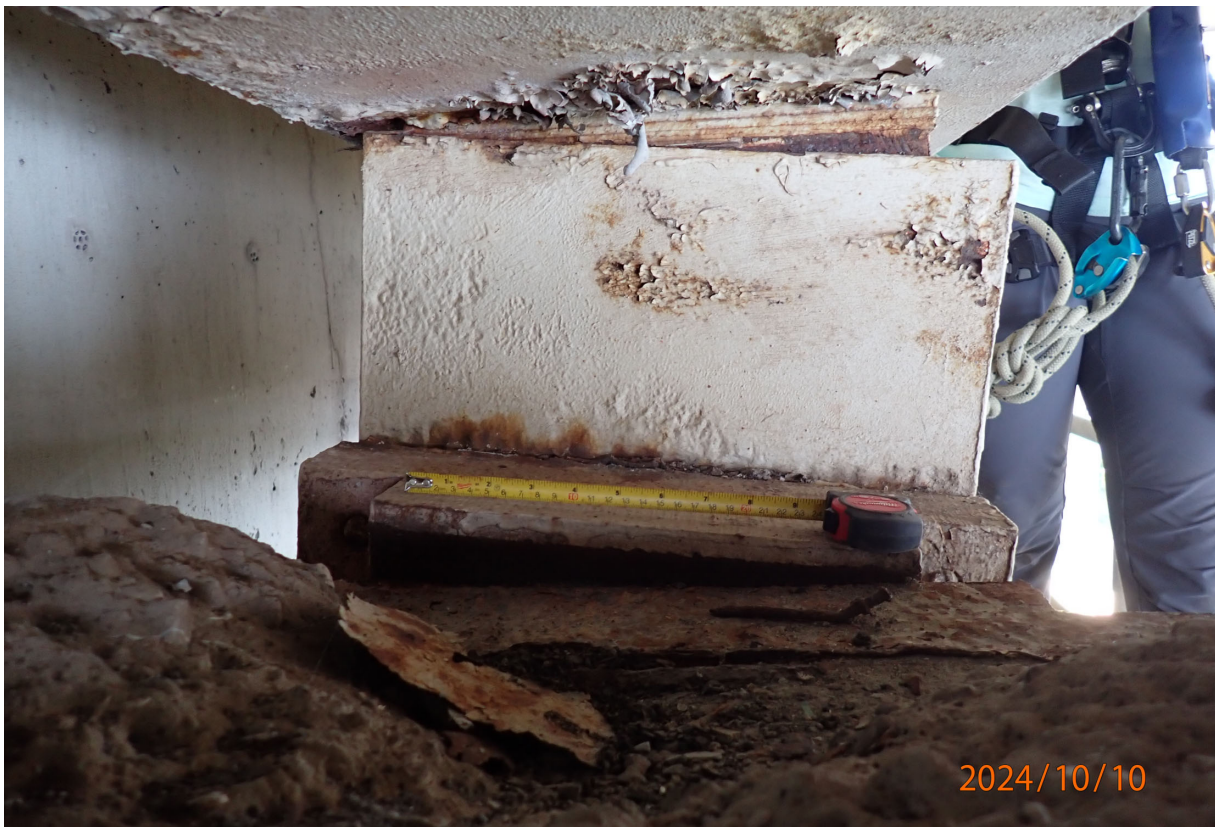
At the west end of the east wind shear beam, the bolted plate assembly is rotated relative to the beam.

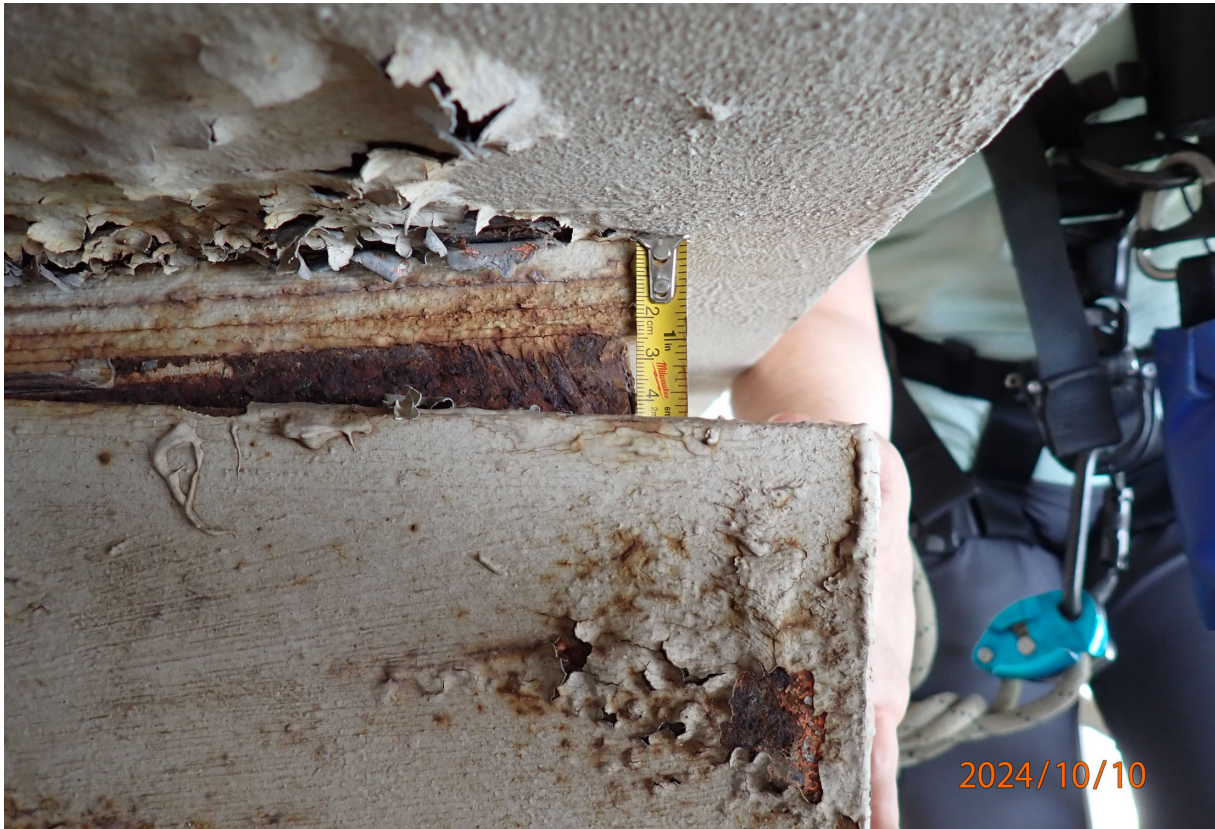
At the west end of the east wind shear beam, the bolted plate assembly is rotated relative to the beam (close up at south side of plate).

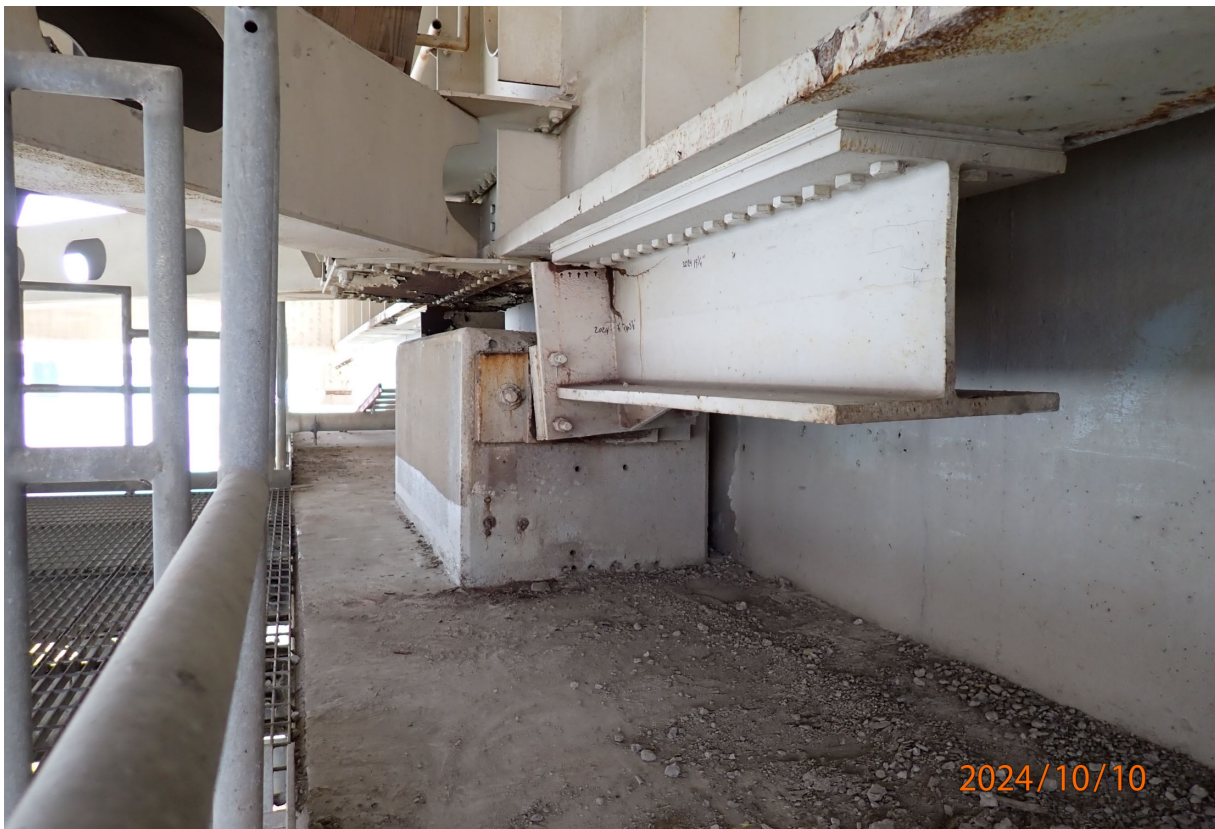
East wind shear beam at Floorbeam 0', Pier 6 (south face, looking west)

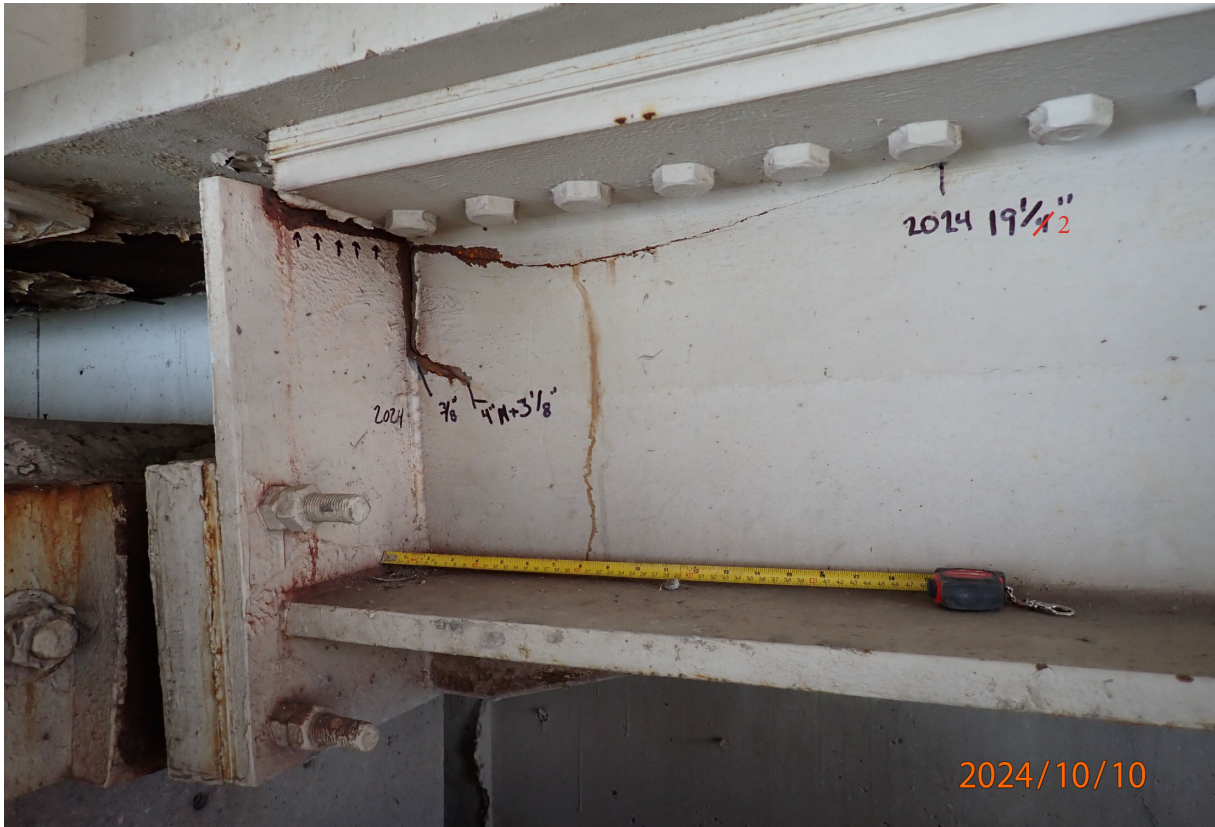
The east wind shear beam has a sheared connection bolt on the north side of the beam (see next page) and a full width crack initiating at the top flange to end plate weld which has propagated 19-1/2" along the web. A smaller crack has also propagated down the web to end plate weld.

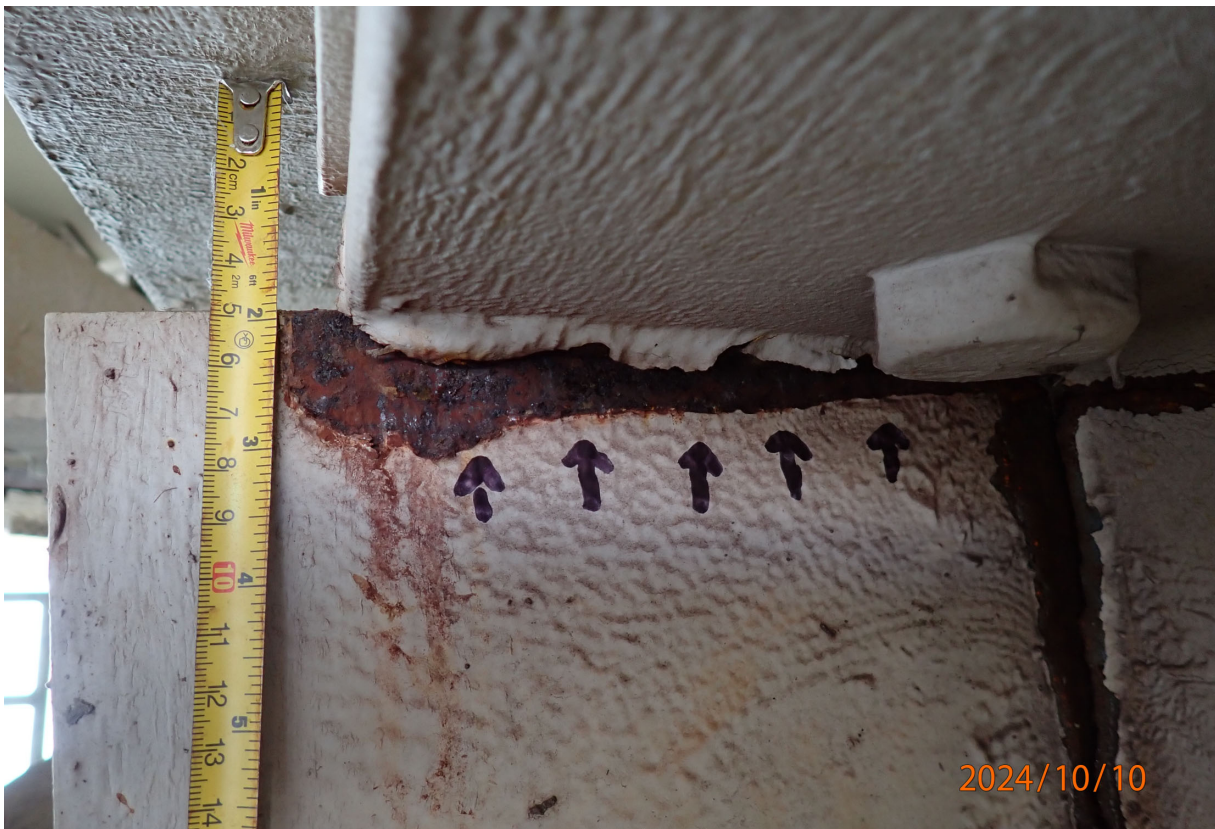
Close up of top flange to end plate weld at south termination - note end plate has rotated
