## **MEMORANDUM**

**SUBJECT:** **Mercer-Garrard County  
KY 152 (Kennedy Bridge Road) over Herrington Lake  
Item # 7-1116.00  
Preliminary Geotechnical Assessment**

P-001-2011  
Mercer-Garrard County  
KY 152 over Lake Herrington

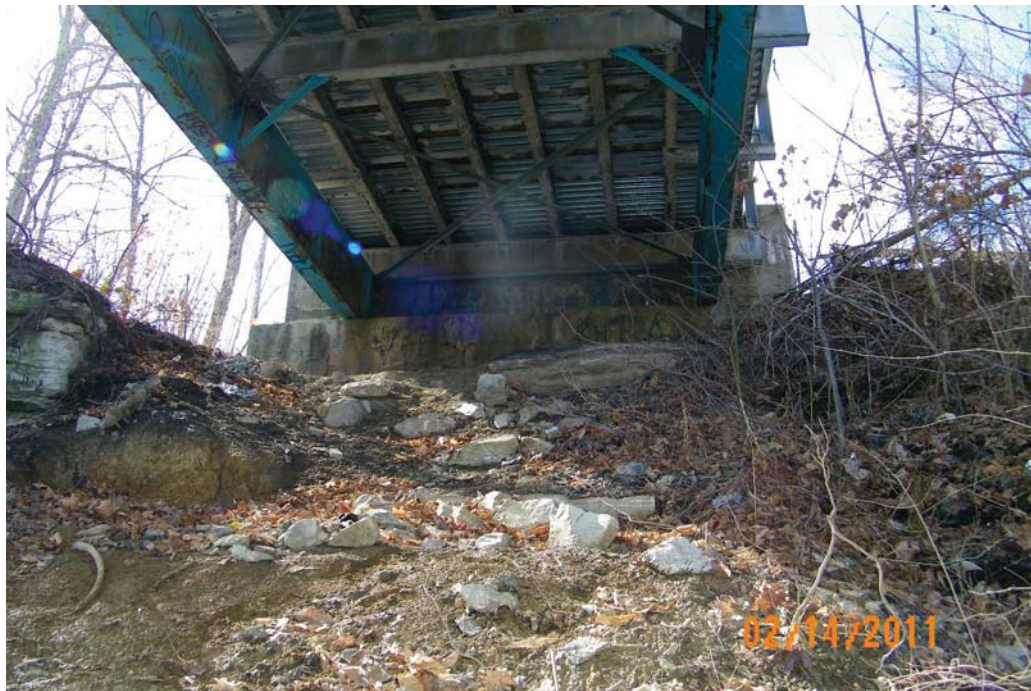
Abutment 1

A site visit was performed to review the existing piers. It is unlikely that it would be desirable or economically viable to reuse abutment number 1, abutment number 2, or piers 1, 4 or 5 as shown in the below schematic (retrieved from the Division of Structural Design's plan database). Due to their size and location in the lake, it could be very desirable to reuse piers 2 and/or 3.

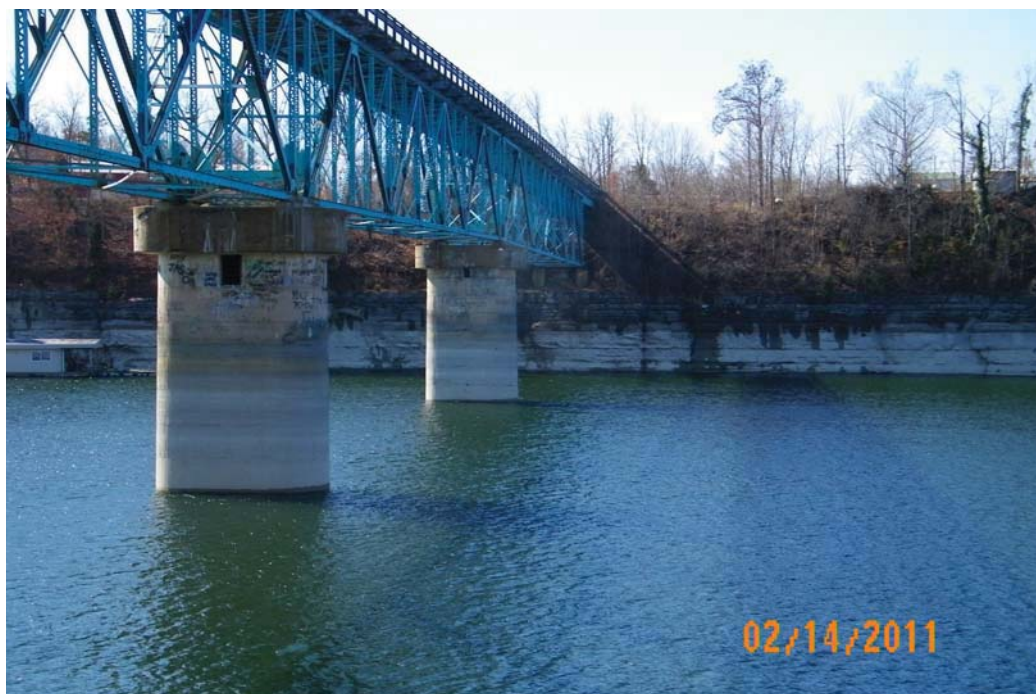
**Pier 3 (front) Pier 2 (rear)**

An article by F.C. Mahan from the *Kentucky Engineer* (year unknown - see appendix) supplied to this office by the District indicates that there have been some significant problems at Pier 2. Once the downstream dam was constructed and water began to back up around the piers it was noted that Pier 2 was actually rising and rotating. In the article Mahan states that the earliest inspection on record was in March of 1932 and that the top of Pier 2 was 1.33 feet higher than pier 3. (Mahan indicates that earlier records had been lost in a fire). Both were supposedly constructed to the same elevation. Mahan also states that "At the height of the movement the pier had risen approximately 30" and had tilted upstream and toward the Mercer County side approximately 12". This office does not have current information that indicates the elevation difference between the two piers.

There was no conclusive evidence at that time or at this point to indicate the probable mechanism that caused the movement. Mapping does indicate that bentonite layers are prevalent in the Tyrone formation, which is presumably above the footing elevation of Pier 2. Some types of bentonite are known to swell to numerous times their dry size when water is added.

Replacement of the bridge at approximately the same location or just adjacent to this location, without the reuse of the piers, will also require a very thorough site investigation. It would be very desirable to try to find out the mechanism that caused the movement at pier 2 so that future problems with a new bridge can be avoided.

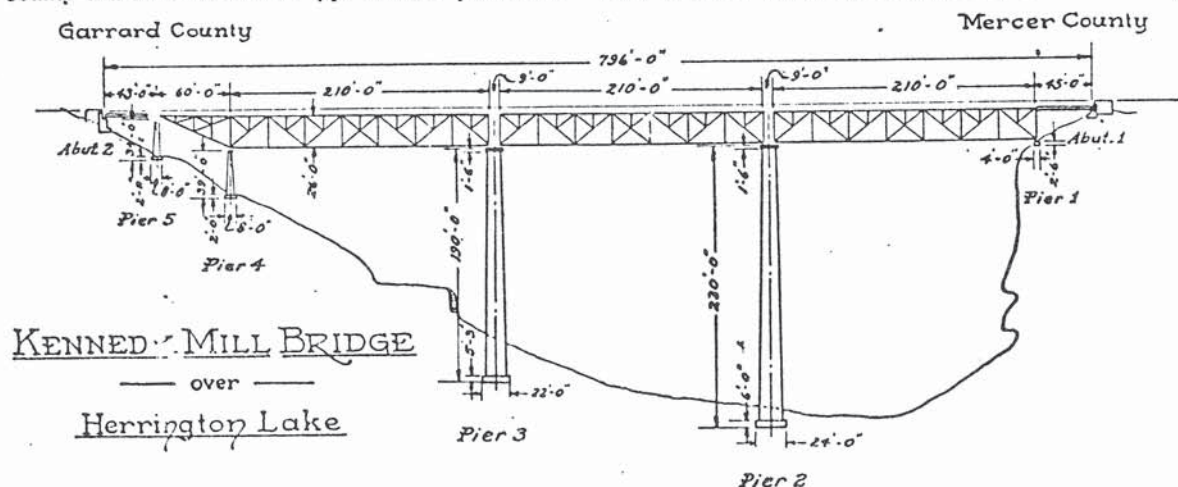
Fig. 1

At about the time the bridge was completed the "Engineering News Record" had a very good description of the two taller piers. (See Figure No. 1.) These piers are hollow reinforced concrete tubes, similar to chimneys. They were built by the Weber Chimney Company of Chicago by its regular chimney building procedure. The foundation for the 230' pier has a 6' 1/2" reinforced concrete slab and the shaft or stack is anchored to the footing with 1" steel bars. The shell thickness at the bottom is 26 7/8". Both piers are 12' wide and 22'-0" long at the top and covered with a concrete slab, and both piers have 3' square ports at top and bottom to permit them to fill with water. They are flat on the sides and round on both ends and the shell thickness gradually decreases toward top.

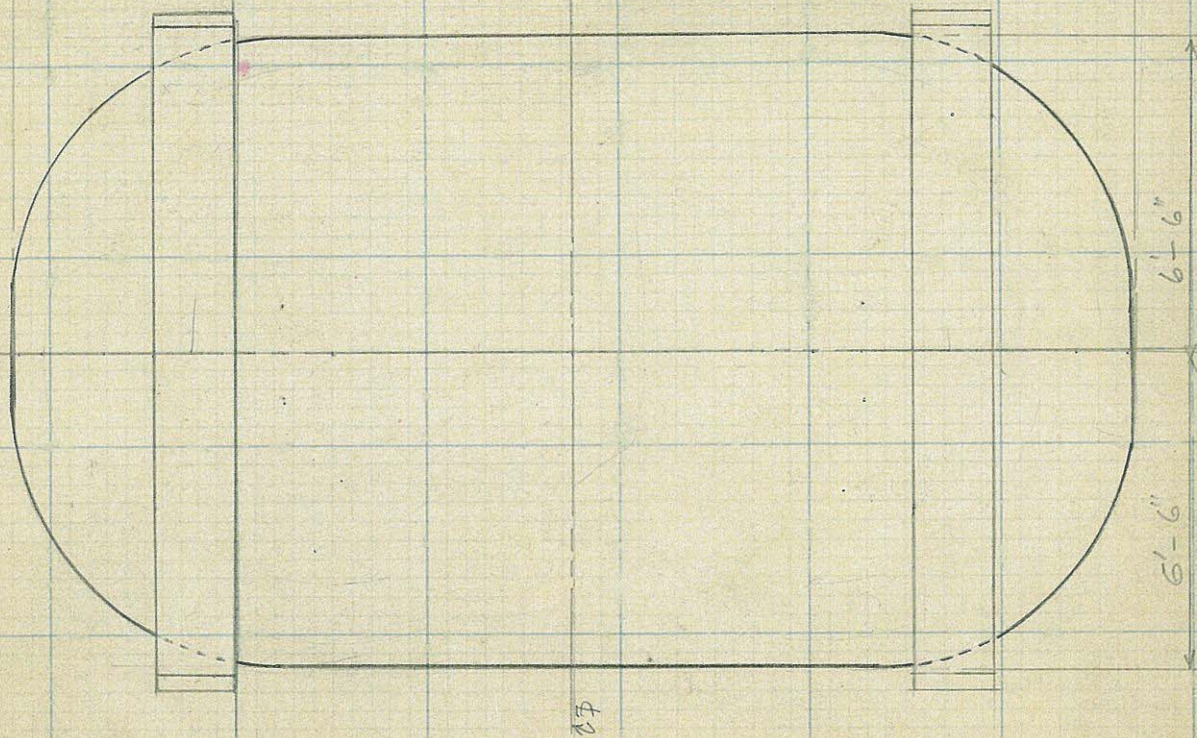
Disintegration on top Pier #4 both shoes.  
Plenty of room on grillages Pier #3, channel  
span shoes hang over pier cap to second  
bolt. Upstream cap broken off & downstream cap  
cracked under grillages.

This bolt over edge of pier cap.
