MICROSURFACING

District 12
Pike County
October 2020

Some challenges we faced!

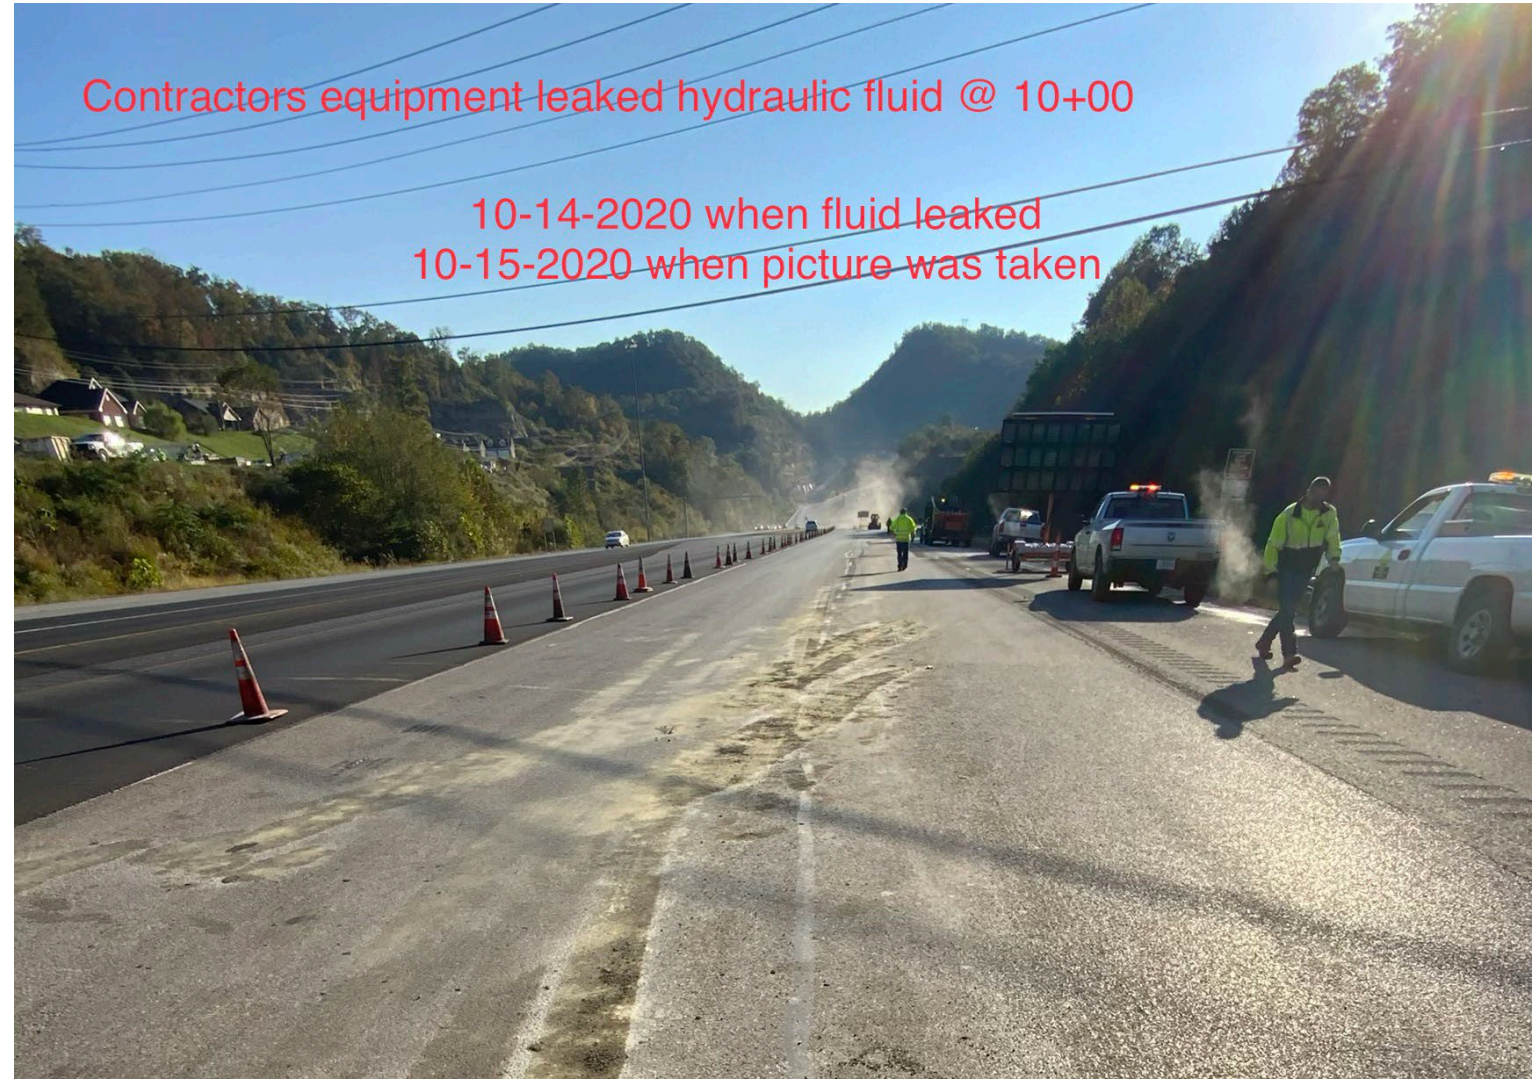
2nd Day
Paver Leaking
Hydraulic fluid..

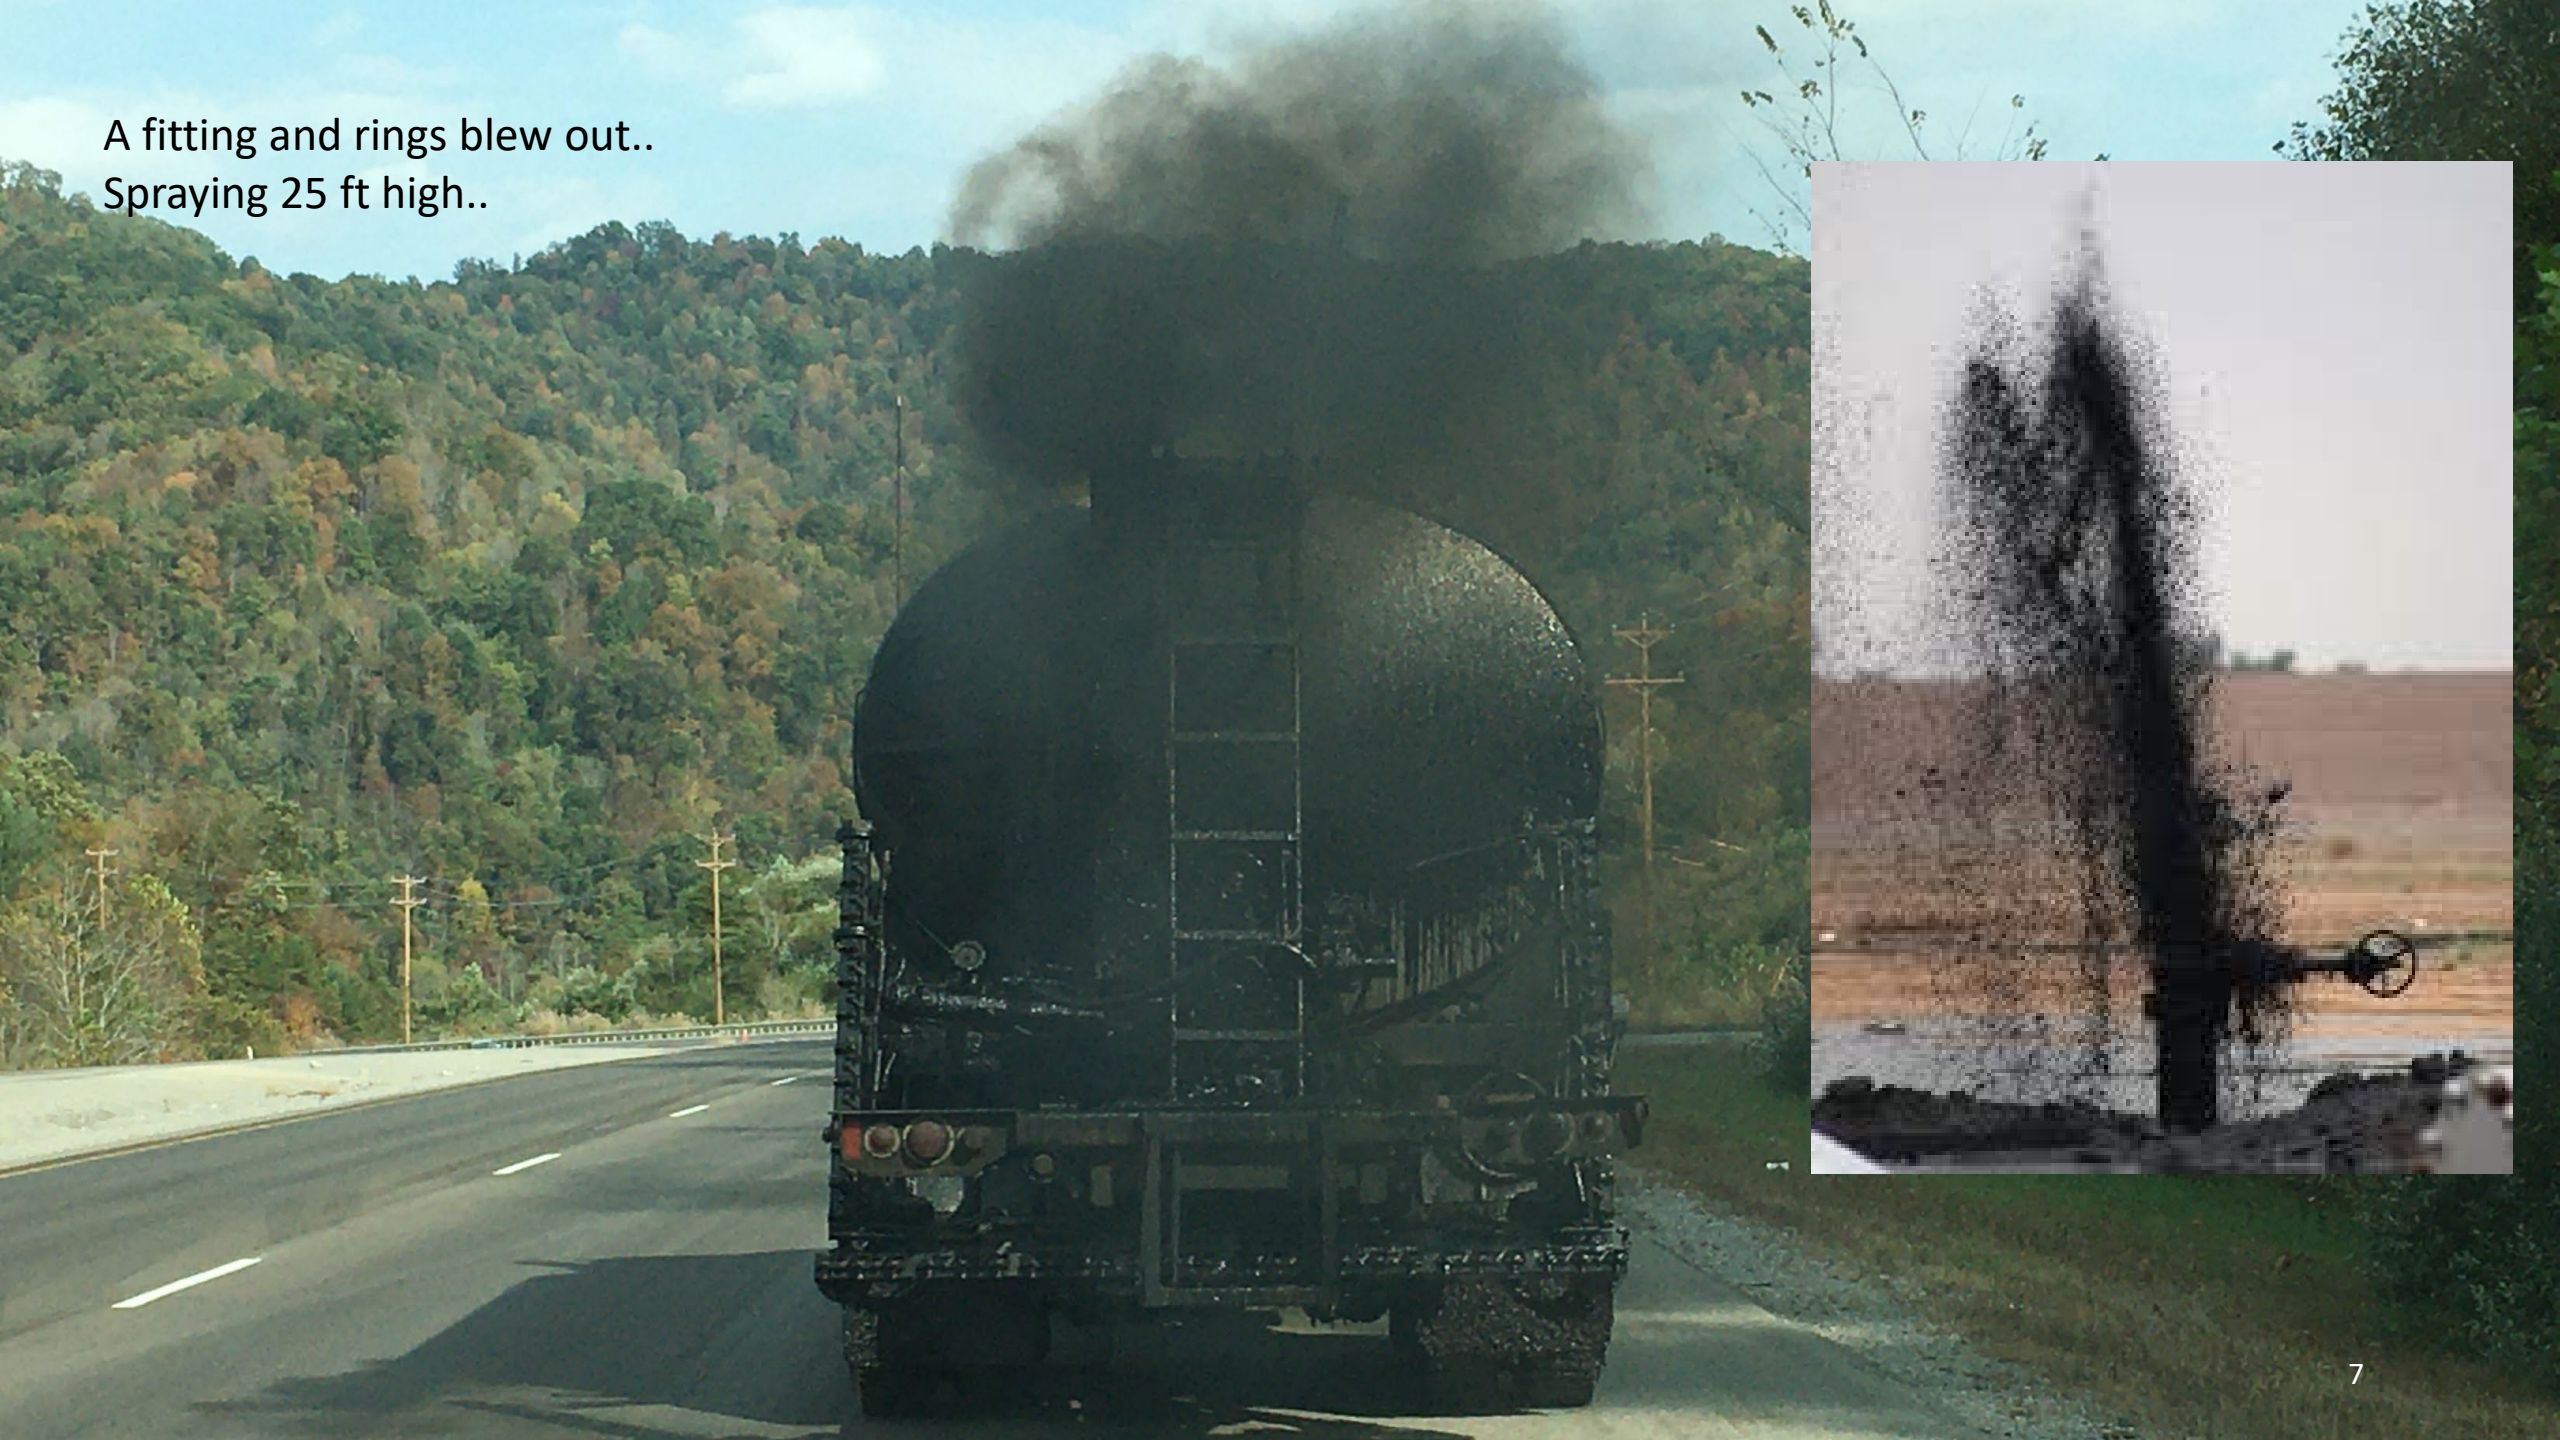
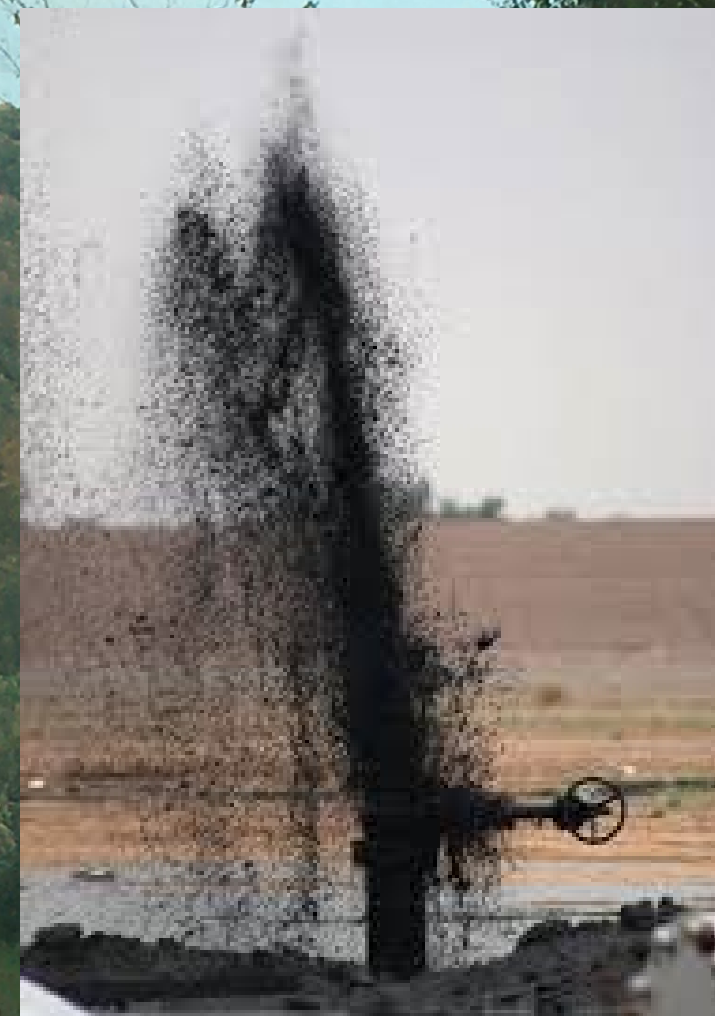
A fitting and rings blew out..
Spraying 25 ft high..

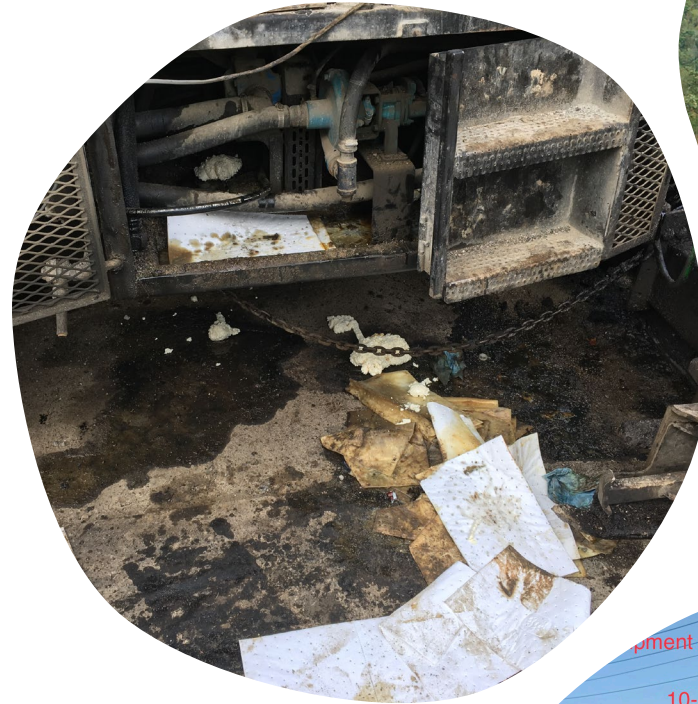
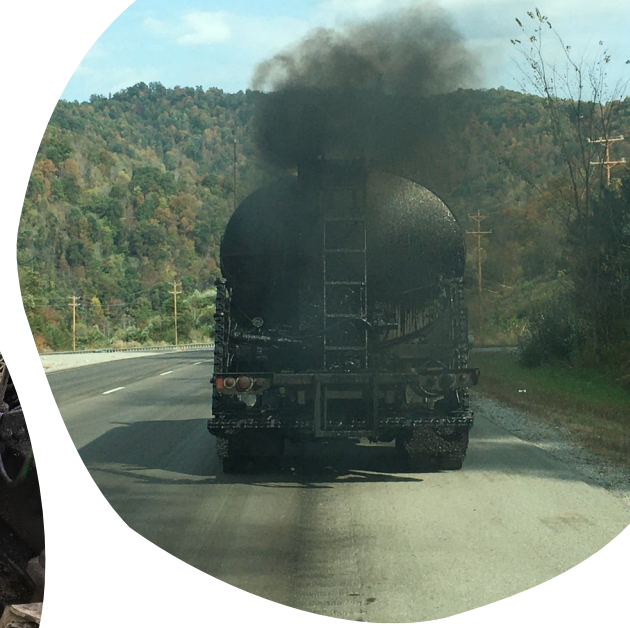
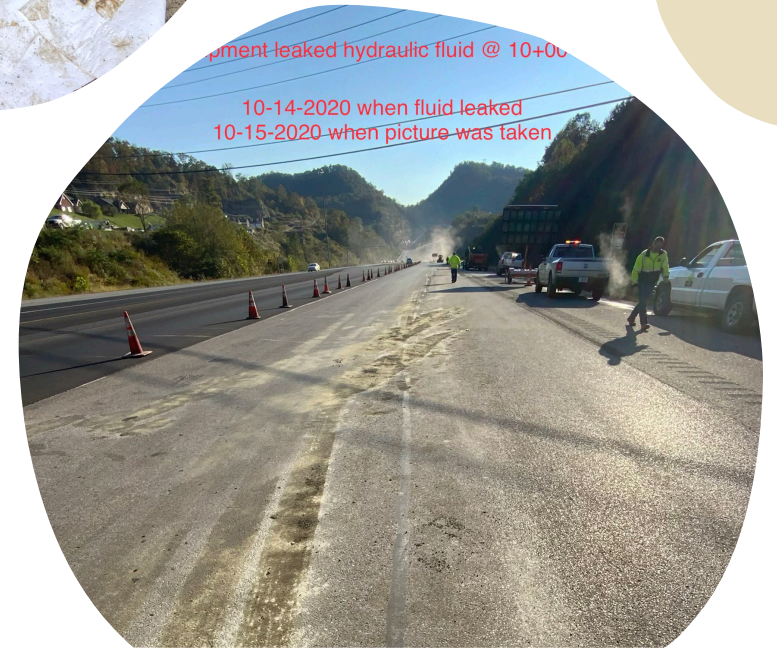
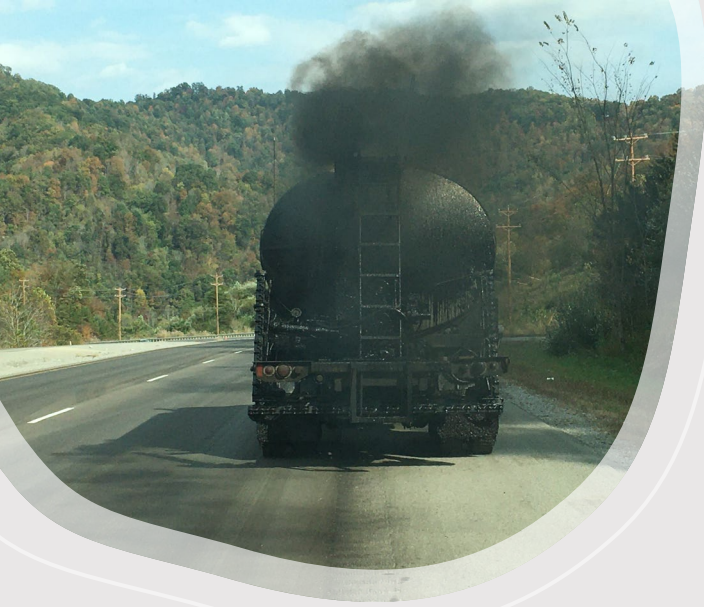
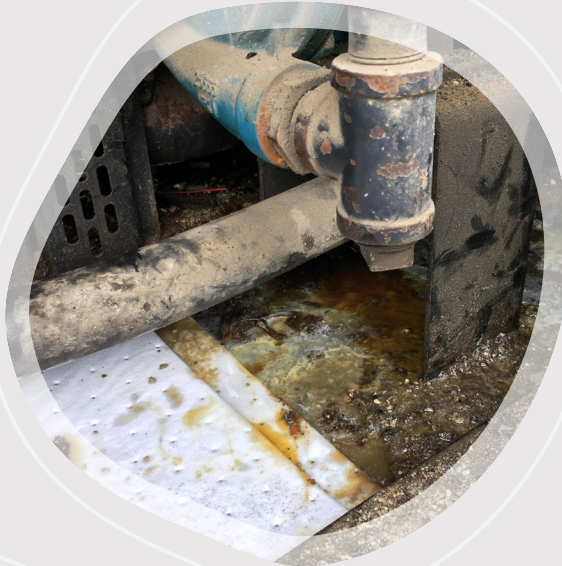
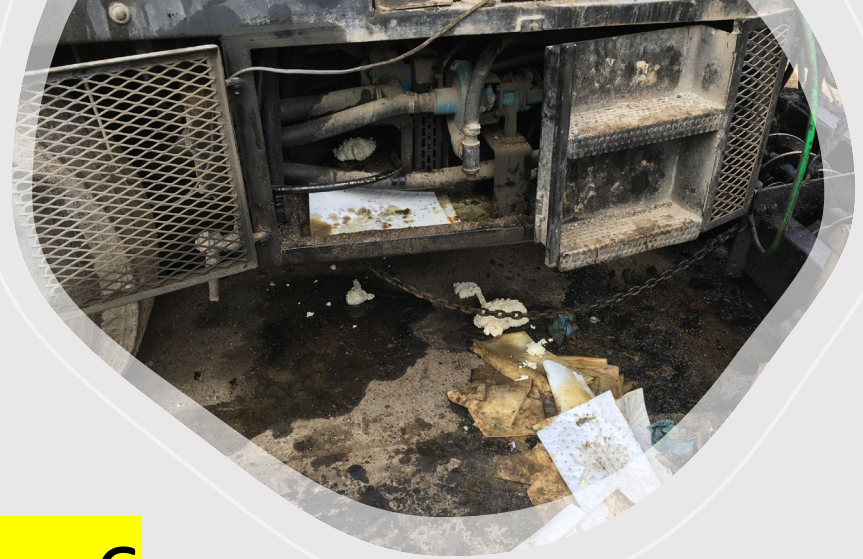
Day 6 - Attempted to microsurface (in the lot) - blew a water hose fitting.....hydraulic fluid still leaking...

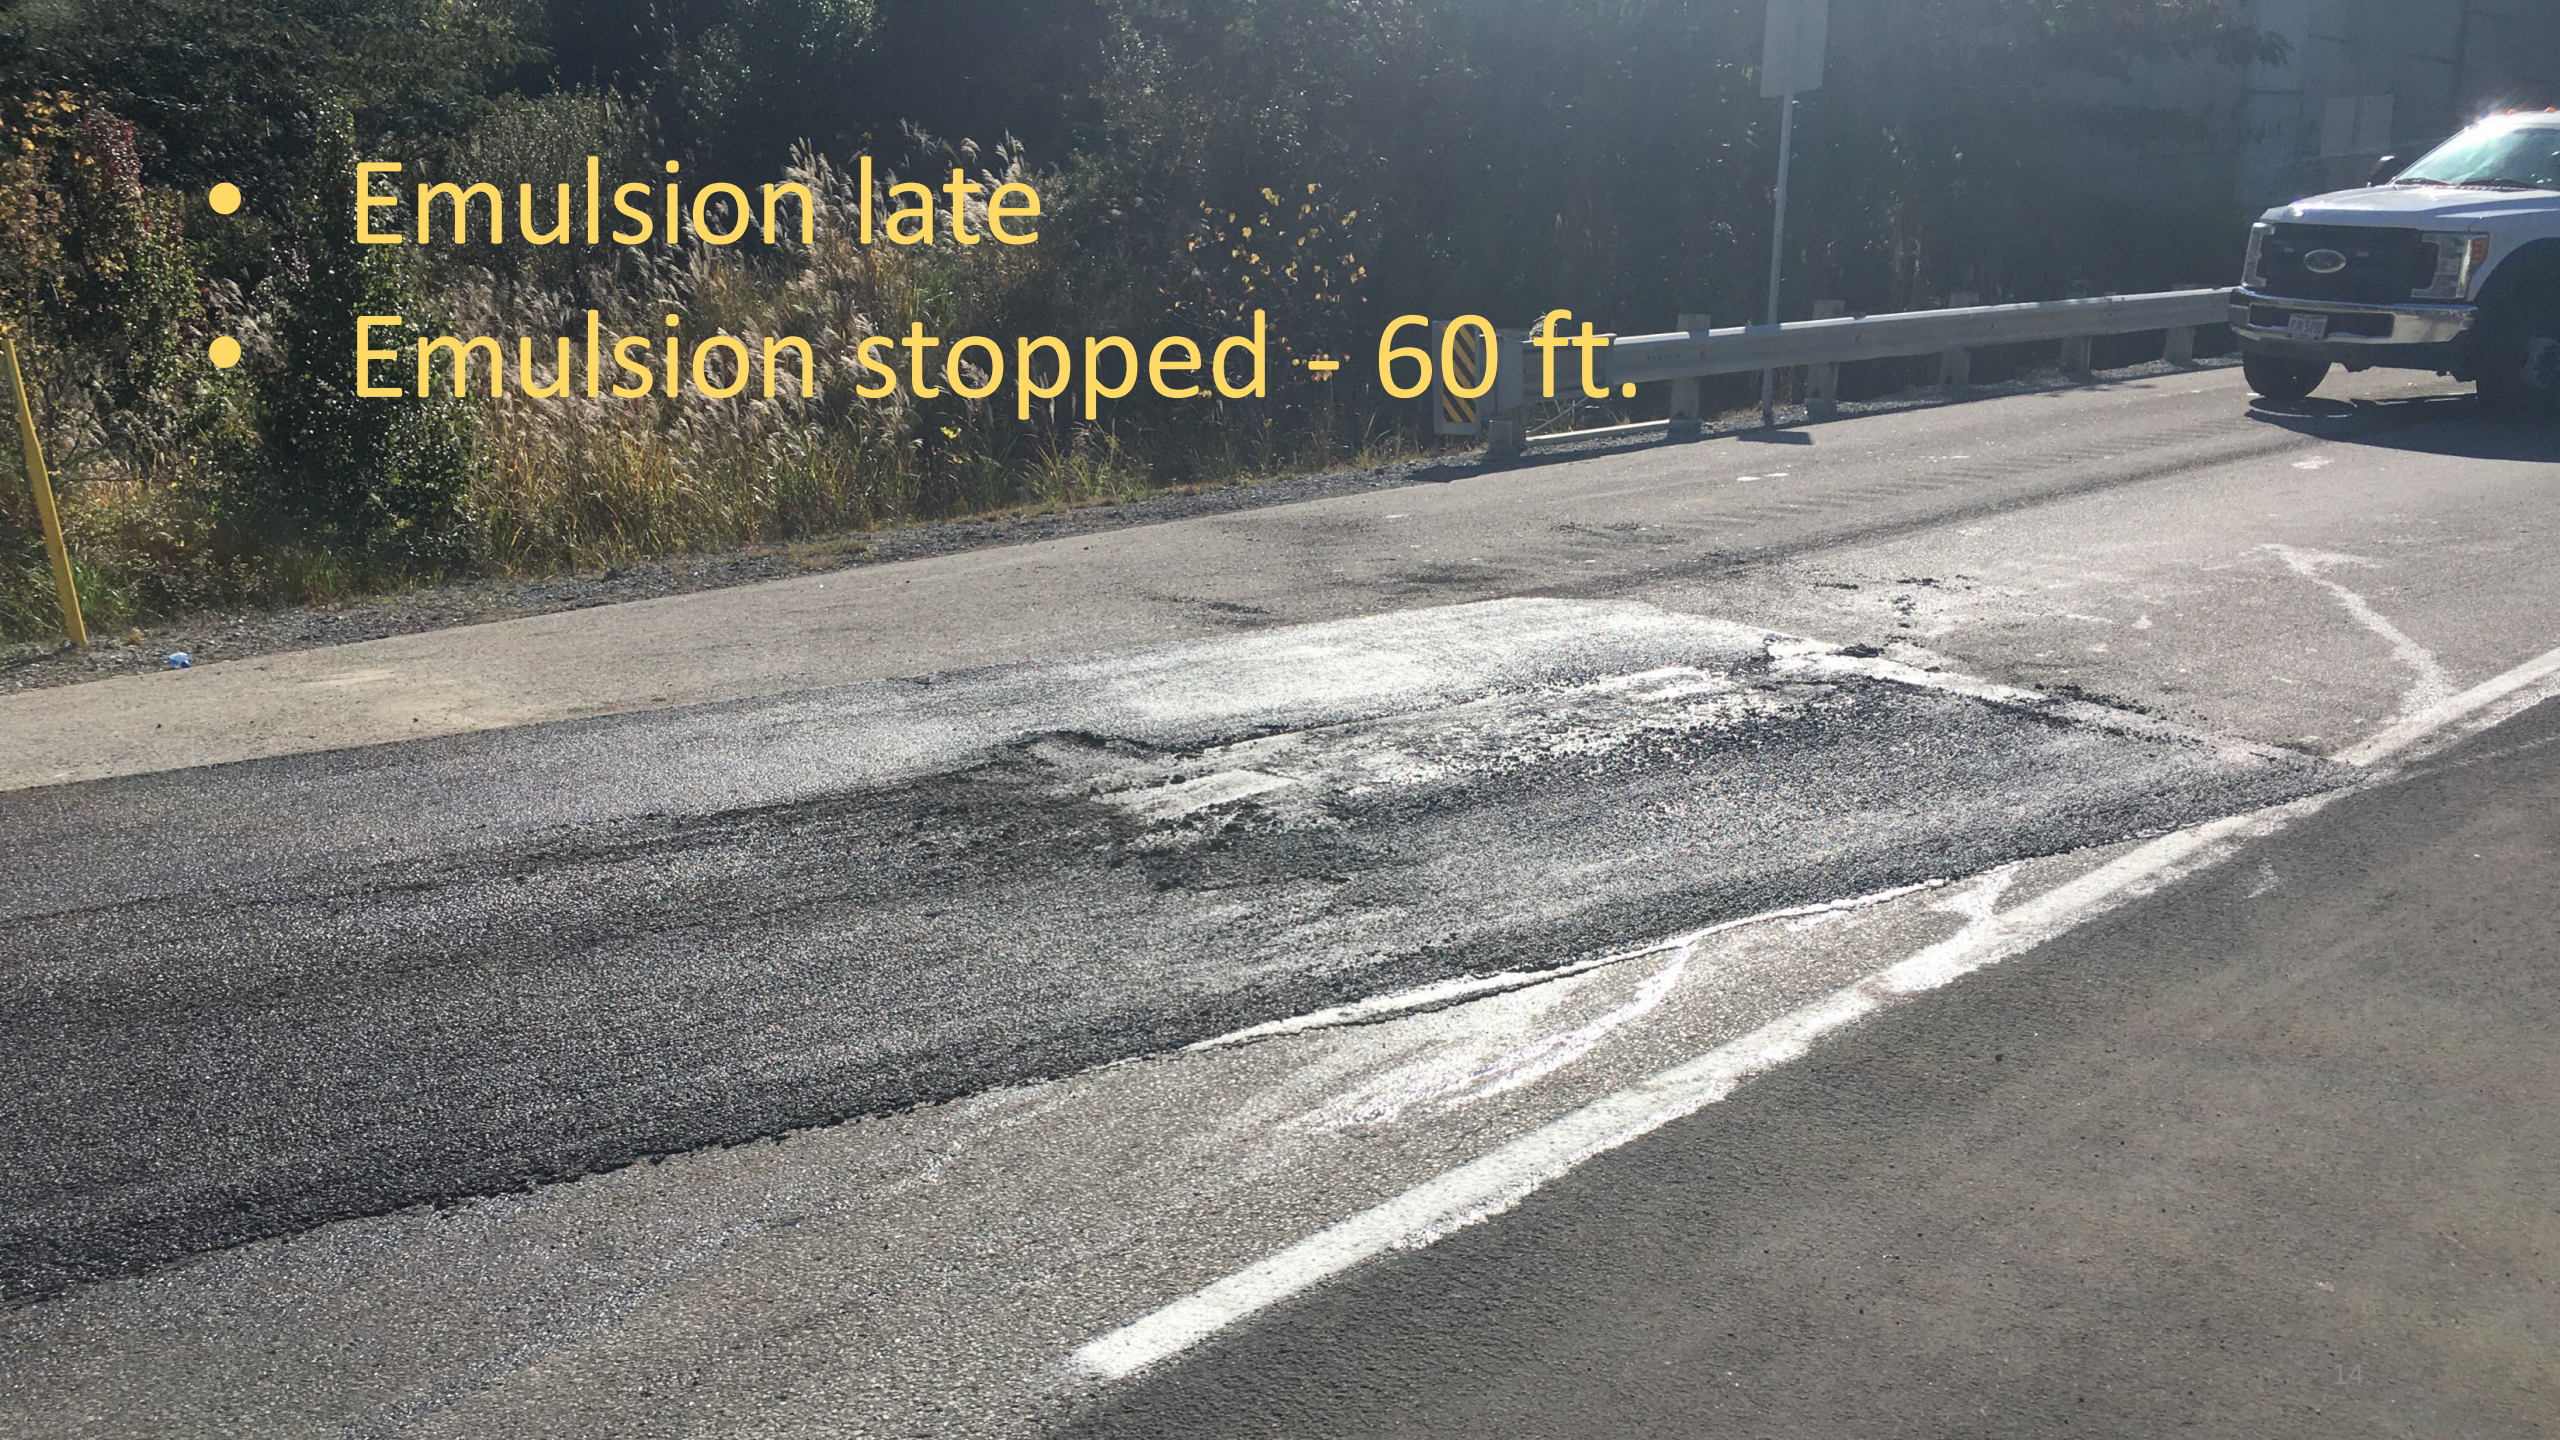
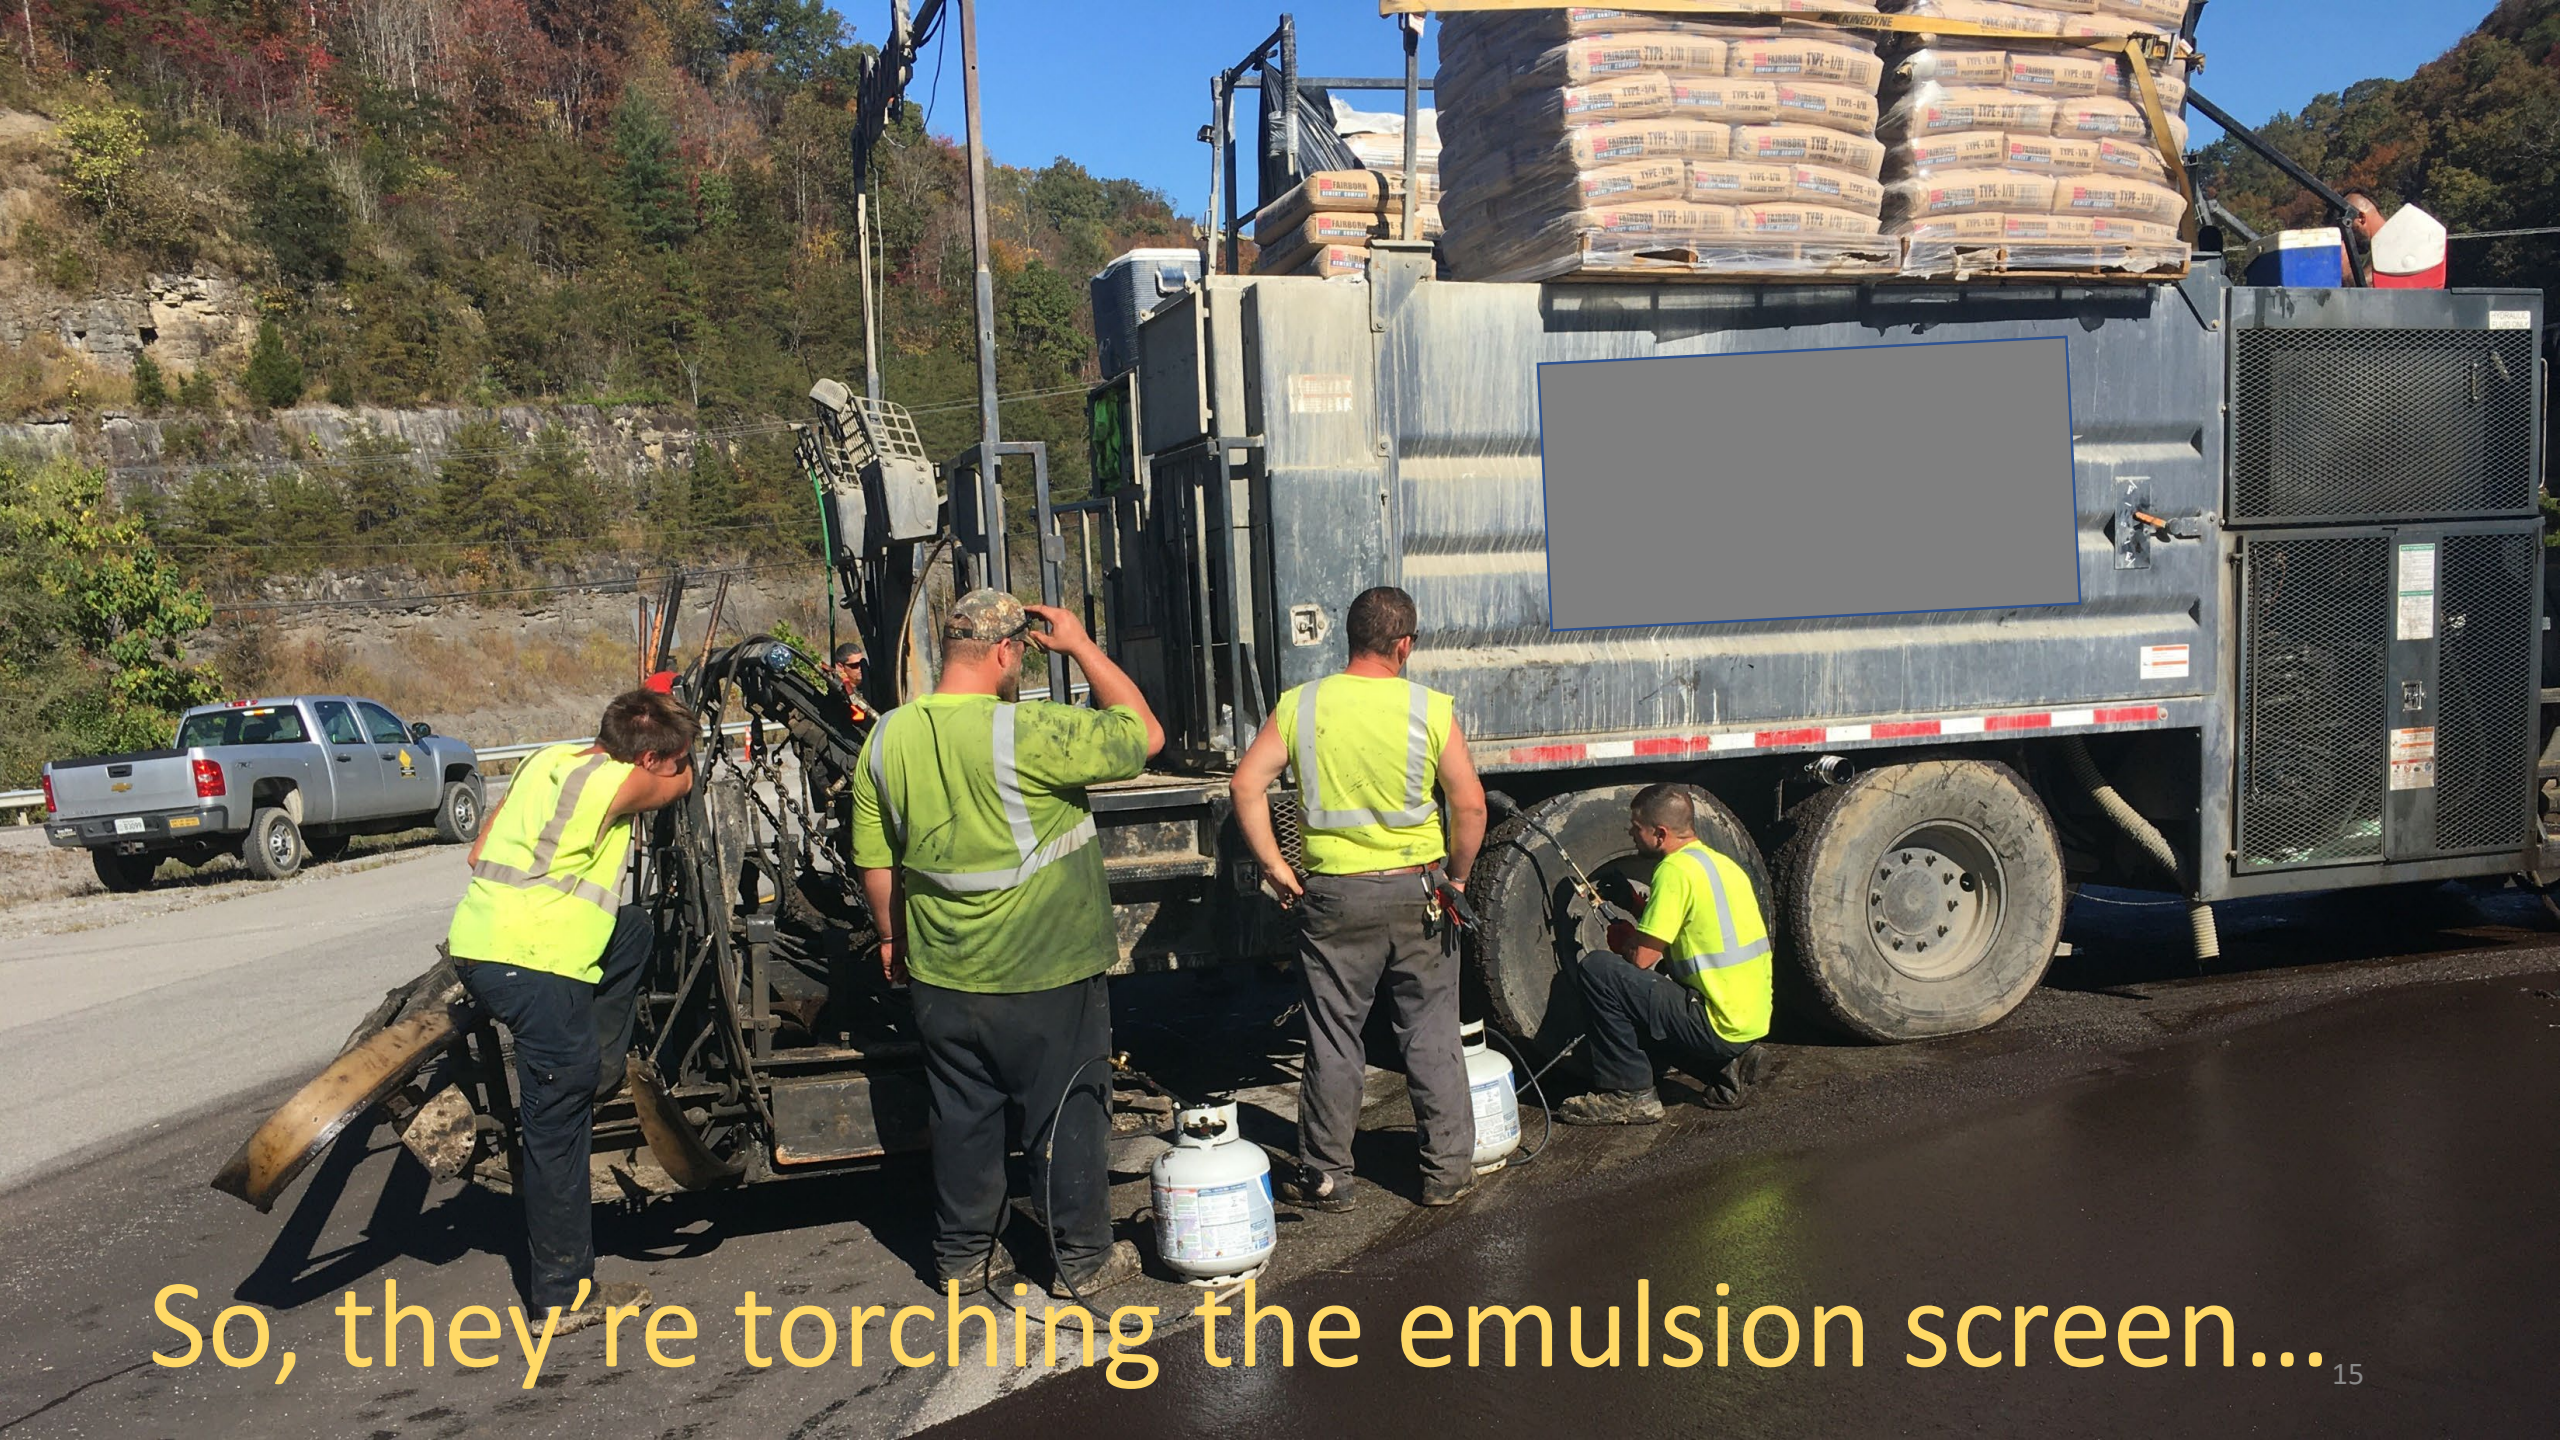
- Emulsion late
- Emulsion stopped - 60 ft.

So, they're torching the emulsion screen...

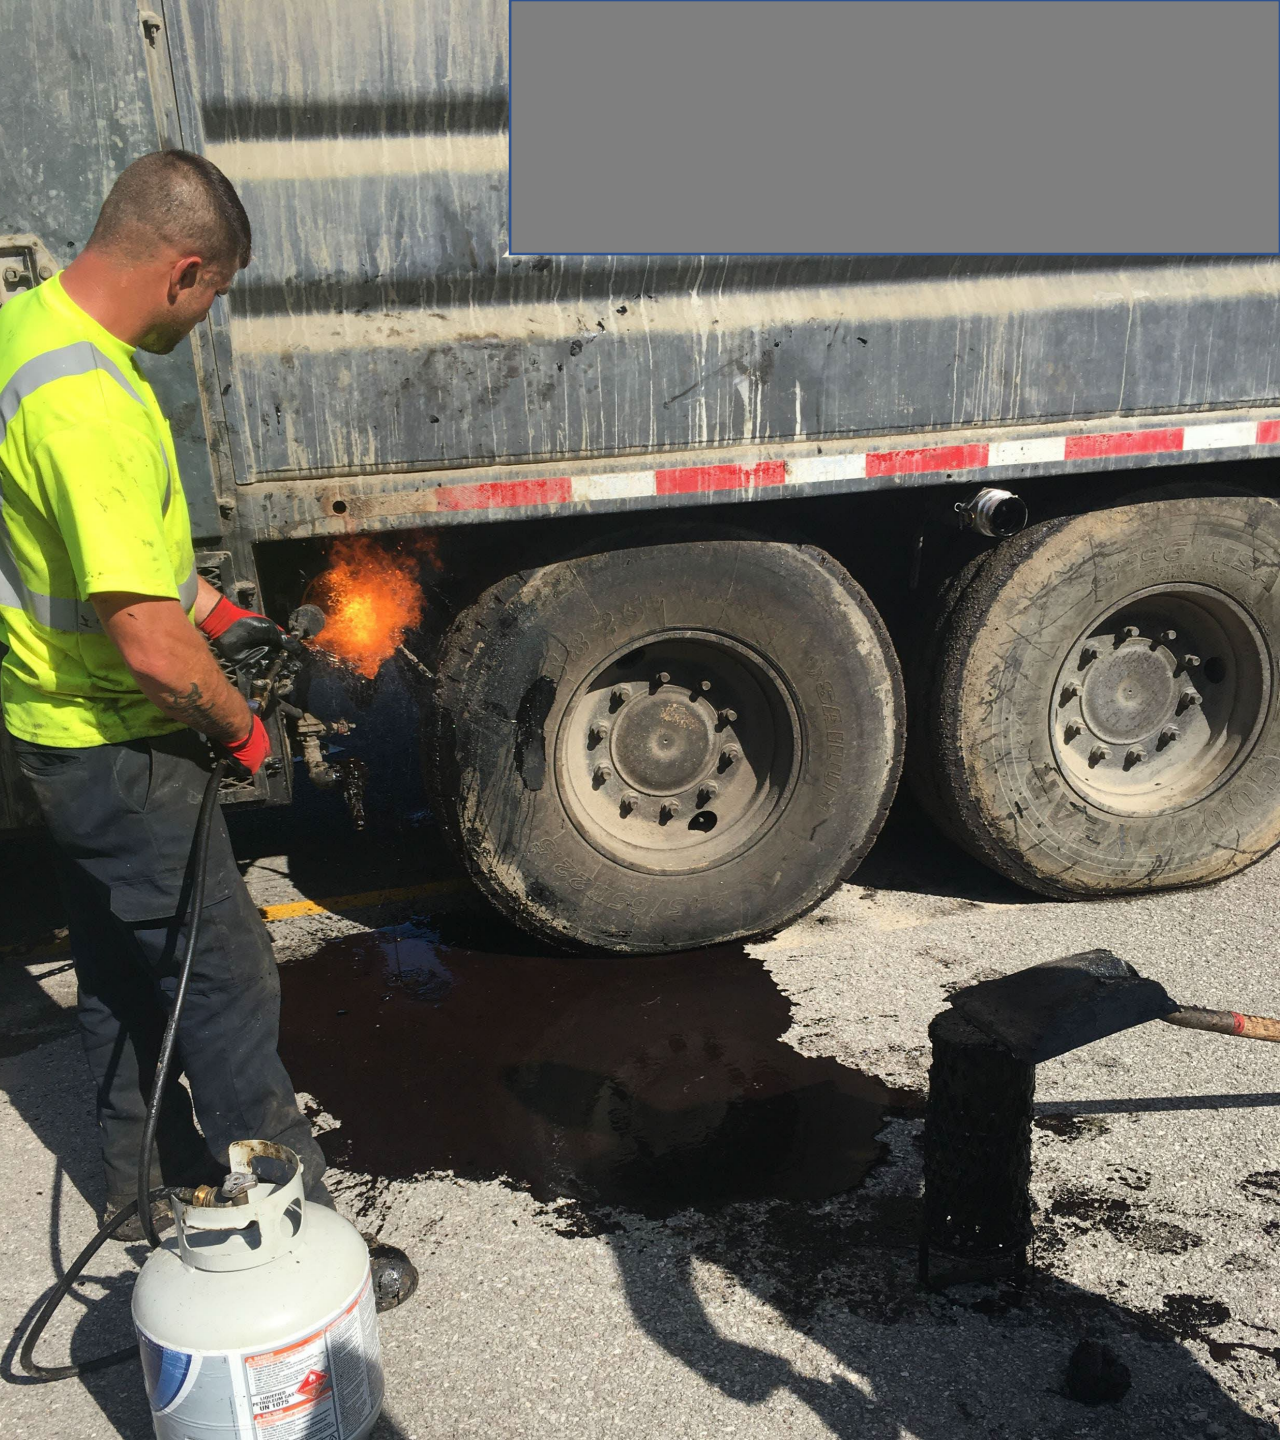
Just cleaned that morning

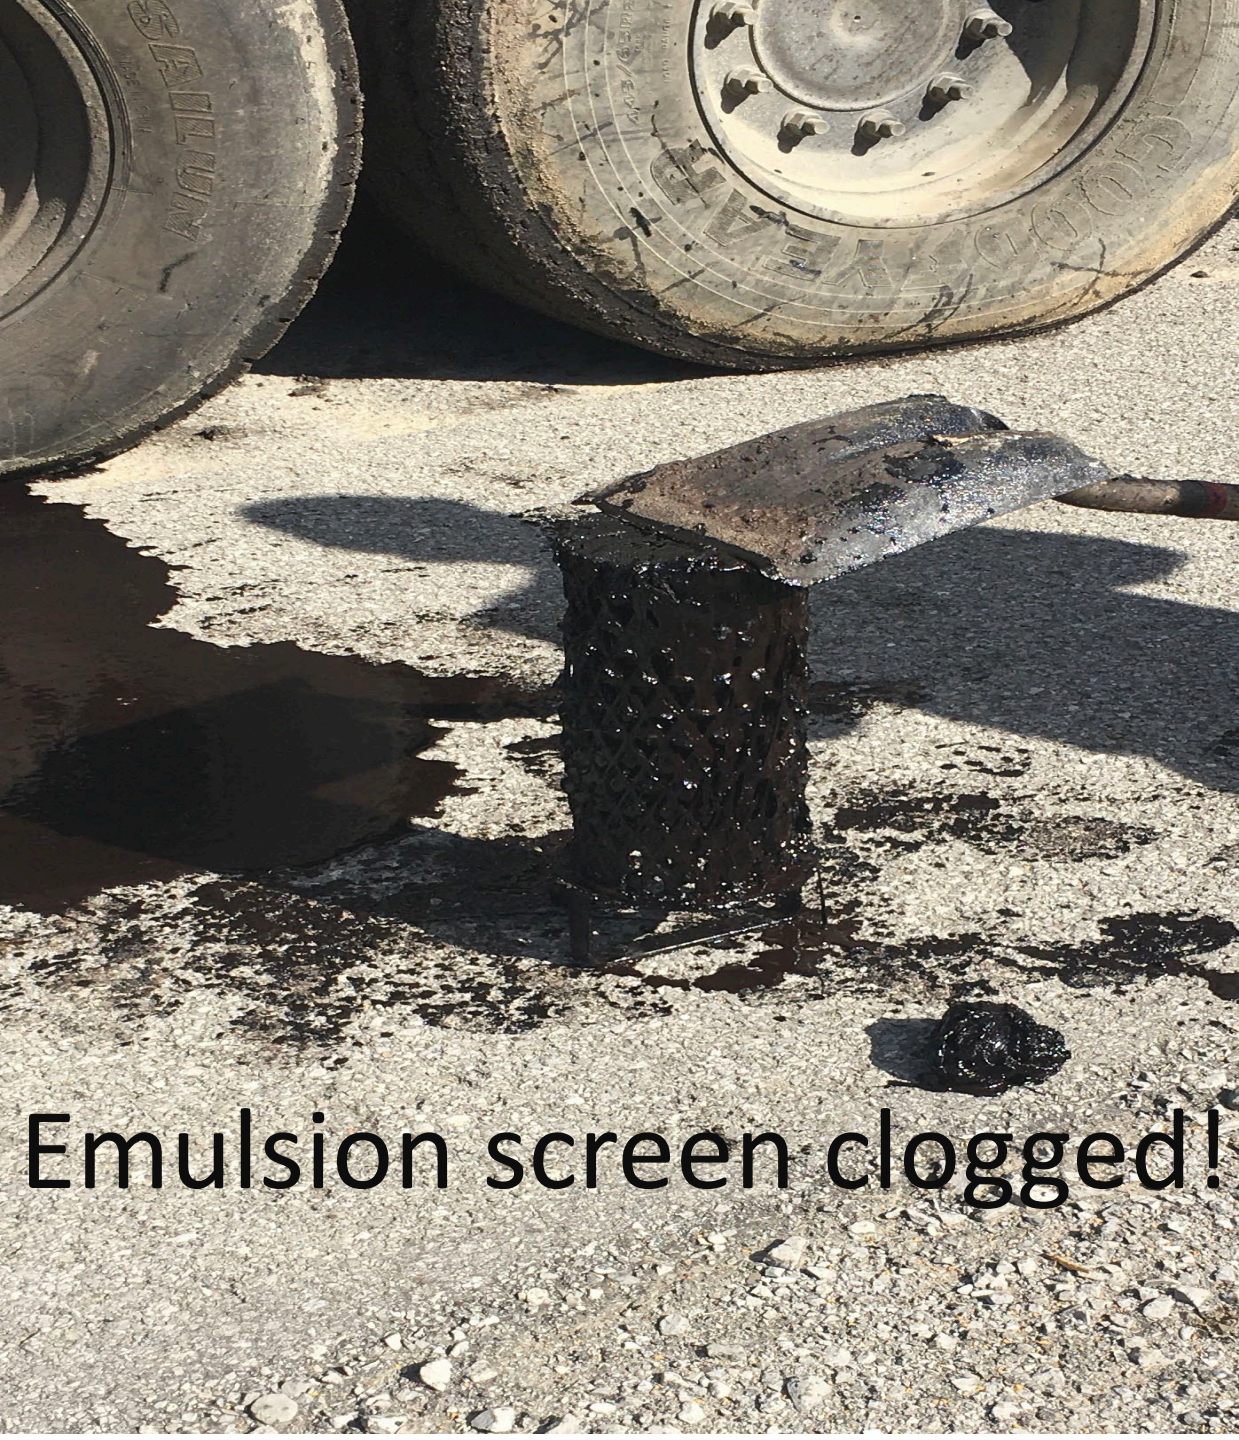
Emulsion screen clogged!

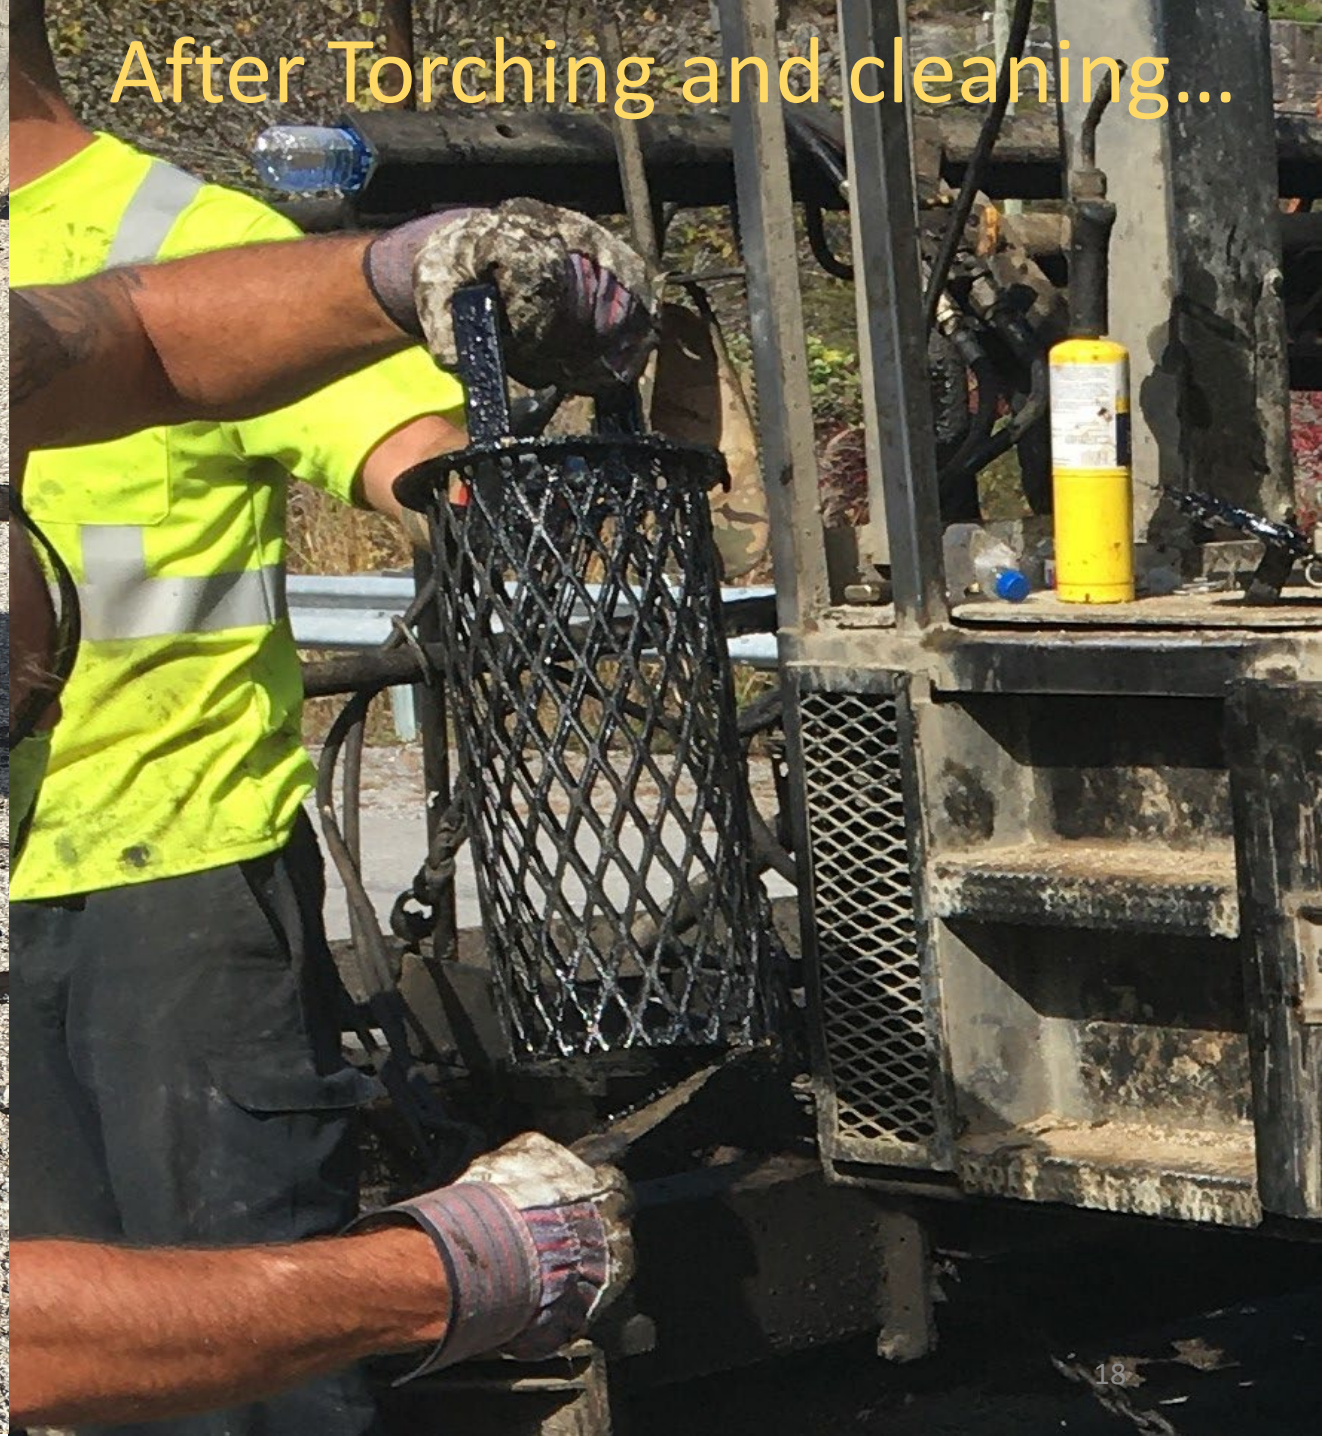
After Torching and cleaning...

Emulsion entering the mix very late...
And the emulsion stopping in about 60 ft.

Continued to happen.. 3 or 4 times in 300 ft!

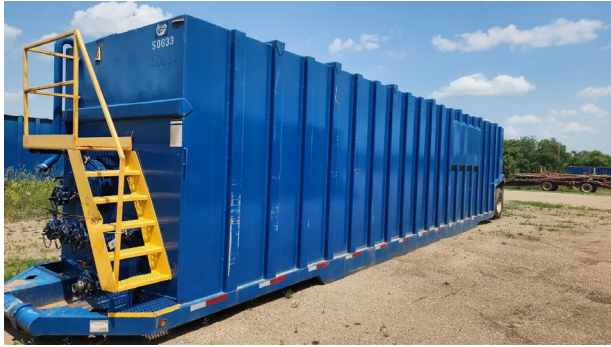
- Foreman looked into frac tank
- Emulsion seperated

One part: Solid asphalt material

Another part: Thin gray liquid
