MICROSURFACING

District 12
Pike County
October 2020

Some challenges we faced!

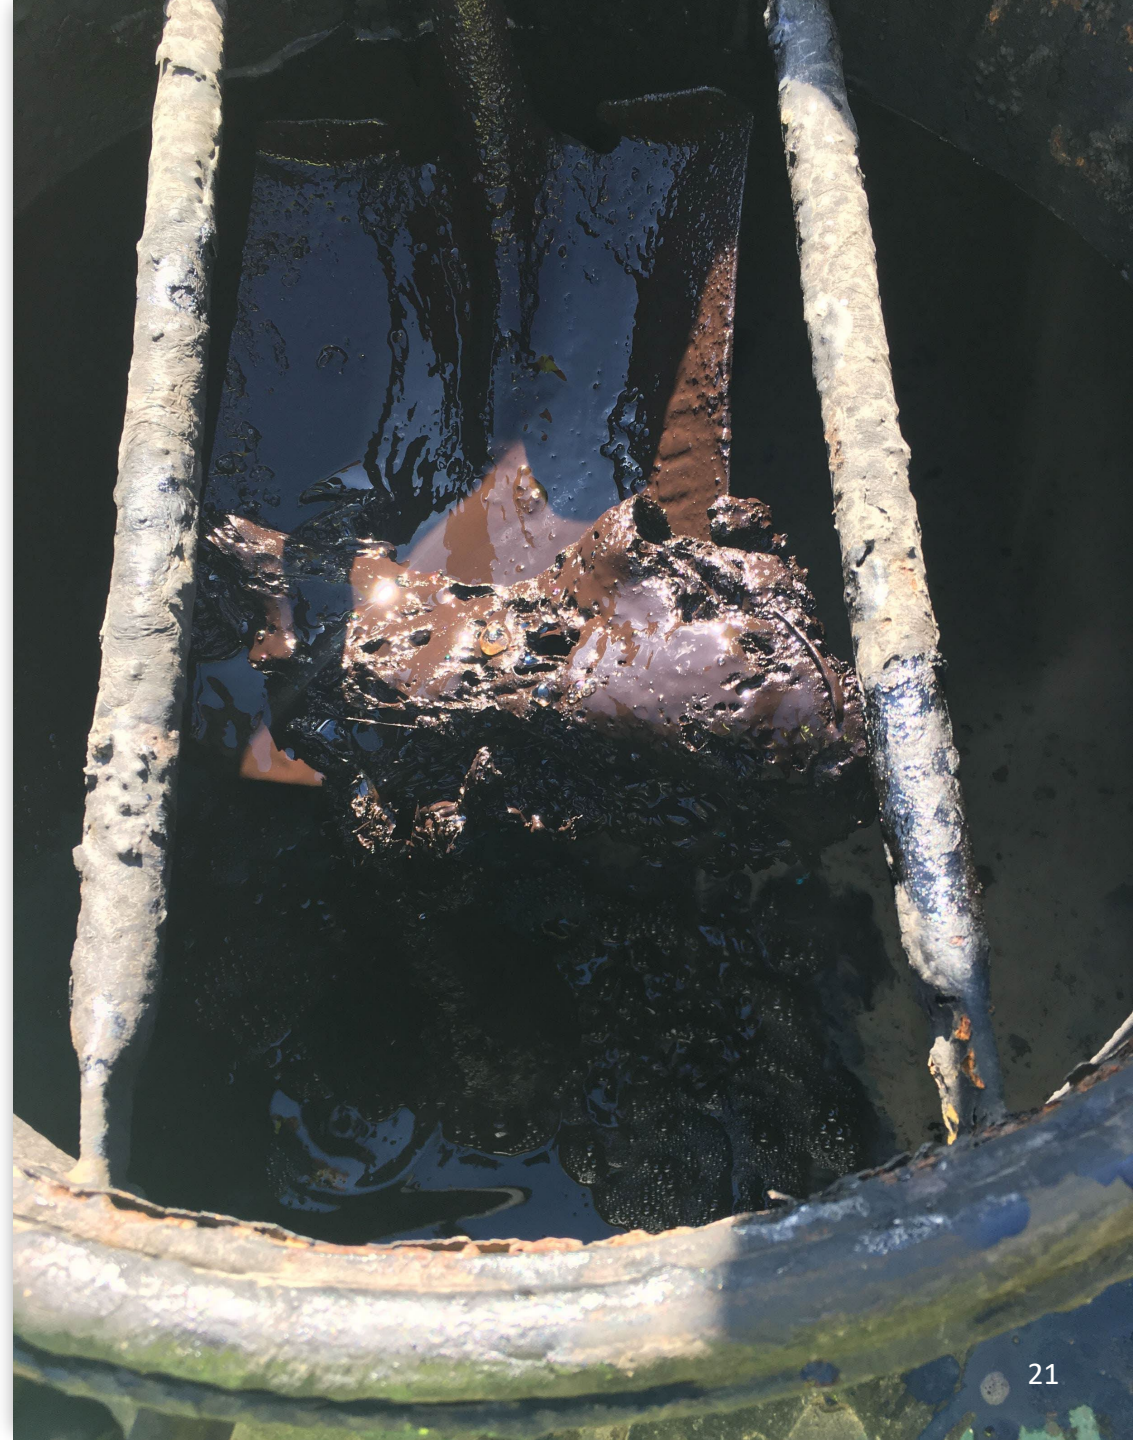
Workday 8, Calendar day 10!

Not circulated
or heated

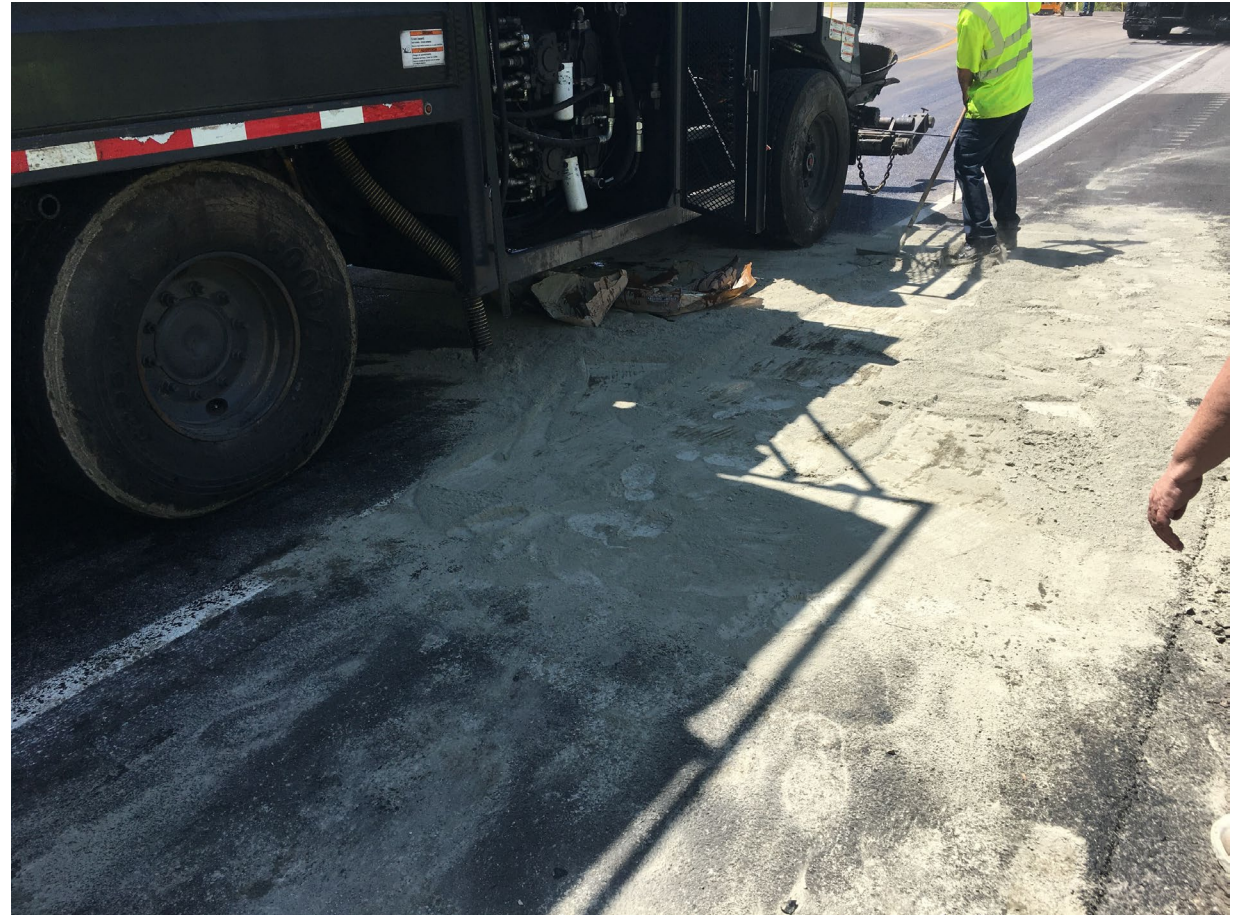
Another Hydraulic hose busted!

- Cement
- Pressure washed
- Fixed the hose

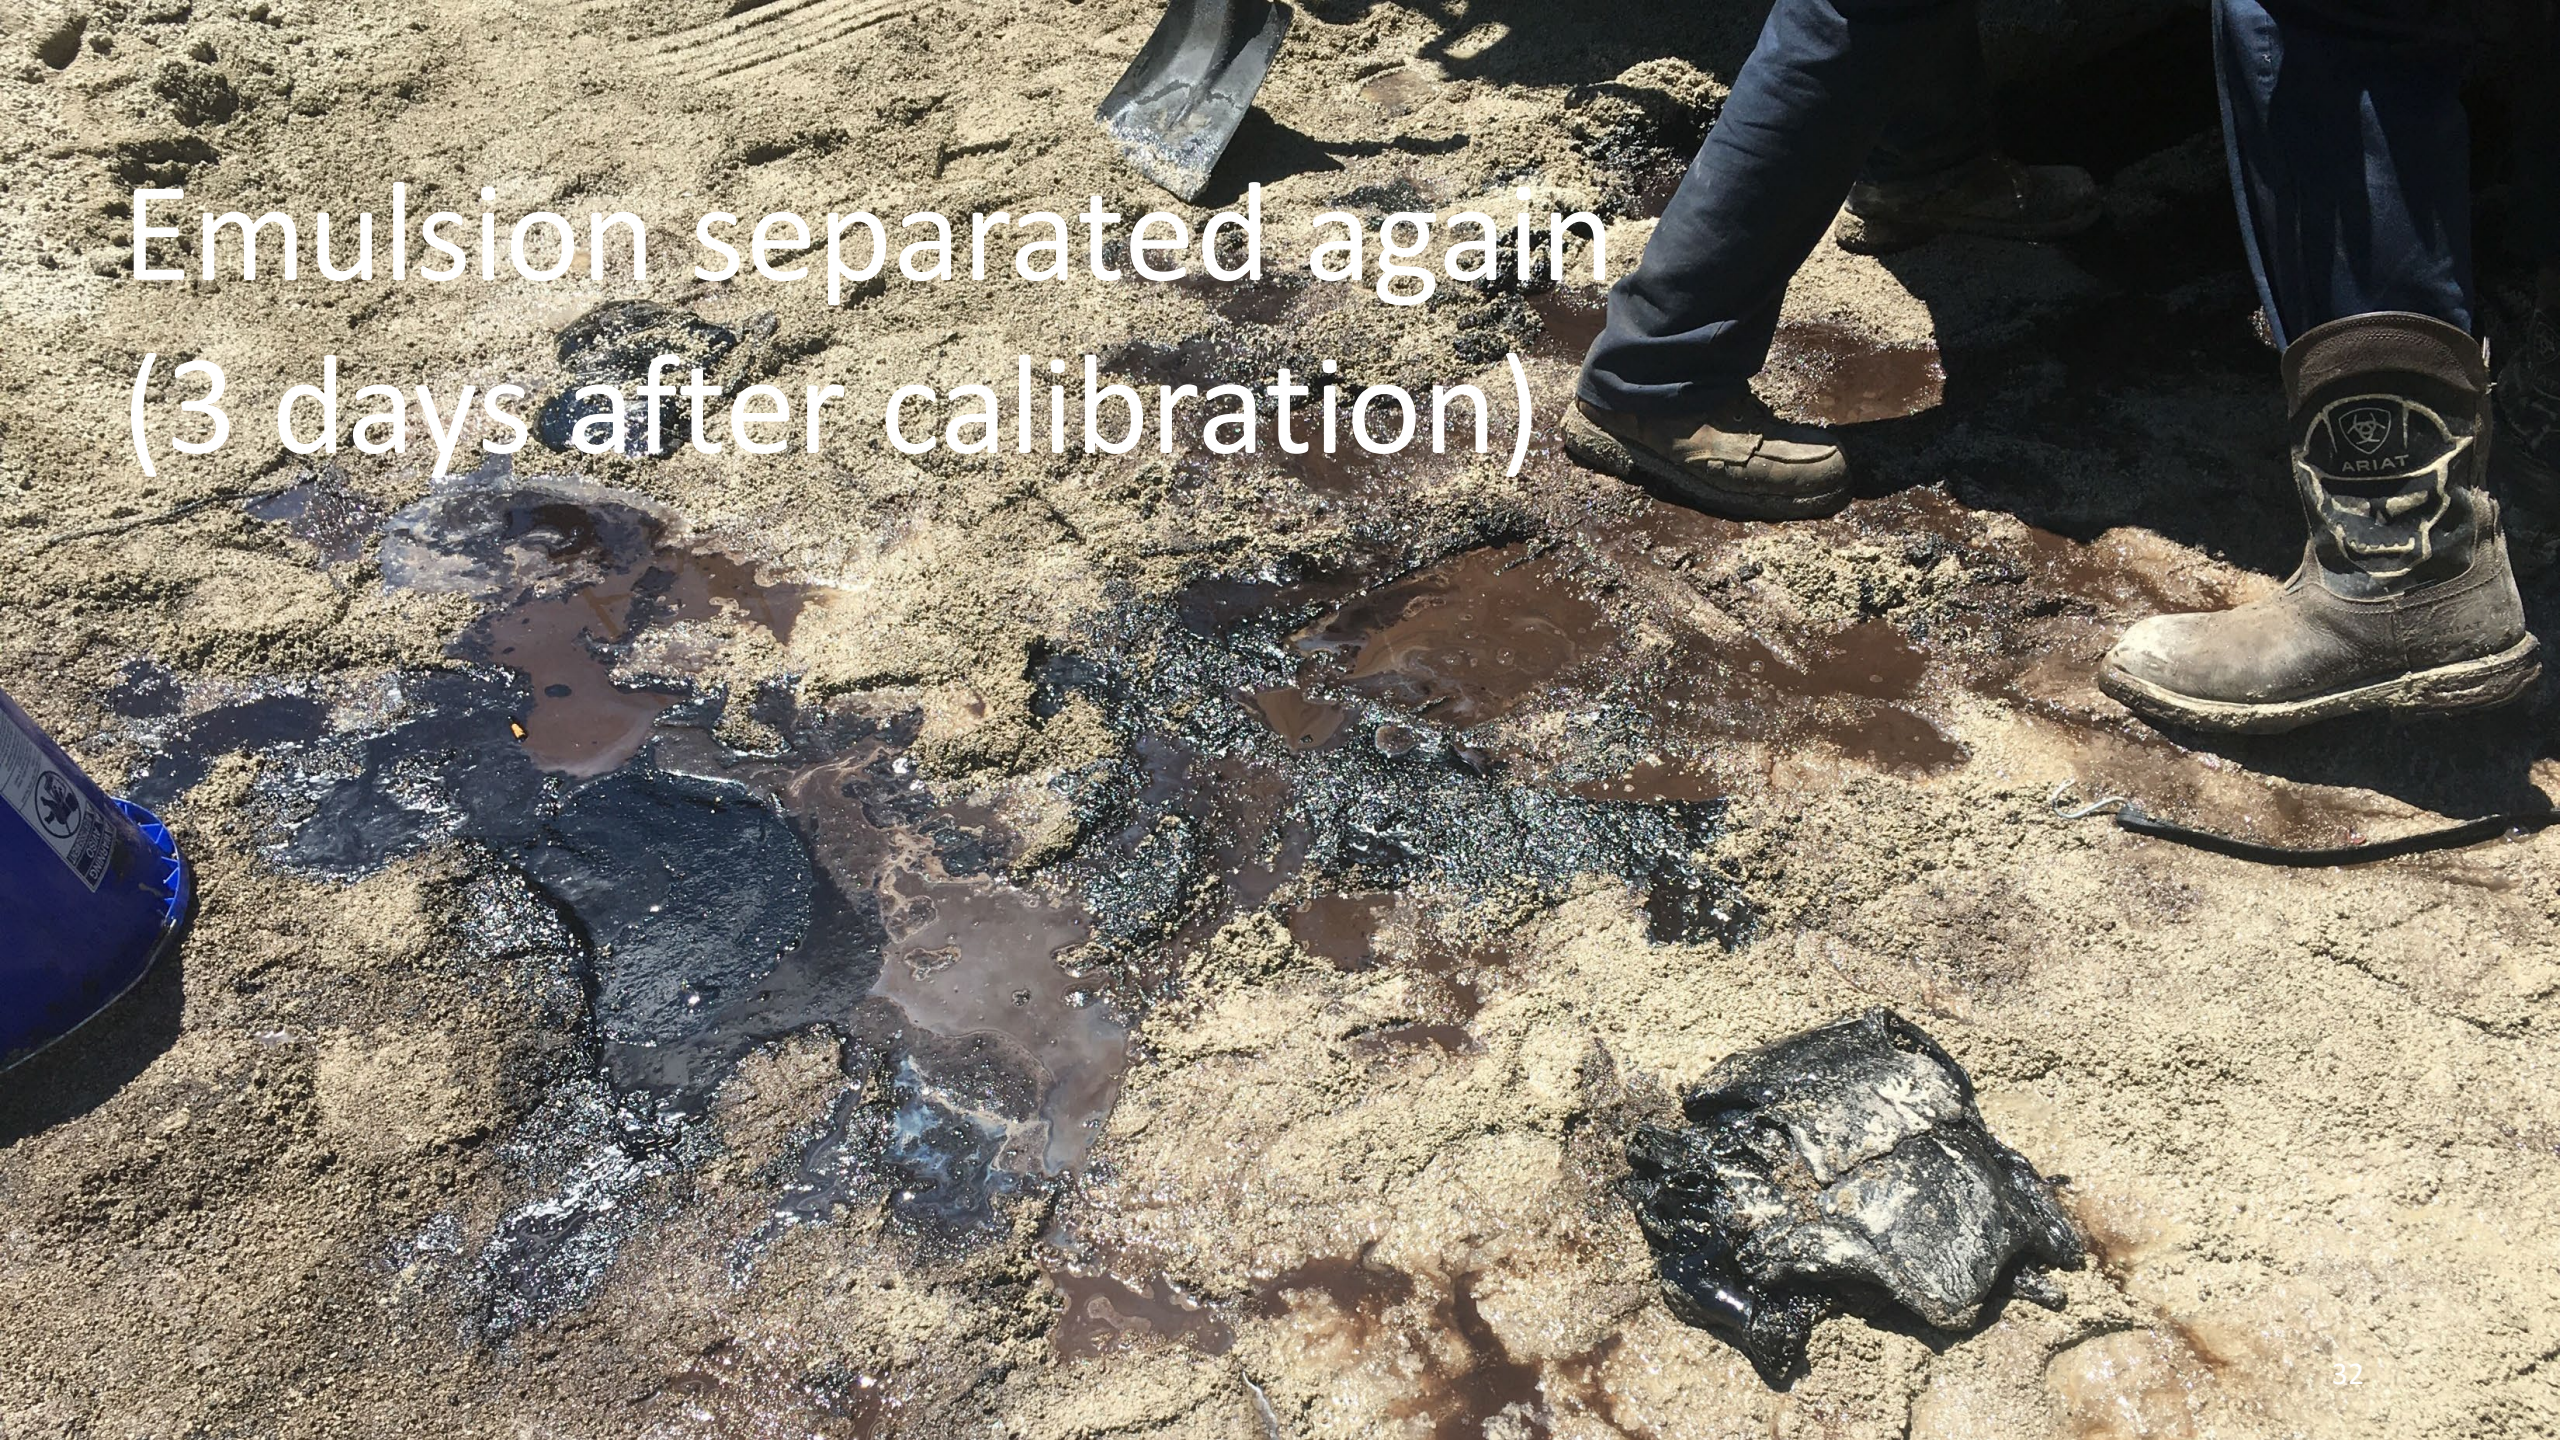
Water pump shaft broke

Emulsion separated again
(3 days after calibration)
