August 31, 2019

**Re: Broadway Bridge (KY 3506) over Kentucky River
 Bridge No. 037B00066N
 Frankfort, Kentucky
 In-Depth Bridge Inspection Report**

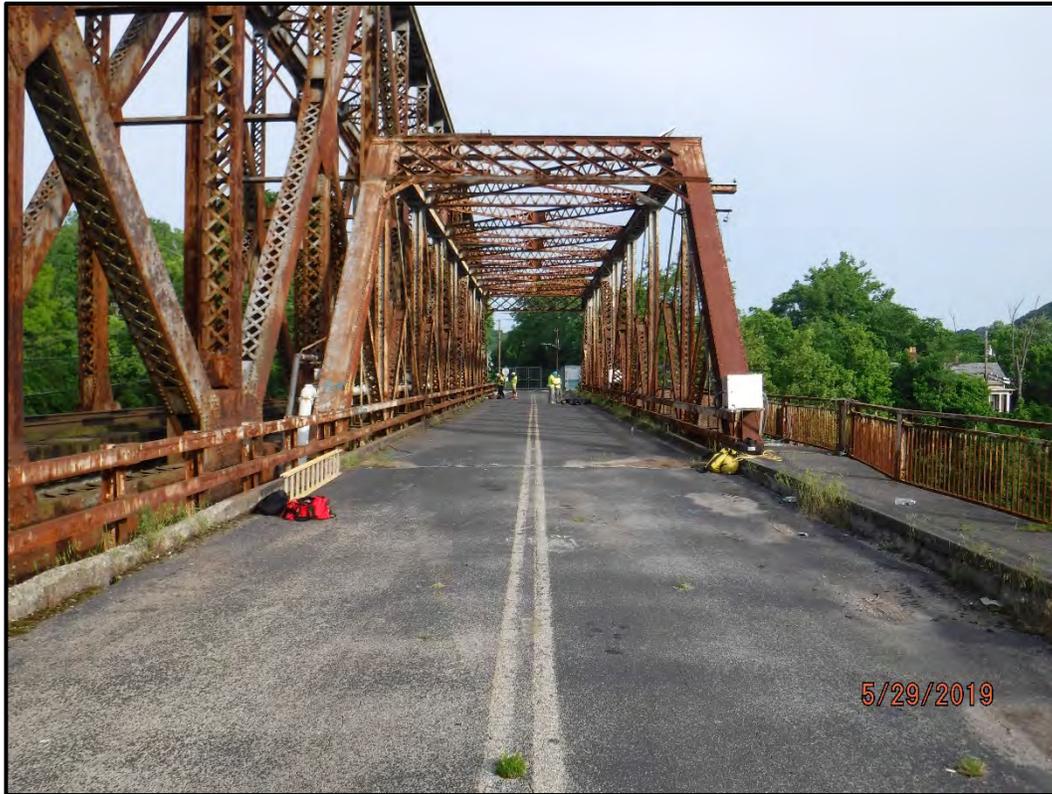
- The deck is in serious condition (NBI Rating is 3 out of 9).
- The asphalt wearing surface has widespread transverse, longitudinal, and map cracking. There is heavy vegetation growth in the gutterlines, and intermittent light vegetation growth in the surface cracks. There is heavy rutting adjacent the curbs. (See Photo 12-1)

Photo 12-1: Typical cracking and rutting of the asphalt wearing surface with vegetation growth.

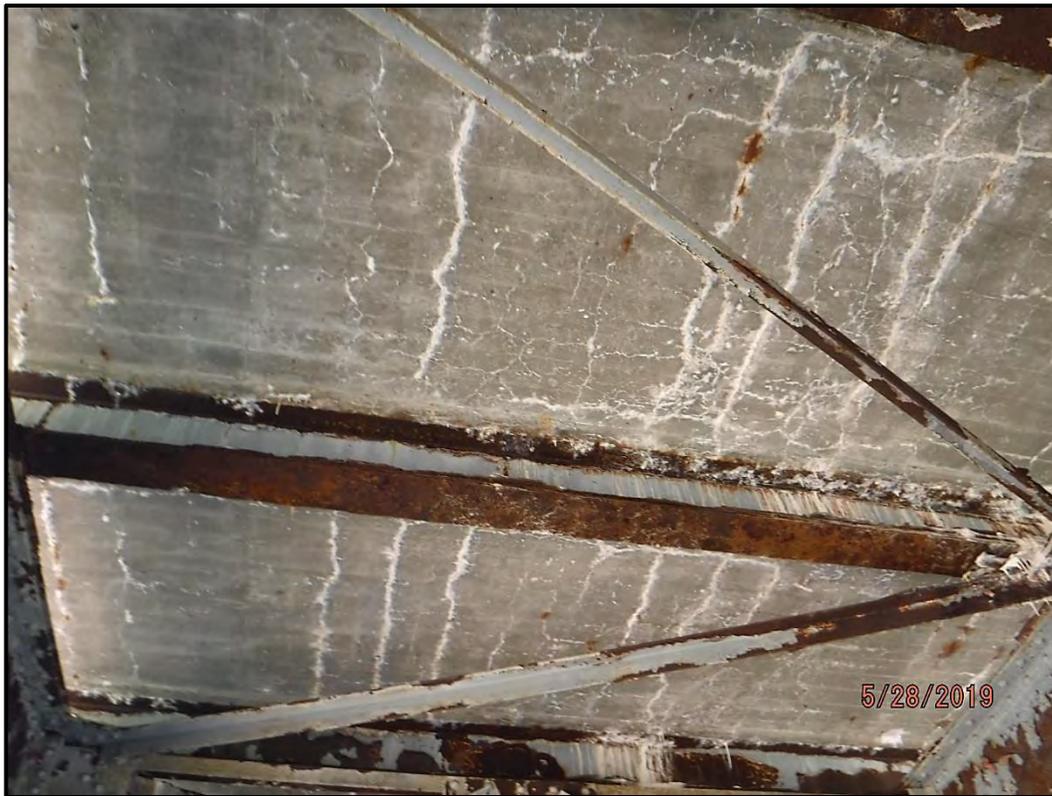
- The underside of the deck on all spans has widespread heavy map cracking with efflorescence and rust staining. The underside of the deck on the approach spans has more widespread cracking with heavier accumulation of efflorescence. (See Photos 12-3 through 12-5)

Photo 12-3: Heavy map cracking with efflorescence on the underside of the deck in Span 1.

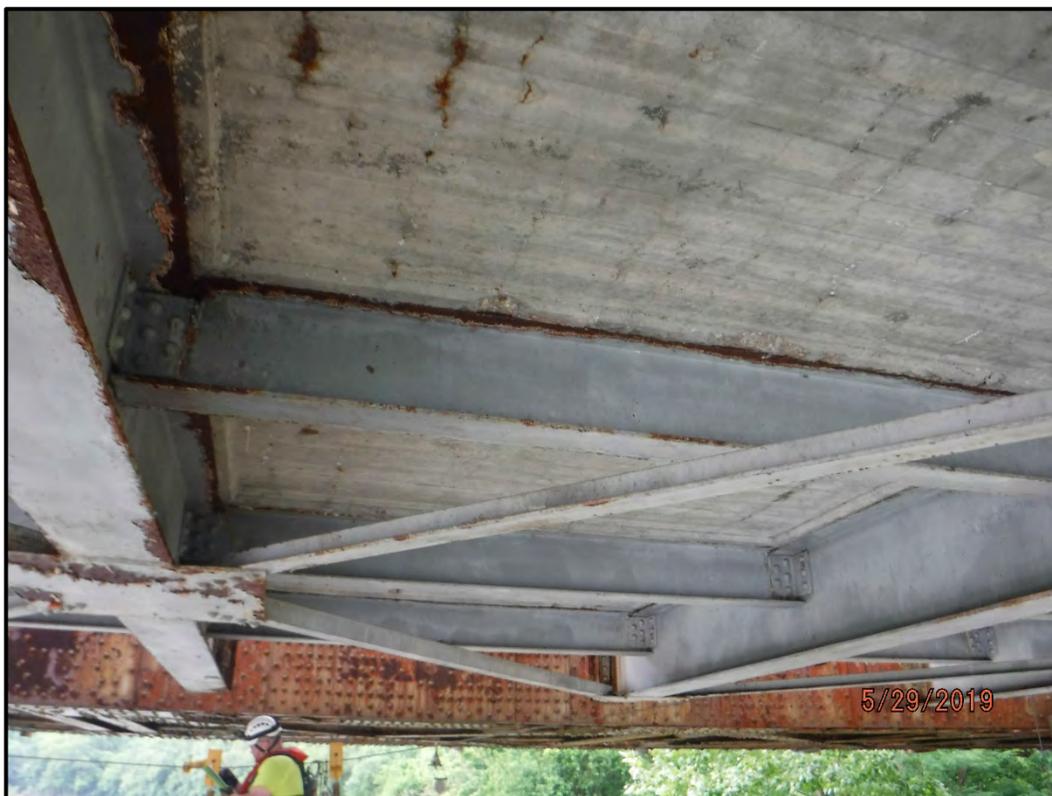
Photo 12-4: Map cracking with rust staining on the underside of the deck between FB 13 and FB 14 of Span 5.

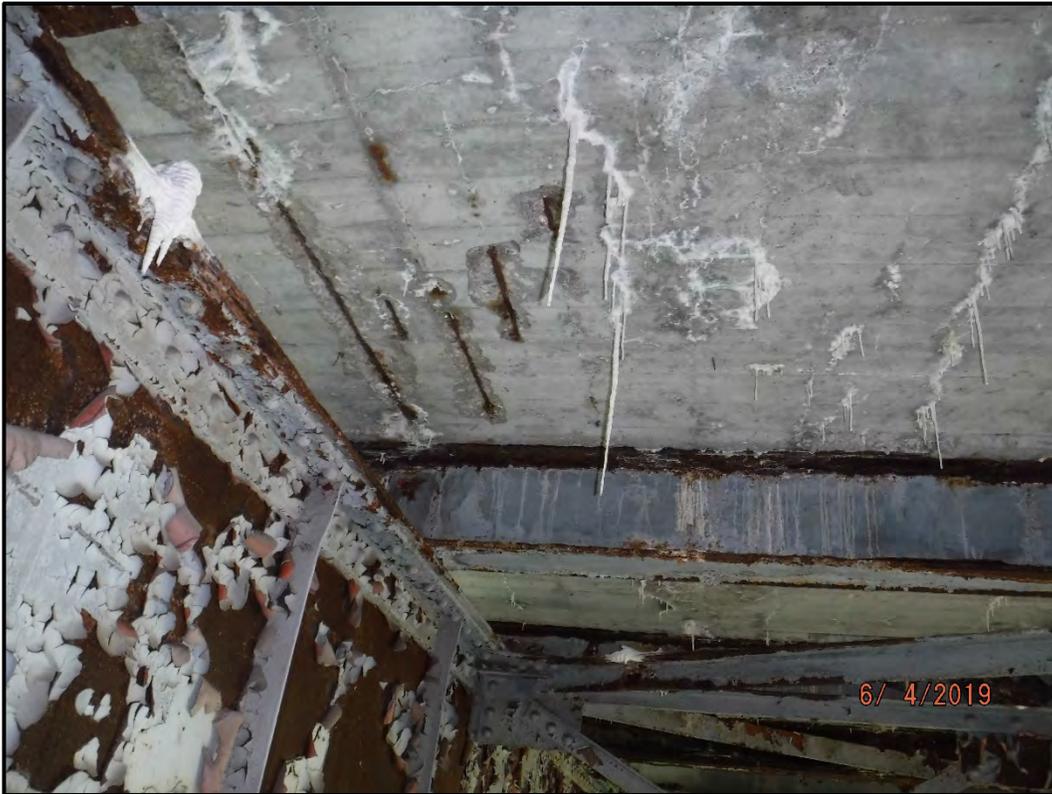
Photo 12-5: Heavy map cracking with efflorescence and exposed rebar on the underside of the deck in Span 6.

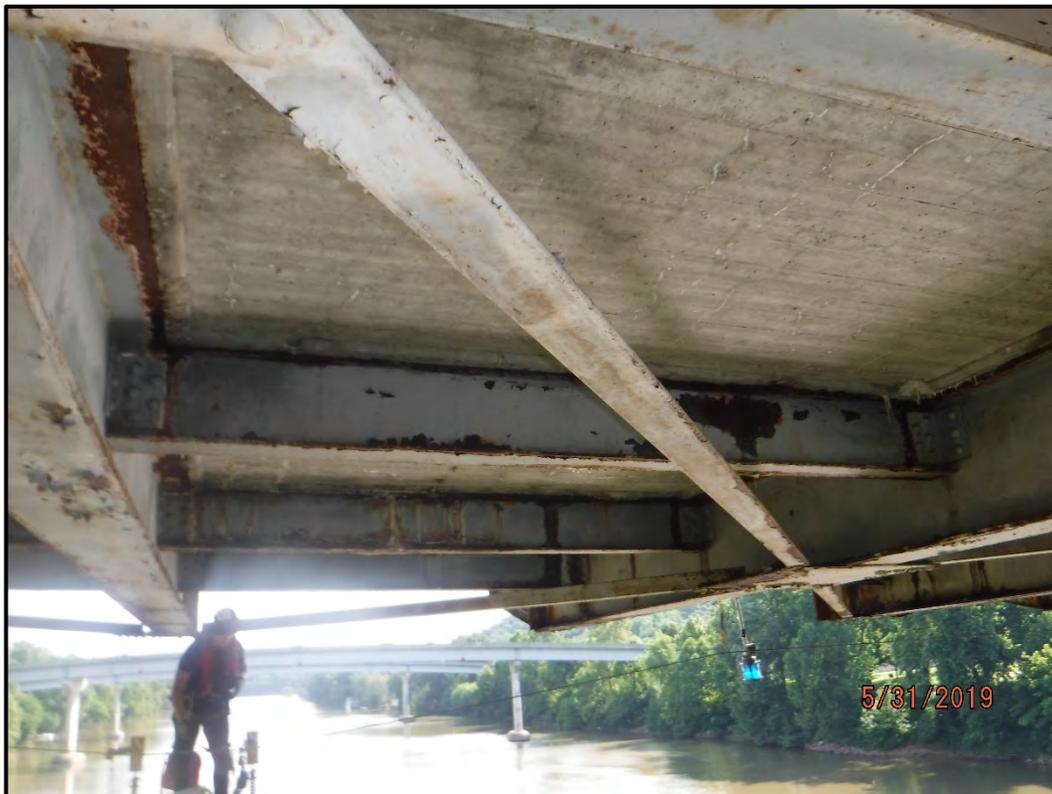
- Steel stringers are present in Span 5. The steel stringers are in “imminent” failure condition (NBI Rating is 1 out of 9).
- The protective coating has failed in many locations and active corrosion is widespread on the stringer webs and bottom flanges. The interior stringers show less deterioration than the fascia stringers. (See Photo 113-1)

Photo 113-1: Typical active corrosion of the truss stringers.

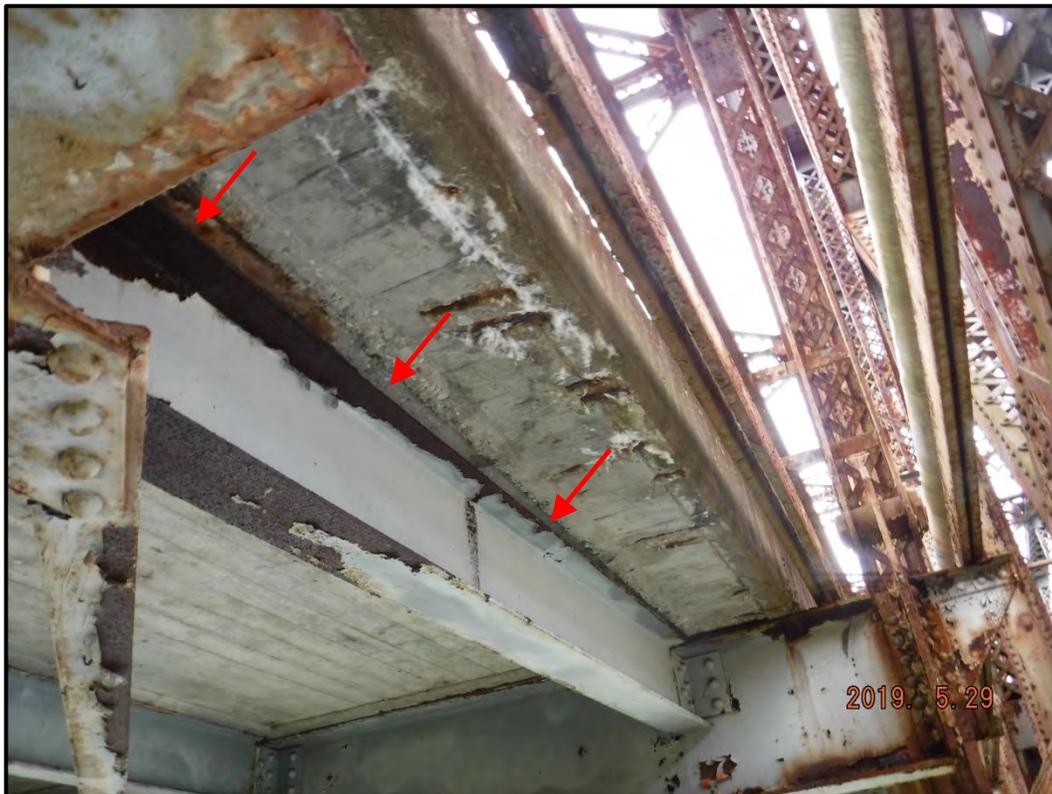
- Stringer 1 has failed at its connection to the east face of Floorbeam (FB) 12. The stringer has separated from the bridge deck and is only being supported as a cantilever by its connection to the west face of FB 11. (See Photos 113-2 and 113-3)

Photo 113-3: Stringer 1 has separated from the deck between FB 11 and FB 12 due to its failure adjacent FB 12. The stringer is only being supported as a cantilever by the connection at FB 11.

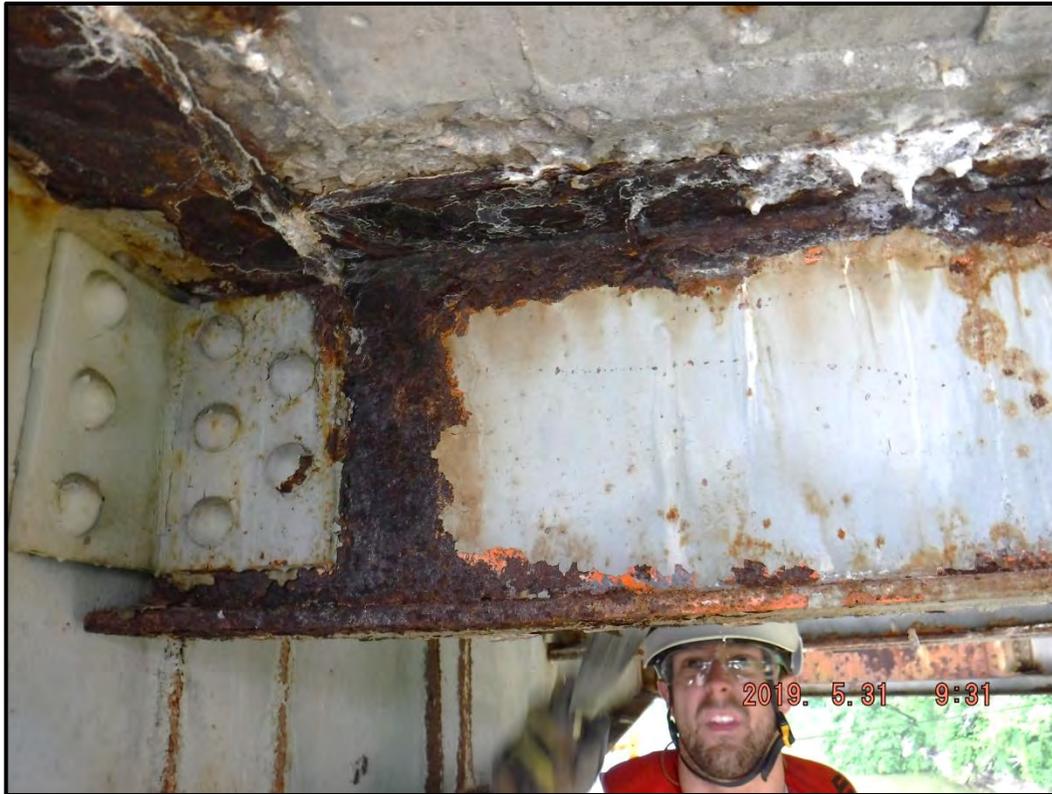
- There are locations of heavy laminar corrosion on the stringer bottom flanges and webs. This laminar corrosion is more prevalent on the fascia stringers, but the two interior stringers have isolated areas as well. (See Photos 113-4 through 113-6)

Photo 113-4: Heavy laminar corrosion of Stringer 4 at the connection to the west face of FB 10.

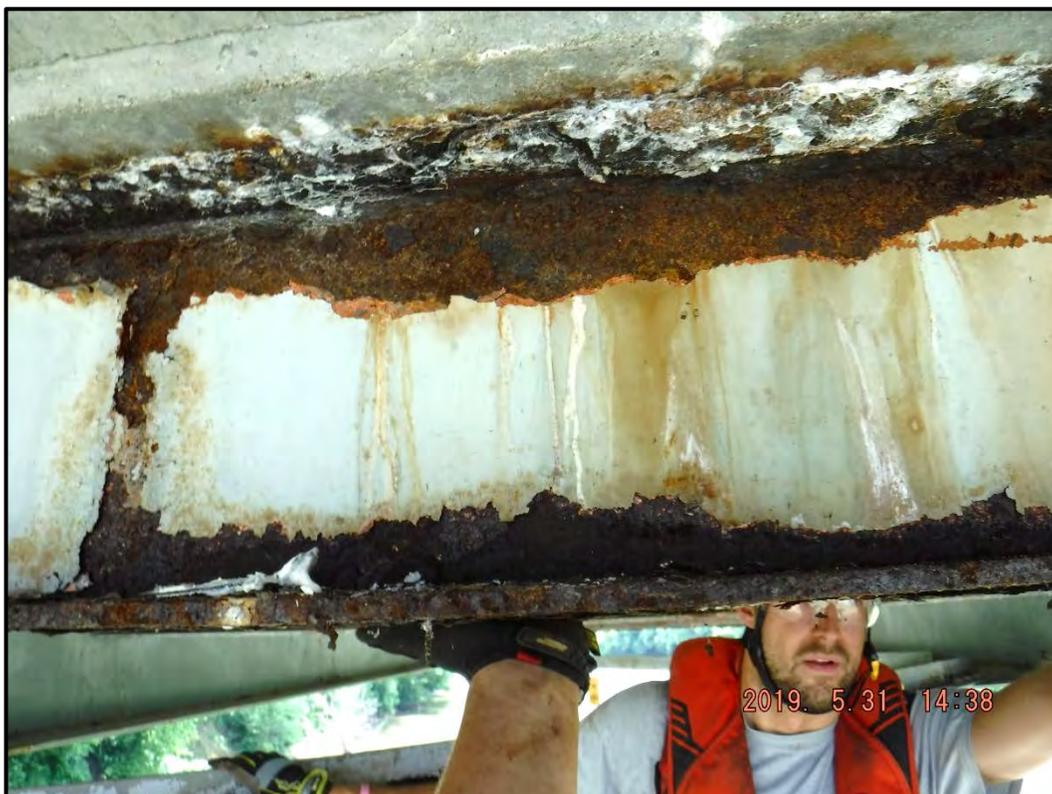
Photo 113-5: Section loss of the Stringer 4 web (0.3'' thickness remains out of 0.305'') and heavy corrosion of both flanges mid-span between FB 2 and FB 3.

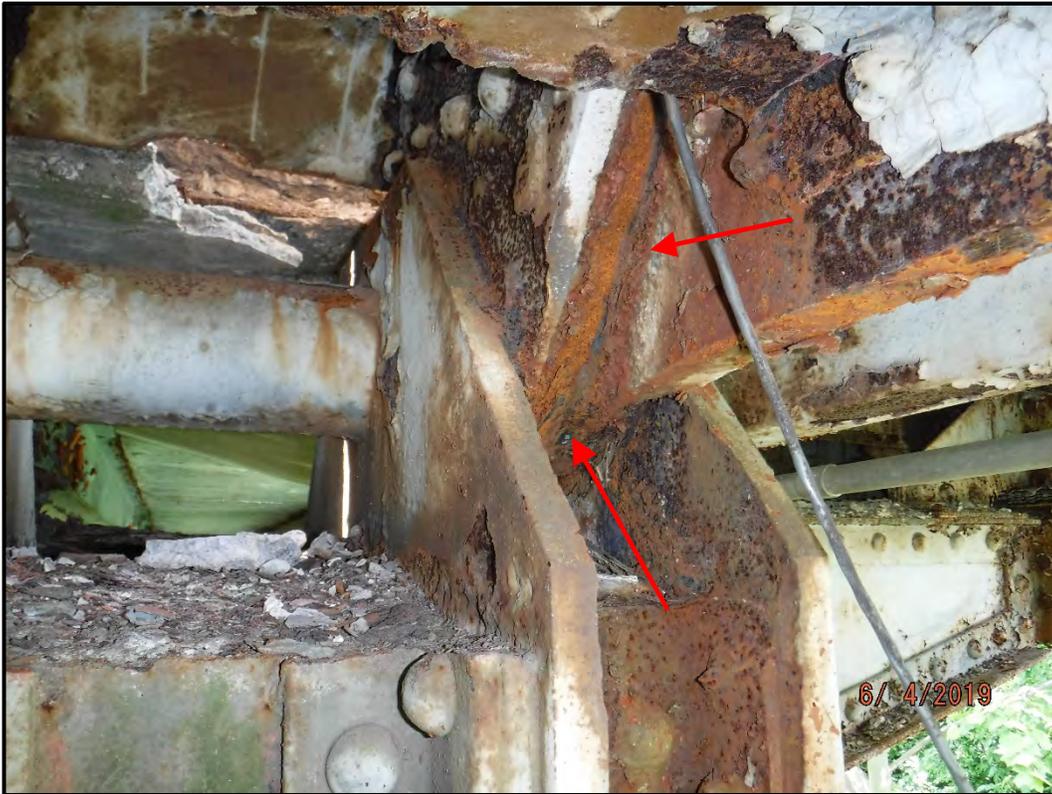
Photo 120-11: 15% section loss of the outboard eyebar head at panel point L16 on the downstream truss. The inboard eyebar is in similar condition.

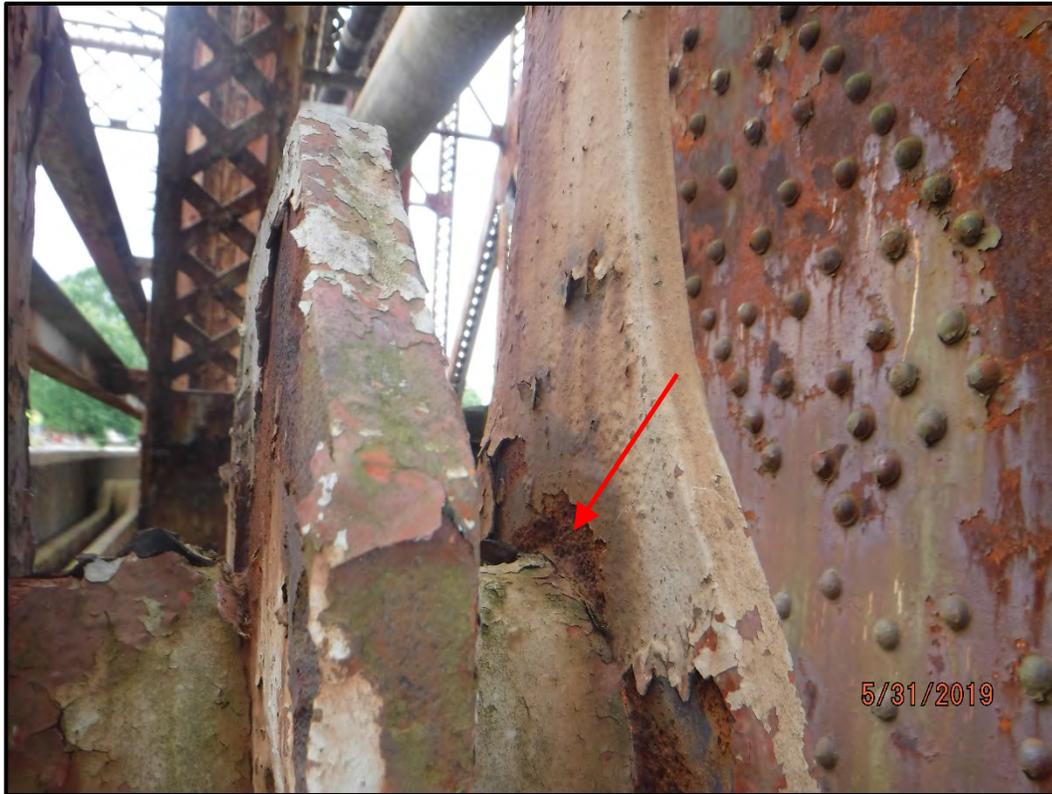
Photo 120-13: Active corrosion and pitting on the eyebar head at panel point L7 on the upstream truss. 9/16" out of 3/4" thickness remains.

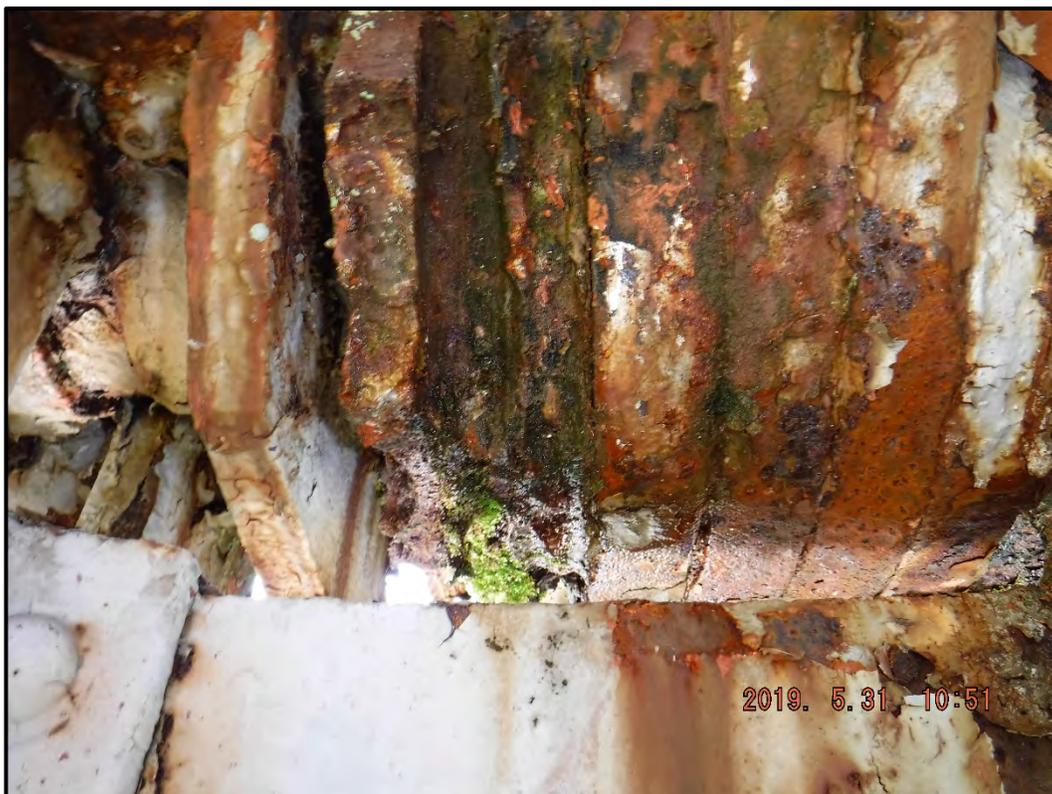
Photo 120-14: Pack rust and section loss on the lower chord pin connection at L8 on the downstream truss.

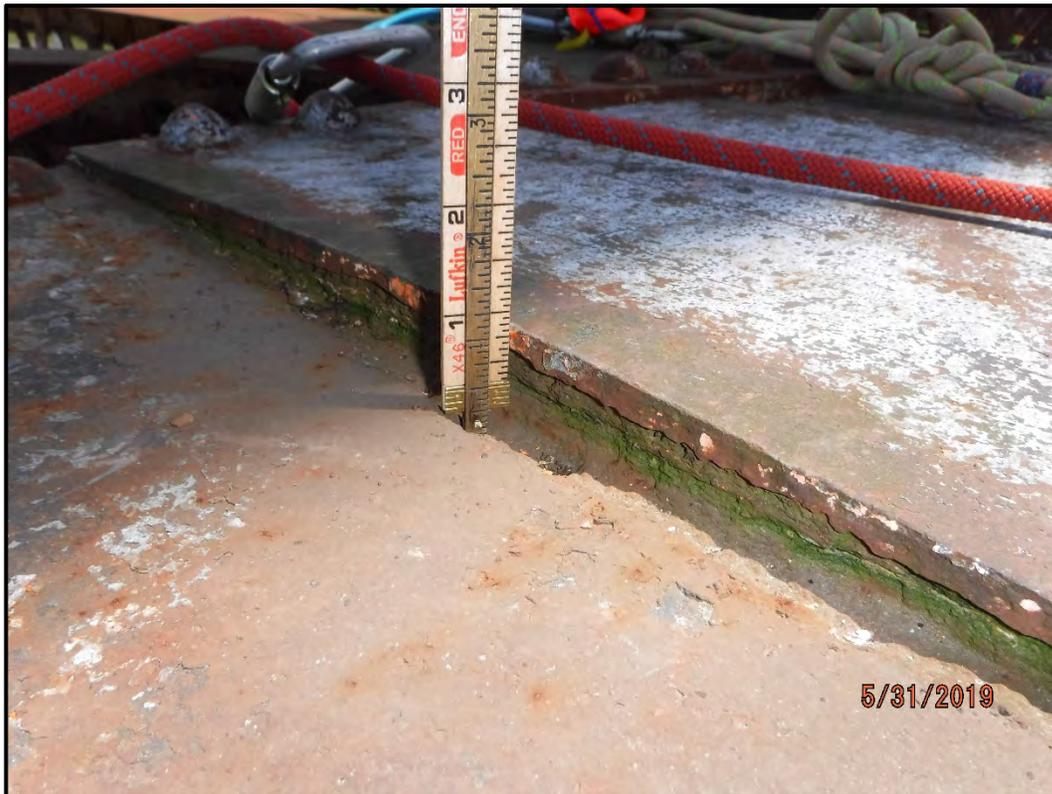
- 9/16” pack rust is typical between the upper chord top flange plate and the horizontal splice plate along with 1/4” pitting of the top flange plate at this location. (See Photo 120-23)

Photo 120-23: Typical 9/16" pack rust and 1/4" pitting of the upper chord along the top flange splice plate at panel point U8 on the upstream truss.

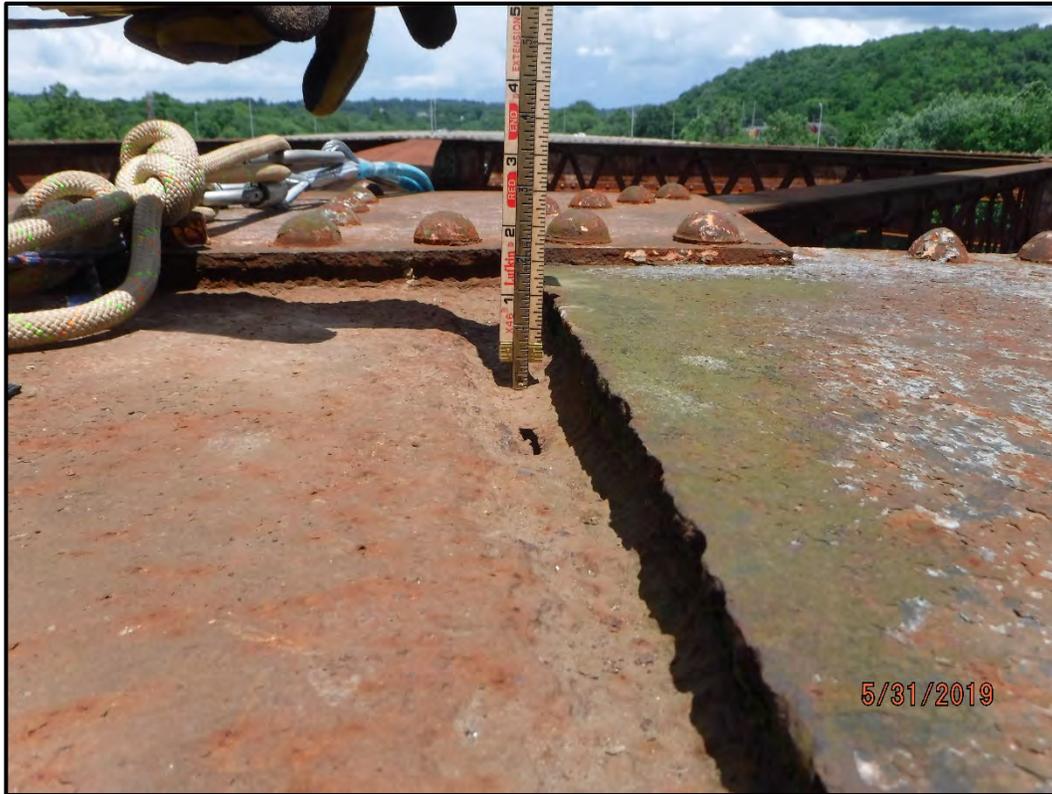
- corrosion hole within this pitting. The nominal thickness of the top flange plate is 1/2" and this is the worst location of pitting on the top flange plate. (See Photos 120-24 and 120-25)

Photo 120-25: Close-up of Photo 120-24.

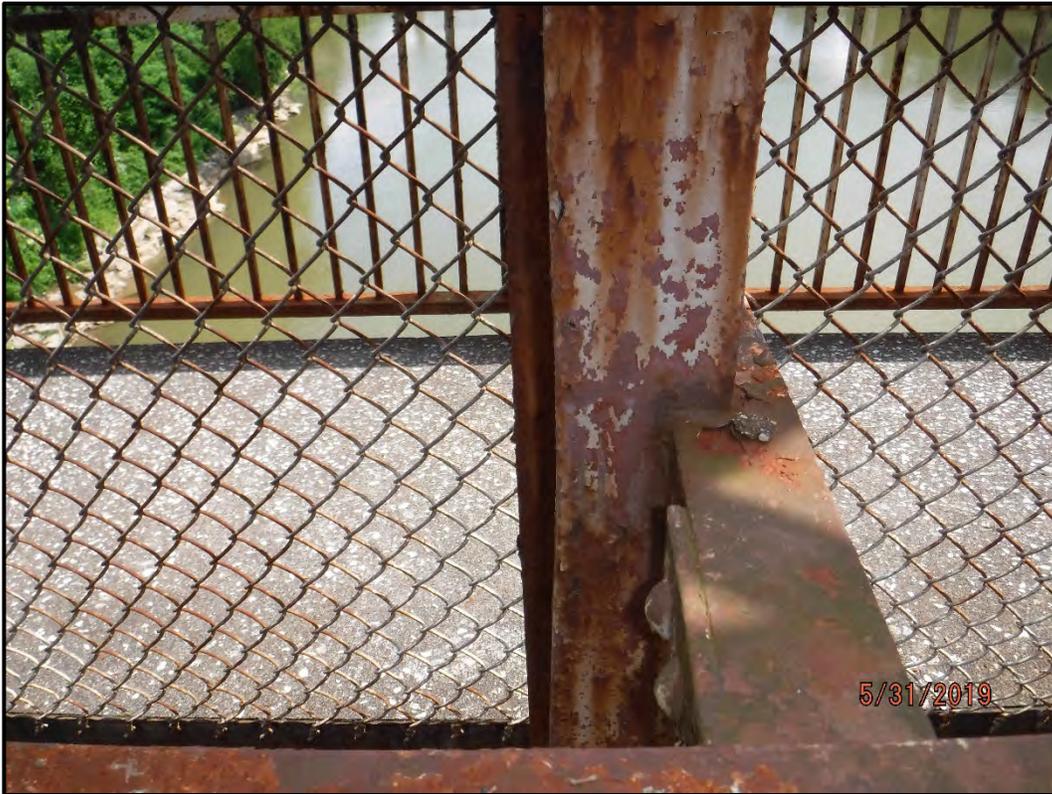
- The inboard eyebar of downstream member L11-M11 is distorted 1 1/2" to the east at the traffic rail welded connection (which is a fatigue-prone detail in and of itself). MT was performed and there were no crack indications. (See Photos 120-33 and 120-34)

Photo 120-33: Impact damage has distorted the inboard eyebar of downstream truss member L11-M11 1 1/2" to the east at the traffic rail welded connection (which is a fatigue-prone detail in and of itself).

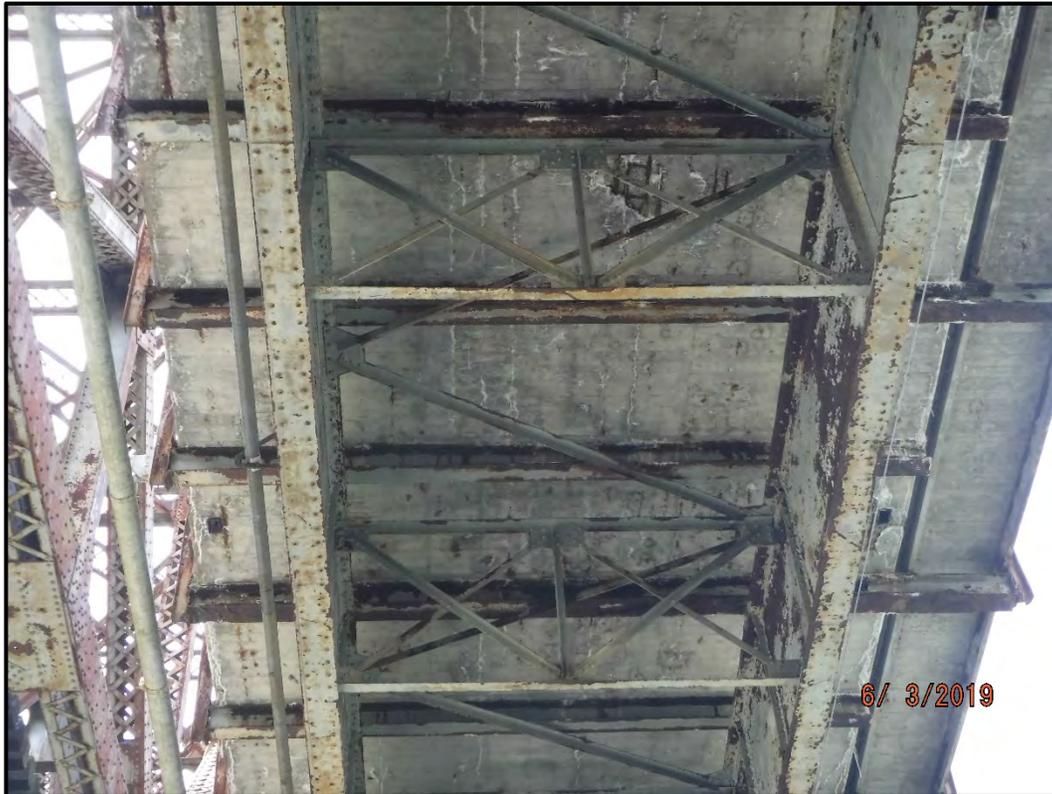
Photo 152-3: Typical active corrosion of the floorbeams. The floorbeams in Span 3 are shown.

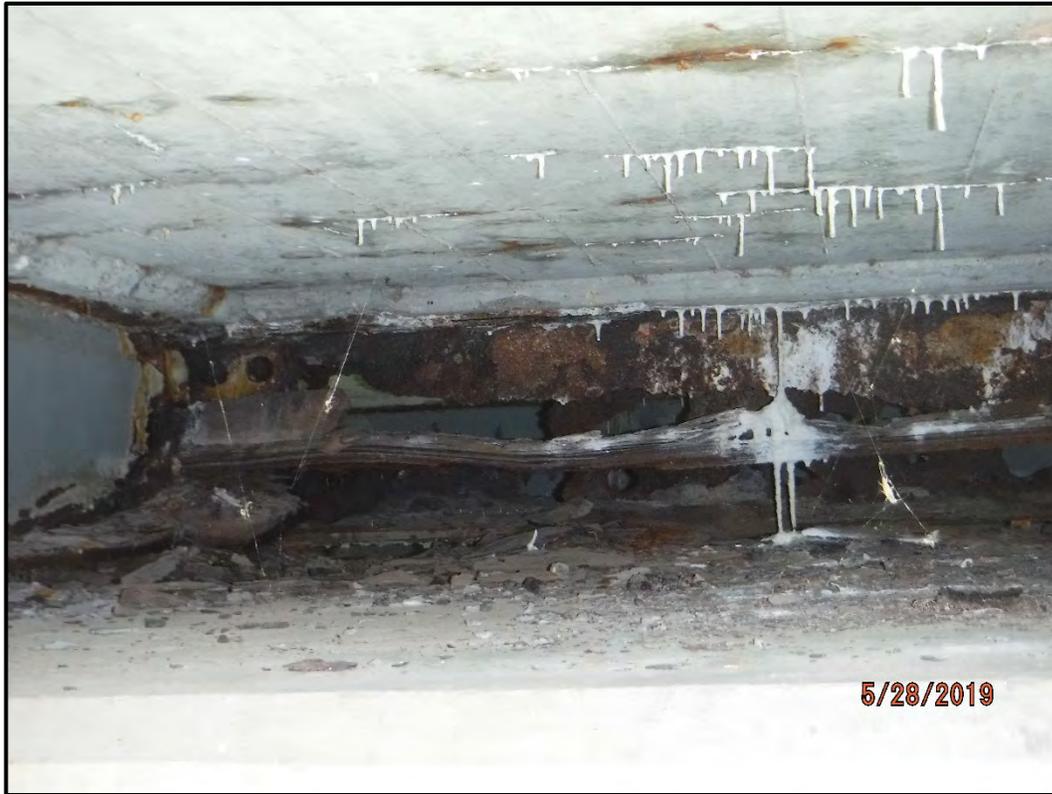
- Floorbeams 0 and 16 have severe active corrosion, and the members are severely deteriorated with failure imminent. (See Photos 152-4 and 152-5)
- The upstream end of Floorbeam 1 has active corrosion with section loss up to 100% in the web. (See Photo 152-6)
- The downstream end of Floorbeam 4 has 100% section loss in the web and heavy corrosion extending onto the bottom flange. (See Photo 152-7)
- Floorbeams 4, 9, 12, and 13 all have active corrosion with section loss on the top flange adjacent to the fascia stringers. The remaining section ranges from 0.25"-0.475". (See Photo 152-8).
- Floorbeams 4, 5, 7, 8, 12, 14 have web pitting with section loss. The remaining section ranges from 0.1875"- 0.5. (See Photo 152-9)
- Floor beams 4, 8, 10, and 15 have bottom flange section loss with 0.3125"-0.5" remaining on the bottom flange. (See Photo 152-10)

Photo 152-5: Floorbeam 16 of the truss span is severely deteriorated with failure imminent.

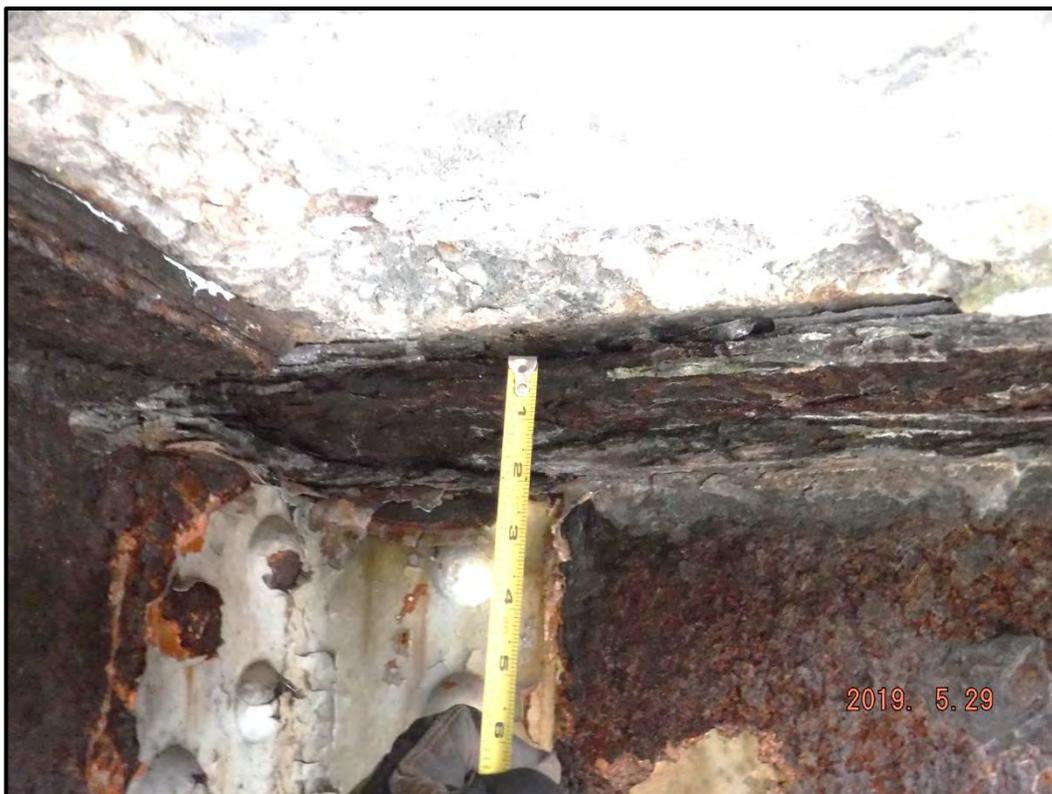
Photo 152-8: There is active corrosion with section loss of the top flange and web of Floorbeam 1 adjacent to Stringer 1. There is 0.25" remaining thickness of the top flange and 0.36" remaining thickness of the web.

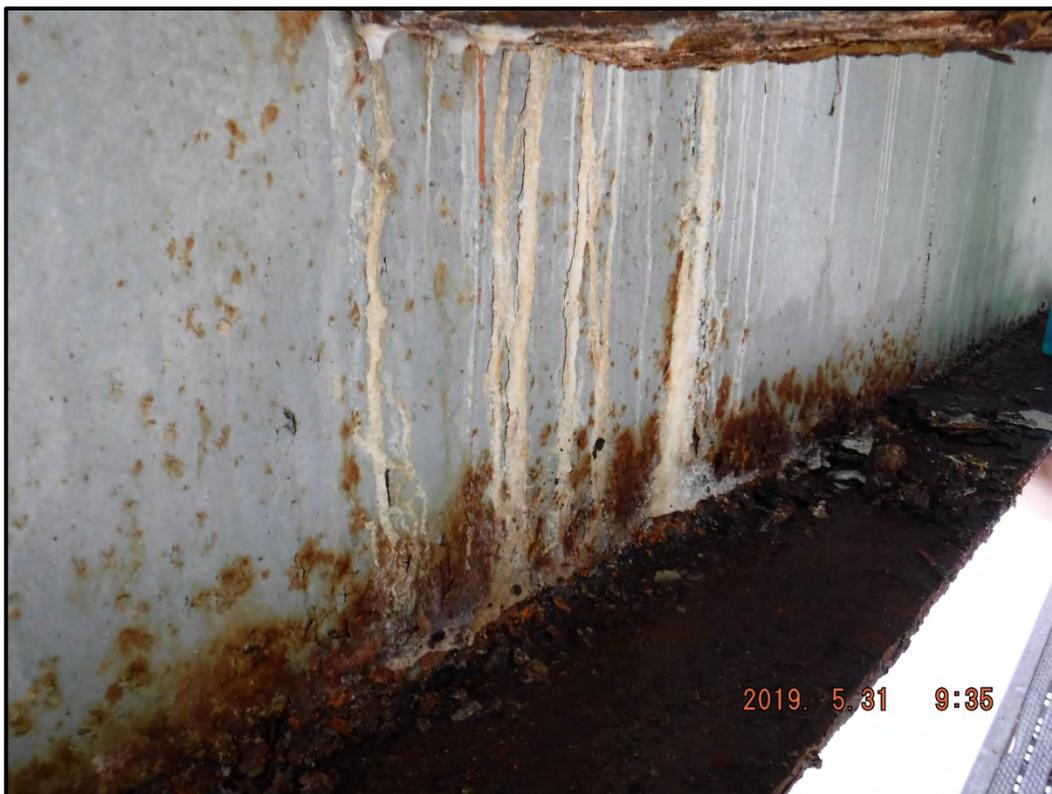
Photo 152-10: There is efflorescence and active corrosion on the web and bottom flange of Floorbeam 10 under Stringer 4. There is 0.4" remaining on the bottom flange.

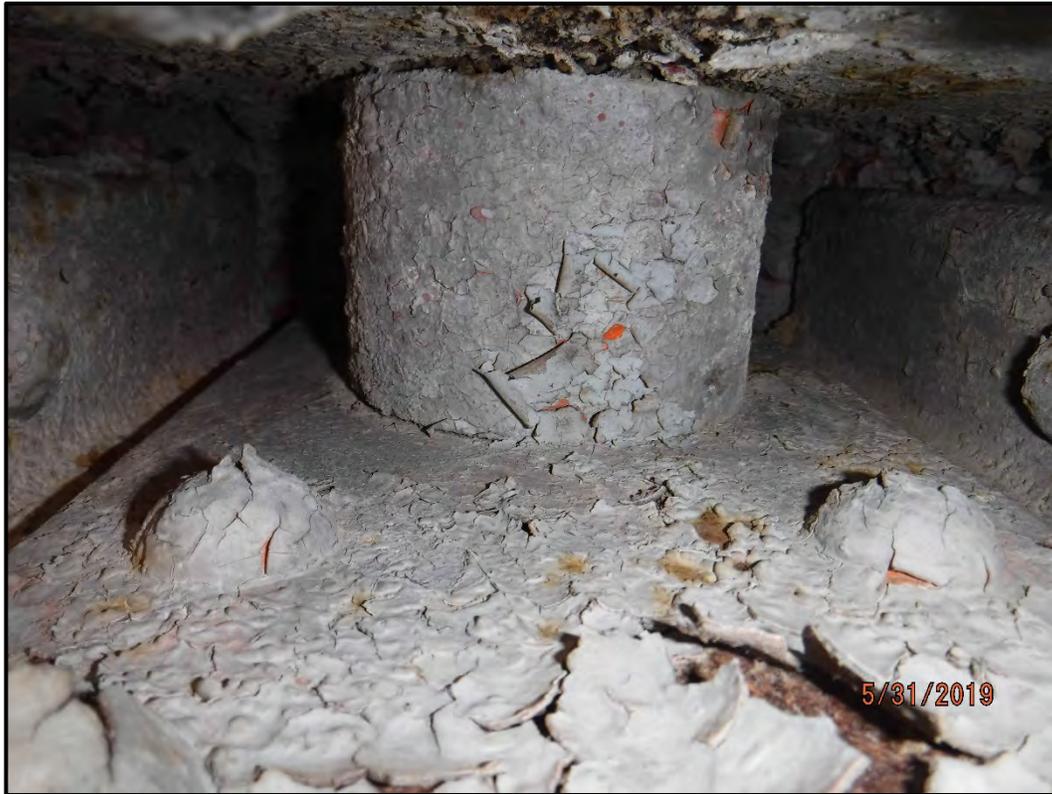
Photo 161-3: Typical upper chord pin and collar. Note there is less corrosion than the mid-height and lower chord panel points.

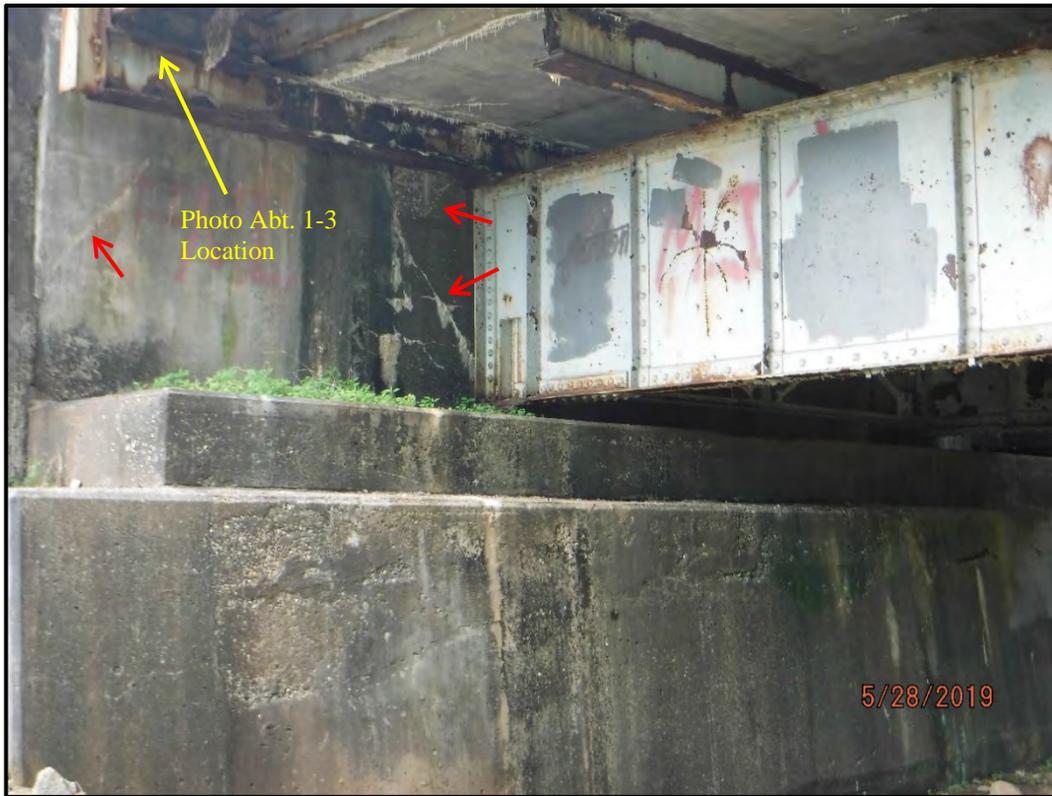
Photo Abt. 1-2: Cracking with heavy efflorescence and spalling in the Abutment 1 backwall behind Girder 2. Note the scaling on the face of the abutment.

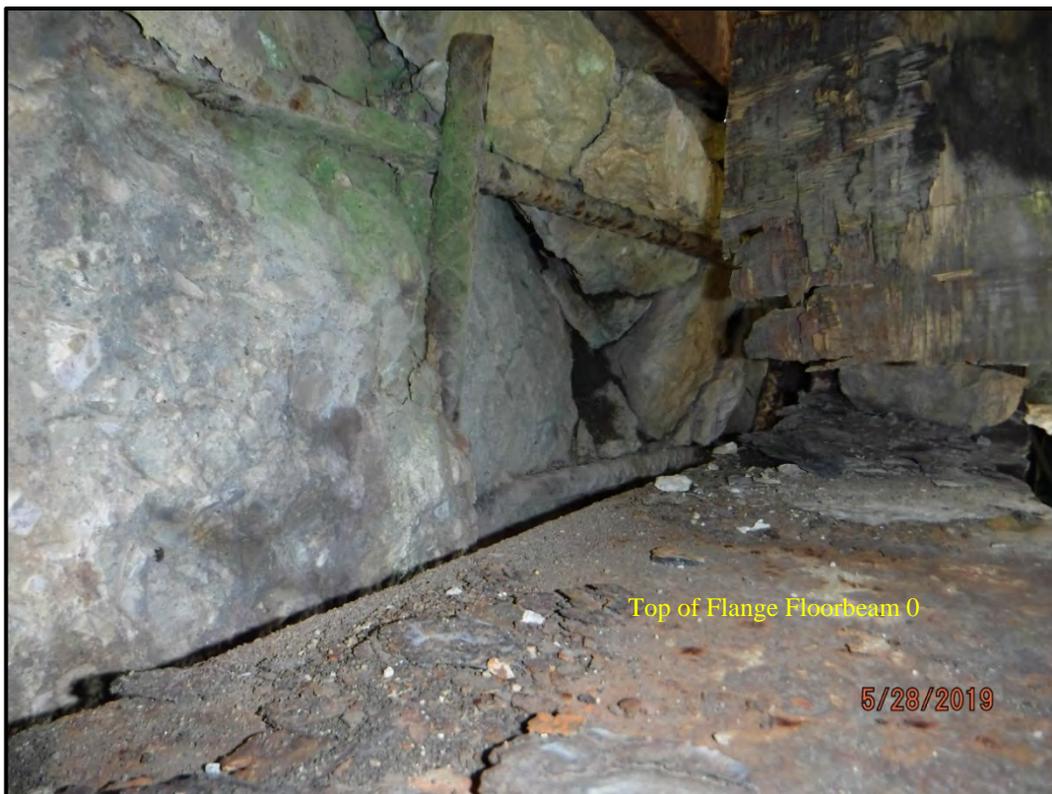
Photo Abt. 1-3: Spalling with exposed reinforcement at the top of the Abutment 1 back-wall on the exterior face of Girder 2.

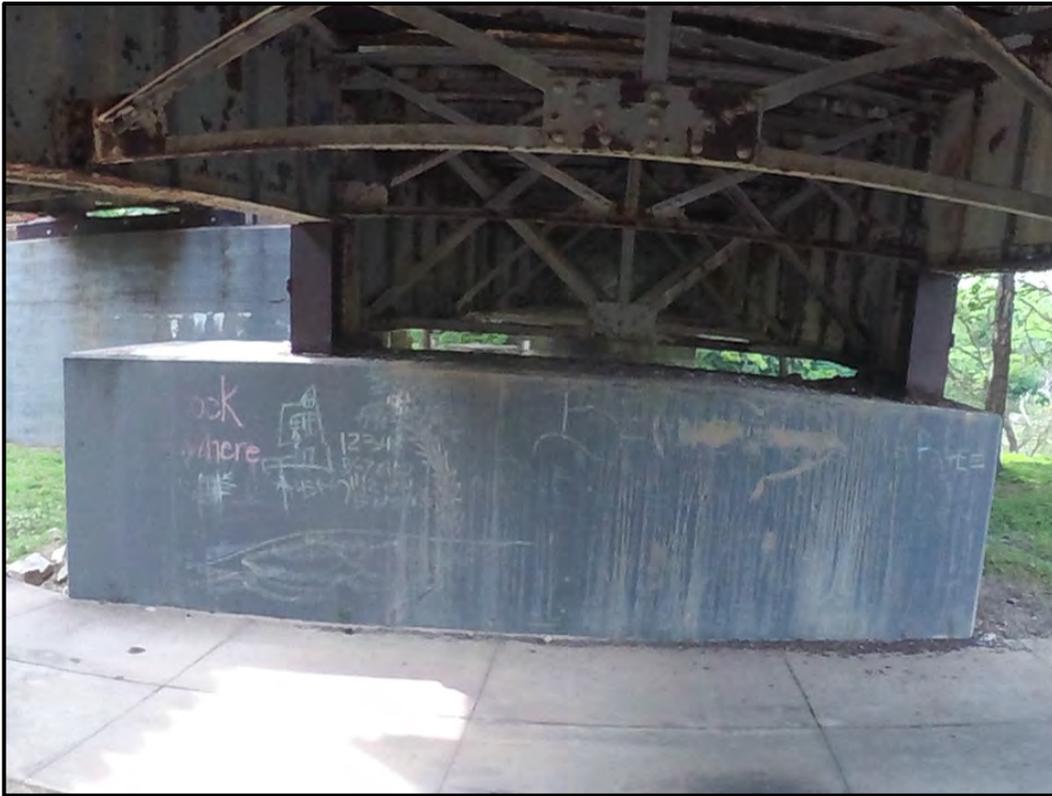
Photo P2-1: East face of Pier 2. Only minor deterioration is present.

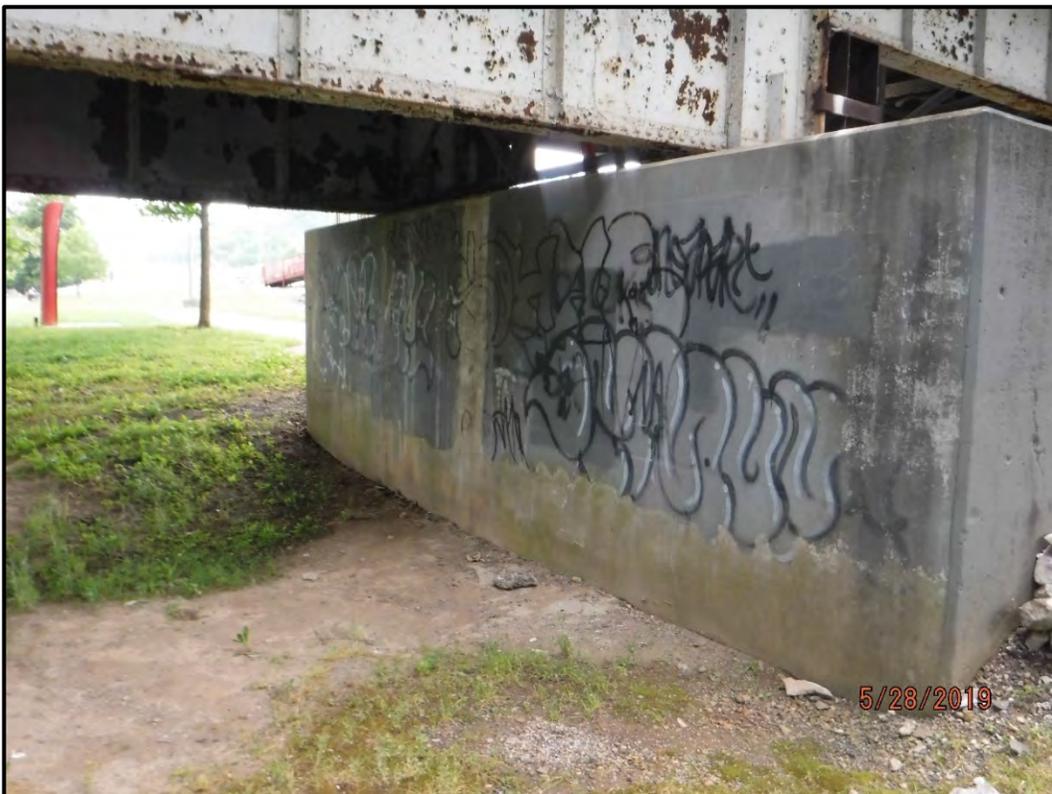
Photo P2-2: West face of Pier 2. Only minor deterioration is present.

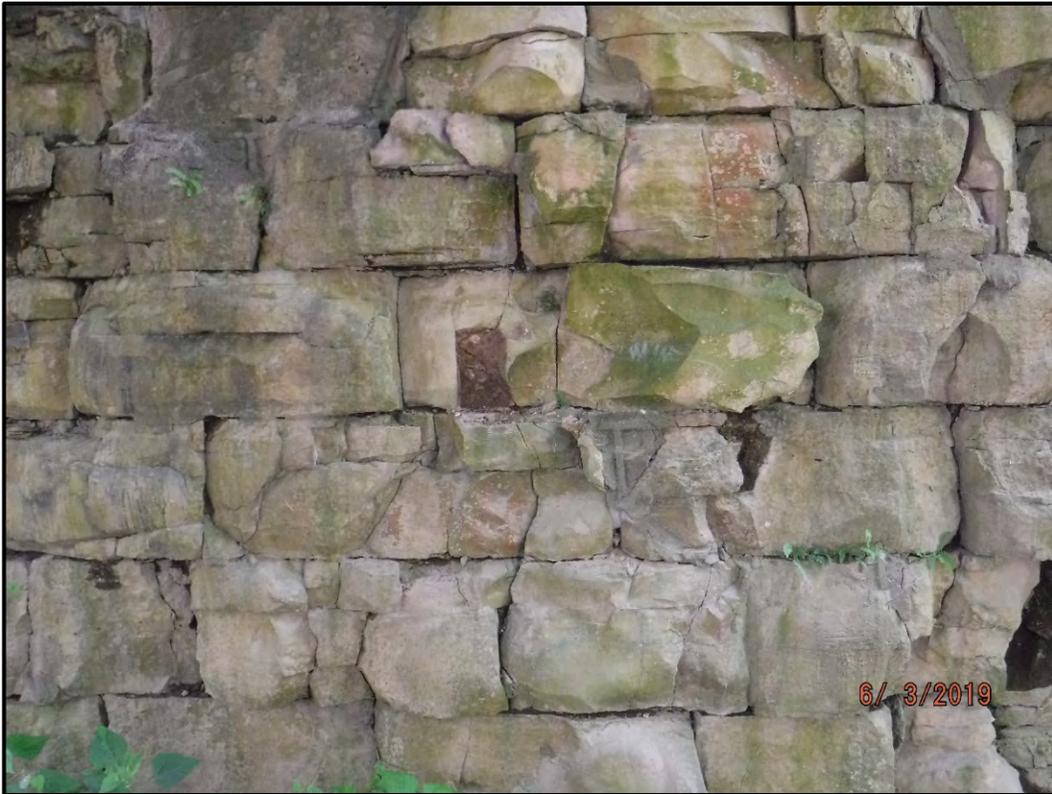
Photo P3-3: Close-up of the typical masonry cracking and heavy deterioration of the mortar on the north end of the Pier 3 east face.

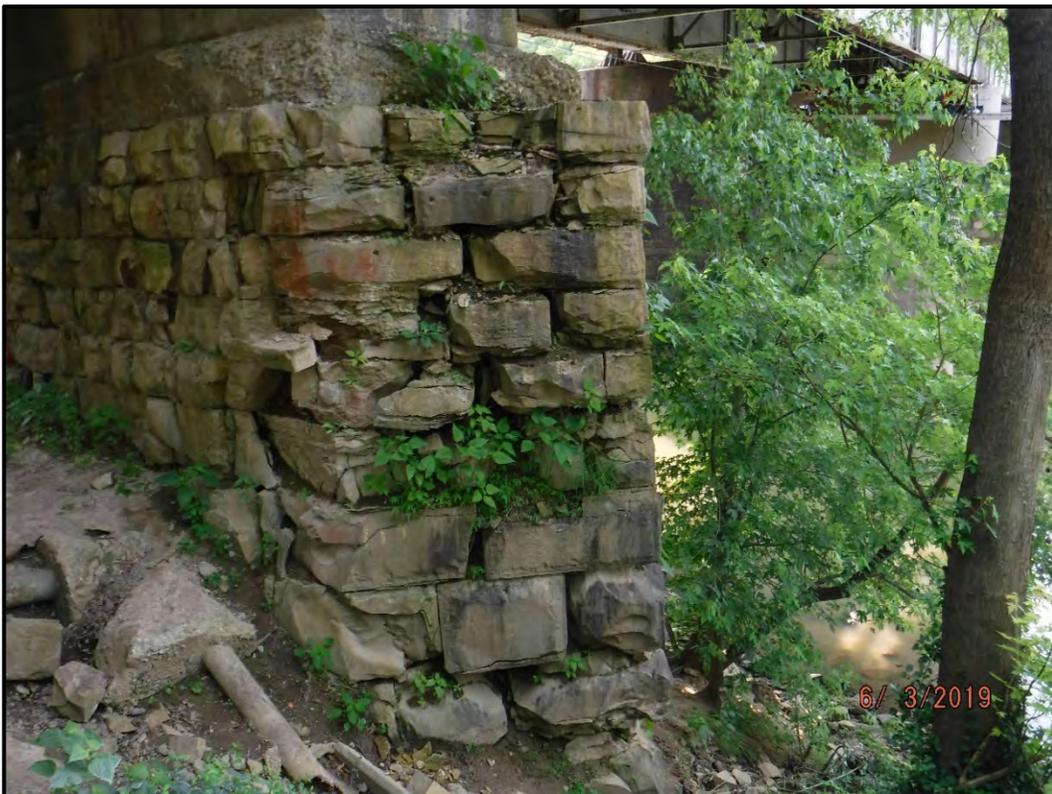
Photo P3-4: Northeast face of Pier 3. Note the heavy cracking and voids that are 3in wide and up to 2.5ft deep.
