August 31, 2019

**Re: Broadway Bridge (KY 3506) over Kentucky River
 Bridge No. 037B00066N
 Frankfort, Kentucky
 In-Depth Bridge Inspection Report**

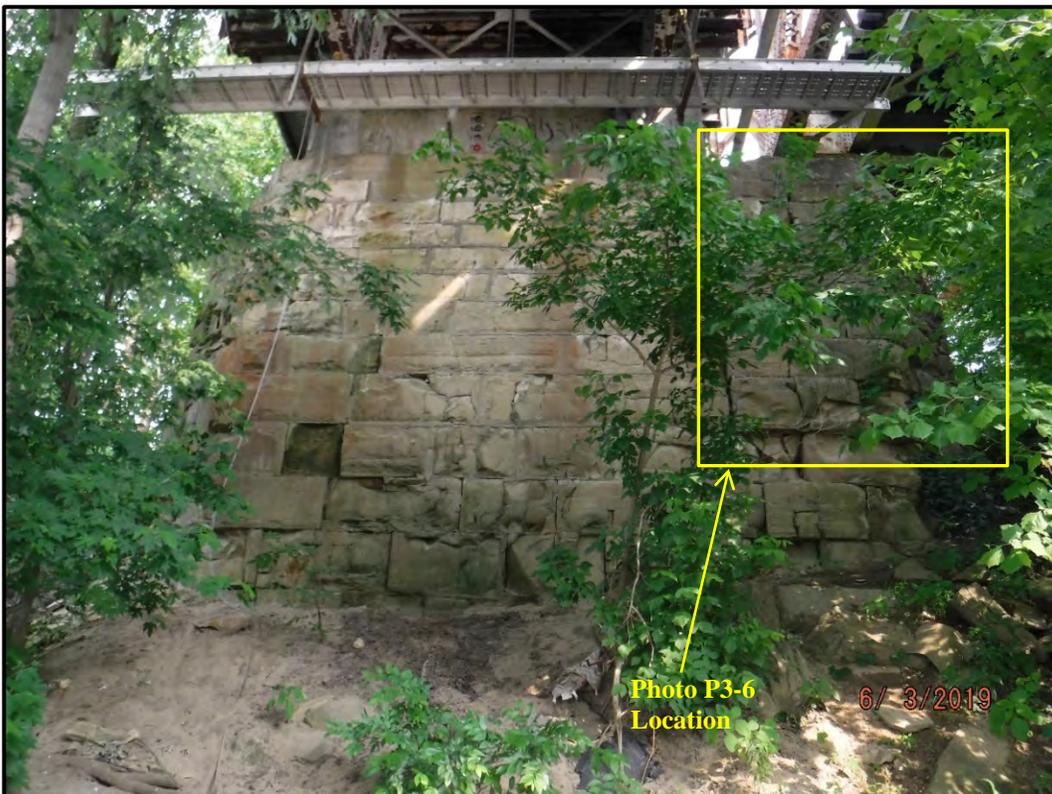
Photo P3-6: West face of Pier 3. Note the heavy cracking and deterioration of the bottom 8ft and exterior of the concrete beam seat. The top 10ft directly under the concrete beam seat is in fair condition with minor cracking.

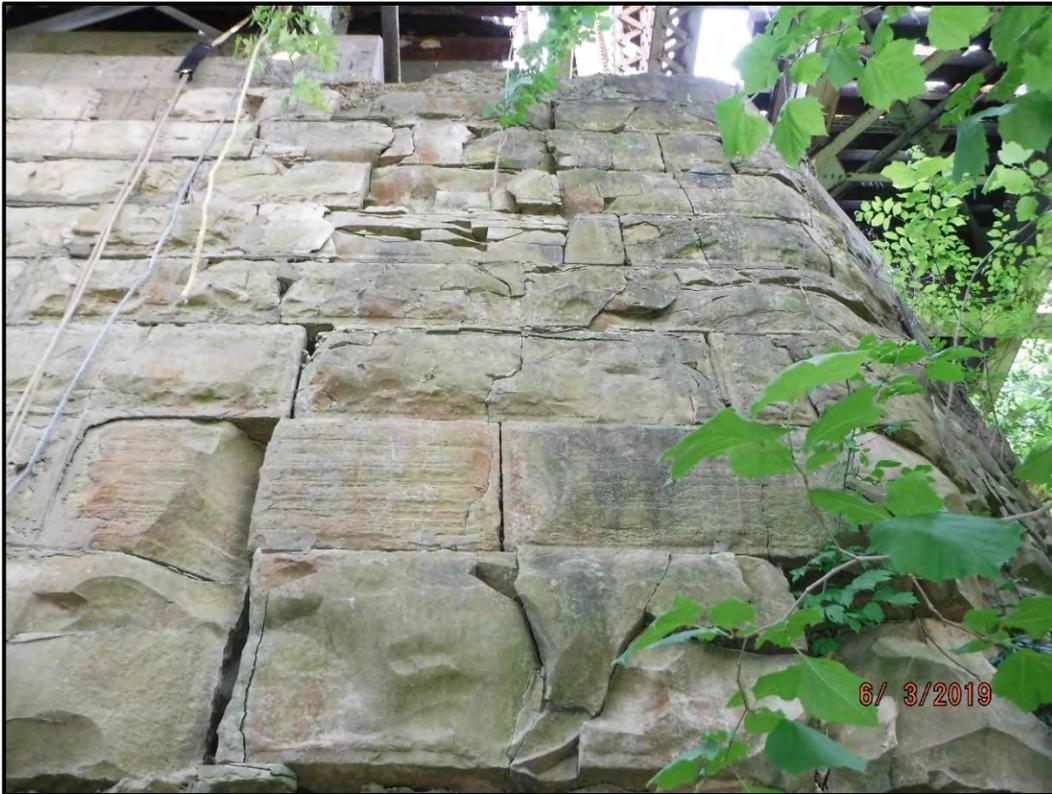
Photo P3-7: Close-up of the typical heavy masonry cracking and deterioration of the mortar on the south end of the Pier 3 west face. Note the higher concentration of cracking in the top 8ft that is exterior of the concrete beam seat.

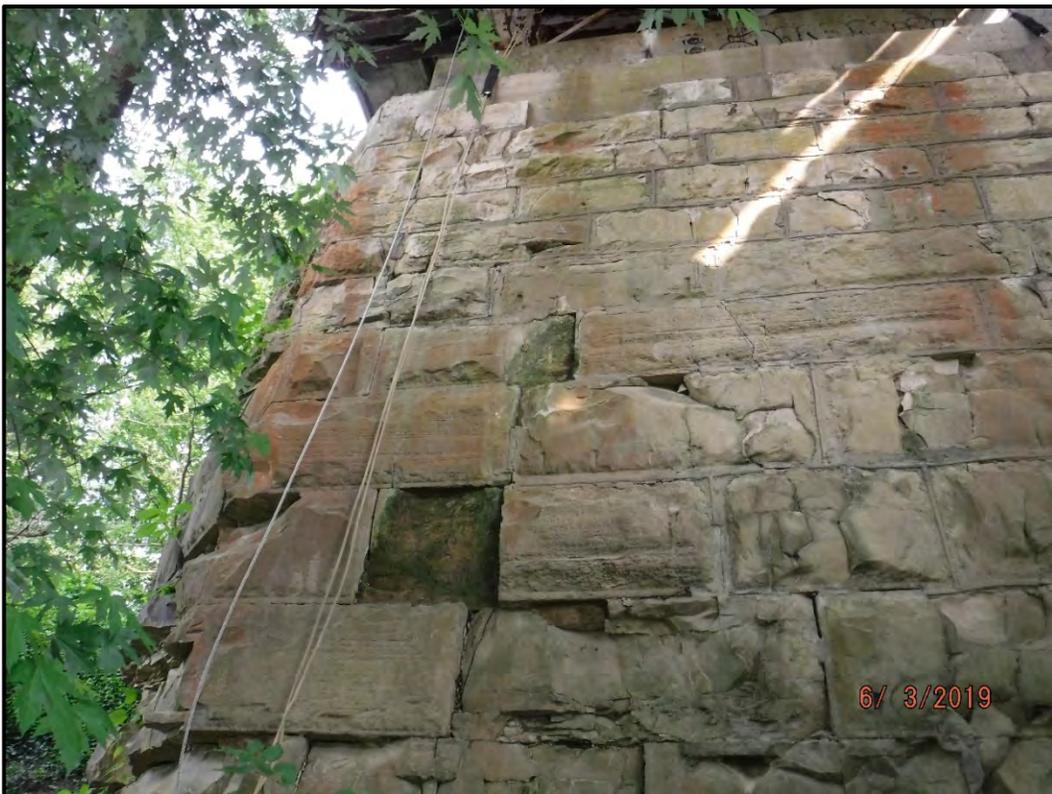
Photo P3-8: Minor to moderate cracking and delamination on the north end of the Pier 3 west face. Note the higher concentration of cracking exterior of the concrete beam seat.

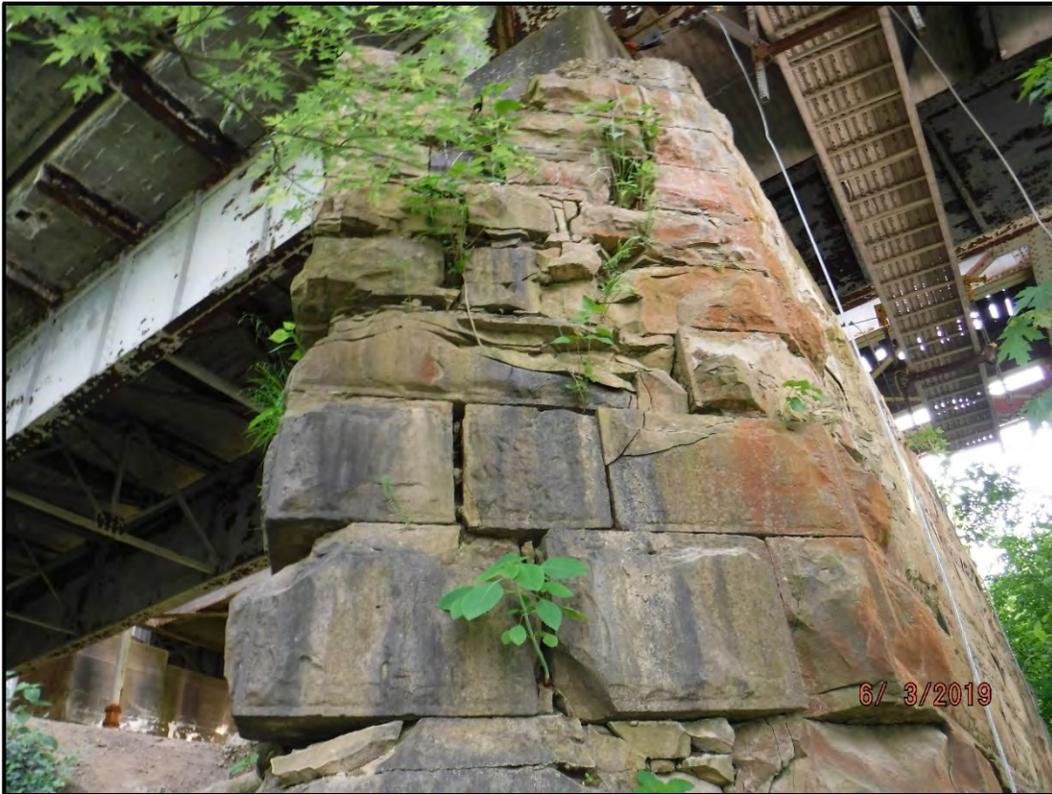
Photo P3-9: Northwest face of Pier 3. With heavy cracking and delamination throughout. Note the vegetation growing in the voids.

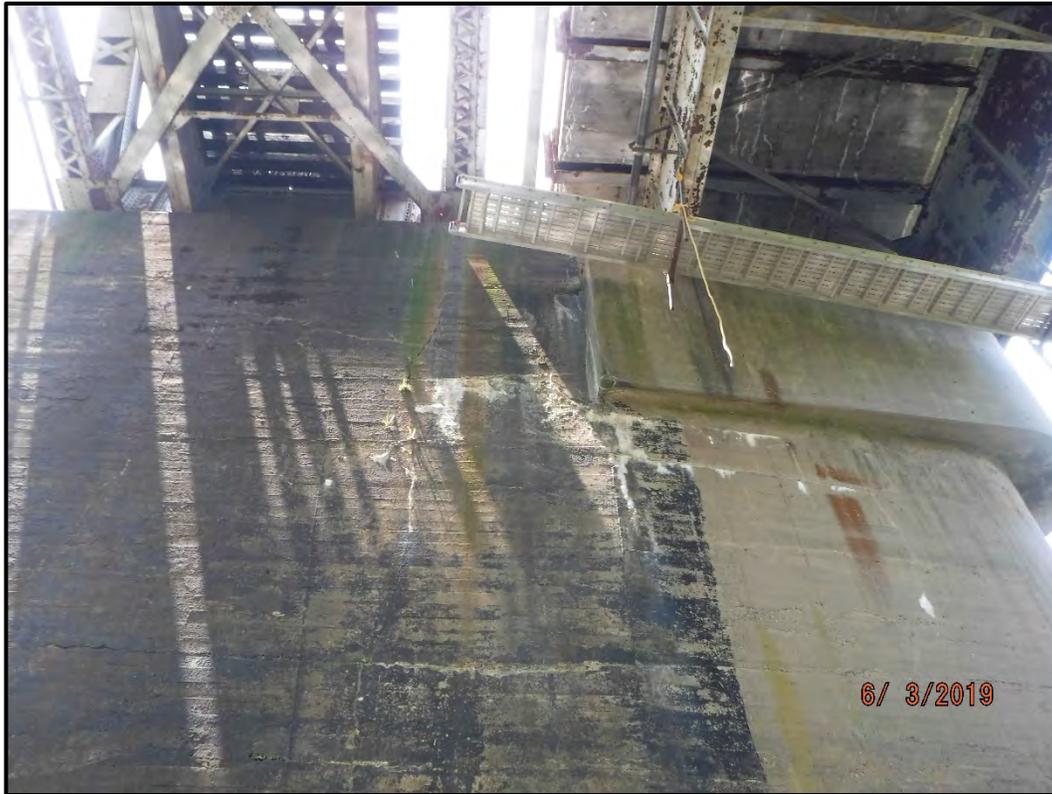
Photo P4-2: Close-up of the cracking with heavy efflorescence on the east face of Pier 4 under the pier cap. Notice the horizontal cracking is consistent with the masonry joints that are encased in concrete.

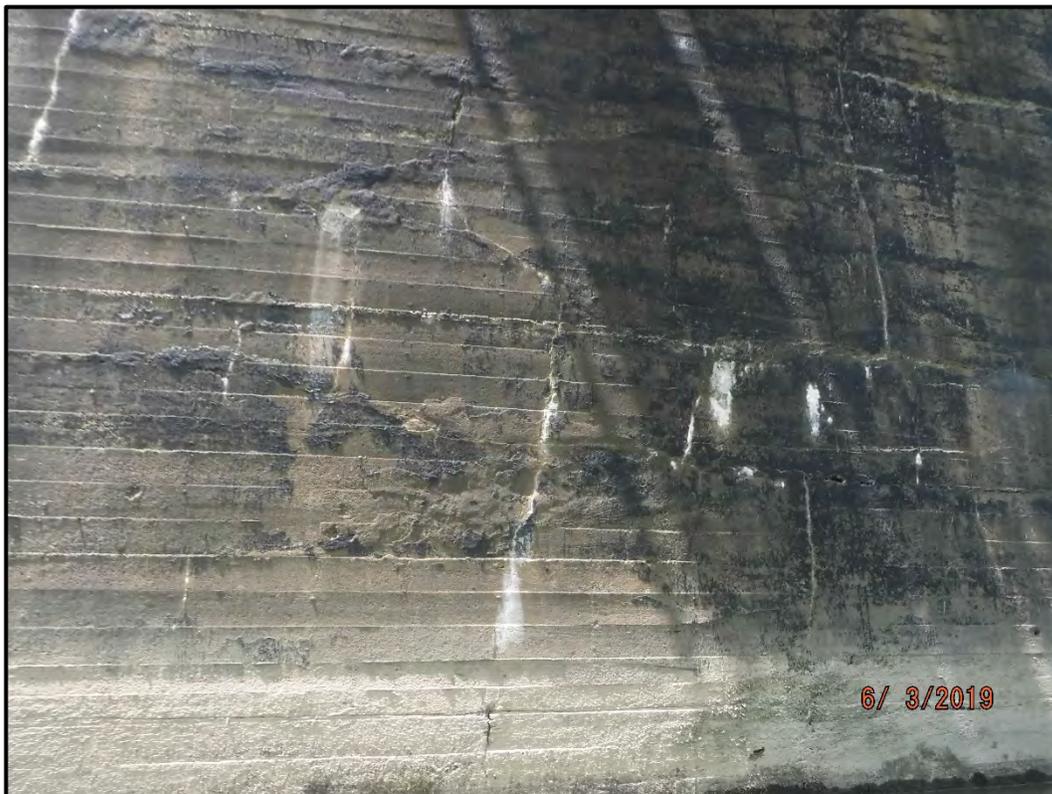
Photo P4-3: Close-up of the cracking with efflorescence on the south end of the Pier 4 east face.

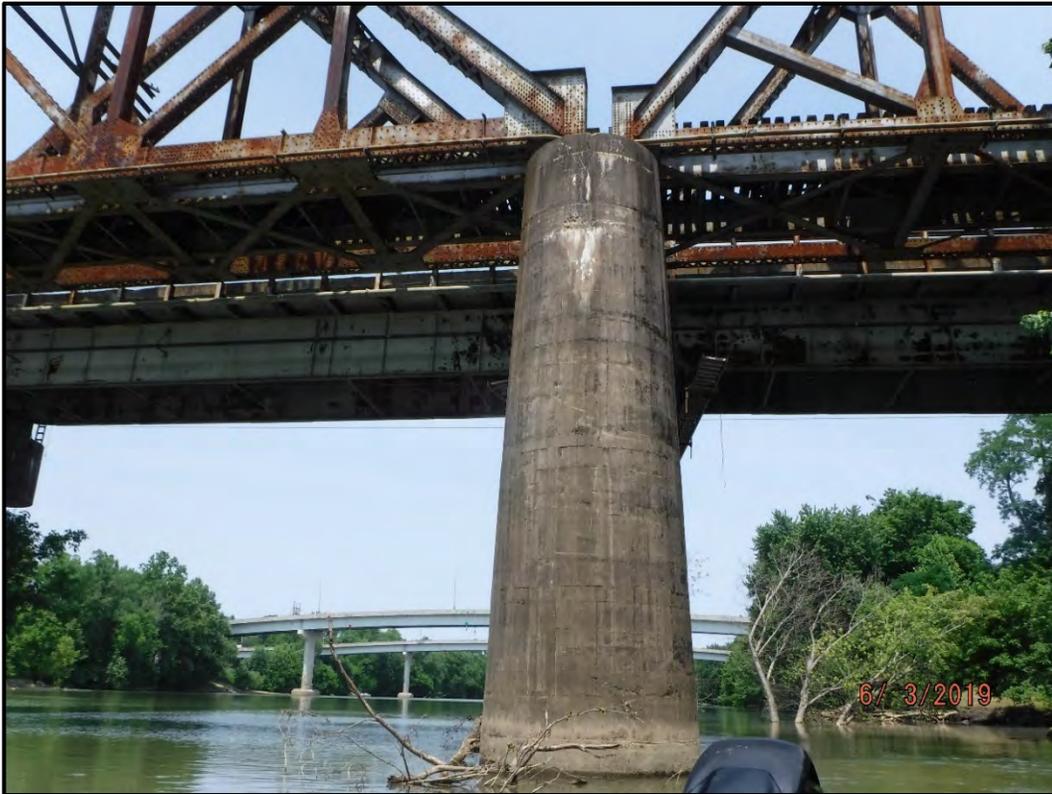
Photo P4-4: South face of Pier 4. Note the cracking with heavy efflorescence near the top of the pier and the debris collected on the upstream face of the pier.

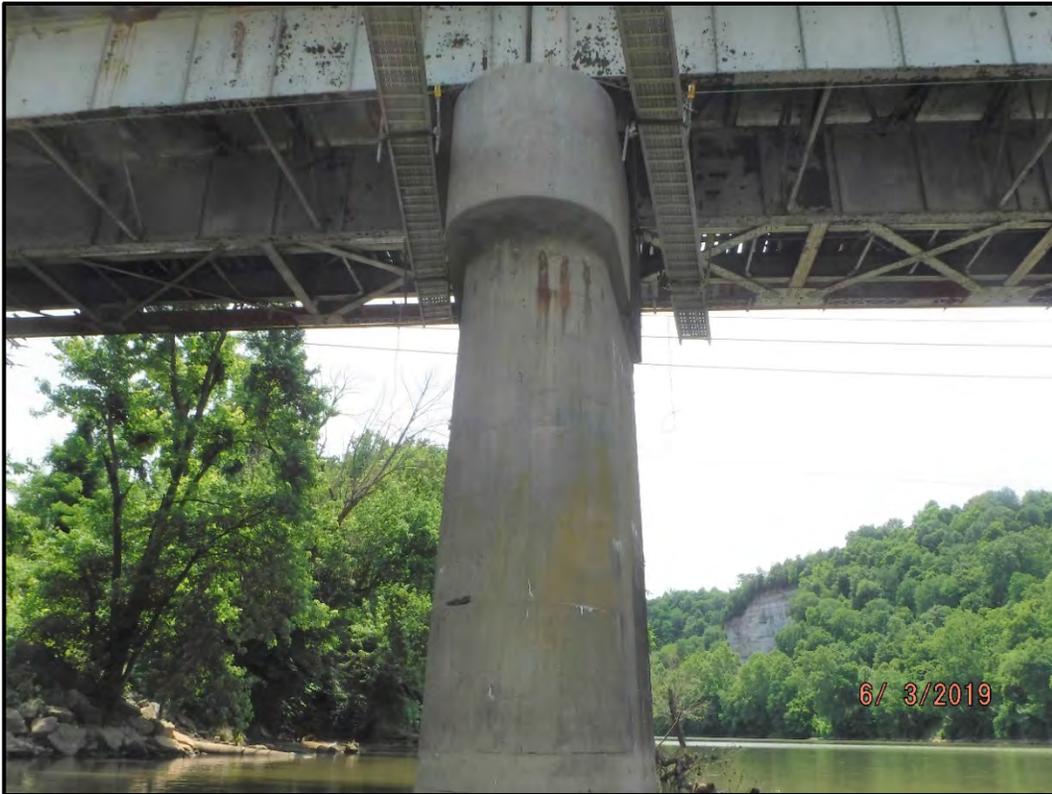
Photo P4-6: North face of Pier 4. There is rust staining on the pier wall directly below the pier cap. Note the 1ft wide honeycombing 10ft above the water line along with horizontal and vertical cracking with efflorescence.

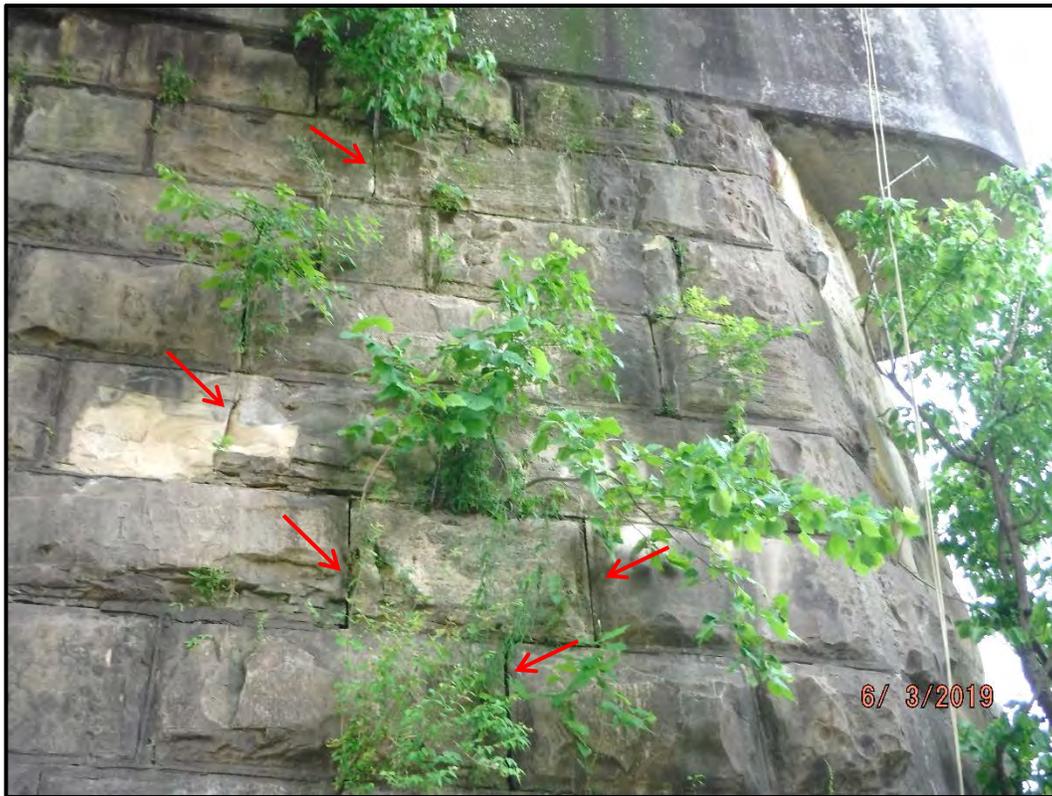
Photo P5-2: Vertical cracking on the east face of Pier 5 under Girder 2 that extends from the pier cap to the water line. Note how the cracks get wider as they extend downward and the amount of vegetation on the pier.

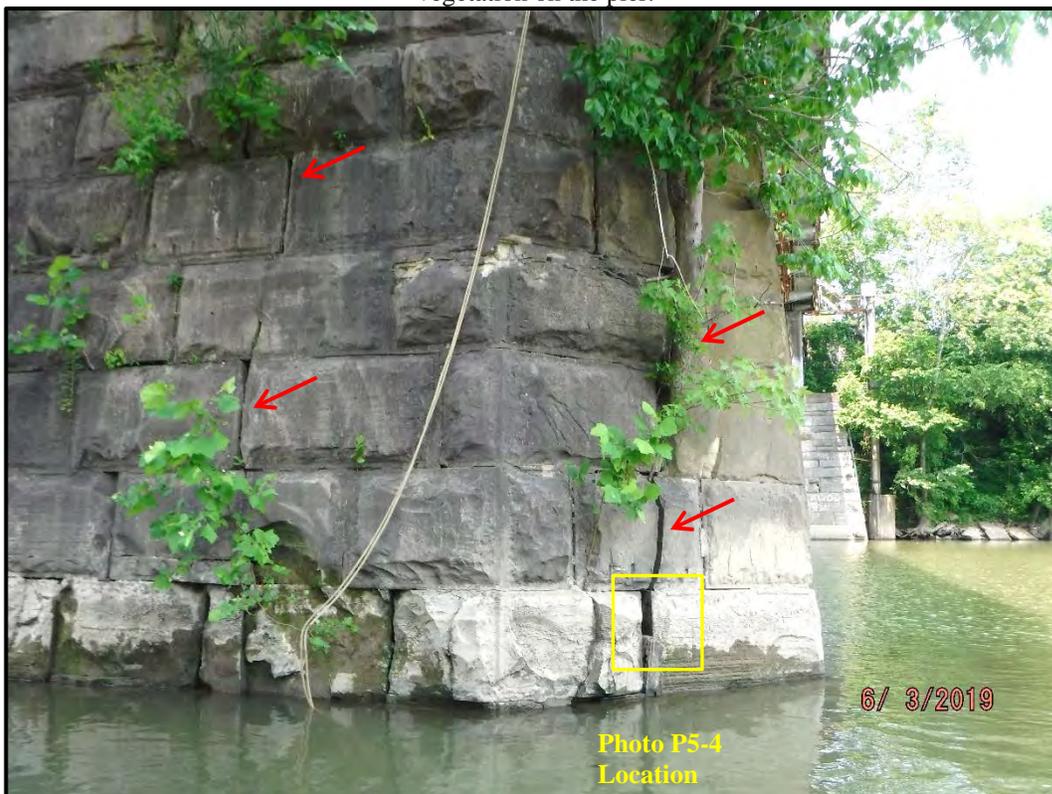
Photo P5-3: 3in diameter tree growing from a void in the north east face of Pier 5. Note the vertical crack in the stone under the tree and the vertical crack on the east face that extends from the pier cap to the water line.

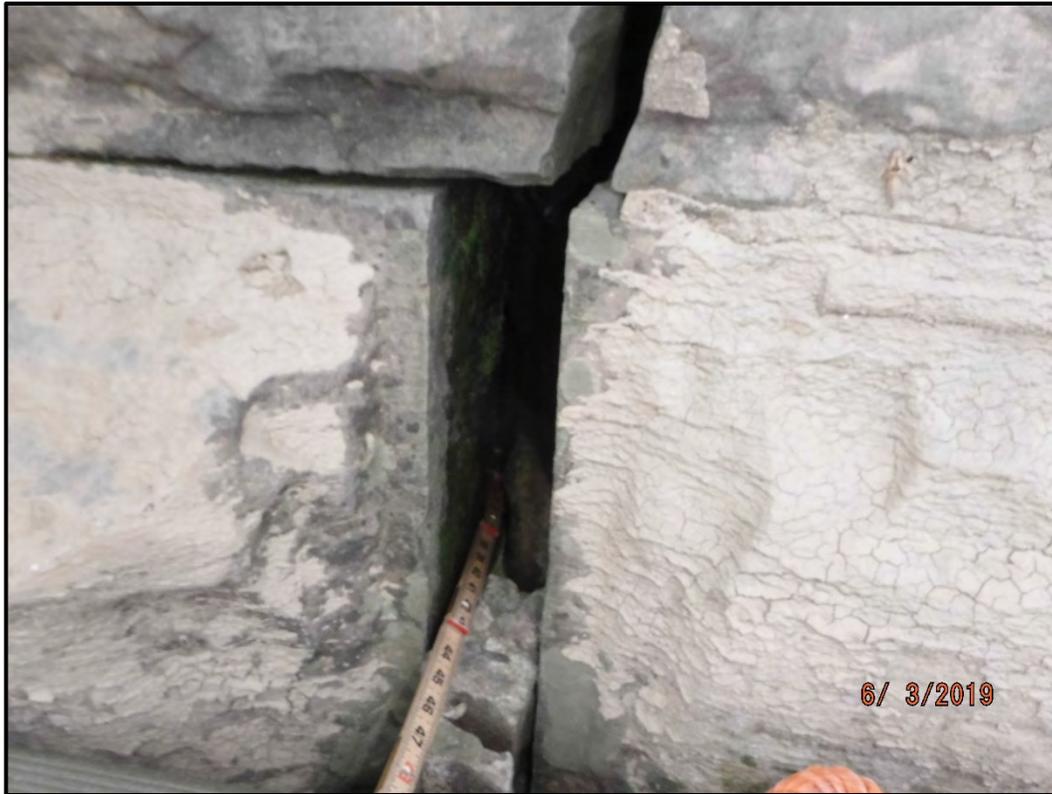
Photo P5-4: A 3in wide by 43in deep void between stones at the water line on the north east face of Pier 5 under the 3in diameter tree.

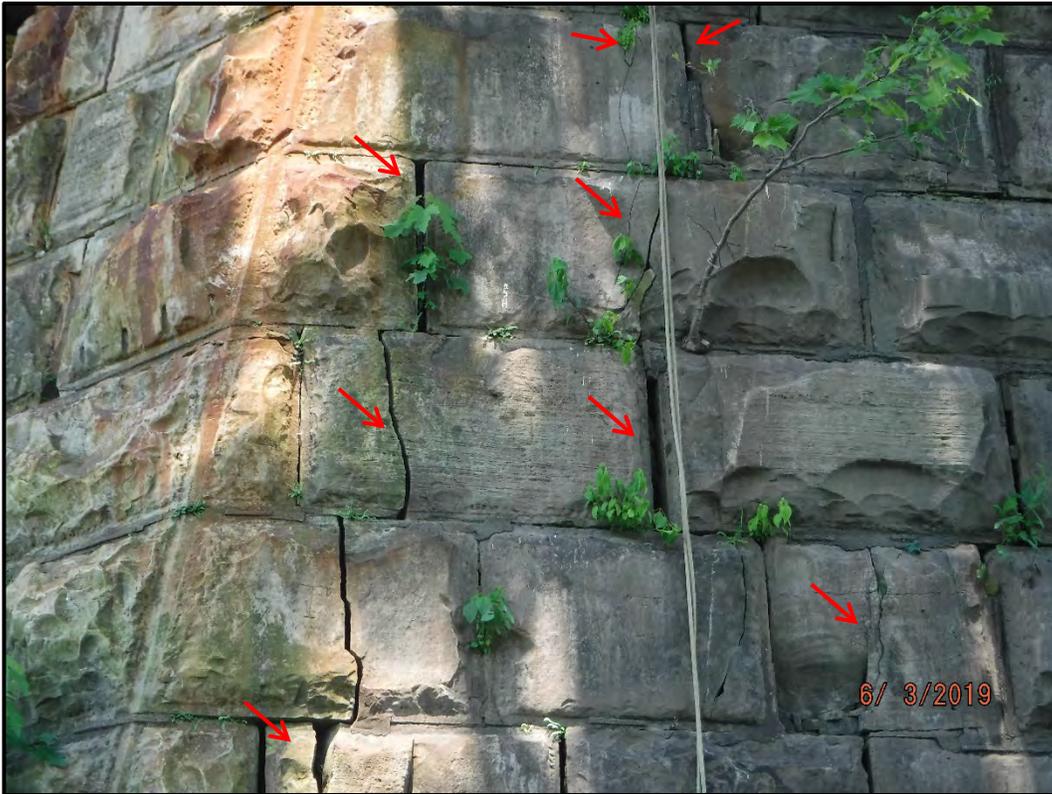
Photo P5-6: Vertical cracking on the east face of Pier 5 that extends from the pier cap, at the south edge of the truss beam seat, to the waterline with the crack width increasing to 7/8in wide at the waterline.

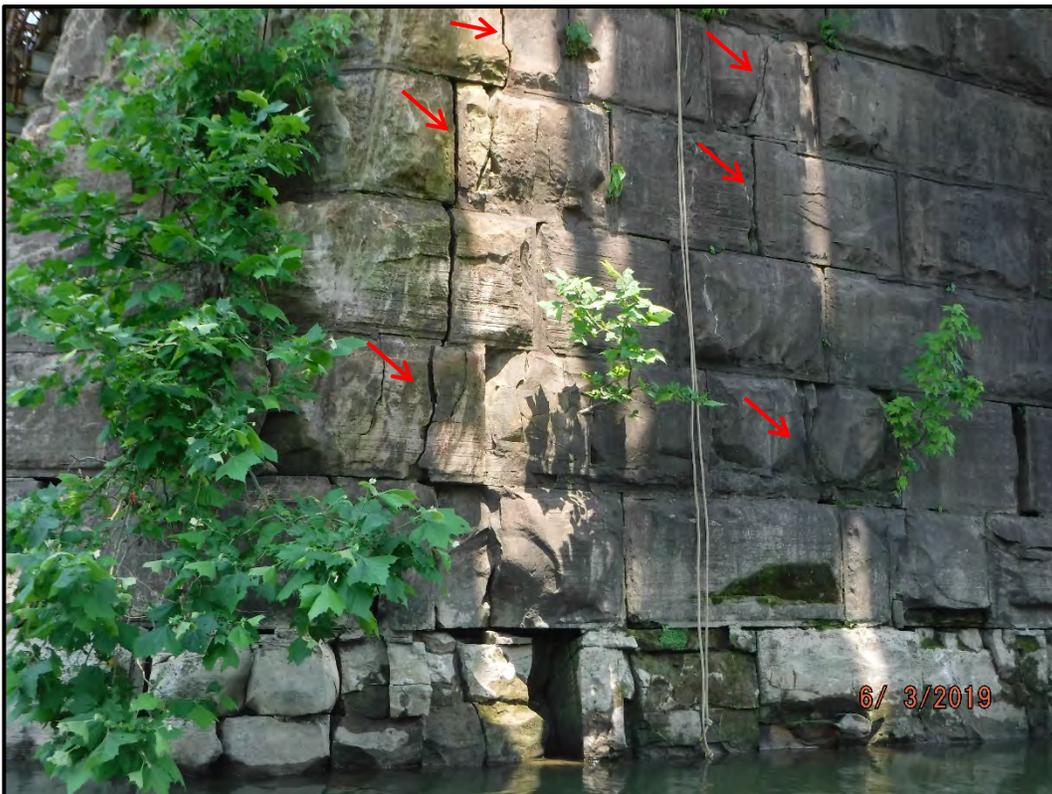
Photo P5-7: Vertical crack on the east face of Pier 5 that extends from the pier cap, at the south edge of the truss beam seat, to the waterline with the crack width increasing to 7/8in wide at the waterline. Note the typical heavy cracking of the stone at the waterline.

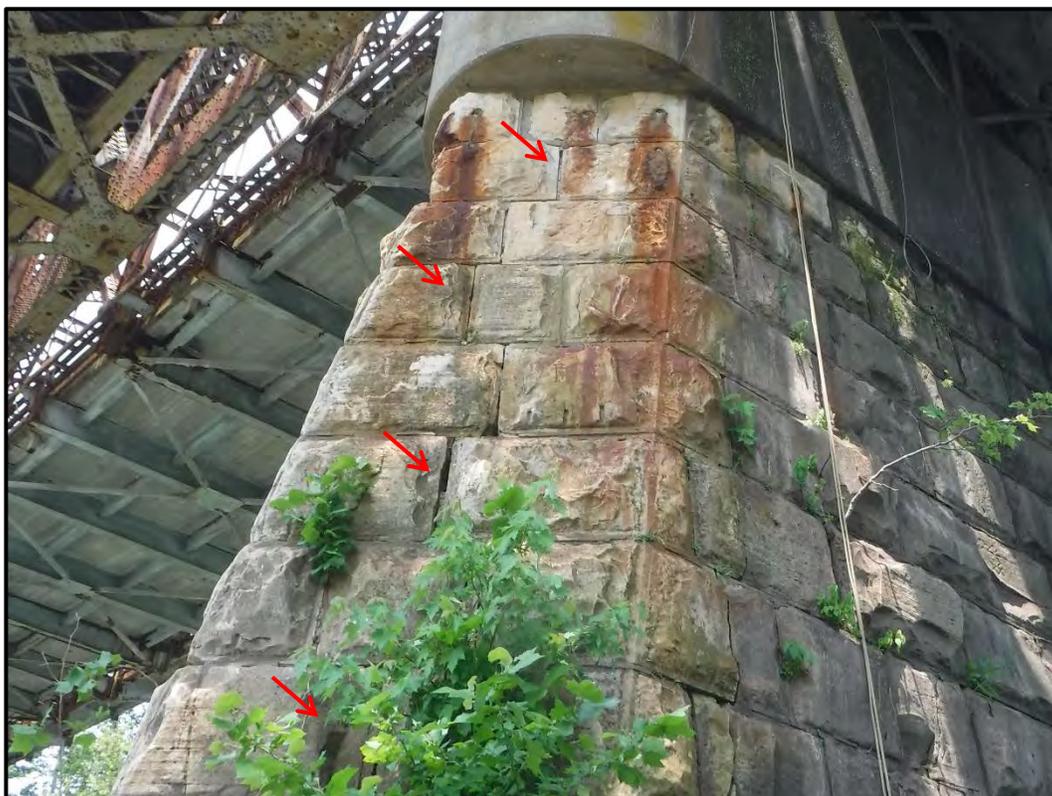
Photo P5-9: Rust staining from the top stones on the southeast face of Pier 5. Note the vertical cracking that extends from the pier cap to the water line and the vegetation growing in the cracks.

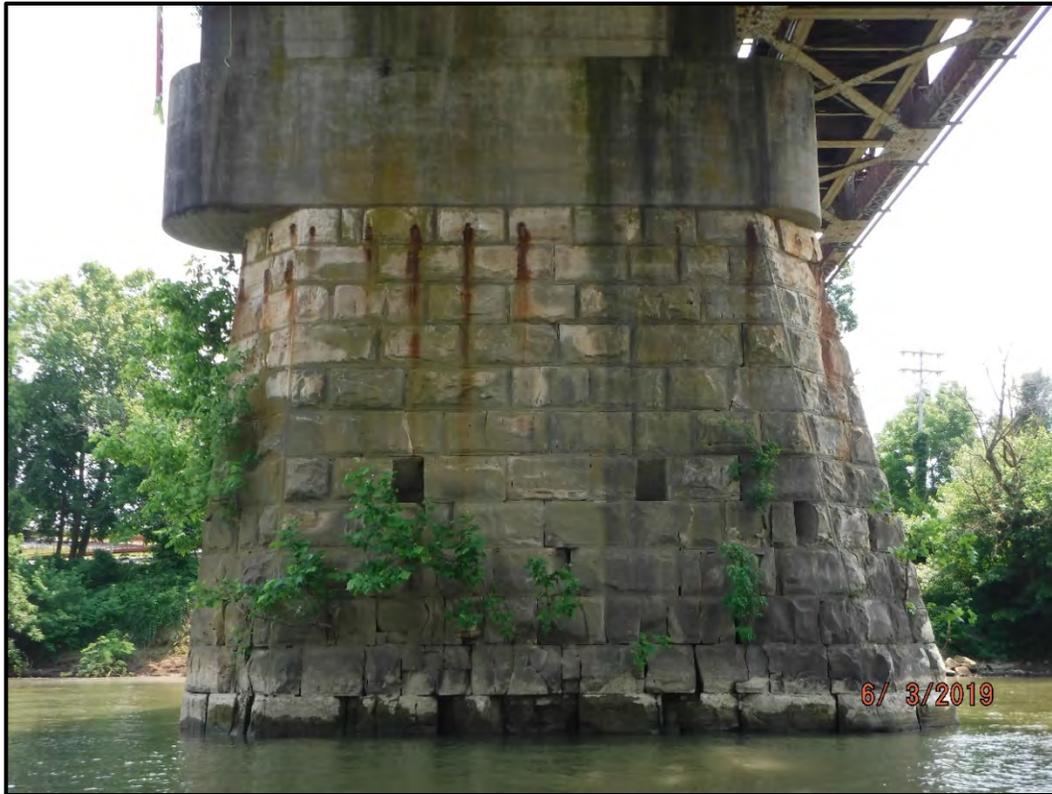
Photo P5-12: West face of Pier 5 has rust staining from the top row of stones and 3 full height vertical cracks, one in the middle and then one on each end. Note the vegetation and the heavy cracking of the stones near the water line. The voids near the middle of the pier appear to be from shoring when the superstructure was built.

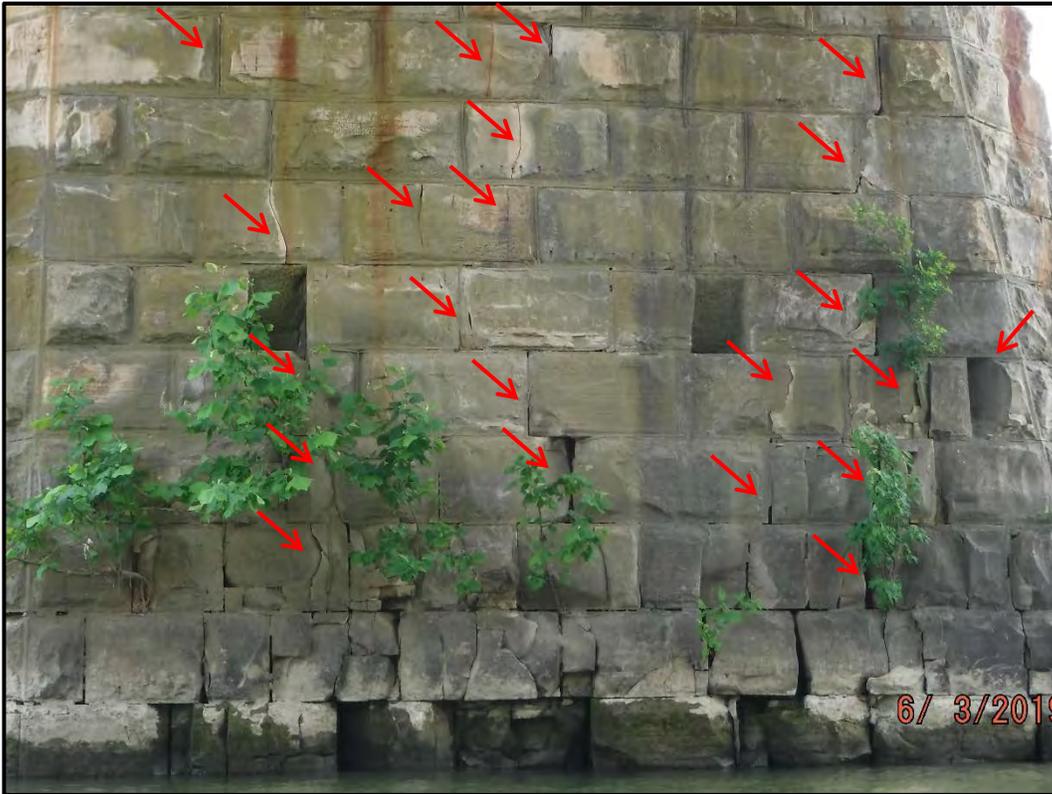
Photo P5-14: West face of Pier 5 has 3 full height vertical cracks, one in the middle and then one on each end. Note the vegetation and the heavy cracking of the bottom 3 rows of stones near the water line.

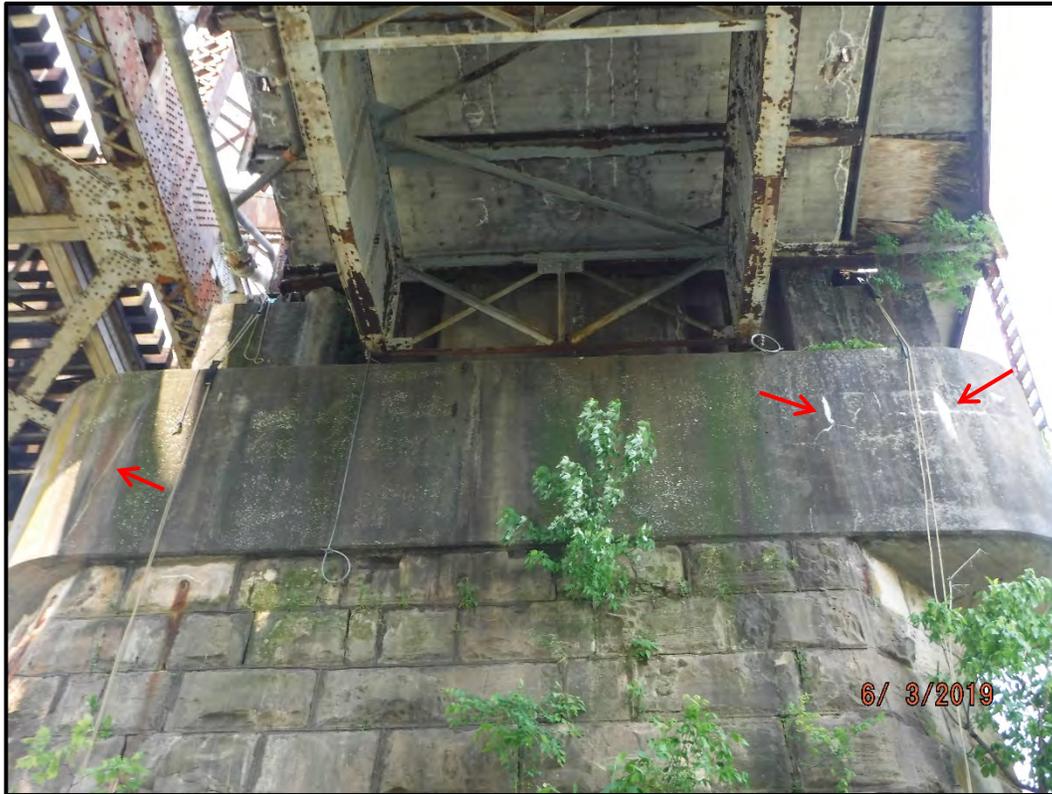
Photo P5-18: Minor cracking with efflorescence on east face of the Pier 4 cap, typical throughout.

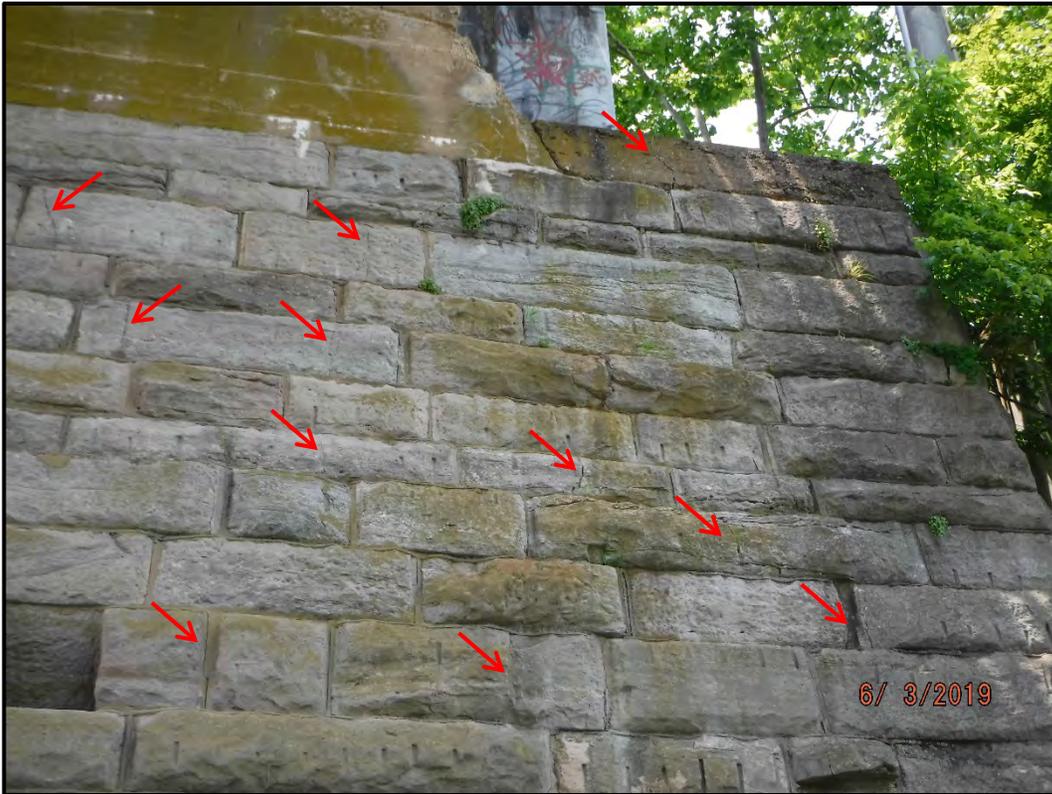
Photo P6-2: Minor cracking throughout the north end of the Pier 6 east face.

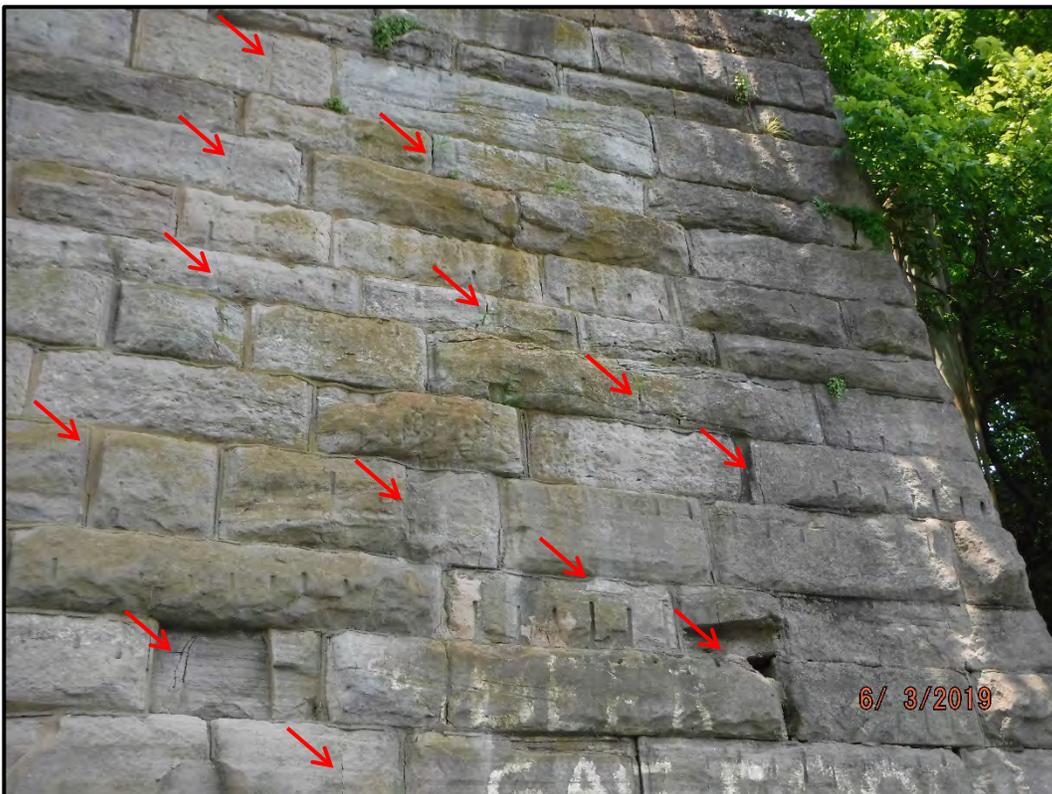
Photo P6-3: Minor cracking throughout the north end of the Pier 6 east face.

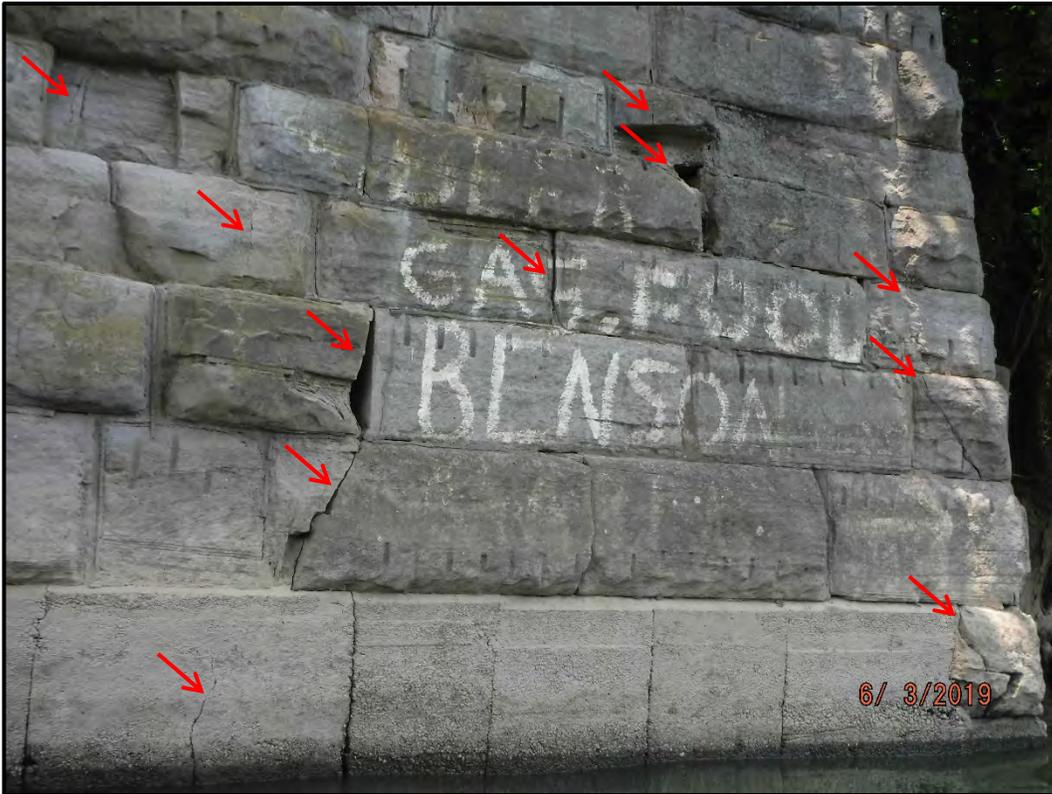
Photo P6-4: Minor cracking throughout the north end of the Pier 6 east face. Note the 2 sections of partial missing stones and that the stones at the waterline are encased in concrete. The stones at the waterline have vertical cracks spaced at 2ft.

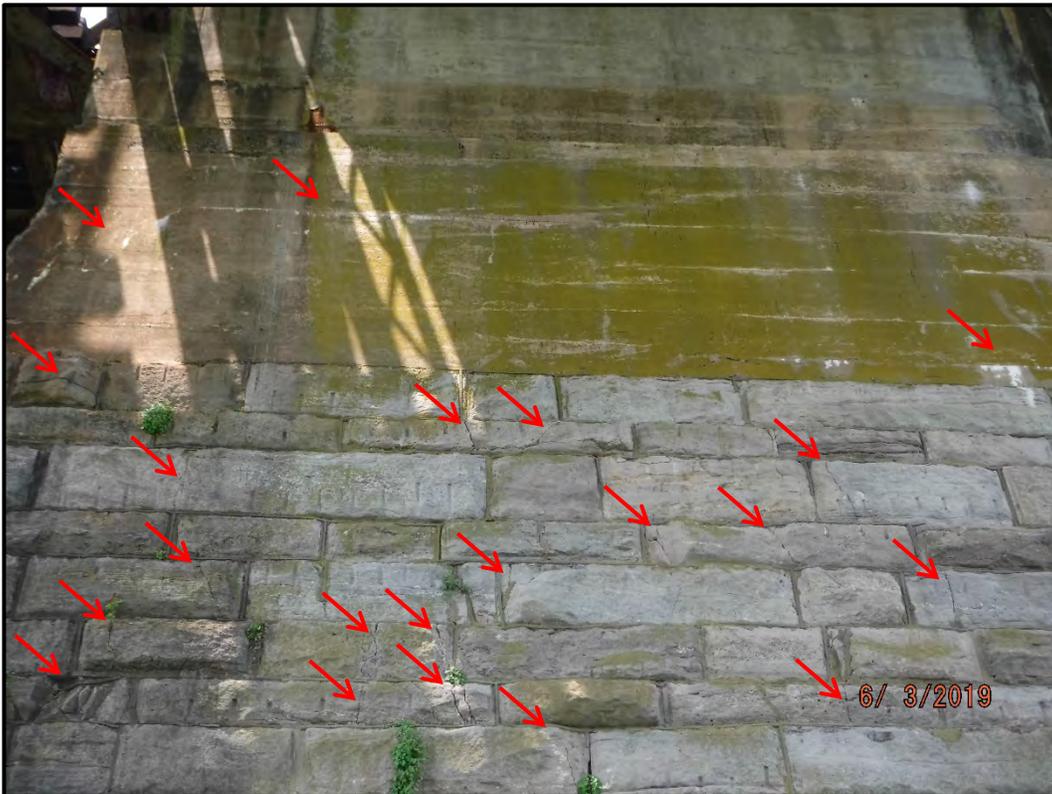
Photo P6-5: Minor cracking throughout the middle of the Pier 6 east face. Note the cracking with efflorescence on the face of the concrete pier cap.

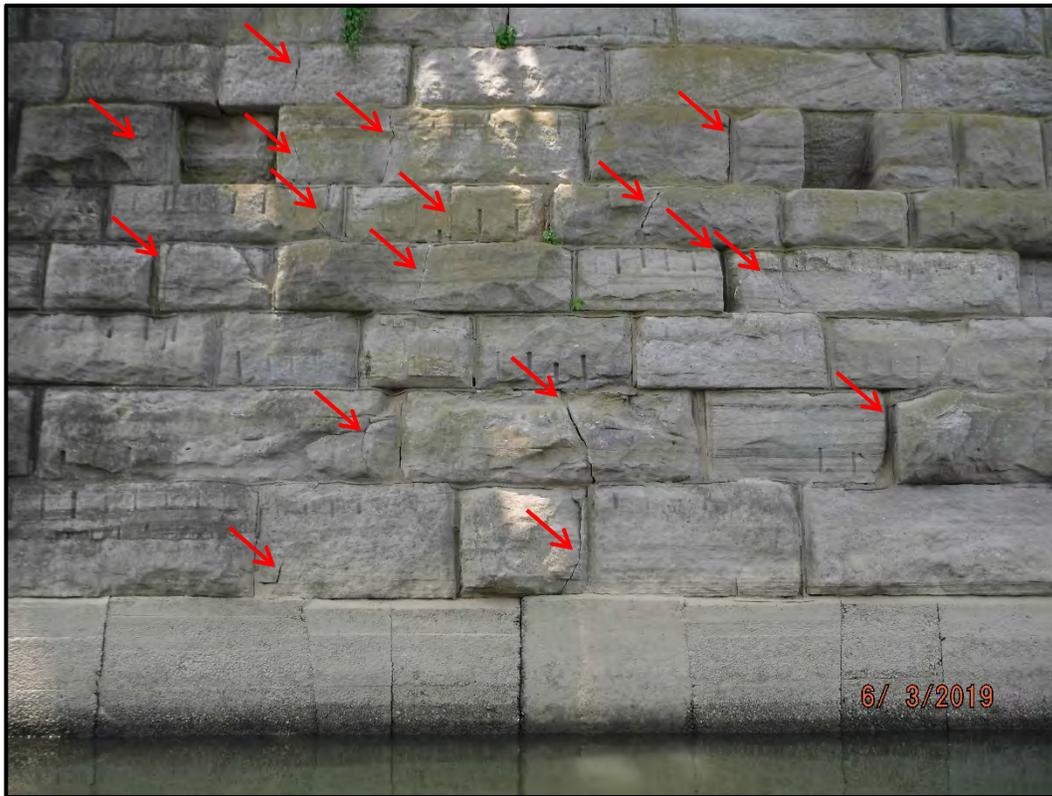
Photo P6-6: Minor cracking throughout the middle of the Pier 6 east face. Note the stones at the waterline are encased in concrete and have vertical cracks spaced at 2ft.

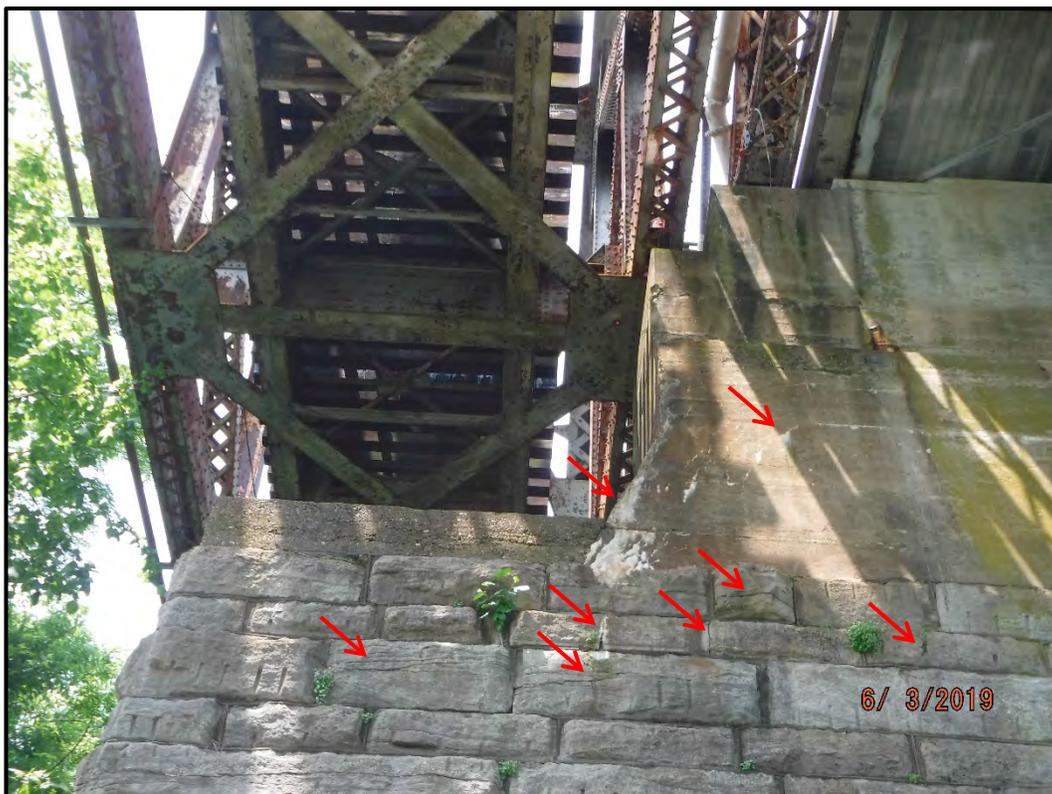
Photo P6-7: Minor cracking throughout the south end of the Pier 6 east face. Note the deterioration of the cap concrete and the heavy efflorescence.

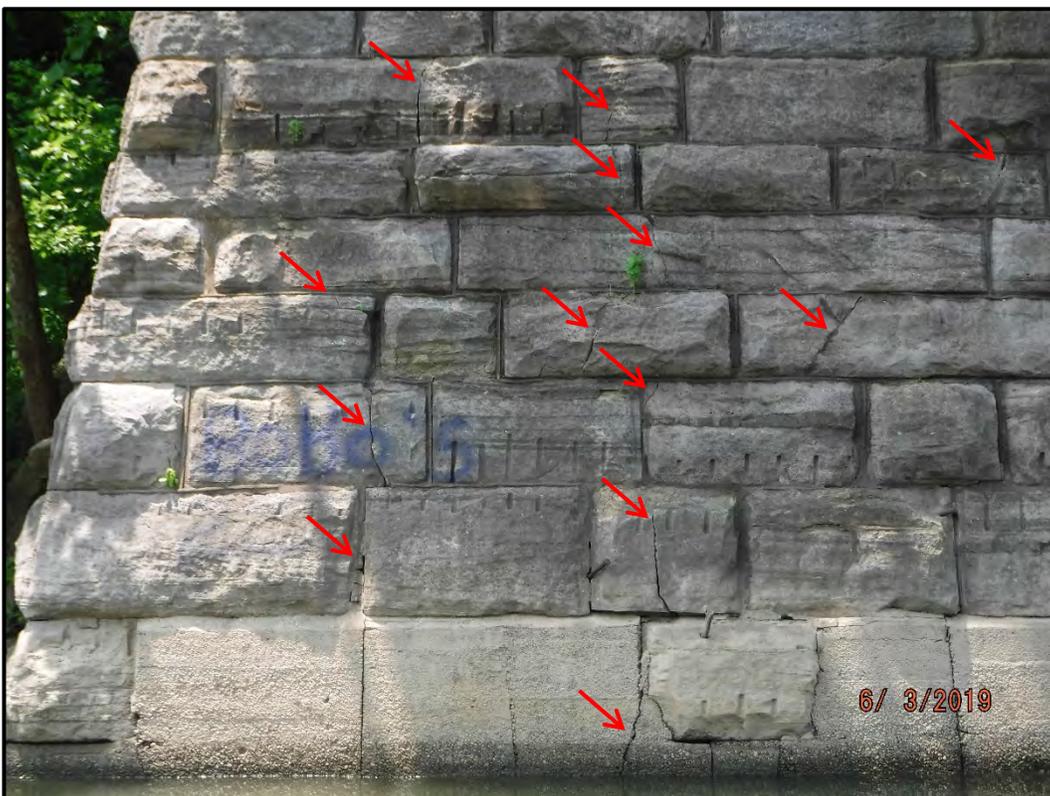
Photo P6-9: Minor cracking throughout the south end of the Pier 6 east face. Note the stones at the waterline are encased in concrete and have vertical cracks spaced at 2ft.

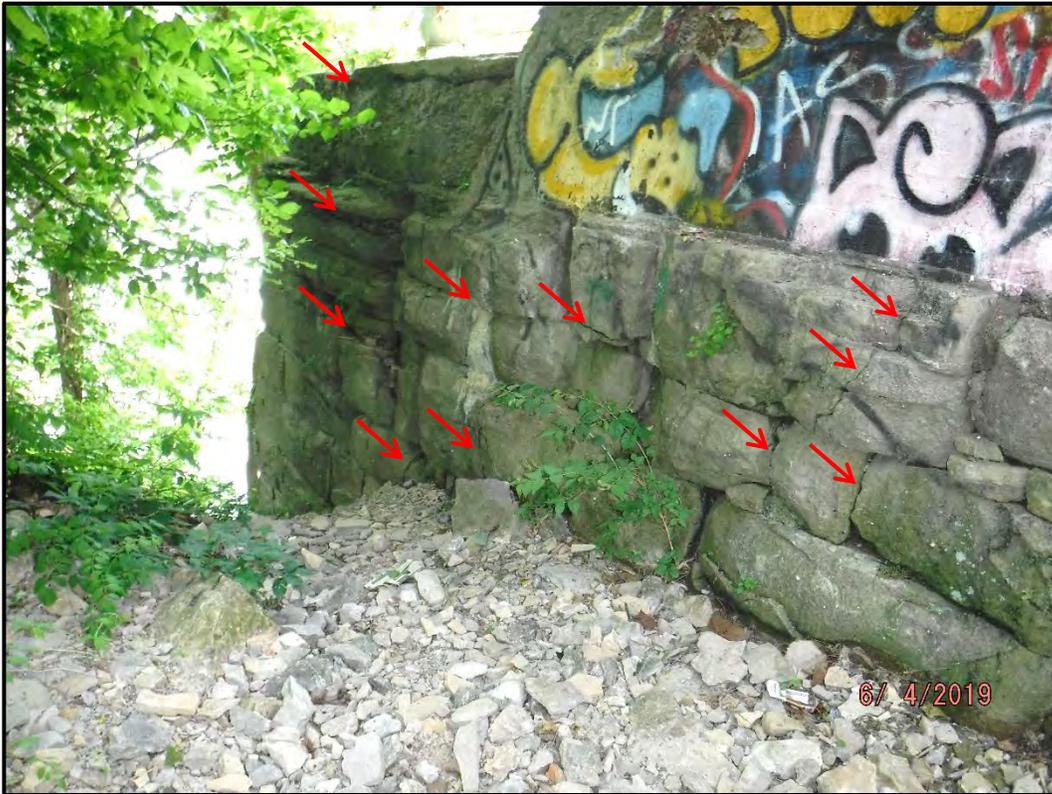
Photo P6-16: Cracking on the north end of the Pier 6 west face. Note the heavy efflorescence on the stone and the deterioration of the concrete cap.

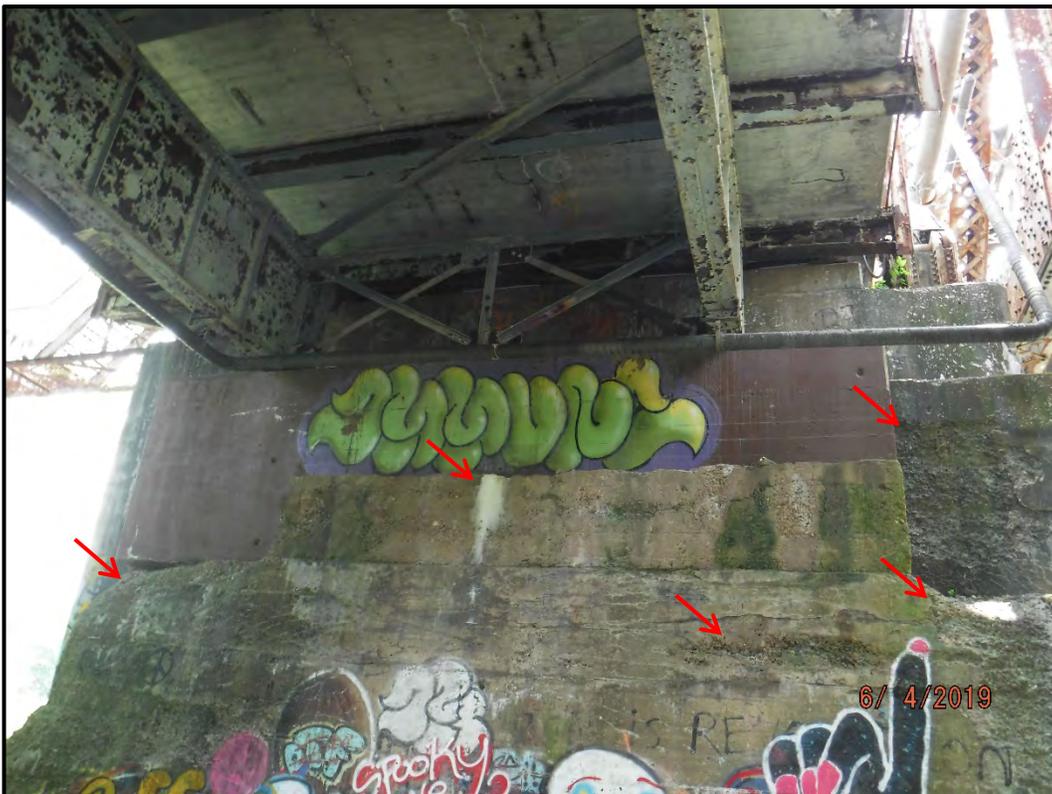
Photo P6-17: West face of the Pier 6 concrete cap has map cracking and deterioration throughout that has caused the exterior layer of cement to crumble. Note the heavy efflorescence at the center line of the cap.
