August 31, 2019

**Re: Broadway Bridge (KY 3506) over Kentucky River
 Bridge No. 037B00066N
 Frankfort, Kentucky
 In-Depth Bridge Inspection Report**

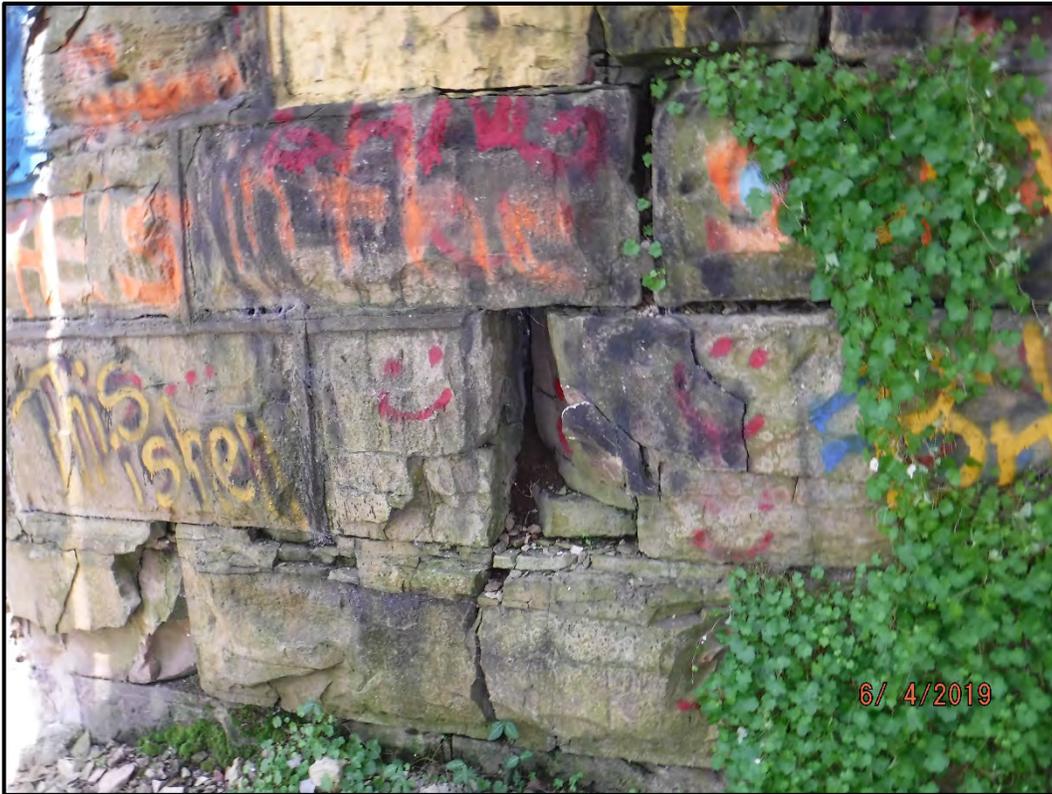
Photo Abt. 7-2: Close-up of the voids on the south end of the Abutment 7 east face.

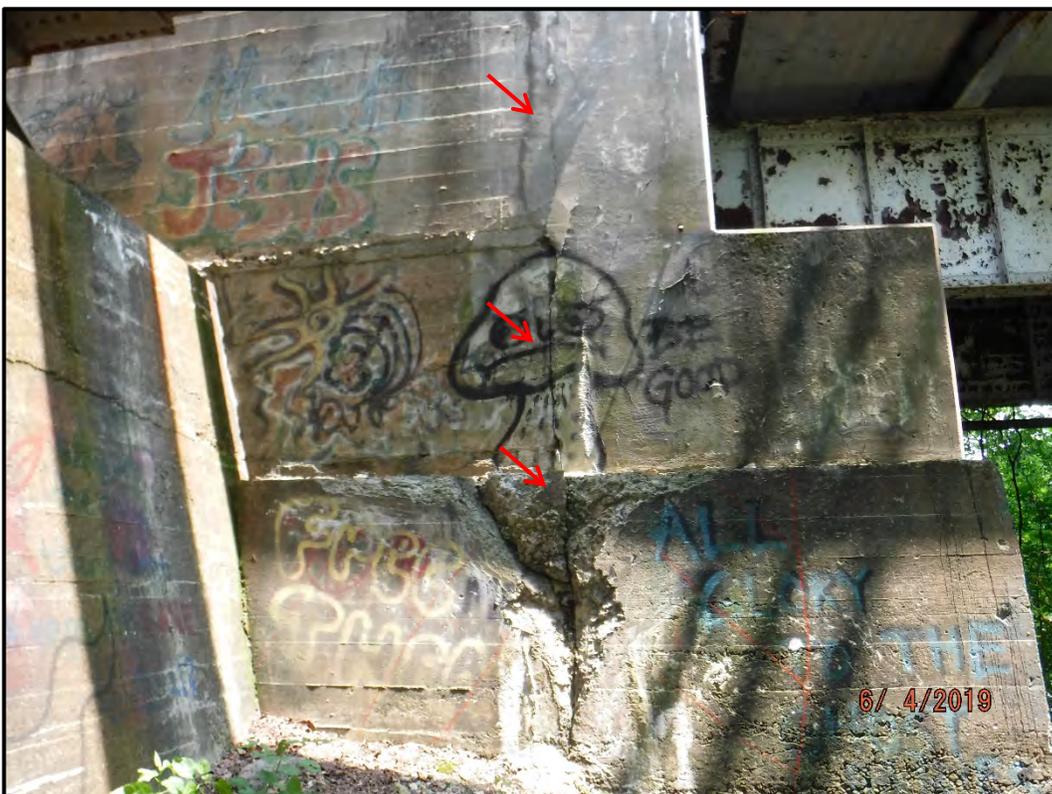
Photo Abt. 7-3: Vertical crack and large 4in deep spall on the south face of Abutment 7 where the backwall meets the wing wall.

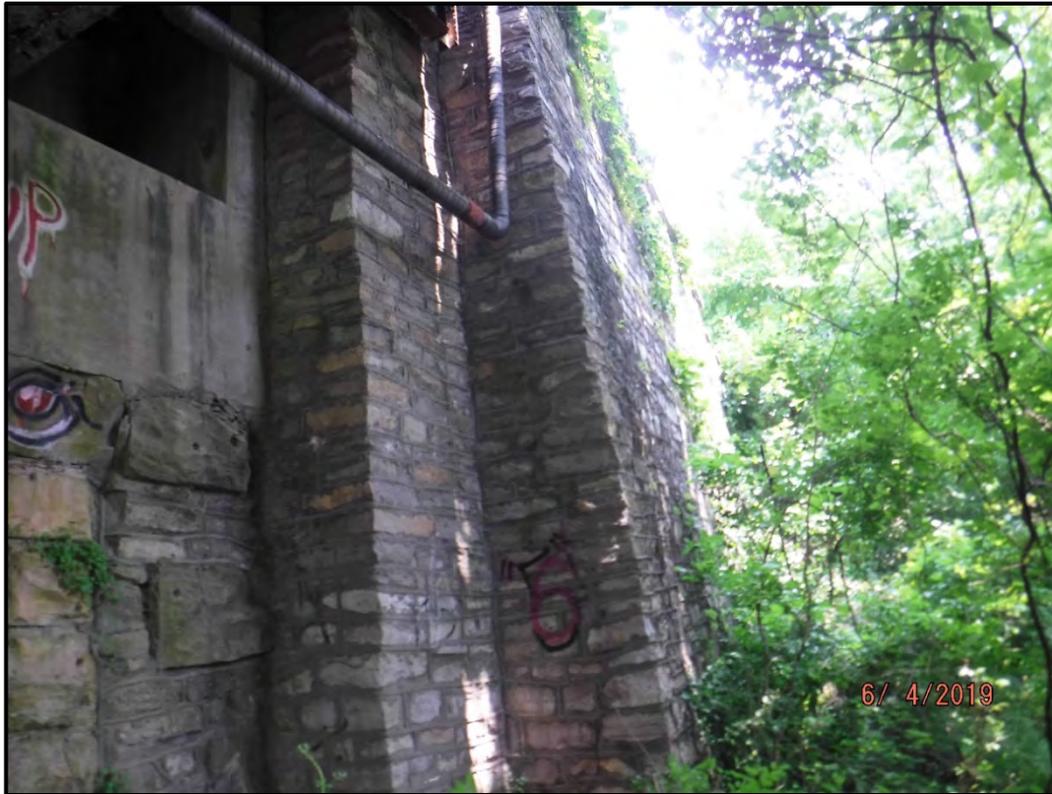
Photo Abt. 7-4: Retaining wall north of Abutment 7 is in good condition.

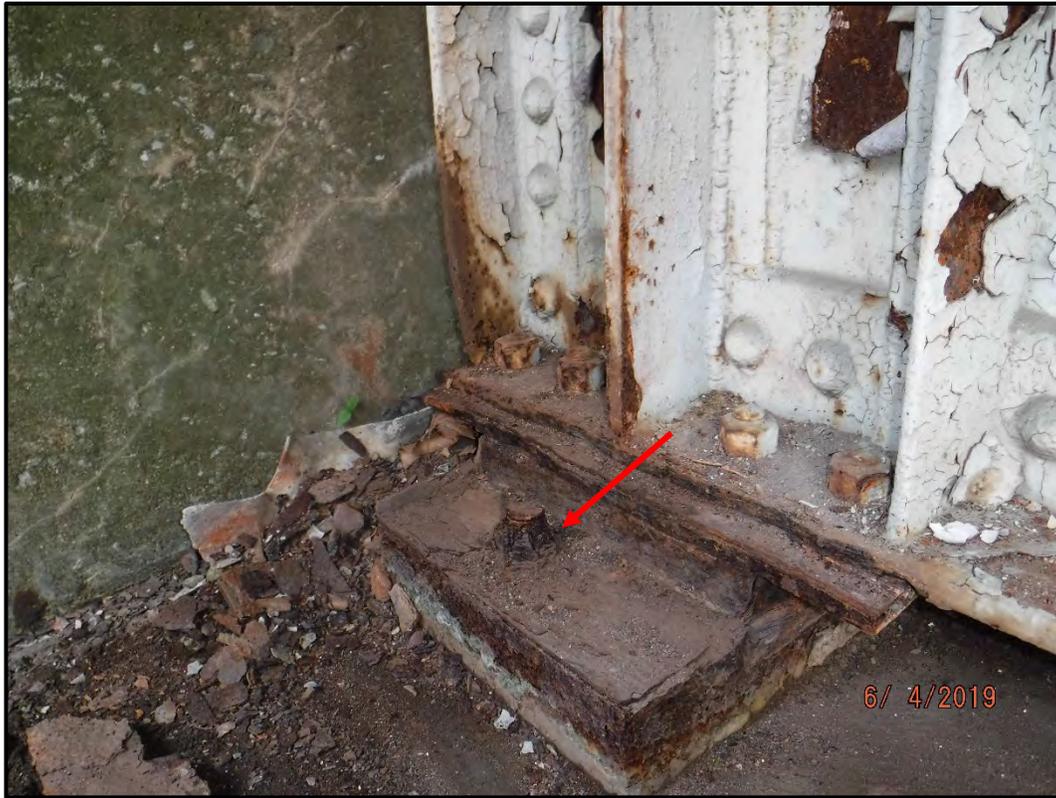
BRG-2: Abutment 7 bearing. There is section loss of the anchor bolt head.

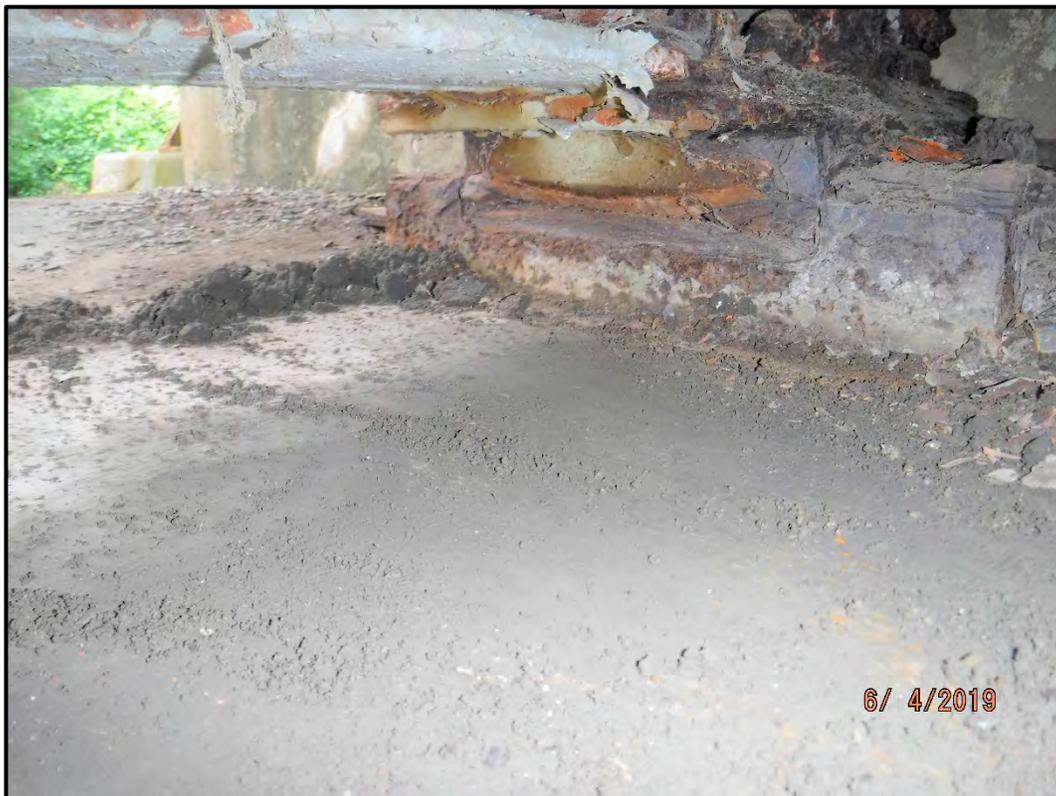
BRG-3: Abutment 7 bearing. There is pack rust on the bearing rocker.

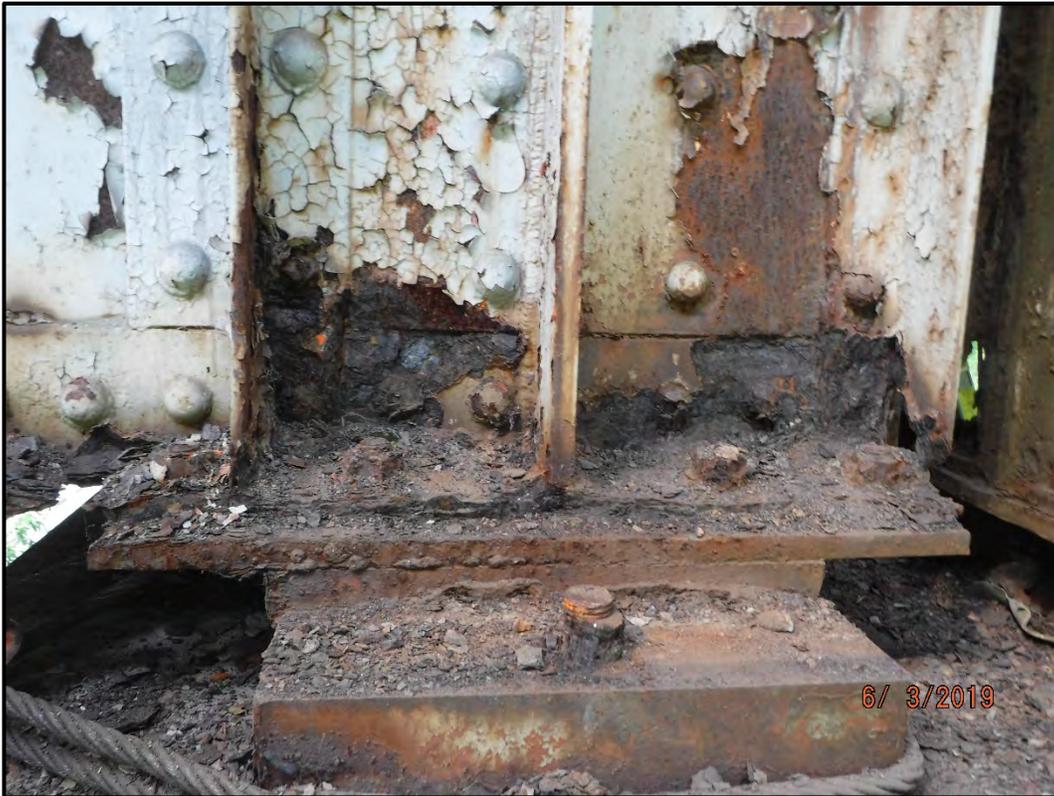
BRG-4: Span 3 bearing at Pier 3. There is section loss of the anchor bolt head.

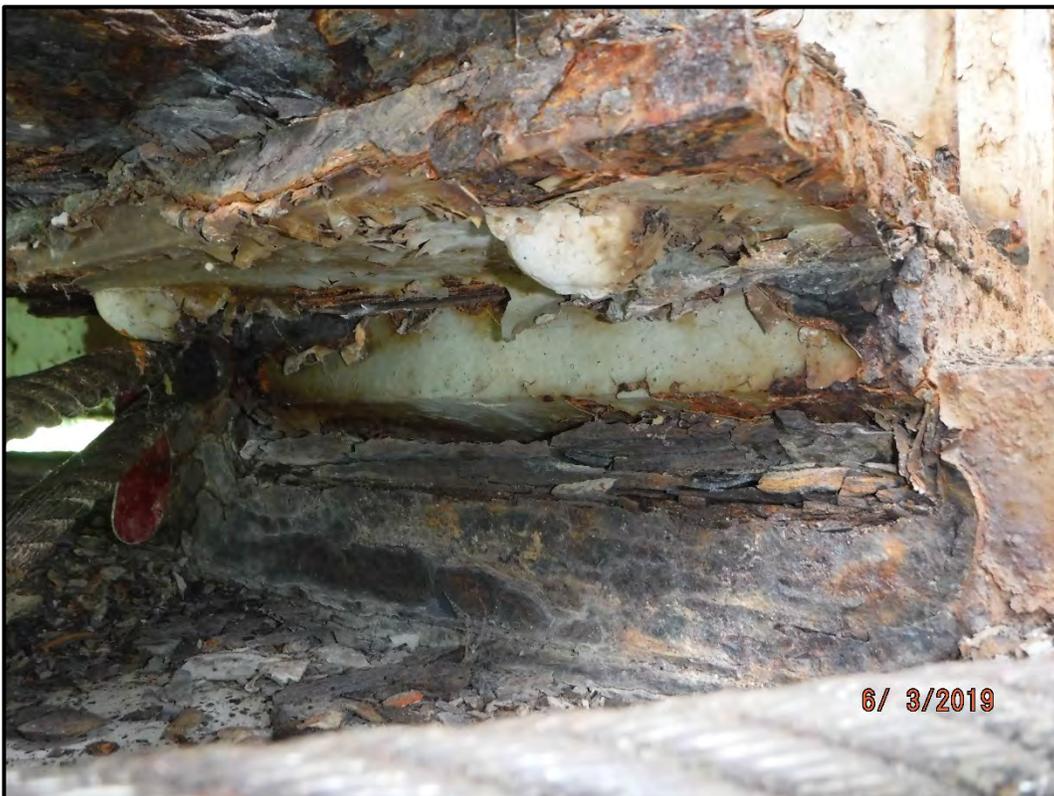
BRG-4: Span 3 bearing at Pier 3. There is pack rust on the bearing rocker.

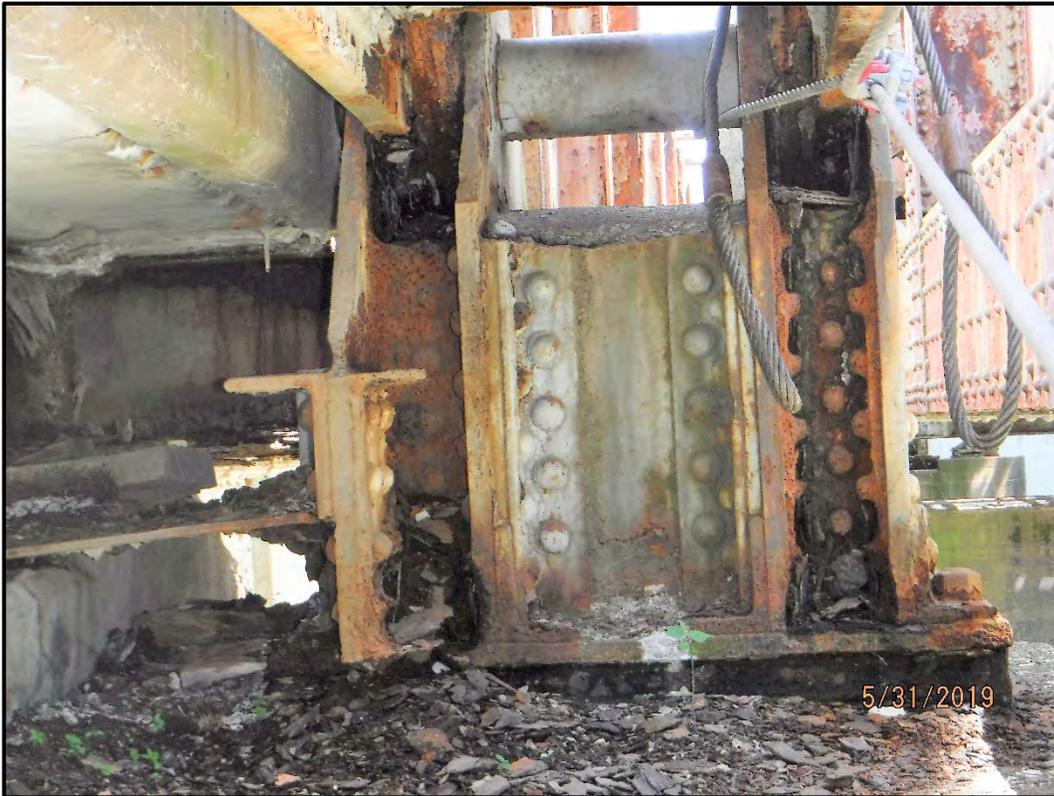
BRG-5: Bearing of the upstream truss. There is active corrosion with section loss of the rivet heads and pitting on the bearing plates.

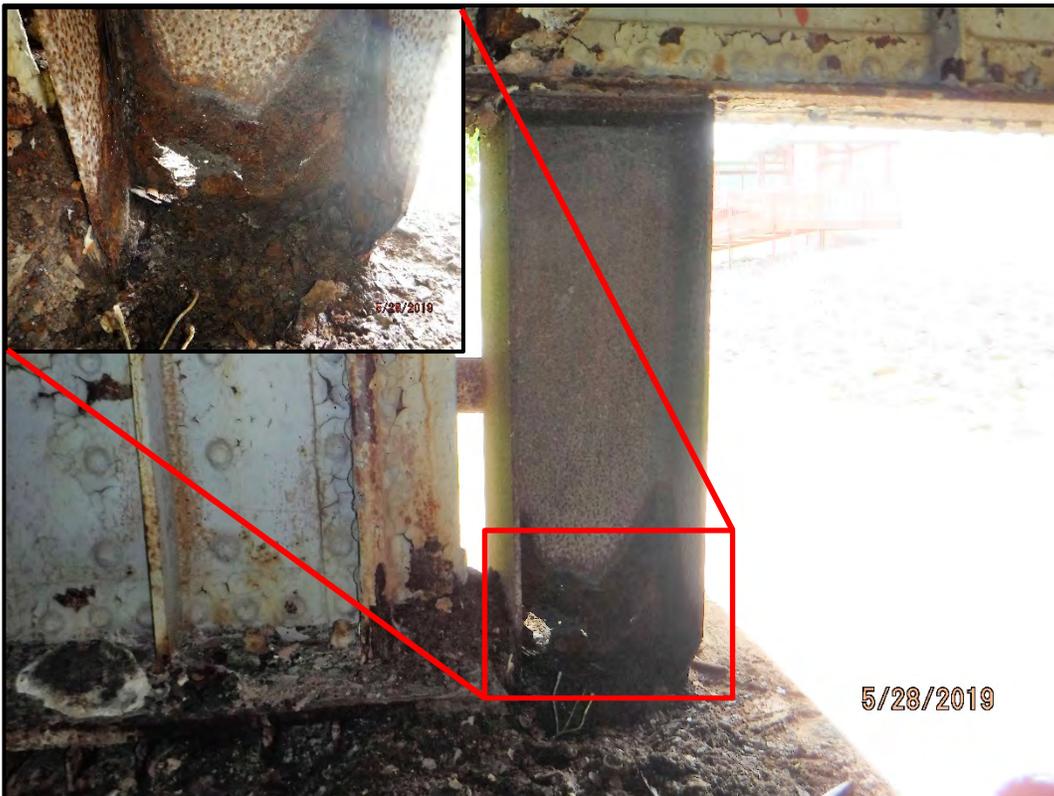
BRG-7: Typical stub column at Pier 2 under Girder 2 of Span 1. There is active corrosion and section loss up to 100% at the base of the column.

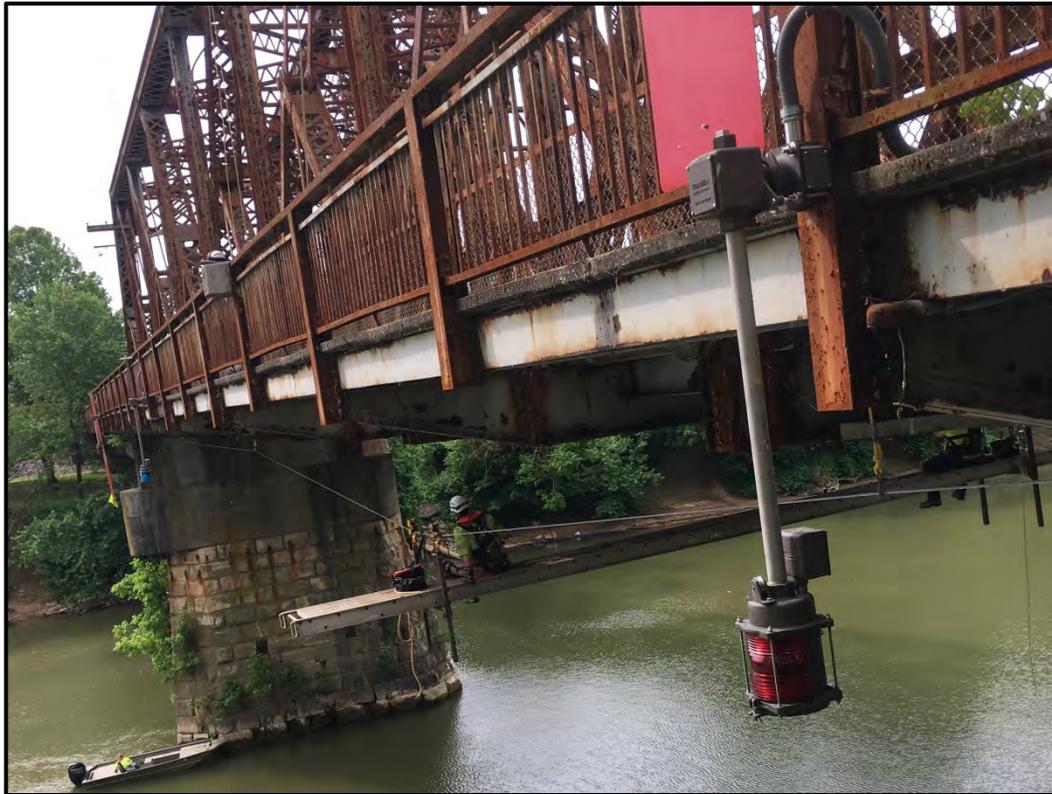
Photo 330-3: Pedestrian bridge railing on downstream side is in fair condition with widespread active corrosion.

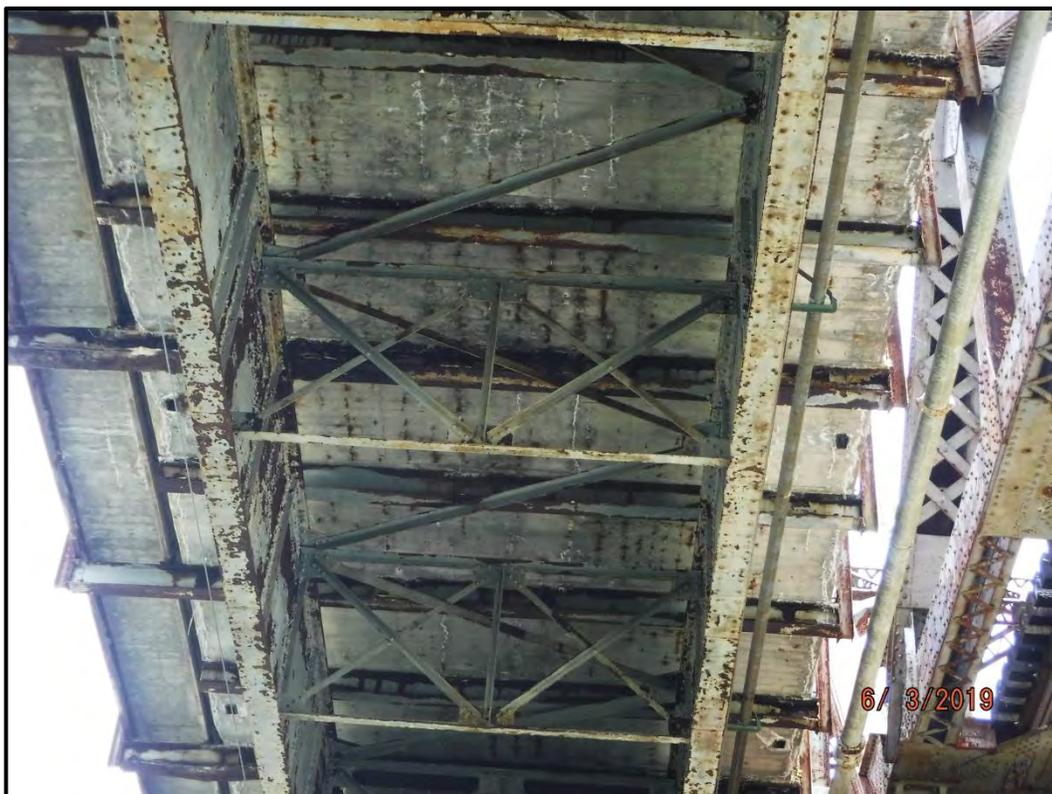
Photo 850-1: Typical underside of Span 4 showing lateral bracing and steel diaphragm. Moderate corrosion is apparent on the lateral bracing.

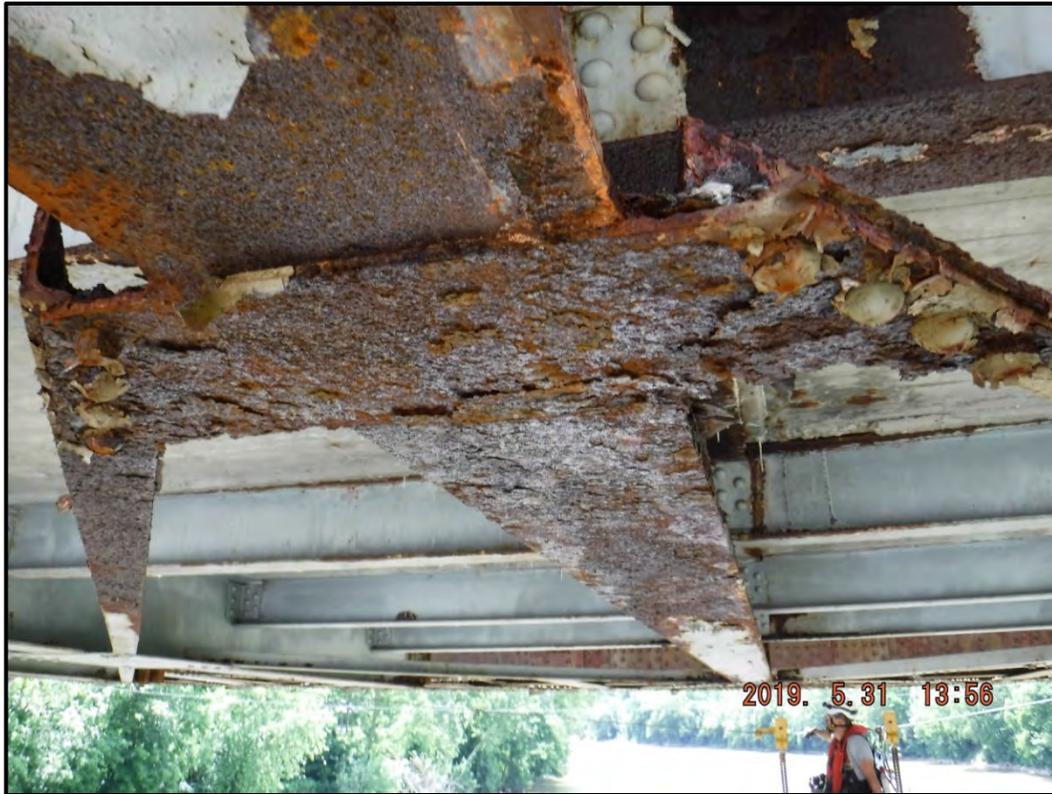
Photo 850-6: Active corrosion on the lateral bracing connection on the downstream end of Floorbeam 4.

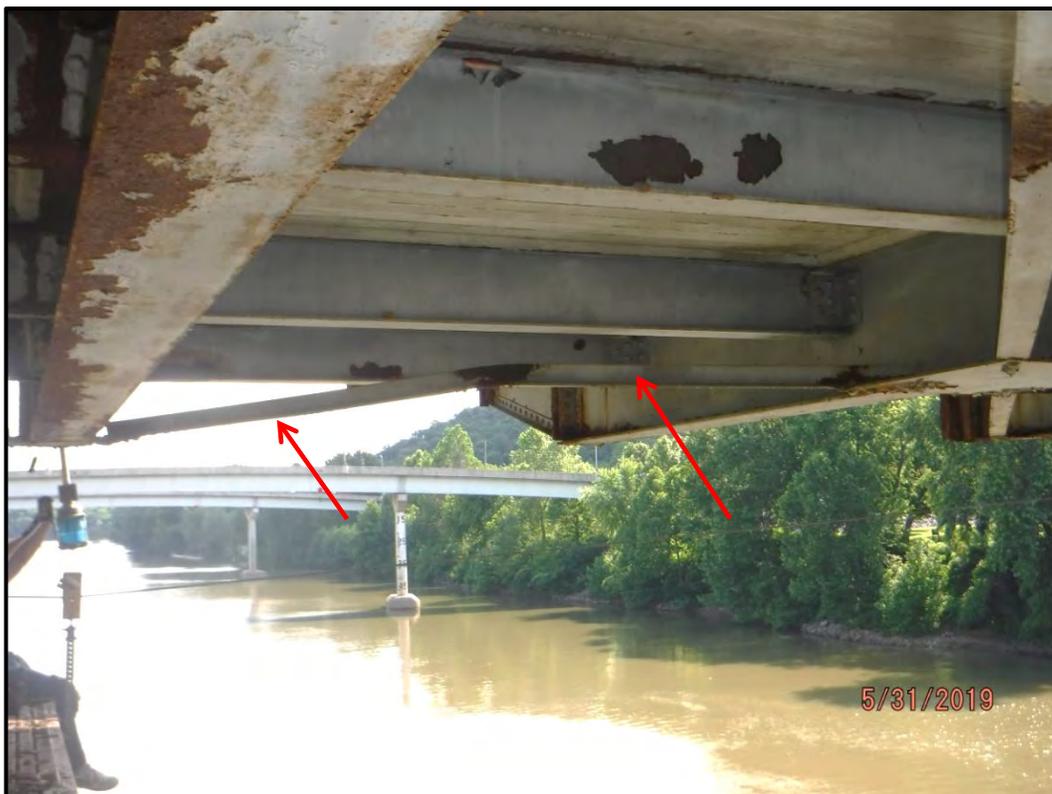
Photo 850-7: Deformation of the lateral bracing between L8 and L7.
