Underwater Bridge Inspection Report

Structure No.: 037B00066N

Route: Old Broadway Pedestrian Bridge

Inspection Date: October 5, 2020

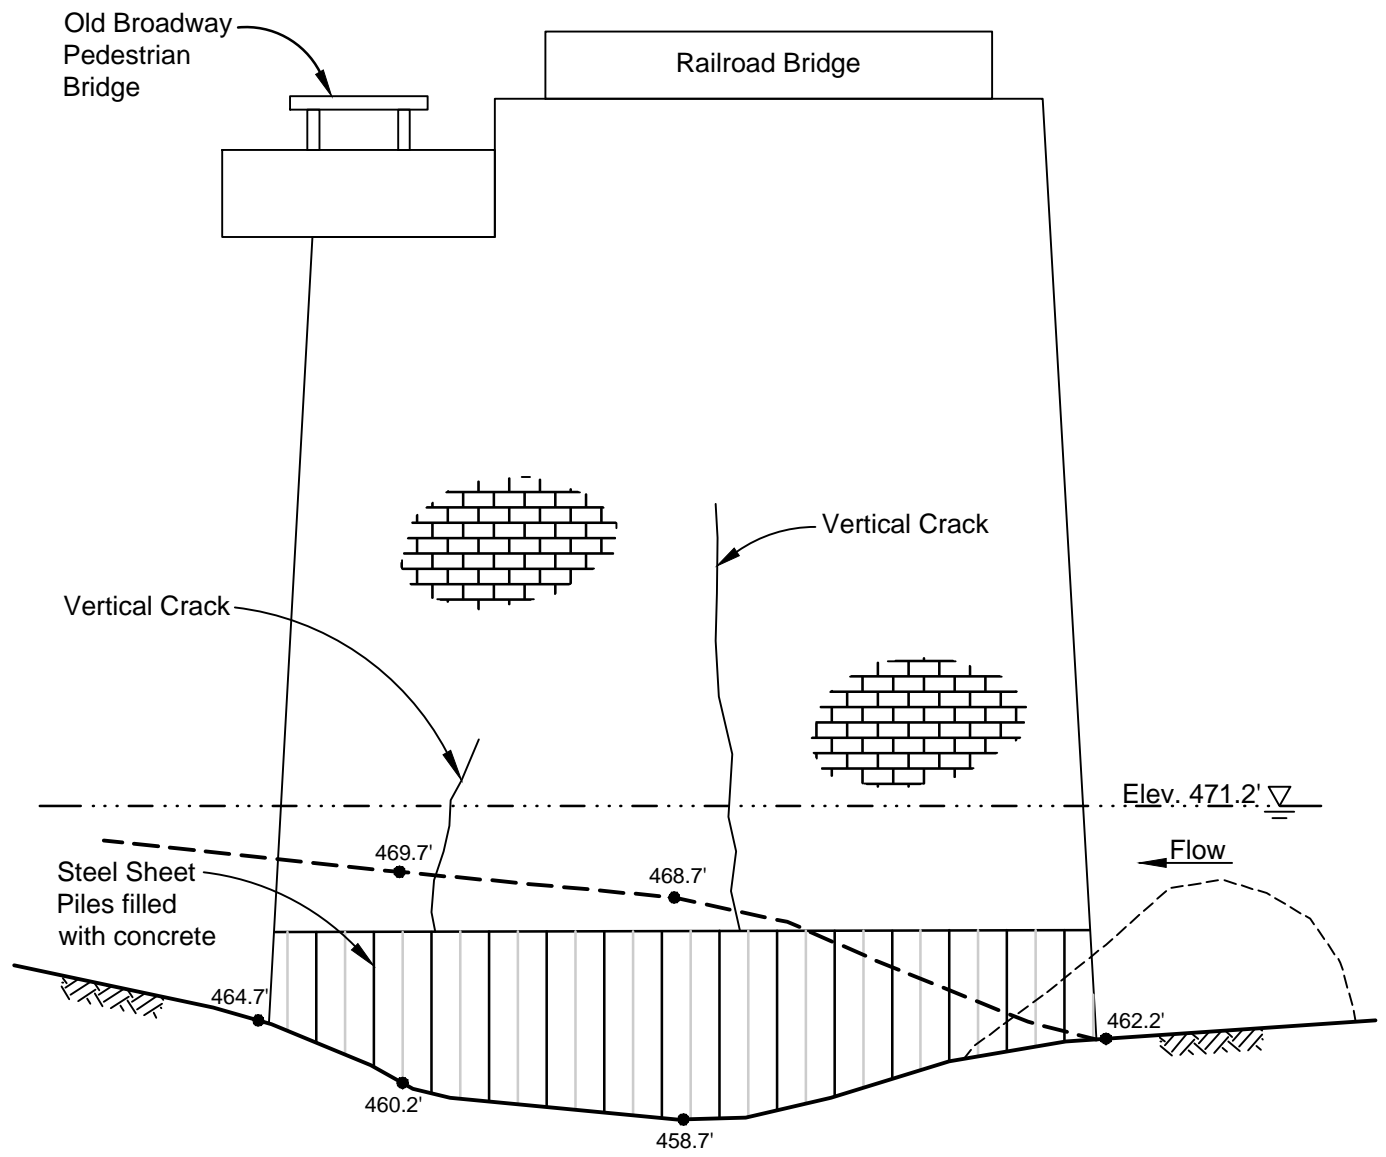
**PIER 4
SHARED PIER
LOOKING EAST**

- This pier is shared for the support of 037B00066N and the adjacent railroad.
- Tree debris is present around the entire south face extending from the river bottom to 2' above the bottom.

- There is a vertical crack located in the center of the west face measuring 1/8" wide with up to 3/4" penetration extending from 10' above the water surface to the river bottom.

- There is a vertical crack located just north of the center of the face measuring 1/4" wide with up to 1" penetration extending from the 2' above the water surface to 6' below the water surface.

- There is an area of honeycombing on the NW corner measuring 1' wide by 6" tall with up to 1" penetration located 6' below the water surface.
- There is a vertical crack on the east face located 8' and 18' north of the south face measuring 1/4" wide with up to 1" penetration extending from 6' above the water surface to 3' below the water surface.

- There is a vertical crack located in the center of the east face measuring 1/4" wide with up to 1/2" depth extending from the water surface to the river bottom.

- Steel sheet is exposed from the mid-point on the eastern side and extends around the upstream nose and becomes buried by the mudline on the downstream nose. The top of the sheet pile is 6' below the water surface and is located 6' outboard of the pier. There is concrete fill between the sheet pile wall and the pier. The top of the concrete is located 6' below the water surface.
- There is an area of honeycombing on the east face located 5' north of the center of the pier measuring 2' wide by 6" tall up to 1.5" deep.

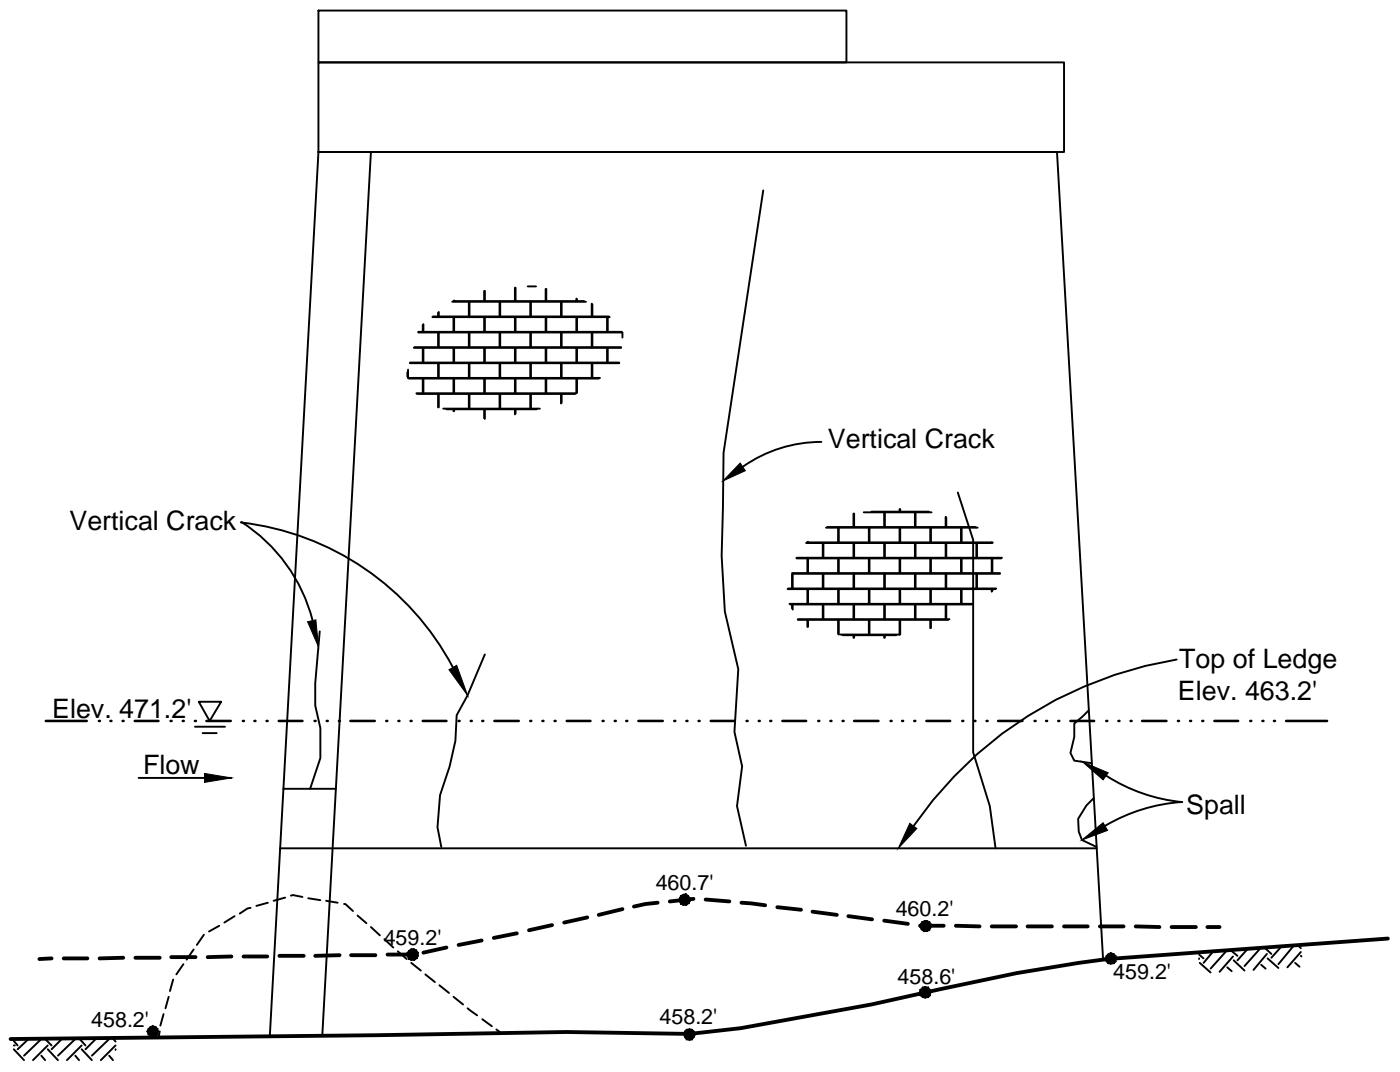
**PIER 5
LOOKING WEST**

- There is a vertical crack on the west face:
 - 8' north of the SW corner measuring 3" wide up to 3' penetration extending from the top of the masonry to the river bottom

- 2' north of the SW corner measuring 5" wide up to 3' penetration extending from 4' above the surface to 6' below the water surface,
 - 1' north of the south face measuring 3" wide up to 2' penetration extending from 4' above the water surface to 6.5' below the water surface

- 10' south of the north point measuring 2" wide up to 2' penetration extending from 4' above the water surface to the river bottom.
- Section loss of a masonry block:

- 6' bws south face 3' wide by 2' tall up to 1' penetration
 - center of west face at the water surface 3' wide by 2' tall up to 1' penetration
 - 6' south of north point on the west face 2' tall by 1' wide up to 2' penetration

- 8' north of the SW corner at the water surface 2' tall by 1' wide up to 1' penetration
- The joints between the blocks vary from 3/4" to 3" wide and are occasionally noted to have loose rock in the voids.

- There is blocks missing from the south point on the east face 10' below the water surface and NE corner 8' below the water surface
- There is a vertical crack in the center of the east face

- 2" wide up to 2' penetration extending from the water surface to the river bottom
 - 3.5' north of the SE corner measuring 3" wide up to 2' penetration extending from 15' above the ledge to the river bottom.

- There is a 2 missing masonry block on the south face 12' and 15' below the water surface measuring 3' wide by 2' tall by 2' penetration.
- There is a missing masonry block on the southwest face approximately 8' below the water surface measuring 4' wide by 3' tall by 1.5' penetration.

Damage or deterioration which may have significantly affected the integrity, stability or load bearing capacity of the observed substructure elements was not detected at or below the water surface for pier 4. Pier 5 shows significant section loss on the masonry blocks within the splash zone. There are also missing masonry blocks as noted in Section 2.2. If this bridge is reopened to pedestrian traffic it is recommended that Pier 5 would need substantial rehabilitation to repair missing and broken blocks. In additions, missing and cracked mortar would need to be cleaned and pointed. Pier 6 shows minor areas of masonry section loss and the pier should be repointed.

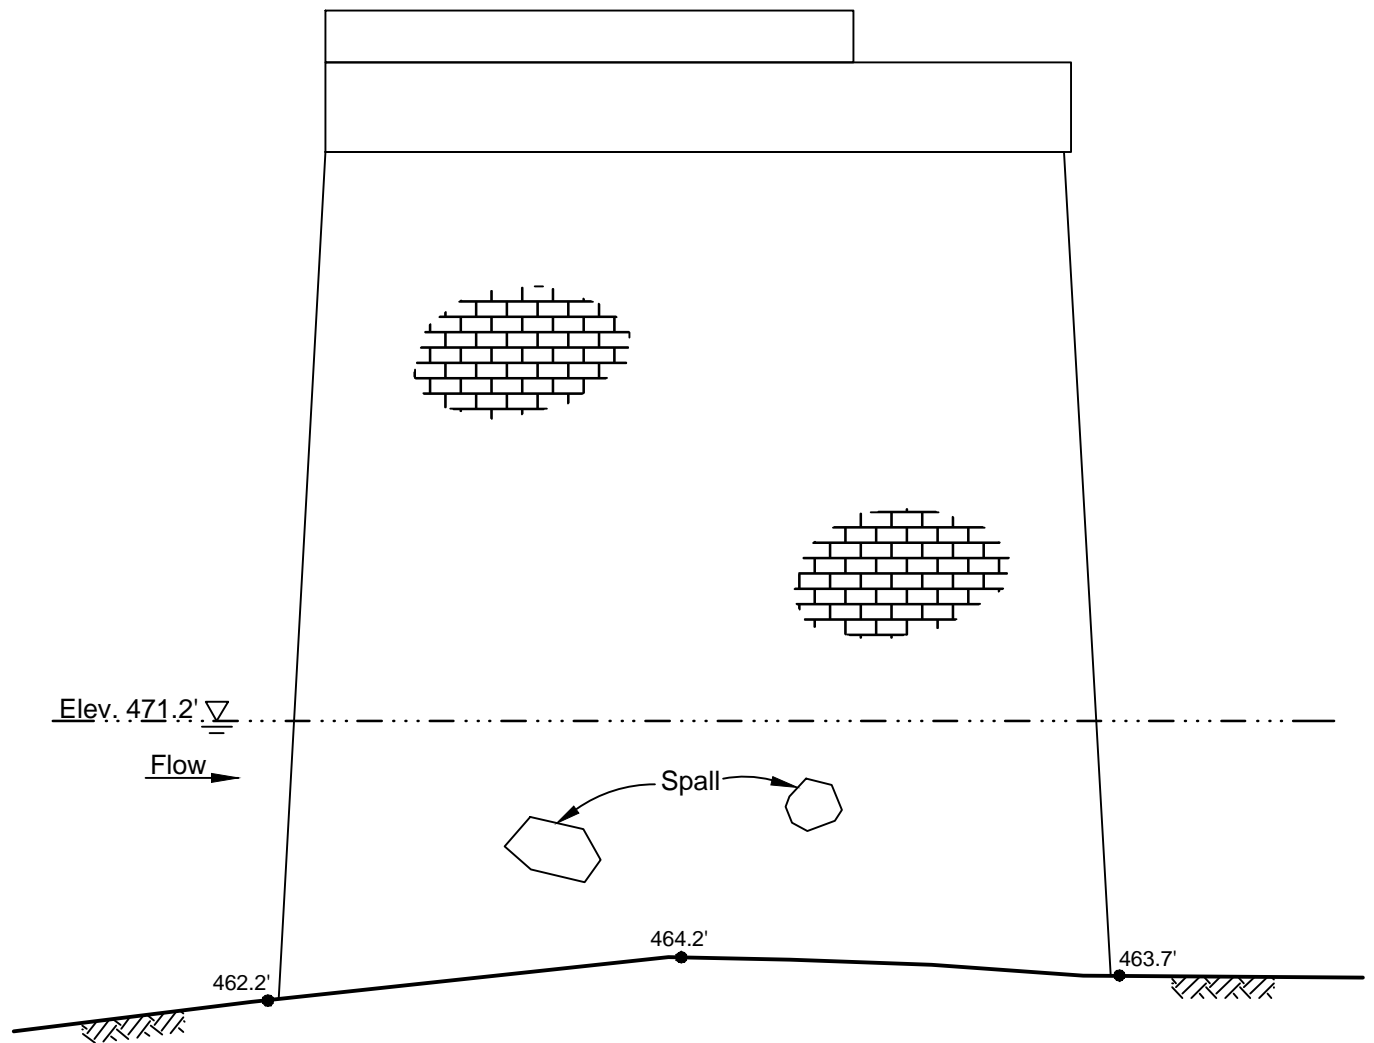
**PIER 6
LOOKING WEST**

- There is a concrete/mortar overlay covering the masonry block on the east face from 3 feet above the water surface to 1' below the water surface.
- Section loss of the masonry block 25' south of the north face measuring 2' wide by 1' tall by 8" penetration located 6' below the water surface.
- There is a highly fractured block on the east face 10' north of the south face located 10' below the water surface.
- Several blocks on the east face are exhibiting areas of delamination and pointing.
