Bridge Inspection Report

056B00250N

01/11/2023

IDENTIFICATION		
Structure Num (8):	056B00250N	
NBI Number:	056B00250N	
Structure Name:	—	
Location (9):	0.4 MI W OF RALPH AVE	
Carries (7):	I-264	
Type of Service (42A):	1 Highway	
Feature Crossed (6):	P&L RAILWAY	
Type of Service (42B):	2 Railroad	
Placecode (4):	Not Applicable	
County (3):	Jefferson (056)	
State (1):	21 Kentucky	
Admin Area:	Inventory	
District:	District 5	
Latitude (16):	38° 12' 49"	
Longitude (17):	85° 49' 23"	
Owner (22):	State Highway Agency	
Maint. Resp. (21):	State Highway Agency	
Year Built (27):	1970	Border State (98A): Not Applicable (P)
Year Recon (106):	2003	Border Number (99):
		% Responsibility (98B): -1

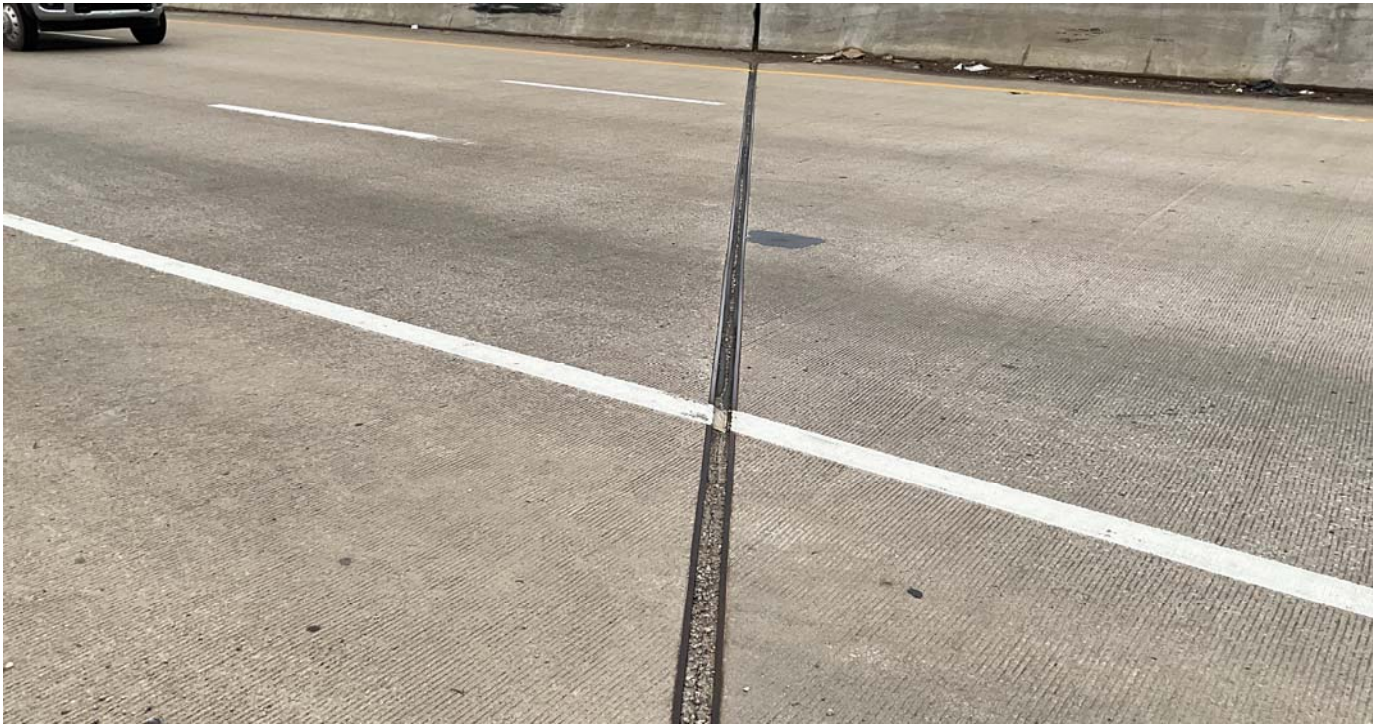
Joint at Pier 5

Compression joint seals have majority of length affected by adhesion failure at the EB Abutment 1 and Pier 5 joints. Partial adhesion loss in a portion of WB Pier 5 and full length along Abutment 8 joints. All joints have debris in both shoulders, and WB Pier 5 joint has debris throughout.

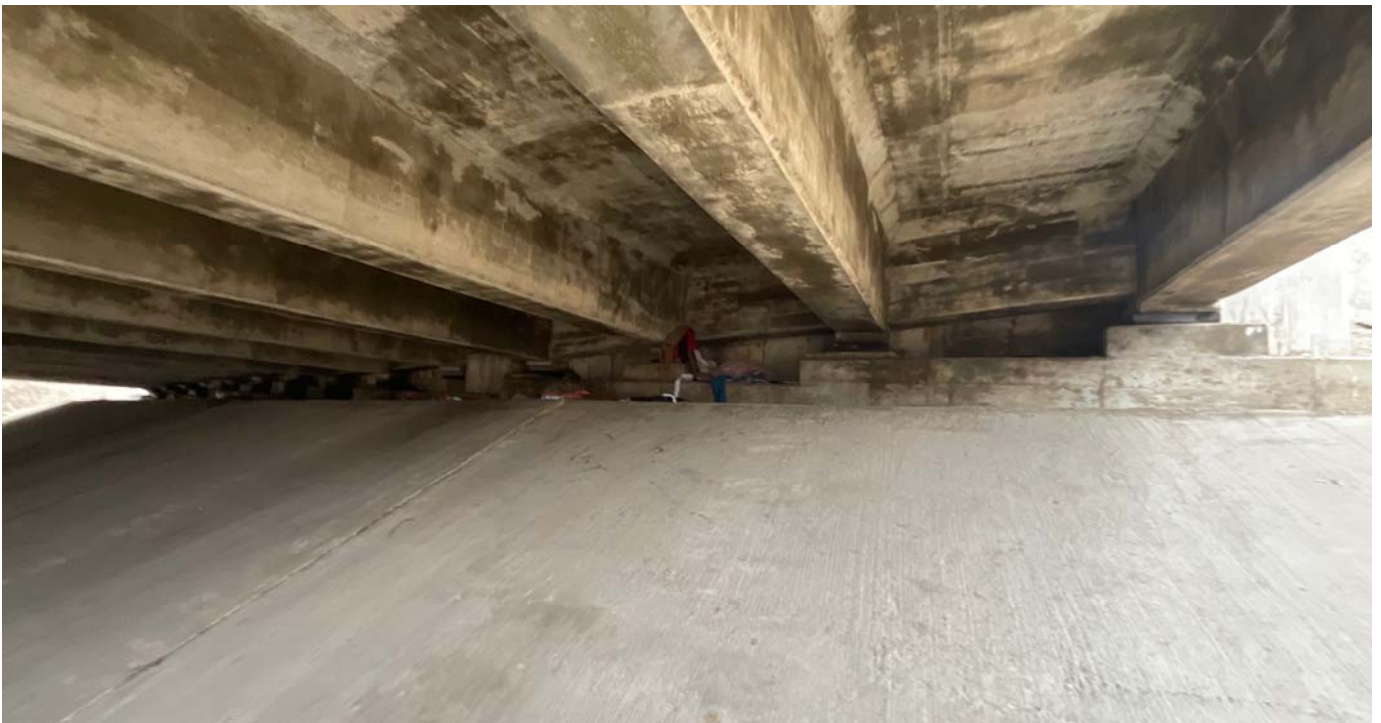
All bearing pedestals have had concrete repairs, some are cracking. Abutments have moderate to wide vertical cracking, delaminated areas, and a few spalls greater than 6 inches wide with exposed steel reinforcement, some with section loss at Abutment 1 near the south end.

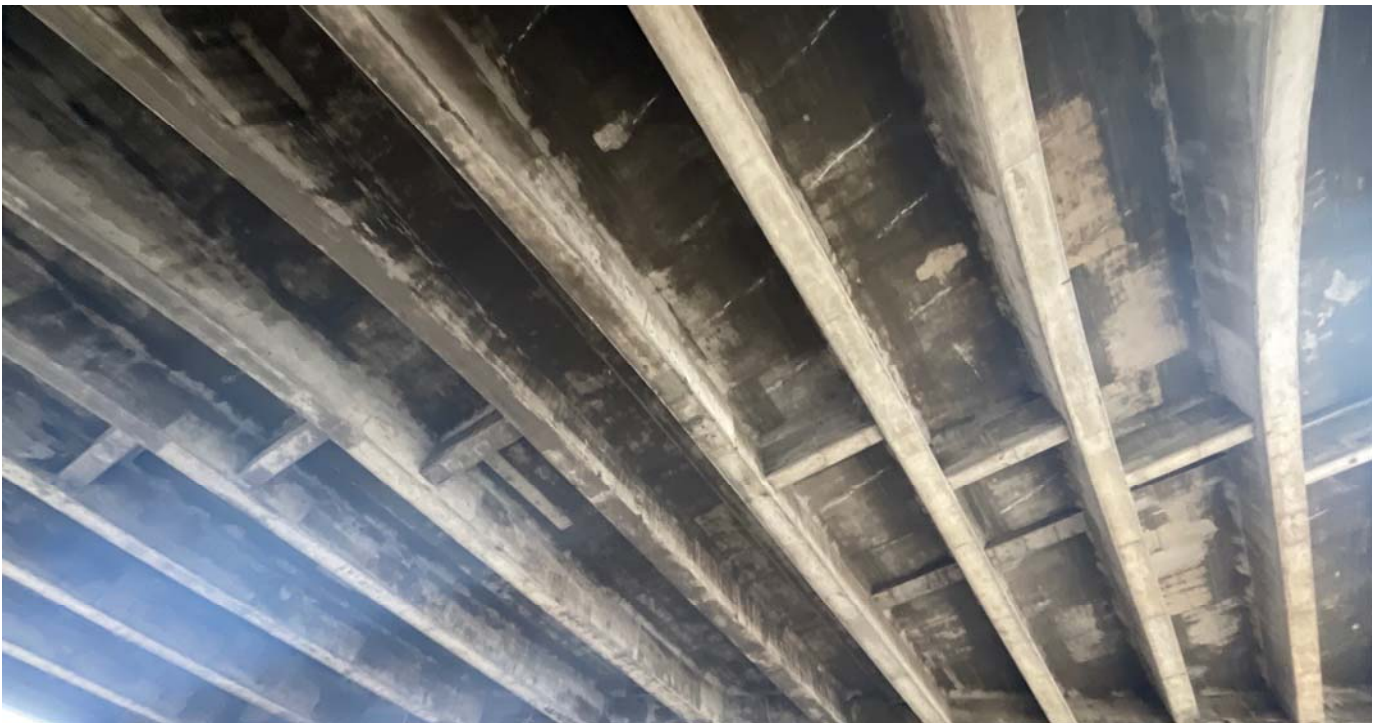
Top surface cannot be inspected due to 2003 deck rehabilitation. Top flange soffit has transverse cracking with efflorescence in Span 5 along WB half and in Span 6 along EB and WB, and a few other localized areas. North overhang has deep spalling with exposed rebar over Pier 5, and there are a few other spalls scattered throughout, some with exposed steel reinforcement.

Span 5 Soffit - note cracking with efflorescence

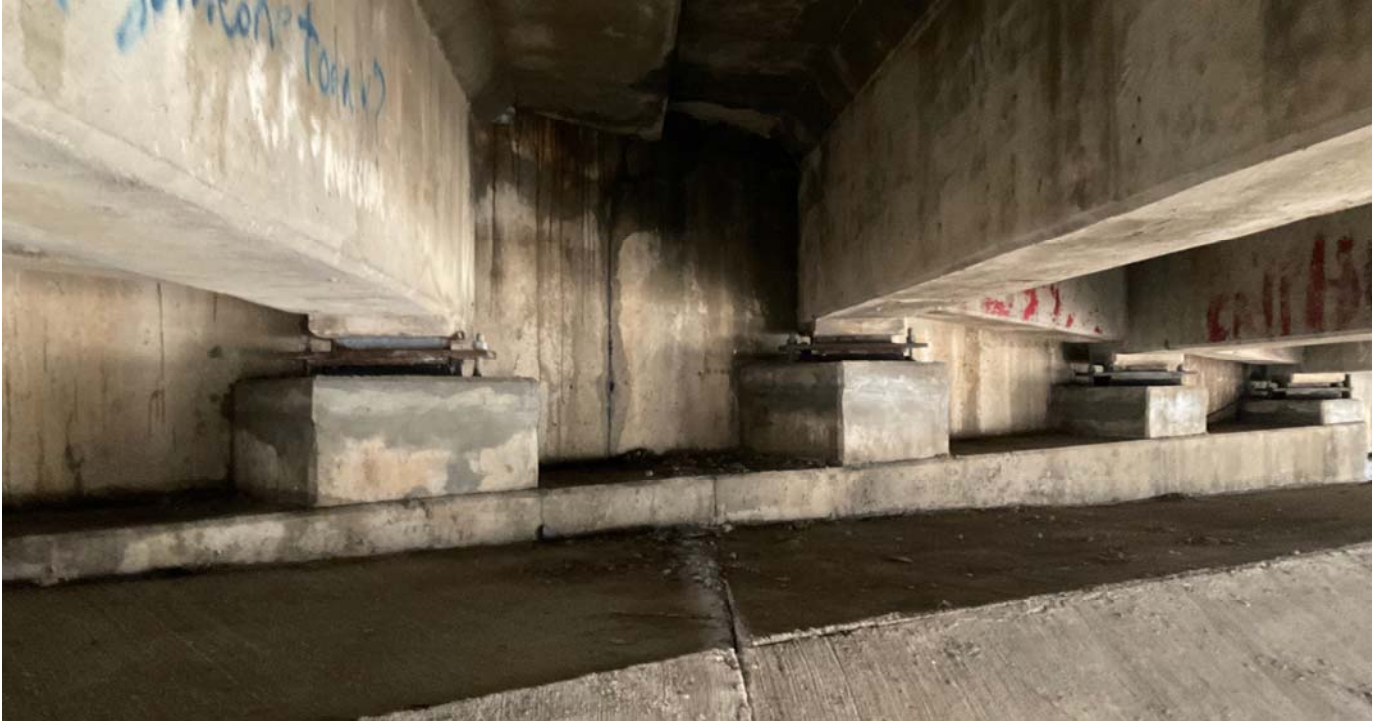
Bearing assemblies have freckling rust. At Abutment 8, anchor bolts at Girders 1, 8, 10, 11, 13, and 14 appear to have been installed out of vertical plumb. Elastomeric pads for all girders except Girder 12 show no signs of eastward expansion (50 degrees at time of inspection). Beam 5 at Abutment 8 has a missing nut on anchor bolt.

Typical bearing - Abutment 8

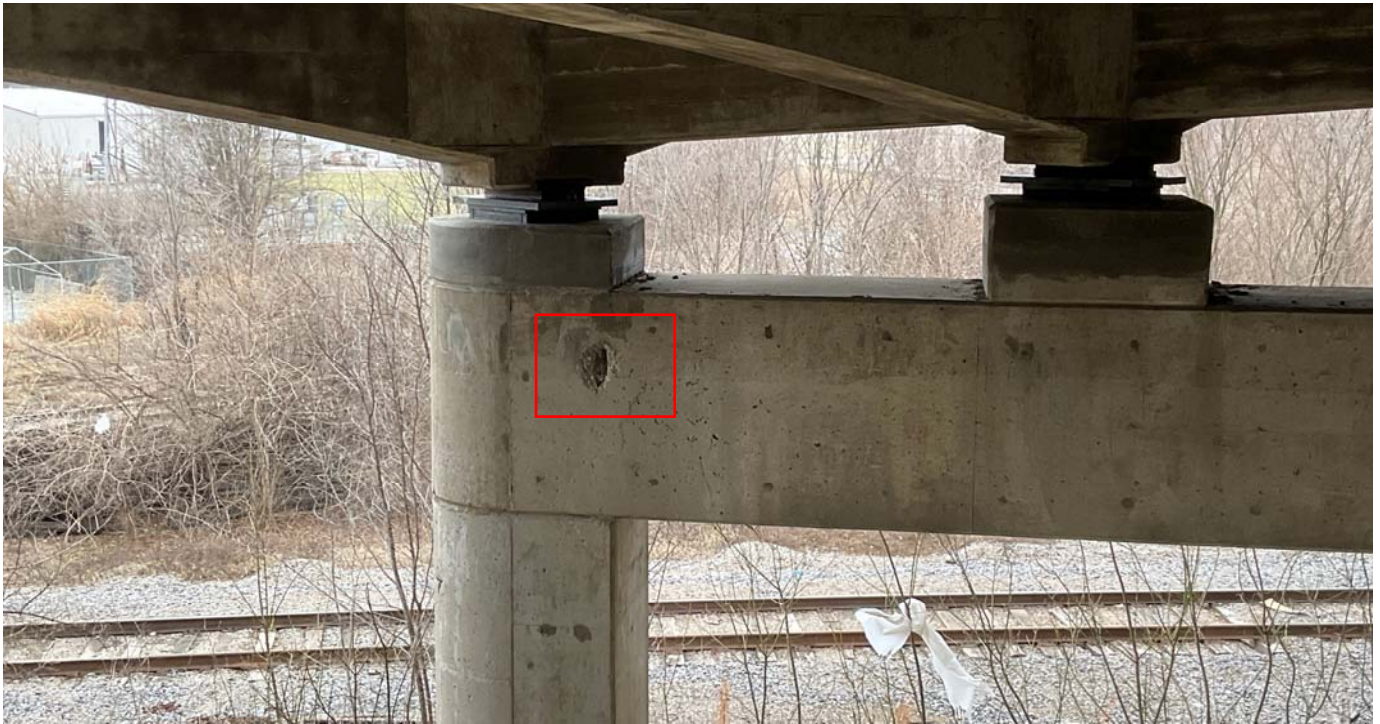
Spall - Pier 7 Span 7 under Beam 14.

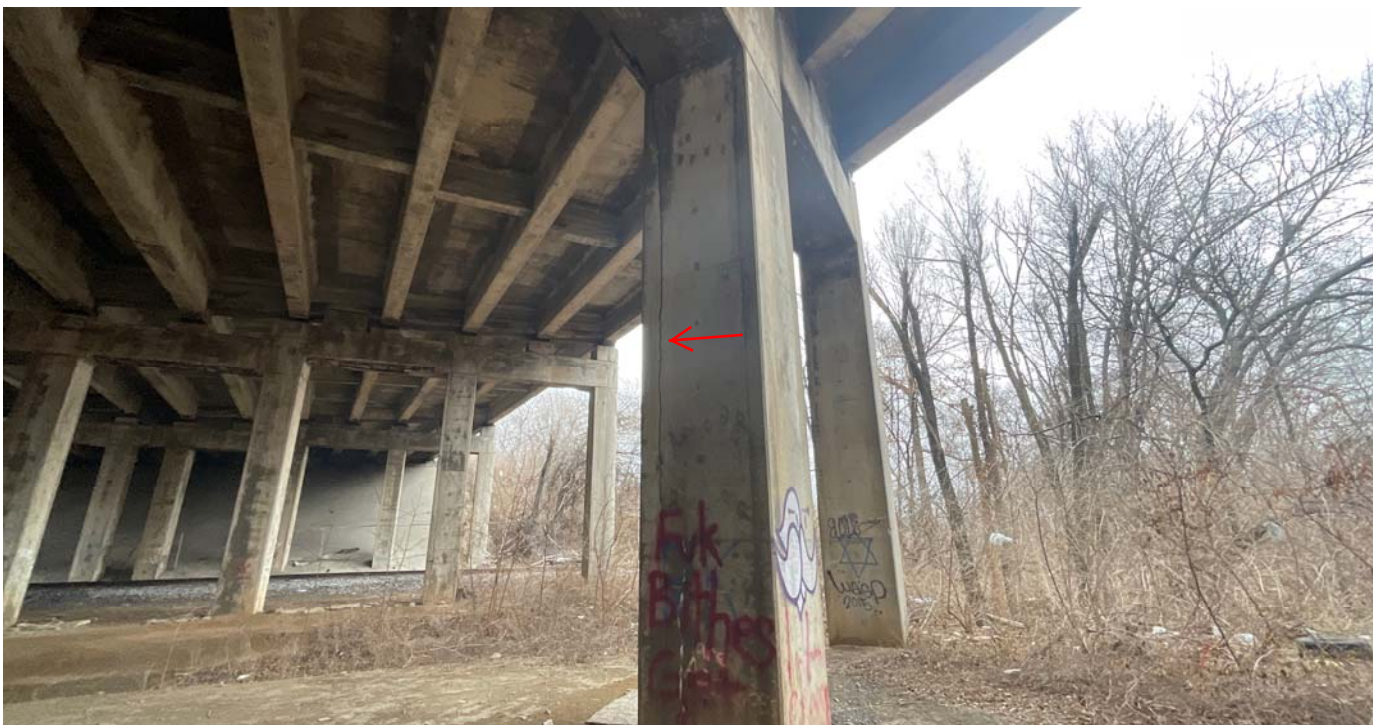
Vertical crack in Pier 5 - Column 2

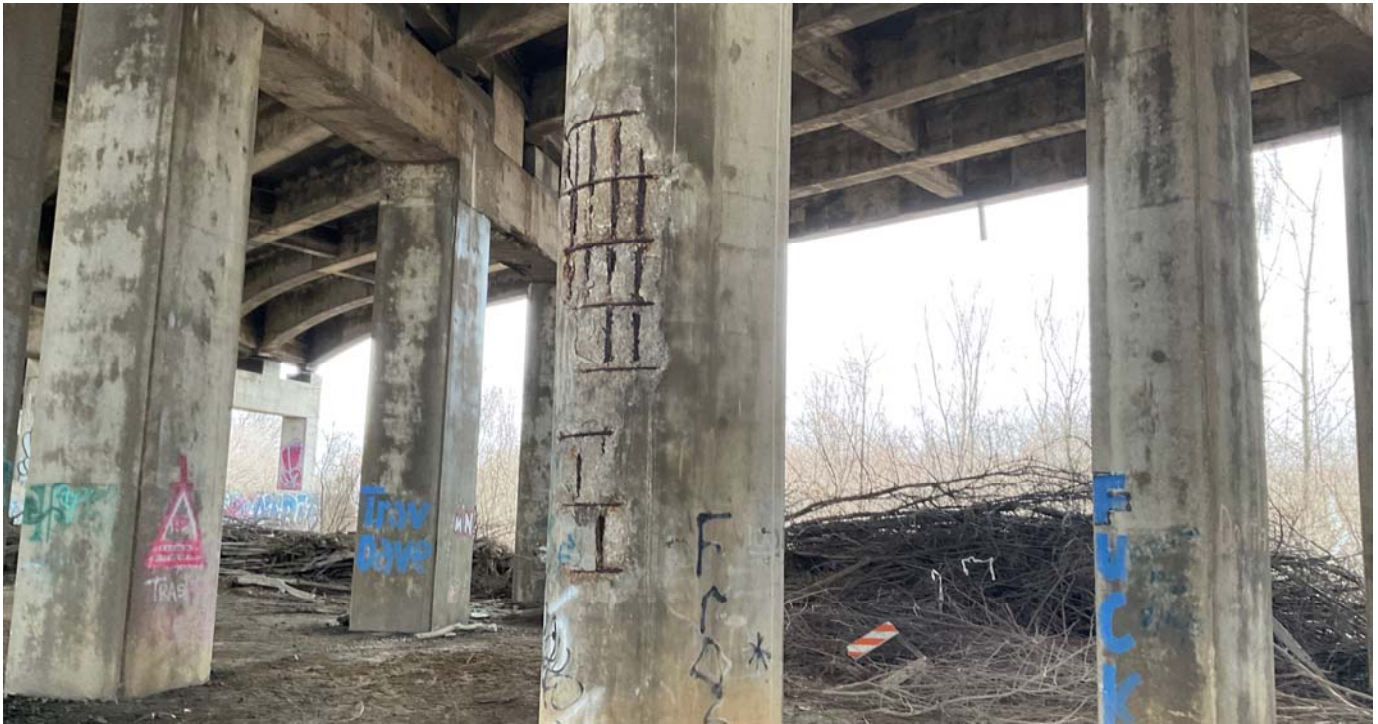
Columns have wide vertical cracking (up to 5/8 inch wide), delaminated areas, unsound patches, large spalls, and/or exposed steel reinforcement. Pier 2 Columns 4,6, and 7 have 12" spalls on the Span 1 face. Pier 3 Columns 1-3 and 5-7 have spalls with exposed reinforcement. Column 1 at Pier 4 has 10 feet (vertically) of spalling on the north face. Columns 2-4 also have spalls with exposed steel. All columns at Pier 5 have spalling, with Column 2 having 2 wide vertical cracks, one of which is along a line of epoxy injection completed during 2003 rehab project. Column 5 at Pier 6 has a large spall at the top on the Span 5 side.

Spalling in Column 1 - Pier 4

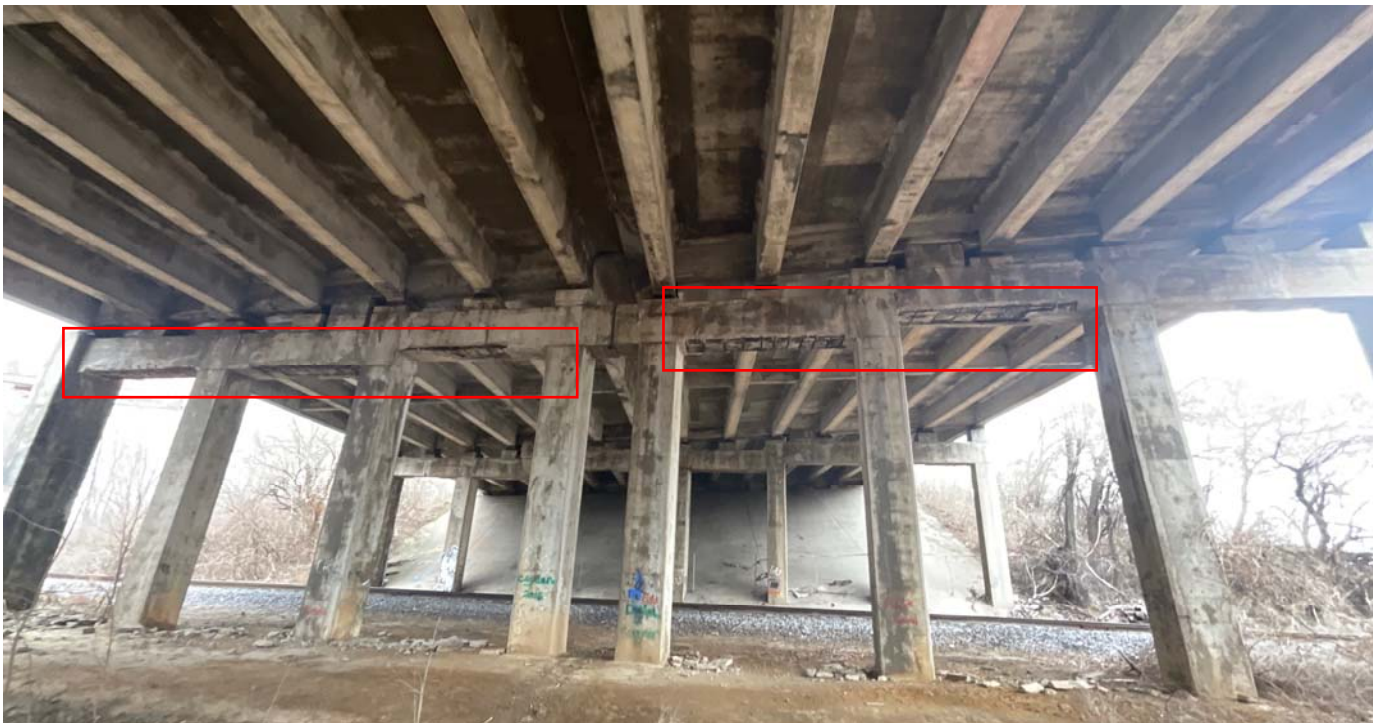
All bearing pedestals have had concrete repairs, some are cracking. Piers 2-5 have widespread spalling and wide cracking. Pier 3 has spalling on the underside with exposed steel for nearly the full length. CS3 spalling also is present for roughly 50% of Pier 2, 75% of Pier 4, and 75% of Pier 5.

Spalling along underside of Pier 3 cap

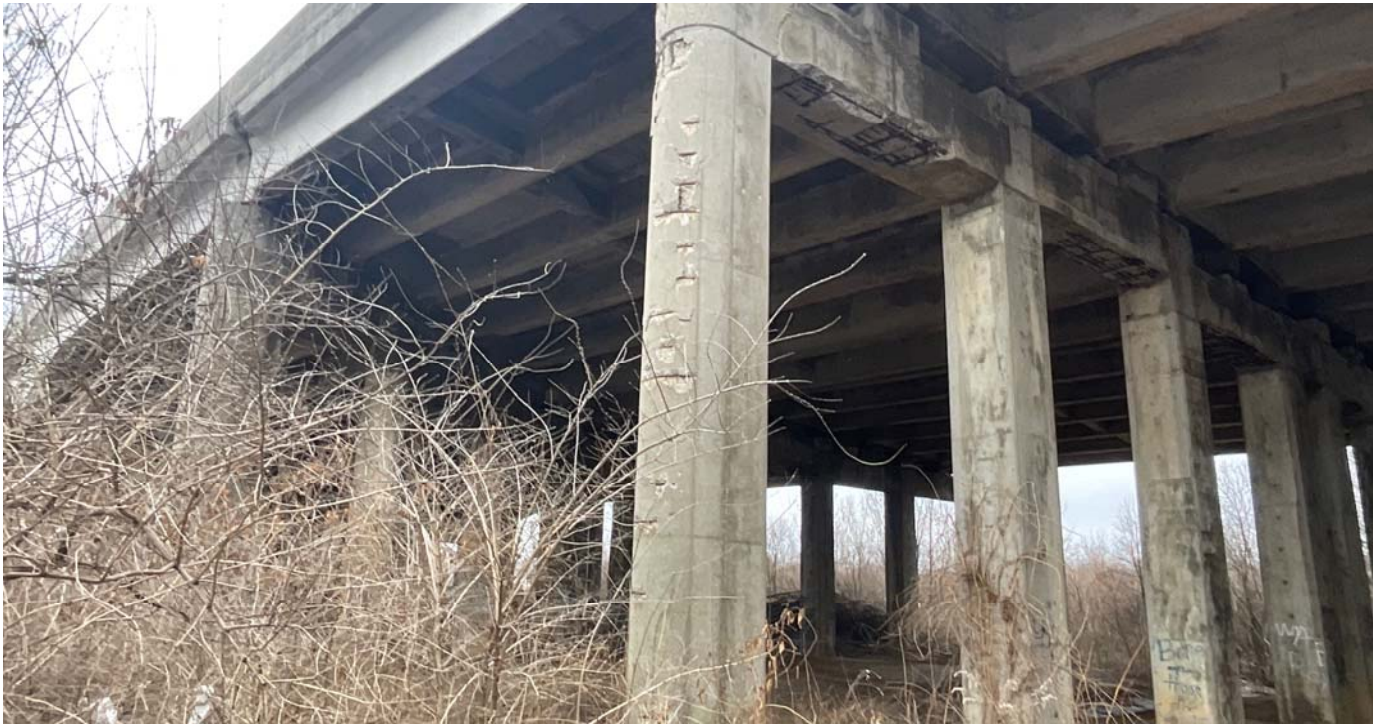
Pier 3 Column 1 spalling

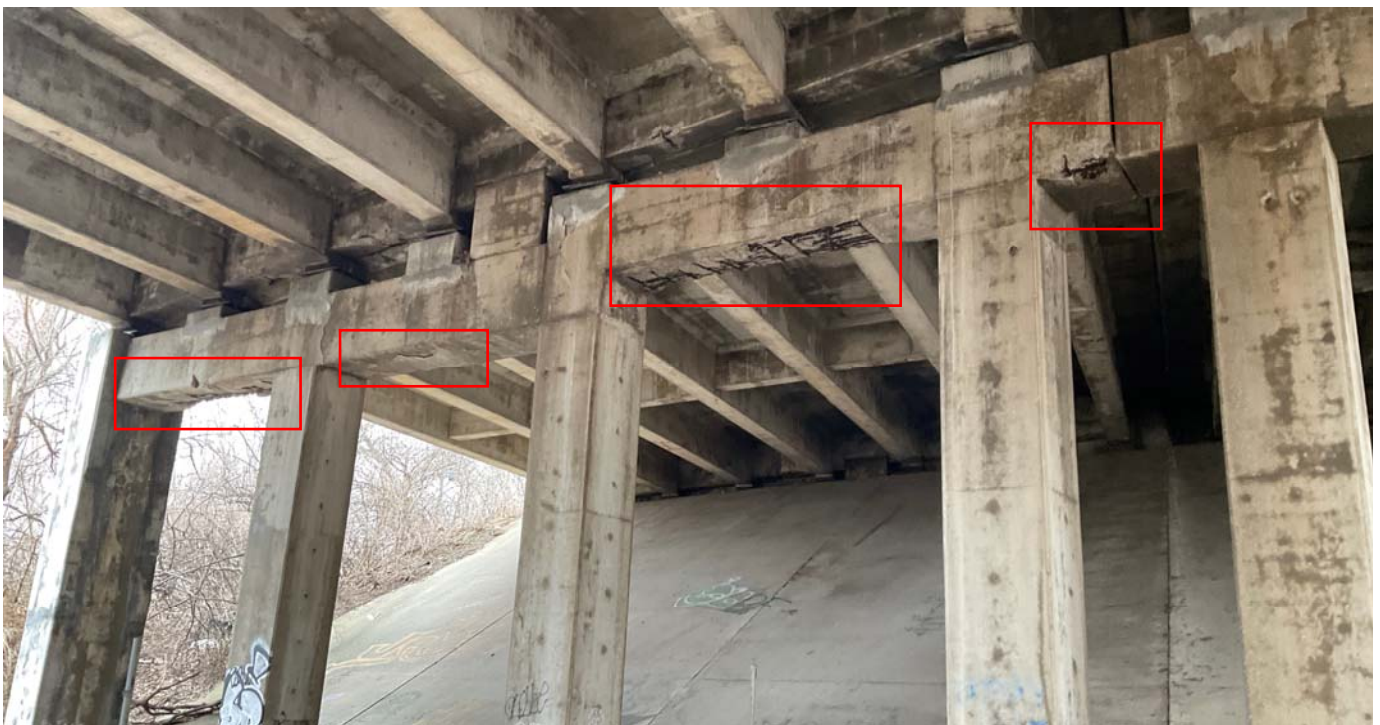
Spalling along Pier 2 cap

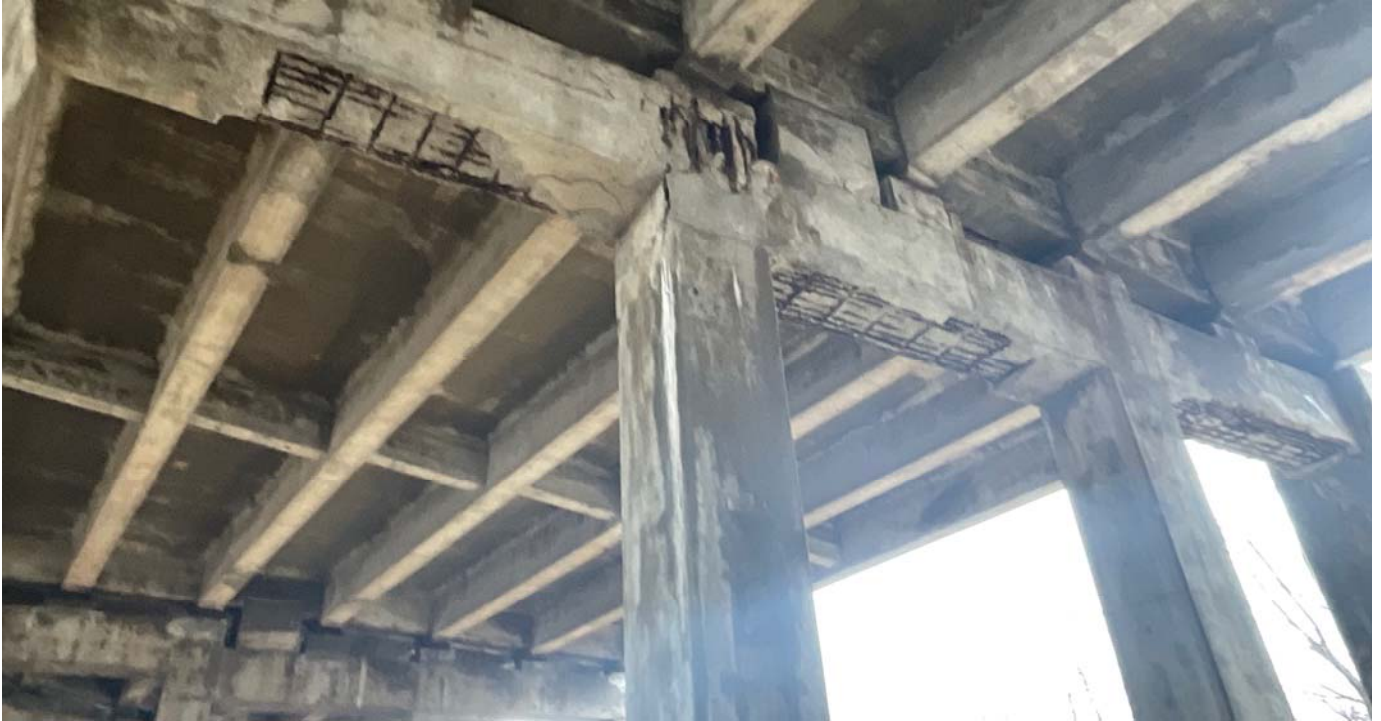
Pier 3 - Column 6 spalling at top

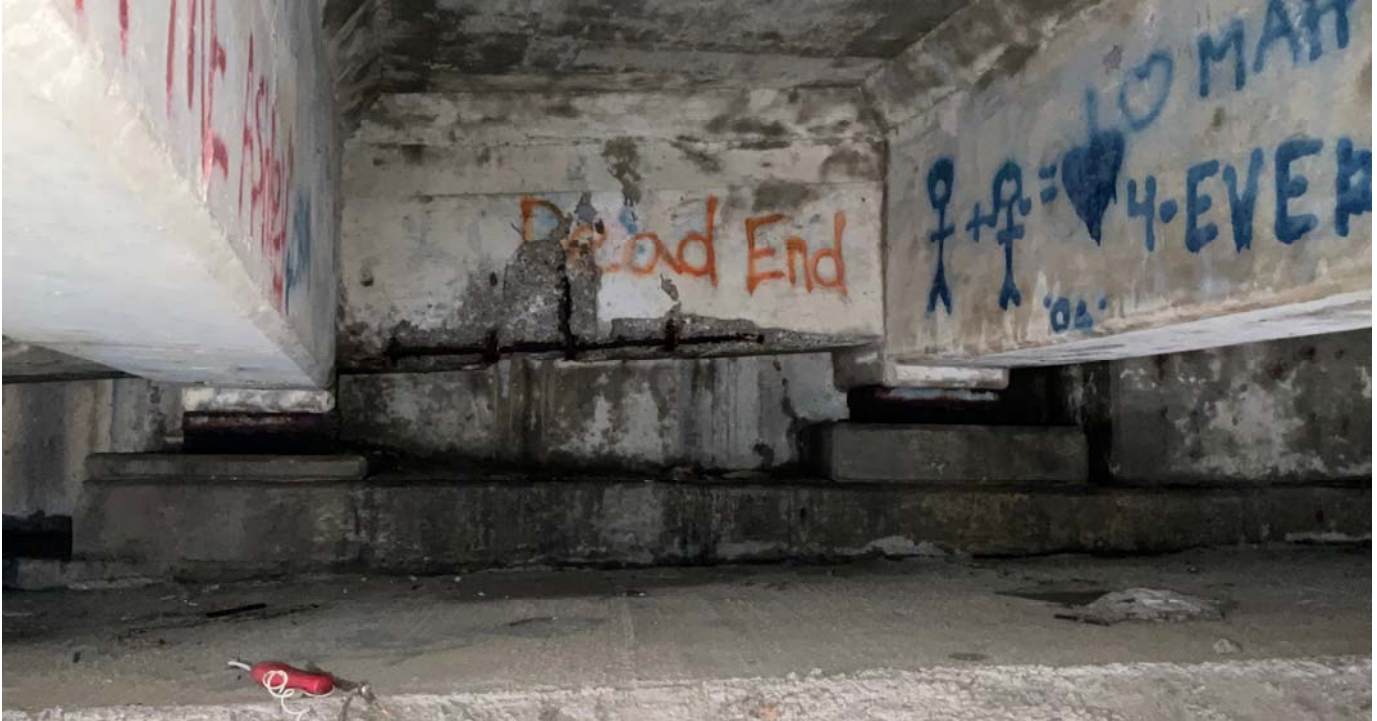
Diaphragms have cracking and spalling, some areas with exposed steel reinforcement.

Diaphragm at Abutment 1 between Beams 11 and 12.

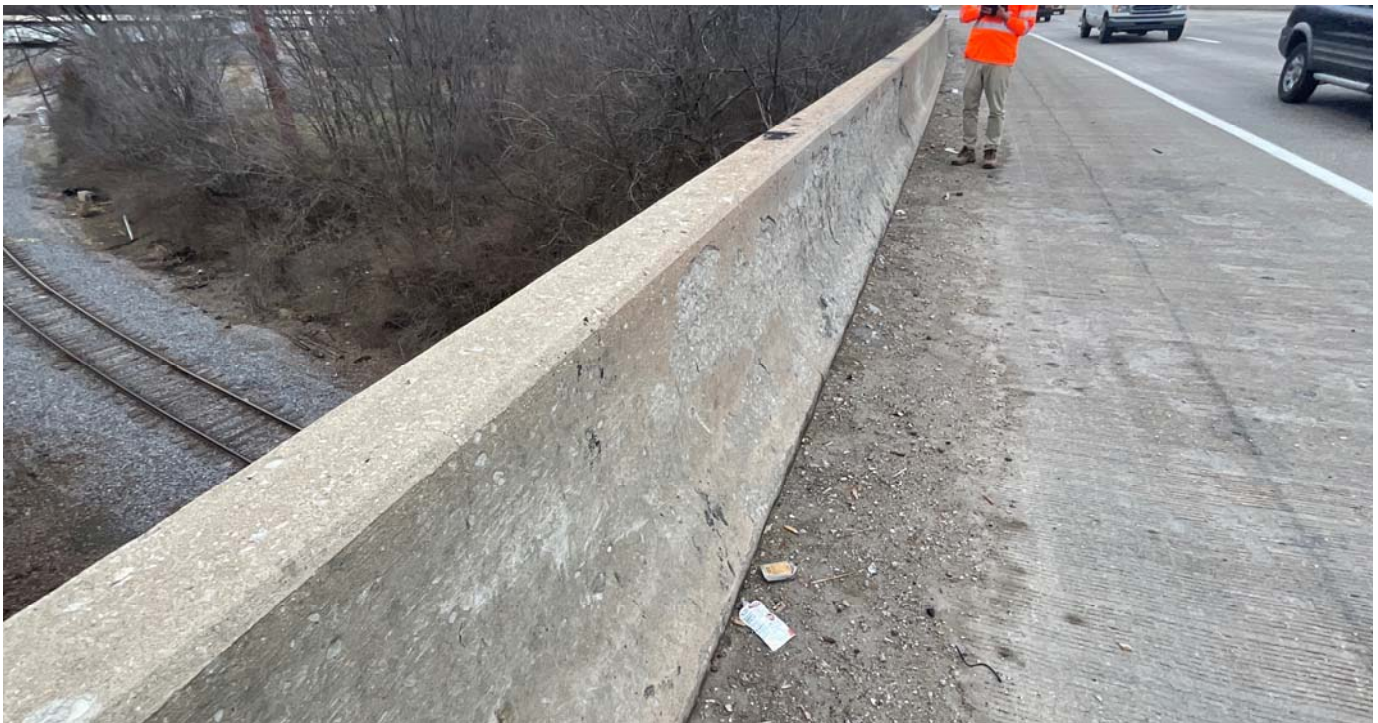
Barrier walls have moderate to wide vertical cracks, some with efflorescence, and horizontal cracking in WB median rail. The eastbound exterior railing has roughly 27 feet of heavy scaling from collision and fire damage in Span 2, and two wide cracks.

Barrier wall is scaled - EB barrier – Span 2
