Bridge Inspection Report

056B00250N

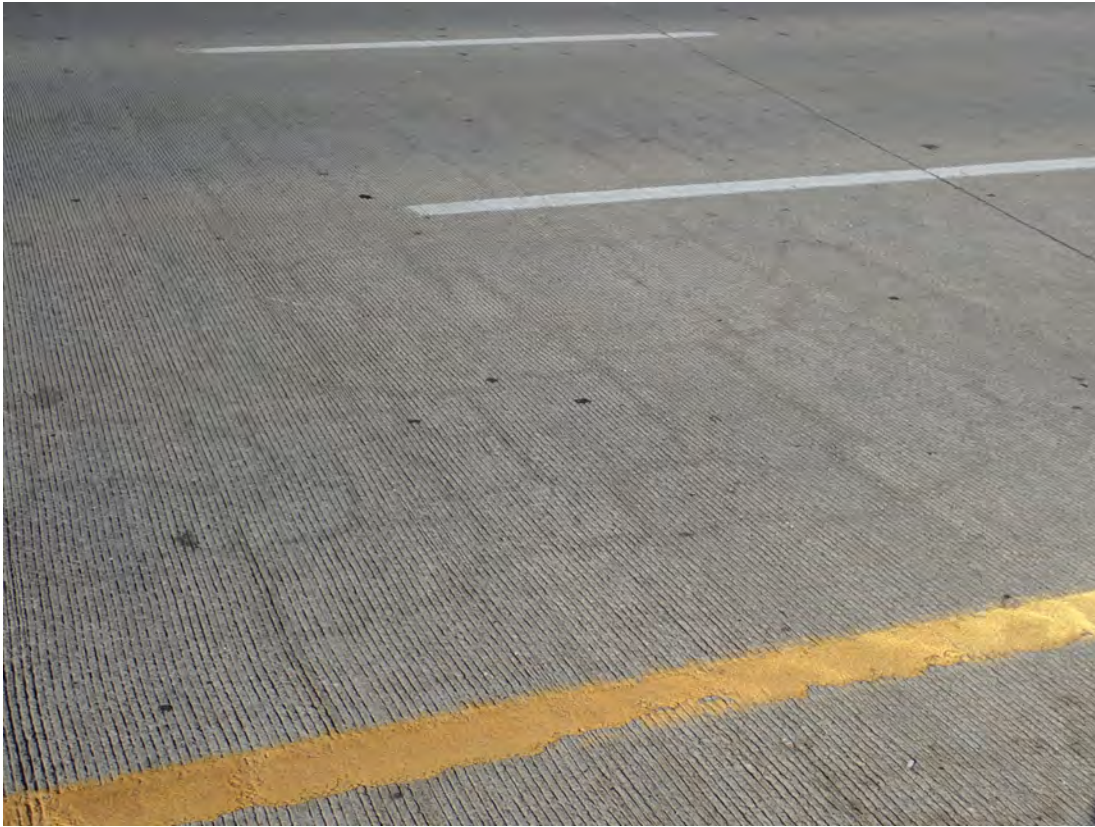
Map cracking noted in deck over Span 1

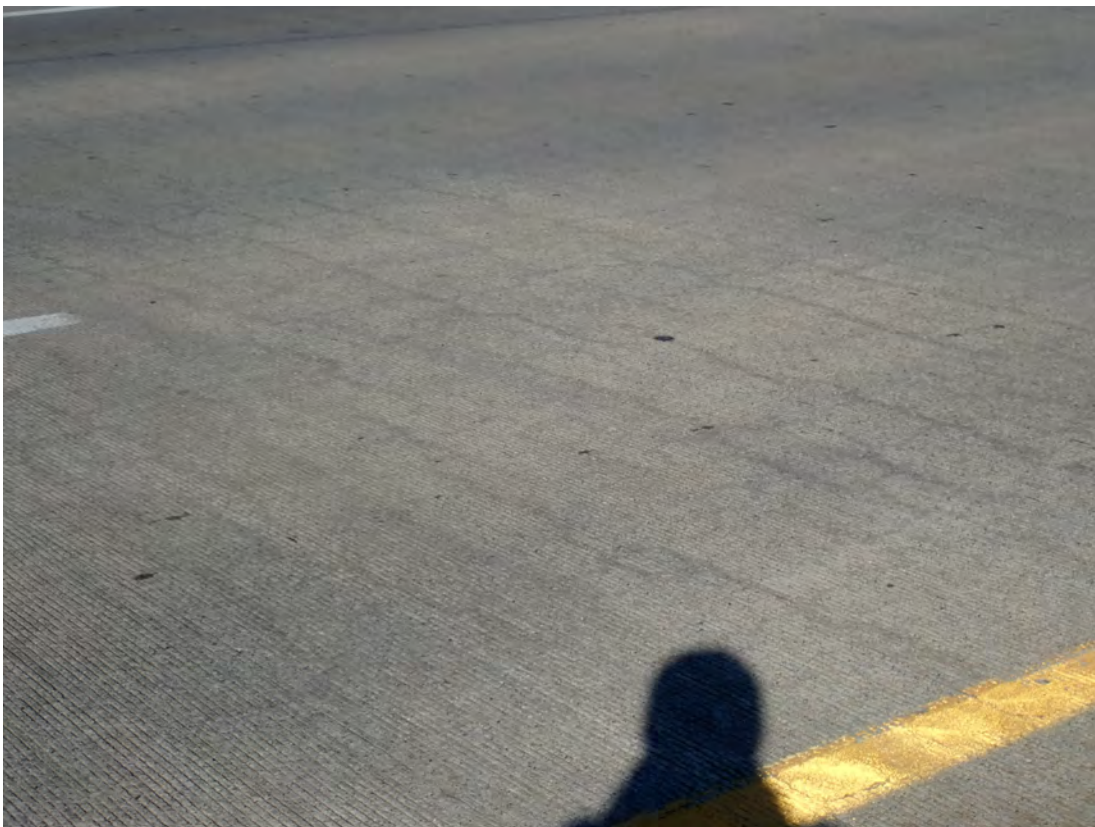
Another location of map cracking noted in deck over Span 1

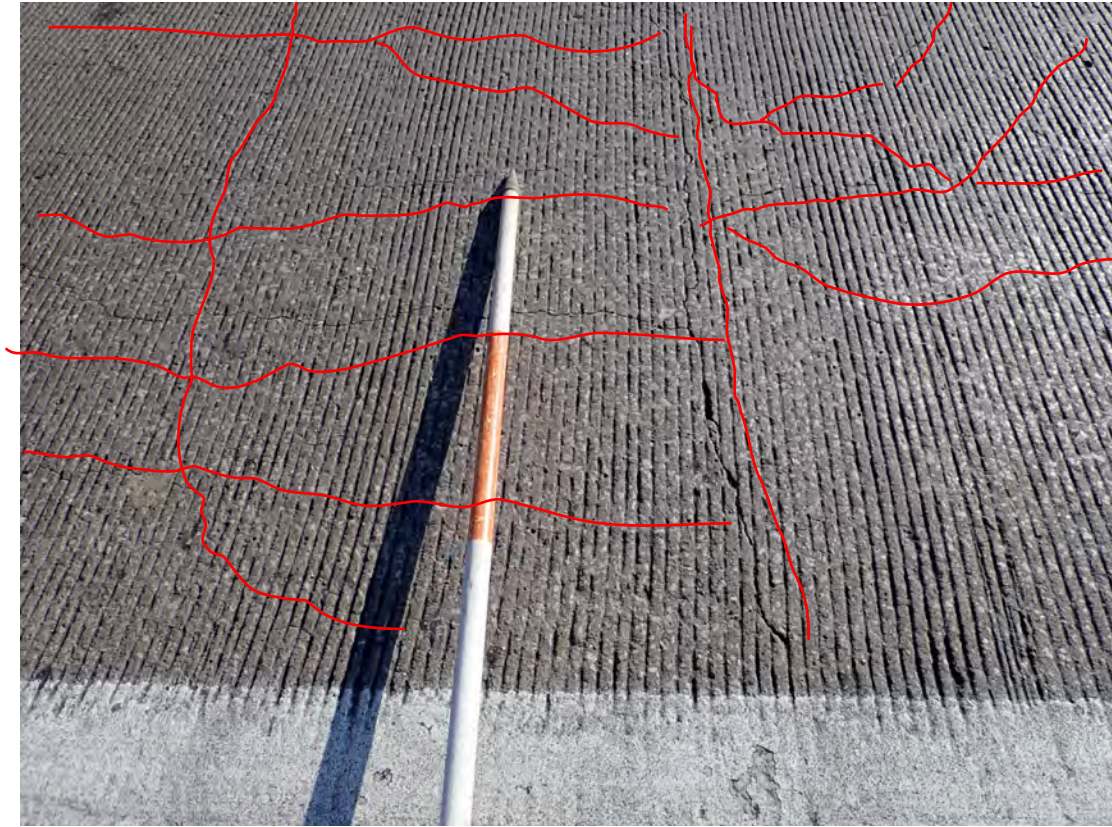
Closer view of dense map cracking in Span 1 -- heavier amounts typical of all but Span 4 EBL; affects full length of WBL & full lane widths in each direction of travel

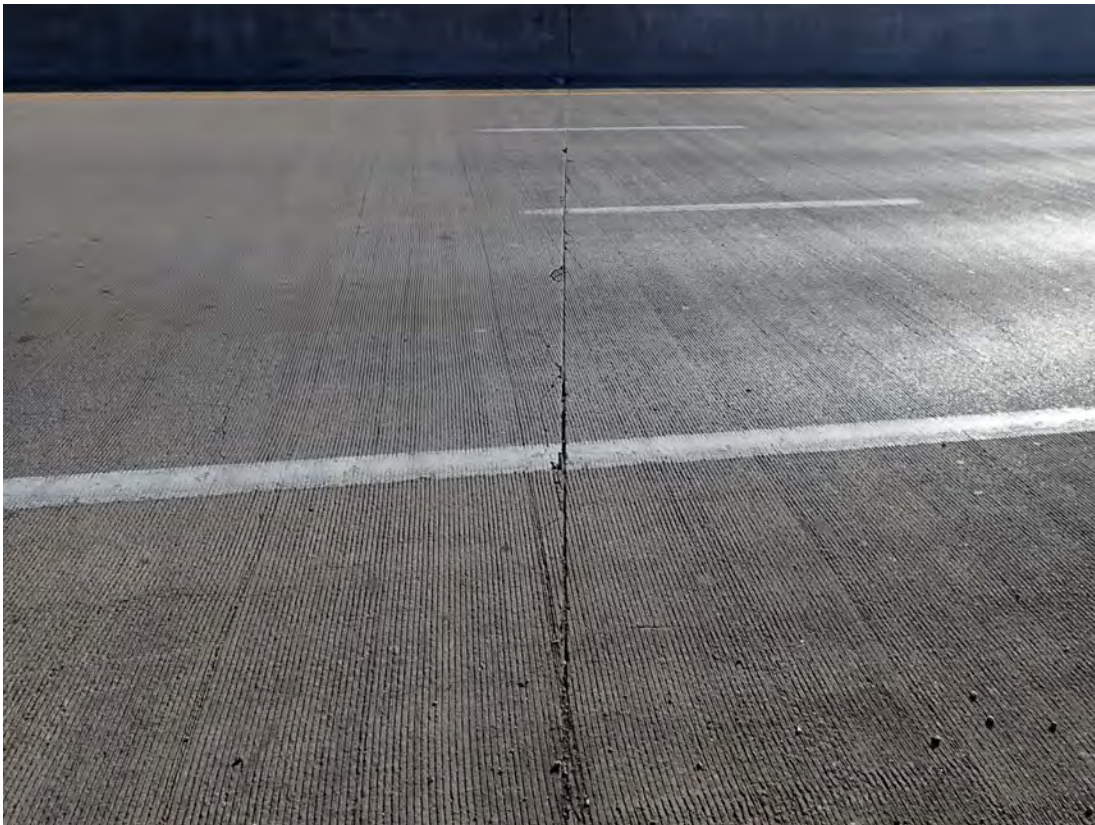
Relief cut over Pier 2 EBL with what appears to be a pourable sealant material across 53 feet of the deck with edge failure at random locations along length of joint. 16 feet affected by sealant failure

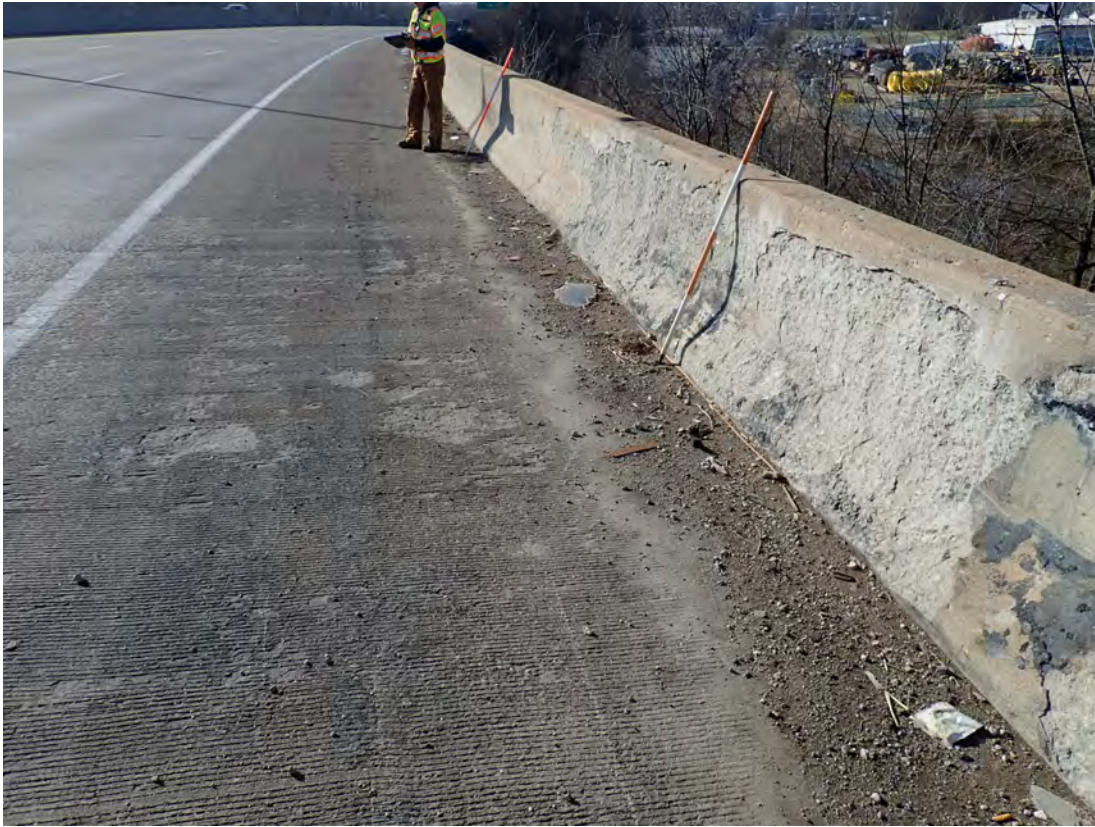
Fire damage along the south barrier wall of EBL in Span 2

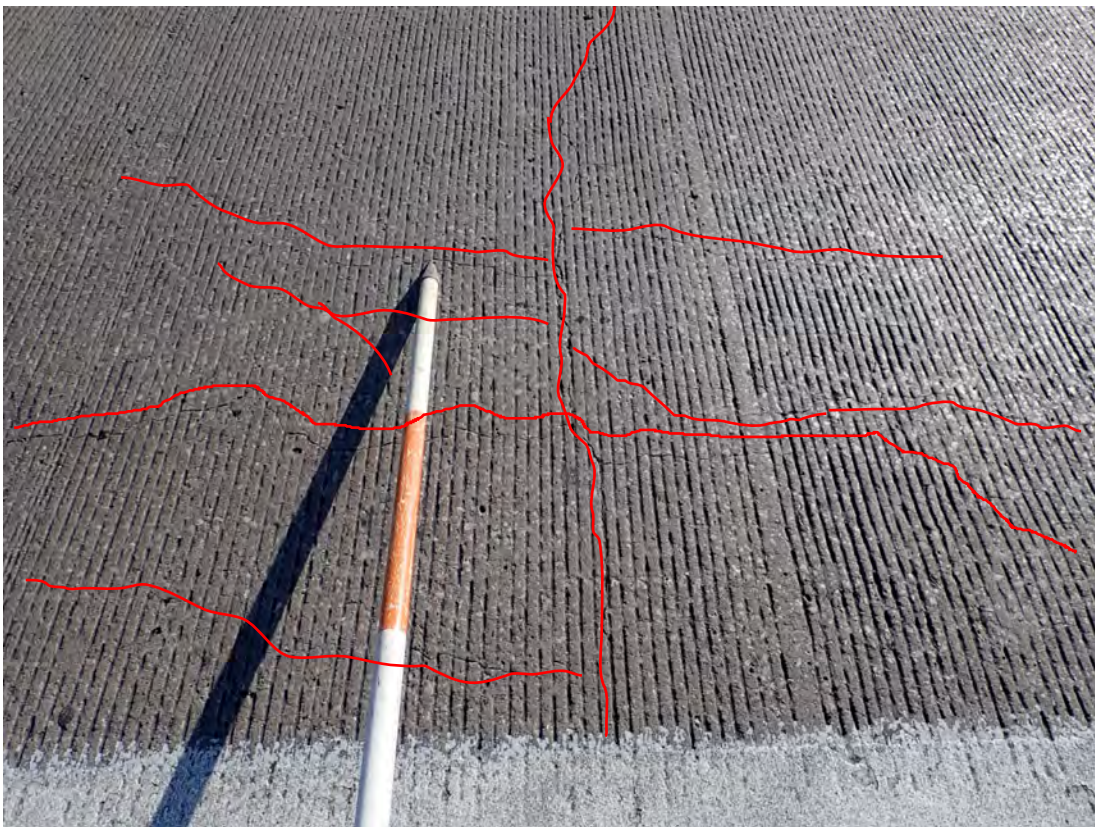
Map cracking typical of that found in deck over Span 2

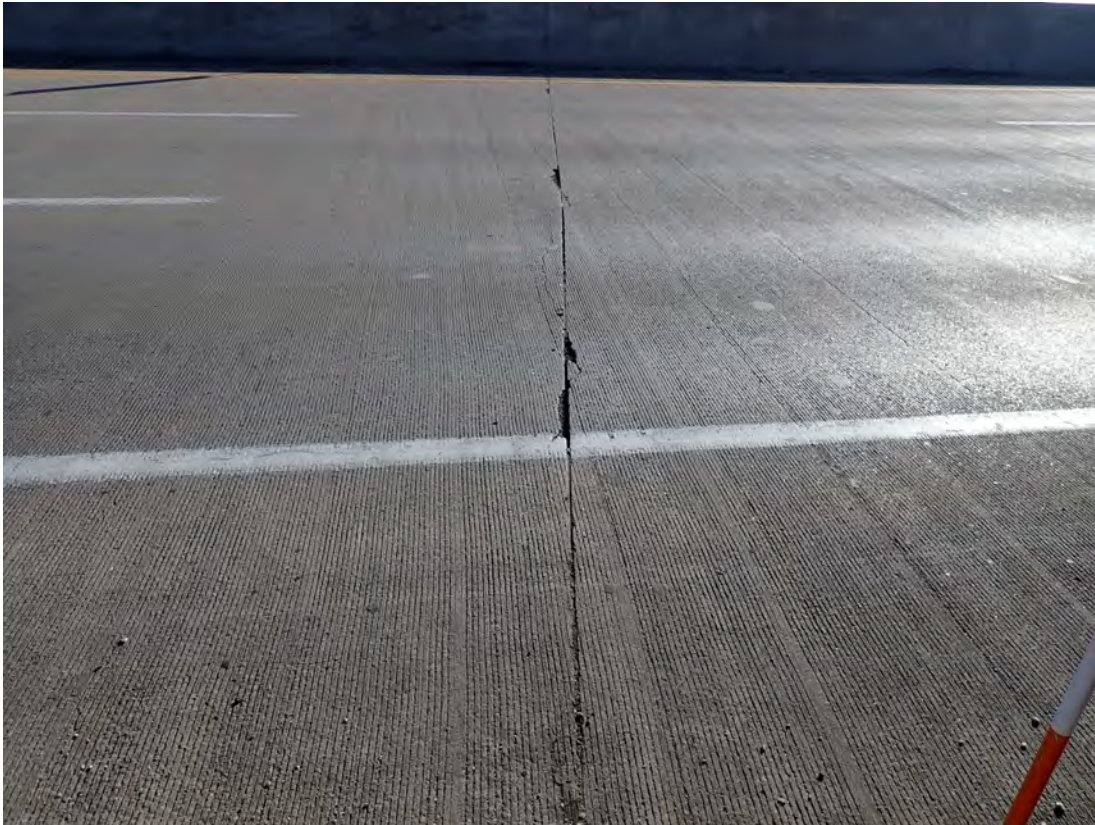
Relief cut over Pier 3 EBL with what appears to be a pourable sealant material across 53 feet of the deck with edge failure at random locations along length of joint. 14 feet affected by sealant failure

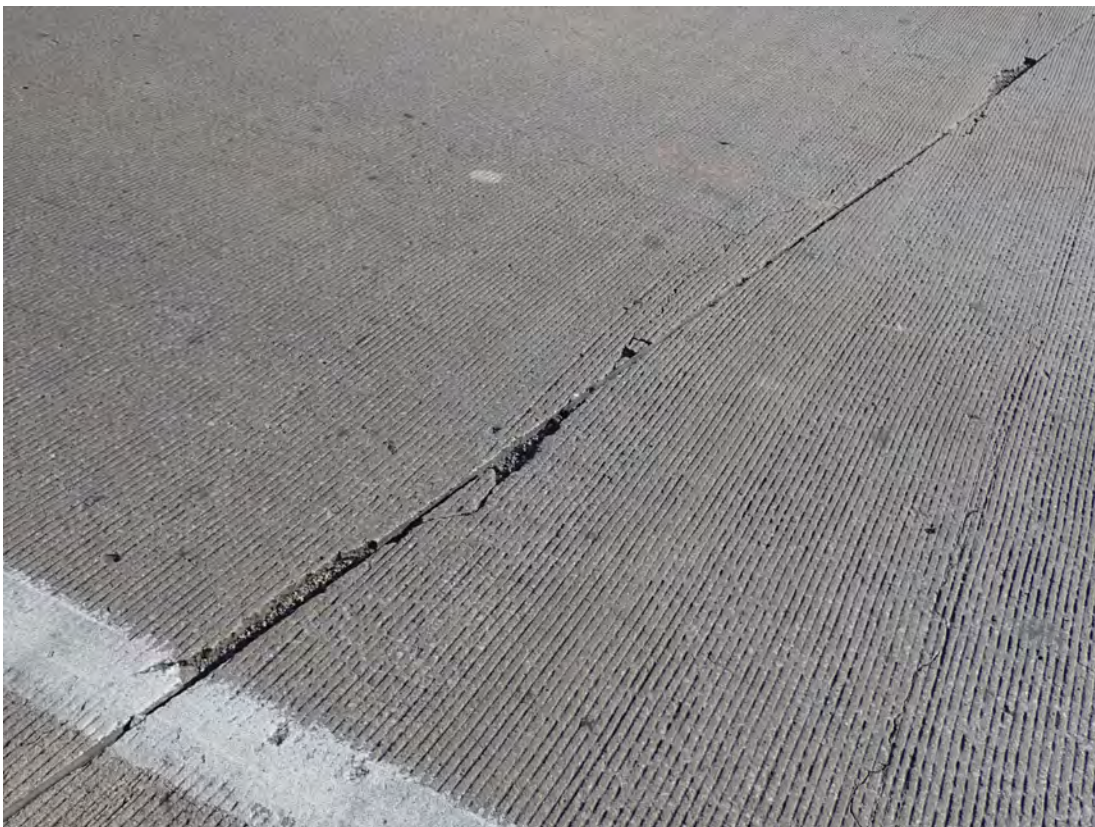
Closer view of edge failure over Pier 3 EBL

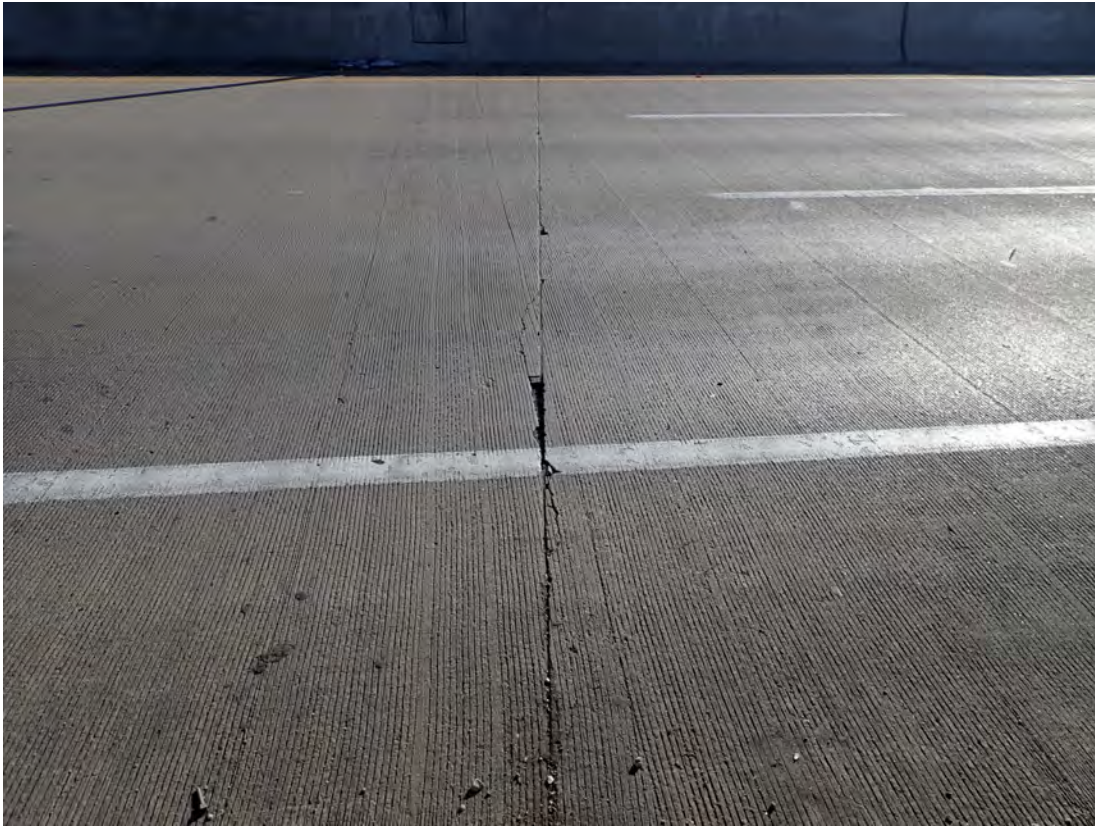
Relief cut over Pier 4 EBL with what appears to be a pourable sealant material across 53 feet of the deck with edge failure at random locations along length of joint. 10 feet affected by sealant failure

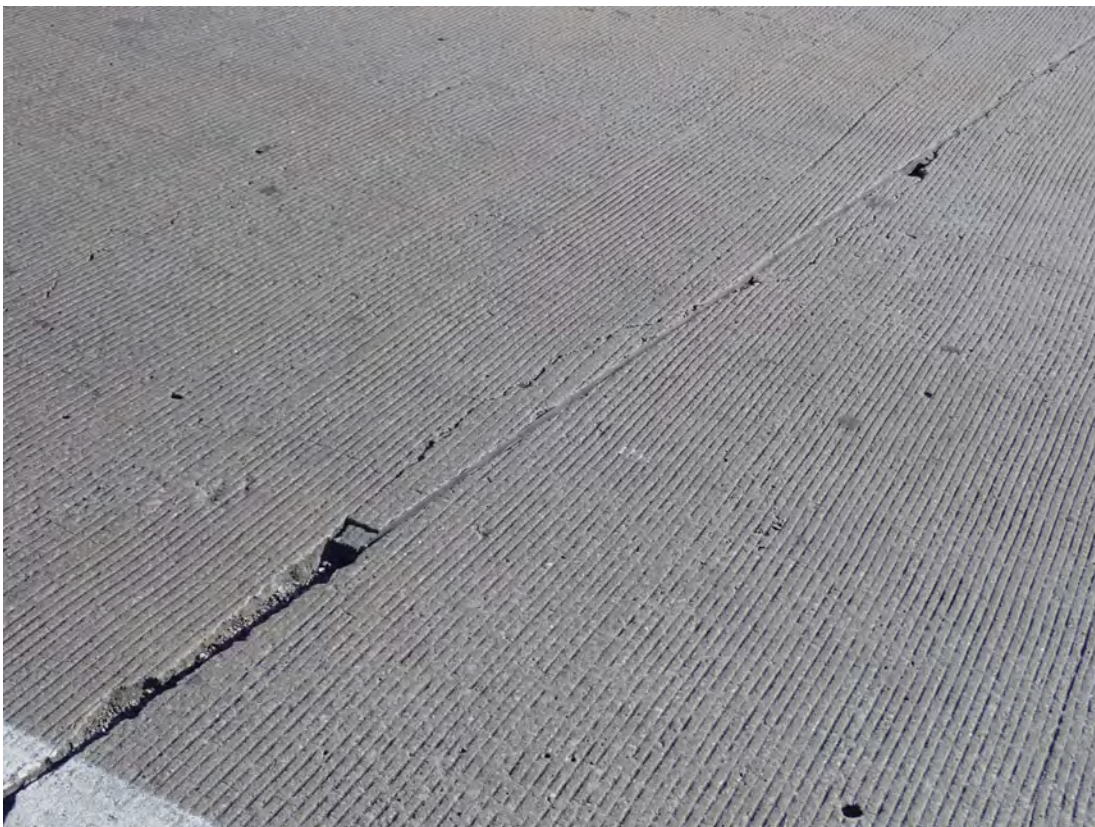
Closer view of edge failure over Pier 4 EBL

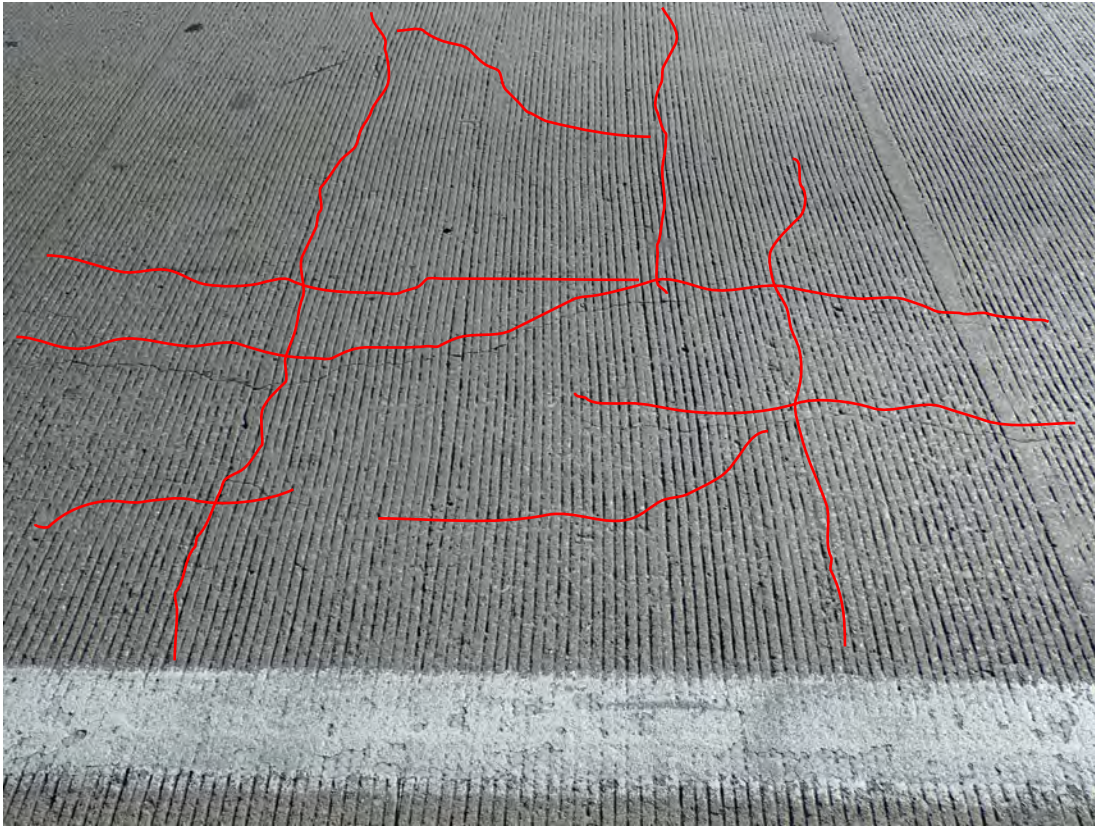
Map cracking again found in Span 3

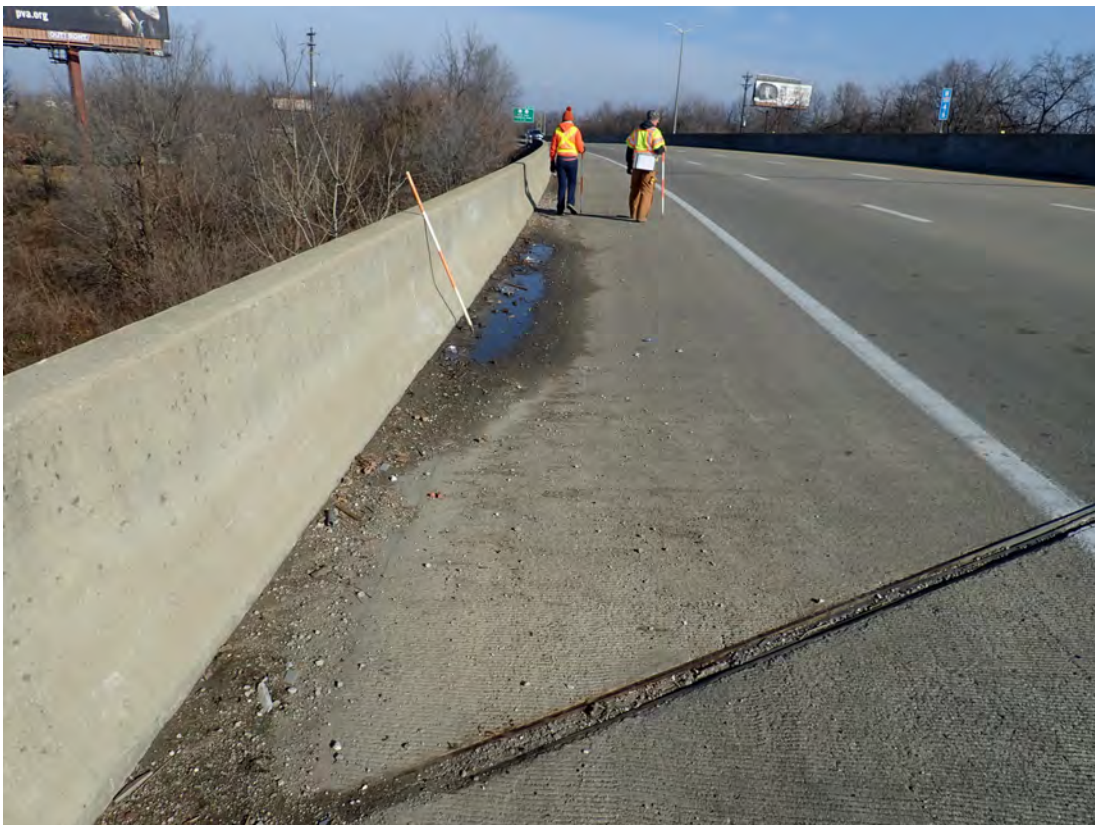
Ponding against barrier wall in Span 4 EBL

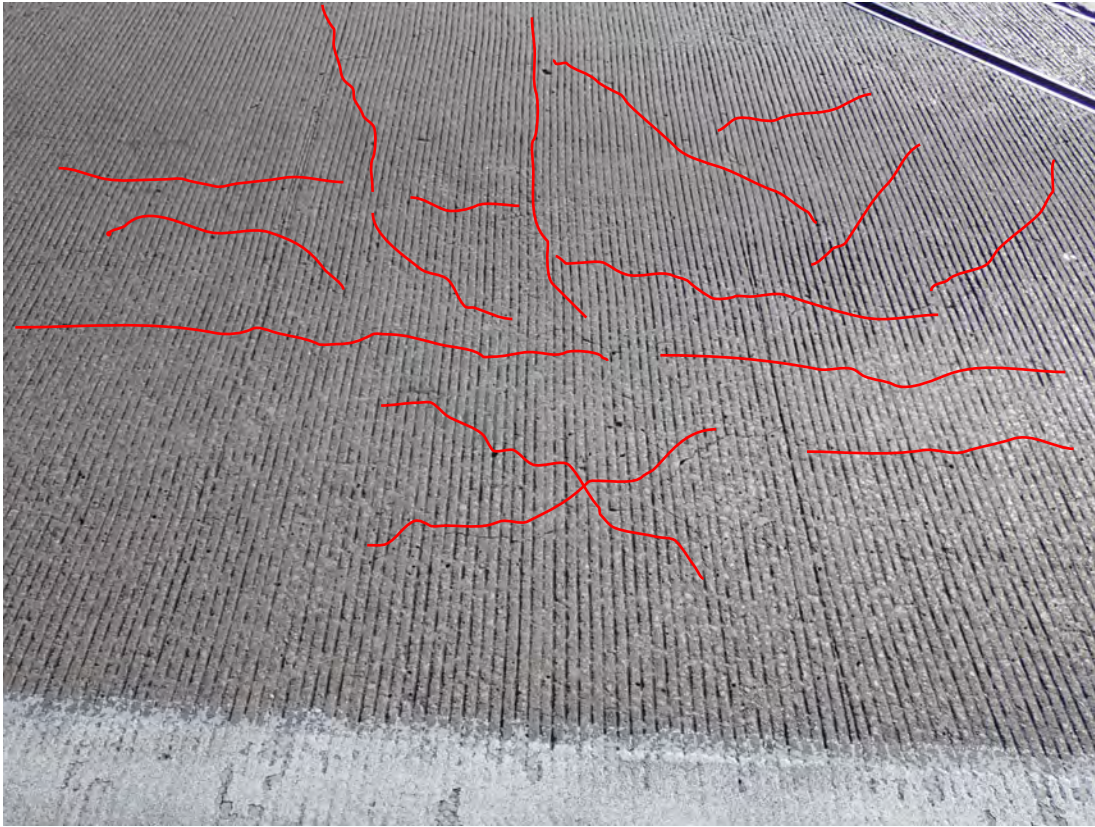
Deck cracking over Span 7 EBL

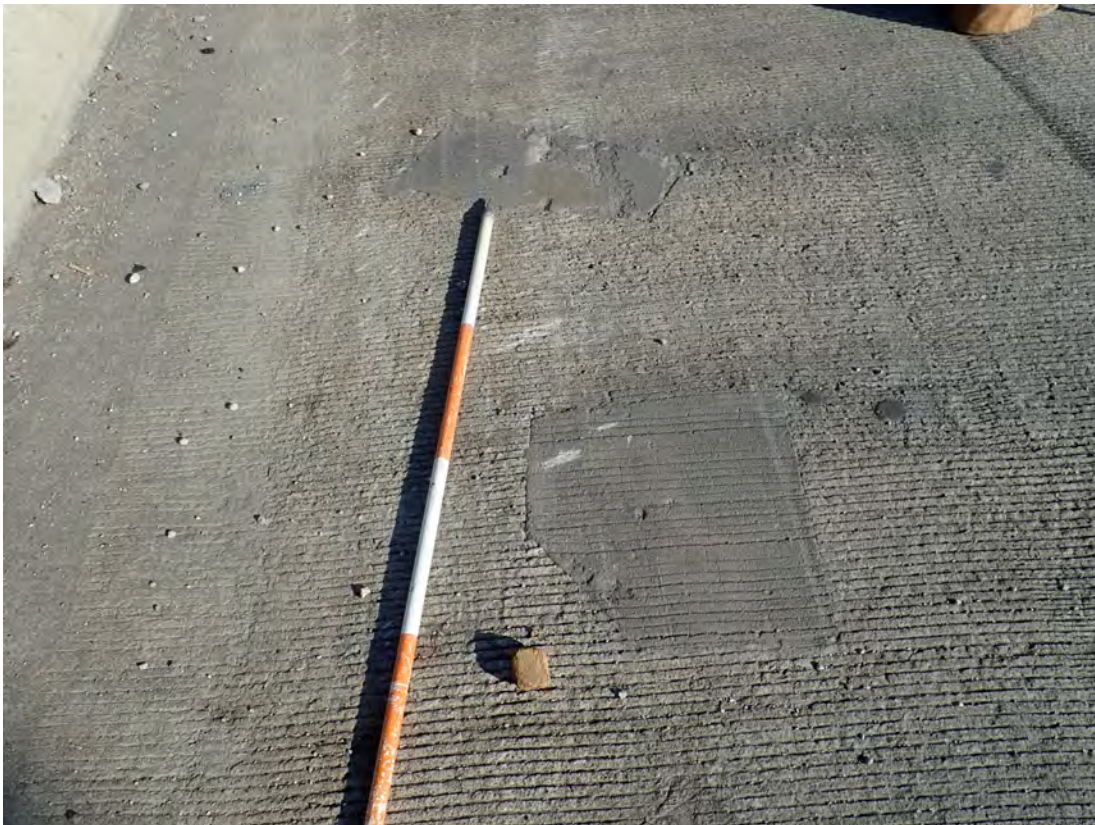
Some areas in emergency lane EBL with sound patching

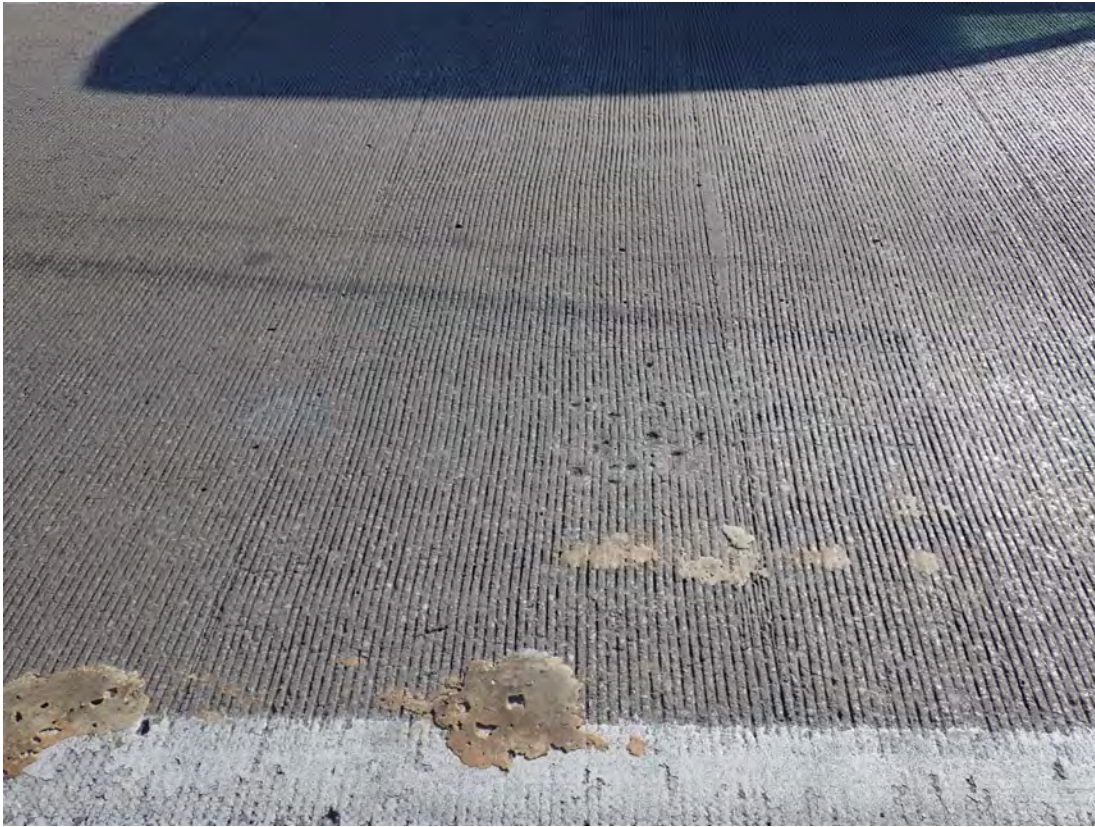
Deck has popout aggregate failures throughout

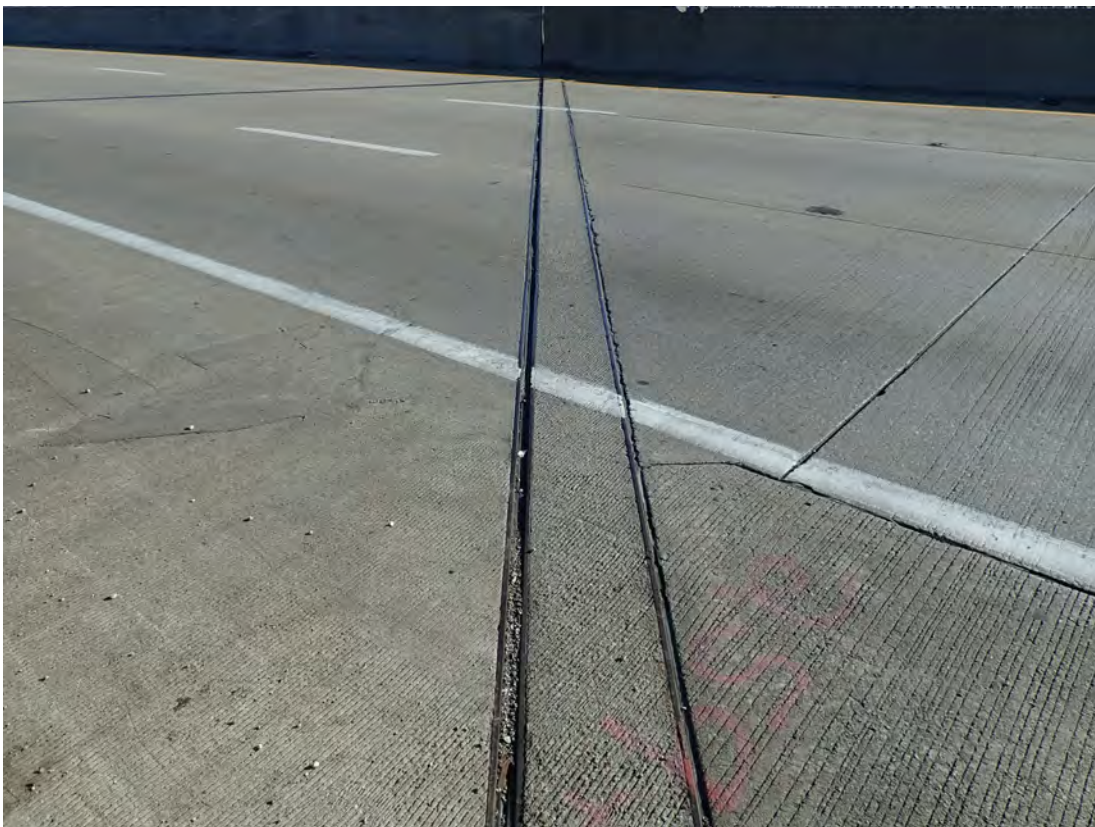
Compression joint seal over Abutment 8 EBL

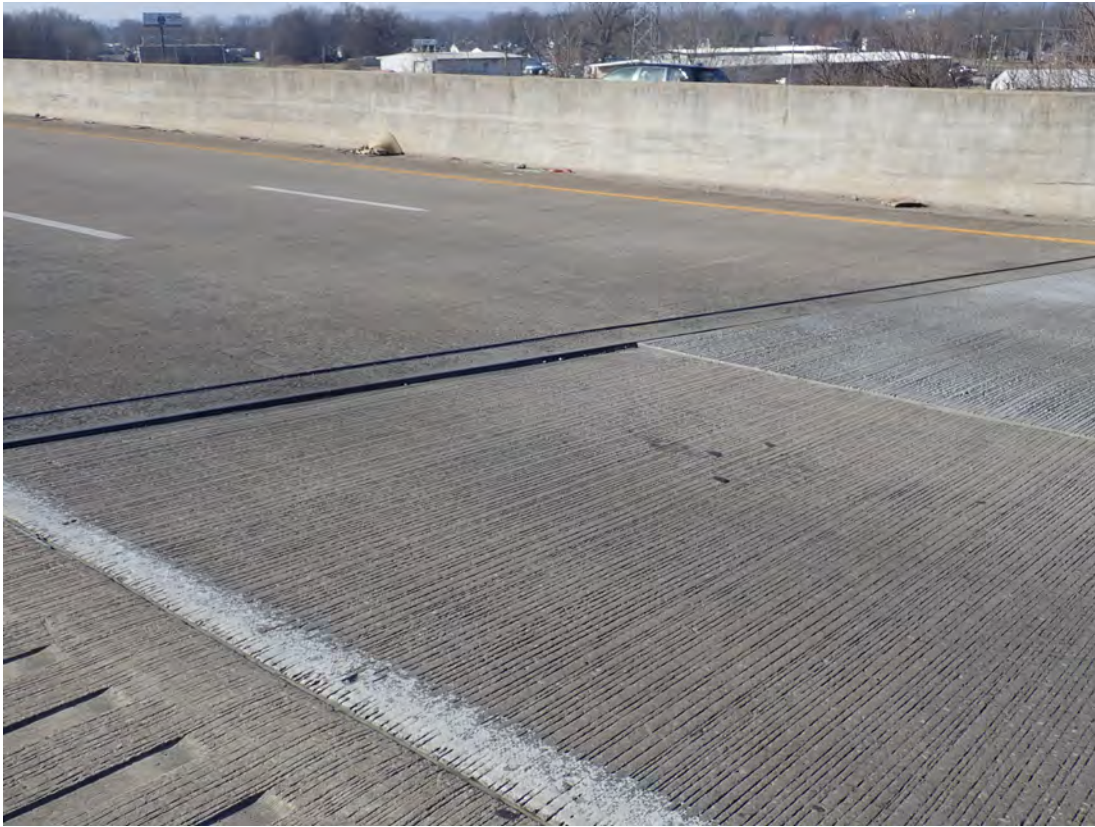
Abutment 1 WBL transition repair left one lane with transition unchanged

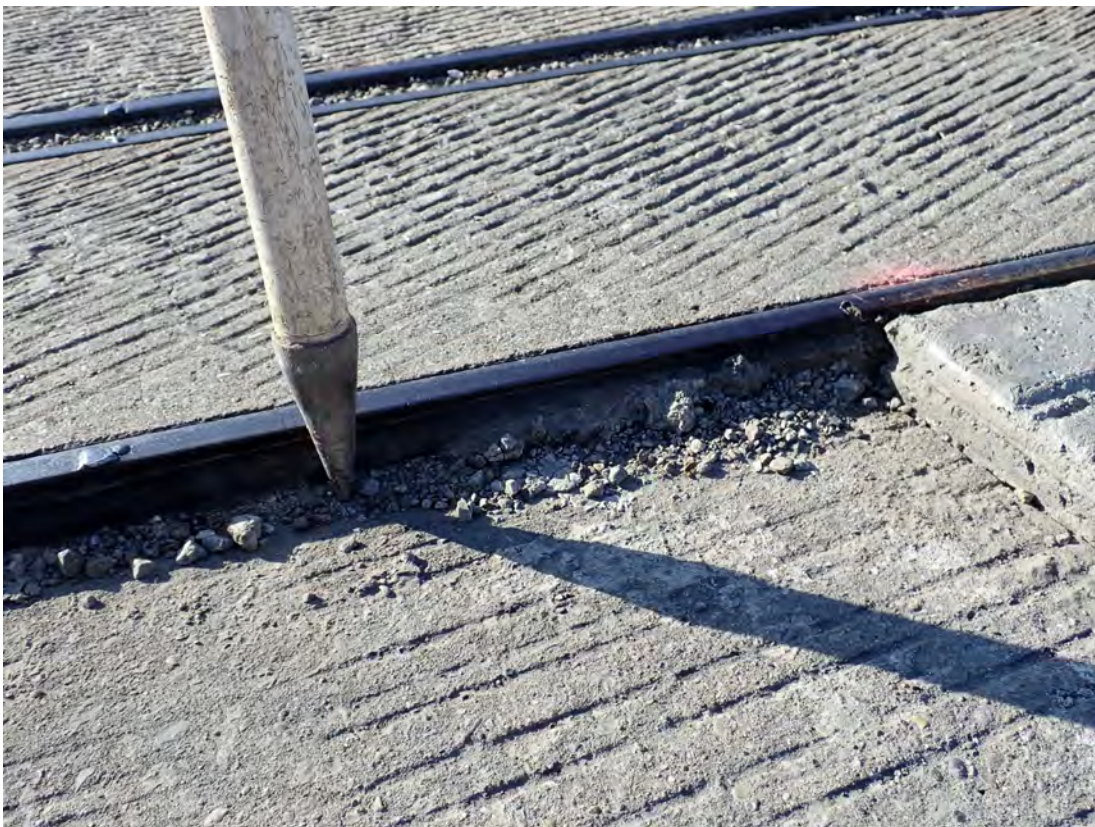
Closer view of transition at Abutment 1 WBL

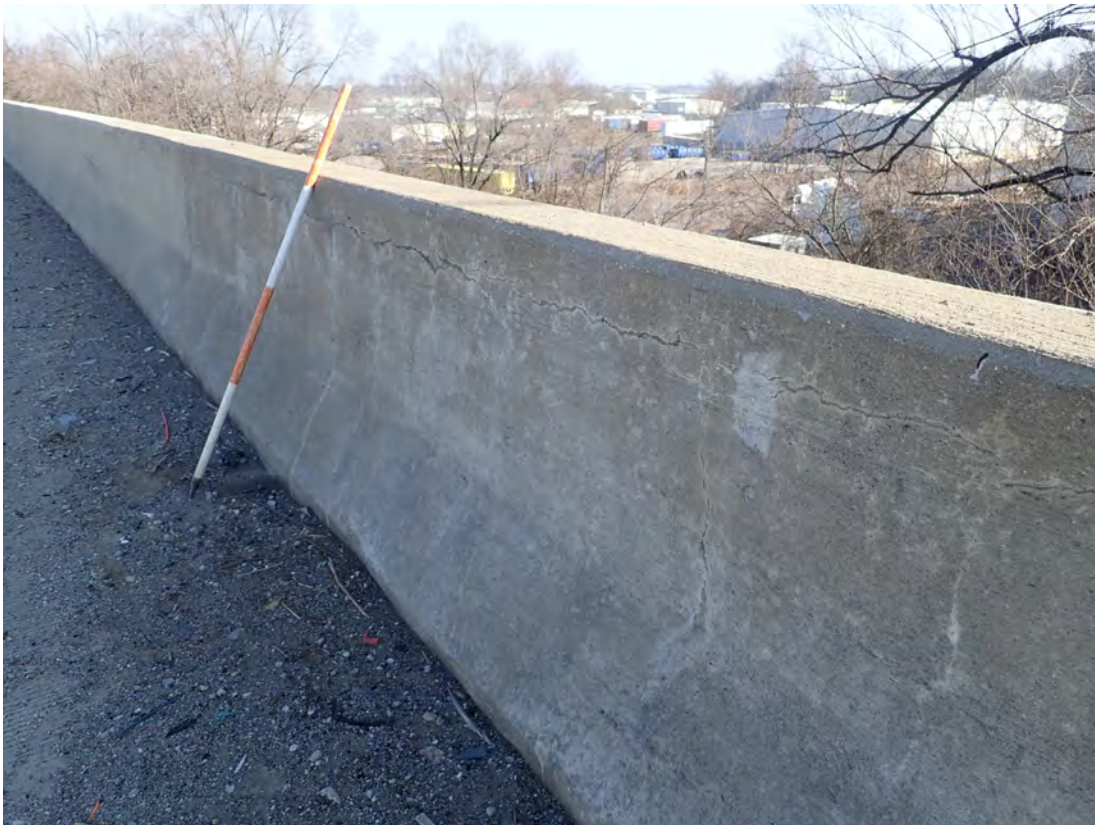
Typical condition of barrier wall

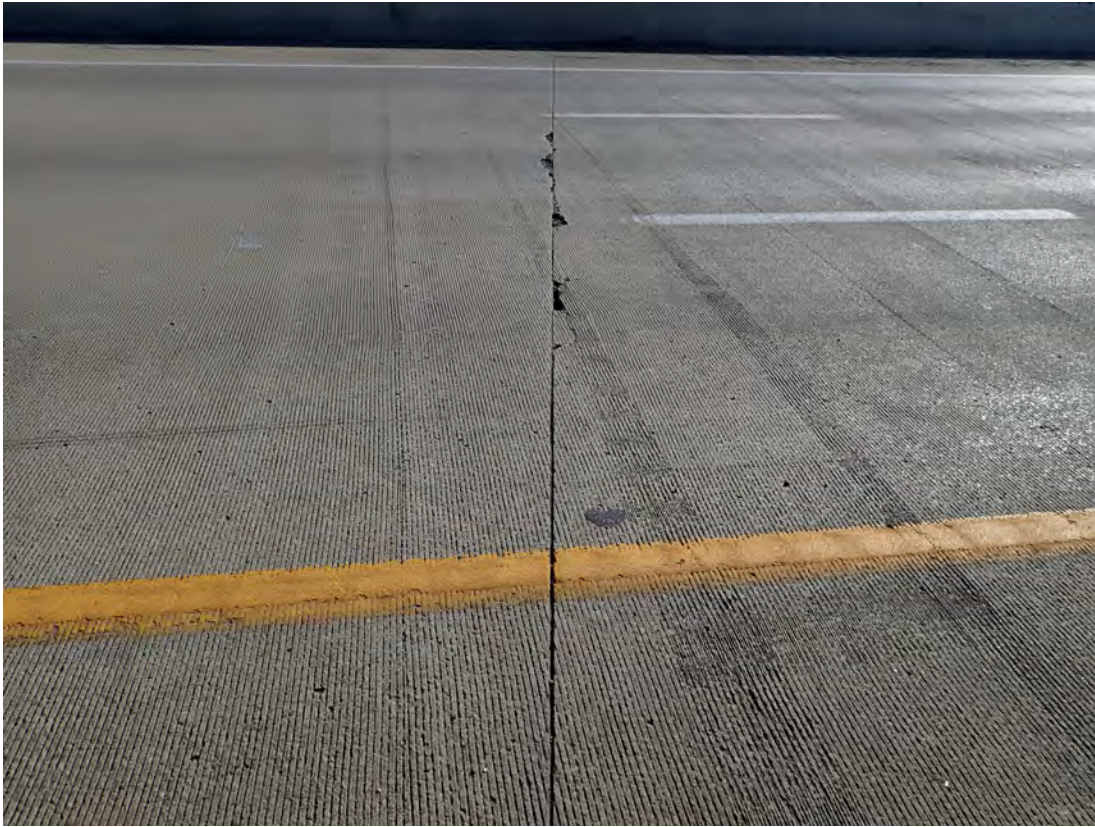
Relief cut over Pier 2 WBL with what appears to be a pourable sealant material across 53 feet of the deck with edge failure at random locations along length of joint. 9 feet affected by sealant failure

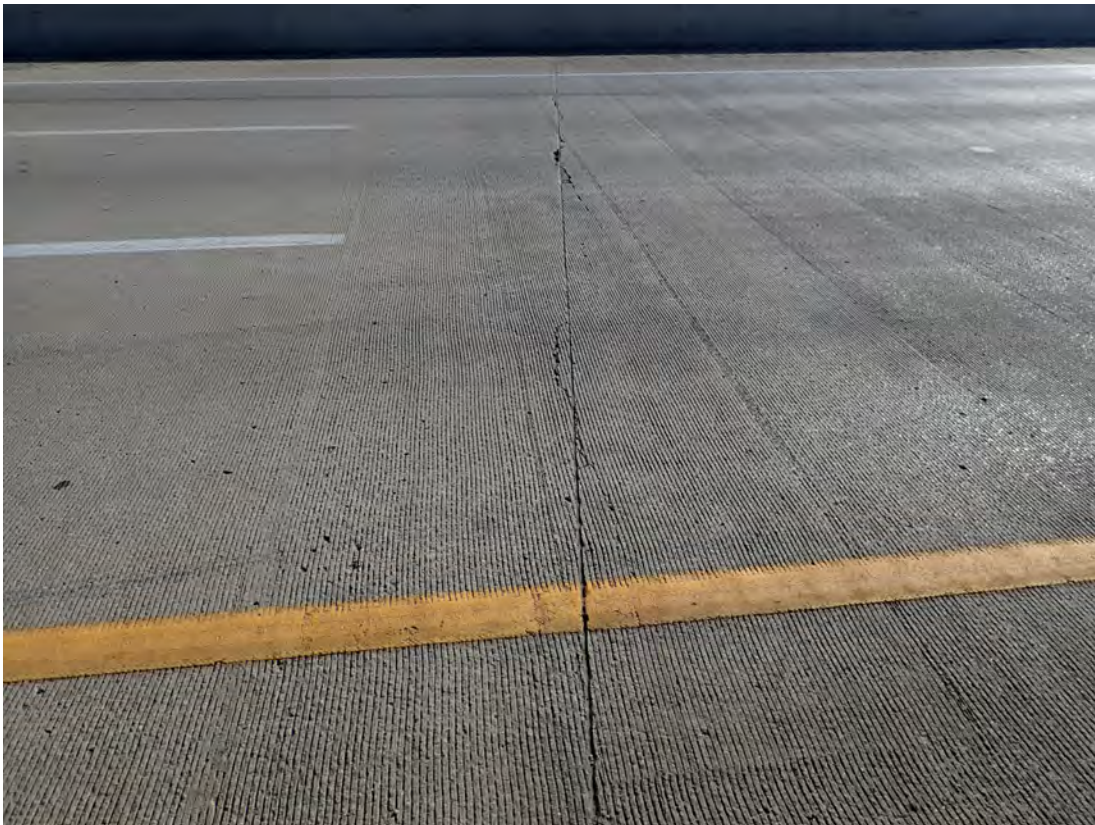
Relief cut over Pier 3 WBL with what appears to be a pourable sealant material across 53 feet of the deck with edge failure at random locations along length of joint. 4 feet affected by sealant failure

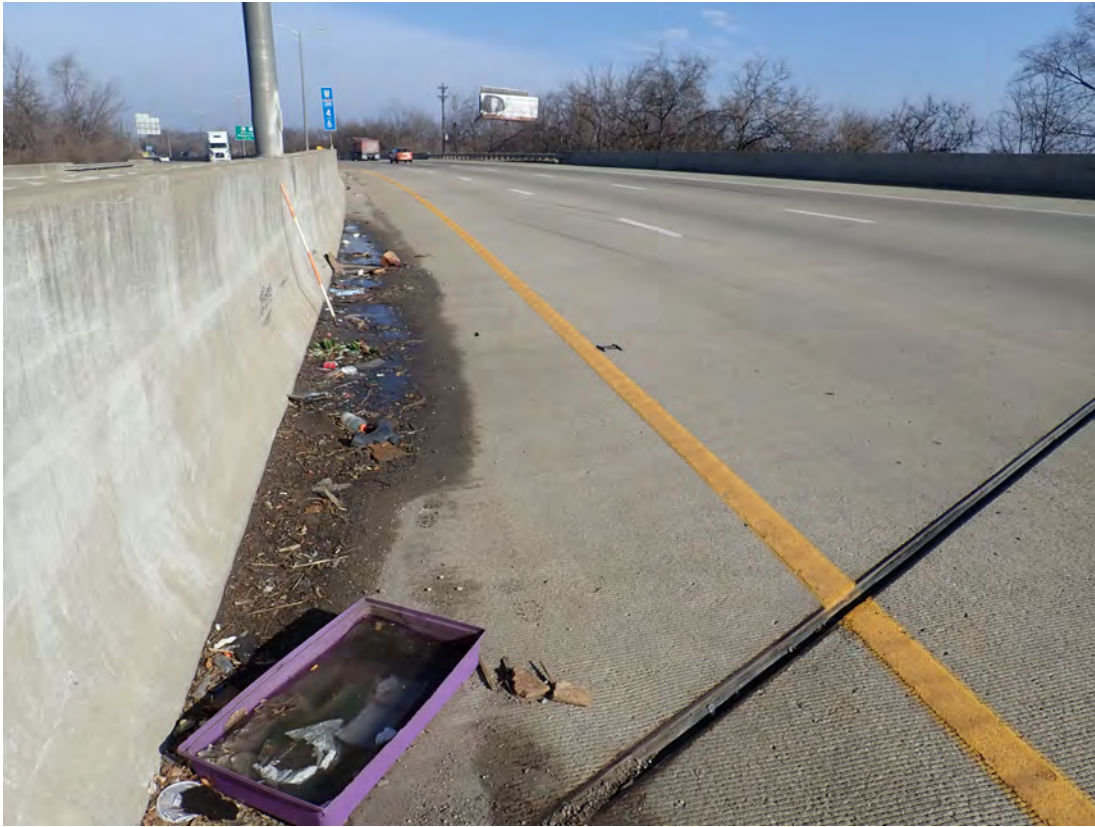
Ponding along barrier wall in Span 4 WBL

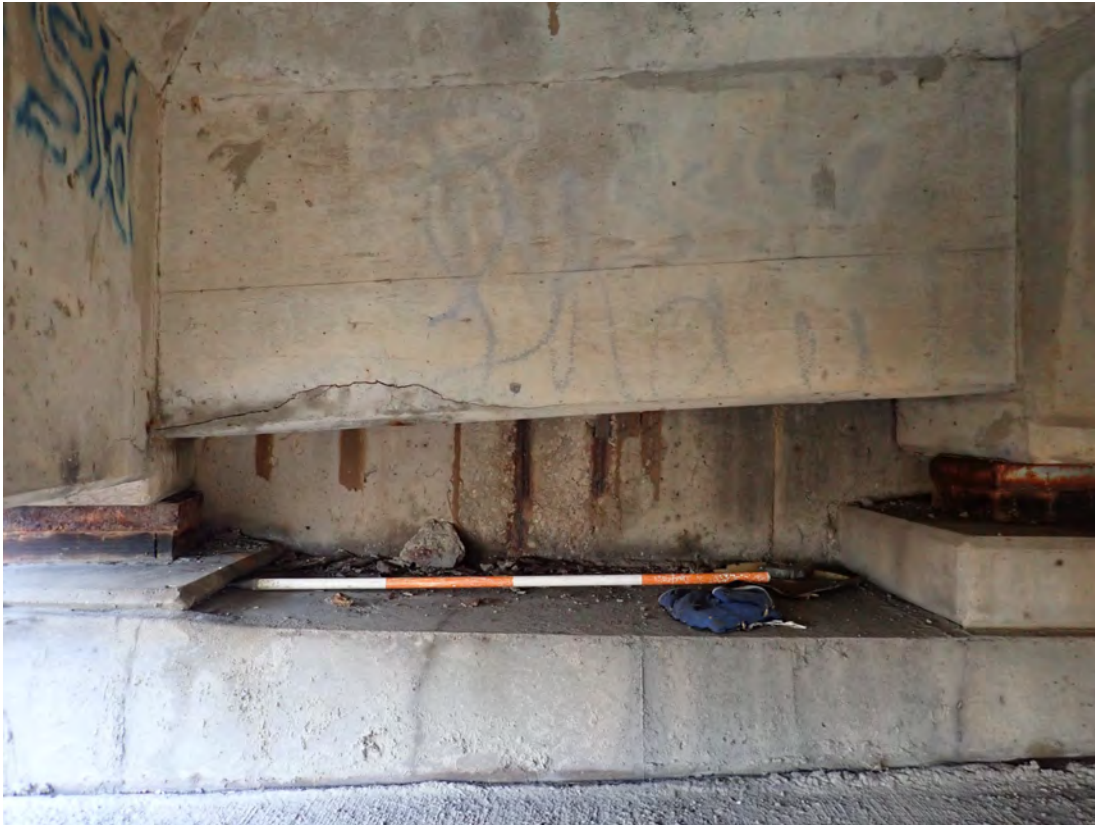
South end of Abutment 1 with spalling, exposed steel reinforcement with section loss

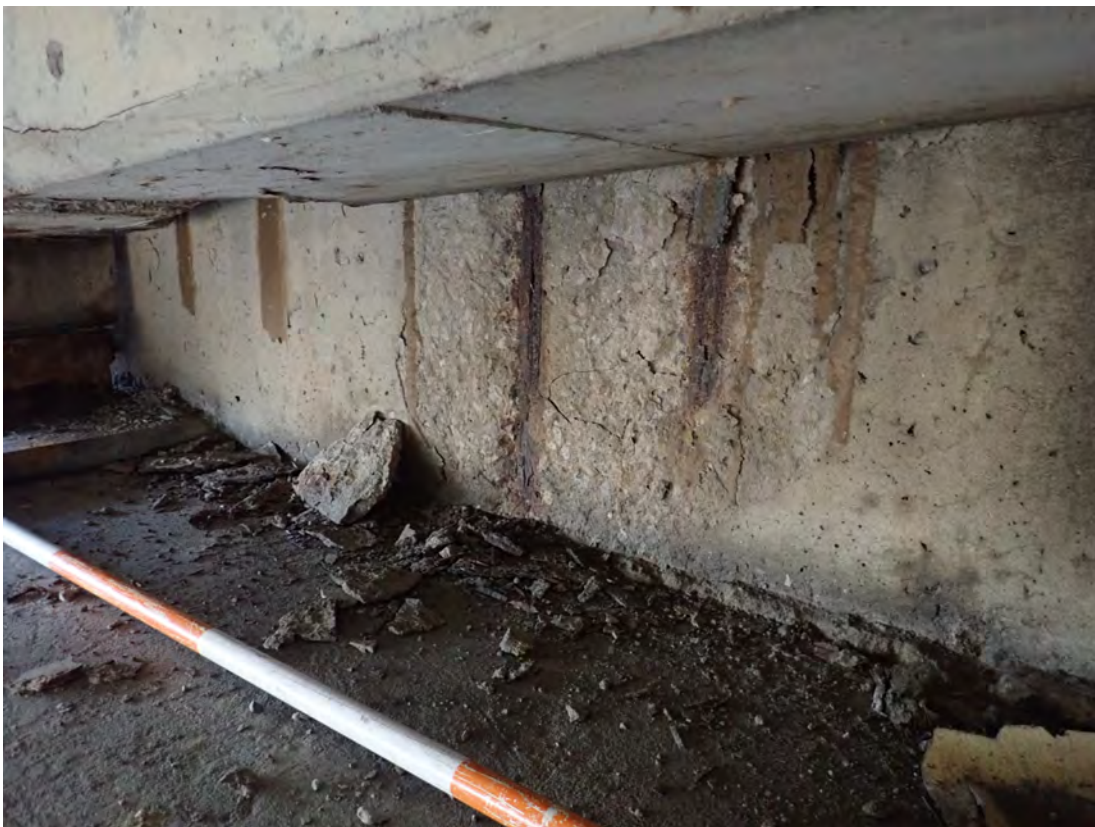
Closer view of above photo

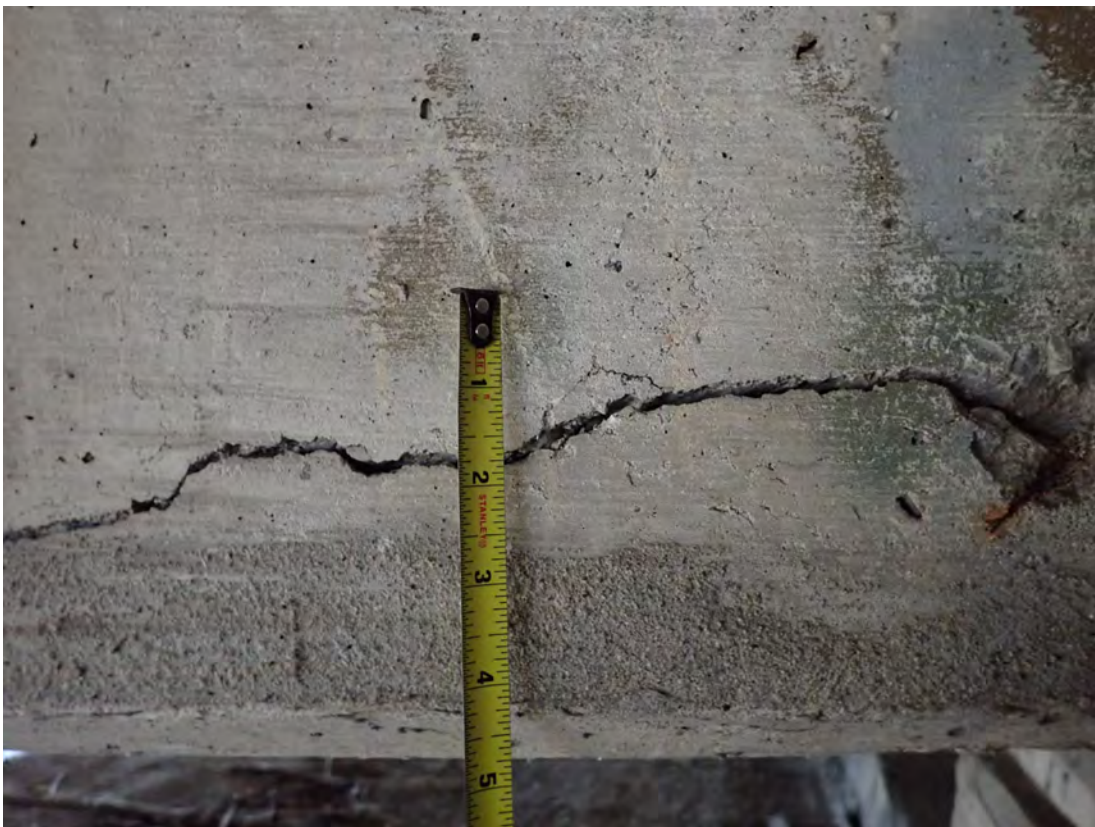
Closer view of Abutment 1-Girder 12 with side longitudinal cracking in lower portion of beam web
