Bridge Inspection Report

056B00250N

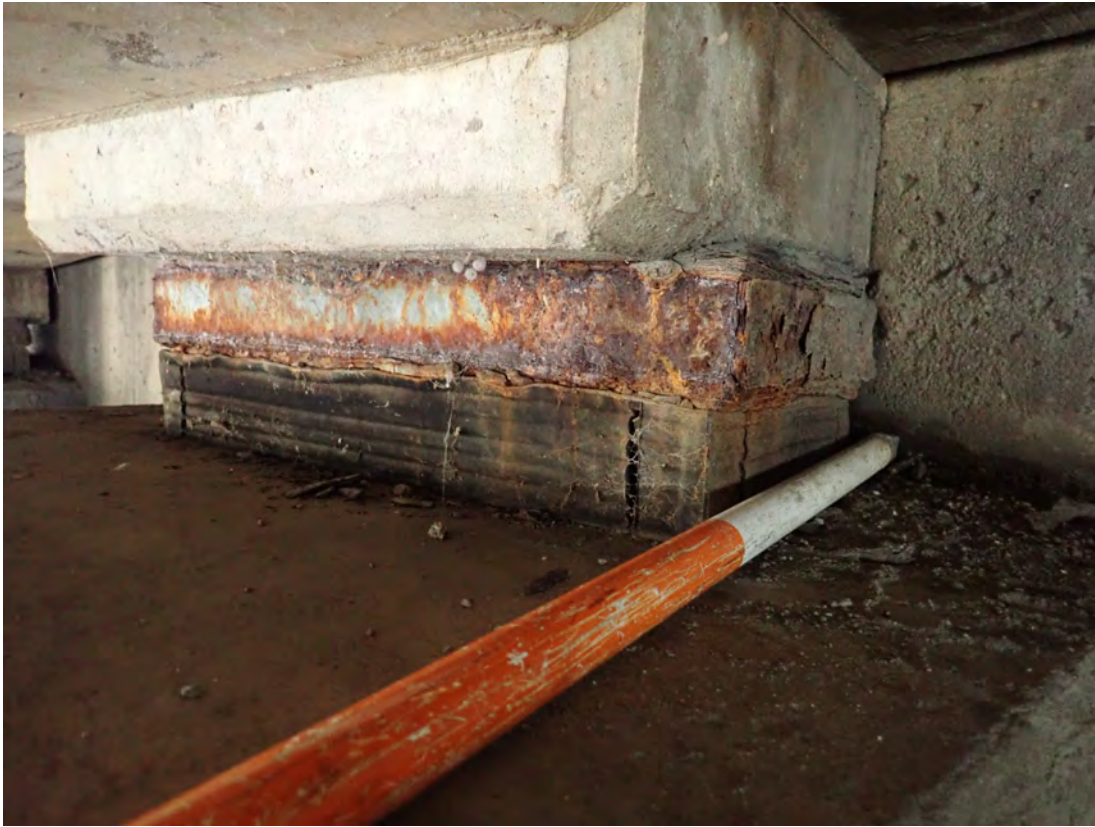
Typical bearing device condition at Abutment 1, showing Beam 12 device

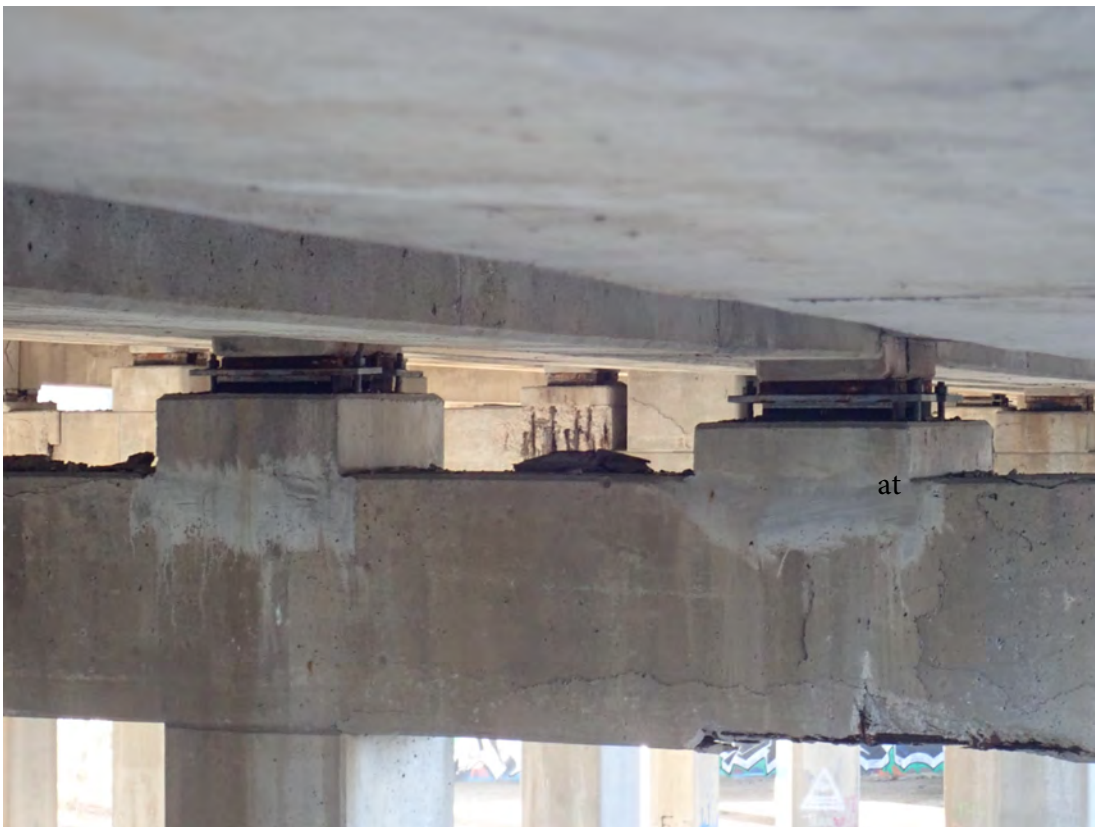
Typical repaired bearing device & pedestal condition at Pier 2

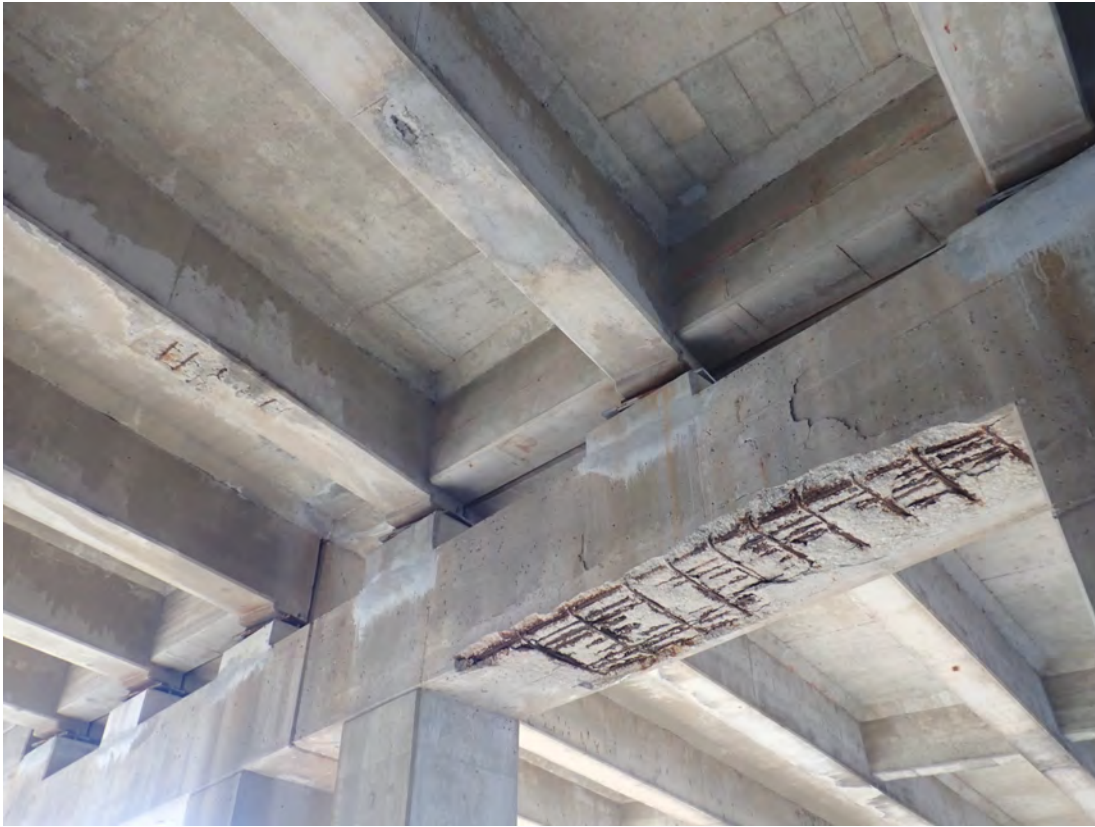
Looking up at Span 2 girders with patched areas & Pier 2 cap deterioration

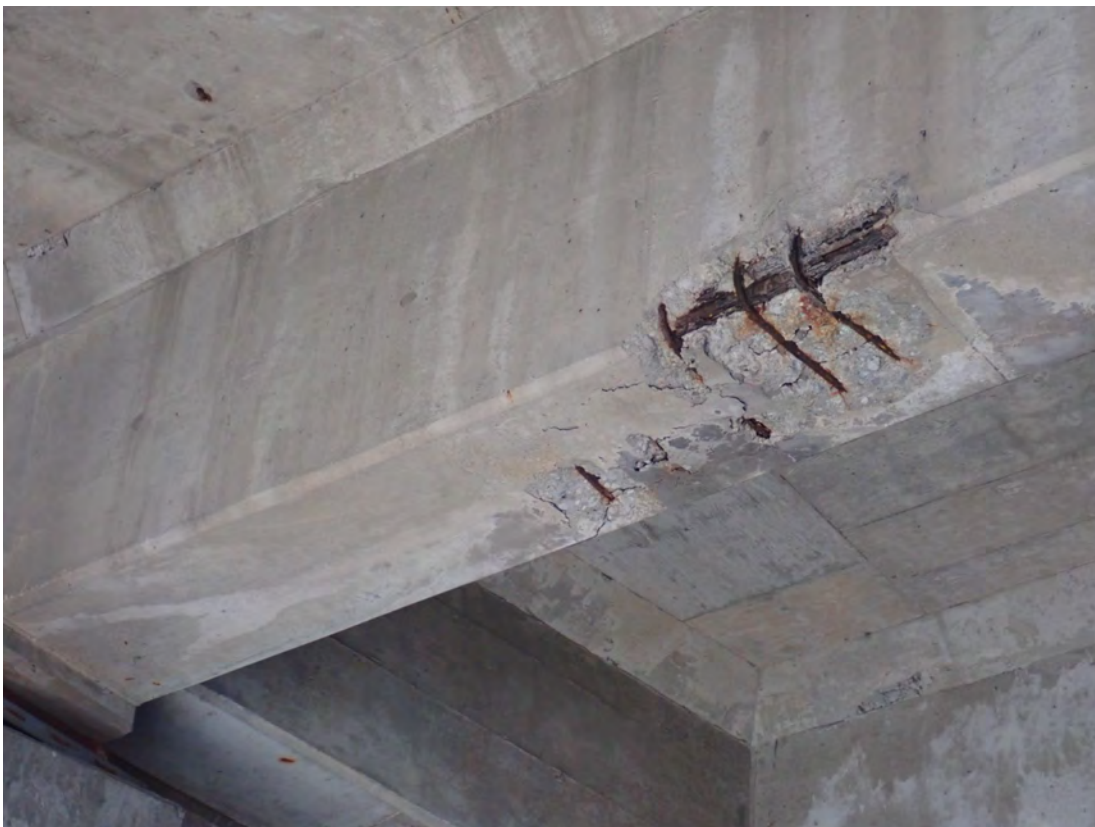
Span 2 girders have spalling with exposed steel reinforcement

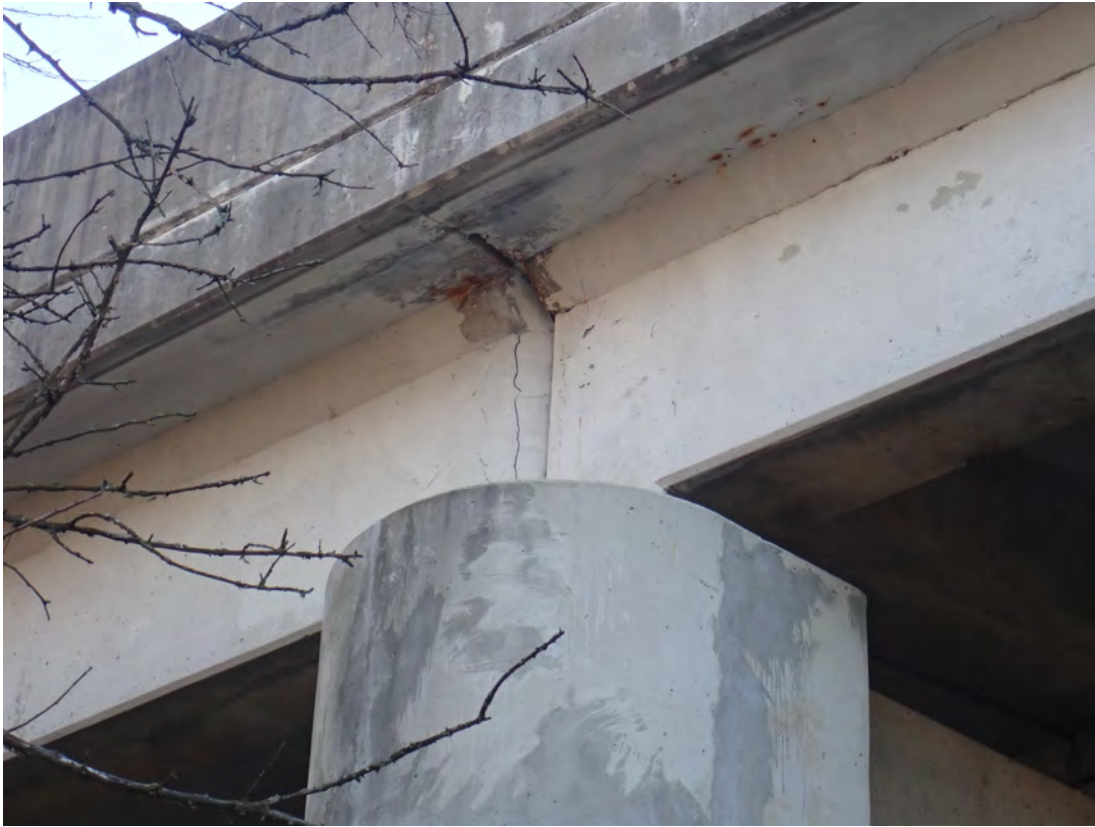
Pier 2-Girder 14 with vertical cracking at beam end

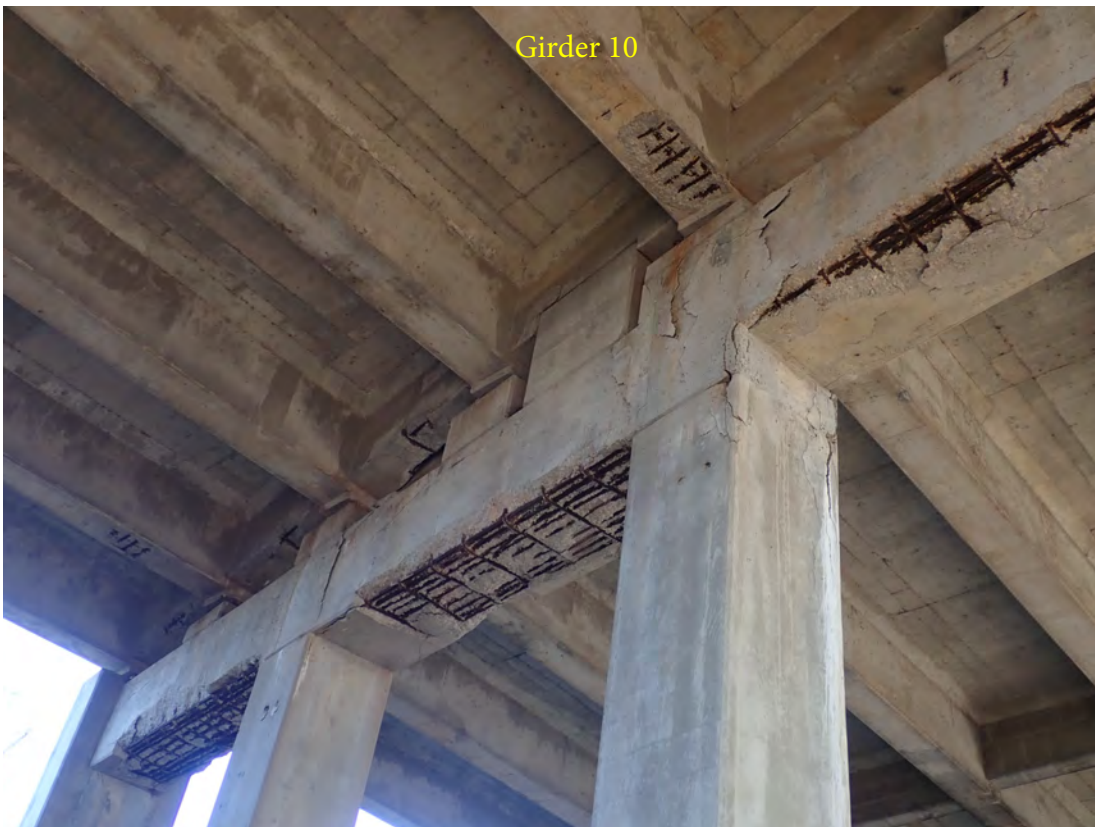
Span 3-Pier 3-Girder 10 with spalling and exposed steel reinforcement

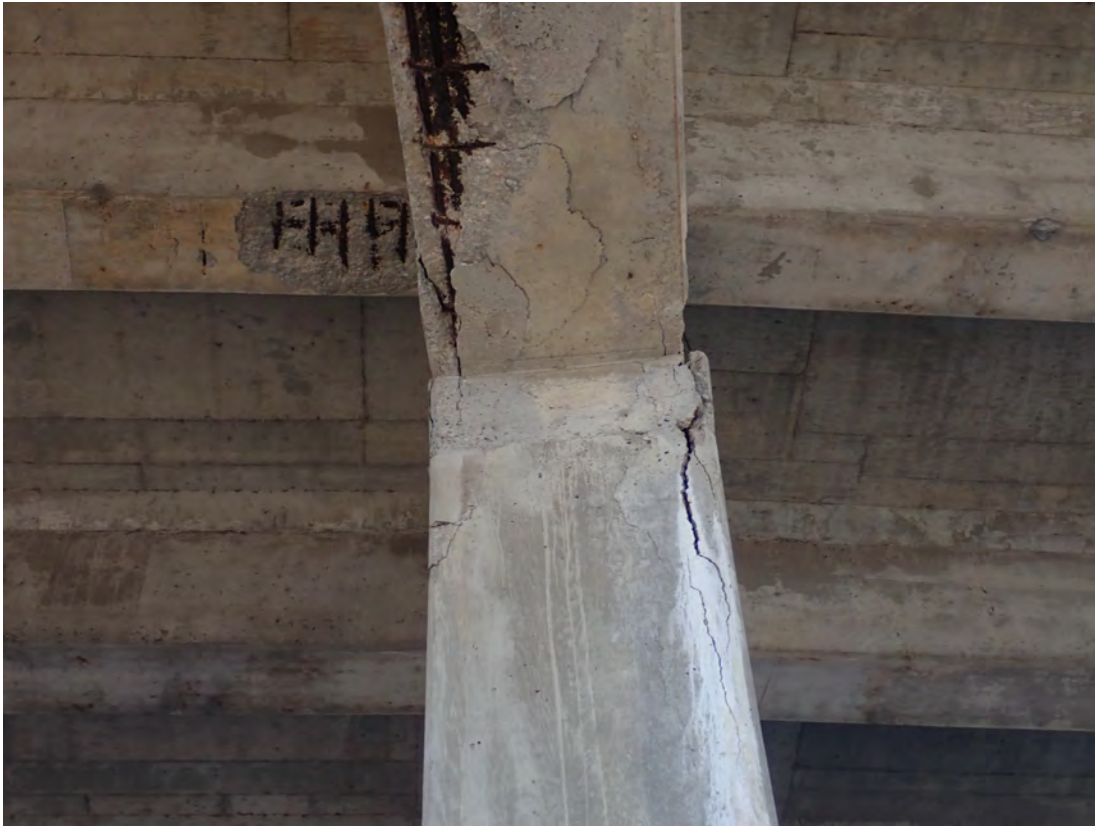
Pier 3-Column 6 with wide cracking & delamination near bottom of cap

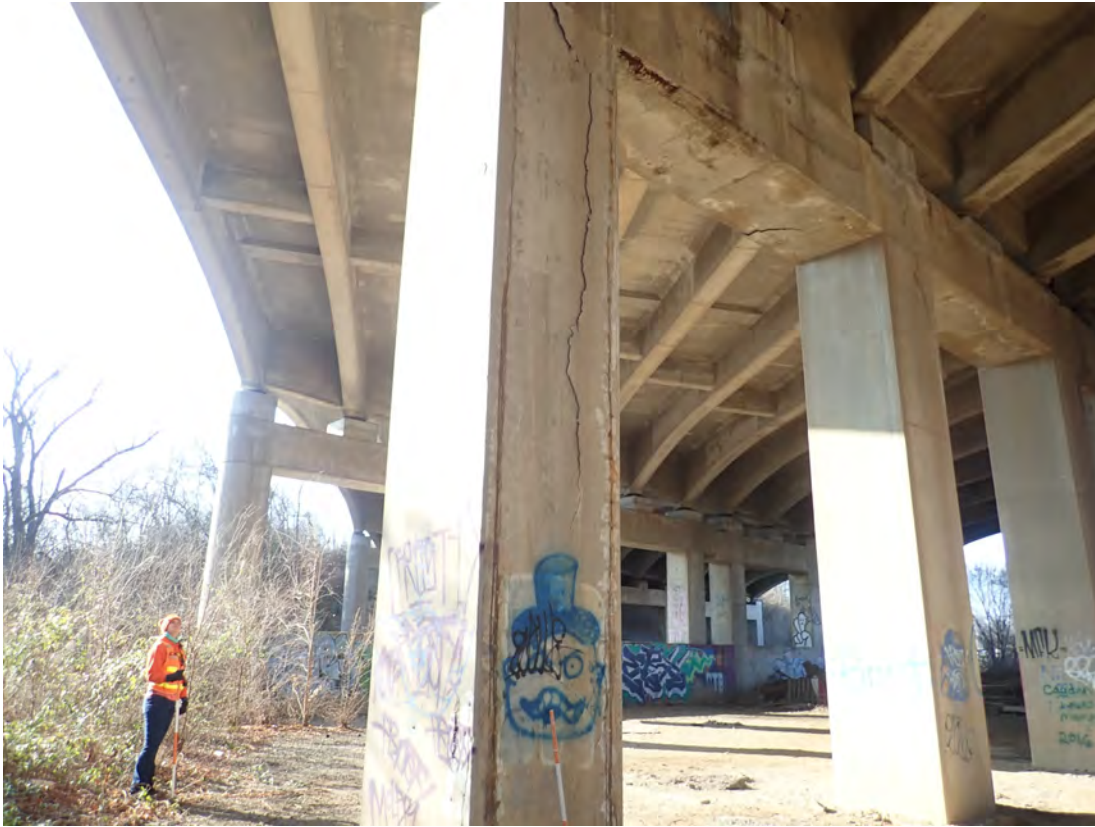
Pier 5-Column 2 with side vertical cracking on multiple faces

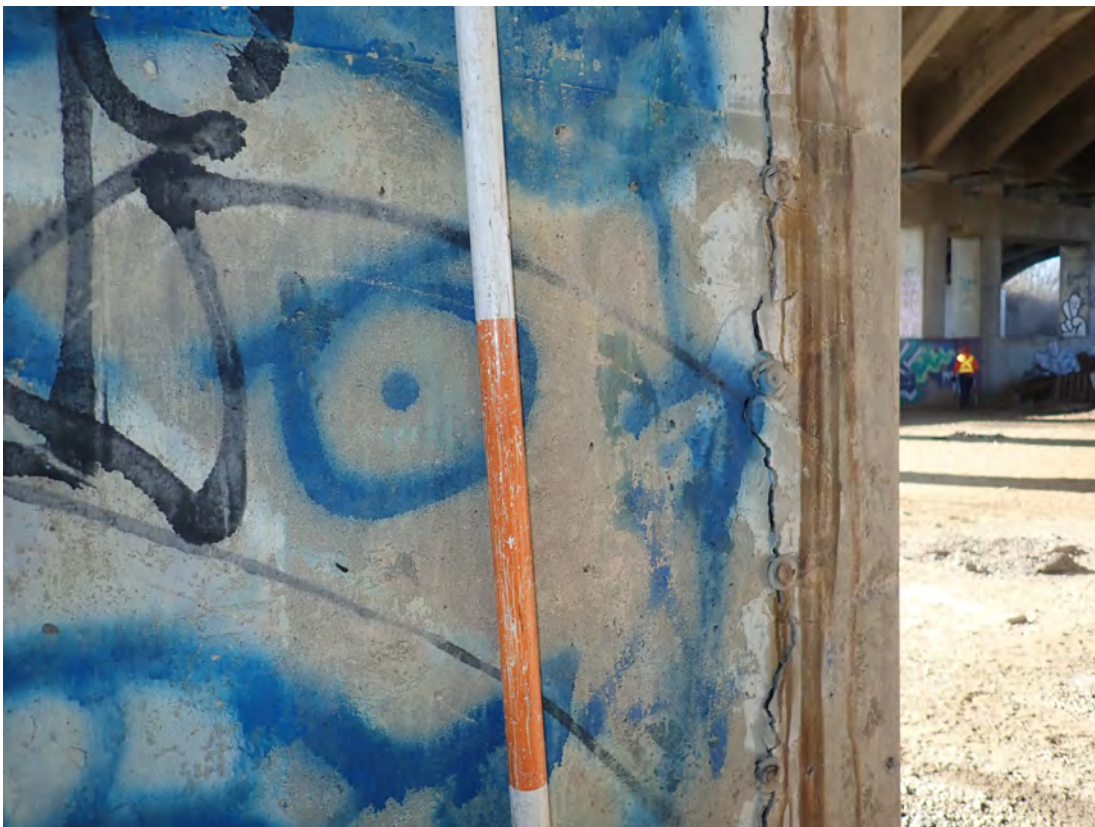
Pier 5-Column 2 west face with full height wide vertical cracking along a line of epoxy injection locations made as part of 2003 rehab project

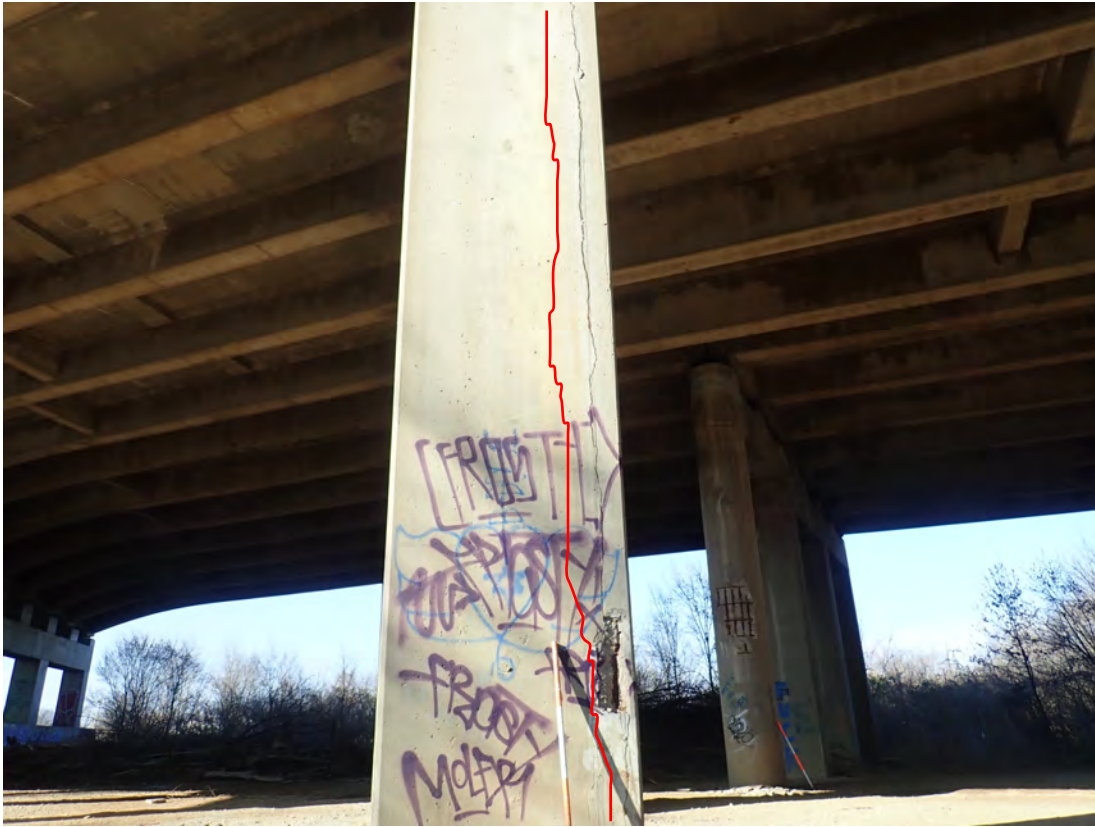
Pier 5-Column 2 south face with full height wide vertical cracking

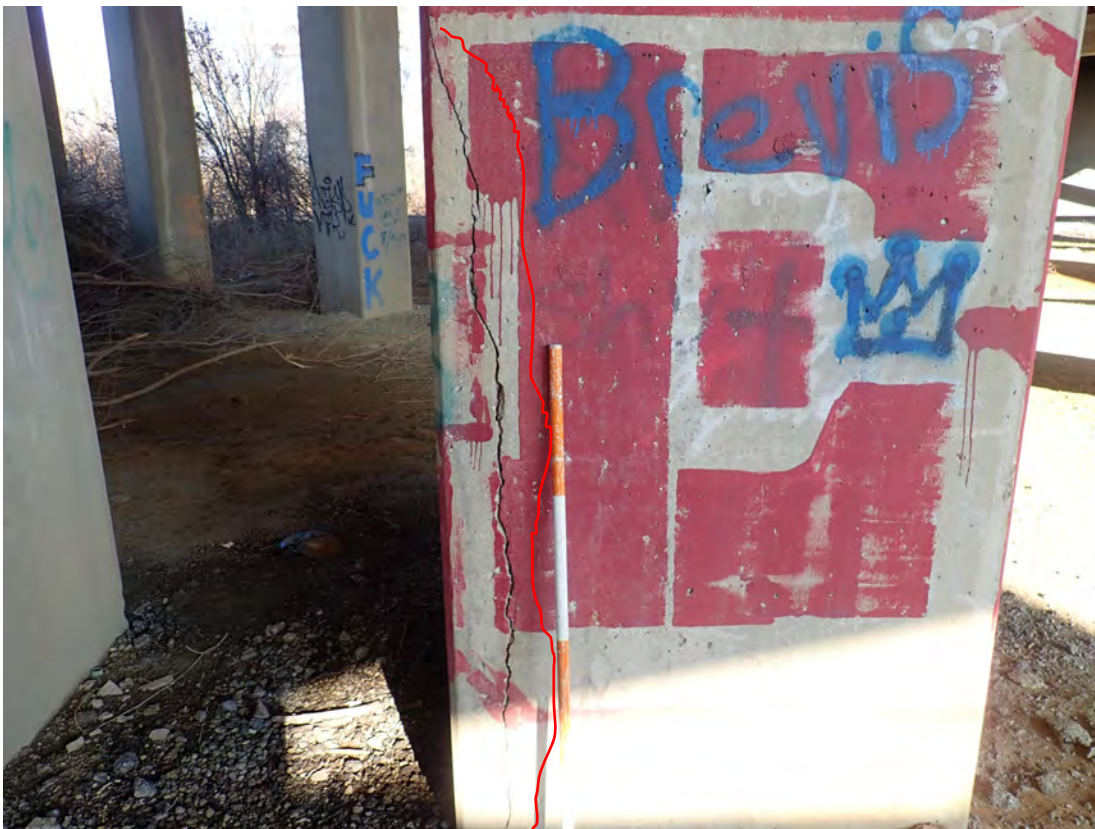
Pier 5-Column 4 with wide vertical cracking

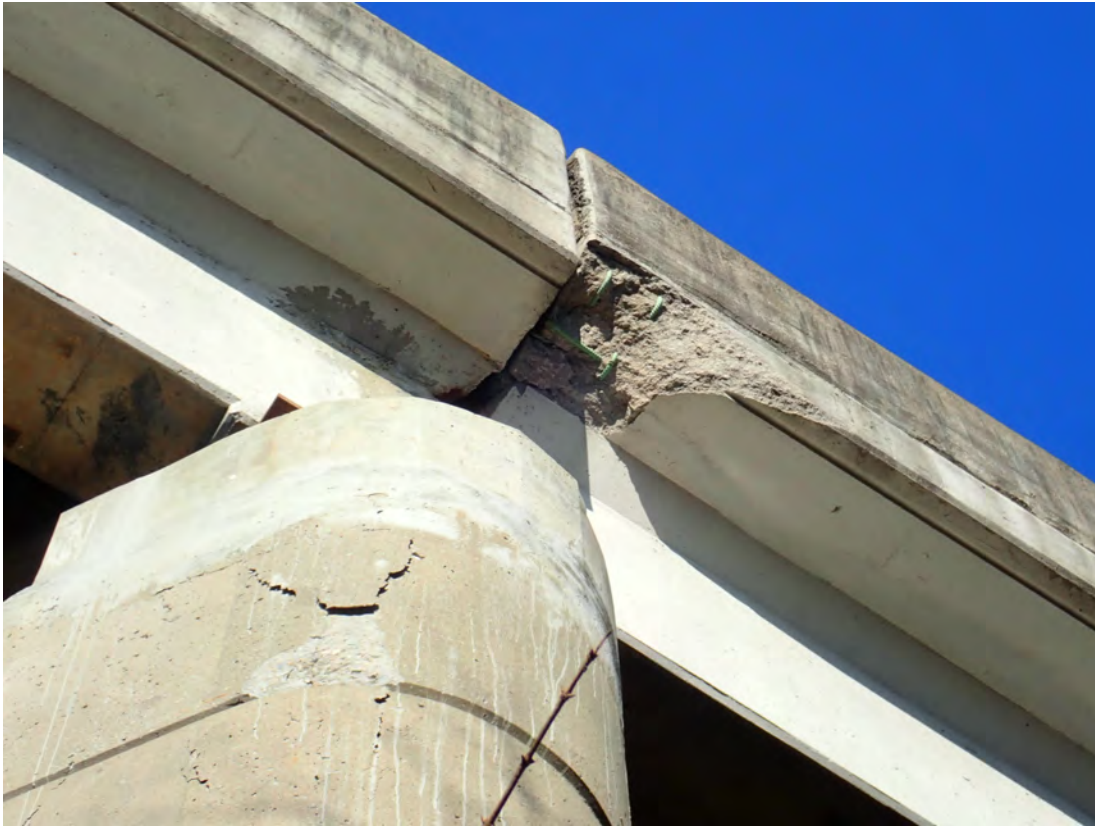
Deep large spalling in overhang above north end of Pier 5

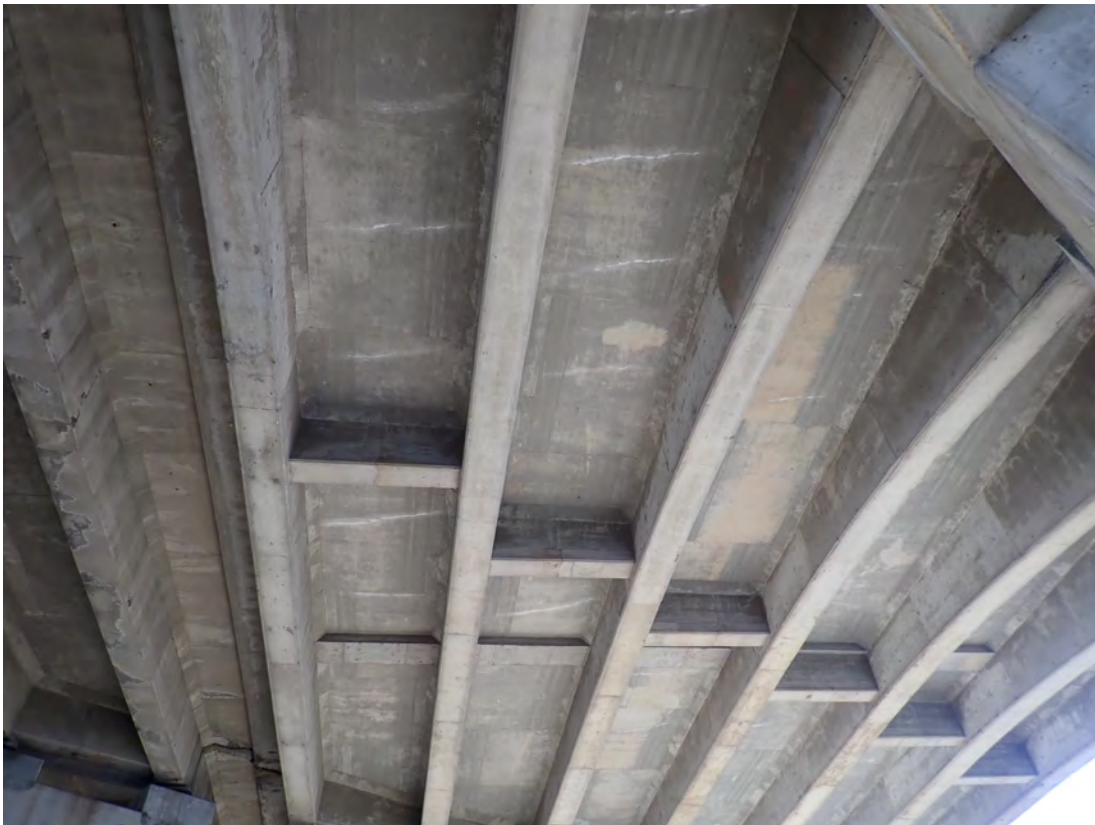
Span 5 deck soffit under WBL

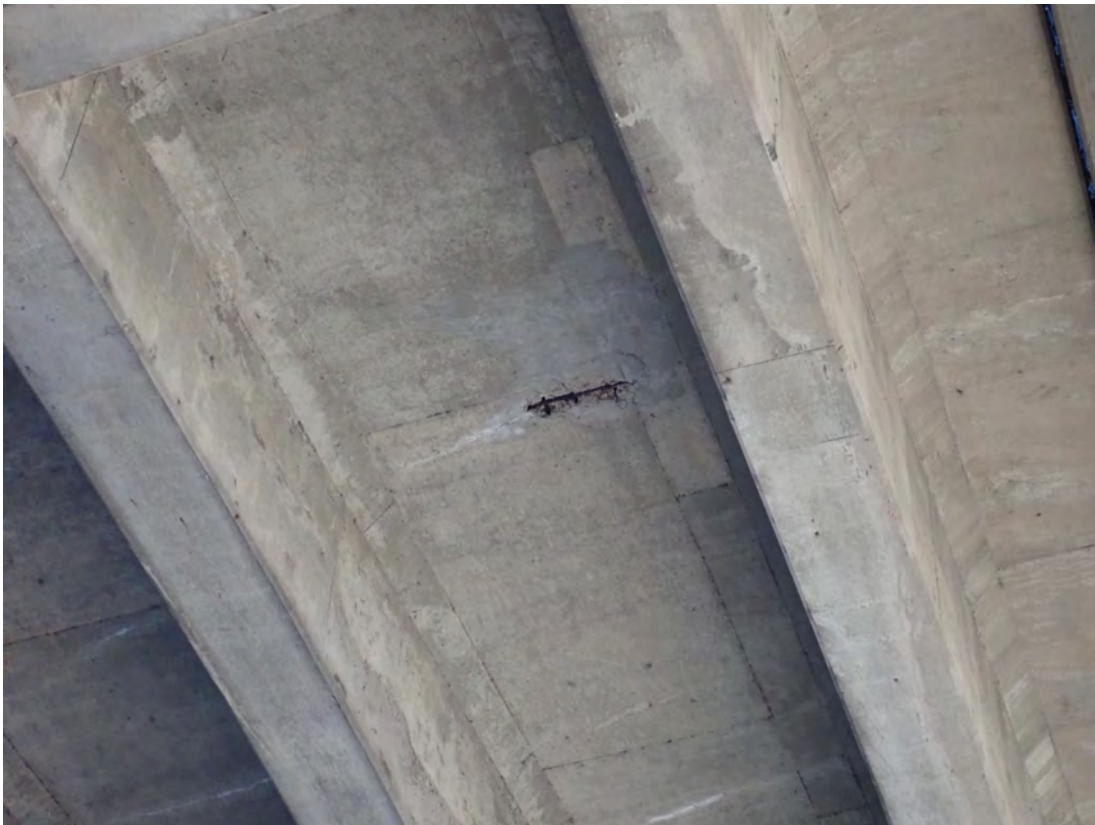
Deck soffit has some spalling with exposed steel reinforcement

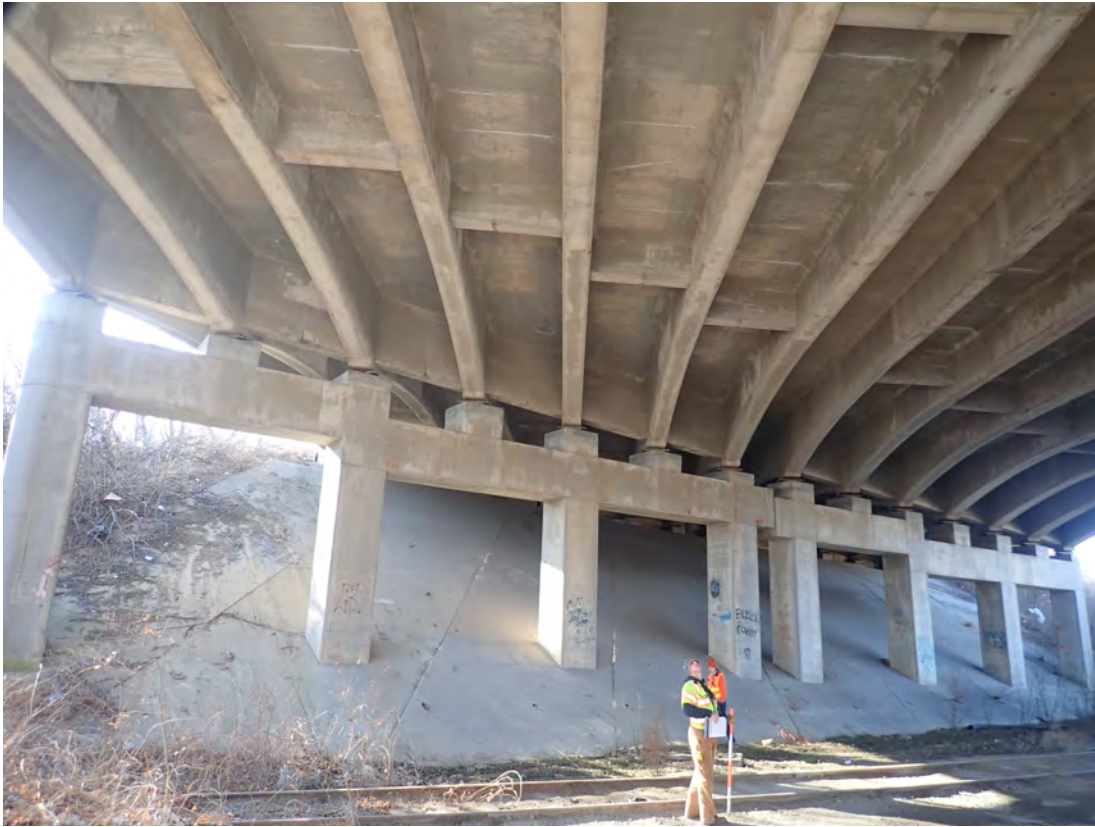
056B00250N Routine Inspection 01/13/2021

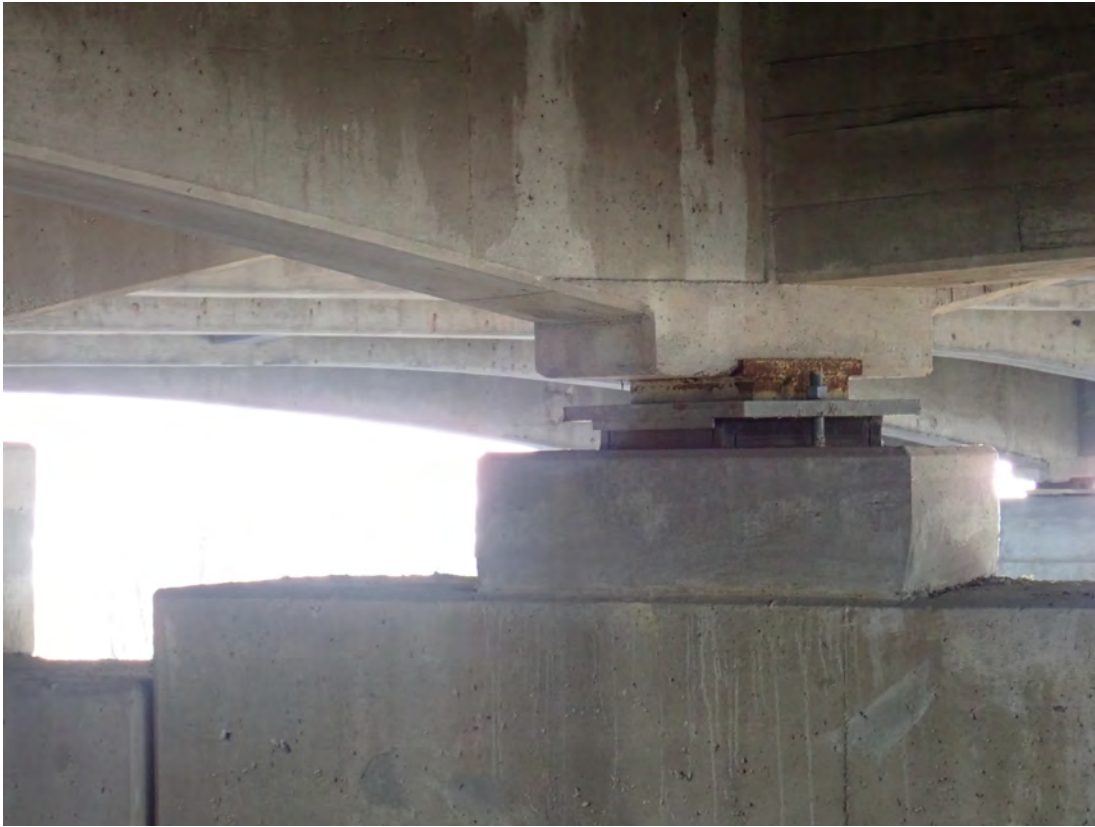
Typical repaired condition of bearing devices and pedestals at Pier 7

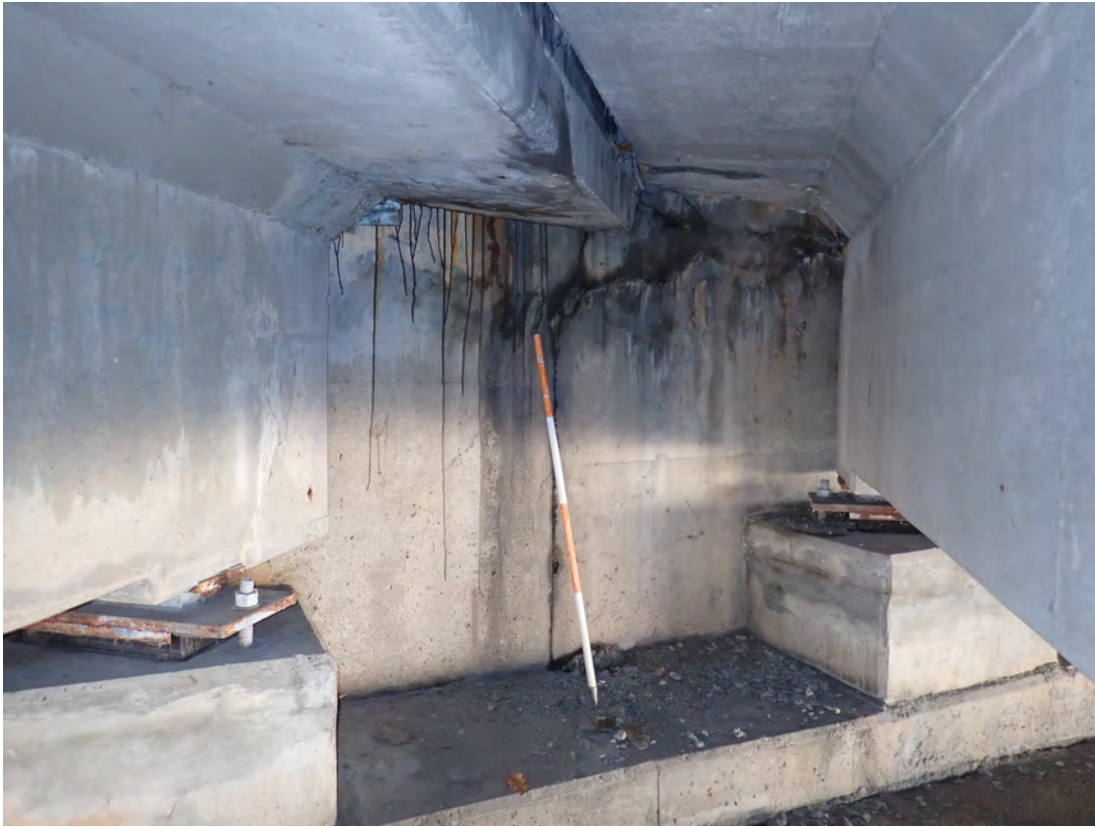
Centerline of Abutment 8 backwall with cracking and staining

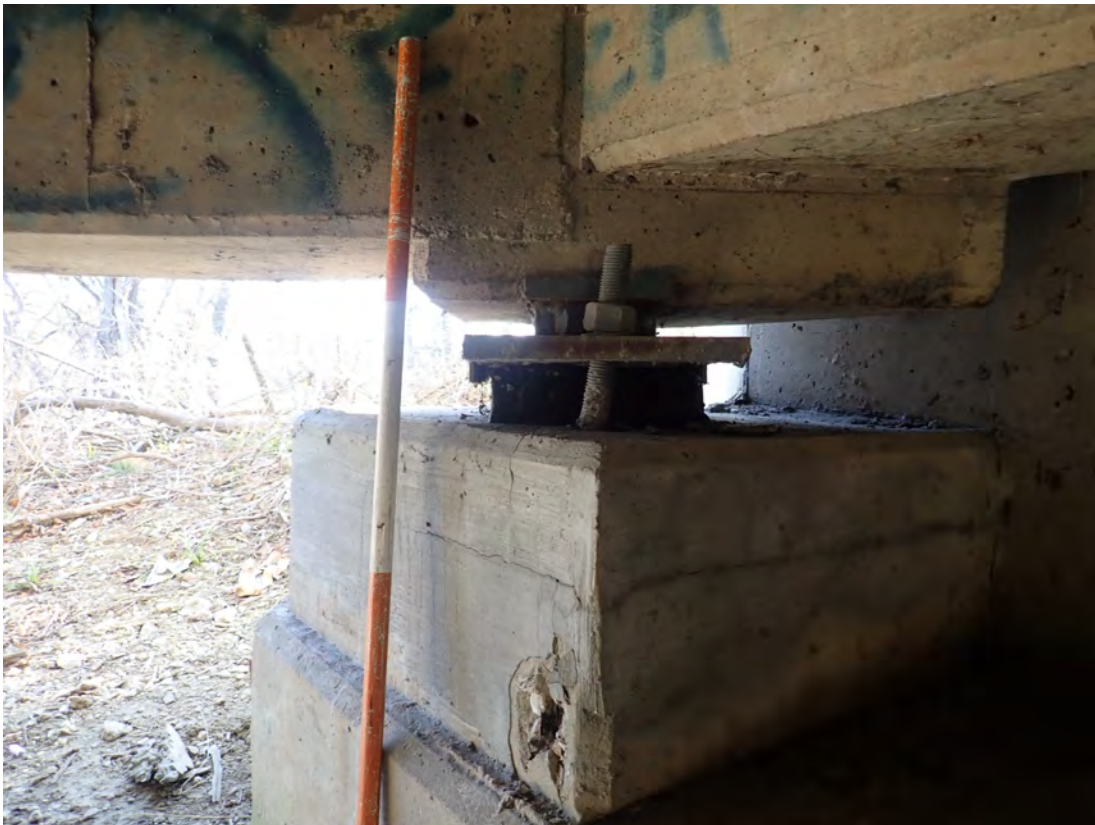
Abutment 8-Girder 1 pedestal spalling

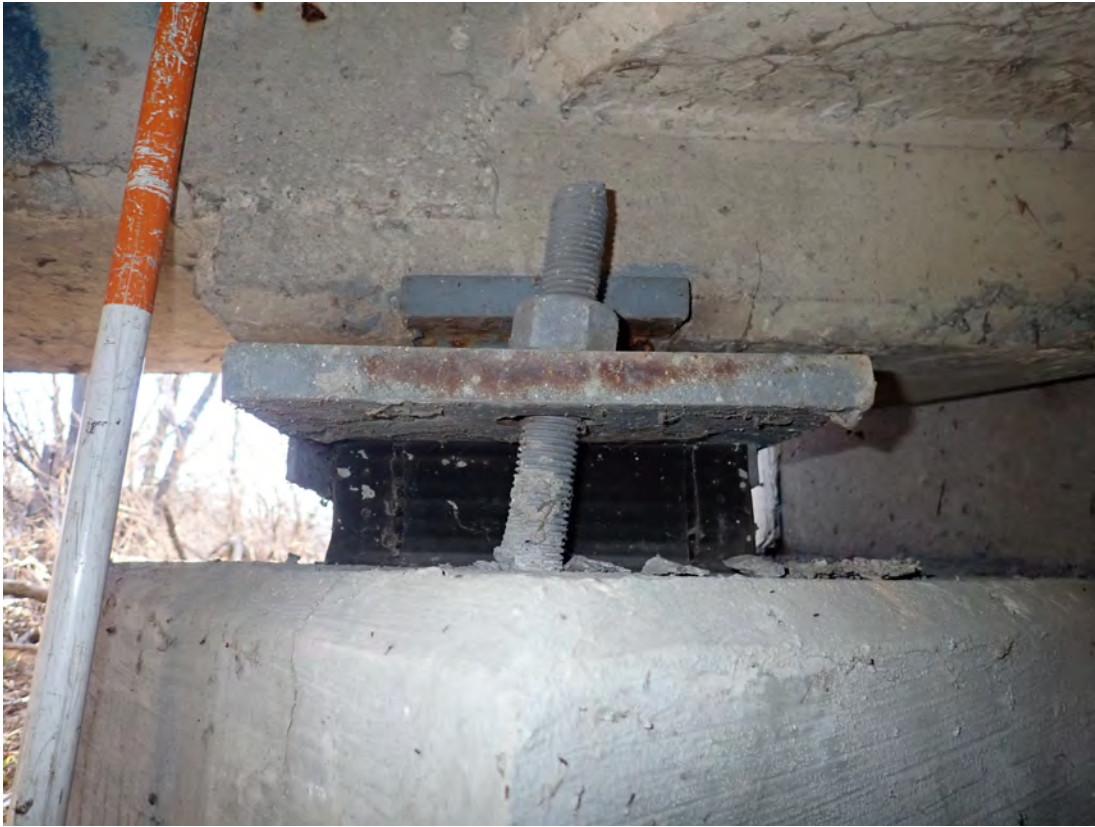
Abutment 8-Girder 1 anchor bolt appears to have been epoxied out of vertical plumb, as the bearing pad has no sign of expansion

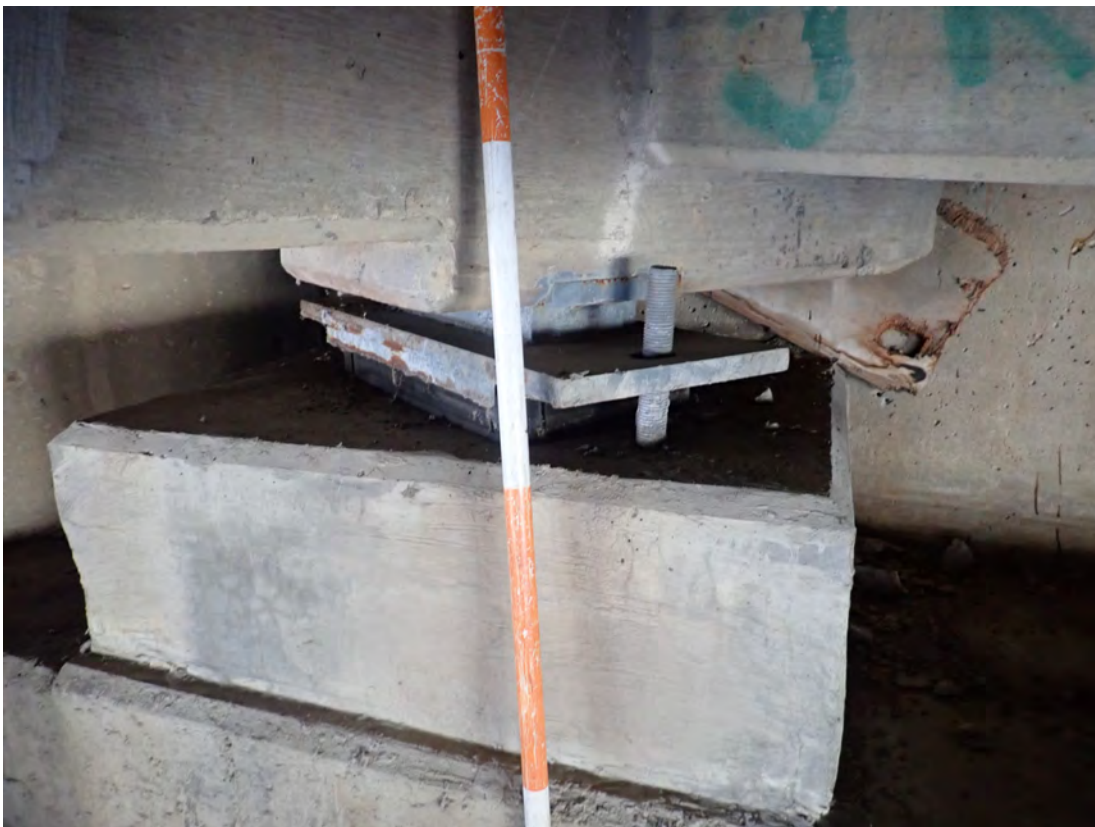
Abutment 8-Girder 5 missing nut on north side

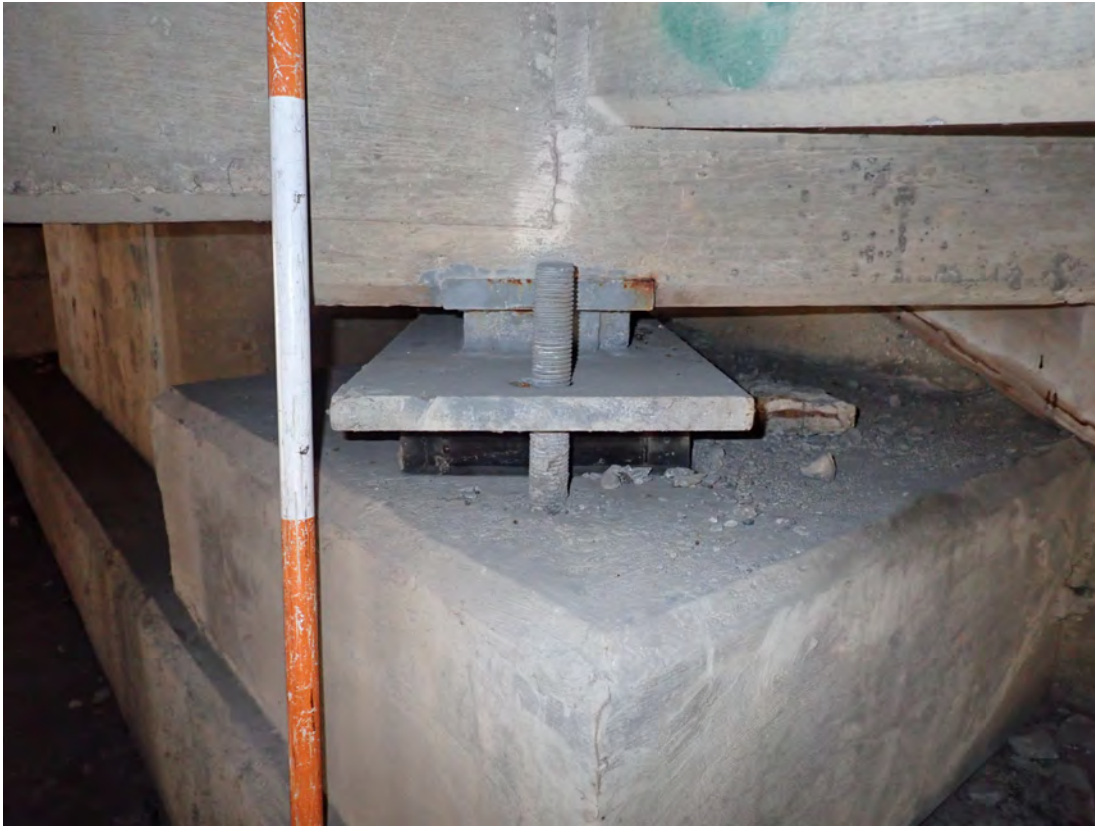
Closer view of Abutment 8-Girder 7 missing nut on north side -- note vertical cracking over bearing

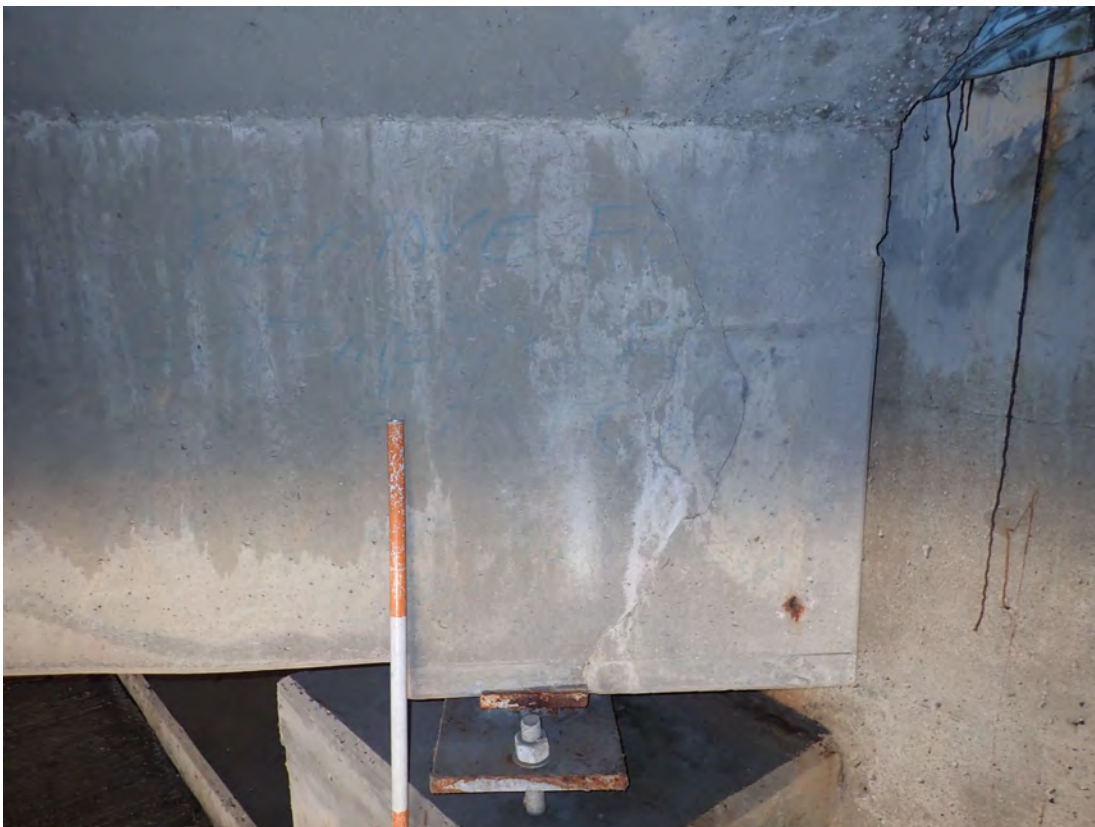
Abutment 8-Girder 10 with vertical/diagonal cracking just behind the sole plate of bearing device

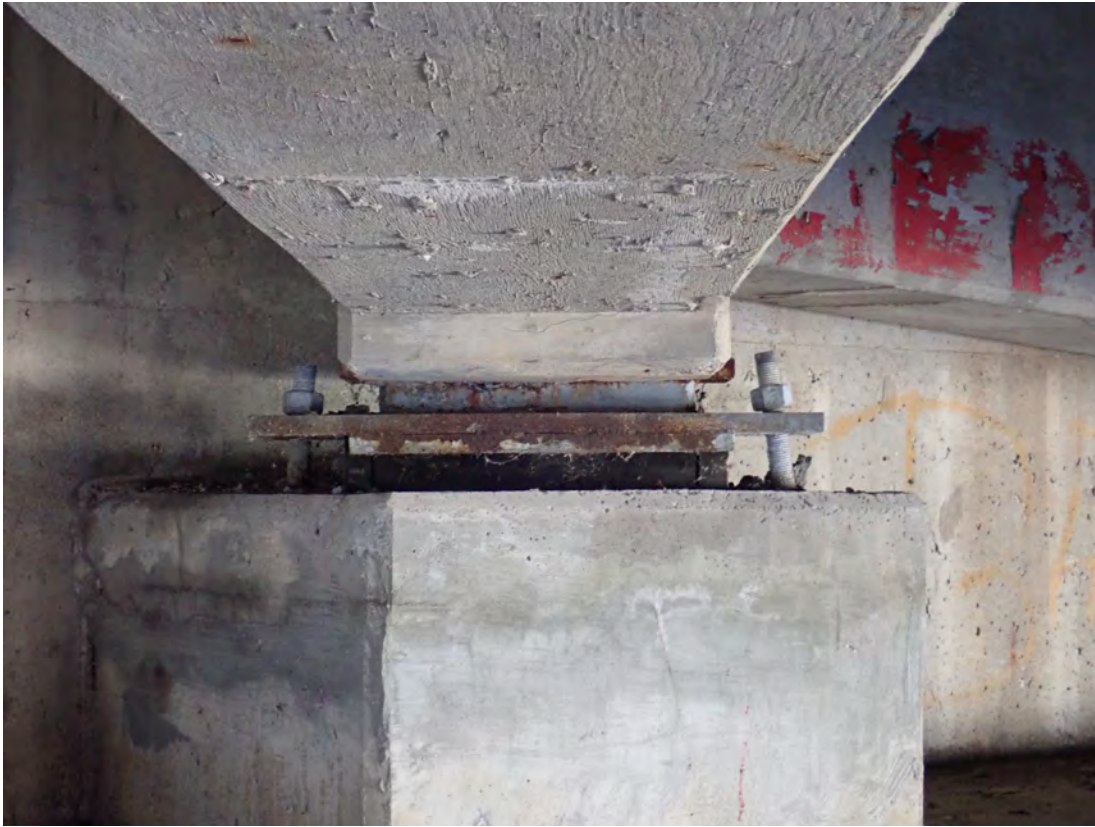
Abutment 8-Girder 12 with misaligned anchor bolt
