# CHOCTAW INDIAN ACADEMY / SITE 8 ROCK FENCE ASSESSMENTS

## KY 227 Safety Curve Revision Project

### Stamping Ground Road, Scott County

Re: **Assessment & Report on Historic Rock Fence Resources F & G**  
Choctaw Academy / Blue Spring Farm / CRA Site 8 (SC 174)  
KY 227 Safety Curve Revision Project  
Scott County, Kentucky  
Item No. 7-9018.01

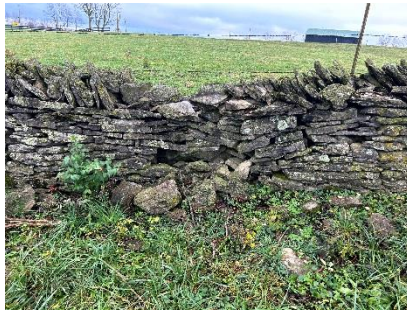
*South perpendicular F, showing full depth tie stone in the center that prevented total collapse.*

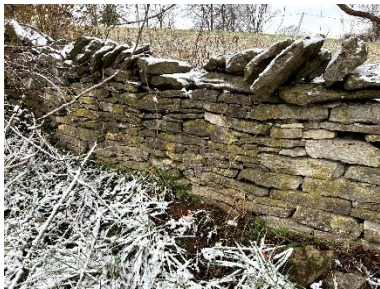
*Roadside G south of entrance, section with covers and single copes.*

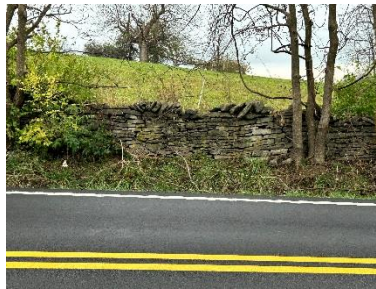
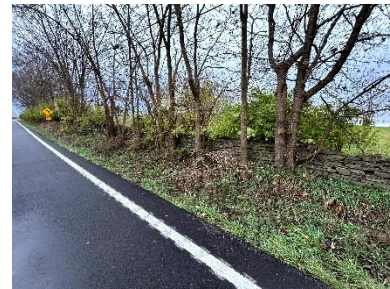
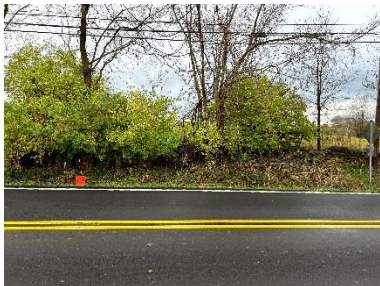
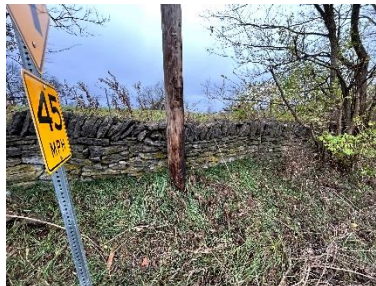
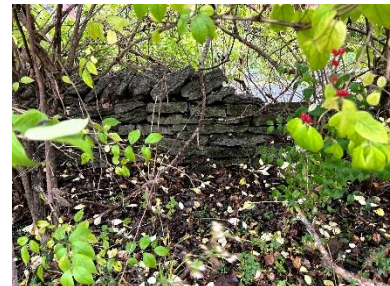
### South Resource G (Roadside Fence, South of Farm Entrance) @ 375 LF:

**Summary:** More than half is in good condition despite vegetation, 90% of the stone is on site, 1 crash site, 2 repairs, entry curve looks like it was added later (slightly different build)

Batter: yes, but mostly pushed over by surcharge (soil creep)

Good: 225 LF @ 5%-15% of height down, 80-90% stone still there, w/ 50 LF repaired

Fair: 50 LF @ 50% of height down, 80-90% stone still there

Poor: 100 LF @ 70%-100% of height down, 80-90% stone still there, w/25 LF crash site

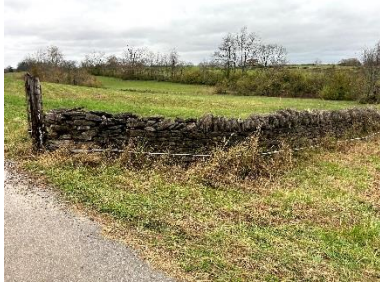
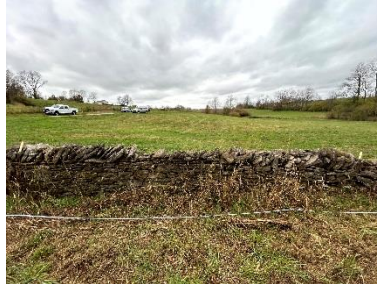
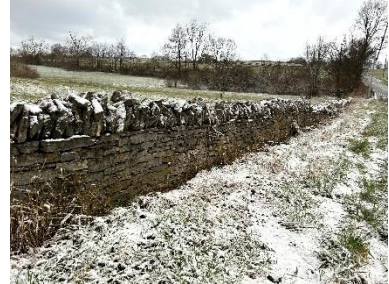
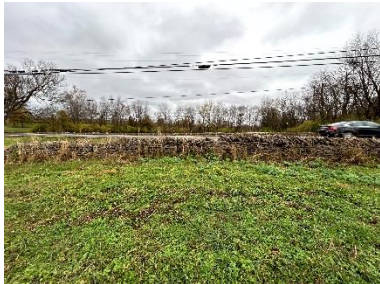
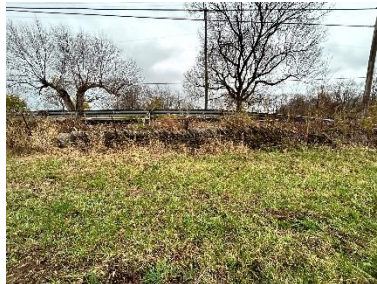
## North Resource G (Roadside Fence, North of Farm Entrance) @ 275 LF:

**Summary:** None in poor condition, more than half in good-excellent condition, transitions to retaining as approaches bridge, 100% of the stone is on site, two 7 LF failures, entry curve looks like it was added later (slightly different build)

Batter: Yes, 1:12 in some places, closer to 1:6 in others

Excellent: 75 LF @ fully intact, 100% stone is still there

Good: 100 LF @ 5%-15% of height down, 100% stone still there

Fair: 100 LF @ 50% of height down, 100% stone still there

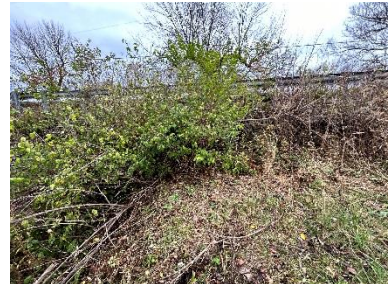
*Roadside G north of entrance, view from field side at transition to bridge.*

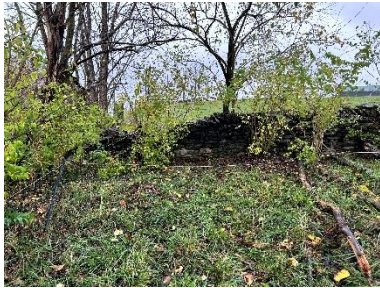
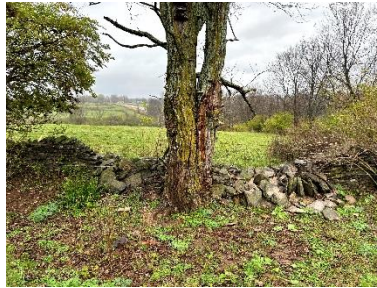
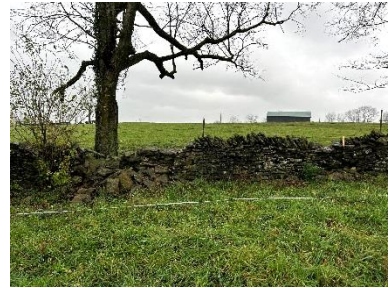
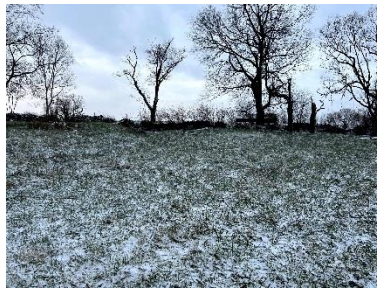
**South Resource F (Perpendicular Field Fence) @ 150 LF (assessed only within APE):**

**Summary:** 100% of the stone is on site, only 1 section is entirely down, the build is consistent within the APE and further to the west (beyond the old roadbed curve) indicating it was all built at the same time.

Excellent: 25 LF @ fully intact, 100% stone on site

Good: 50 LF @ 5%-15% of height down, 100% stone still there

Fair: 50 LF @ 50% of height down, 100% stone still there

Poor: 25 LF @ 100% down, 100% of the stone still there

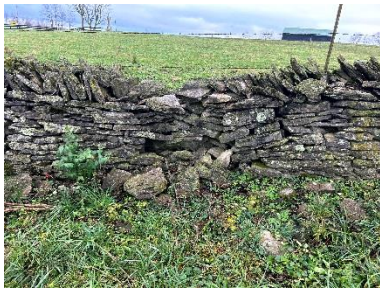
*South F perpendicular fence, showing tie holding fence up.*

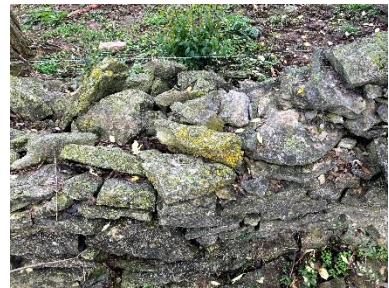
*South F perpendicular fence, failure at 75', showing face stones length in.*

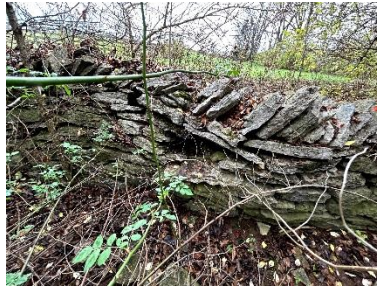
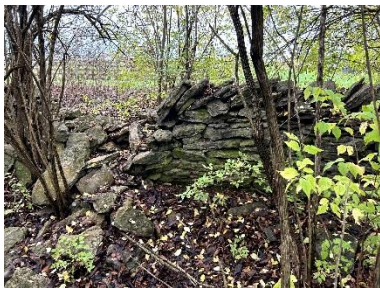
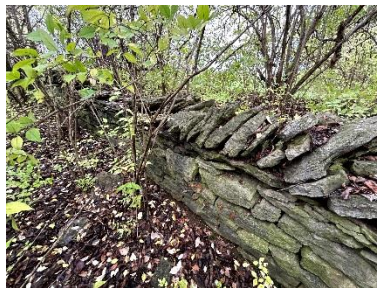
## North Resource F (Perpendicular Field Fence) @ not measured

**Summary:** in good condition but threatened by vegetation, kept mostly clear of vegetation on the north side but full of brush on south side, 100% of the stone is on site, 3' offset from the corner where it intersects with the roadside wall, partially-retaining on north side (soil creep).

Batter: Yes, but only slight, has straightened up over time (soil creep)

Good condition throughout, but threatened by vegetation.

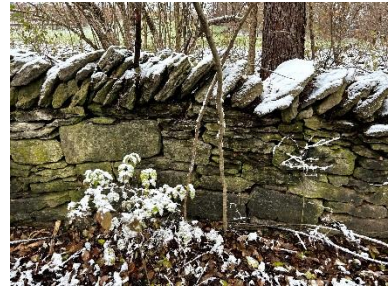
*North F perpendicular fence, showing single copes and unusual thick stone near top of build.*

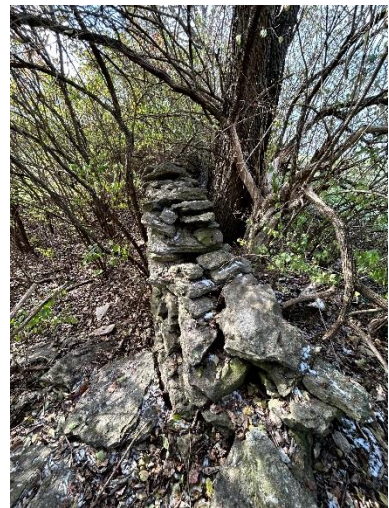
*North F perpendicular fence, showing profile and batter.*

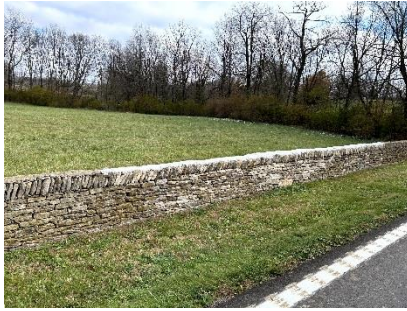
*Groverland Farm Resource W roadside fence showing recent repair with concrete cap over double copes.*

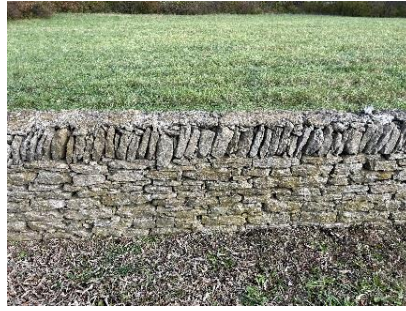
*Groverland roadside fence, close up of repaired section with concrete cap, coursed stonework, and face chinking.*

Additionally, the Groverland Farm fence actually has a mortared coping course of double copes, not mortared single copes. It also has long stretches that are semi- to fully coursed, patterns more often indicative of fences that were commissioned (or later rebuilt) by individual farm owners, rather than the random build (not coursed) pattern typical of most turnpike fences that spanned multiple properties. The Site 8 fences are laid in a random build pattern.

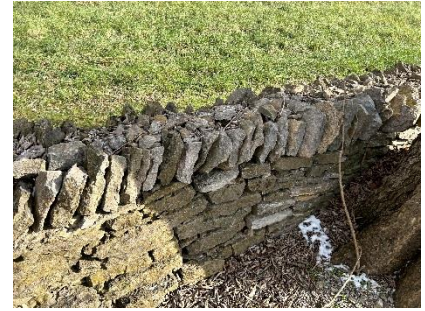
*Groverland roadside fence, showing an unrepaired section with original double copes, random build and no face chinking.*
