# Inspecting the Deepest Bridge in Kentucky

Kennedy Mill Bridge over Herrington Lake

John J. Loftus P.E.  
September 3, 2024

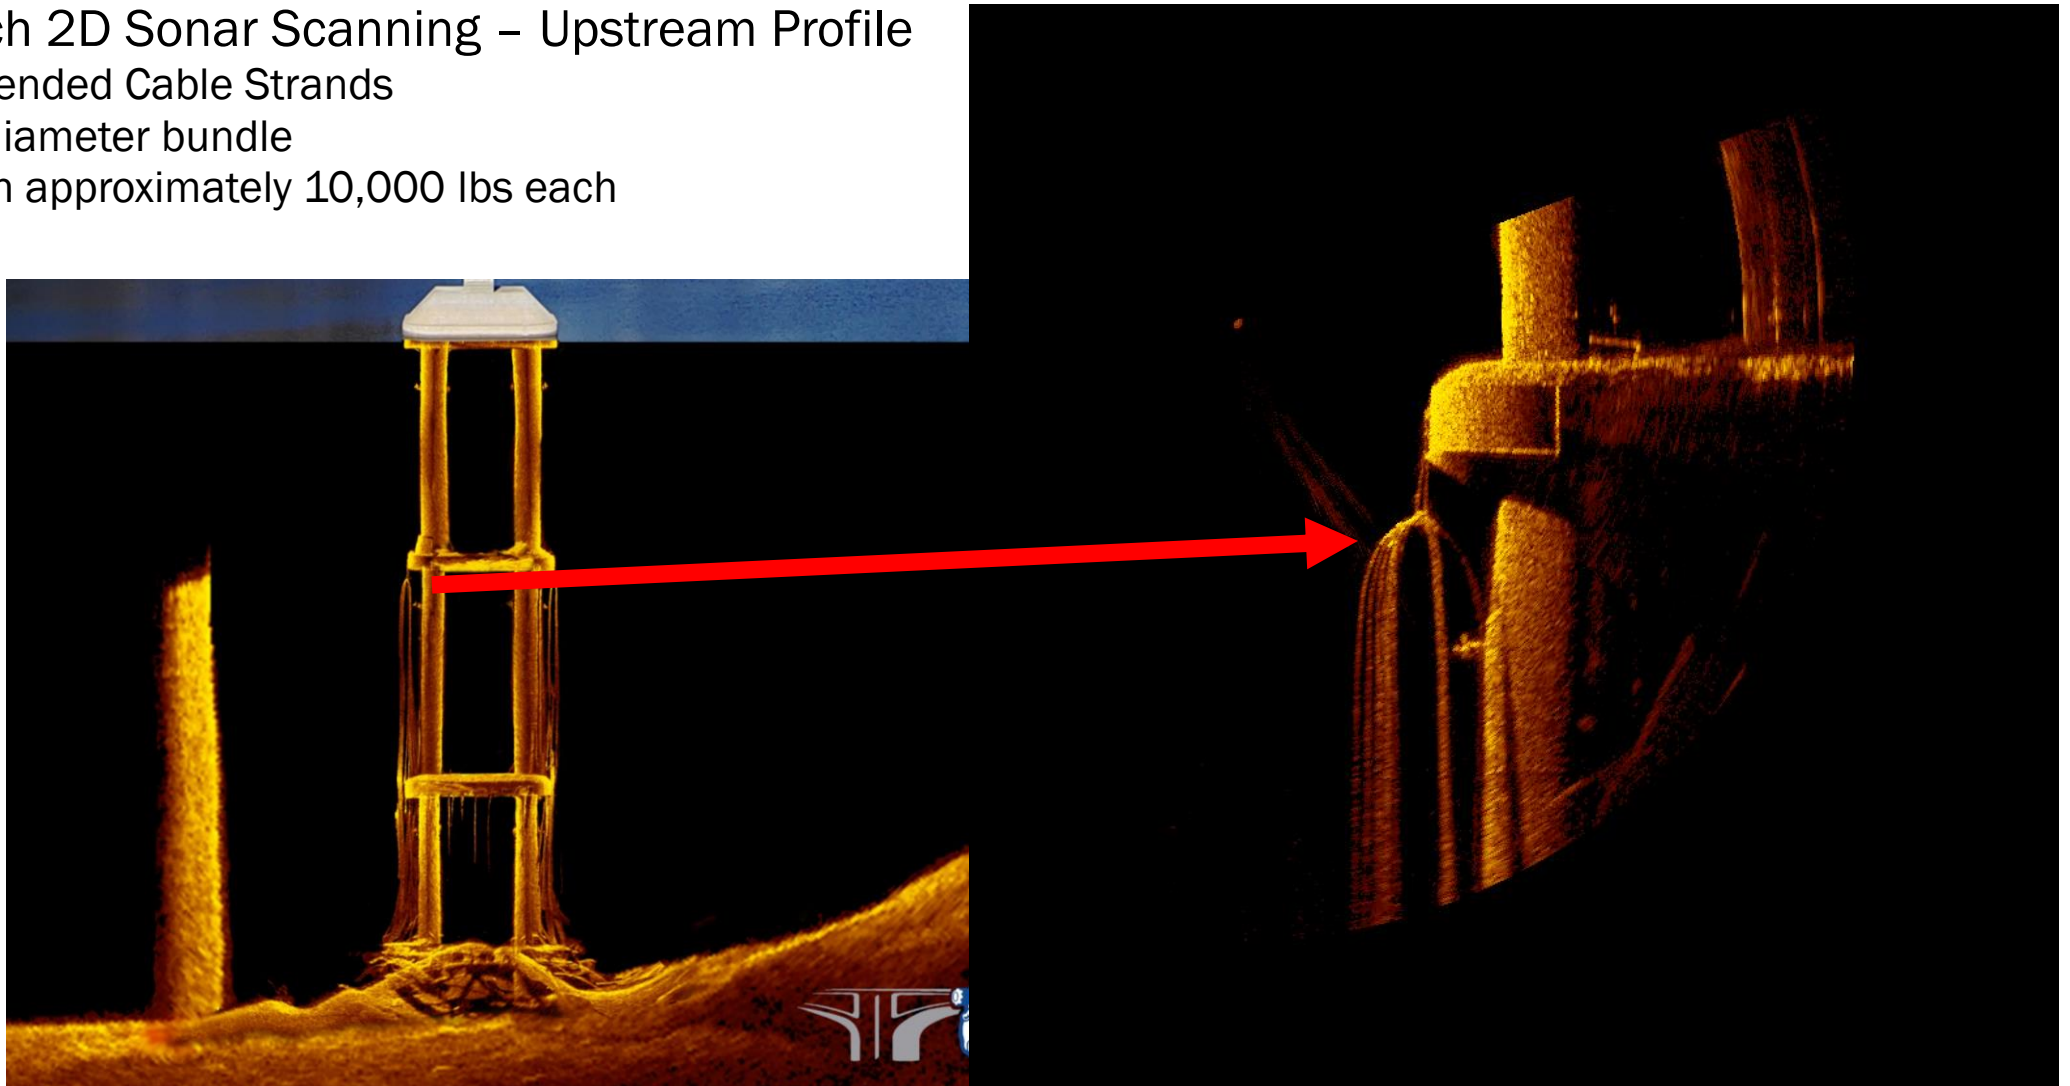
- Mesotech 2D Sonar Scanning – Upstream Profile
  - Suspended Cable Strands
  - 10” diameter bundle
  - Weigh approximately 10,000 lbs each

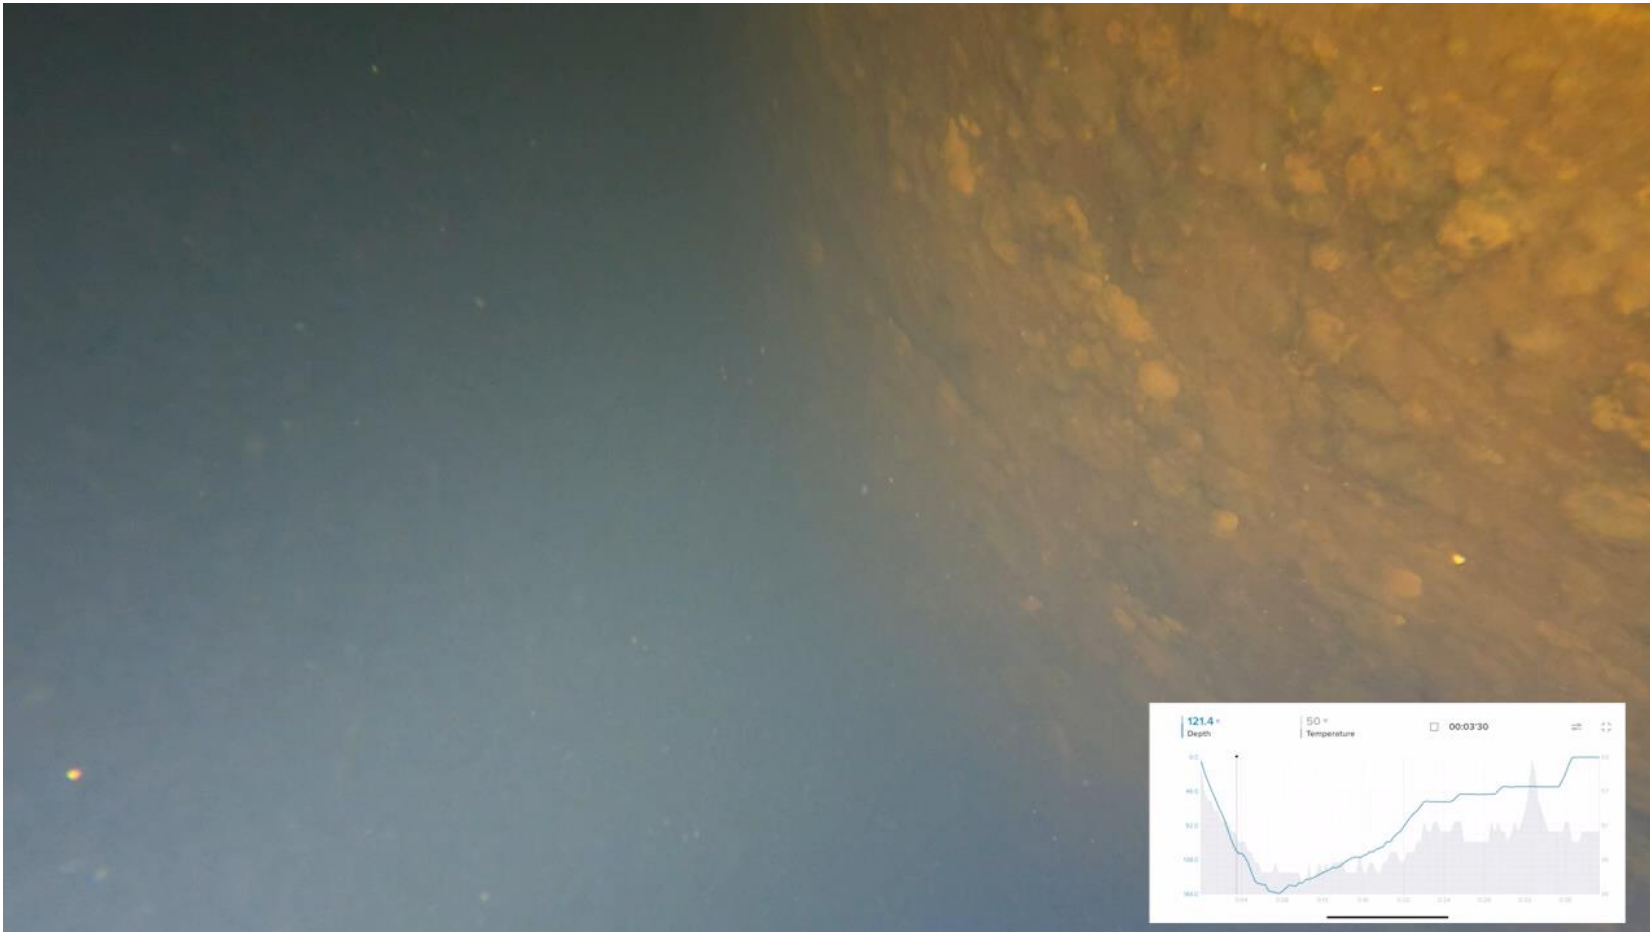
- Diver Entanglement
  - Lifting strands cut and hanging from all 4 corners of the main pier

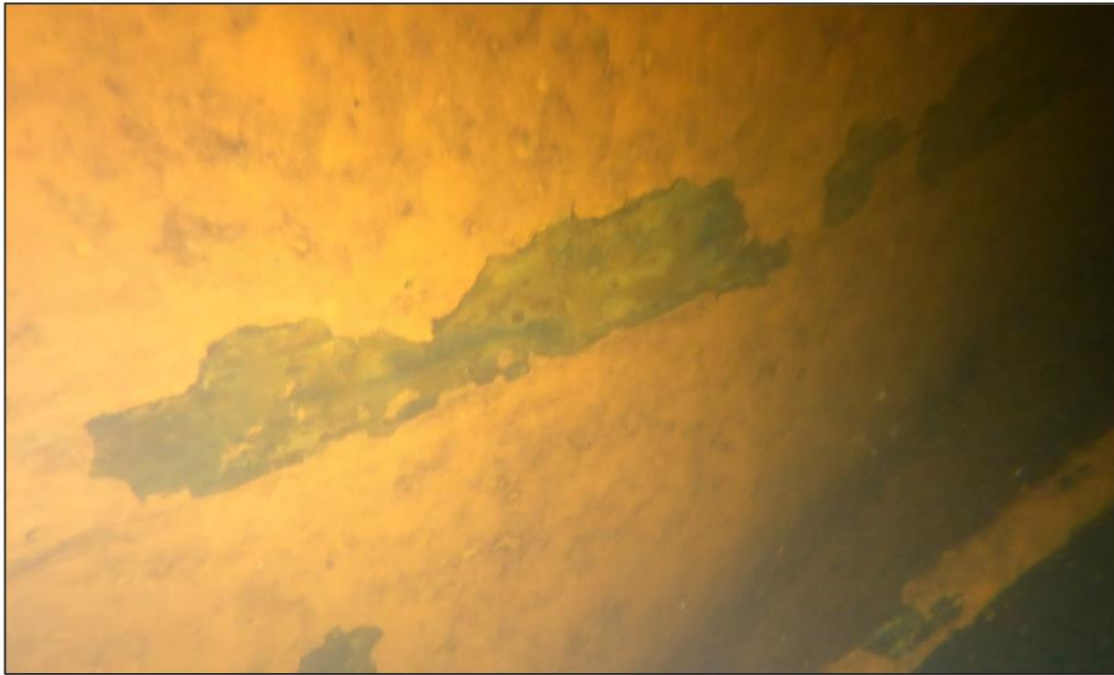
- Bridge is in Good Condition
  - Minor scaling on steel column casings

Photograph 16 View of the typical condition of the welds beneath the rust scaling on the steel pile casings on Pier 2.

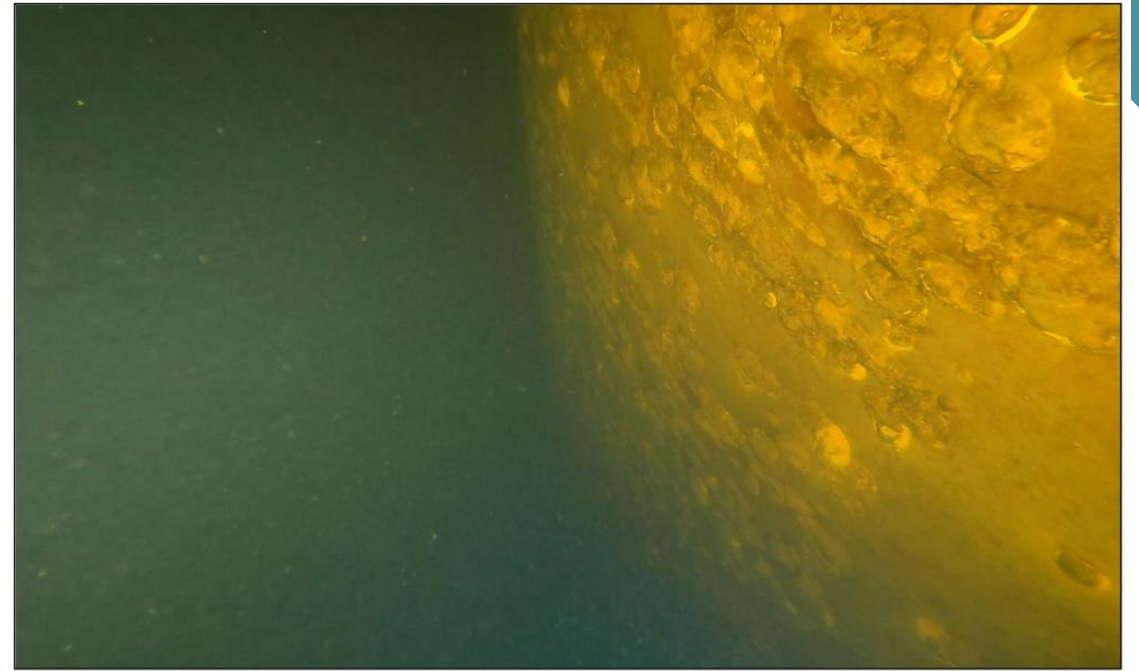
Photograph 15 View of typical rust nodules on the steel pile casings of Pier 2.

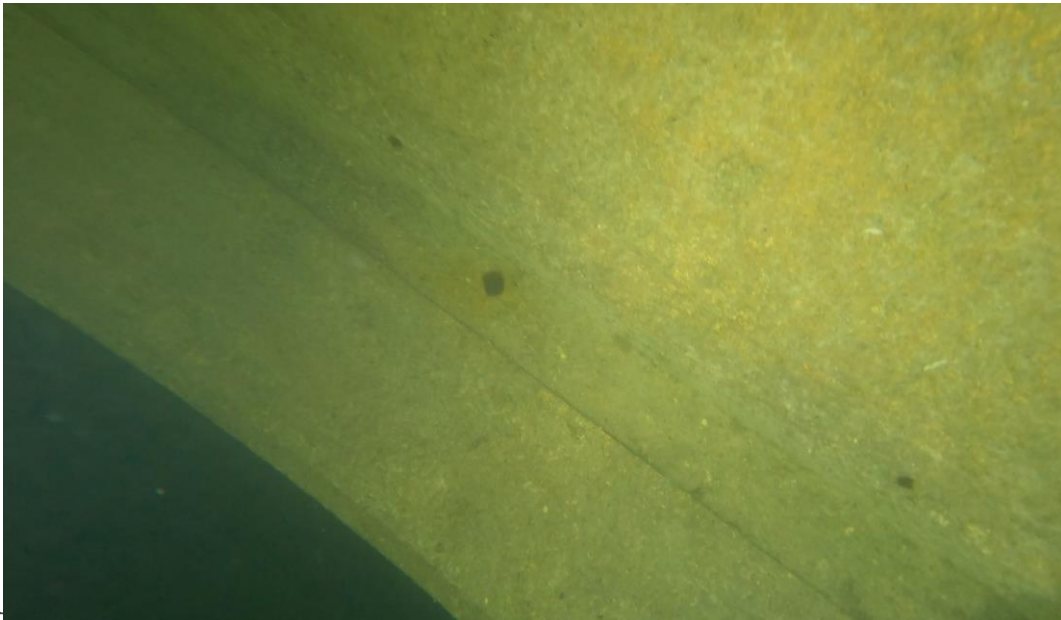
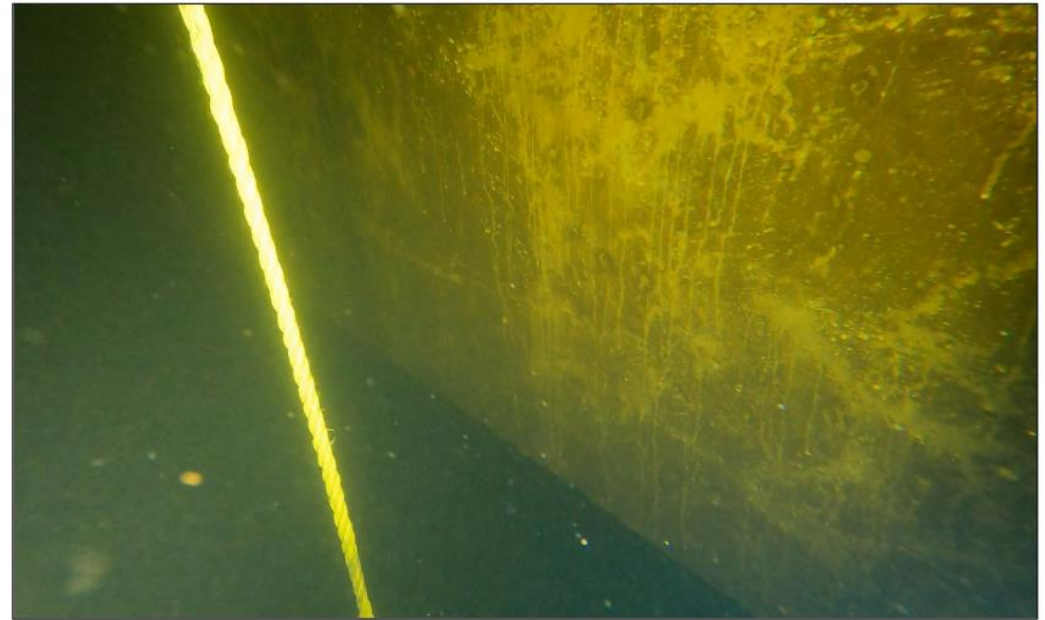
- Bridge is in Good Condition
  - Concrete sound, smooth, and free of defects.

*Photograph 17 View of the typical condition of the concrete on the lower brace of Pier 2.*

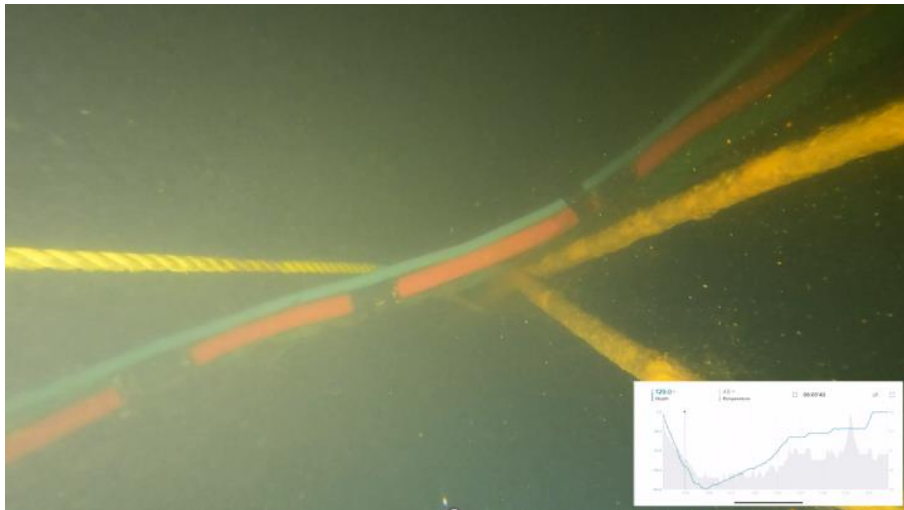
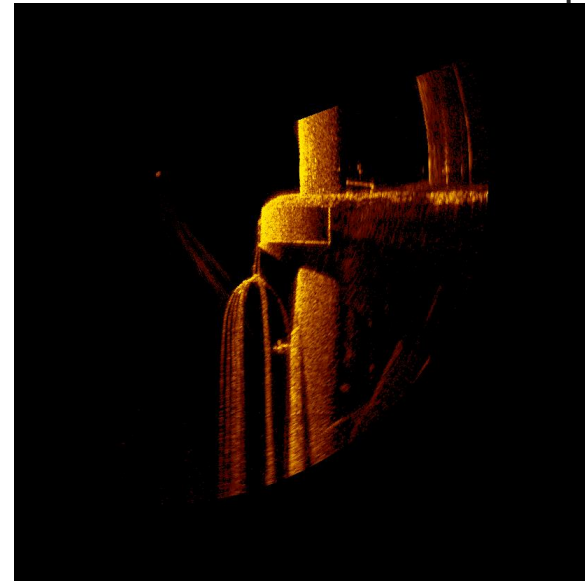
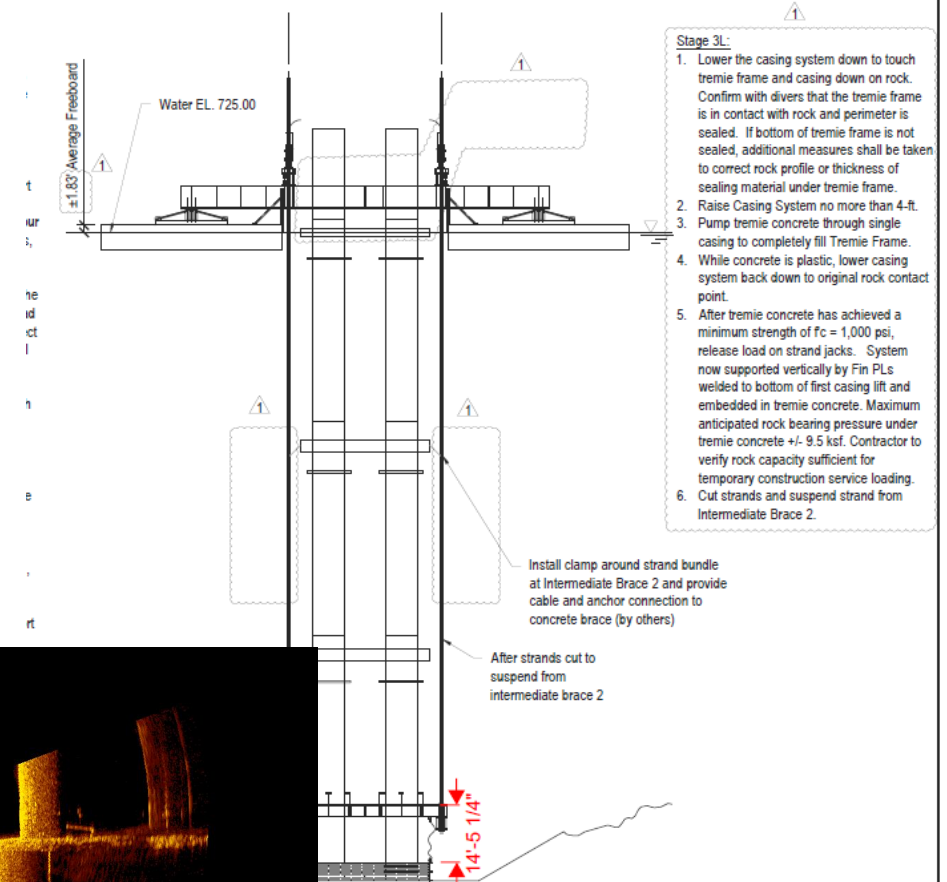
- The cables left in place are a significant hazard to divers and equipment.
  - With the cables in place, an ROV inspection can not be done without a dive team.
  - Recommend the cables be removed.
