# US68 Lawrence Creek Bridge

## Embankment Settlement & Proposed Solutions

ACEC-KY/FHWA/KYTC Partnering Conference

September 4, 2019

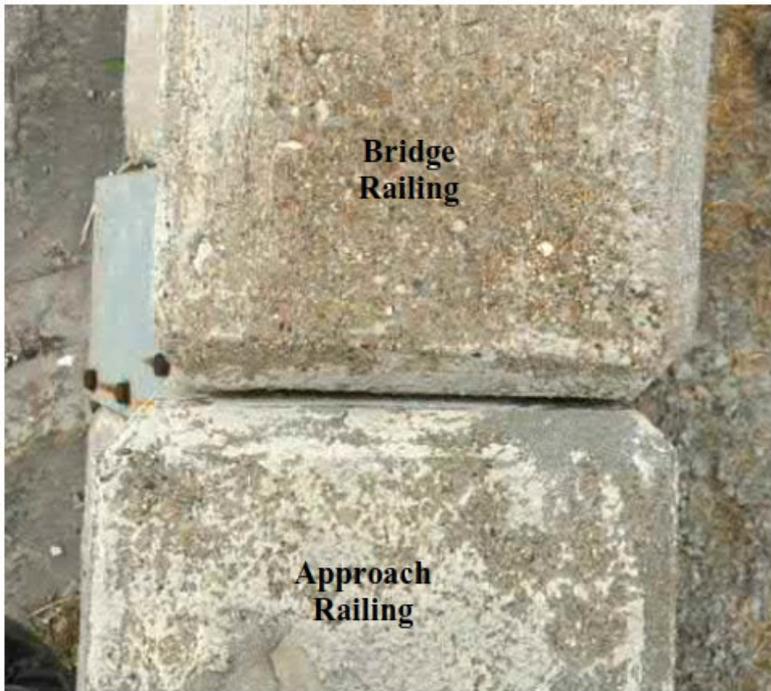
**Photo 58.7-3: West railing at Abutment 6 misaligned transversely 1 inch to the west**

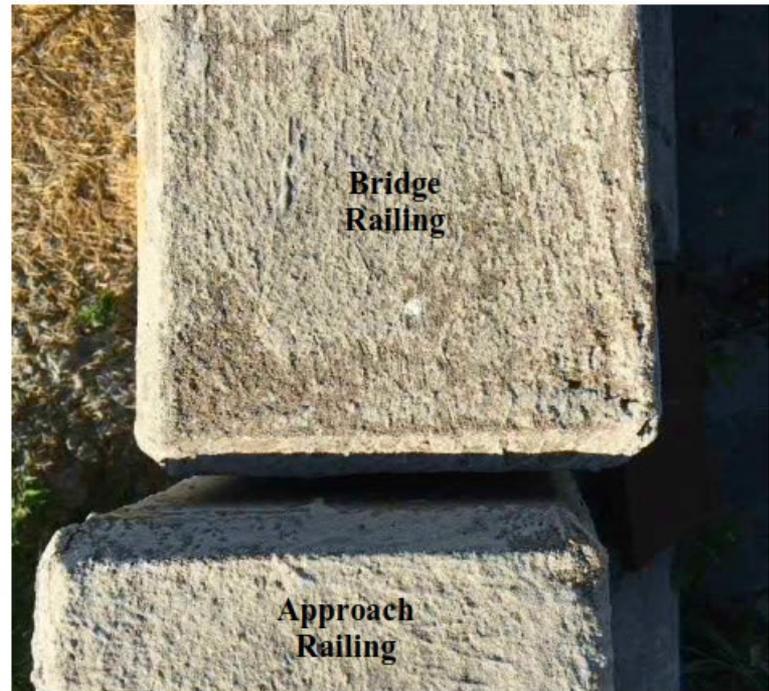
**Photo 58.7-4: East railing at Abutment 6 misaligned transversely 1½ inch to the west**

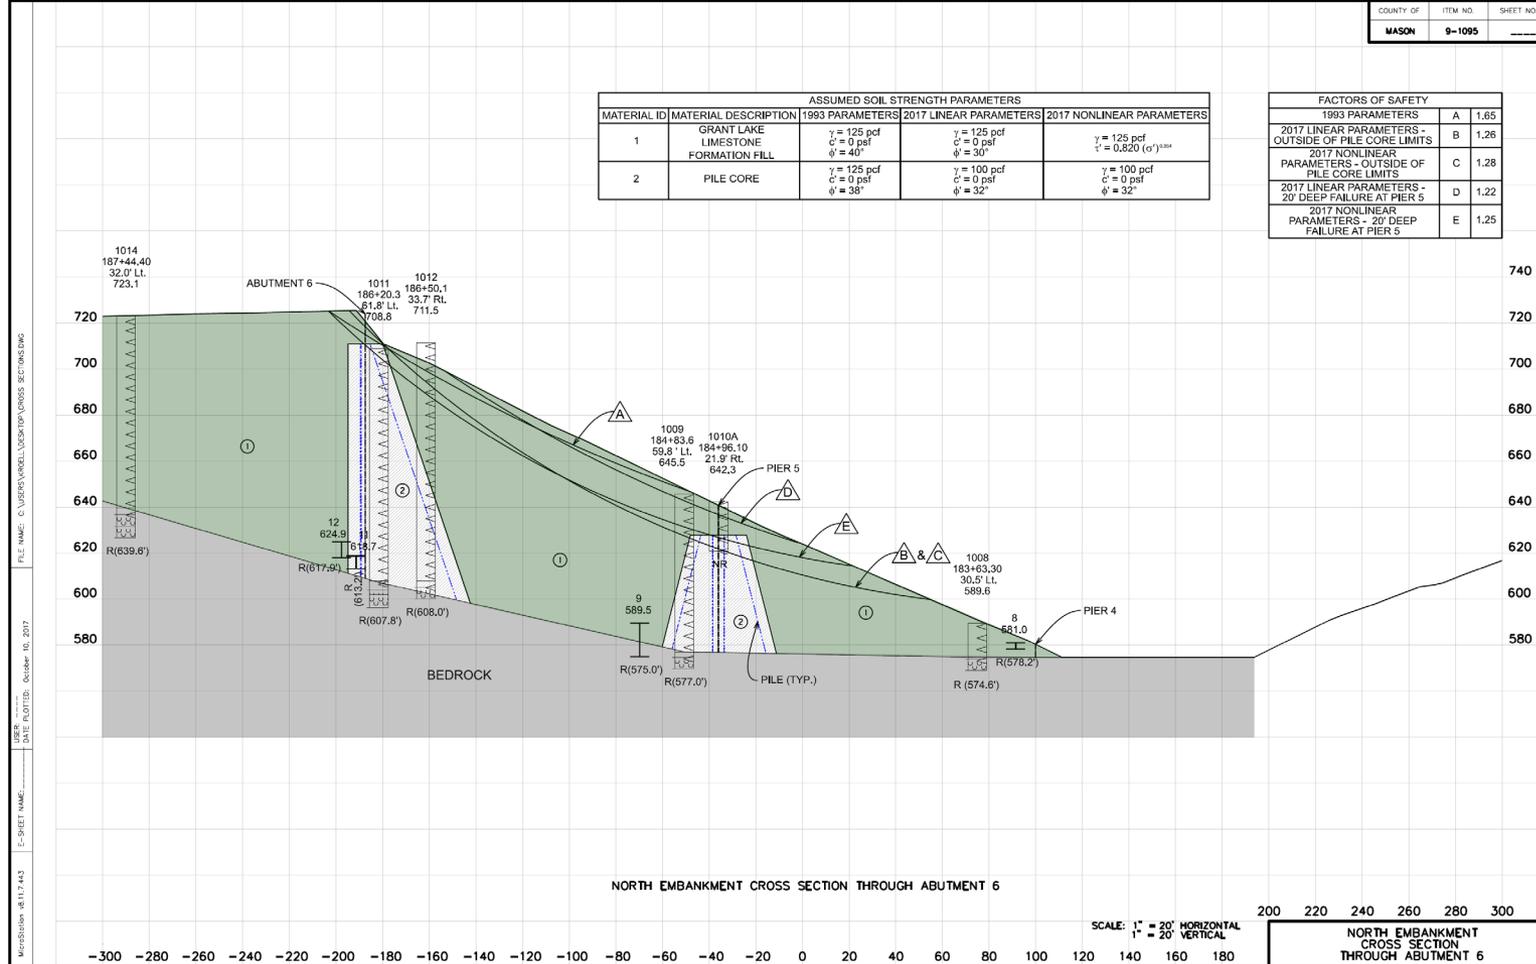
## Abutment 6 – North Embankment

FACTORS OF SAFETY		
1993 PARAMETERS	A	1.65
2017 LINEAR PARAMETERS - OUTSIDE OF PILE CORE LIMITS	B	1.26
2017 NONLINEAR PARAMETERS - OUTSIDE OF PILE CORE LIMITS	C	1.28
2017 LINEAR PARAMETERS - 20' DEEP FAILURE AT PIER 5	D	1.22
2017 NONLINEAR PARAMETERS - 20' DEEP FAILURE AT PIER 5	E	1.25

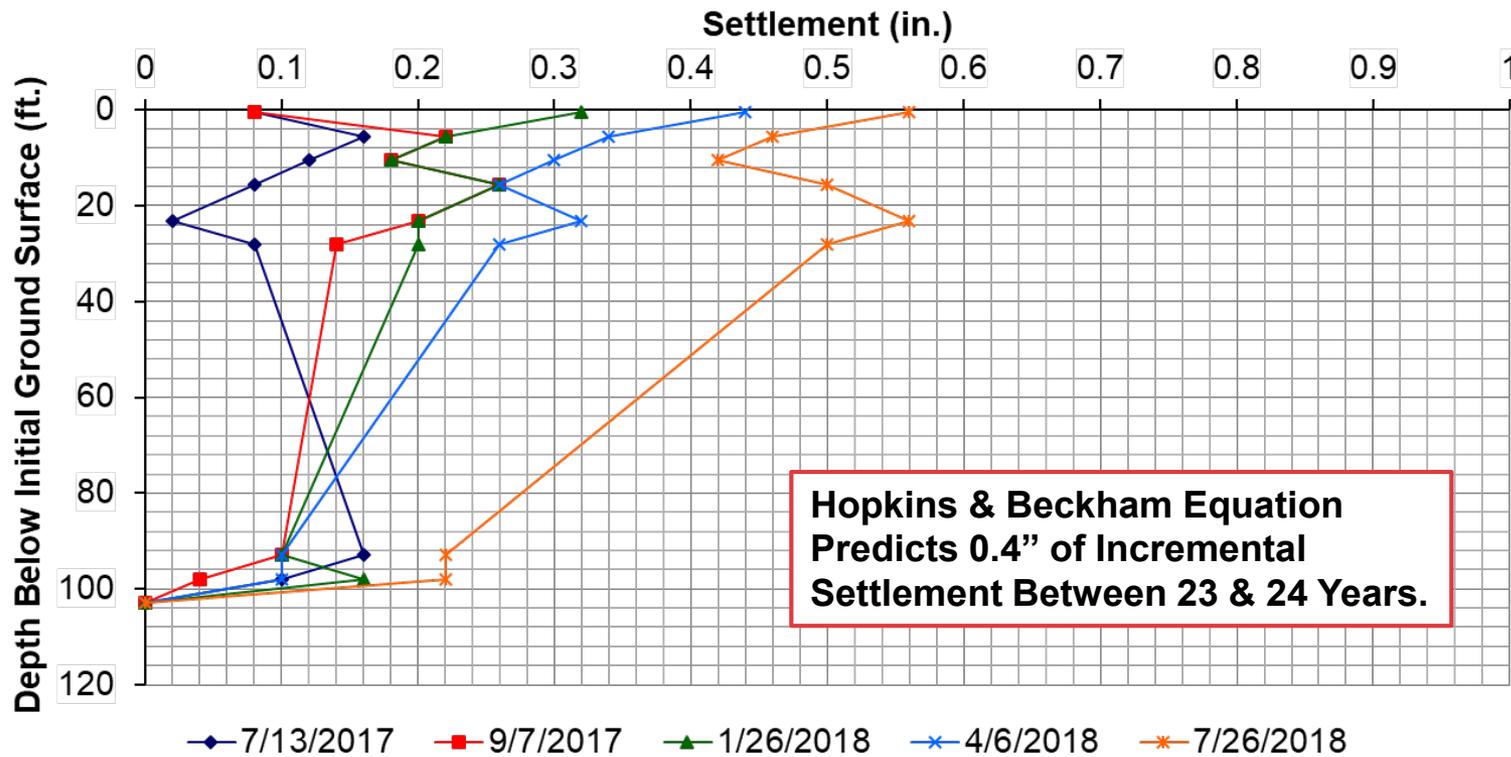
## Boring 1011A Sondex Instrumentation at Abutment 6

### Settlement Profile at Boring 1011A

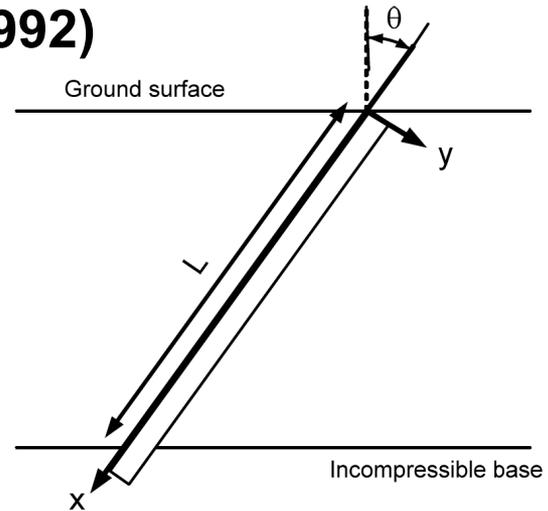
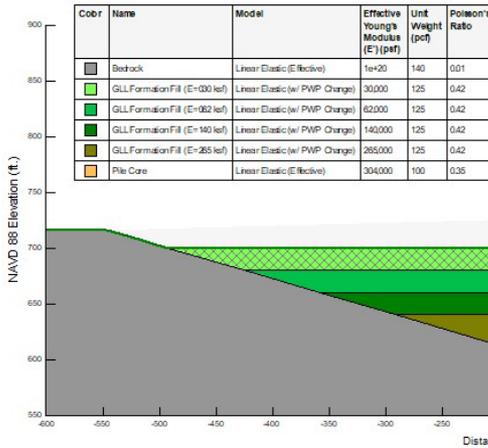
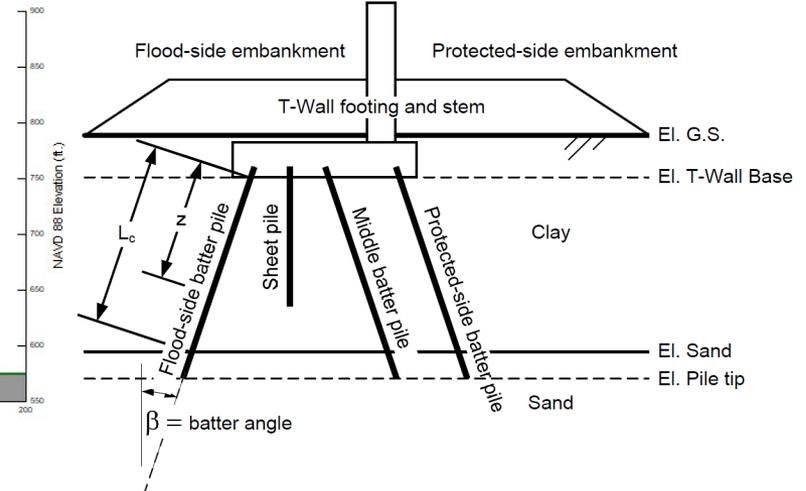
## Battered Pile Analyses– (Shibata et al 1992)

### Battered piles analyses for evaluating bending moment:

- Bending of batter piles, which “pulled” creek side of pile caps down and towards the creek
- Time-dependent horizontal deformations within the fill, related to primary compression of the shot-rock fill, which “pushed” the piles towards the creek
