# Bridge Inspection Report

056B00211N

12/03/2024

Standard (24 months)

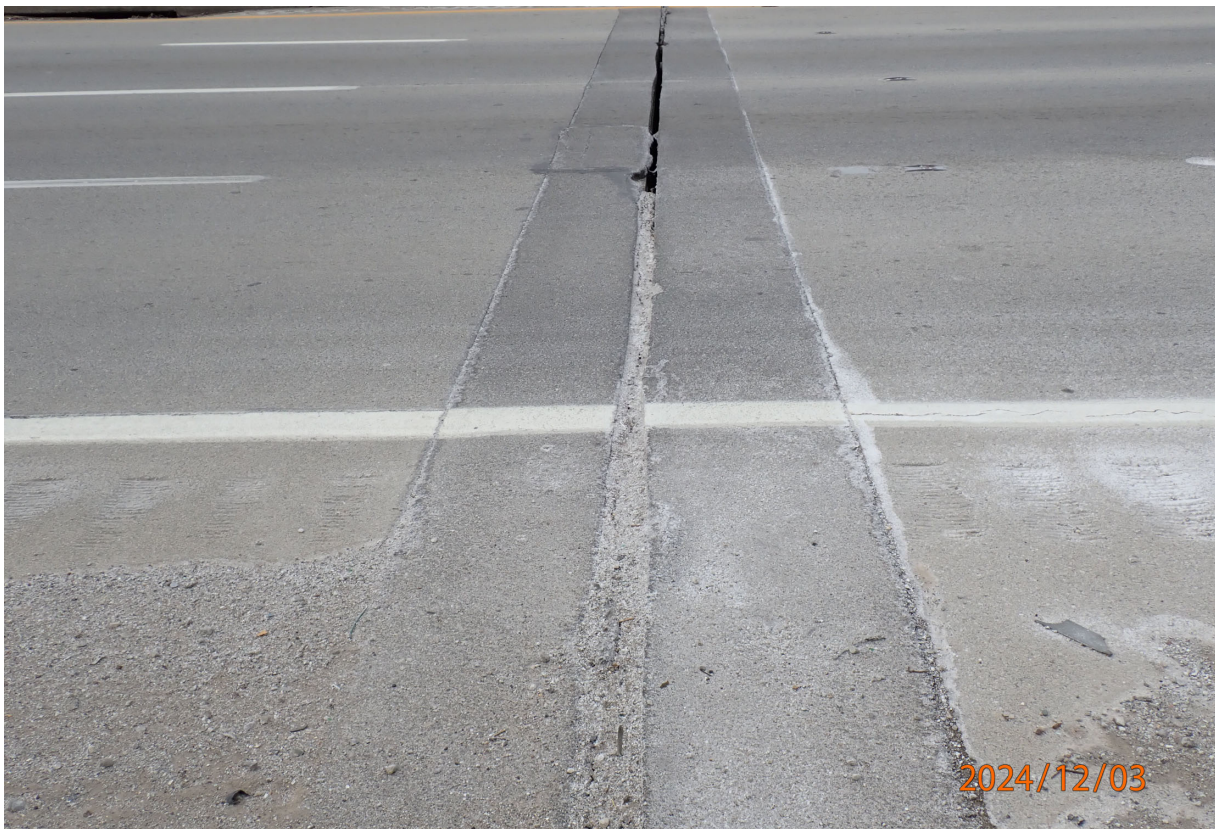
The asphalt plug joints are located at Abutments 1 & 4, installed over the existing joints in 2012, and redone in 2017. The plug joints have failed in several areas of the traffic lanes, exposing portions of the original joints and allowing free flow of water through the joints. The Abutment 4 joint on the NB side has some areas where the joint is starting to break up. The joints are partially filled with debris and have some minor cracking.

South bridge joint over Abutment 1 for NB traffic.

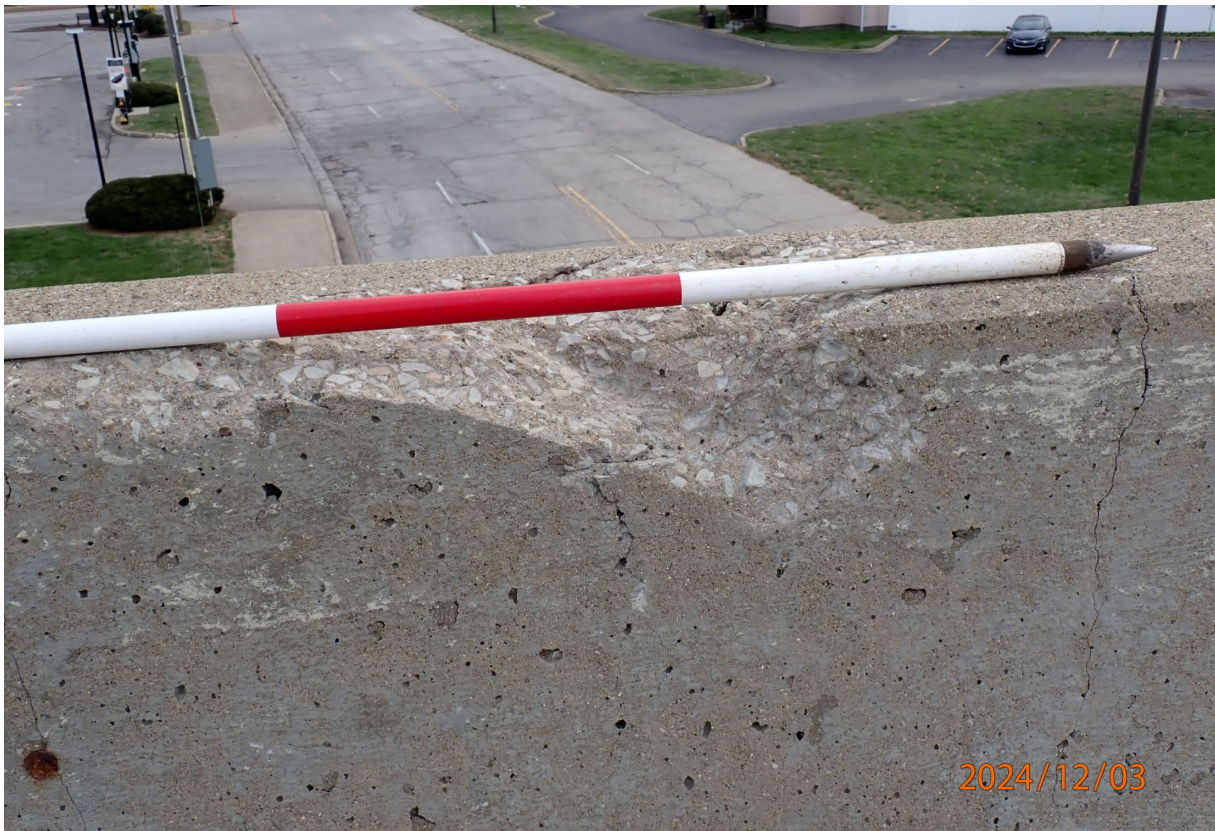
The east railing has several spalls deeper than 1". The railings have moderate width vertical cracks and small spalls throughout.

East barrier has a few impact spalls.

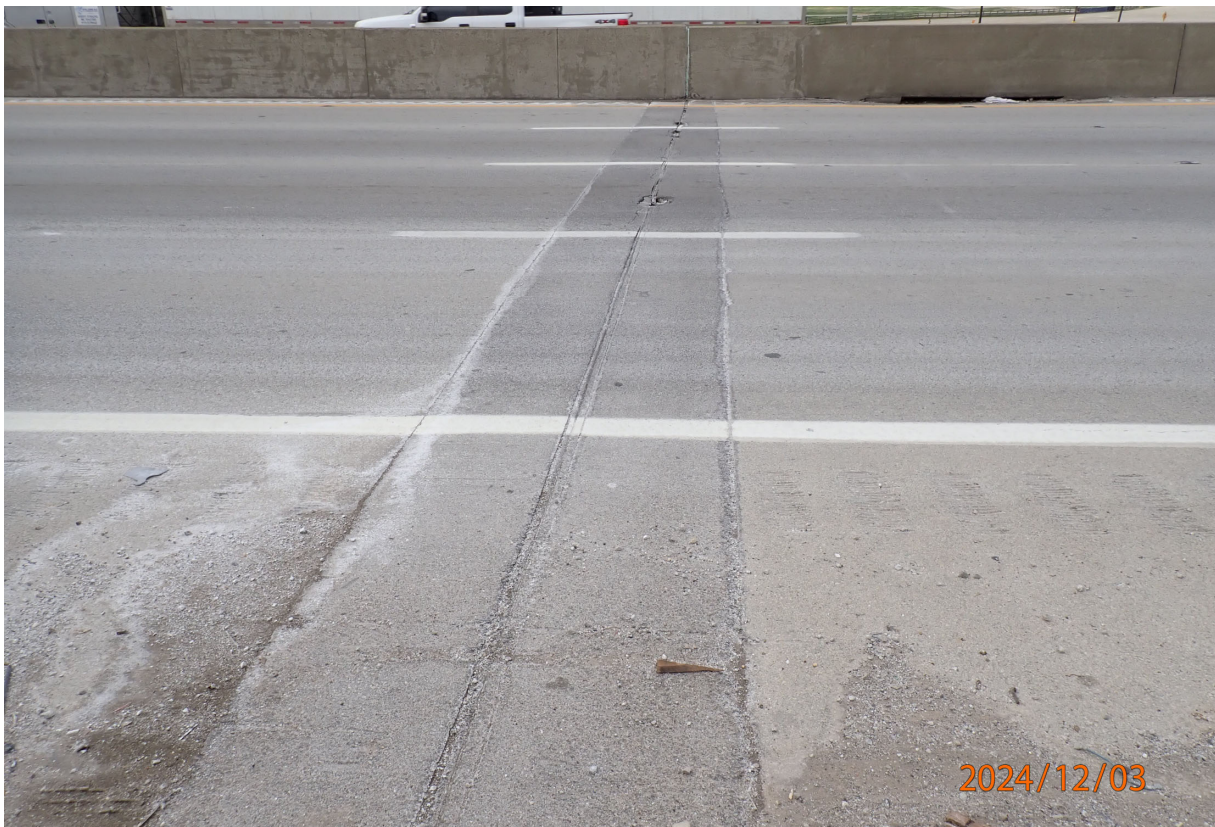
North bridge joint over Abutment 4 for NB traffic.

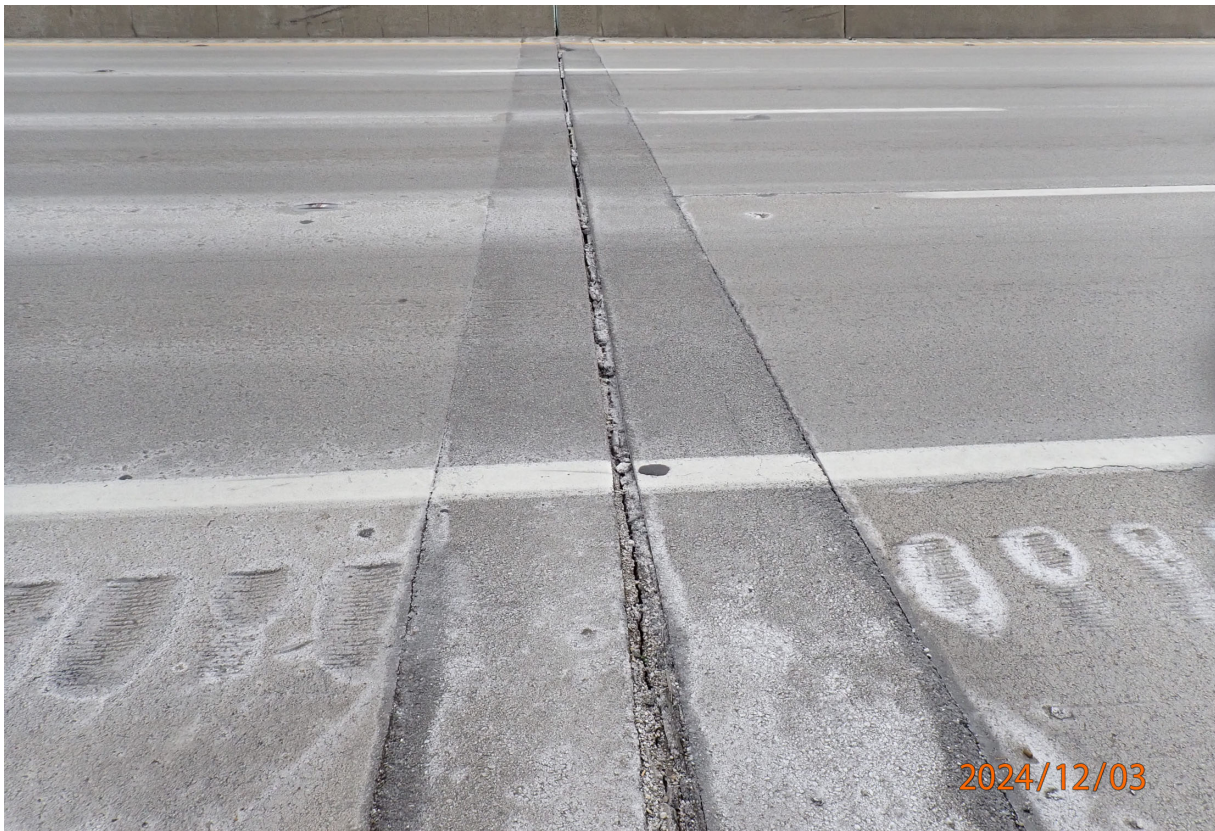
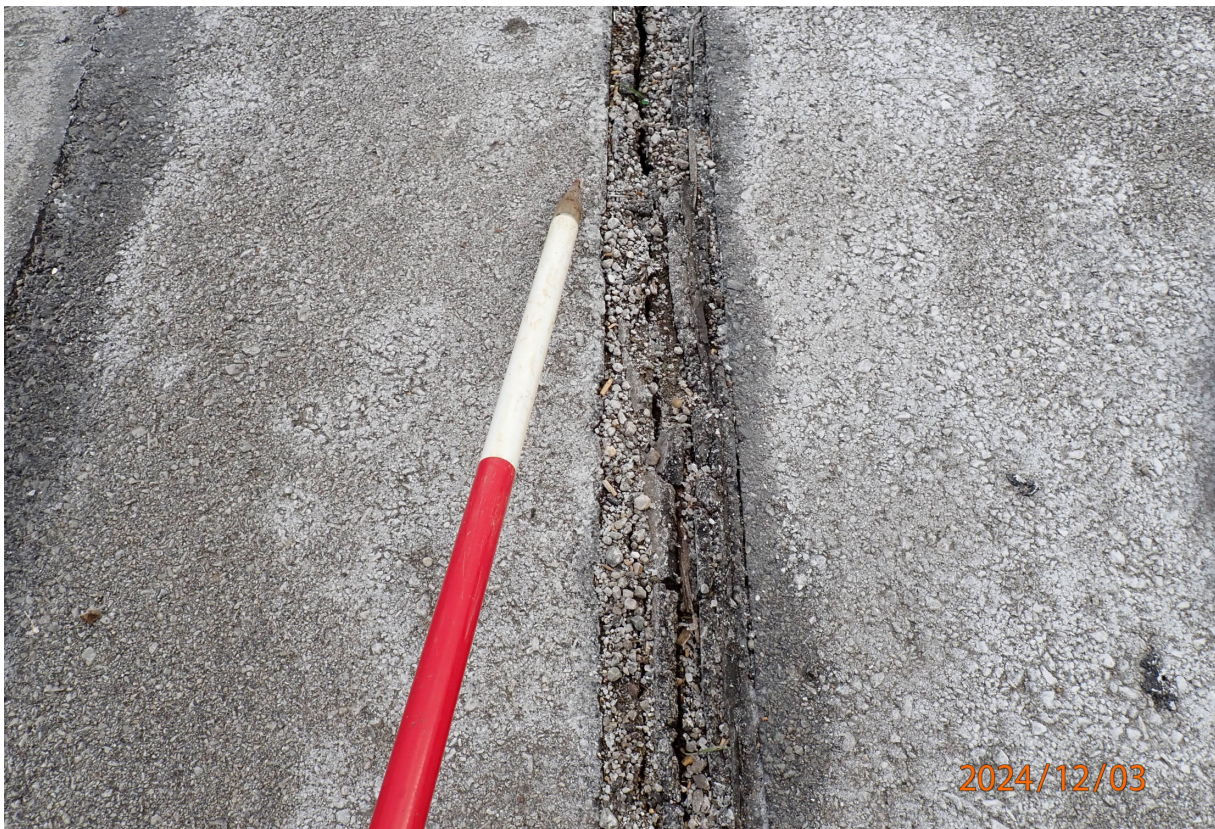
South bridge joint over Abutment 1 for SB traffic.

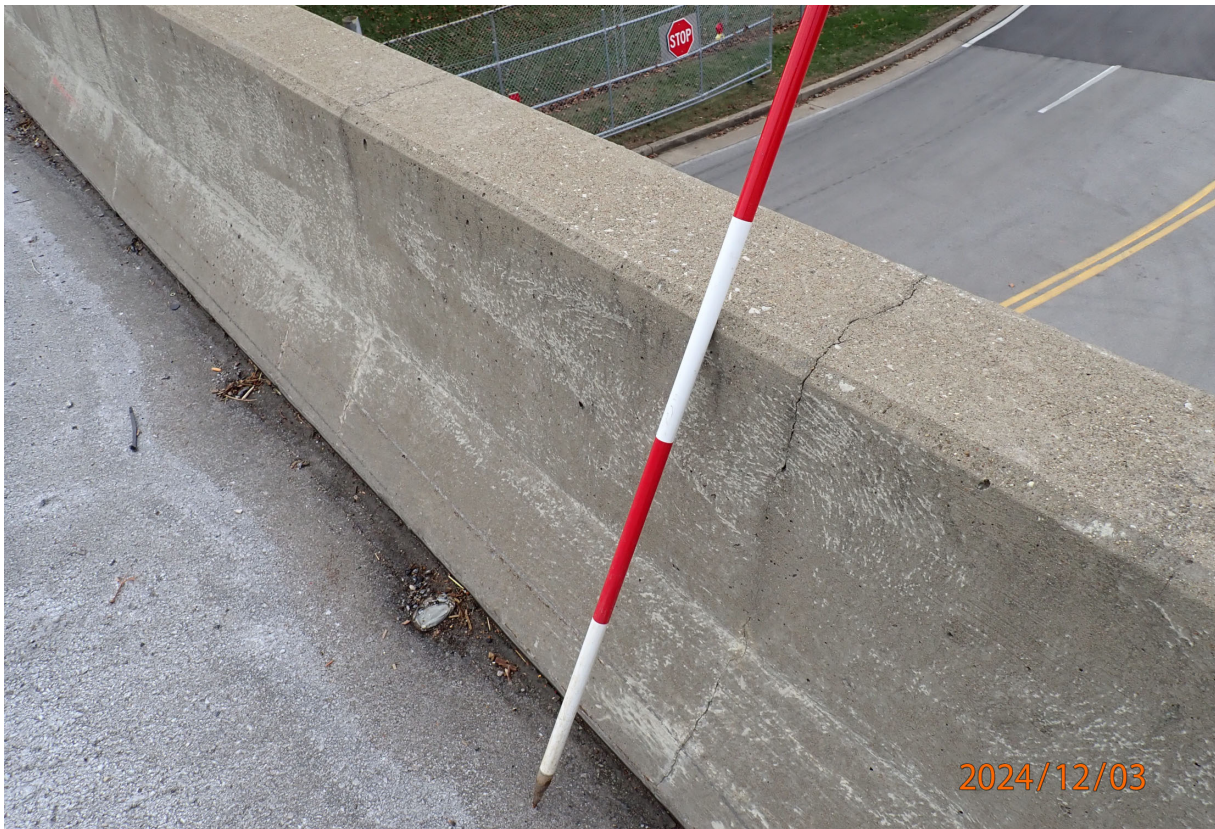
Typical barrier vertical cracking.

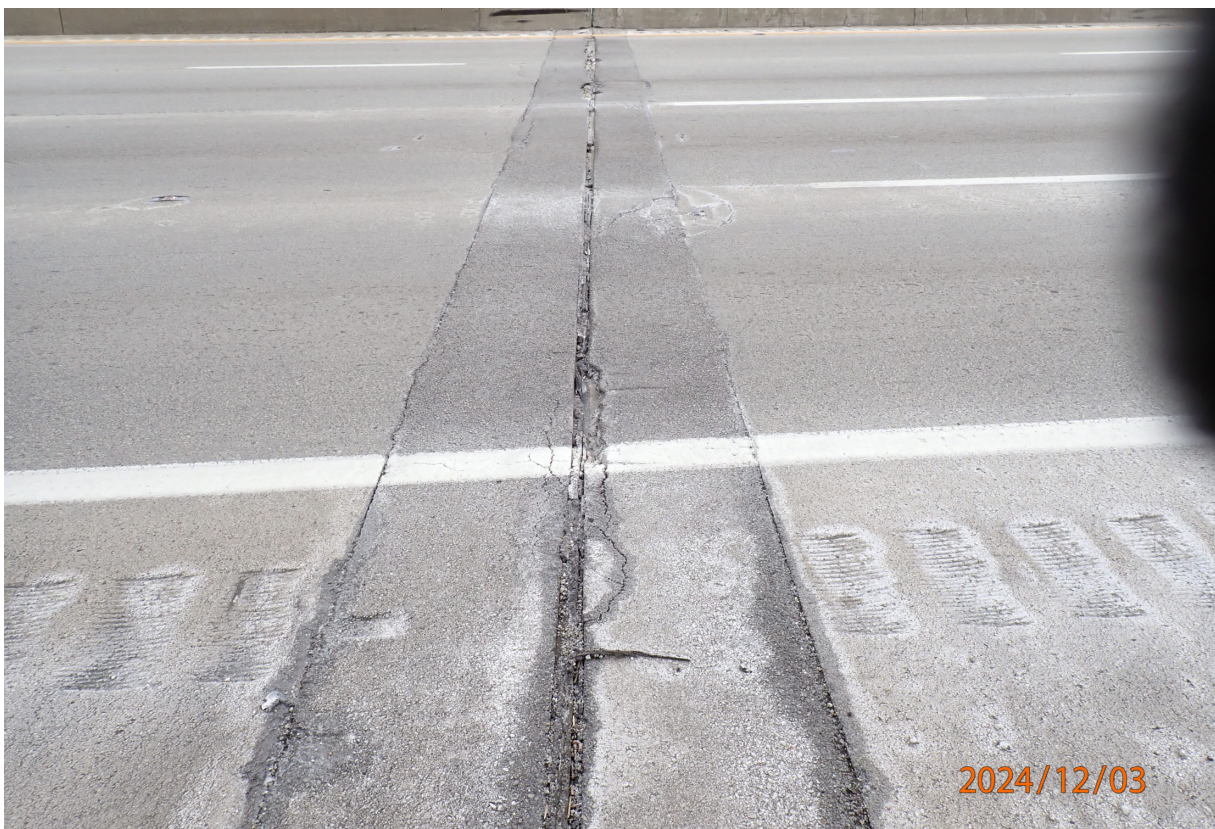
North bridge joint over Abutment 4 for SB traffic.

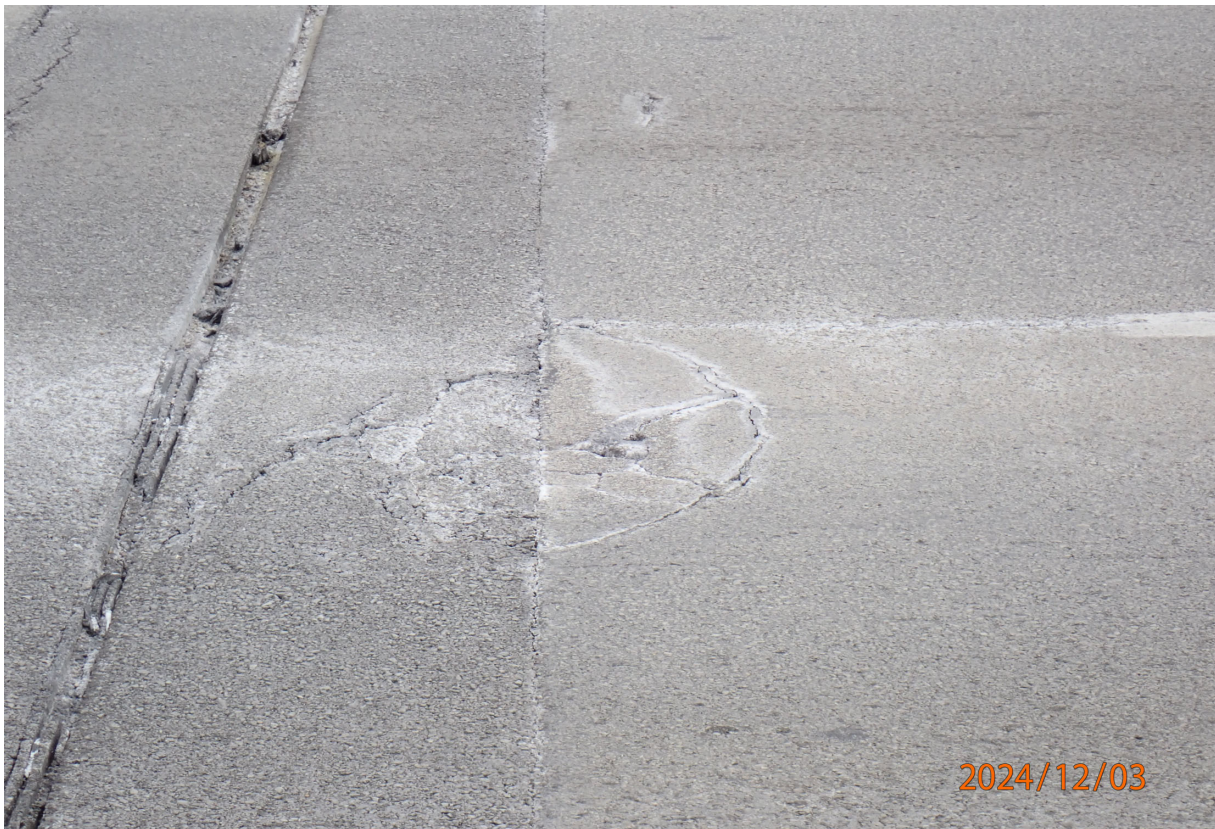
Asphalt overlay has cracking in the SB right lane at the north bridge end. There is minor debris in the shoulders.

Asphalt overlay has cracking in the SB right lane at the north bridge end.

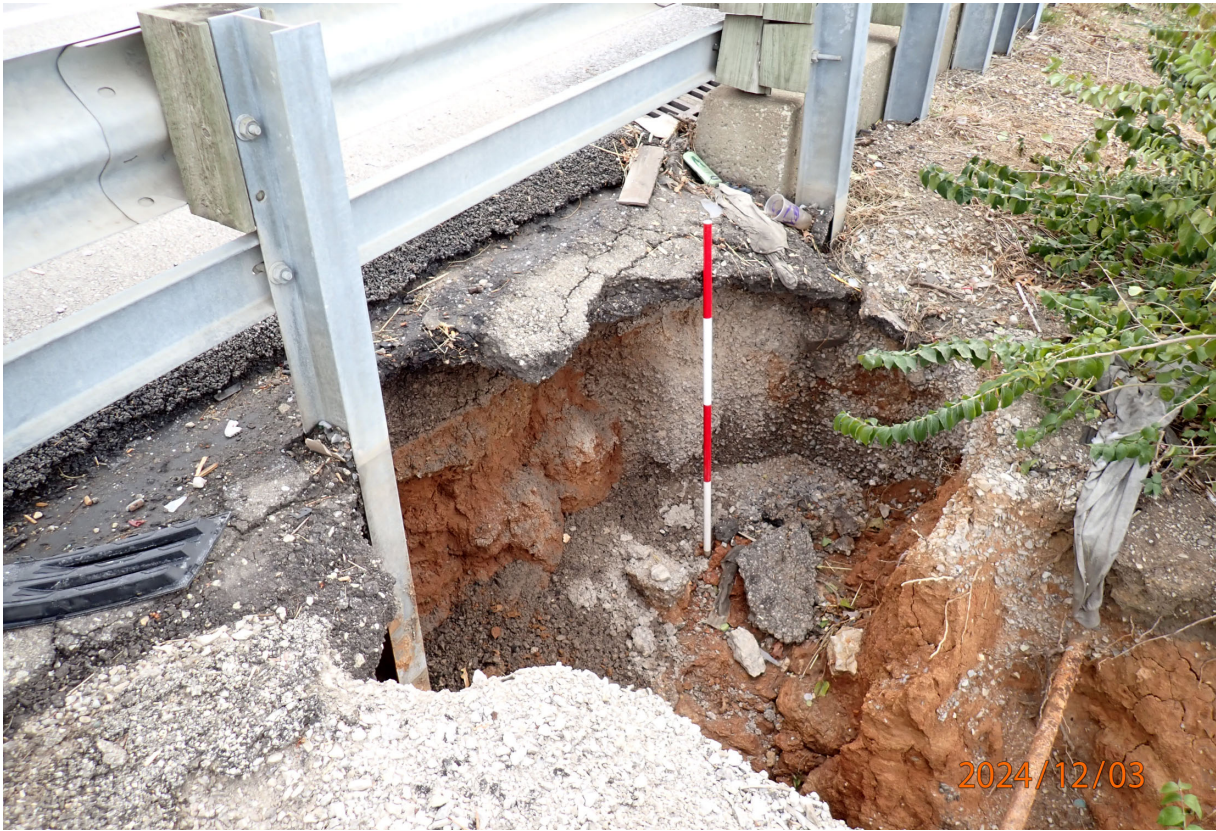
- Routine inspection performed by Daniel Coulter and Stephanie Stoops.
- DBE was notified on 12/03/24 about the erosion hole along the roadway at the NW corner.

NW embankment has a large erosion hole along the roadway shoulder just north of the bridge.

NW embankment has a large erosion hole along the roadway shoulder.

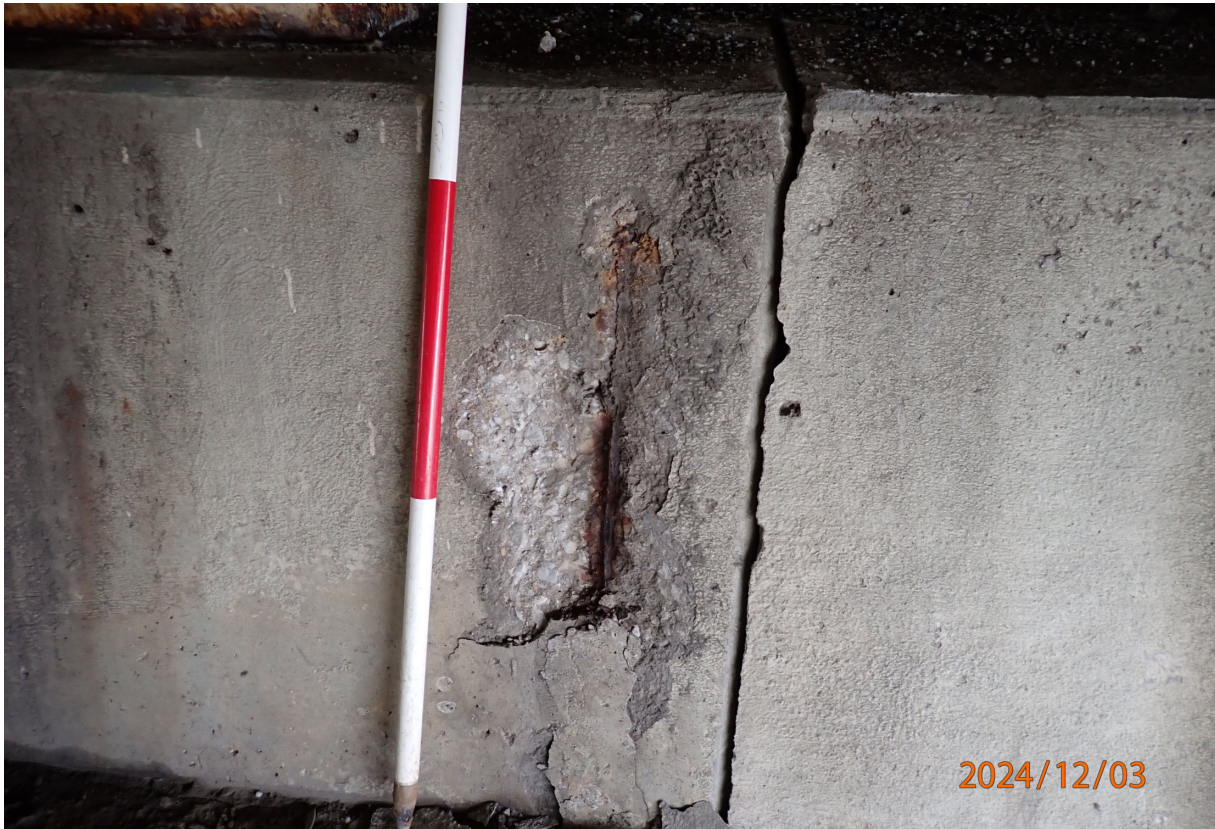
Abutment 1 backwall has wide diagonal cracks at the ends and a spall with exposed rebar adjacent to Beam 11. Abutment 1 has heavy debris on top of the cap, especially near the east end. The Abutment 4 backwall has widespread patching with some large unsound areas, spalling with exposed rebar, and moderate width cracks. The Abutment 4 cap has wide horizontal cracks in the front face below Beams 15, 17 and 20.

Abutment 1 spall with exposed rebar below Beam 3.

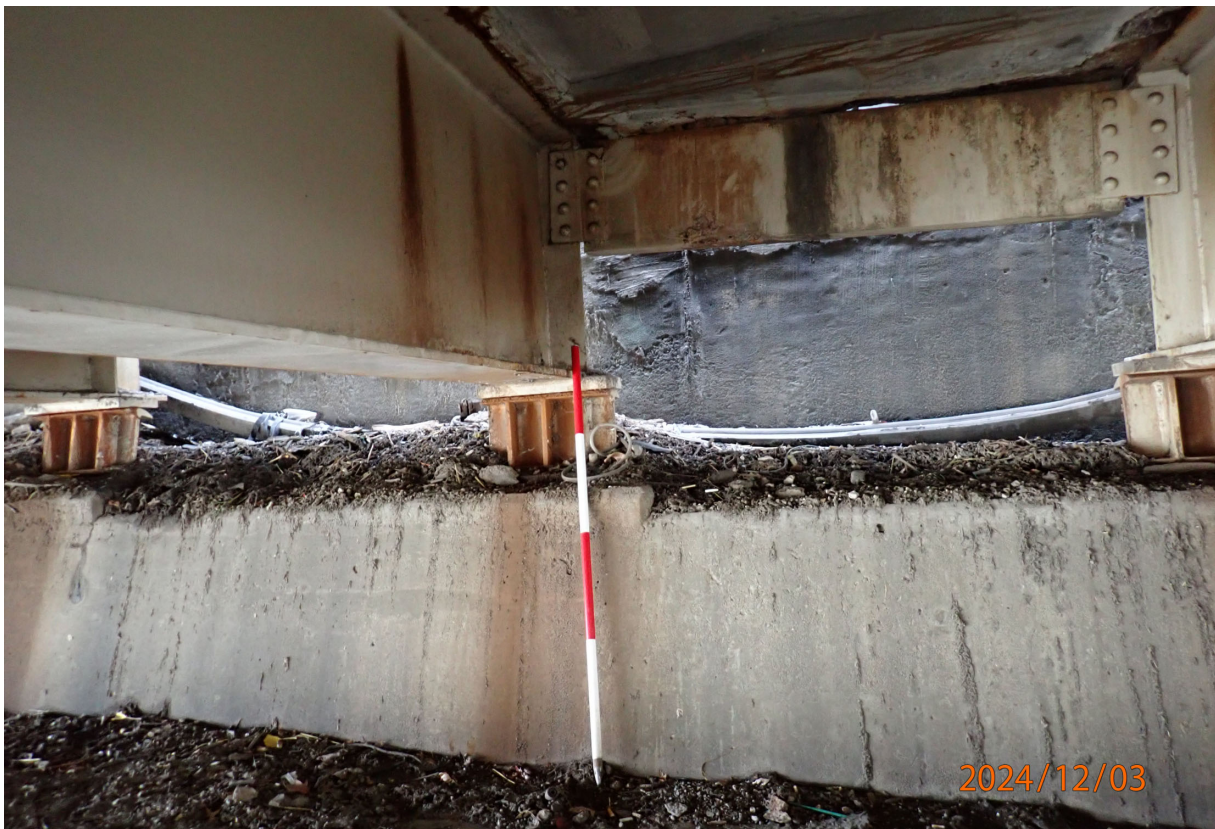
Abutment 1 has heavy debris on the cap, especially near the east end.

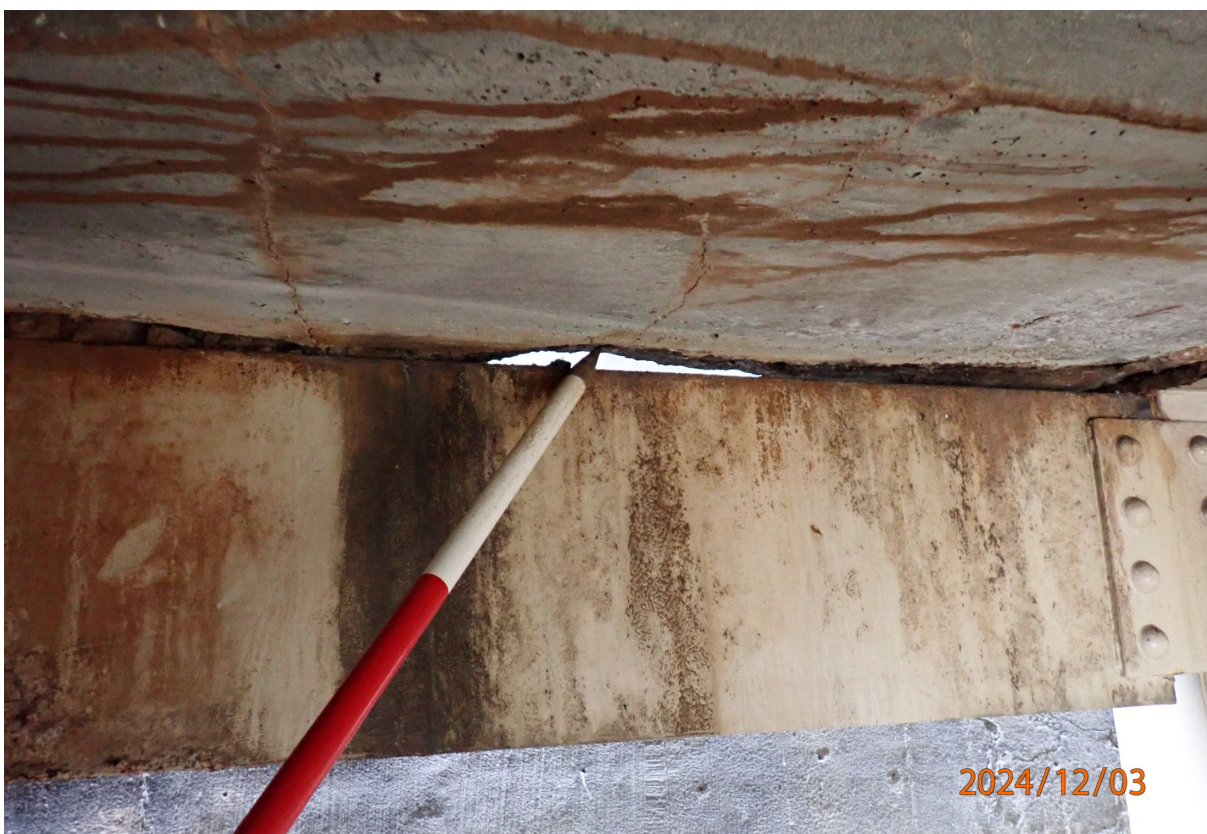
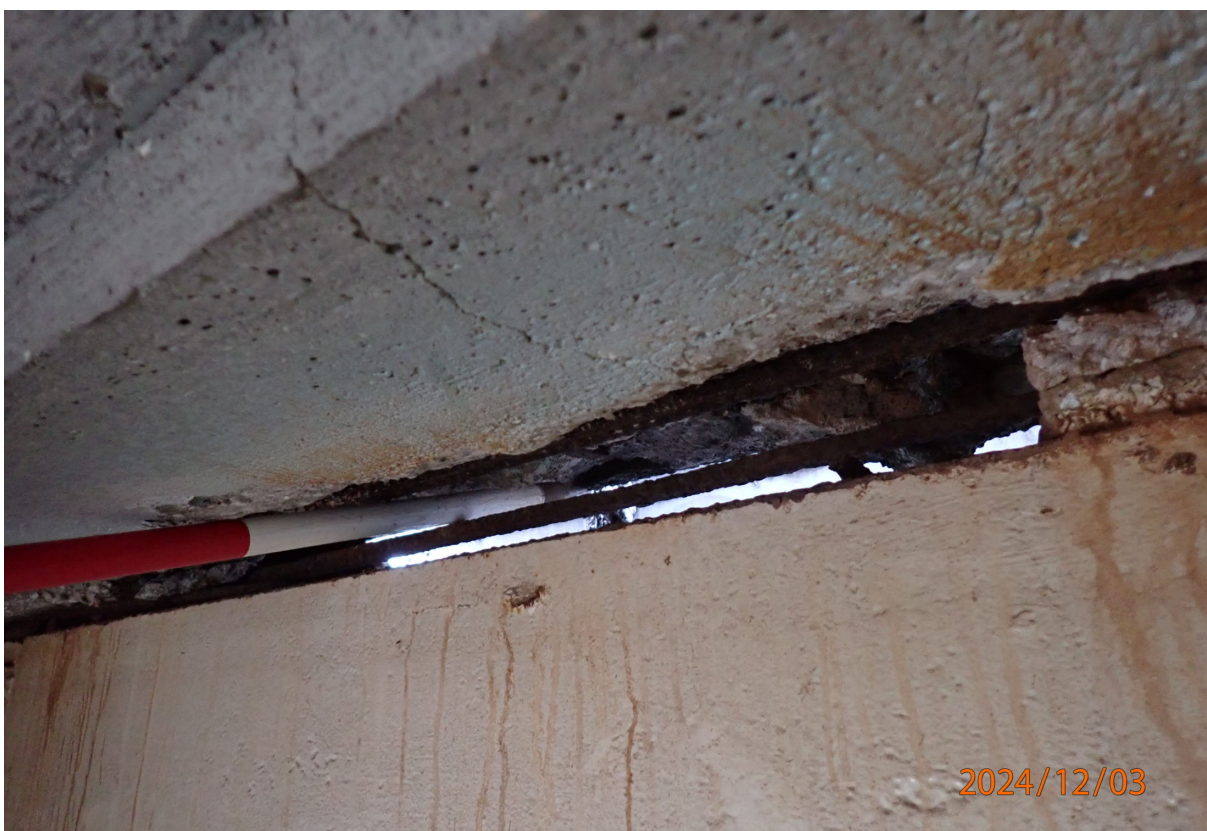
The top of the deck cannot be inspected due to asphalt overlay. The underside has transverse cracks with efflorescence and moderate width cracks at the bridge ends. The underside of the deck adjacent to the Abutment 1 joint is in poor condition, especially from Bays 15 through 17, and has spalling with exposed rebar with portions of spalls resting on top of the diaphragms. There are a few other spalls with exposed rebar, mostly below the longitudinal joint, and haunch spalls along the beam top flanges. Separation of deck and top flange was observed at several beam ends at Abutment 1 (deck deflected under live load while beams remained stationary).

The underside of the deck adjacent to the Abutment 1 joint has spalling with exposed rebar, especially from Bays 15 through 17. Bay 15 shown.

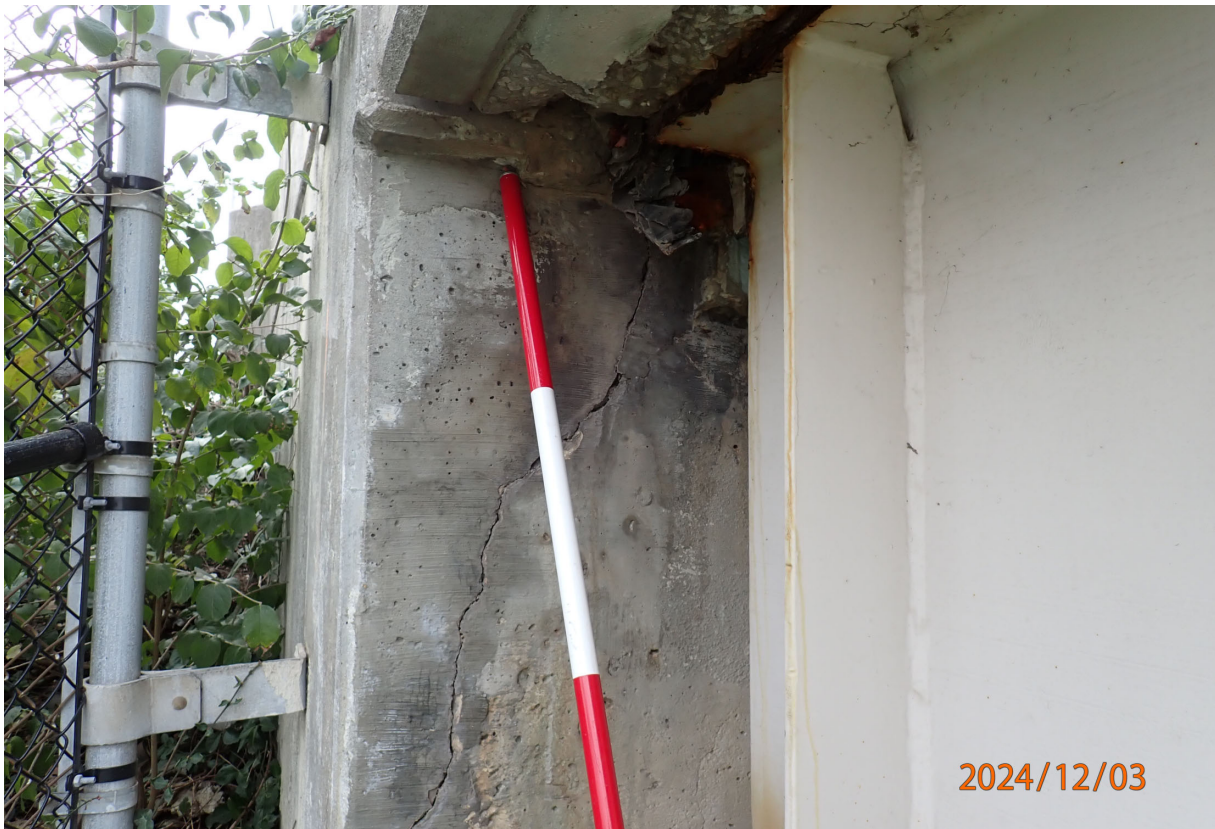
Abutment 1 backwall has moderate to wide diagonal cracks at the ends.

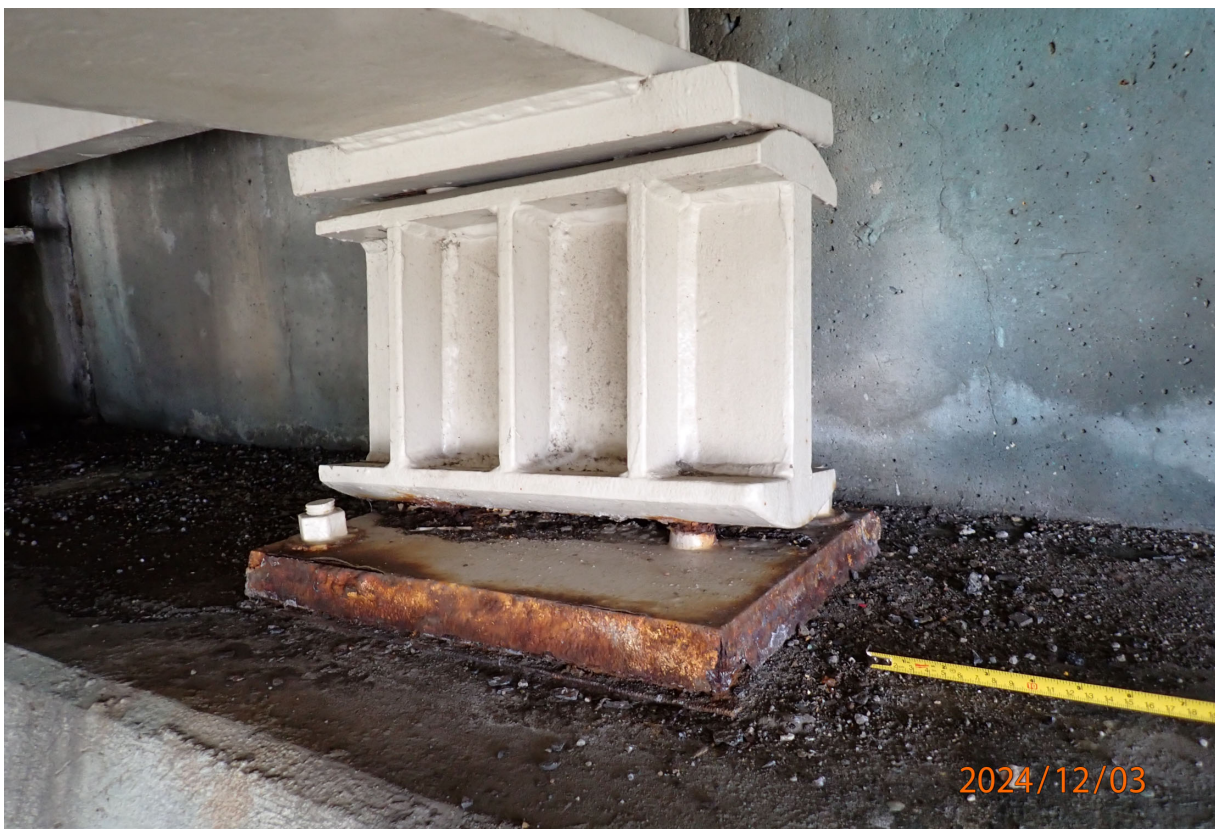
Abutment 1 bearings are over-expanded and all bearings have corrosion, many with section loss. At Abutment 1, several girder sole plates are not fully bearing on the rocker bearings and bang under live load (most notably at Girders 15, 17, and 18). Many bearings at Abutment 1 are slightly misaligned, and some of the masonry plates no longer sit flush on the abutment seat due to extensive pack rust. Rocker bearings are over-expanded at Pier 2 and some bearings have freckling rust. Abutment 4 bearings have corrosion, some with section loss. Abutment 4 bearings have inconsistent rotations throughout.

Abutment 1 bearings have corrosion, many with section loss.

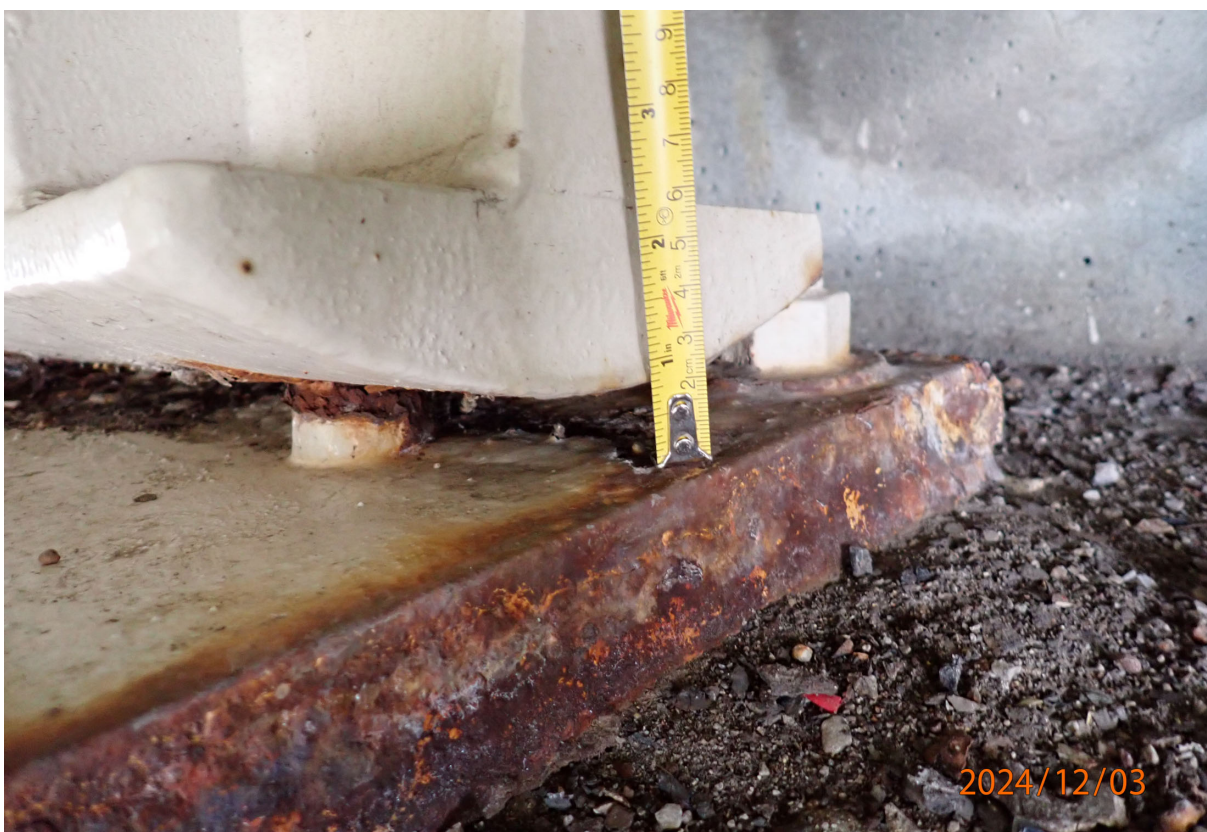
Several beam sole plates at Abutment 1 are not fully bearing on the rocker bearings and bang under live load. Beam 2 shown.

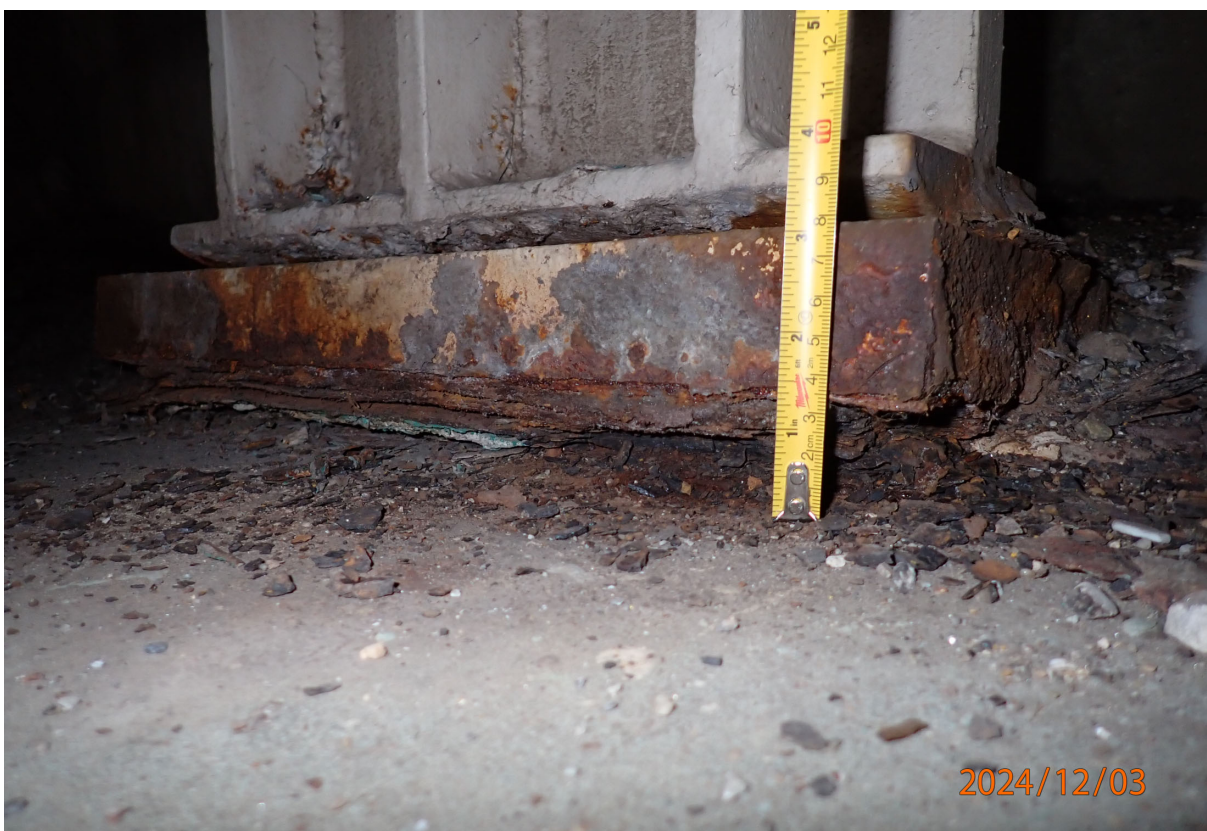
Some of the masonry plates at Abutment 1 no longer sit flush on the abutment seat due to extensive pack rust.

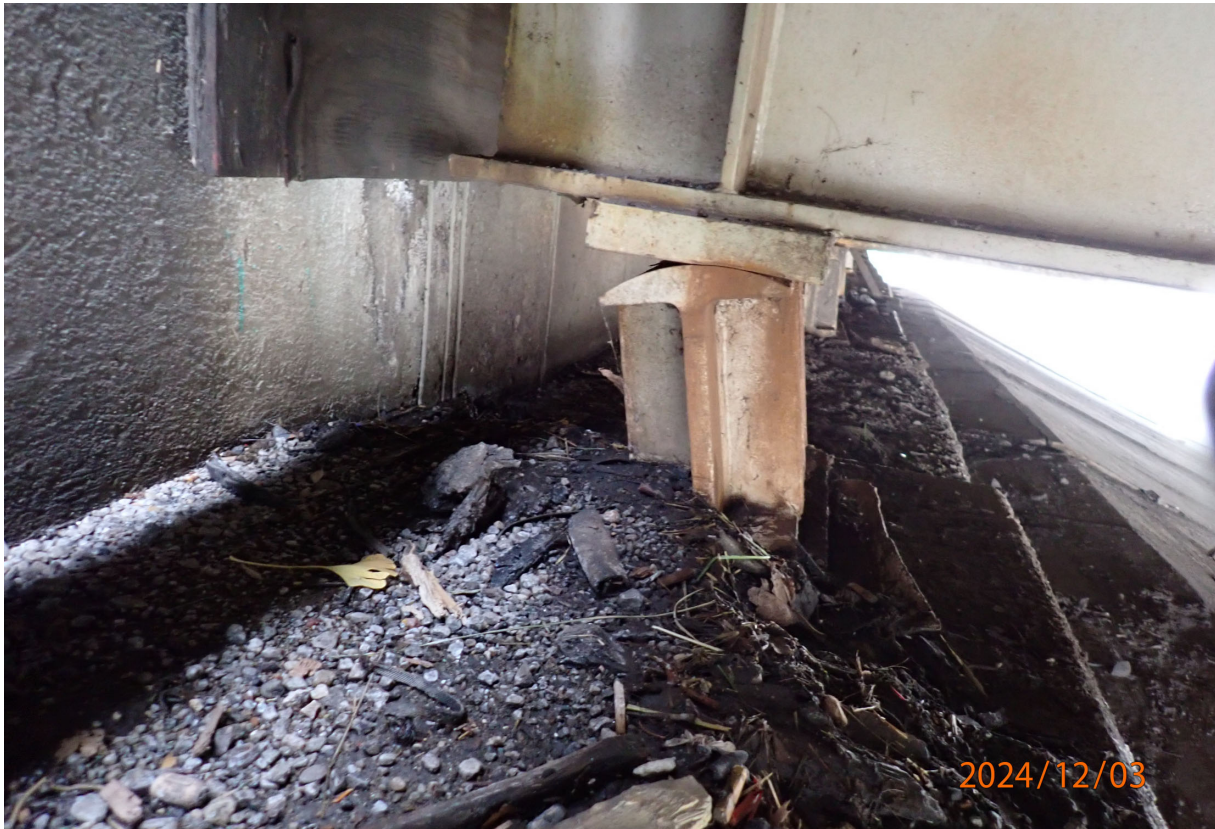
Abutment 1 bearings are over-expanded.

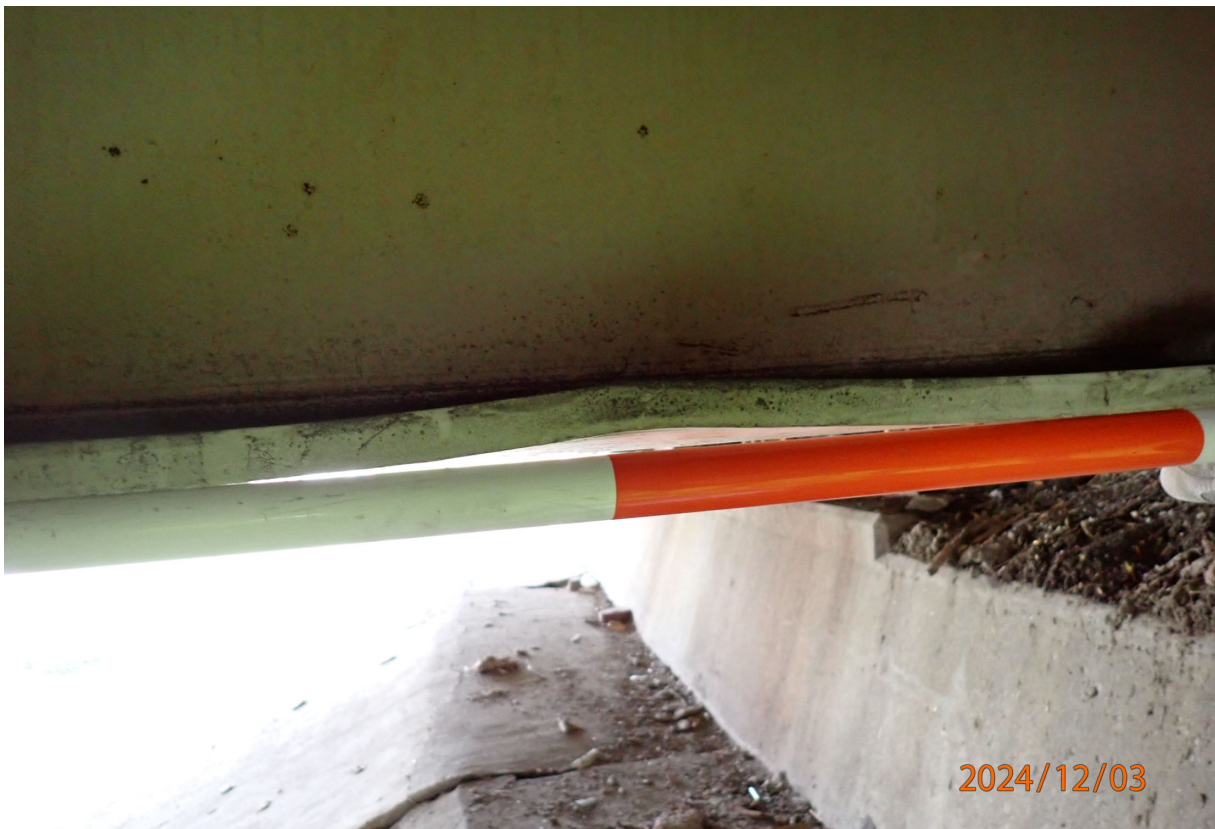
The beams have painted over pitting, with some areas of minor section loss, in the bottom flange scattered throughout. The beam ends have laminating corrosion at the abutments and at haunch spalls. The beams have scattered surface corrosion throughout, mostly along the top and bottom flanges. Beam 17 has a 3/8" T x 1'-3" L distortion in the bottom flange near Abutment 1. The welded bottom cover plates contain a fatigue sensitive detail, Category E, and Beam 5 in Span 1 near Pier 2 has some surface corrosion at the end weld. Previous in-depth inspections noted cracks in the stiffener to top flange tack welds (some are visible from the abutments) (concurrent CS2).

Beam 17 has distortion in the bottom flange near Abutment 1.

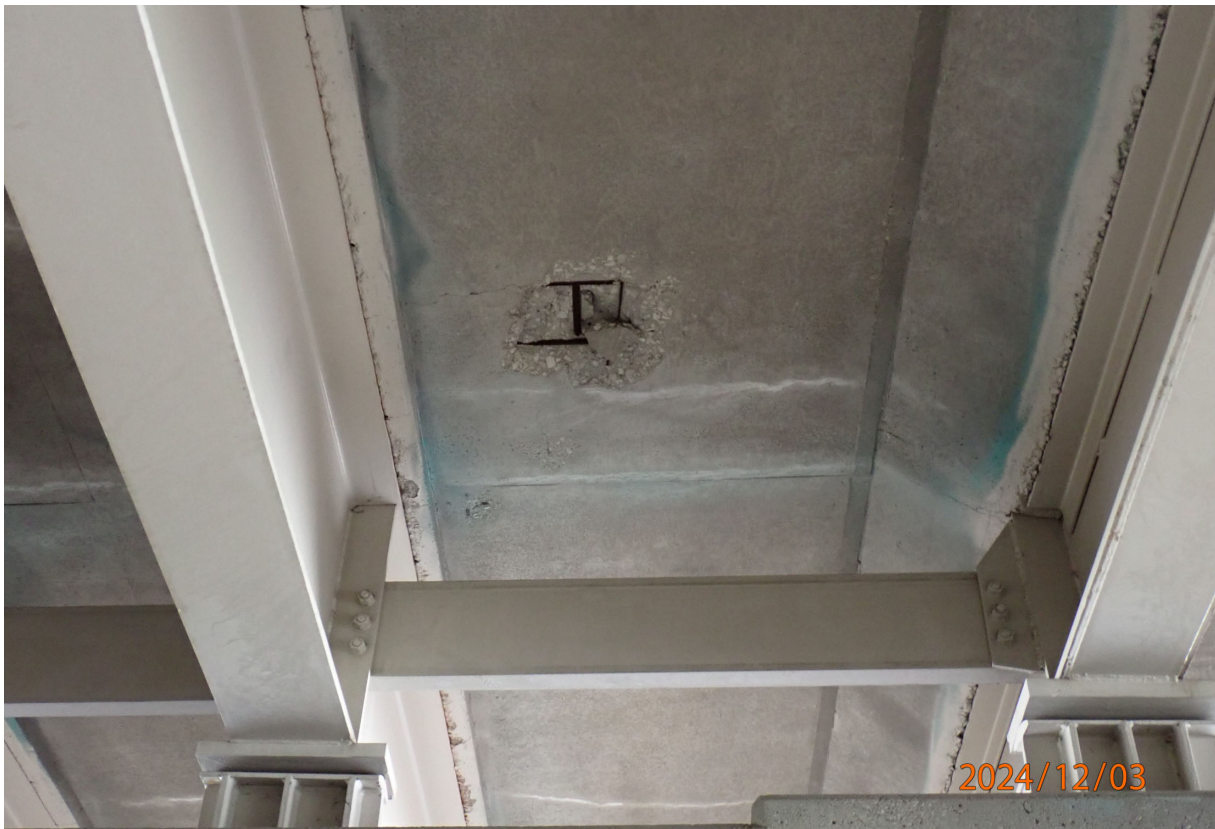
Large deck soffit spall with exposed rebar in Bay 13 of Span 1 near Pier 2.

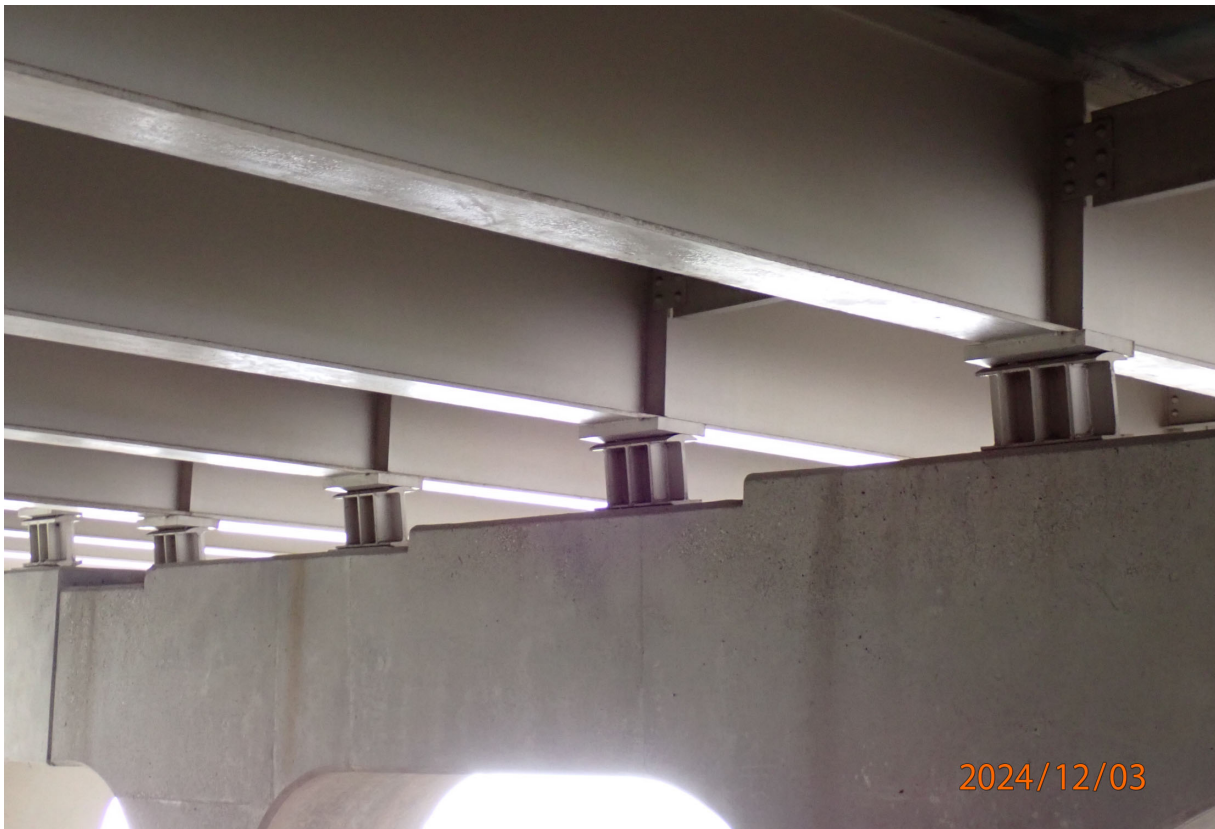
Typical expanded Pier 2 bearings.
