# Bridge Inspection Report

056B00211N

12/03/2024

Standard (24 months)

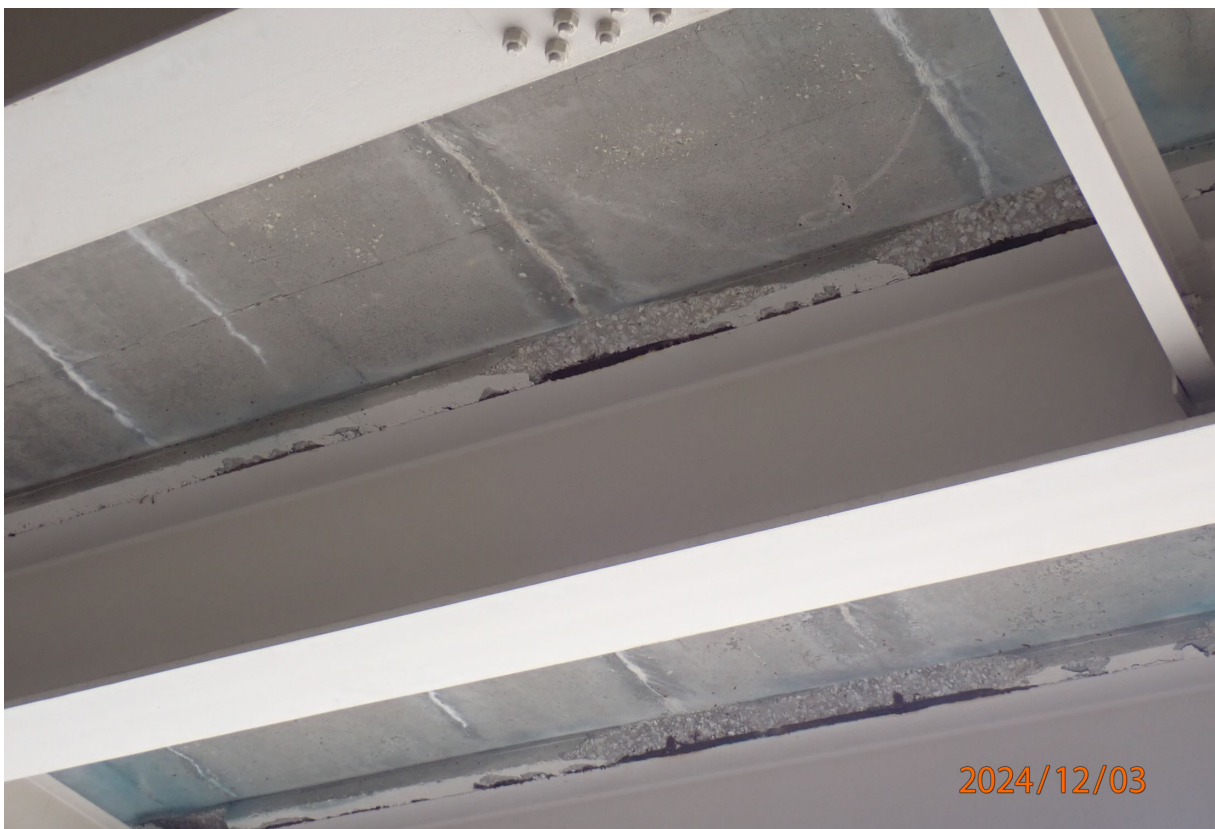
Underside of the deck has several haunch spalls along the beam top flanges.

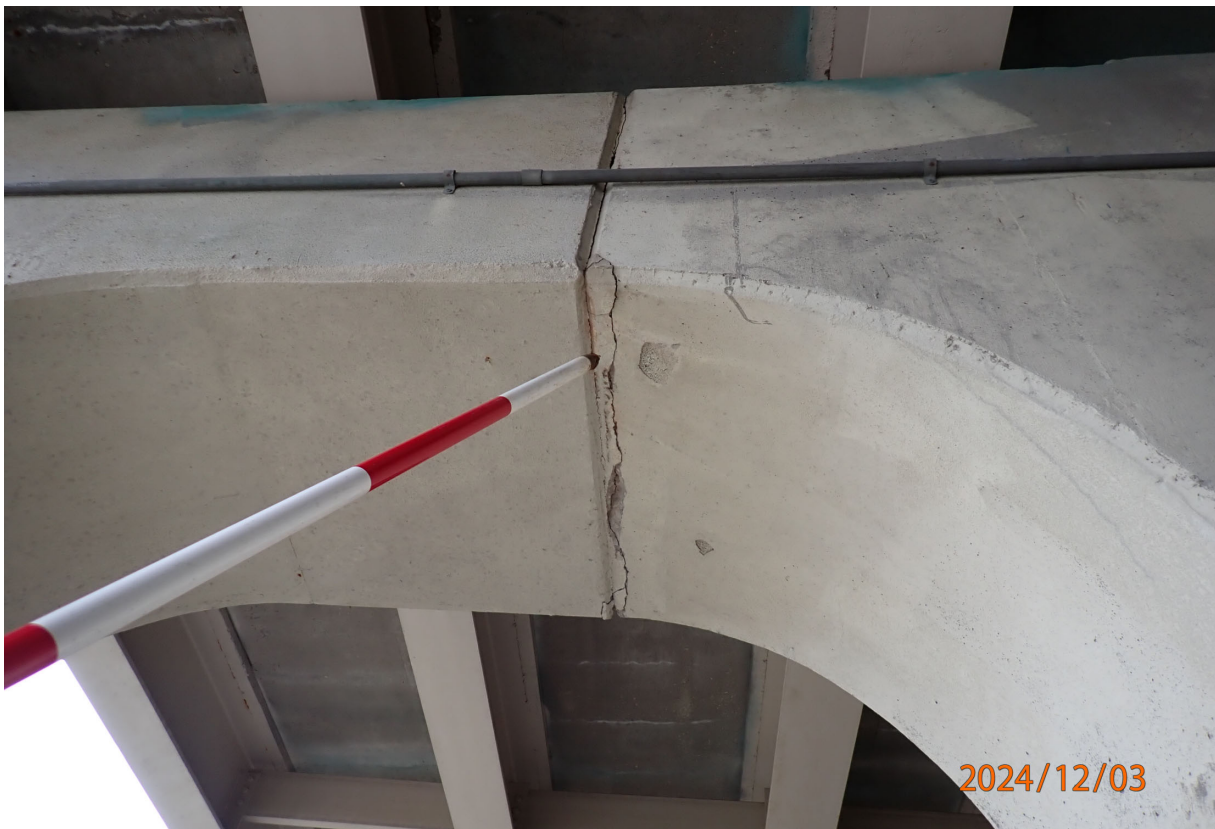
Pier caps have moderate width vertical cracks, delaminations, and shallow spalls. The Pier 3 cap has a wide crack in the bottom face between Columns 1 and 2 adjacent to the construction joint.

Pier 3 cap has a wide crack between Columns 1 and 2.

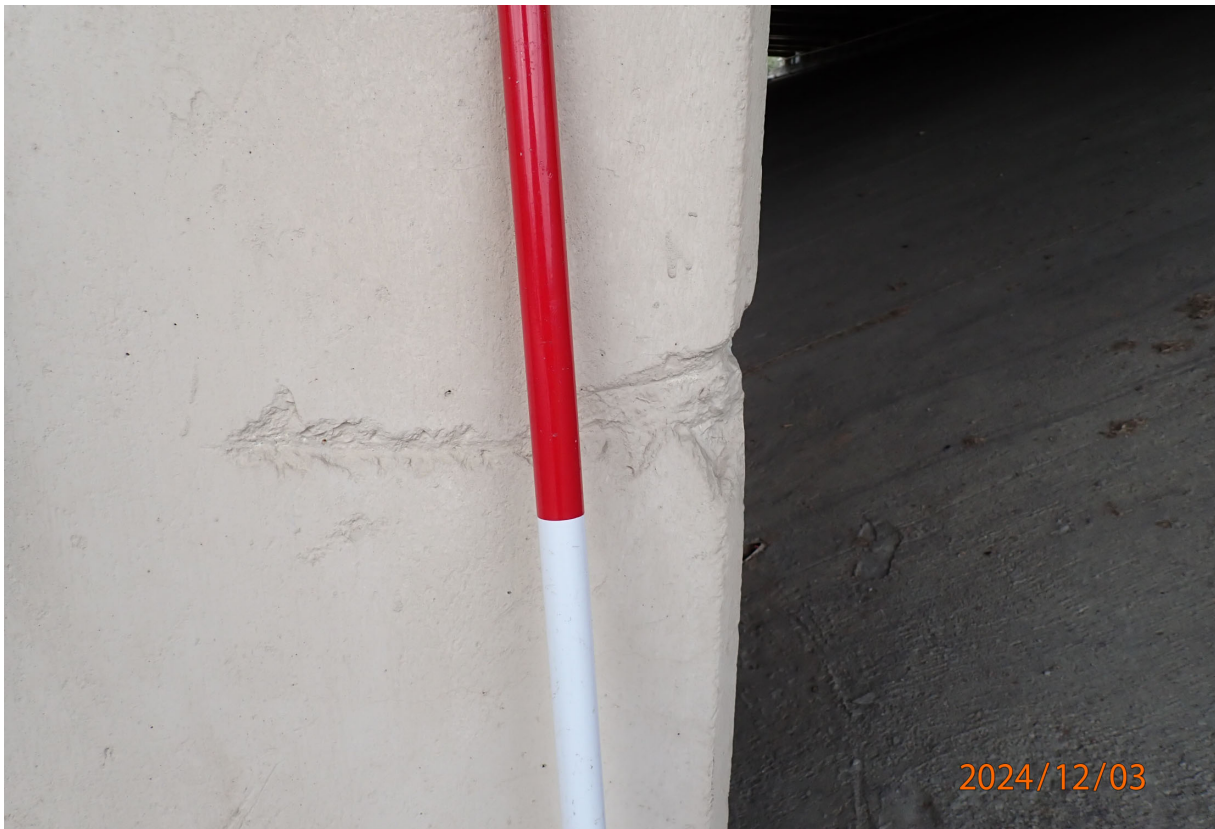
The columns have moderate width vertical and horizontal cracks, abrasion with exposed coarse aggregate, scrapes, and small spalls with occasional exposed tie wire. Pier 2 Column 3 has scaling with missing coarse aggregate at the bottom. Pier 2 Column 10 has a shallow spall in the east face. Pier 3 Column 9 has a shallow spall.

Pier 3-Column 9 spall.

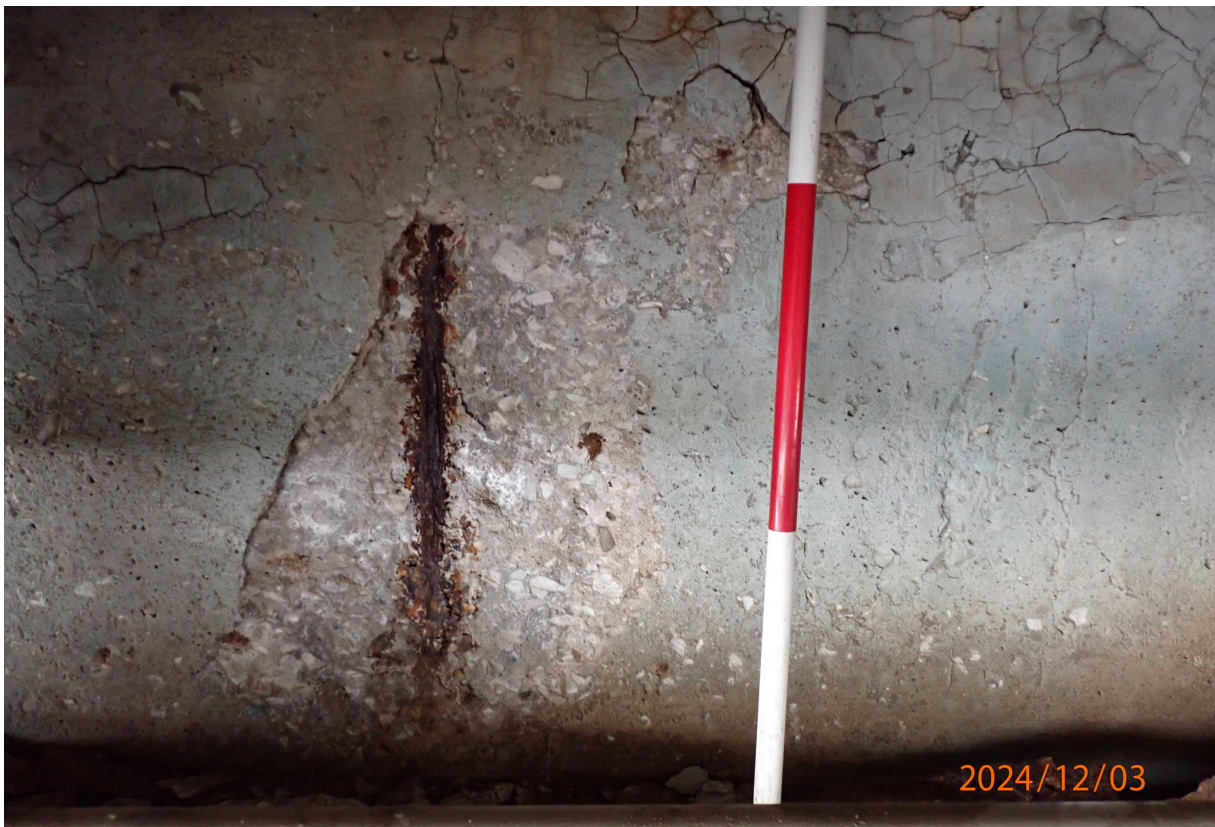
Abutment 4 backwall has widespread patching with some large unsound areas and spalling with exposed rebar.

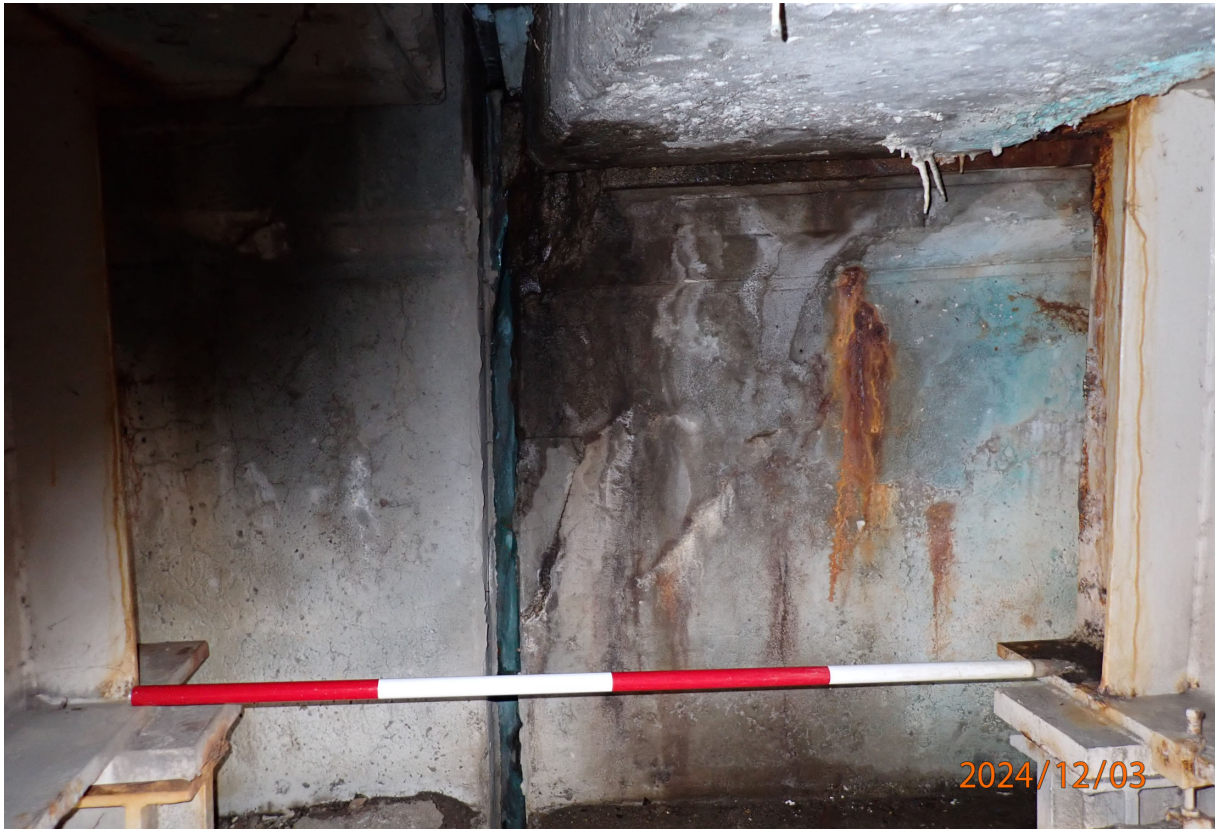
Abutment 4 moderate cracking with rust staining below the longitudinal joint.

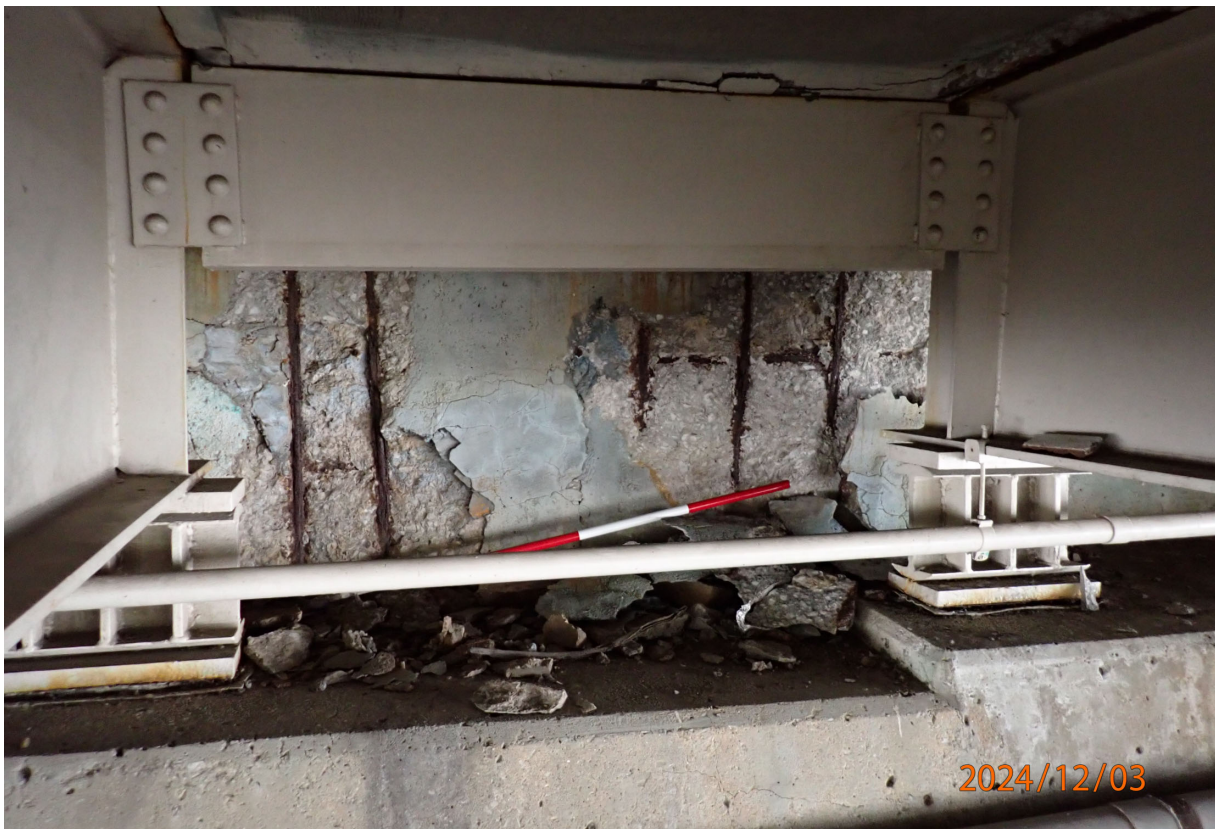
Large area of unsound patching and spalling with exposed rebar in Bay 14 of Abutment 4.

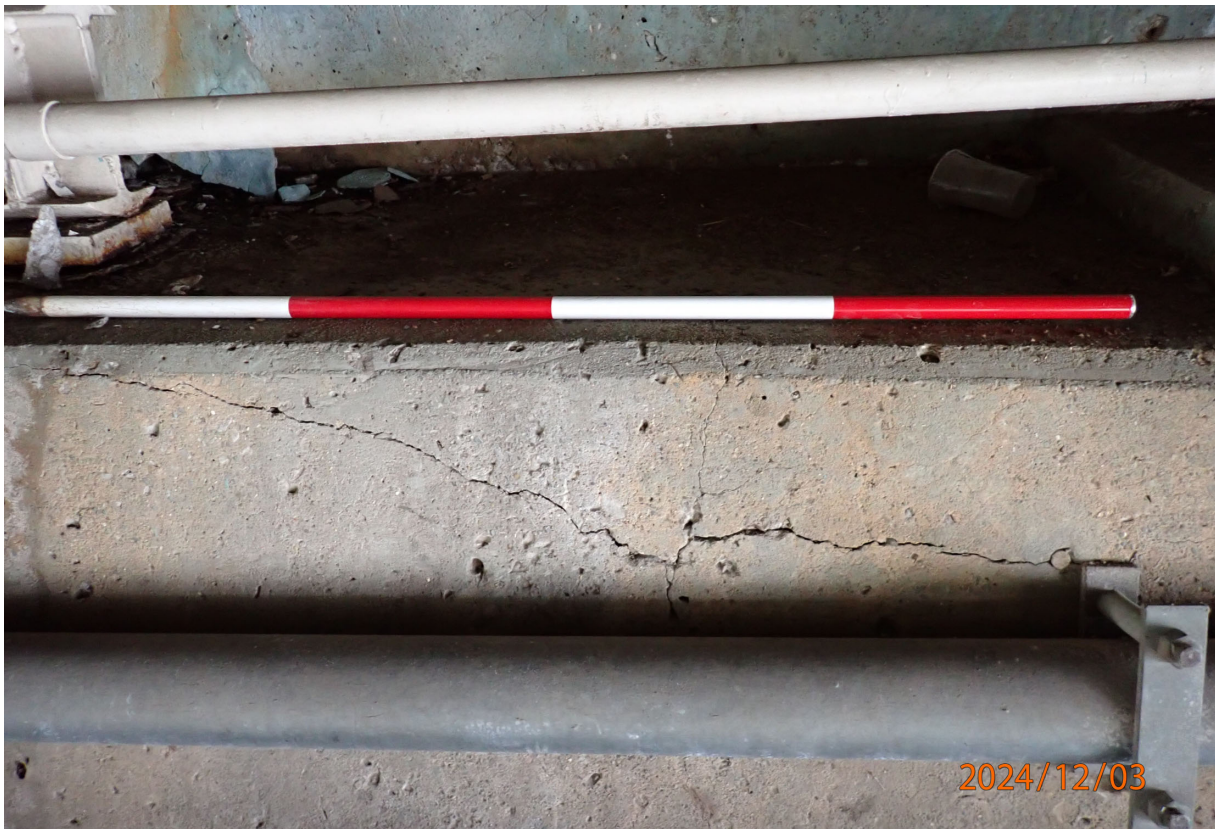
Abutment 4 cap has wide horizontal cracks in the front face. Bay 15 shown.

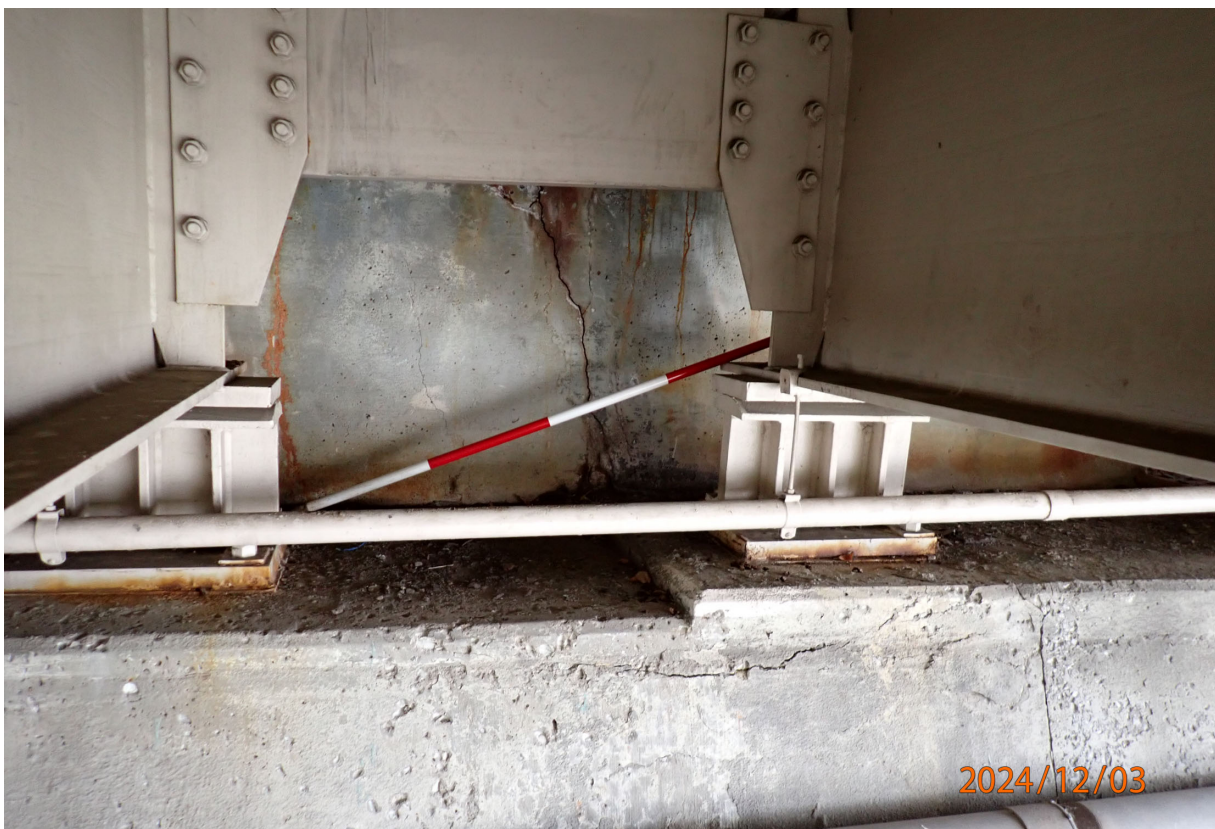
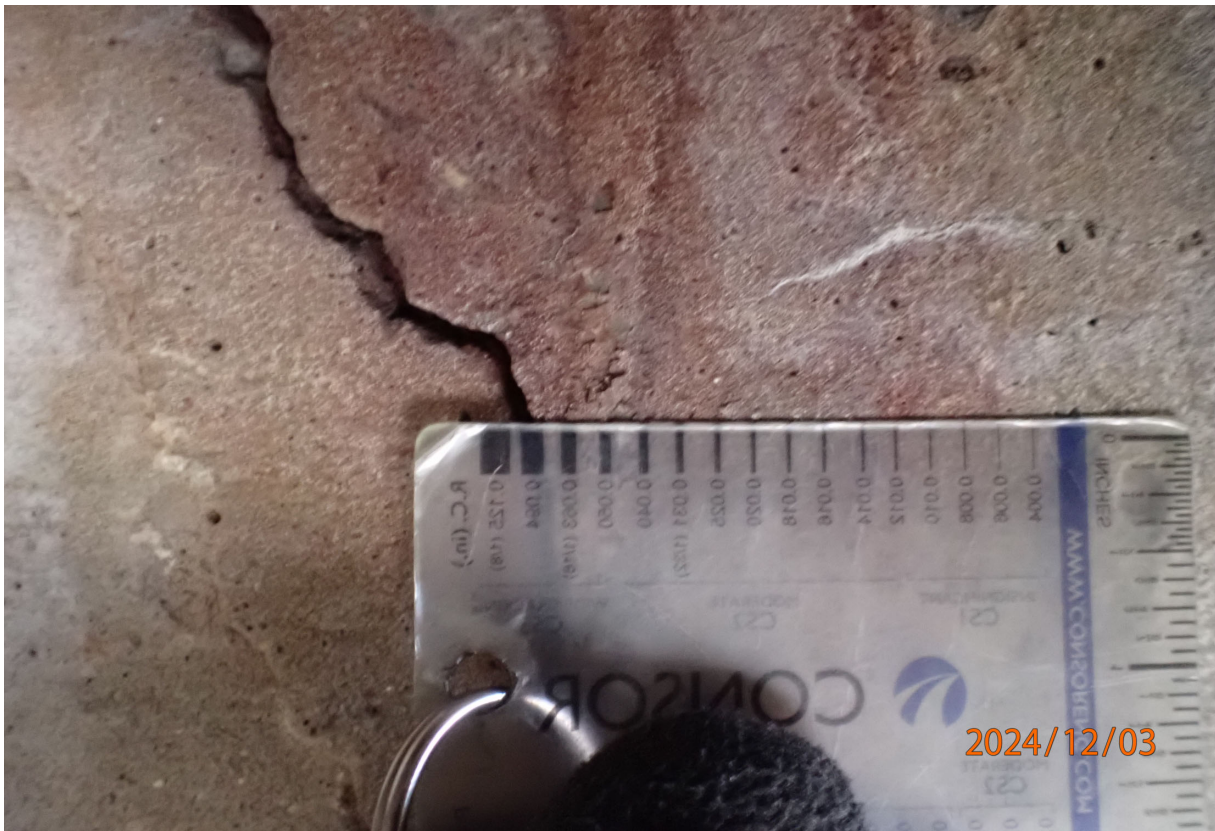
Abutment 4 backwall wide vertical crack in Bay 19.

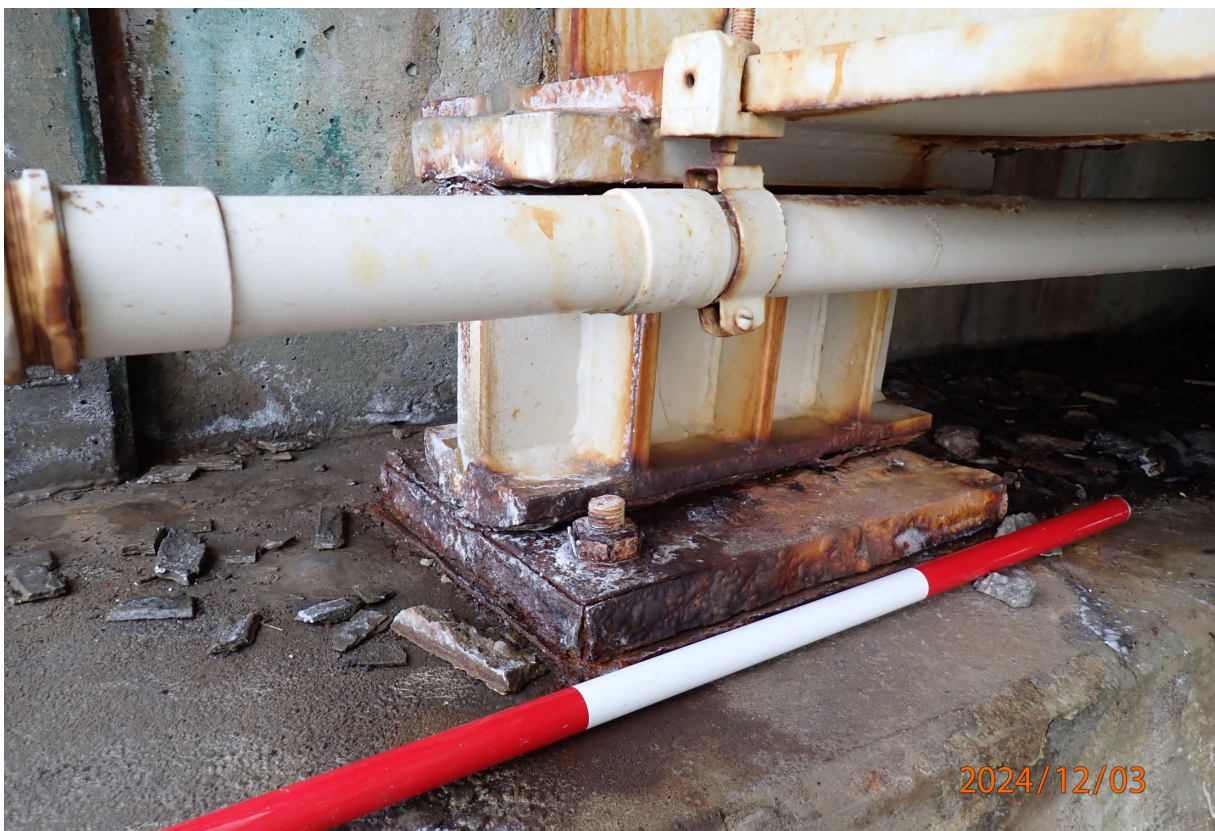
Typical Abutment 4 bearing with corrosion.

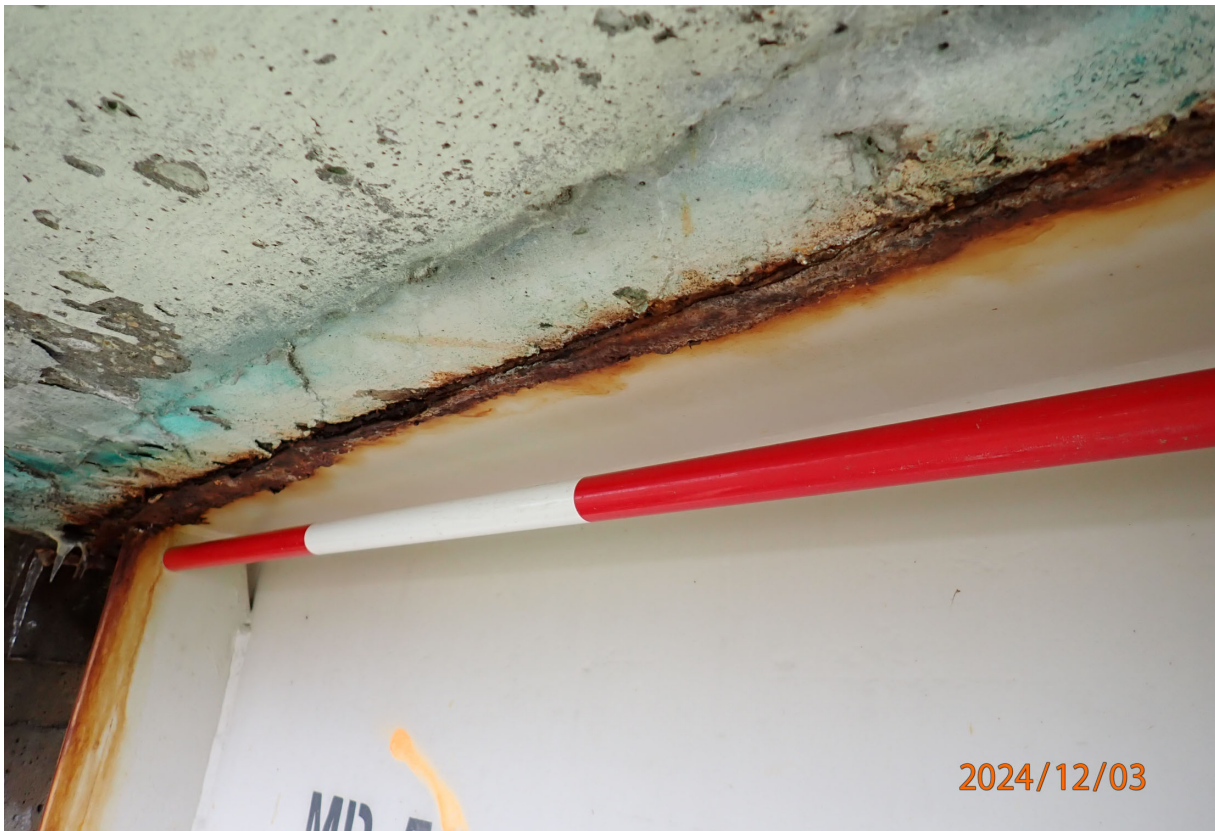
Beam 1 at Abutment 4 with corrosion along the top flange.
