# Bridge Inspection Report

056B00180N

12/11/2024

IDENTIFICATION			
Structure Num (8):	056B00180N		
NBI Number	056B00180N		
Structure Name:			
Location (9):	2.1 MI N OF I-264		
Carries (7):	I-65		
Type of Service (42A):	1 Highway		
Feature Crossed (6):	US 60A (EASTERN PKWY)		
Type of Service (42B):	1 Highway		
Placecode (4):	Not Applicable		
County (3):	Jefferson (056)		
State (1):	21 Kentucky		
Admin Area:	Inventory		
District:	District 5		
Latitude (16):	38° 12' 44"		
Longitude (17):	85° 45' 10"		
Owner (22):	State Highway Agency		
Maint. Resp. (21):	State Highway Agency		
Year Built (27):	1957	Border State (98A):	Not Applicable (P)
Year Recon (106):	1982	Border Number (99):	
		% Responsibility (98B):

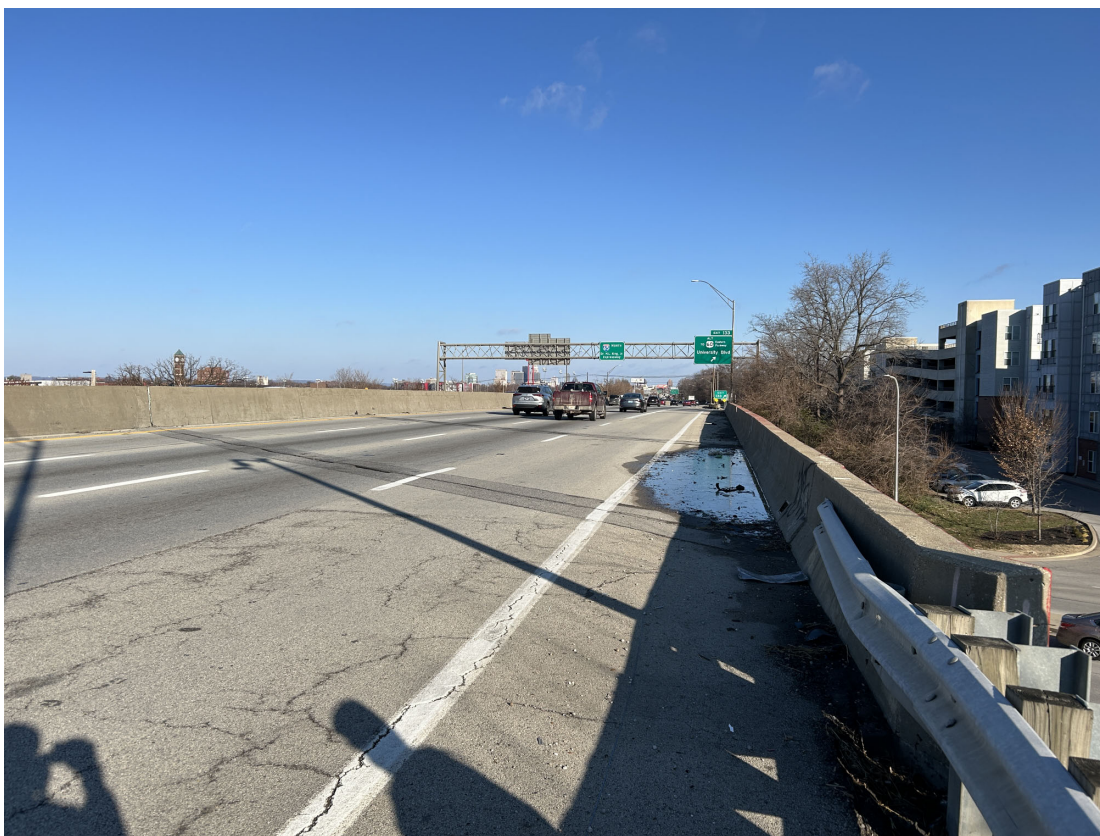
Looking north along I-65 NB.

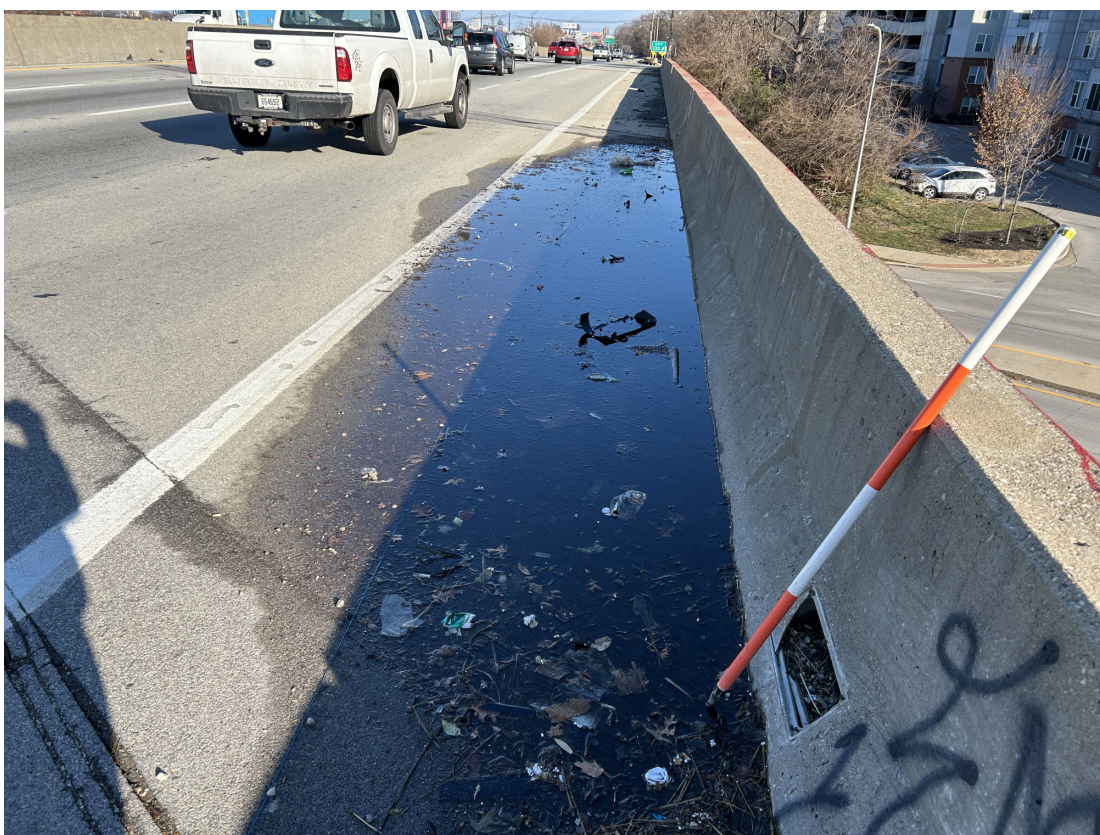
Asphalt overlay has minor raveling throughout. A 2023 infrared thermographic deck scan completed by AECOM noted 106 square feet of debonded overlay along the Abutment 1 joint in NB lane 3, along most of the Pier 2 joint in both NB and SB lanes, along the Pier 3 joint in the NB lanes, and small scattered areas in the SB lanes in Spans 2 and 3 (primarily in lane 1). Water ponds in the east shoulder of Span 1.

Water is ponding in the SE shoulder.

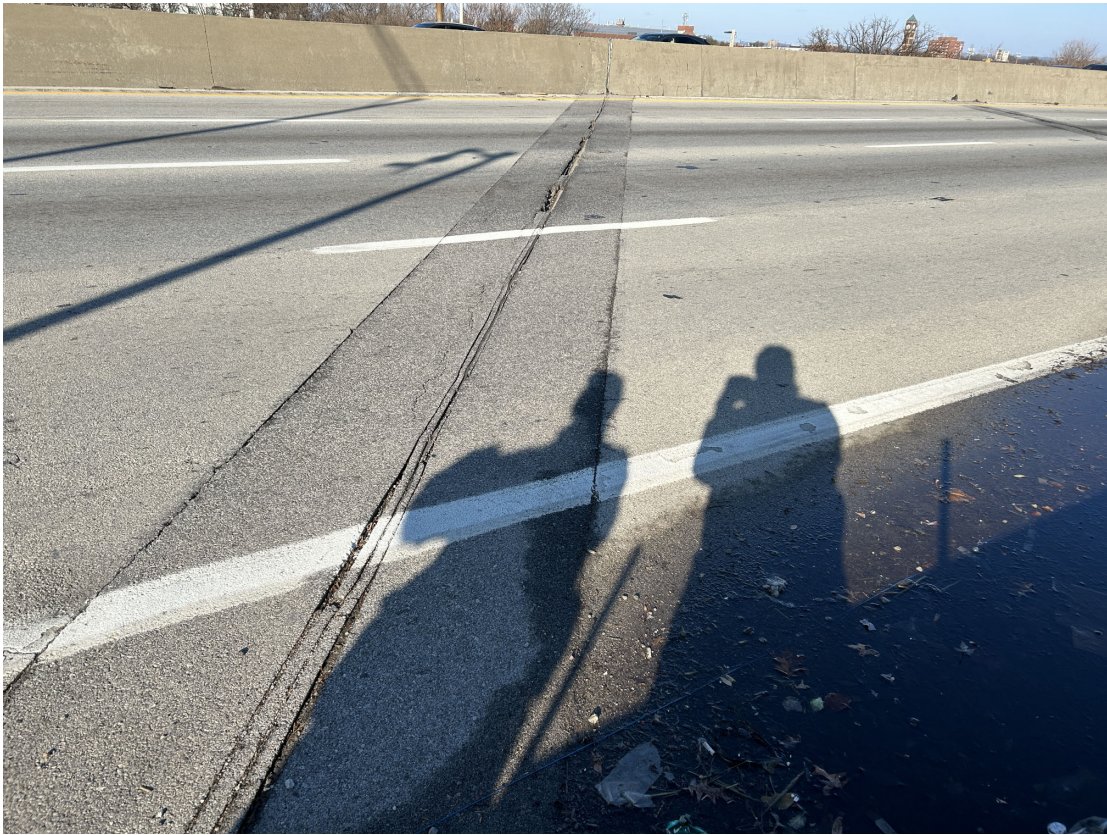
Asphalt plug joints were installed over the existing joints in 2012 and the plug joints were redone in 2017. Plug joints have failed in several areas of the traffic lanes, including along all SB joints, half of the NB Abutment 1 joint, and the NB Abutment 4 joint, exposing portions of the original joints, and allowing free flow of water through the joints. There is spalling in the adjacent asphalt in several areas throughout the traffic lanes. The joints have moderate to wide cracking elsewhere.

Asphalt plug joint over Abutment 1 NB.

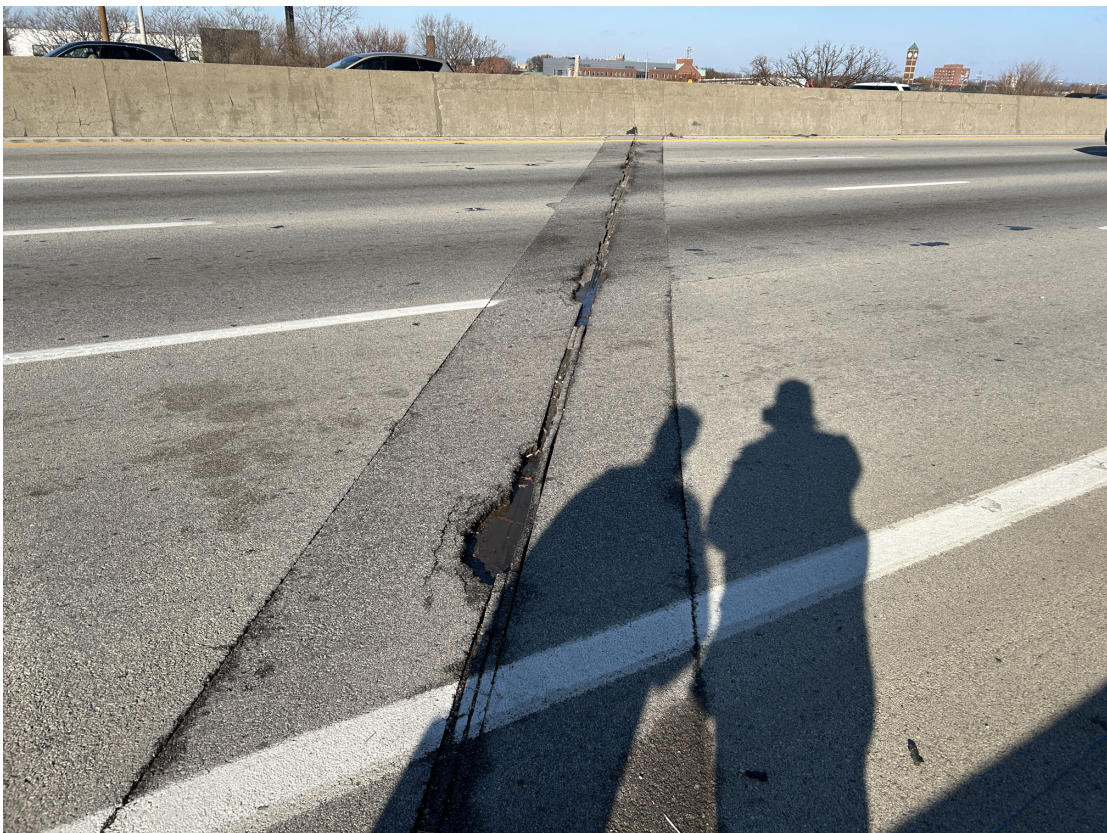
Asphalt plug joint over Pier 2 NB.

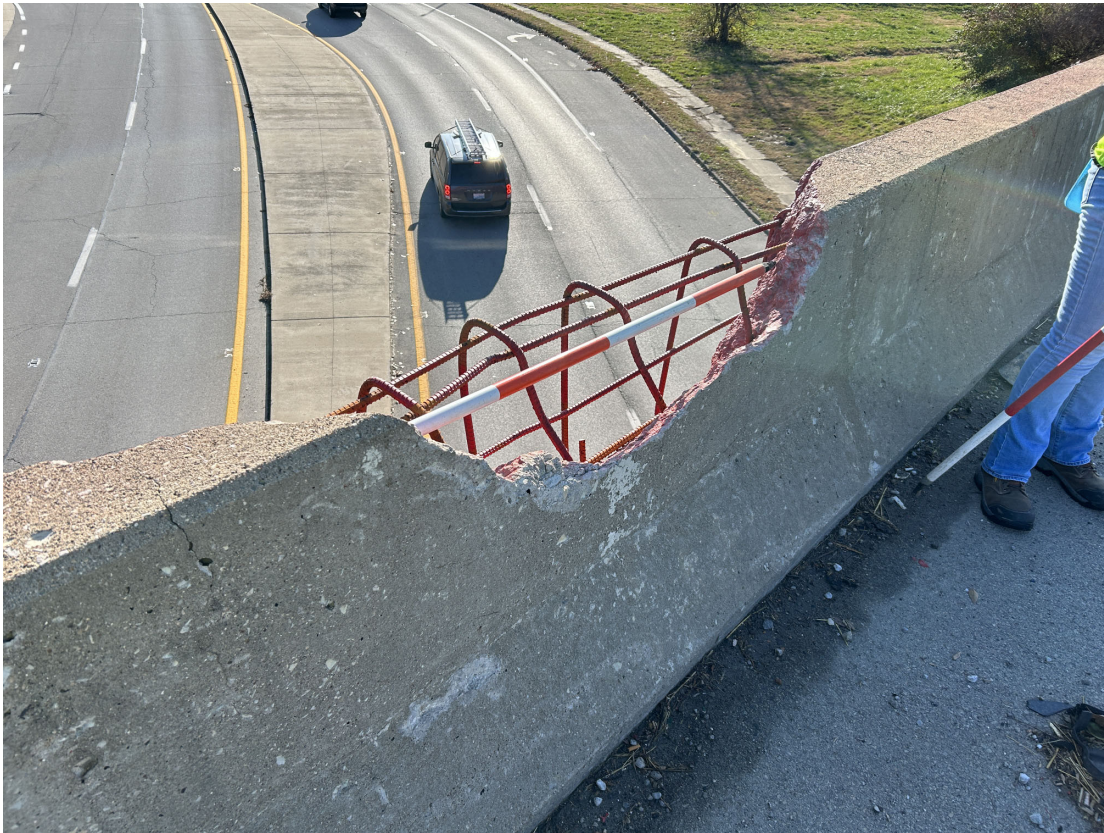
The railings have moderate width vertical cracks and intermittent scaling. The east railing has an 8-foot long x 3-foot high x full depth spall with exposed reinforcement due to impact in Span 2 (8 ft CS4). The west railing has a 2-foot long x 1.5-foot high x 4-inch deep spall with exposed reinforcement on the outside face at Abutment 1.

East rail in Span 2 has a full depth spall.

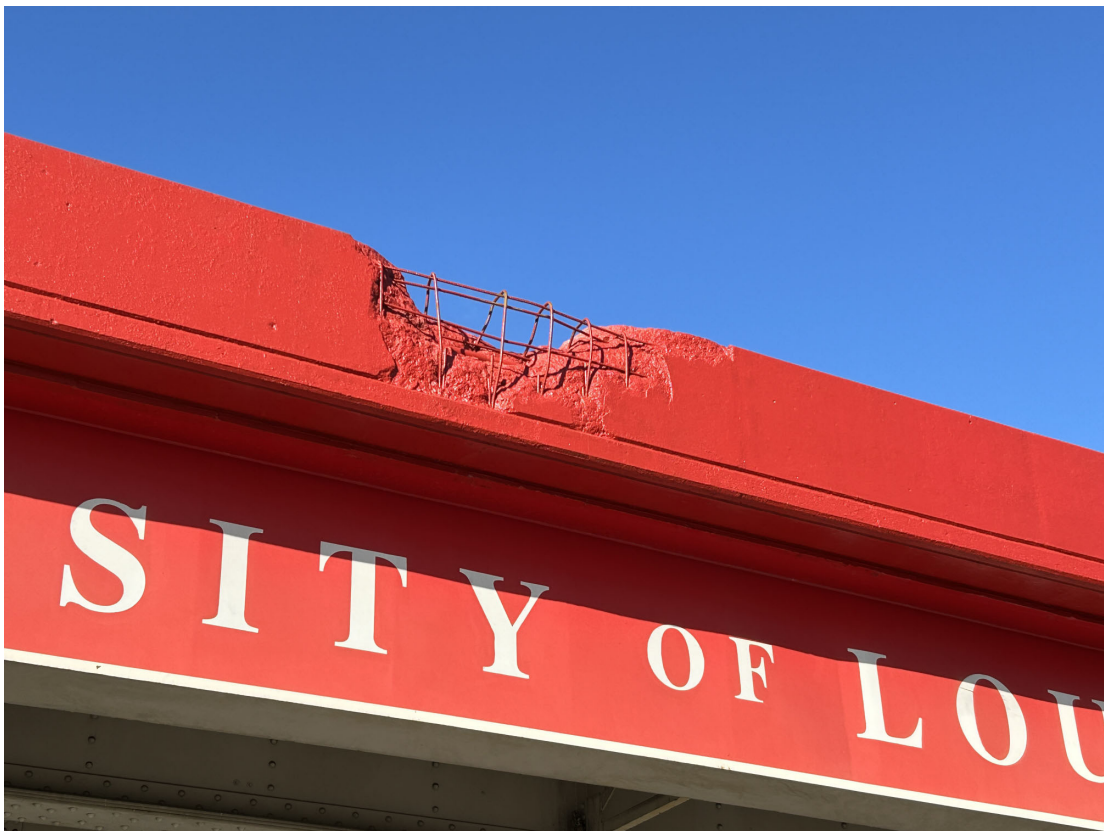
Another view of east rail spall mid-Span 2.

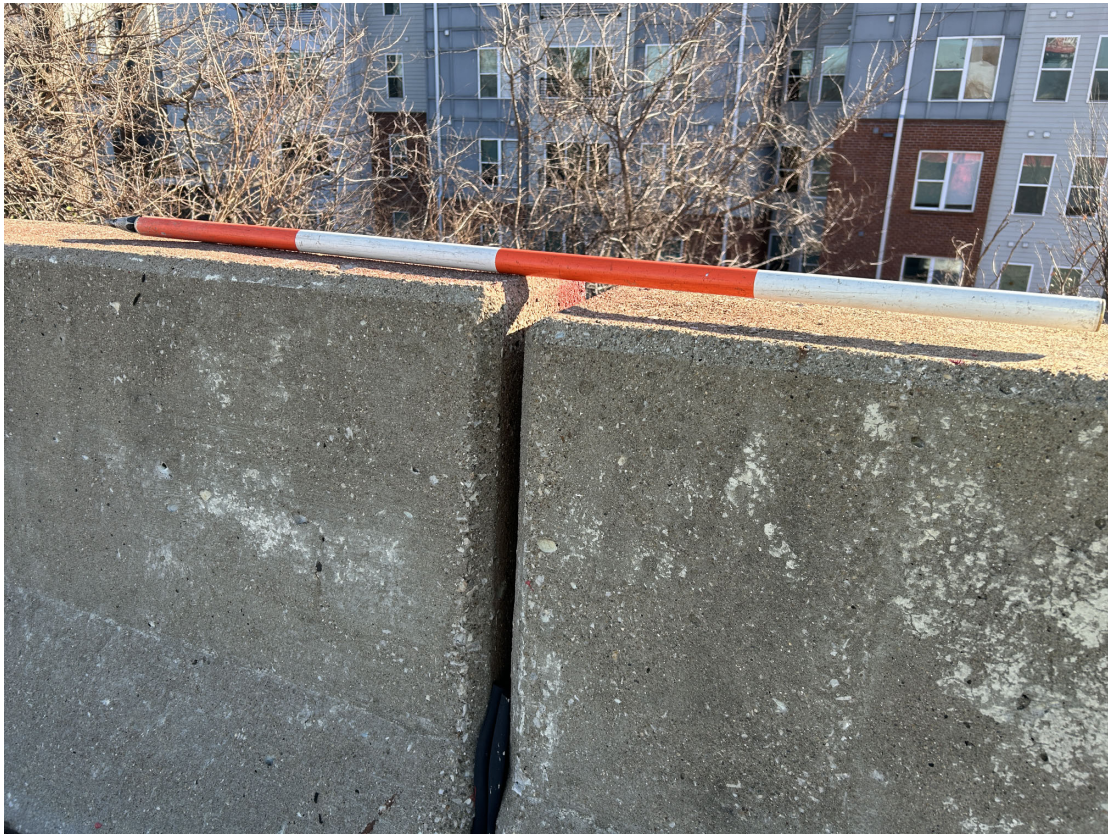
East rail at Pier 3 has a vertical offset. Span 3 is roughly 1 inch higher than Span 2.

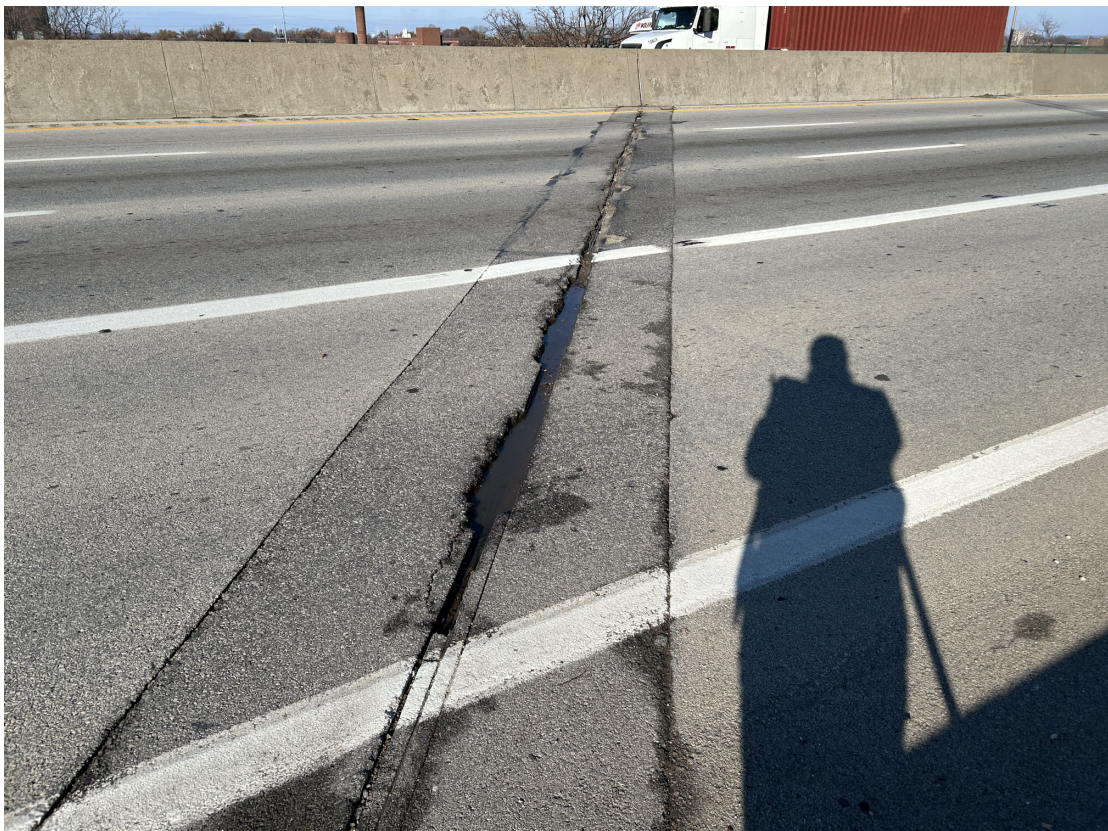
Asphalt plug joint over Pier 3 NB.

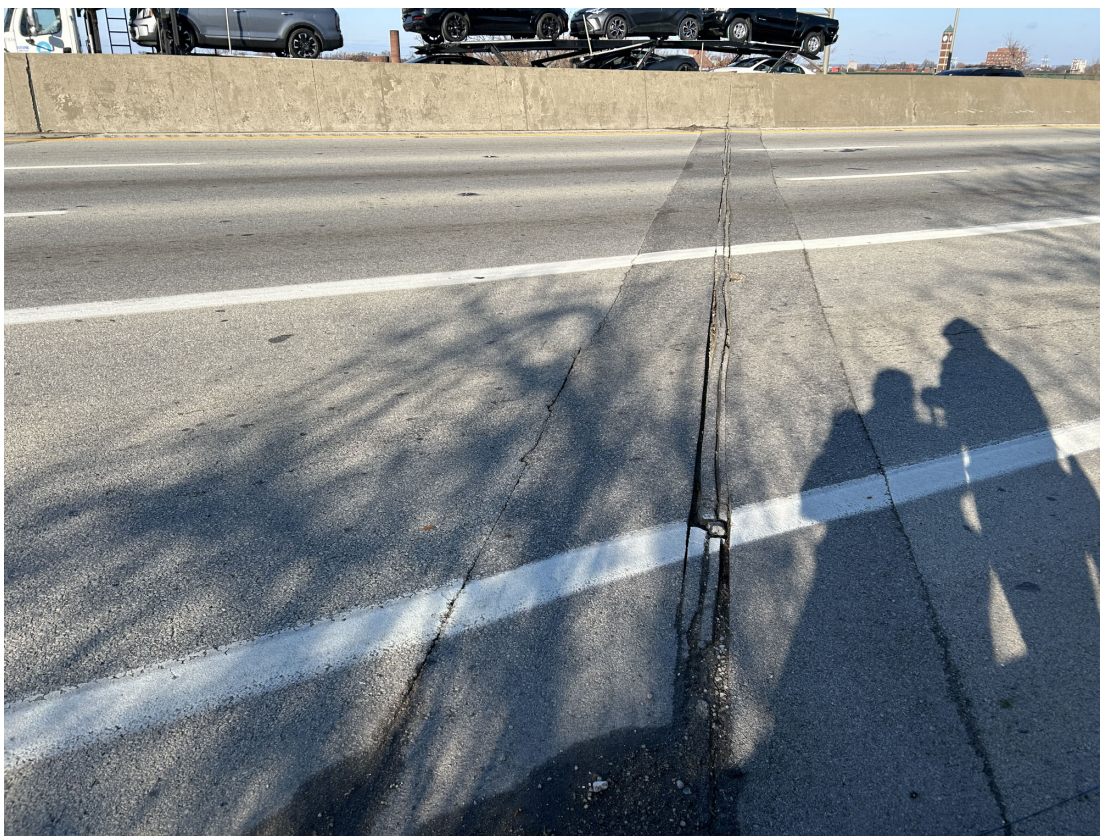
Asphalt plug joint over Abutment 4 NB.

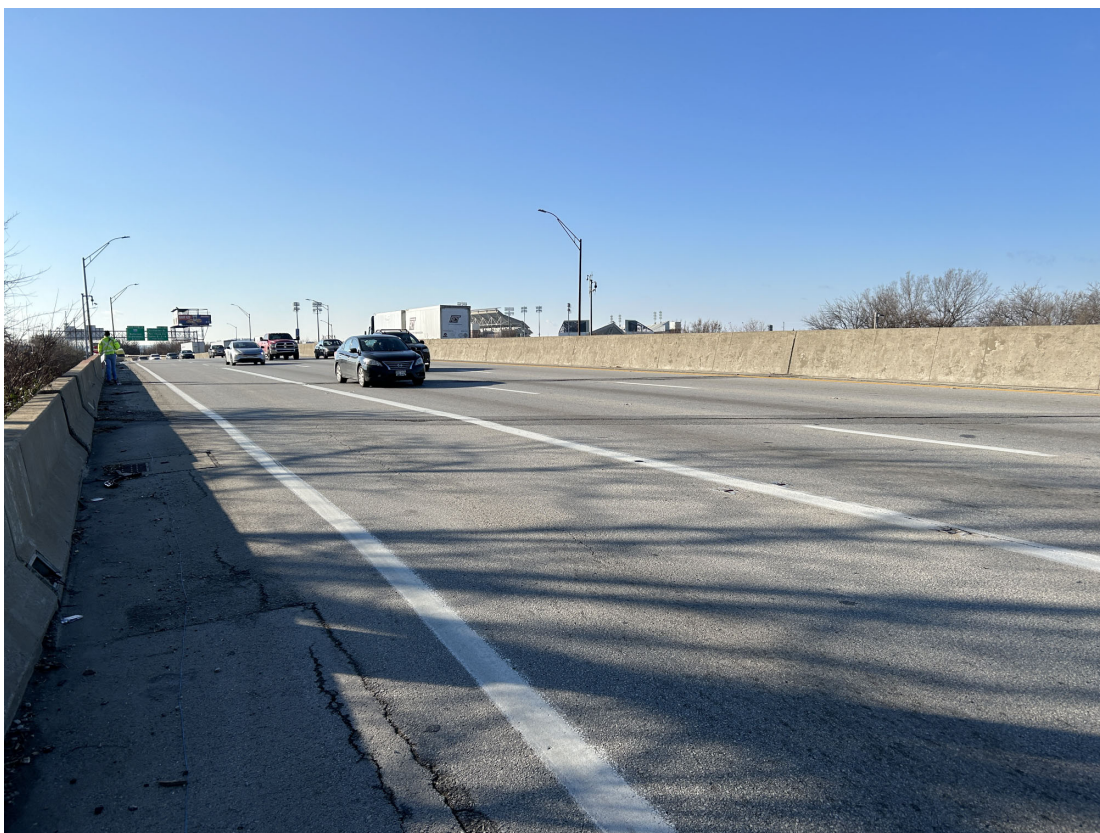
Looking south along I-65 NB.

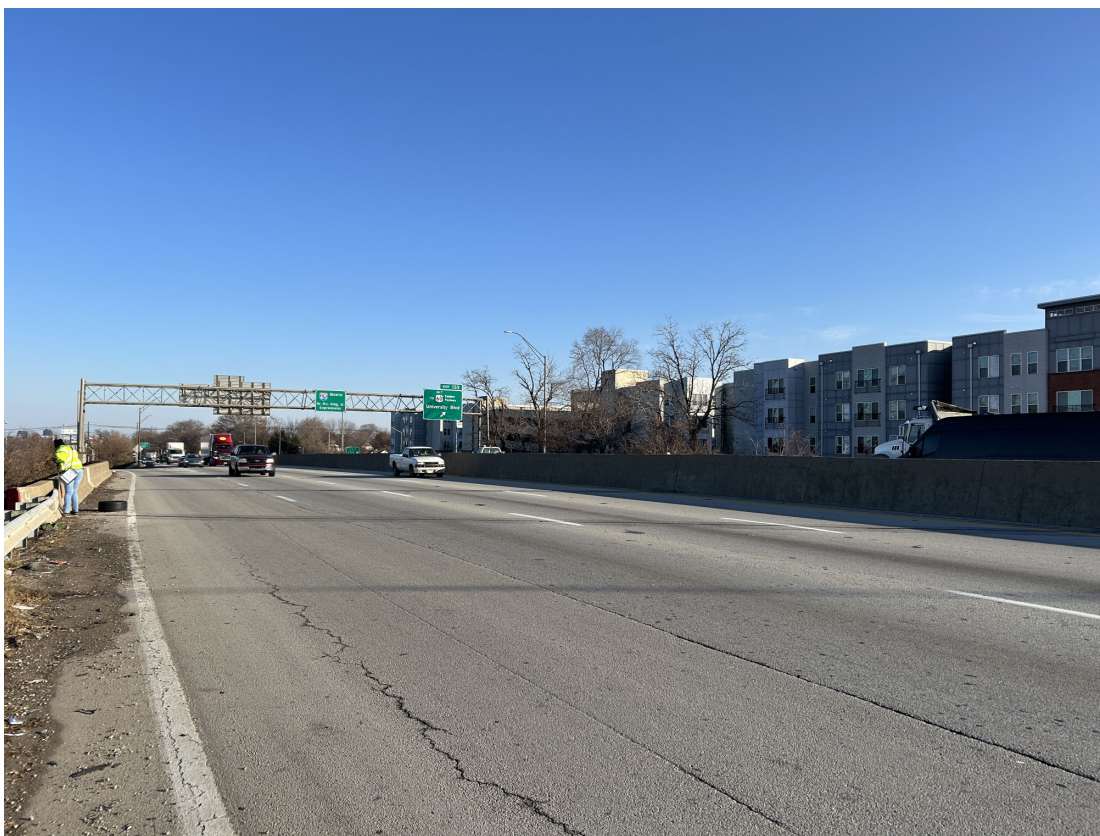
Looking north along I-65 SB.

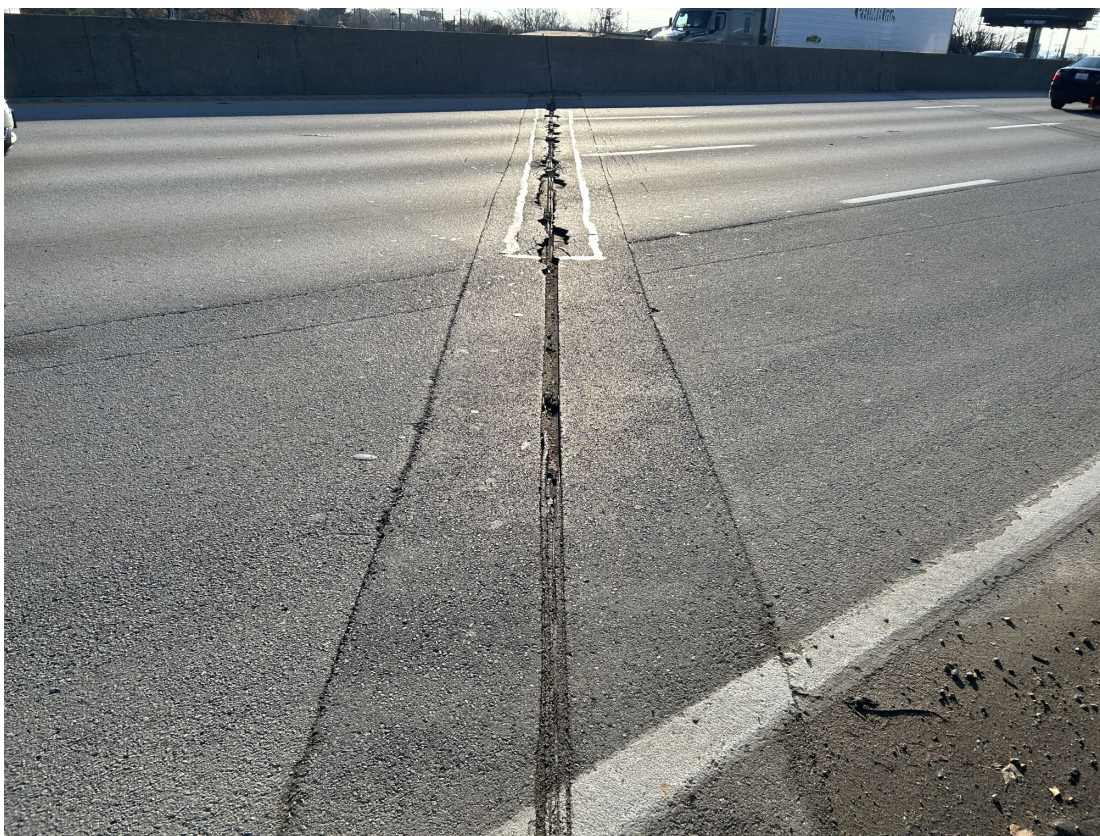
Asphalt plug joint over Pier 2 SB.

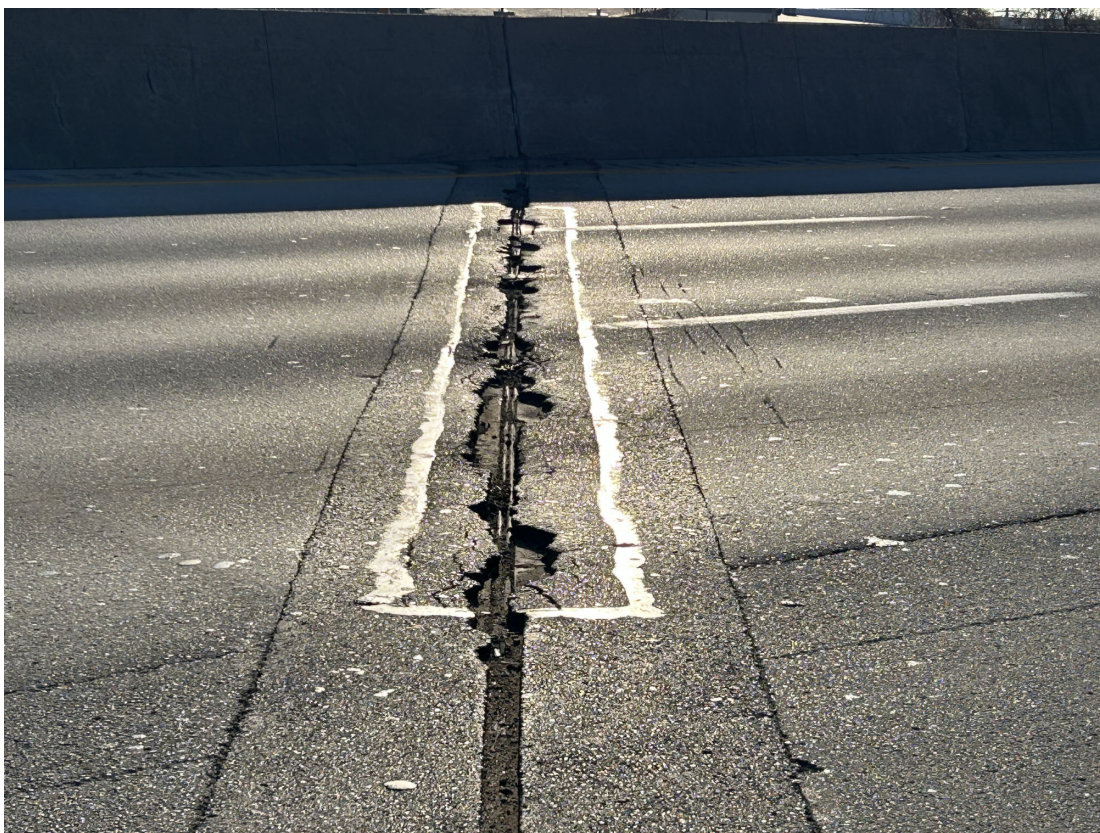
Close-up of typical failing asphalt plug joints.

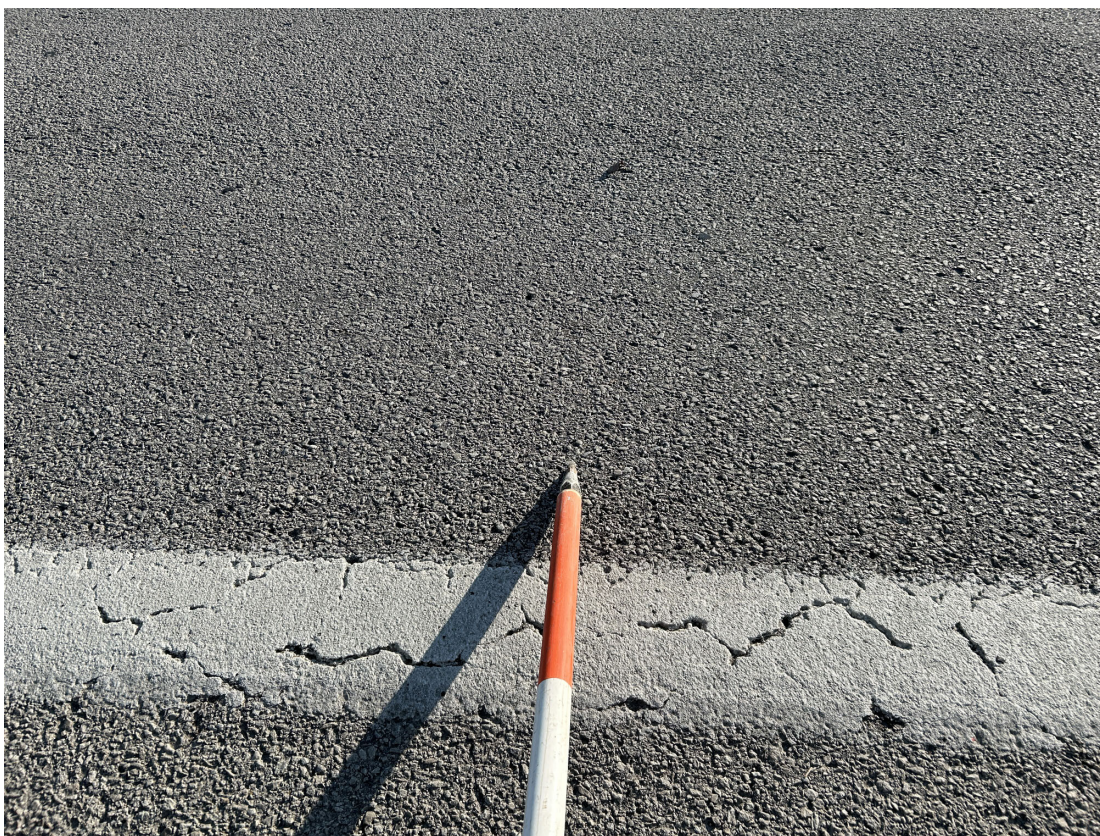
Typical raveling of the asphalt overlay.

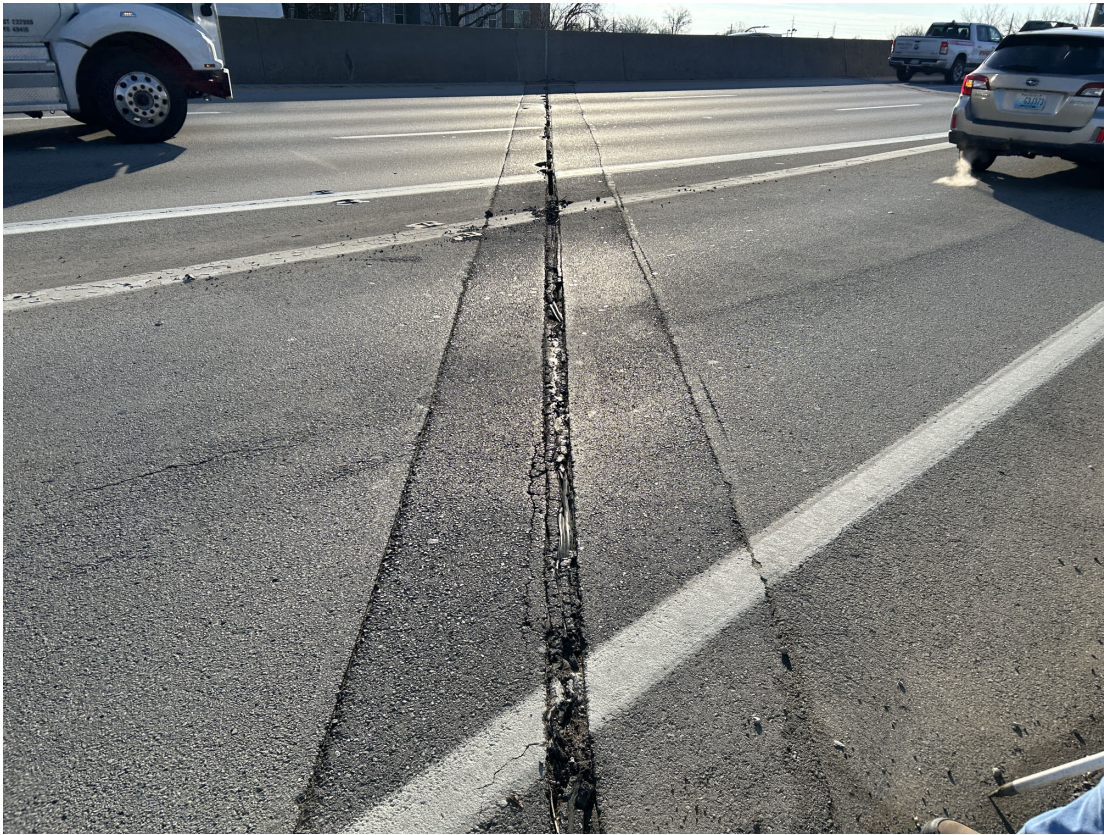
Asphalt plug joint over Abutment 4 SB.

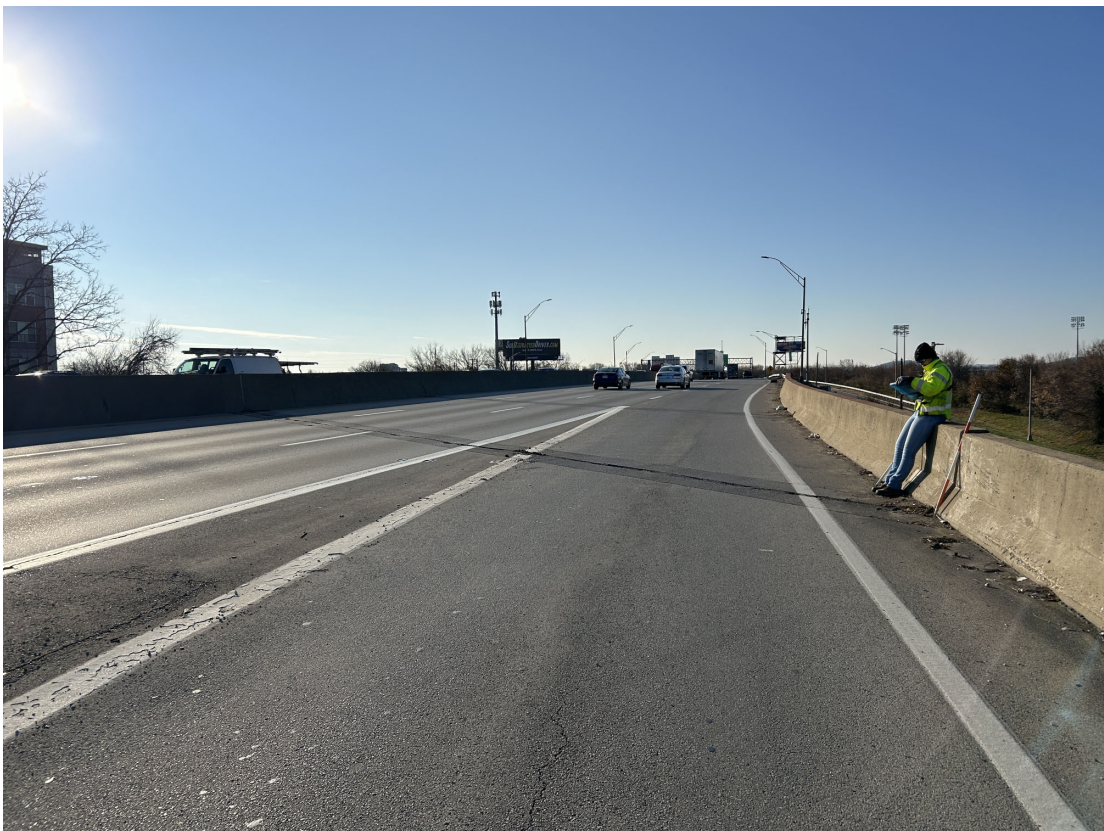
Looking south along I-65 SB.

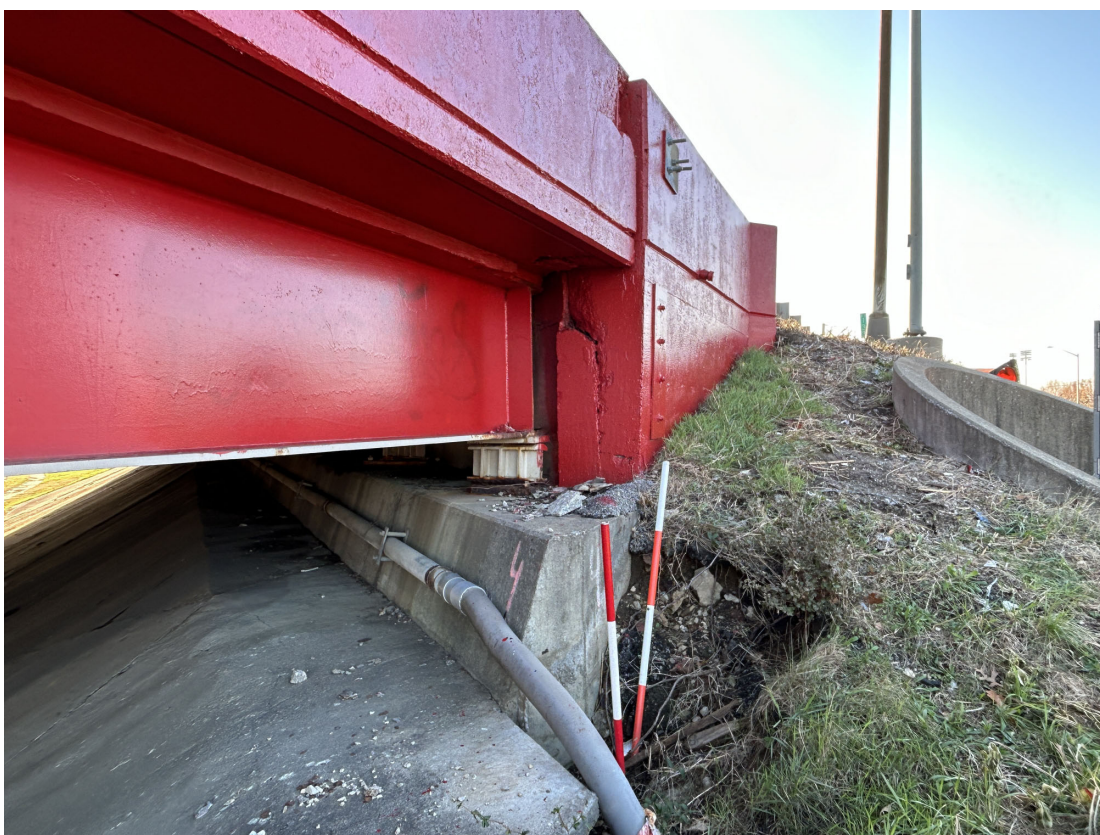
The top corner of the Abutment 1 slope wall is undermined by at least 4 feet at the west end, up to 1.7 feet in height. The Abutment 1 embankment has settled 3 inches vertically below the slope protection below Beam 7. The slope wall section at the northwest corner has settled and slightly separated from adjacent section.

West end of Abutment 1 showing erosion plus damage to SW wingwall.

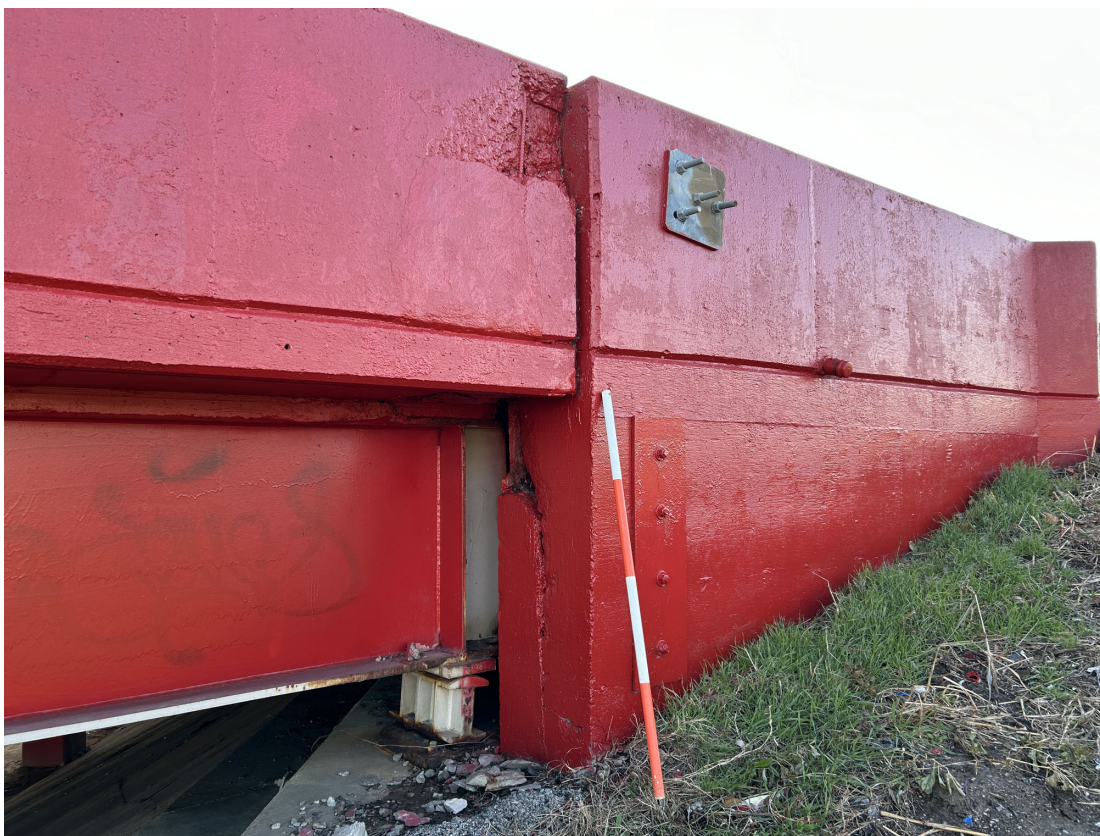
SW wingwall is fractured at the Abutment 1 backwall and is tilting out. There is also a 2-foot long spall with exposed rebar in the west rail at the south end.

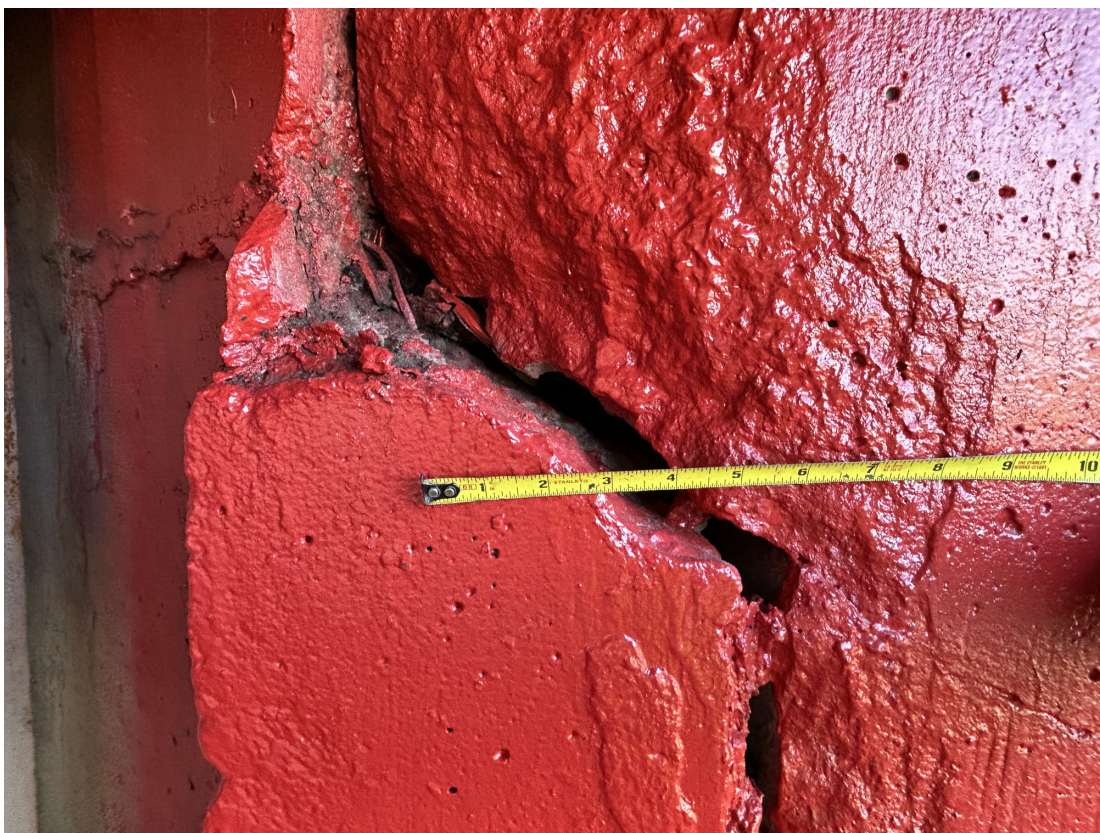
Close-up of fracture width.

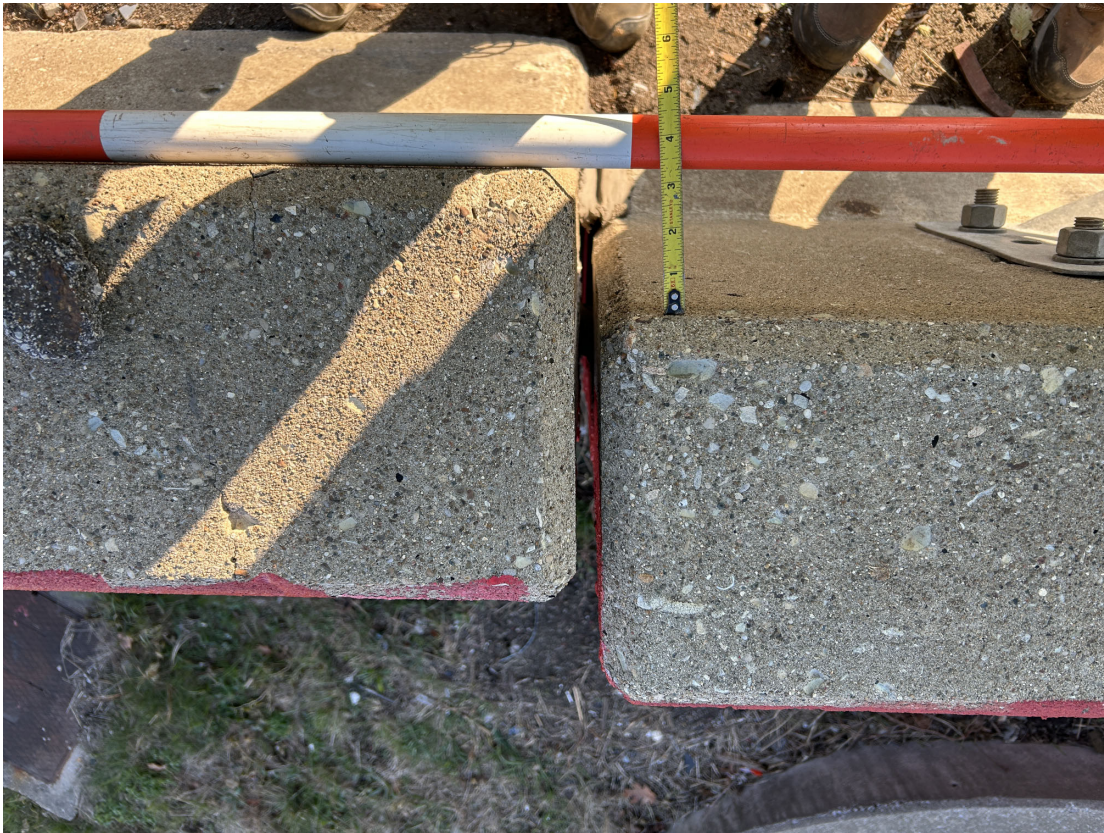
Quantity includes parallel wingwalls at the abutments. The abutment caps have moderate width vertical and horizontal cracks and corner spalls up to 3 feet (L) x 1 foot (W) x 6 inches (D) with exposed reinforcement. Largest spall is along the Abutment 4 beam seat under Bay 1. The backwalls have moderate width cracks and patching, with some unsound patched areas, spalls with exposed reinforcement, and wide diagonal cracking at the ends. There is a fracture at the west end of Abutment 1 and the SW wingwall is tilted out due to impact damage, with a 3.25 inch offset measured at the top of the rail.

SW wingwall is tilted out roughly 3.25 inches at the top of the rail.

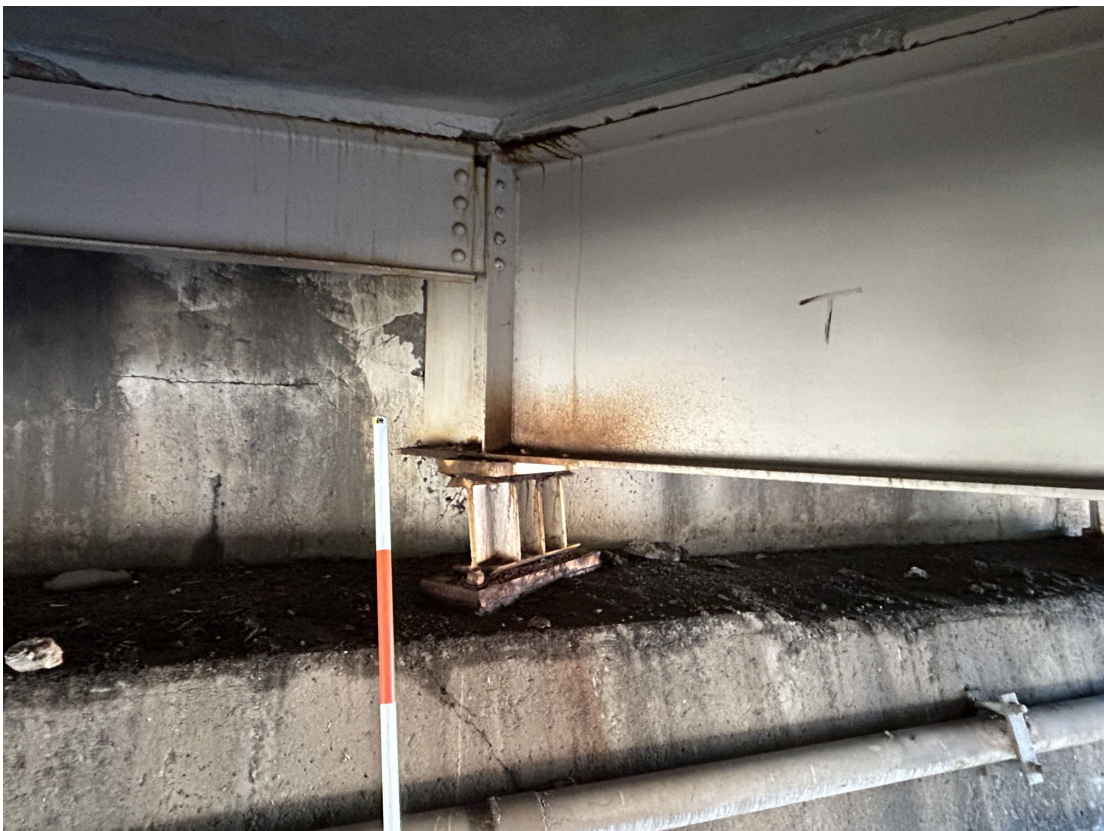
The rocker bearings are located at Abutment 1, Pier 2 Span 2, and Abutment 4. The bearings have laminating corrosion and pack rust, generally worst along the bottom of the bearings at the masonry plates. The bearings were slightly expanded at Abutment 1 and Abutment 4 at 38° F. The Pier 2 bearings were also rotated in expansion. Abutment 1 Bearing 18 has a 1/4-inch gap between the outside edge of the rocker and the sole plate due to pack rust. Abutment 4 Bearing 7 is not in contact with the sole plate and can be slightly moved by hand under dead load (CS4). Abutment 4 Bearing 11 has uplift between the front face of the masonry plate and the cap with approximately 65% of the masonry plate in contact with the cap.

Typical bearing at Abutment 1. Bearings are expanded and have corrosion. Girder 3 shown.

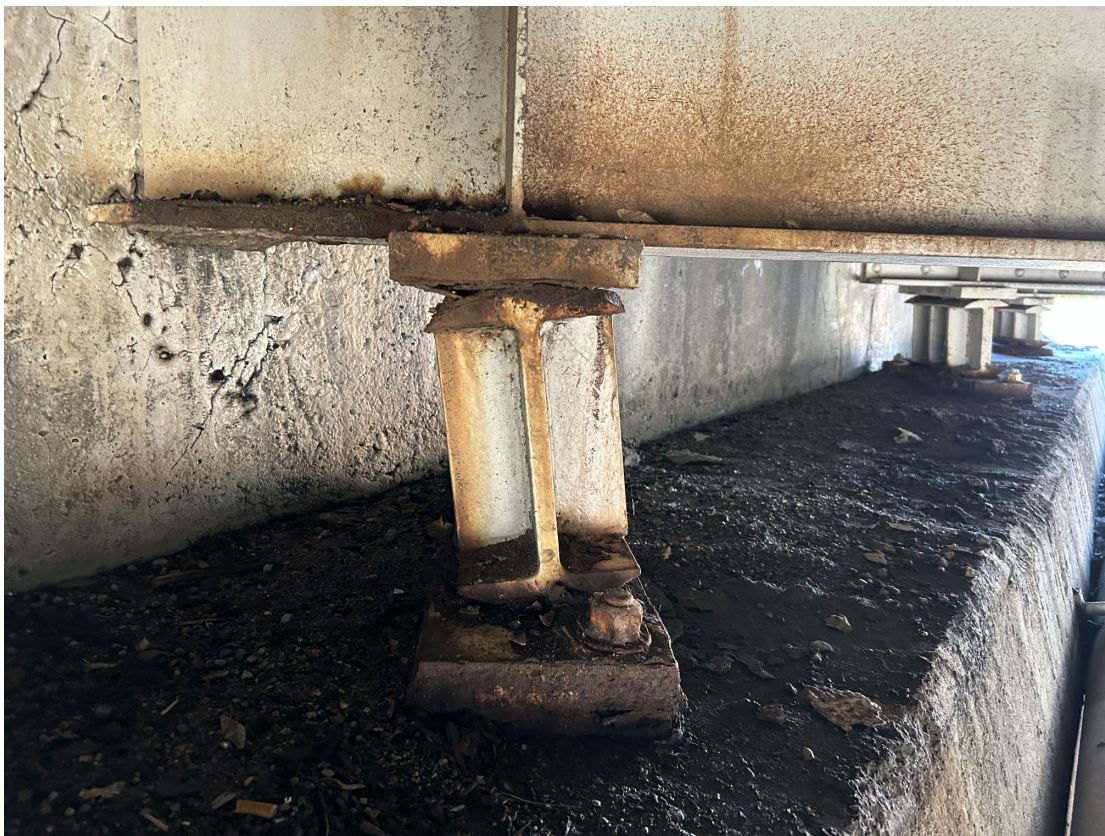
Abutment 1-Girder 3 bearing close-up

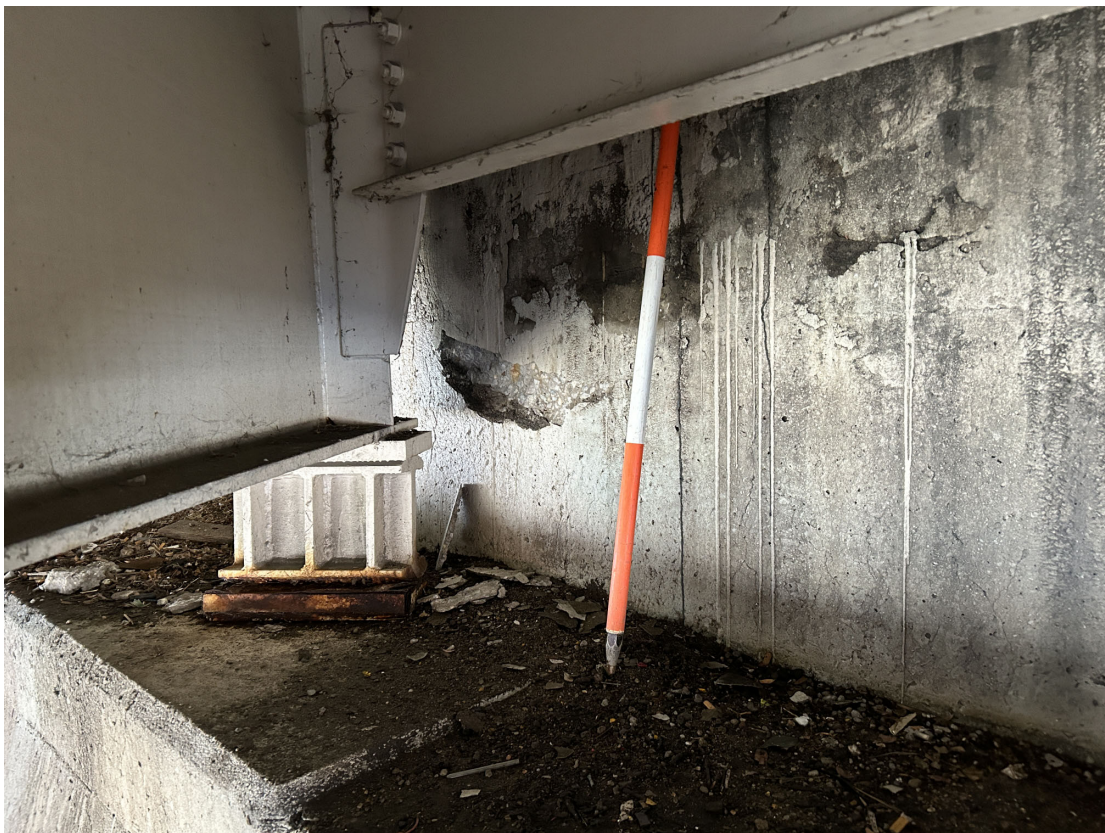
Abutment backwalls have failing patches and spalls. Abutment 1 backwall at Bay 8 shown.
