# Bridge Inspection Report

056B00180N

12/11/2024

IDENTIFICATION			
Structure Num (8):	056B00180N		
NBI Number	056B00180N		
Structure Name:			
Location (9):	2.1 MI N OF I-264		
Carries (7):	I-65		
Type of Service (42A):	1 Highway		
Feature Crossed (6):	US 60A (EASTERN PKWY)		
Type of Service (42B):	1 Highway		
Placecode (4):	Not Applicable		
County (3):	Jefferson (056)		
State (1):	21 Kentucky		
Admin Area:	Inventory		
District:	District 5		
Latitude (16):	38° 12' 44"		
Longitude (17):	85° 45' 10"		
Owner (22):	State Highway Agency		
Maint. Resp. (21):	State Highway Agency		
Year Built (27):	1957	Border State (98A):	Not Applicable (P)
Year Recon (106):	1982	Border Number (99):	
		% Responsibility (98B):

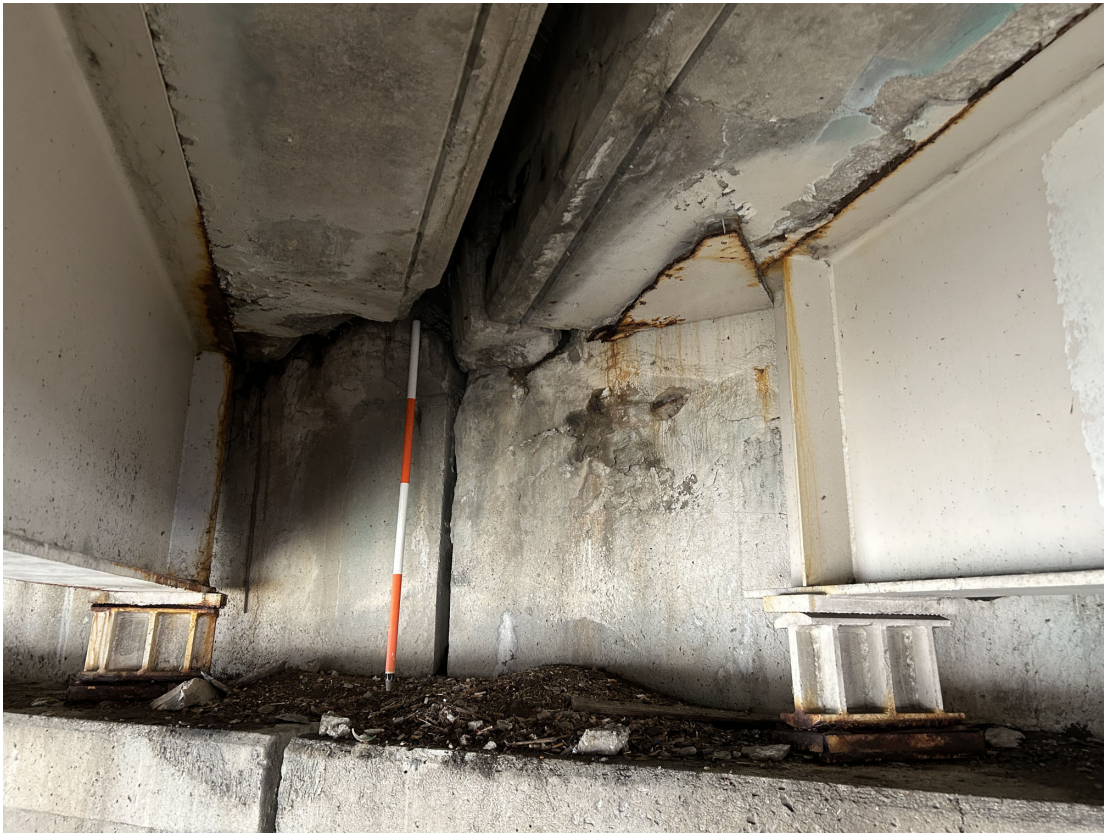
Abutment 1 and deck at longitudinal joint.

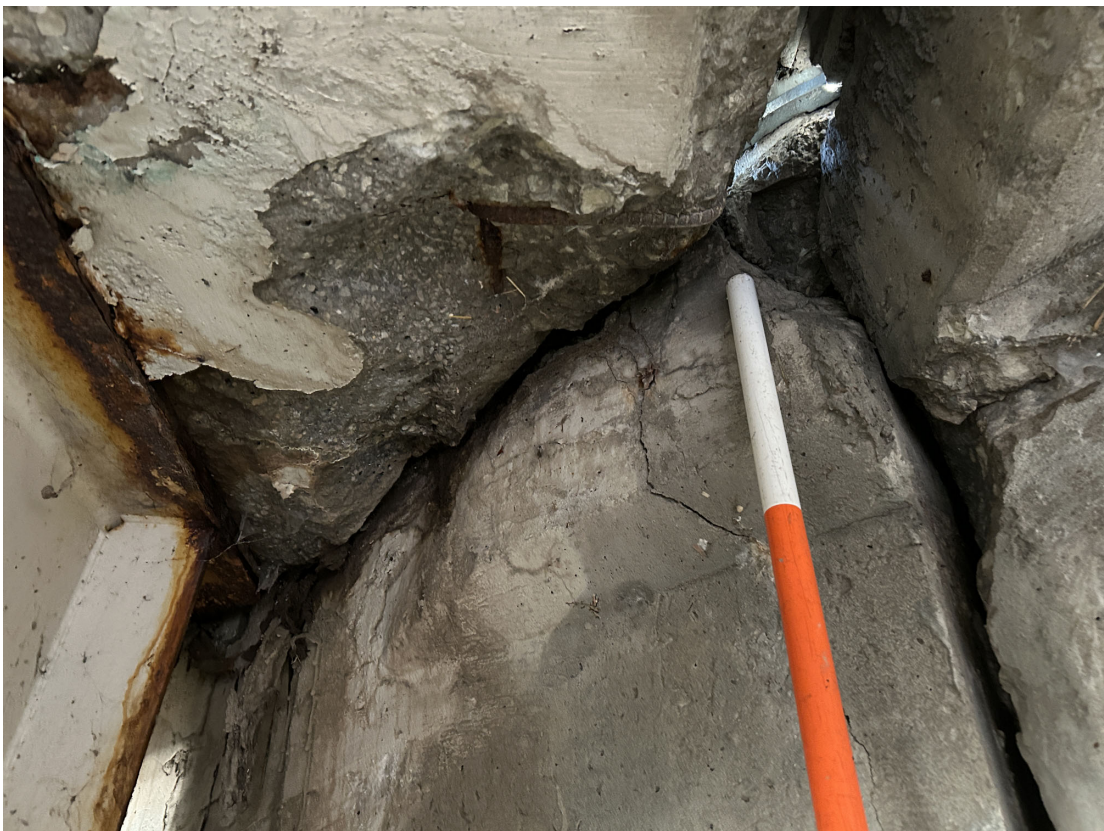
Close-up of deck spalling at the south end at the longitudinal joint.

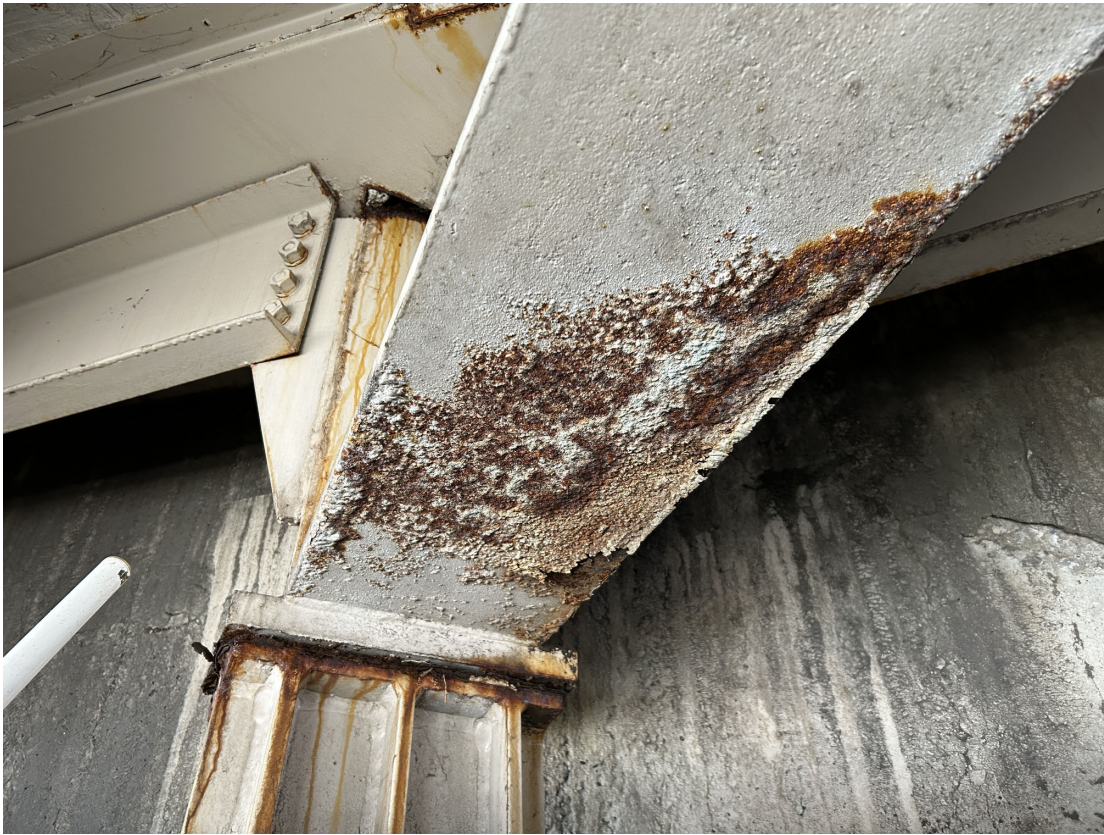
Beams ends have corrosion. Example along Girder 11 at Abutment 1.

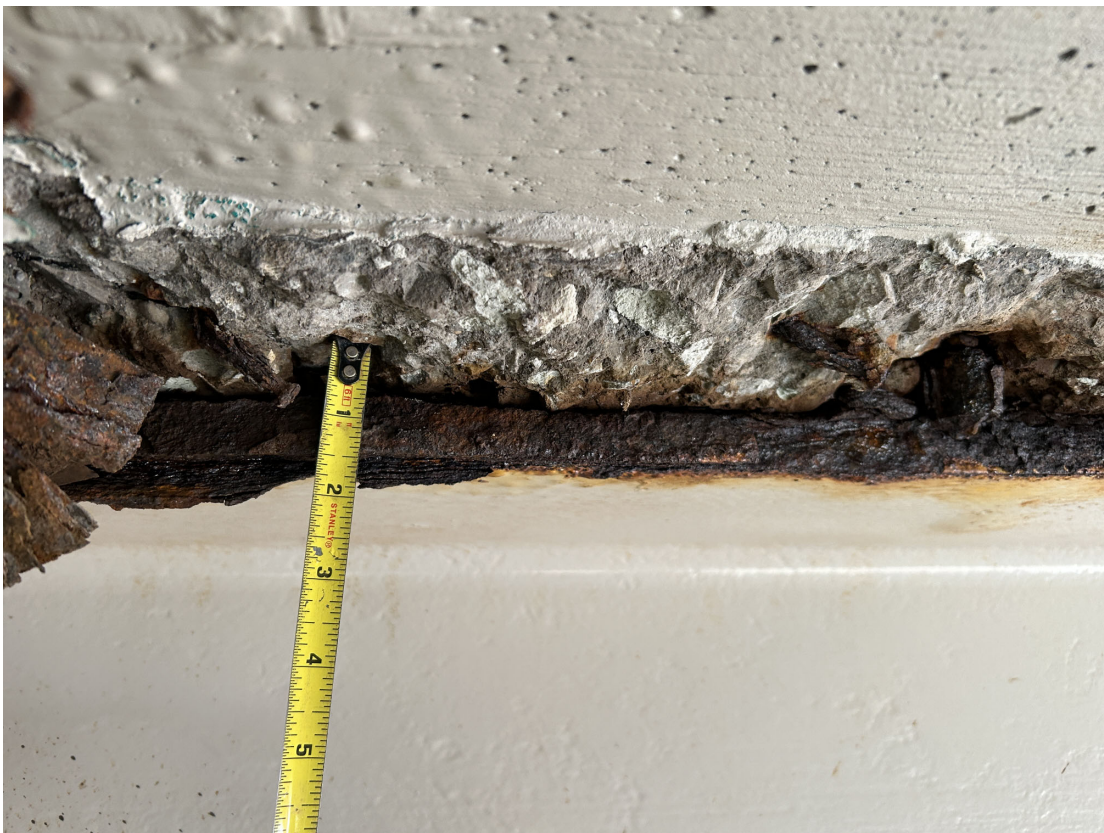
Deck moves independent of girders at several locations along abutments. Gaps between the deck and top flanges, along with haunch spalls are present at these locations. Example at Girder 14 at Abutment 1.

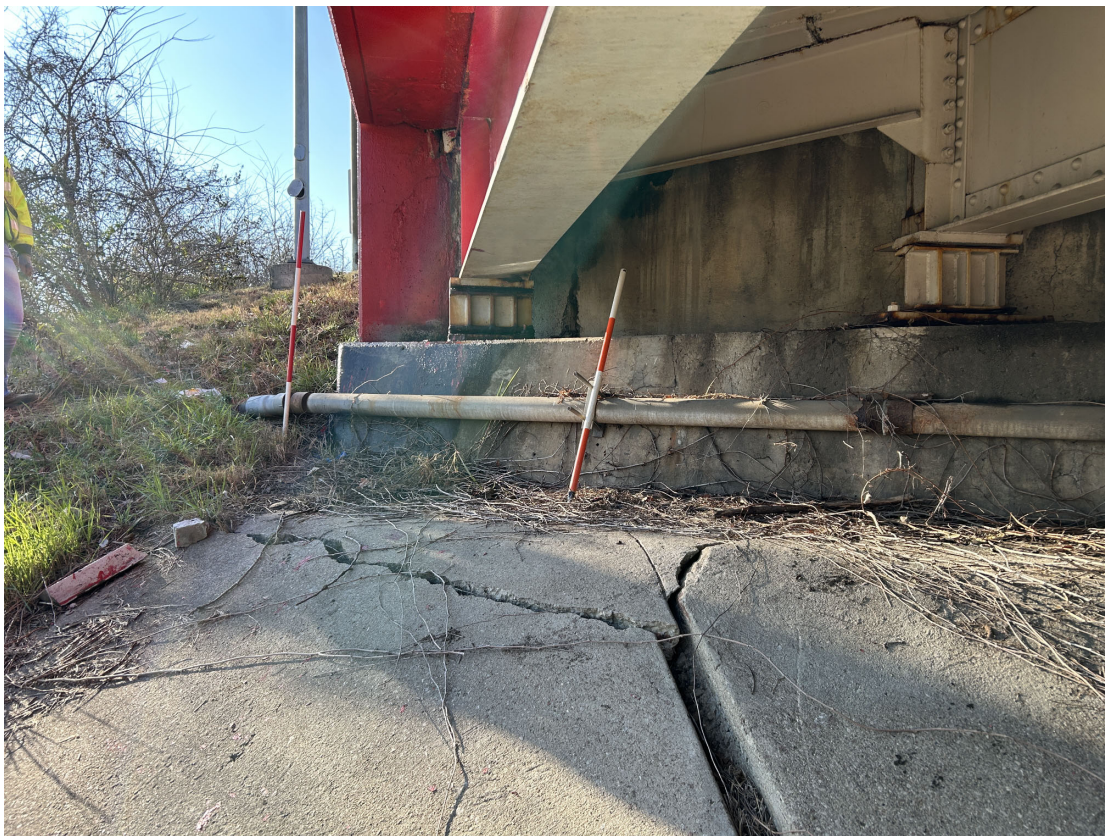
East end of Abutment 1 showing cracking slope protection.

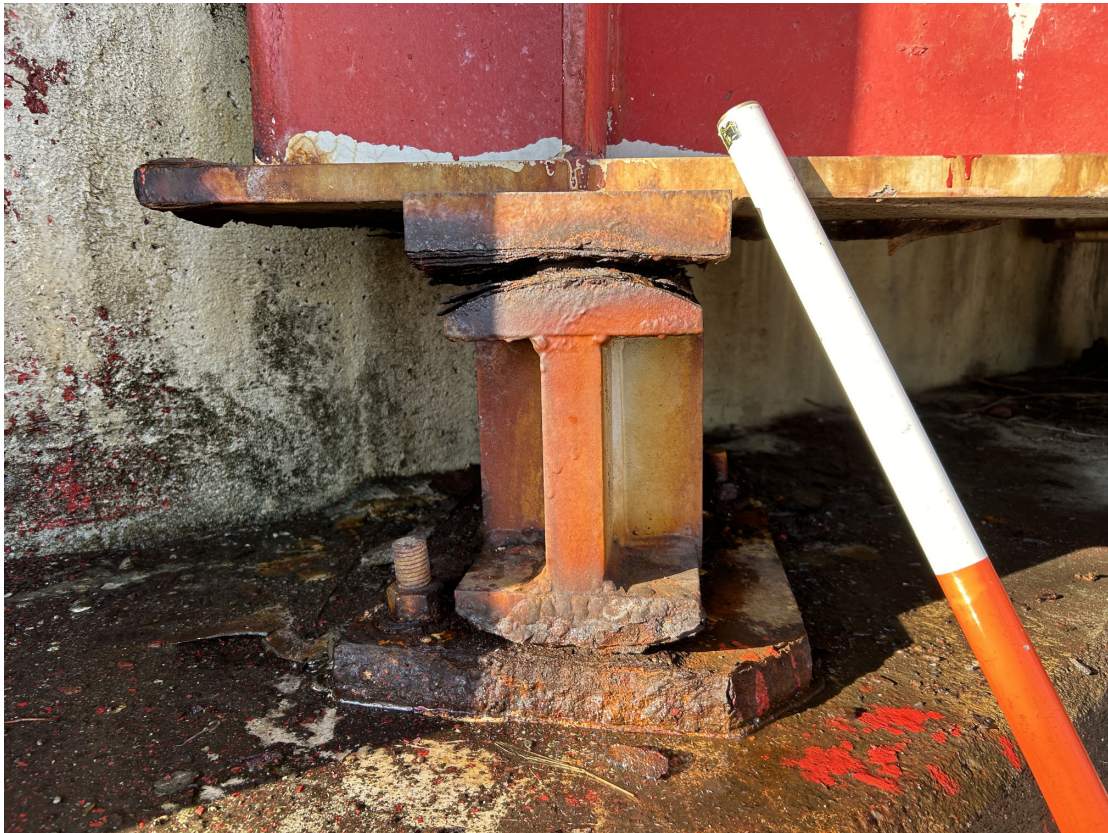
Bearing for Girder 18 at Abutment 1 has pack rust, creating a gap between the top of the rocker and the sole plate.

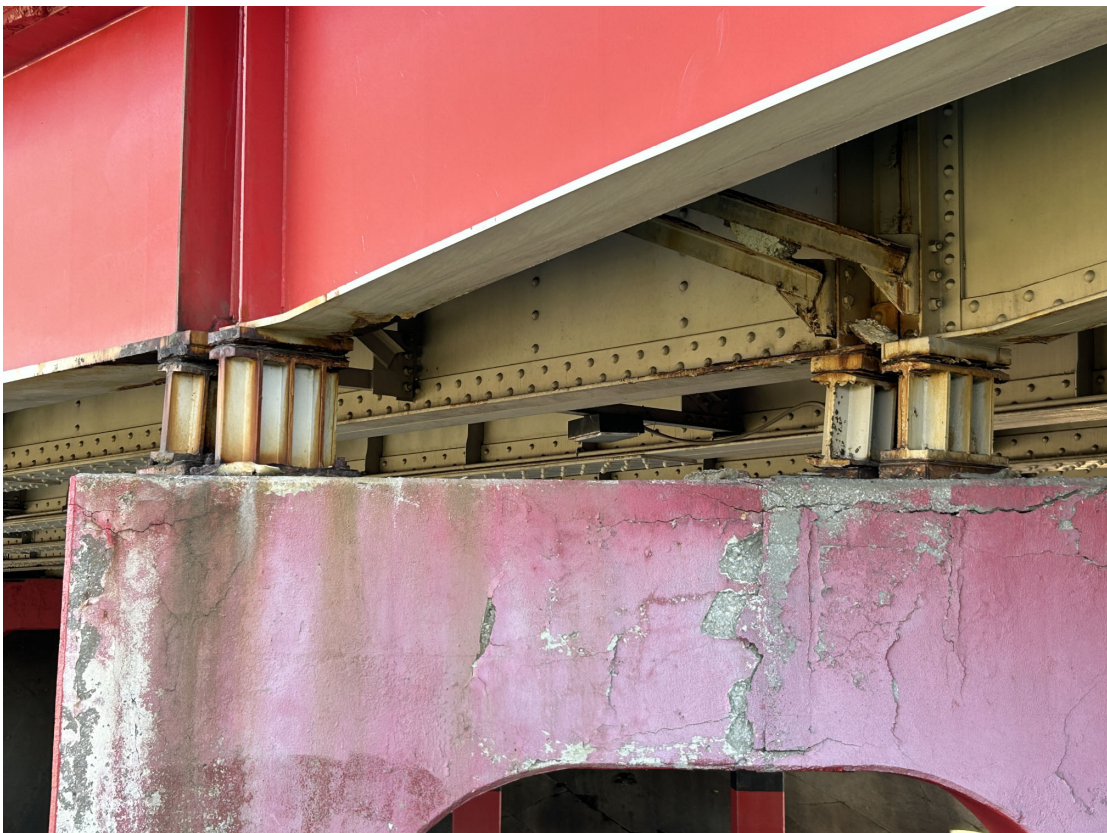
Fixed bearings are located at Pier 2-Span 1 and Pier 3. As part of the 2012 rehab contract, pier pedestals under the fixed bearings were repaired or replaced, new bearing stiffeners and bearing plates were added at each repaired pedestal, and 14 bearings at each pier were greased (28 total - Pier 2-Span 1 and Pier 3-Span 3 Beams 3-16). Pier 2-Span 1 fixed bearings at Beams 1, 2, 17, and 18 have corrosion with section loss. Pier 2-Span 1 bearing for Beam 17 is tilted to the north due to pack rust. At Pier 3, fixed bearings for both spans at Beams 1, 2, and 18 have corrosion with section loss. The remaining fixed bearings have light surface rust.

Pier 2-Span 1 fixed bearings at Girders 1 and 2 showing corrosion, plus there is cracking in the pier cap.

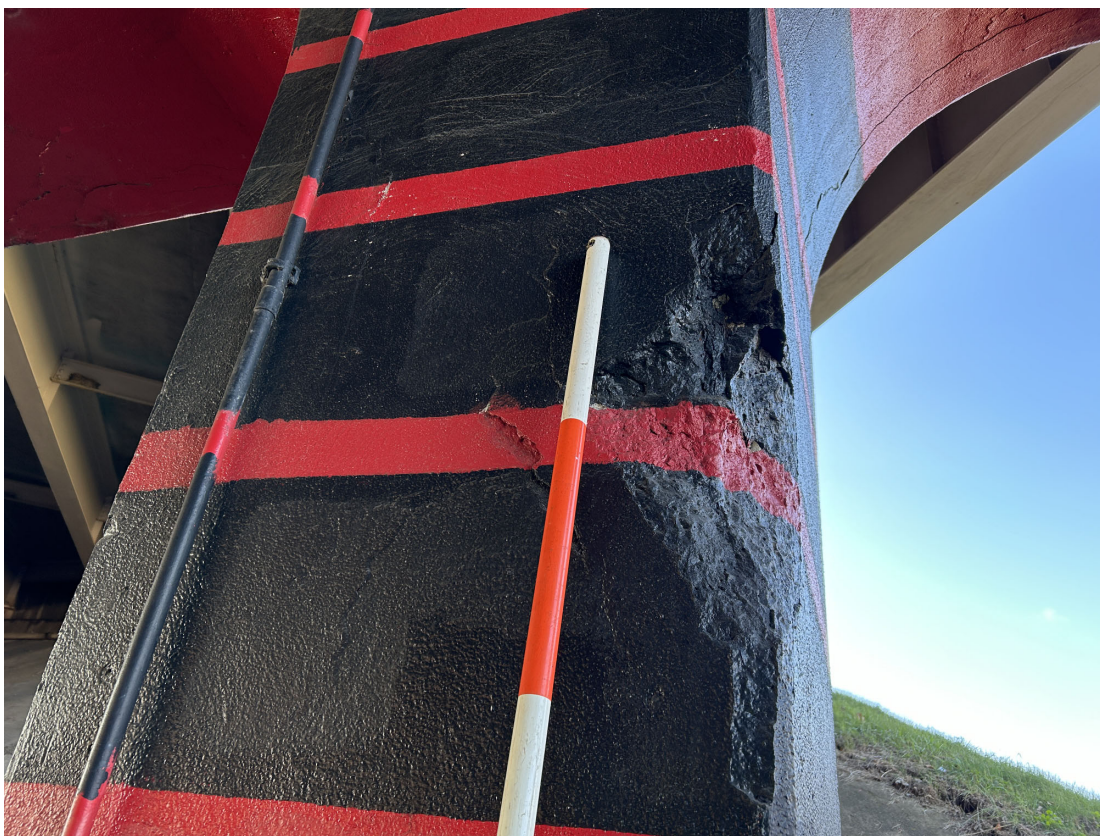
Pier 2-Column 2 - example of painted over spall with exposed rebar.

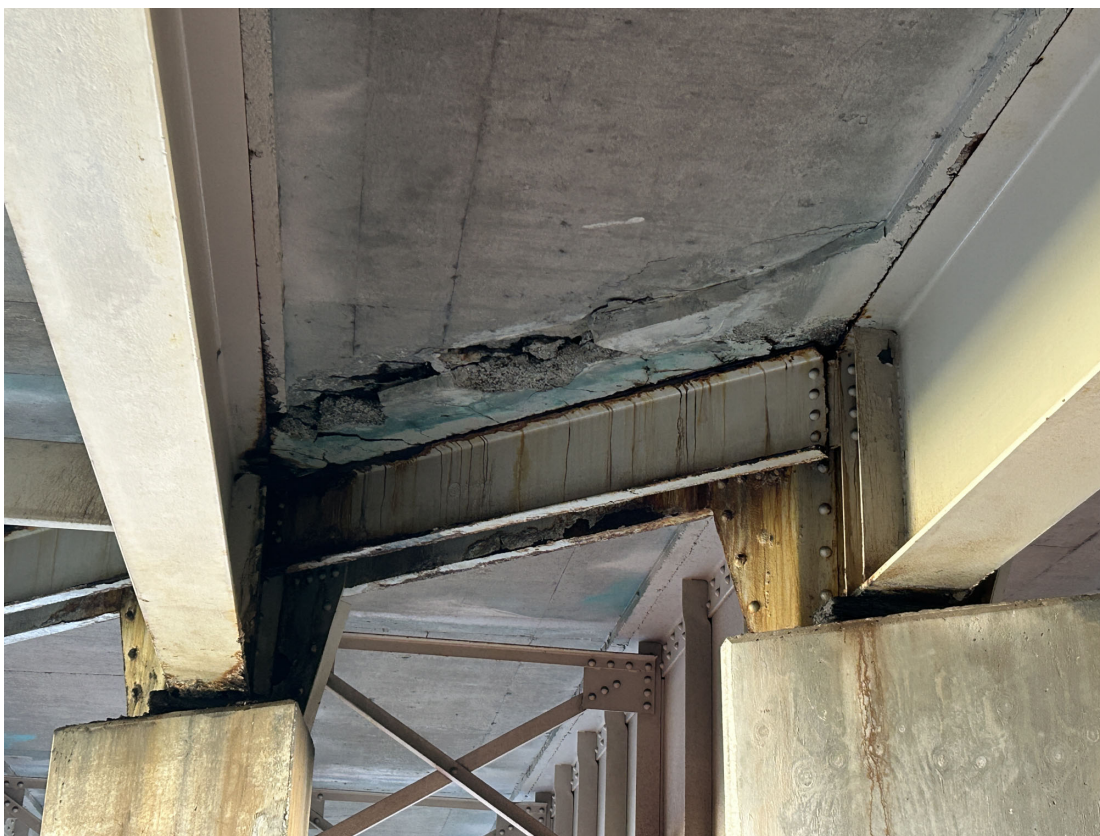
Span 1 soffit has a spall with exposed rebar in Bay 4 at Pier 2.

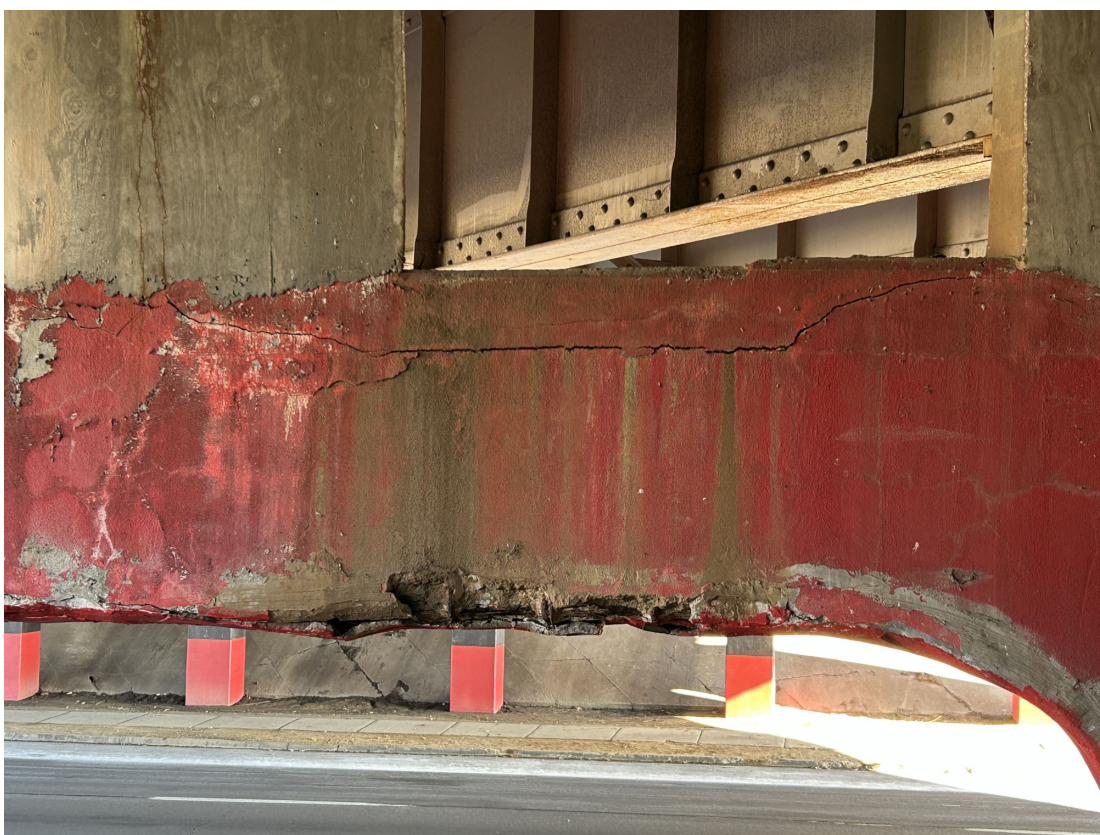
Cracking and spalling in the Pier 2 cap below Girder 5.

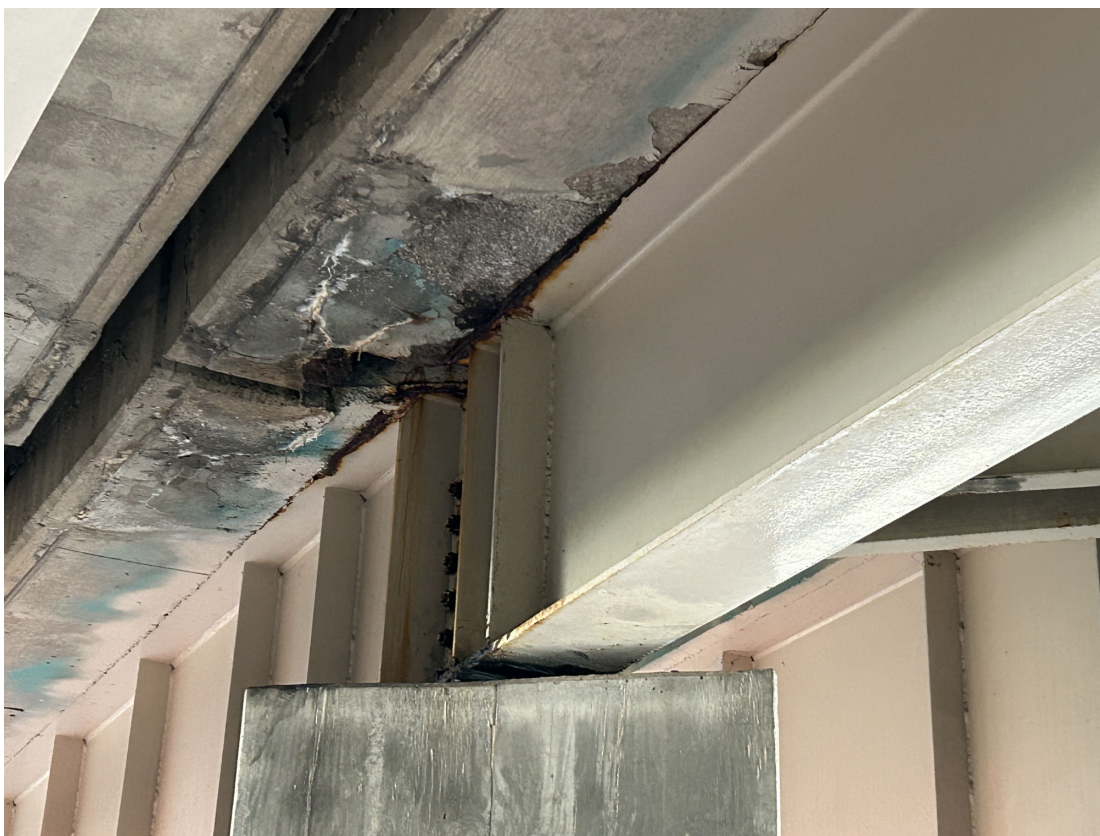
Deterioration in the soffit at the longitudinal joint over Pier 2.

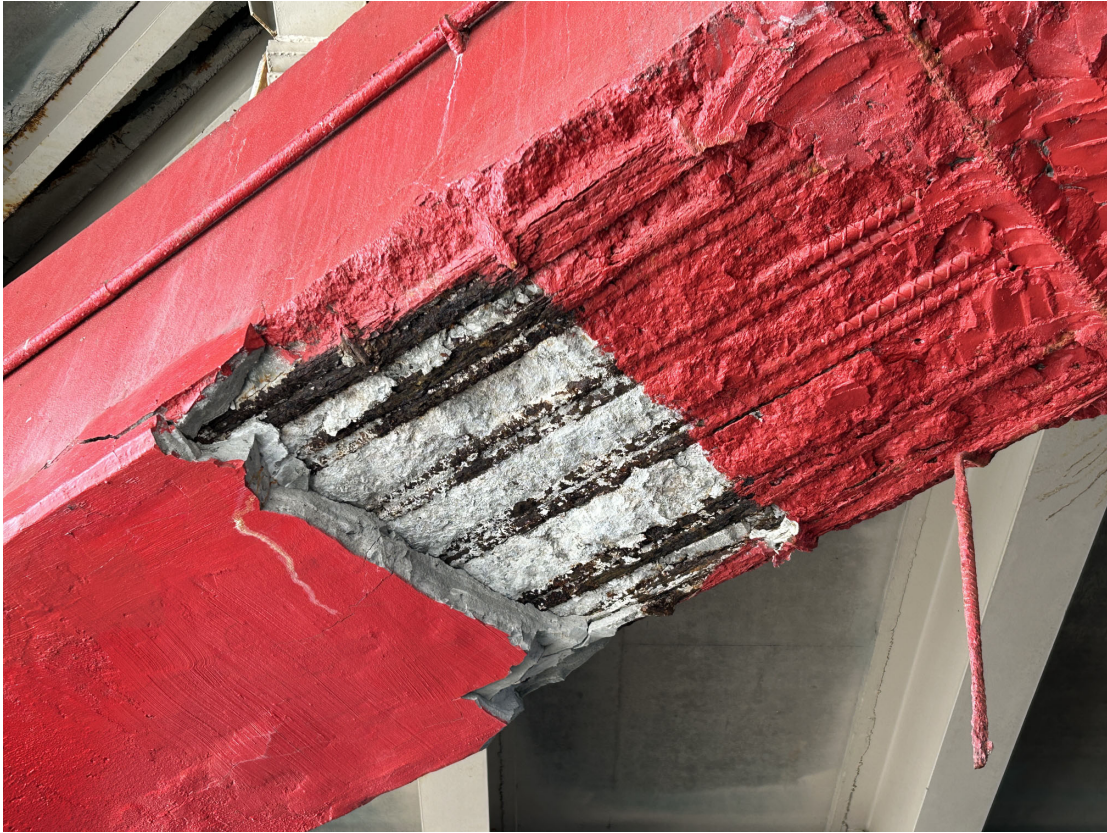
The pier caps have been painted by the University of Louisville, somewhat restricting visual inspection. The caps have wide cracking, heavy map cracking, delamination, and spalls with exposed rebar scattered throughout. Spalling is worst along the bottom face of caps between the columns, with worst cases along Pier 2 between Columns 3/4, 7/8, and 9/10.

Pier 2 cap has multiple areas of spalling with exposed rebar. Example between Columns 7 and 8.

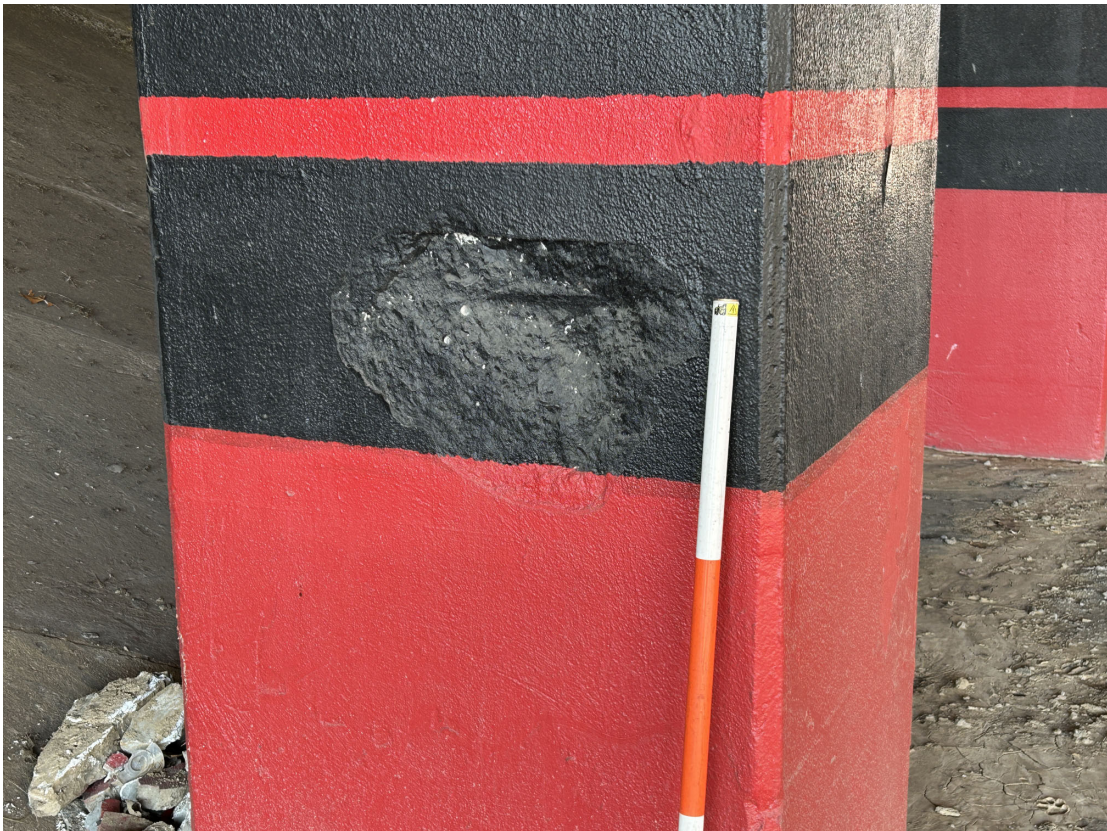
Pier 2-Column 7 painted over spall.

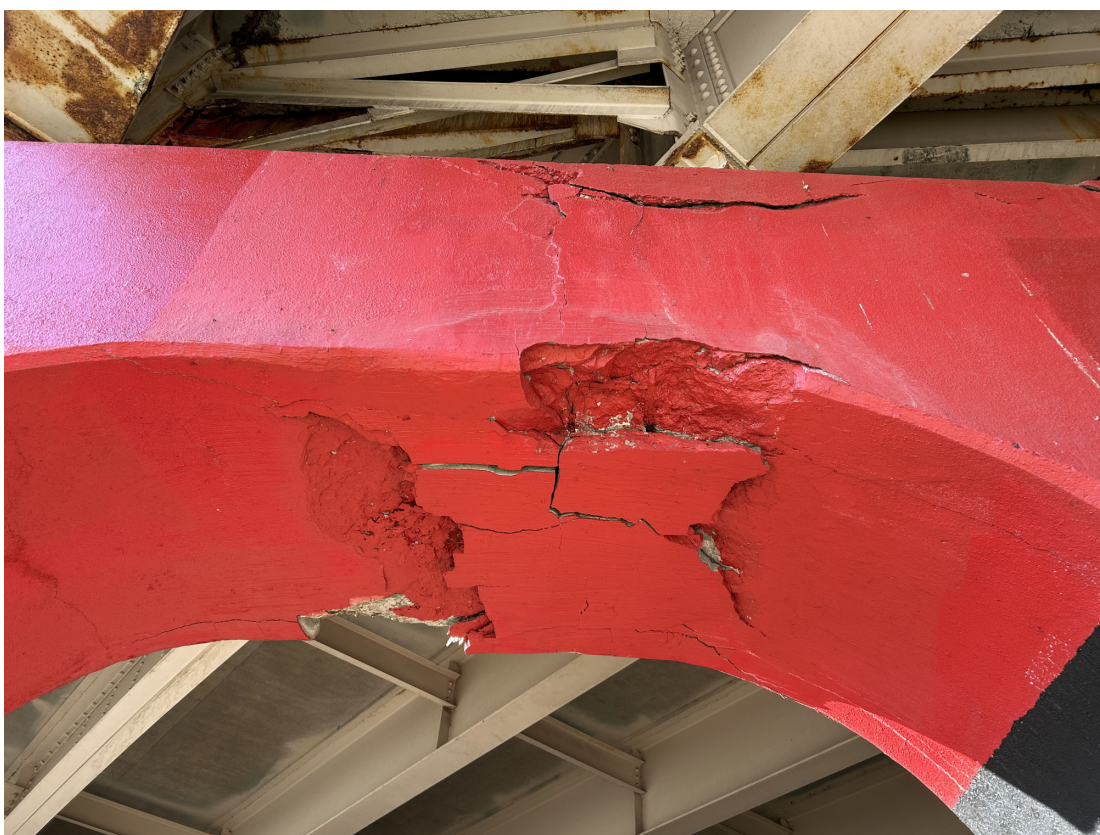
Cracking and spalling in the Pier 2 cap between Columns 9 and 10.

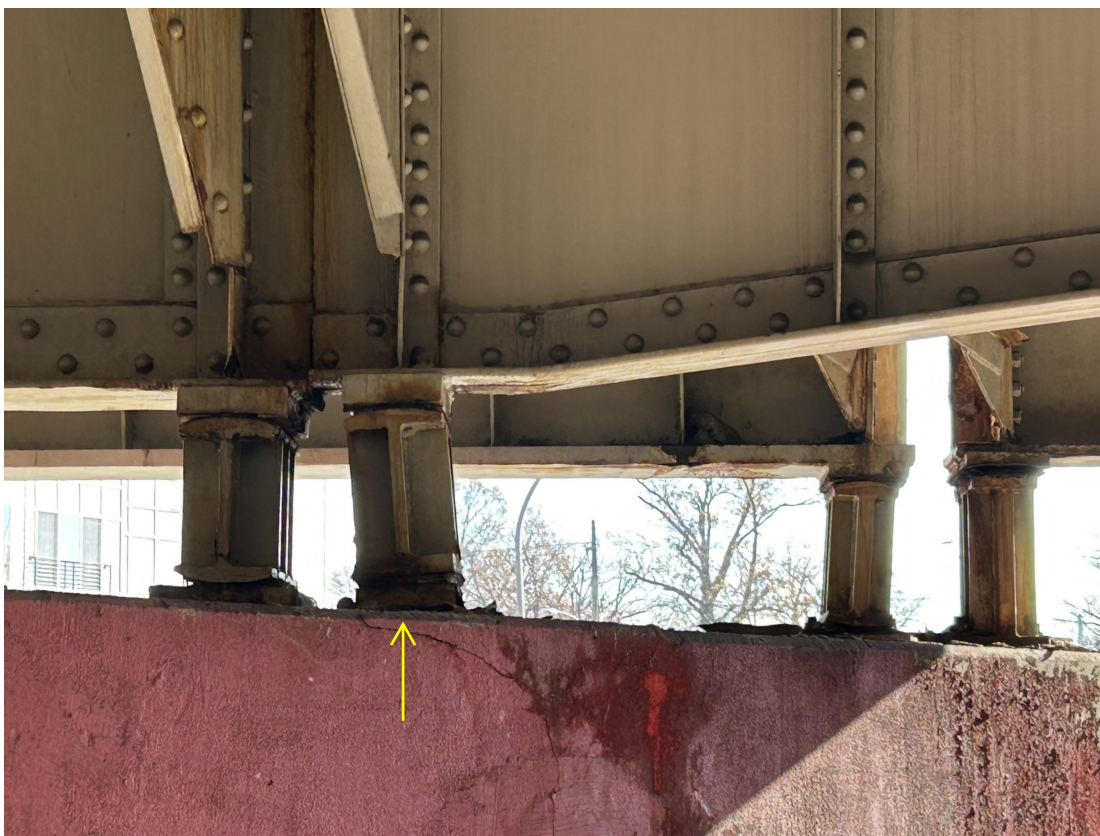
Pier 2 bearings for Girders 17 and 18. Span 1 bearings are fixed. Note Girder 17-Span 1 fixed bearing is tilted to the north due to pack rust.

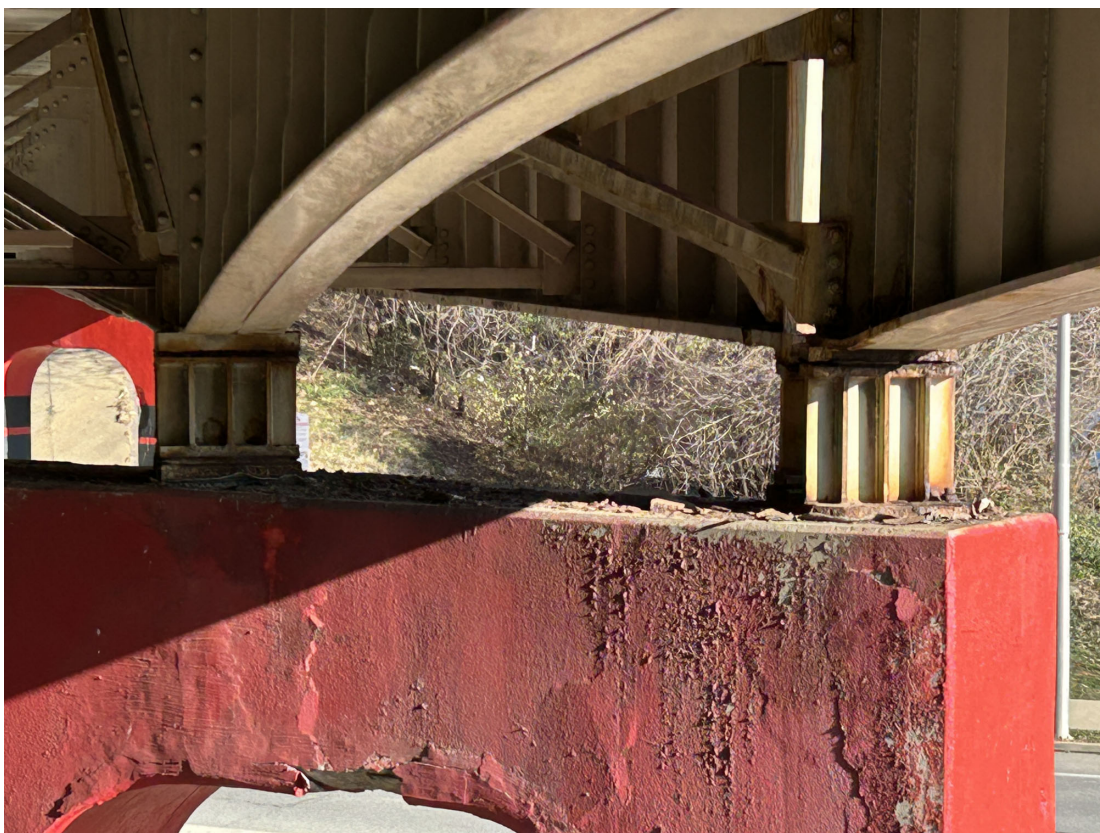
Another view of Pier 2-Girders 17 and 18 showing corrosion on bearings.

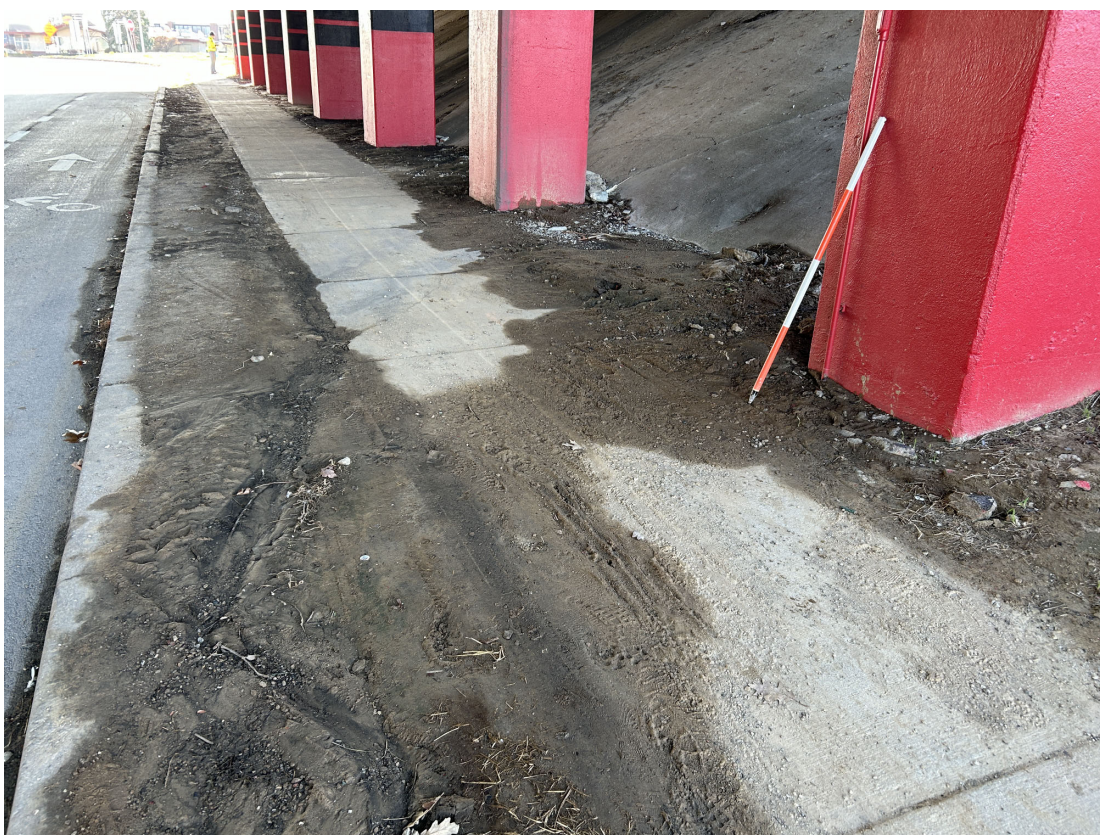
Dirt is accumulating on the sidewalk at Pier 2.

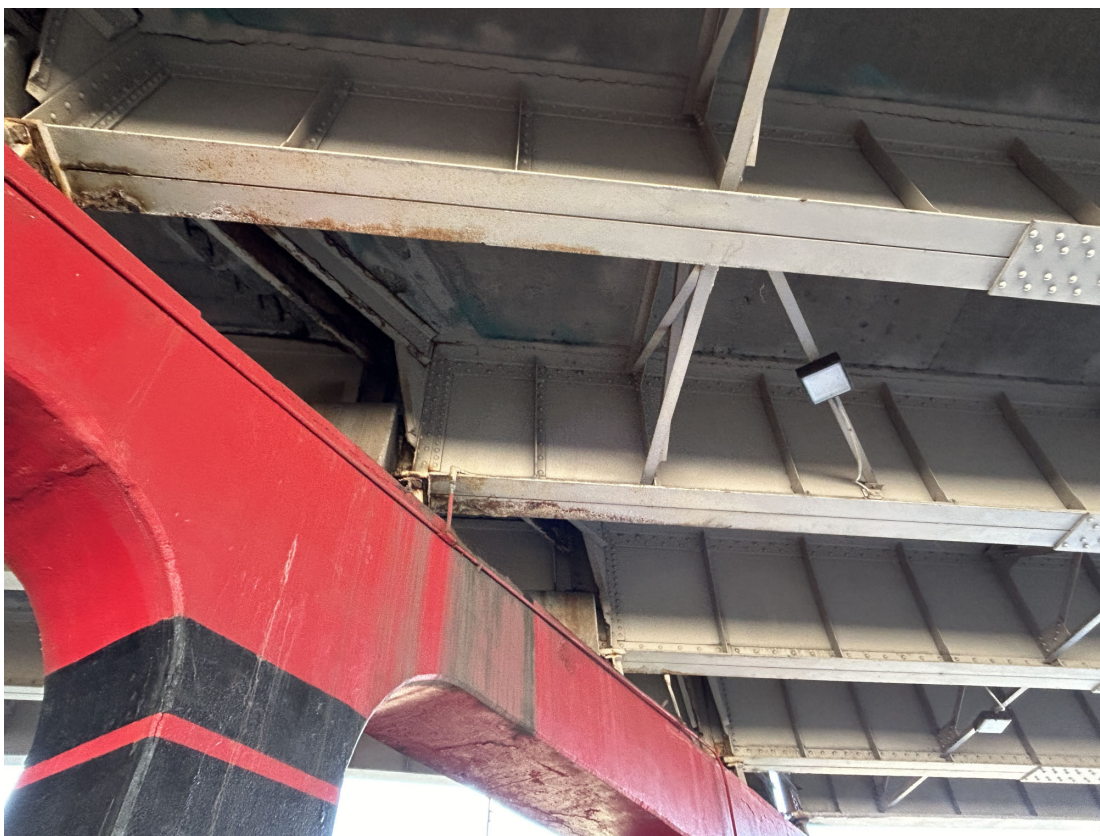
Span 2-Girders 4 and 5 at Pier 2 showing corrosion along bottom flanges.

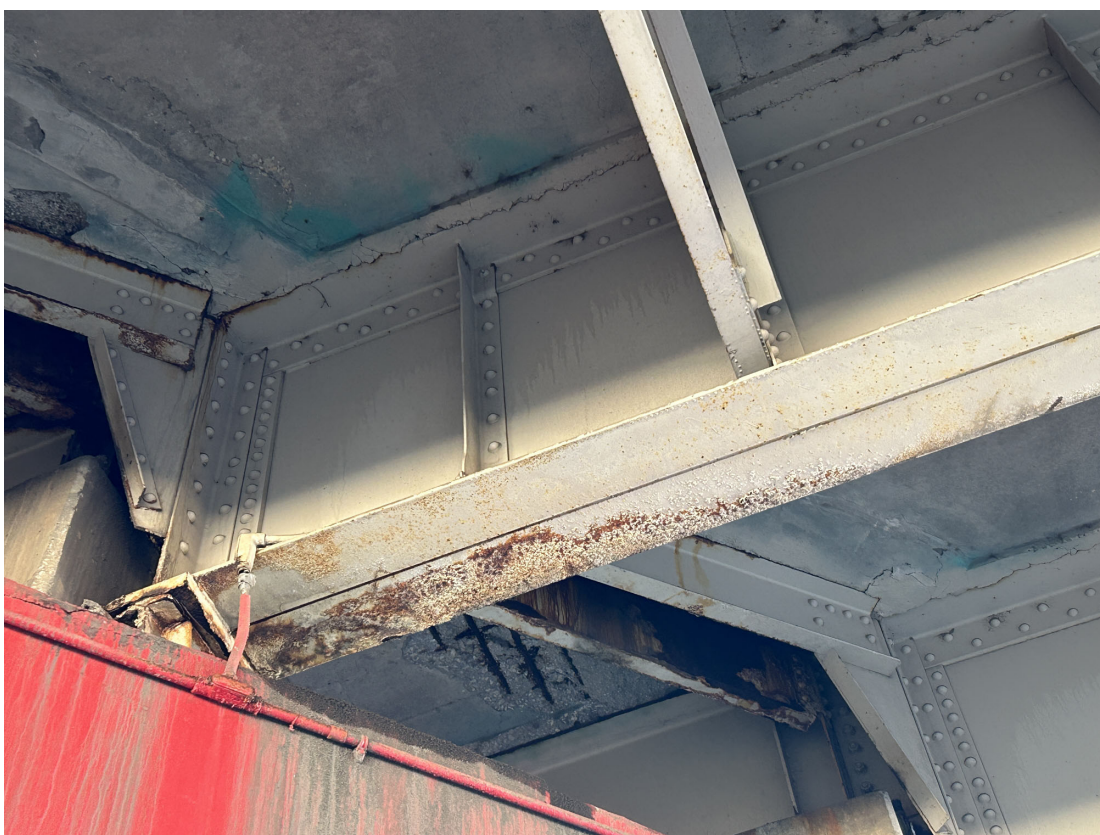
Close-up of Girder 5 at Pier 2 in Span 2.

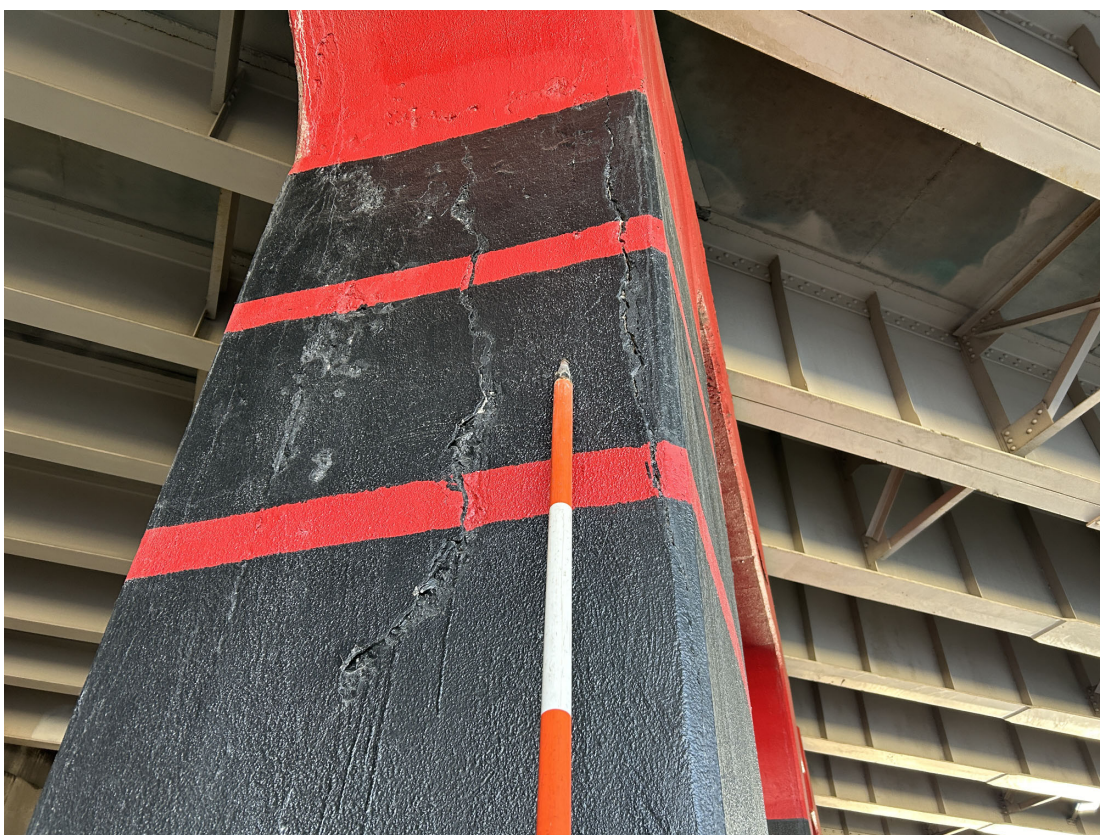
The pier columns have been painted by the University of Louisville, somewhat restricting visual inspection. There are wide vertical cracks with some delaminations in Pier 2-Columns 1, 7, and 9 and Pier 3-Columns 2, 3, 4, and 10. There are corner spalls up to 5.2 feet (H) x 1 foot (W) x 3 inches (D) with exposed reinforcement in Pier 2-Columns 2, 7, 8, and 10 and Pier 3-Column 10. There are moderate cracks and small spalls in Pier 2-Columns 3, 4, 5, and 6 and Pier 3-Columns 1, 5, and 6.

Pier 3-Column 4 with closely spaced wide vertical cracks.

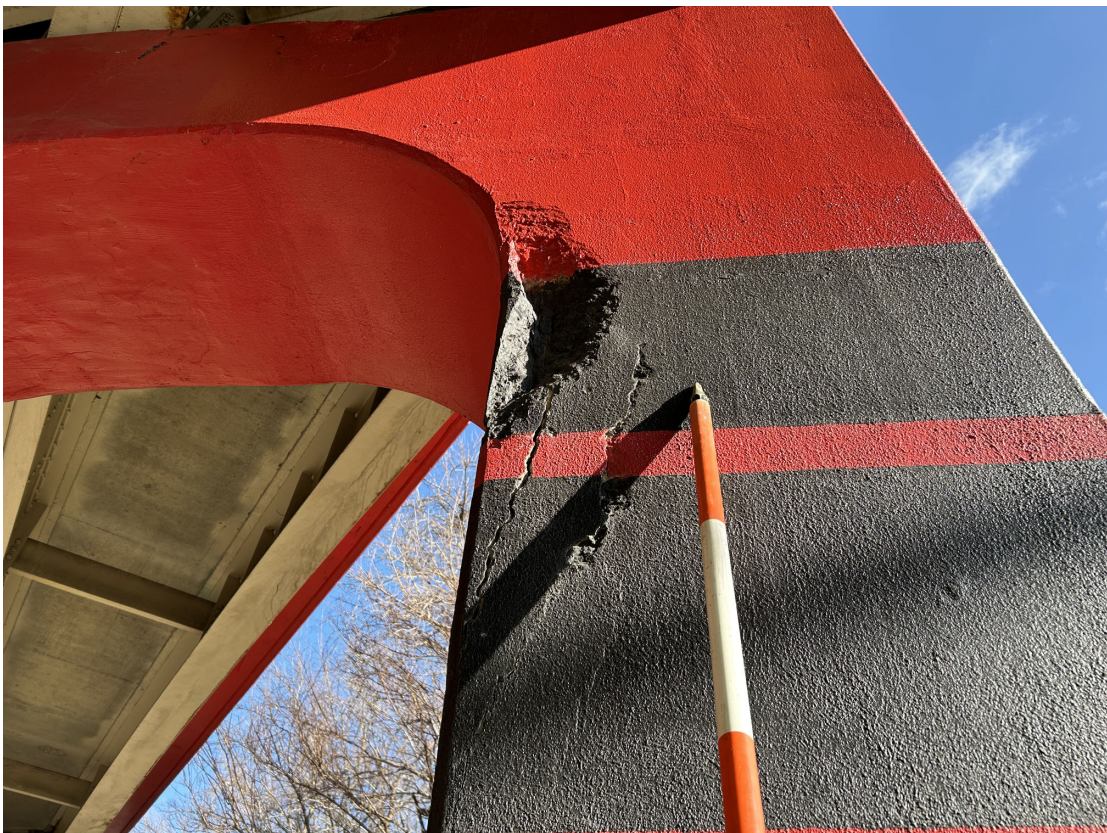
Spall in Pier 3-Column 10

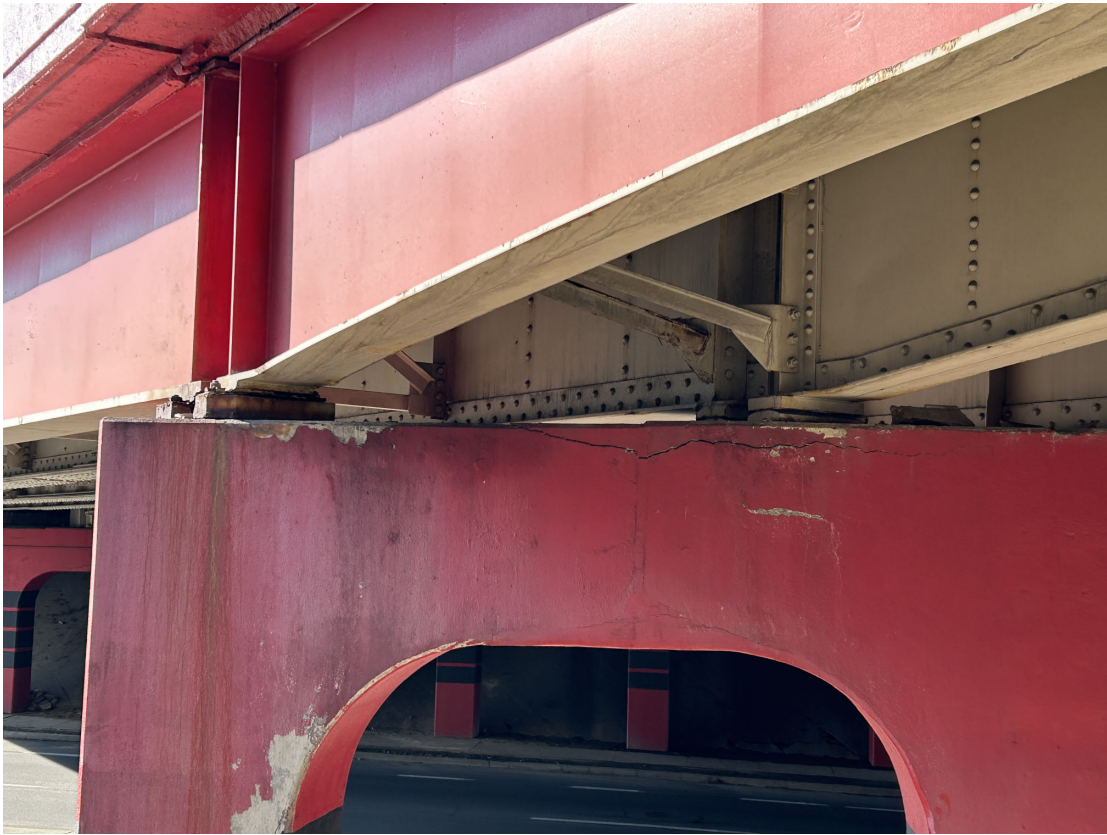
Pier 3 east end of the north face showing wide cracking in the cap plus typical bearings.

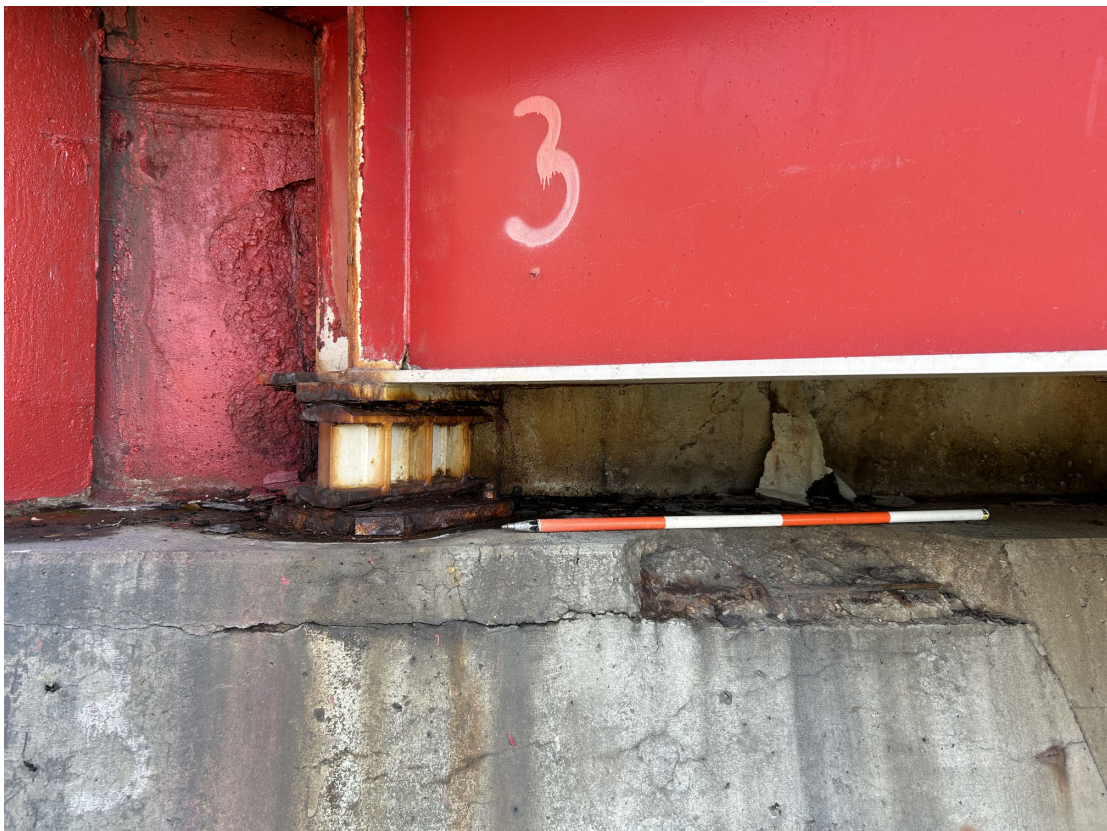
West end of Abutment 4 has spalling with exposed rebar in the backwall and spalling in the beam seat in Bay 1. Also note heavy corrosion of the Girder 1 bearing.

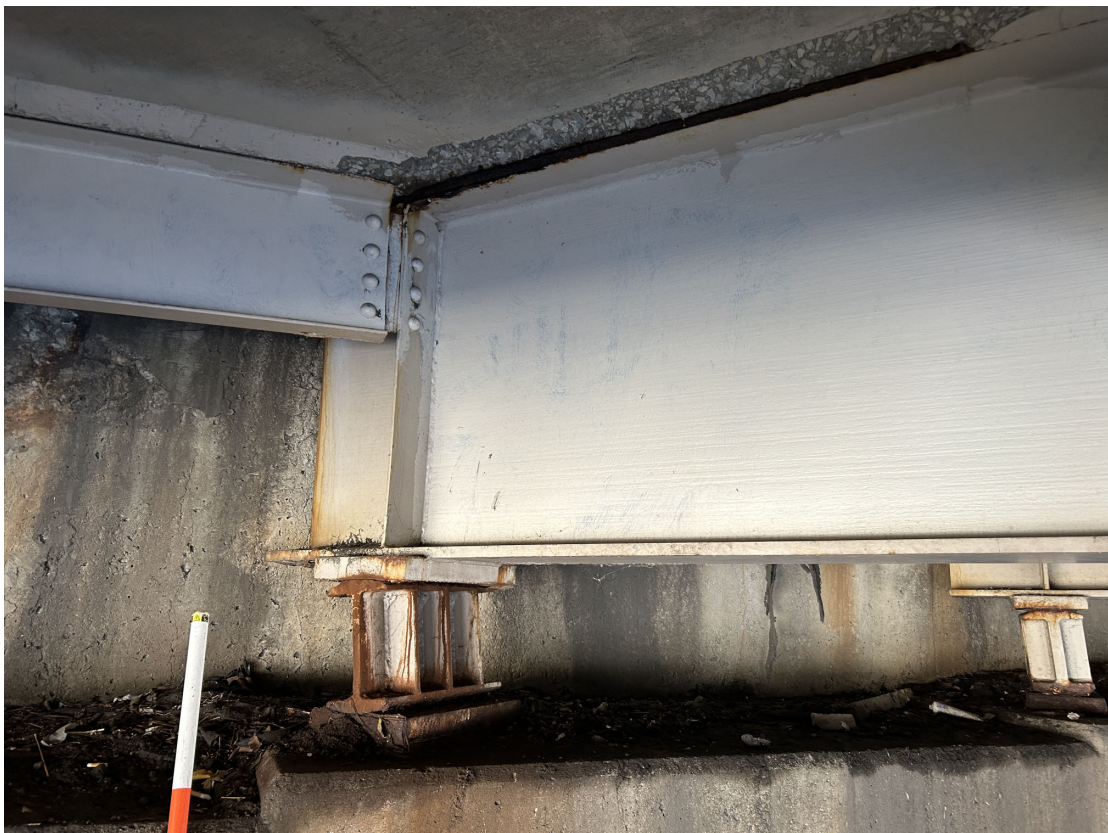
Girder 7 at Abutment 4

Deck and beam move independently under traffic. Deck haunch is spalled, plus beam is not in contact with the bearing when not under live load.
