# Bridge Inspection Report

056B00180N

12/11/2024

IDENTIFICATION			
Structure Num (8):	056B00180N		
NBI Number	056B00180N		
Structure Name:			
Location (9):	2.1 MI N OF I-264		
Carries (7):	I-65		
Type of Service (42A):	1 Highway		
Feature Crossed (6):	US 60A (EASTERN PKWY)		
Type of Service (42B):	1 Highway		
Placecode (4):	Not Applicable		
County (3):	Jefferson (056)		
State (1):	21 Kentucky		
Admin Area:	Inventory		
District:	District 5		
Latitude (16):	38° 12' 44"		
Longitude (17):	85° 45' 10"		
Owner (22):	State Highway Agency		
Maint. Resp. (21):	State Highway Agency		
Year Built (27):	1957	Border State (98A):	Not Applicable (P)
Year Recon (106):	1982	Border Number (99):	
		% Responsibility (98B):

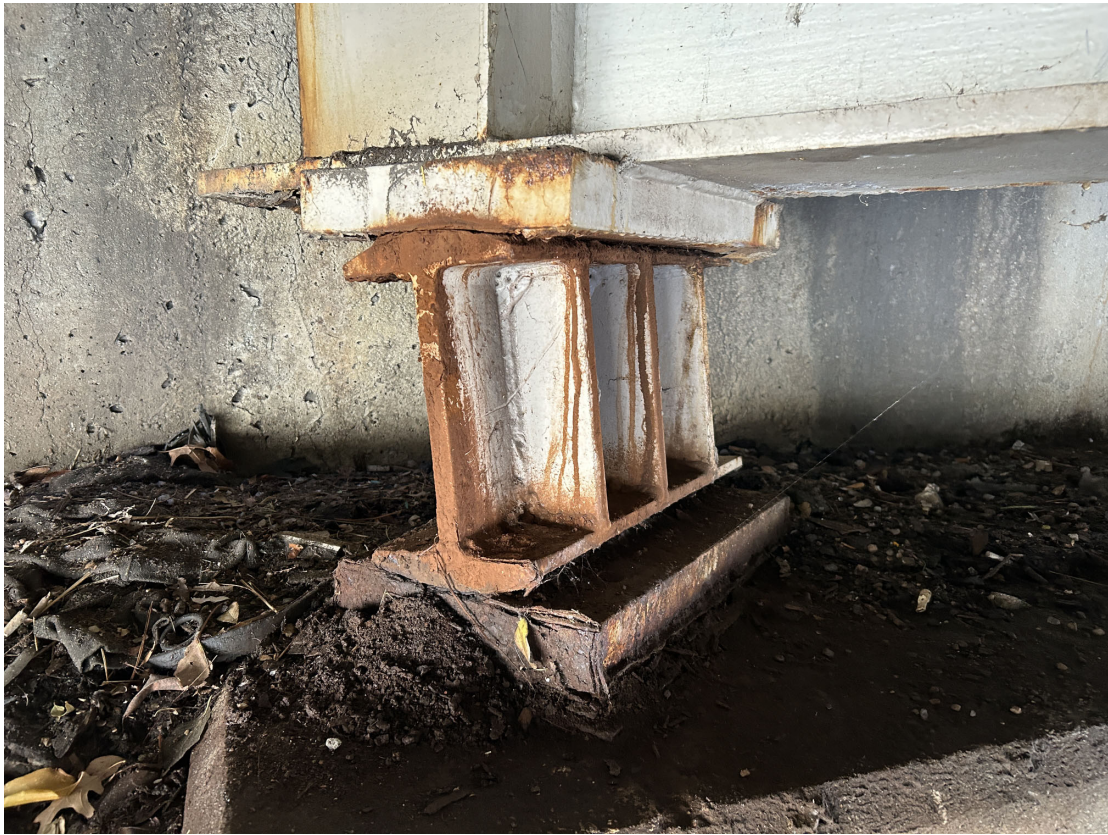
Close-up of Girder 7 bearing with fretting rust. Rocker can be moved slightly by hand.

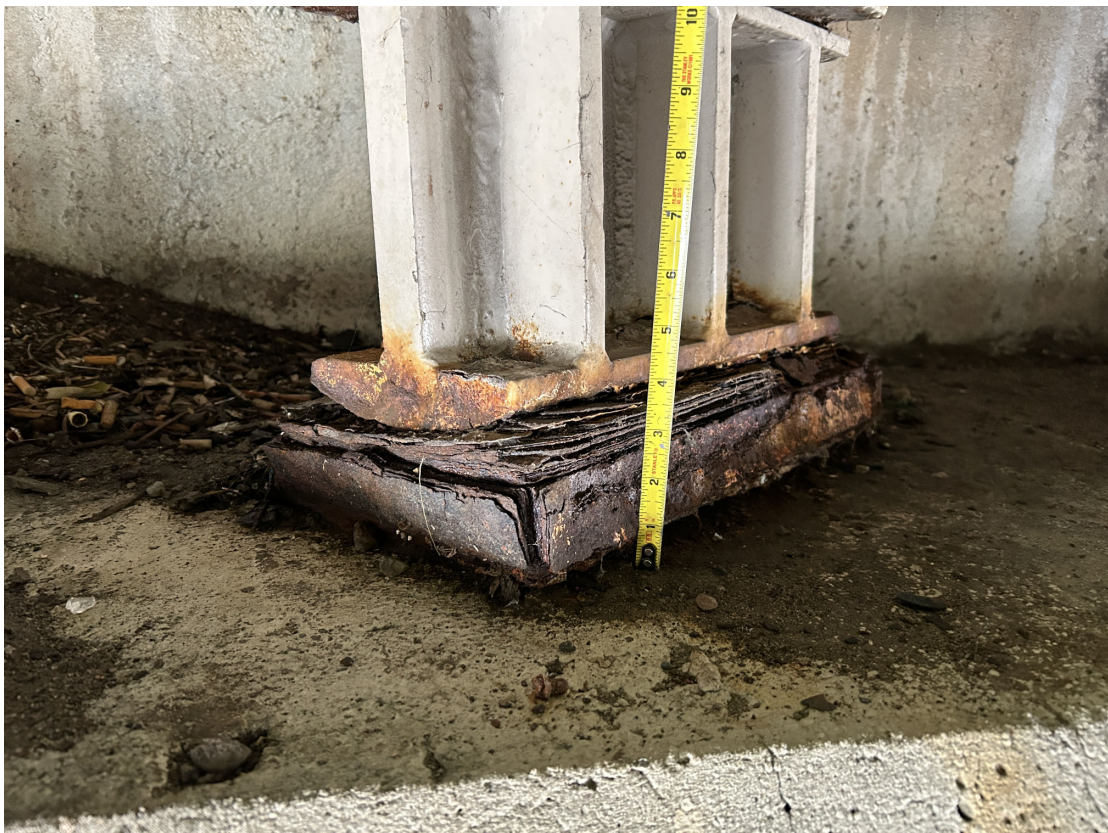
Abutment bearings typically have pack rust and section loss, primarily along the masonry plates. Example at Abutment 4 Girder 10.

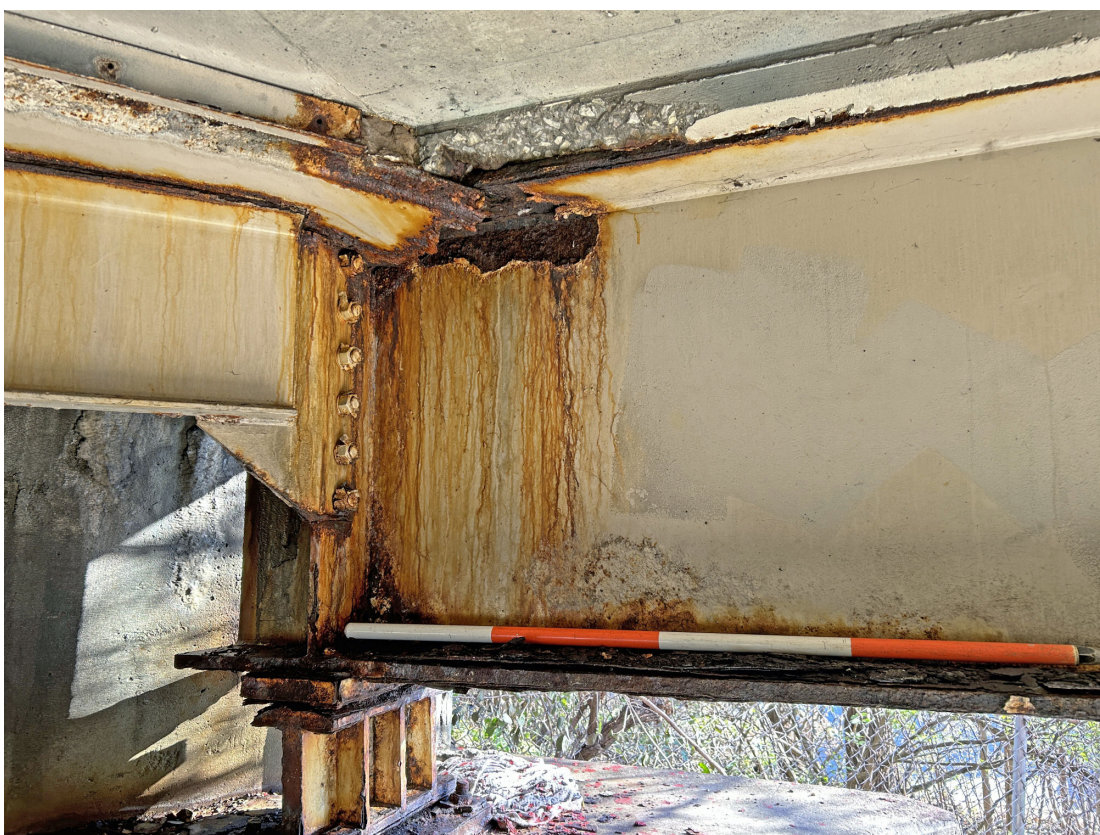
Girder 18 has corrosion with section loss at Abutment 4 end.

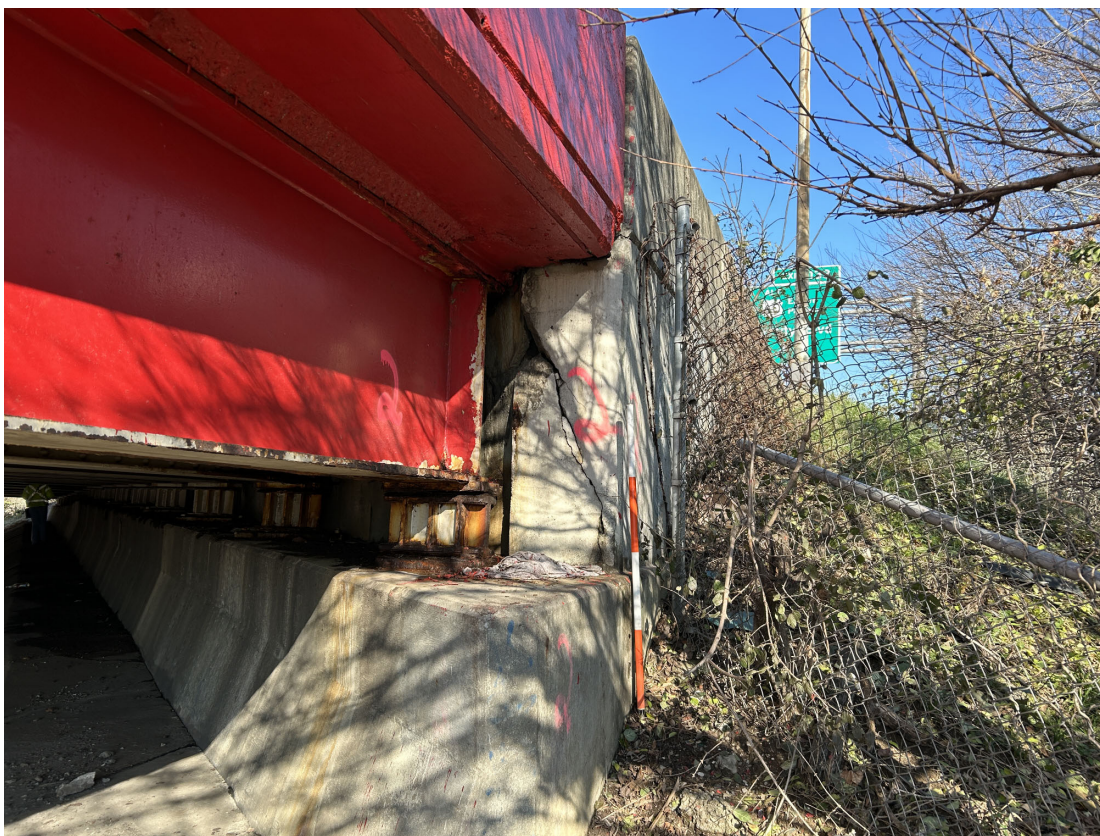
East end of Abutment 4 has a wide crack in the backwall.
