Bridge Inspection Report

056B00181N

12/11/2024

<u>IDENTIFICATION</u>			
Structure Num (8):	056B00181N		
NBI Number	056B00181N		
Structure Name:			
Location (9):	0.15 MI N OF US 60A		
Carries (7):	I-65		
Type of Service (42A):	1 Highway		
Feature Crossed (6):	UNIVERSITY BLVD		
Type of Service (42B):	1 Highway		
Placecode (4):	Not Applicable		
County (3):	Jefferson (056)		
State (1):	21 Kentucky		
Admin Area:	Inventory		
District:	District 5		
Latitude (16):	38° 12' 52"		
Longitude (17):	85° 45' 9"		
Owner (22):	State Highway Agency		
Maint. Resp. (21):	State Highway Agency		
Year Built (27):	1957	Border State (98A):	Not Applicable (P)
Year Recon (106):	1982	Border Number (99):	
		% Responsibility (98B):

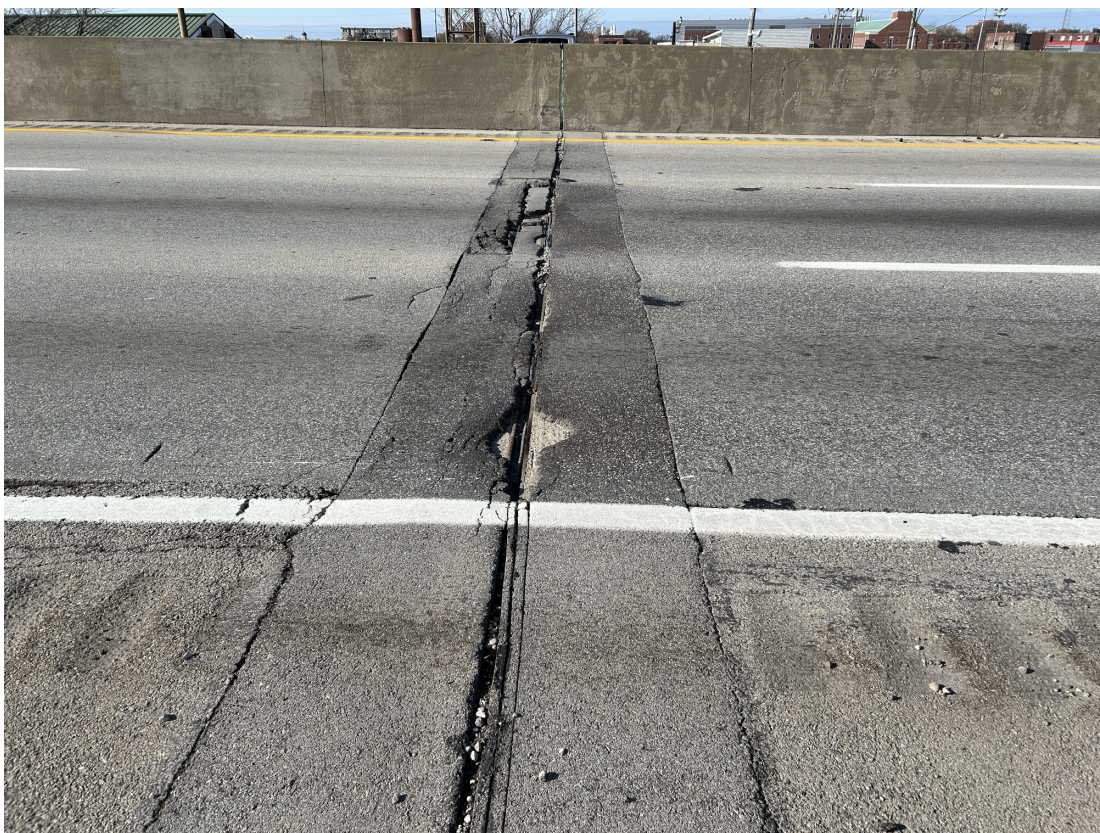
Asphalt plug joint over Abutment 1 NB

The asphalt plug joints are located at the abutments and were installed over the existing joints in 2012, and redone in 2017. Plug joints have failed nearly throughout the traffic lanes, exposing portions of the original joints and allowing free flow of water through the joints. Deterioration is less in the shoulders, with a few areas of moderate to wide cracking.

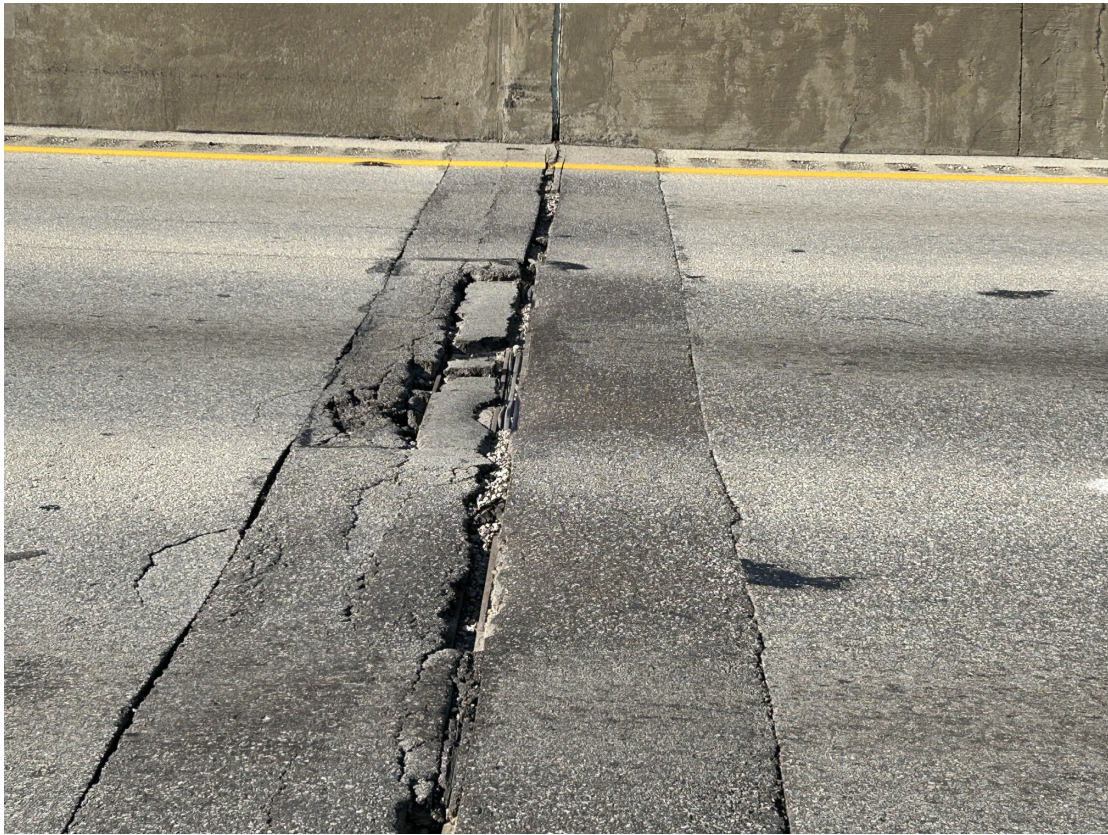
Joint and pavement over the Abutment 1 backwall in the center NB lane is breaking up.

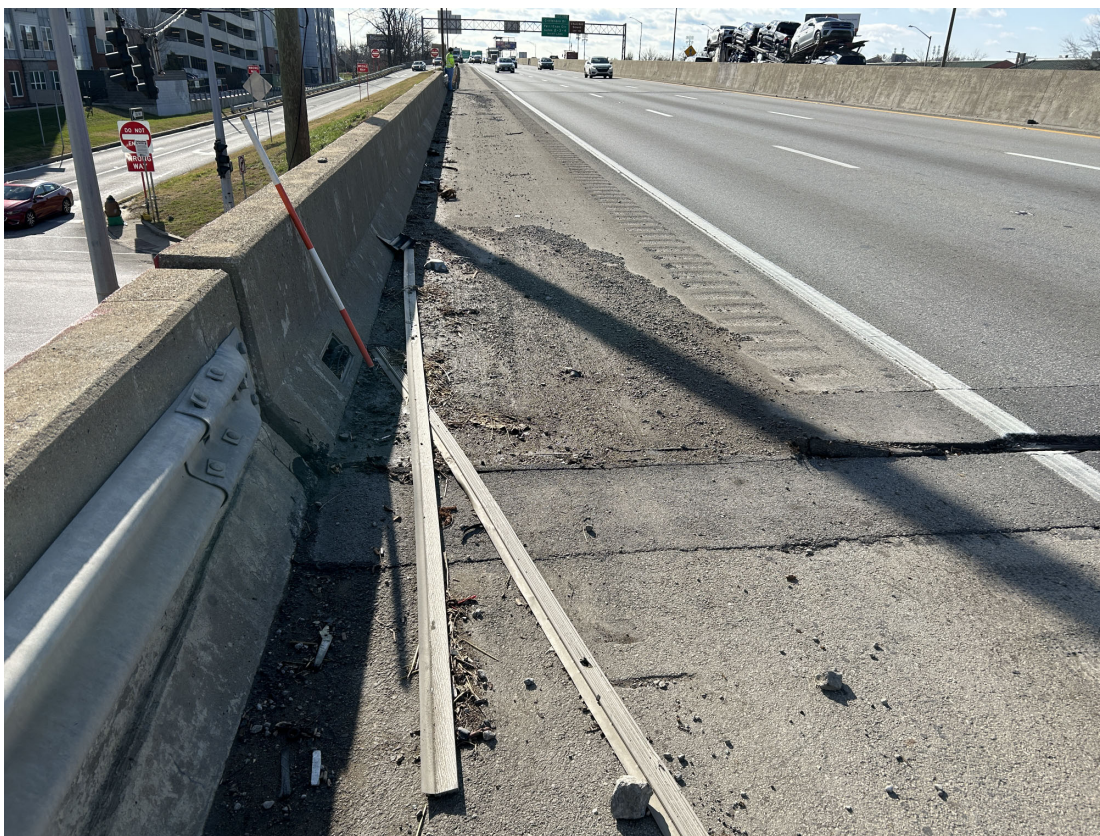
Debris accumulating in the NE shoulder.

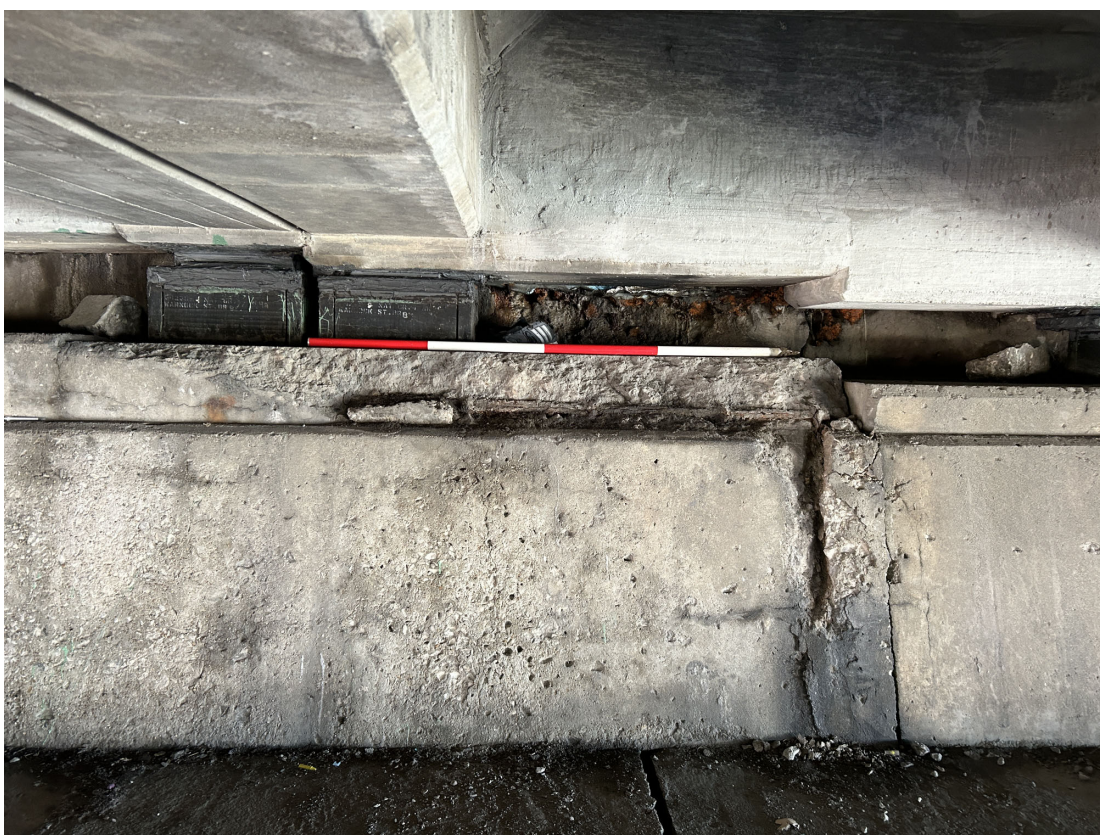
Quantity includes parallel wingwalls at the abutments. The abutments have moderate width horizontal cracking below the beam seats and the backwalls have widespread patching and cracking. Abutments have deep spalls with exposed rebar at the ends of the original abutments (west side of Beam 7 and east side of Beam 12). Abutment 1 also has a wide horizontal crack with a delamination in the cap between Beams 15 and 16. Abutment 4 has more widespread spalling with exposed rebar in the beam seat and the backwall, especially in the east half. There is a wide crack and spall in the Abutment 4 backwall at the west end, and the NW wingwall it tilted out, measuring 1.5 inch lateral offset at the top of the railing.

Abutments have spalling along the beam seats and backwalls. Abutment 1 at Girder 7 shown.

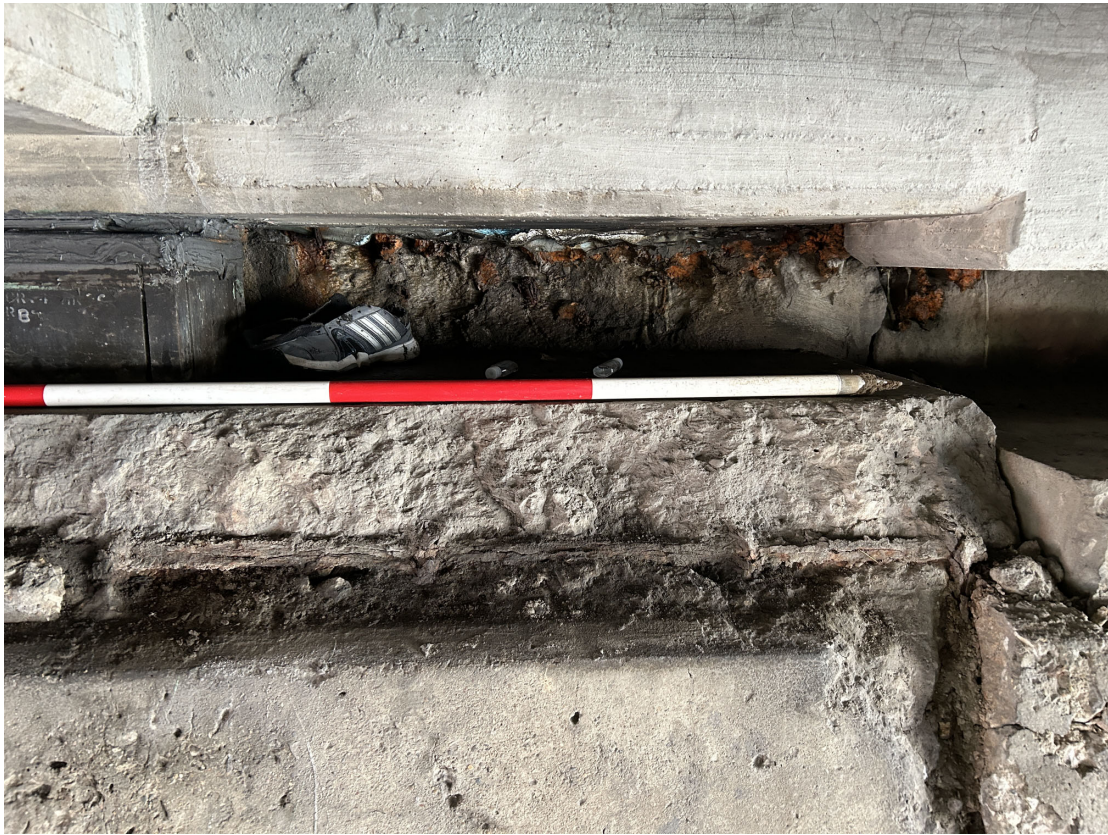
Close-up of deep spalling in Abutment 1 west of Girder 7 at end of original abutment.

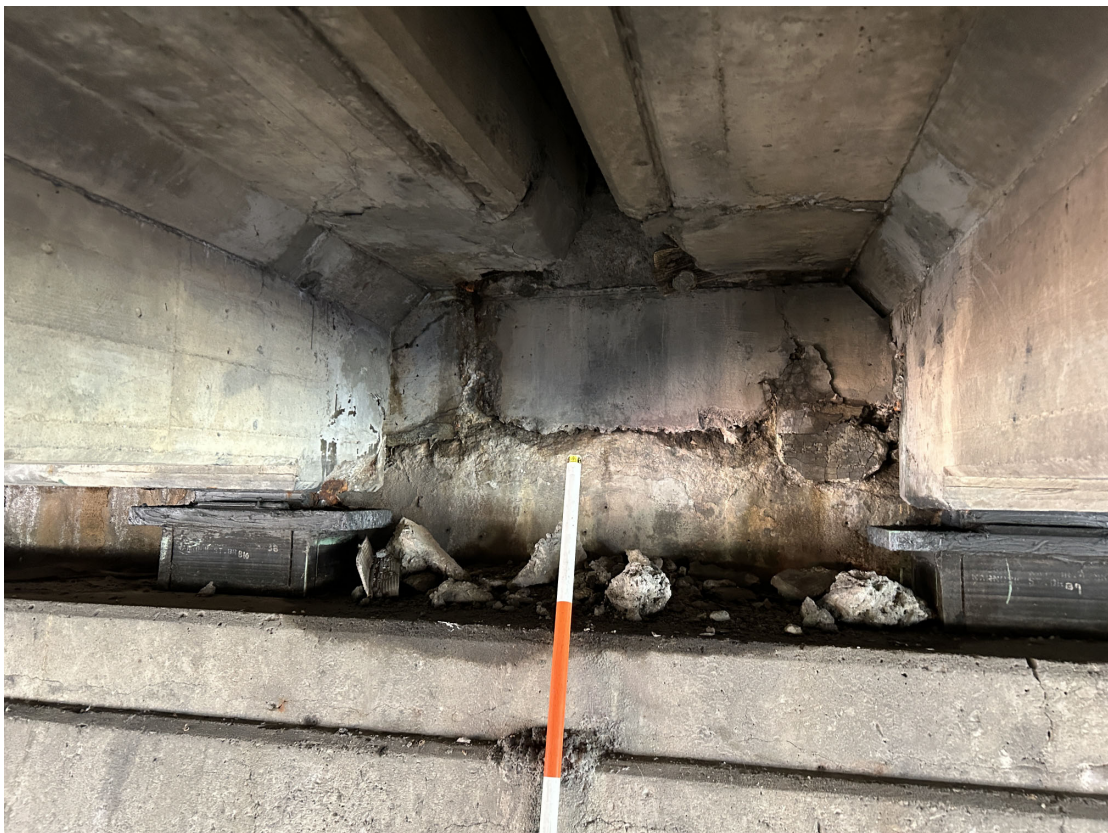
Failing patching in the backwall of Abutment 1 at the I-65 centerline.

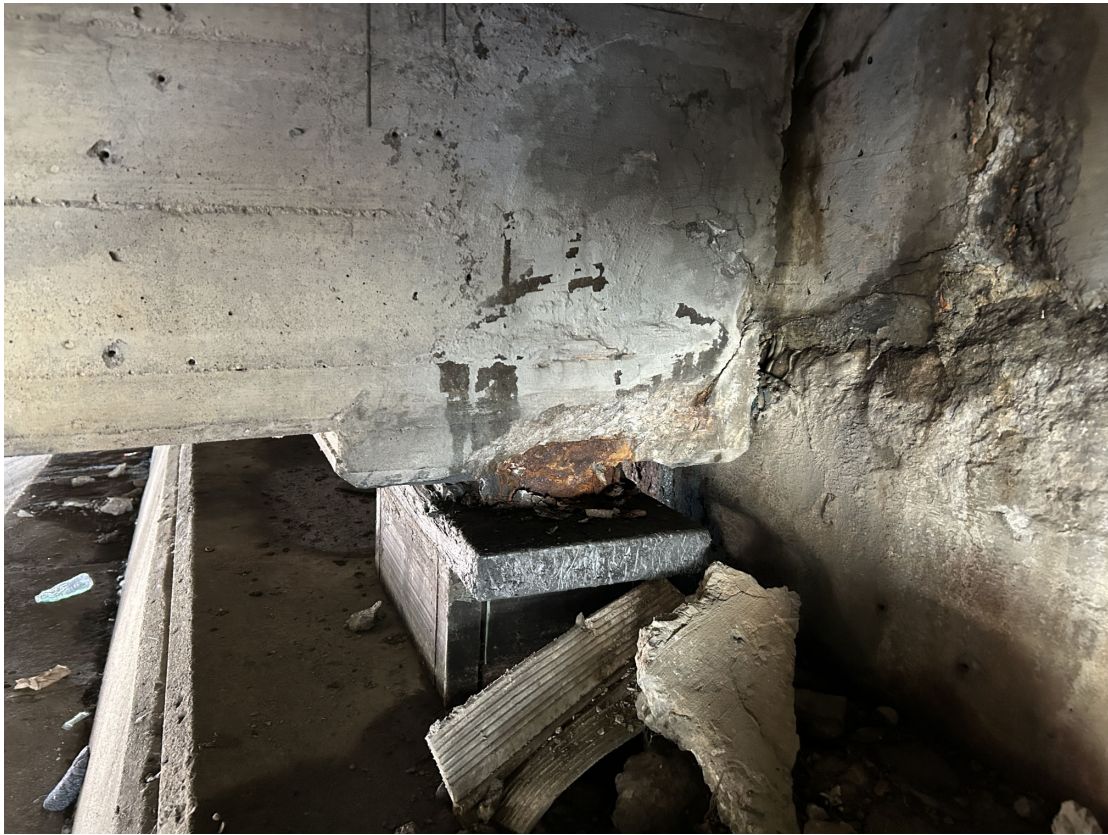
Several beams have sound patching along the top of the webs in all spans, with a 3-foot long unsound area in Beam 12 near Abutment 4. Beams in Span 2 have scattered transverse cracks with some efflorescence. At Abutment 1, Beam 10 has a 12 inch (L) x 4-inch (H) x 1.75-inch (D) spall above the bearing; there are similar spalls at Abutment 4 at Beams 5, 12, 13, and 15. In Span 2, Beam 18 has scrapes and spalls from impact damage, six are greater than 6-inch diameter or 1 inch deep. Beam 16 at Abutment 4 has moderate cracking. Exterior beams have been painted by the University of Louisville.

Girder 10 has a spall at the bearing at Abutment 1 end.

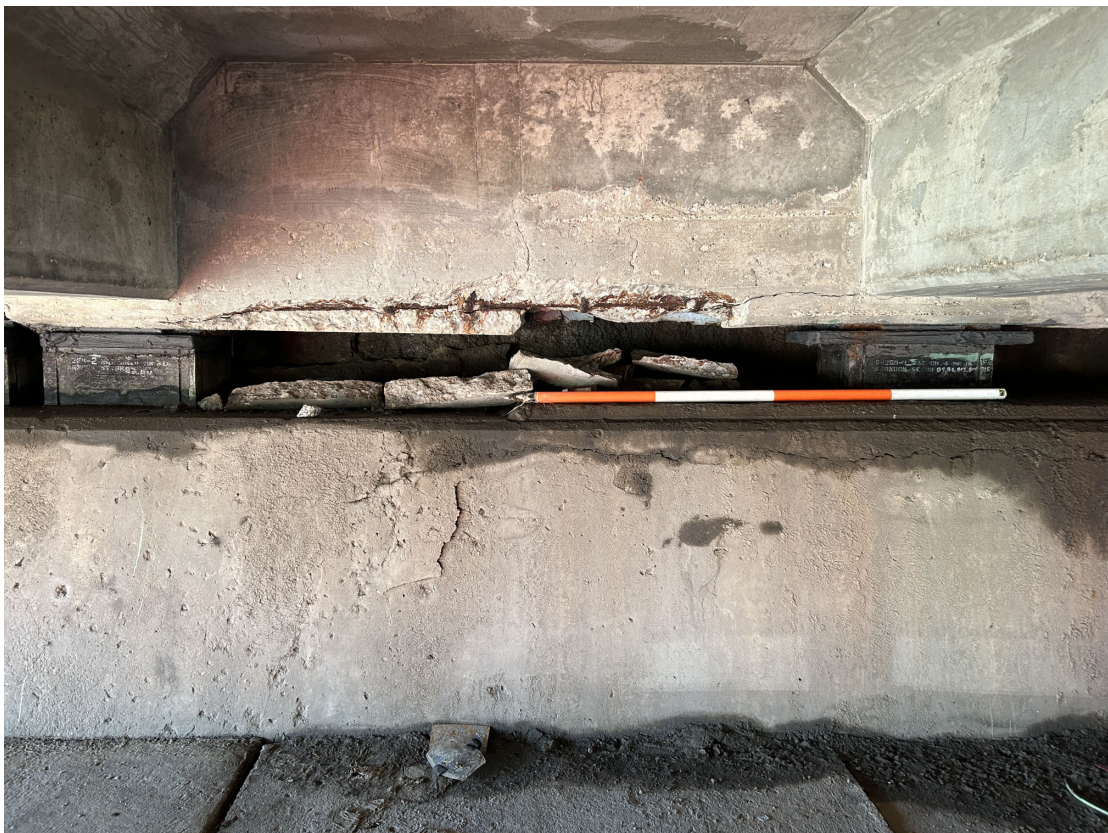
The diaphragms have moderate width to wide cracks and spalls at the abutments; most have been patched but many patches are unsound. The worst deterioration is below the longitudinal joint.

End diaphragms have numerous spalls and cracks. Abutment 1 end diaphragm between Girders 15 and 16 shown.

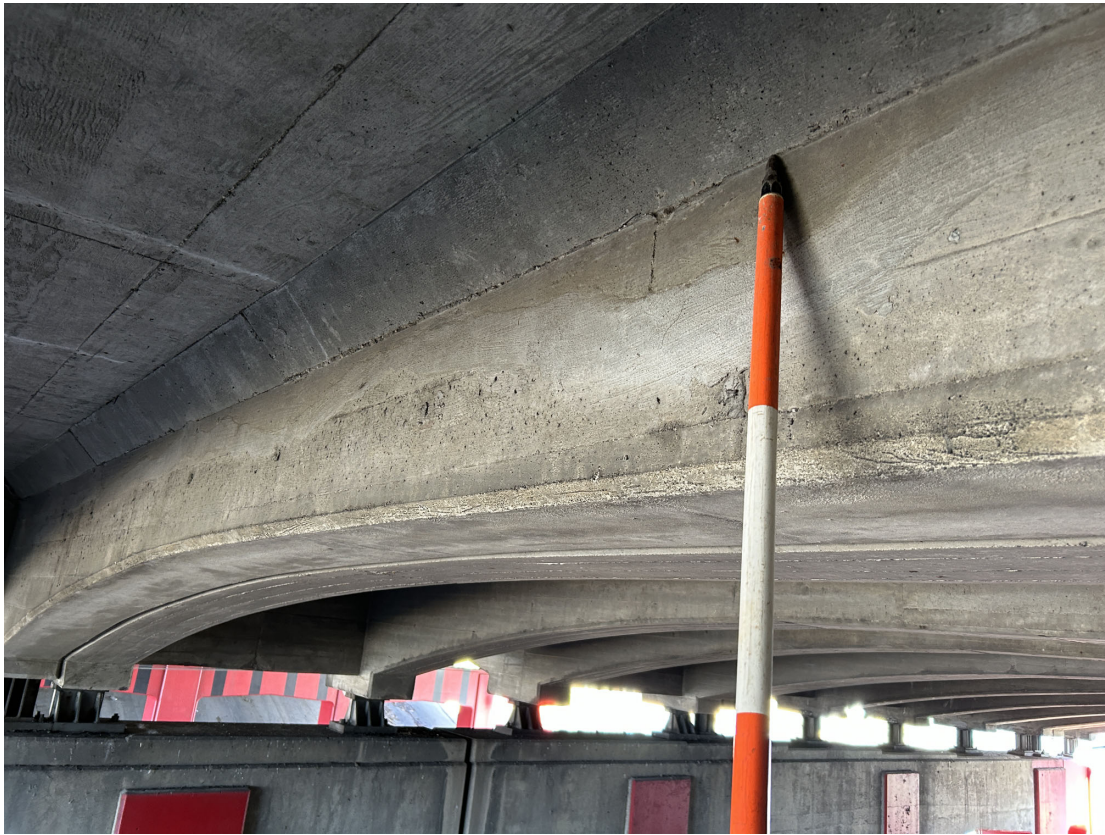
Several girders have sound concrete patching along the top of the webs in all three spans. Example along Girder 7 in Span 1.

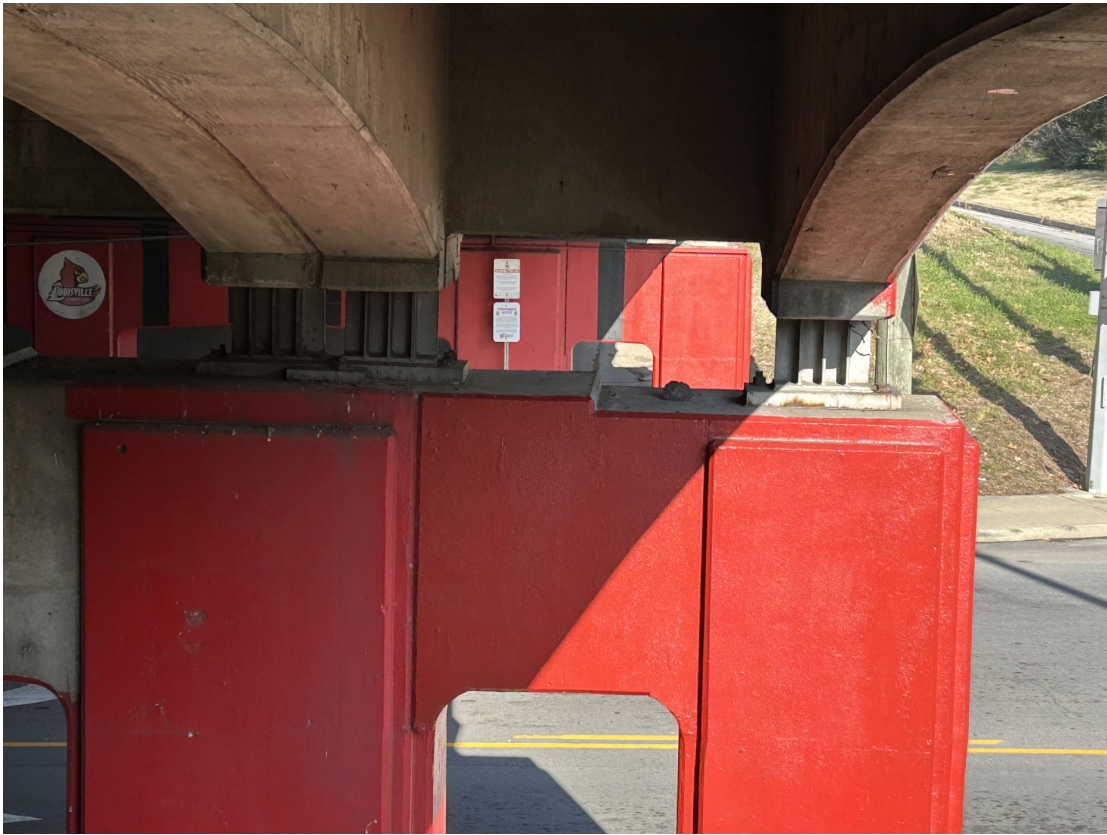
The fixed bearings at Pier 2 have surface corrosion scattered throughout.

Typical fixed bearing at Pier 2 with some surface corrosion.

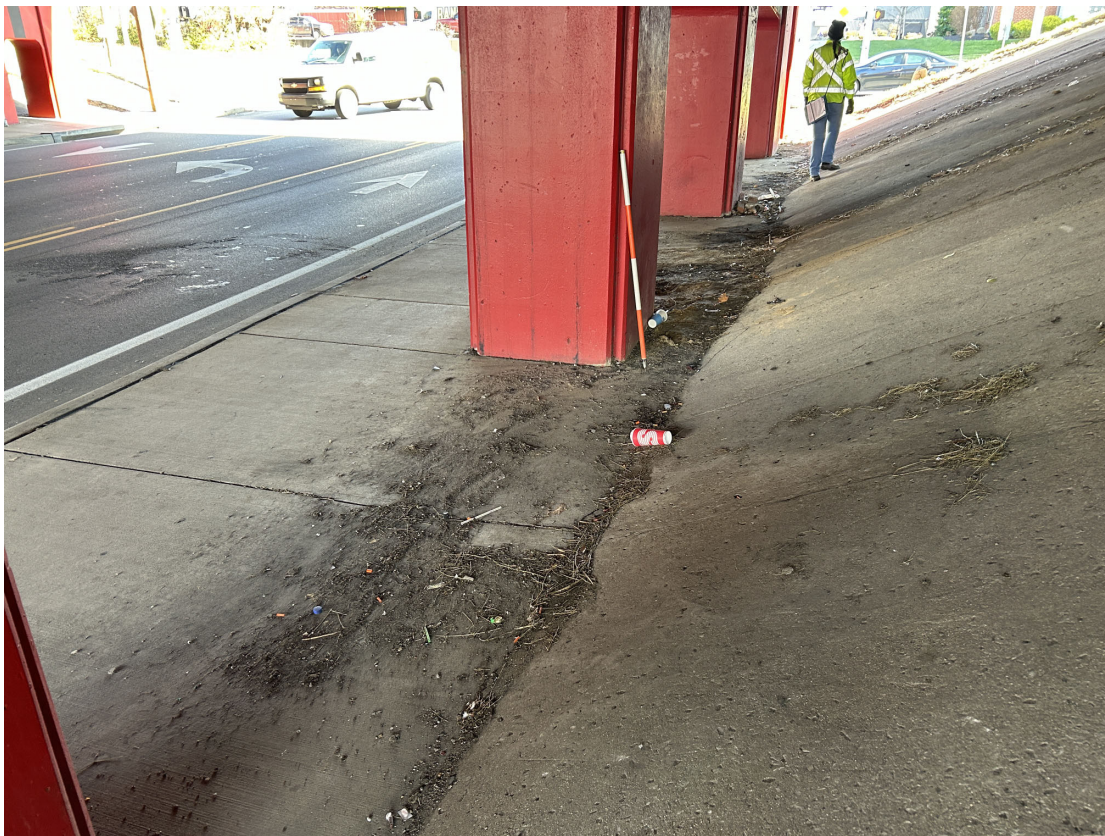
Dirt accumulating along the sidewalk at Pier 2.

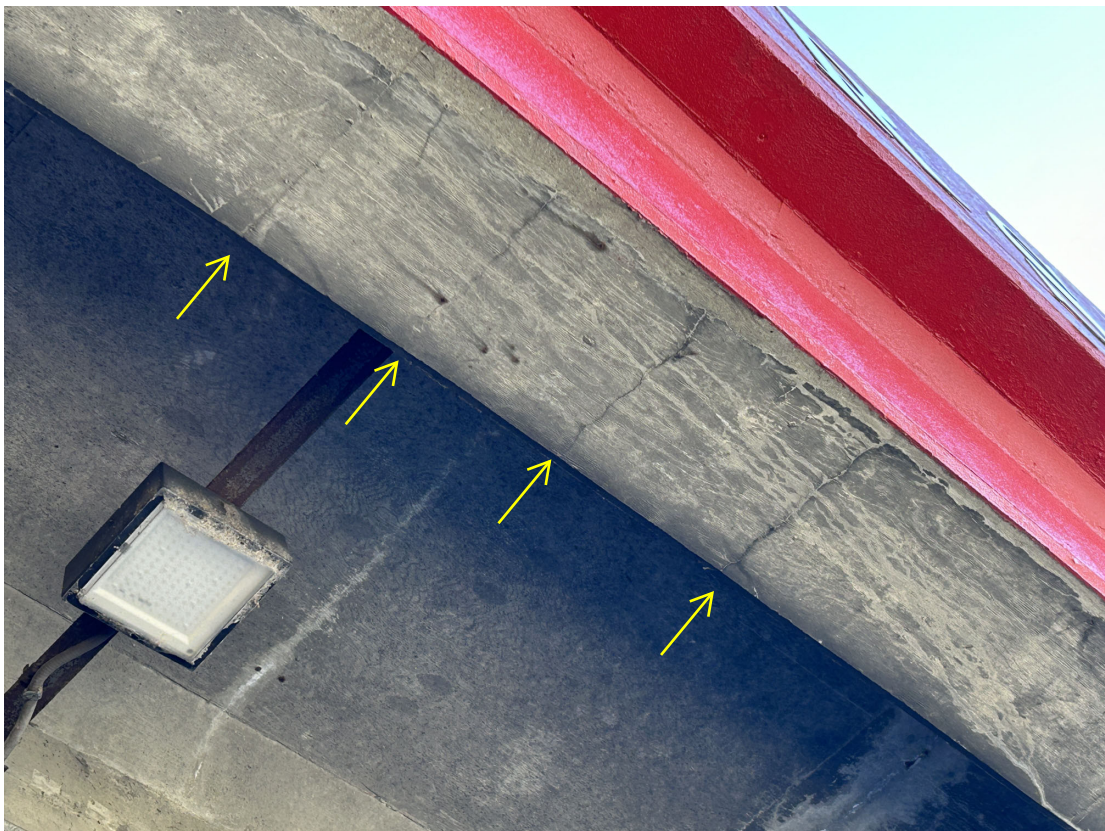
Girder 1 in Span 2 has traverse cracks in the bottom flange spaced just over 1 foot apart.

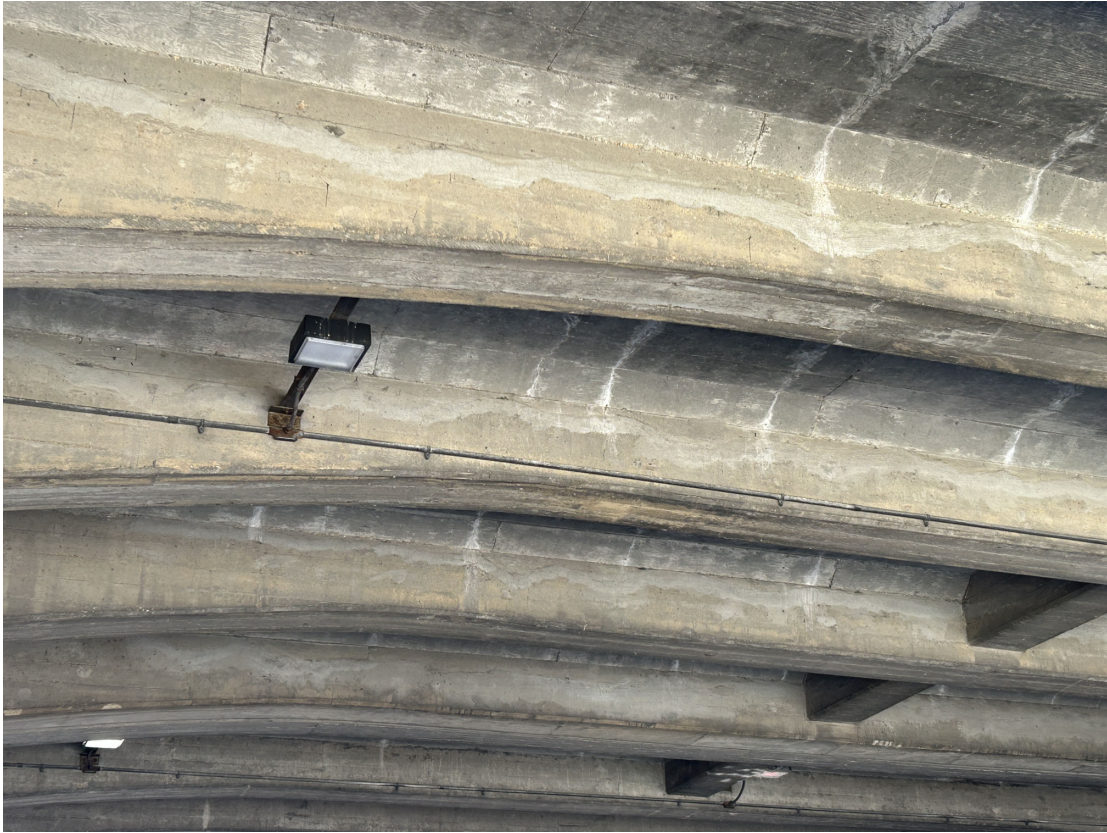
Sound concrete patches along the tops of the girder webs in Span 2, plus transverse cracking in the deck soffit.

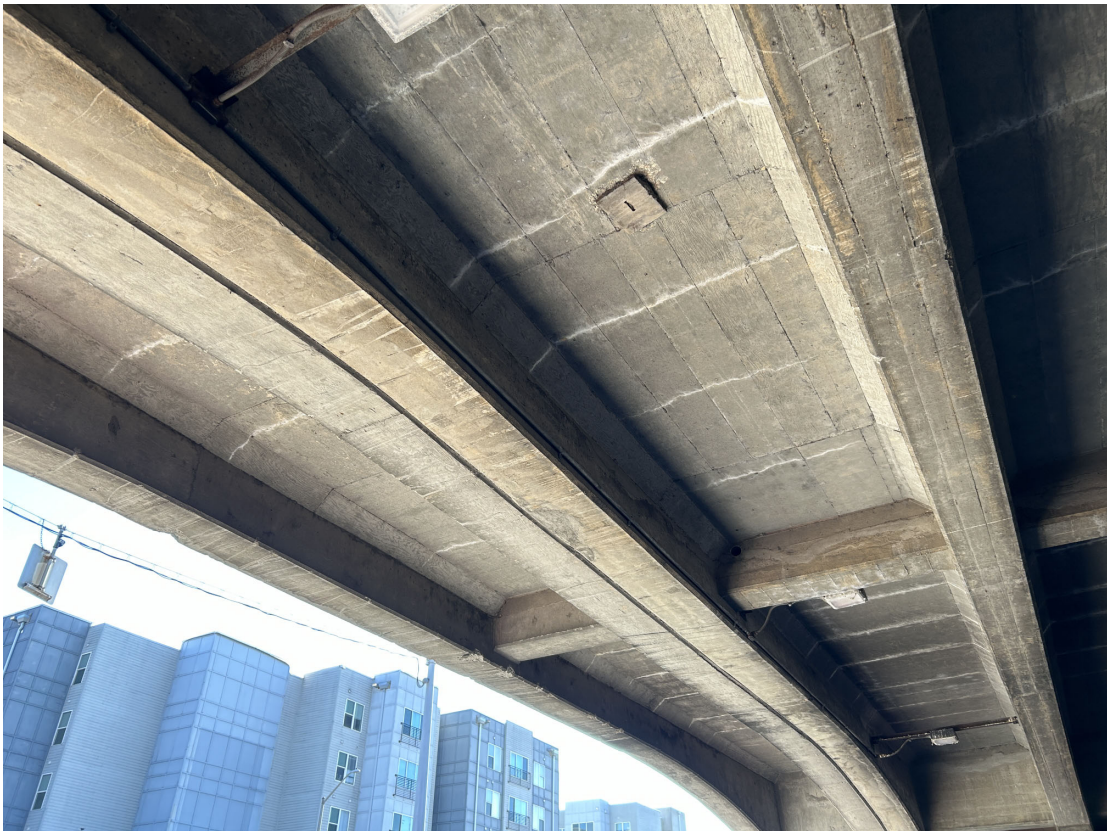
The top surface is not visible for inspection due to asphalt overlay. However, an infrared thermographic deck scan was completed by AECOM. Scan indicated small areas of delamination scattered in Span 2 and in the SB right lane in Span 1. The soffit has transverse cracking with efflorescence (Span 2 being the worst case with cracks spaced less than 3 feet apart for much of the span) and sound patching in Span 3 Bays 6 and 7. There are cracks with heavy efflorescence, spalls with exposed reinforcement, and unsound patching near the abutments at the longitudinal joint between Beams 9 and 10.

East end of Span 2 soffit showing transverse cracks with efflorescence spaced less than 3 feet apart.

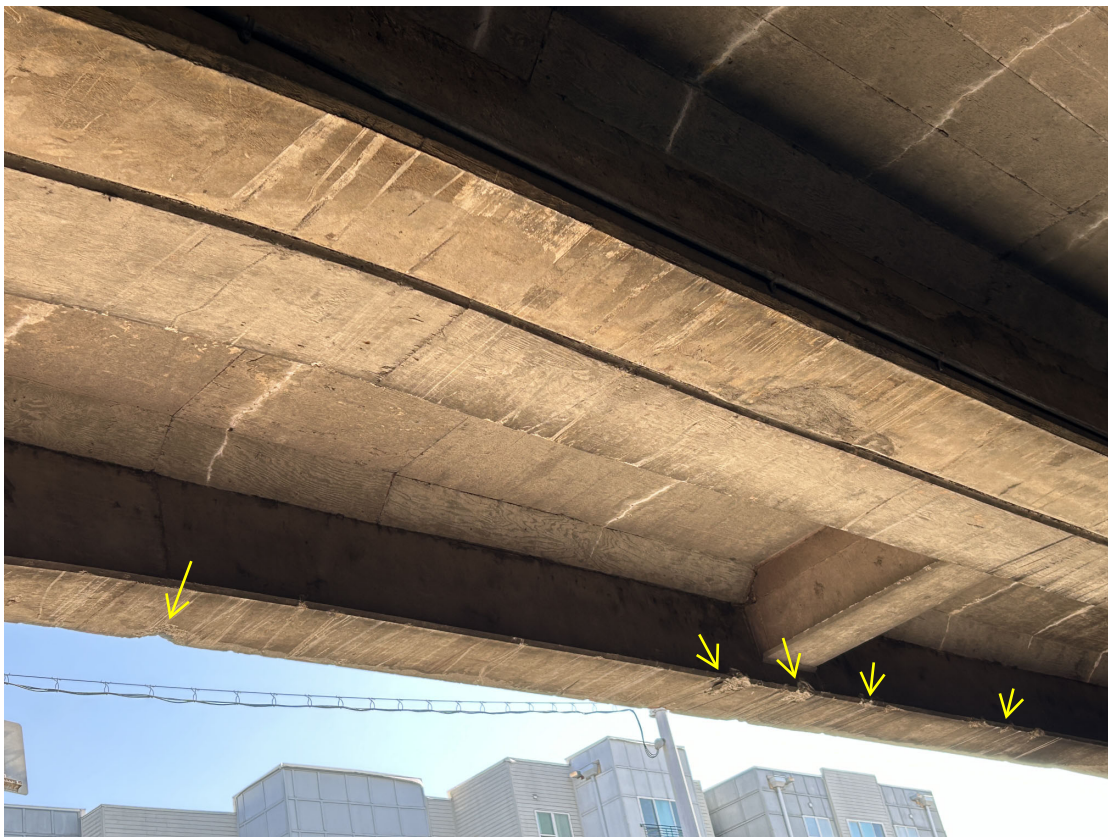
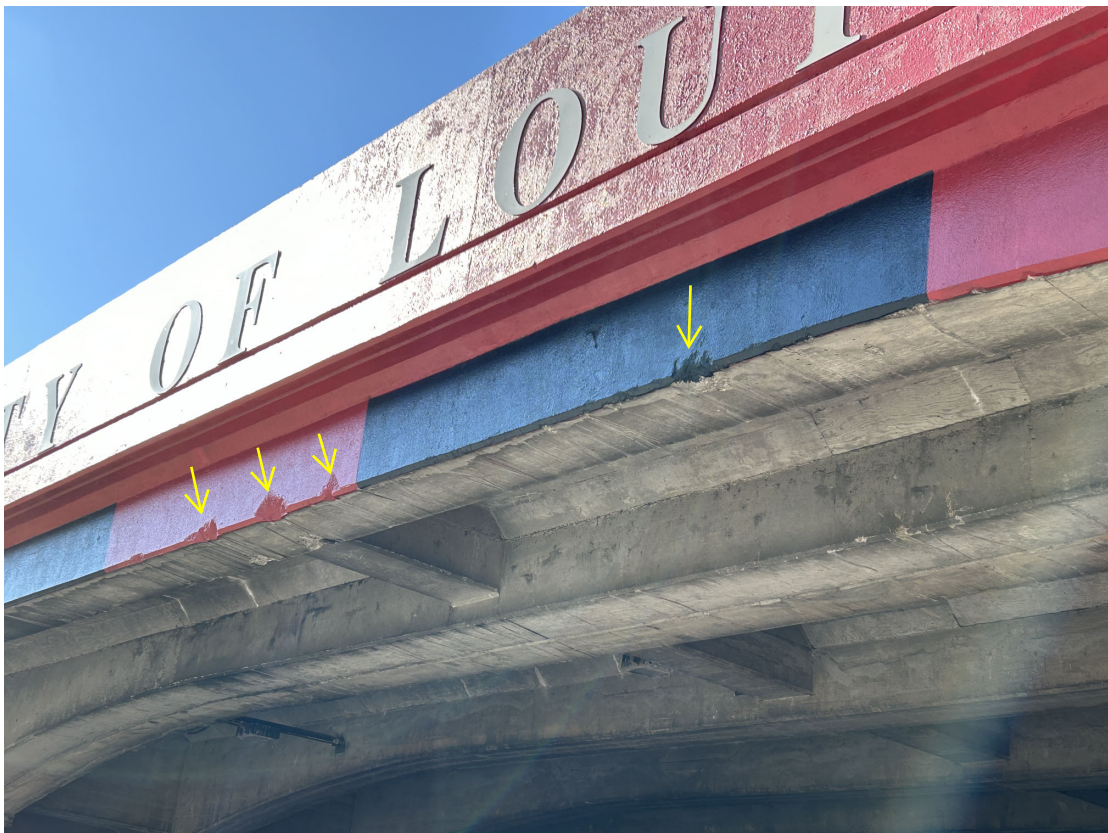
Girder 18 in Span 2 has impact spalls and scrapes.

Another view of Girder 18 in Span 2.

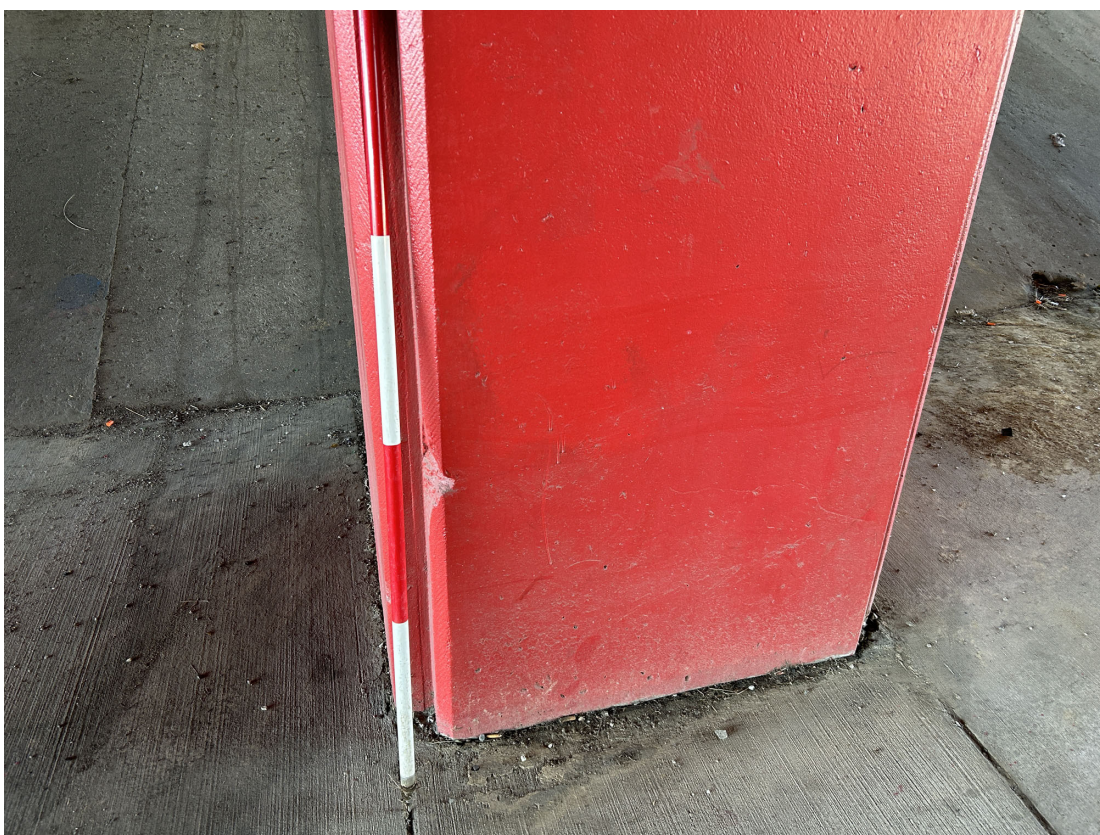
Pier 3-Column 7 has a small spall near the bottom.

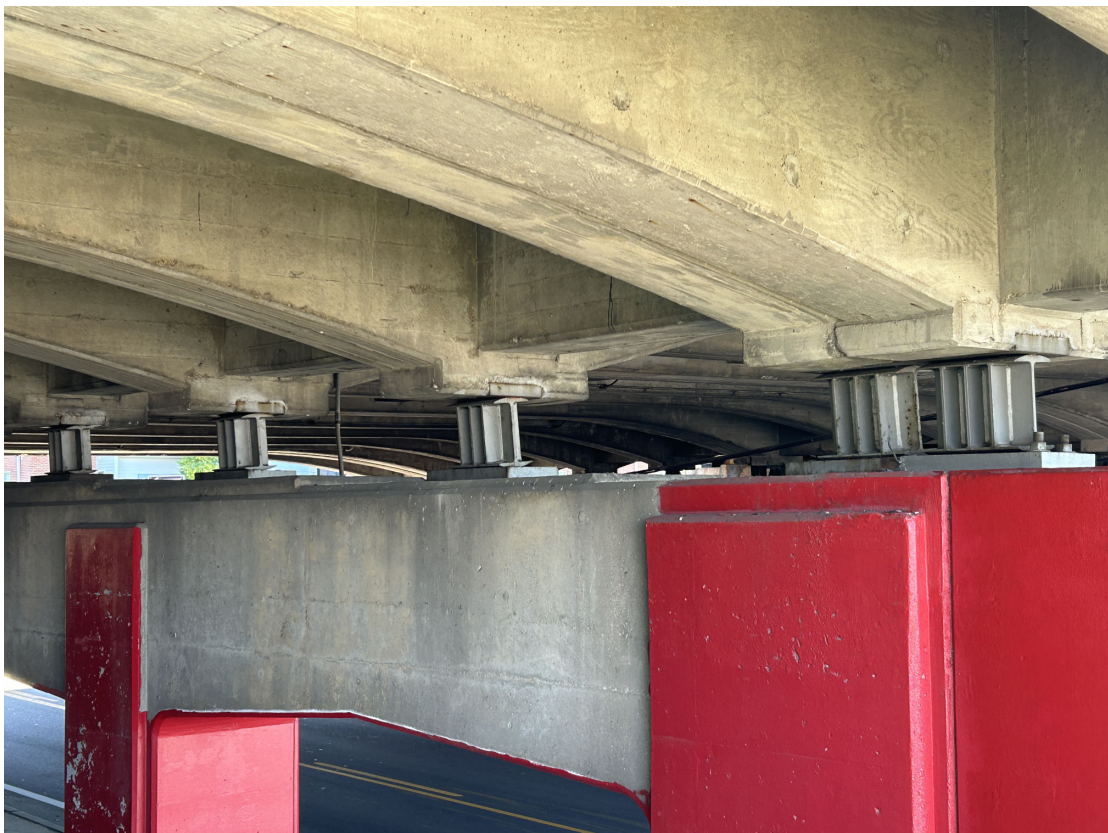
The rocker bearings at Pier 3 have surface corrosion scattered throughout. The bearings within original bridge section are in expansion inconsistent with temperature around 32-degrees F and the other bearings are nearly vertical at the median and exterior widened portions. Pier 3 Bearing 1 has a loose anchor bolt nut.

Pier 3 bearings are expanded towards Abutment 4, inconsistent with ~32 degree weather.

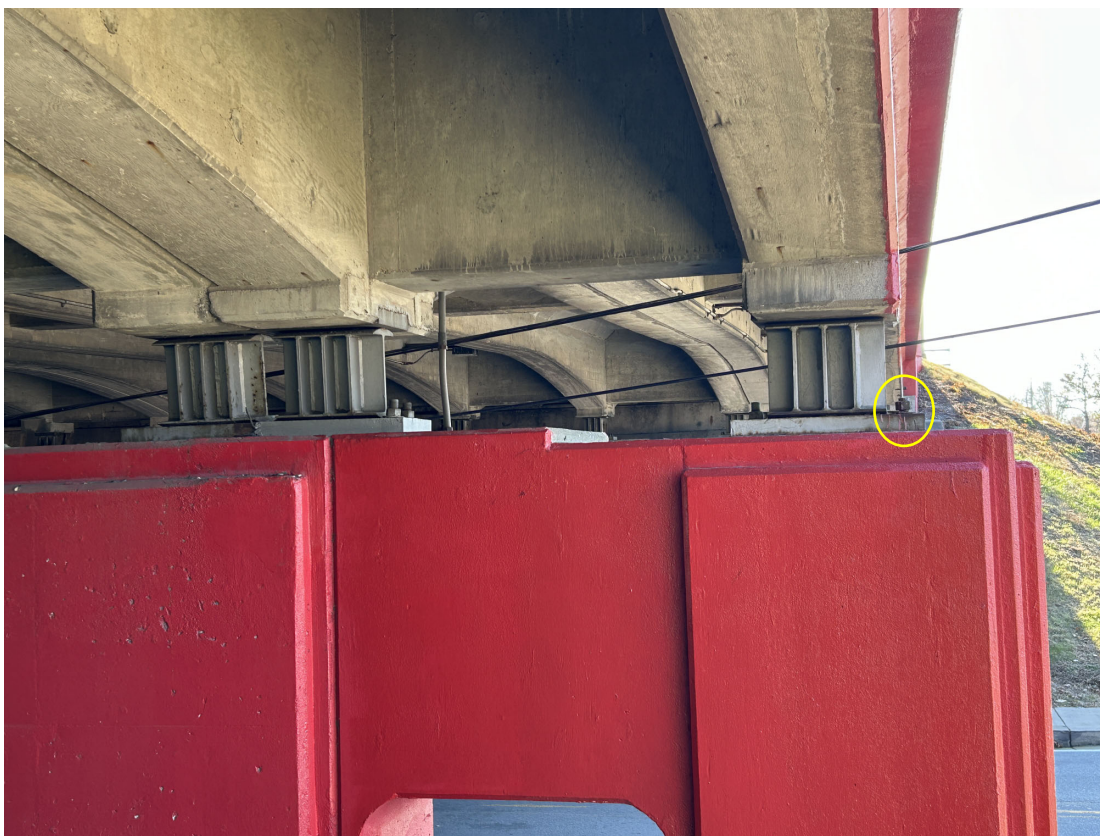
Pier 3-Girder 1 bearing has a loose nut on the NW anchor bolt.

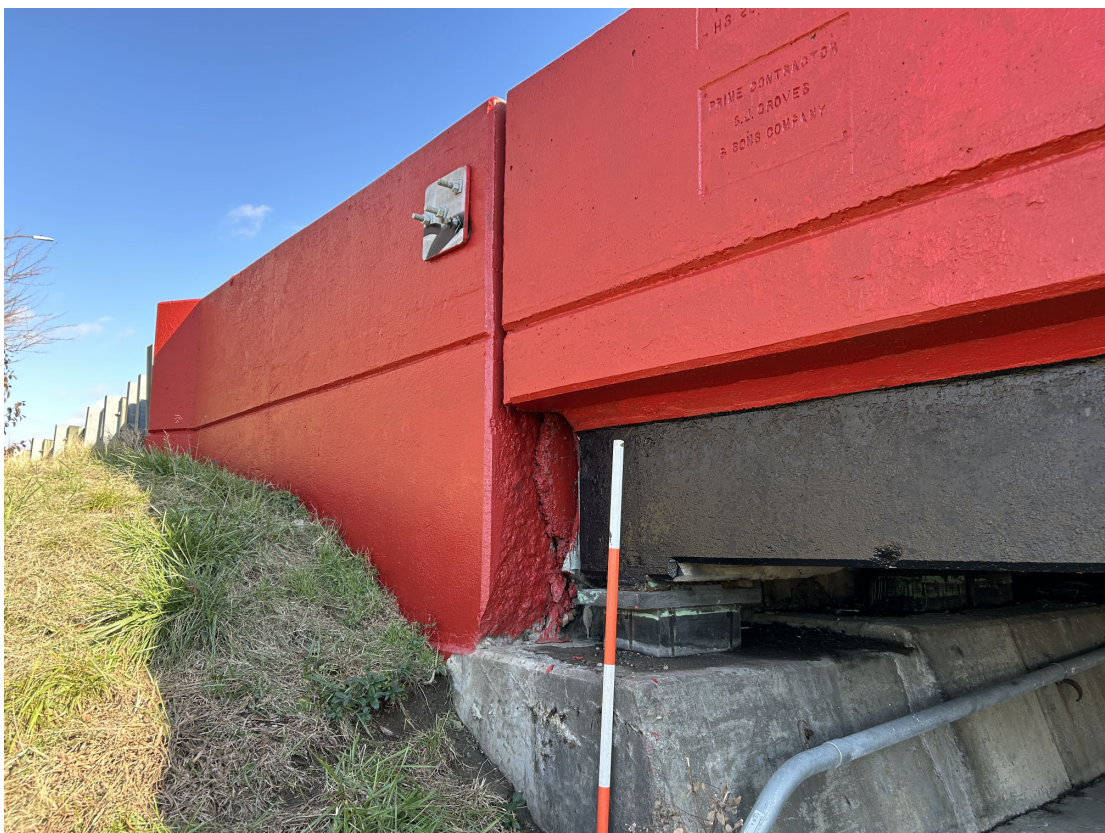
NW wingwall is tilted out and there is spalling at the abutment backwall.

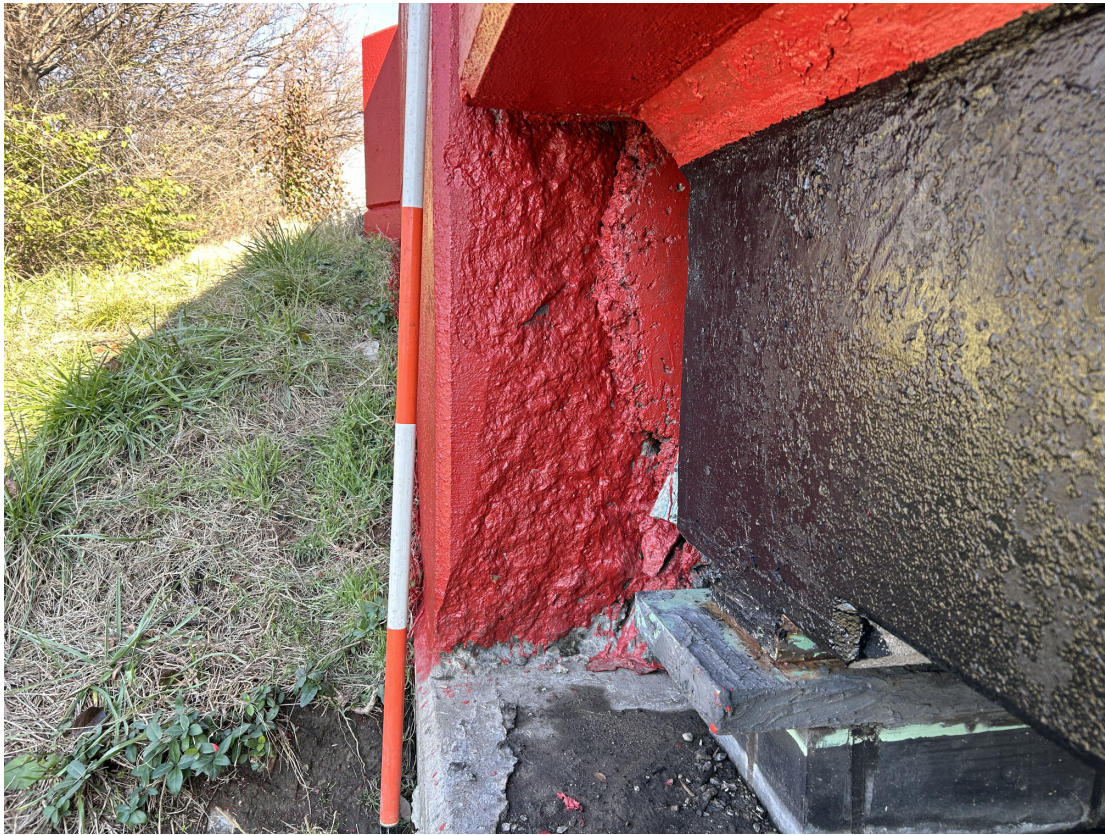
Spalling and cracking at the west end of the Abutment 4 backwall.

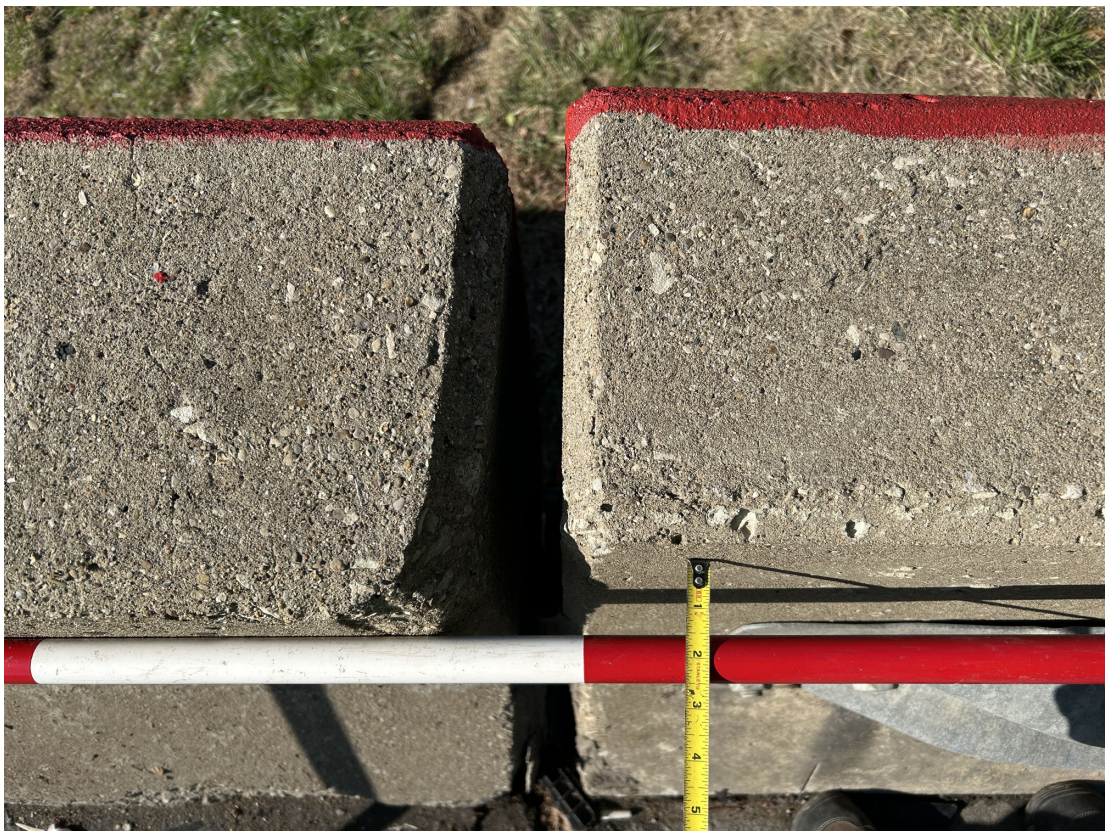
NW wingwall is tilted out 1.5 inches at the top of the rail.

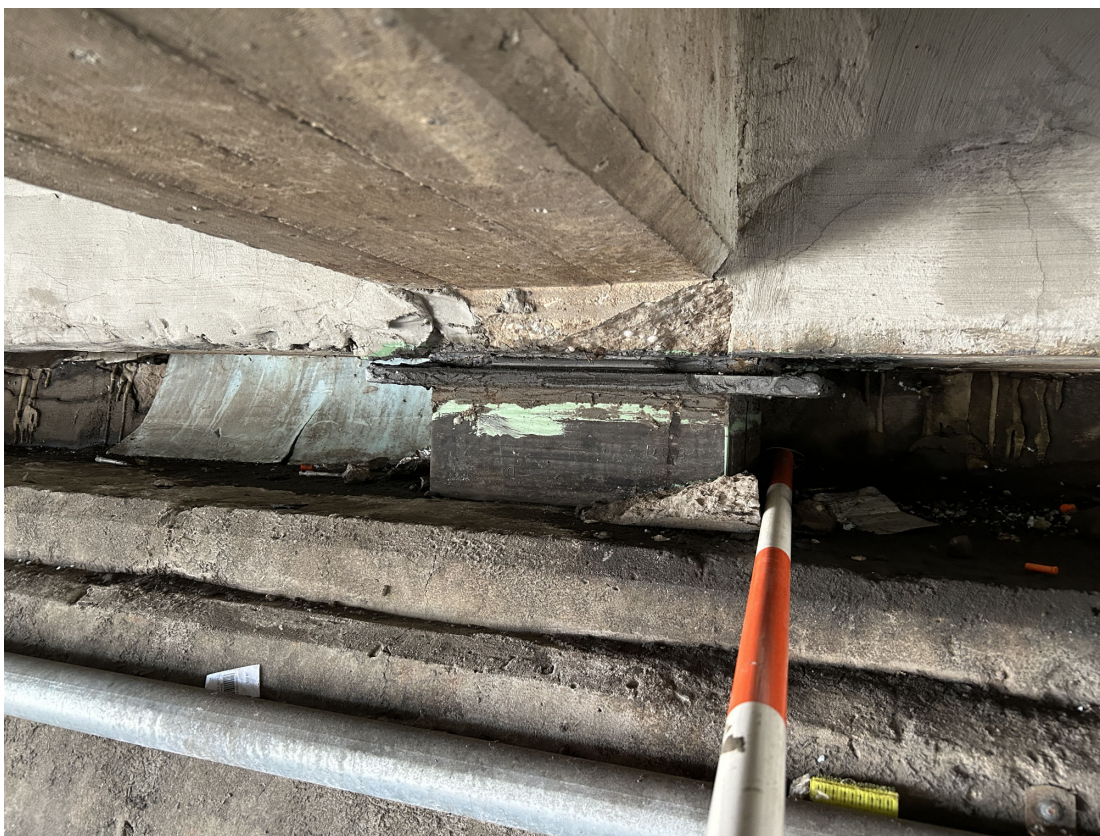
Girder 5 has a spall at the Abutment 4 bearing.
