Bridge Inspection Report

056B00181N

12/11/2024

<u>IDENTIFICATION</u>			
Structure Num (8):	056B00181N		
NBI Number	056B00181N		
Structure Name:			
Location (9):	0.15 MI N OF US 60A		
Carries (7):	I-65		
Type of Service (42A):	1 Highway		
Feature Crossed (6):	UNIVERSITY BLVD		
Type of Service (42B):	1 Highway		
Placecode (4):	Not Applicable		
County (3):	Jefferson (056)		
State (1):	21 Kentucky		
Admin Area:	Inventory		
District:	District 5		
Latitude (16):	38° 12' 52"		
Longitude (17):	85° 45' 9"		
Owner (22):	State Highway Agency		
Maint. Resp. (21):	State Highway Agency		
Year Built (27):	1957	Border State (98A):	Not Applicable (P)
Year Recon (106):	1982	Border Number (99):	
		% Responsibility (98B):

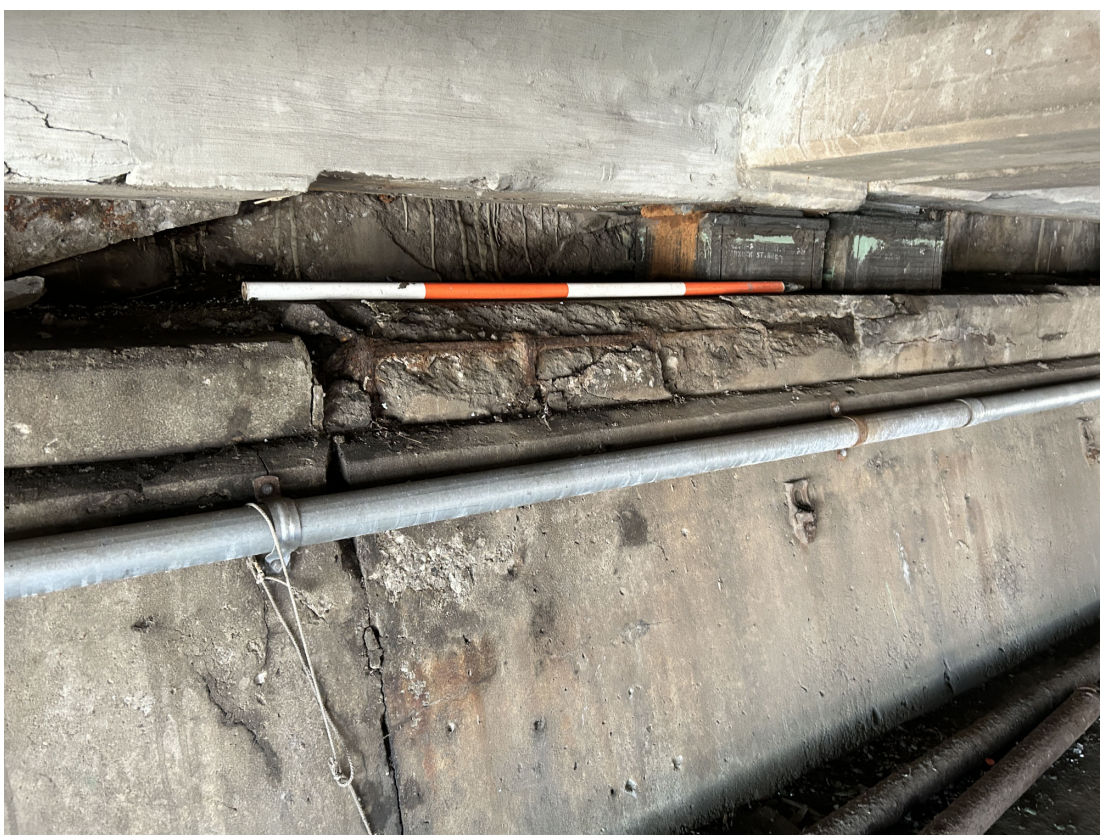
Abutment 4 is spalling at the ends of the original length. Spall between Girders 6 and 7 shown.

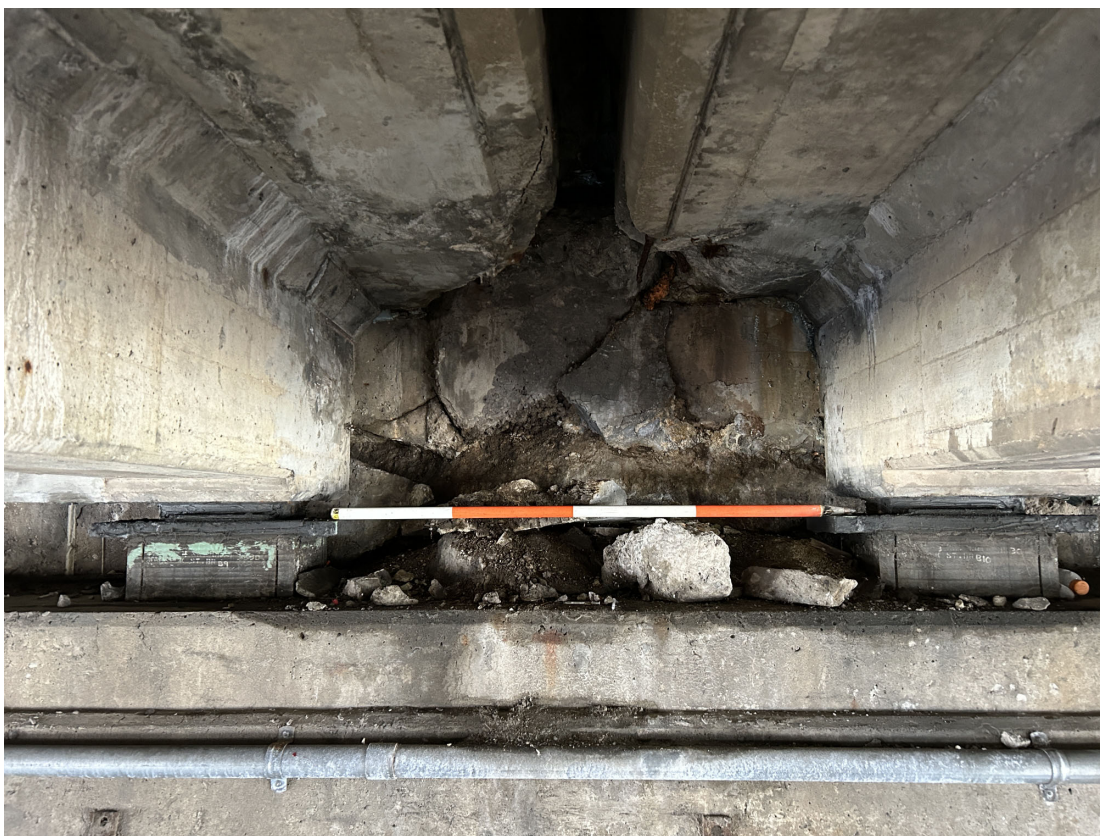
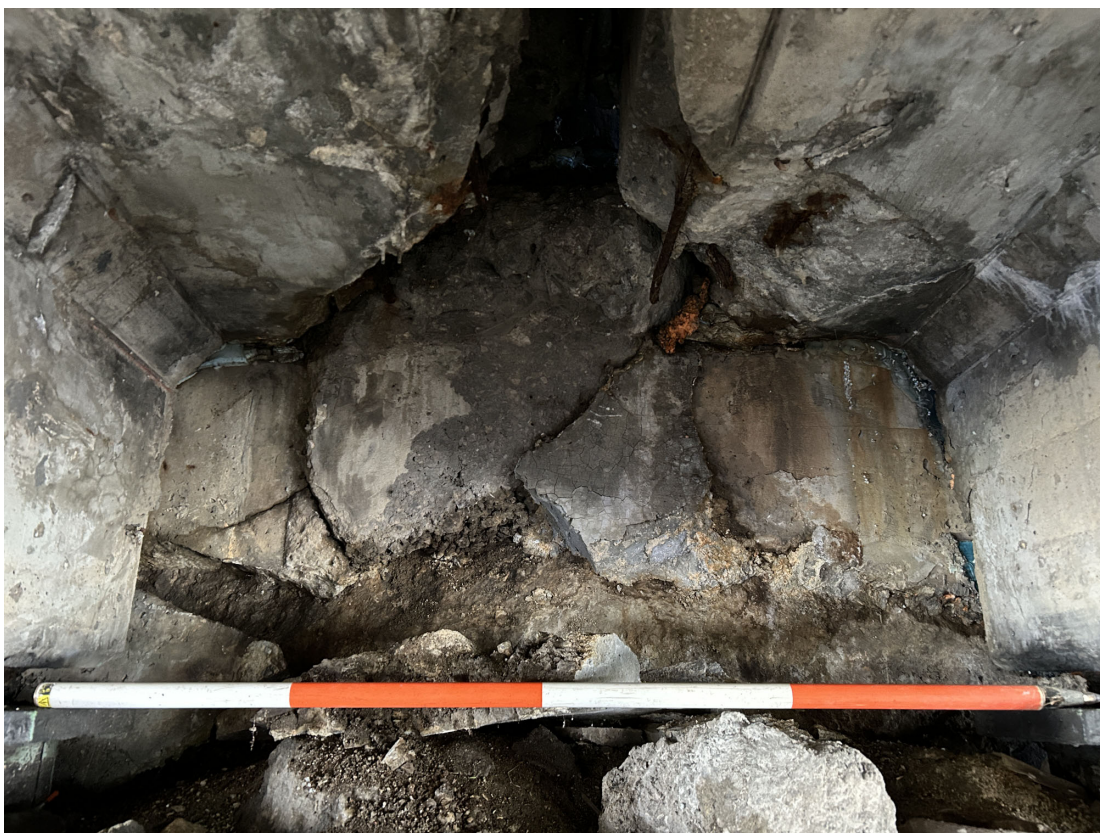
Spalling and failing patch in the Abutment 4 backwall at the I-65 centerline.

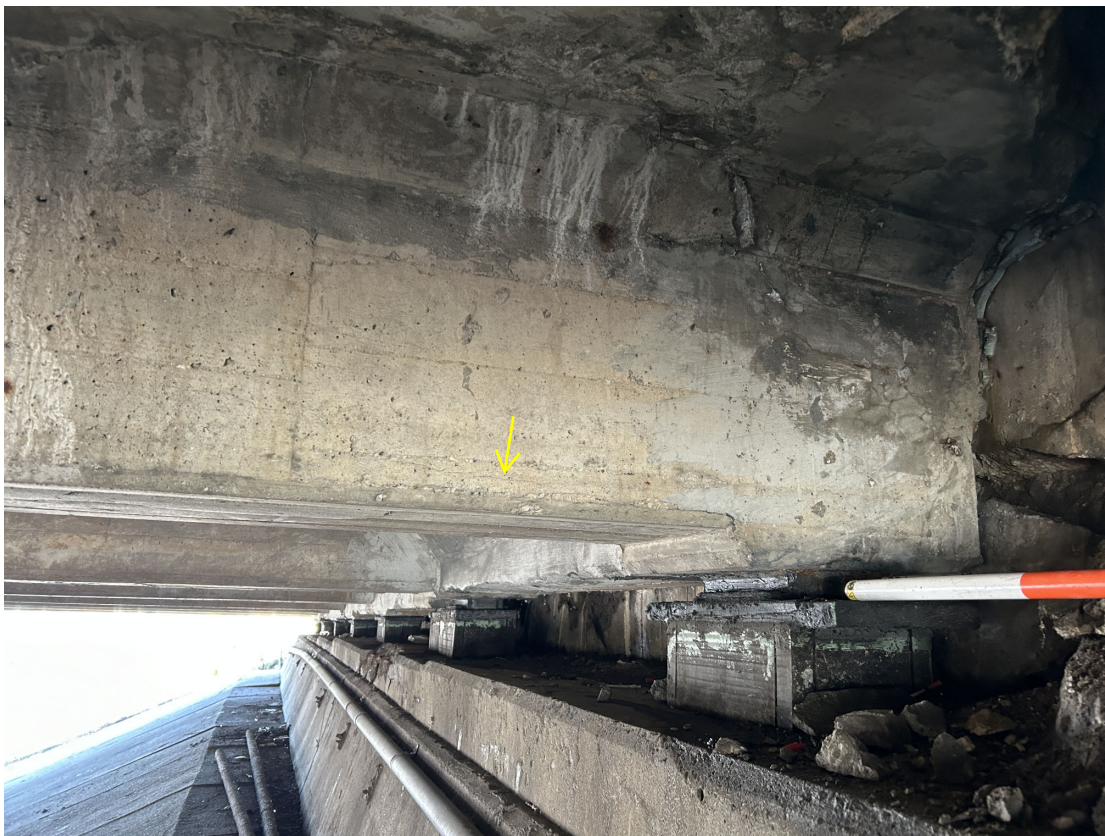
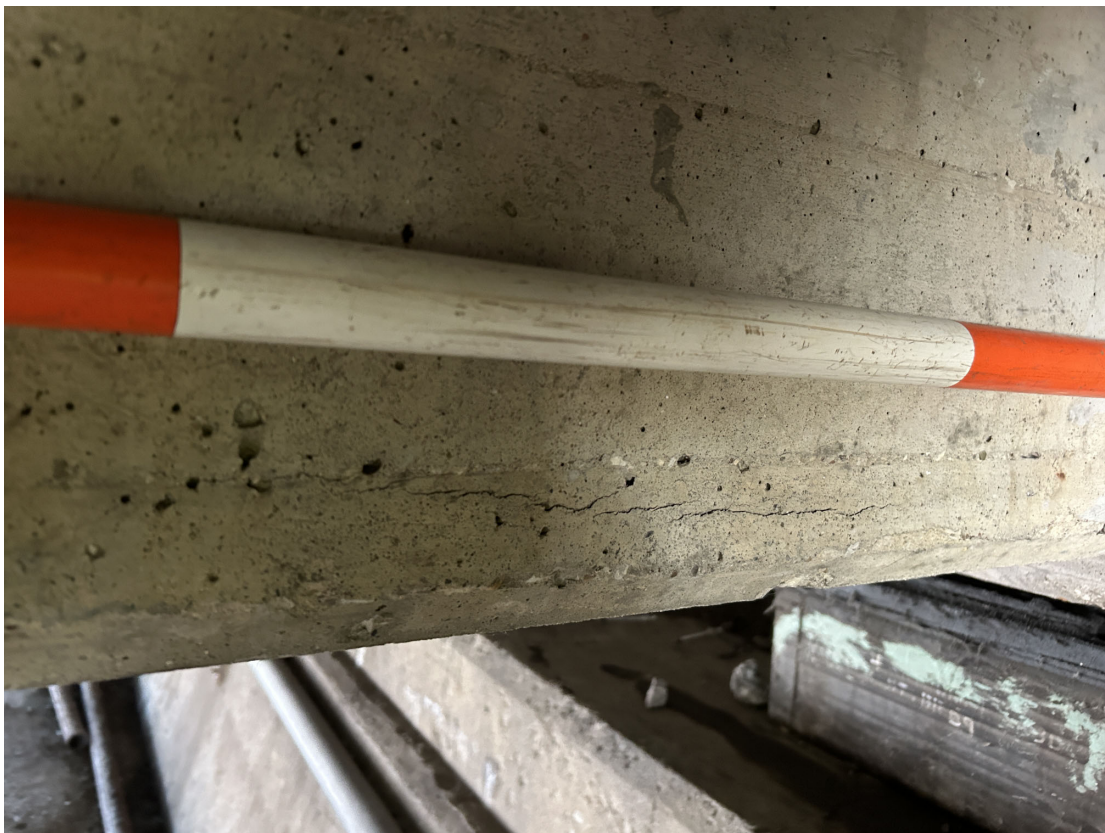
Girder 9 has a longitudinal crack in the east face near Abutment 4.

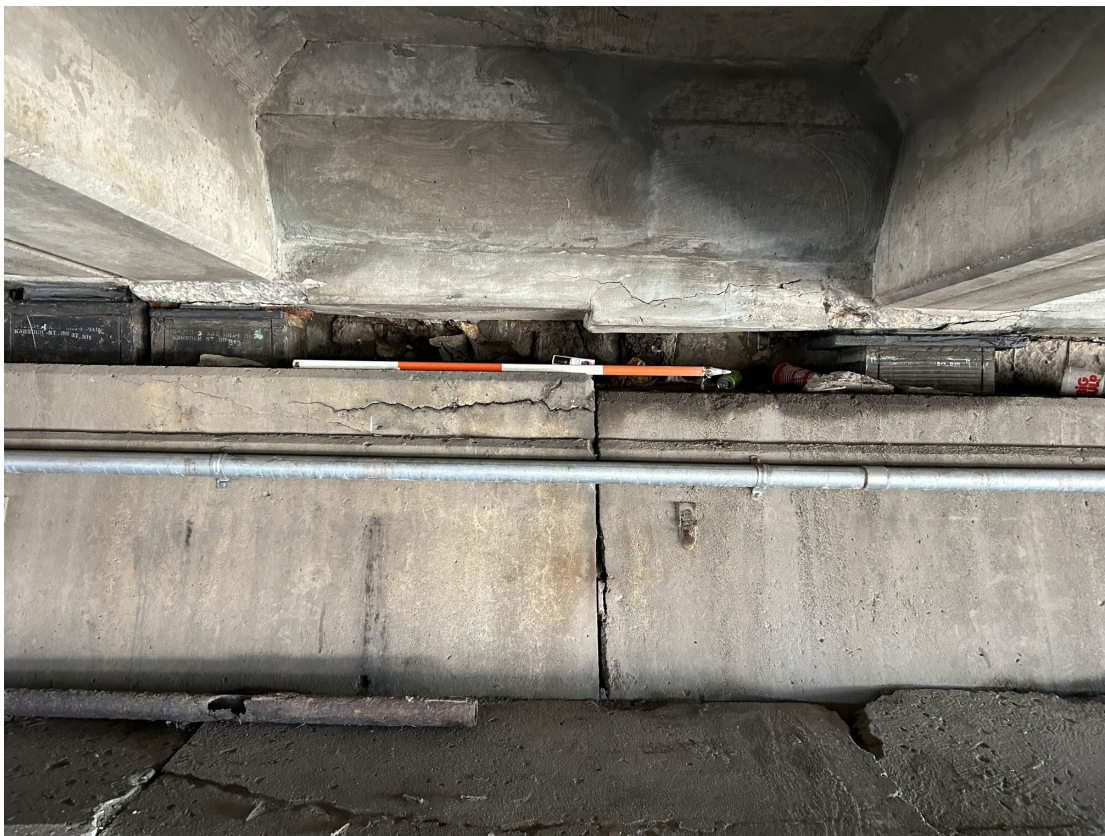
Wide cracking in Abutment 4 seat between Girders 12 and 13.

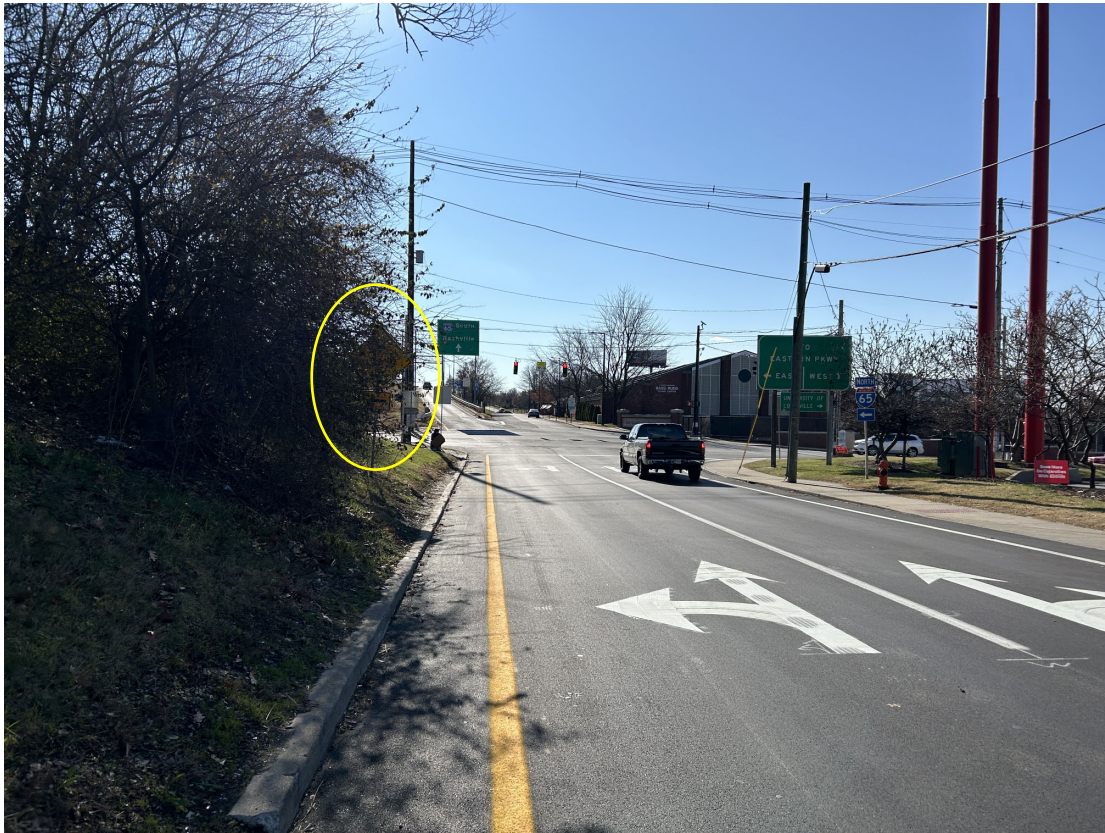
-There is vegetation growth restricting visibility of the minimum vertical clearance sign on Arthur Street.

Vegetation growth is restricting visibility of vertical clearance sign on Arthur St.

Vertical clearance sign along Arthur St is in place, though is partially obstructed by vegetation.
