Bridge Inspection Report

056B00182N

Inspector: Blake Combs
Entered by: BCOMBSCON
12/10/2024
Standard (24 months)

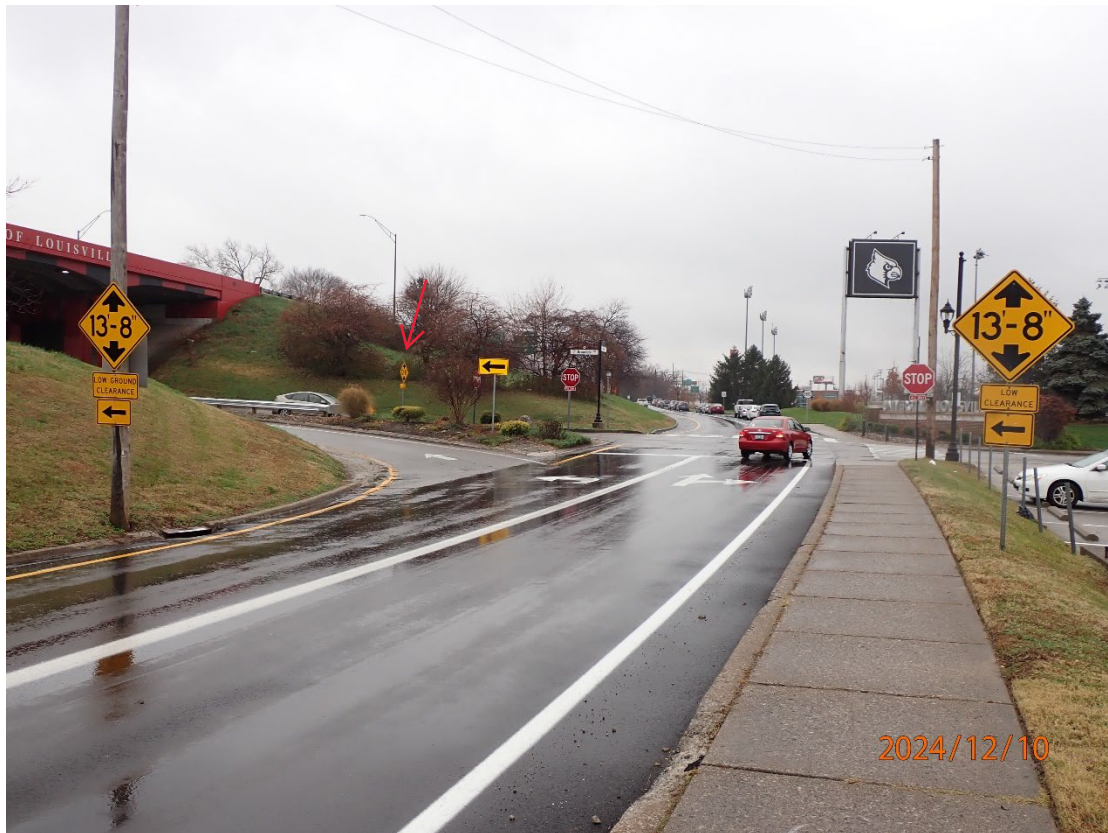
-MINIMUM VERTICAL UNDER-CLEARANCE MEASURED AT 13'-11". SHOULD BE POSTED AT 13'-8".

Vertical clearance signs on Arthur Street and East Brandeis Avenue

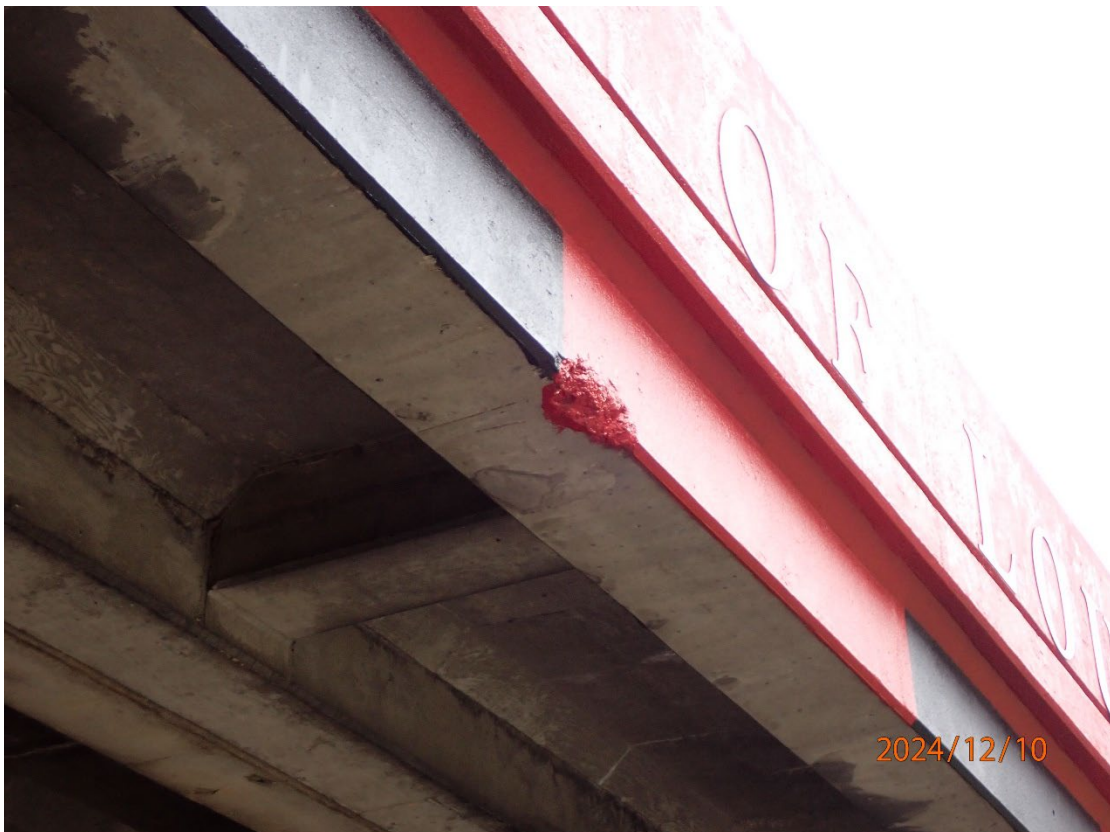
Spall in the bottom north edge of Beam 18 near midspan of Span 2

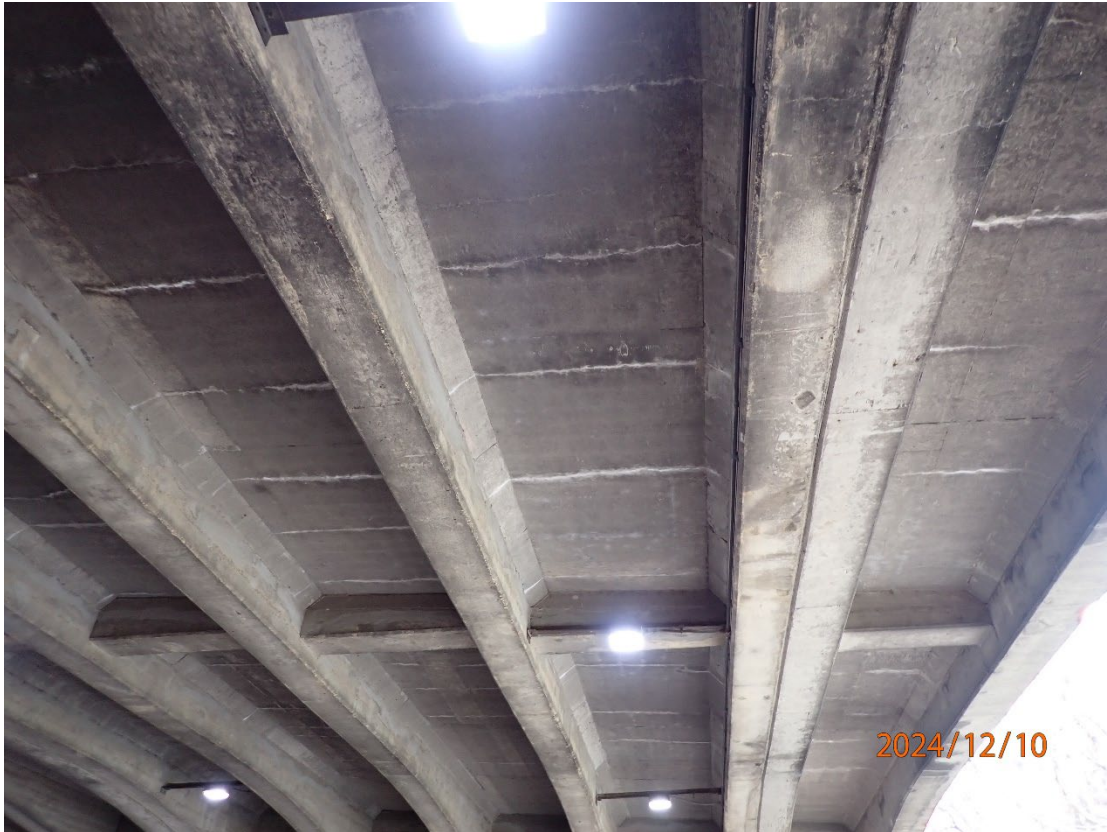
Top of the deck cannot be inspected due to 2012 asphalt overlay. Soffit has intermittent transverse cracking with efflorescence, with heaviest density in Span 2. In Spans 1 and 3, soffit cracking is denser below the southbound lanes. Bays 1 & 3 near Abutment 1 have spalling up to 8" diameter with exposed rebar. The spalling in Bay 3 has adjacent delamination. Bay 8 in Span 2 has 15 SF of full depth deterioration near the 3/4 point. At the longitudinal joint, there is 4 SF of full depth deterioration at Abutment 1 and roughly 8 SF of full depth deterioration with closely spaced cracking, efflorescence, and rust staining at Abutment 4.

Typical transverse cracking with efflorescence in the Span 2 soffit

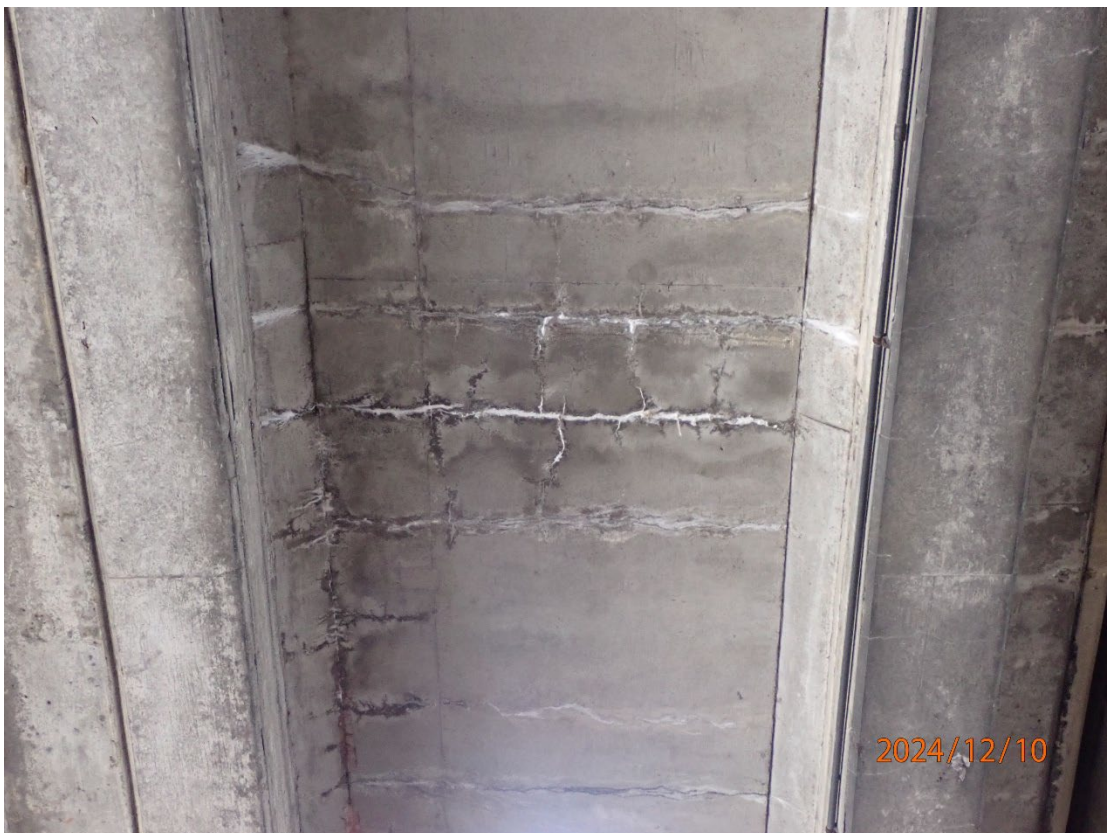
Area of full depth deterioration in Bay 8 of Span 2 near the 3/4 point

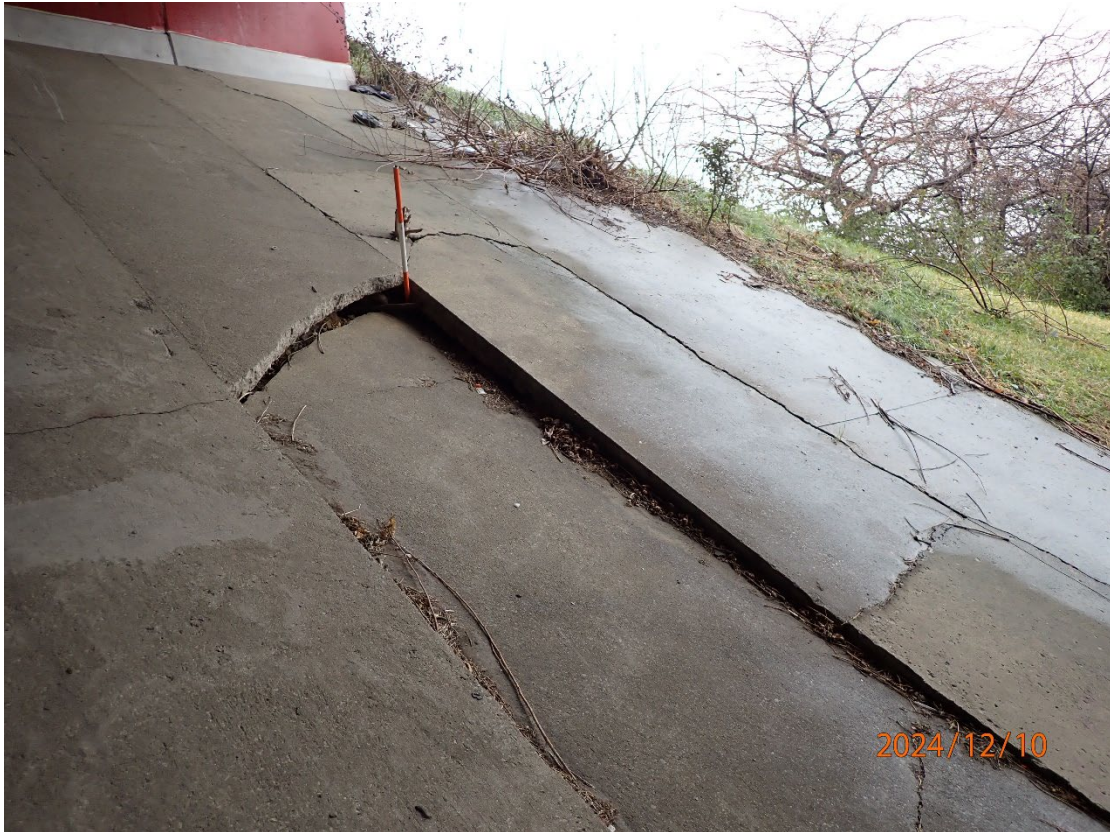
Concrete slope protection is cracked and undermined near the west end of Abutment 1, near the longitudinal joint at Abutment 4, and near the west end of Abutment 4.

Undermined and settlement concrete slope protection near the west end of Span 1

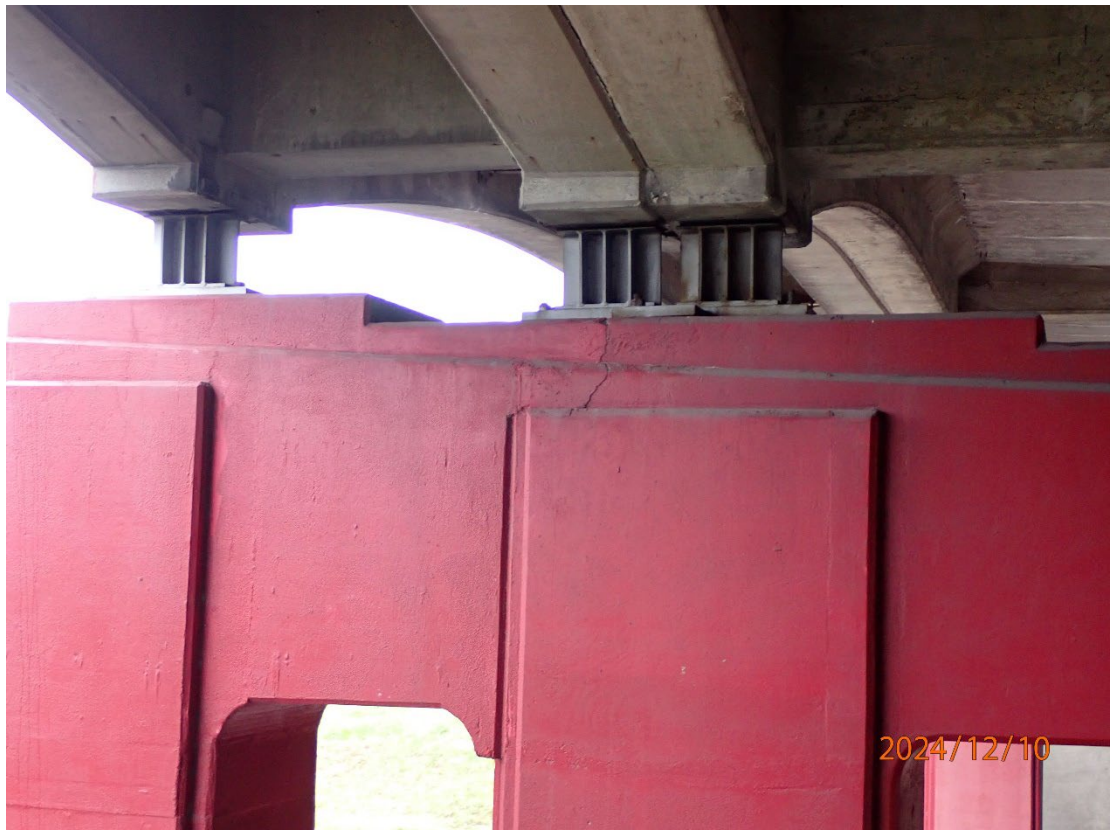
Pier caps have moderate cracks, spalls, and sound patches (difficult to inspect due to paint). There is one area of wide vertical cracking in the south face of the Pier 2 cap under Beam 2.

Wide cracking in the south face of the Pier 2 cap under Beam 2

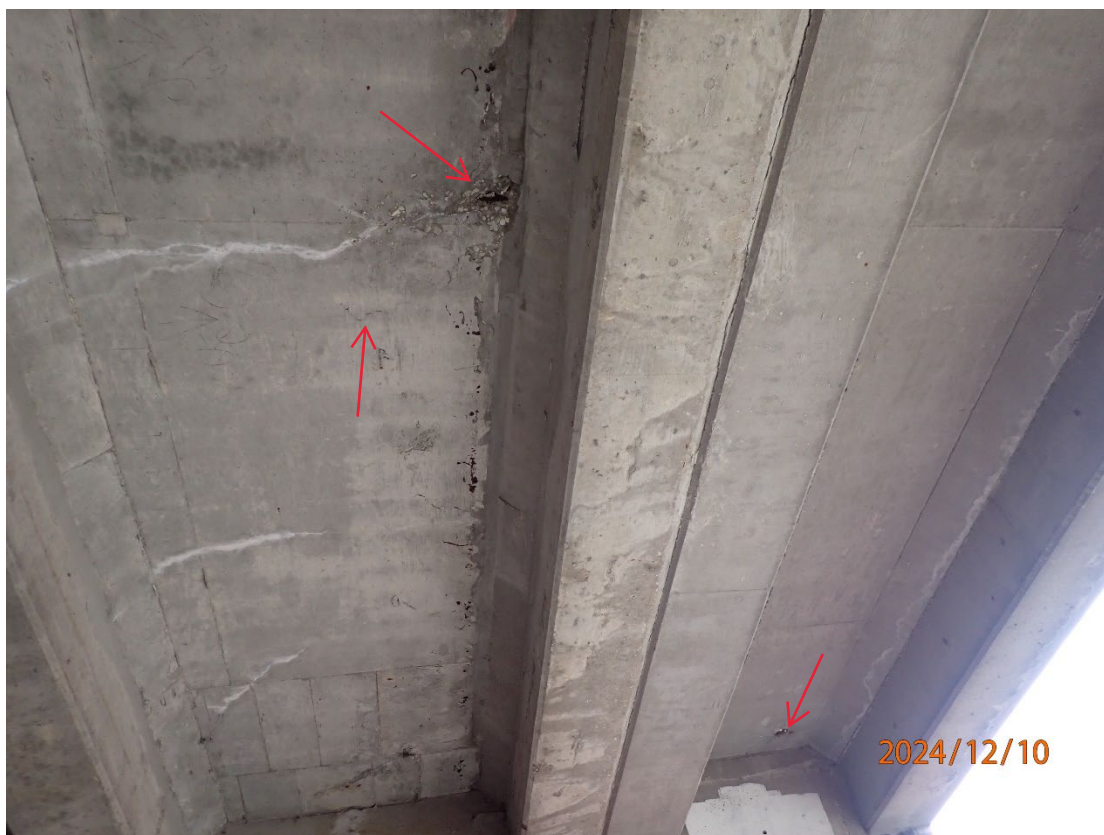
Spalling with exposed rebar in the underside of Bays 1 & 3 near Abutment 1.
Note there is adjacent delaminations next to the Bay 3 spalling

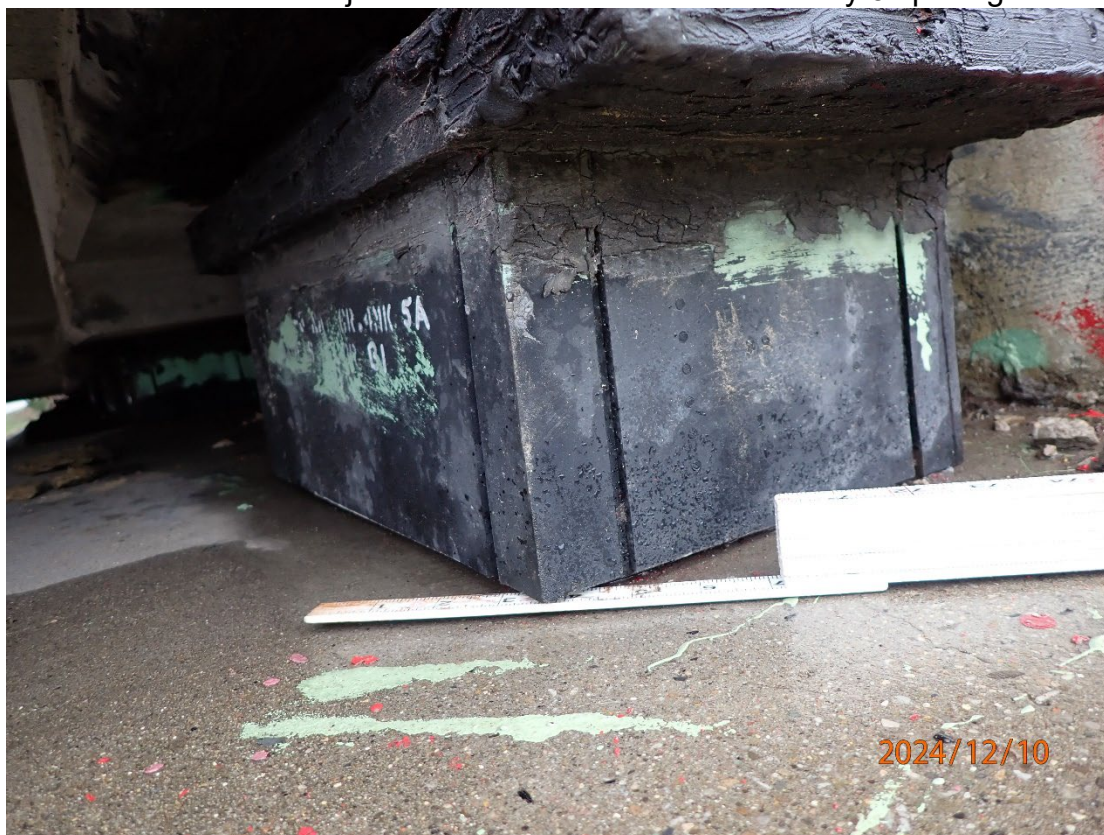
Bearings at abutments were replaced with elastomeric bearings as part of the 2012 overlay project. Elastomeric bearing pad under Beam 1 at Abutment 1 is not fully in bearing and has a 1/4 inch gap under the northwest corner and the Beam 4 sole plate is hovering above the bearing. Abutment 4, Beam 10 bearing movement is restricted by debris on the abutment seat. Bearing pads are in overall good condition, but a few sole plates have moderate corrosion at each abutment.

Up to a 1/4" gap under the northwest corner of the Beam 1 bearing pad at
Abutment 1

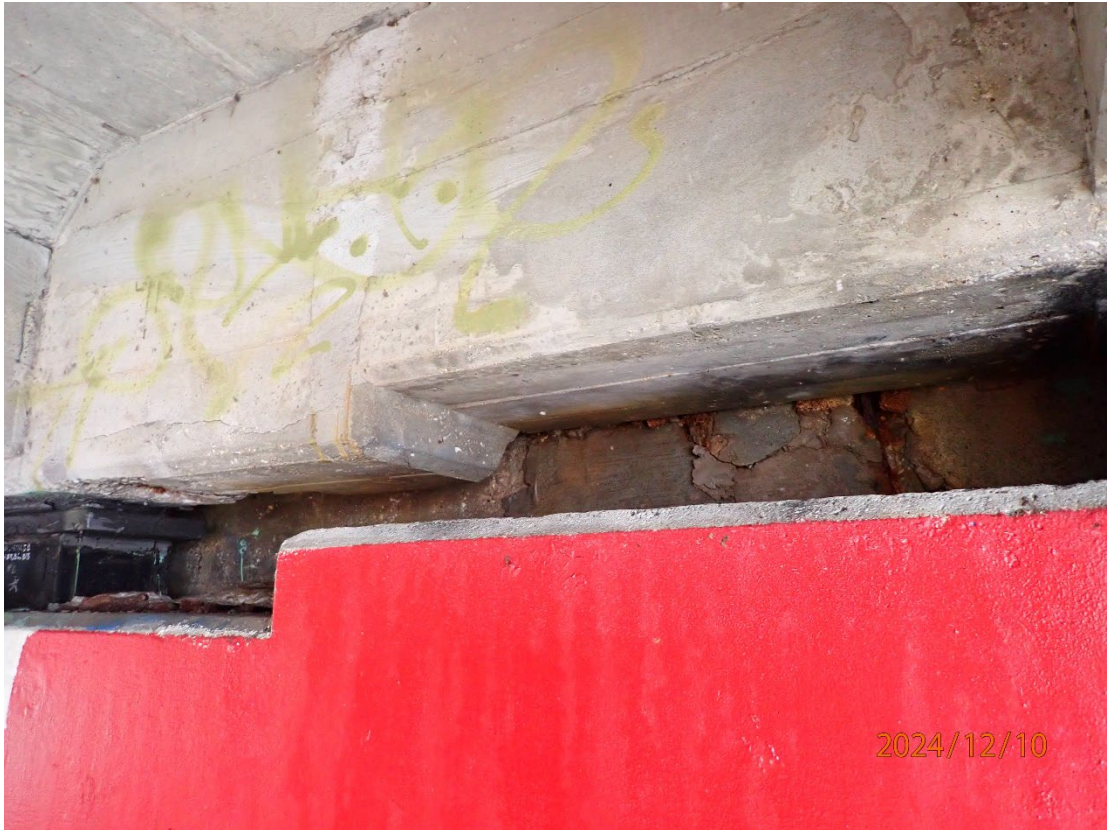
Abutment backwalls have intermittent patching, many areas unsound or spalling with exposed rebar. The spalling in the backwall is most notable in Bays 3, 9, and 10 at Abutment 1 and between Beams 3-10 (35' CS4) at Abutment 4. The Abutment 4 backwall appears to be nearly completely spalled with Bay 9 having exposed and broken rebar. Heavy patching is also present in the asphalt plug joint above this location. Spalling in Abutment 1 backwall at the longitudinal joint is up to 5 inches deep with exposed rebar and section loss; there is similar spalling at Abutment 4. Abutment 1 backwall has wide diagonal crack at the east end with spalling along the crack. Abutment seats have moderate to wide horizontal cracking, scaling, and spalling with exposed rebar.

Areas of spalling with exposed rebar in the Abutment 1 backwall. Bay 3 shown

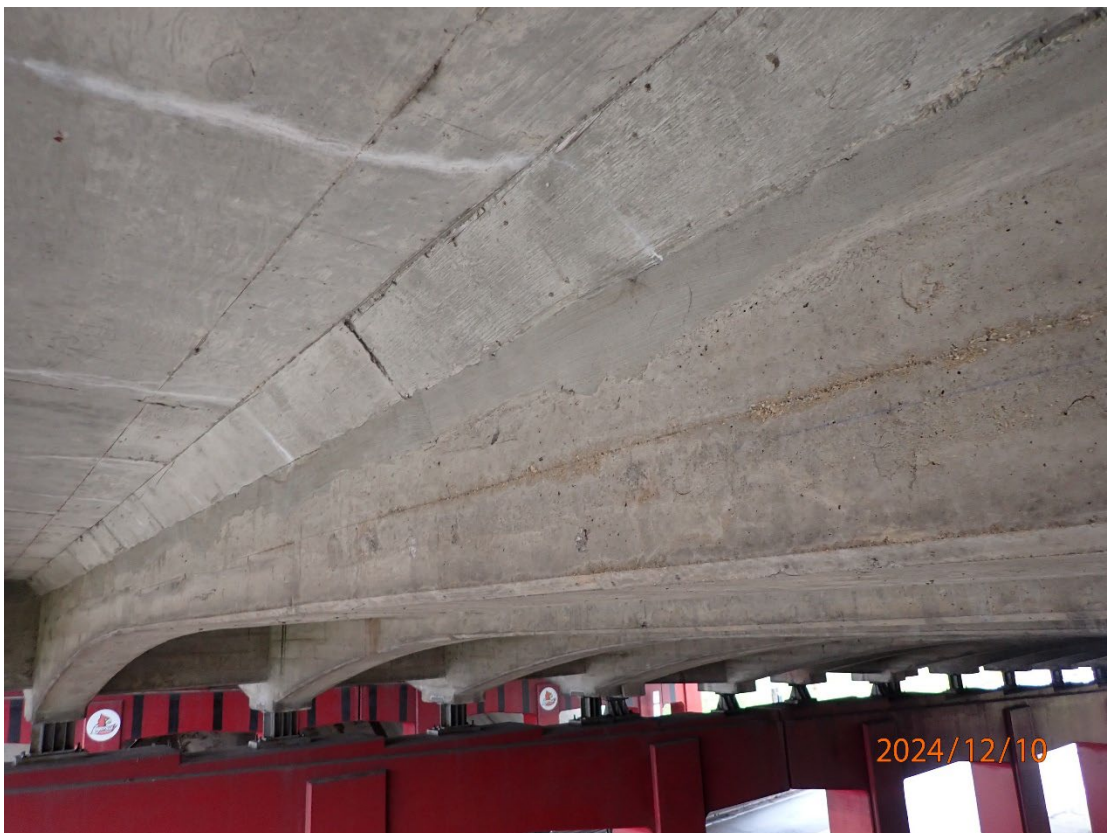
Typical patching along the top of the beams. Beam 4 in Span 1 shown

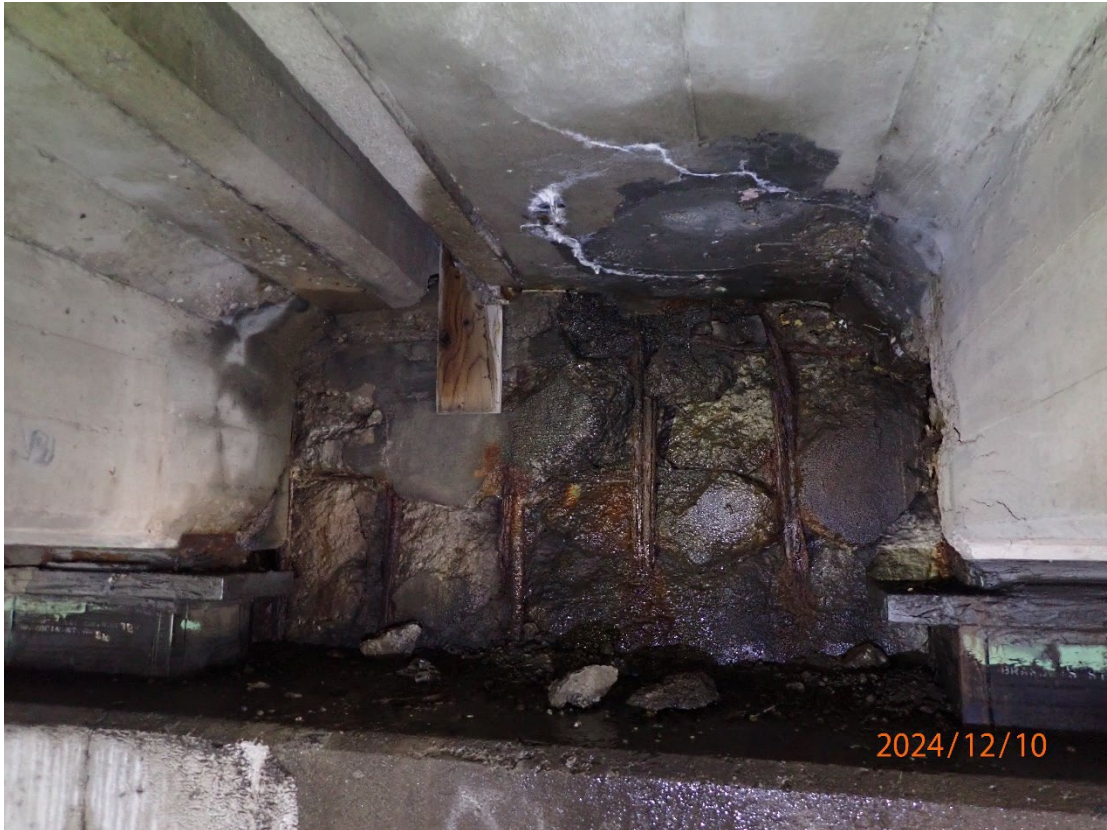
Heavy spalling with exposed rebar in the Abutment 1 backwall under the longitudinal joint in Bay 9

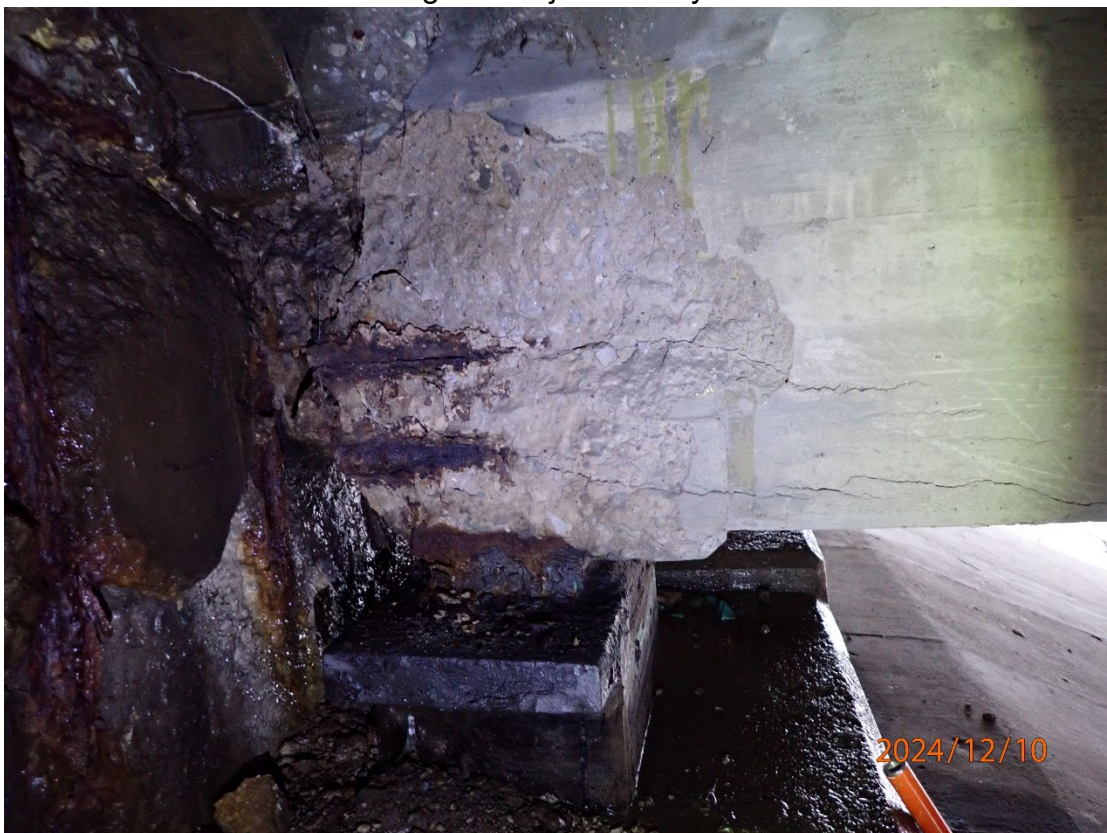
Beams have intermittent patching along the top, some unsound with pattern cracking, as well as moderate to wide vertical and diagonal cracking, mostly near the ends. At Abutment 1, east face of Beam 9 has 2 feet of spalling with exposed rebar plus closely spaced cracking; patching in the top of the beam is unsound with a 4 inch deep void. Beam 10 has a 1' long x up to 6" high spall at Abutment 1. In Span 2, Beam 18 has several spalls and scrapes in the bottom face from impact, with two spalls being greater than 1 inch deep. At Abutment 4, Beam 9 has unsound patching and spalling, and Beam 16 has 2 feet of wide horizontal cracking. Beams 5, 7, and 14-16 also have spalling under them that is nearing the sole plates.

Spalling with exposed rebar and horizontal cracking in the east face of Beam 9 at Abutment 1

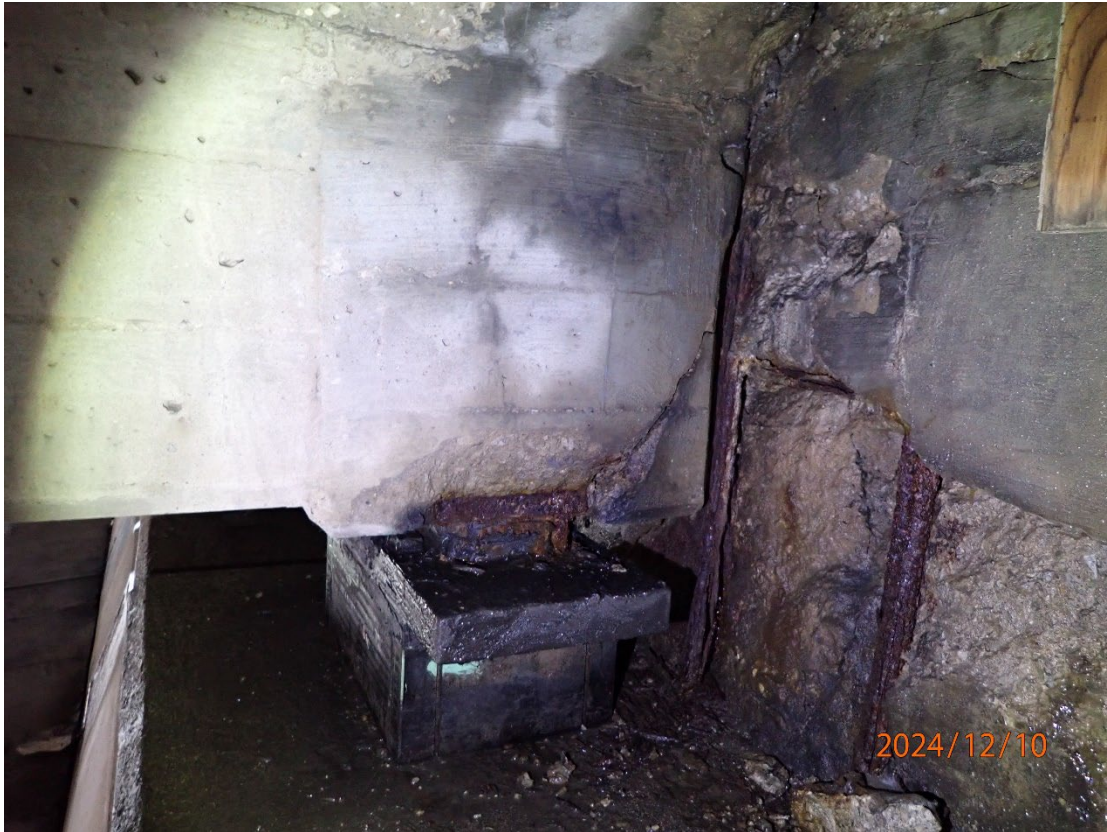
Spalling in the west face of Beam 10 at Abutment 1

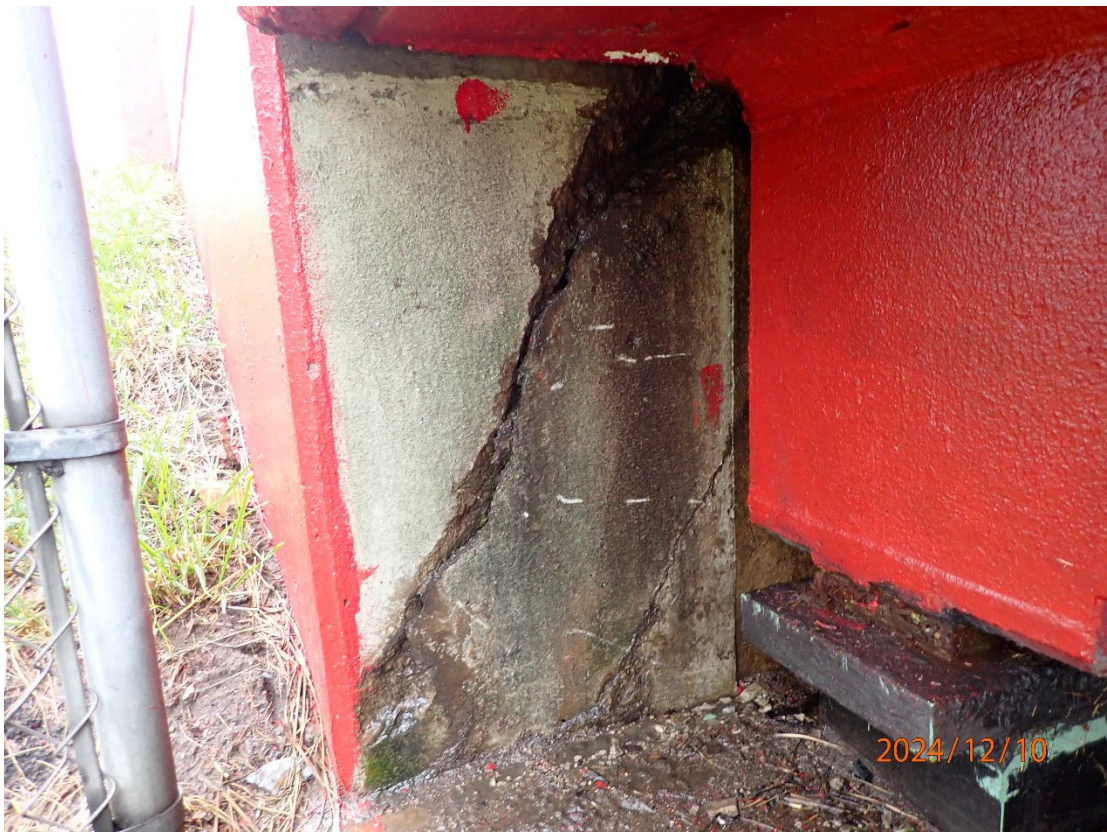
Wide diagonal crack with edge spalling in the east end of the Abutment 1 backwall

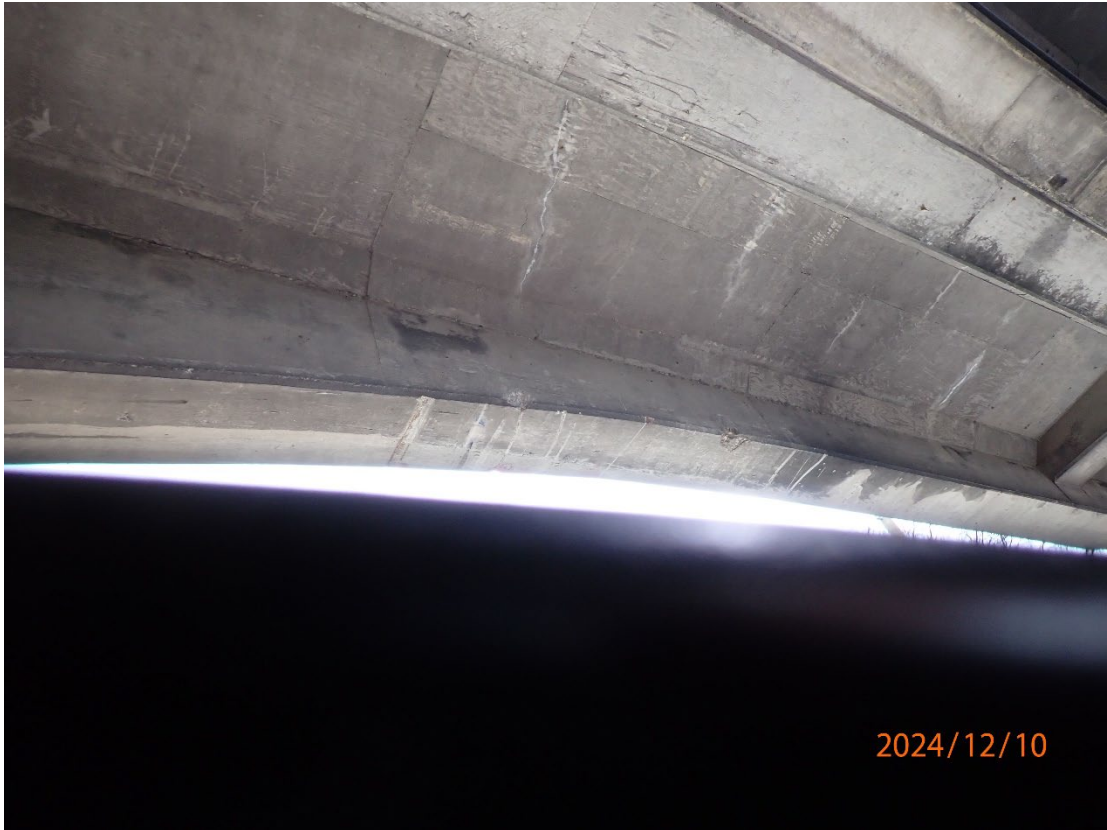
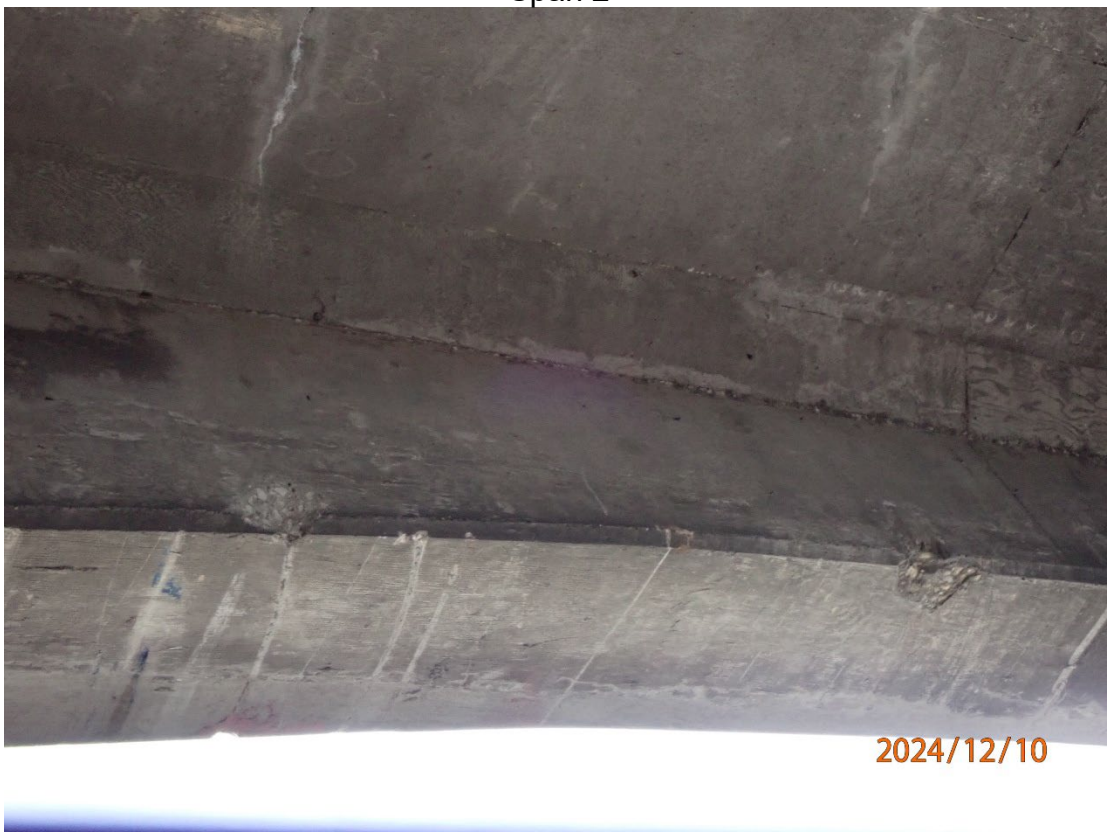
Scraping with edge spalling in the bottom face of Beam 18 near the 3/4 point of Span 2

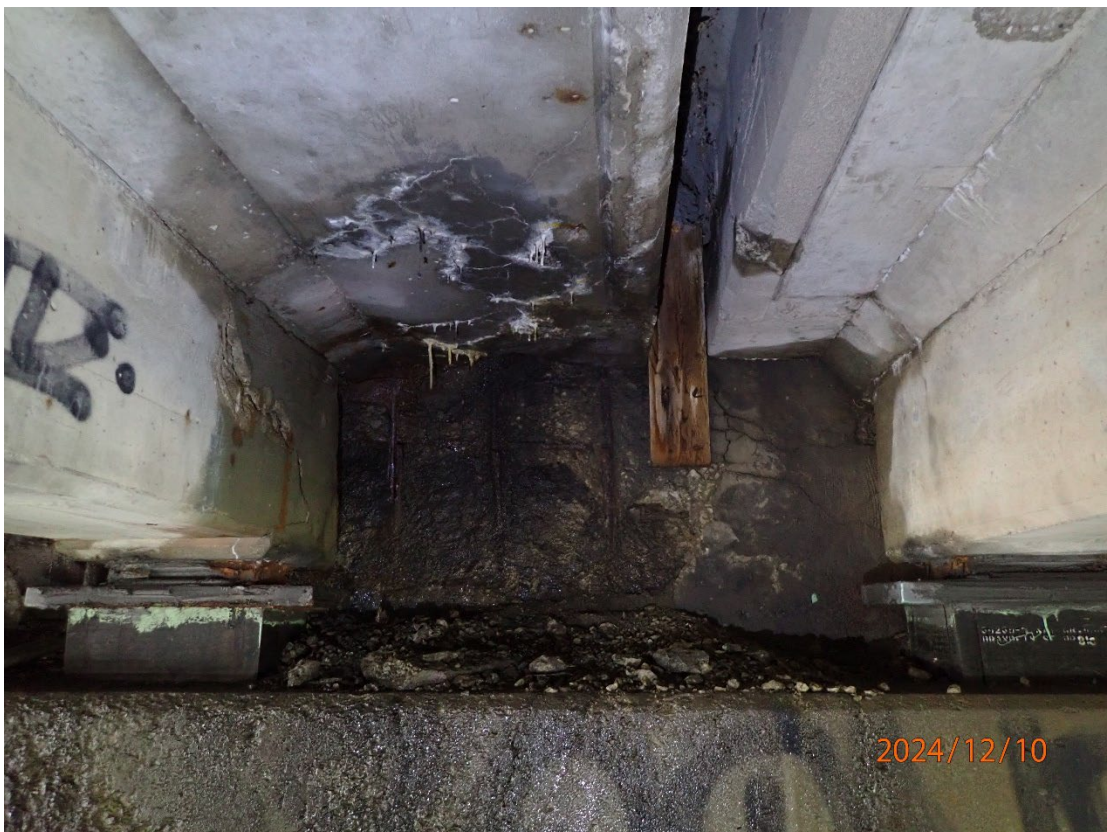
Due to the heavy spalling in the Abutment 4 backwall between Beams 3-10 (35' CS4), the substructure rating has been lowered from a 5 to a 4.

Heavy spalling in the Abutment 4 backwall along with full depth deterioration along the soffit in Bay 9

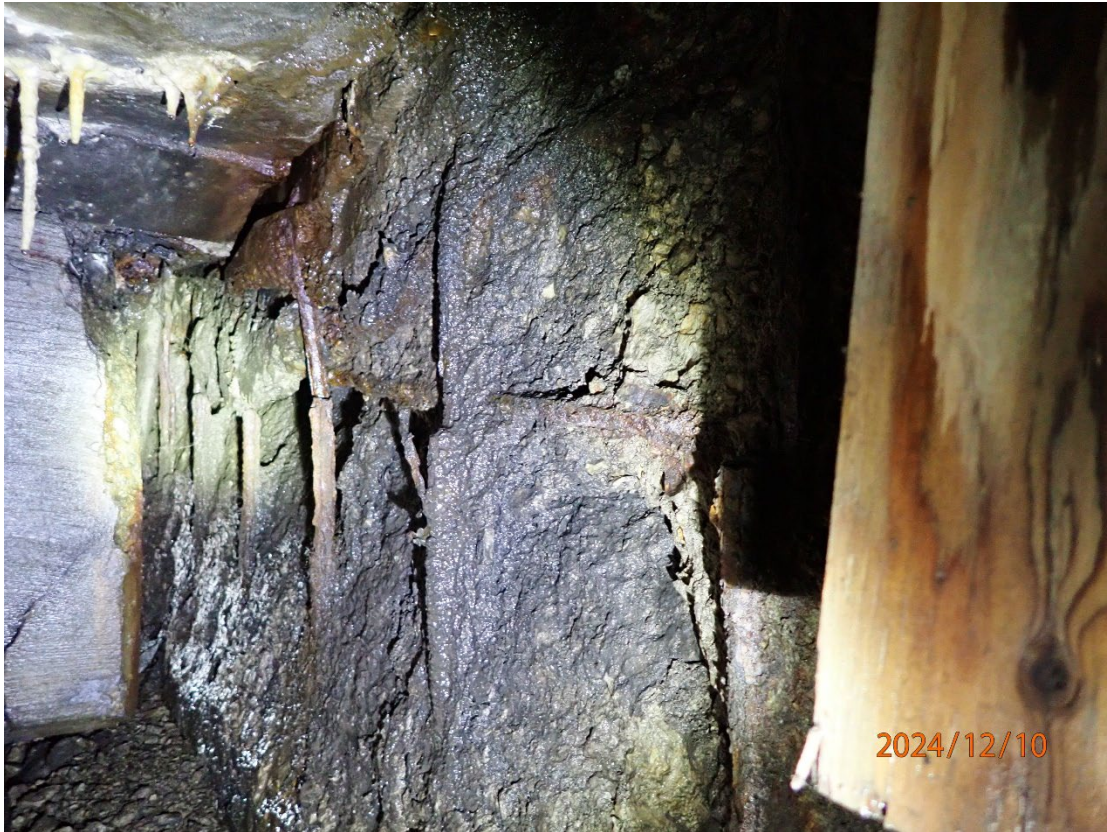
Heavy spalling with exposed and broken rebar in the Abutment 4 backwall.
Bay 9 shown

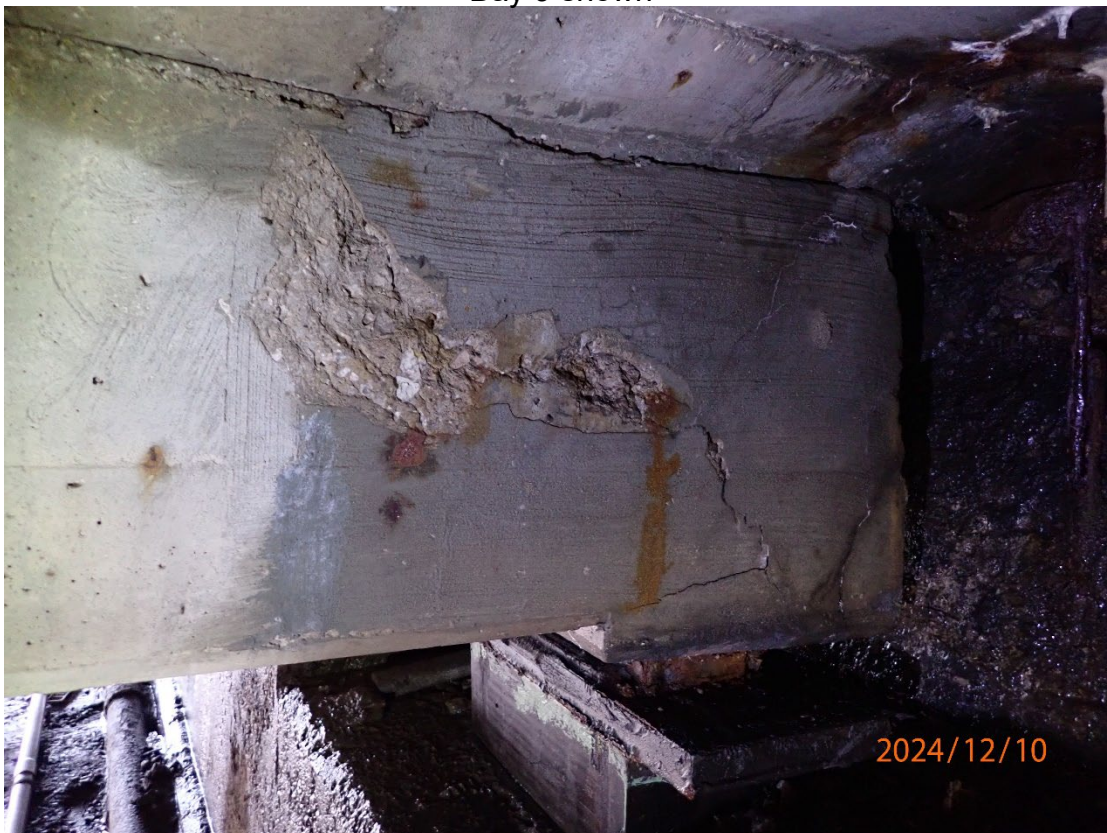
Unsound patching and spalling in the east face of Beam 9 at Abutment 4

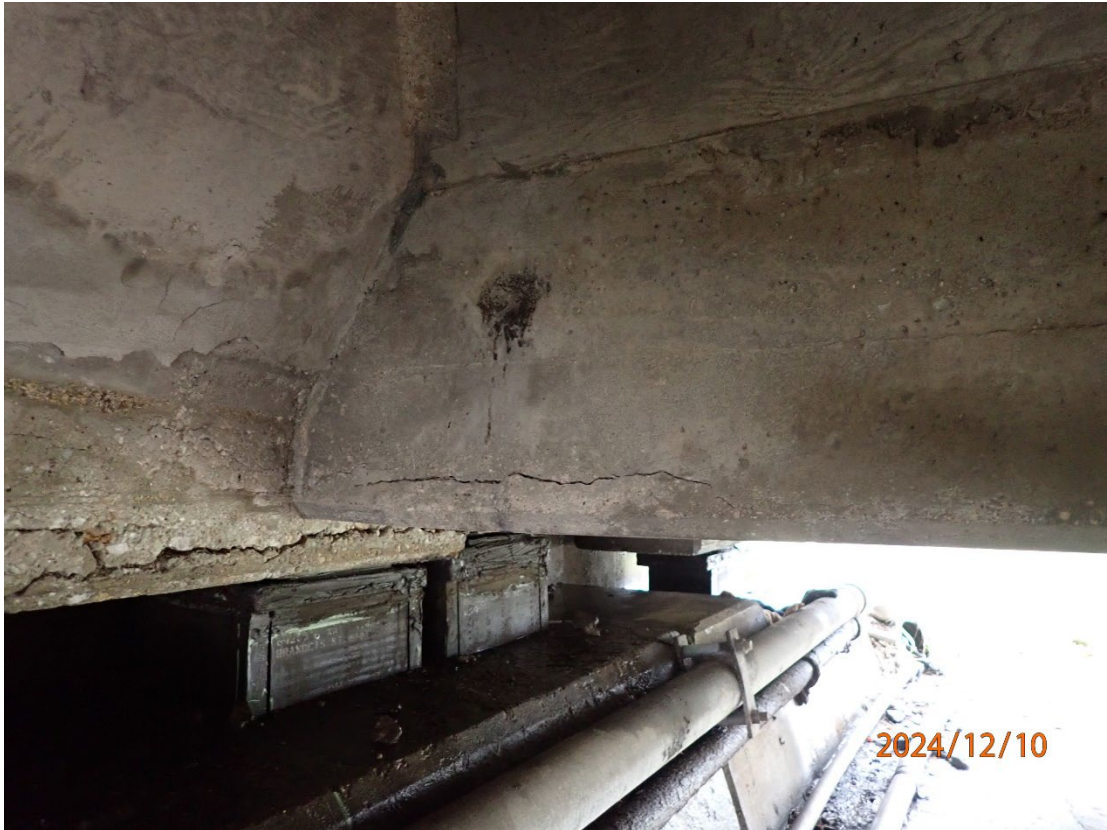
2' wide horizontal crack in the west face of Beam 16 at Abutment 4

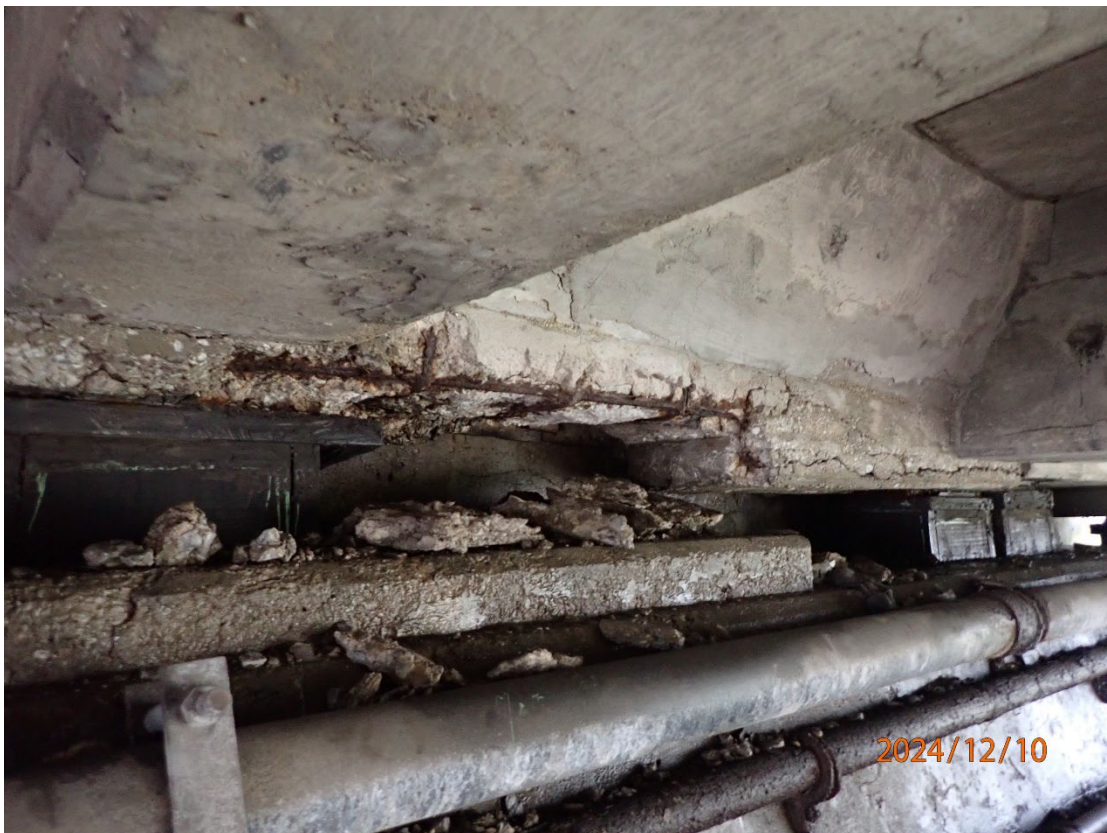
Abutment diaphragms have wide cracking, unsound patches, and spalling with exposed rebar.

Spalling with exposed steel in the Bay 15 diaphragm at Abutment 4

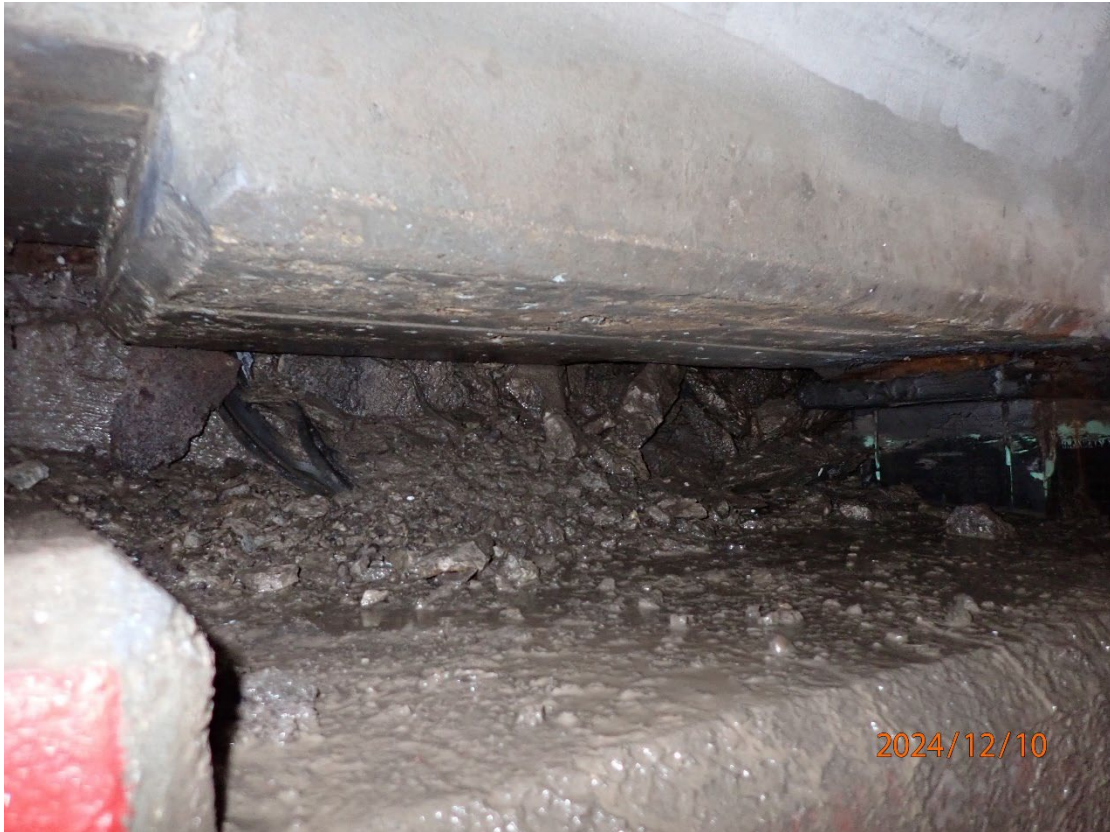
Heavy spalling in the Abutment 4 backwall. Bay 3 shown

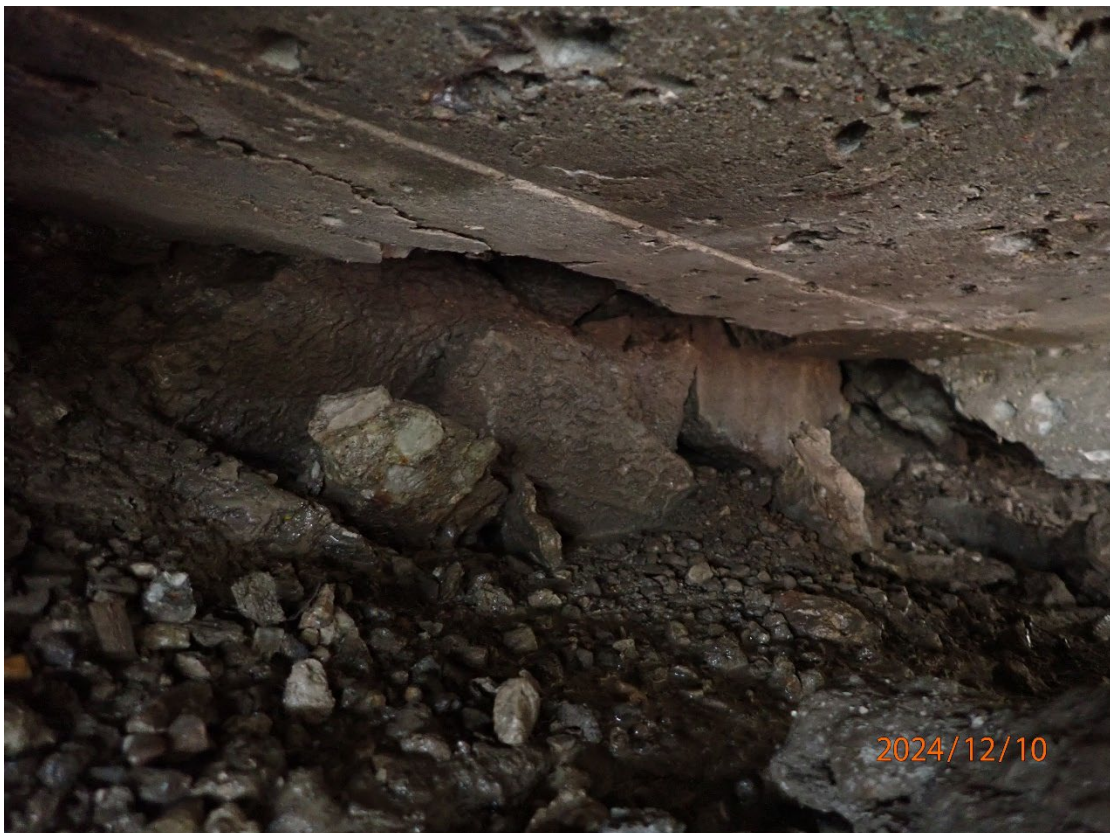
Heavy spalling in the Abutment 4 backwall. Bay 4 shown
