Bridge Inspection Report

056B00182N

Inspector: Blake Combs
Entered by: BCOMBSCON
12/10/2024
Standard (24 months)

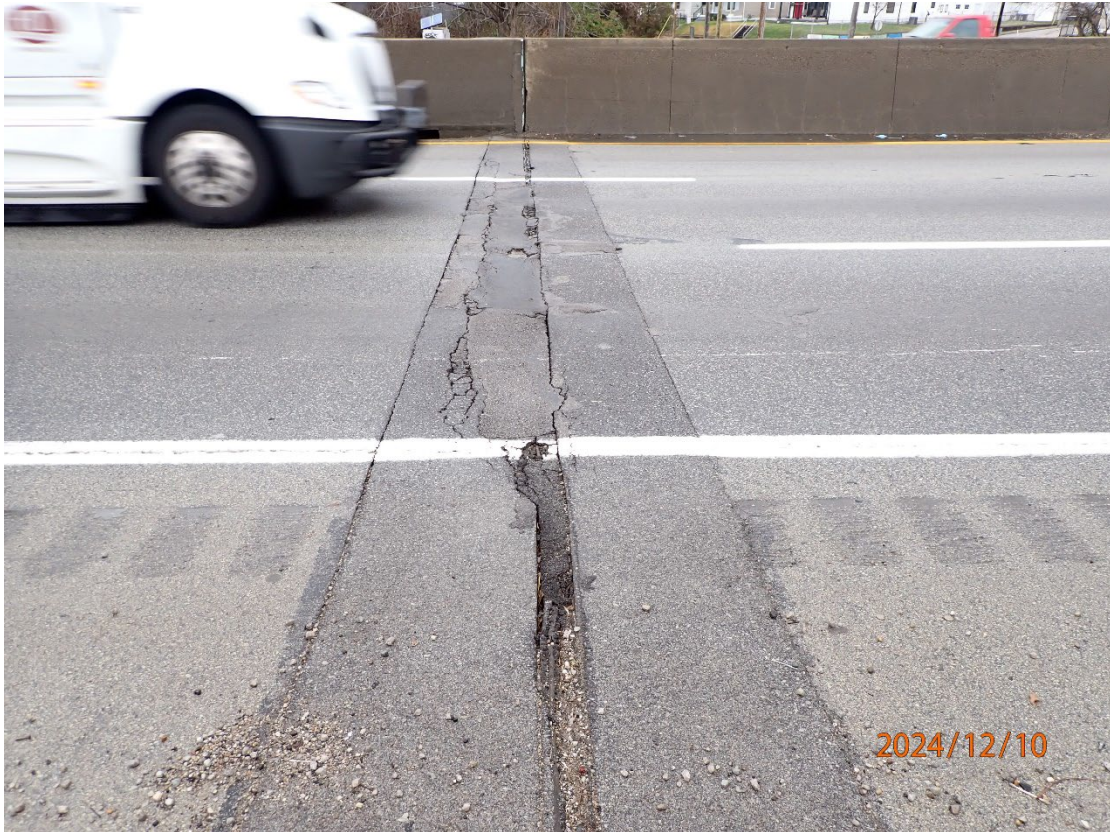
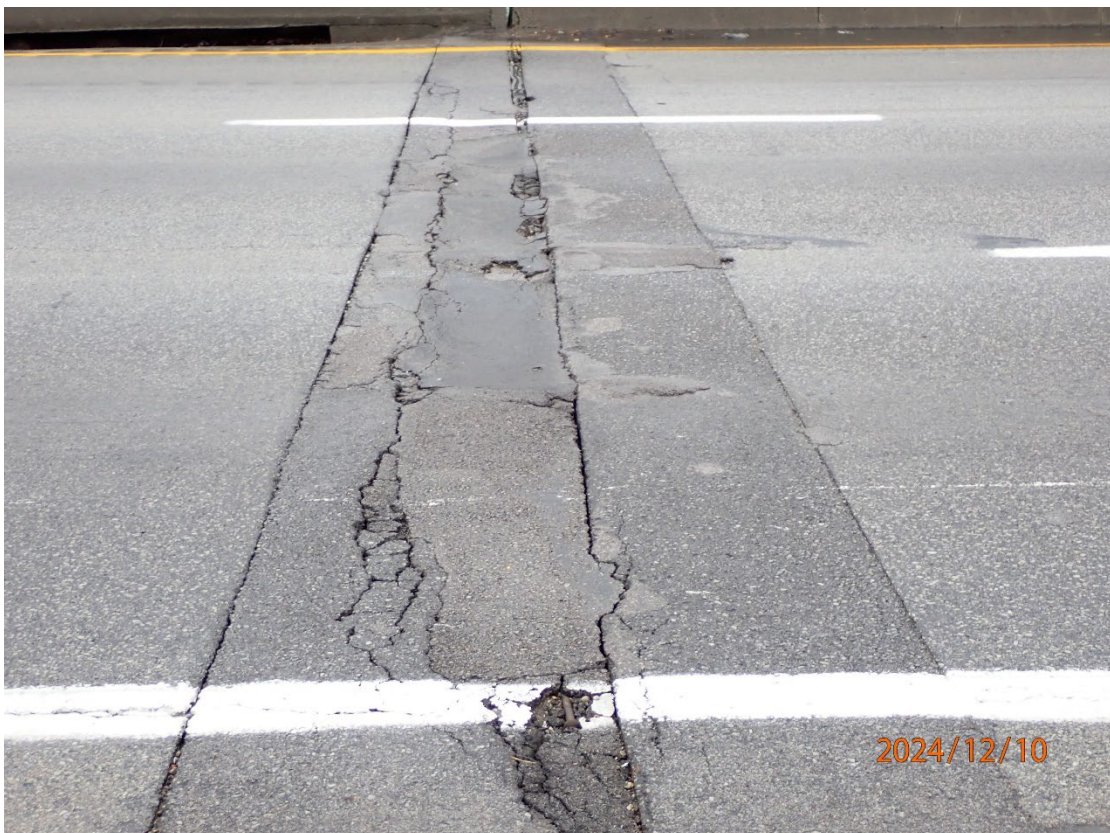
Asphalt plug joints were installed over the existing joints in 2012 and plug joints were redone in 2017. Asphalt plug joints have cracking, rutting, and spalling, some spalls with original joints exposed. Water drains moderately to freely onto the elements below. Spalling and patching in the asphalt plug joints is most notable in the southbound lanes over Abutment 4 with most of the asphalt plug having patching.

Soundbound joint over Abutment 4. Note the areas of spalling and patching

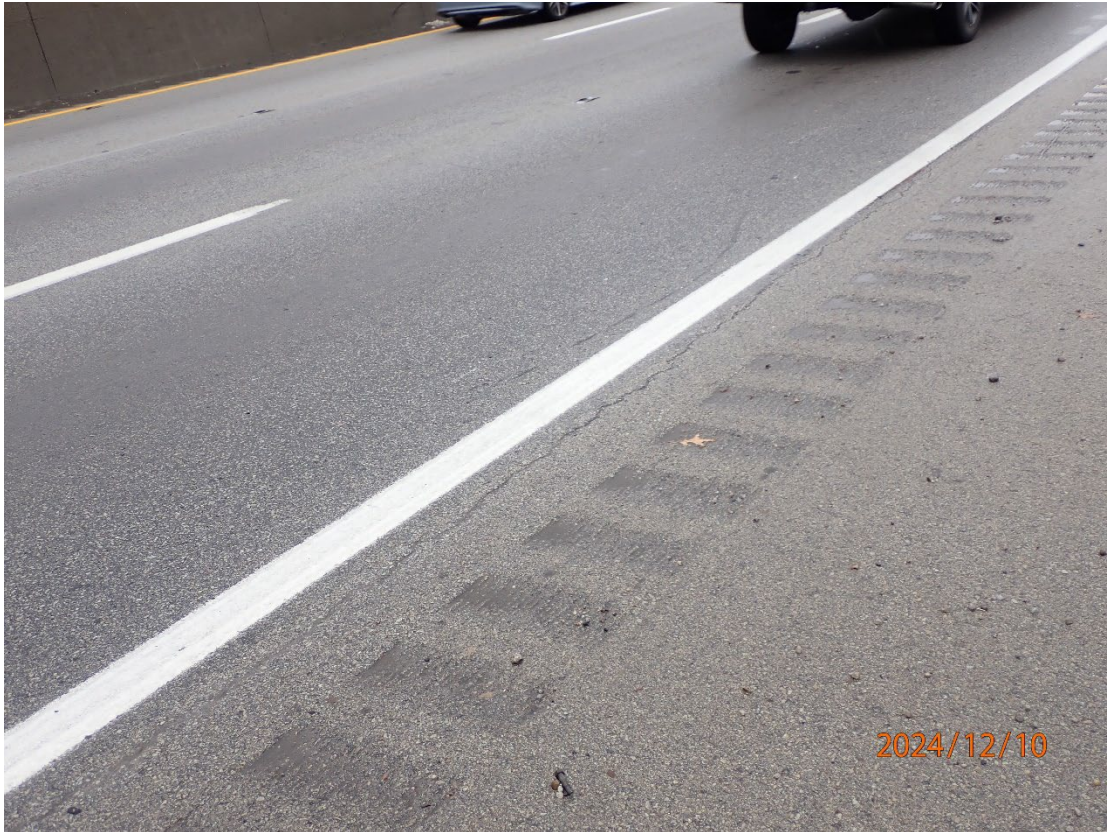
Asphalt wearing surface has a full length longitudinal crack along the west southbound shoulder edge line.

Full length longitudinal crack along the west southbound shoulder edge line.
Span 1 shown
