Bridge Inspection Report

056B00184N

12/04/2024

Standard (24 months)

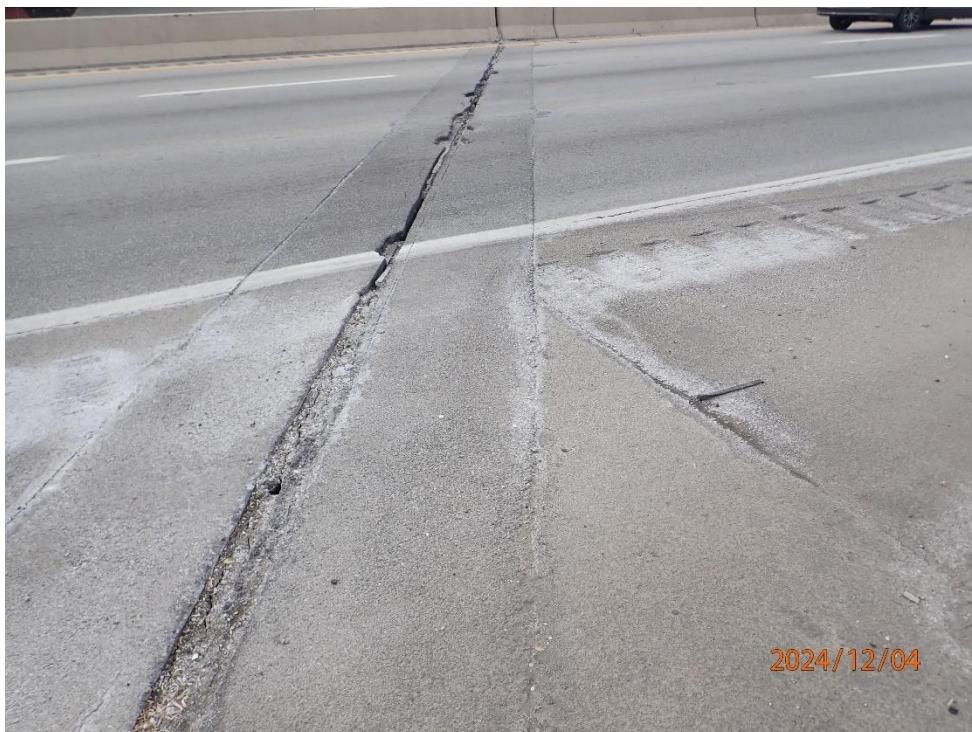
Joint over Abutment 4, NB lanes

The asphalt plug joints were reconstructed in 2017. Joint material is gapping and/or breaking up throughout. Some areas have spalled out exposing the original joint - worst along the Abutment 4 joint in SB lanes.

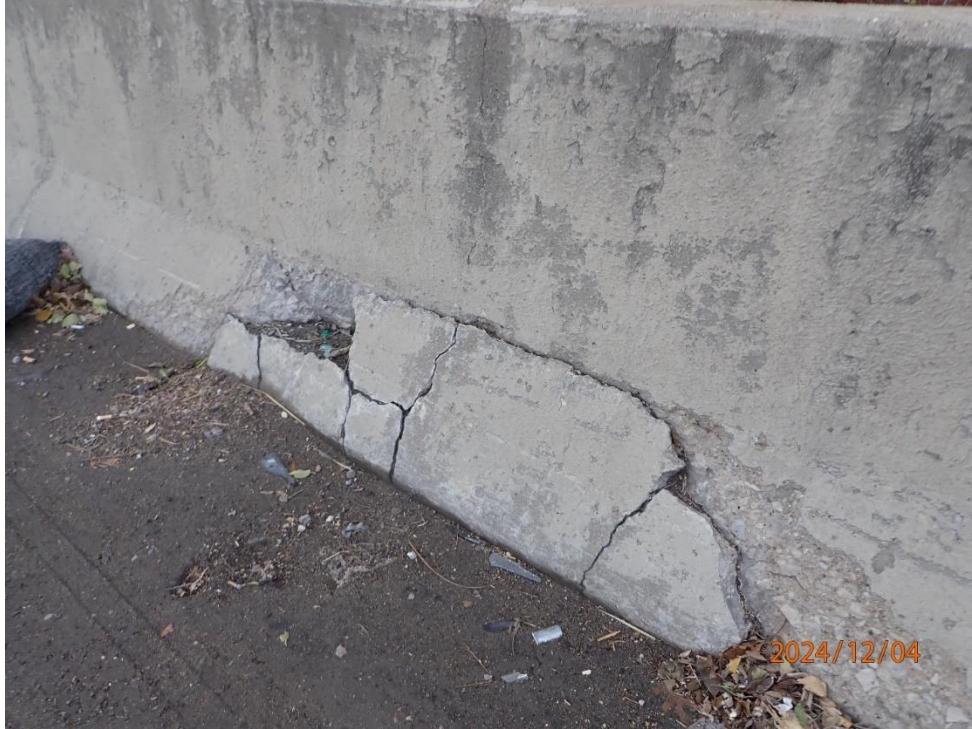
Concrete railings have moderate vertical cracking. The SB median barrier exhibits areas of shallow spalling/scaling throughout and there is a large area of shallow scrapes/spalls near Pier 2. The west SB rail has an area of wide delamination cracking and spalling in Span 1.

The west SB rail has an area of wide delamination cracking and spalling in Span 1.

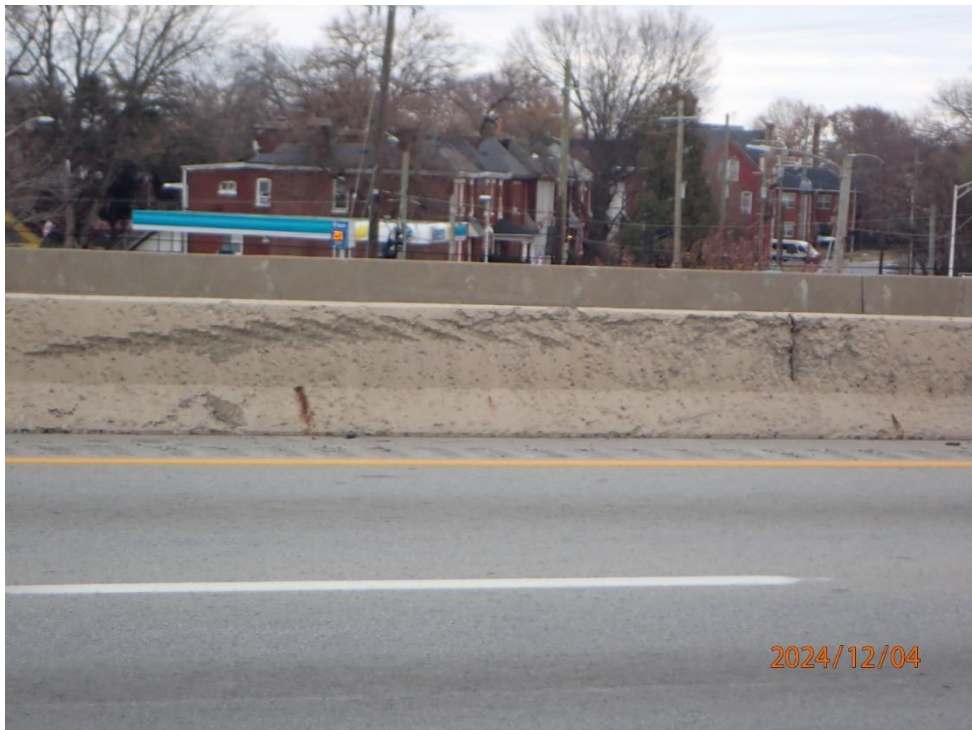
The SB median barrier has a large area of shallow scrapes/spalls near Pier 2

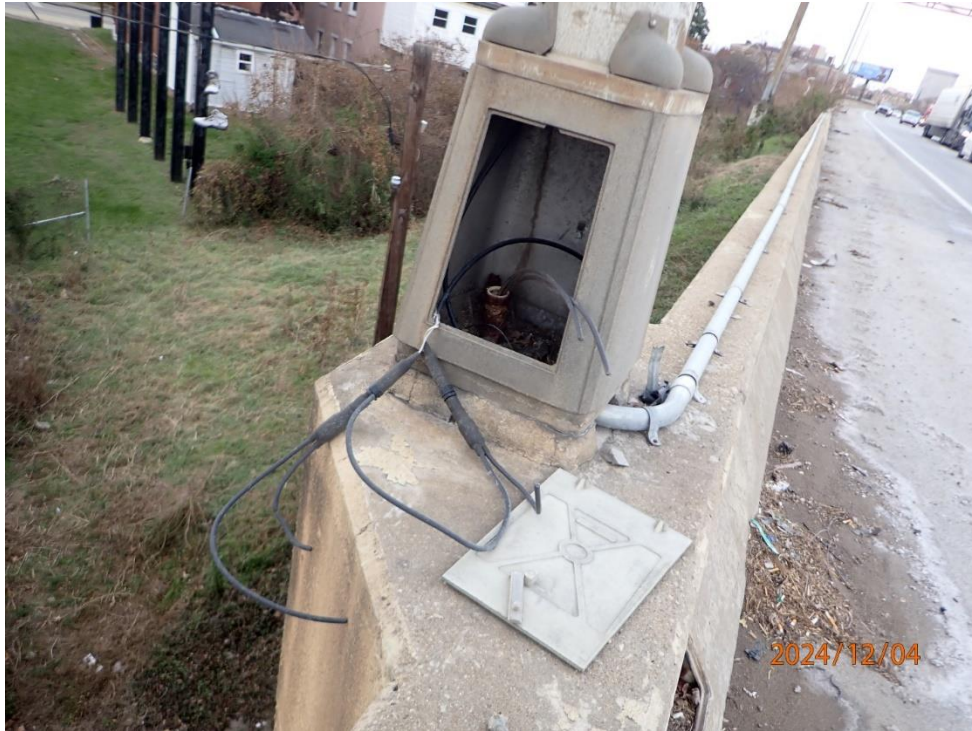
There are streetlights attached to the superstructure is Span 2 that appear to not be functioning. SB west rail has a light fixture with missing cover plate and disconnected wiring near Pier 3. NB east rail has a light fixture with missing cover plate near Pier 3.

SB west rail has a light fixture with missing cover plate and disconnected wiring near Pier 3

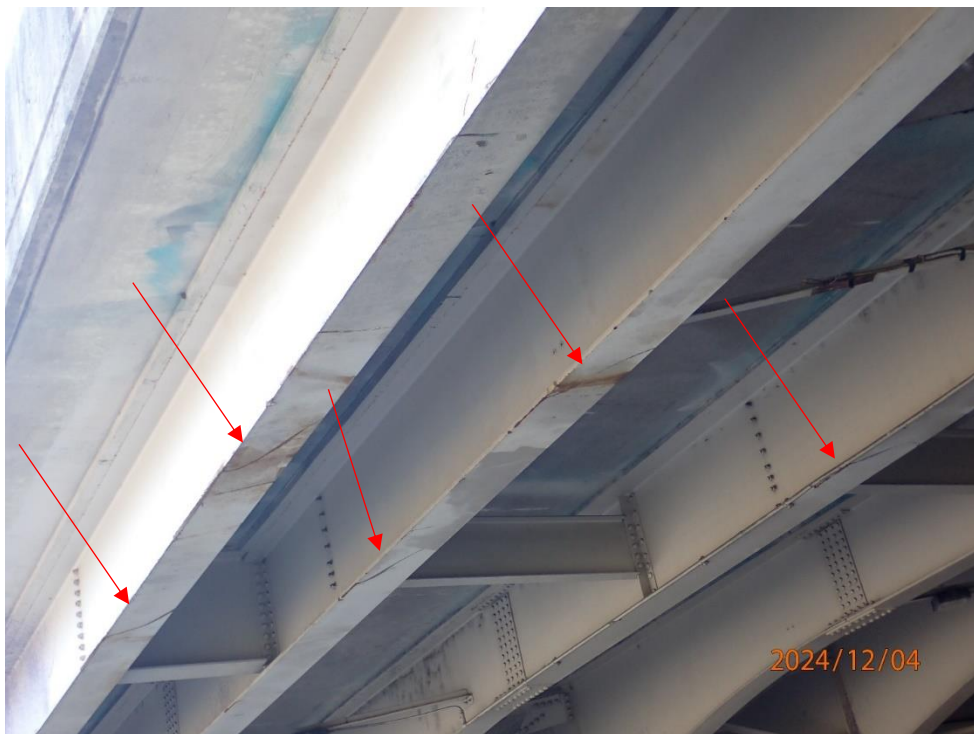
Beam ends have some areas of heavy surface corrosion below the joints. There are random isolated areas of freckled rust. Bottom face of bottom flanges in non-haunch sections typically have painted over minor pitting. Parts of superstructure near Abutment 1 are covered in soot from fires. Span 2 Beams 9-14 have shallow scrapes/gouges with surface corrosion. Beam 13 bottom flange has a 1.5'L area of minor distortion at Abutment 4.

Span 2 Beams 9-14 have shallow scrapes/gouges with surface corrosion (Beams 12-14 pictured)

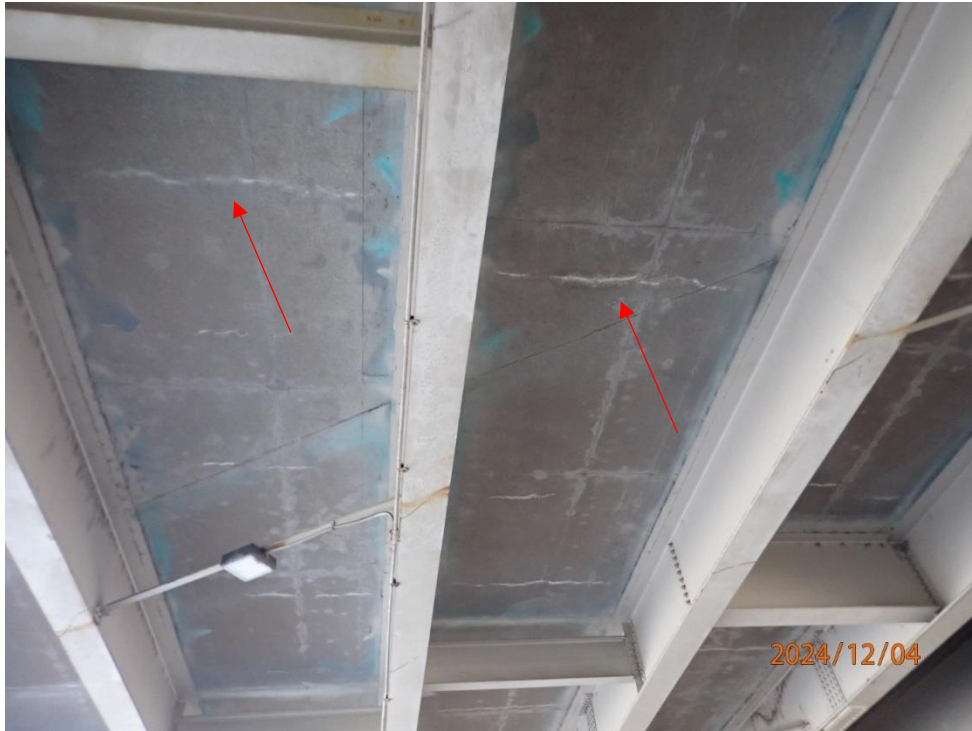
Top of deck cannot be visually inspected due to asphalt overlay. Soffit has transverse cracks, some with efflorescence. There is spalling with exposed rebar along the longitudinal joint at each abutment. There is spalling with exposed rebar in each overhang at Abutment 1.

Soffit has transverse cracks, some with efflorescence

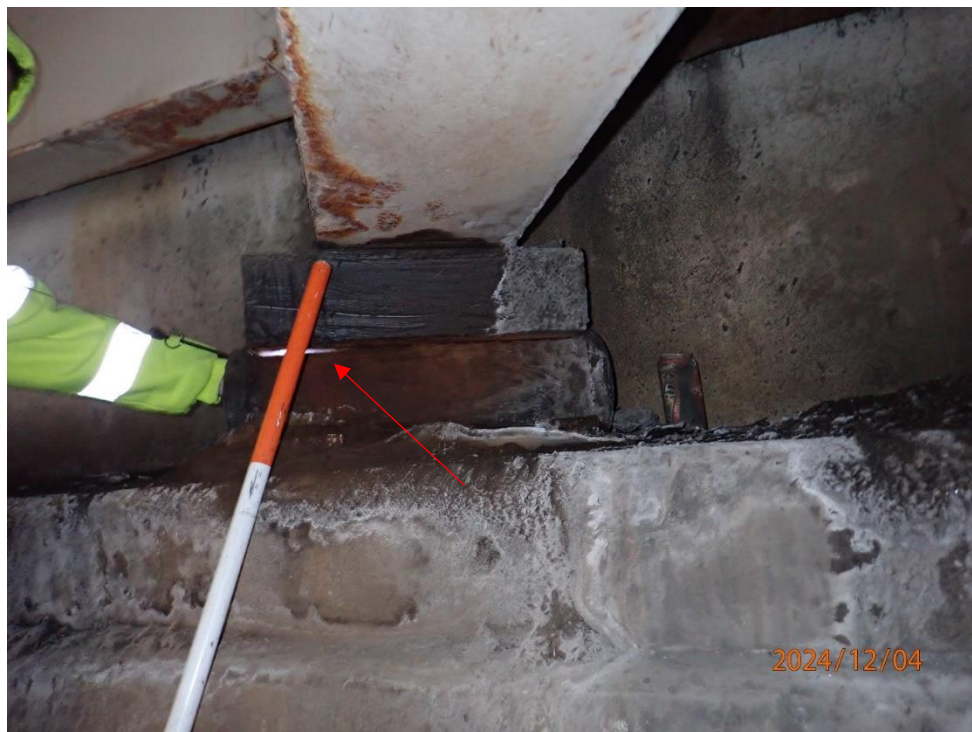
Roller bearings have been greased, but the rollers and masonry plates typically have flaking corrosion, and some areas have section loss. Several roller bearings are misaligned, and movement is inconsistent with temperature conditions. Sole plates are worn/gouged, not in contact with the rollers, and move vertically under live load at Abutment 1-Beams 3, 4, 6, and 10 and at Abutment 4-Beams 3, 4, 5, 6, 11. Abutment 4-Beam 5 bearing seems to be the worst and moves vertically at least 1/8 inch. A few rocker bearings at Pier 3 have surface rust.

Beam 5 sole plate not in contact with the roller and moves vertically under live load at Abutment 1 (note light visible between sole plate and roller)

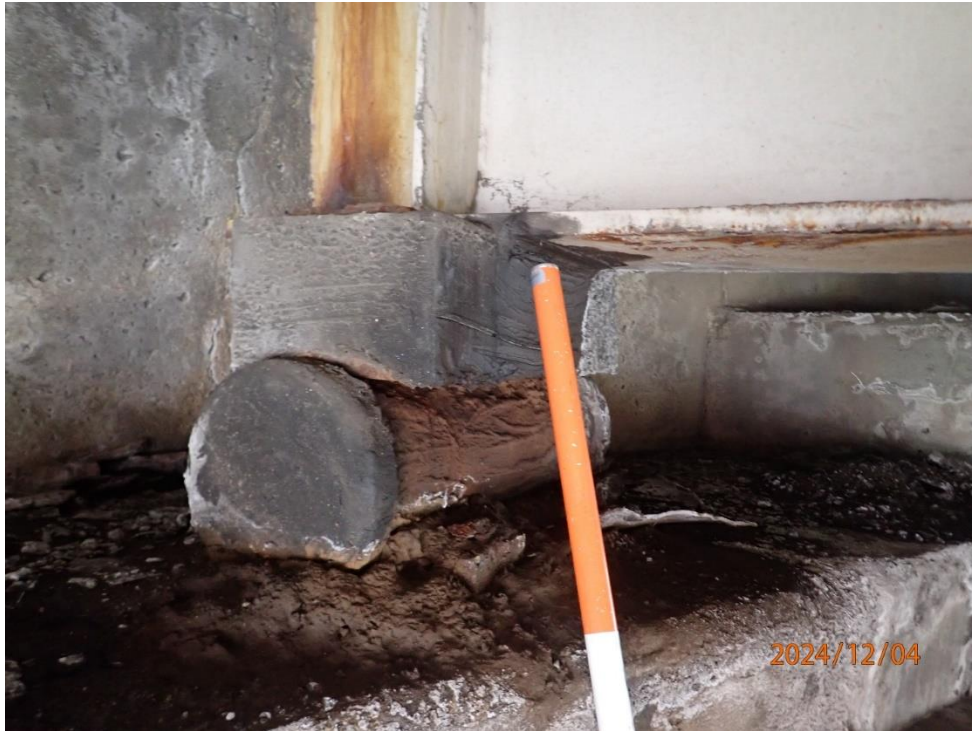
Rollers and masonry plates typically have flaking corrosion, and some areas have section loss (Beam 5 at Abutment 4 pictured)

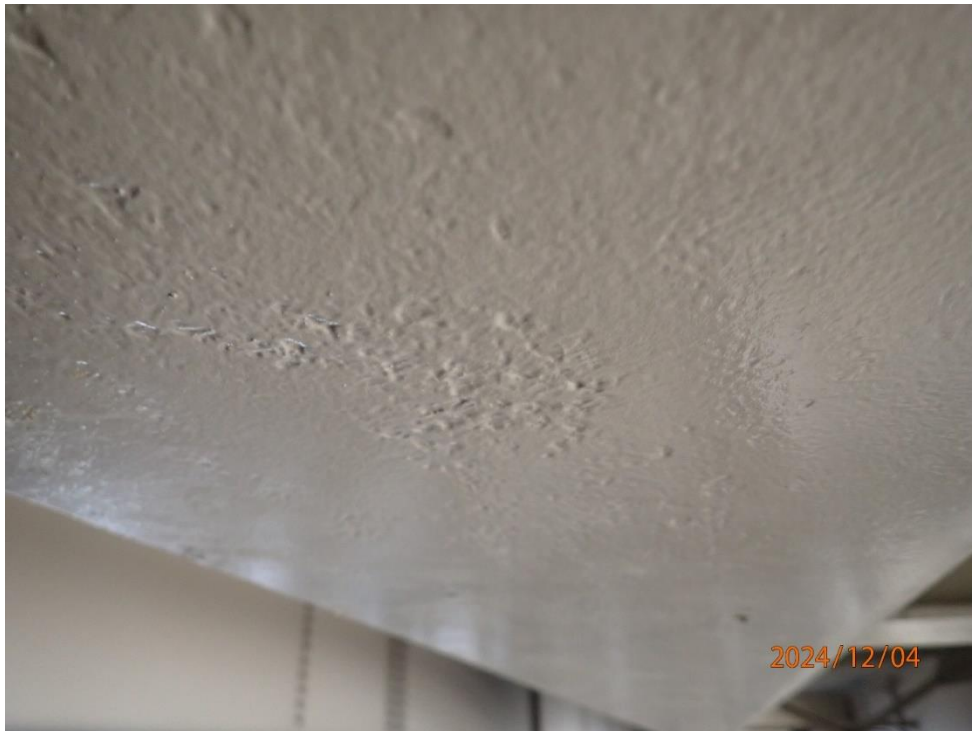
Bottom face of bottom flanges in non-haunch sections typically have paint over minor pitting

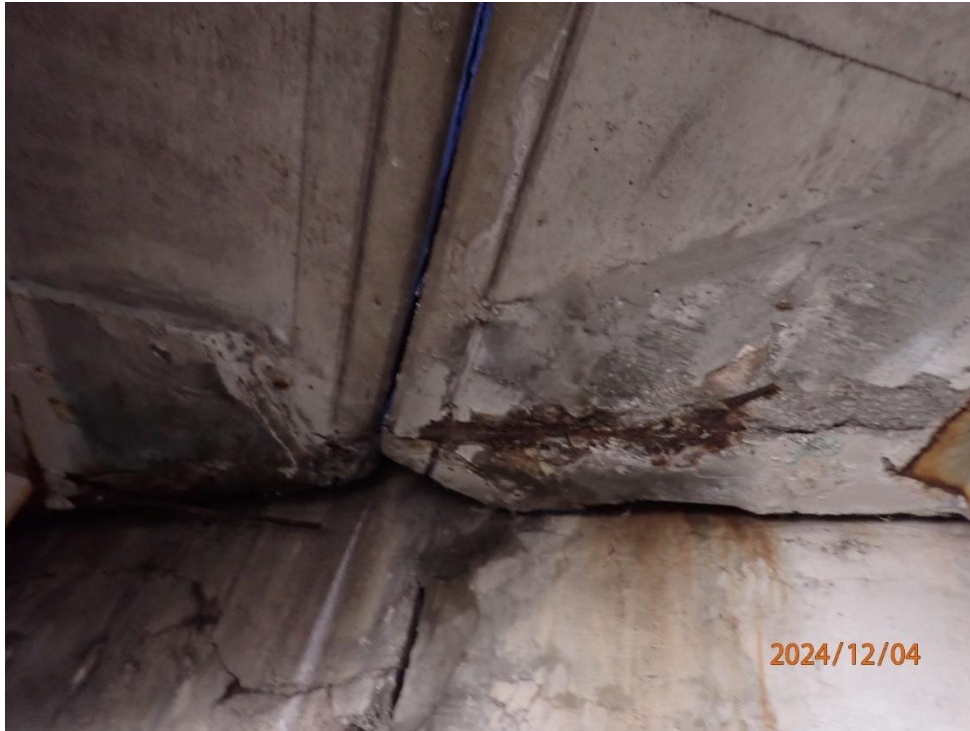
There is spalling with exposed rebar along the longitudinal joint at each abutment (at Abutment 4 pictured)

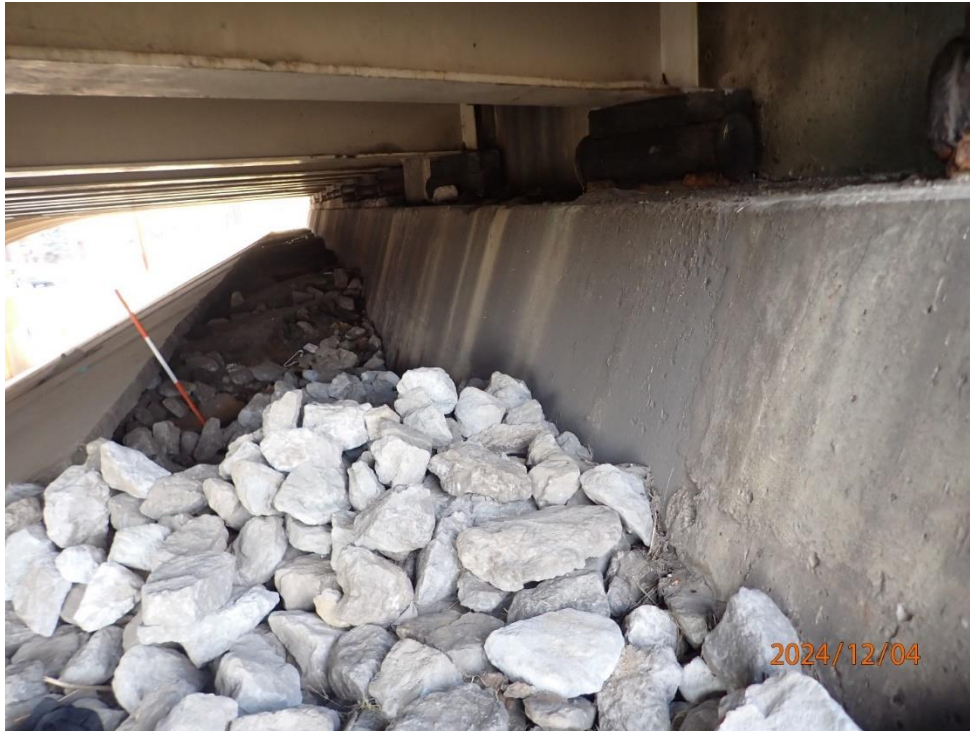
Rip rap has been placed at the NE corner to correct erosion and undermining of the concrete slope protection and is functioning as intended. Minor undermining still exists along the top of the remainder of Abutment 4 slope protection.

Abutment 4. Note rip rap in place at the NE corner and undermining along the top of Abutment 4 slope protection.

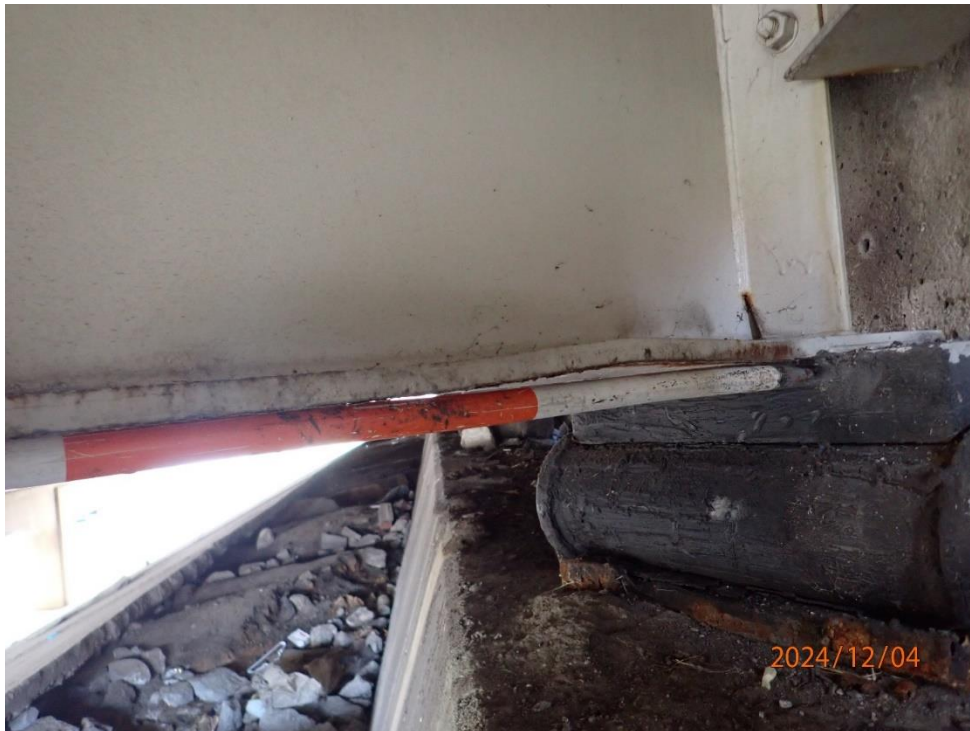
Beam 13 bottom flange has a 1.5'L area of minor distortion at Abutment 4

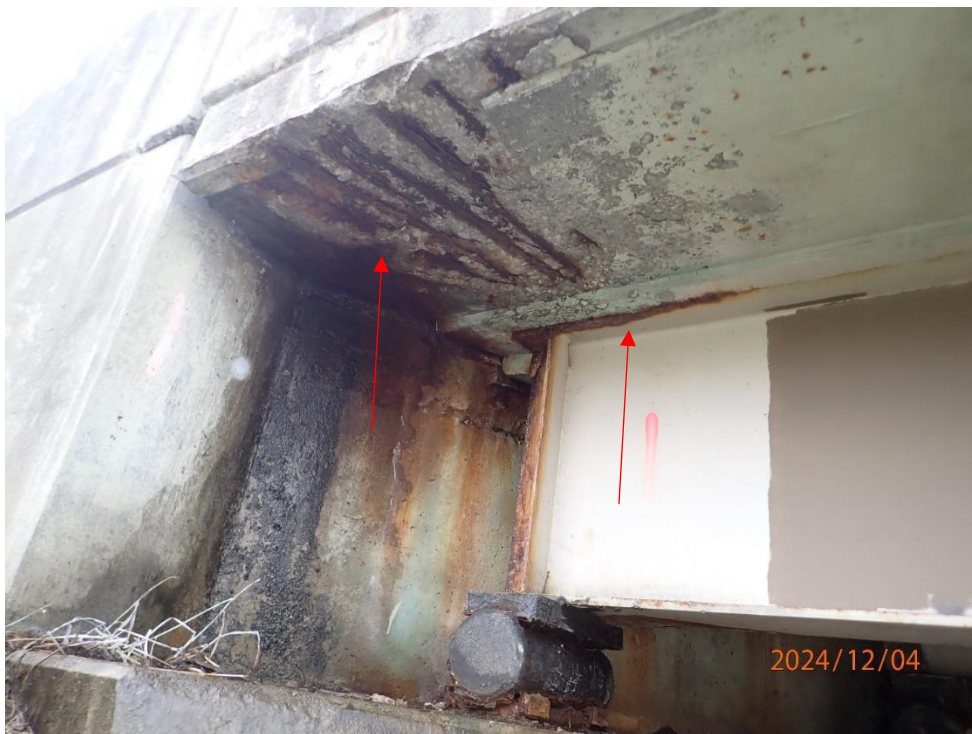
There is spalling with exposed rebar in each overhang at Abutment 1 (east overhang pictured). Note heavy surface corrosion along top flange of Beam 14.
