# Bridge Inspection Report

056B00186N

12/09/2024

Standard (24 months)

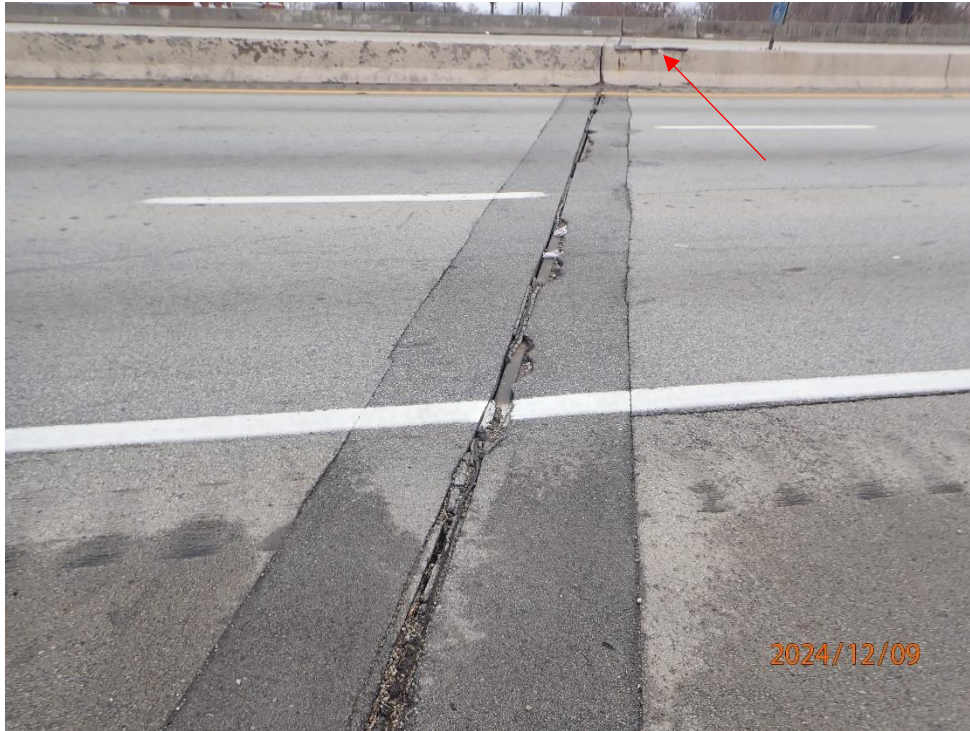
Concrete railings have vertical and horizontal cracks. SB median barrier has moderate to heavy scaling for the south half of the bridge length. There is a 3'L spall with exposed rebar along the top of the approach median at Abutment 1 (not included in quantities). The approach guardrail and concrete rail at the NE corner along the exit ramp has impact damage (not included in quantities).

Joint over Abutment 1, SB lanes. There is a 3'L spall with exposed rebar along the top of the approach median at Abutment 1.

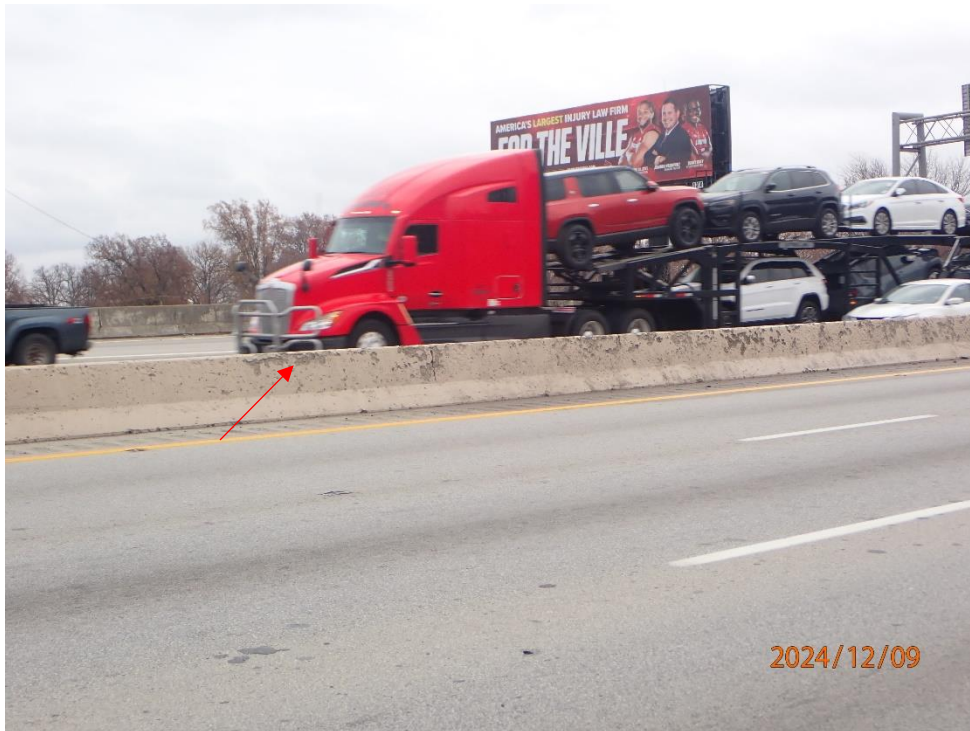
SB median barrier has moderate to heavy scaling for the south half of the bridge length

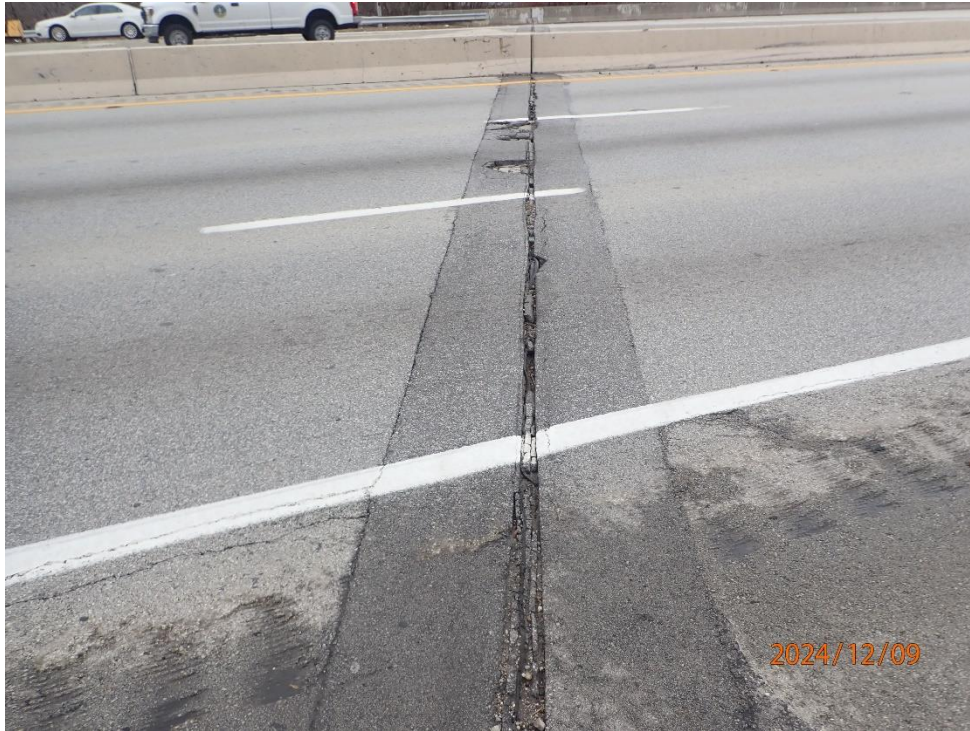
Joint over Abutment 4, SB lanes

Asphalt plug joints were reconstructed in 2017. Asphalt joints have gapping, wide cracks, and spalls, some exposing the original joints and allowing moderate to free flow of water. Asphalt joints are also heaving in portions of the NB lanes. From below the deck, daylight is visible through the joints in the two left NB lanes over Abutment 4 and the two left SB lanes over Abutment 1.

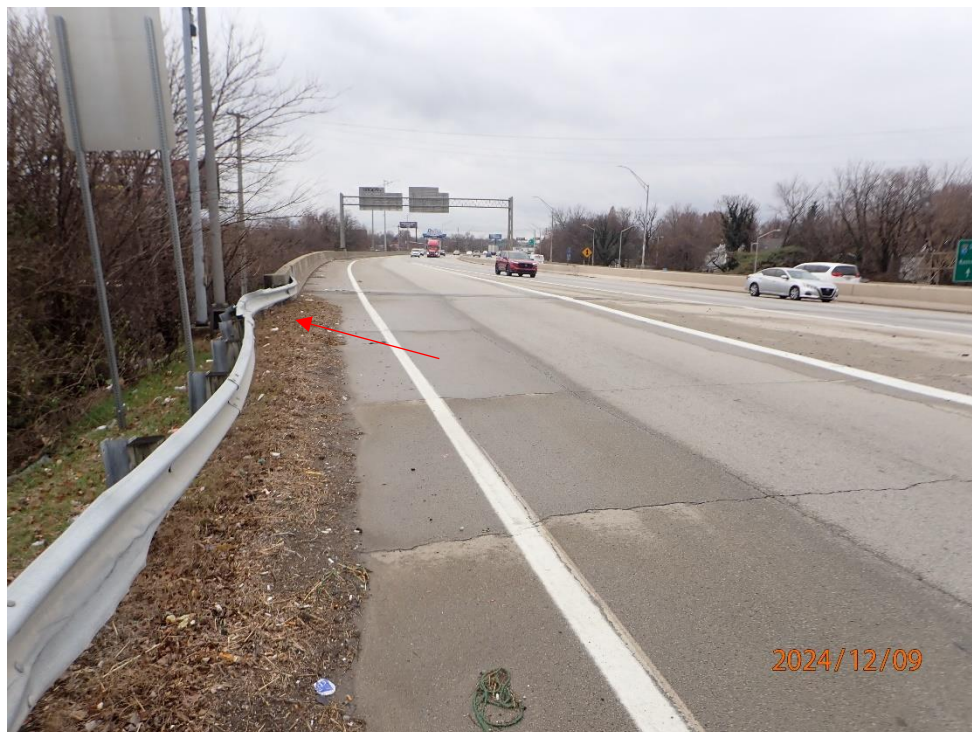
Looking south along I-65 NB. The approaching guardrail at the NE corner along the exit ramp has impact damage.

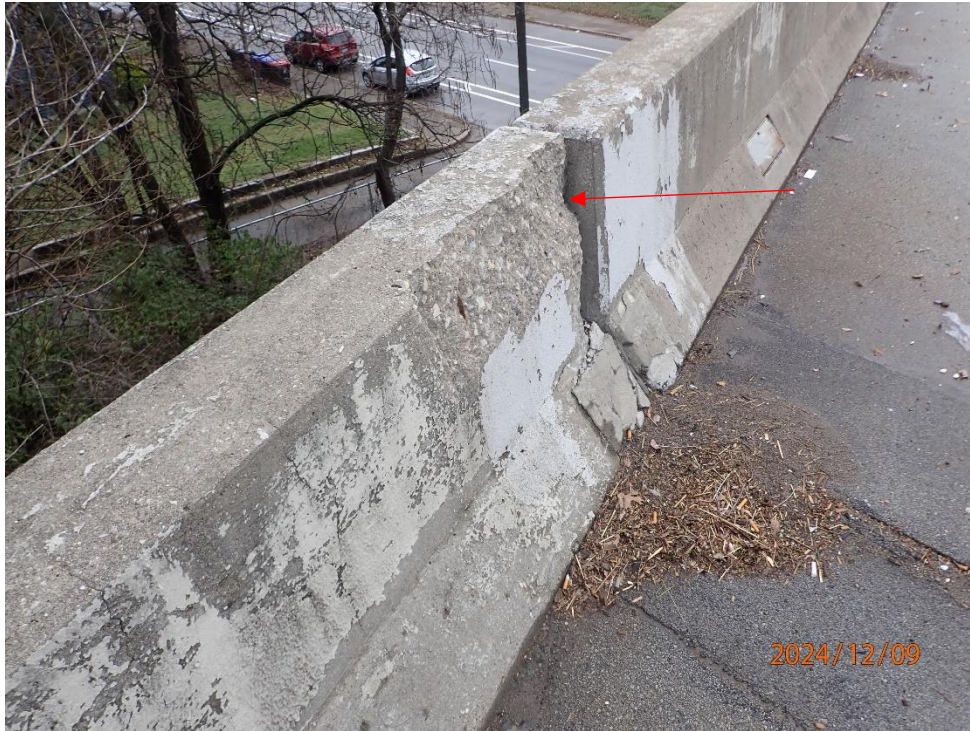
The approach concrete rail at the NE corner along the exit ramp has impact damage

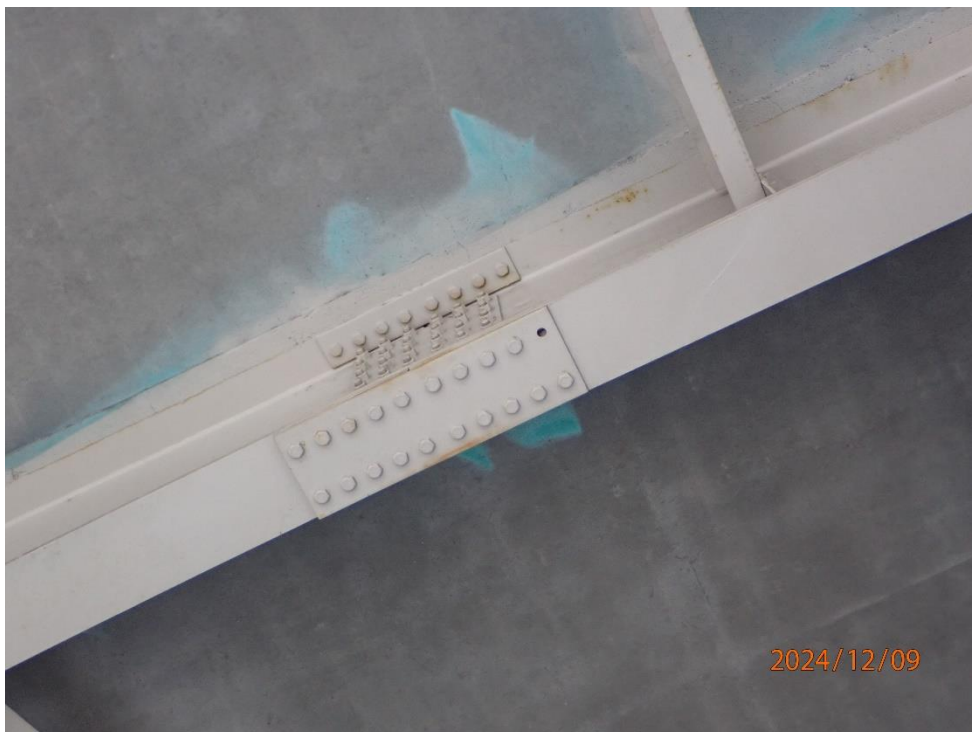
Span 2 Beam 15 splice plate near Pier 2 has one missing bolt

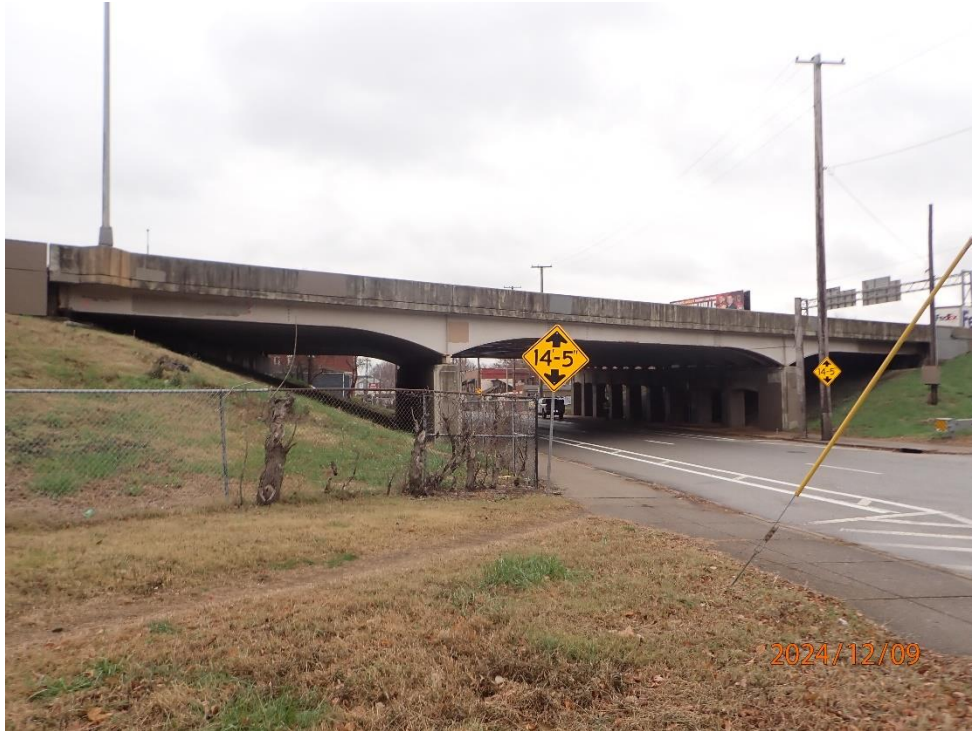
-MINIMUM VERTICAL UNDER-CLEARANCE MEASURED AT 14'-8". SHOULD BE POSTED AT 14'-5".

West profile. Note vertical clearance signs. There are also vertical clearance signs on each corner of the intersection at the west side of the bridge.

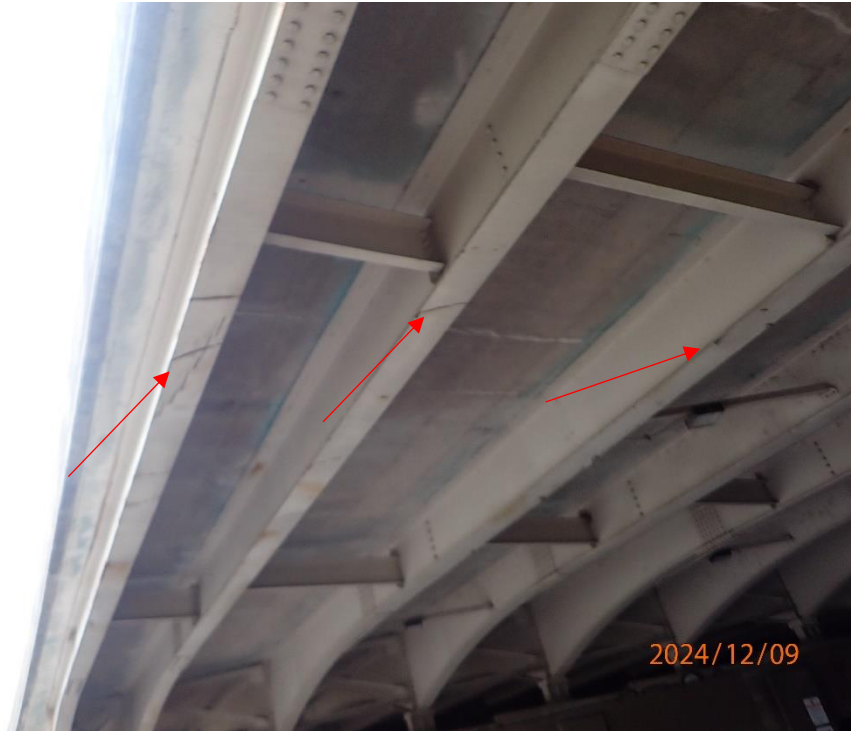
Beams have freckling rust scattered throughout the bottom flanges, and flaking corrosion with very minor section loss on the flanges below the joints, worst case being Beam 11 at Abutment 4. Beam 1 also has minor section loss in the web and bearing stiffener at both abutments. In Span 2, Beams 1, 2, and 3 bottom flanges are scraped due to vehicular impact, and the Beam 15 splice plate near Pier 2 has one missing bolt. The northeast corner of Beams 13 through 15 bottom flanges are bearing against the Abutment 4 backwall.

Span 2 Beams 1, 2, and 3 bottom flanges are scraped due to vehicular impact

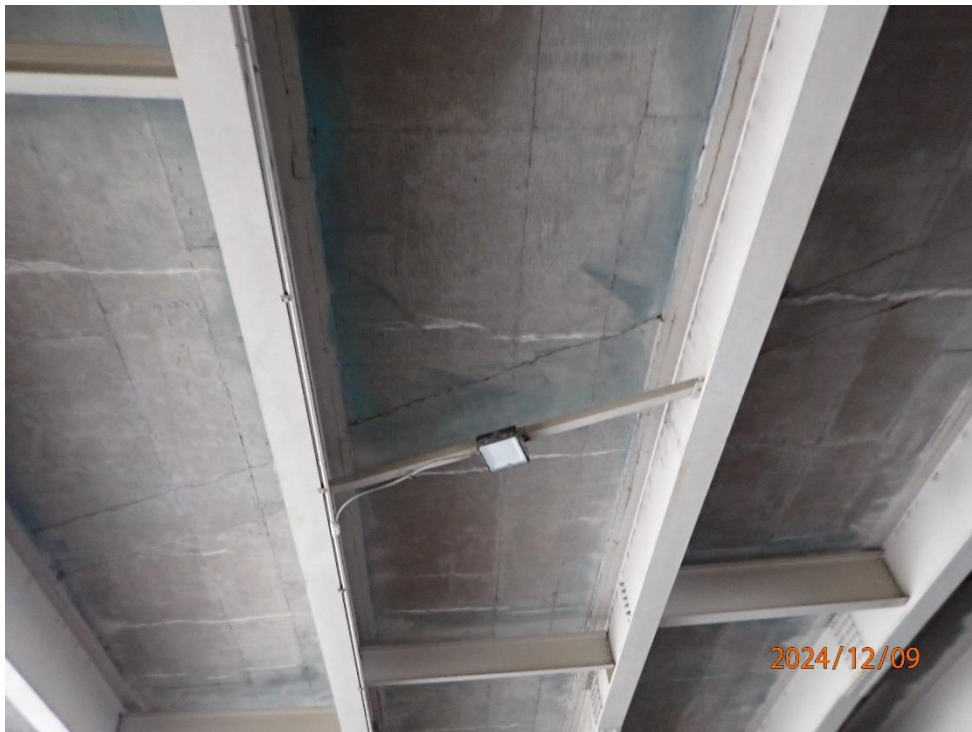
Top of deck cannot be visually inspected due to overlay. Soffit has transverse cracks with efflorescence. There are local areas of full depth deterioration along the longitudinal joint and Bay 1 in all three spans, especially at the abutments. There are areas of spalling with exposed rebar at Abutment 1 in the west overhang and at the longitudinal joint.

Soffit has transverse cracks with efflorescence

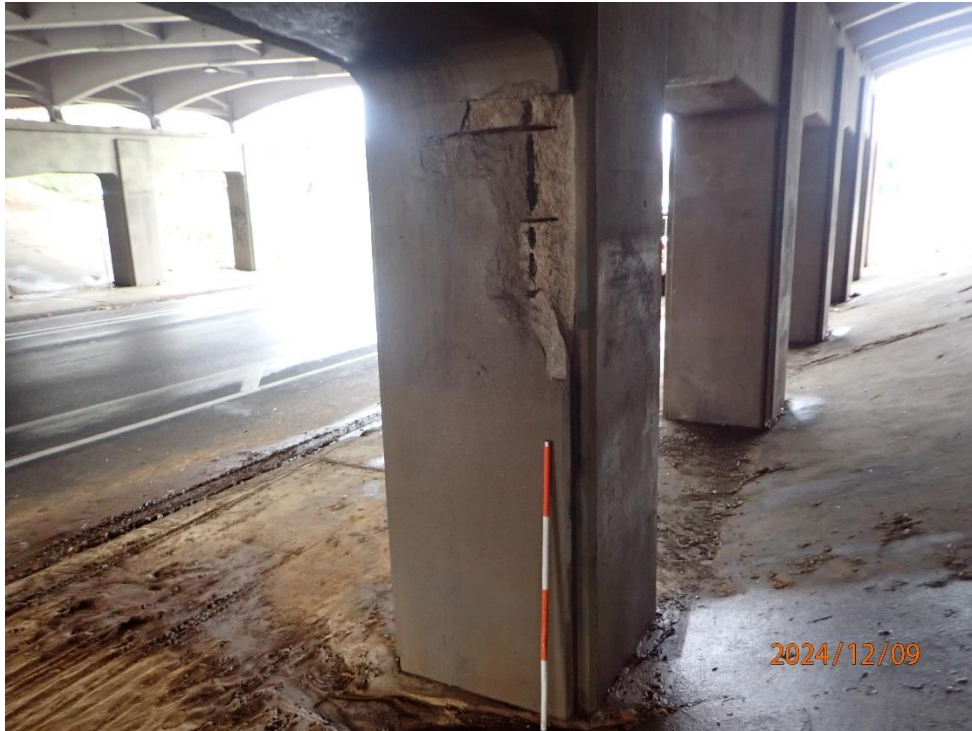
The following columns have moderate cracking and/or small spalls: Pier 2-Columns 1, 2, and 4, and Pier 3-Column 2. Pier 2-Column 5 has a 3.5-foot tall by 2-foot wide by 2-inch deep spall with exposed rebar in the west face. Pier 3-Column 7 has a delamination.

Pier 2 Column 5 has a 3.5-foot tall by 2-foot wide by 2-inch deep spall with exposed rebar in the west face

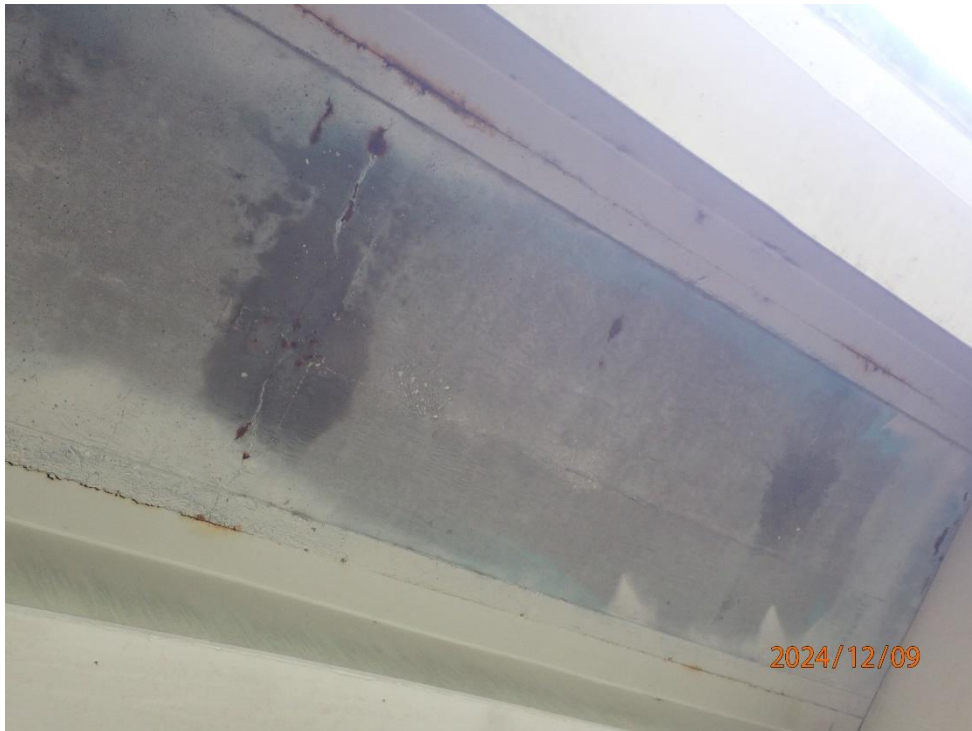
There are local areas of full depth deterioration along the longitudinal joint and Bay 1 in all three spans (Span 1 Bay 1 pictured)

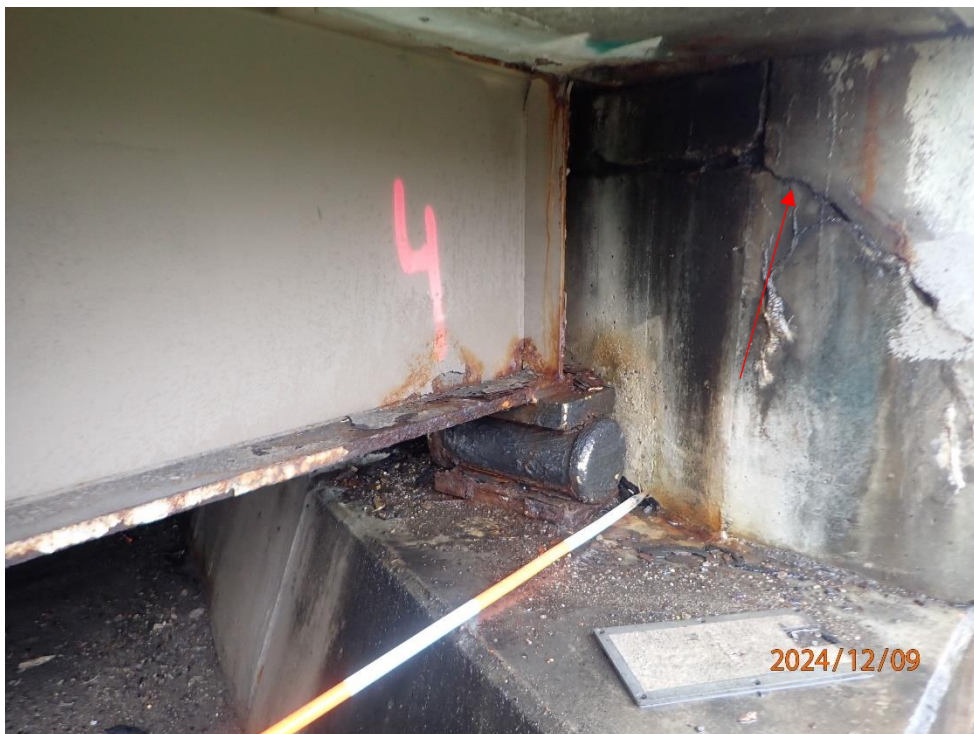
Abutment backwalls have moderate to wide vertical cracks, diagonal cracks with rust staining at each end, and intermittent patching; some areas are unsound or spalling with exposed rebar, especially at the longitudinal joint. Worst deterioration is in the Abutment 1 backwall at the longitudinal joint, with spalling up to 13 inches deep and two layers of exposed rebar with section loss. Abutment 4 has horizontal cracking and scaling in the seat, with 14 feet of wide cracking at the west end. Abutment 4 seat also has spalls varying from 1 to 2 feet wide with exposed rebar below Bays 3, 4, and 12.

Abutment 1 backwall has wide diagonal cracking with rust staining at the west end

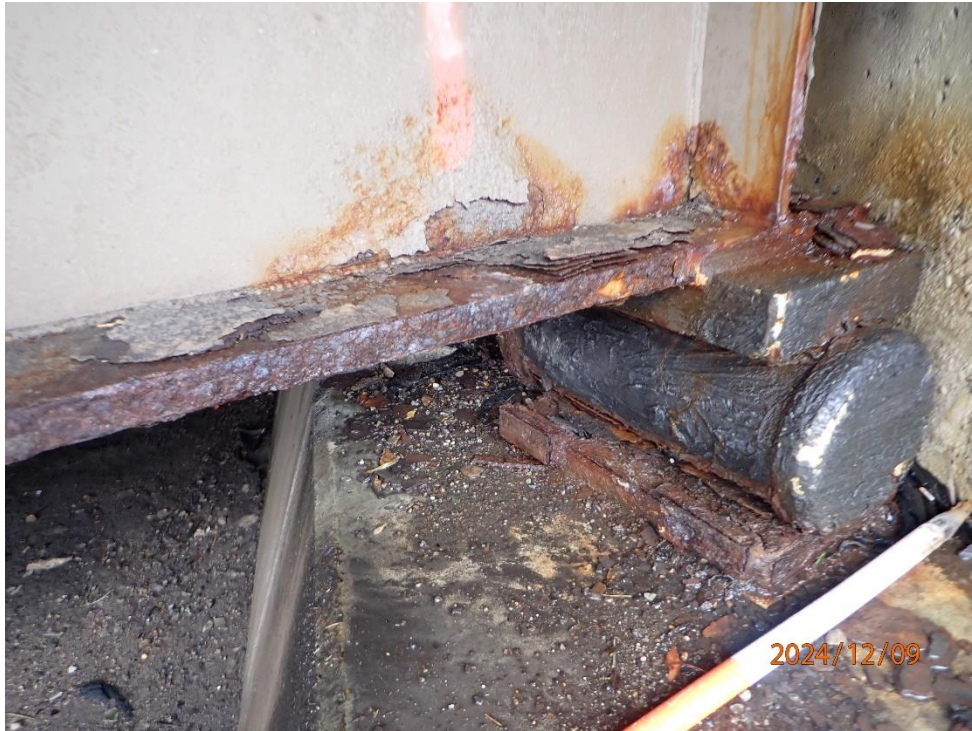
Flaking corrosion with very minor section loss on the bottom flange of Beam 1 at Abutment 1. Note flaking corrosion in the masonry plate.

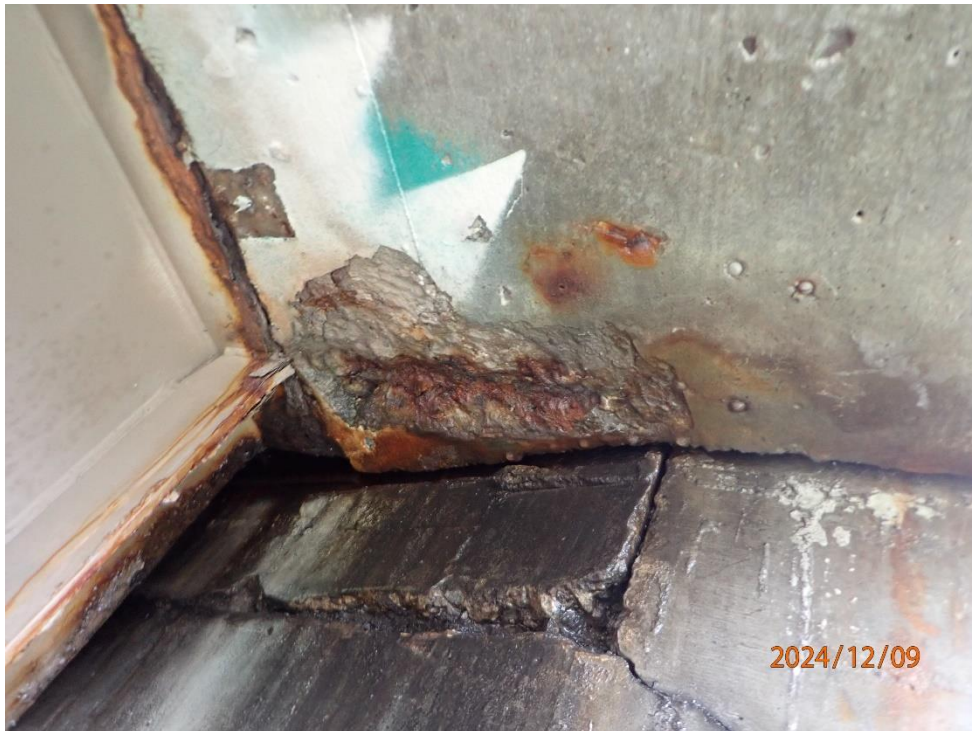
spalling with exposed rebar at Abutment 1 in the west overhang

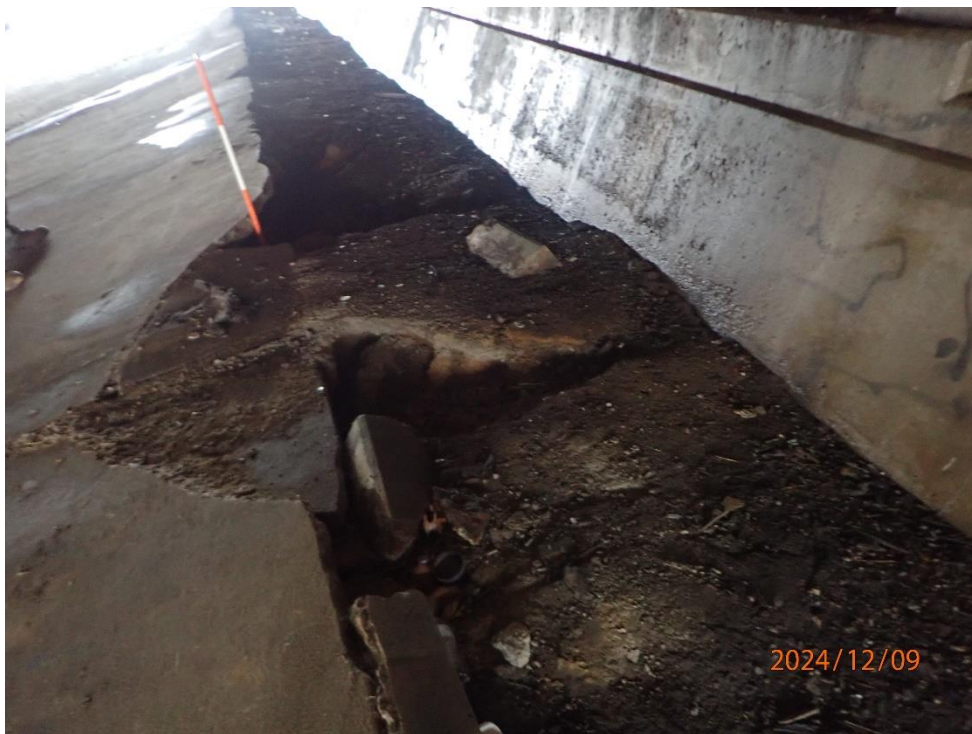
Abutment 1 slope wall has areas of undermining along the top, up to 1.5'D. There is a broken/cracked/settled section at the top below Beam 4.

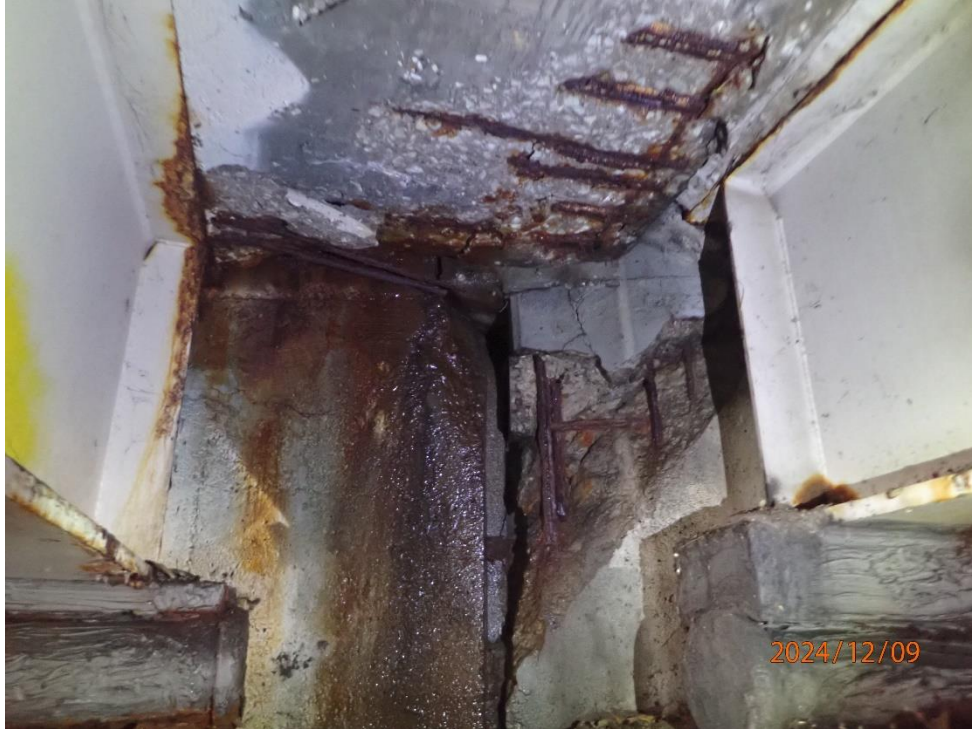
Soffit has spalling with exposed rebar at Abutment 1 at the longitudinal joint

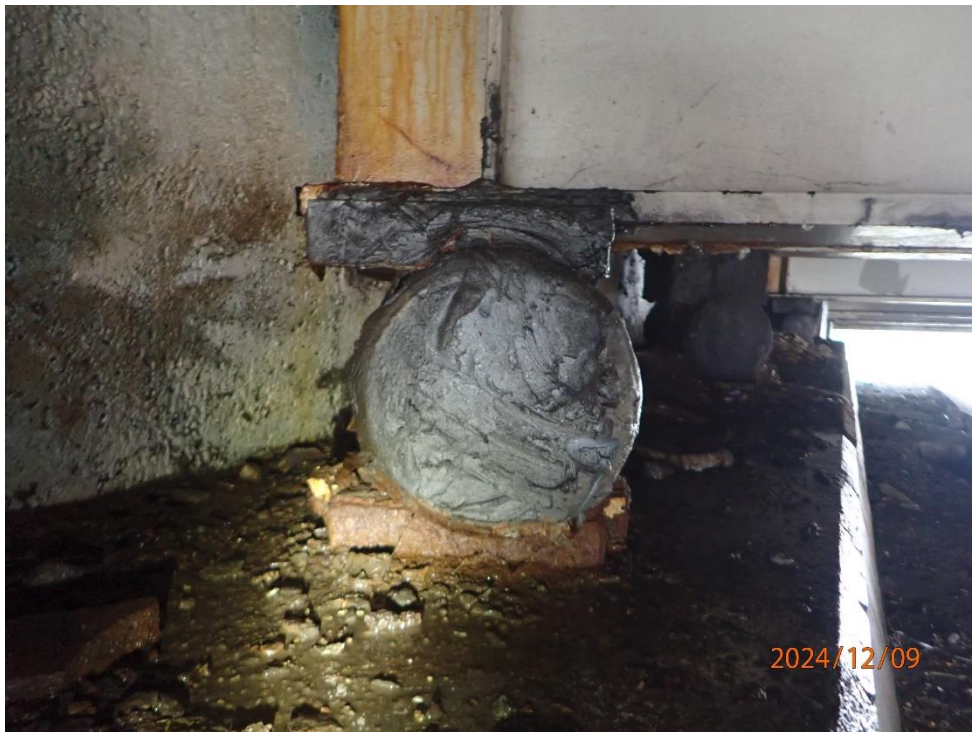
Roller bearings have been greased, but corrosion has reinitiated on the rollers and masonry plates and several have flaking corrosion. Many roller bearings are misaligned, movement is inconsistent with temperatures conditions, and some beam ends are bearing on the Abutment 4 backwall. Beam sole plates are floating (in contact with the roller only under live load) with vertical movement up to 1/8 inch at the following locations: Abutment 1-Beams 4, 6, and 7 and Abutment 4-Beams 10, 11, and 12. The following rollers were reset in 2012: 1, 7, 8, 10, 11, 13, 14 and 15 at Abutment 4.

Many roller bearings are misaligned, movement is inconsistent with temperatures conditions (Beam 8 at Abutment 1 pictured)

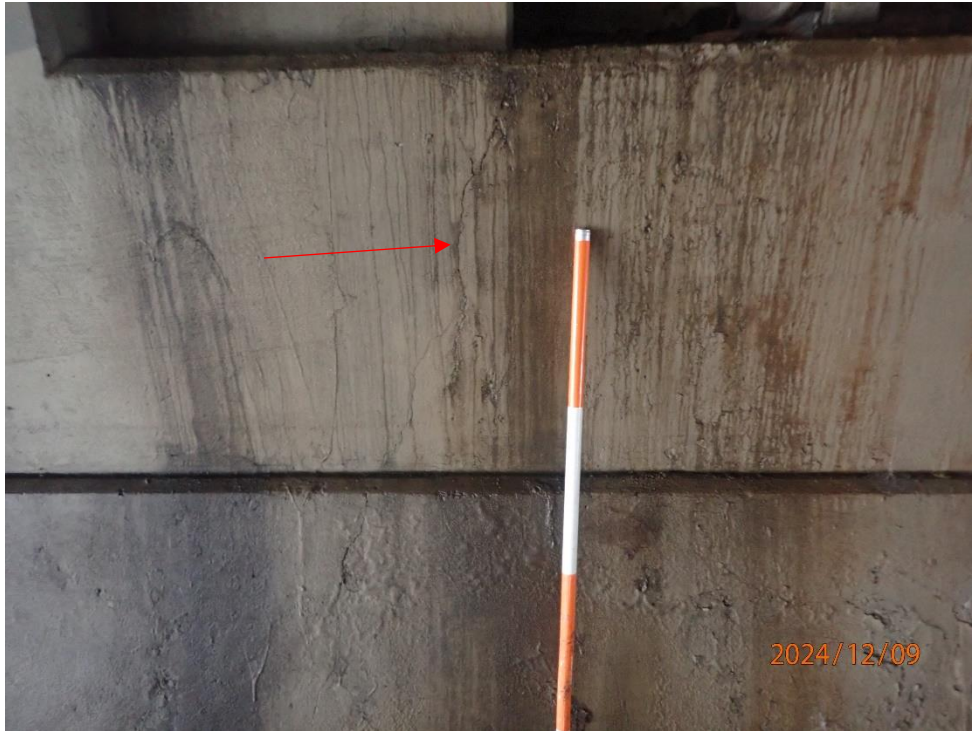
Typical vertical cracking in abutments

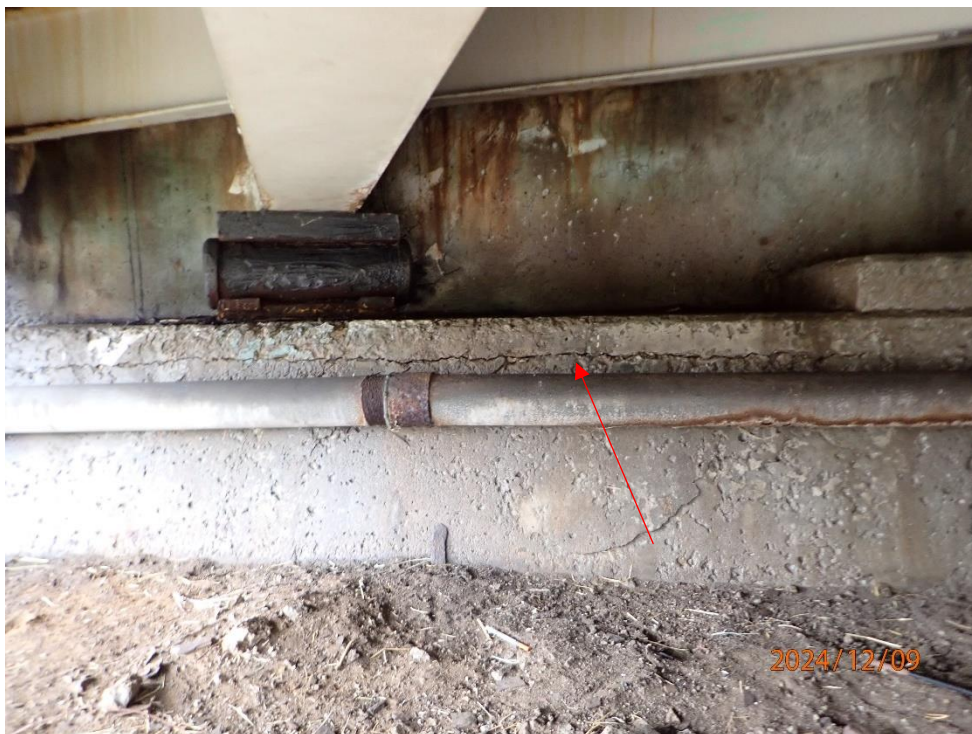
Abutment 4 has 14 feet of wide horizontal cracking at the west end

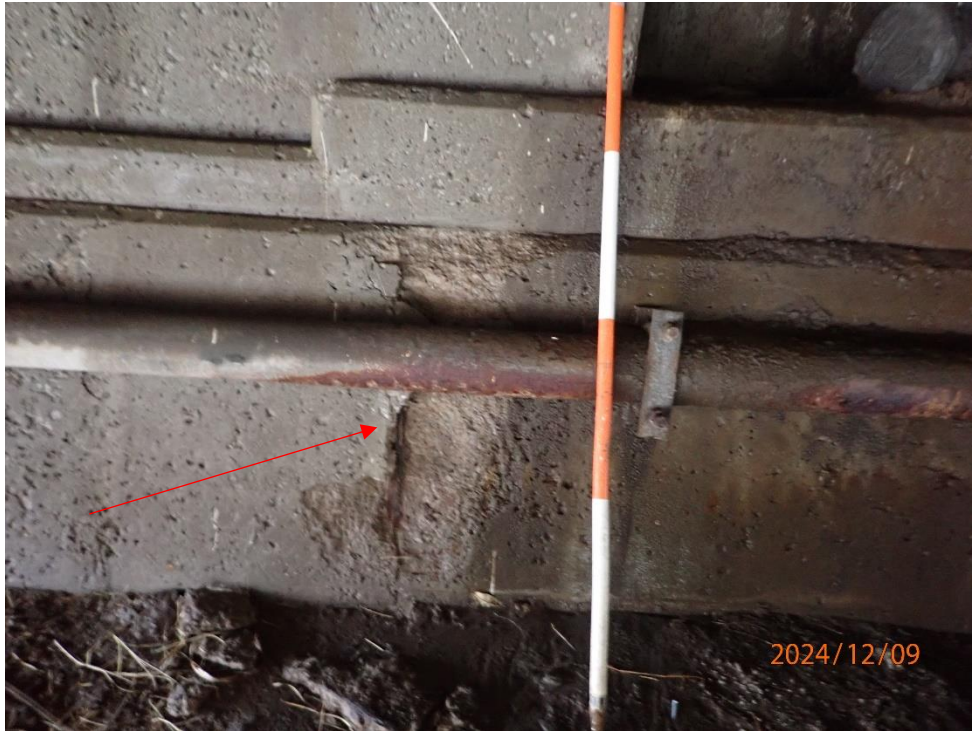
Spalling in Abutment 4 below Bay 3

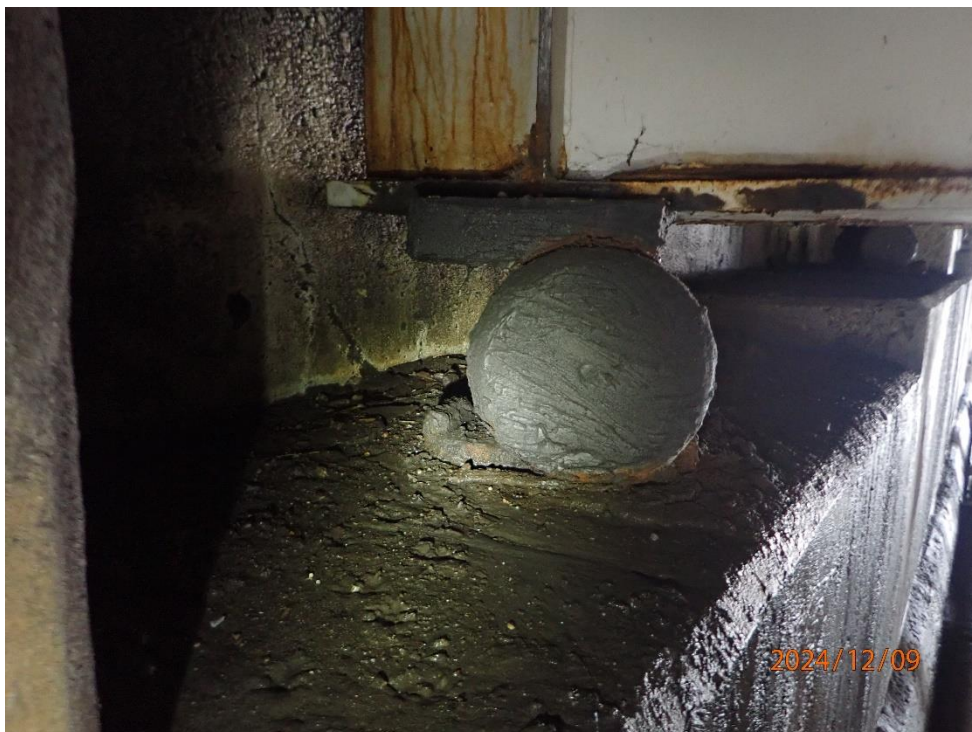
Many roller bearings are misaligned, movement is inconsistent with temperatures conditions (Beam 10 at Abutment 4 pictured)

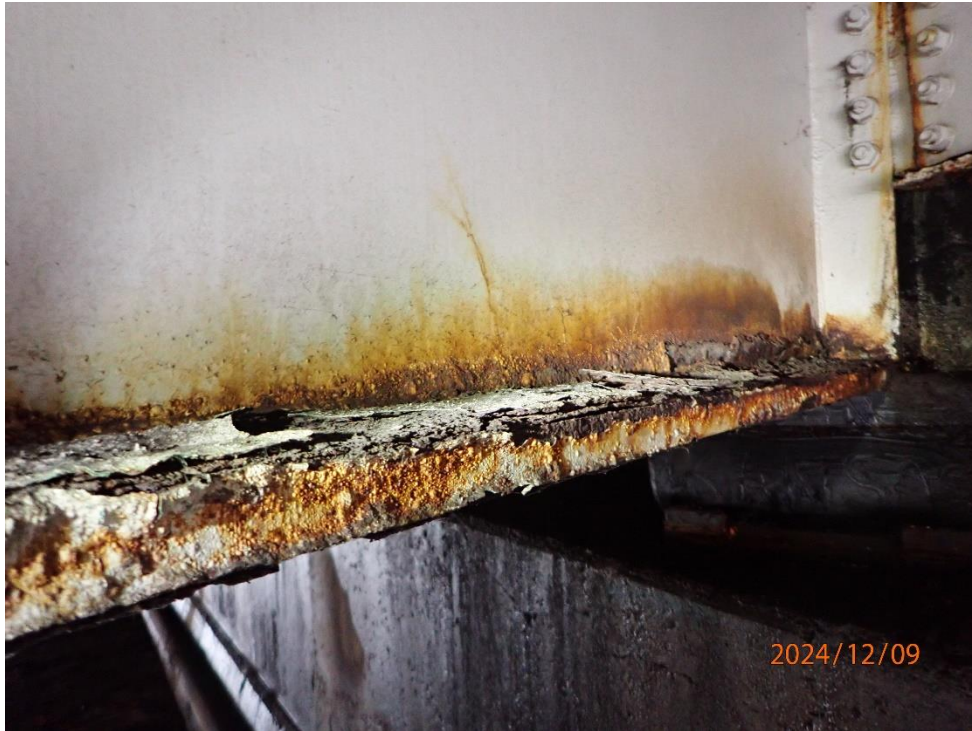
Beam 11 at Abutment 4 has flaking corrosion with very minor section loss on the bottom flange

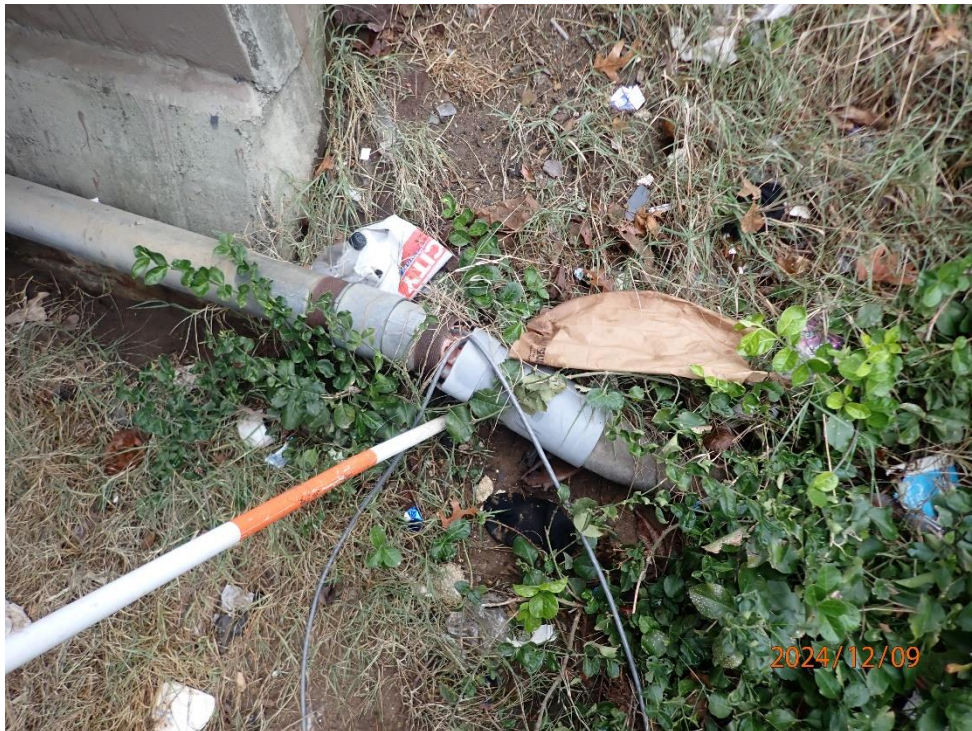
There are streetlights attached to the superstructure in Span 2, but they were not on (unclear if they are functioning). There is metal conduit attached to the full-length of Abutment 4 that has flaking corrosion and is broken at the east end.

There is metal conduit attached to the full-length of Abutment 4 that has flaking corrosion and is broken at the east end

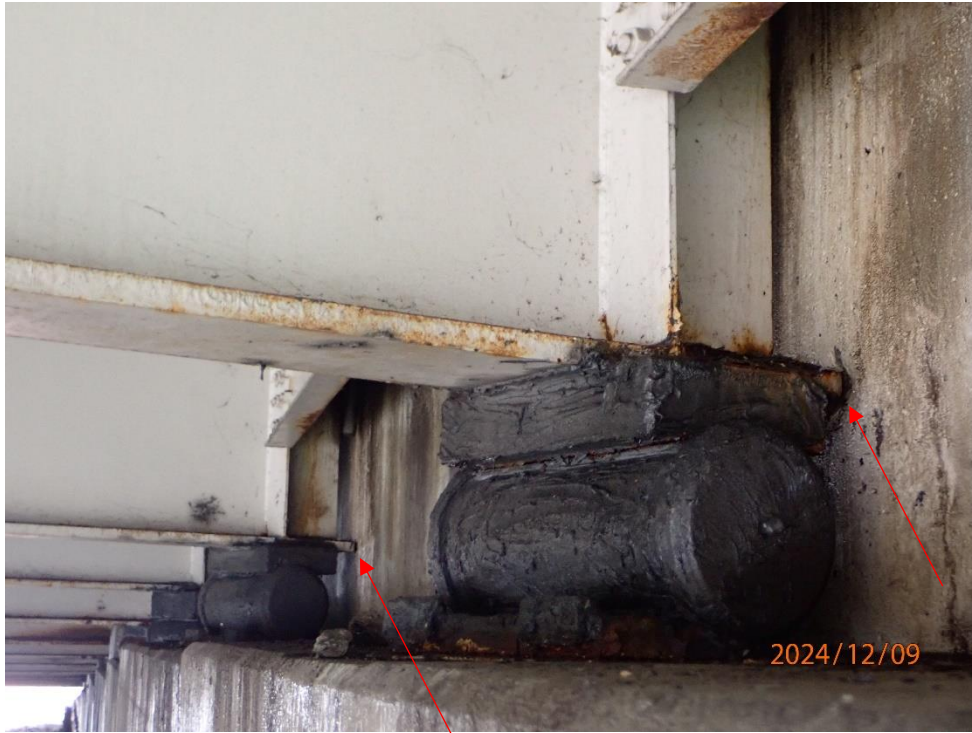
The northeast corner of Beams 13 through 15 bottom flanges are in bearing against the  
Abutment 4 backwall
