# Bridge Inspection Report

056B00191N

12/09/2024

Standard (24 months)

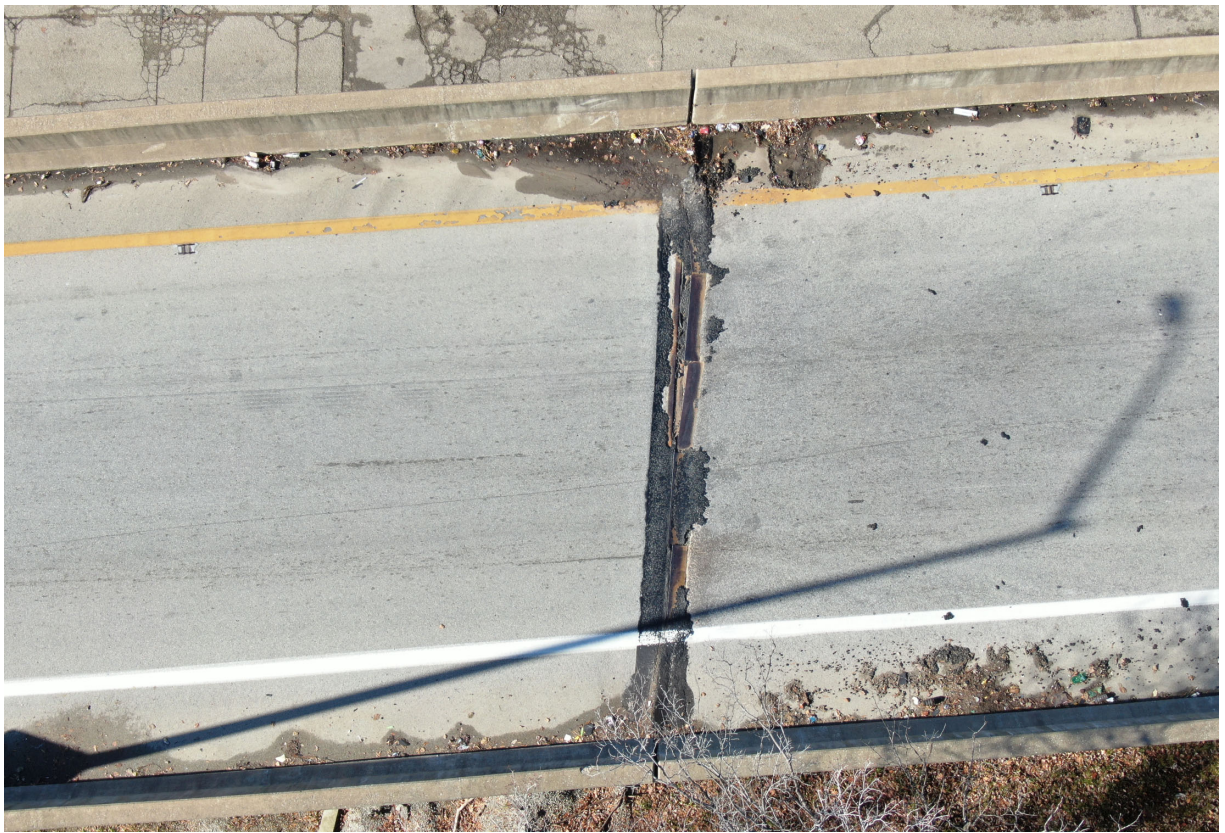
Joint over Pier A-5.

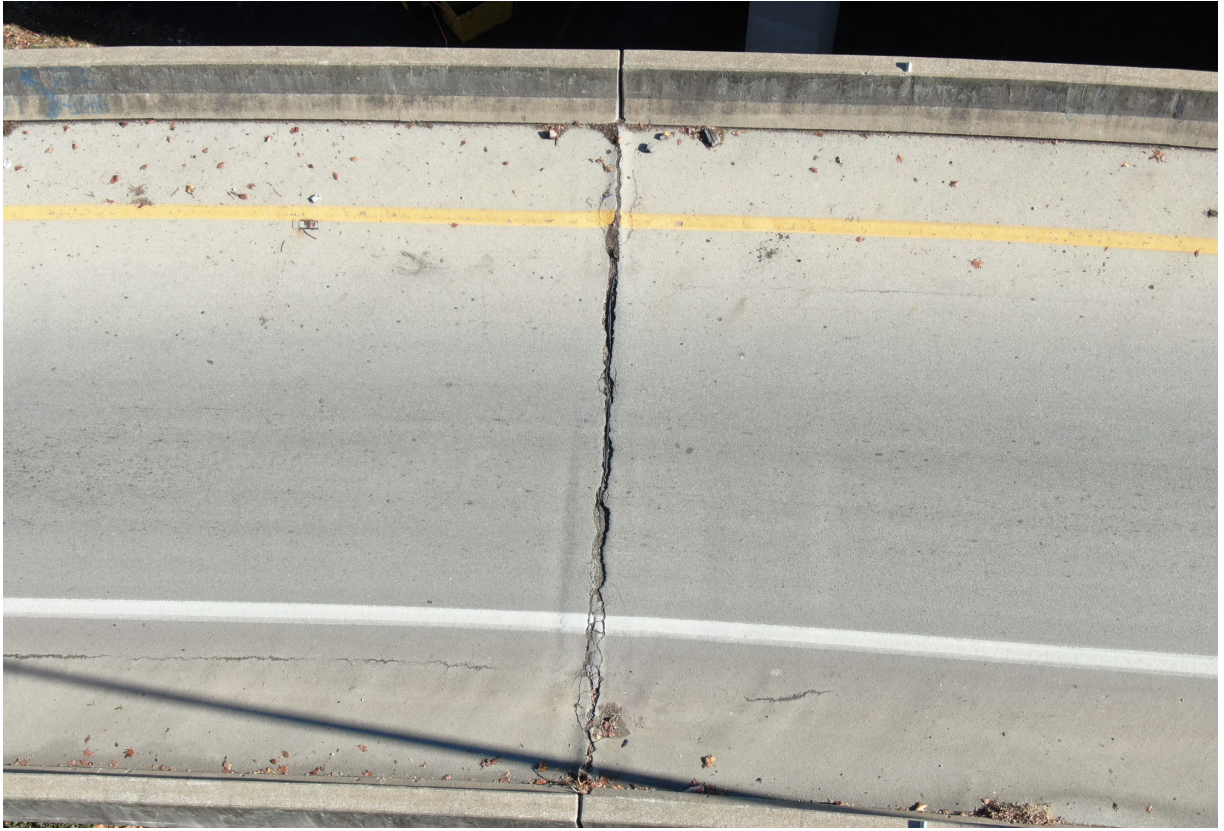
Joint over Pier A-1.

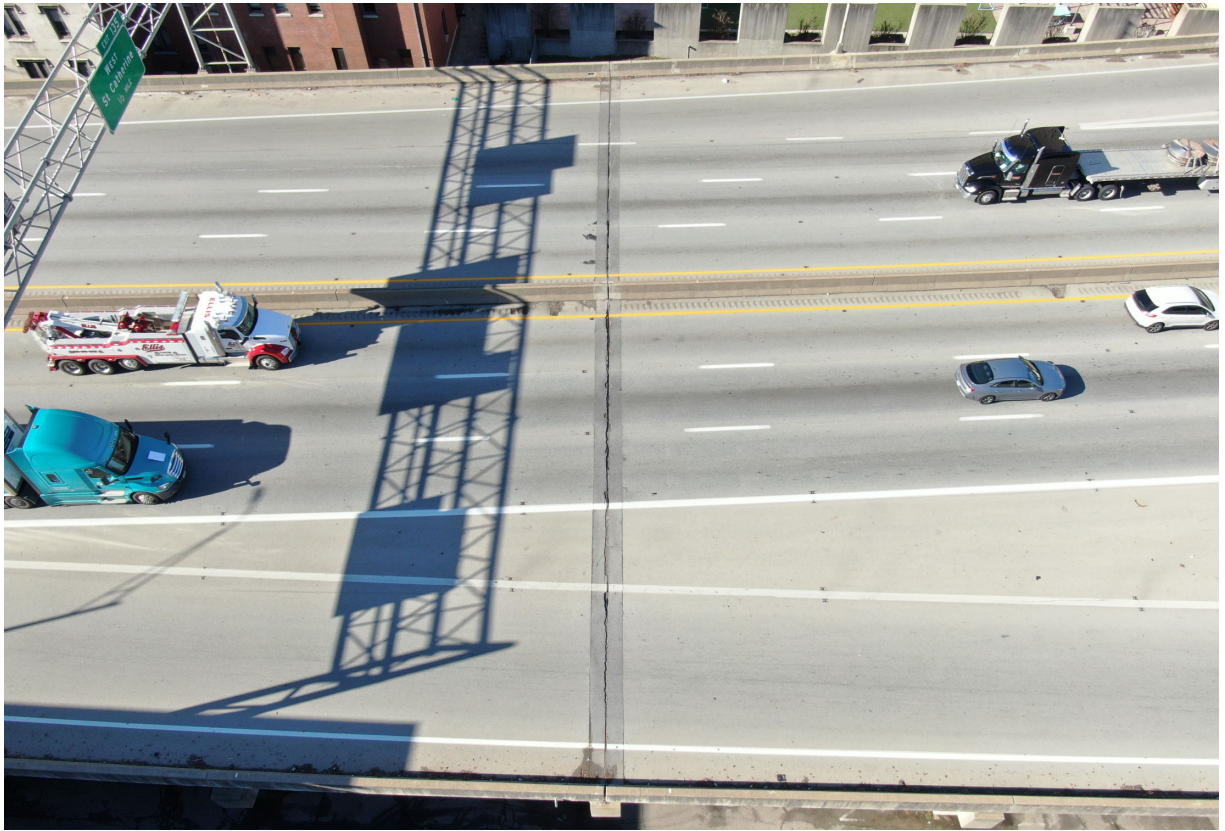
Joint over Pier 109.

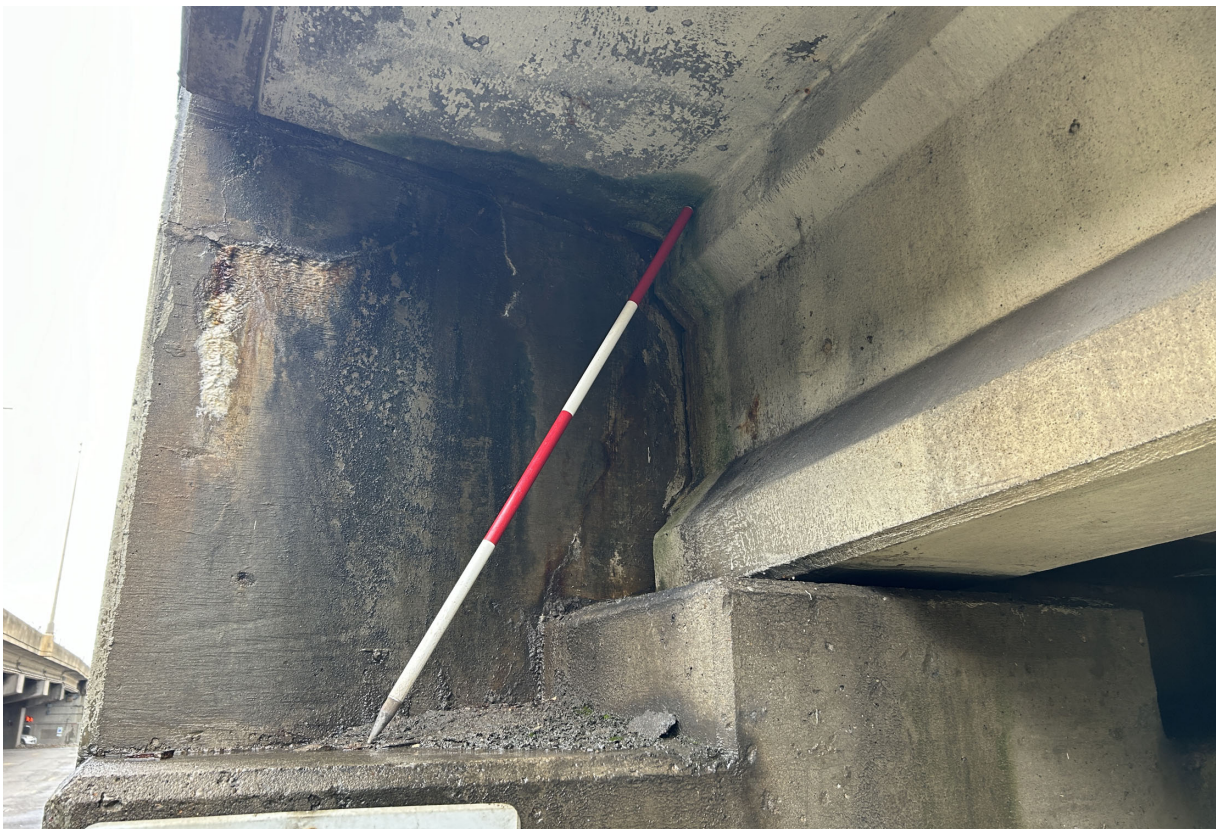
Abutment A has moderate vertical and diagonal cracks, some with efflorescence and/or rust staining at the west end. Abutment B has a few vertical cracks and small delaminations. Abutment C has moderate to wide horizontal cracking, delamination, unsound patches, and several spalls with exposed rebar.

Ramp A: Backwall of Abutment A has cracking with efflorescence and rust staining at the west end.

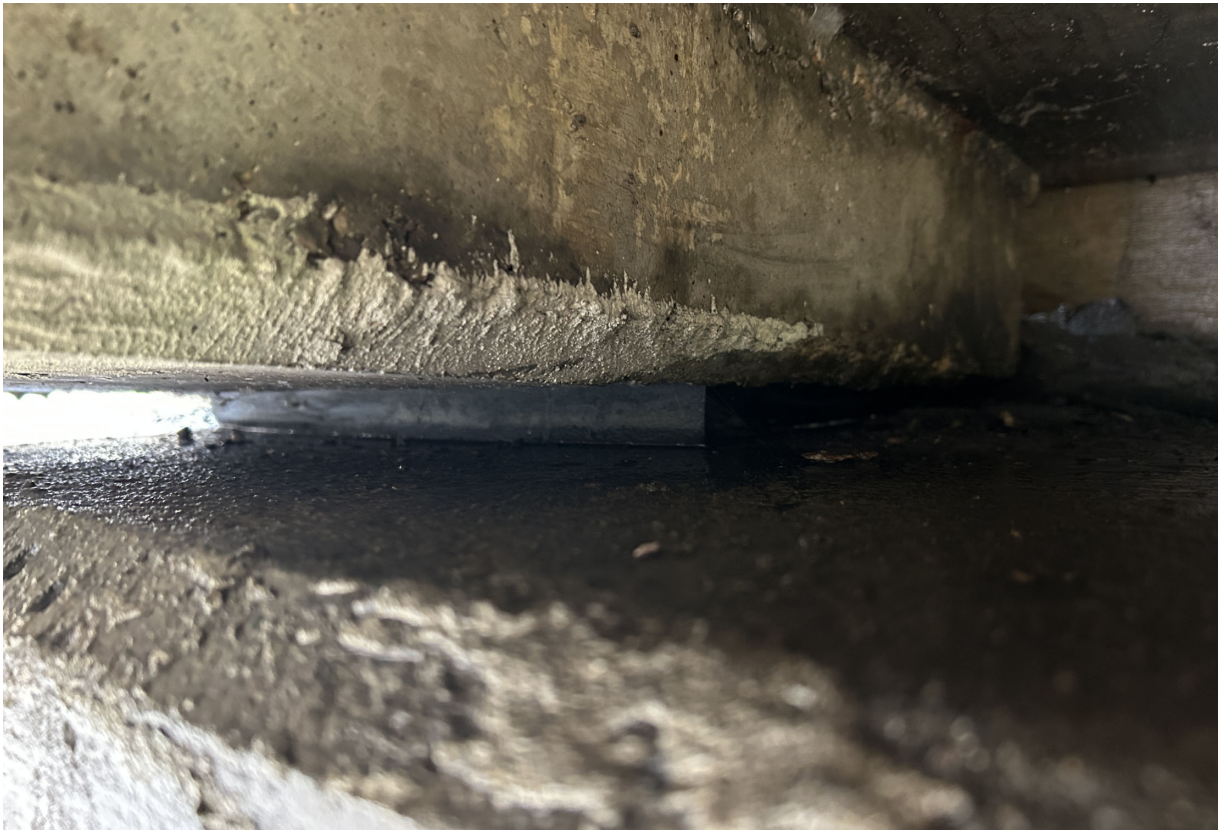
Ramp A: Typical Abutment A bearing pad.

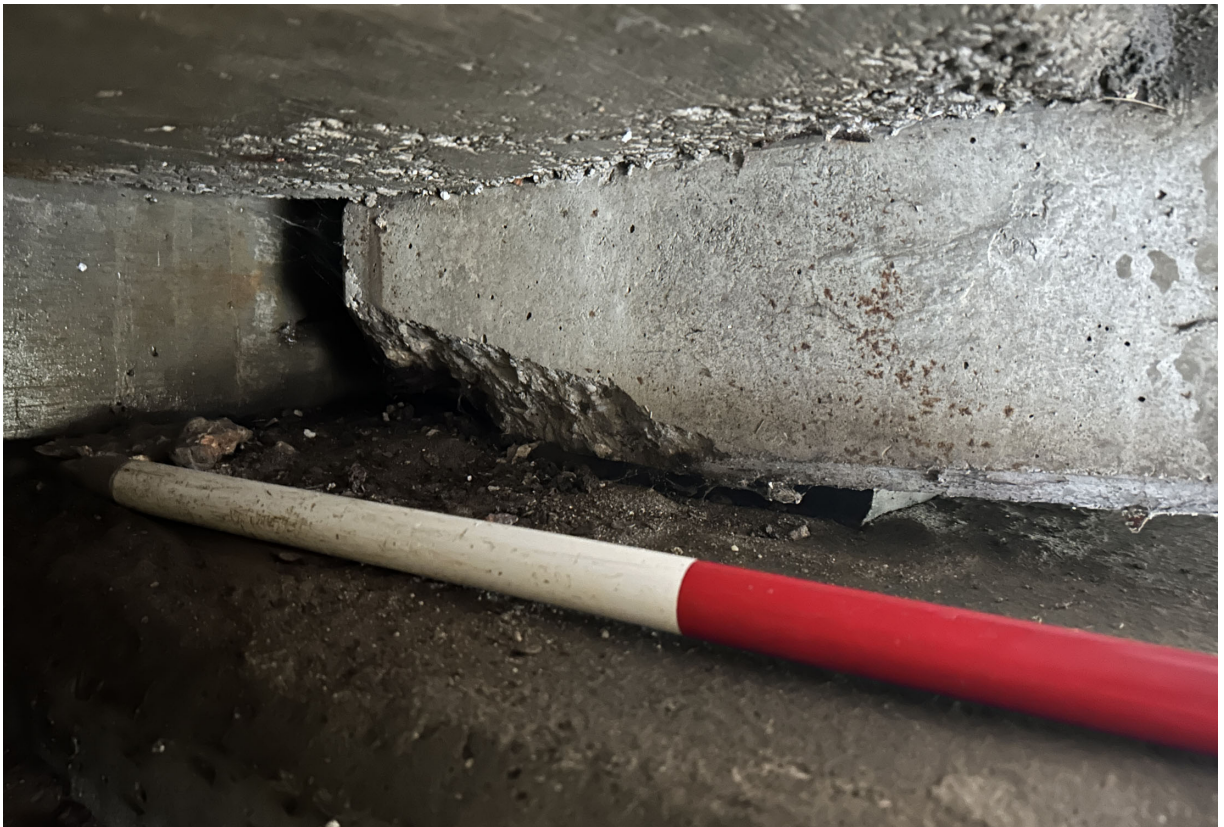
PCI beams have some moderate to wide longitudinal cracks and/or rust staining, delaminations, and small spalls; most defects are at beam ends and below the deck joints. At Abutment A, end spalling in the bottom flange with exposed strands (ES) was noted on Beam 3 (2 ES) and Beam 4 (1 ES). Ramp A Beam 1 at PA-5 has 2 feet of cracking. In Ramp B, Beams 1, 2, and 3 have cracking and spalling with exposed rebar at Abutment B, Piers B-1 and B-2, and Beam 4 has spalling with exposed rebar at PB-1. In Span 107 at Pier 106, Beams 4, 12, 16, 21, 22, and 24 have wide cracks or spalls with exposed rebar, typically in the bottom flanges. At P109W, Beam 1 has wide cracking and spalling with exposed rebar on both sides of the pier. In Span 119, Beam 16 bottom flange has 3 feet of spalling with exposed stirrups and wide longitudinal cracking at Pier 119W. In Span 120, Beam 16 bottom flange has 10 feet of cracking and spalling with one exposed prestressed strand near midspan.

Beams 3 and 4 at Abutment A have end spalls with exposed strands. Beam 3 shown.

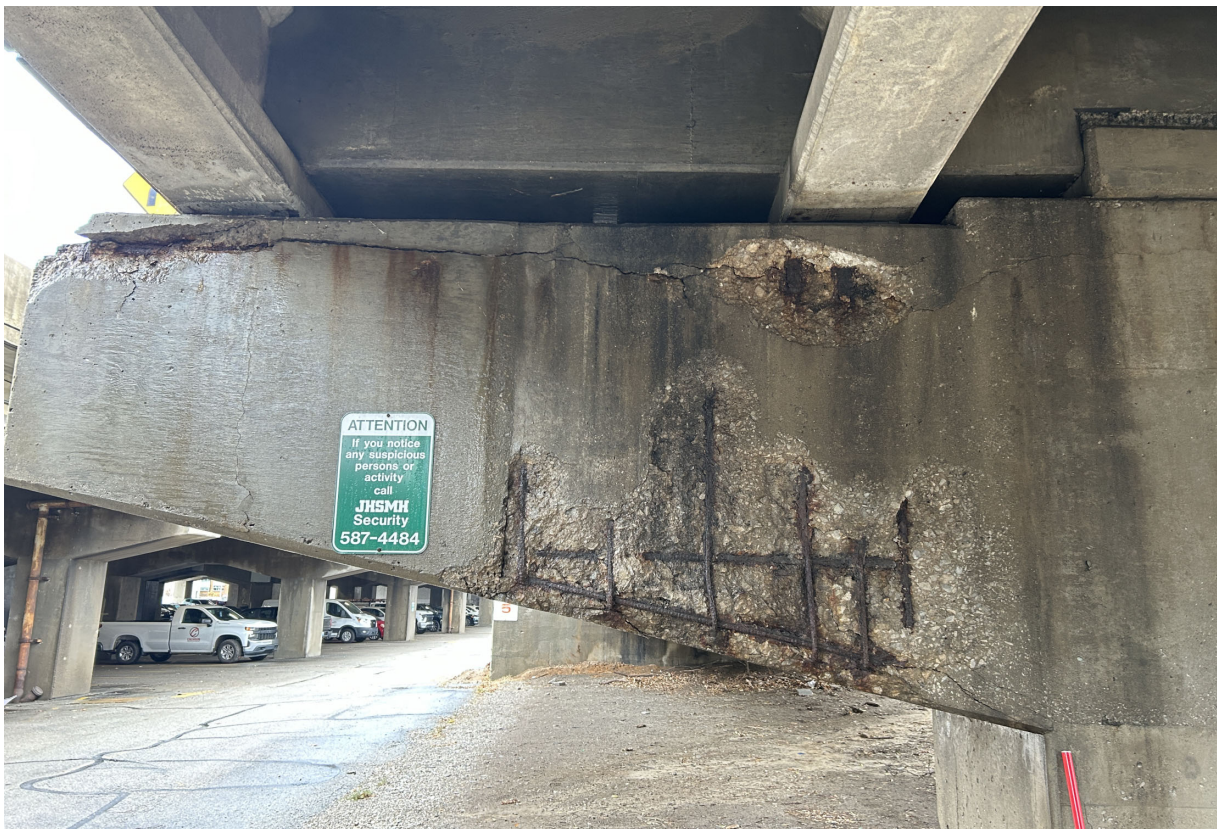
South face of Pier A-5 has large spalls with exposed rebar and wide horizontal cracking.

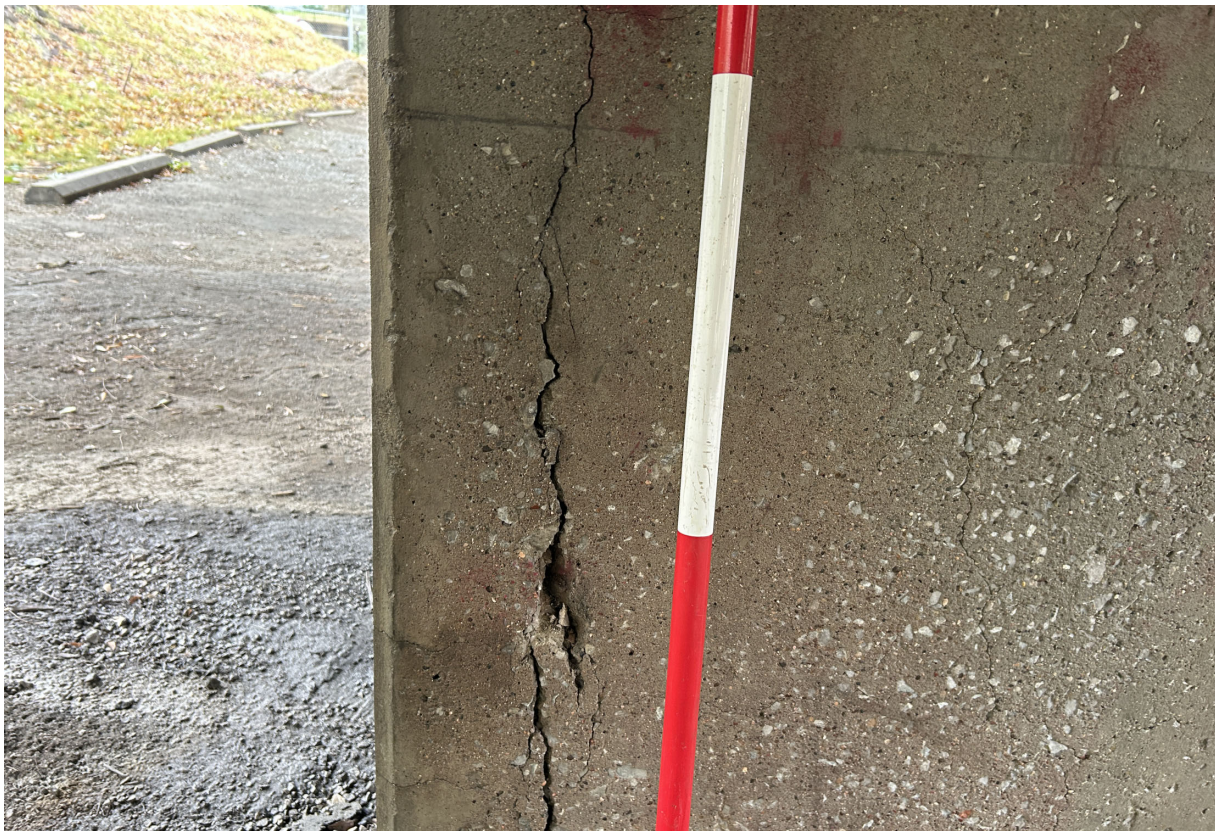
Ramp A: Wide vertical cracking in Pier A-5 column.

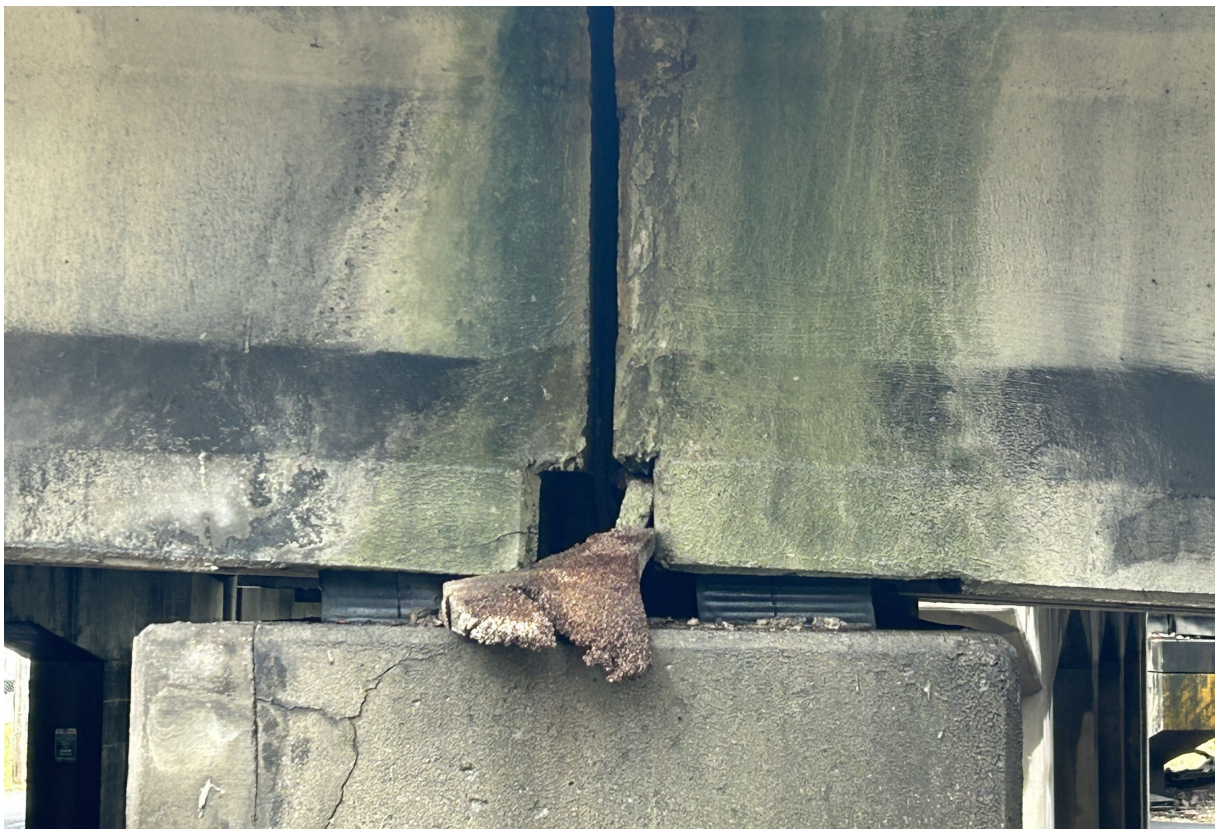
Typical Pier A-5 bearing pads.

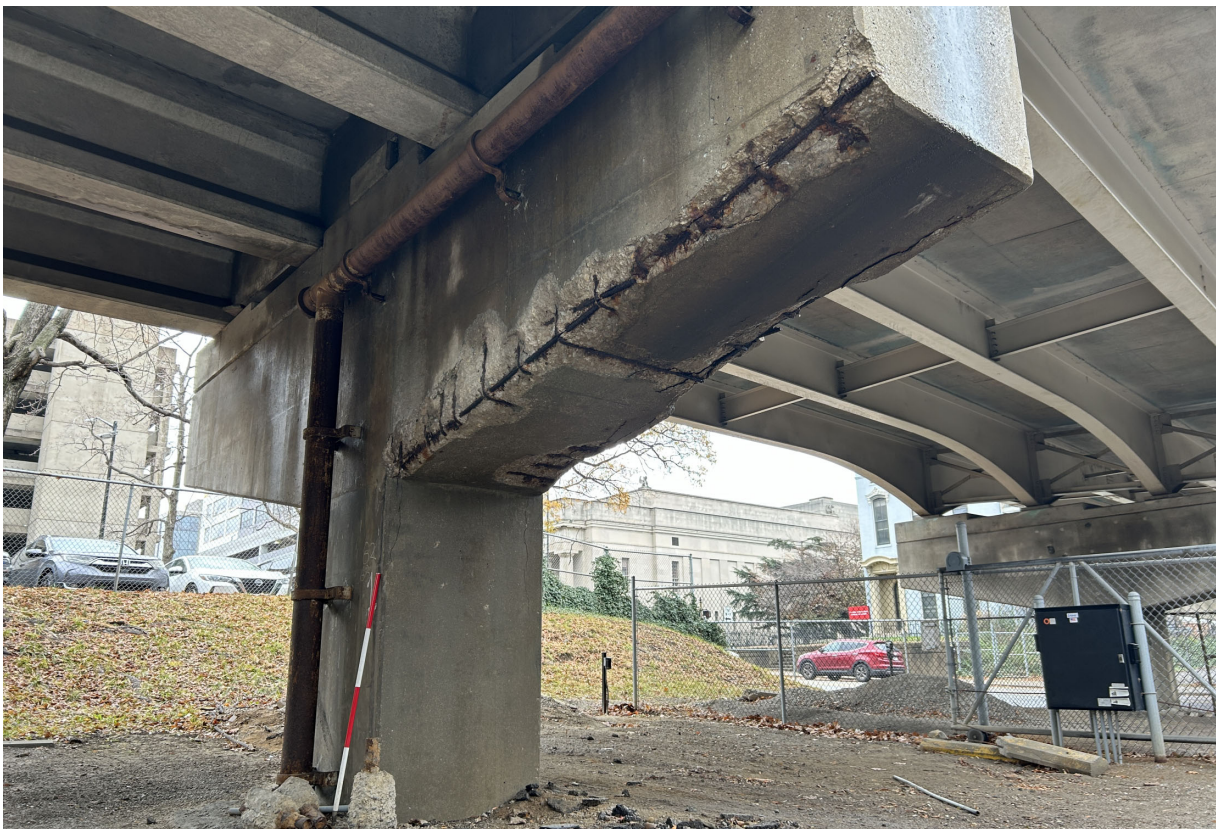
Ramp A: Pier A-4 has large spalls with exposed rebar on the west end of the cap.

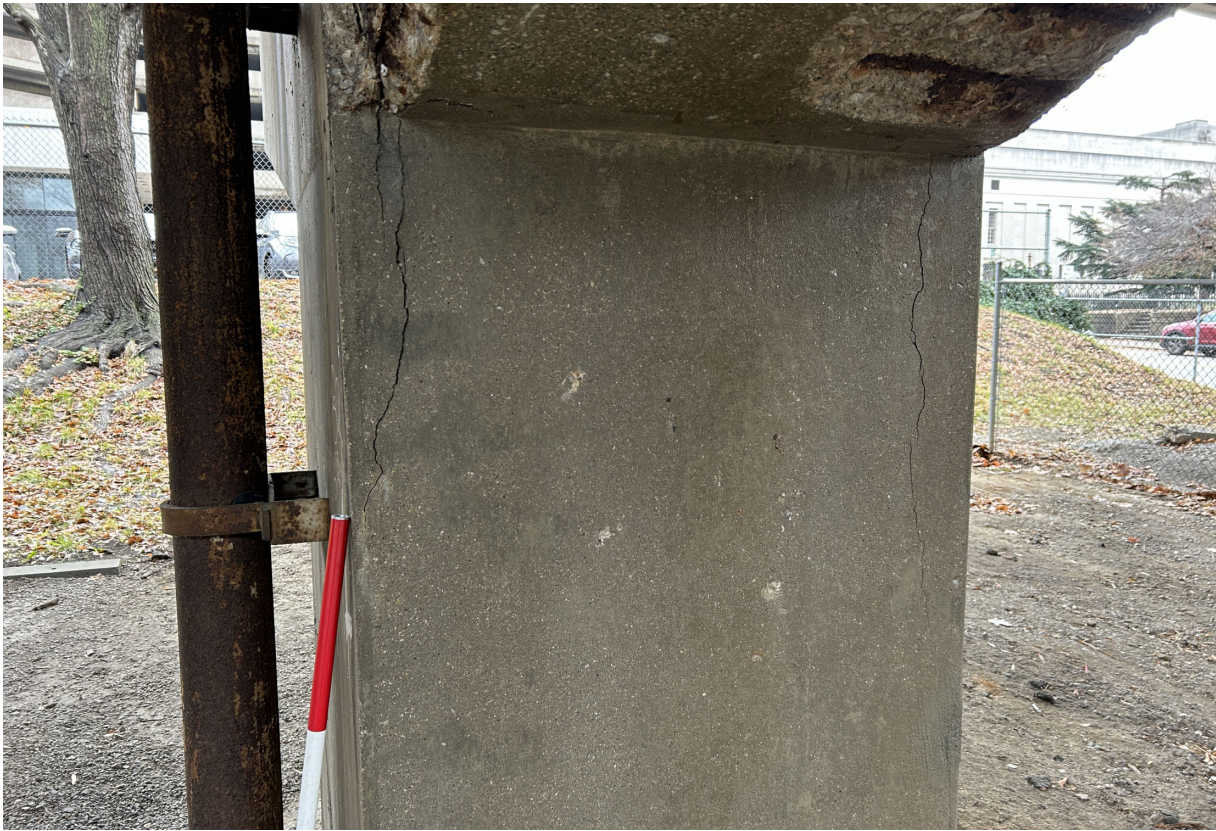
Ramp A: Pier A-4 column wide vertical cracks.

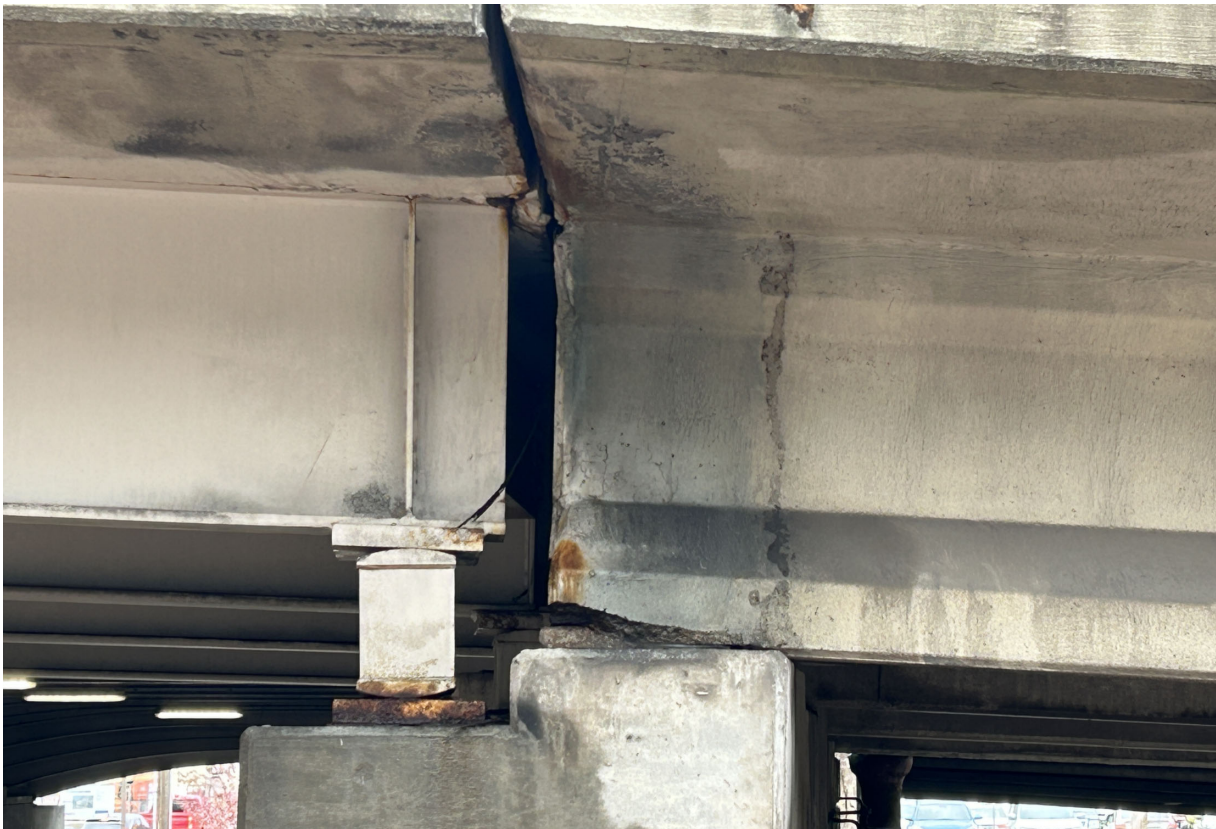
Ramp A: Pier A-4 typical bearings.

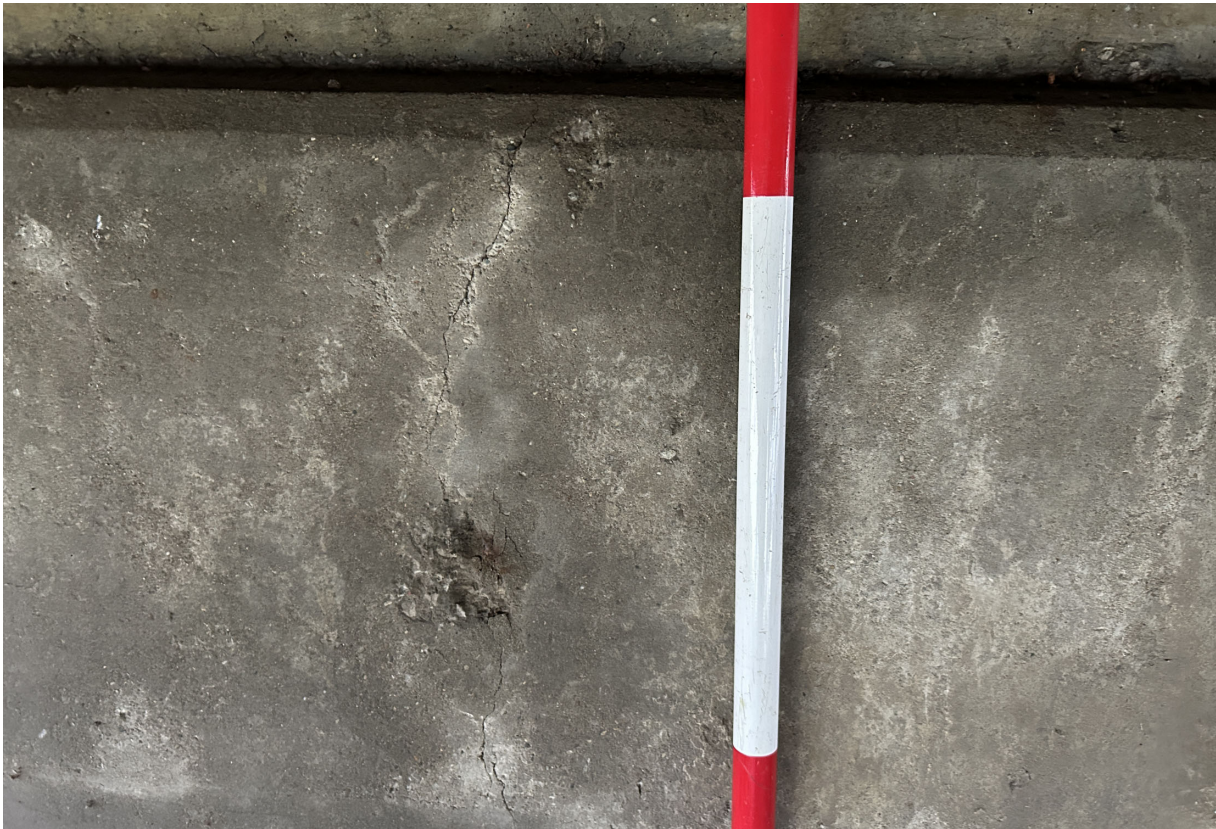
Abutment B has a few vertical cracks and small delaminations.

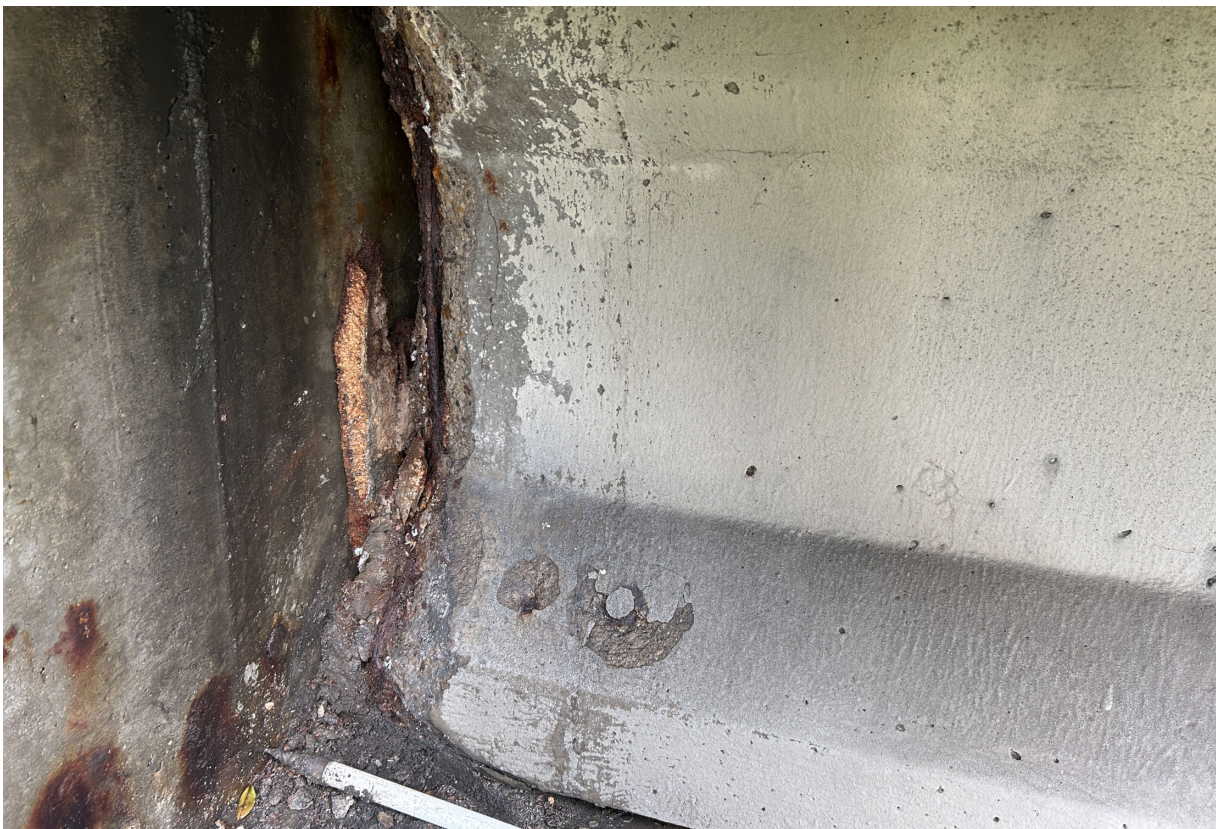
Ramp B Beam 1 has cracking and spalling with exposed rebar at the end.

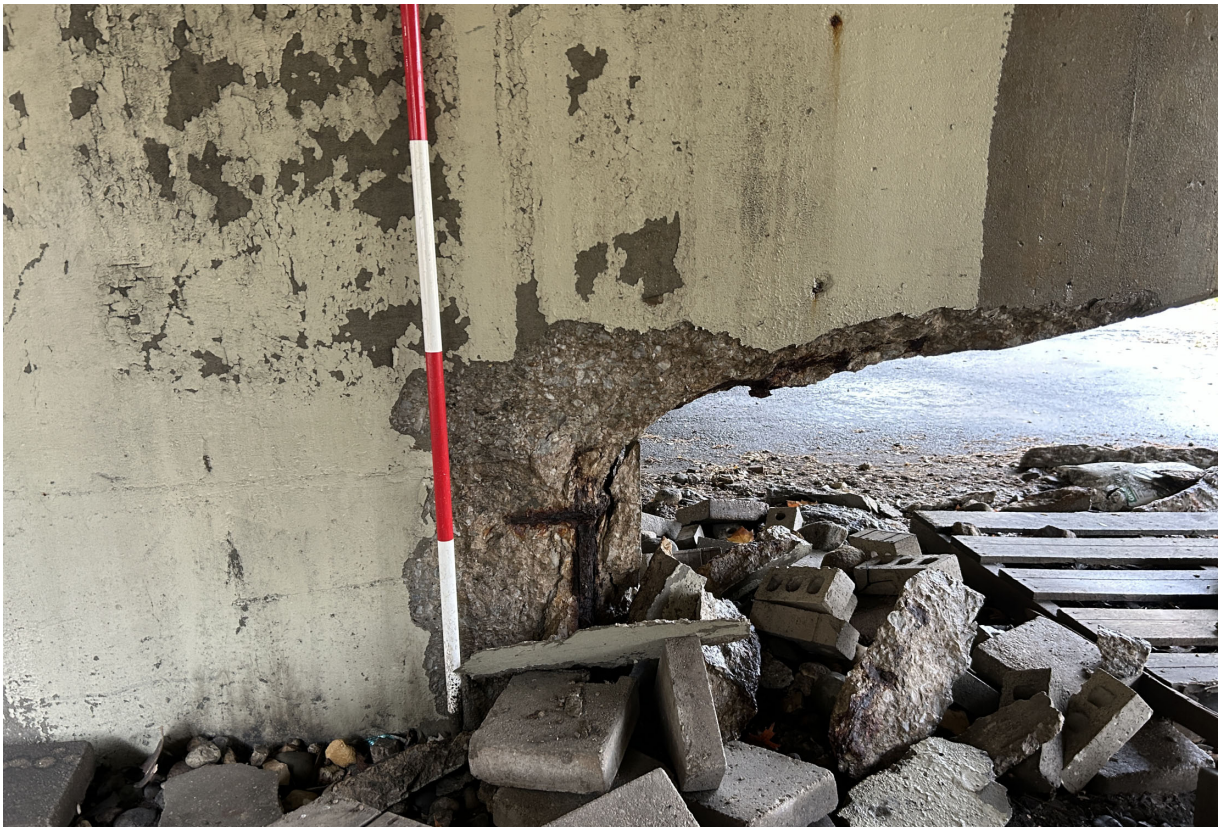
Ramp B: Pier B-1 Column 2 has deep spalls with exposed rebar.

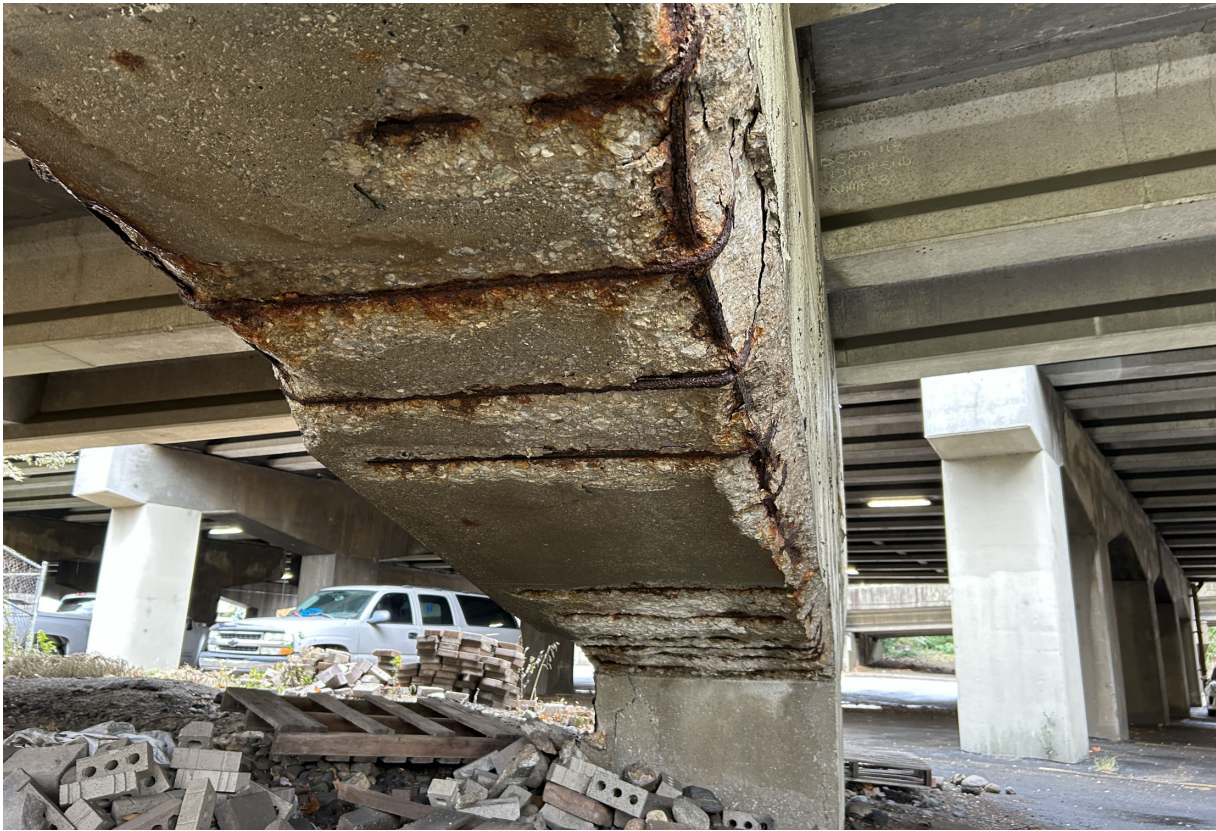
Ramp B: Bottom face of Pier B-1 cap has large spalls with exposed rebar.

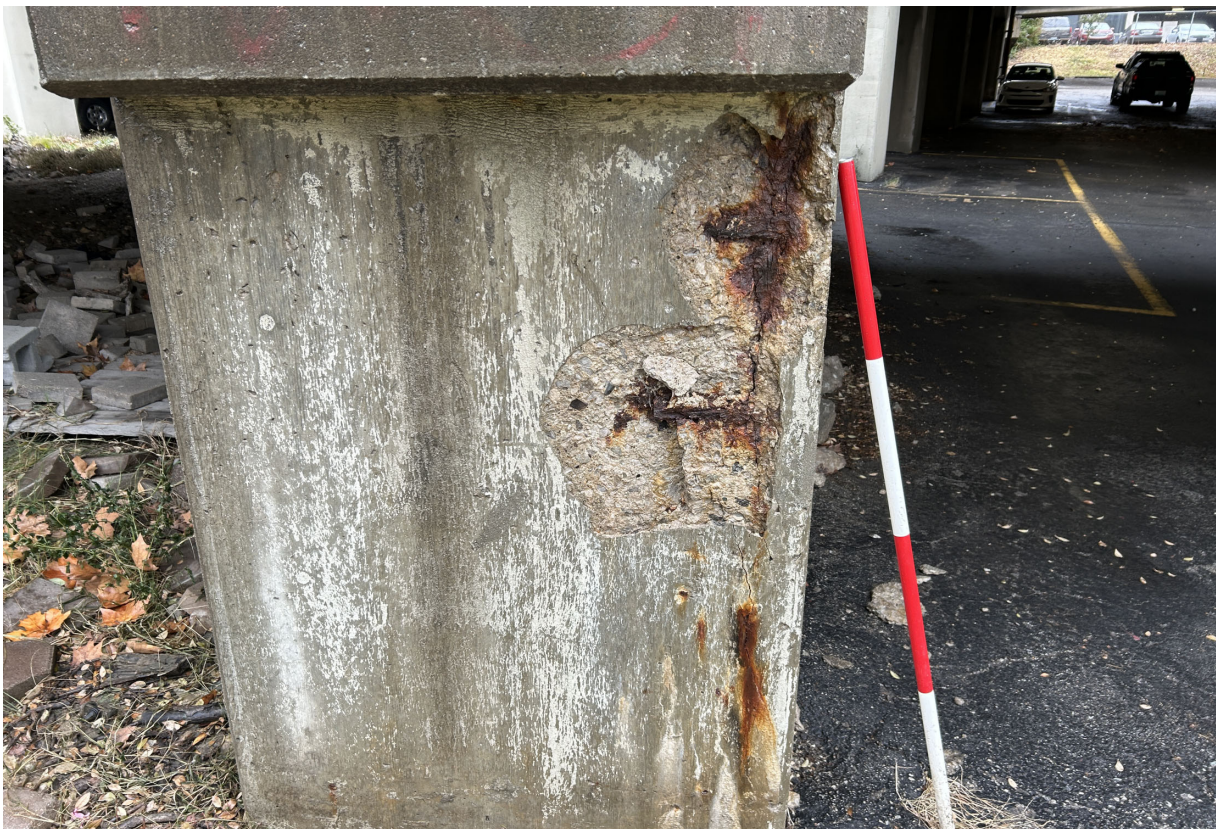
Ramp B: Pier B-1 Column 1 has large spalls with exposed rebar.

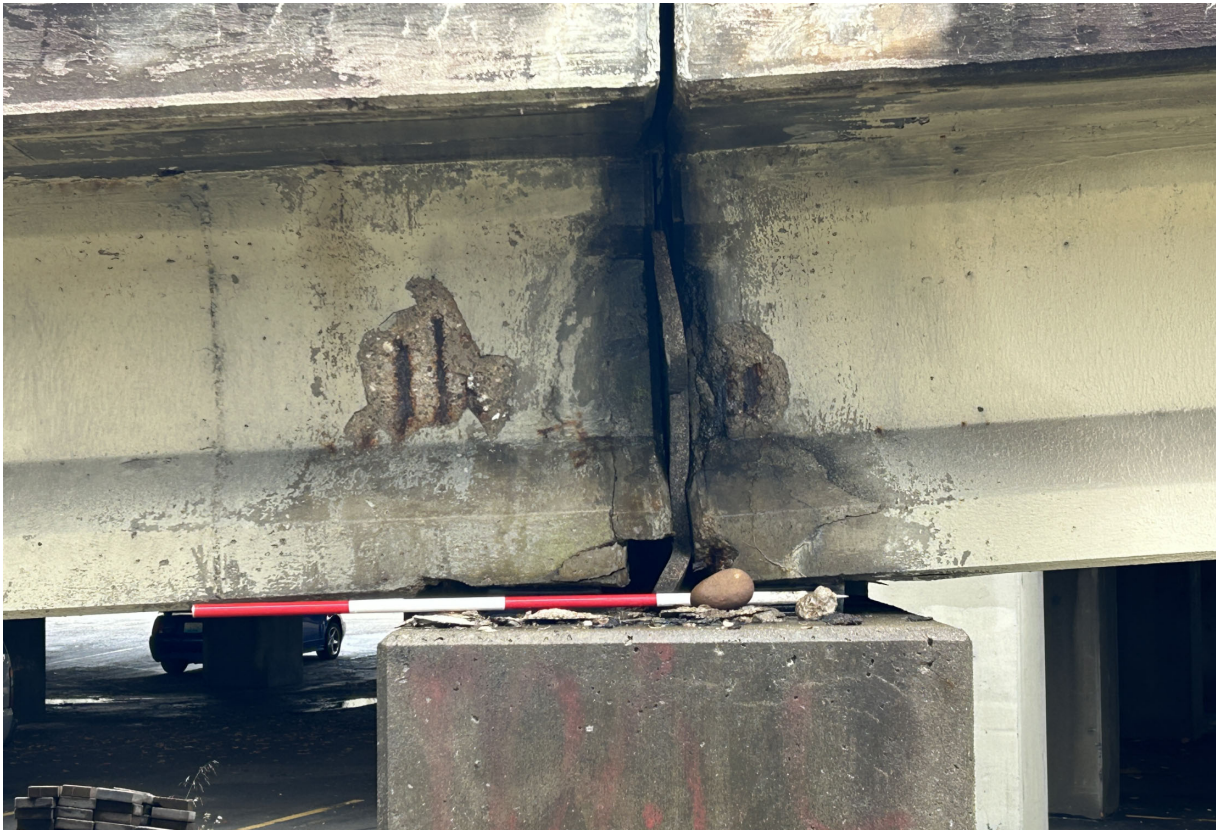
Ramp B Beam 4 at Pier B-1 wide cracking and spalls with exposed rebar.

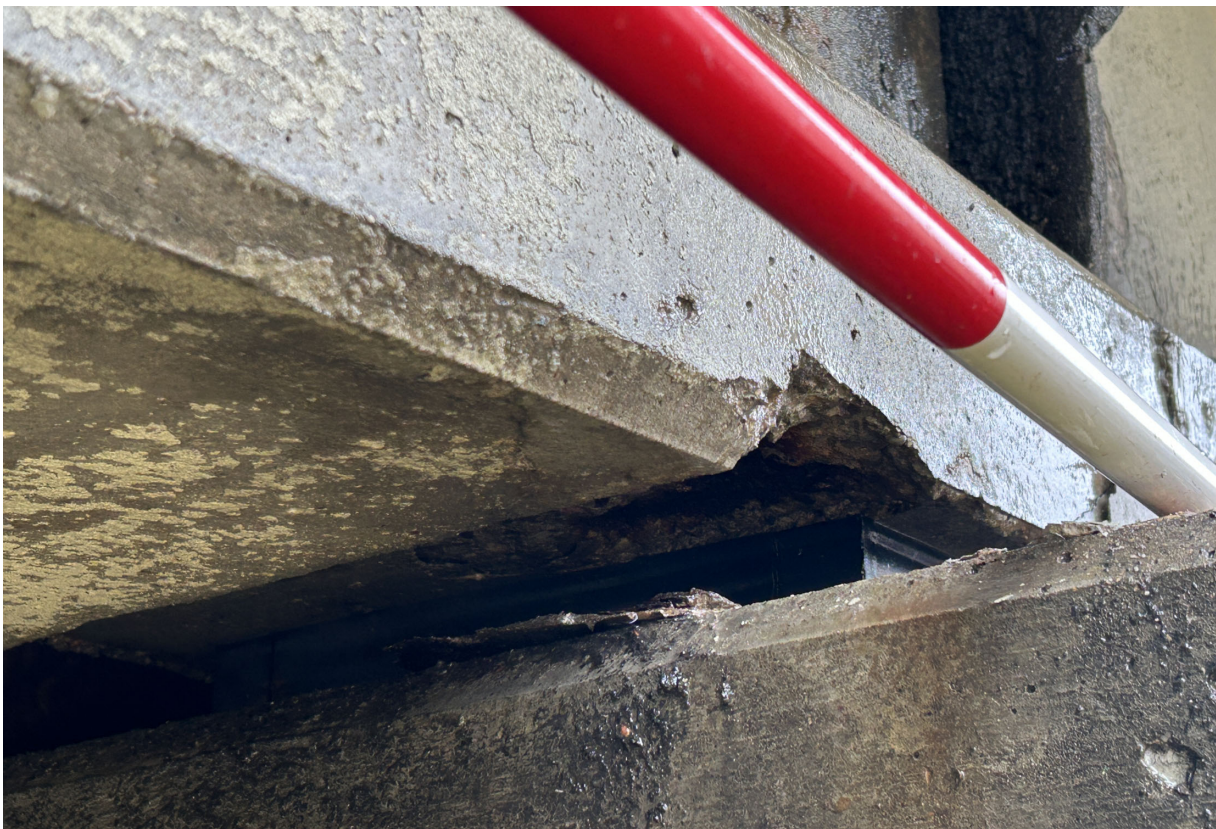
Ramp B: Pier B-1 typical bearing pad.

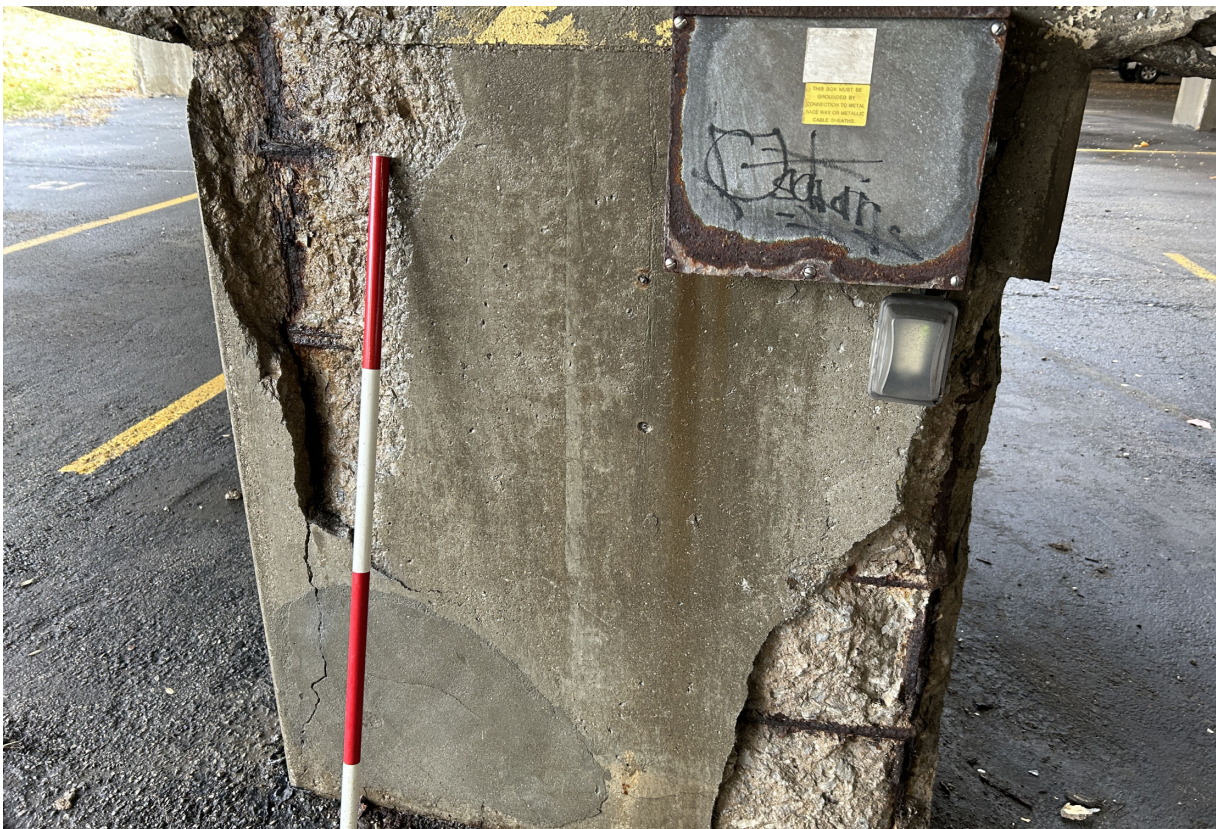
Ramp B: Pier B-2 Column 2 has deep spalls with exposed rebar.

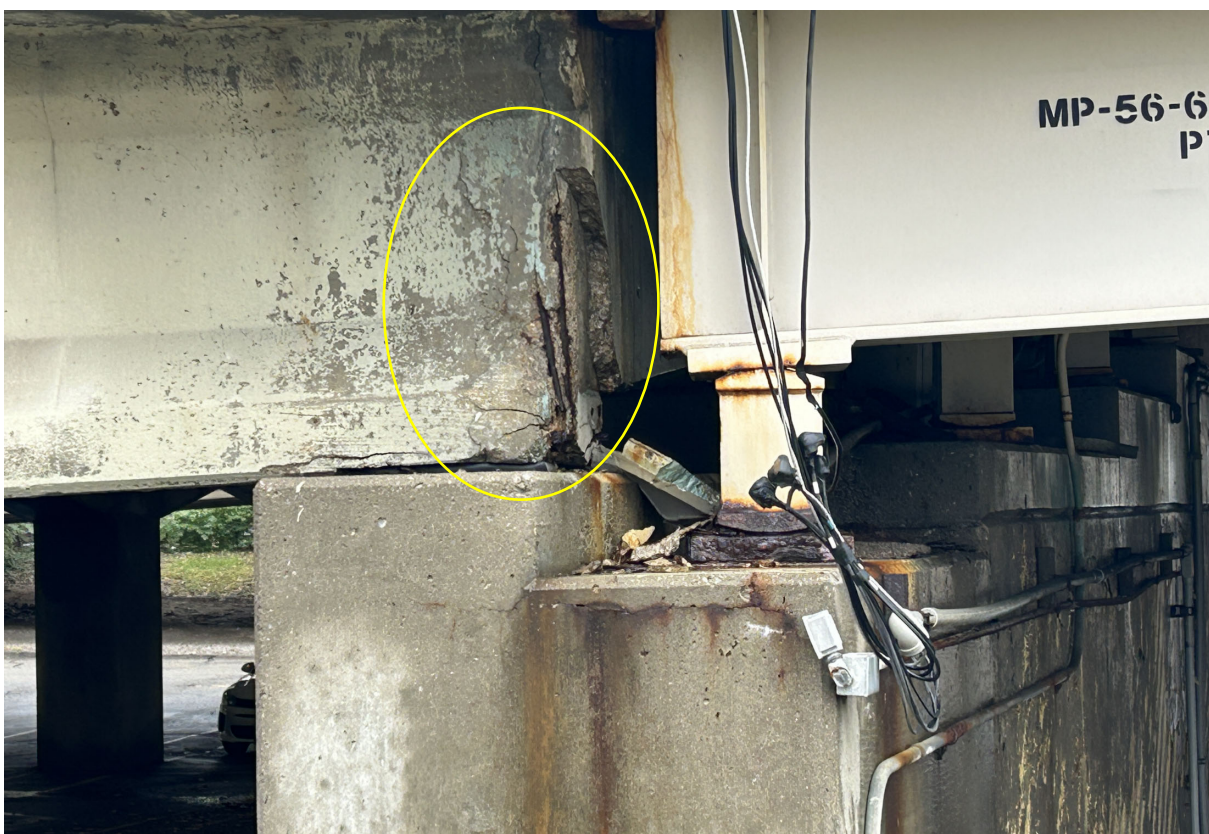
Ramp B: Beam 1 at Pier B-2 spalling with exposed rebar.

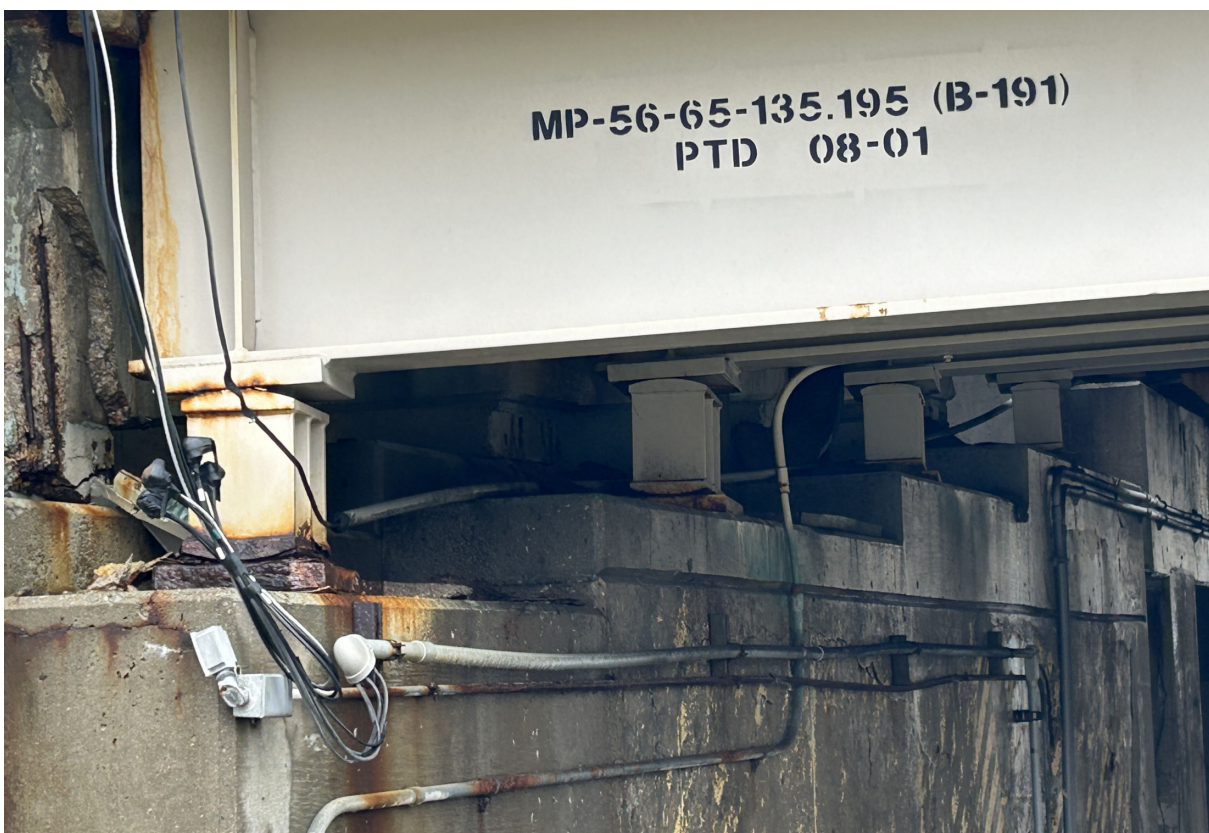
Ramp B: Pier B-2 typical rocker bearing in Span 104 with corrosion on the lower part of the bearing and the masonry plate.
