# Bridge Inspection Report

056B00191N

12/09/2024

Standard (24 months)

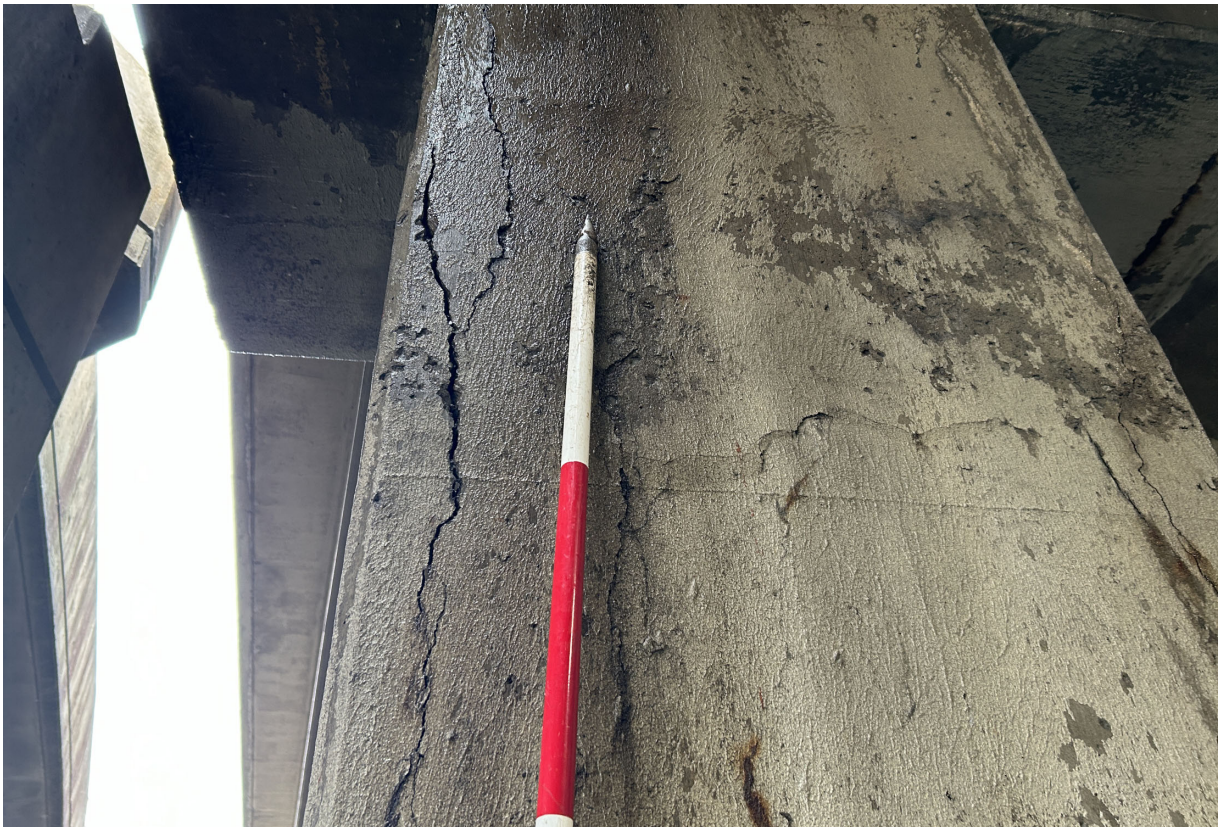
Pier 103W wide vertical cracking on Column 1.

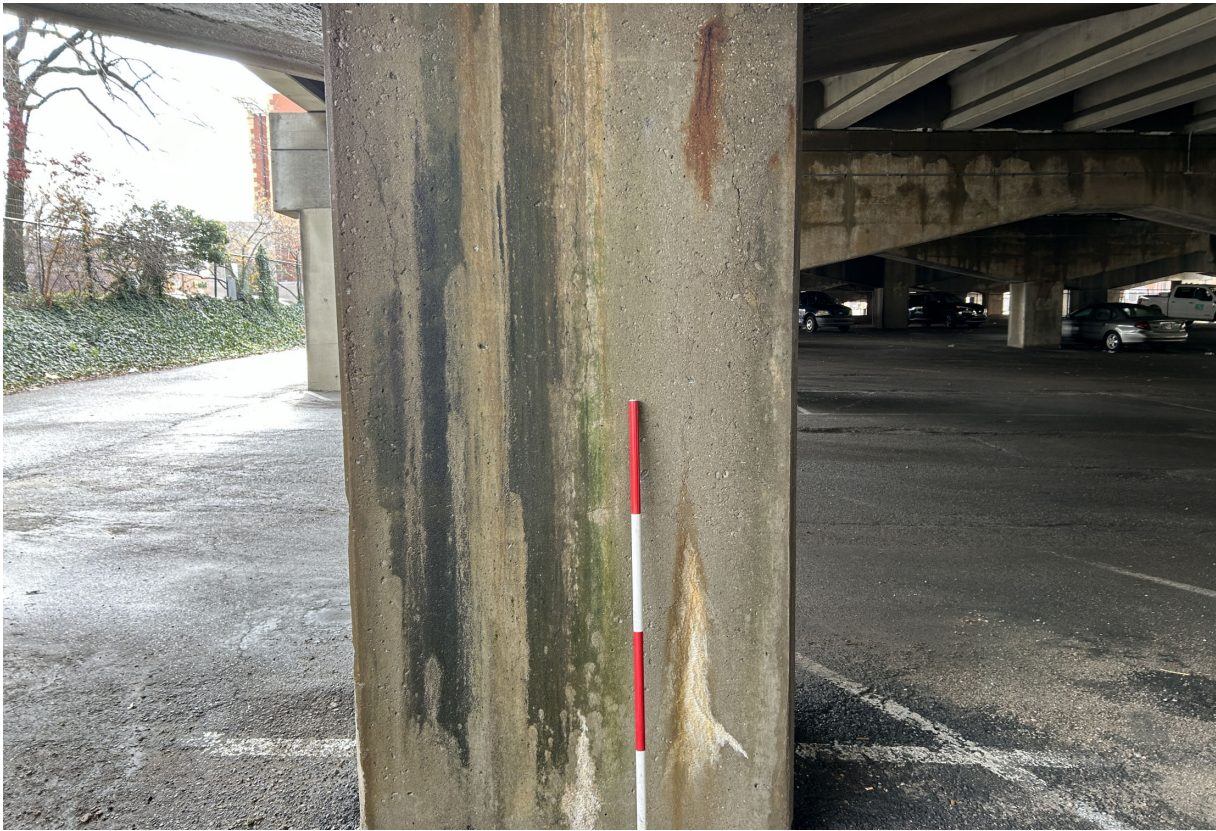
Pier A-1/Column 1 cracking with efflorescence and rust staining.

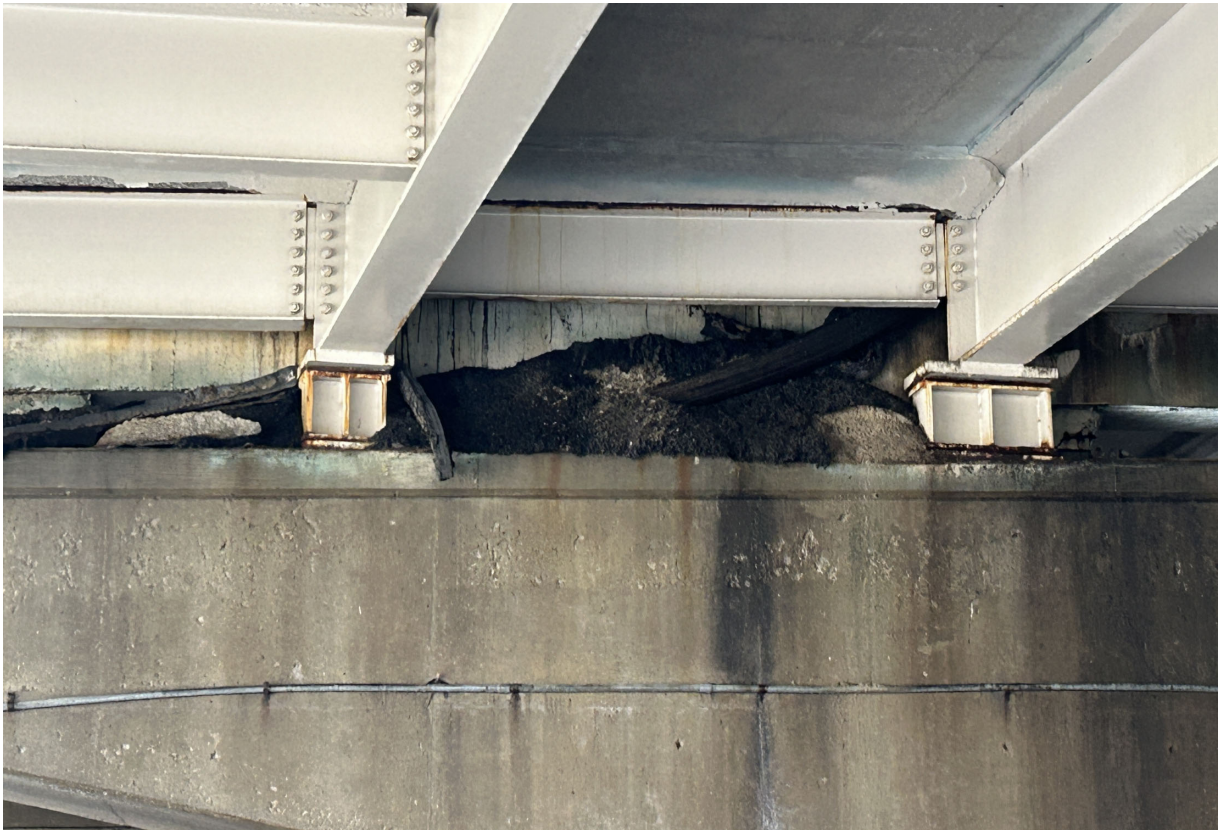
Pier 106E north face bearings partially covered with asphalt.

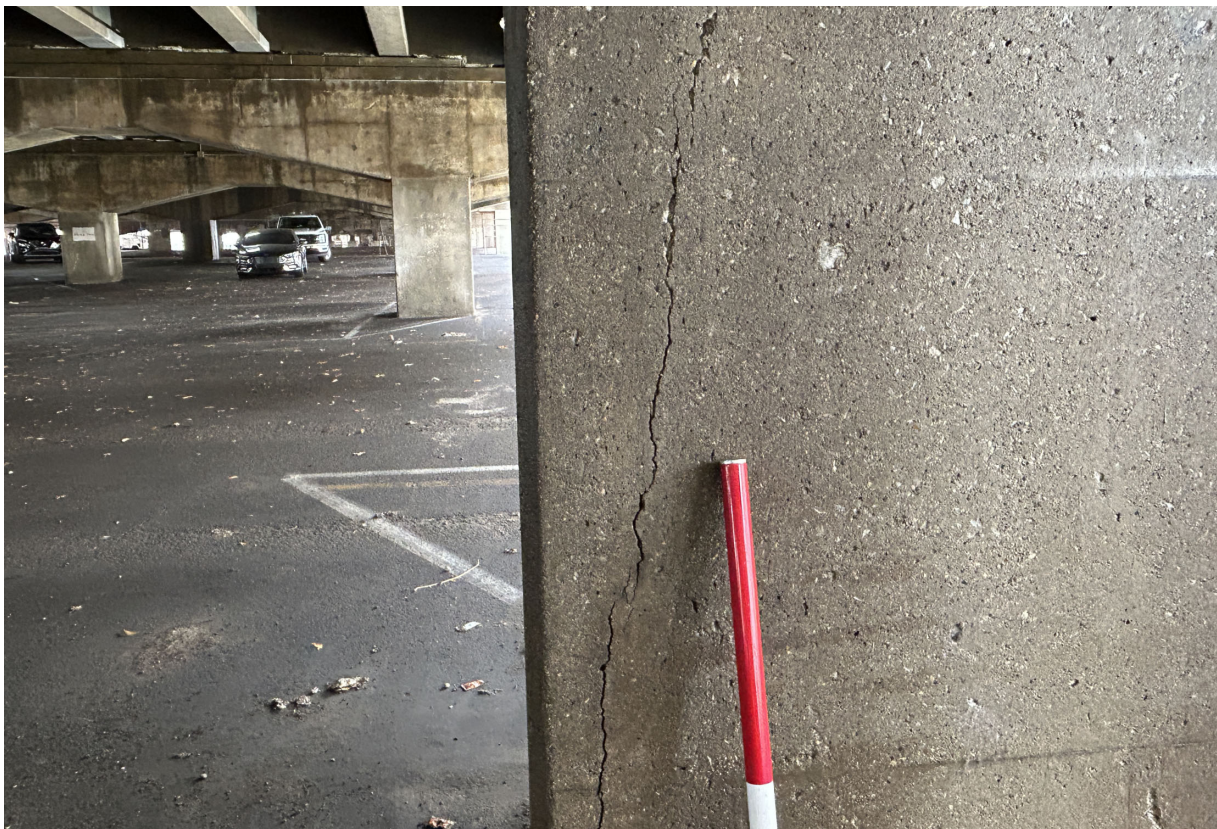
Pier 106W Column 2 wide vertical crack.

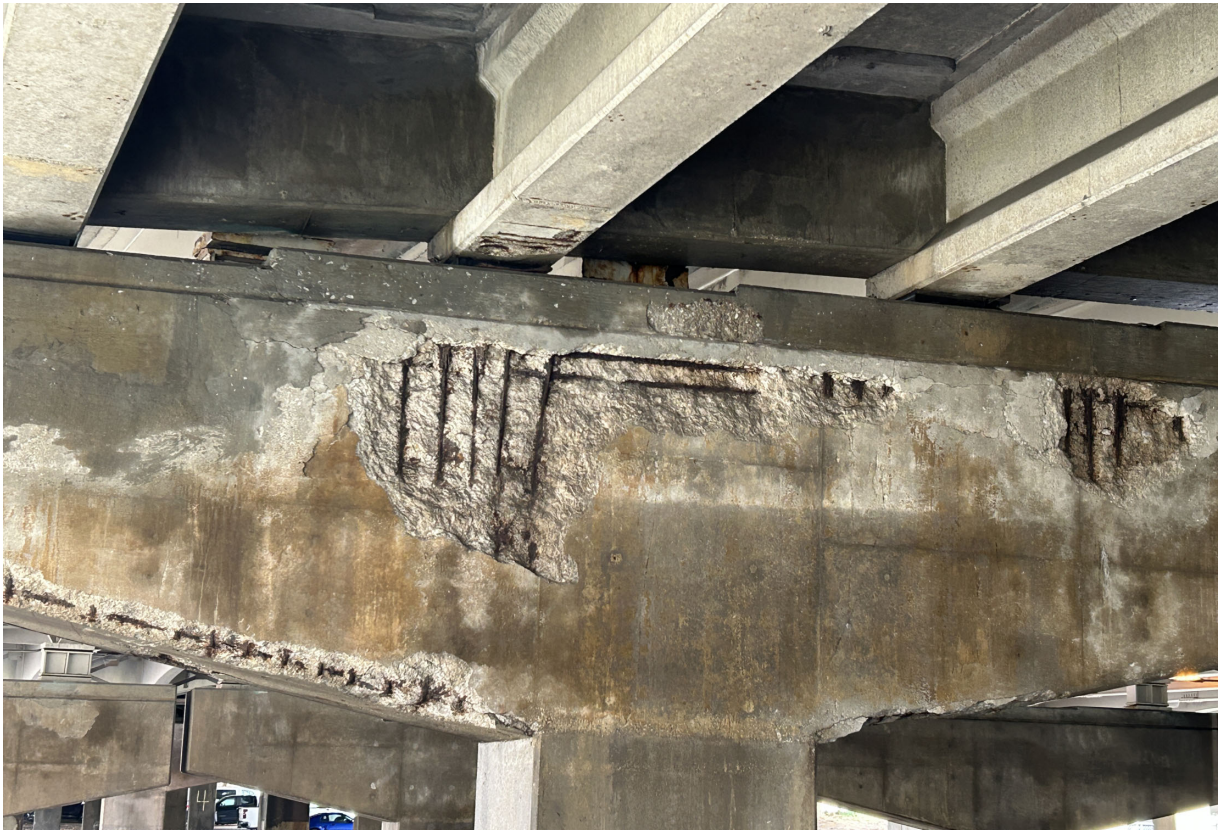
Pier 106W south face large spalls with exposed rebar.

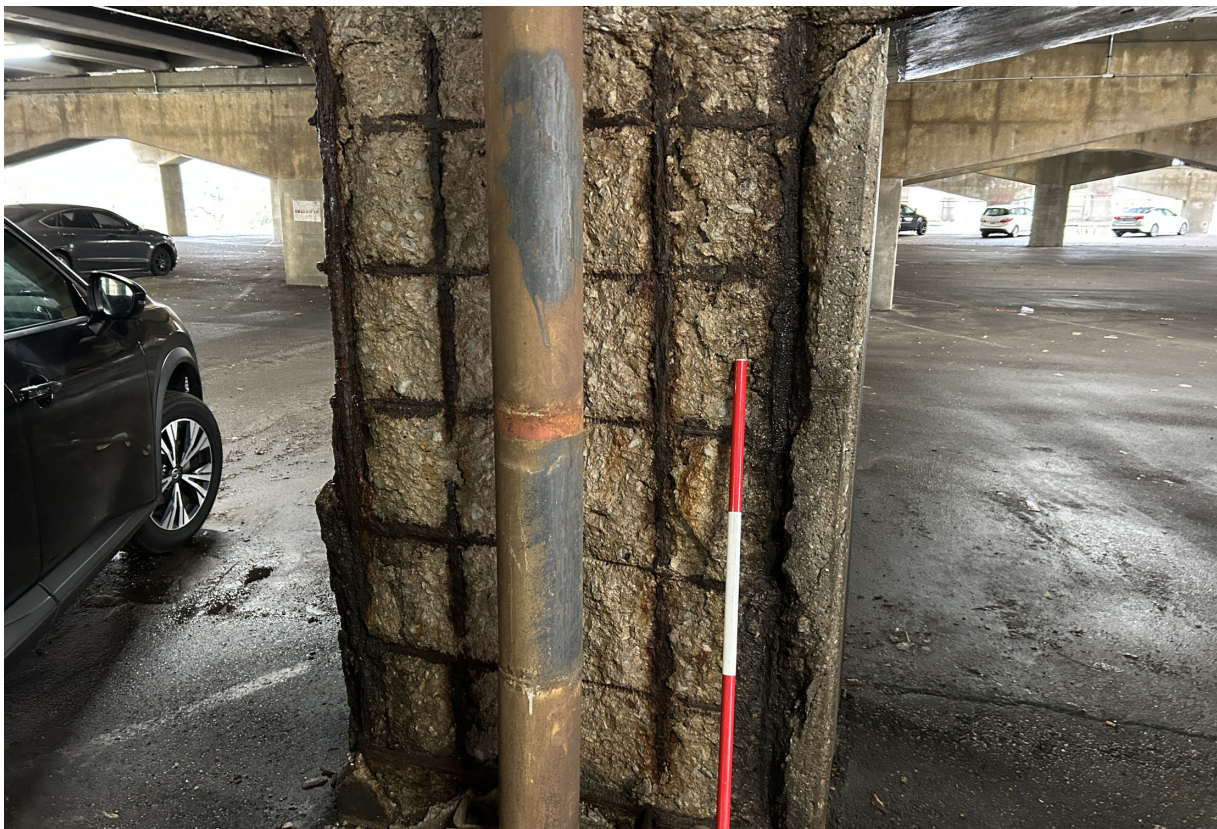
Pier 109E-Column 1 has spalling with exposed rebar throughout the south face.

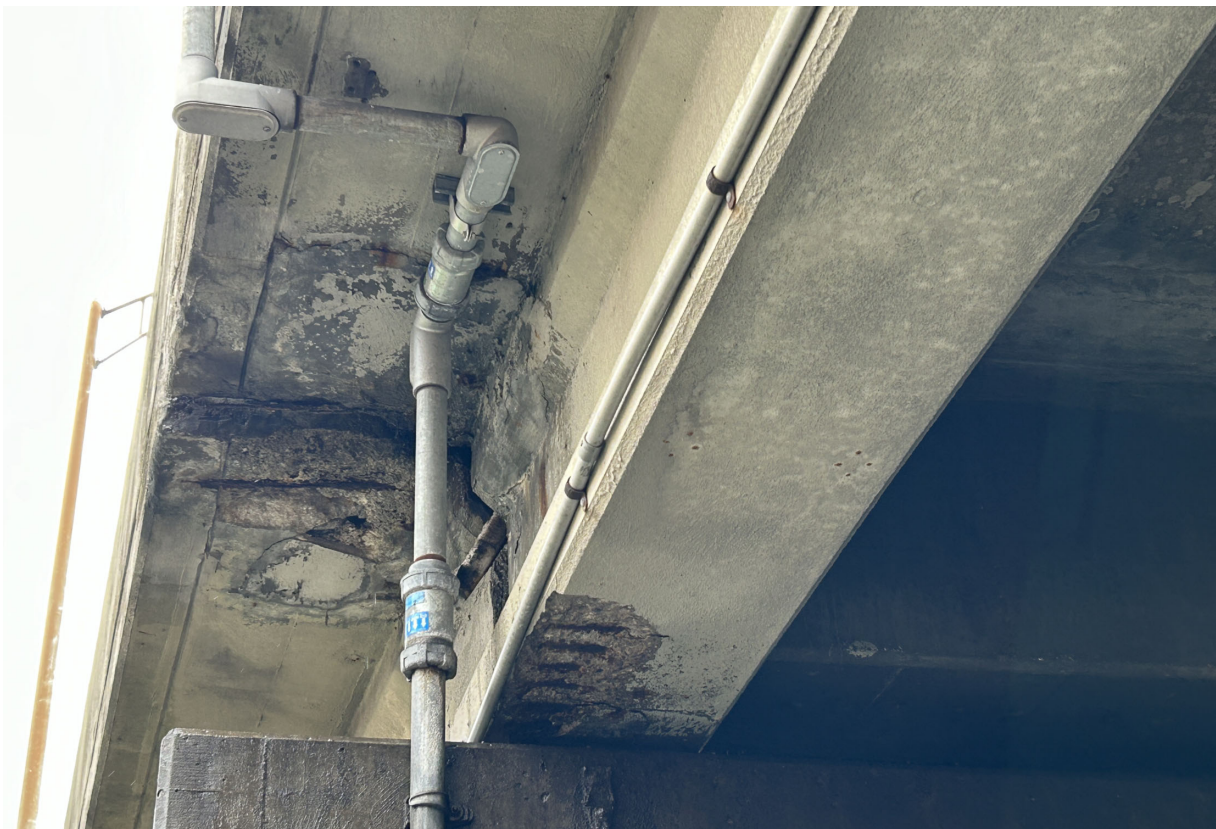
Beam 1 at Pier 109W in Span 110 has a large spall with exposed rebar in the bottom face. West overhang also has large spalling at the pier joint.

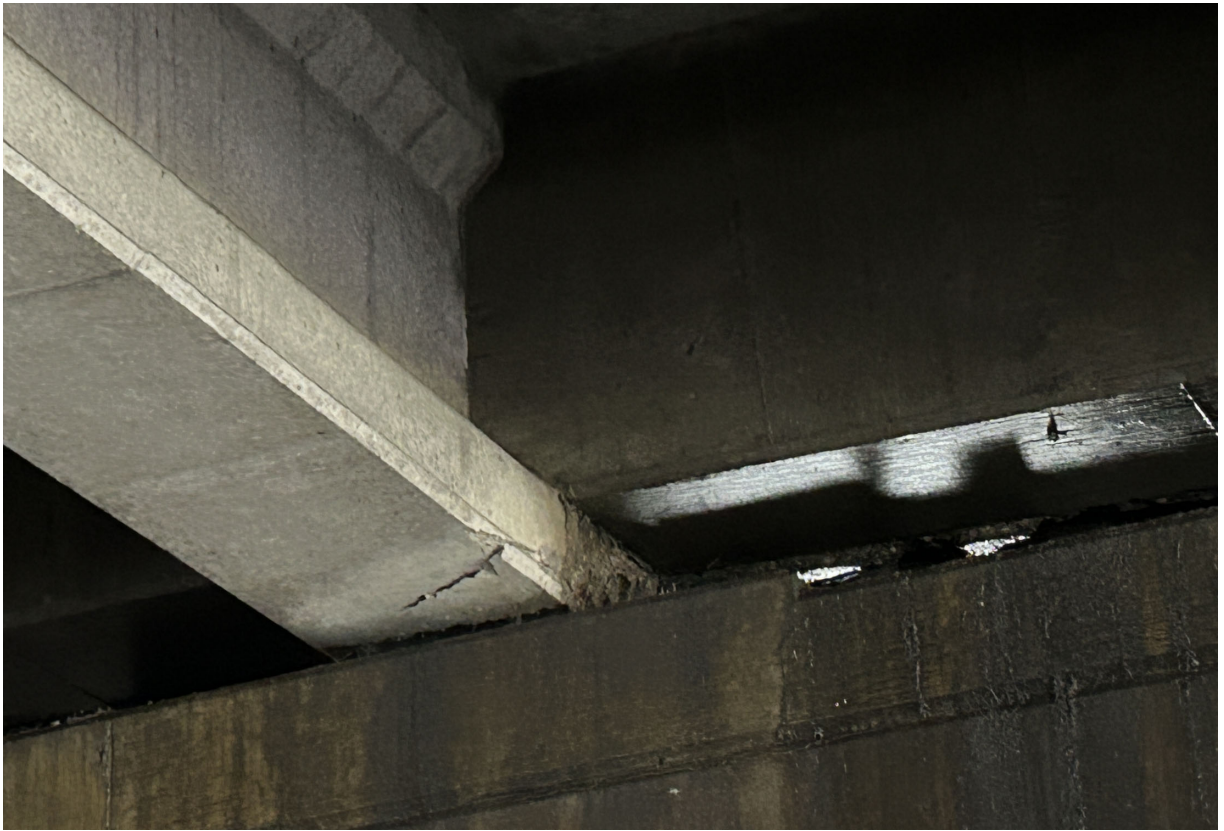
Beam 9 at Pier 109W has a wide crack in the bottom face in Span 109.

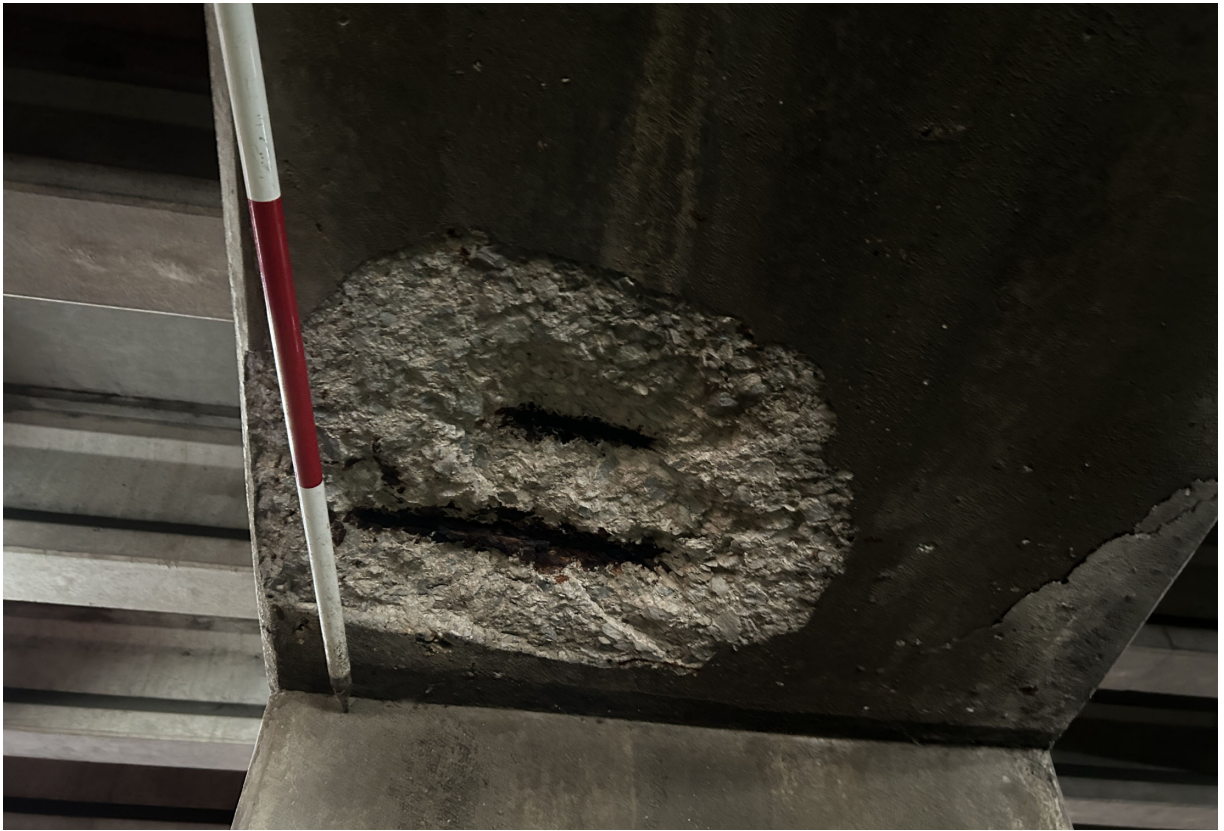
Pier 111E cap has a large spall with rebar in the bottom face.

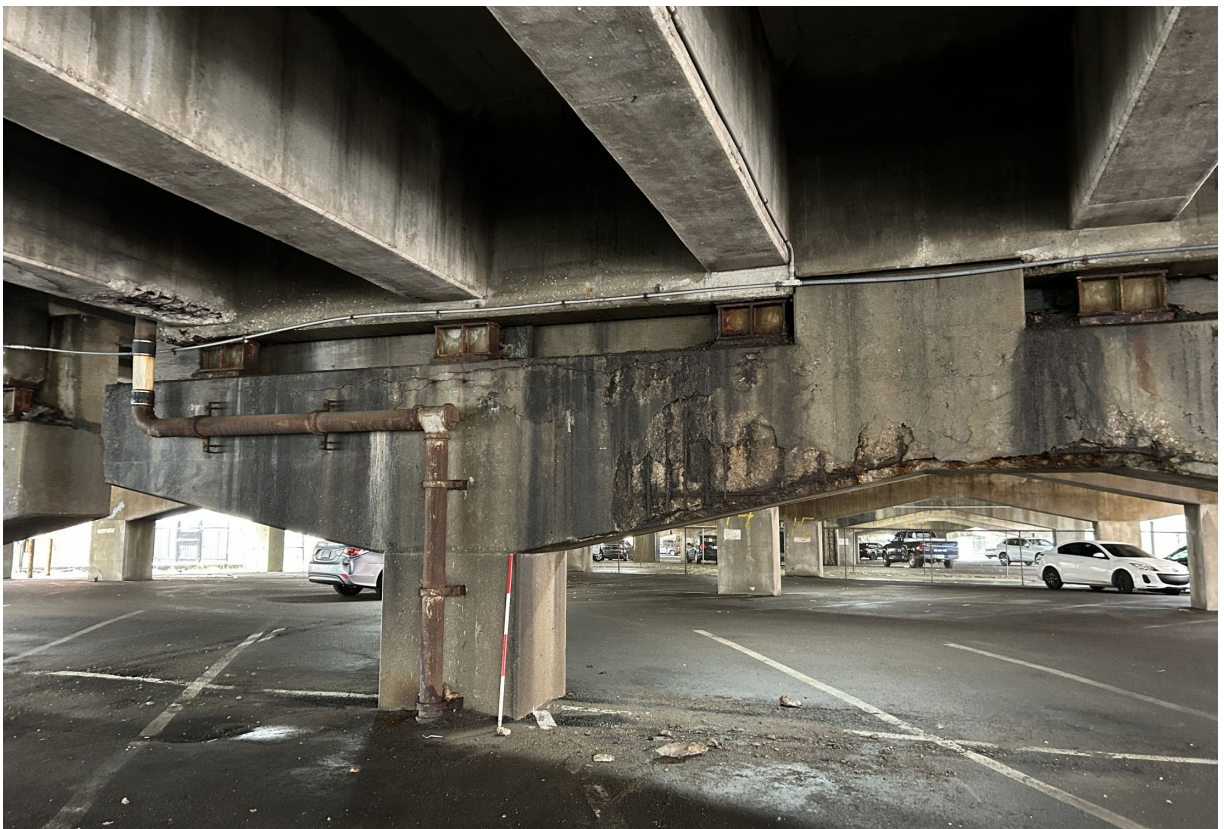
Pier 112E south face large spalls with exposed rebar and wide horizontal cracking.

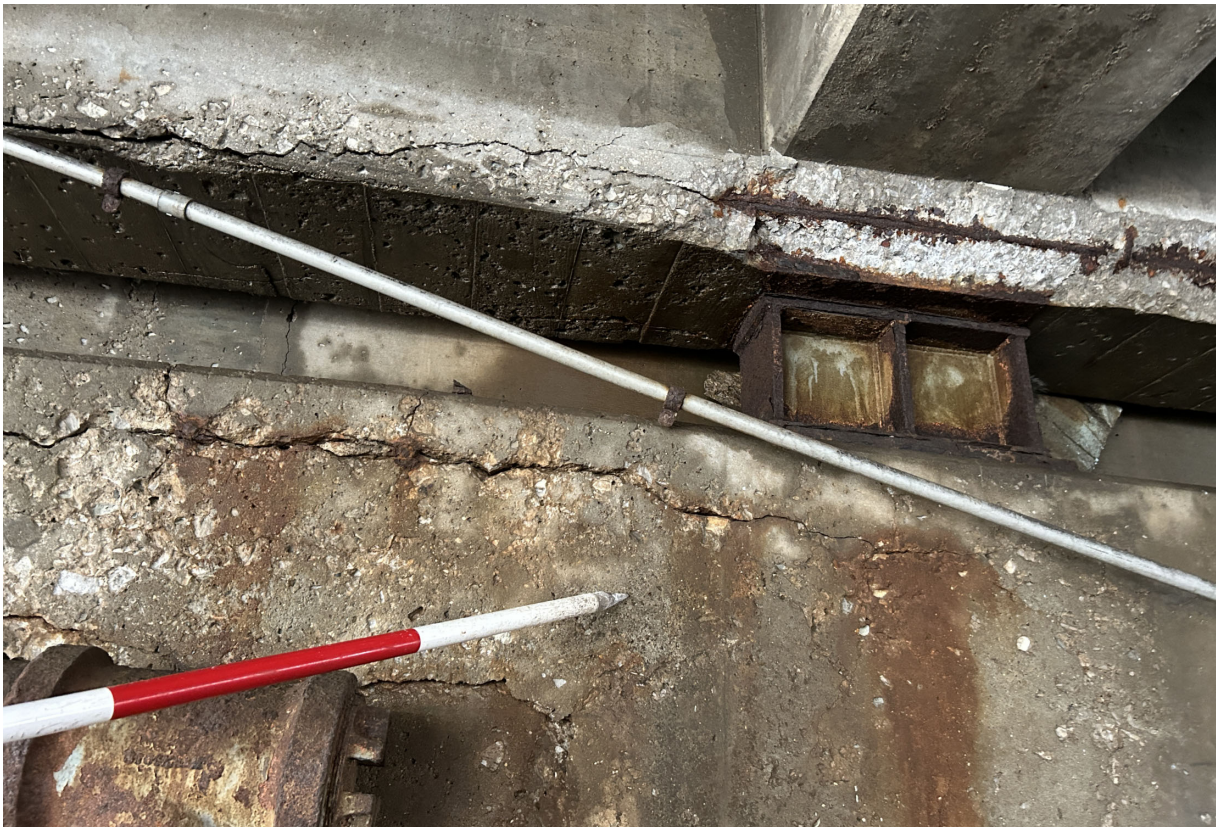
Pier 112W south face wide horizontal crack.

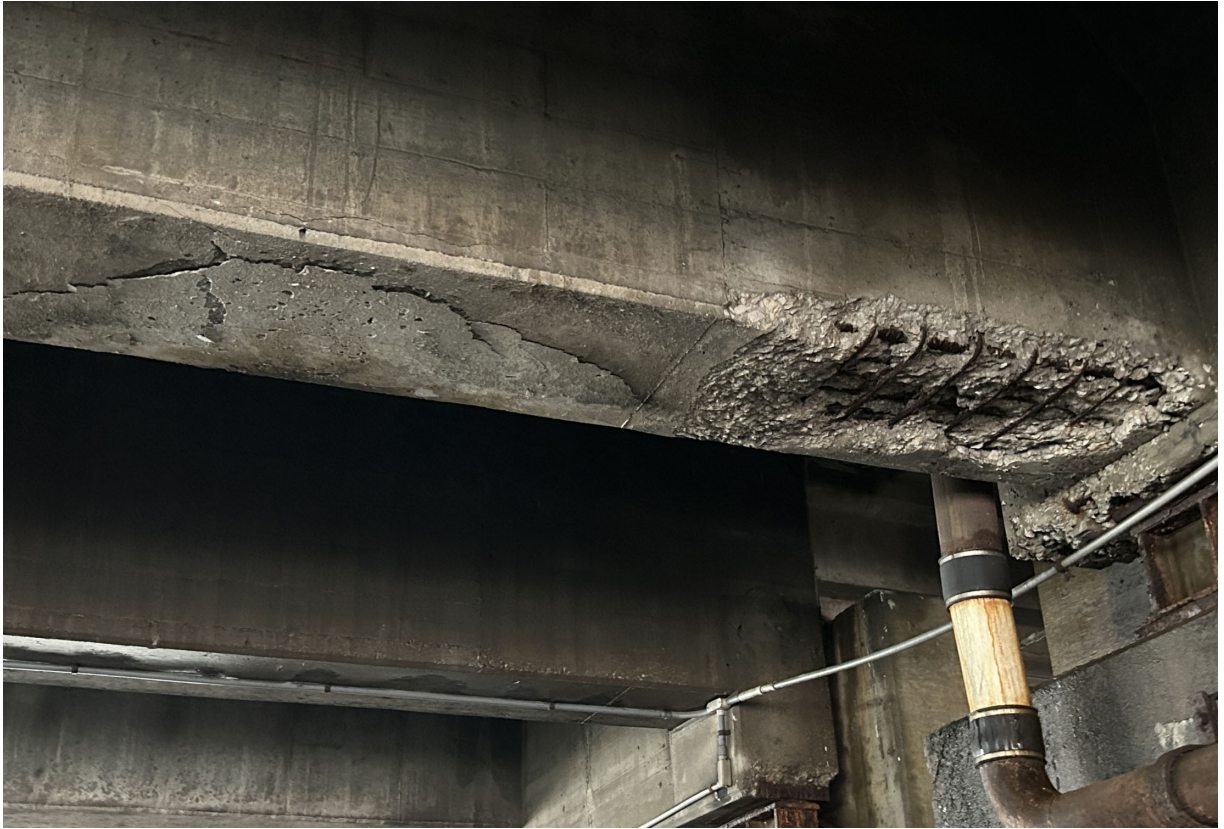
Beam 8 in Span 113 near Pier 112E has wide cracking and a large spall with exposed rebar.

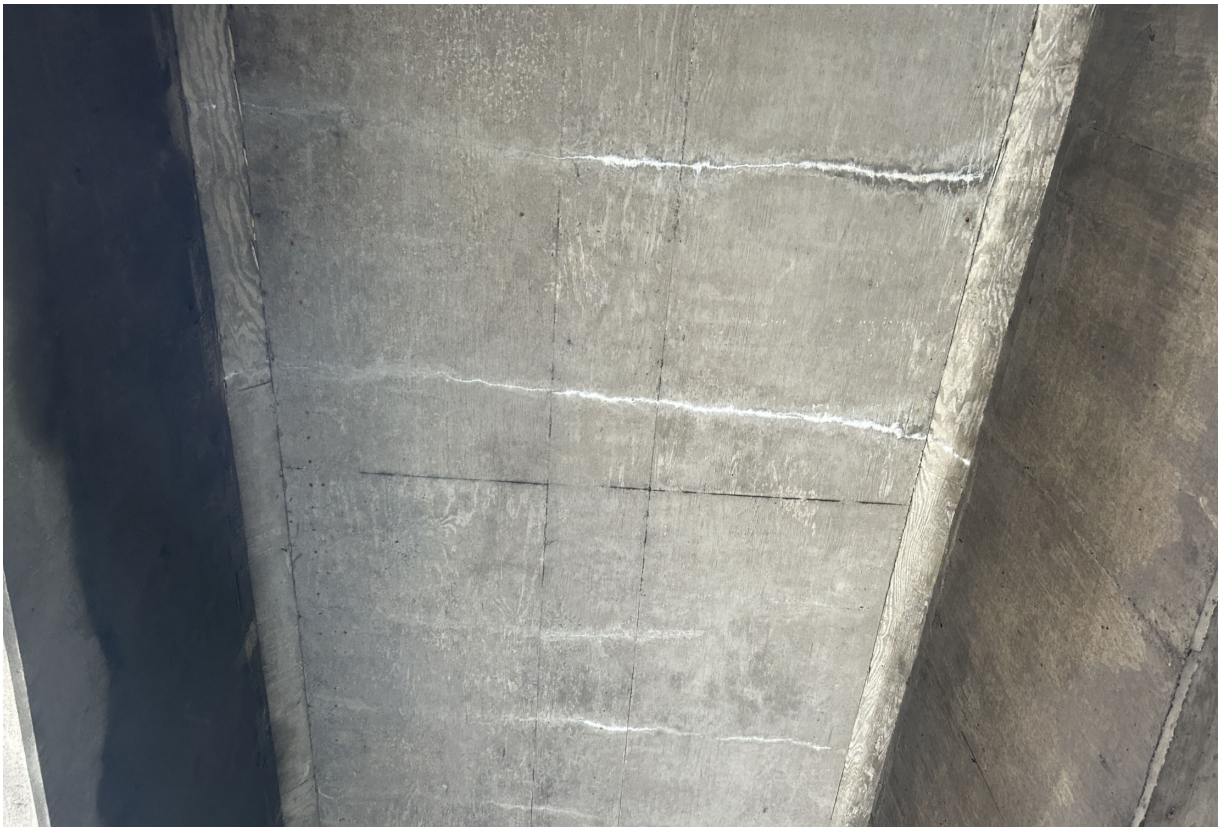
Span 113 soffit has a few intermittent transverse cracks with efflorescence.

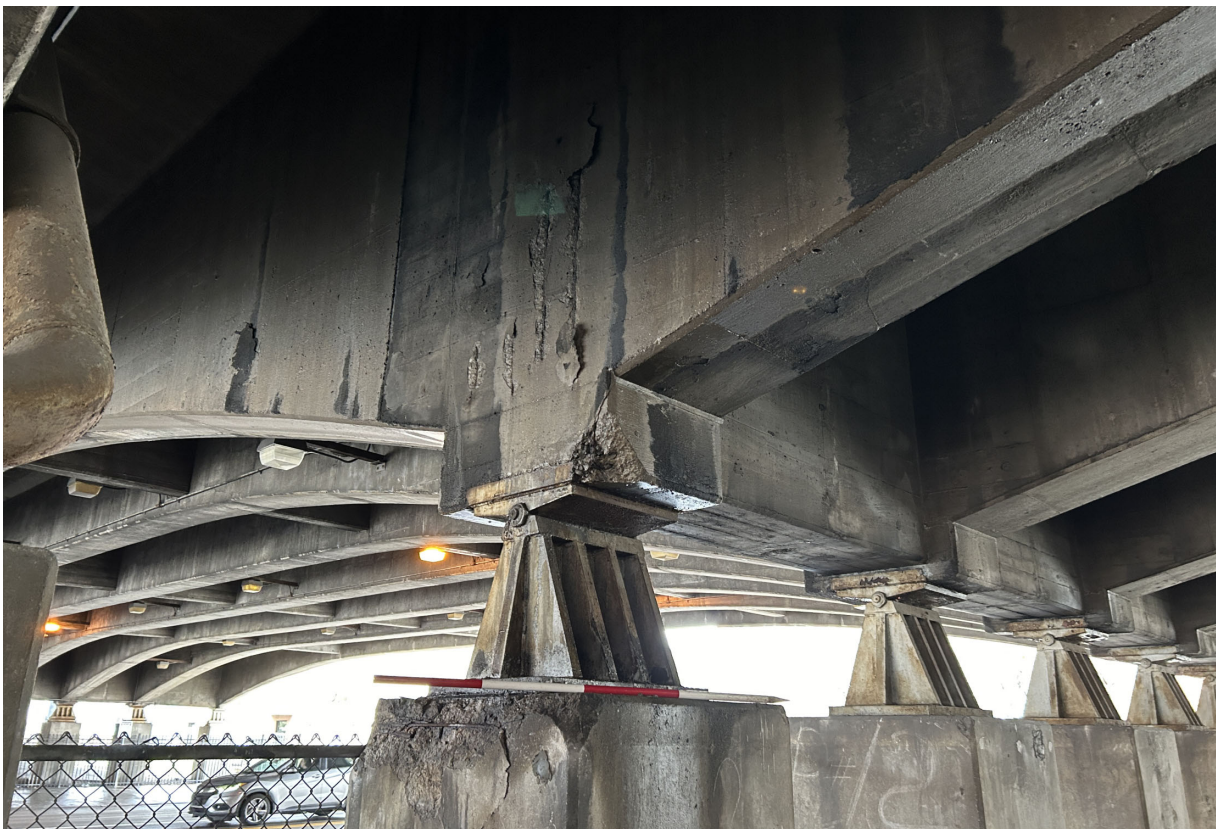
Pier 113 Column 7 has a large corner spall with exposed rebar.

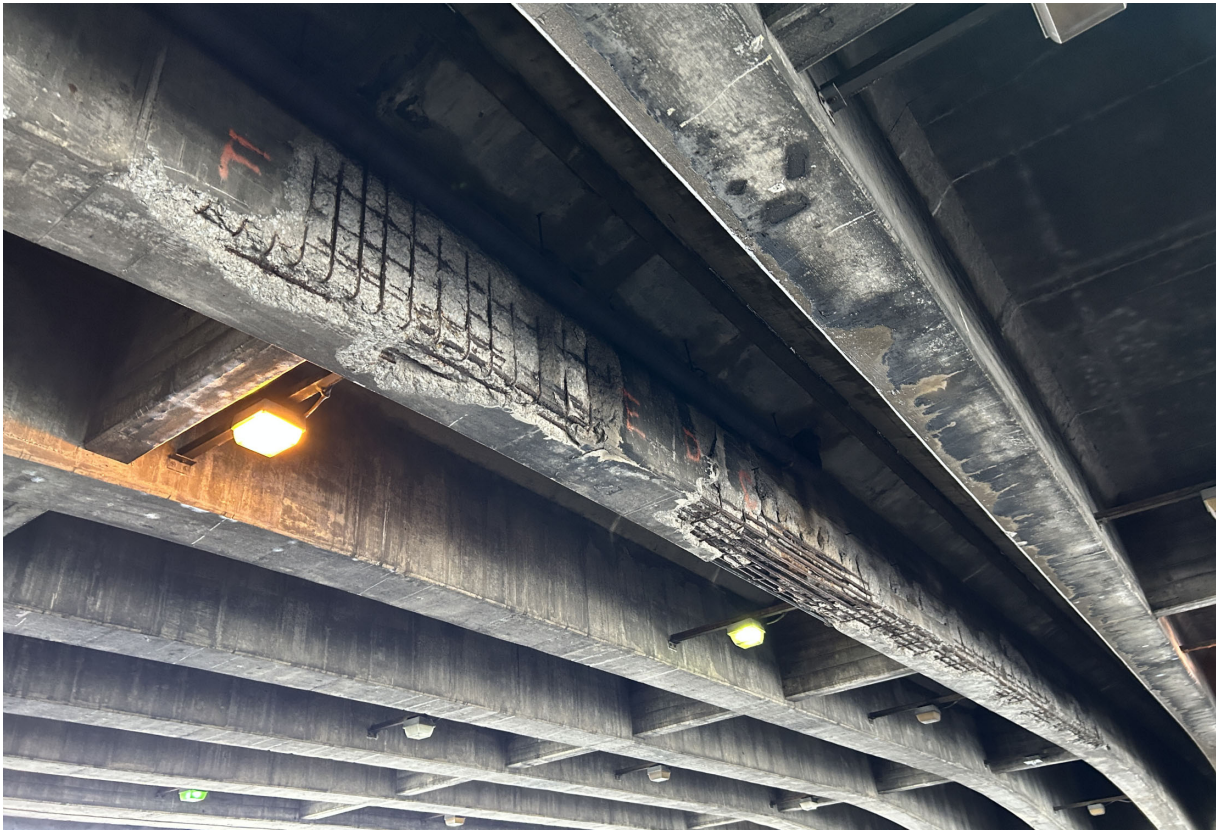
Beam 8 in Span 114 over Broadway has large spalls with exposed rebar for 72 linear feet.

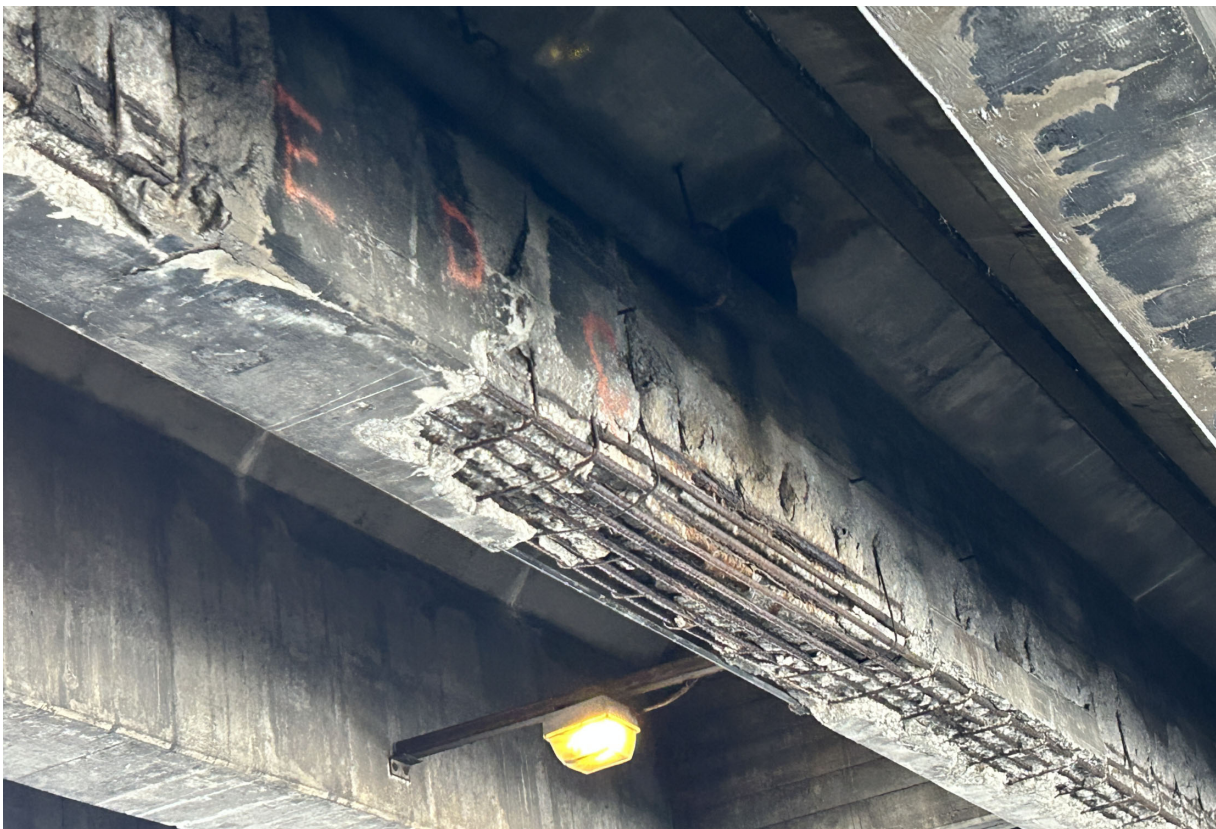
Spalling in Beam 8 is worst near midspan exposing 3 layers of rebar with section loss.

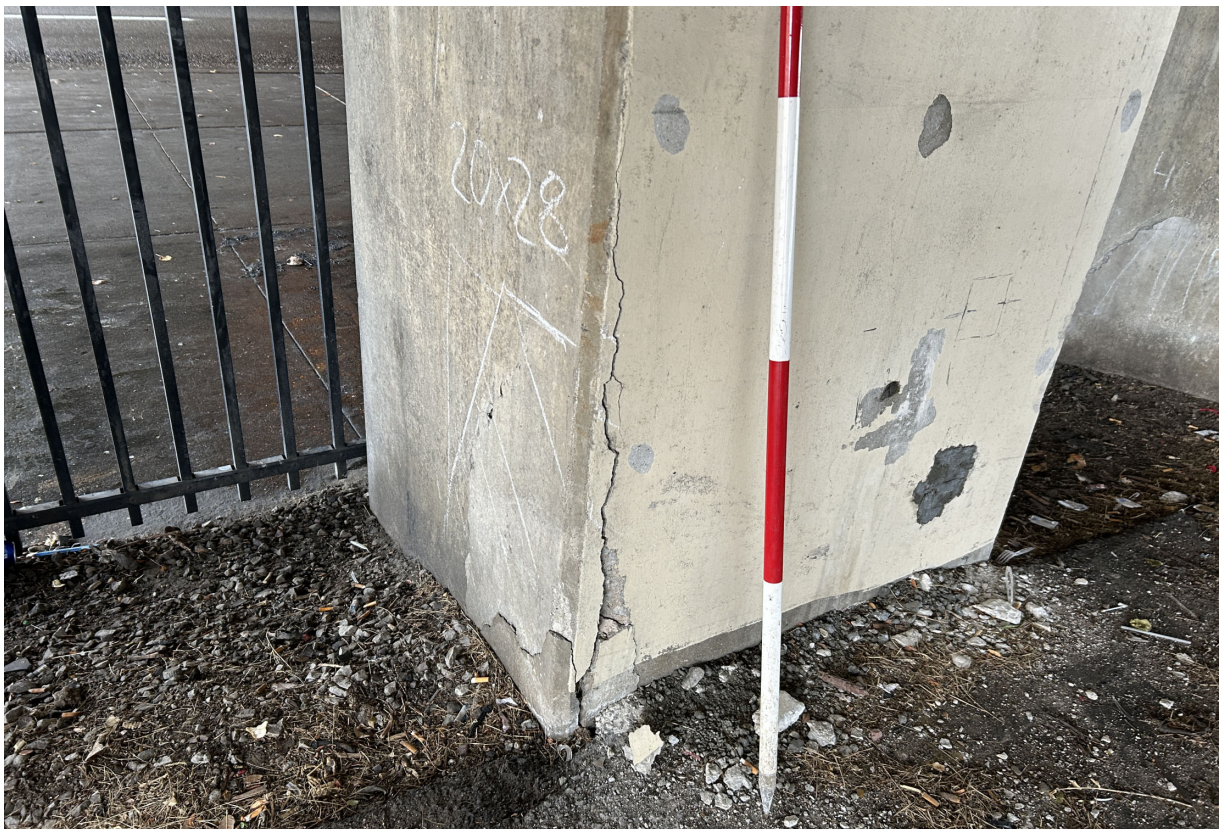
Wide vertical cracking on Column 4 at Pier 114.

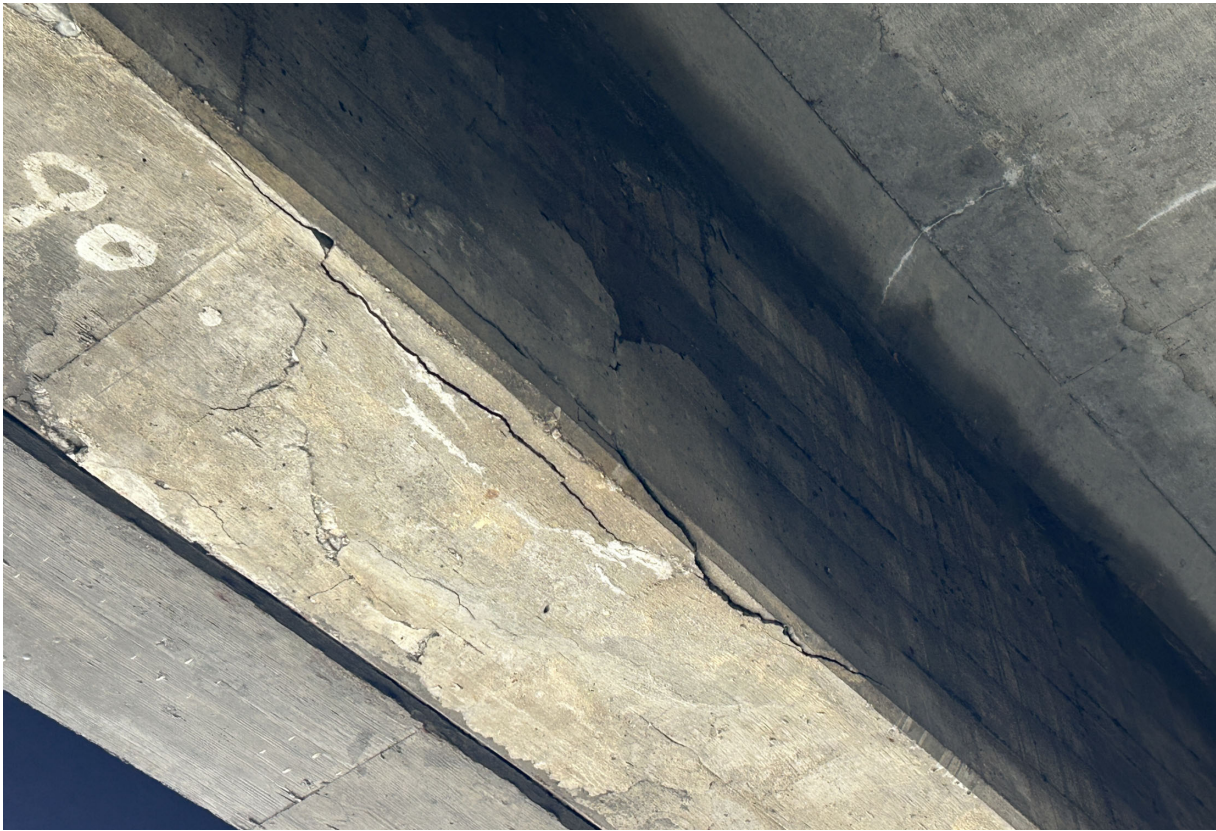
Beam13 in Span 115 has wide longitudinal cracking in the bottom flange.

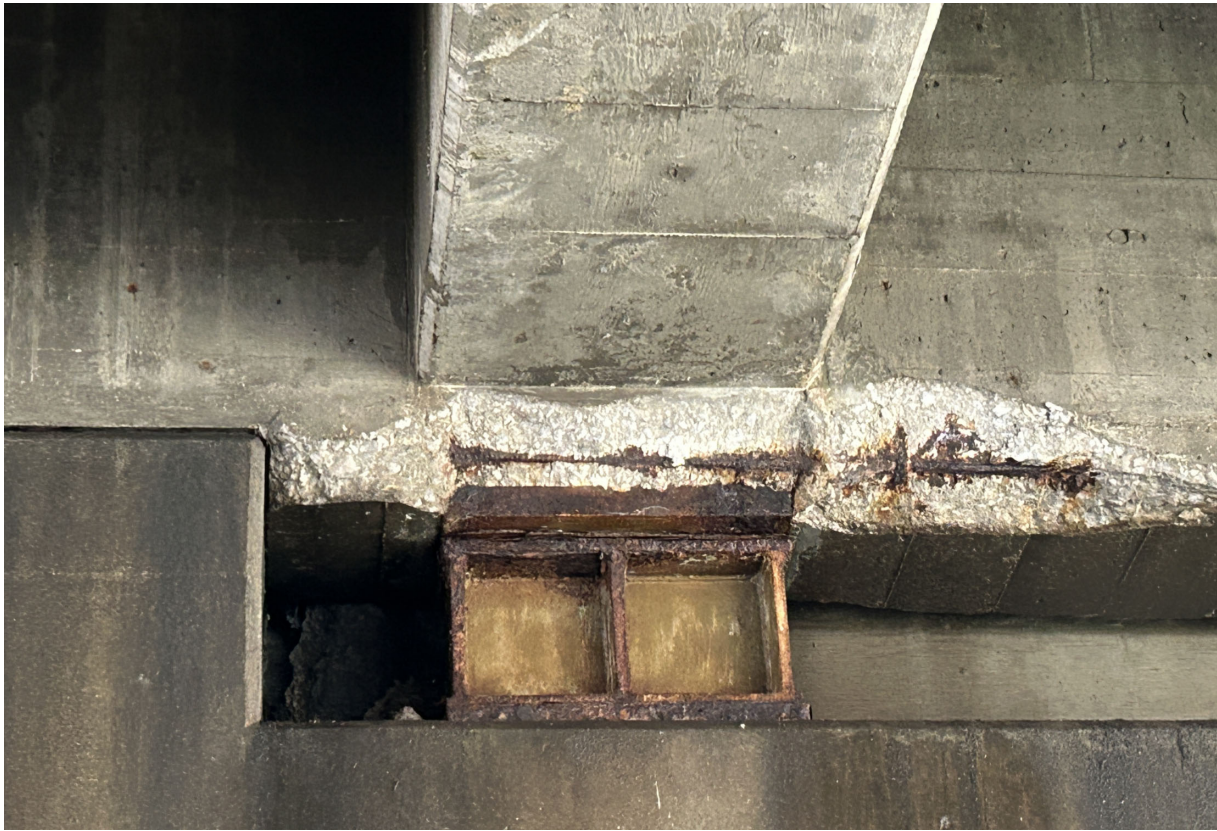
Typical Pier 115 bearing. Note spalling in diaphragm.

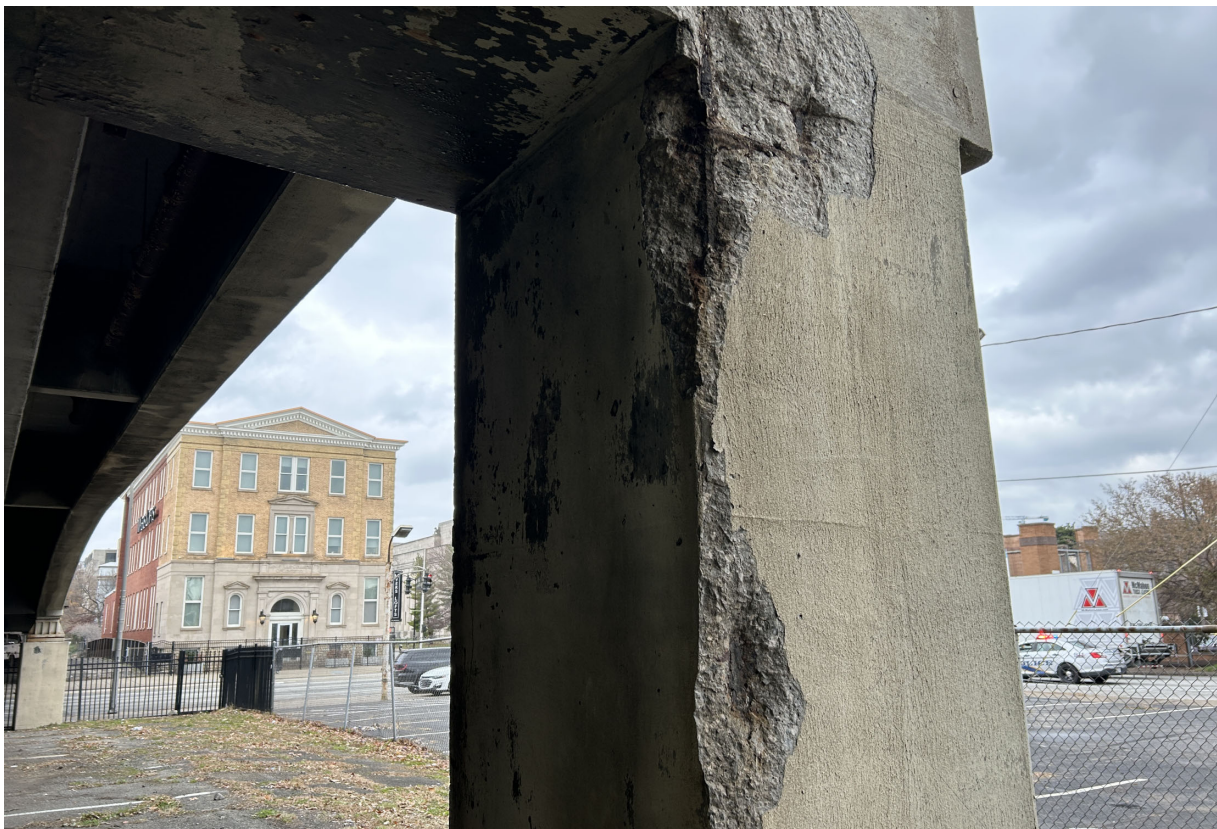
Spalling with exposed rebar in Pier 115E Column 3.

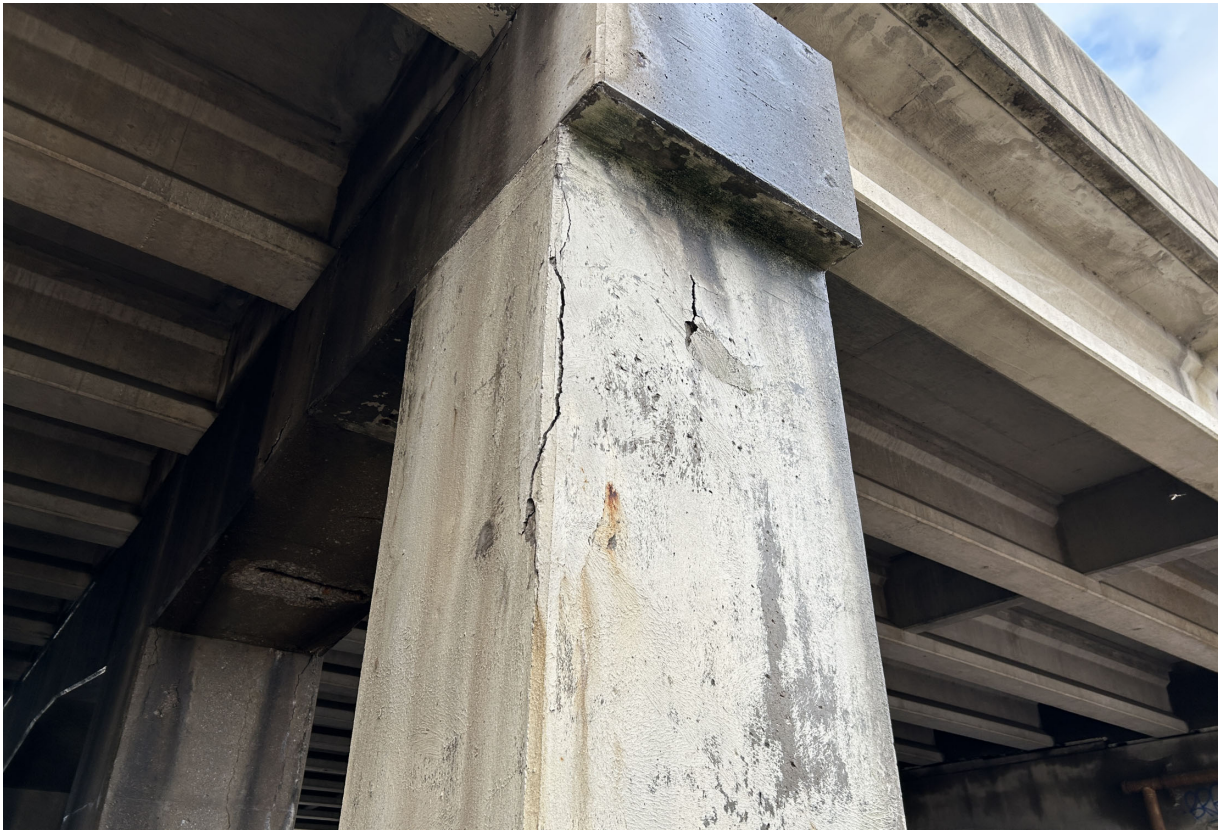
Wide vertical cracking on Column 6 at Pier 118E.

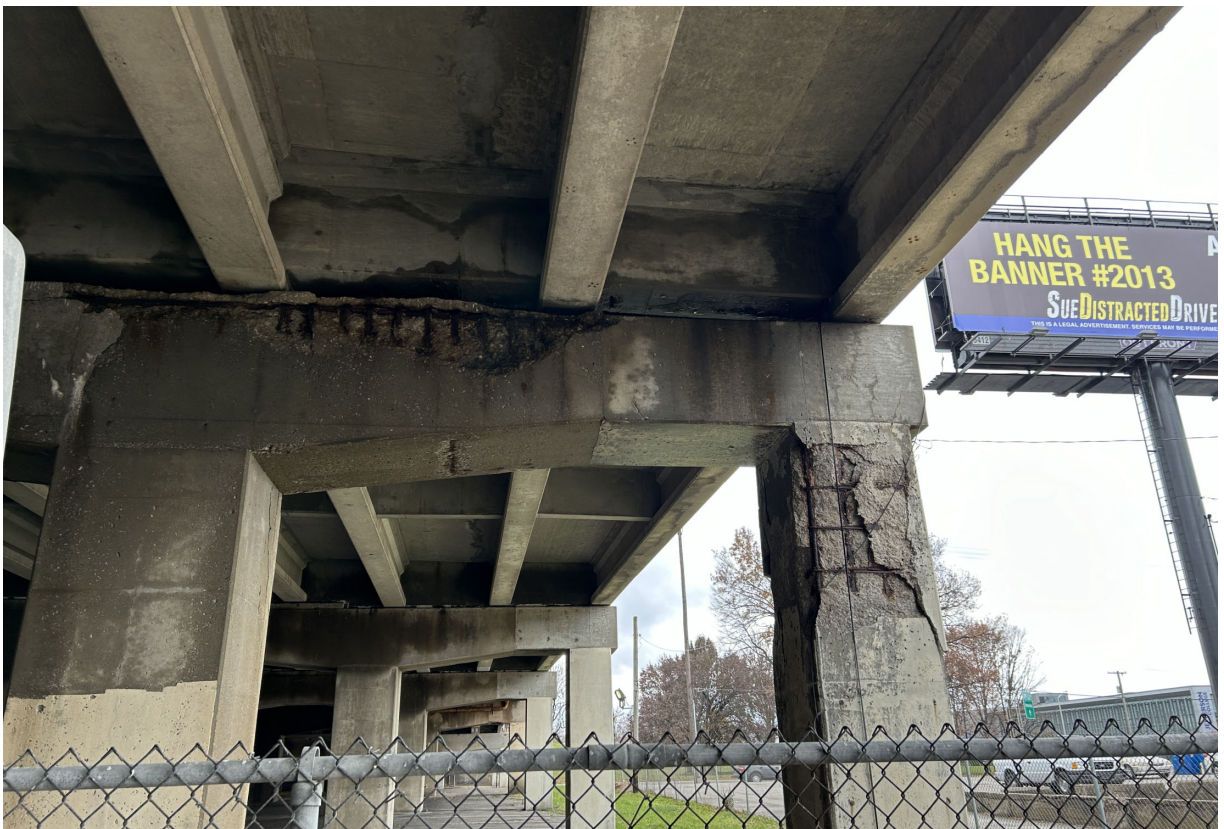
Large spalling in Pier 118W north face and Column 1.
