# Bridge Inspection Report

056B00191N

12/09/2024

Standard (24 months)

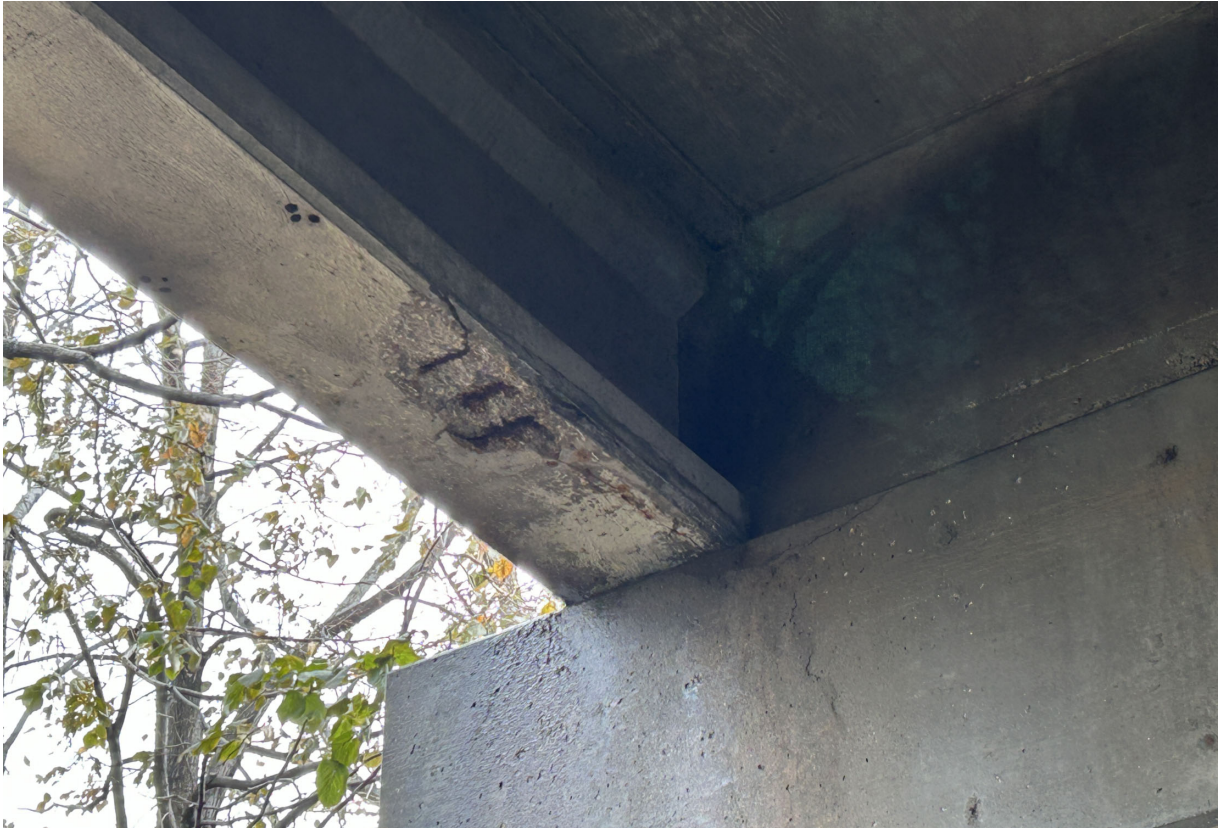
Large spall and wide longitudinal cracking on the bottom face of Beam 16 in Span 119 at Pier 119E.

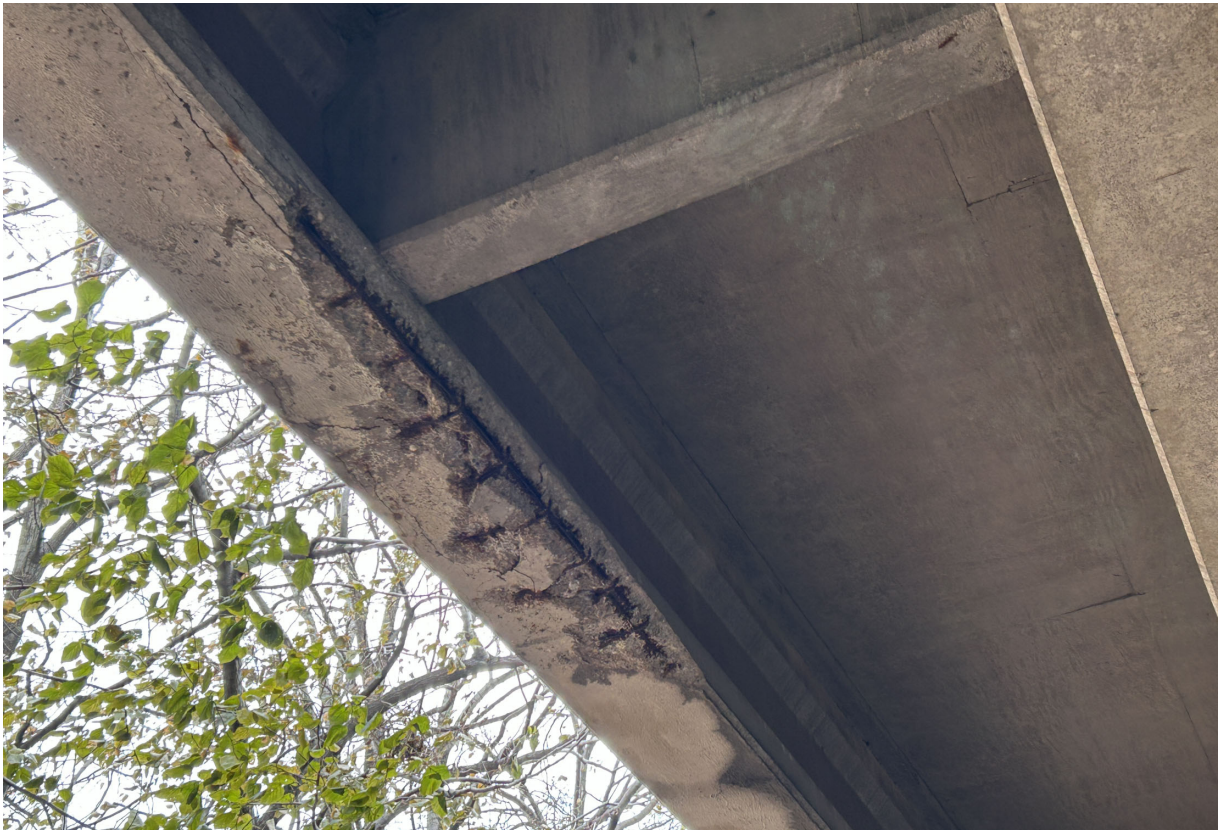
Beam 16 bottom flange in Span 120 has cracking and a large spall with exposed rebar mid-span.

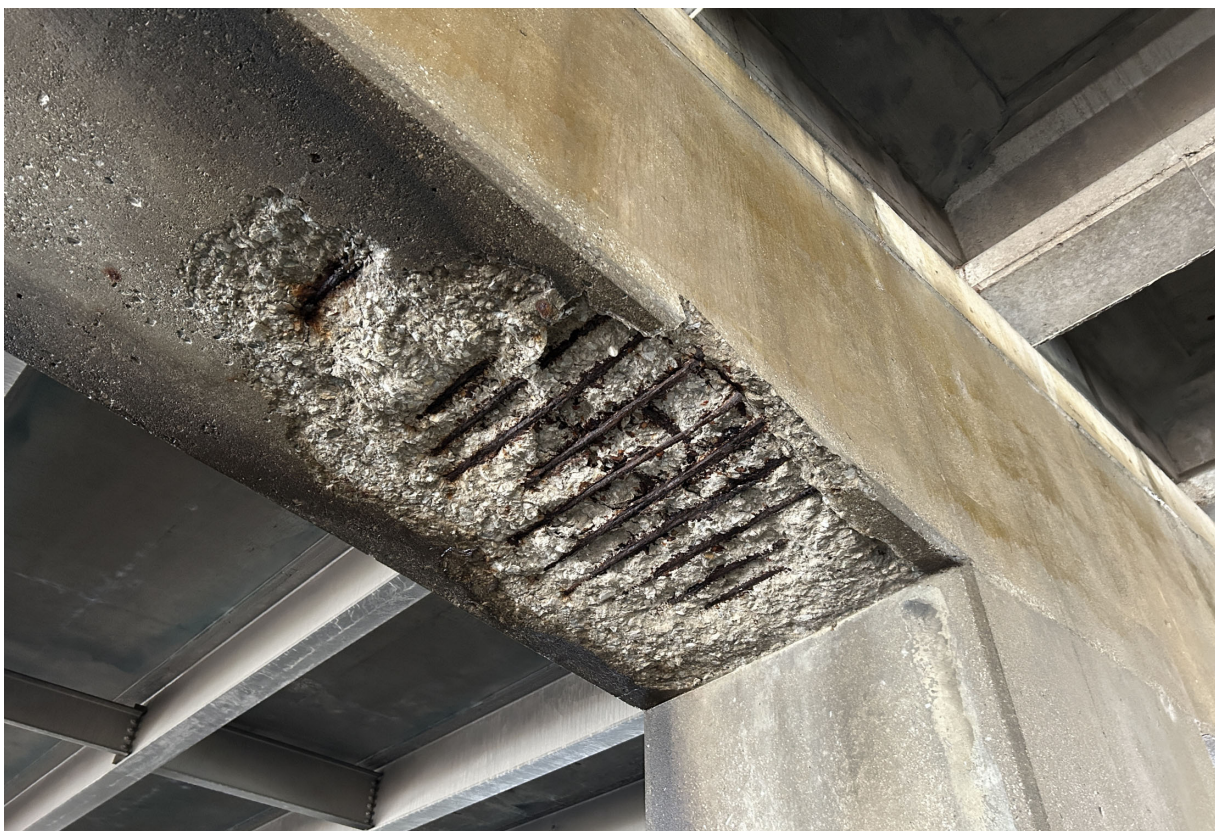
Bottom face of Pier 121E cap has a large spall with exposed rebar.

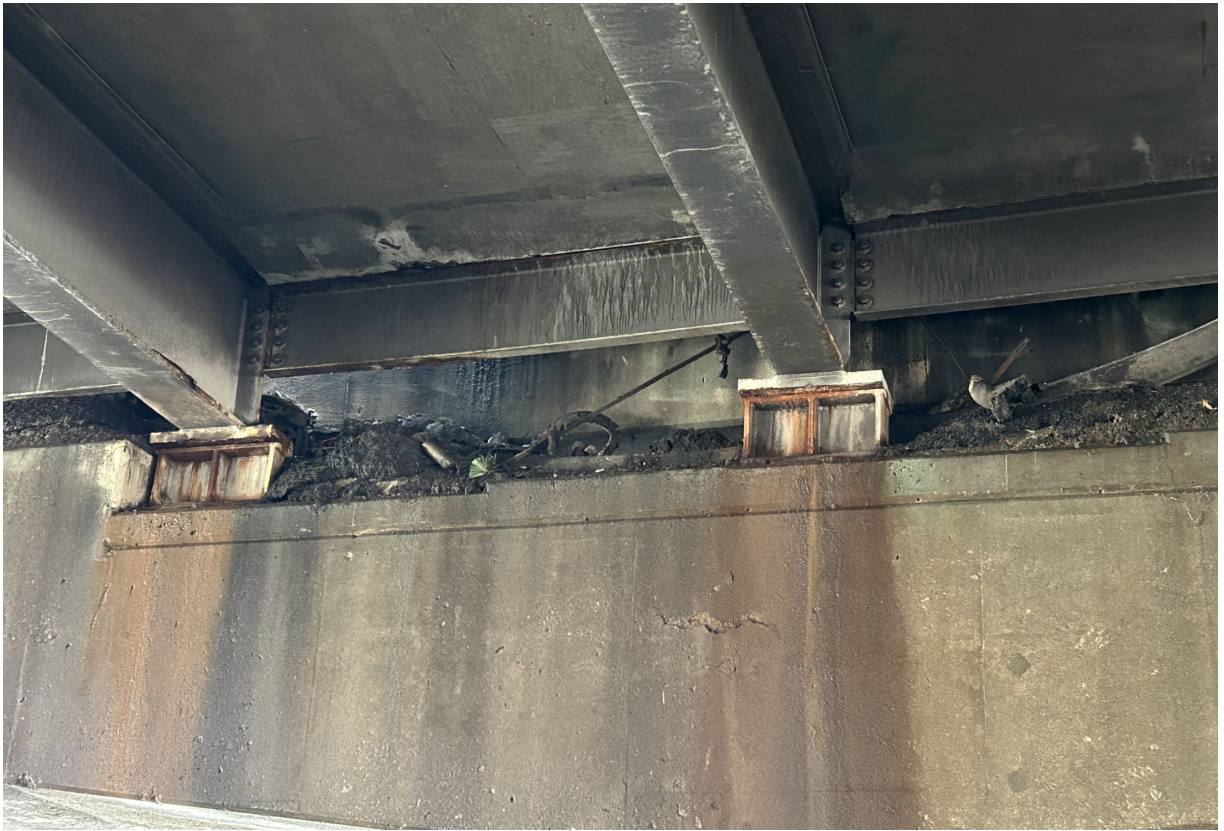
Typical Pier 121 bearings partially covered with debris.

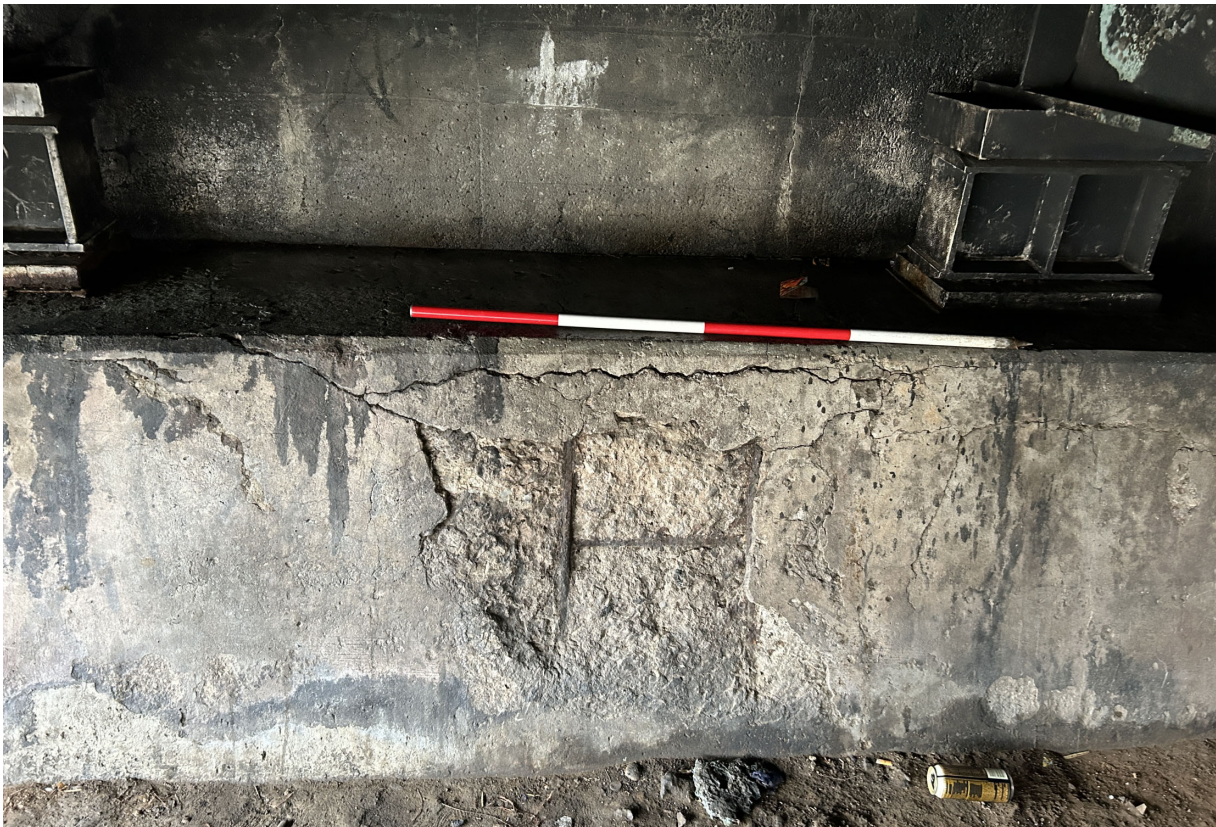
Abutment C has moderate to wide horizontal cracking, delamination, unsound patches, and several spalls with exposed rebar.

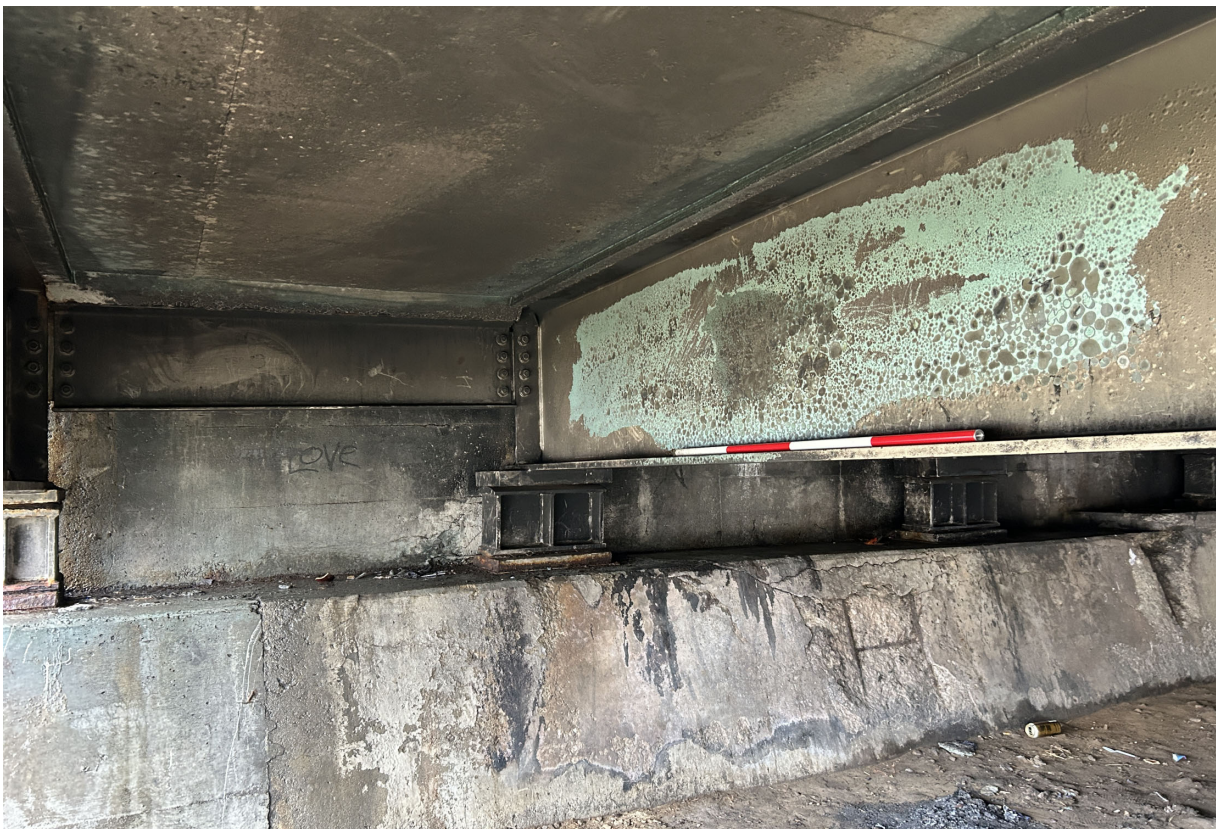
Steel protective coating is dulling throughout, with areas of limited effectiveness below the deck joints. Span 123 is covered in soot from fires under the bridge. There is evidence of fire damage in Span 124 at Abutment C in Bays 2-5, 7, and 8. Coating is worst in these locations and is especially dull and has some bubbling and peeling. Coating has failed along 3 feet of the bottom flange on Girder 14 at Abutment C.

There is evidence of fire damage in Span 124 at Abutment C in Bays 2-5, 7, and 8; coating is especially dull in this area and has some bubbling/peeling paint.

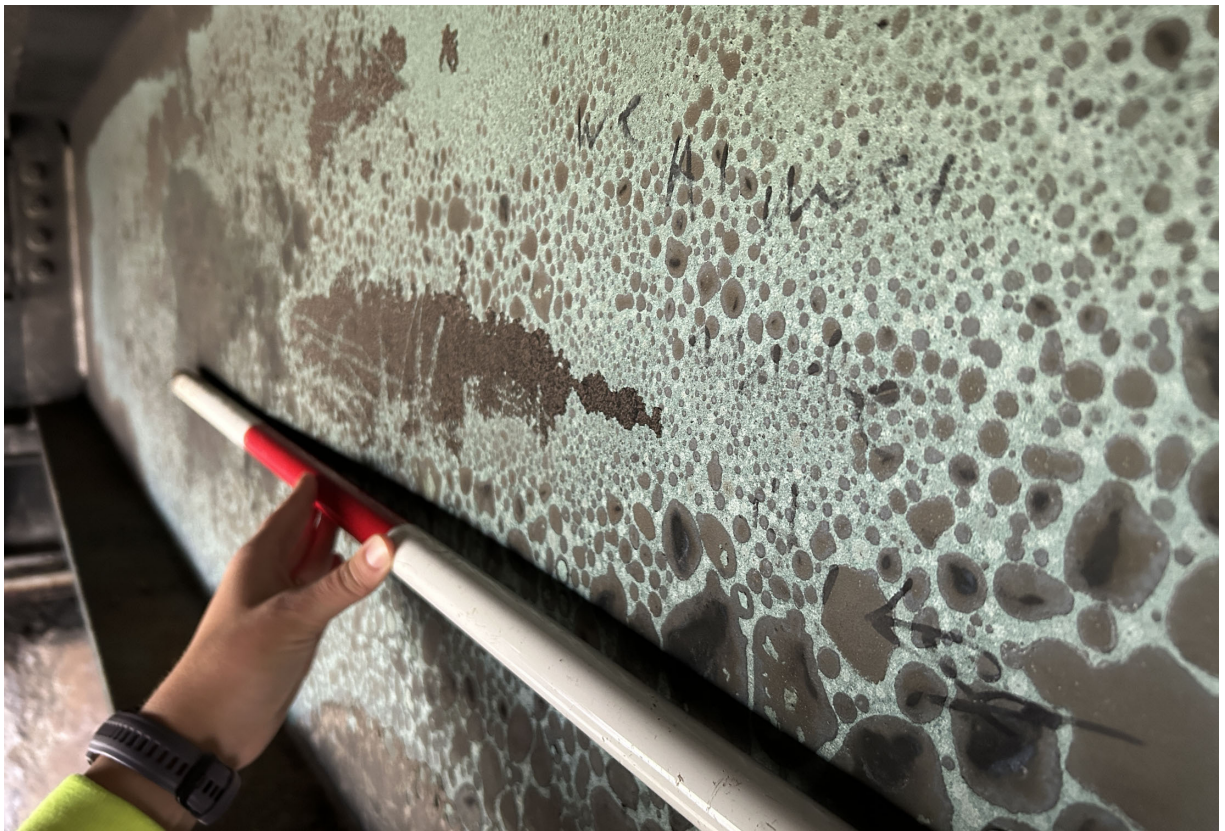
Close up of peeling paint on Beam 13 at Abutment C.
