Bridge Inspection Report

056B00192N

12/09/2024

<u>IDENTIFICATION</u>			
Structure Num (8):	056B00192N		
NBI Number	056B00192N		
Structure Name:			
Location (9):	0.18 MI N OF US 150		
Carries (7):	I-65		
Type of Service (42A):	1 Highway		
Feature Crossed (6):	E CHESTNUT ST		
Type of Service (42B):	1 Highway		
Placecode (4):	Not Applicable		
County (3):	Jefferson (056)		
State (1):	21 Kentucky		
Admin Area:	Inventory		
District:	District 5		
Latitude (16):	38° 14' 54"		
Longitude (17):	85° 45' 8"		
Owner (22):	State Highway Agency		
Maint. Resp. (21):	State Highway Agency		
Year Built (27):	1963	Border State (98A):	Not Applicable (P)
Year Recon (106):	1980	Border Number (99):	
		% Responsibility (98B):

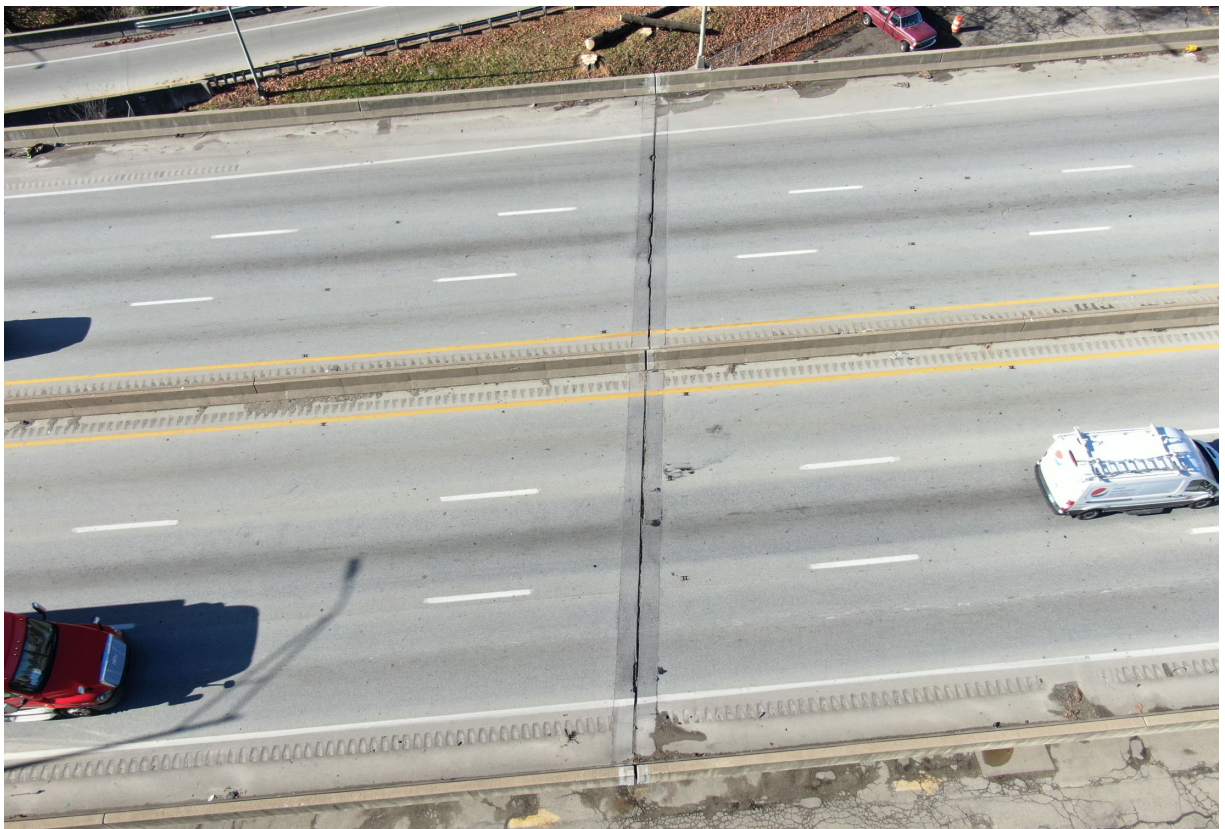
Asphalt plug joint over Pier 3

Asphalt plug joints were installed over the existing joints in 2012 and plug joints were redone in 2017. Asphalt plug joints have cracking, rutting, and spalling, some spalls exposing the original joints and allowing moderate leakage. Over Piers 3 and 7, the joints have failed in the traffic lanes and allow free flow of water. There are also a few asphalt patches on the joints in the NB lanes.

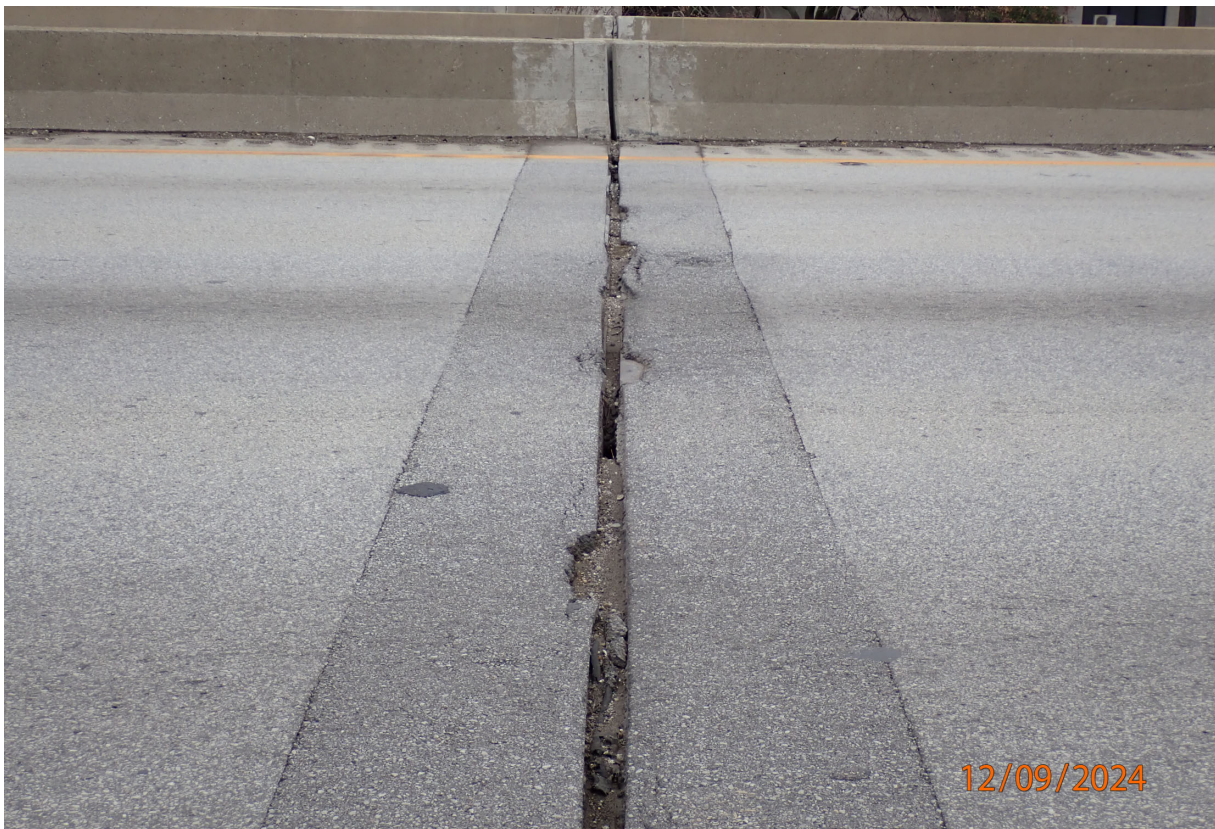
Asphalt plug joints have failed in the traffic lanes, with some spalling and rutting (close up).

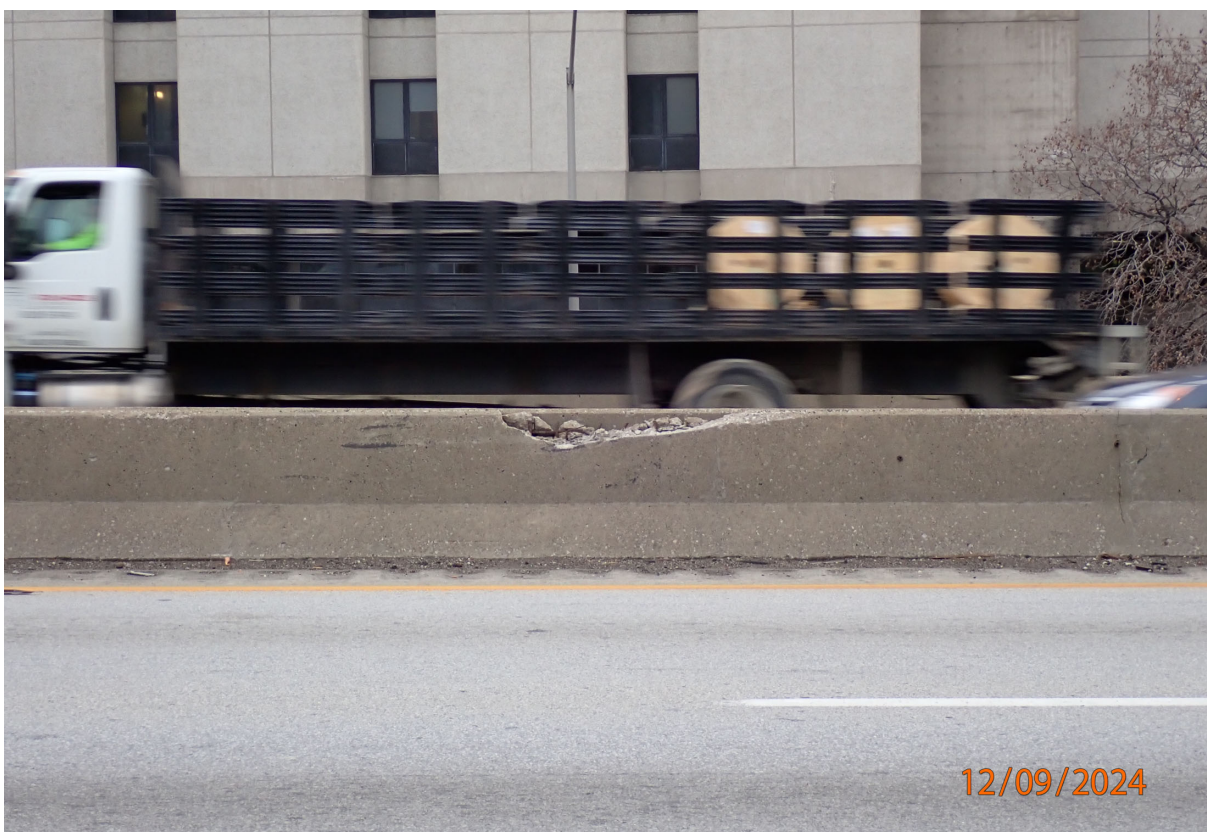
Barriers have moderate cracking and several scrapes and spalls, most from impact and some deeper than 1 inch. There are patches with cracking at the deck joints. The SB median barrier has a 6-foot-long full depth spall with exposed rebar just north of Pier 3W joint.

The SB median barrier has a 6-foot-long full depth spall with exposed rebar just north of Pier 3W joint.

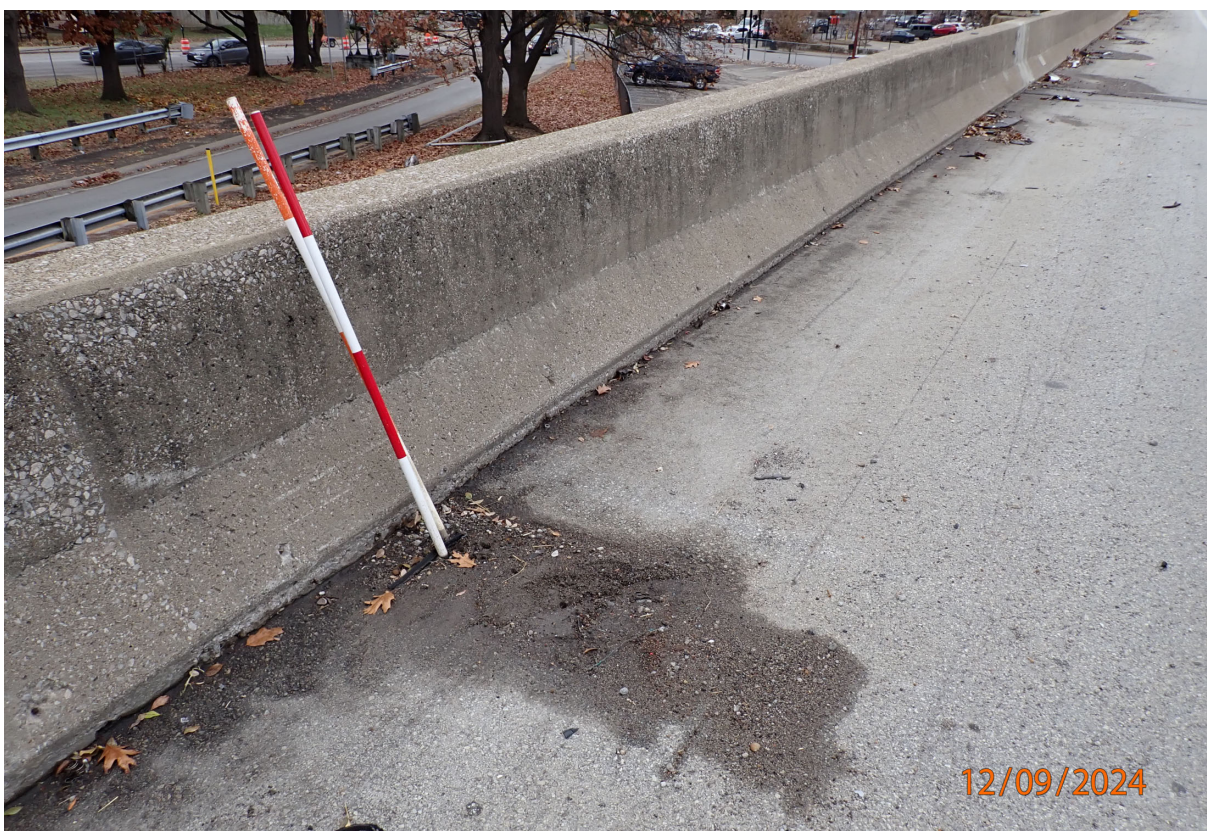
Deck drains are completely clogged.

Deck drains are clogged (SB shoulder near south bridge end shown).

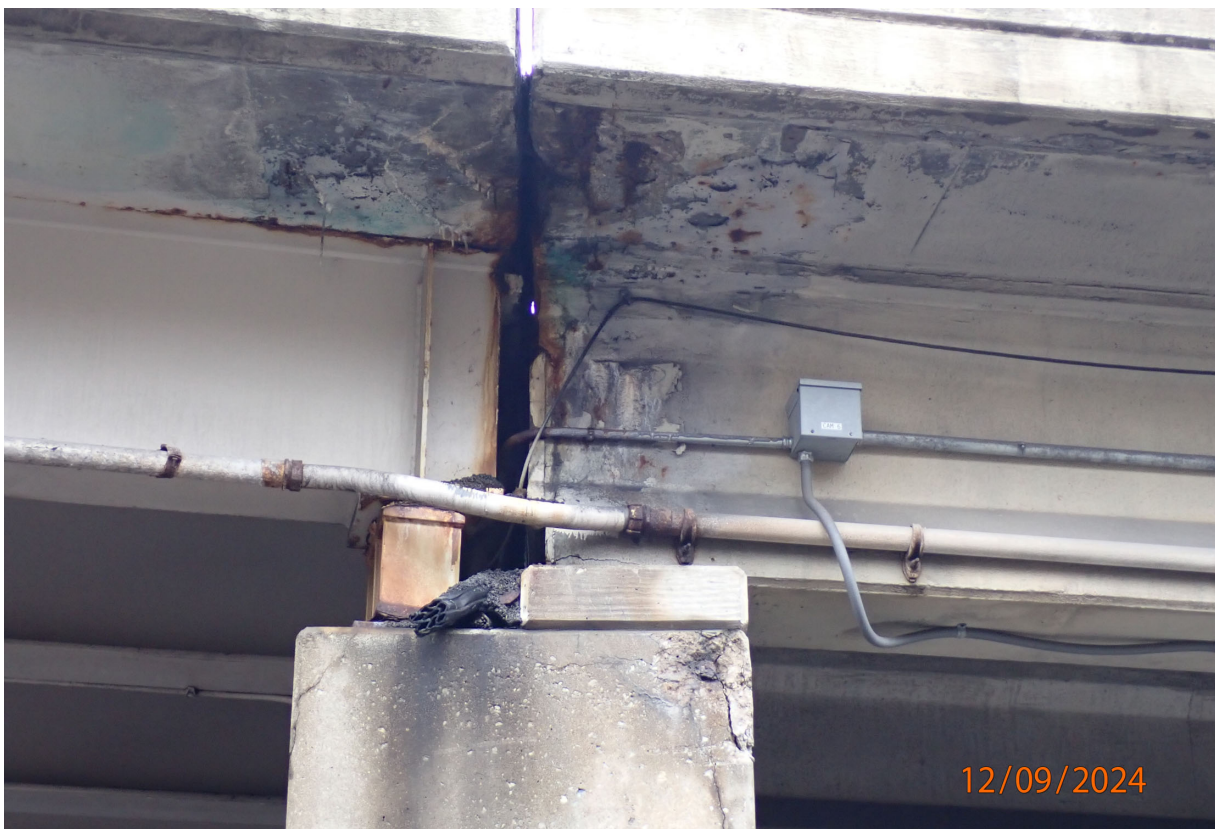
PCI beams have moderate to wide longitudinal cracks and/or rust staining, delaminations, and spalls, some greater than 6" diameter and some with exposed rebar; most defects are at the beam ends and below the deck joints at Piers 3 and 7. In Span 1A, east exterior Beam 14 at Pier 103 (S1A-B14 at P103) has diagonal cracking with efflorescence and rust staining in the web and a wide horizontal crack in the bottom flange (2' CS3).

- S1A-B14 at P103 (2' CS3)
- S1A-B14 at P102 (2' CS3)
- S3-B8 & B14 at P3 (3' CS3)
- S4-B1 & B14 at P3 (3' CS3)

Span 1A-Beam 14 at Pier 103 (S1A-B14 at P103) has diagonal cracking with efflorescence and rust staining in the web and a wide horizontal crack in the bottom flange. Note spall in overhang, numerous utilities anchored to beam, and daylight through failed joint.

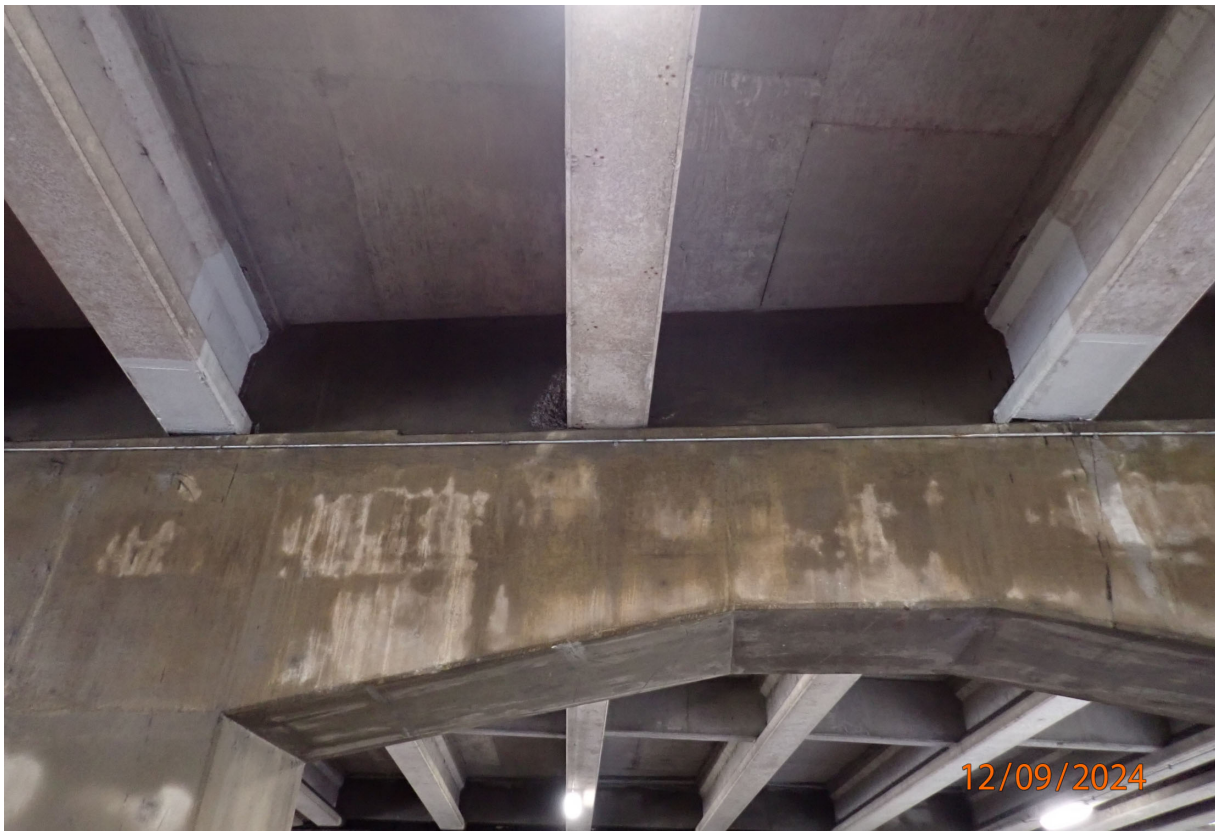
Beam ends have CFRP patches to repair cracking (2007 KTC project) in Spans 1A, 1, 2, and 4 through 7 (2 to 5' long each, totaling approximately 60' CS2 with 3 locations in the NB superstructure and 21 locations in the SB superstructure). Patches are in good condition, although Span 2-Beam 1 at Pier 1W appears to have some insignificant shrinkage cracking.

Some beam ends have CFRP patches (S1-B5 and B7 at P102 shown).

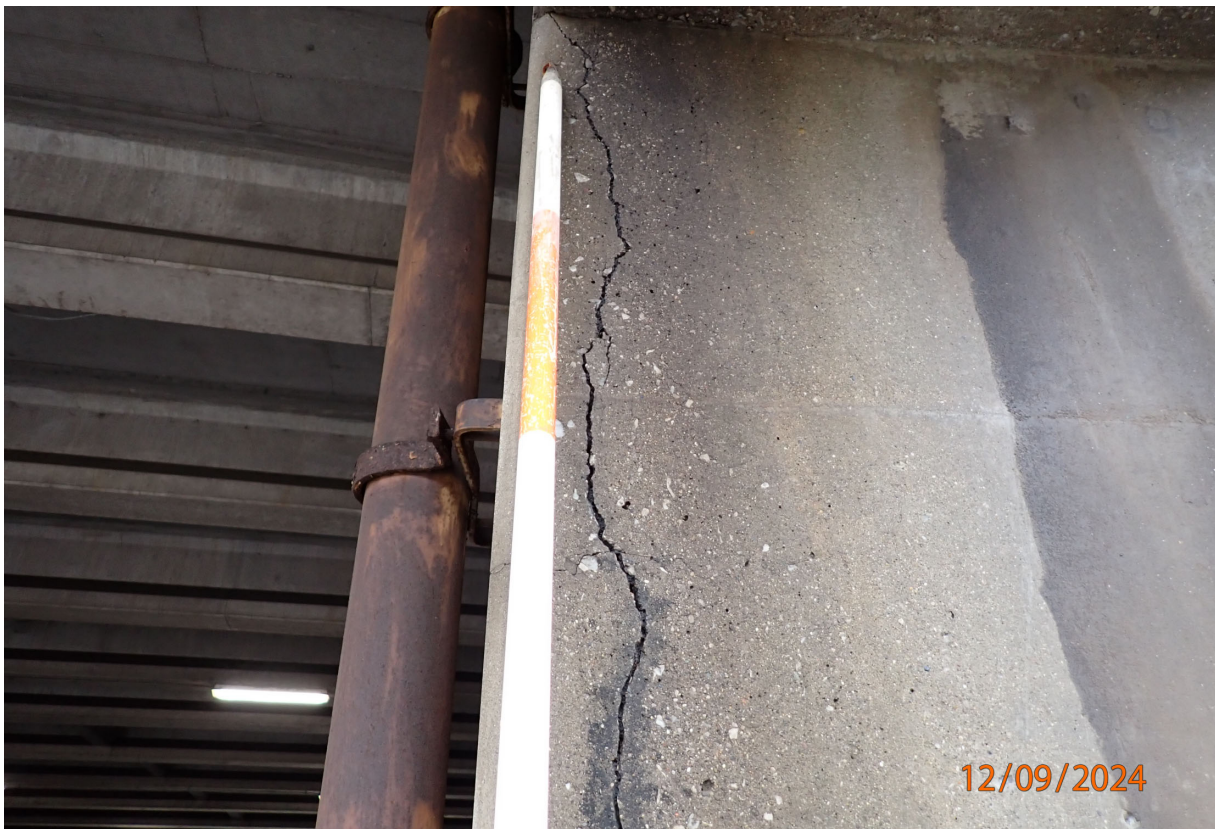
Some columns have wide vertical cracks (P102-C5 shown).

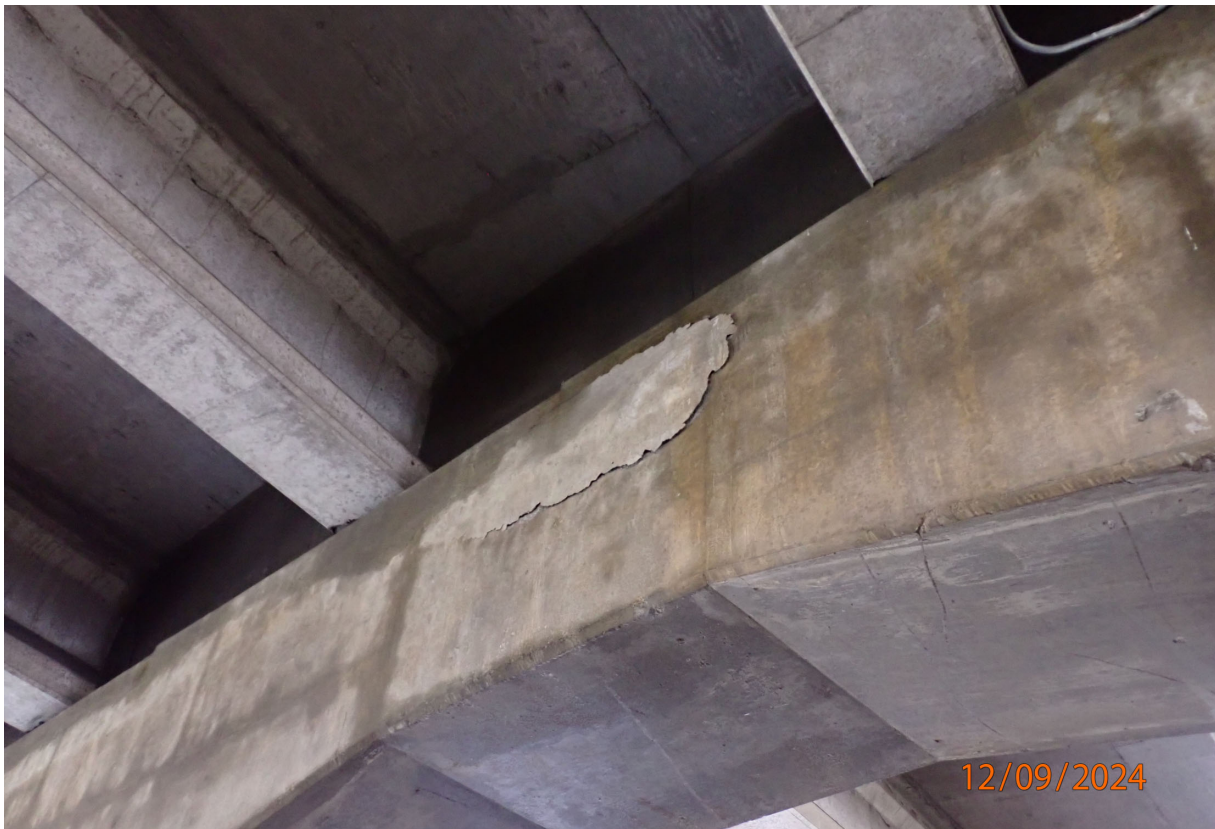
Pier caps have several delaminated areas (south face of P102 shown).

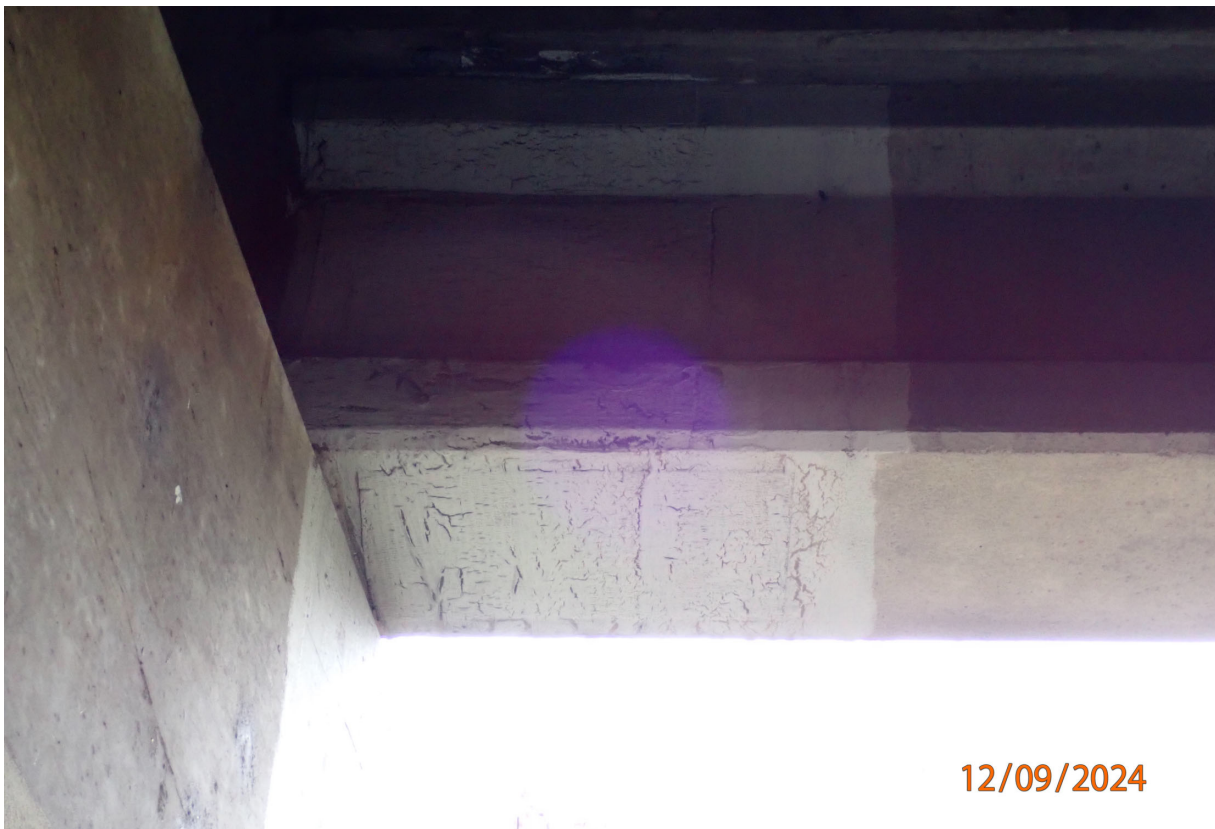
CFRP patch on S2-B1 at P1 has insignificant shrinkage cracking.

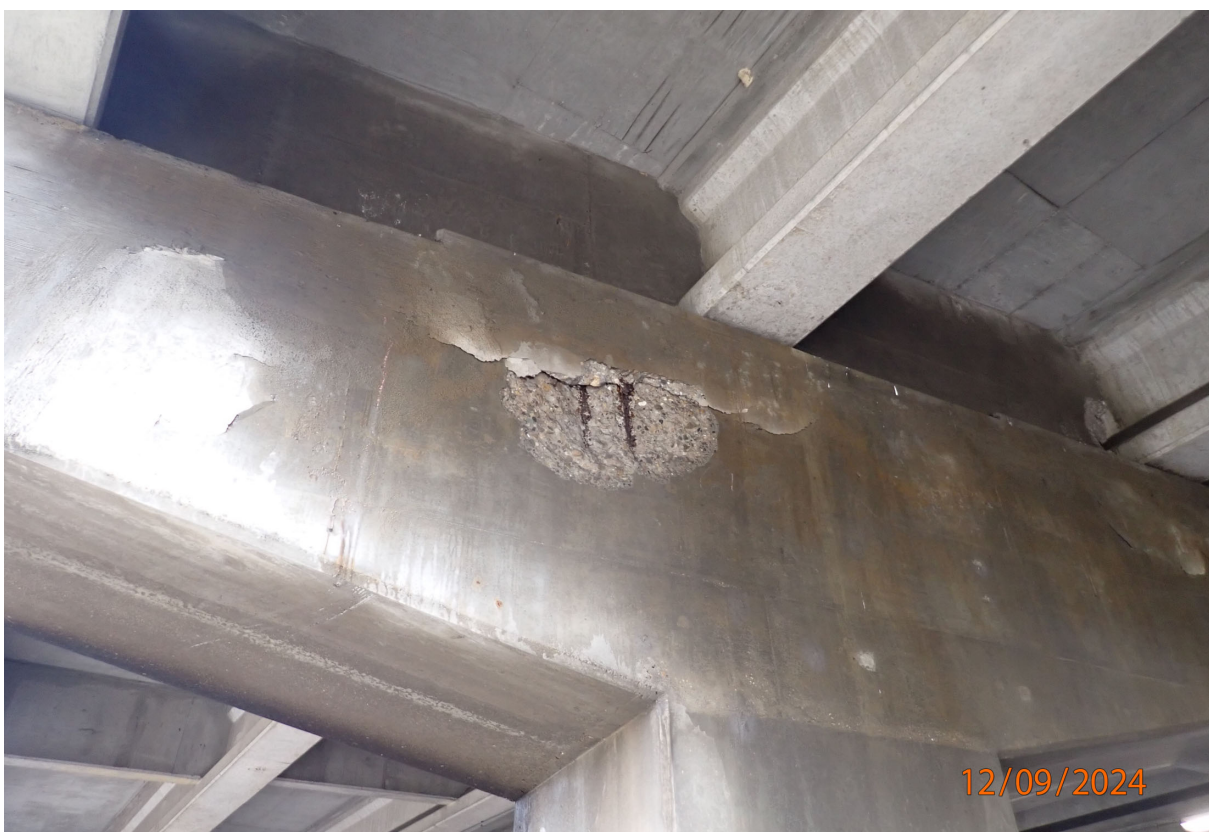
Pier caps have moderate to wide cracking, delaminated areas, and spalling with exposed rebar (P1 shown).

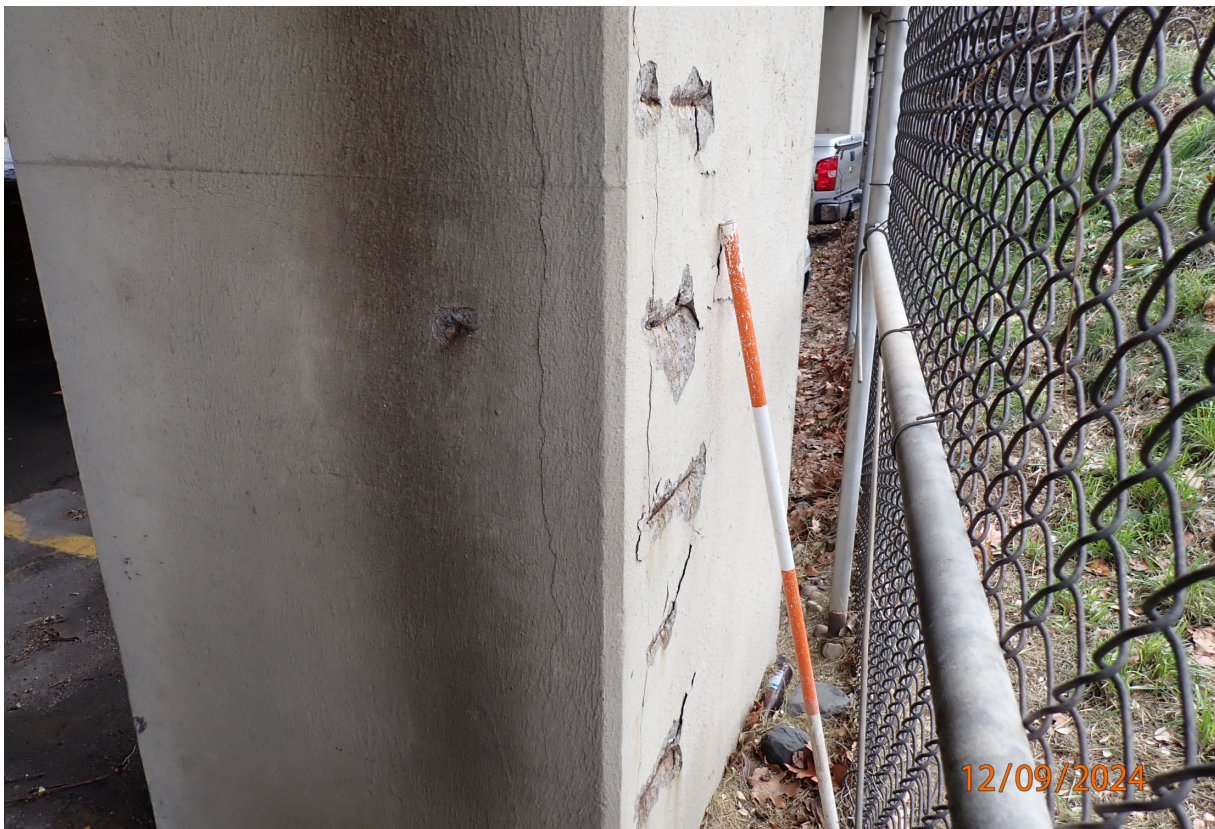
P2-C1 has several 1 SF spalls with exposed rebar in the west face.

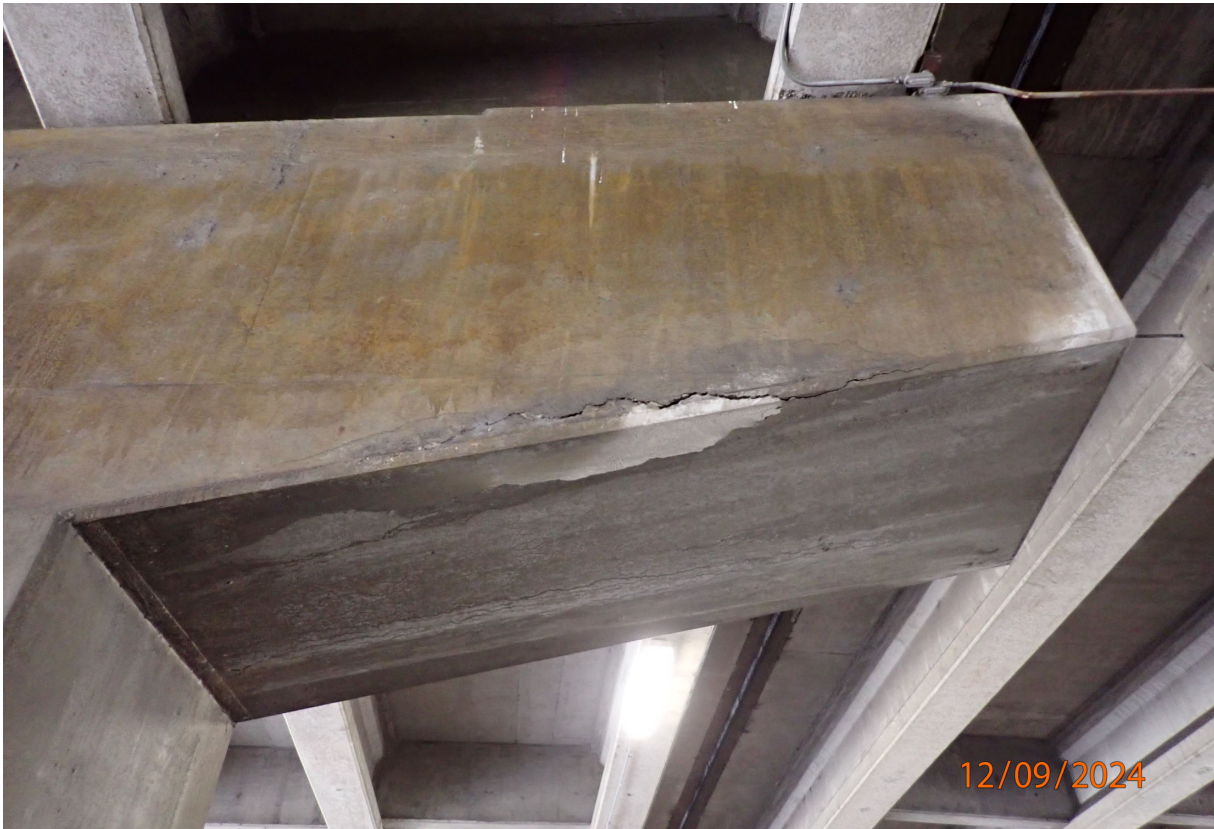
Pier caps have moderate to wide cracking, delaminated areas, and spalling with exposed rebar (south face of P2W shown).

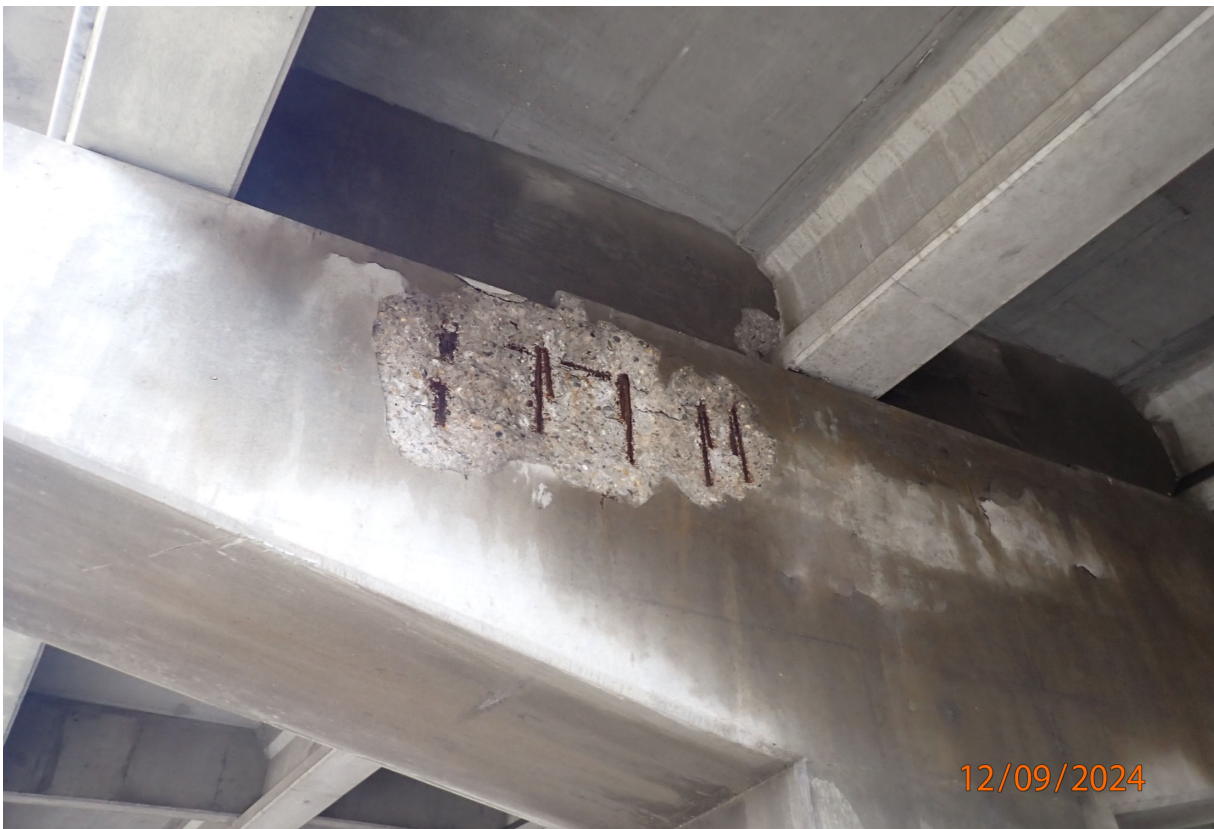
Pier caps have moderate to wide cracking, delaminated areas, and spalling with exposed rebar (north face of P2E shown).

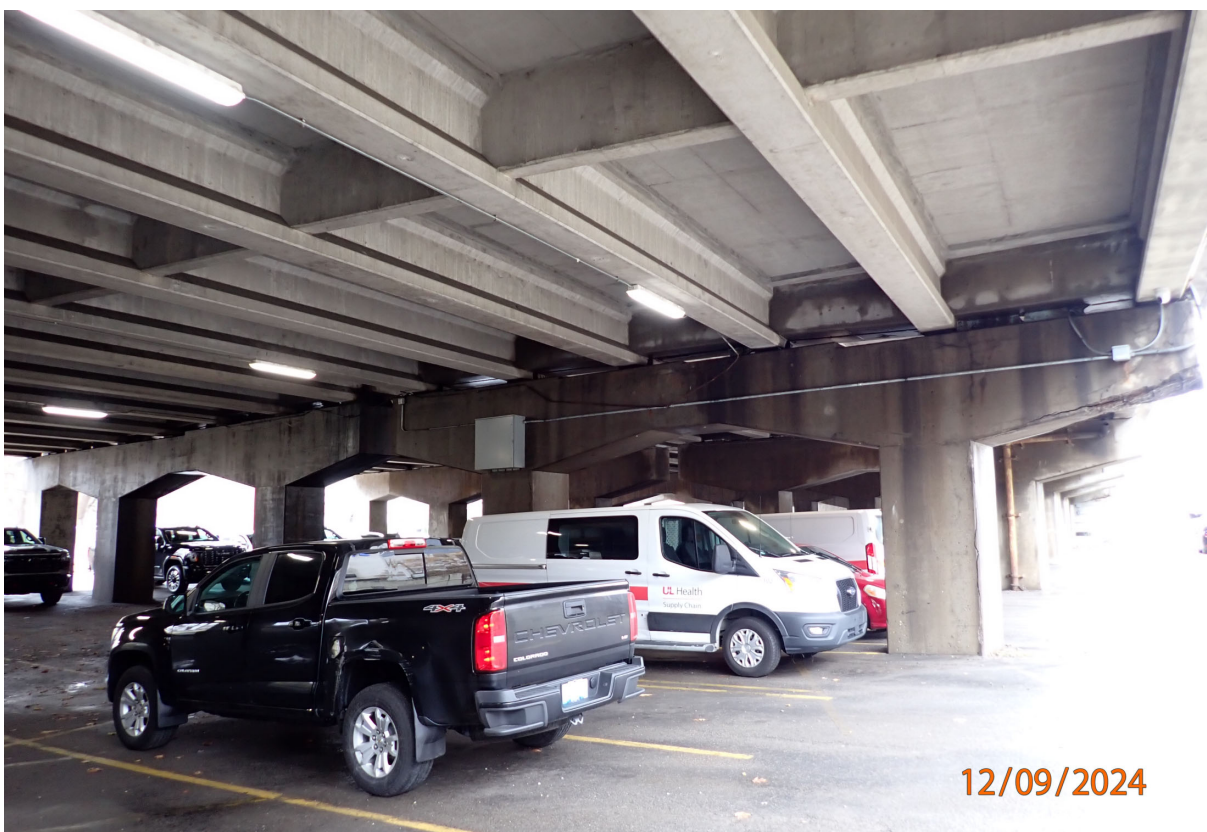
South face of P3
Note staining along the full length of the pier.

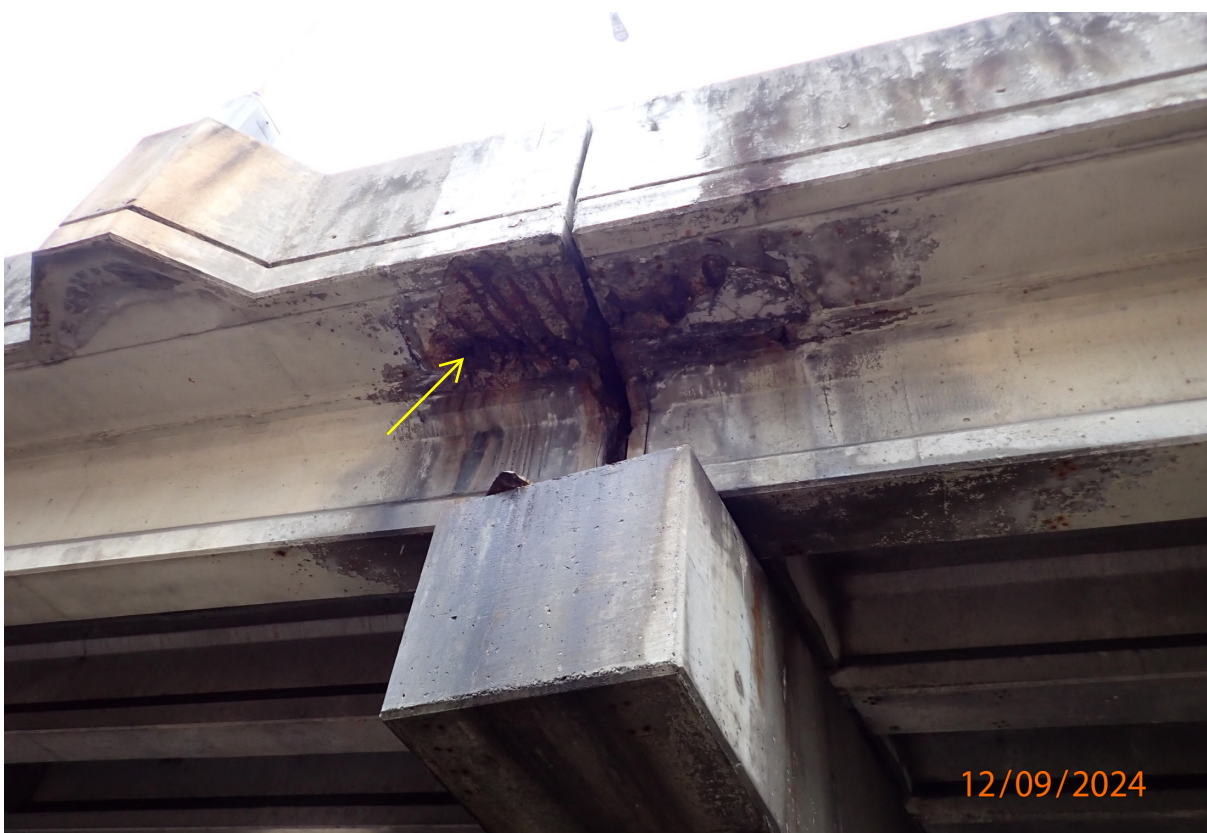
At each deck joint, the soffit has spalls with exposed rebar in the overhangs and below the longitudinal joint. Spalling above the west end of P3W is at least 6 inches deep and leaking.

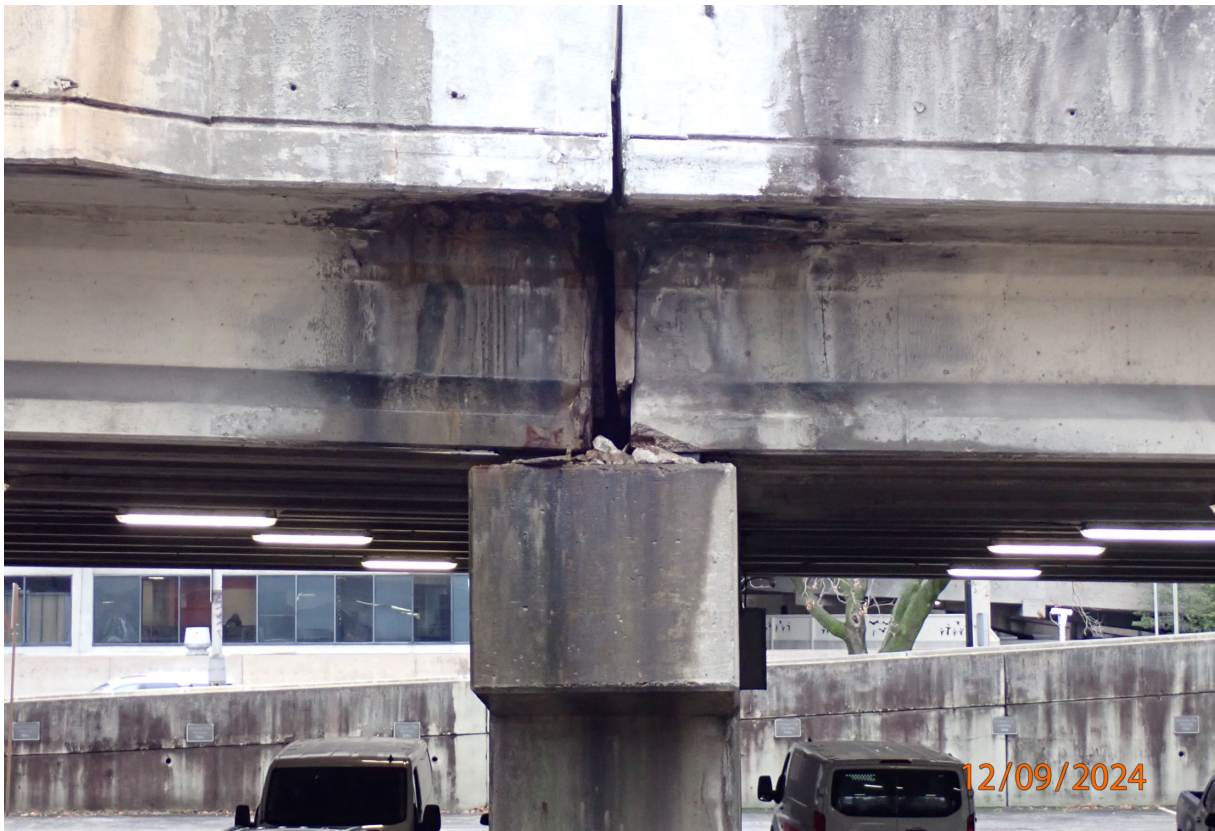
S3-B1 has a deep end spall with at least one exposed prestressed strand at P3W. Note staining on beams and pier.

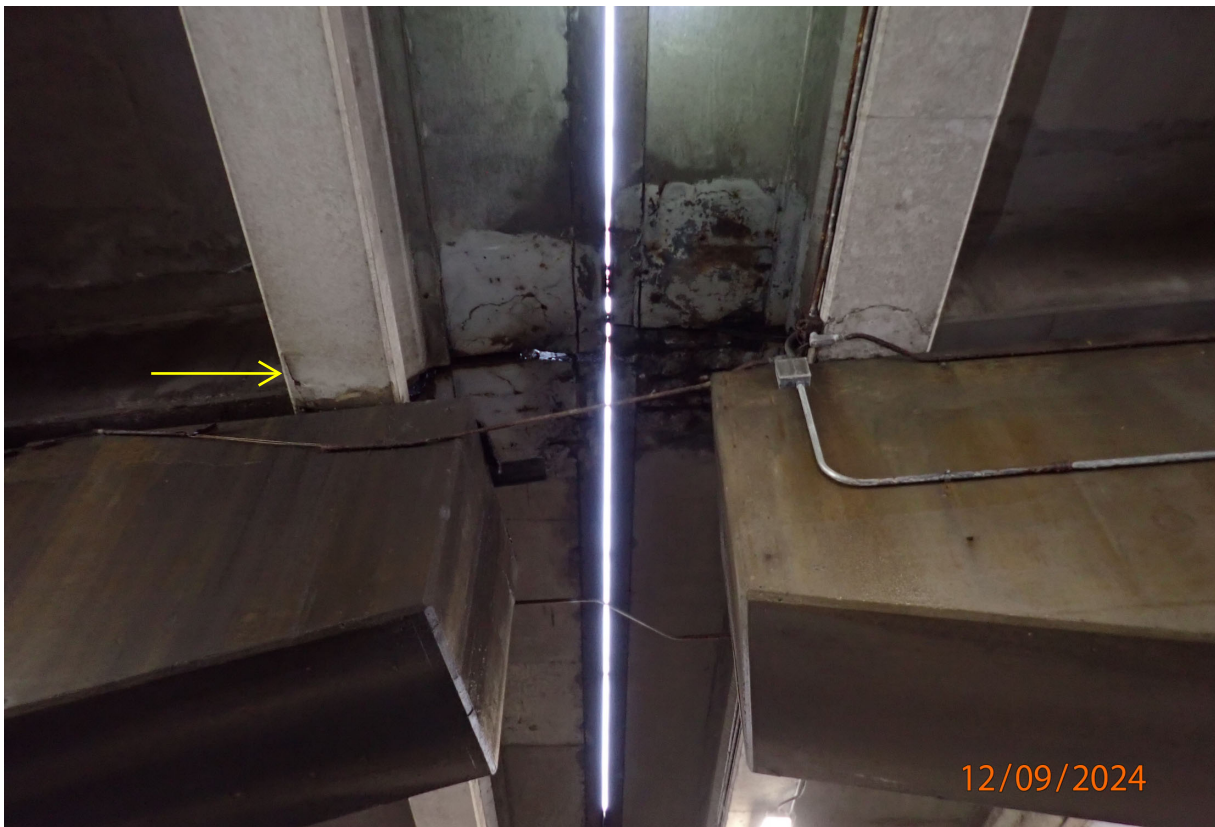
S3-B8 at P3 has a wide longitudinal crack. Note delamination in Beam 9 and deterioration of soffit below longitudinal joint.

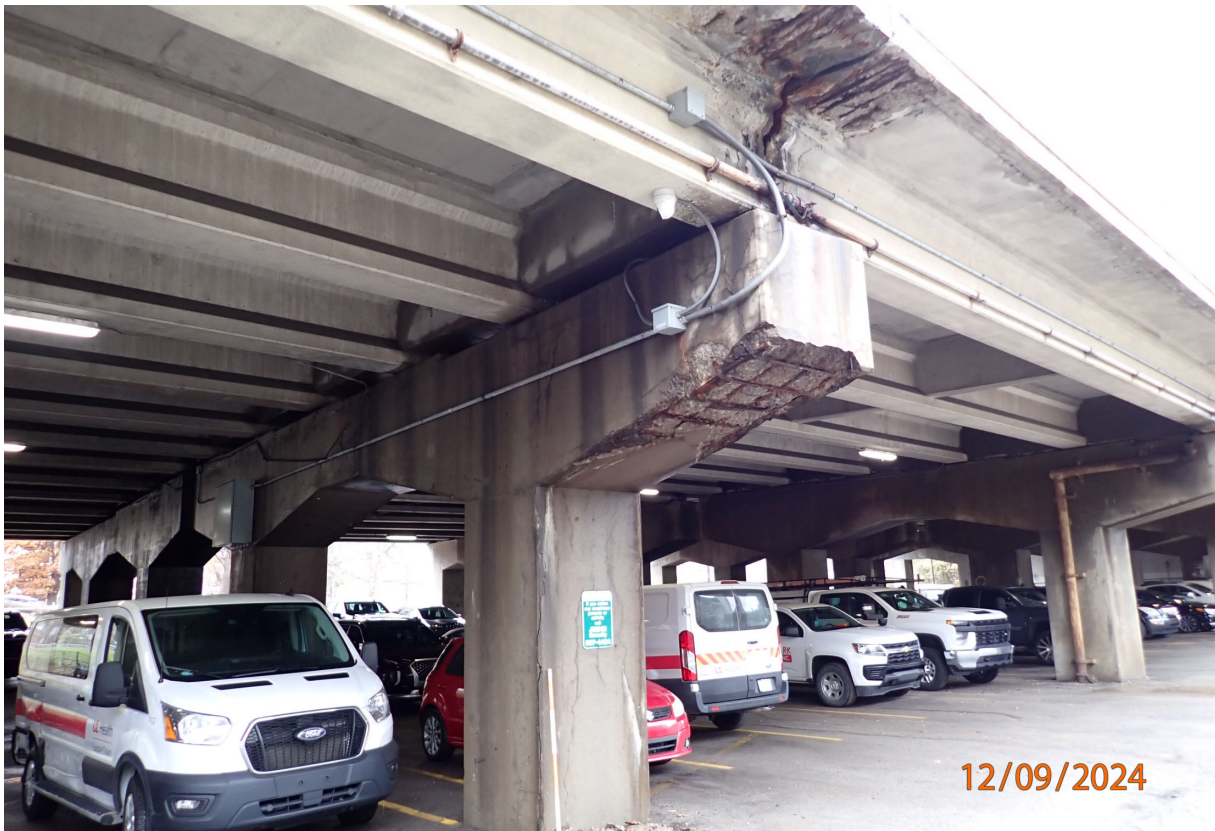
Pier caps have moderate to wide cracking with efflorescence and/or rust staining, many delaminated areas, and some spalling with exposed rebar and section loss. Deterioration is widespread on Piers 3 and 7 below the joints (88' and 56' CS3, respectively), with spalling up to 4" deep and fully exposed rebar in the bottom face at the east ends. Joint construction material is piled on top of pier caps in a few locations.

P3 and P7 caps have spalling up to 4 inches deep with fully exposed rebar in the bottom face at the east end (P3 shown).

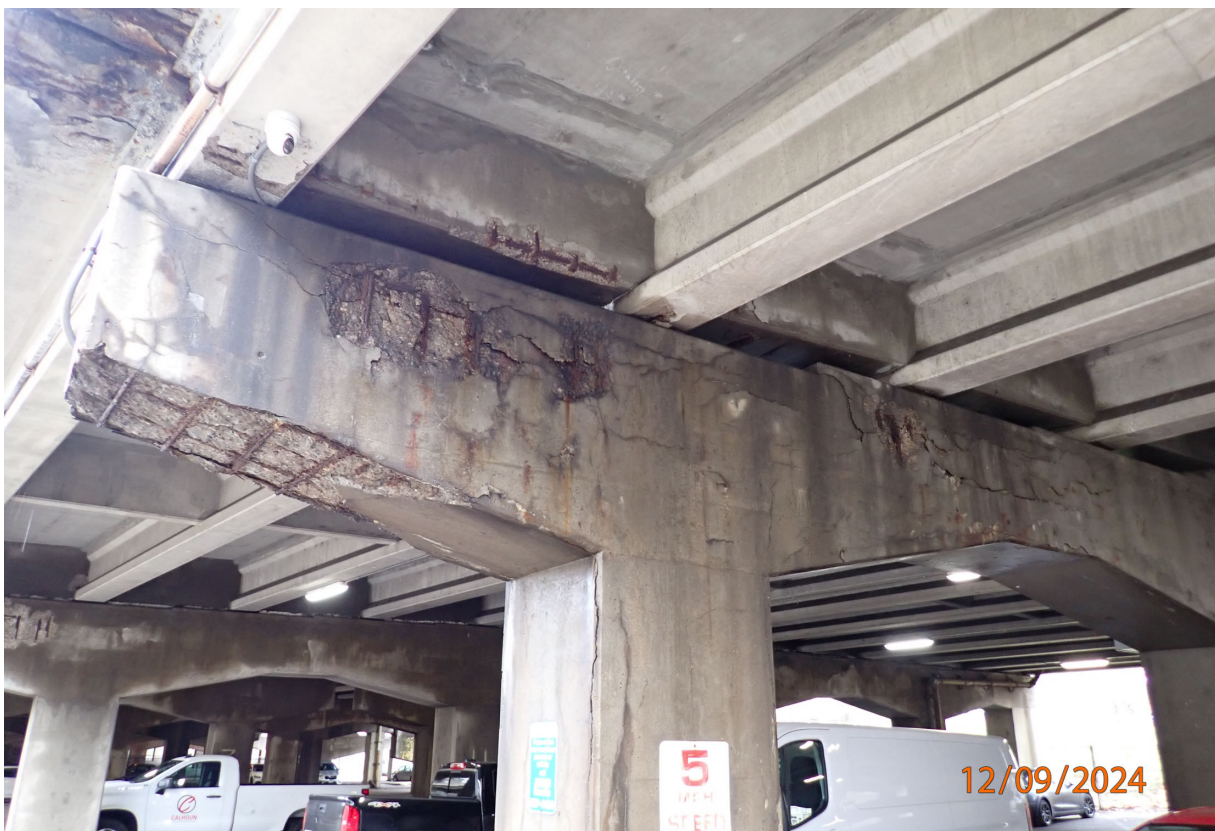
Additional view of east end of P3, north face. Note diaphragm spall with exposed rebar.

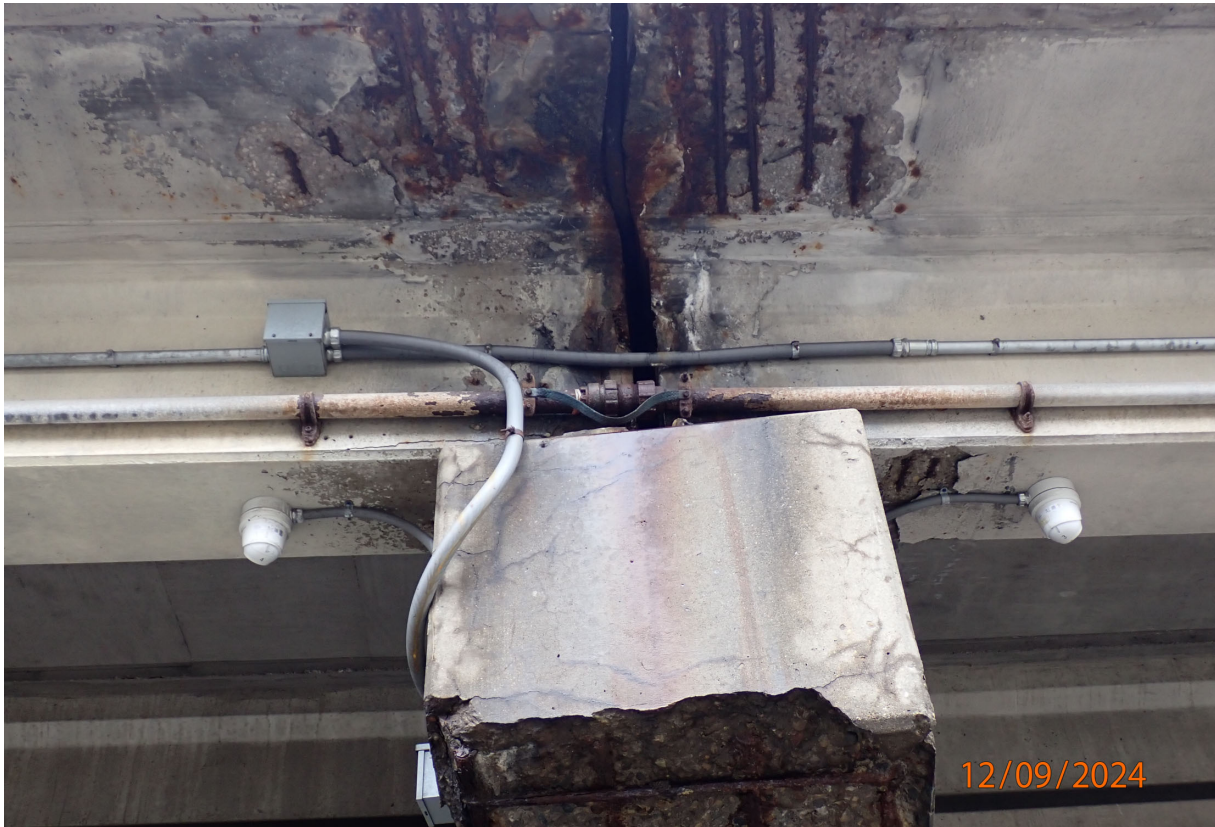
At P3, B14 has wide cracking and spalling, roughly 3 feet long at both beam ends. Note typical overhang spalling below joint.

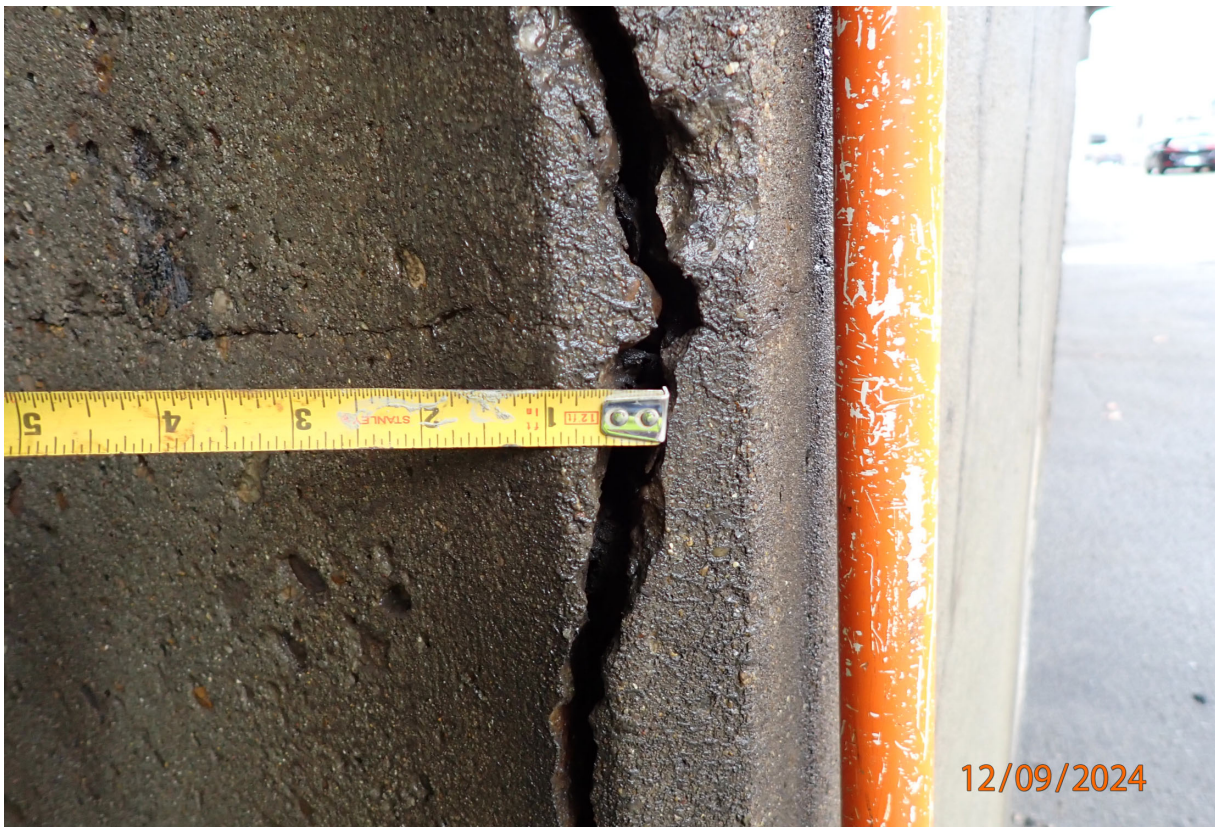
Columns have moderate to wide vertical cracking (up to 1/2" width), delaminated areas, and spalling. All five columns at Pier 3 have wide cracking. Deterioration is heaviest at Pier 7, where Column 5 has a 3' H x 1' W x 3" D spall with exposed rebar and section loss.

Column cracking is up to 1/2 inch wide (P3-C5 shown).
