Bridge Inspection Report

056B00192N

12/09/2024

<u>IDENTIFICATION</u>			
Structure Num (8):	056B00192N		
NBI Number	056B00192N		
Structure Name:			
Location (9):	0.18 MI N OF US 150		
Carries (7):	I-65		
Type of Service (42A):	1 Highway		
Feature Crossed (6):	E CHESTNUT ST		
Type of Service (42B):	1 Highway		
Placecode (4):	Not Applicable		
County (3):	Jefferson (056)		
State (1):	21 Kentucky		
Admin Area:	Inventory		
District:	District 5		
Latitude (16):	38° 14' 54"		
Longitude (17):	85° 45' 8"		
Owner (22):	State Highway Agency		
Maint. Resp. (21):	State Highway Agency		
Year Built (27):	1963	Border State (98A):	Not Applicable (P)
Year Recon (106):	1980	Border Number (99):	
		% Responsibility (98B):

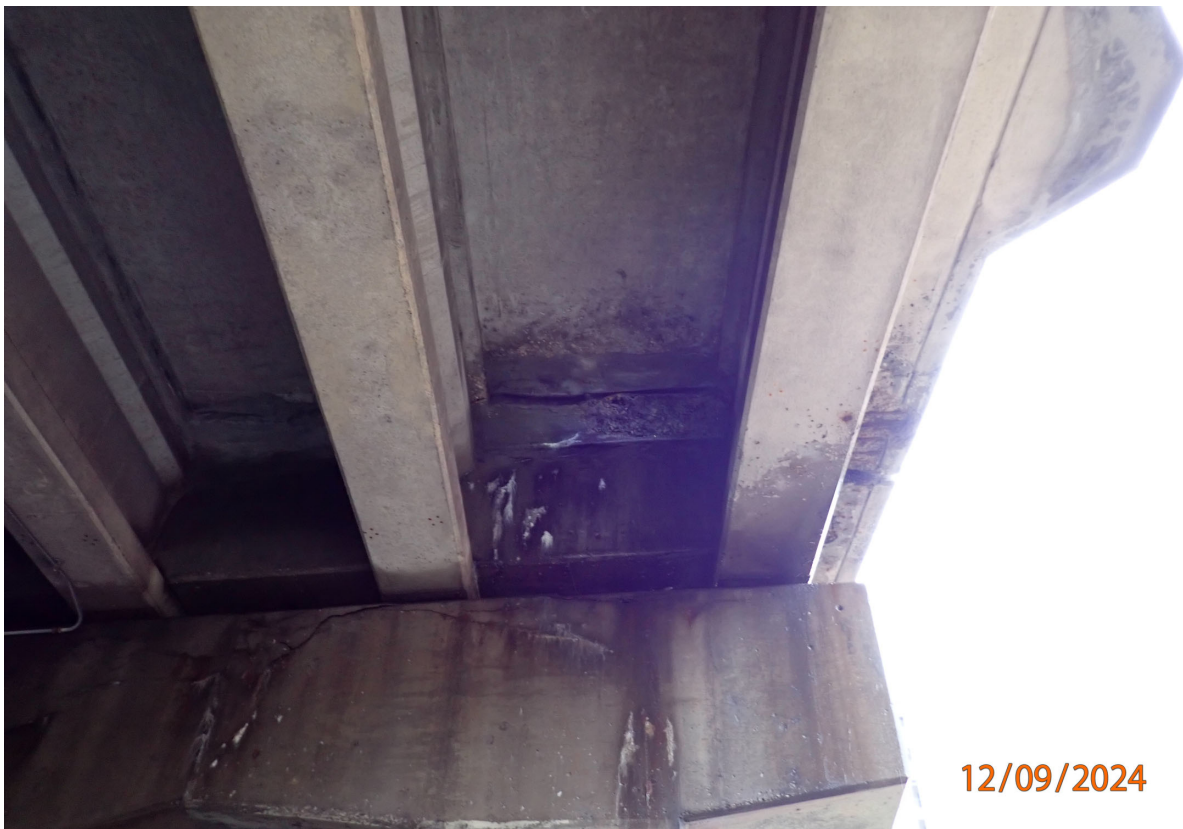
Soffit has a 10 SF area of full depth deterioration in S4-Bay 1 at P3W.

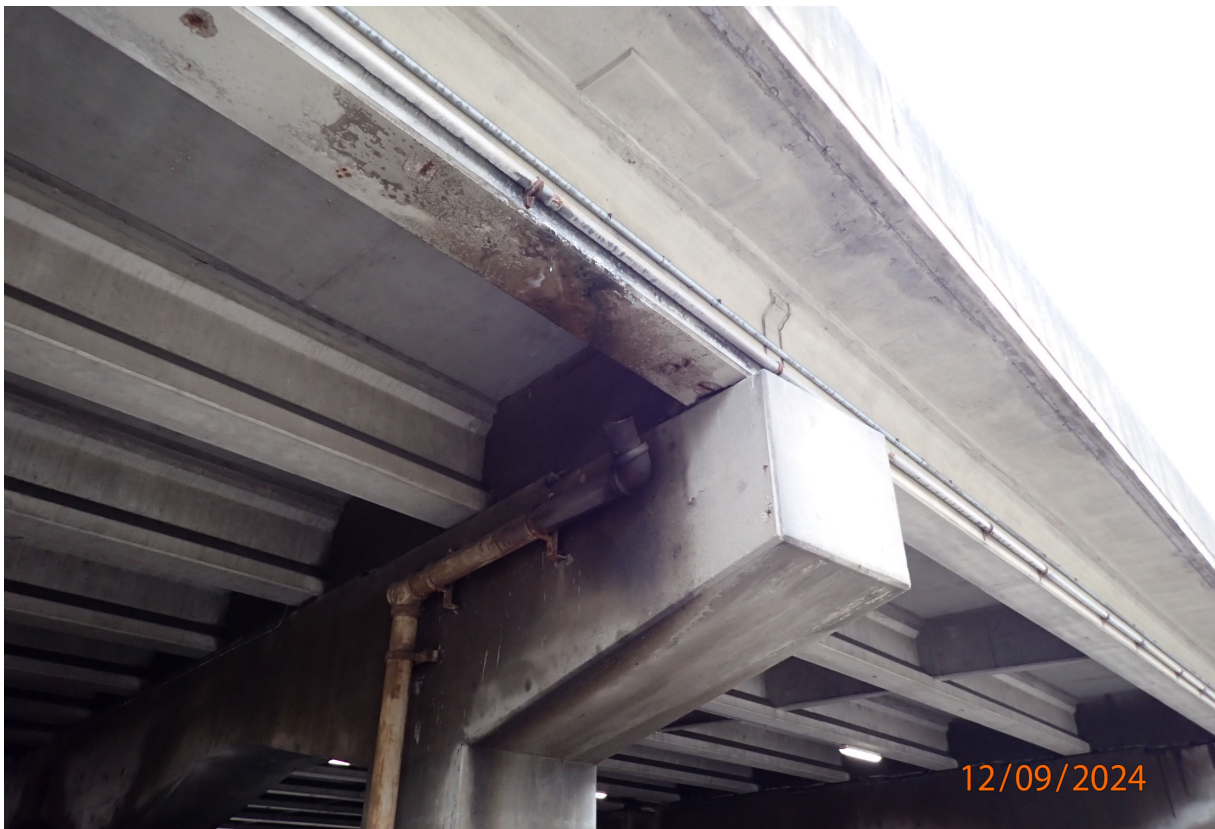
Drainage system is not functioning as intended. Deck drains and scuppers are disconnected at most locations, allowing water to drain onto elements below.

Deck drains and scuppers are disconnected at most locations, allowing water to drain onto elements below (southeast corner of P4 shown).

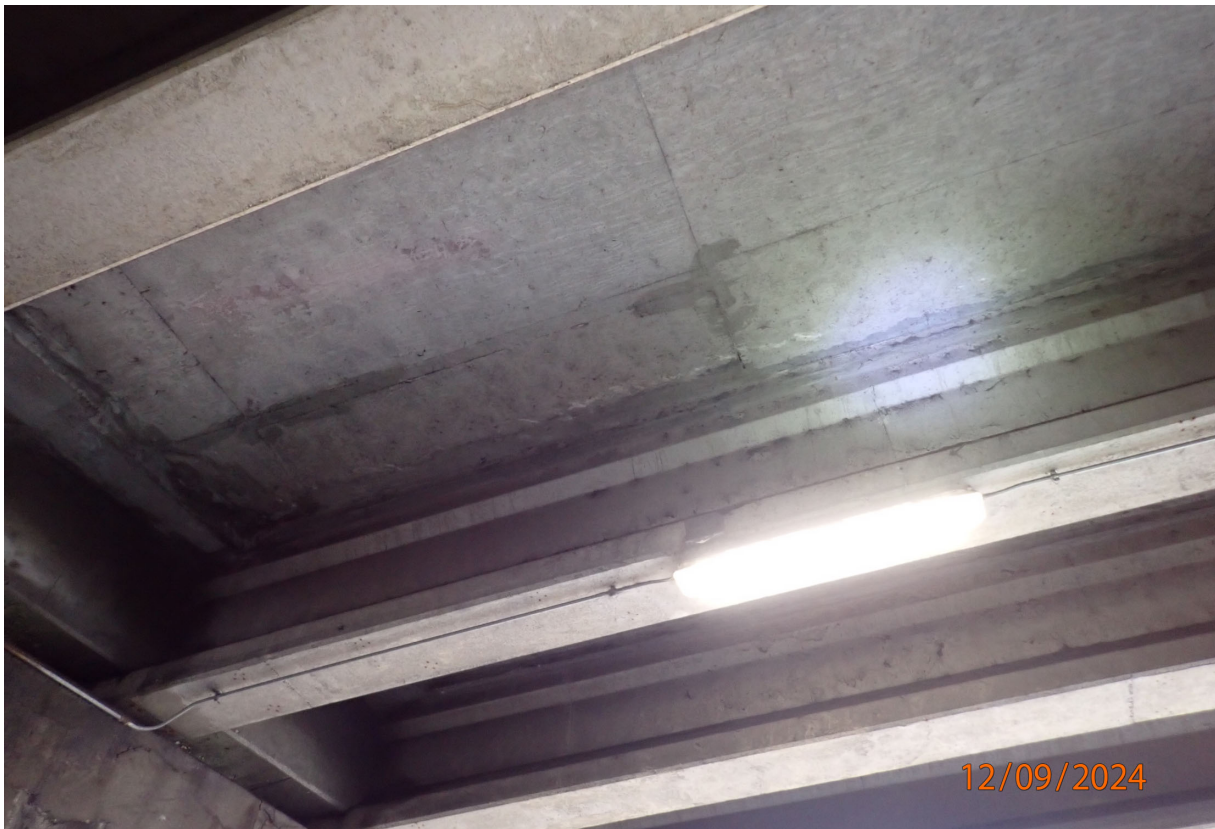
S4-Bay 3 soffit has 14 feet of longitudinal cracking with light efflorescence.

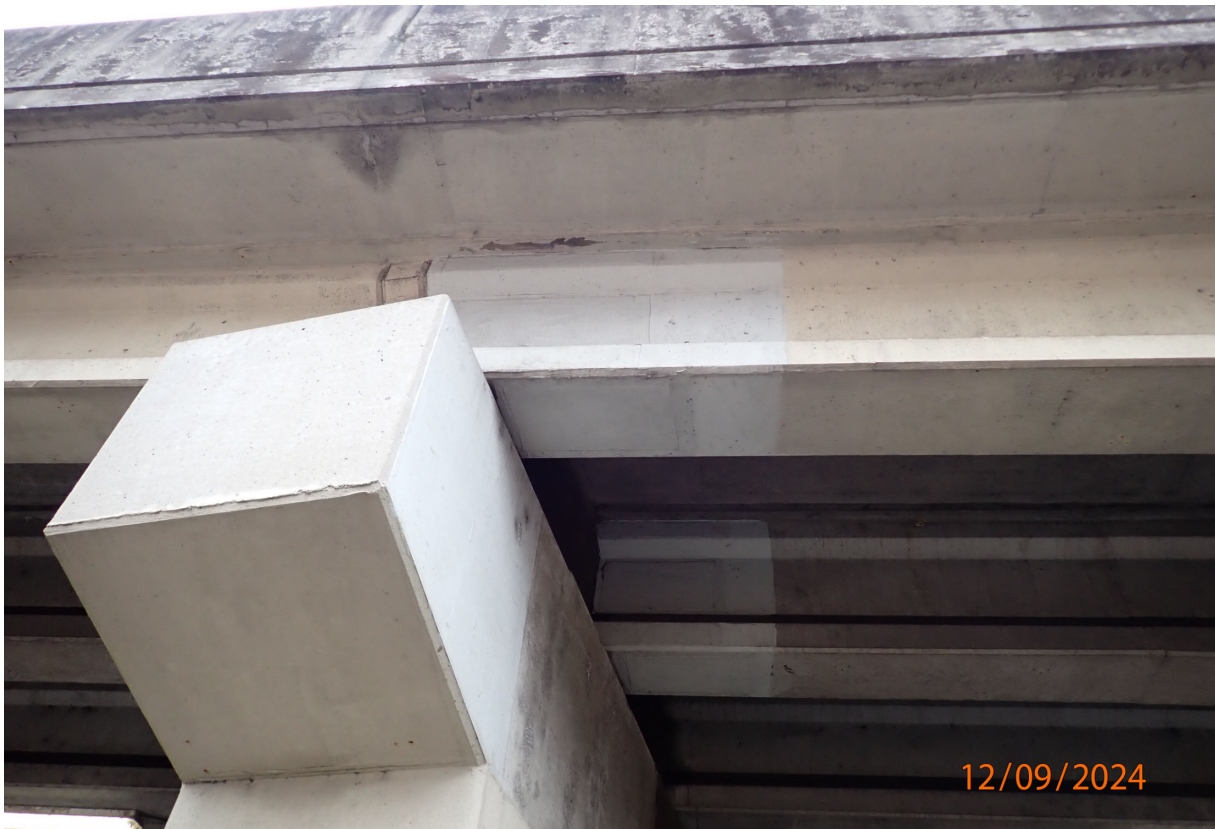
Some beam ends have CFRP patches (S4-B1 and B2 at P4 shown).

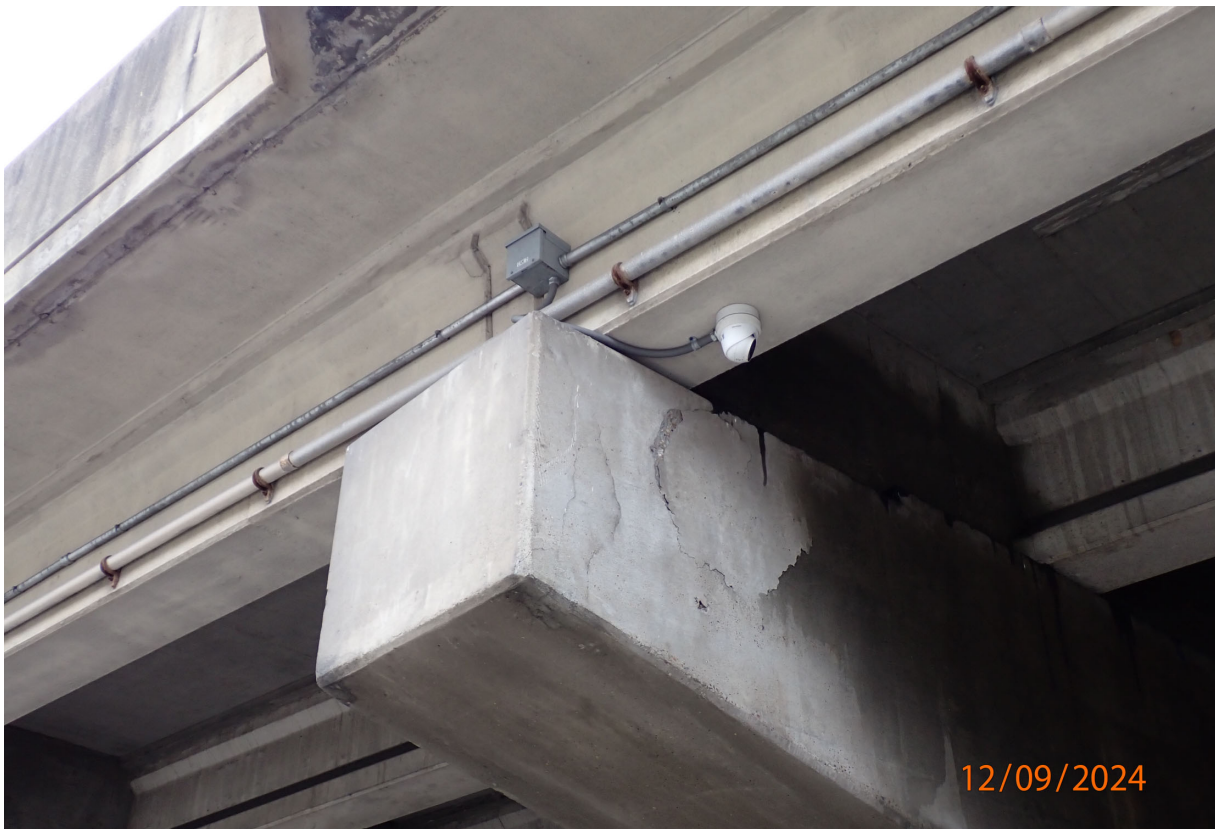
Pier caps have moderate to wide cracking, delaminated areas, and spalling with exposed rebar (north face of P5 shown).

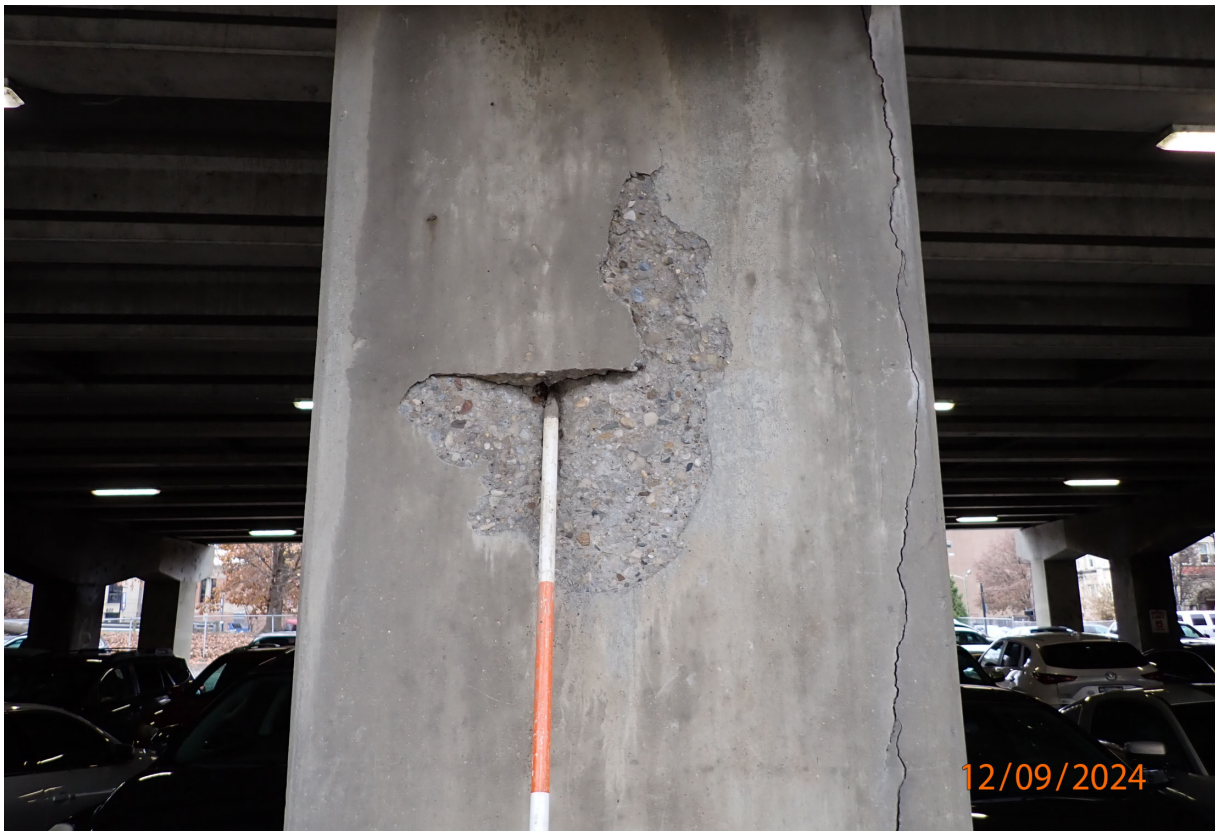
P5-C5 has a 2 SF spall and wide vertical cracking.

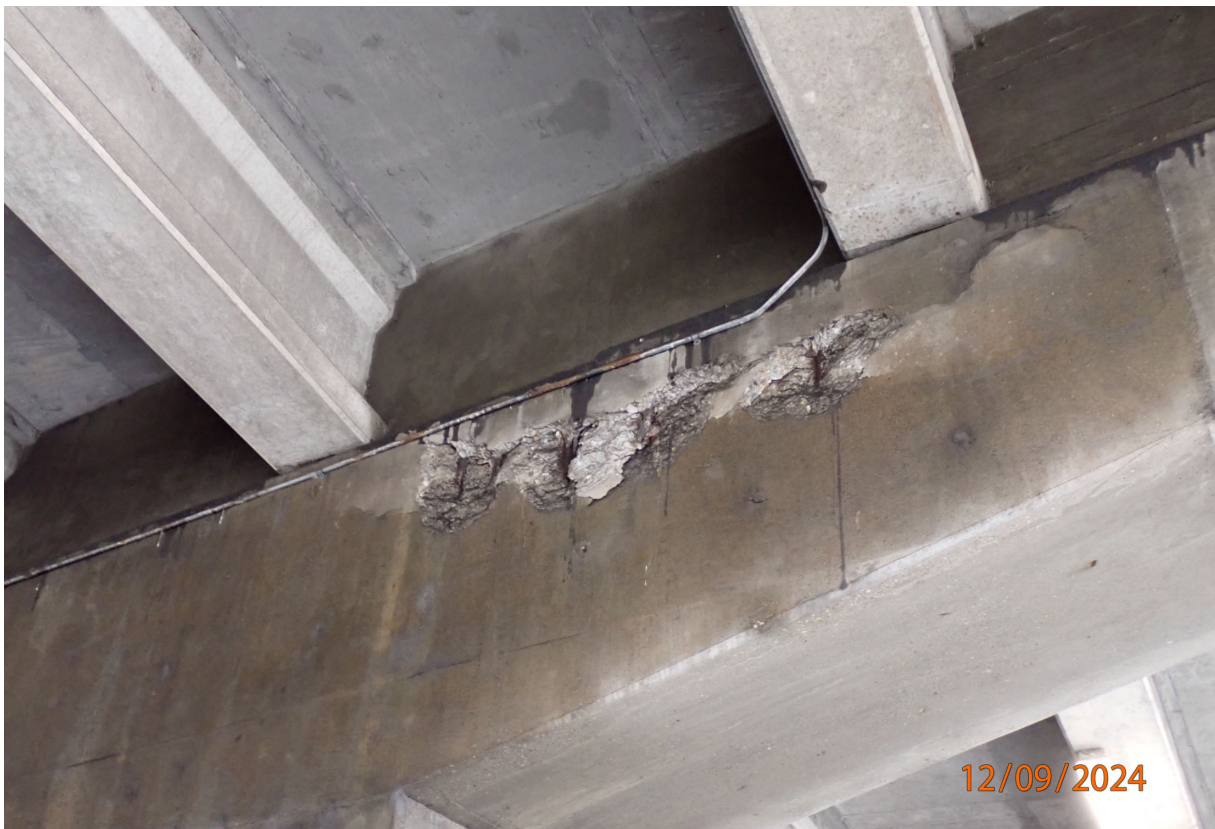
Pier caps have moderate to wide cracking, delaminated areas, and spalling with exposed rebar (north face of P6 between B3 and B4 shown).

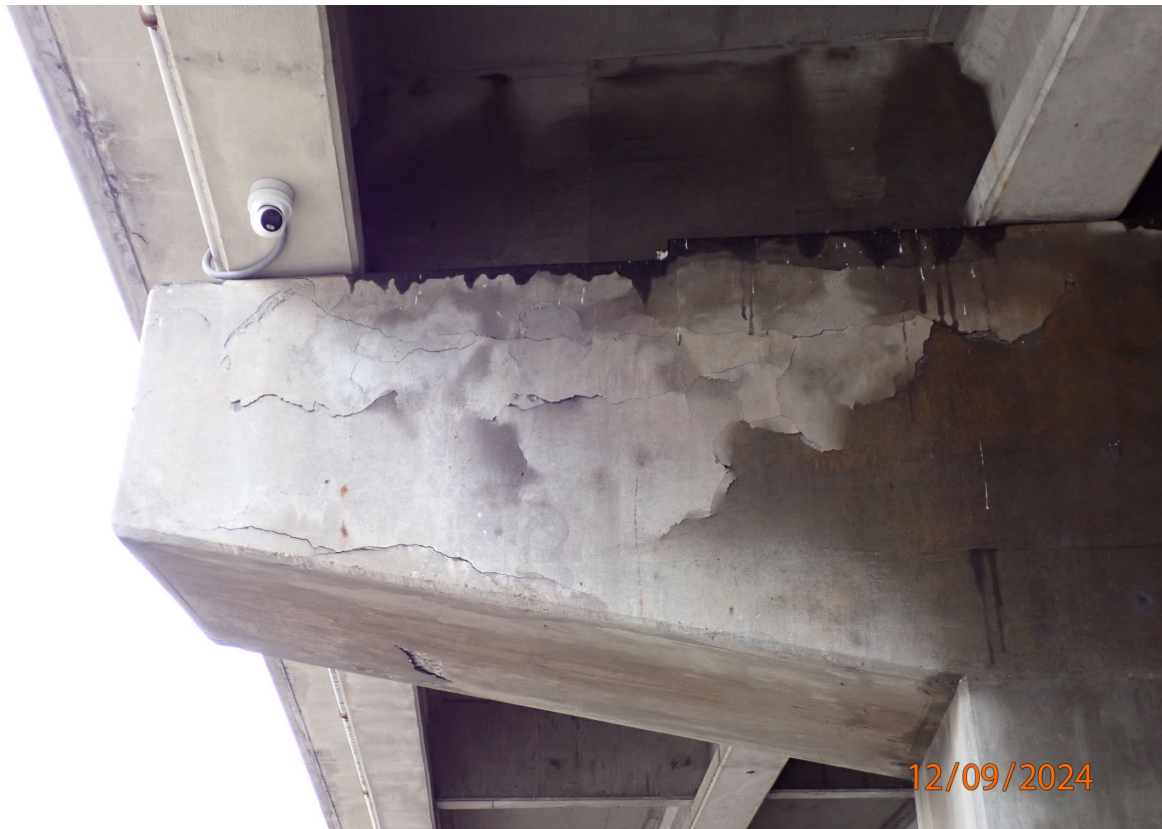
Large delaminated area with map cracking on the north face of P6 at the east end

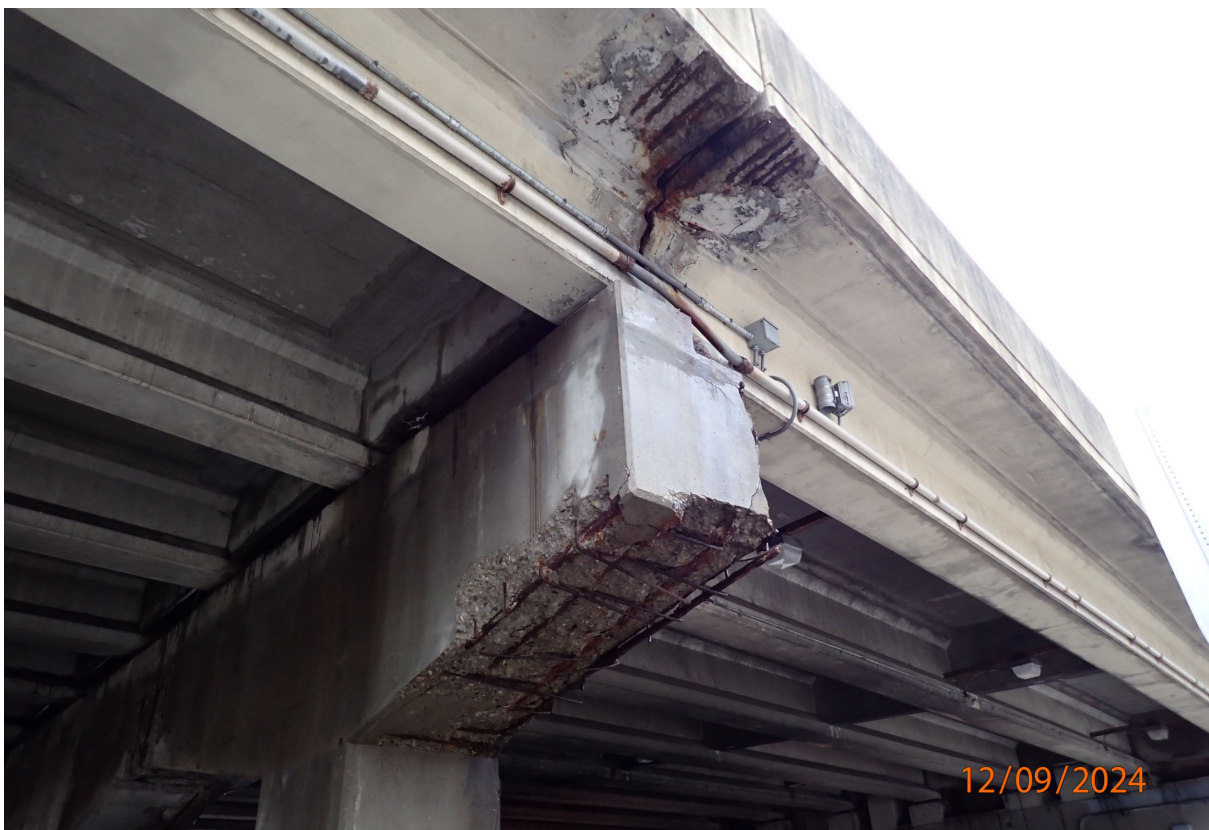
P3 and P7 caps have spalling up to 4 inches deep with fully exposed rebar in the bottom face at the east end (P7 shown). Note typical overhang spall at joint.

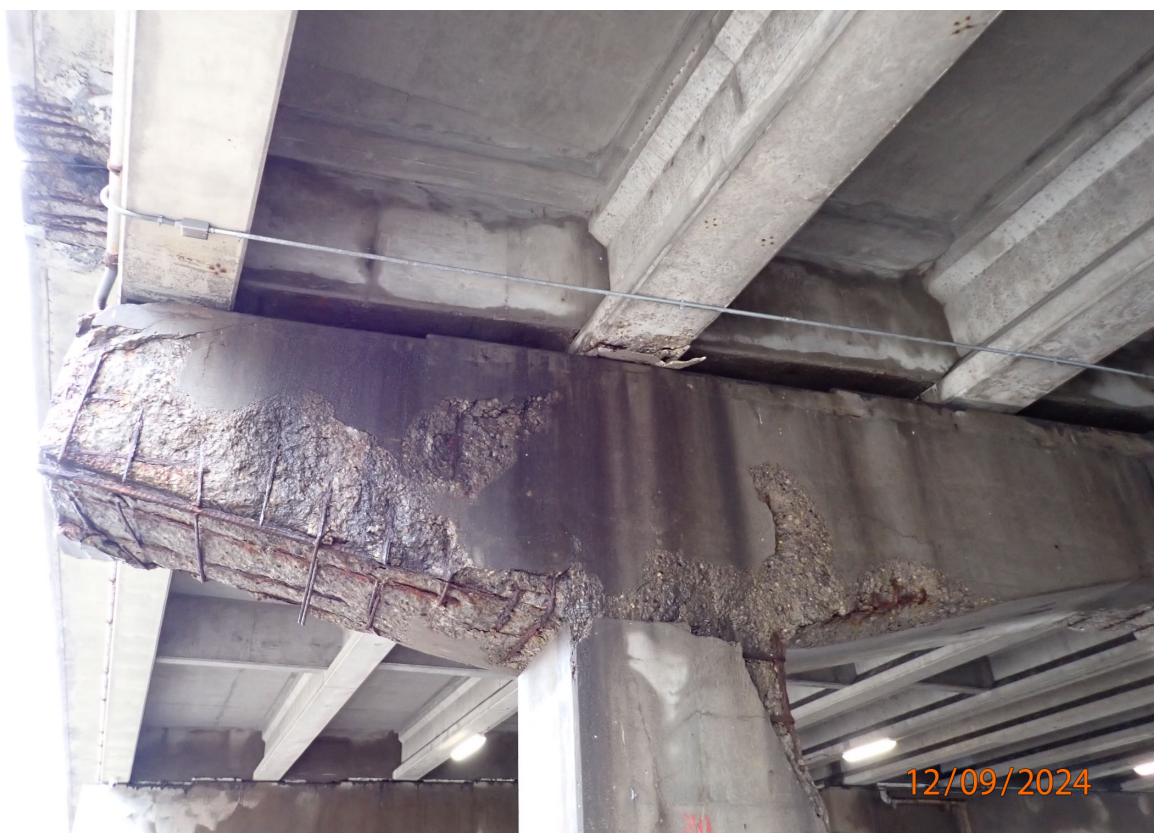
Deterioration is widespread on P3 and P7 (east end shown) below the joints. Note spall in B13 bottom flange.

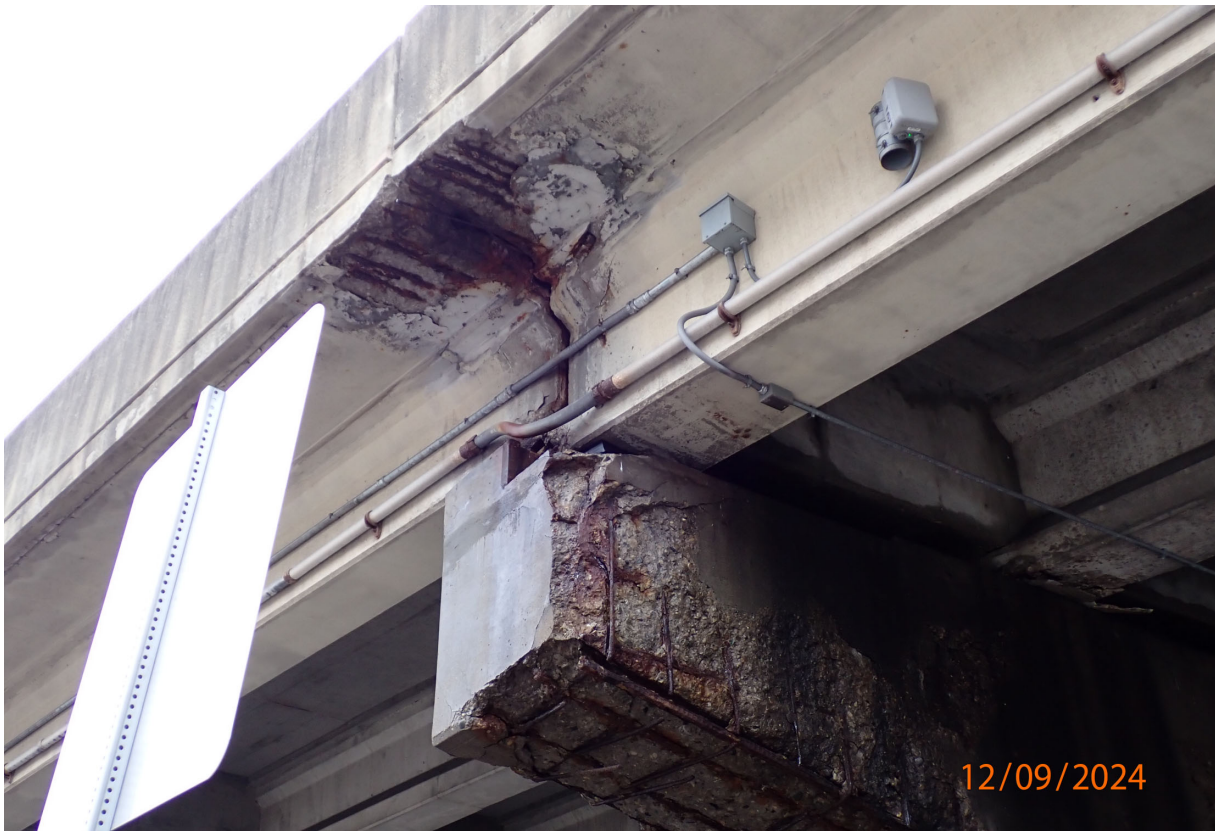
No deficiencies noted, although bearings are difficult to inspect from the ground. Pier 7 cap spalling is encroaching on the Span 8-Beam 14 bearing area.

P7 cap spalling is encroaching on S8-B14 bearing area. B14 has a spall with one exposed strand.

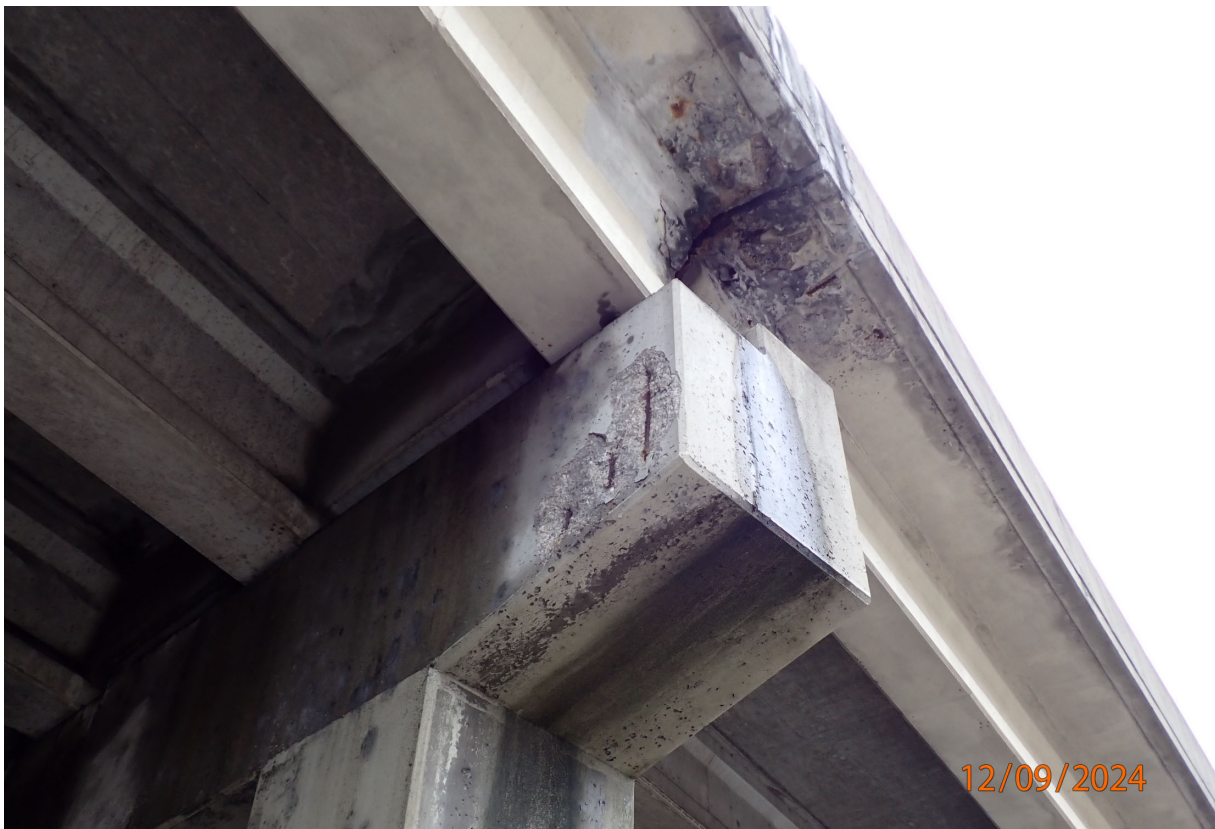
Delamination in S8-B1 top flange, and staining on overhang and pier

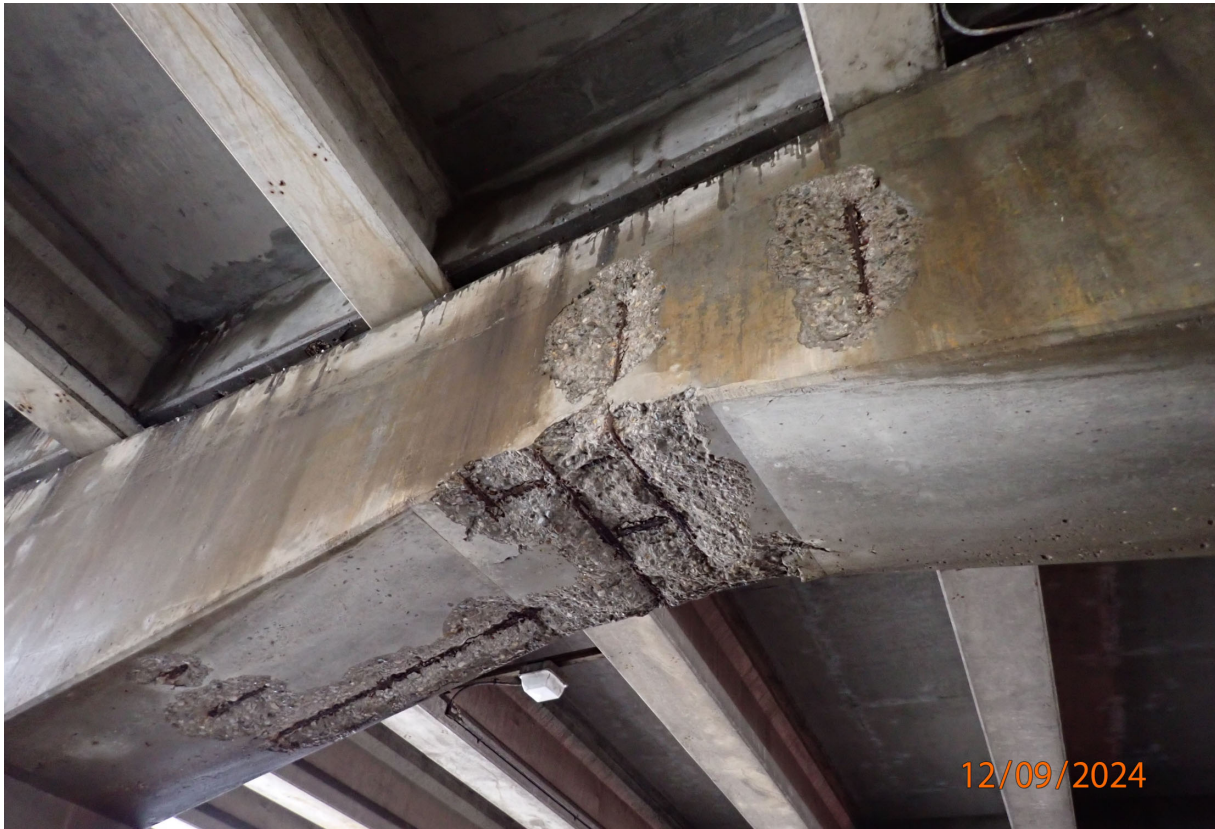
Deterioration is widespread on P3 and P7 (between C1 and C2 shown) below the joints.

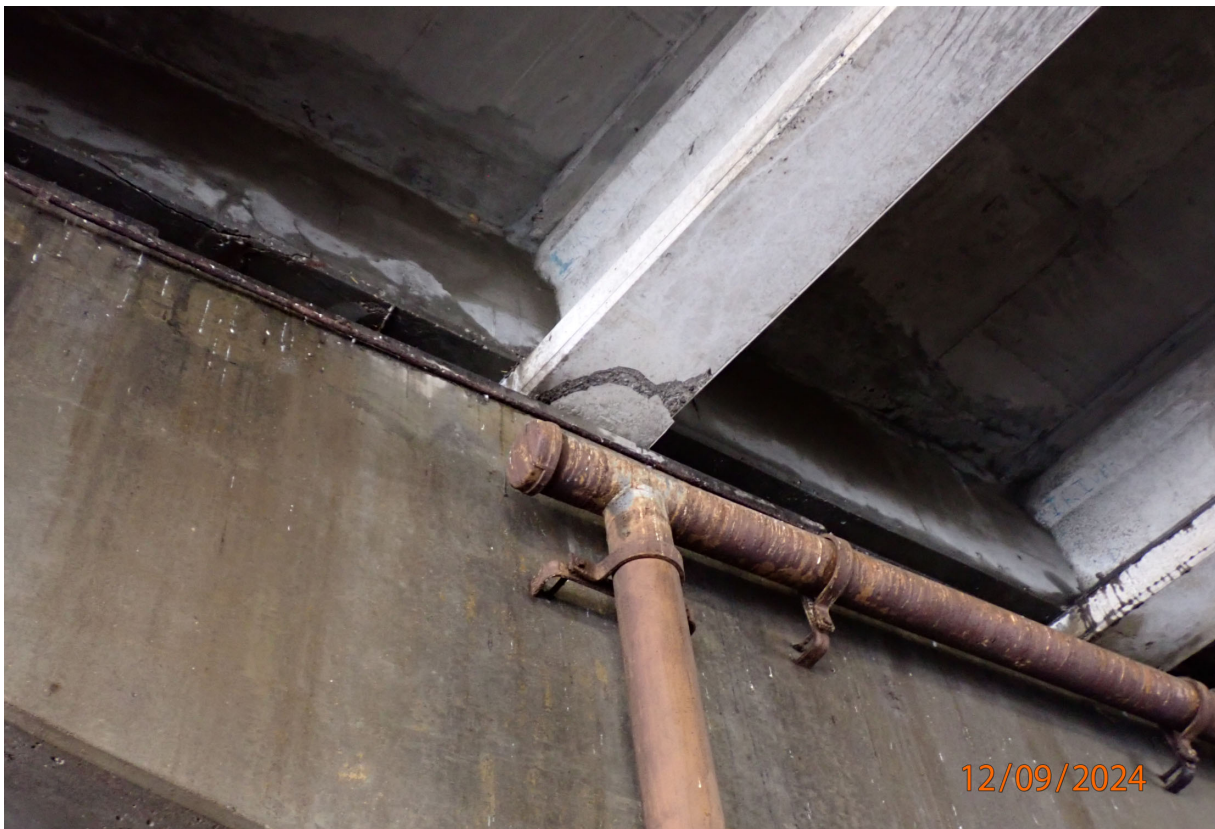
S7-B7 at P7 has a spall with three exposed prestressed strands (difficult to see due to spalled concrete sitting on cap).

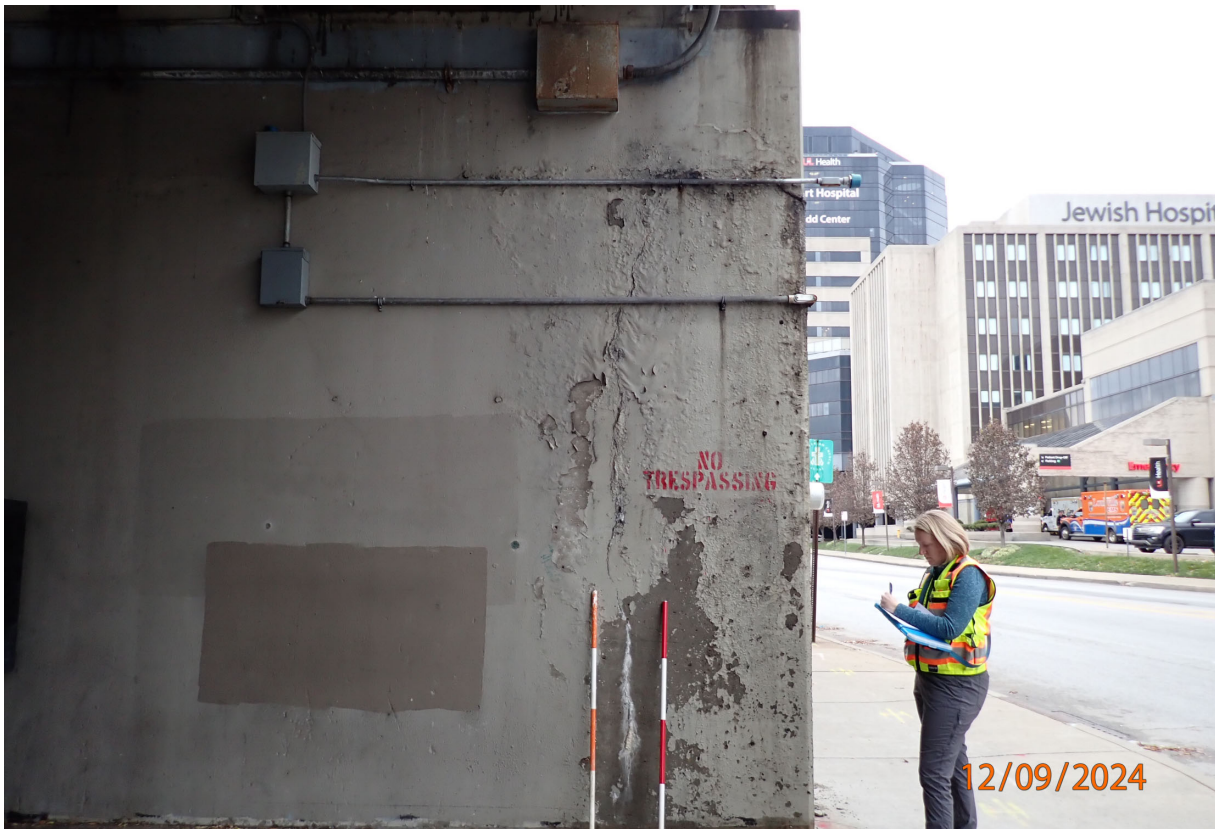
North abutment has a few full height cracks and small spalls, plus diagonal cracking and staining in the backwall at each end. The northeast wingwall has heavy pattern cracking with efflorescence along the top (14' CS3).

The north abutment has full height vertical cracks, some with efflorescence.

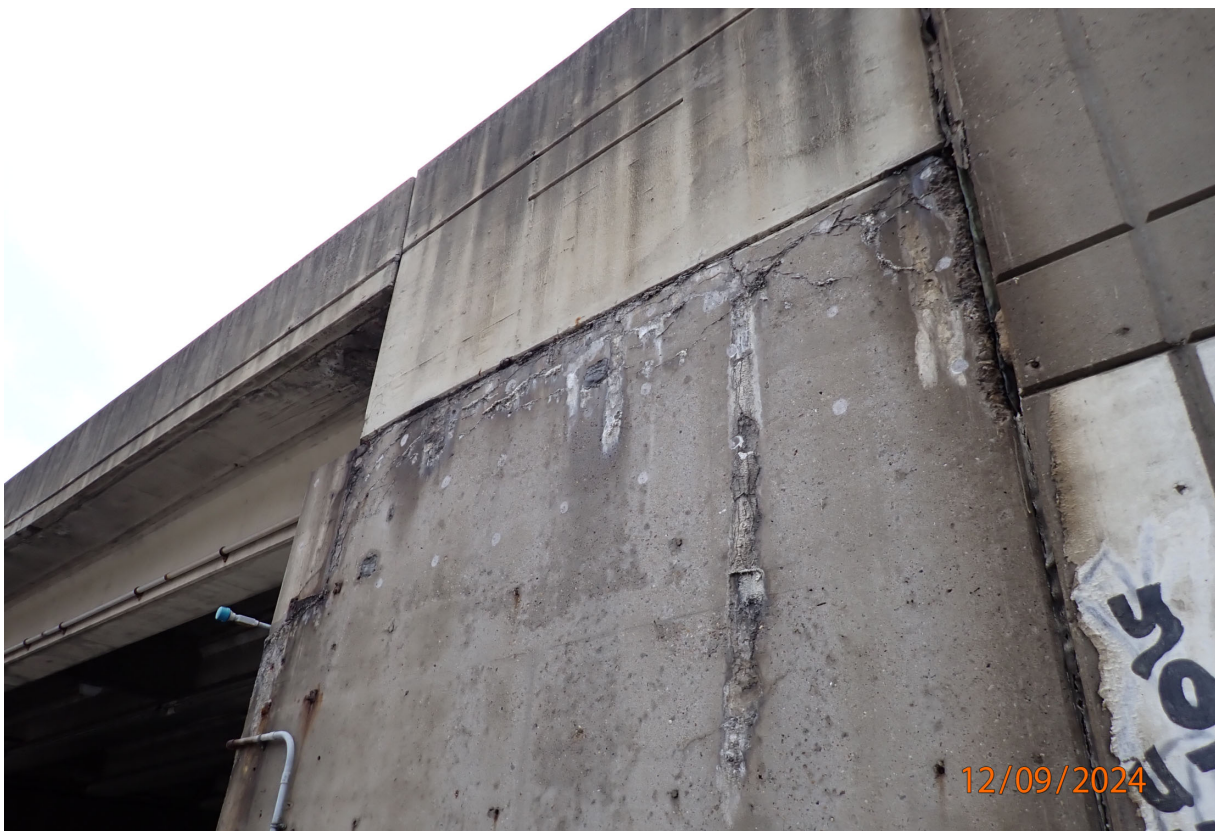
The northeast wingwall has heavy pattern cracking with efflorescence along the top for the full length, plus some spalling along the end joint.
