Bridge Inspection Report

056B00193N

07/15/2024

Special-Other

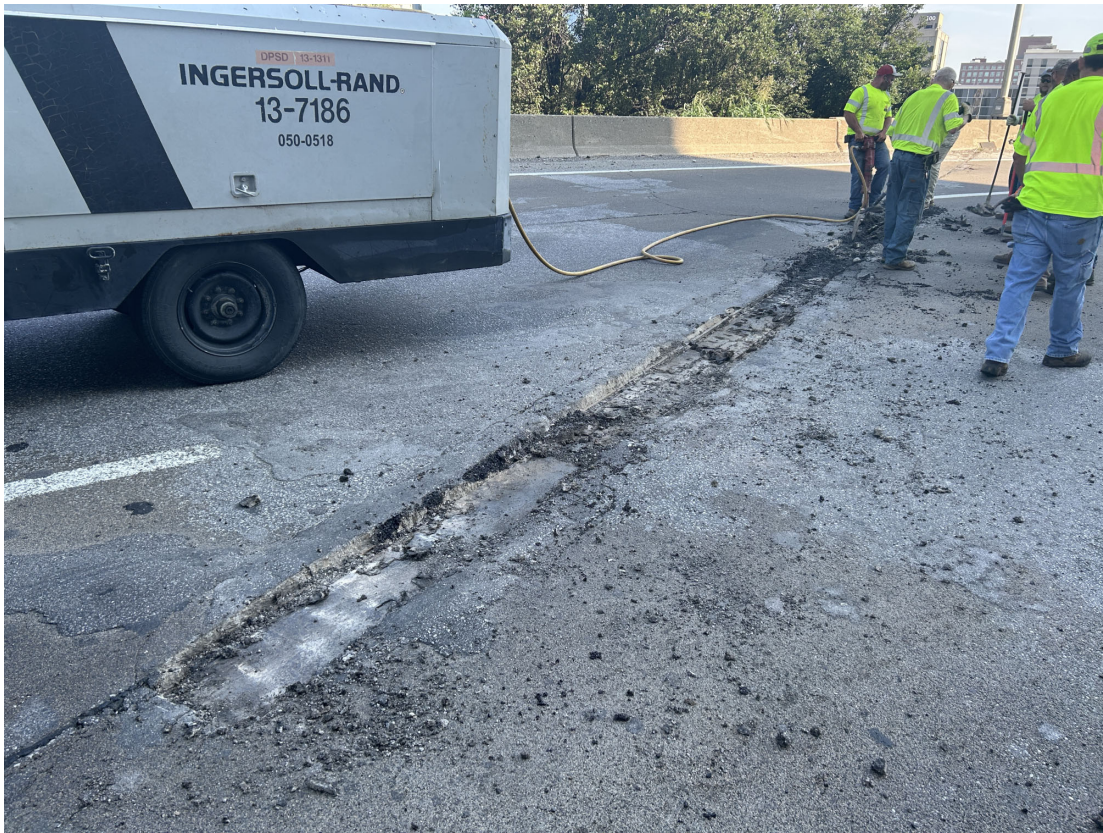
SB Lanes: Pourable Joint over Abutment 1
(drone view)

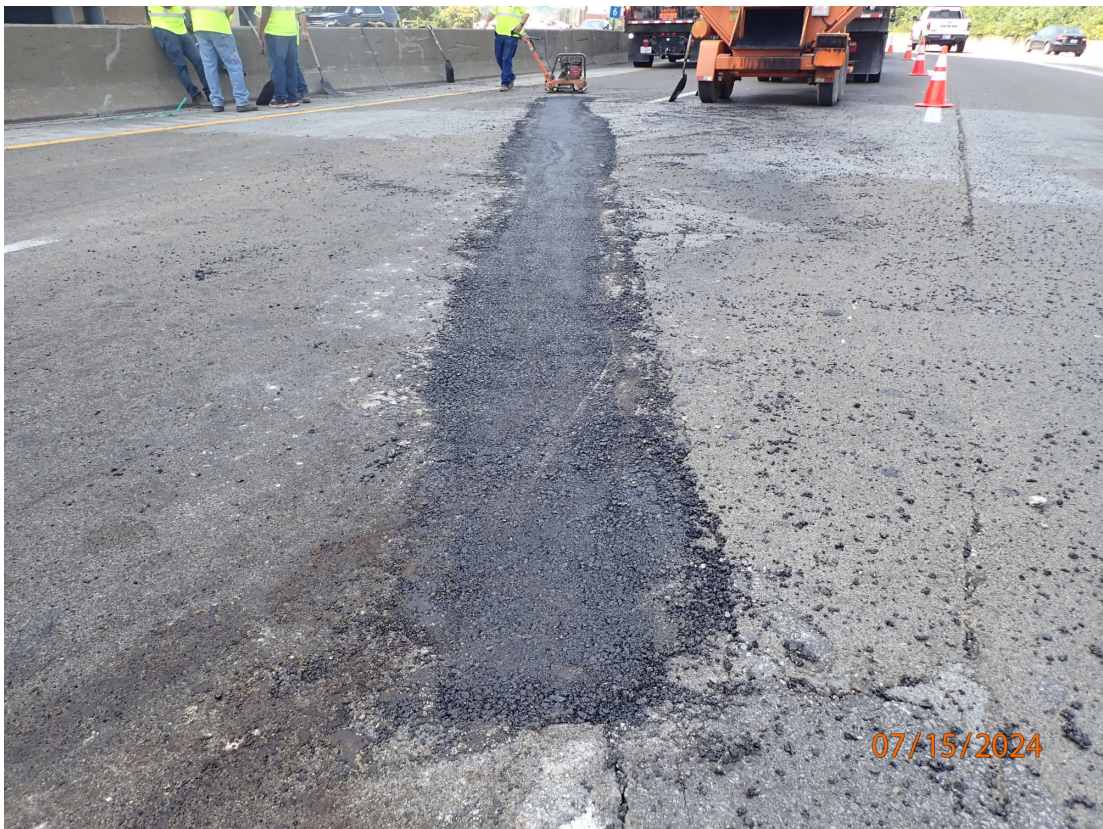
SB Lanes: Pourable Joint over Abutment 1
(before repair)

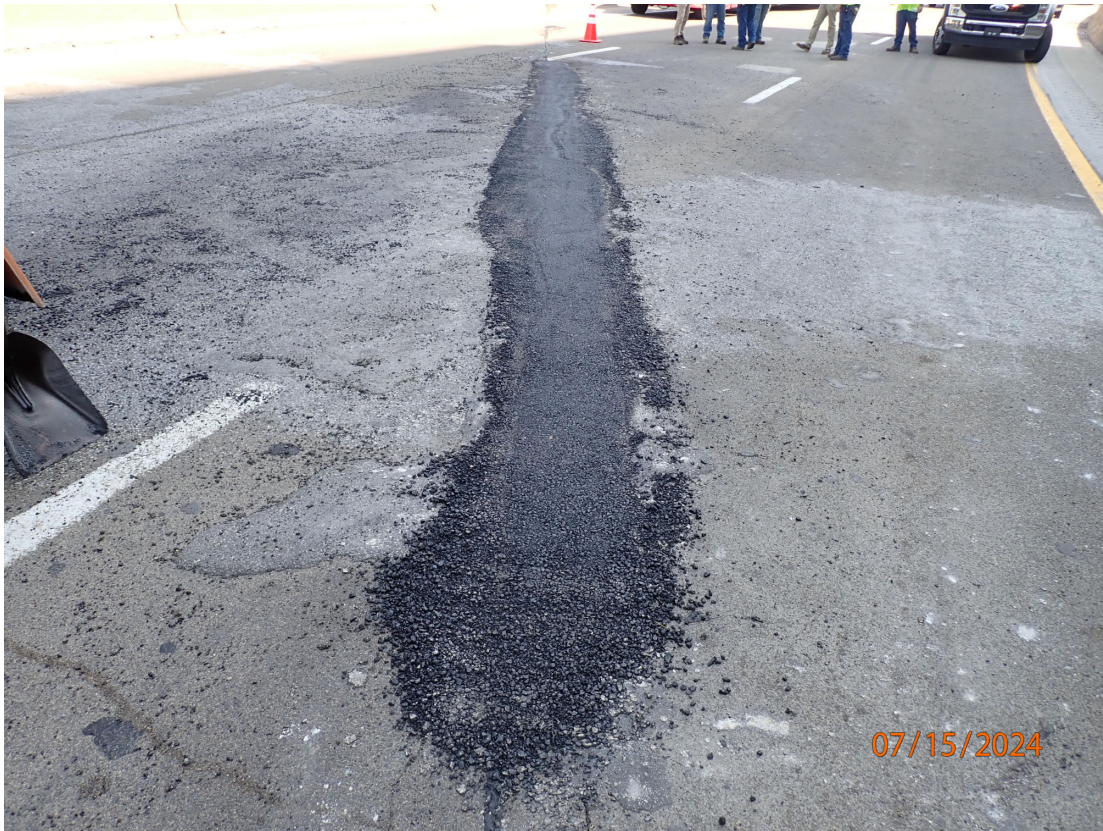
SB Lanes: Pourable Joint over Abutment 1
(after repair; looking east)

-The Bridge Crew repaired the pourable joint over Abutment 1 along the southbound center lane again on 08/23/2024. The Bridge Crew has been on site at least 13 times between 01/01/2023 and 08/23/2024 to patch the deck or repair the joints.

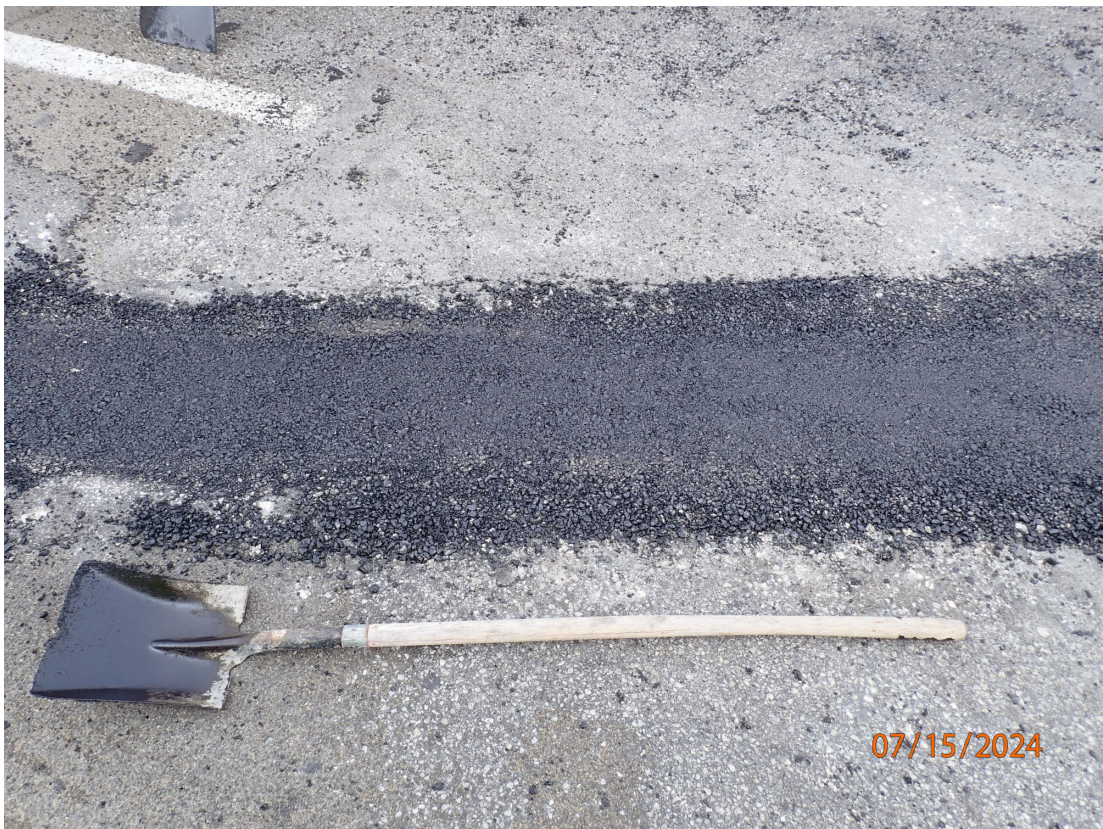
SB Lanes: Pourable Joint over Abutment 1
(after repair; looking west)

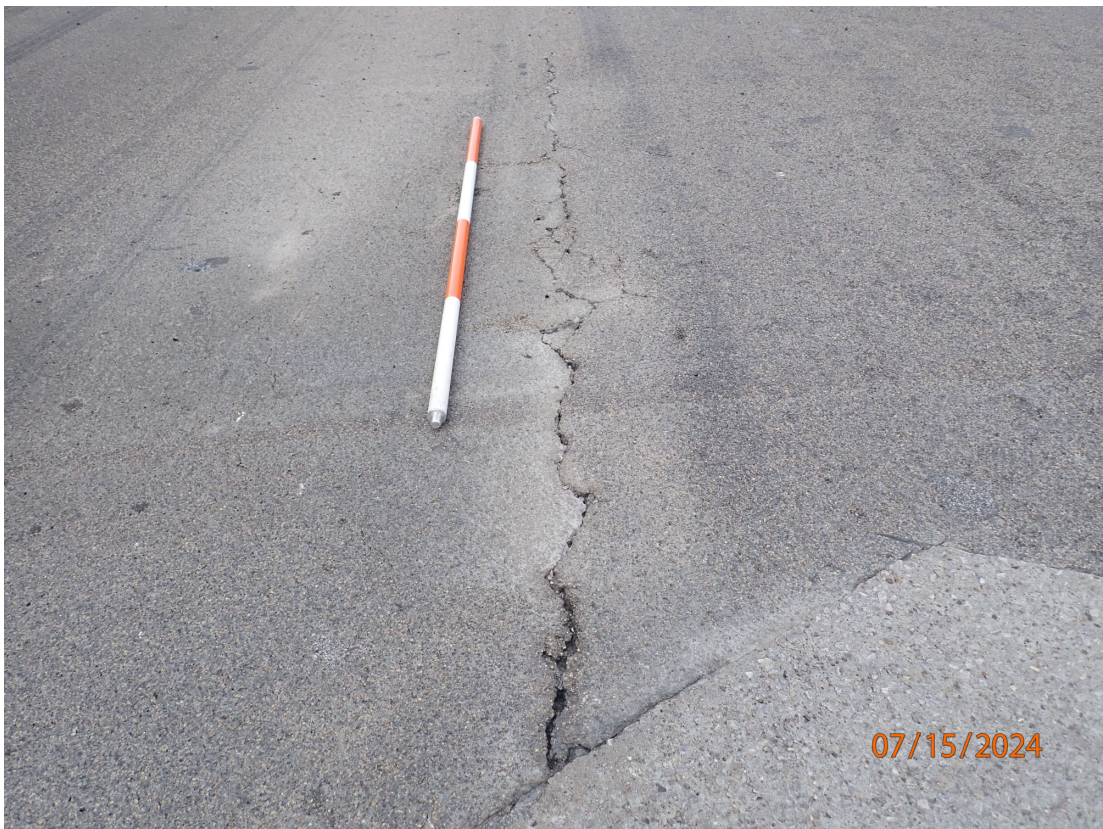
SB Lanes: Wide Crack from Concrete Patch
(typical; closer view)

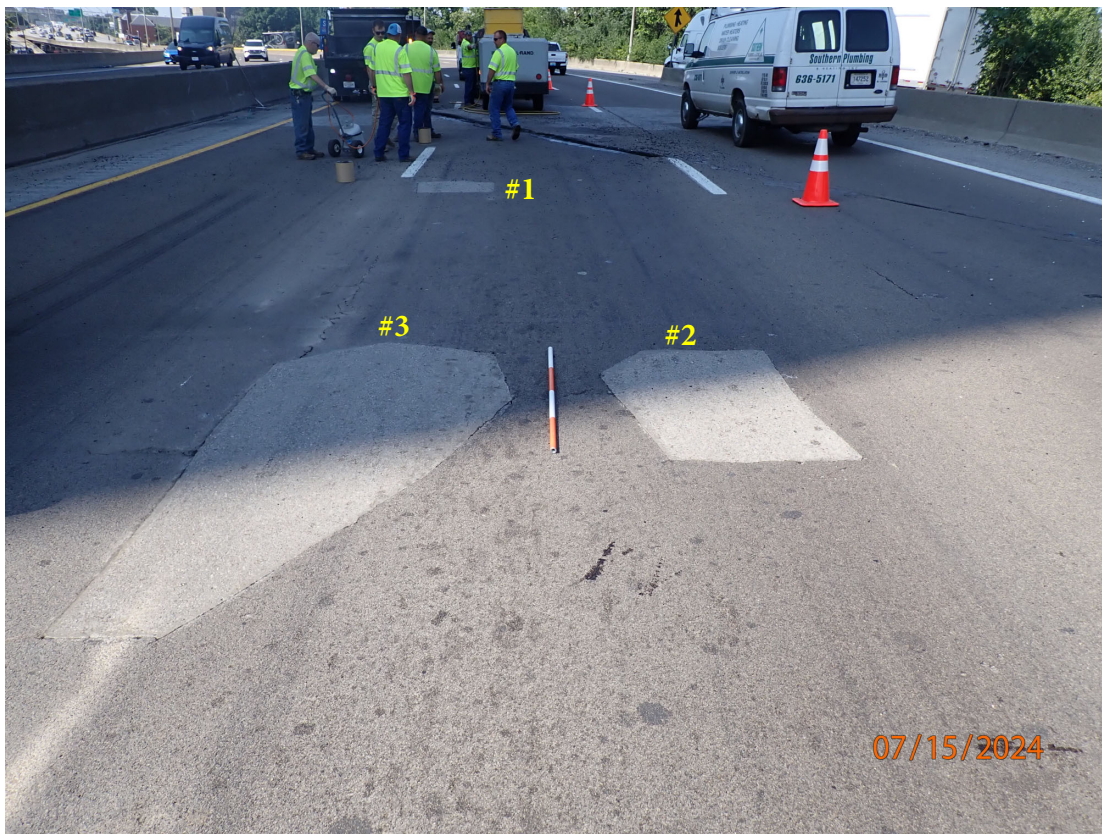
SB Lanes: Concrete Patches #1-3 in Span 1
(closer to A1 joint)

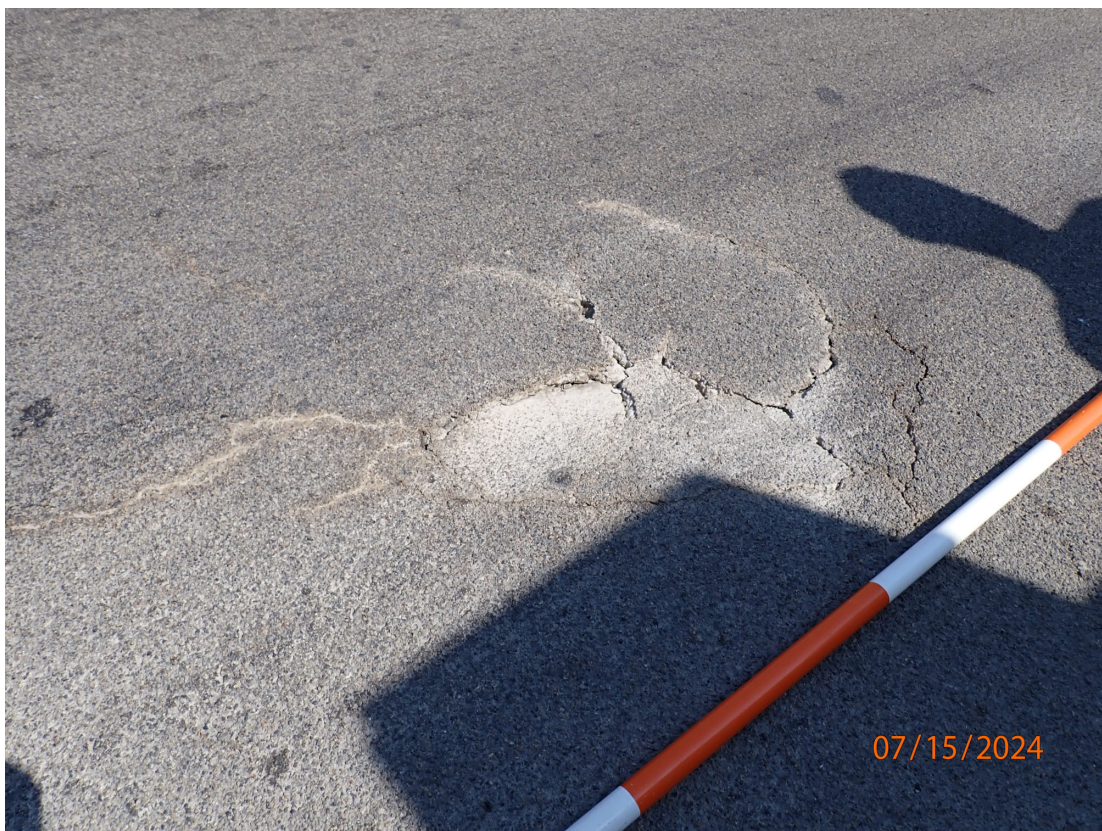
SB Lanes: Deck Spall in Span 1

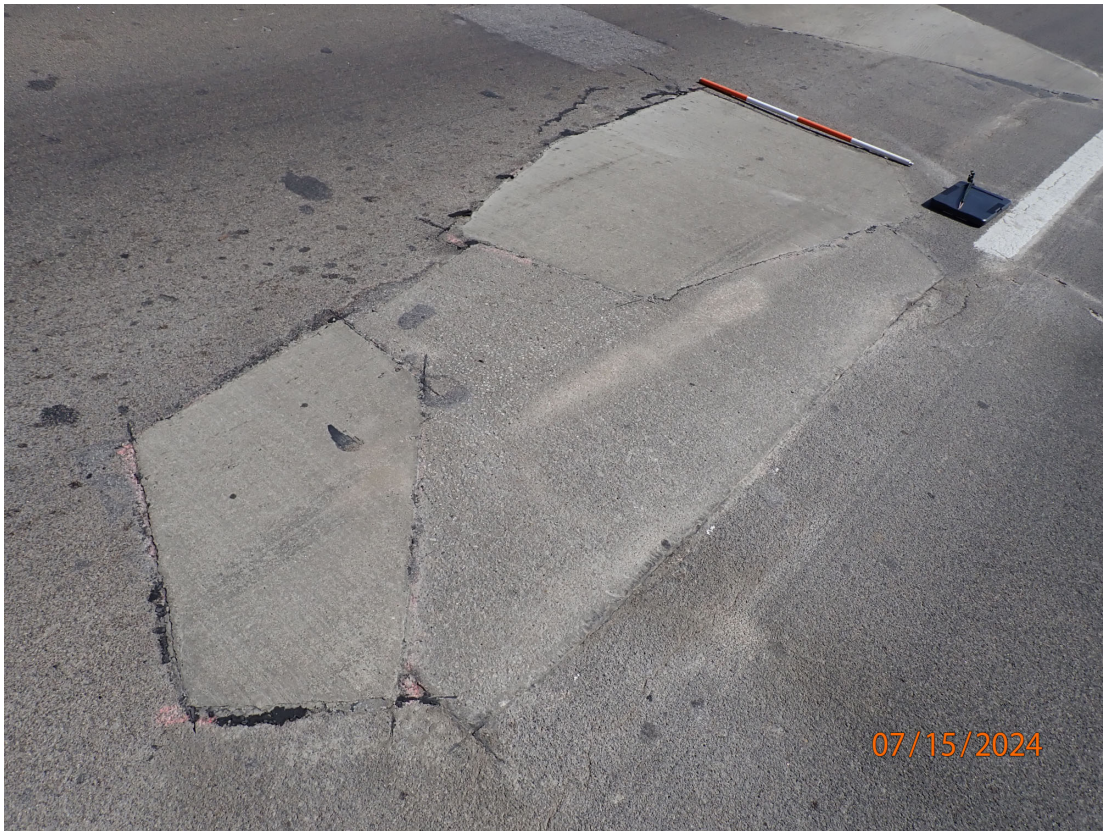
SB Lanes: Concrete Patch #4 = 12'L x 5'W = 60 SF

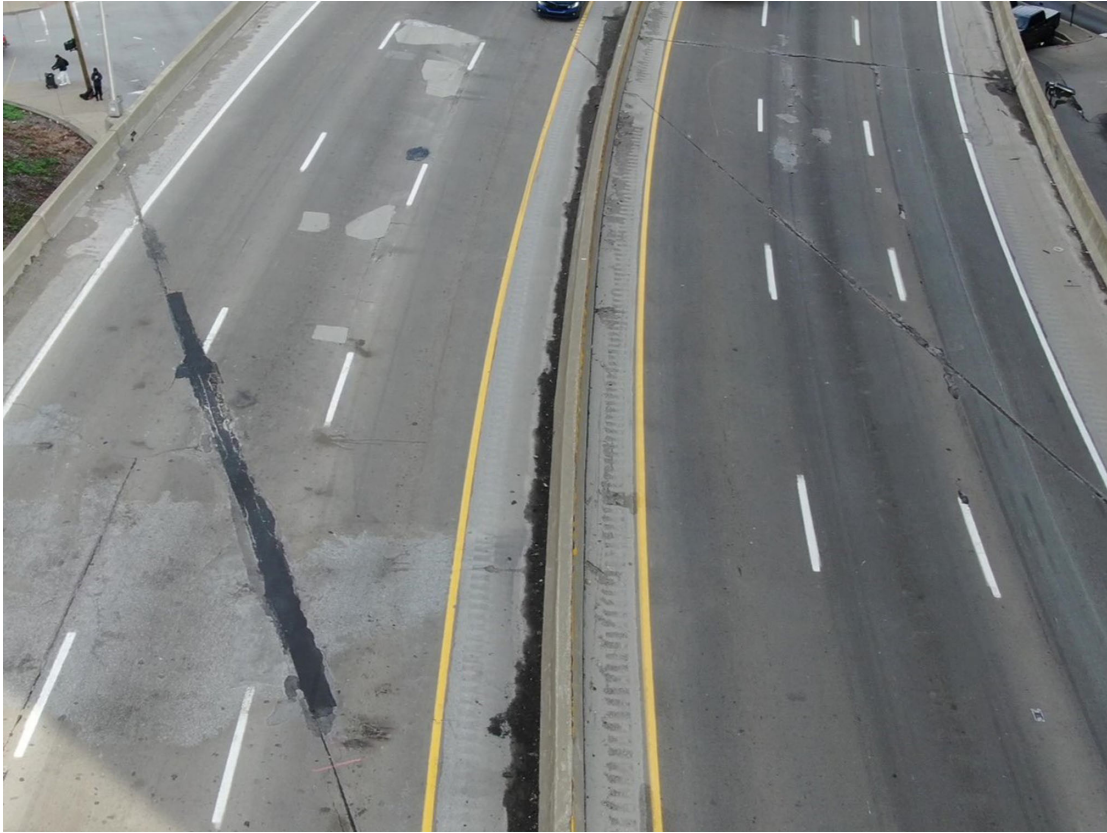
Abutment 1 SB joint plus Span 1. SB Span 1 deck and overlay has several full depth concrete patches. SB joint has been patched numerous times with asphalt and is cracking in the center lane.

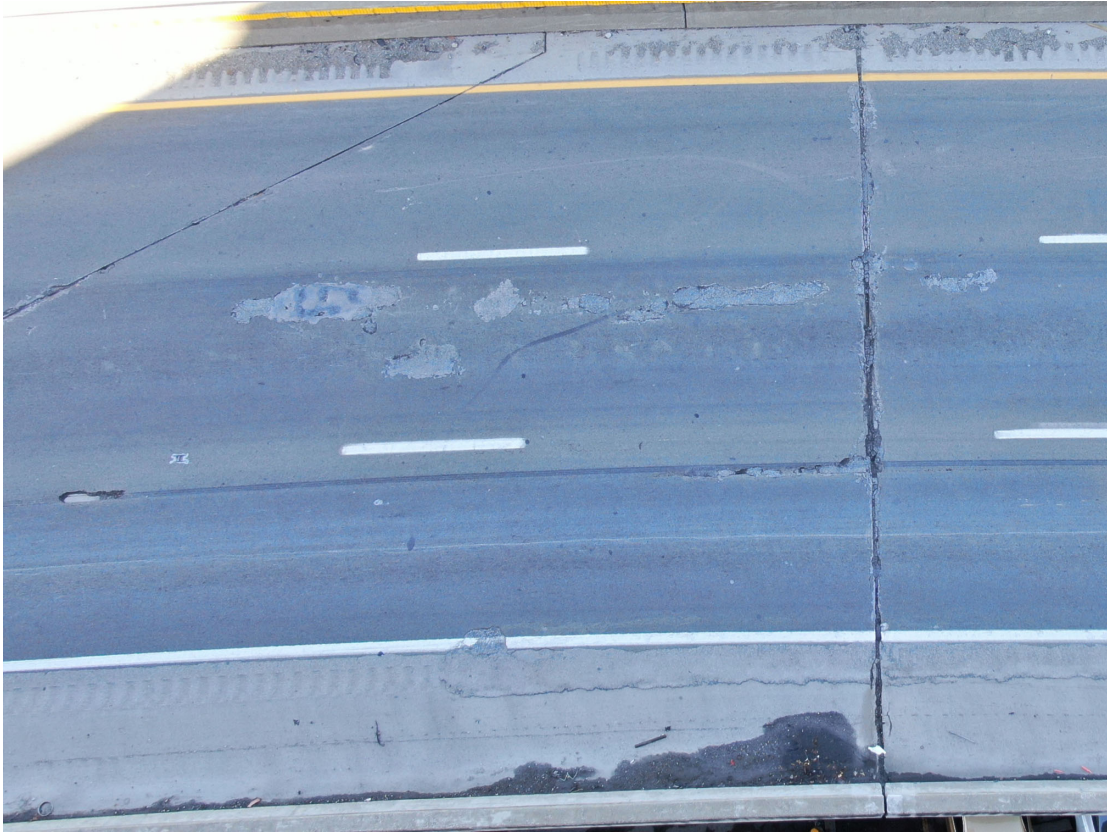
Span 2 and joint over Pier 3
Rosphalt overlay in Span 2 has several asphalt patches in the center NB lane. There is also spalling along the lane line between the center and right lanes.

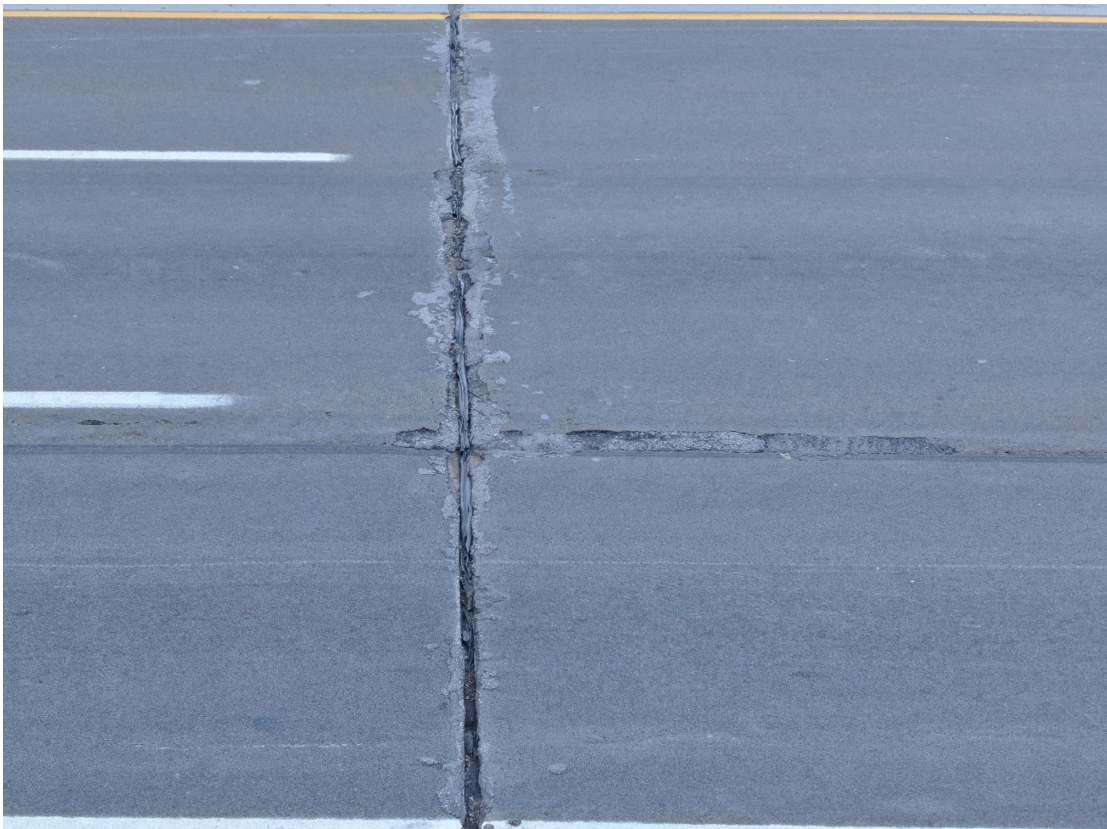
Close-up of joint over Pier 4 with original deteriorated joint seal visible.

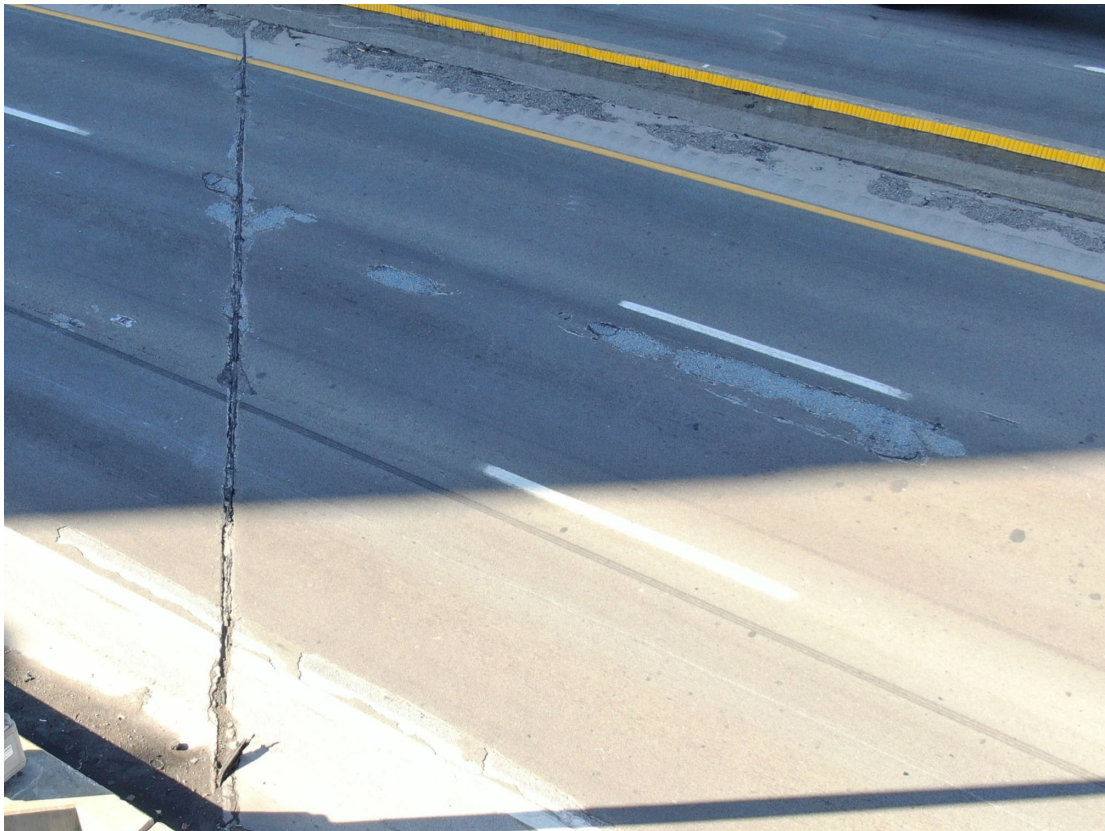
Close-up of failing joint over Pier 5 NB plus overlay patching in Span 6 NB.

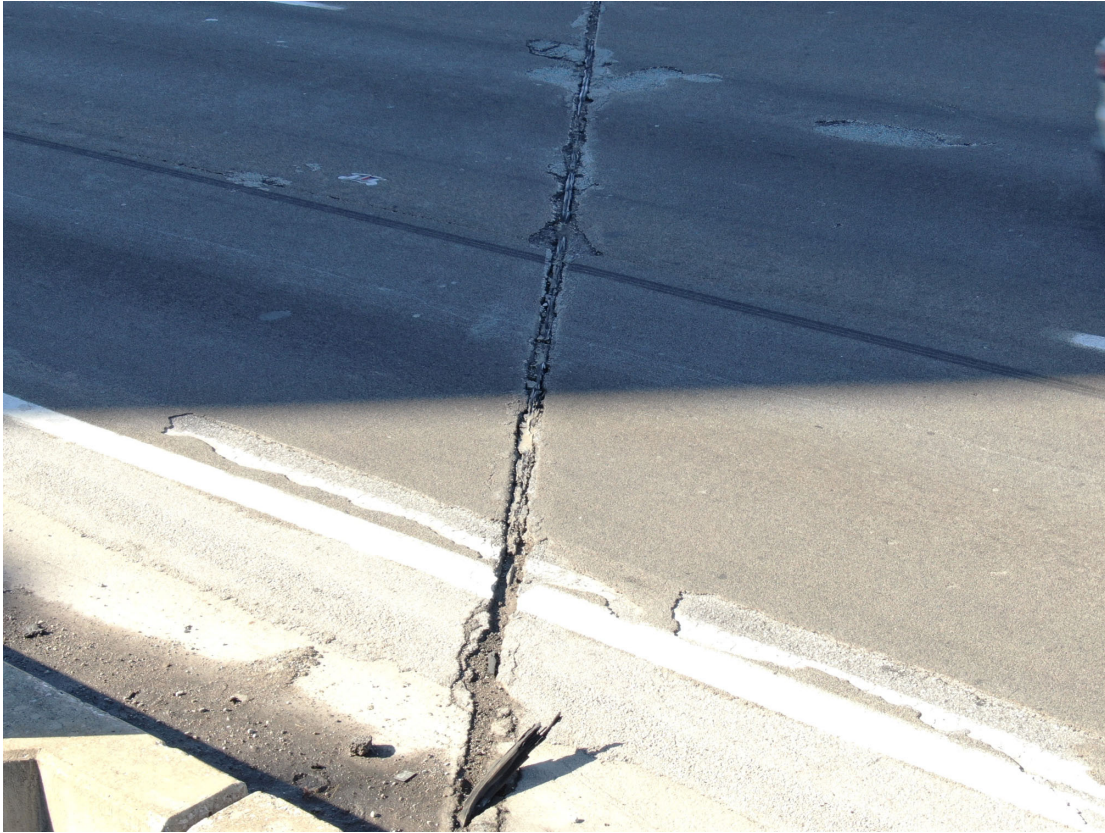
Joint over Pier 5 NB has failed and original torn joint material is exposed.

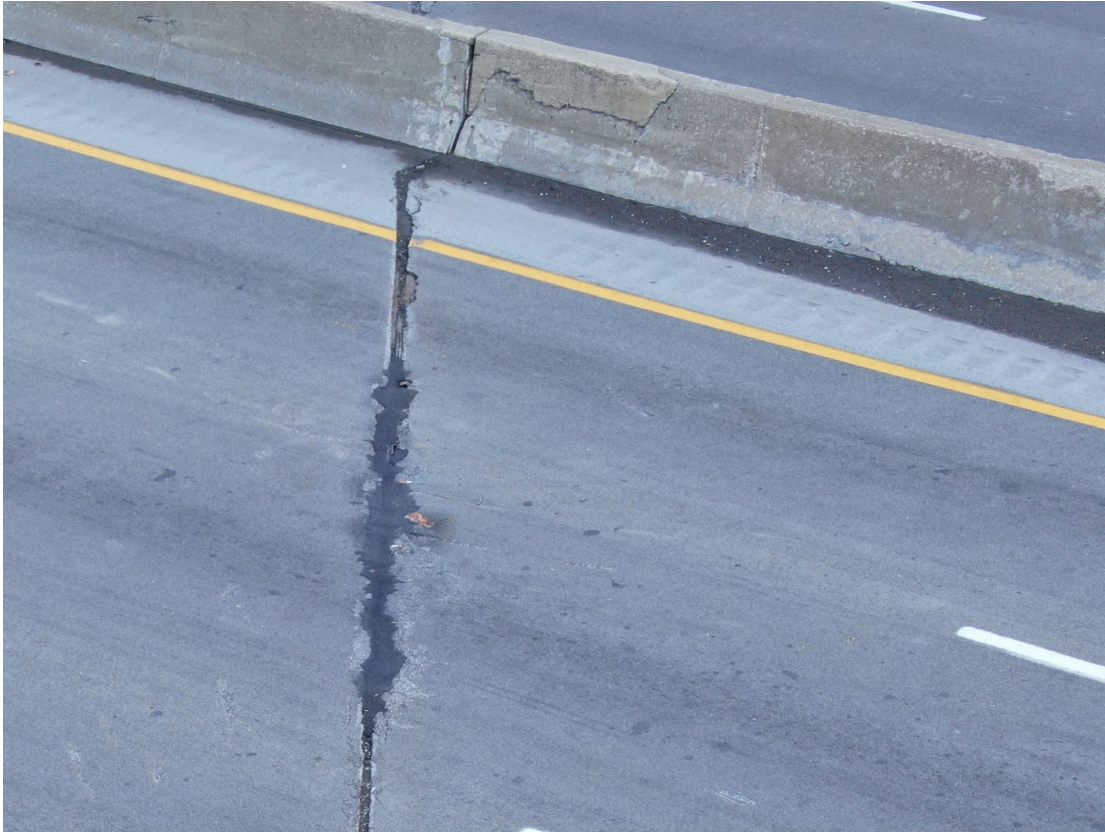
Joint over Pier 5 SB has generally failed. There is asphalt patching in the center and left lanes. Also not patch in median railing.

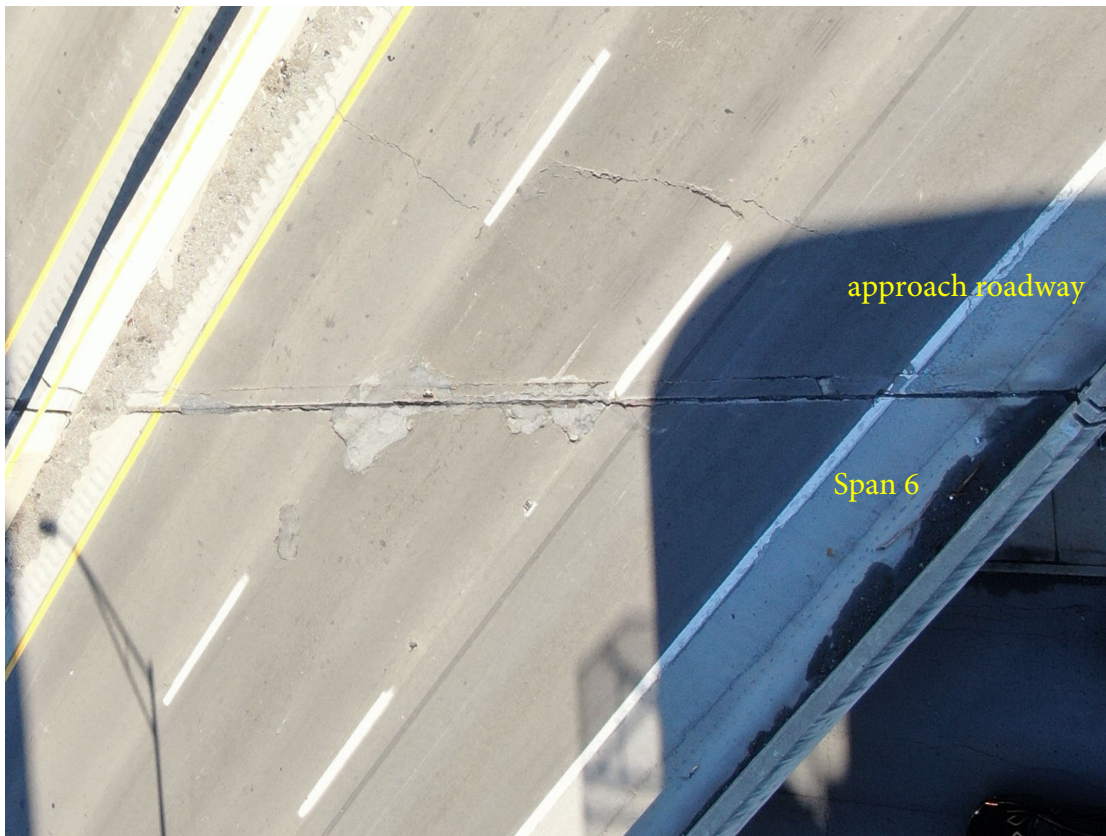
Joint over Abutment 6 NB
Note patches along the joint extending into Span 6 in the center lane.

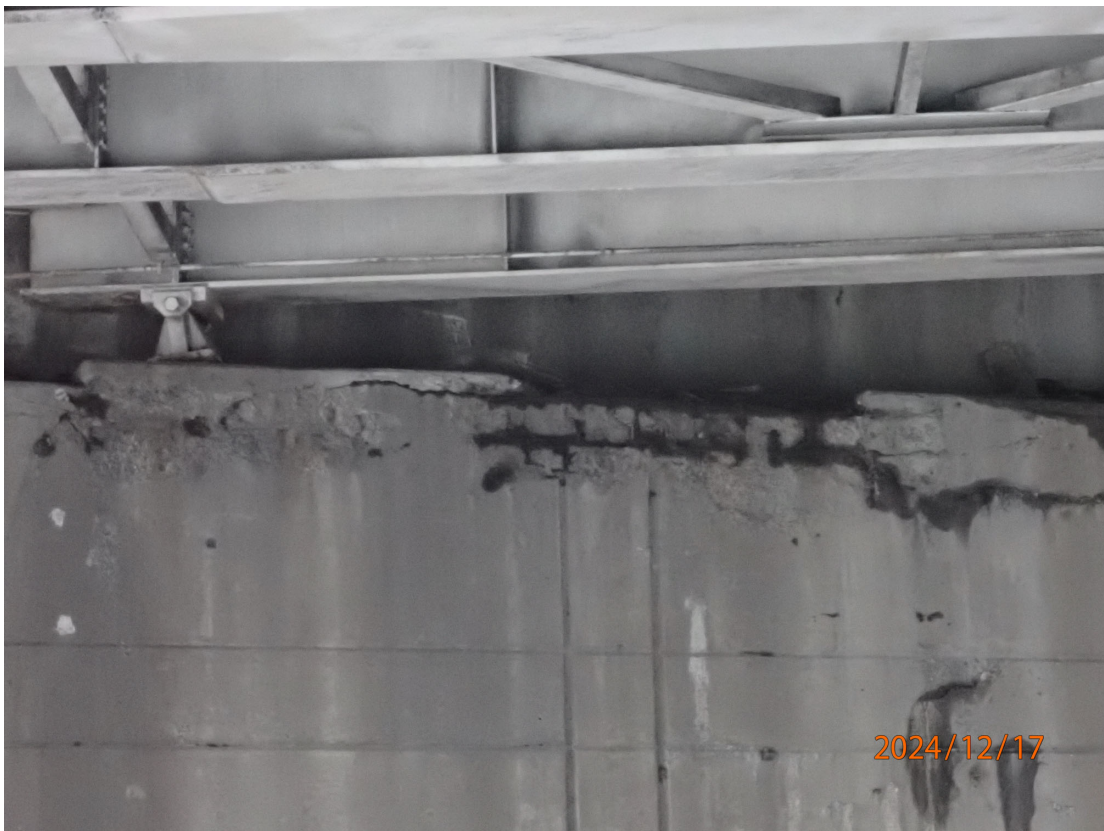
Abutment 1 has wide cracks and spalls with exposed rebar, primarily near the top along the beam seat, worst under Bays 1-3 and Bay 8. Example below Bay 2 shown.

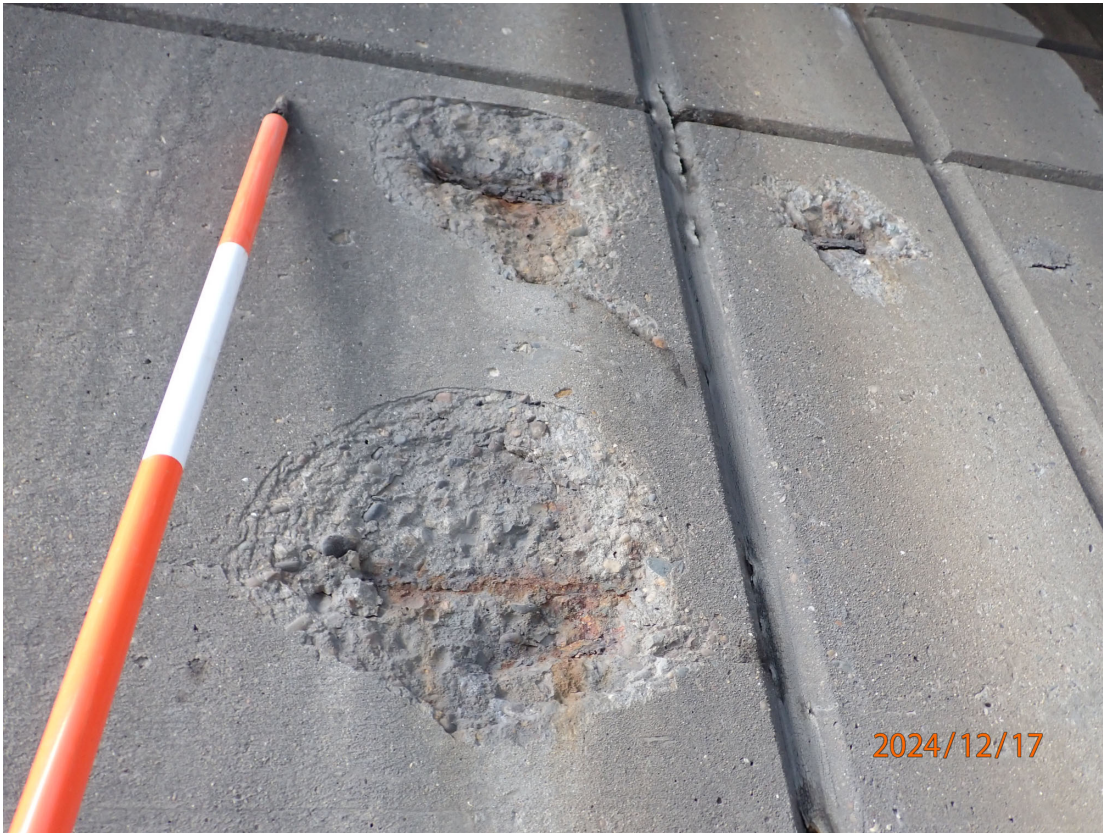
There are a few mid height 1-2 foot diameter spalls with exposed rebar near the east end.

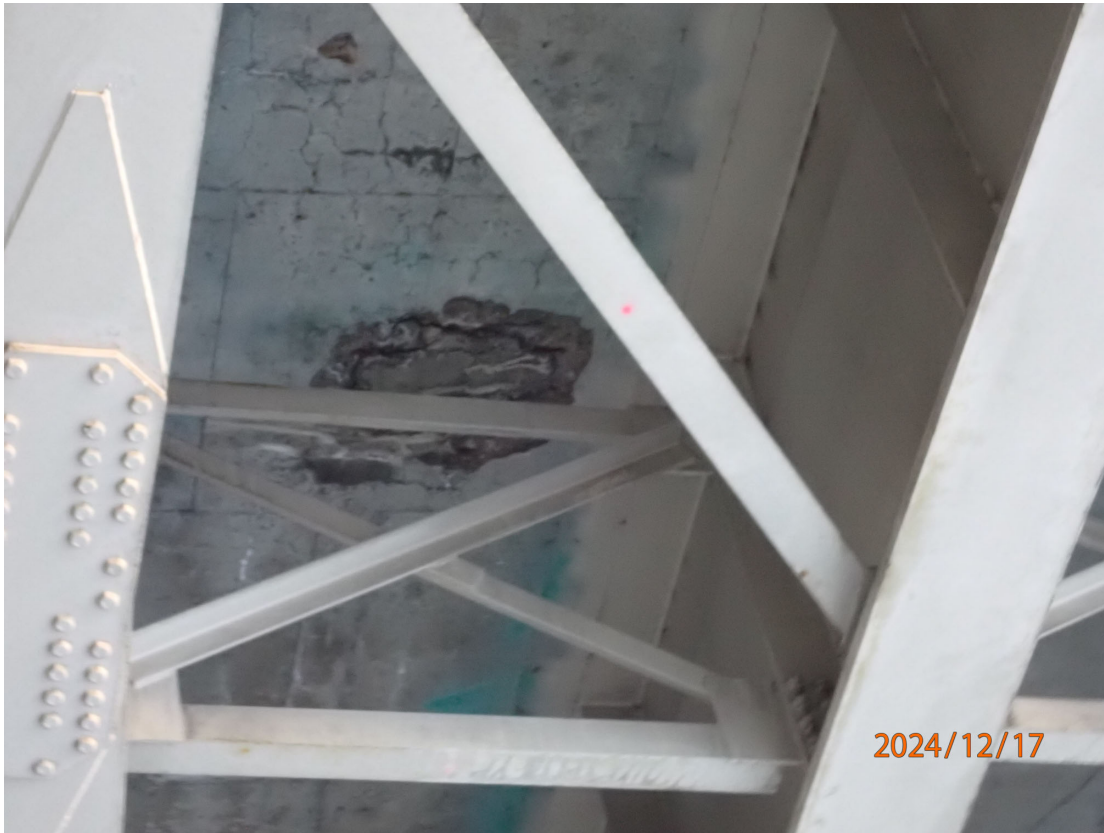
Soffit has cracks with efflorescence. Span 1-Bays 3 and 4 has some full depth deterioration with dense pattern cracking and efflorescence, plus there is a full depth patch in Bay 3 (shown).

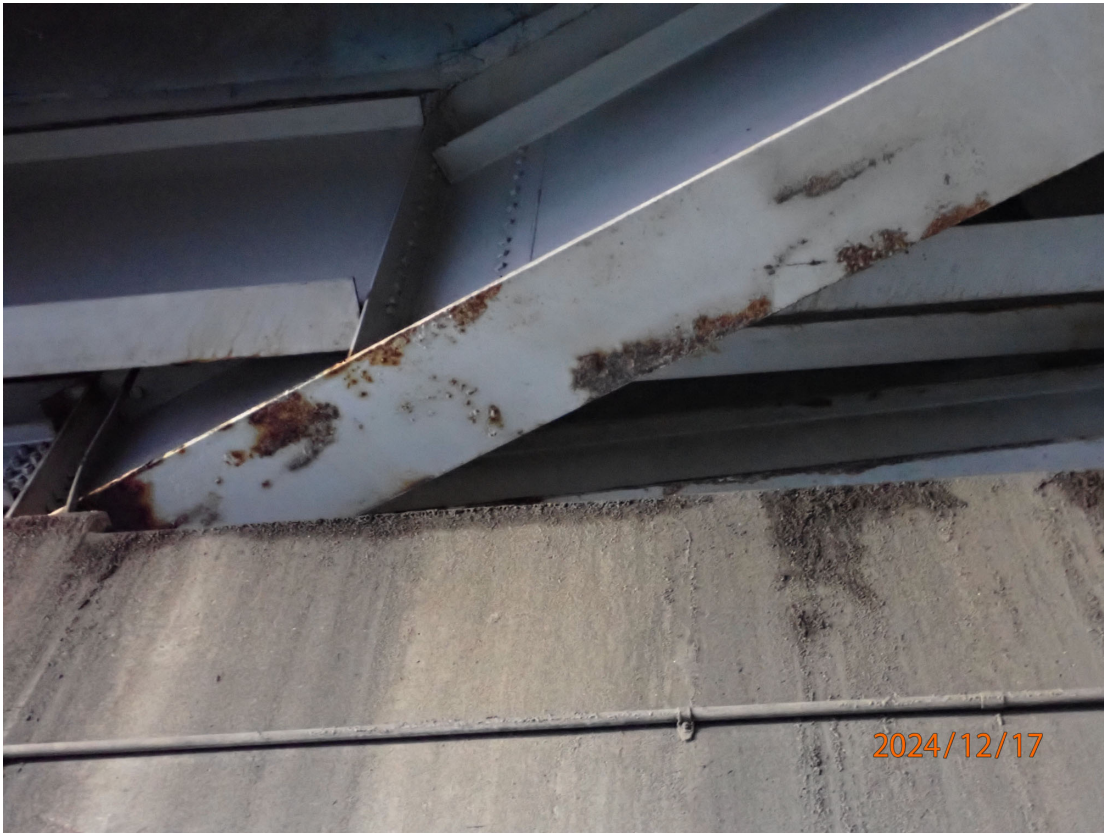
Girder ends typically have corrosion near the substructure units. Example Span 1-Pier 2-Girder 9.

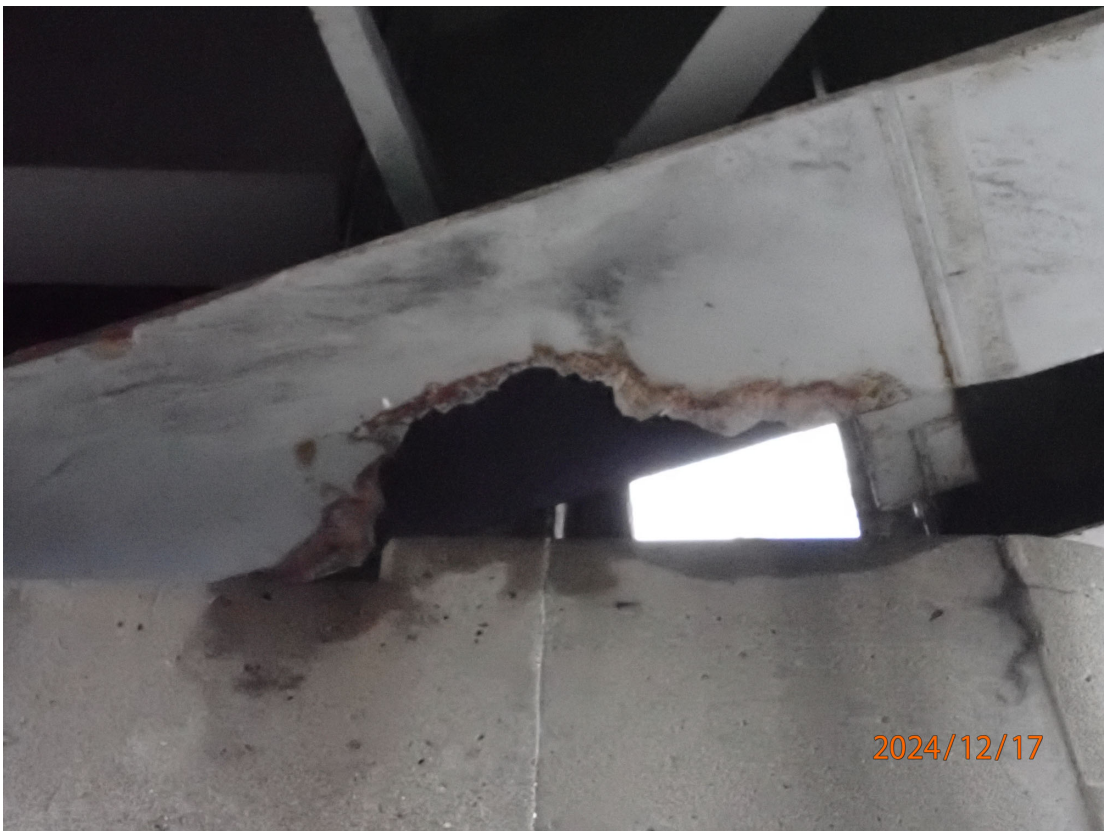
Another example of corrosion and peeling paint in Span 1-Pier 2-Girder 14.

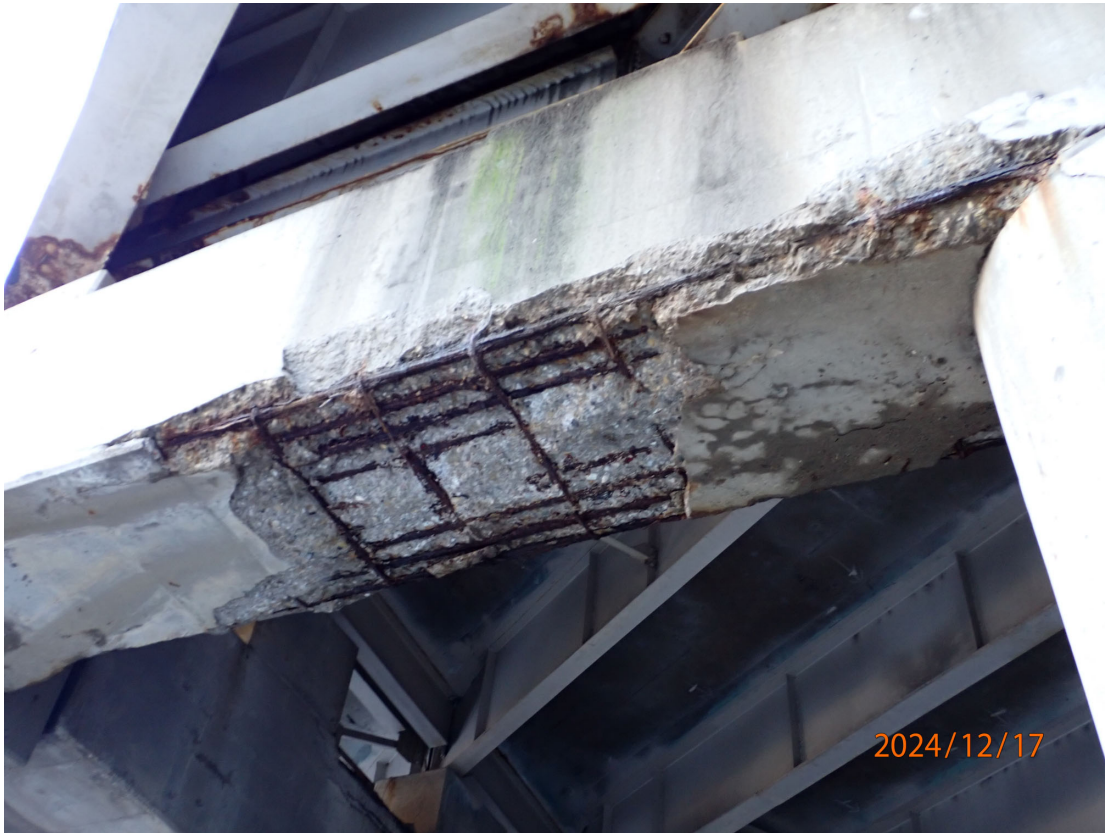
Pier 2 cap has wide cracking and/or large spalls with exposed rebar for much of the length. Largest spall on the bottom face between Columns 1 and 2 shown.

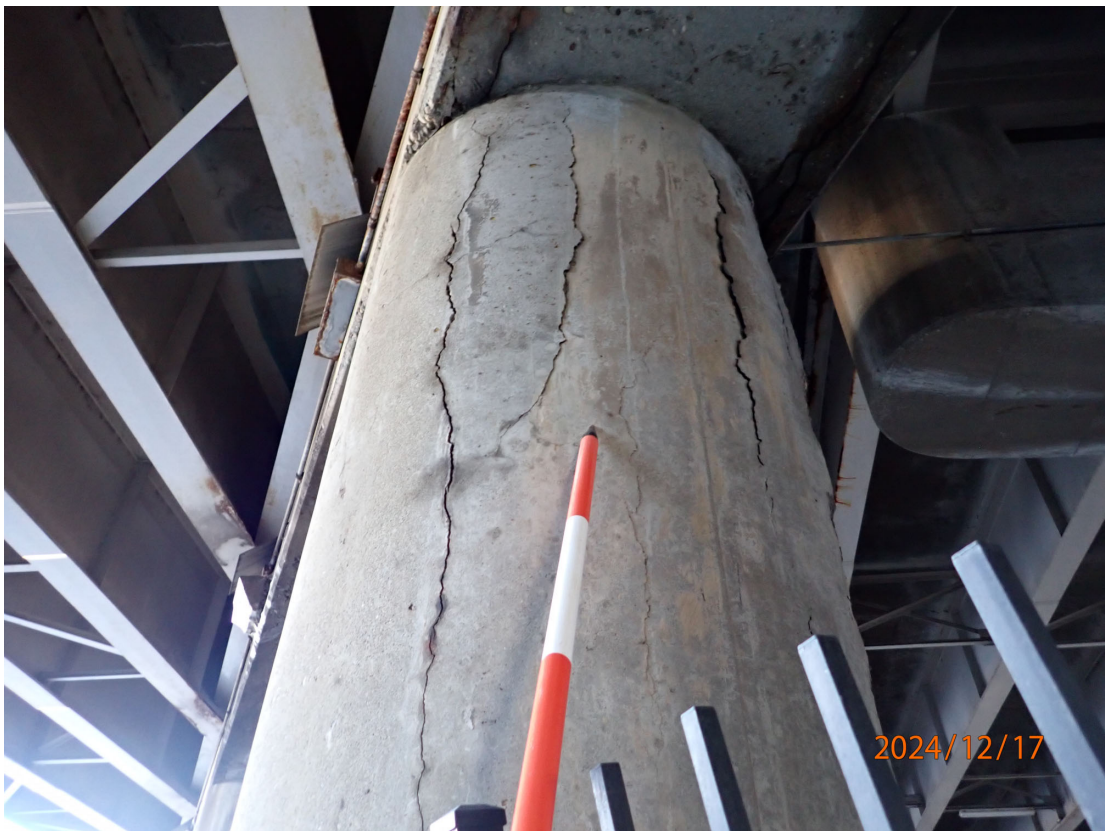
Several columns at Piers 2 and 5 have wide cracks and/or spalls with exposed rebar.
Pier 2-Column 5 south face shown with closely spaced wide cracks.

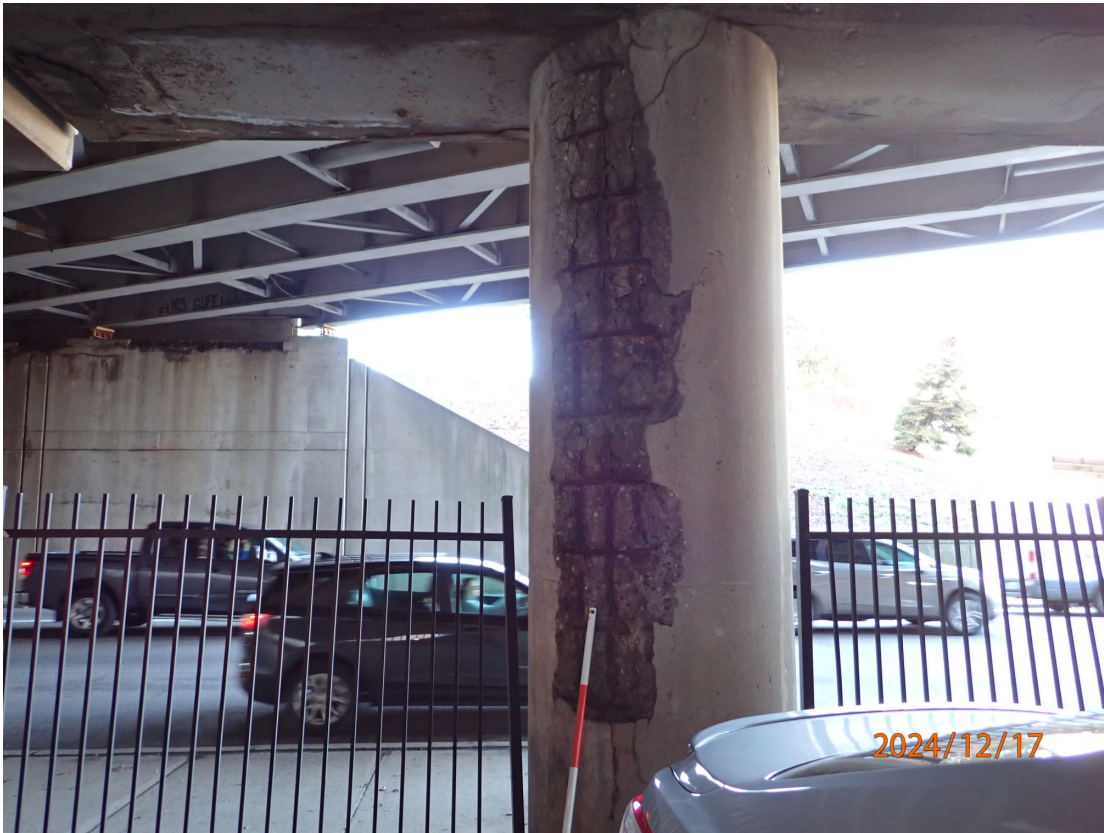
Pier 2-Column 5 has a large spall with exposed rebar, roughly 10 feet tall by 2 feet wide by 2.5 inches deep, on the north side.

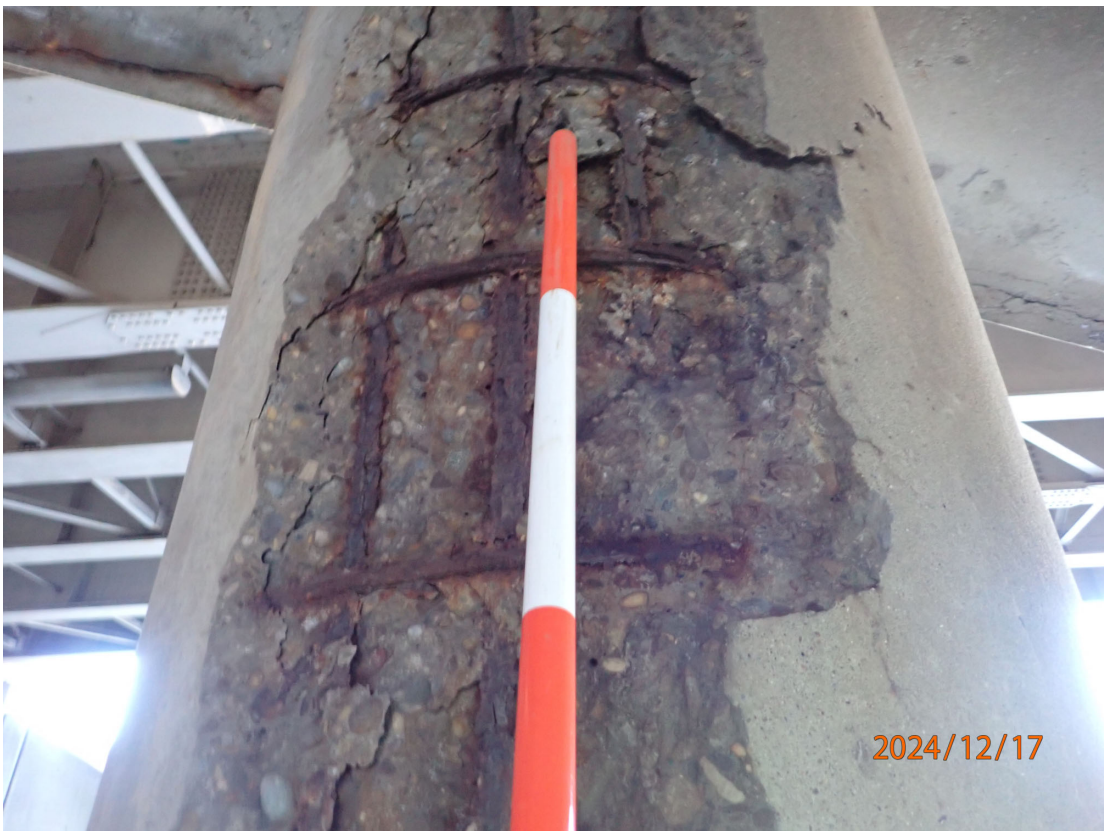
Close-up of Pier 2-Column5 spall with exposed rebar having section loss.
