Bridge Inspection Report

056B00193N

07/15/2024

Special-Other

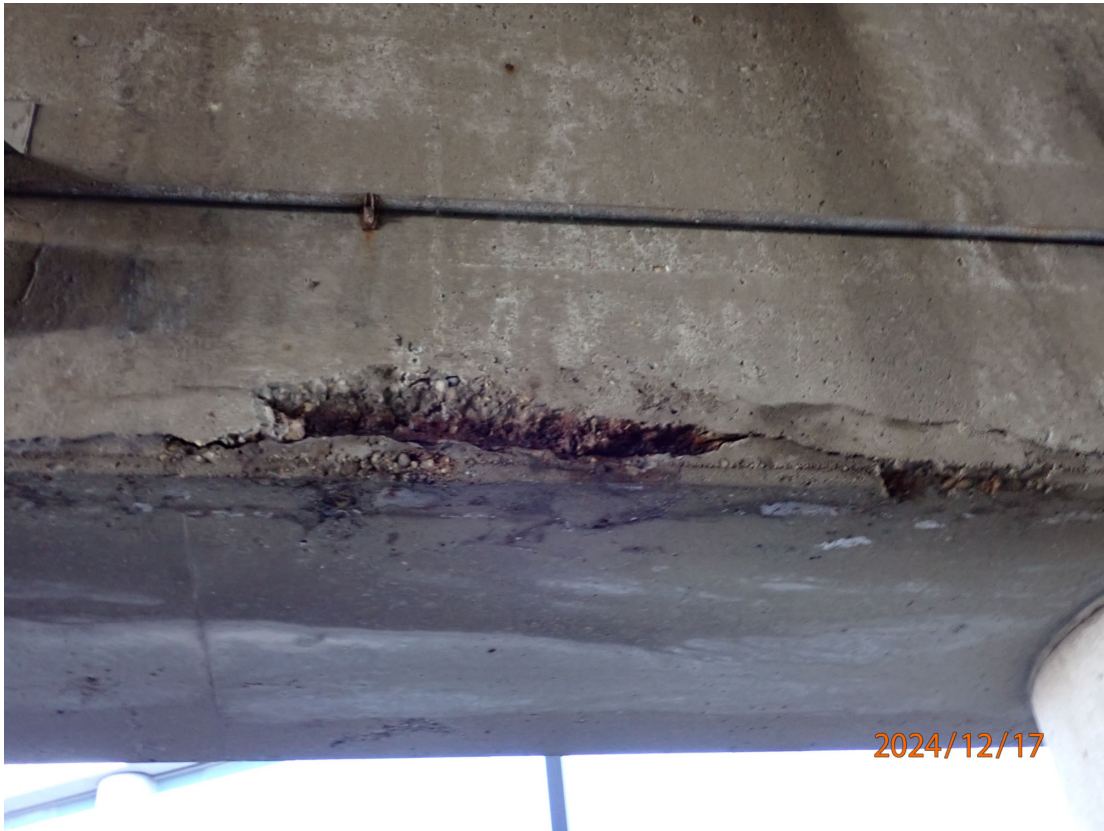
Another example of cracking and spalling in the Pier 2 cap between Columns 9 and 10.

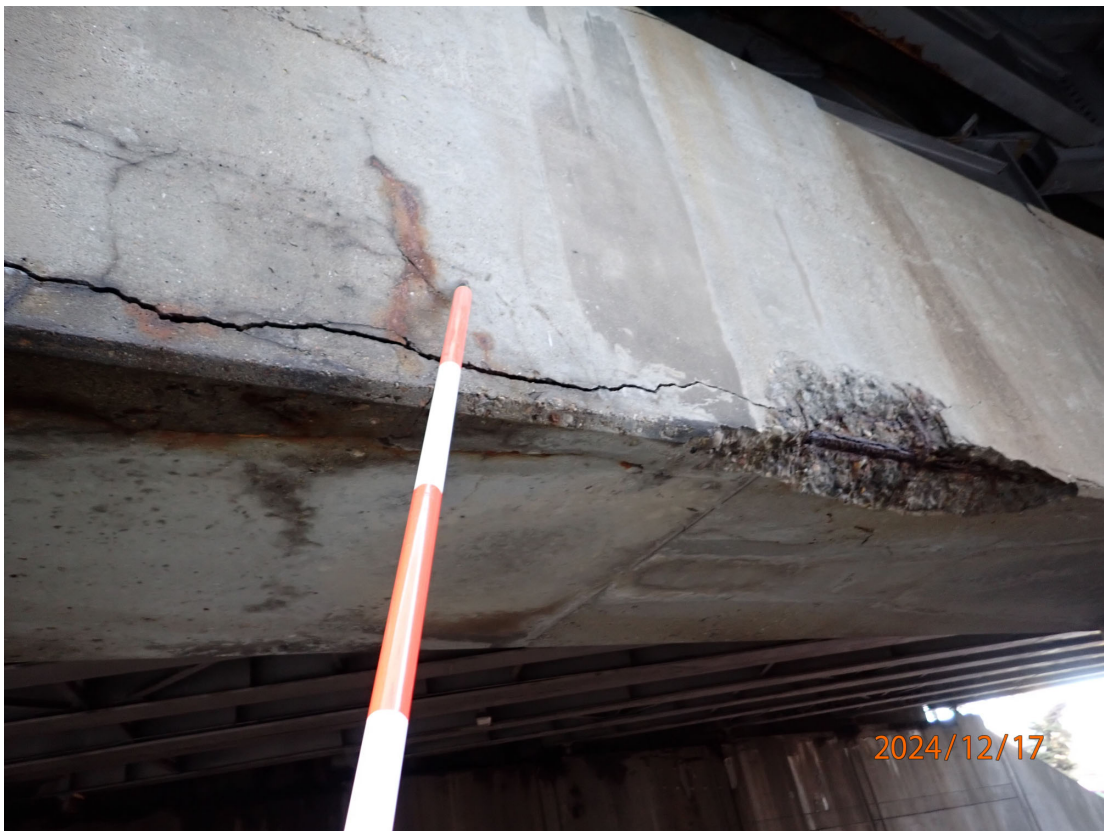
Wide horizontal cracking and spalling along the bottom north face in Pier 2 cap between Columns 10 and 11.

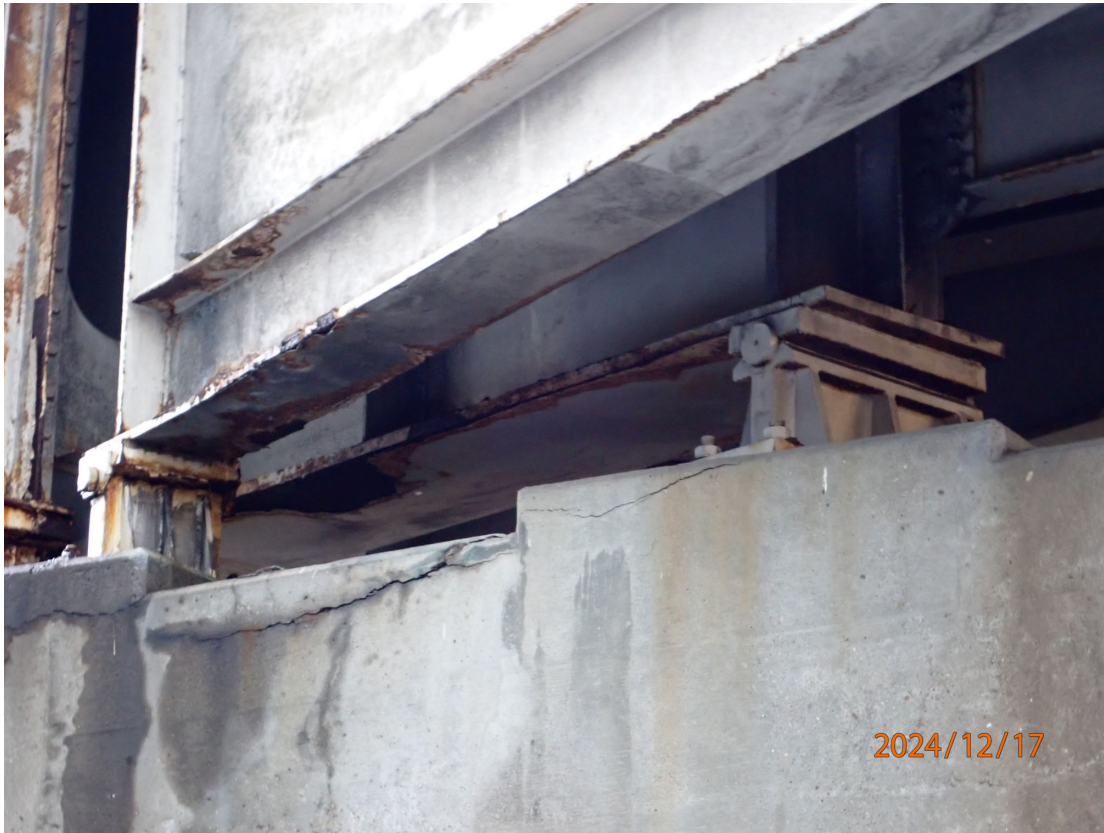
Wide cracking in the east end of Pier 2 north face, plus typical Pier 2 bearings.

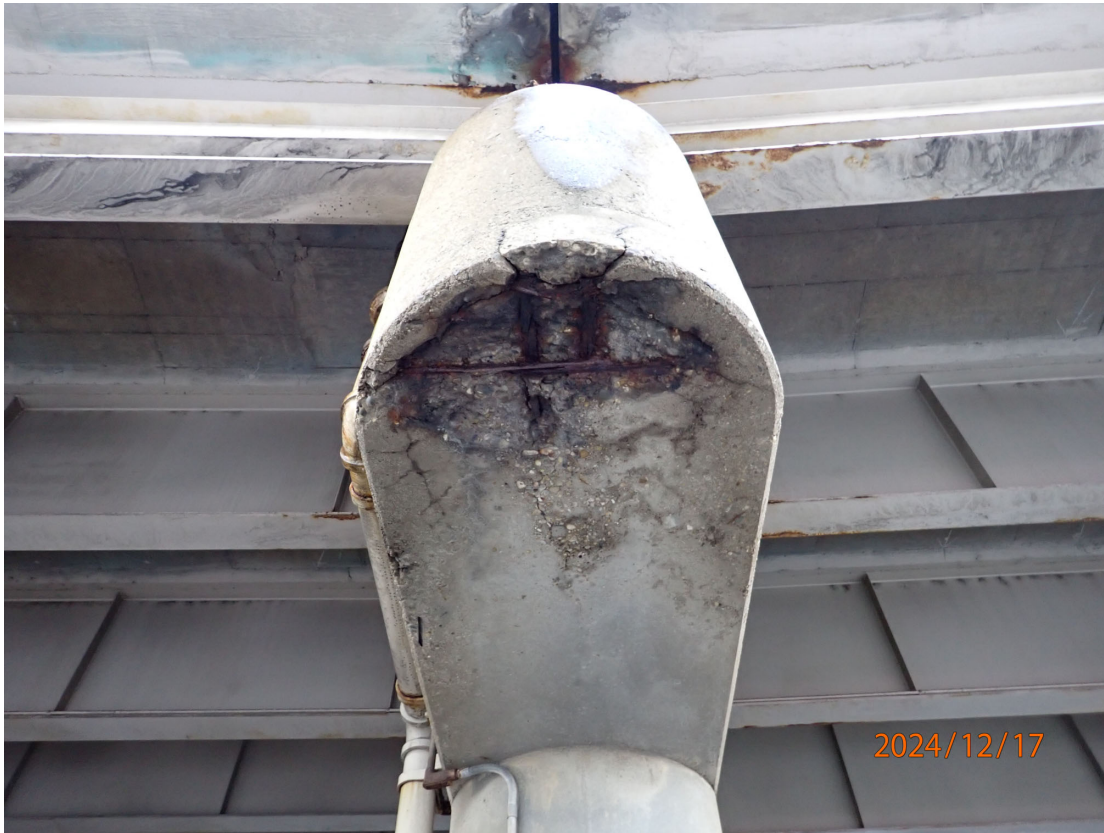
Spalling on the bottom face of Pier. 3 cap at the east end

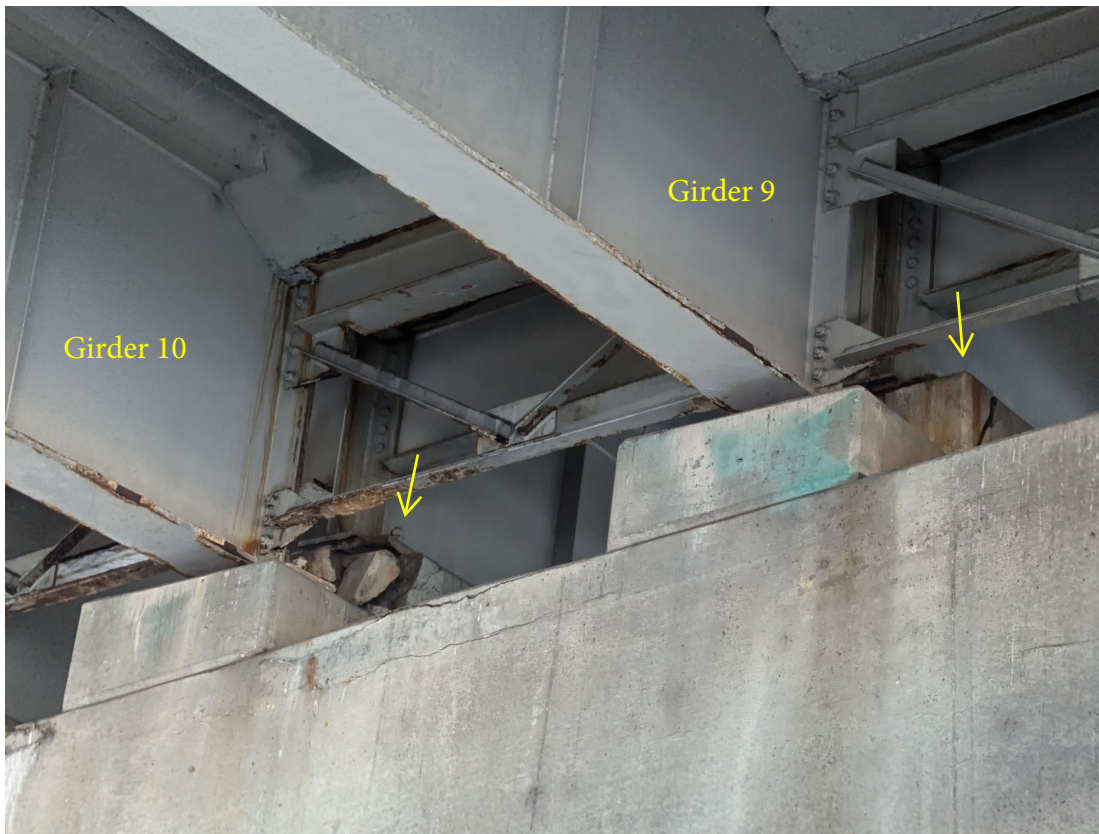
Pier 3 north face at Girders 9 and 10.
Pedestal for girder 9-Span 2 has a wide crack, and pedestal for Girder 10-Span 2 has a deep spall, potentially causing loss of bearing area.

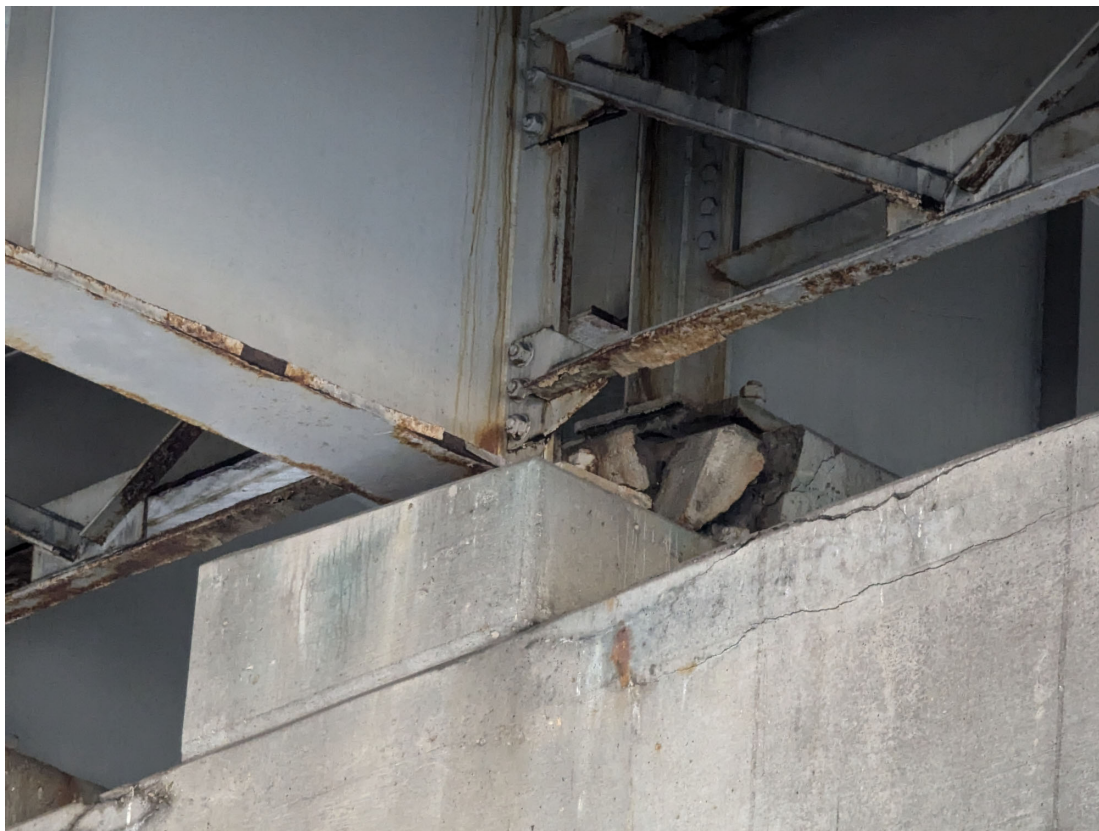
Closer view of pedestal for Pier 3-Girder 10-Span 2 spalling, plus wide cracking in the north face of Pier 3 cap.

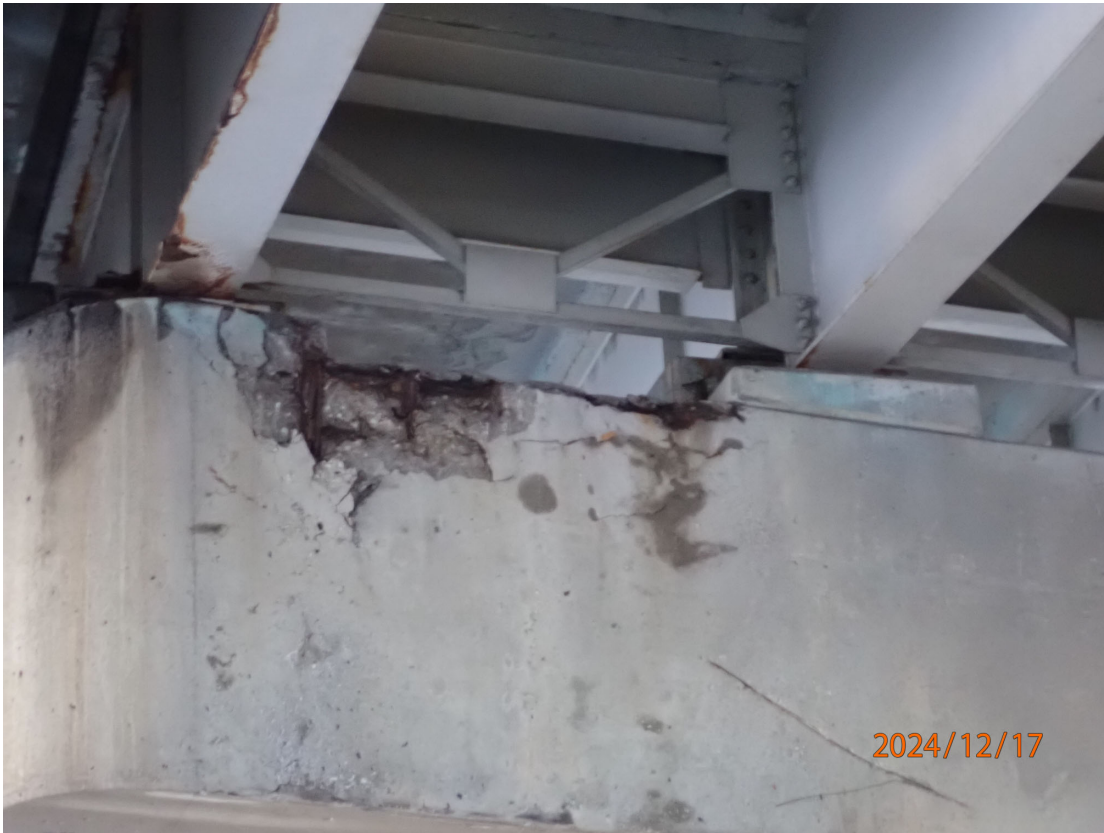
Pier 4 cap has spalls with exposed rebar. Example in the south face under Bay 8 shown.

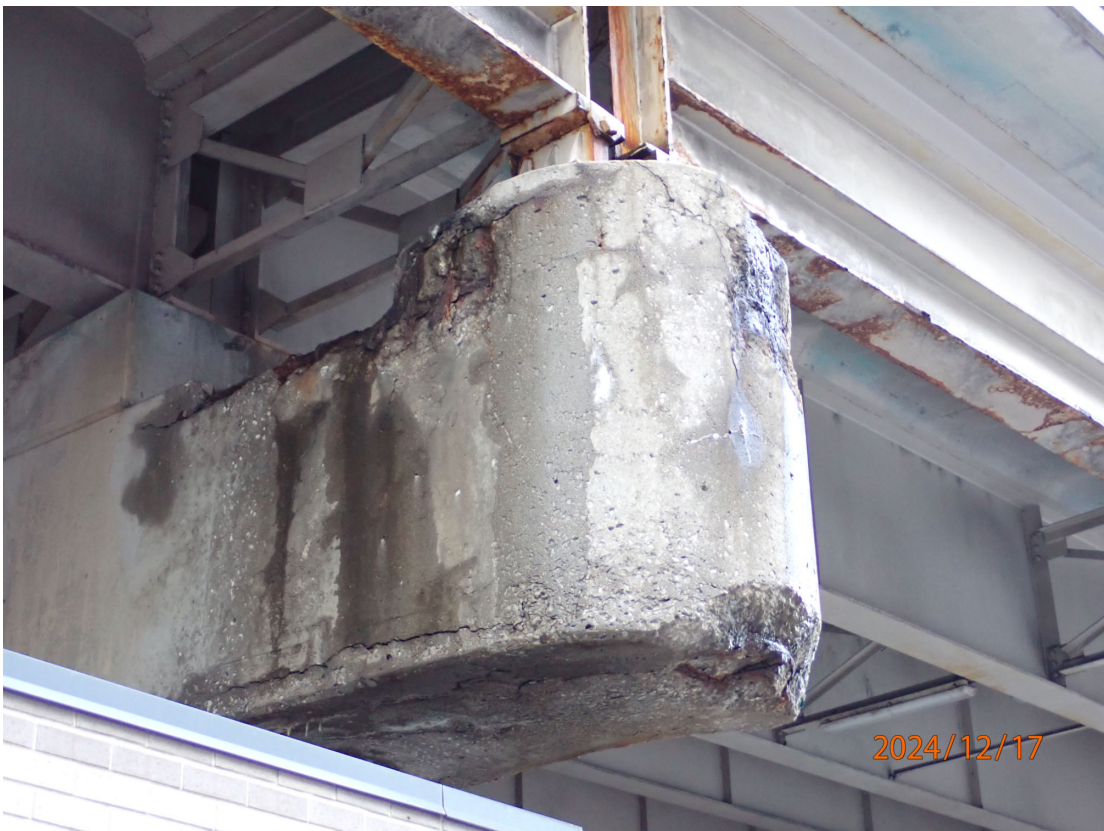
East end of Pier 4 has spalling with exposed rebar and wide cracking. South face shown.

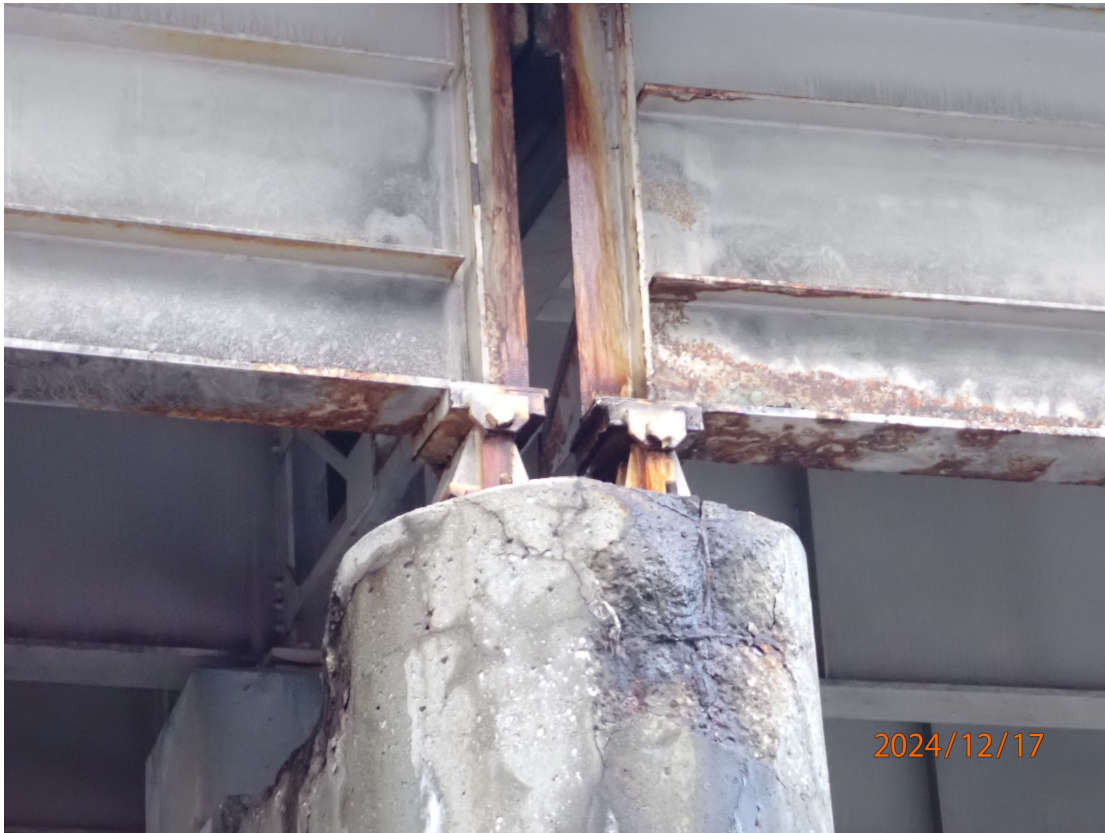
Girder 14 over Pier 4 has heavier corrosion along the girders and the bearings.

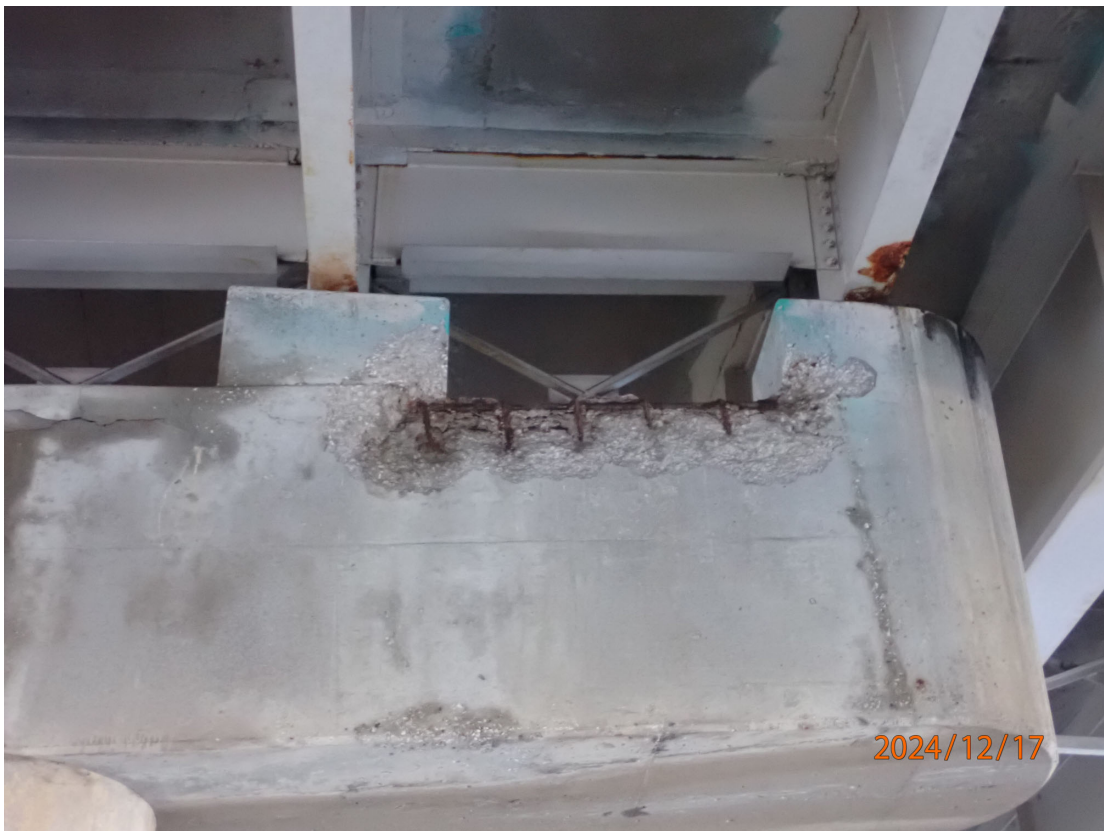
Spalling in the north face of Pier 4 cap under Bay 8.

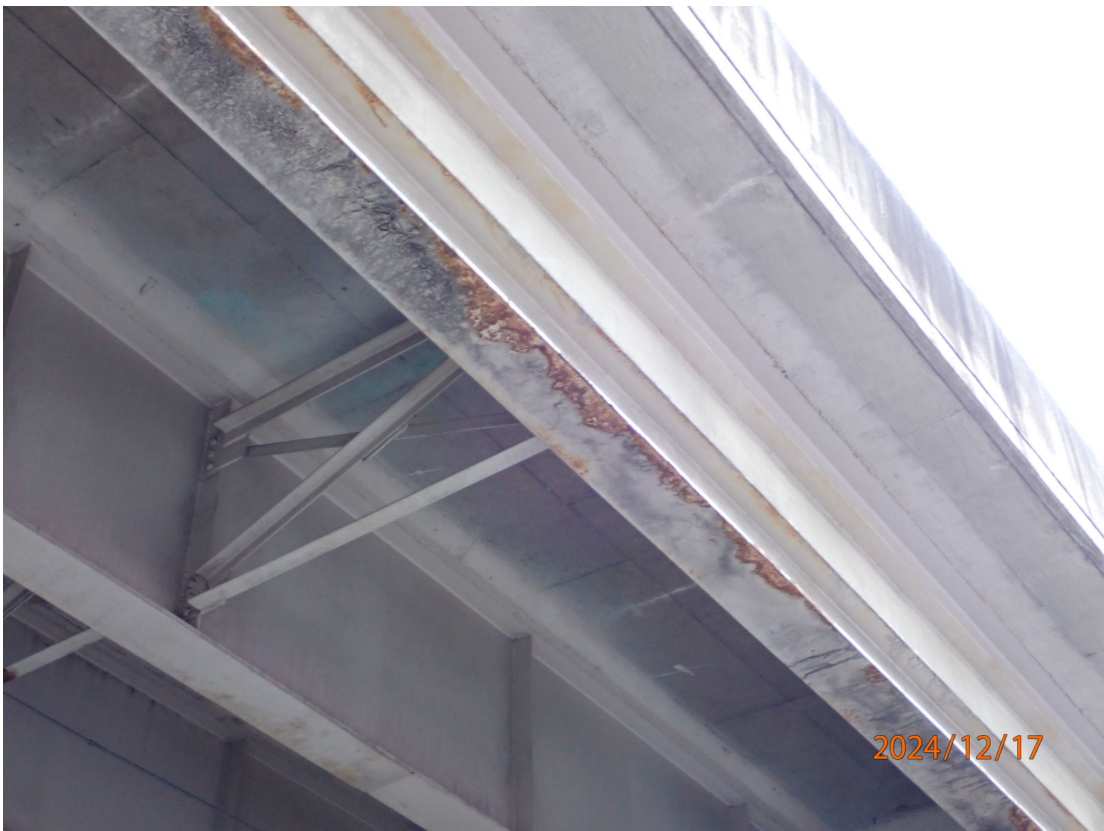
Exterior Girder 14 has light corrosion throughout Span 4 along the bottom flange.

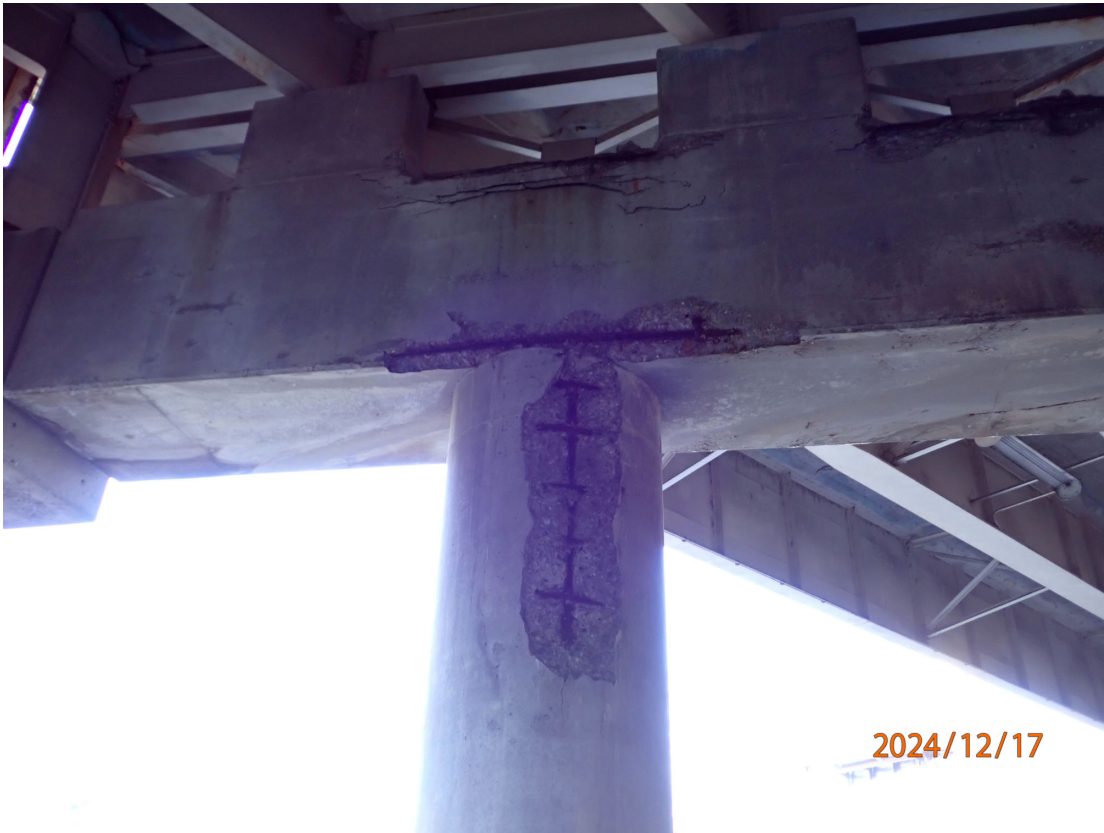
Pier 5 has wide cracking plus spalls with exposed rebar in the cap and several columns. Pier 5 south face at Column 1 shown.

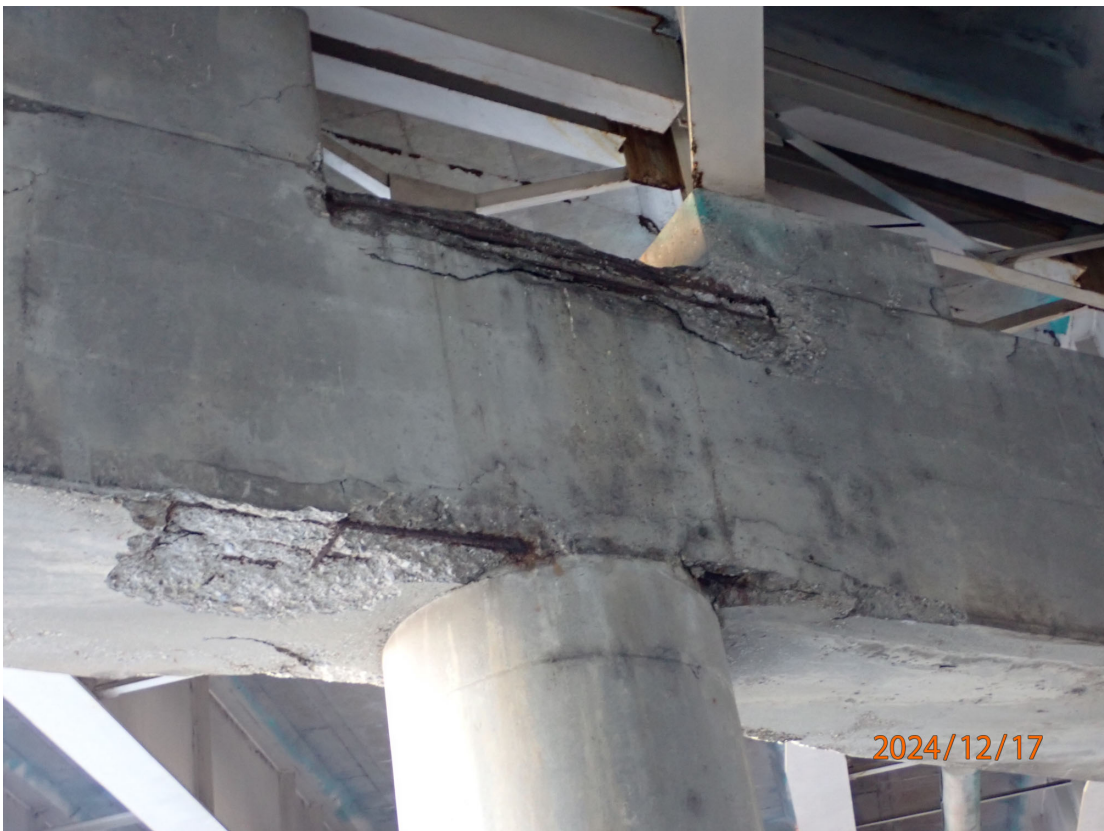
Pier 5 south face at Column 2 with spalling and exposed rebar.

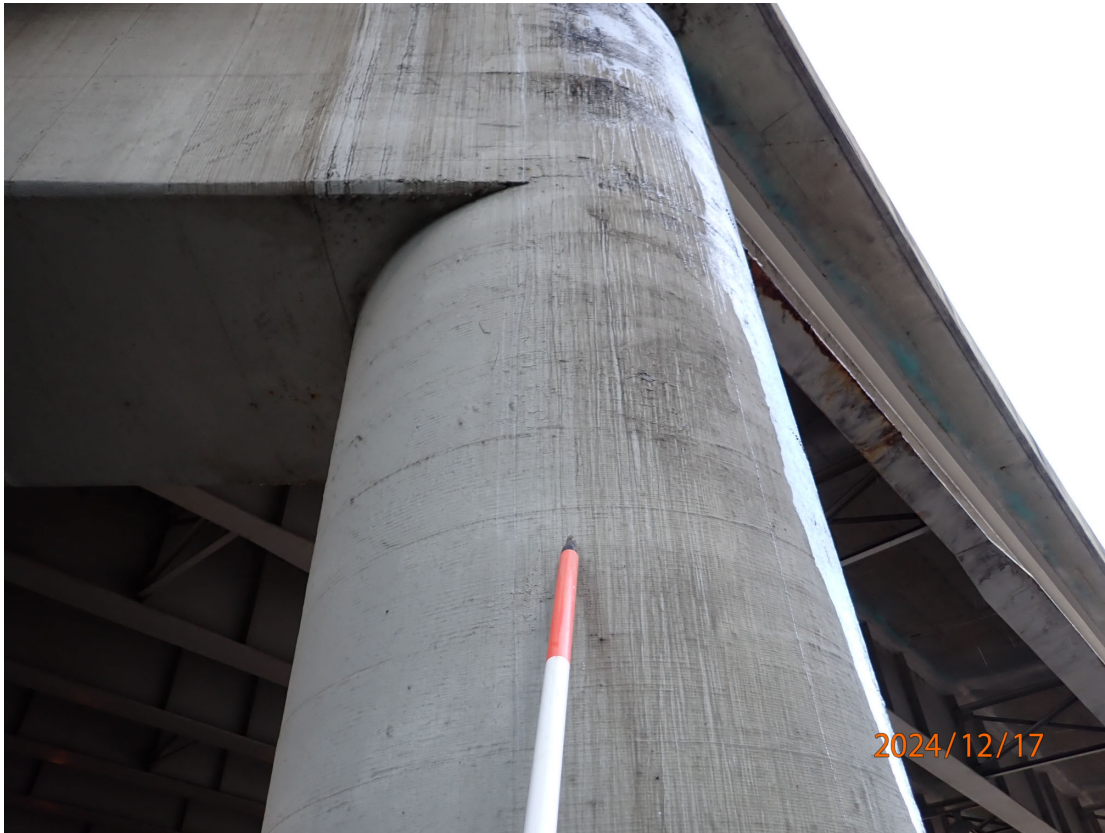
Pier 5-Column 6 and the east end of Pier 5 cap have CFRP repair from 2009. Repairs are in good condition.

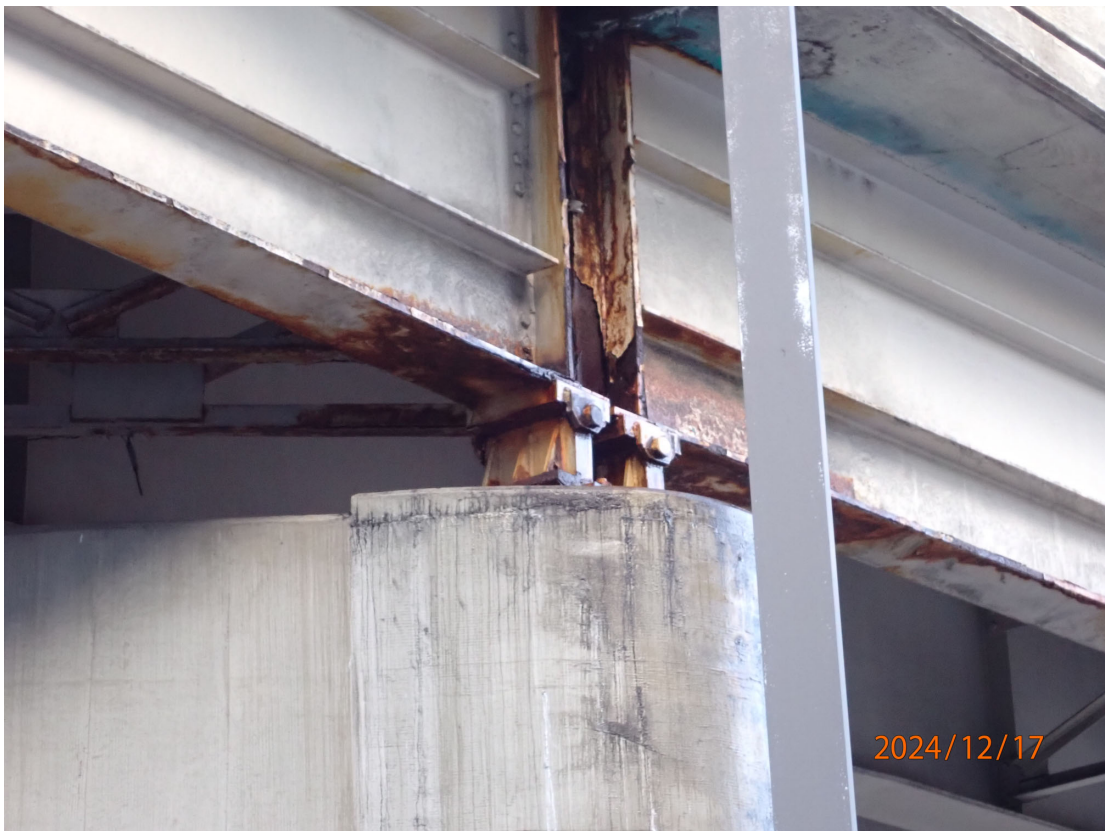
Girder 14 at Pier 5 as well as the bearings have heavy corrosion with section loss.

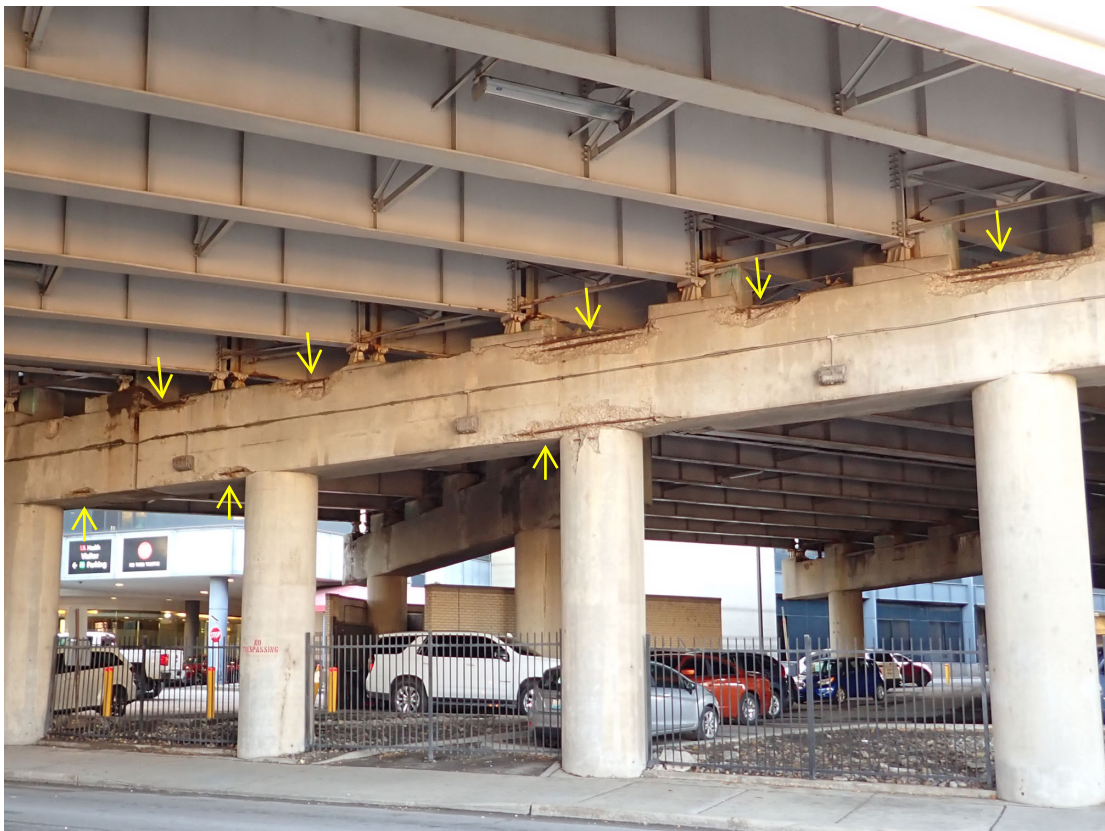
Numerous spalls with exposed rebar in Pier 5 north face between Columns 1 and 4.

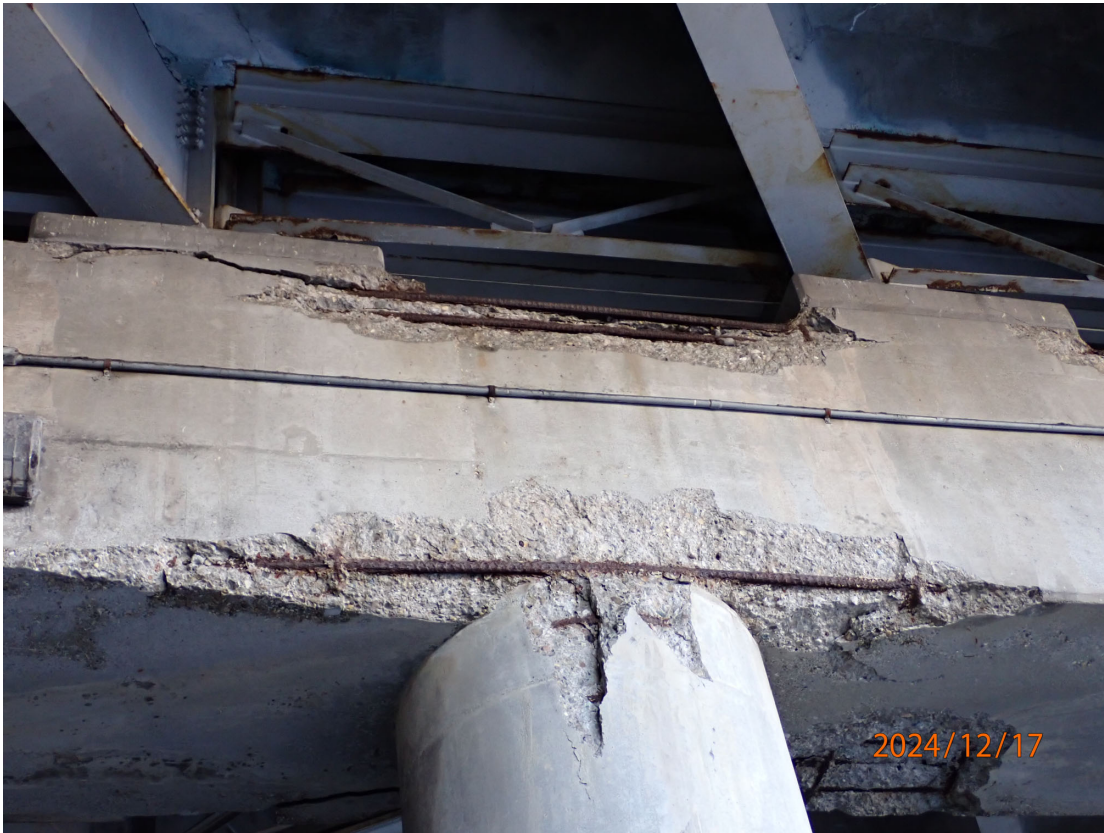
Close-up of deep spalling in the Pier 5 cap north face at Column 2 as well as spalling in the column.

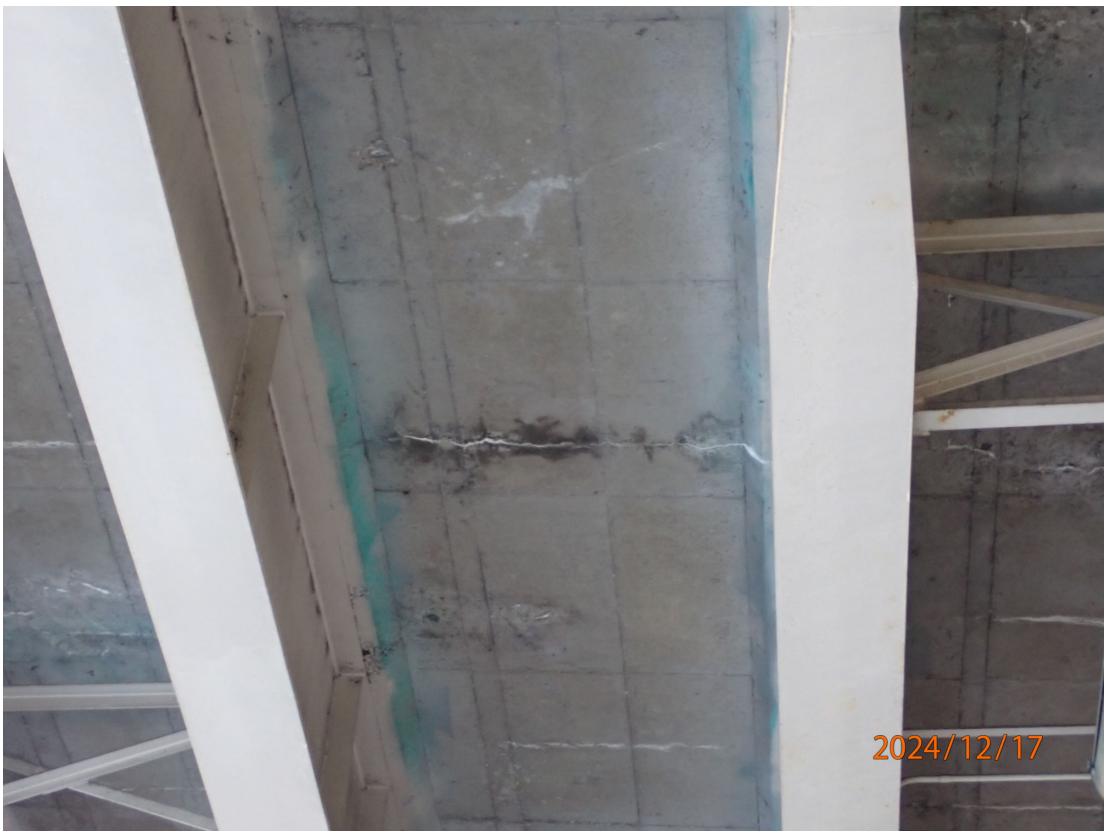
Example of transverse cracking in the deck soffit in Span 6.

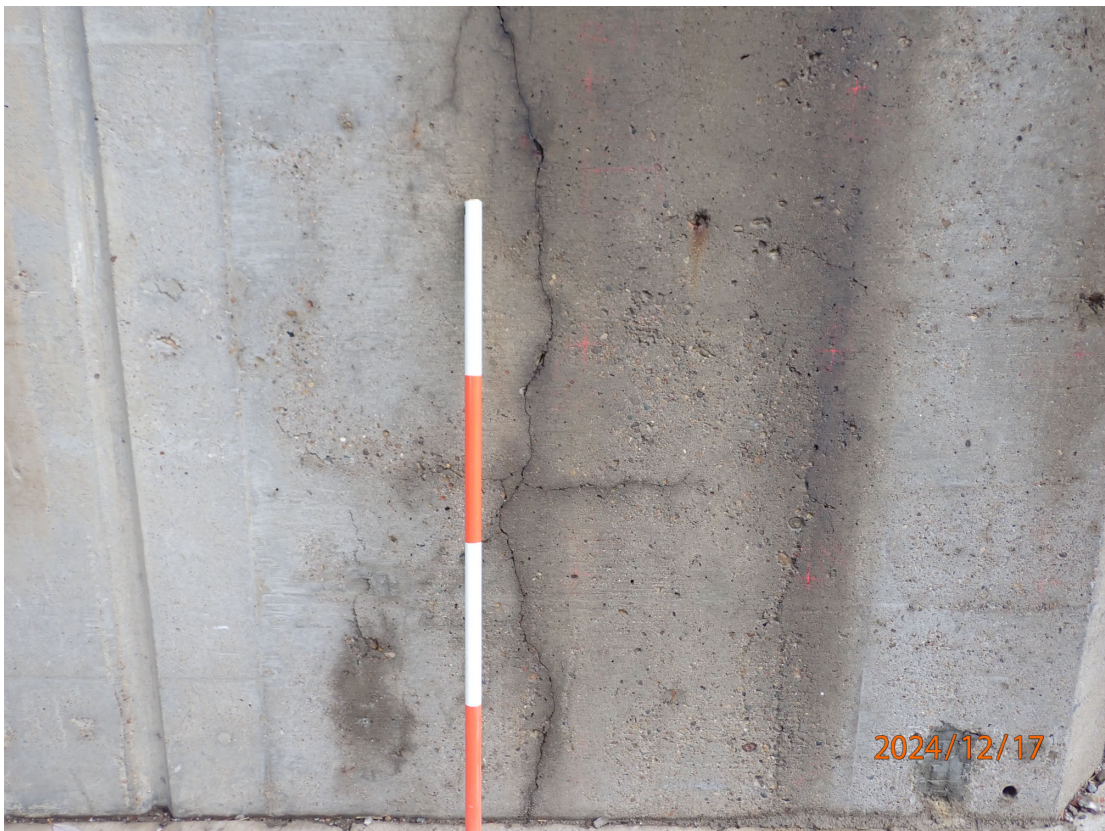
Abutment 6 has a few full height vertical cracks.

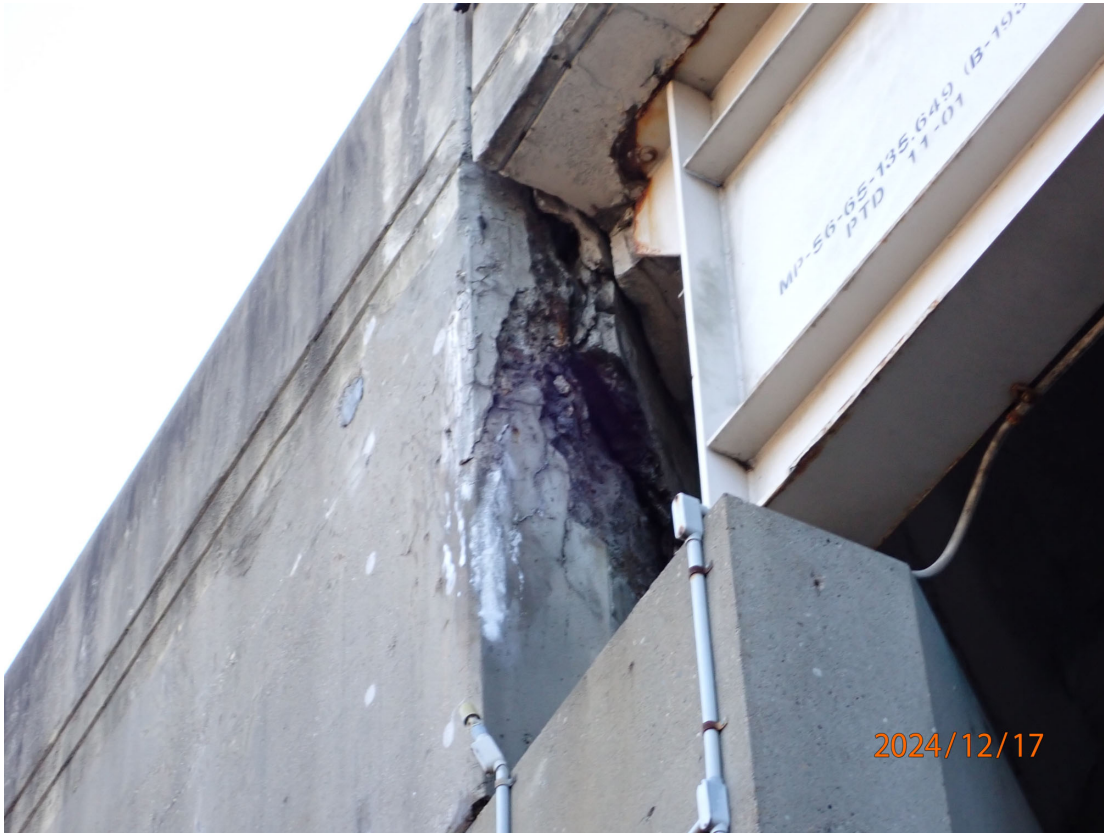
Abutment 6 back wall has dense pattern cracking and deep spalling at the west end.

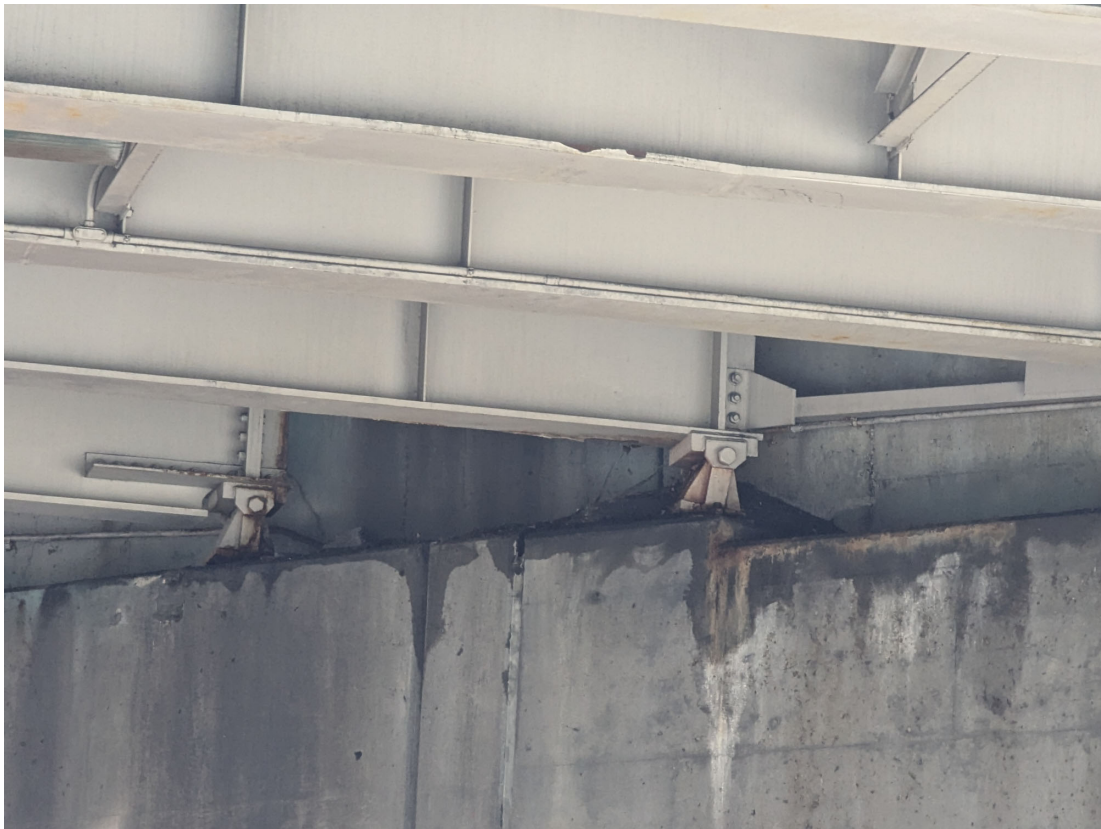
Abutment 6 Girders 7 and 8. Bearings have surface corrosion and are all slightly expanded, inconsistent with temperature. Girder 8 bearing is also partially buried in asphalt, restricting movement.

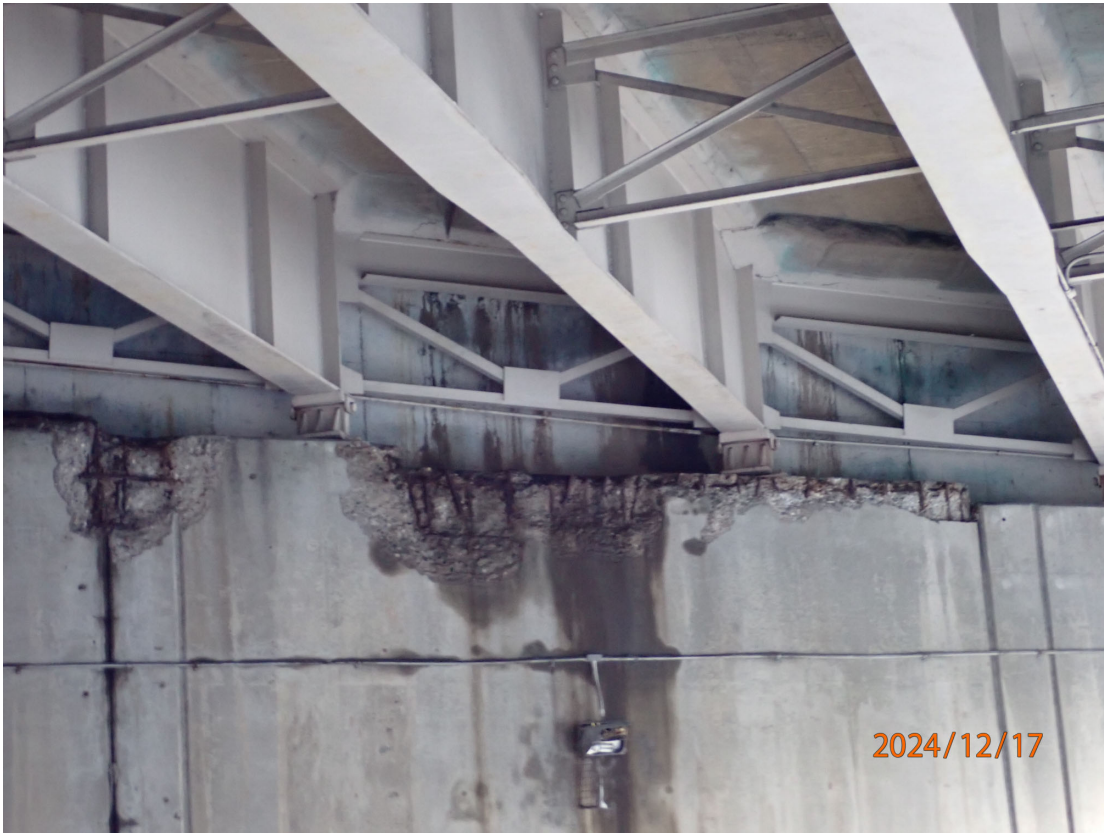
Abutment 6 has large, deep spalls with exposed rebar along the top of the beam seat.
Example below Bays 9-11.

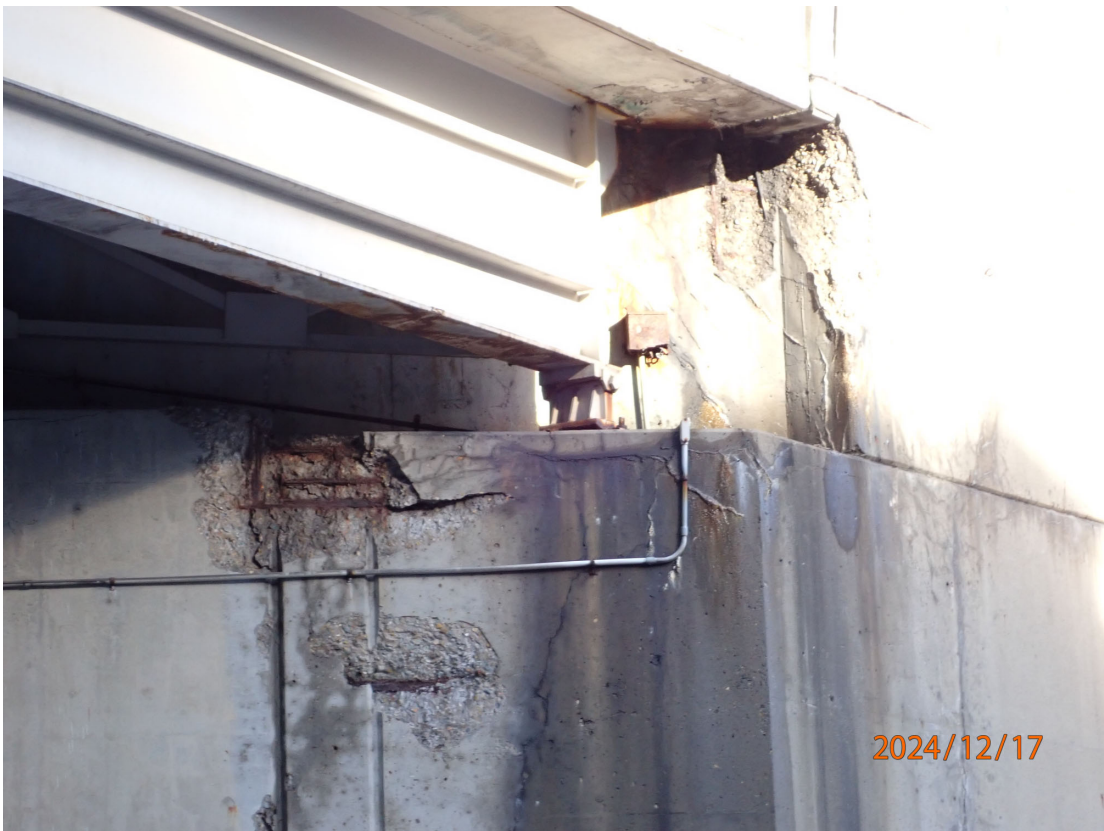
East end of Abutment 6 with cracking, spalling, and exposed rebar.

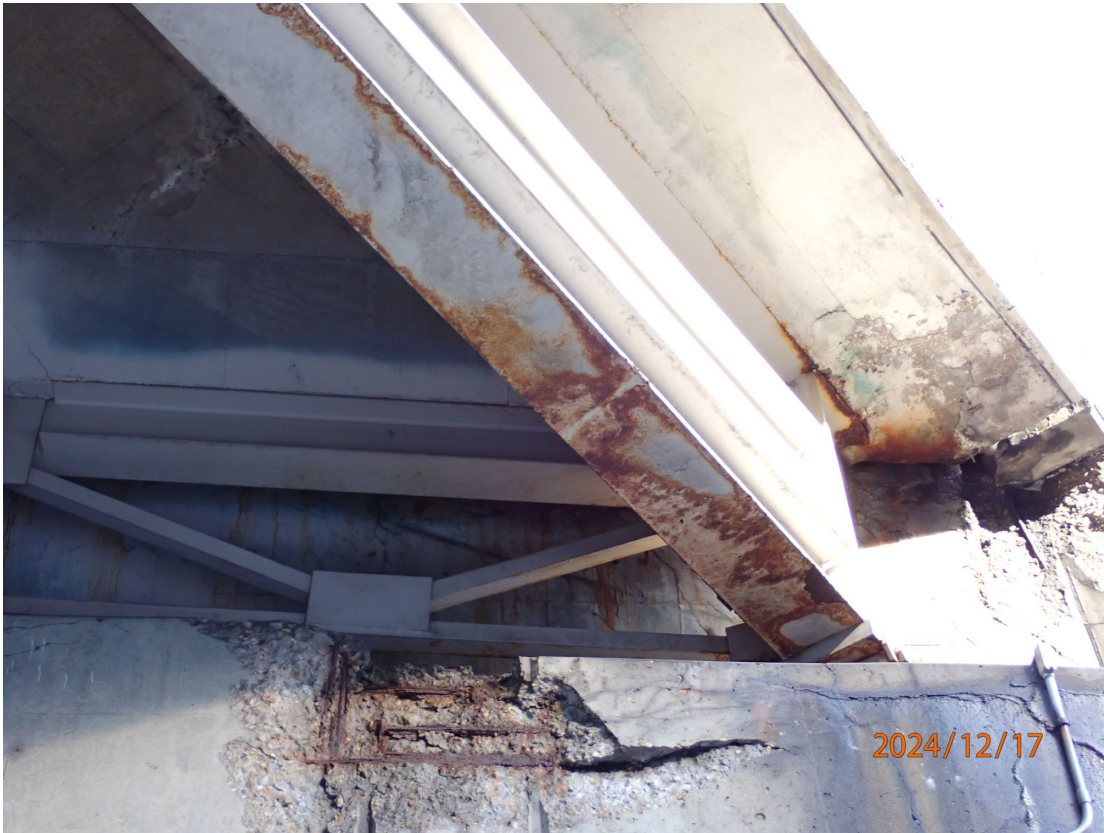
Spall with exposed rebar in Abutment 6 at Girder 14, plus corrosion along the bottom flange of Girder 14.
