Bridge Inspection Report

056B00193N

07/15/2024

Special-Other

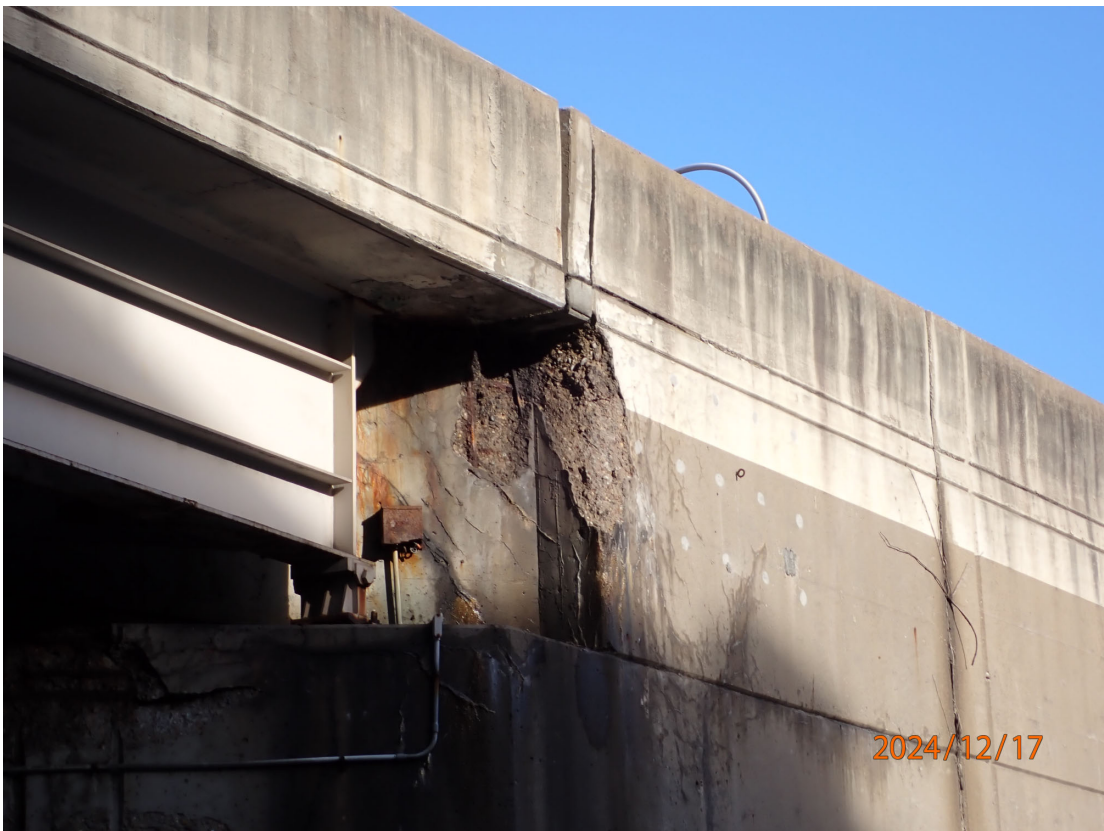
East end of Abutment 6 back wall has closely spaced diagonal cracking with rust staining plus a large spall with exposed rebar.
