# Bridge Inspection Report

056B00194N

12/11/2024

<u>IDENTIFICATION</u>			
Structure Num (8):	056B00194N		
NBI Number	056B00194N		
Structure Name:			
Location (9):	0.1 MI S OF 1ST ST		
Carries (7):	I-65 SB ON RAMP		
Type of Service (42A):	1 Highway		
Feature Crossed (6):	E MUHAMMAD ALI BLVD		
Type of Service (42B):	1 Highway		
Placecode (4):	Not Applicable		
County (3):	Jefferson (056)		
State (1):	21 Kentucky		
Admin Area:	Inventory		
District:	District 5		
Latitude (16):	38° 15' 2"		
Longitude (17):	85° 45' 7"		
Owner (22):	State Highway Agency		
Maint. Resp. (21):	State Highway Agency		
Year Built (27):	1963	Border State (98A):	Not Applicable (P)
Year Recon (106):	1980	Border Number (99):	
		% Responsibility (98B):

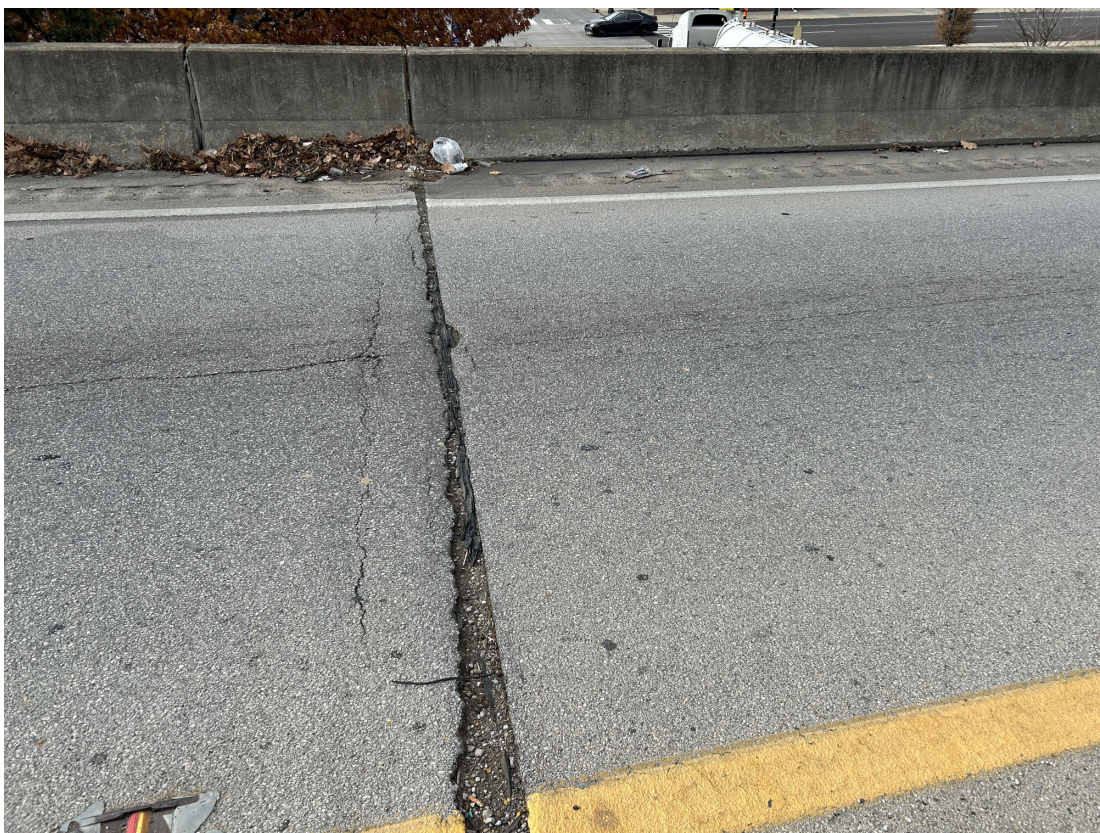
Joint over Abutment 1

Pourable joint seal was installed over existing compression seals. Seal is missing at Abutment 1, and only partially present at Abutment 2 exposing the old compression joint. The exposed compression joint is shredded and filled with debris.

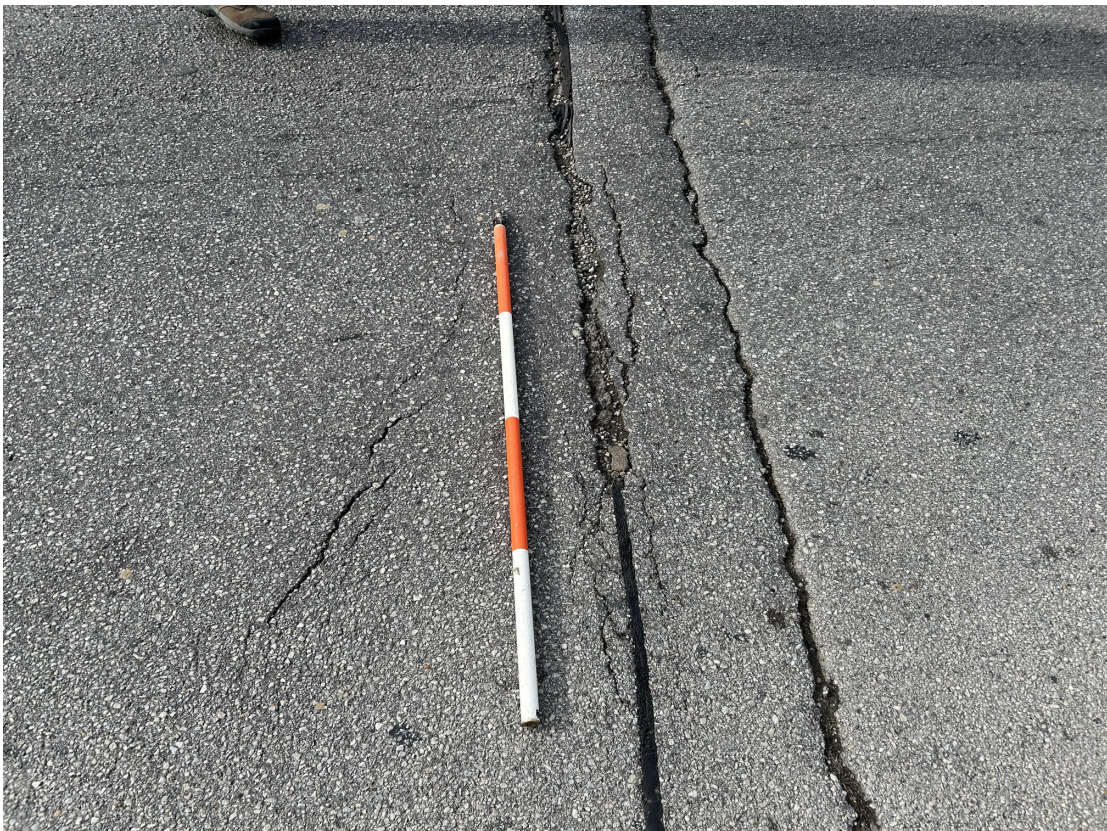
Wearing surface is in good condition except for some cracks/deterioration along joints and diagonal cracking at the northeast corner. Infrared thermographic deck scan from 2022 indicated debonding along the Abutment 2 joint in the lanes.

Asphalt overlay has cracking near the north bridge end. Pourable joint seals have also generally failed.

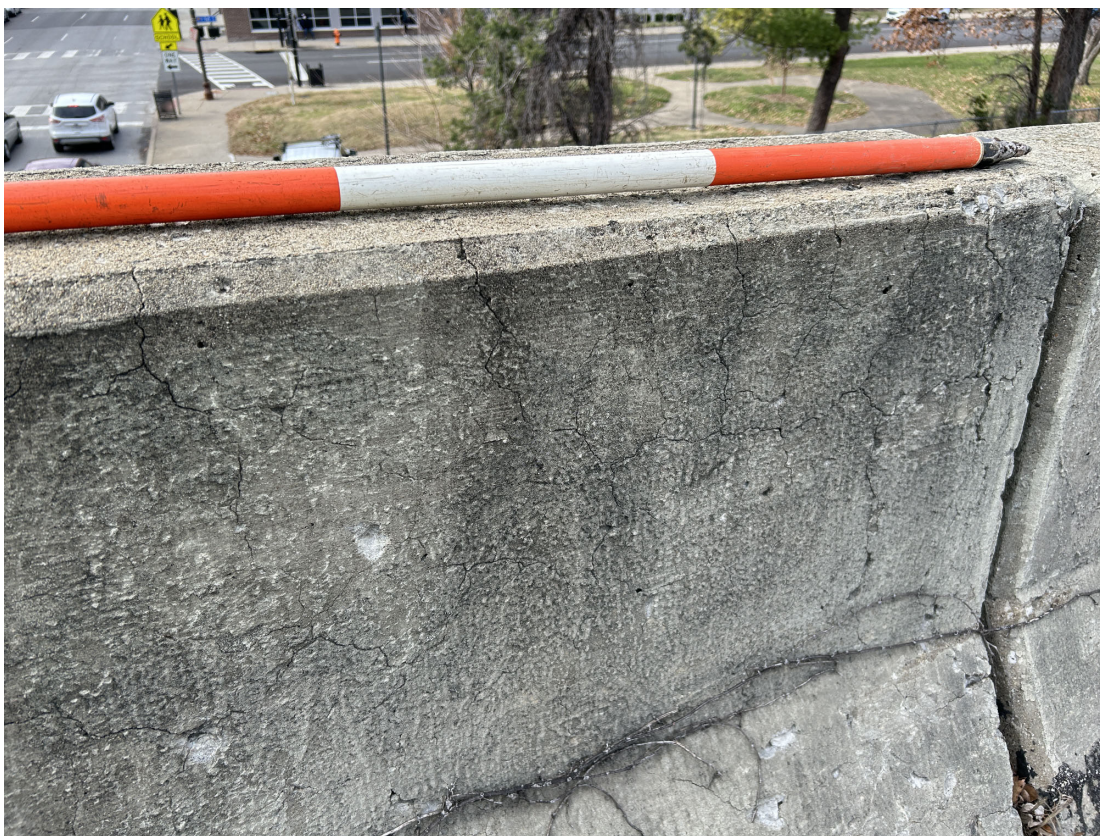
Concrete railings have some moderate cracks and small spalls. West railing has longitudinal cracking along base for the length.

West rail has cracking throughout the length.

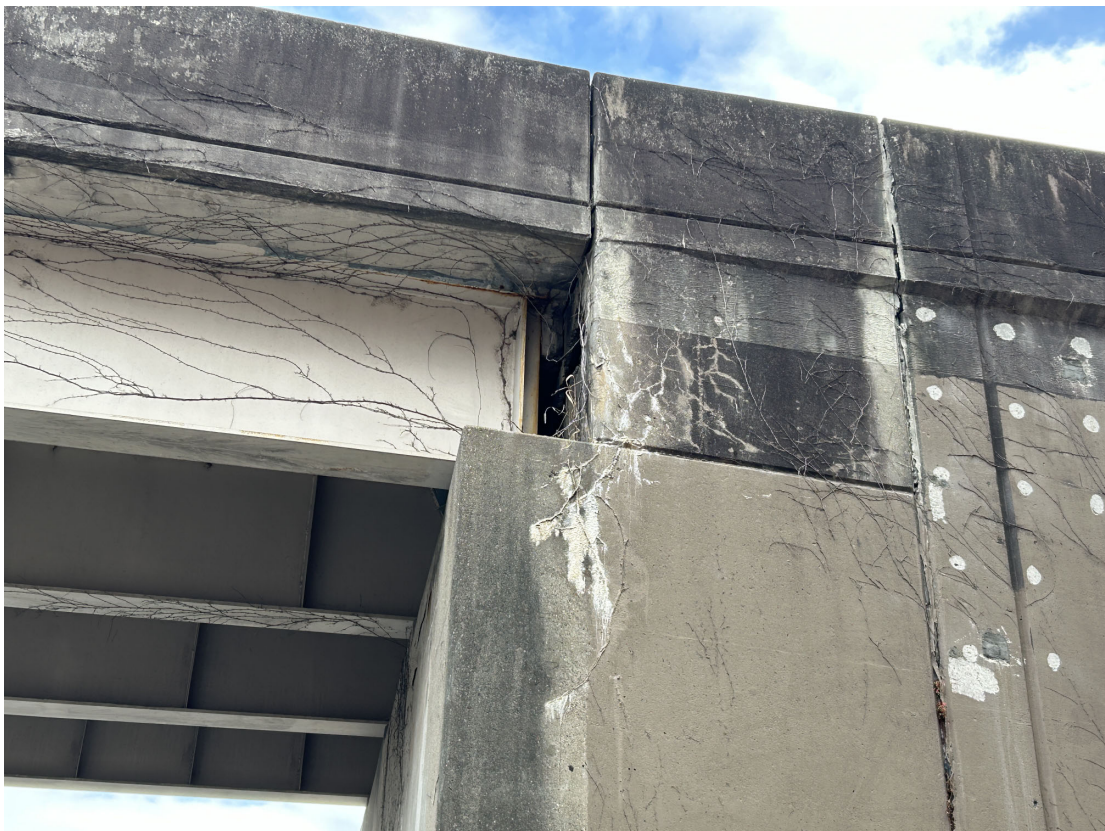
SW wingwall has dense pattern cracking with efflorescence near the top.

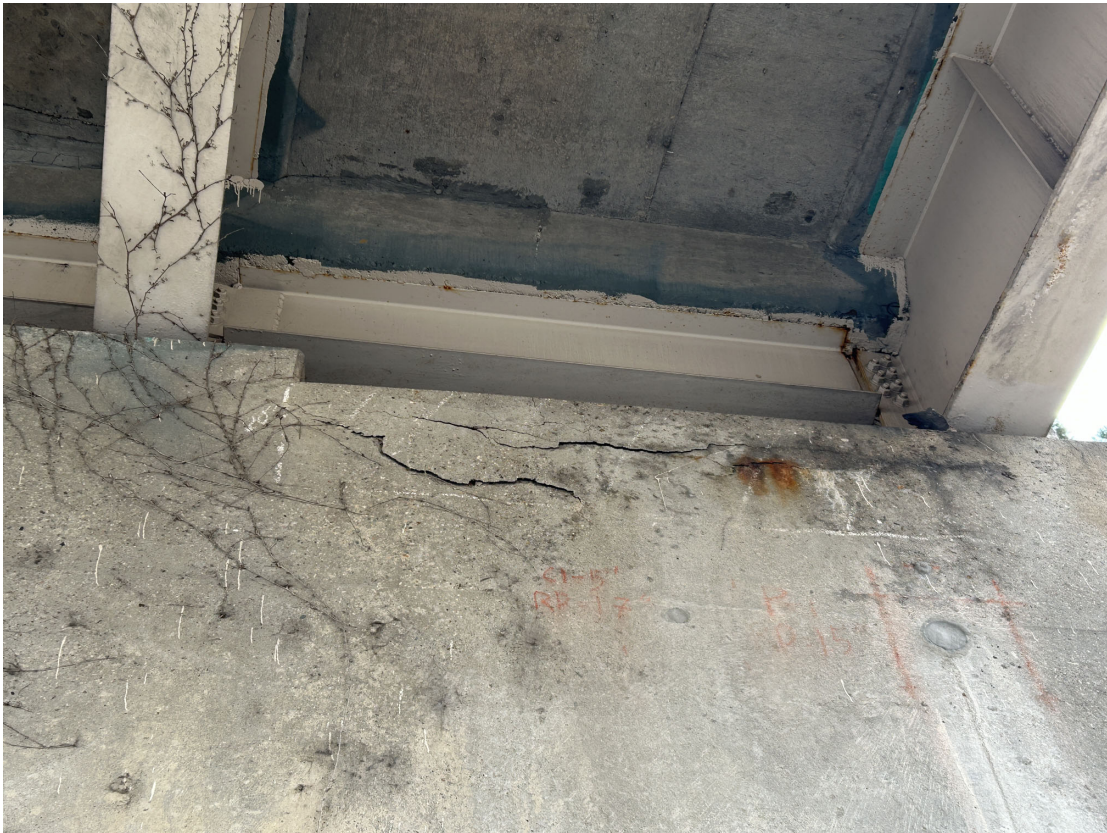
Abutment 1 has wide horizontal cracking with some rust staining near the top of the seat under Bay 1.

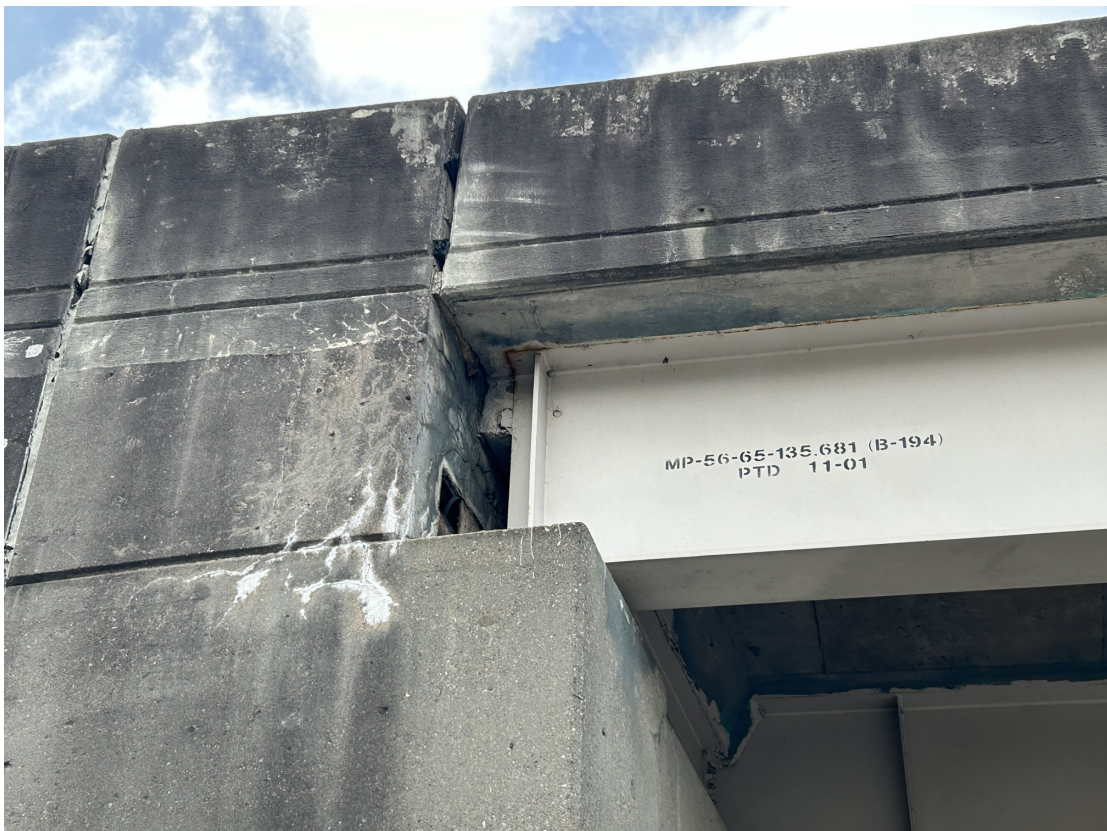
SE wingwall also has dense pattern cracking near the top.

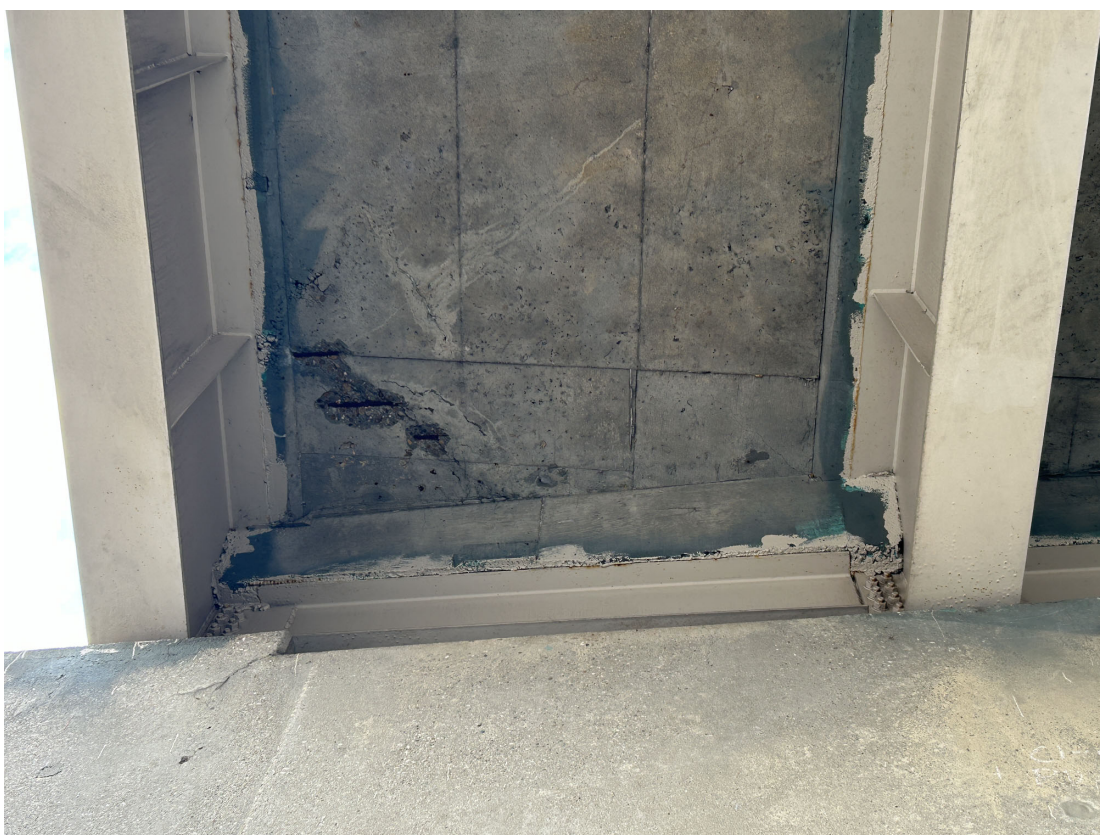
Top of deck cannot be visually inspected due to asphalt overlay. An infrared deck scan was completed by AECOM in 2022, which indicated no delaminations or patches in the top of the deck. Soffit has a few transverse cracks with efflorescence. Spalls with exposed rebar noted in Bay 1 (1.5 inches long by 1.5 feet wide) and Bay 3 (4 inches long by 3 feet wide) mid-span. Soffit also has diagonal cracking and full depth deterioration with seepage, efflorescence, and exposed rebar in Bay 3 at both abutments, worse at Abutment 2.

Deck soffit has an area of spalling with exposed rebar in Bay 3 at Abutment 1.

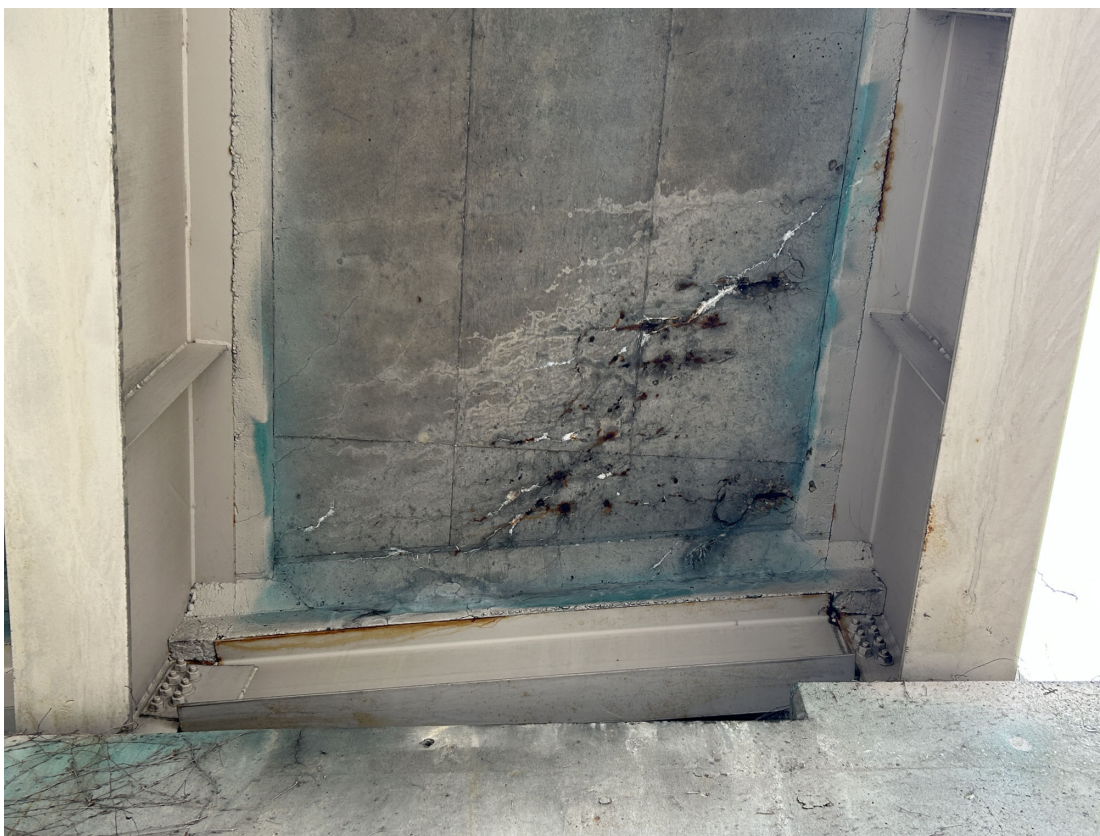
Soffit has an area of full depth deterioration in Bay 3 at Abutment 2.

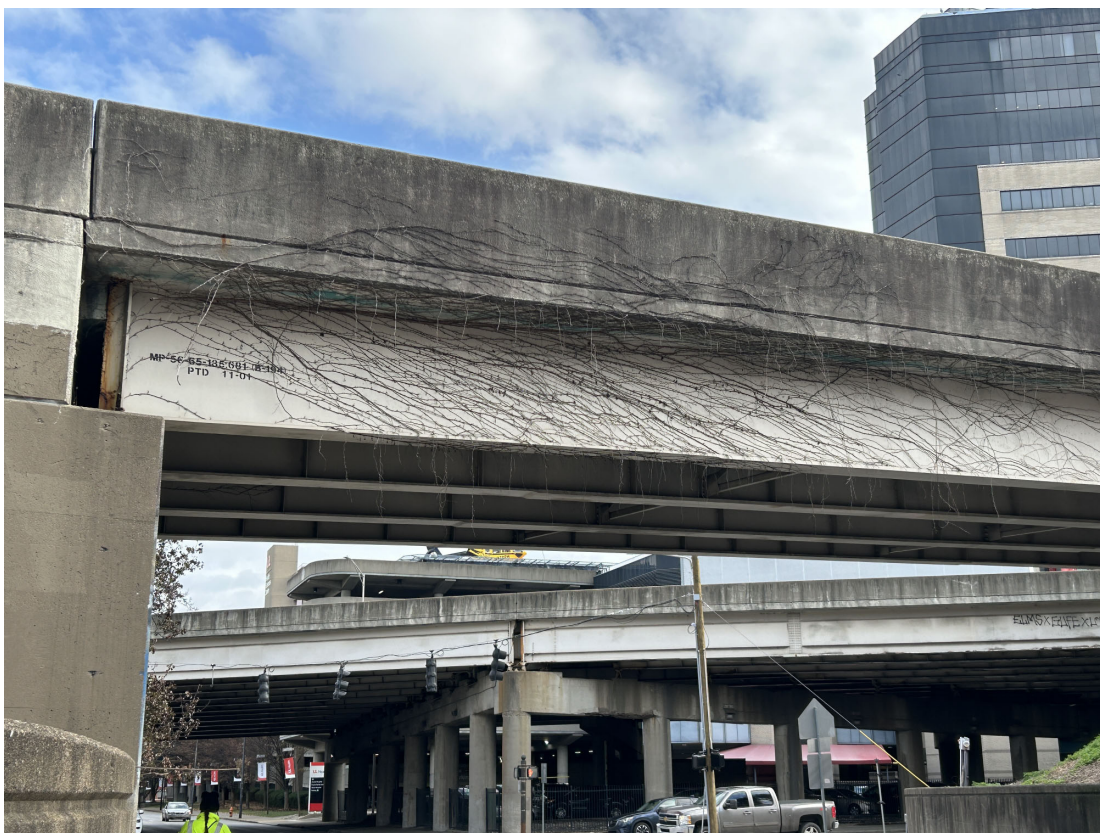
West face of the structure, along with much of Abutment 2, is covered in vines, restricting proper inspection.

Vines are growing along Girder 1.

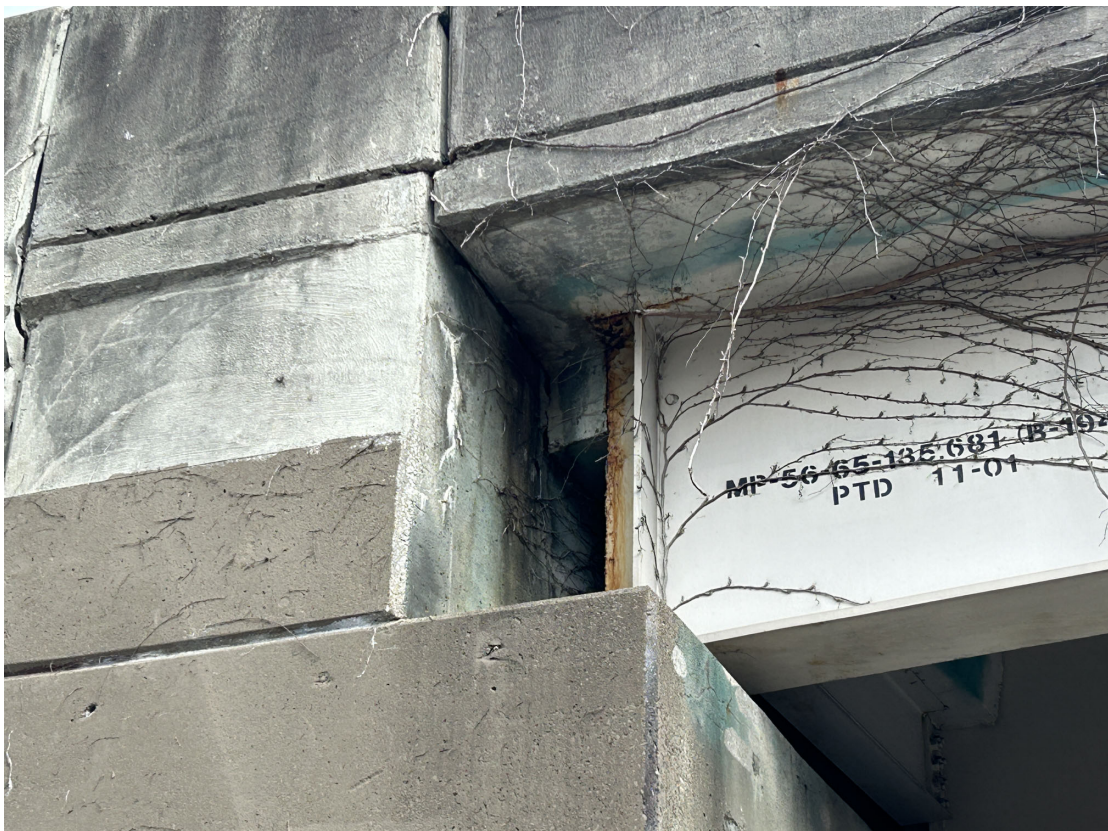
Quantity includes parallel wingwalls at the abutments. Abutments have full height vertical cracks below Beams 2 and 3, plus cracks with efflorescence at the ends of the backwalls. Abutment 1 has dense pattern cracking with efflorescence near the tops of the wingwalls, a 3-foot long by 1-foot high spall in the backwall at the west end/behind Beam 1, and 4 feet of wide horizontal cracking near the top of the breastwall below Bay 1 with rust staining and efflorescence.

Abutment 2 backwall has cracking with efflorescence at the ends. West end shown.
