Bridge Inspection Report

056B00195R

12/17/2024

Standard (24 months)

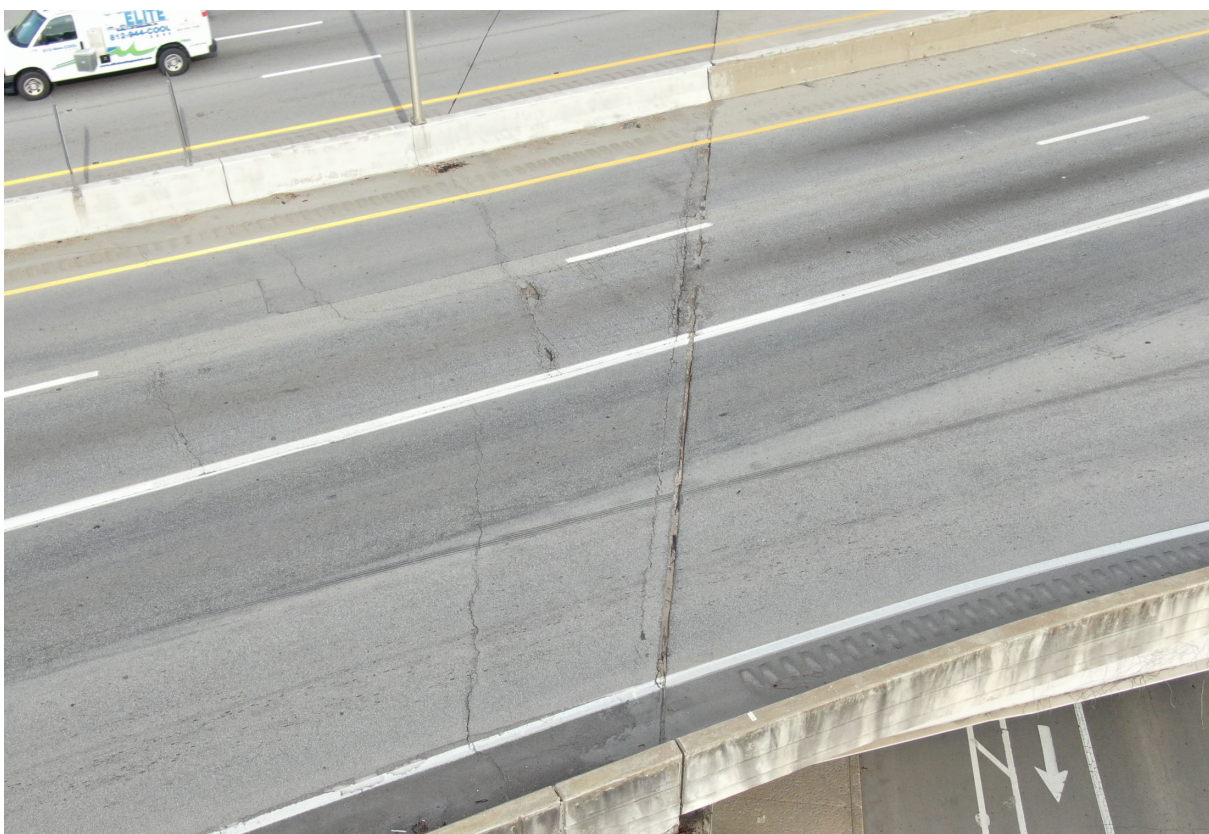
Pourable seal is missing throughout most of joints, exposing original compression seals in places though mostly filled with debris. Adjacent overlay is also cracking and spalling over the armored edges.

Bridge joint over Abutment 1.

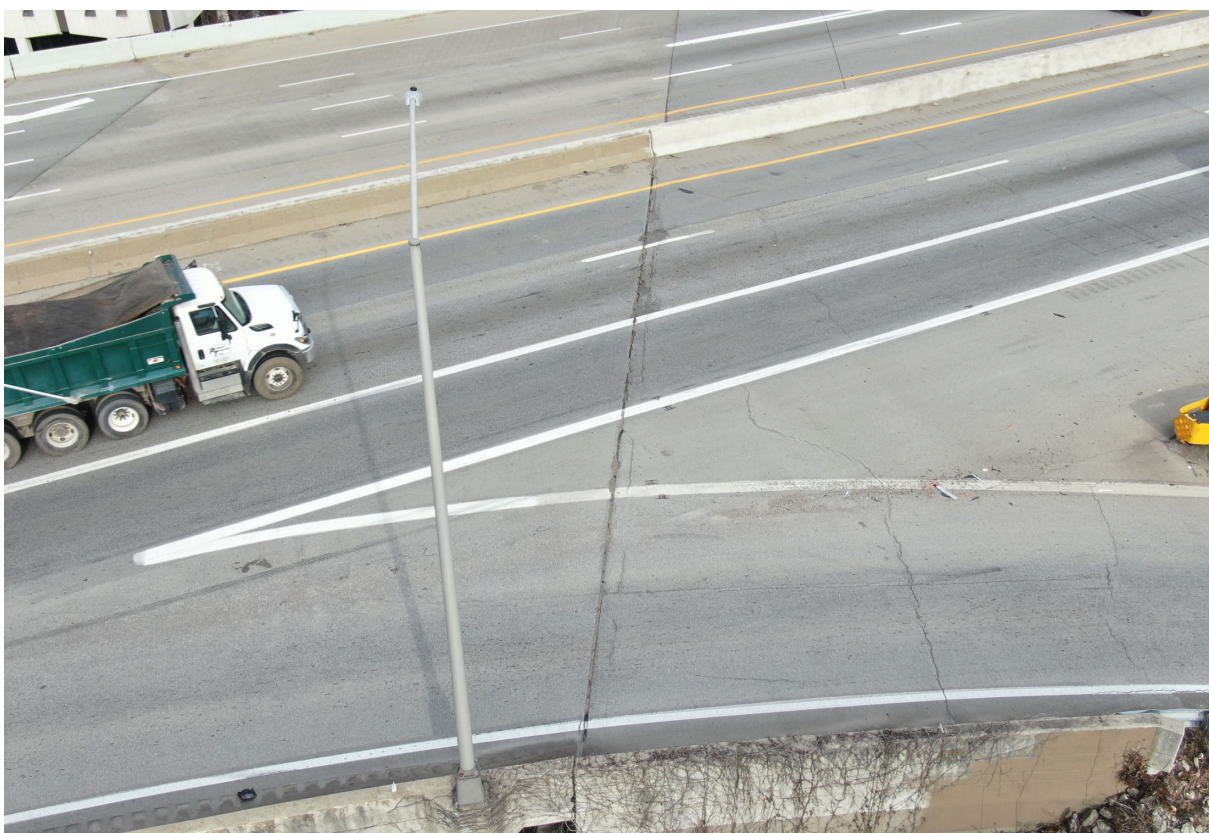
Bridge joint over Abutment 2.

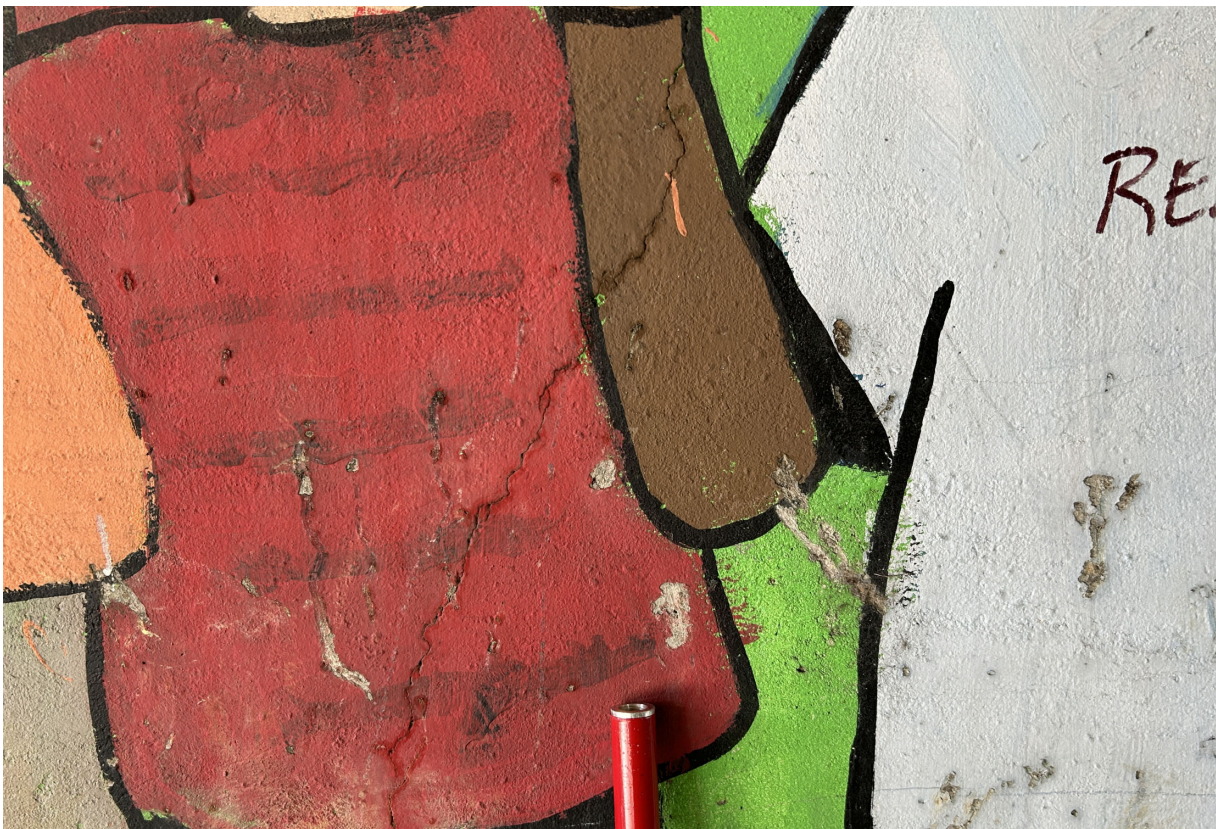
Abutments have moderate to wide full height vertical cracks and spalls. Abutment 1 has a wide horizontal crack below Beam 8. East end of Abutment 1 has cracking and efflorescence below Beam 10 and in the backwall and spalls with exposed rebar at the bottom at the east end. East end of Abutment 2 has a large spall with exposed rebar.

Abutments have moderate to wide full height vertical cracks.

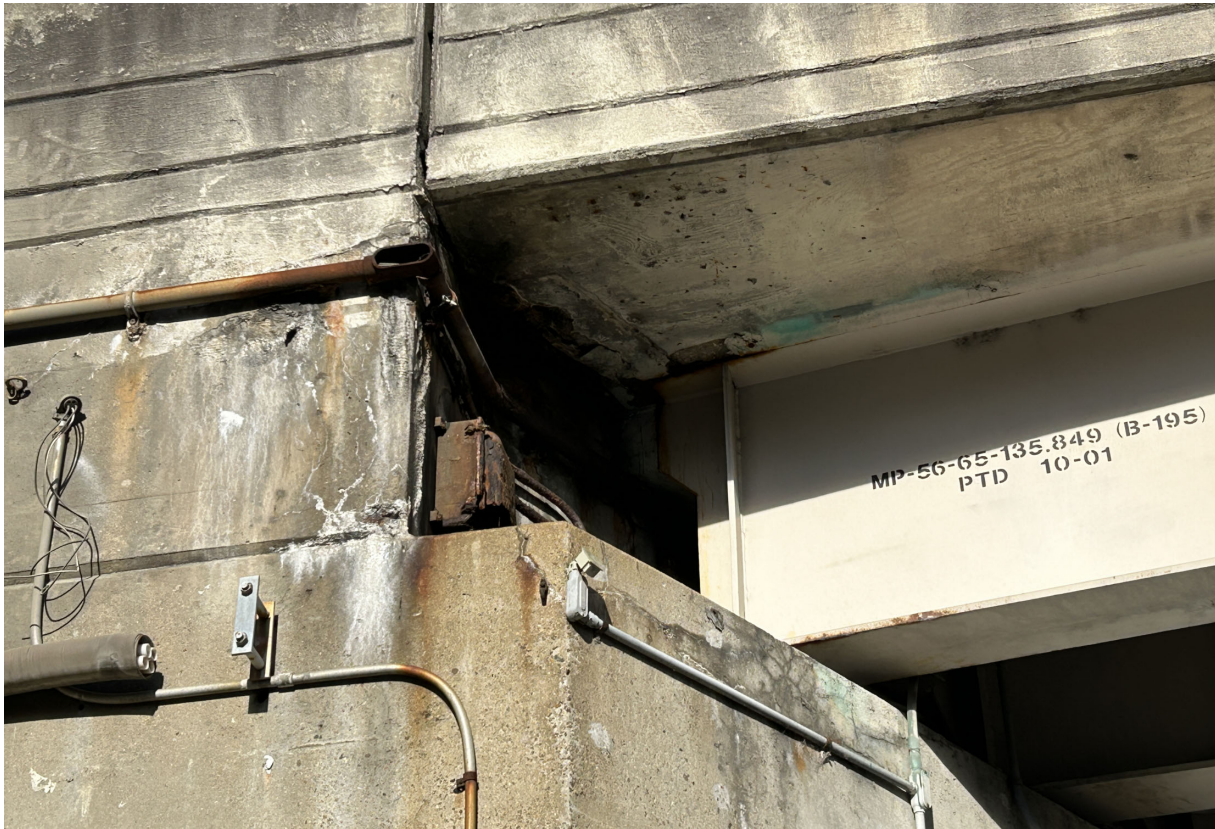
East end of Abutment 1 has cracking and efflorescence below Beam 10 and in the backwall.

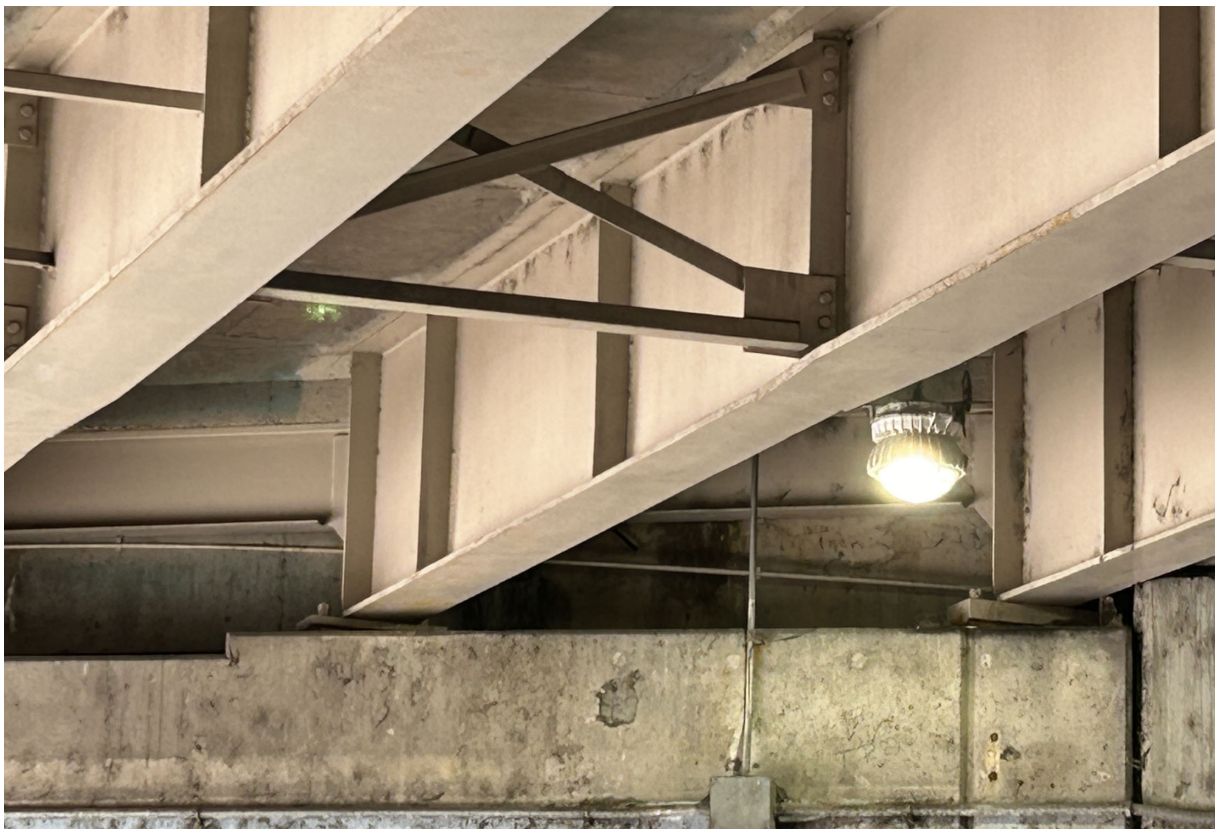
Fixed bearings at Abutment 1 have freckled and surface rust in a few areas, with pack rust between the bearing and masonry plate at Beams 9 and 10.

Typical Abutment 1 bearings.

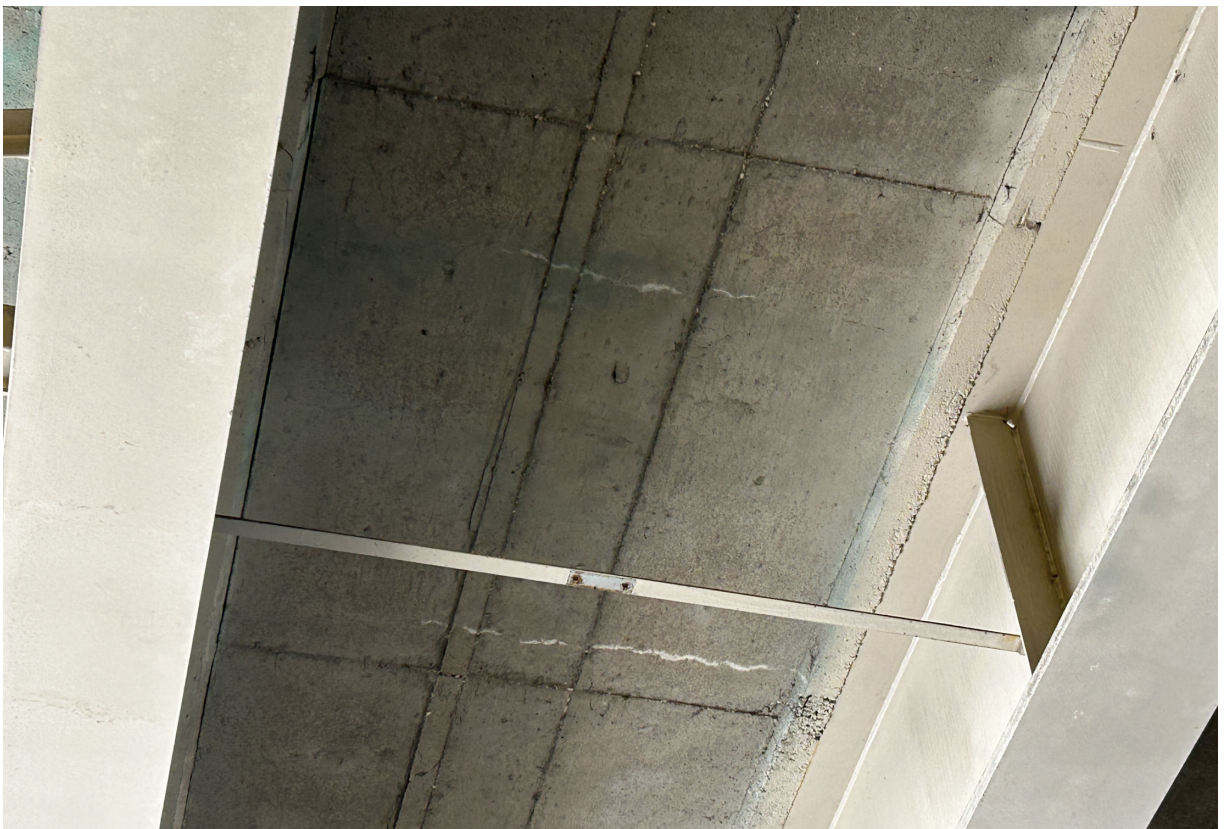
Top of deck cannot be visually inspected due to overlay. Soffit has some transverse cracks with efflorescence, mainly in Bays 7-9. Bay 9 also has large areas of delamination and spalls near mid-span. Bay 1 has some spalling and possible full depth deterioration adjacent to Girder 2.

Soffit has some transverse cracks with efflorescence, mainly in Bays 7-9.

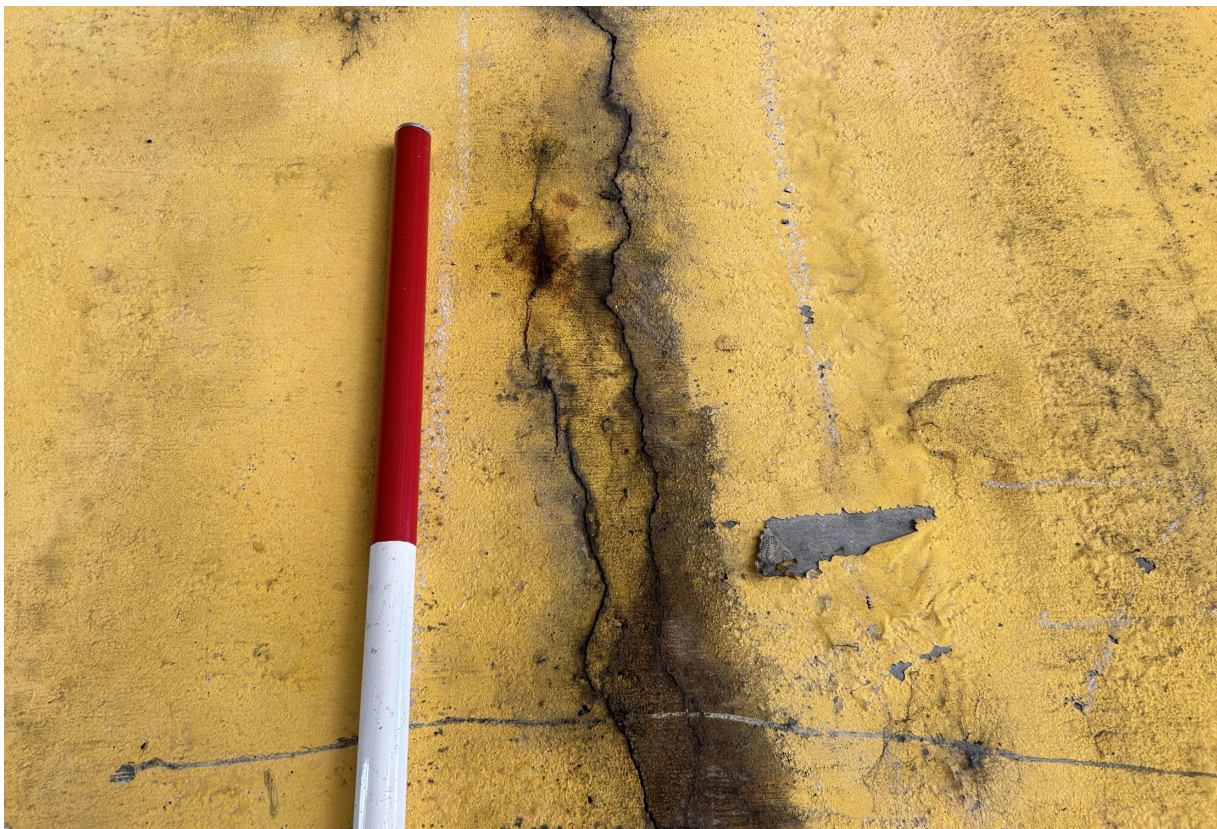
Abutment 2 full height wide vertical crack.

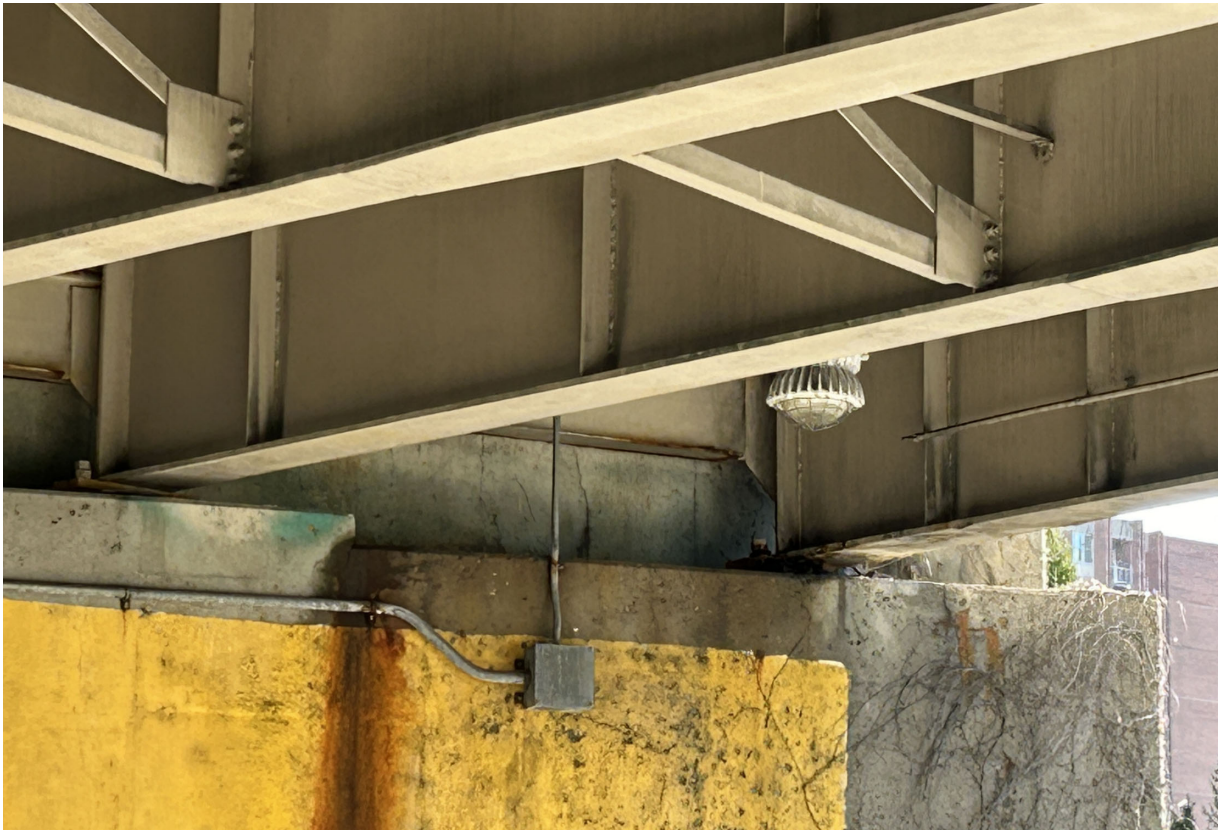
Moveable bearings at Abutment 2 have freckled and surface rust in a few areas, with pack rust between the bearing and masonry plate at Beam 10.

Bearings 9 and 10 at Abutment 2 have pack rust between the bearing and masonry plate.

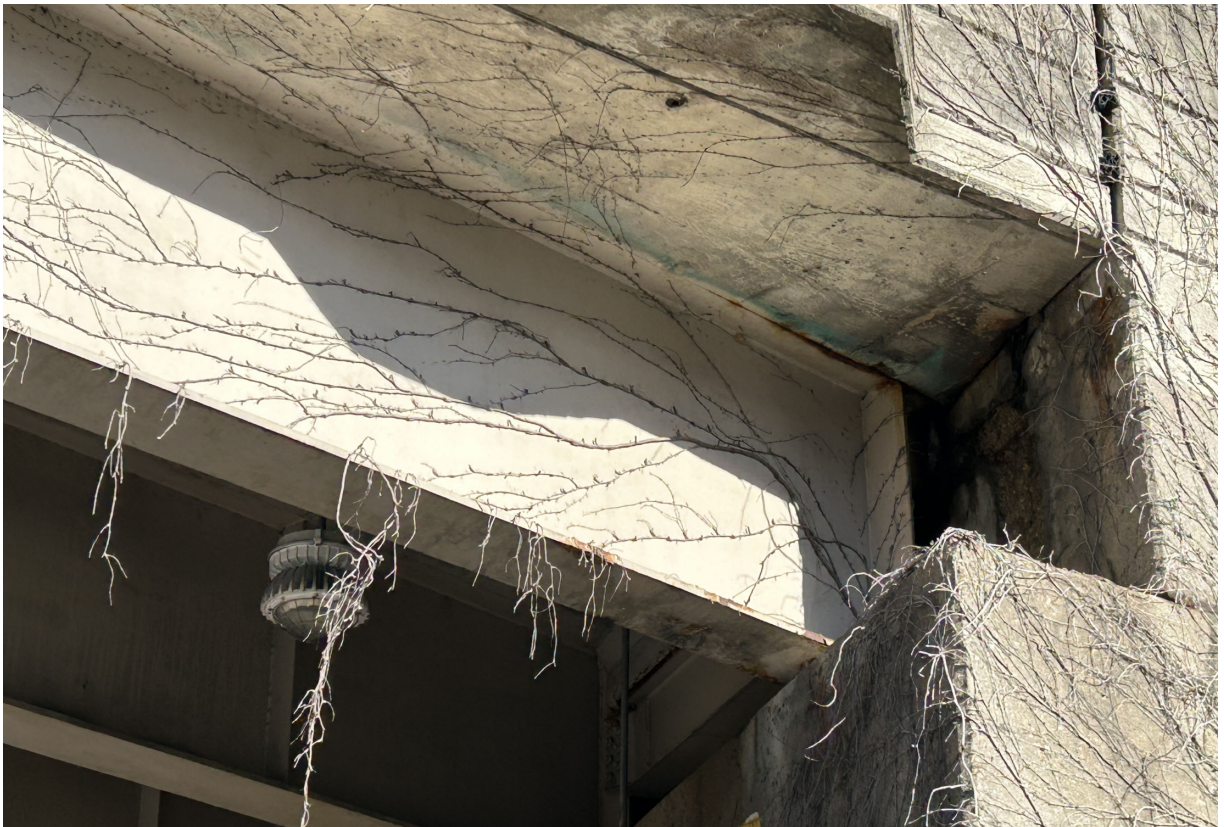
East side of bridge has large portions covered with vines.
